Bathymetric and Velocimetric Surveys at Highway Bridges Crossing the Missouri River near Kansas City, Missouri, June 2–4, 2015

Scientific Investigations Report 2016–5061

By Richard J. Huizinga

Prepared in cooperation with the Missouri Department of Transportation

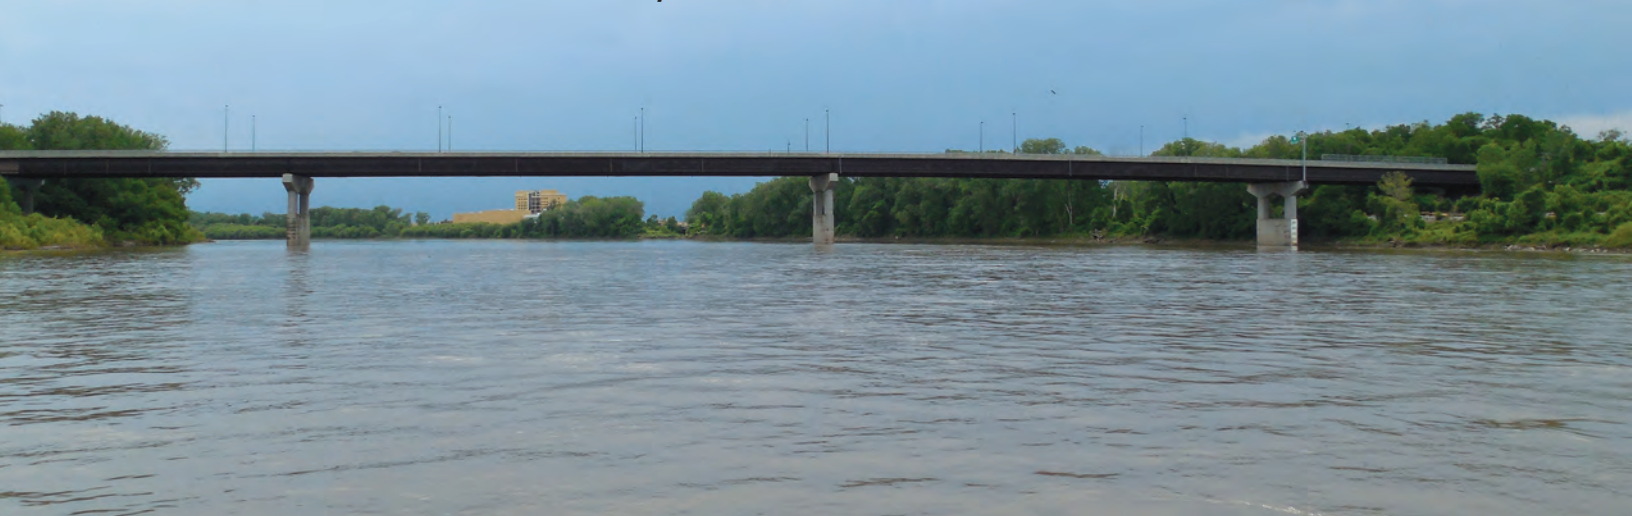
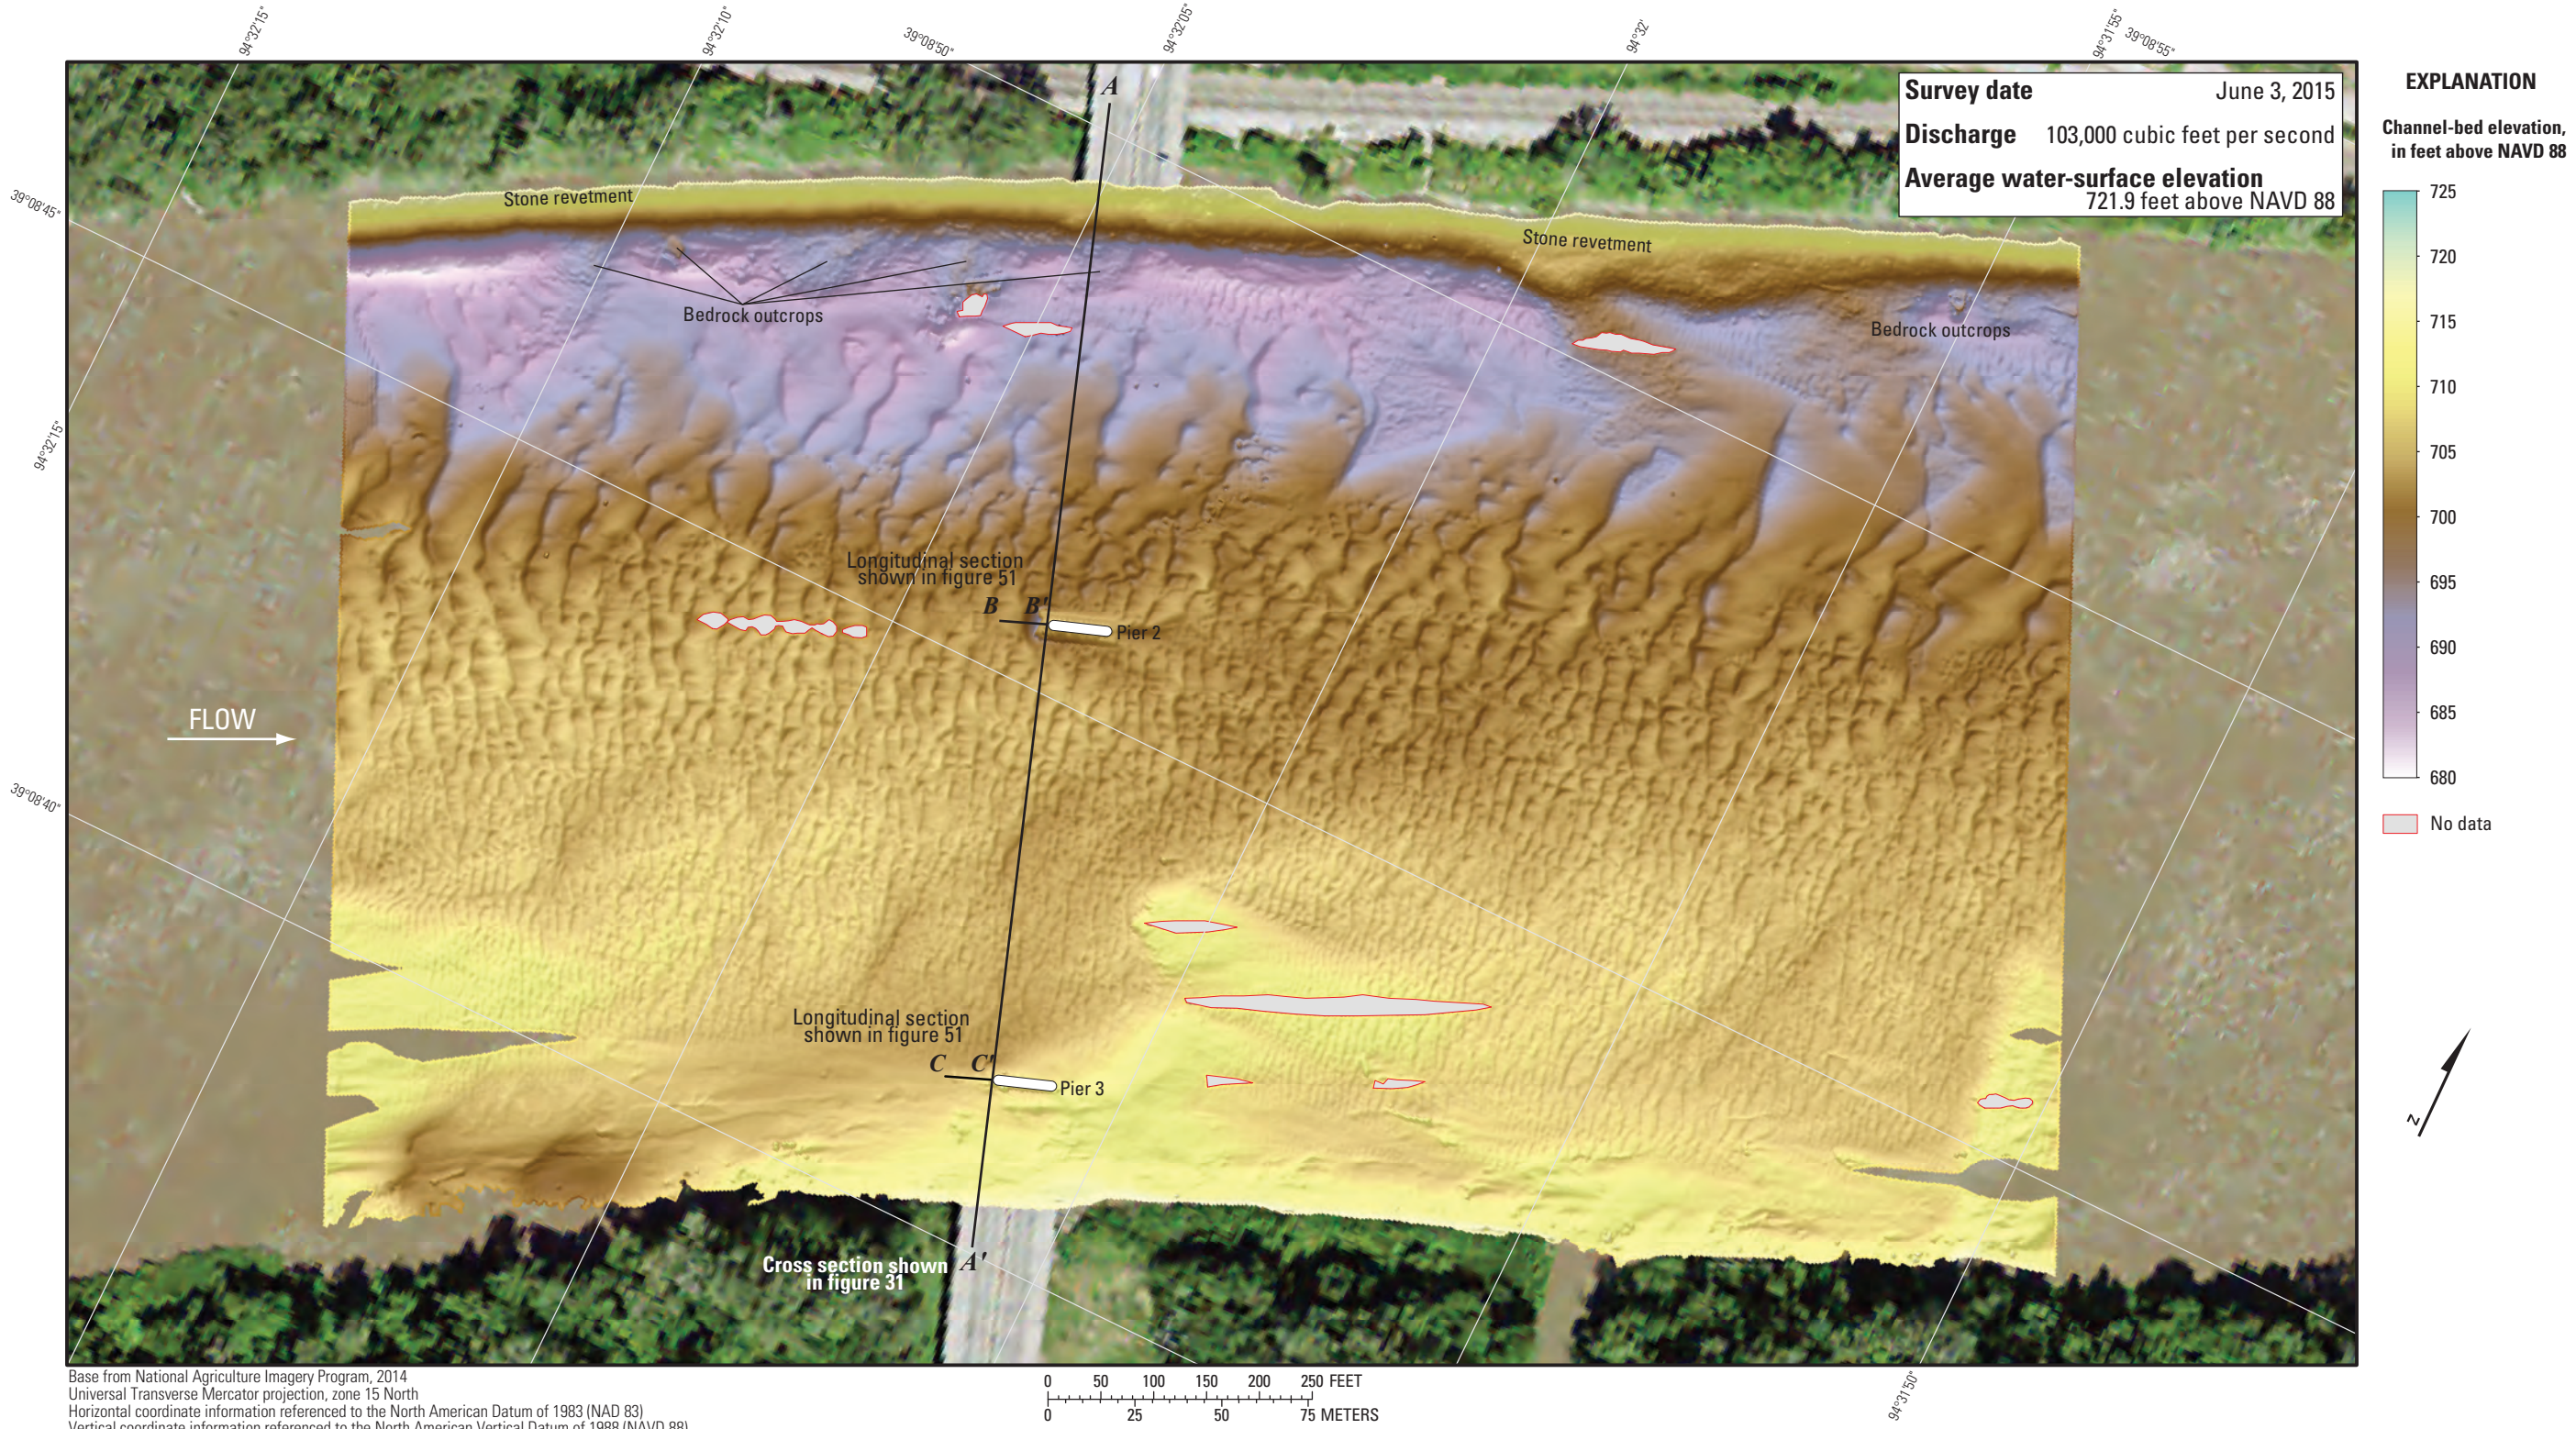
Figure 29. Bathymetric survey of the Missouri River channel near structure A5817 on State Highway 269 in Kansas City, Missouri.

The survey area was about 1,640 ft long and about 970 ft wide, extending from bank to bank in the main channel (fig. 29). Piers 2 and 3 were in the water and away from the banks, and the upstream end of the survey area was about 670 ft upstream from the centerline of structure A5817 at pier 2 (fig. 29). The channel-bed elevations ranged from about 690 to 710 ft for most of the surveyed area (5 to 95 percentile range of the bathymetric data; table 5; fig. 30). A deep thalweg along the left (north) bank throughout the surveyed area contained evidence of bedrock exposure and was about 15 to 20 ft deeper than the channel bed in the middle of the channel (fig. 29). Numerous medium dune features were observed in the channel thalweg, and numerous medium to small dunes and ripples were present throughout the rest of the channel, decreasing in size towards the right (south) bank (fig. 29). In addition to the rock outcrops on the left (north) bank, stone revetment also was present on the left bank throughout the reach (fig. 29).

A minor scour hole near main channel pier 2 (fig. 29) had a minimum channel-bed elevation of about 693 ft (table 6), about 6 ft above the elevation of the bottom of the pier seal course of 687.26 ft (fig. 31; table 6). The top of the pier footing was evident along the length of the pier during the survey (fig. 29). The minor scour hole near pier 3 was difficult to discern from nearby small dunes and ripples (fig. 29). Information from bridge plans indicates that piers 2 and 3 of structure A5817 are founded on shafts drilled 20 ft into bedrock, with about 16 ft of bed material between the bottom of the scour hole and bedrock at pier 2 and about 44 ft of material at pier 3 (fig. 31; table 6).

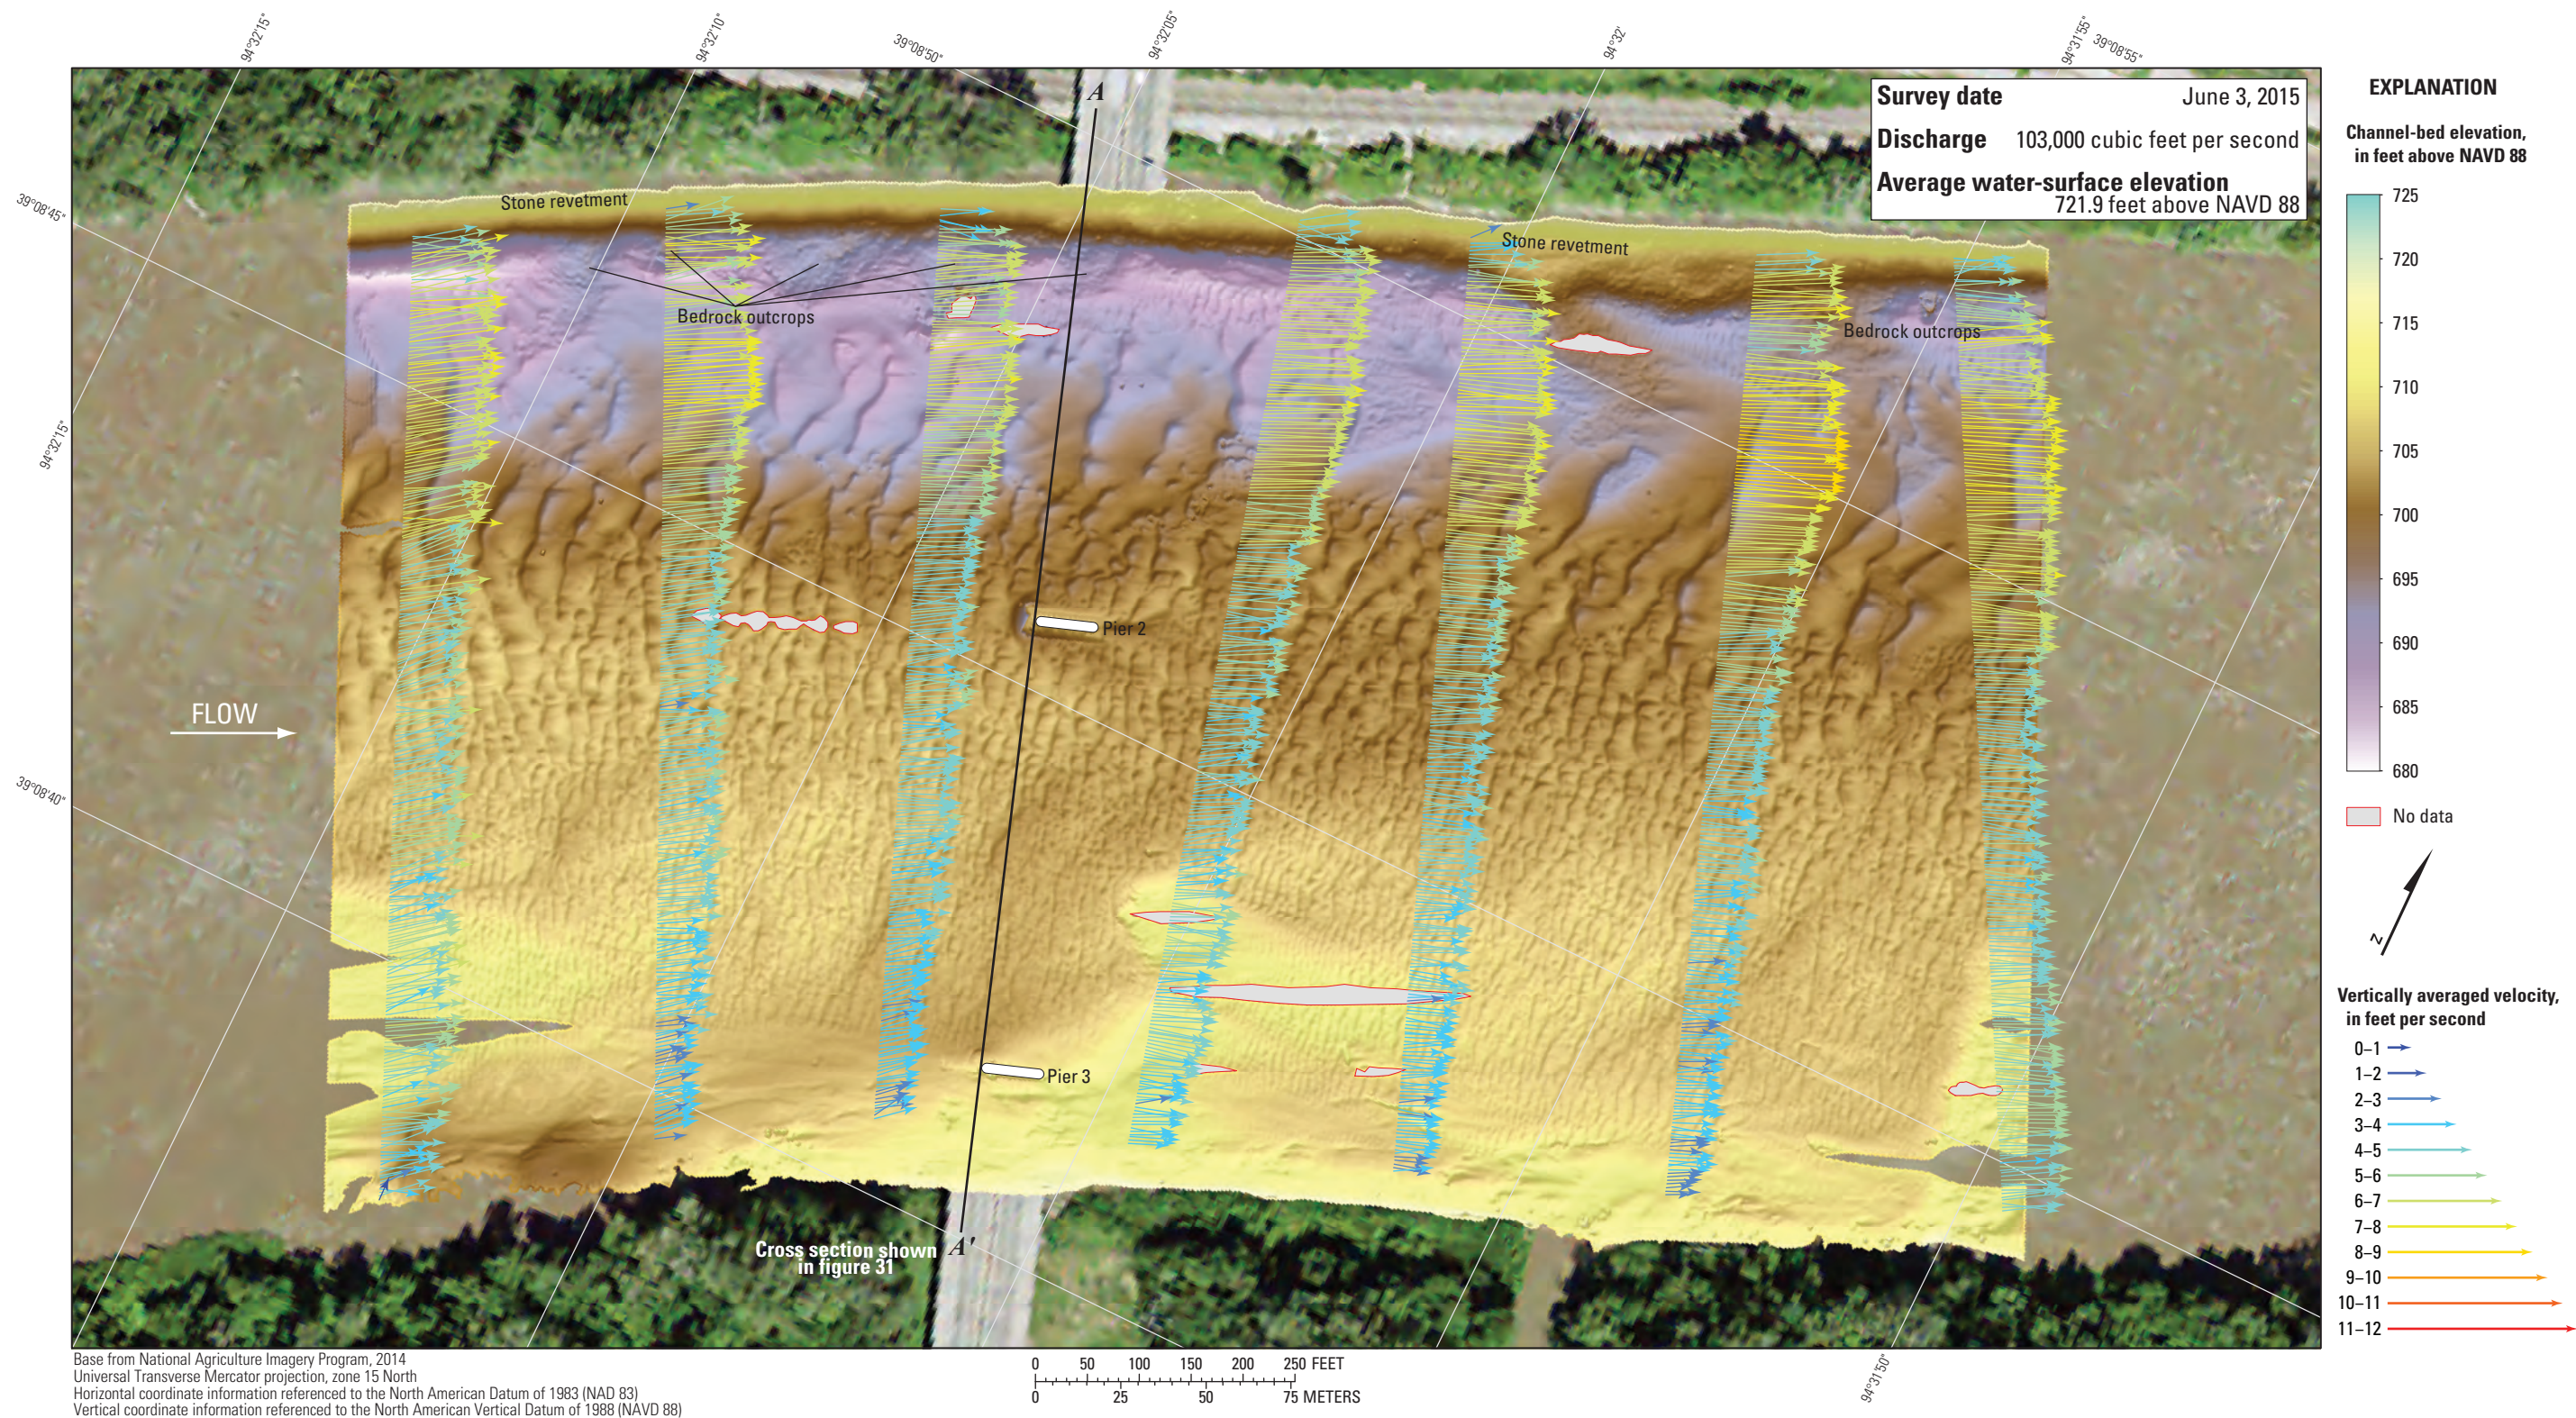
Figure 34. Bathymetry and vertically averaged velocities of the Missouri River channel near structure A5817 on State Highway 269 in Kansas City, Missouri.

along the inside of the bend on the right (south) bank to 9 ft/s in the downstream thalweg (fig. 34). Exceptions to uniform flow include flows angled to the left (north) in the upstream part of the reach because of the bend in the channel (fig. 34). Moderate turbulence also was observed along the thalweg near the bedrock outcrops and along the inside of the bend along the right (south) bank (fig. 34).

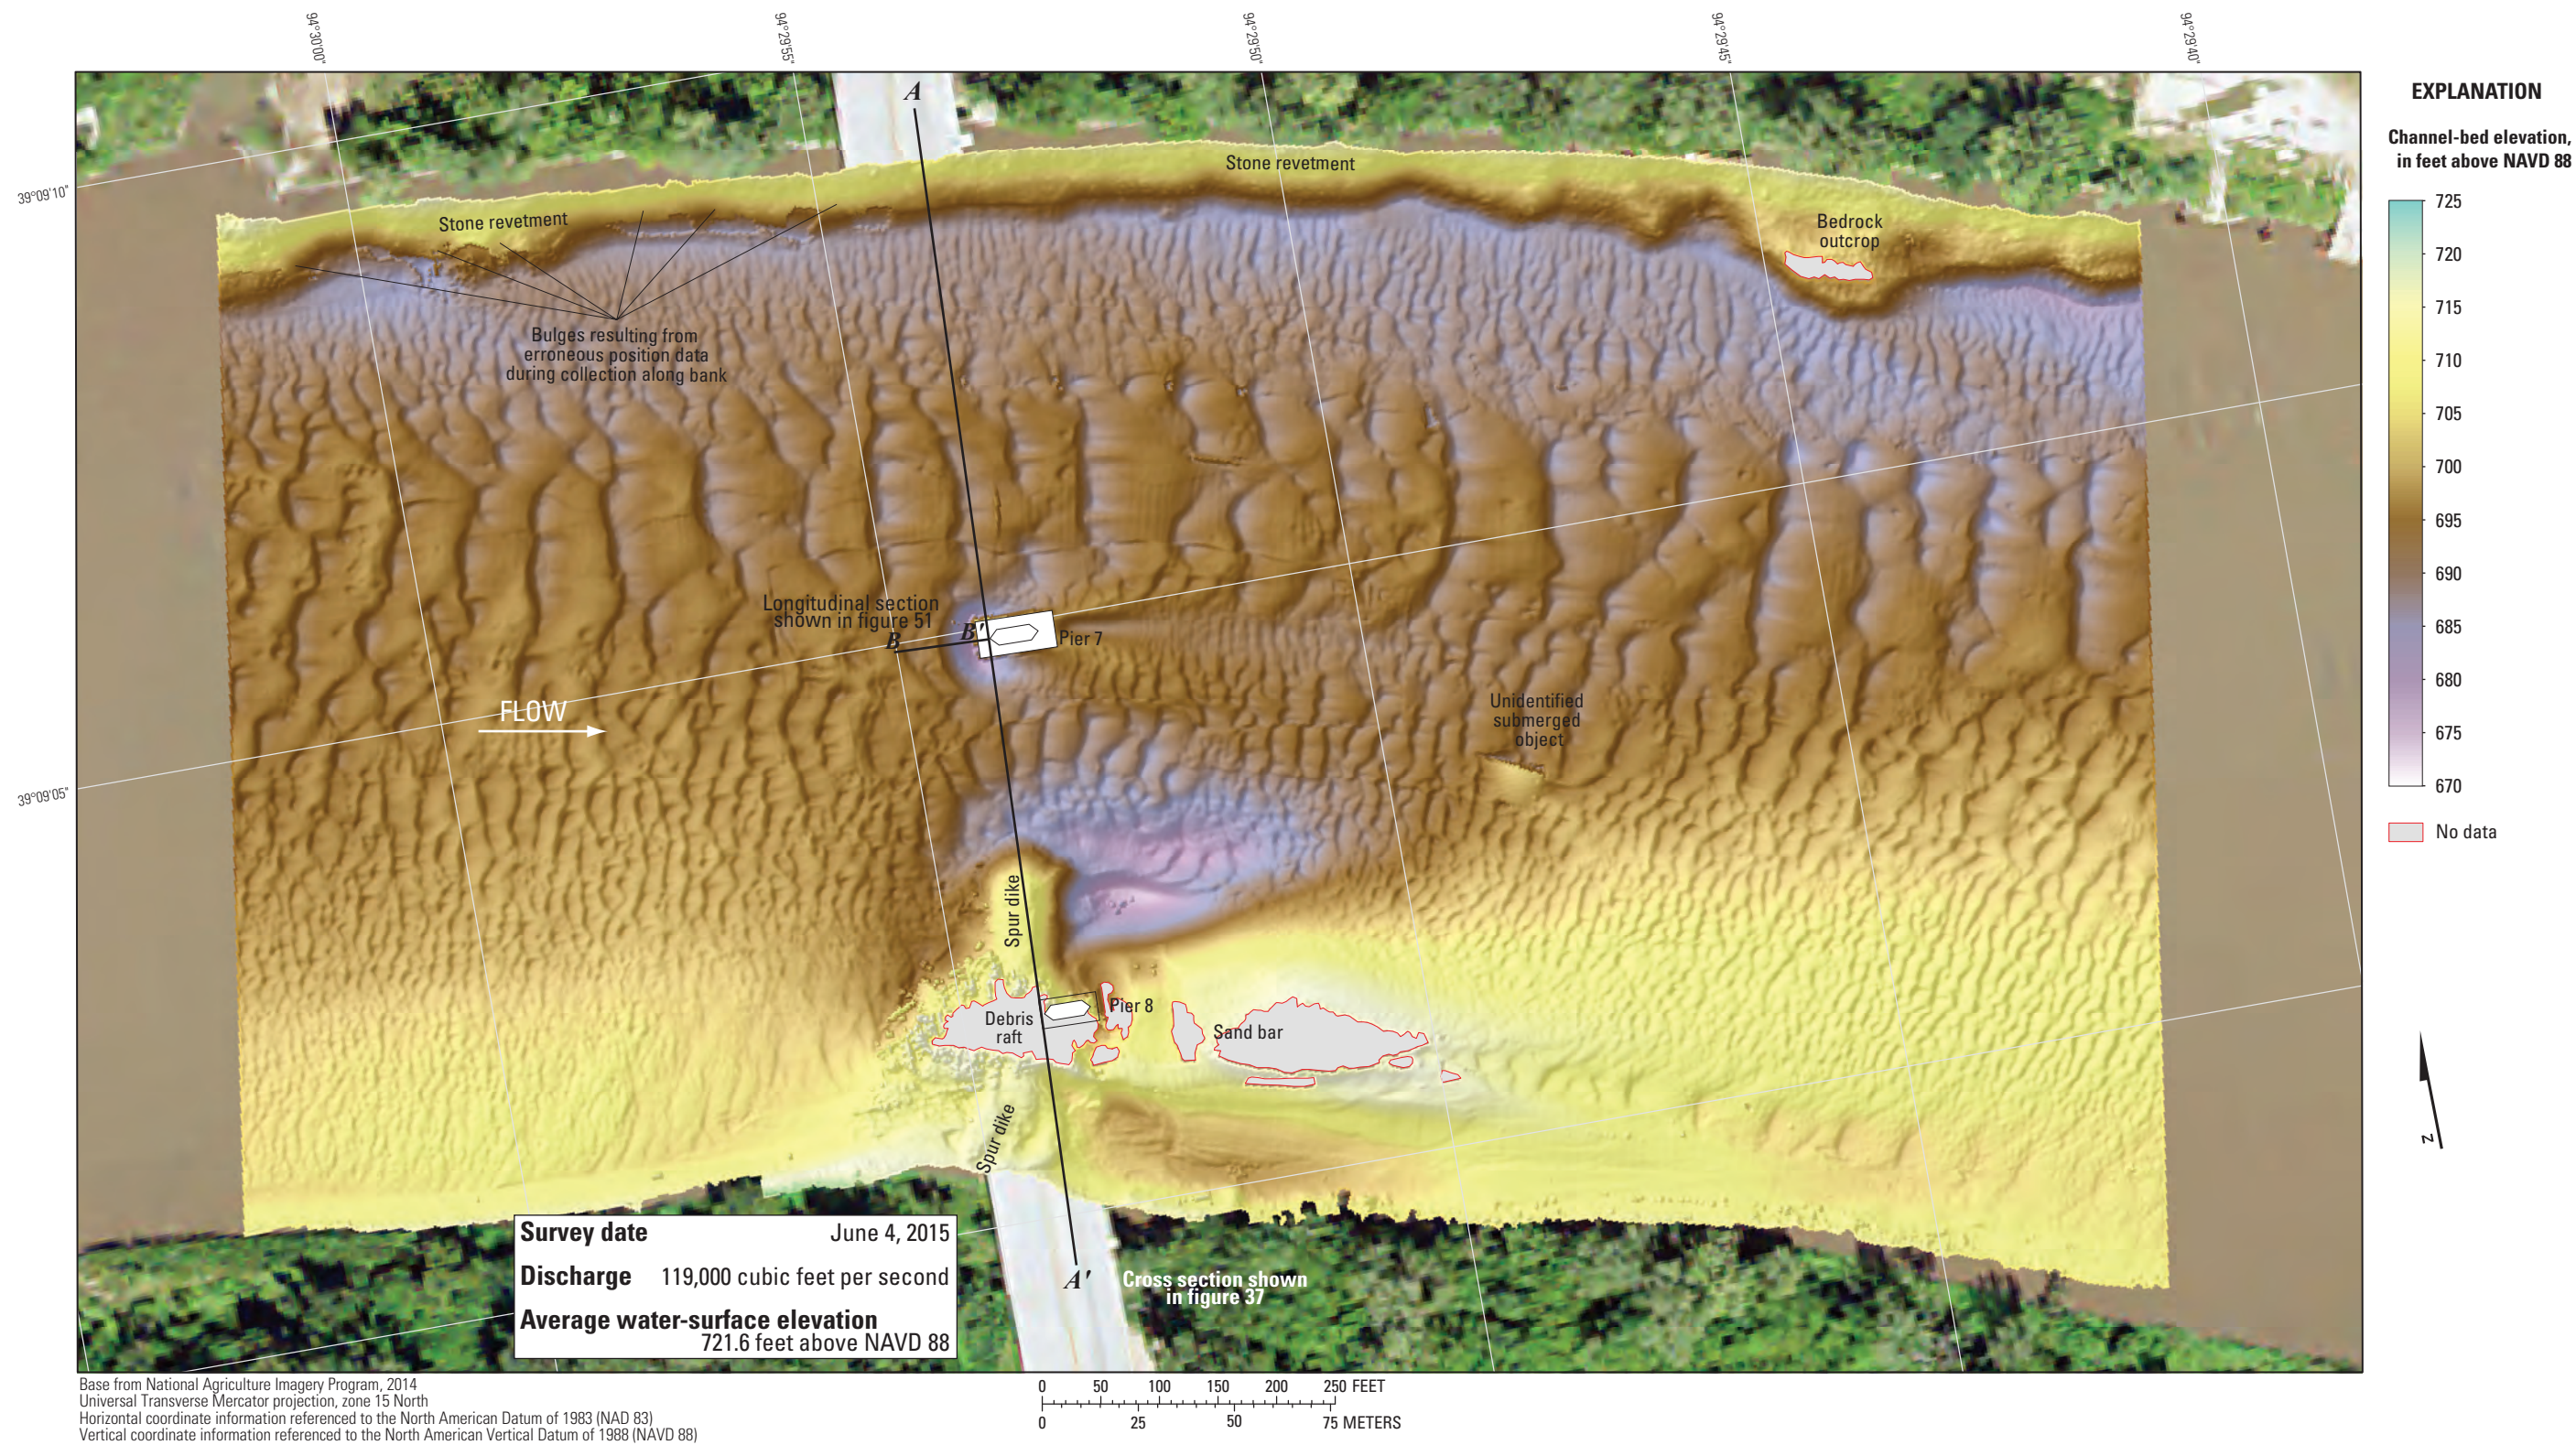
Figure 35. Bathymetric survey of the Missouri River channel near structure A0767 on Interstate 435 in Kansas City, Missouri.

The survey area was about 1,640 ft long and about 890 ft wide, extending from bank to bank in the main channel (fig. 35). Piers 7 and 8 were in the water and away from the banks at structure A0767; however, as in previous surveys (Huizinga, 2010, 2012), pier 8 was immediately downstream from a spur dike and surrounded by a persistent substantial debris raft, and only limited bathymetric data could be obtained near it (fig. 35). A substantial and persistent sand bar also was present downstream from pier 8, as in previous surveys. The upstream end of the survey area was about 660 ft upstream from the centerline of structure A0767 at pier 7 (fig. 35). The channel-bed elevations ranged from about 687 to 710 ft for most of the surveyed area (5 to 95 percentile range of the bathymetric data; table 5; fig. 36), except downstream from the tip of the spur dike and in the downstream reach near the rock outcrop on the left (north) bank (fig. 35). The channel thalweg was along the left (north) bank throughout the surveyed area, and became deeper in the downstream direction. The channel was filled with numerous medium dune features in the middle of the channel and numerous small dunes and ripples throughout the rest of the channel, decreasing in size towards the banks (fig. 35). Bedrock outcrops and stone revetment were present on the left (north) bank throughout the reach (fig. 35). Erroneous positioning during data collection created an offset of the data along the upstream left (north) bank between survey

The scour hole near main channel pier 7 (fig. 35) had a minimum channel-bed elevation of about 679 ft (table 6), about 10 ft below the elevation of the bottom of the pier seal course of 689.26 ft (fig. 37; table 6). The upstream end of pier 8 was embedded in the rock spur dike and could not be surveyed because of the persistent substantial debris raft (fig. 35). The top of the footing on the downstream end of the pier was visible (fig. 35), but the minimum channel elevation was 694 ft, about 5 ft higher than the bottom of the seal course elevation of 689.26 ft (fig. 35; table 6). Information from bridge plans indicates that piers 7 and 8 are founded on shafts drilled 20 ft into bedrock, with about 19 ft of bed material between the bottom of the scour hole and bedrock at pier 7 and about 46 ft of material at pier 8 (fig. 37; table 6). The undermined seal course and upstream-most drilled shaft are evident in a shaded TIN image of the right (south) side of pier 7 (fig. 38).

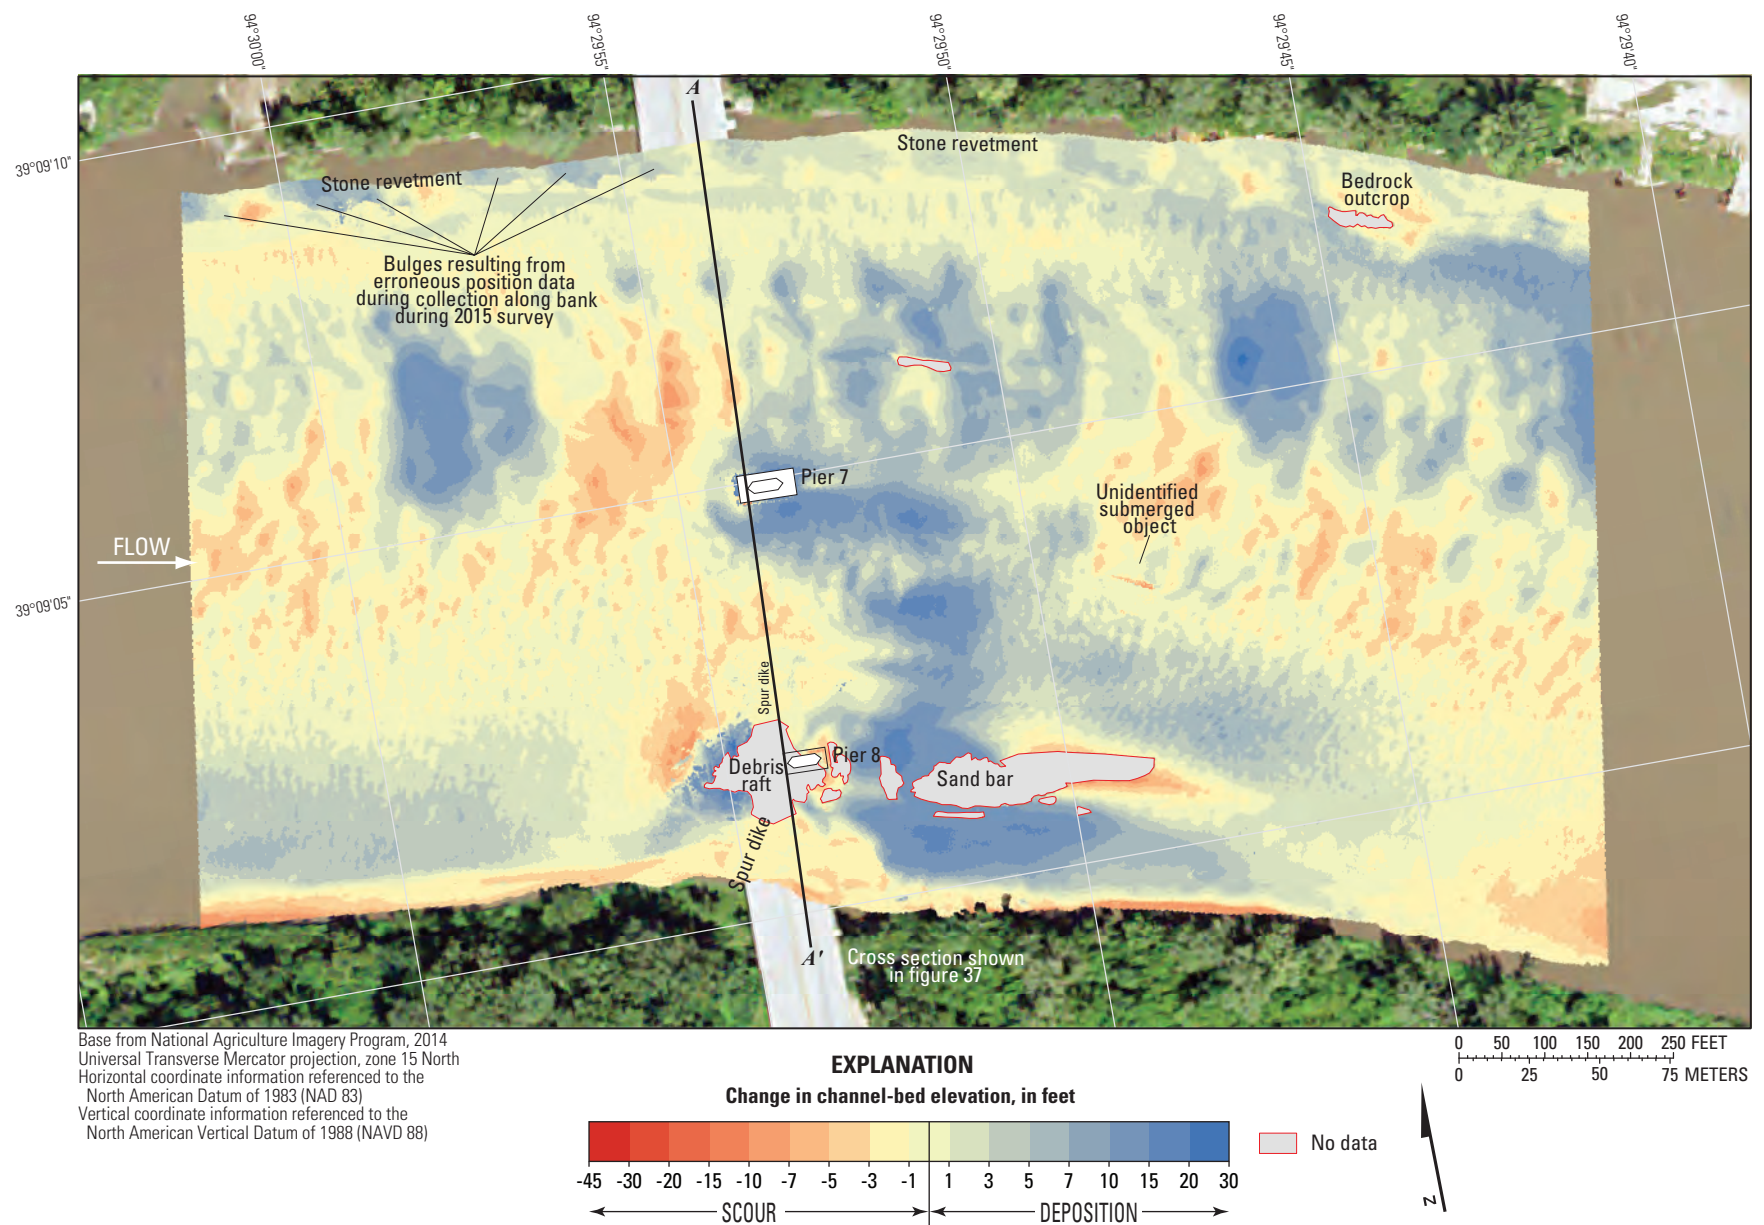
Figure 39. Difference between surfaces created from bathymetric surveys of the Missouri River channel near structure A0767 on Interstate 435 in Kansas City, Missouri, on June 4, 2015, and July 18, 2011.

The difference between the survey on June 4, 2015, and the previous survey on July 18, 2011 (fig. 39), indicates moderate deposition throughout the reach from 2011 to 2015, with an average difference of +1.59 ft between the bathymetric surfaces (table 7). The net volume of cut in the reach from 2011 to 2015 was about 40,000 yd³, and the net volume of fill was about 123,900 yd³, resulting in a net gain of about 83,900 yd³ of sediment between 2011 and 2015. There were a few areas of substantial deposition of more than 20 ft downstream from pier 7 and the spur dike near pier 8 in 2015, and in the troughs of large and very large dunes detected in the 2011 survey on the left (north) side of the channel (fig. 39). The cross sections from the two surveys were similar to each other, with the 2015 survey alternating being above and below the 2011 survey section (fig. 37). The frequency distribution of bed elevations was of a similar shape but narrower in 2015

compared to 2011 and had a higher minimum channel-bed elevation and slightly different distribution of survey-grid cells at a given elevation than in 2011 (fig. 36). The scour hole near pier 7 was shallower and smaller in 2015 than in 2011, as evidenced by the horseshoe-shaped area of deposition around it (figs. 37 and 39). The positional offset of data along the upstream stone revetment on the left (north) bank creates the appearance of substantial deposition in 2015; additional areas of localized shifting evidenced by areas of deposition and scour along the downstream left bank may also be the result of erroneous position data between the 2011 and 2015 surveys (fig. 39).

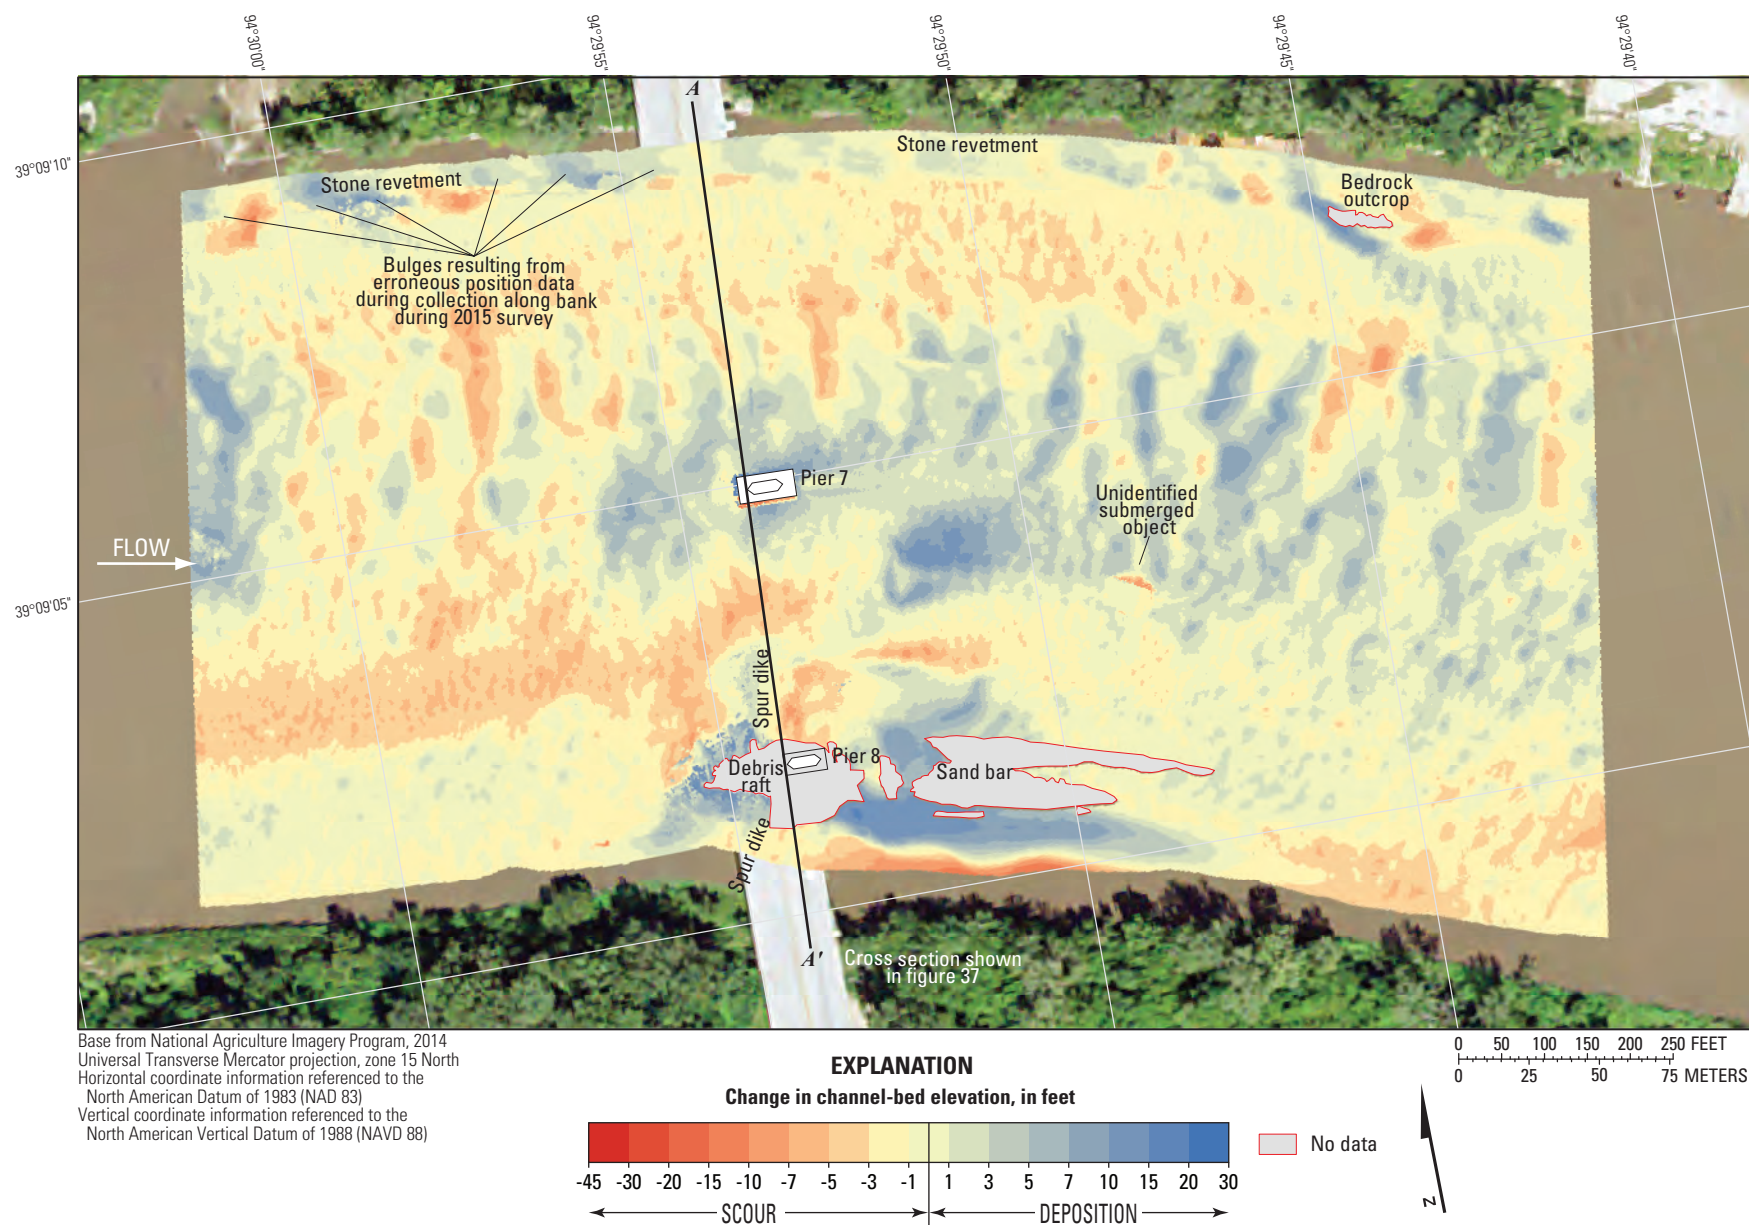
Figure 40. Difference between surfaces created from bathymetric surveys of the Missouri River channel near structure A0767 on Interstate 435 in Kansas City, Missouri, on June 4, 2015, and March 17, 2010.

The difference between the survey on June 4, 2015, and the previous nonflood survey on March 17, 2010 (fig. 40), indicates minor degradation throughout the reach from 2010 to 2015, with an average difference of -0.13 ft between the bathymetric surfaces (table 7). The net volume of cut in the reach from 2010 to 2015 was about 61,700 yd³, and the net volume of fill was about 55,000 yd³, resulting in a net loss of about 6,700 yd³ of sediment between 2010 and 2015. There were a few areas of moderate to substantial deposition downstream from pier 7 and the spur dike near pier 8 in 2015

(fig. 40). The cross sections from the two surveys were similar to each other, with the 2015 survey alternating being above and below the 2011 survey section (fig. 37). The frequency distribution of bed elevations was similar in shape in 2015 compared to 2010 (fig. 36). The scour hole near pier 7 was slightly shallower and smaller in 2015 than in 2010, as evidenced by the moderate deposition along the sides and downstream (figs. 37 and 40). The positional offset of data along the upstream stone revetment on the left (north) bank again creates the appearance of substantial deposition in 2015; additional areas of localized shifting evidenced by areas of deposition and scour along the downstream left bank may also be the result of erroneous position data between the 2010 and 2015 surveys (fig. 39). Apparently, something near the left bank adversely affects the INS at this site.

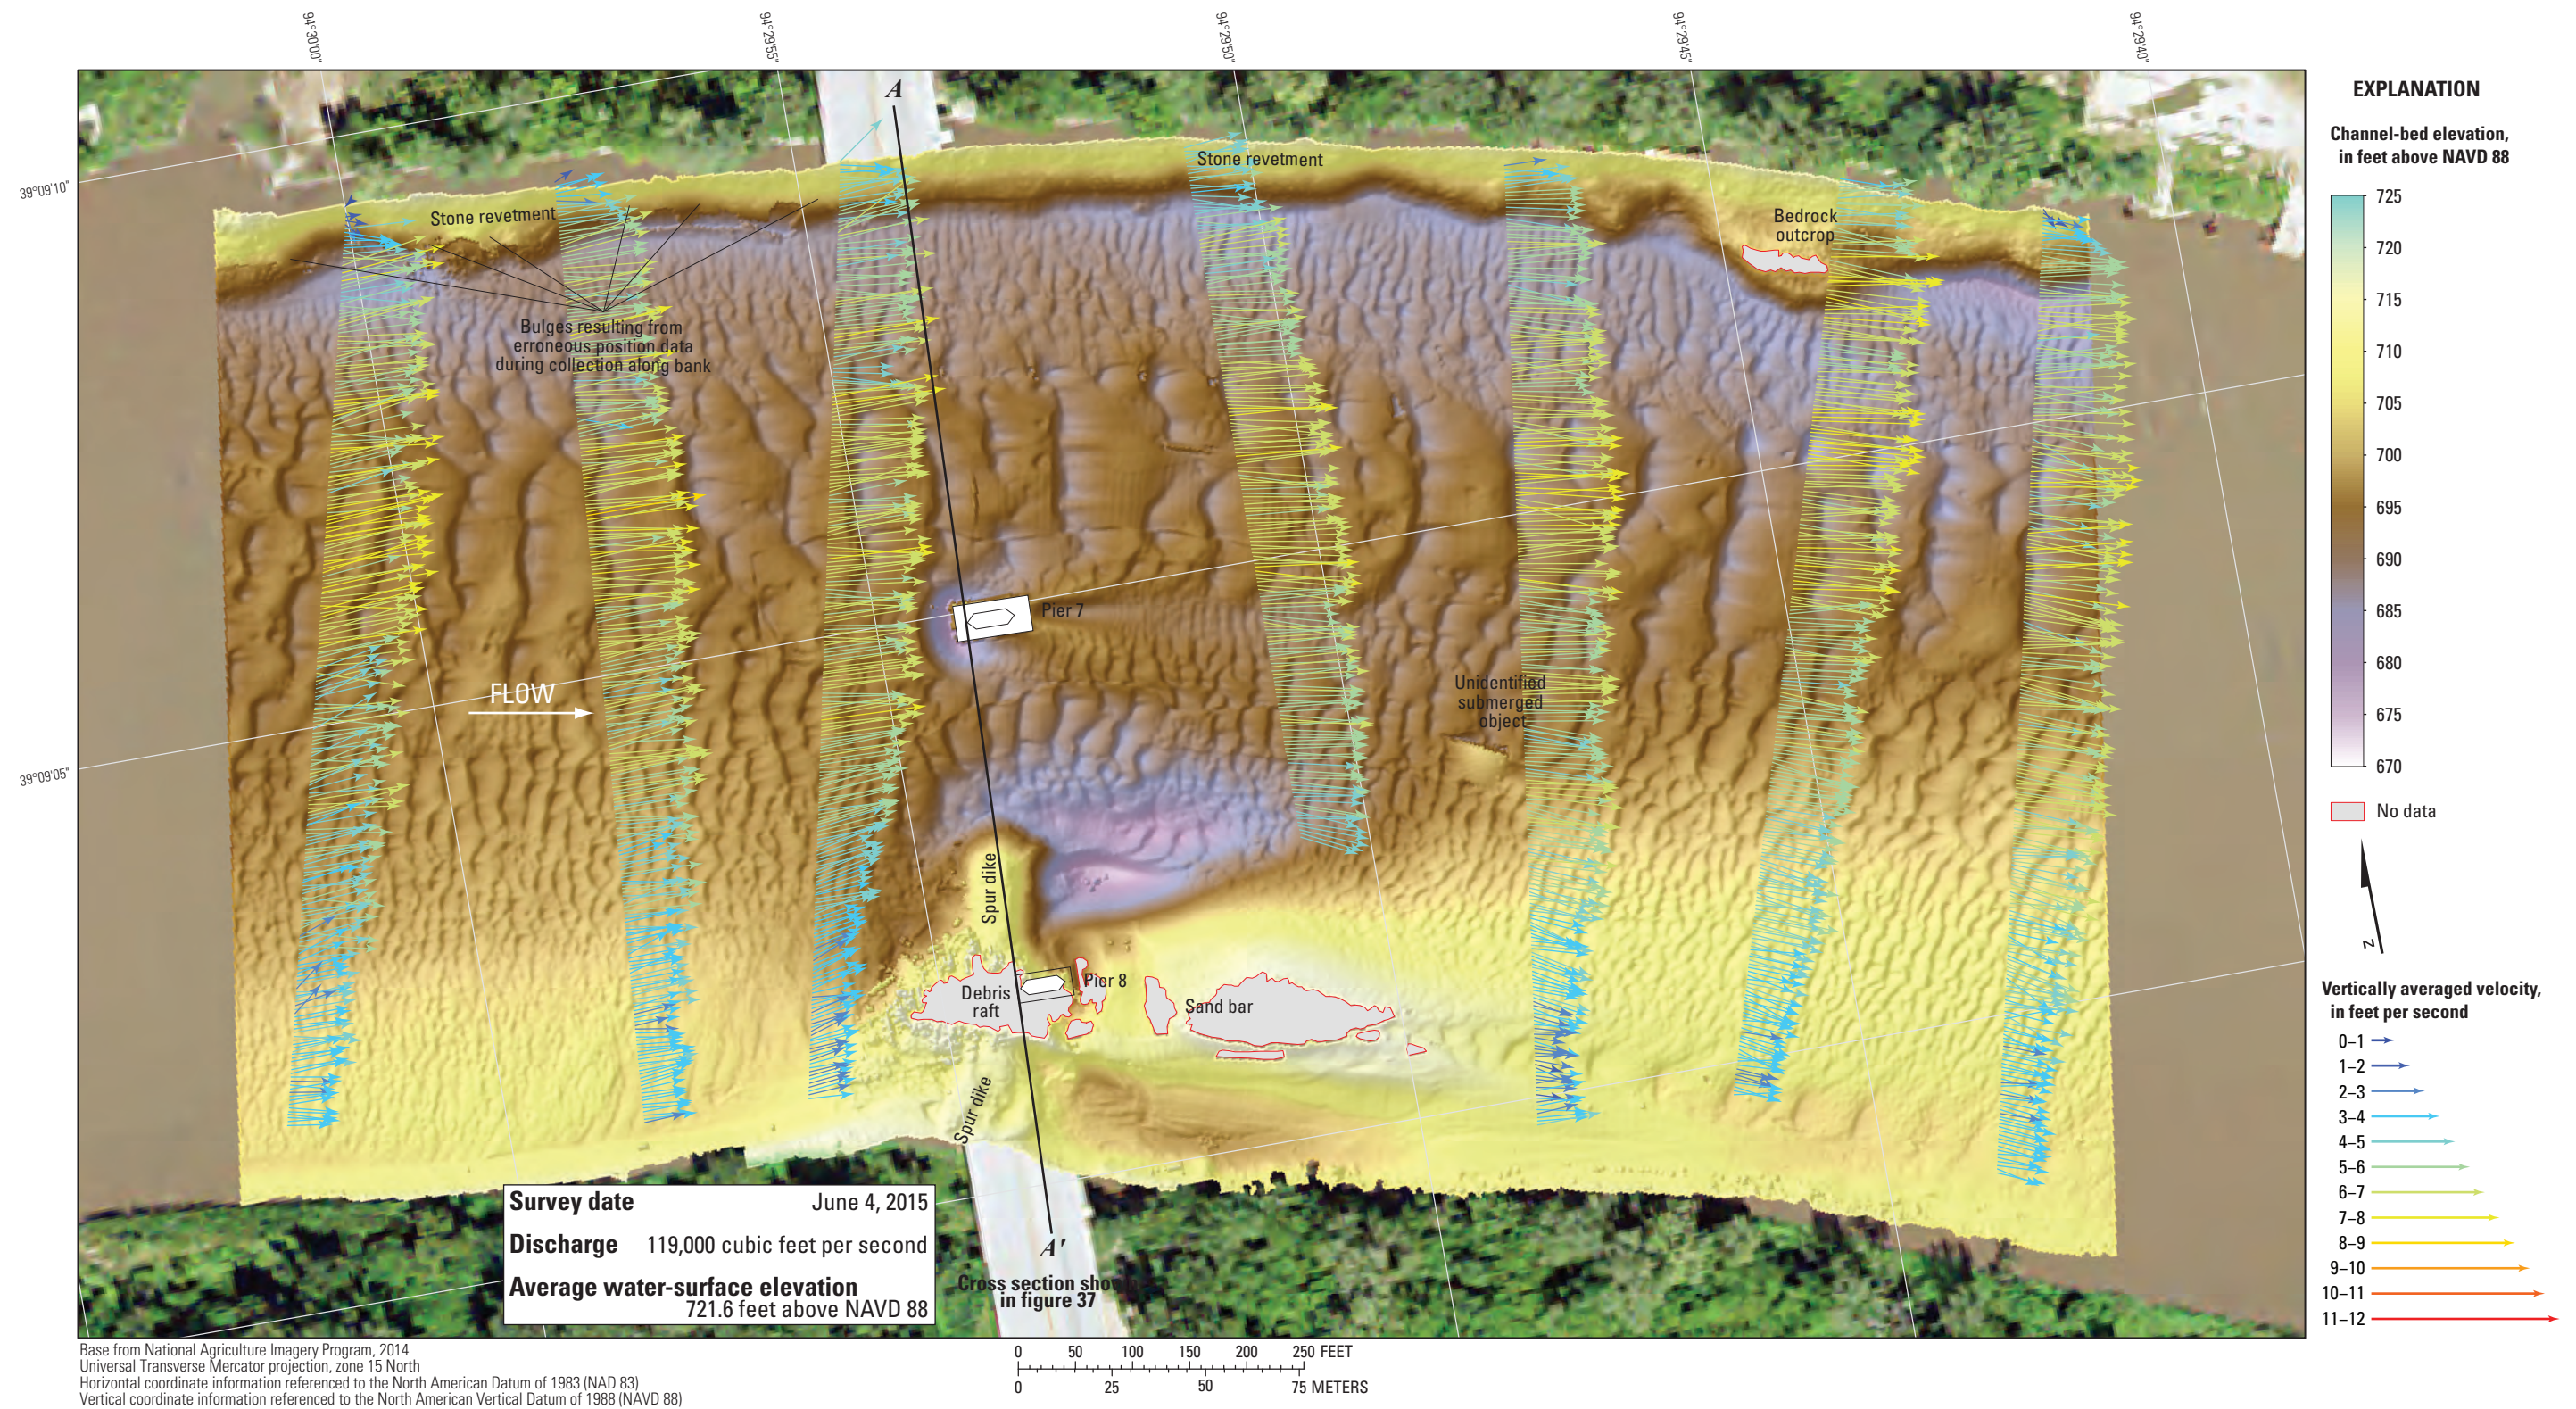
Figure 41. Bathymetry and vertically averaged velocities of the Missouri River channel near structure A0767 on Interstate 435 in Kansas City, Missouri.

The vertically averaged velocity vectors indicate mostly uniform flow throughout the reach, ranging from about 2 ft/s along the inside of the bend on the right (south) bank to 8 ft/s in the thalweg (fig. 41); however, turbulence and velocity reduction were observed downstream from the spur dike, debris raft, and pier 8, and moderate turbulence was observed in several transects (fig. 41).
