Bathymetric and Velocimetric Surveys at Highway Bridges Crossing the Missouri River near Kansas City, Missouri, June 2–4, 2015

Scientific Investigations Report 2016–5061

By Richard J. Huizinga

Prepared in cooperation with the Missouri Department of Transportation

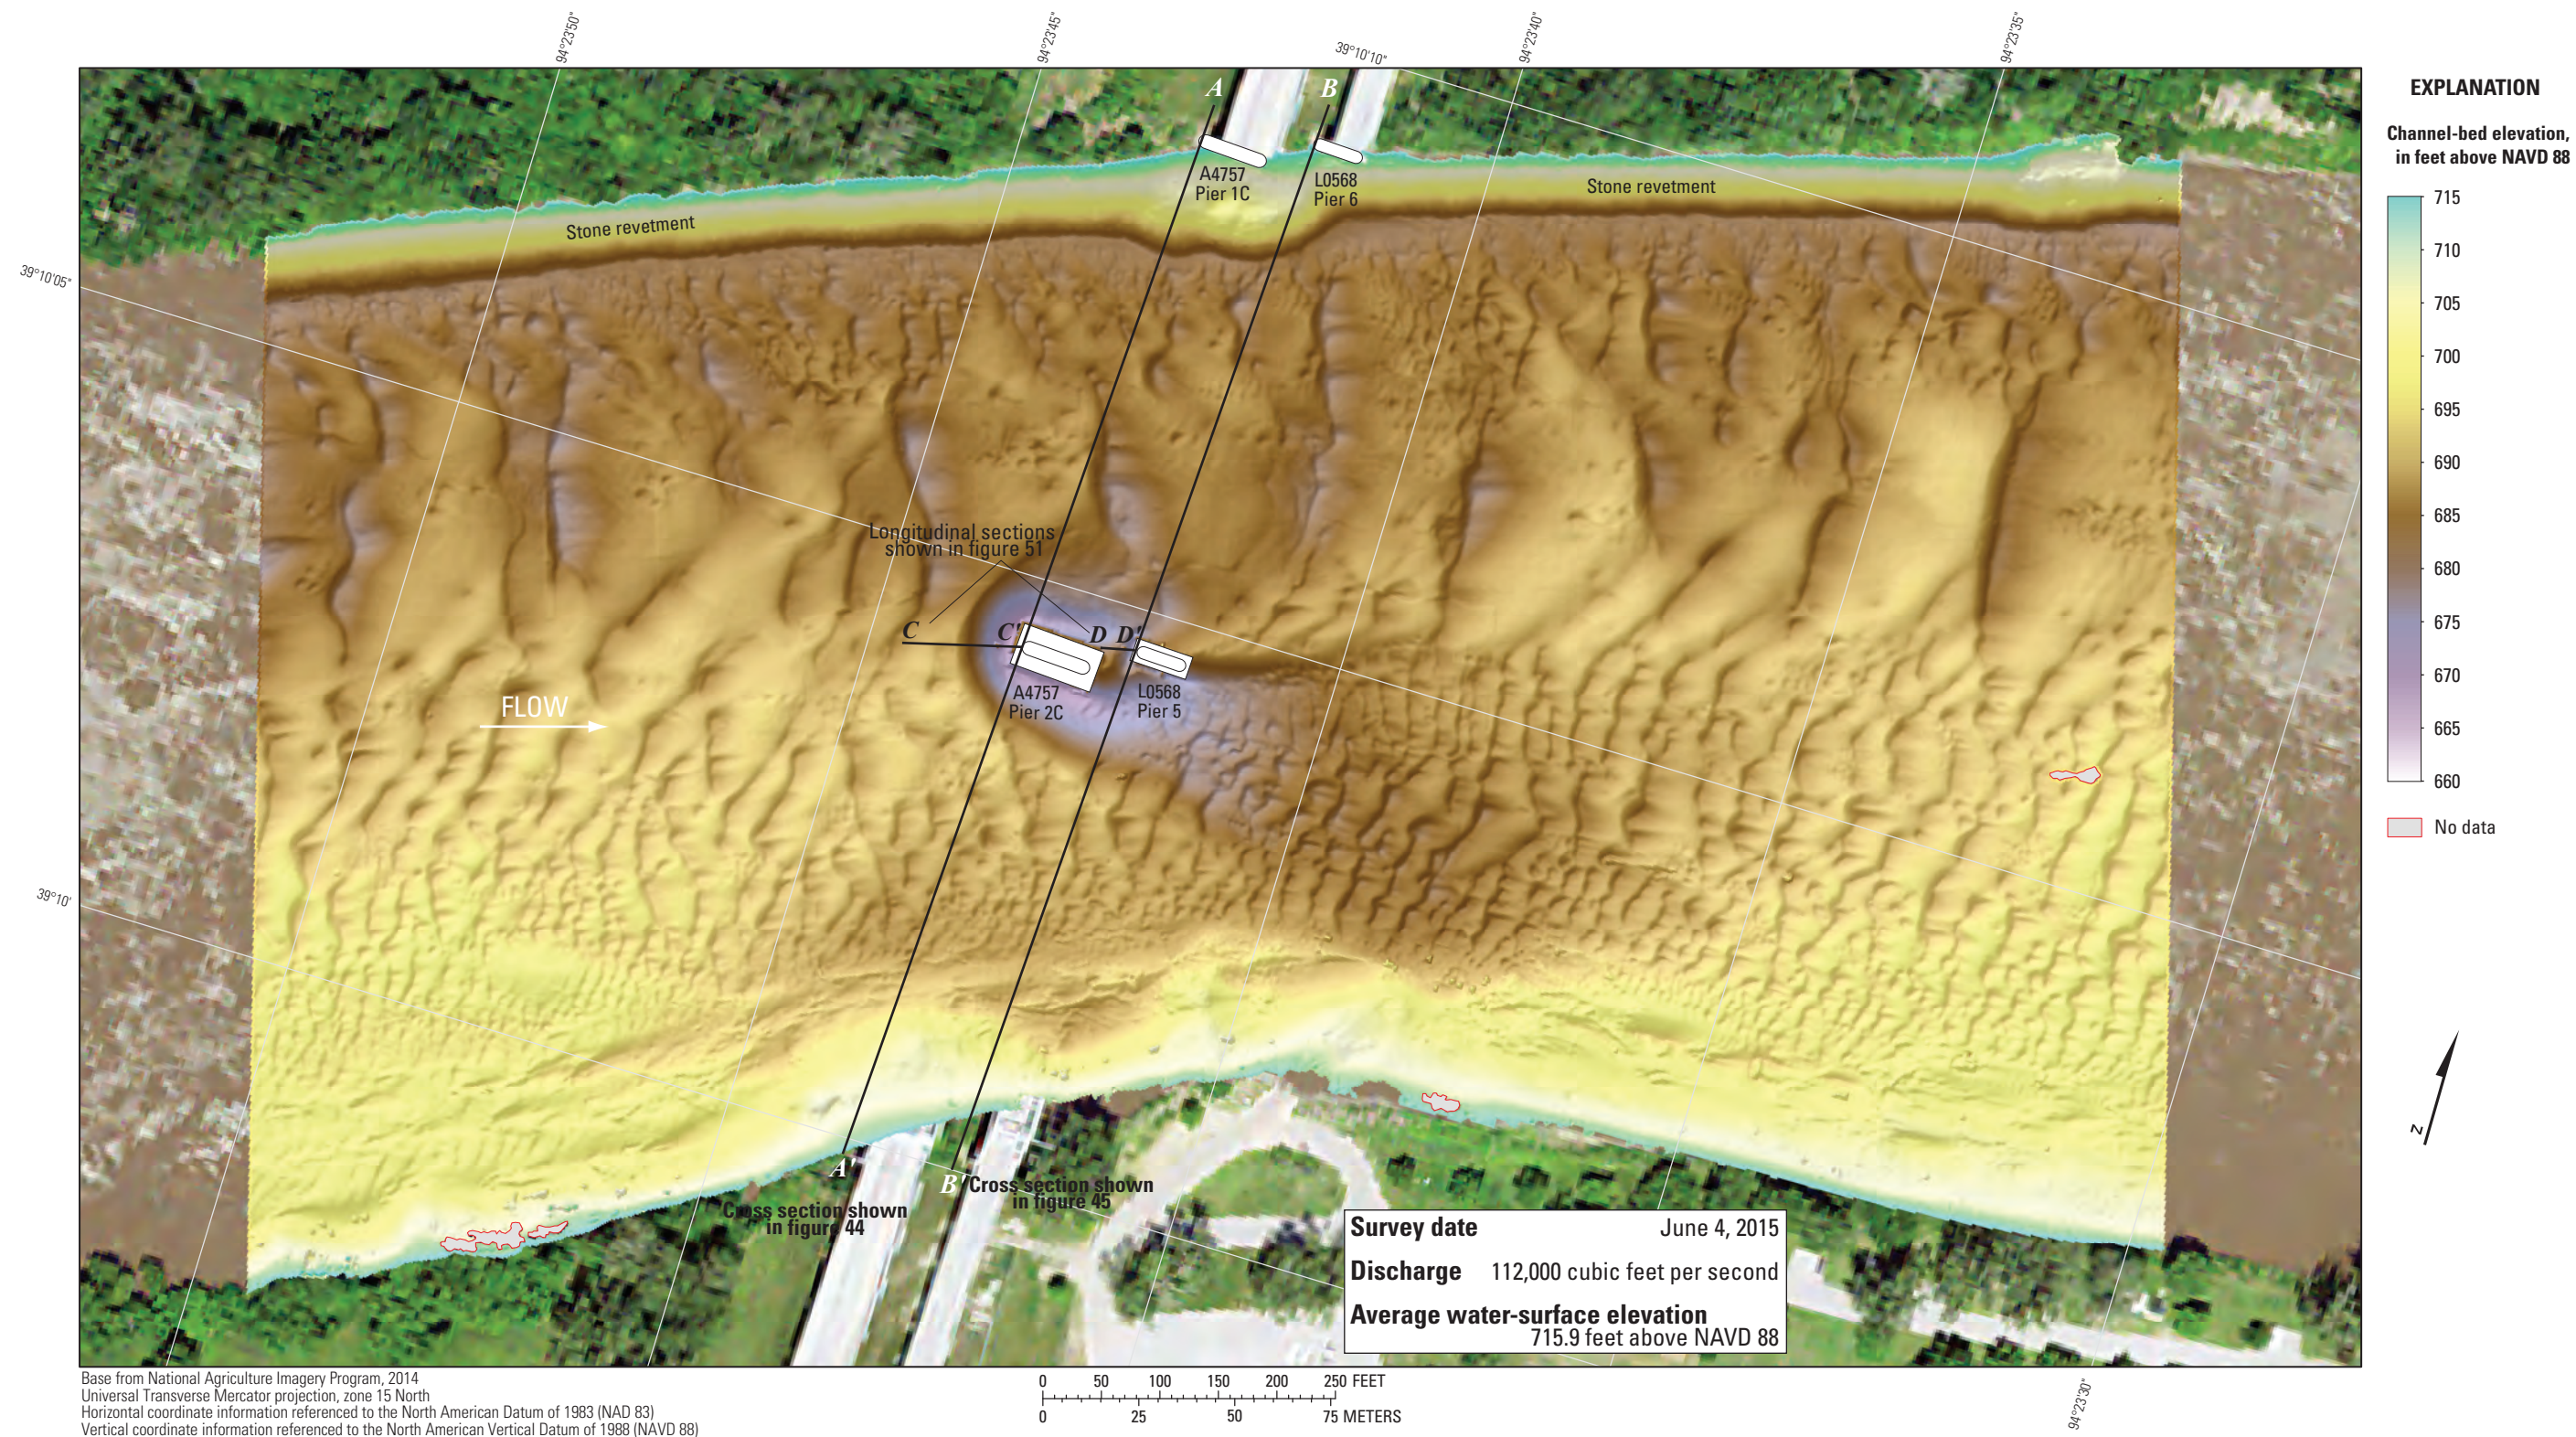
Figure 42. Bathymetric survey of the Missouri River channel near structures A4757 and L0568 on State Highway 291 near Kansas City, Missouri.

The survey area was about 1,640 ft long and about 850 ft wide, extending from bank to bank in the main channel (fig. 42). The upstream end of the survey area was about 720 ft upstream from the centerline between structures A4757 and L0568 (fig. 42). The channel-bed elevations ranged from about 681 to 706 ft for most of the surveyed area (5 to 95 percentile range of the bathymetric data; table 5; fig. 43), except near the main channel piers of structures A4757 and L0568 (fig. 42). A narrow channel thalweg was along the left (north) bank throughout the channel and was about 10 ft deeper than the middle of the channel (fig. 42). A row of medium dune features were observed in the left side of the channel, along with numerous small dunes and ripples throughout the rest of the channel (fig. 42). As in previous surveys, a noticeable channel constriction was at and immediately downstream from the bridges, and the left (north) bank seemed to be covered with stone revetment (fig. 42).

A large scour hole near the main channel piers (fig. 42) that essentially encompasses both piers had a minimum channel-bed elevation of about 668 ft (table 6), which also was the minimum channel-bed elevation for the entire reach (table 5). The main channel piers were skewed to the approaching flow, which caused a wide scour hole with somewhat unique characteristics as compared to scour holes at the other surveyed bridges. Pier 5 of structure L0568 was in the wake of pier 2C of structure A4757 and, therefore, had a poorly defined scour hole near it (fig. 42). At the upstream

end of pier 2C of structure A4757, the minimum channel-bed elevation was about 668 ft, and at the upstream end of pier 5 of structure L0568, the minimum channel-bed elevation was about 674 ft (fig. 42; table 6). Information from bridge plans indicates that the main channel pier of structure A4757 is founded on shafts drilled 20 ft into bedrock (fig. 44), with about 49 ft of bed material between the bottom of the scour hole and bedrock at the point of minimum elevation of the scour hole near the upstream pier face (fig. 44; table 6). At the point of minimum elevation, the surveyed channel bed was about 2 ft above the bottom of the seal course elevation of 666.26 ft (table 6). Information from bridge plans indicate that the main channel pier of structure L0568 is a caisson on bedrock (fig. 45), with about 56 ft of bed material between the bottom of the scour hole and bedrock at the point of minimum elevation of the scour hole near the upstream pier face (fig. 45; table 6).

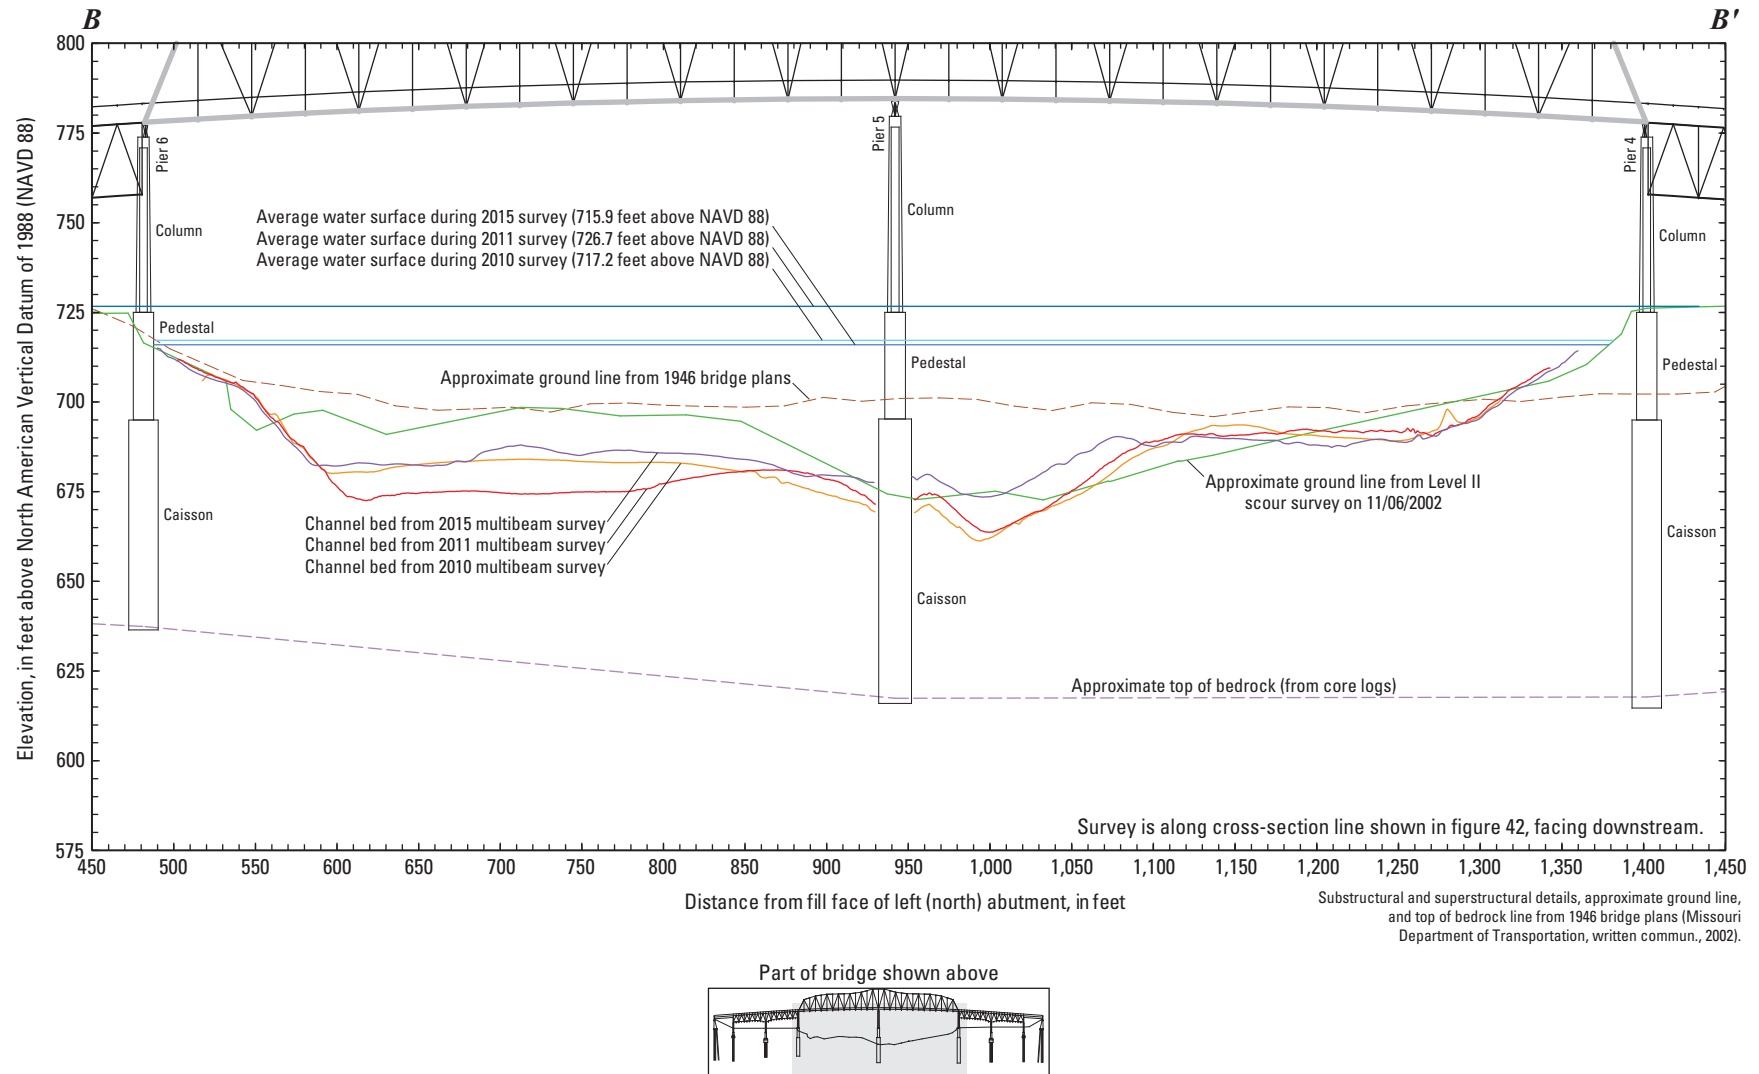
Figure 45. Key features, substructural and superstructural details, and surveyed channel bed of structure L0568 on State Highway 291 crossing the Missouri River near Kansas City, Missouri.

narrower and shallower in 2015 than in 2011 (figs. 44 and 46), whereas the scour hole near pier 5 of structure L0568 was of a similar shape but substantially shallower in 2015 than in 2011 (figs. 45 and 46). The stone revetment on the left (north) bank showed no signs of substantial change, whereas the right (south) bank near the bridges and downstream showed signs of localized deposition and scour (fig. 46). As with all difference maps presented in this report, substantial deposition or scour apparent at the faces of the piers results from minor horizontal positional variances between the surveys (see “Uncertainty Estimation” section).

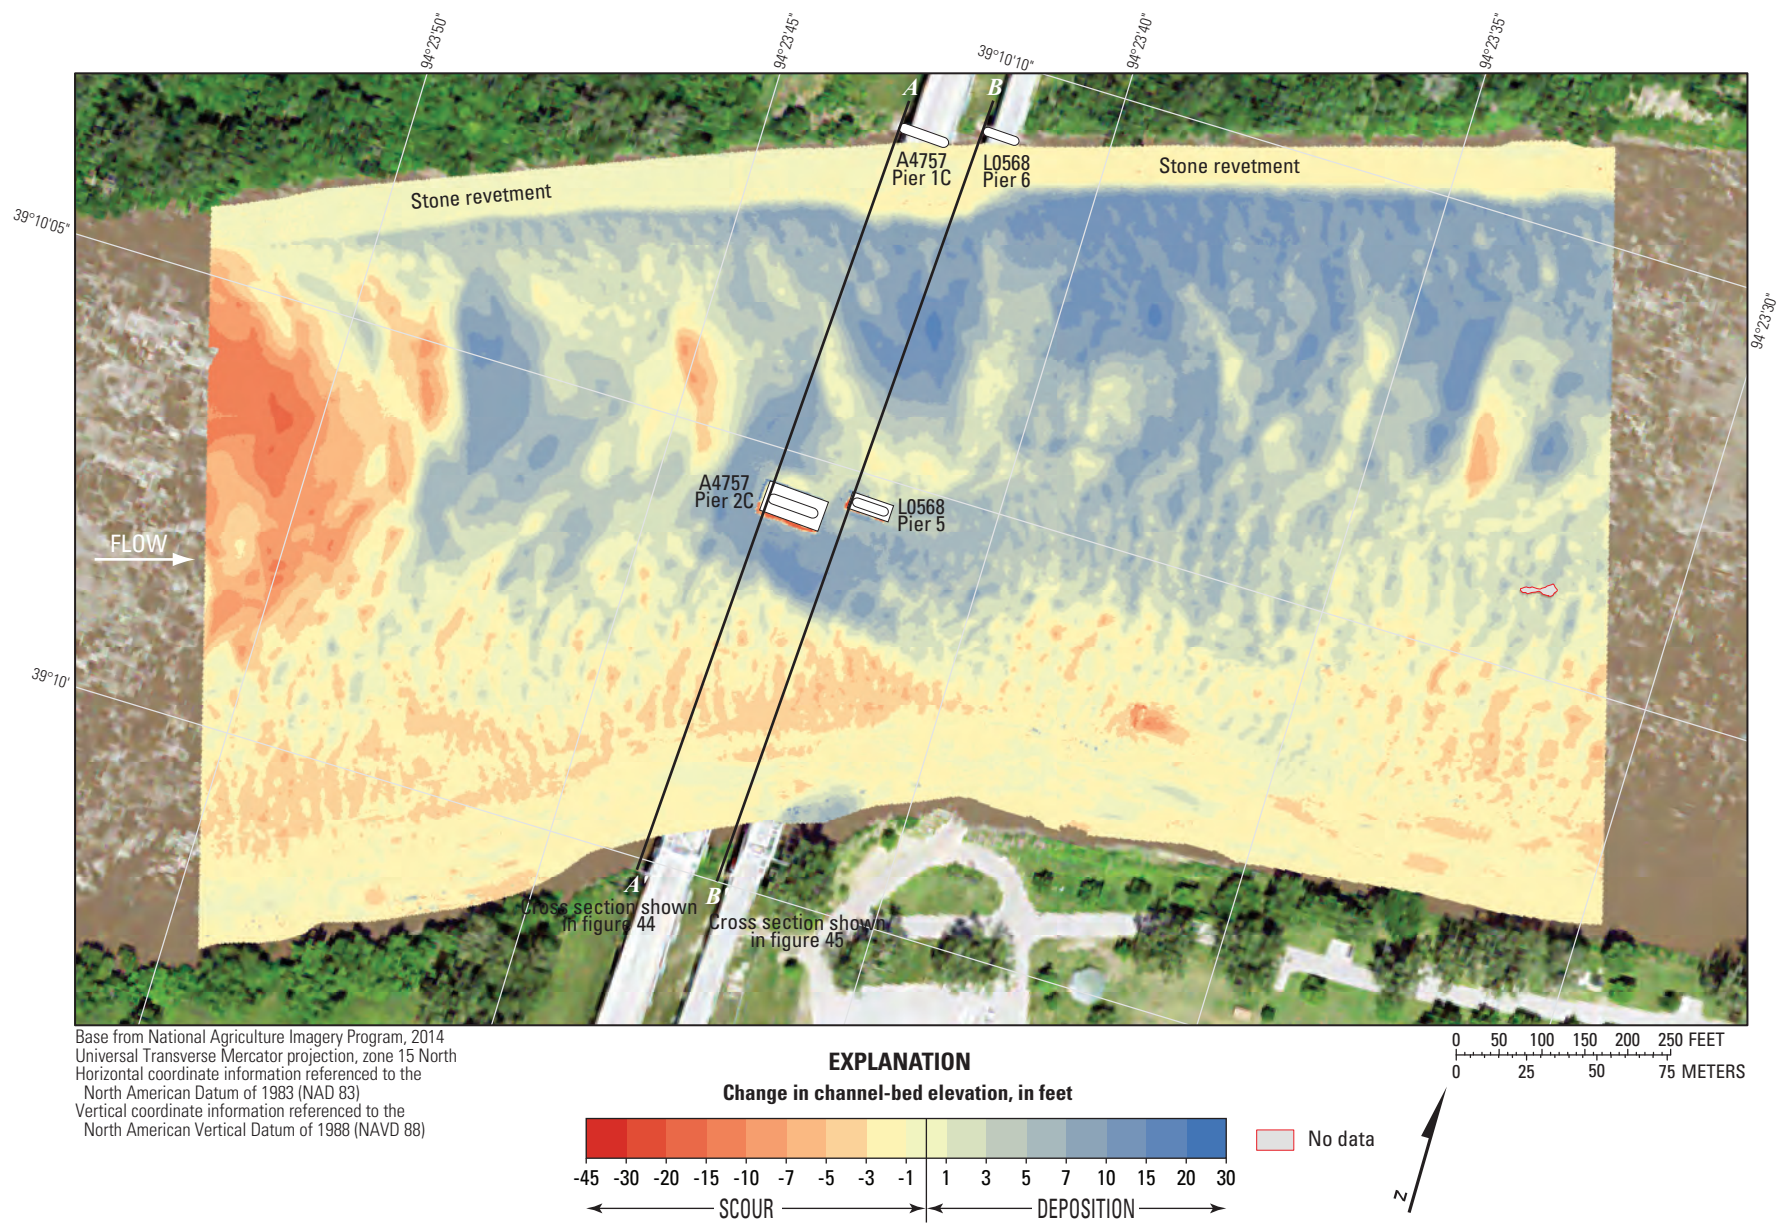
Figure 46. Difference between surfaces created from bathymetric surveys of the Missouri River channel near structures A4757 and L0568 on State Highway 291 near Kansas City, Missouri, on June 4, 2015, and July 19, 2011.

The difference between the survey on June 4, 2015, and the previous survey on July 19, 2011 (fig. 46), indicates moderate deposition throughout the reach from 2011 to 2015, with an average difference of +1.33 ft between the bathymetric surfaces (table 7). The net volume of cut in the reach from 2011 to 2015 was about 59,400 yd³, and the net volume of fill was about 126,200 yd³, resulting in a net gain of about 66,800 yd³ of sediment between 2011 and 2015. There was moderate deposition of over 10 ft on the right (south) side of the main channel piers and throughout most of the (north) side of the channel in 2015 (fig. 46); however, substantial scour of more than 15 ft had been observed in the upstream channel, and minor scour was observed along the right (south) side of the channel (fig. 46). The cross section from the 2015 survey compared to the 2011 survey also shows deposition throughout most of the left side of the channel and on the right side of the main channel piers, with minor scour on the right side (figs. 44 and 45). The frequency distribution of bed elevations was substantially narrower in 2015 than in 2011, with a higher minimum channel-bed elevation than in 2011 (fig. 43). The scour hole near pier 2C of structure A4757 was substantially

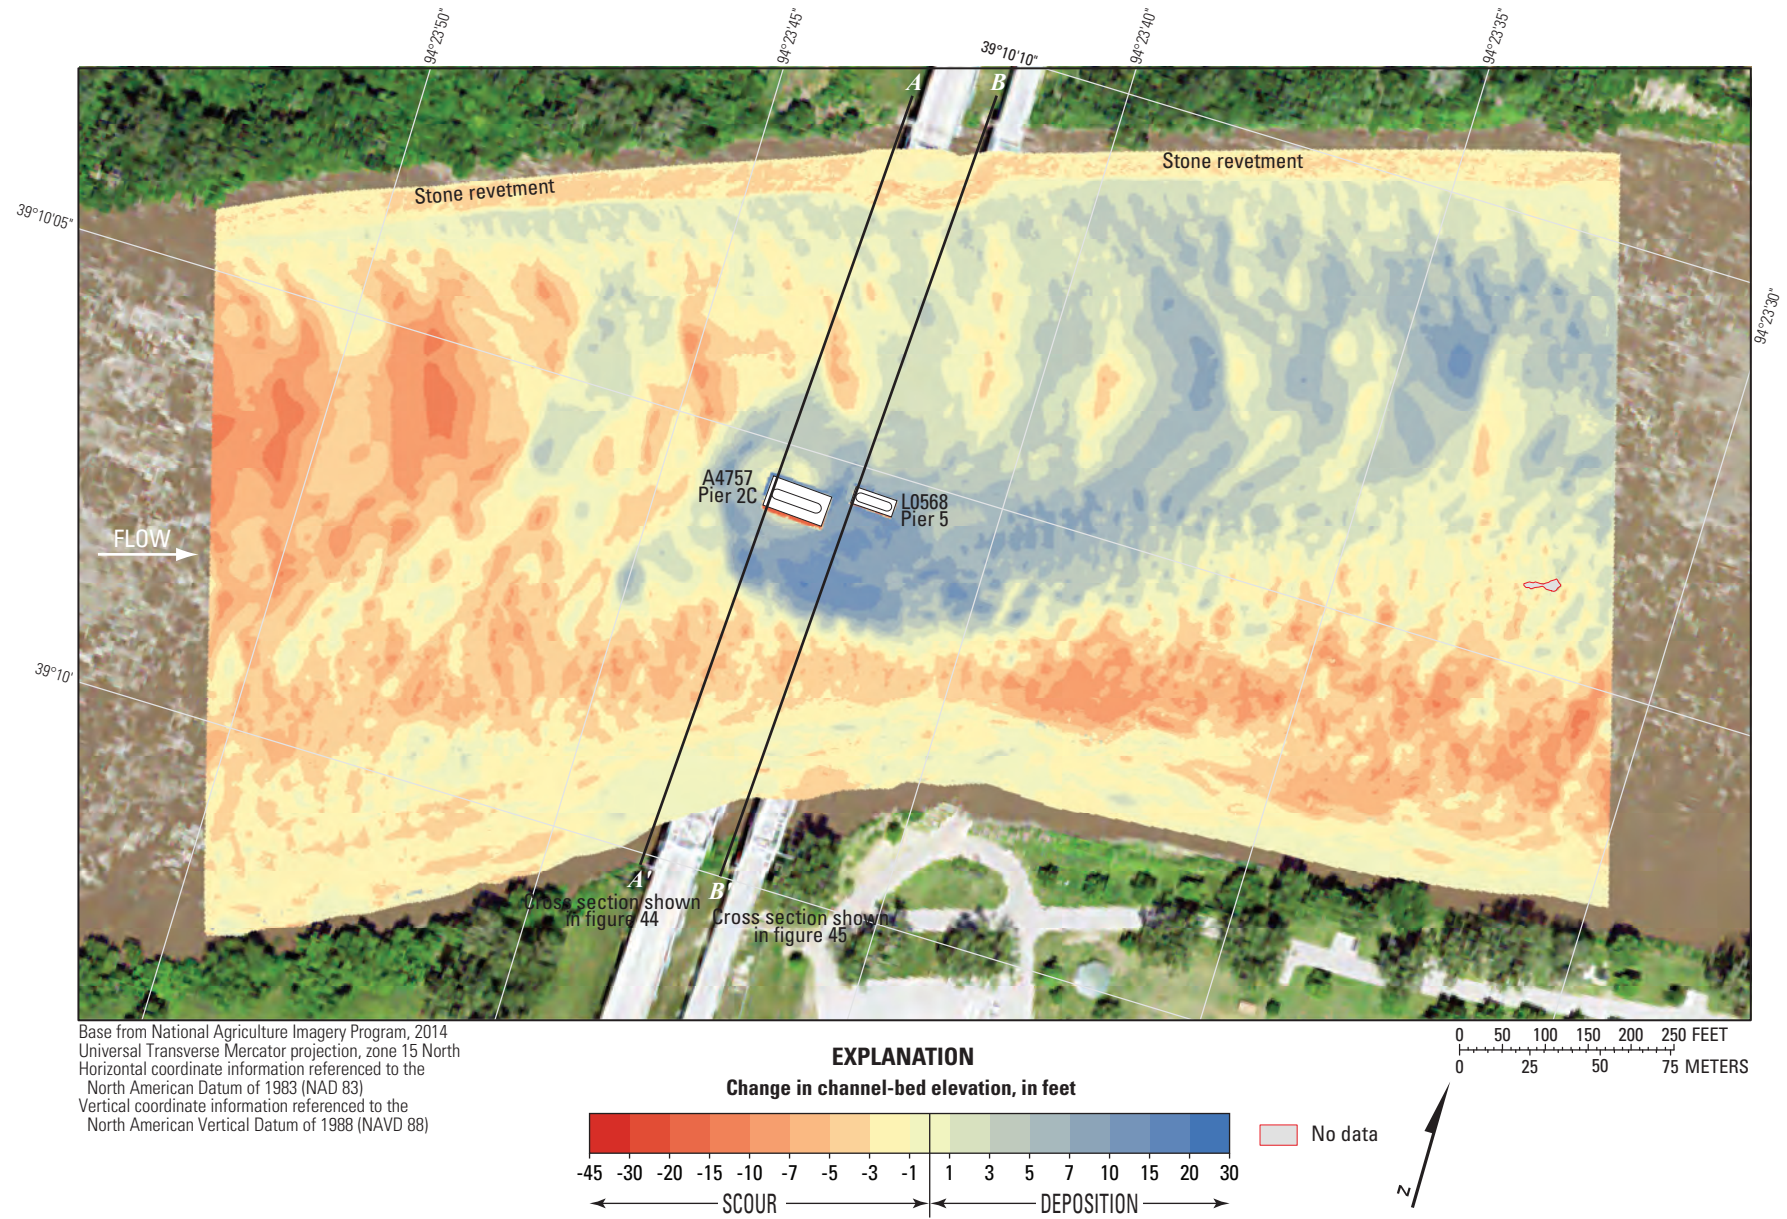
Figure 47. Difference between surfaces created from bathymetric surveys of the Missouri River channel near structures A4757 and L0568 on State Highway 291 near Kansas City, Missouri, on June 4, 2015, and March 18, 2010.

The difference between the survey on June 4, 2015, and the previous nonflood survey on March 18, 2010 (fig. 47), indicates moderate scour throughout the reach from 2010 to 2015, with an average difference of -0.92 ft between the bathymetric surfaces (table 7). The net volume of cut in the reach from 2010 to 2015 was about 103,300 yd³, and the net volume of fill was about 58,200 yd³, resulting in a net loss of about 45,100 yd³ of sediment between 2010 and 2015. There were a few areas of deposition, predominantly along the left (north) side of the downstream reach and in the scour hole around main channel piers 2C and 5 between 2010 and 2015 (fig. 47); however, there was widespread scour throughout the upstream channel and along the right (south) side of the downstream reach. The cross sections from the 2015 survey

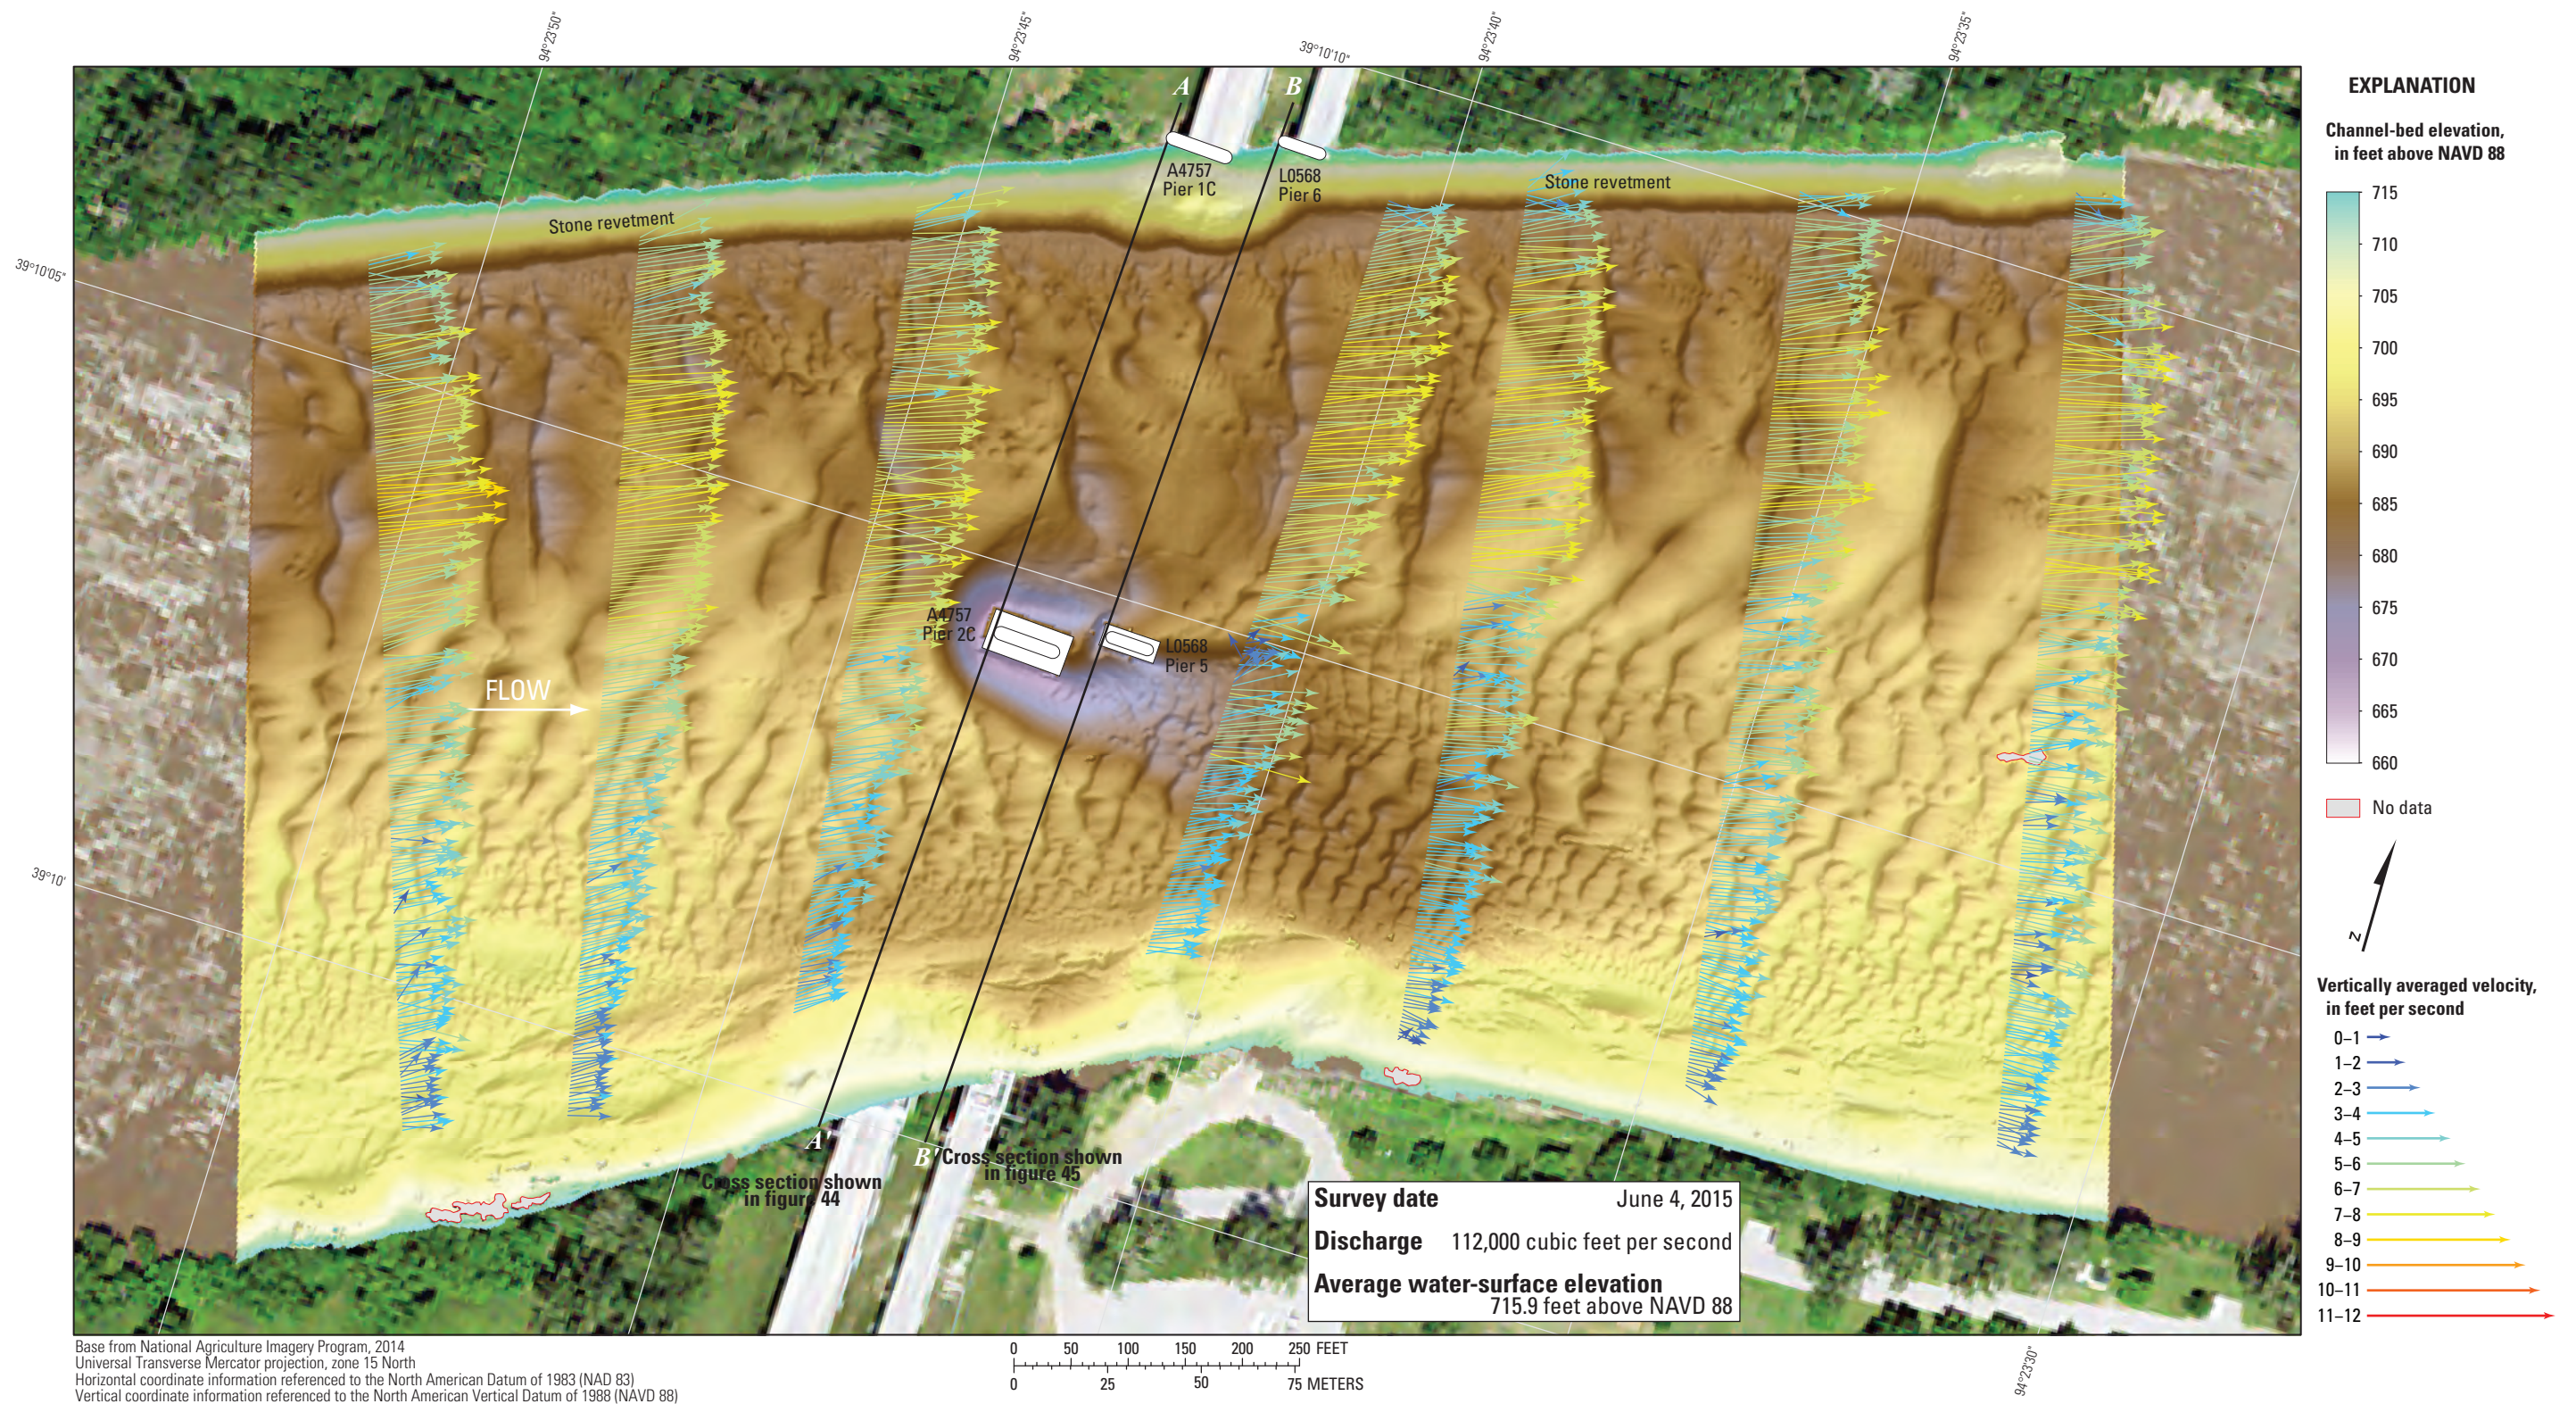
Figure 48. Bathymetry and vertically averaged velocities of the Missouri River channel near structures A4757 and L0568 on State Highway 291 near Kansas City, Missouri.

The vertically averaged velocity vectors indicate mostly uniform flow throughout the reach, ranging from about 2 ft/s along the inside of the bend on the right (south) bank to about 9 ft/s in the thalweg (fig. 48). Exceptions to uniform flow include flows angled to the left (north) near the upstream and downstream faces of the bridges (fig. 48). Moderate turbulence also was observed in several transects, particularly near the bank protrusions near the bridges and downstream from the main channel piers (fig. 48). Velocities were slightly lower downstream from the bridges, likely caused by the flow expansion downstream from the constriction at the bridges (fig. 48).

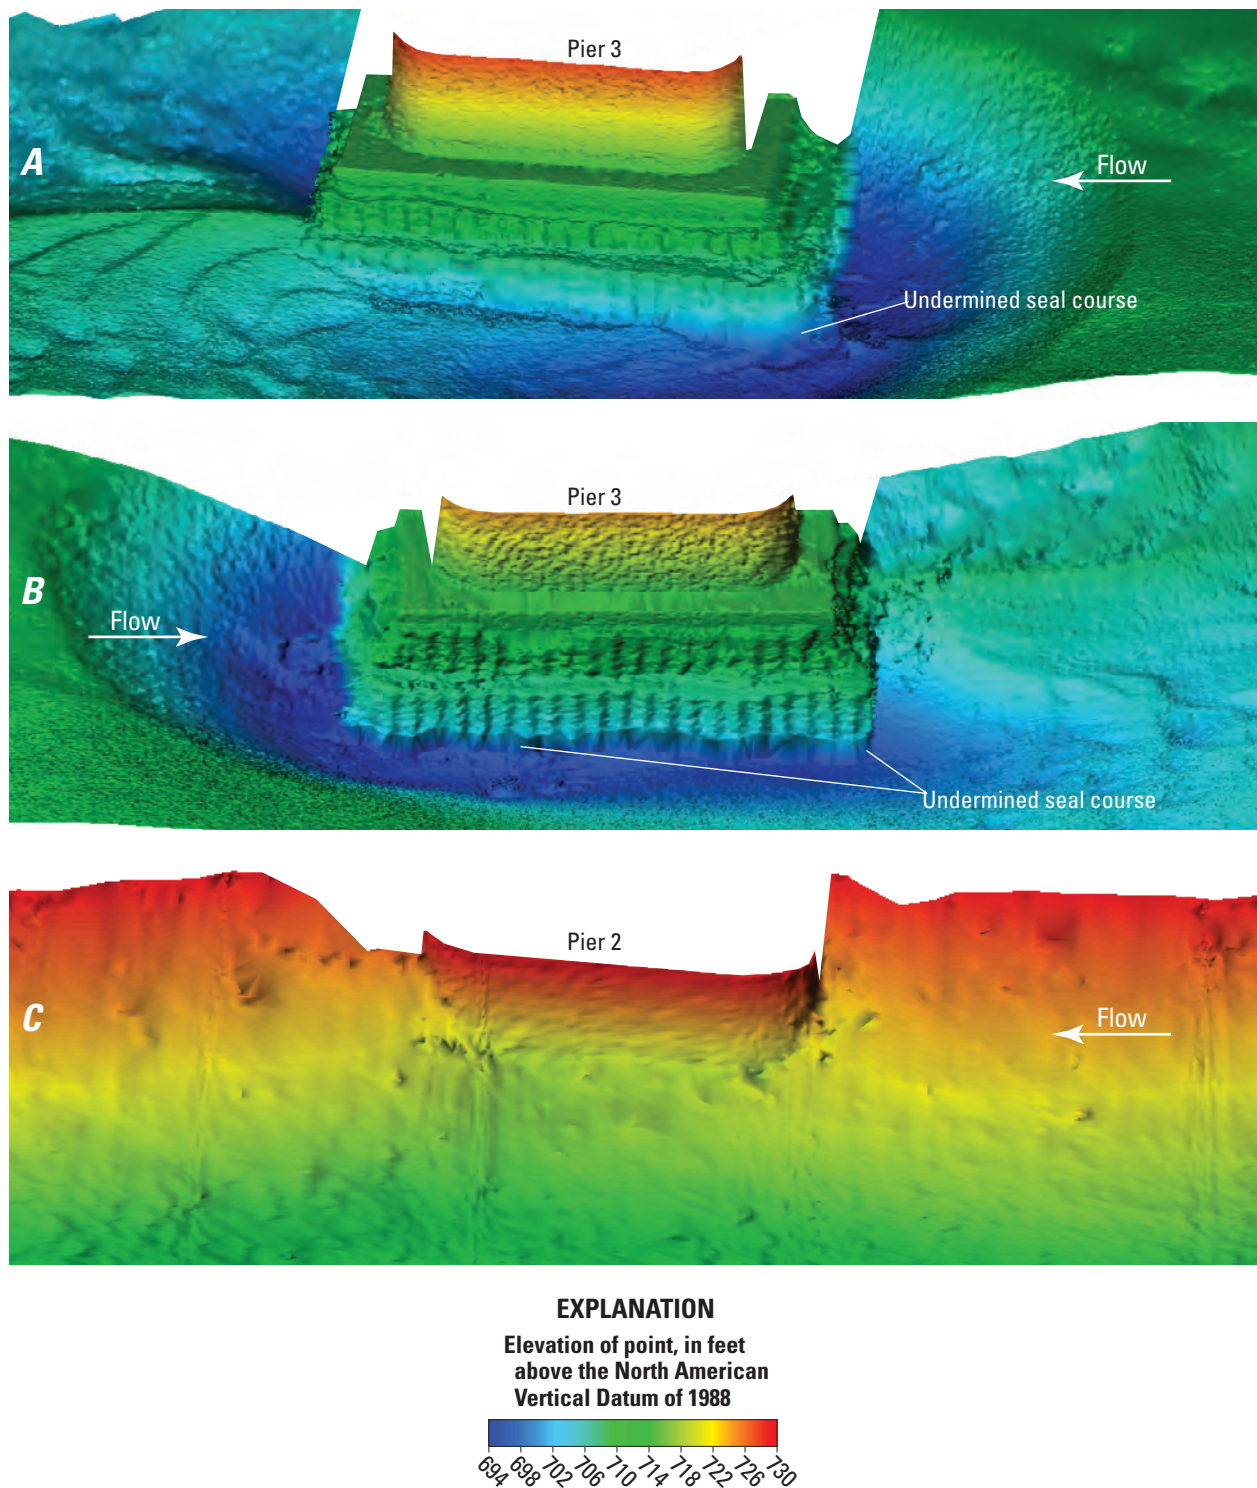
Figure 2–1. Shaded triangulated irregular network visualization of the channel bed of structure A1800 on Interstate 635 crossing the Missouri River near Kansas City, Missouri. *A*, left (northeast) side of main channel pier 3. *B*, right (southwest) side of main channel pier 3. *C*, left (northeast) side of main channel pier 2.

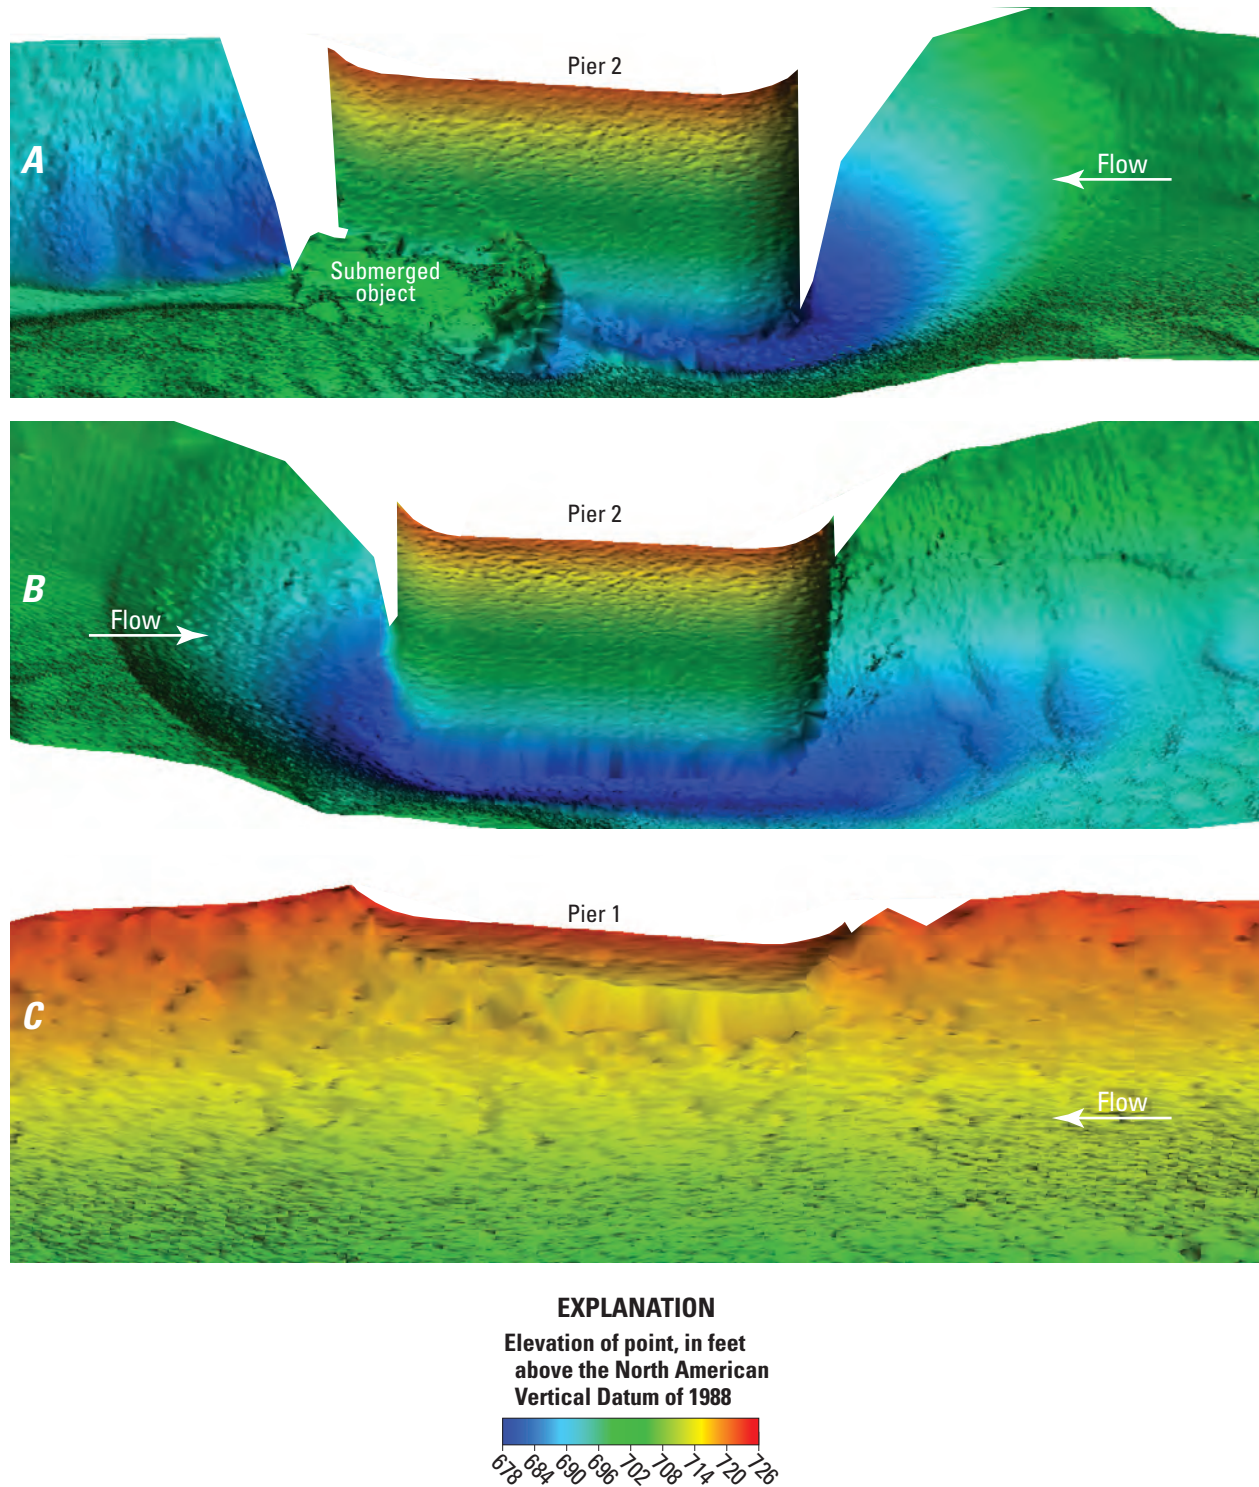
Figure 2-2. Shaded triangulated irregular network visualization of the channel bed of structure A4649 on U.S. Highway 169 crossing the Missouri River in Kansas City, Missouri. *A*, left (northwest) side of main channel pier 2. *B*, right (southeast) side of main channel pier 2. *C*, left (northwest) side of main channel pier 1.

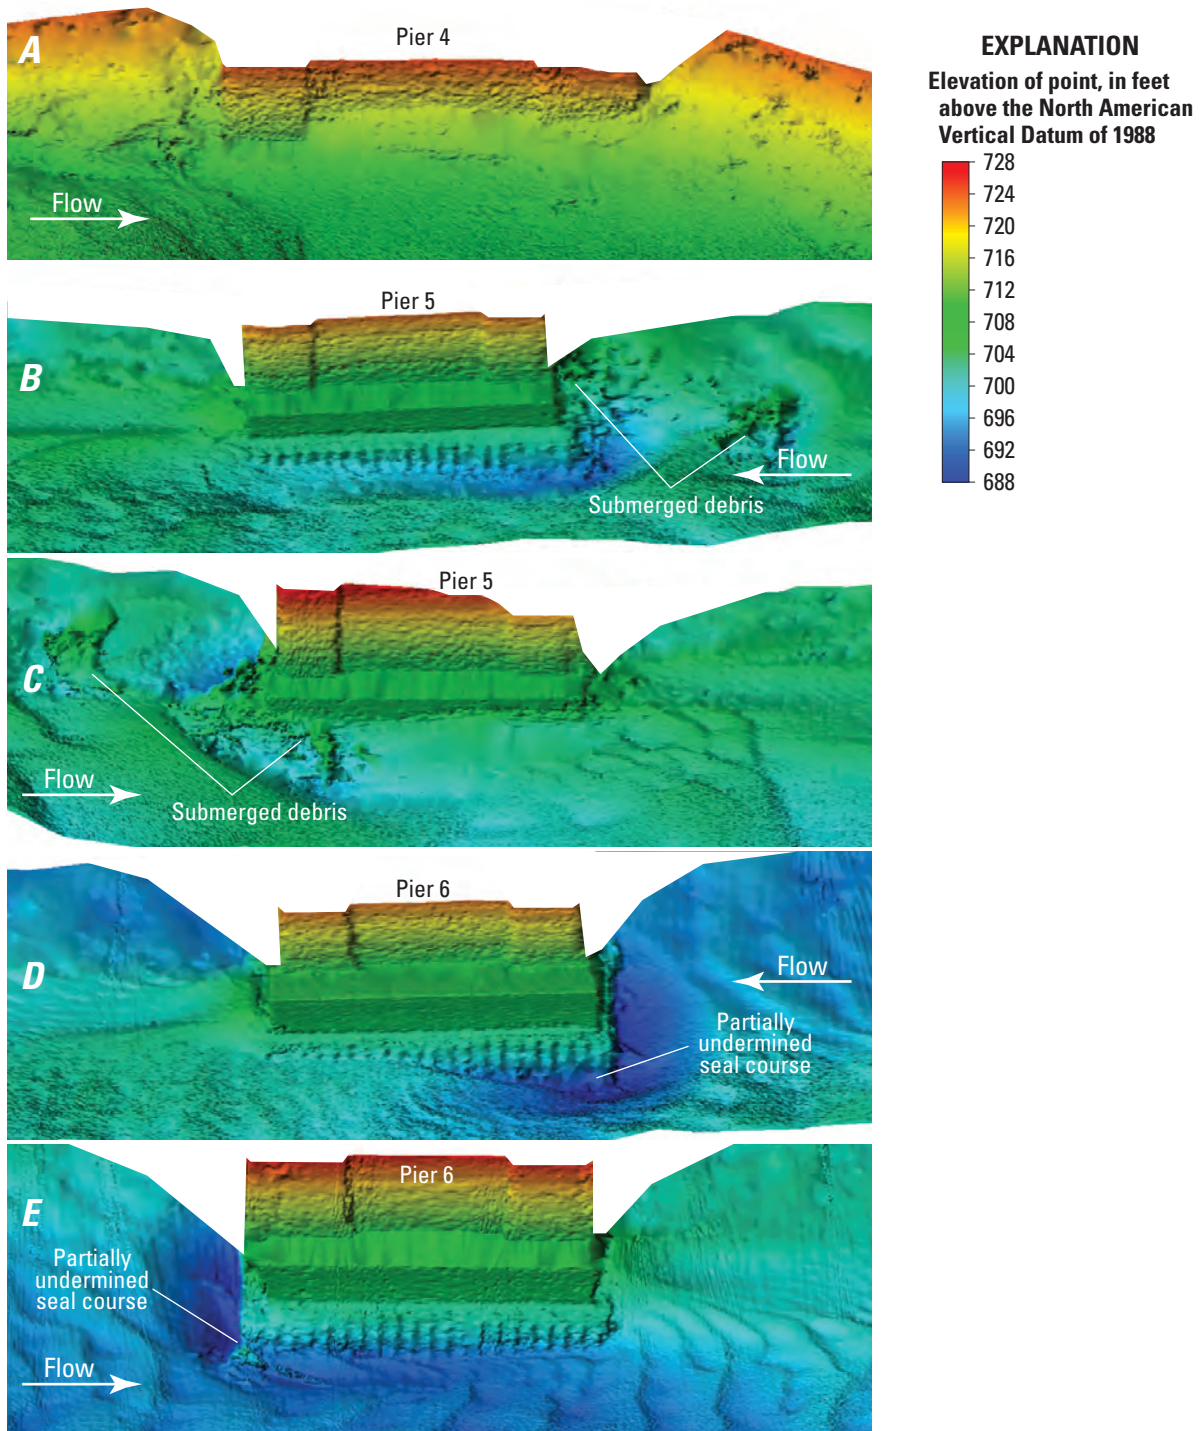
Figure 2-3. Shaded triangulated irregular network visualization of the channel bed of structure A4060 on State Highway 9 crossing the Missouri River in Kansas City, Missouri. *A*, right (southeast) side of main channel pier 4. *B*, left (northwest) side of main channel pier 5. *C*, right (southeast) side of main channel pier 5. *D*, left (northwest) side of main channel pier 6. *E*, right (southeast) side of main channel pier 6.

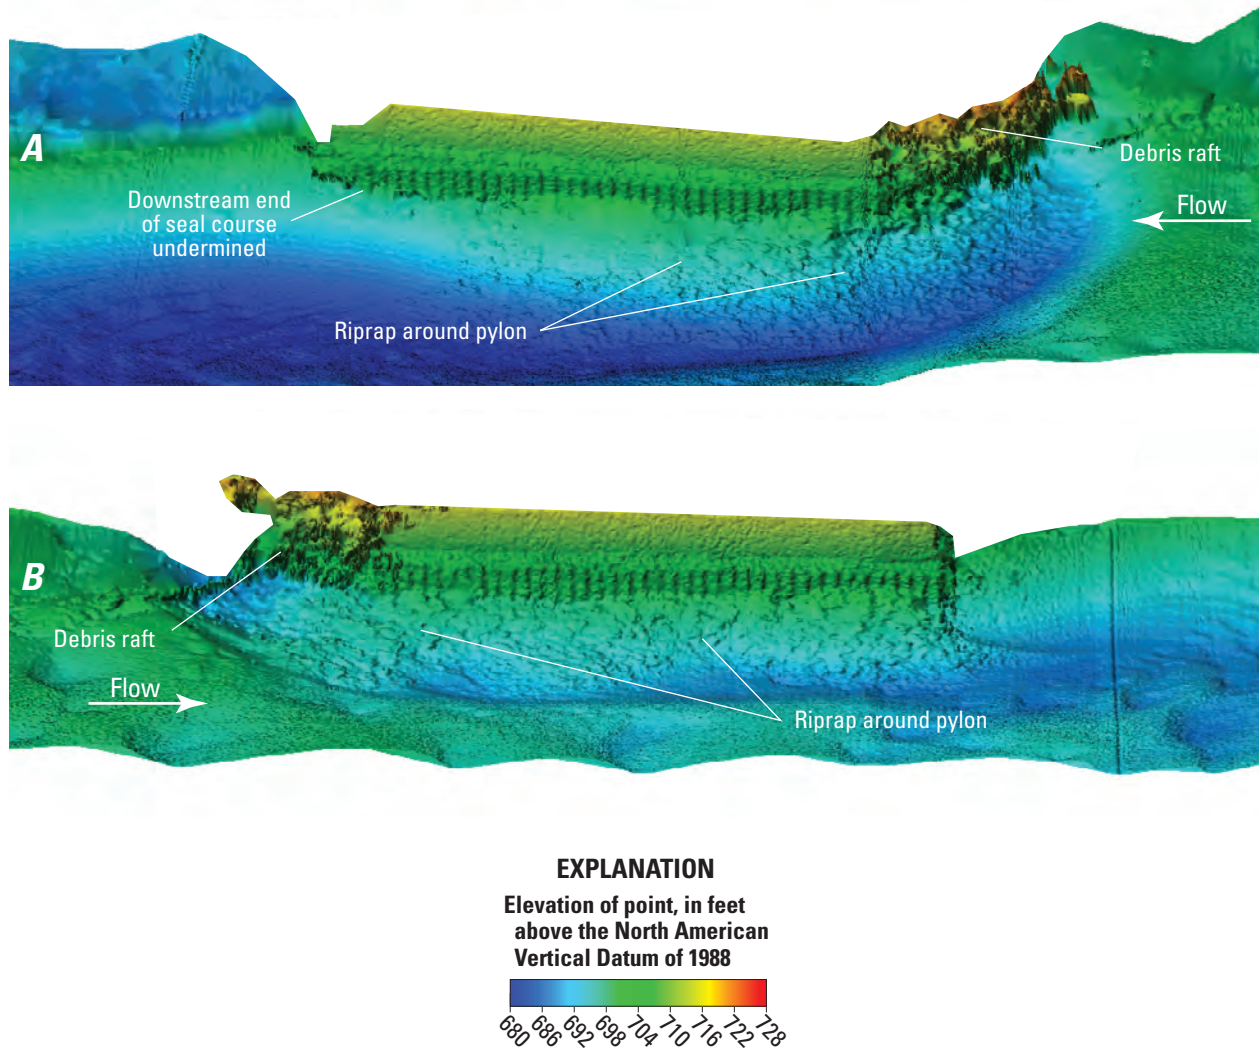
Figure 2-4. Shaded triangulated irregular network visualization of the channel bed of main channel pylon of structure A7650 on Interstate 35 crossing the Missouri River in Kansas City, Missouri. *A*, left (northwest) side. *B*, right (southeast) side.
