Bathymetric and Velocimetric Surveys at Highway Bridges Crossing the Missouri River near Kansas City, Missouri, June 2–4, 2015

Scientific Investigations Report 2016–5061

By Richard J. Huizinga

Prepared in cooperation with the Missouri Department of Transportation

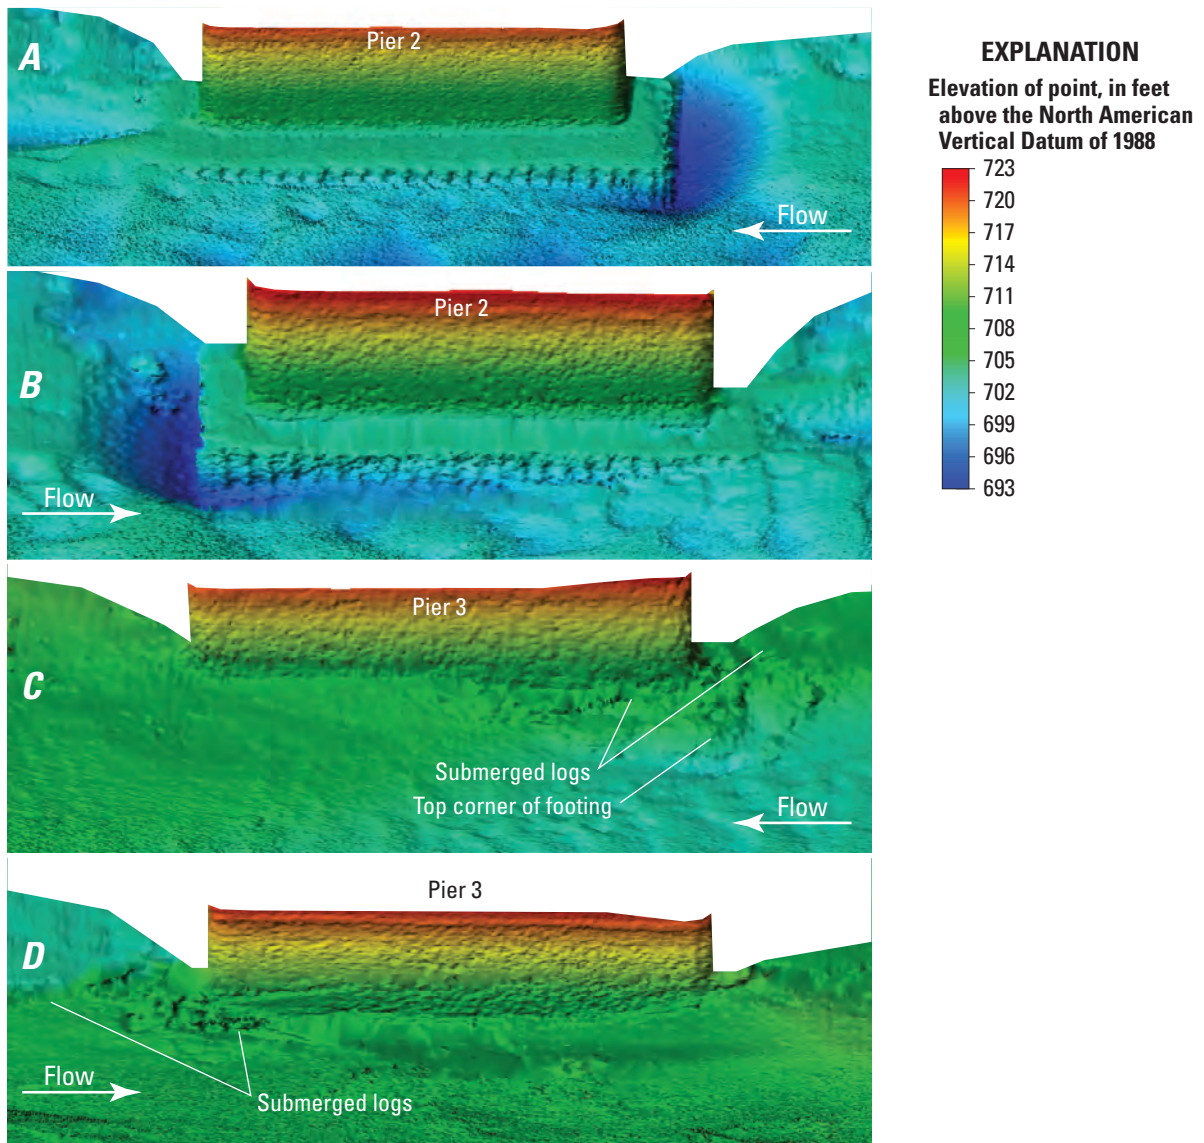
Figure 2-5. Shaded triangulated irregular network visualization of the channel bed of structure A5817 on State Highway 269 crossing the Missouri River in Kansas City, Missouri. *A*, left (northwest) side of main channel pier 2. *B*, right (southeast) side of main channel pier 2. *C*, left (northwest) side of main channel pier 3. *D*, right (southeast) side of main channel pier 3.

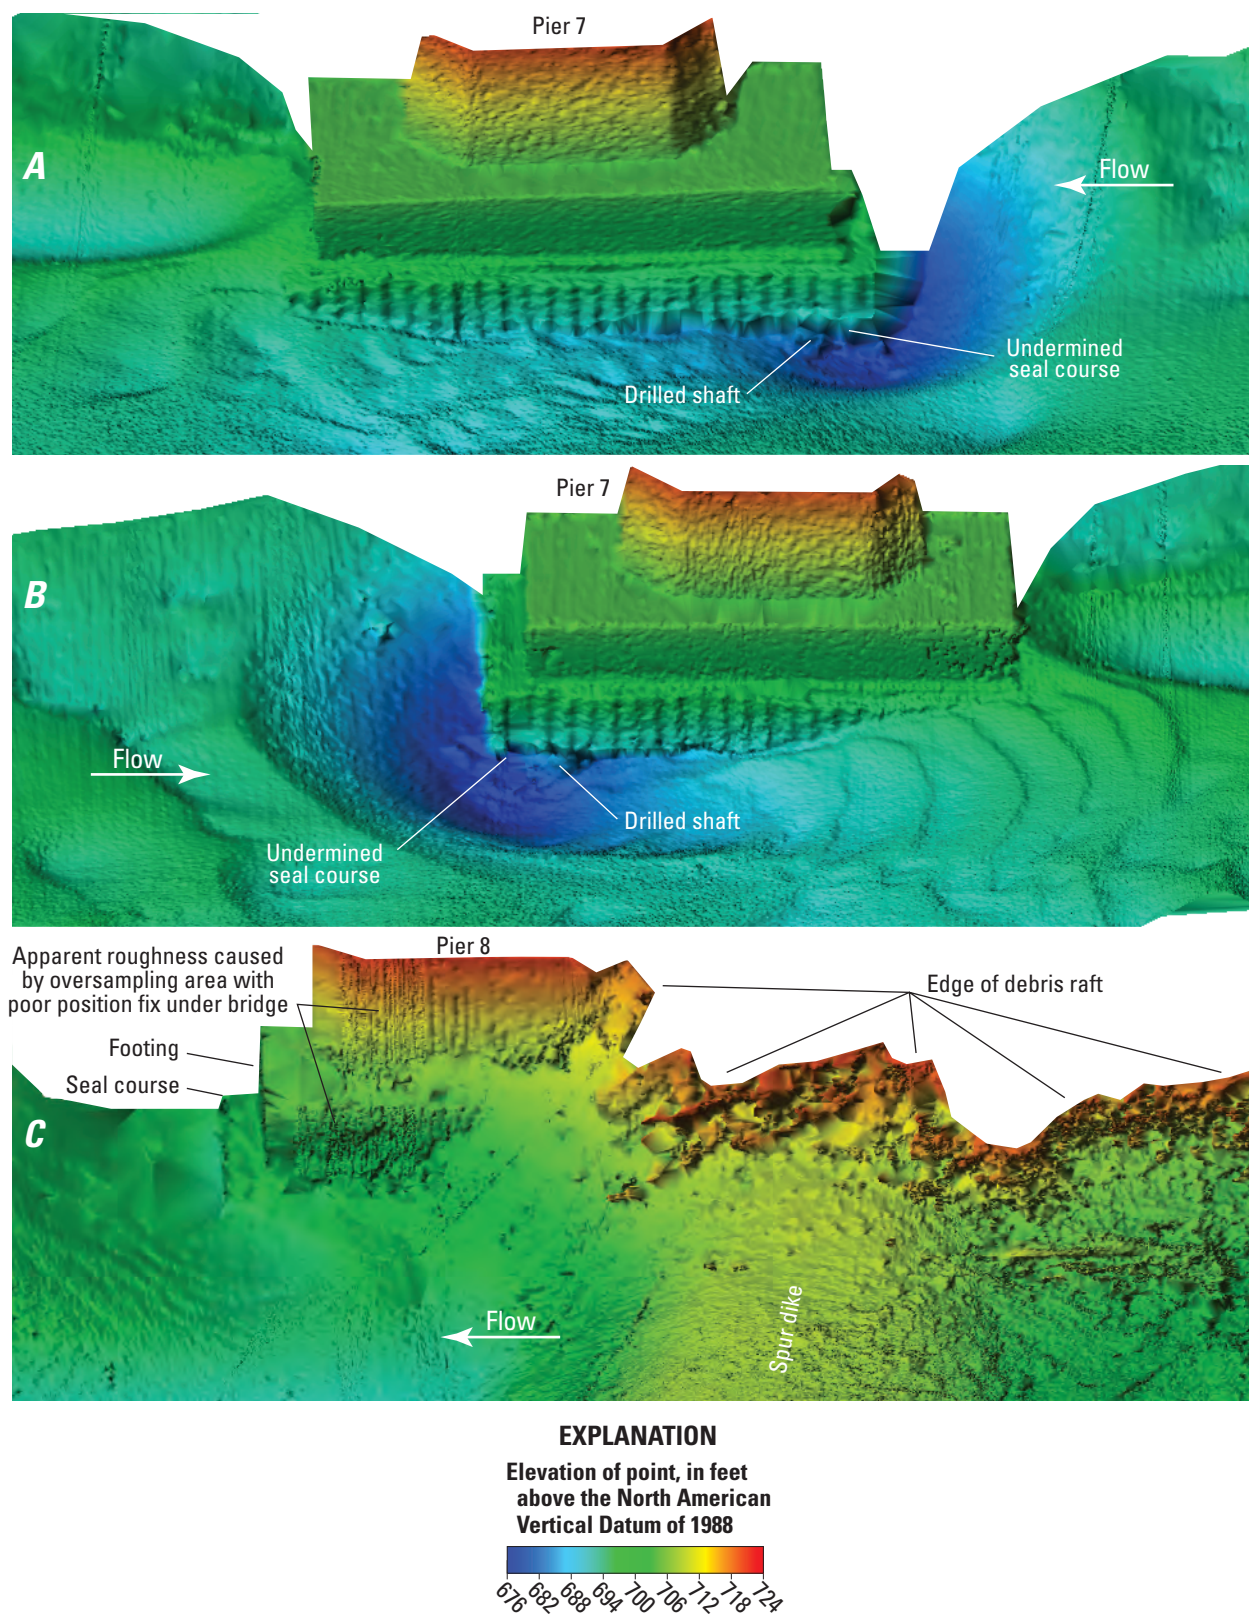
Figure 2-6. Shaded triangulated irregular network visualization of the channel bed of structure A0767 on Interstate 435 crossing the Missouri River in Kansas City, Missouri. *A*, left (north) side of main channel pier 7. *B*, right (south) side of main channel pier 7. *C*, left (north) side of main channel pier 8.

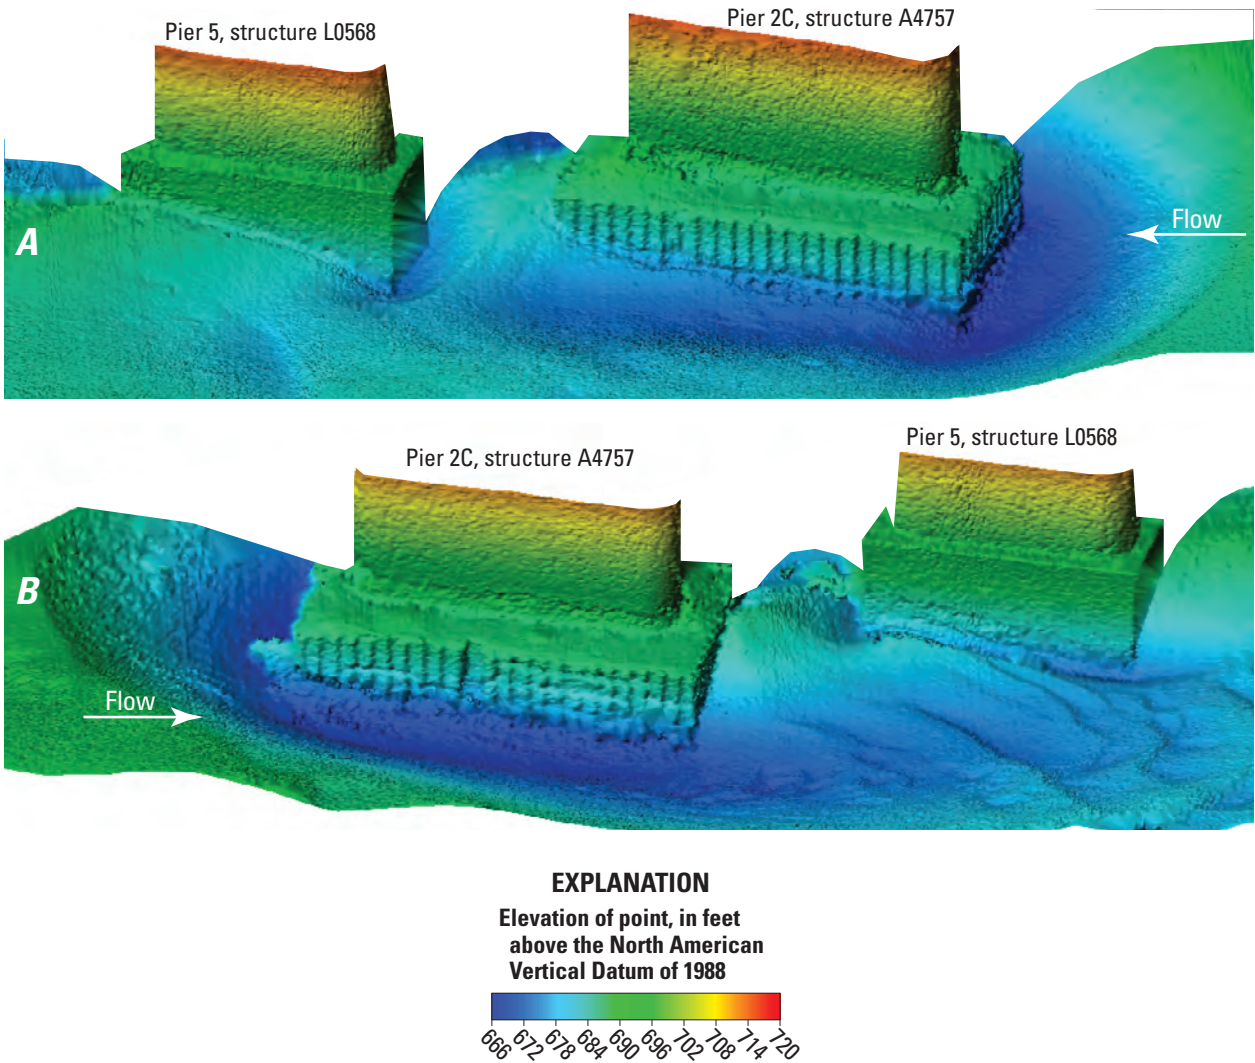
Figure 2–7. Shaded triangulated irregular network visualization of the channel bed of main channel pier 2C of structure A4757 and pier 5 of structure L0568 on State Highway 291 crossing the Missouri River near Kansas City, Missouri. *A*, left (north) side. *B*, right (south) side.
