Bathymetric and Velocimetric Surveys at Highway Bridges Crossing the Missouri and Mississippi Rivers near St. Louis, Missouri, May 23–27, 2016

Scientific Investigation Report 2017–5076

By Richard J. Huizinga

Prepared in cooperation with the Missouri Department of Transportation

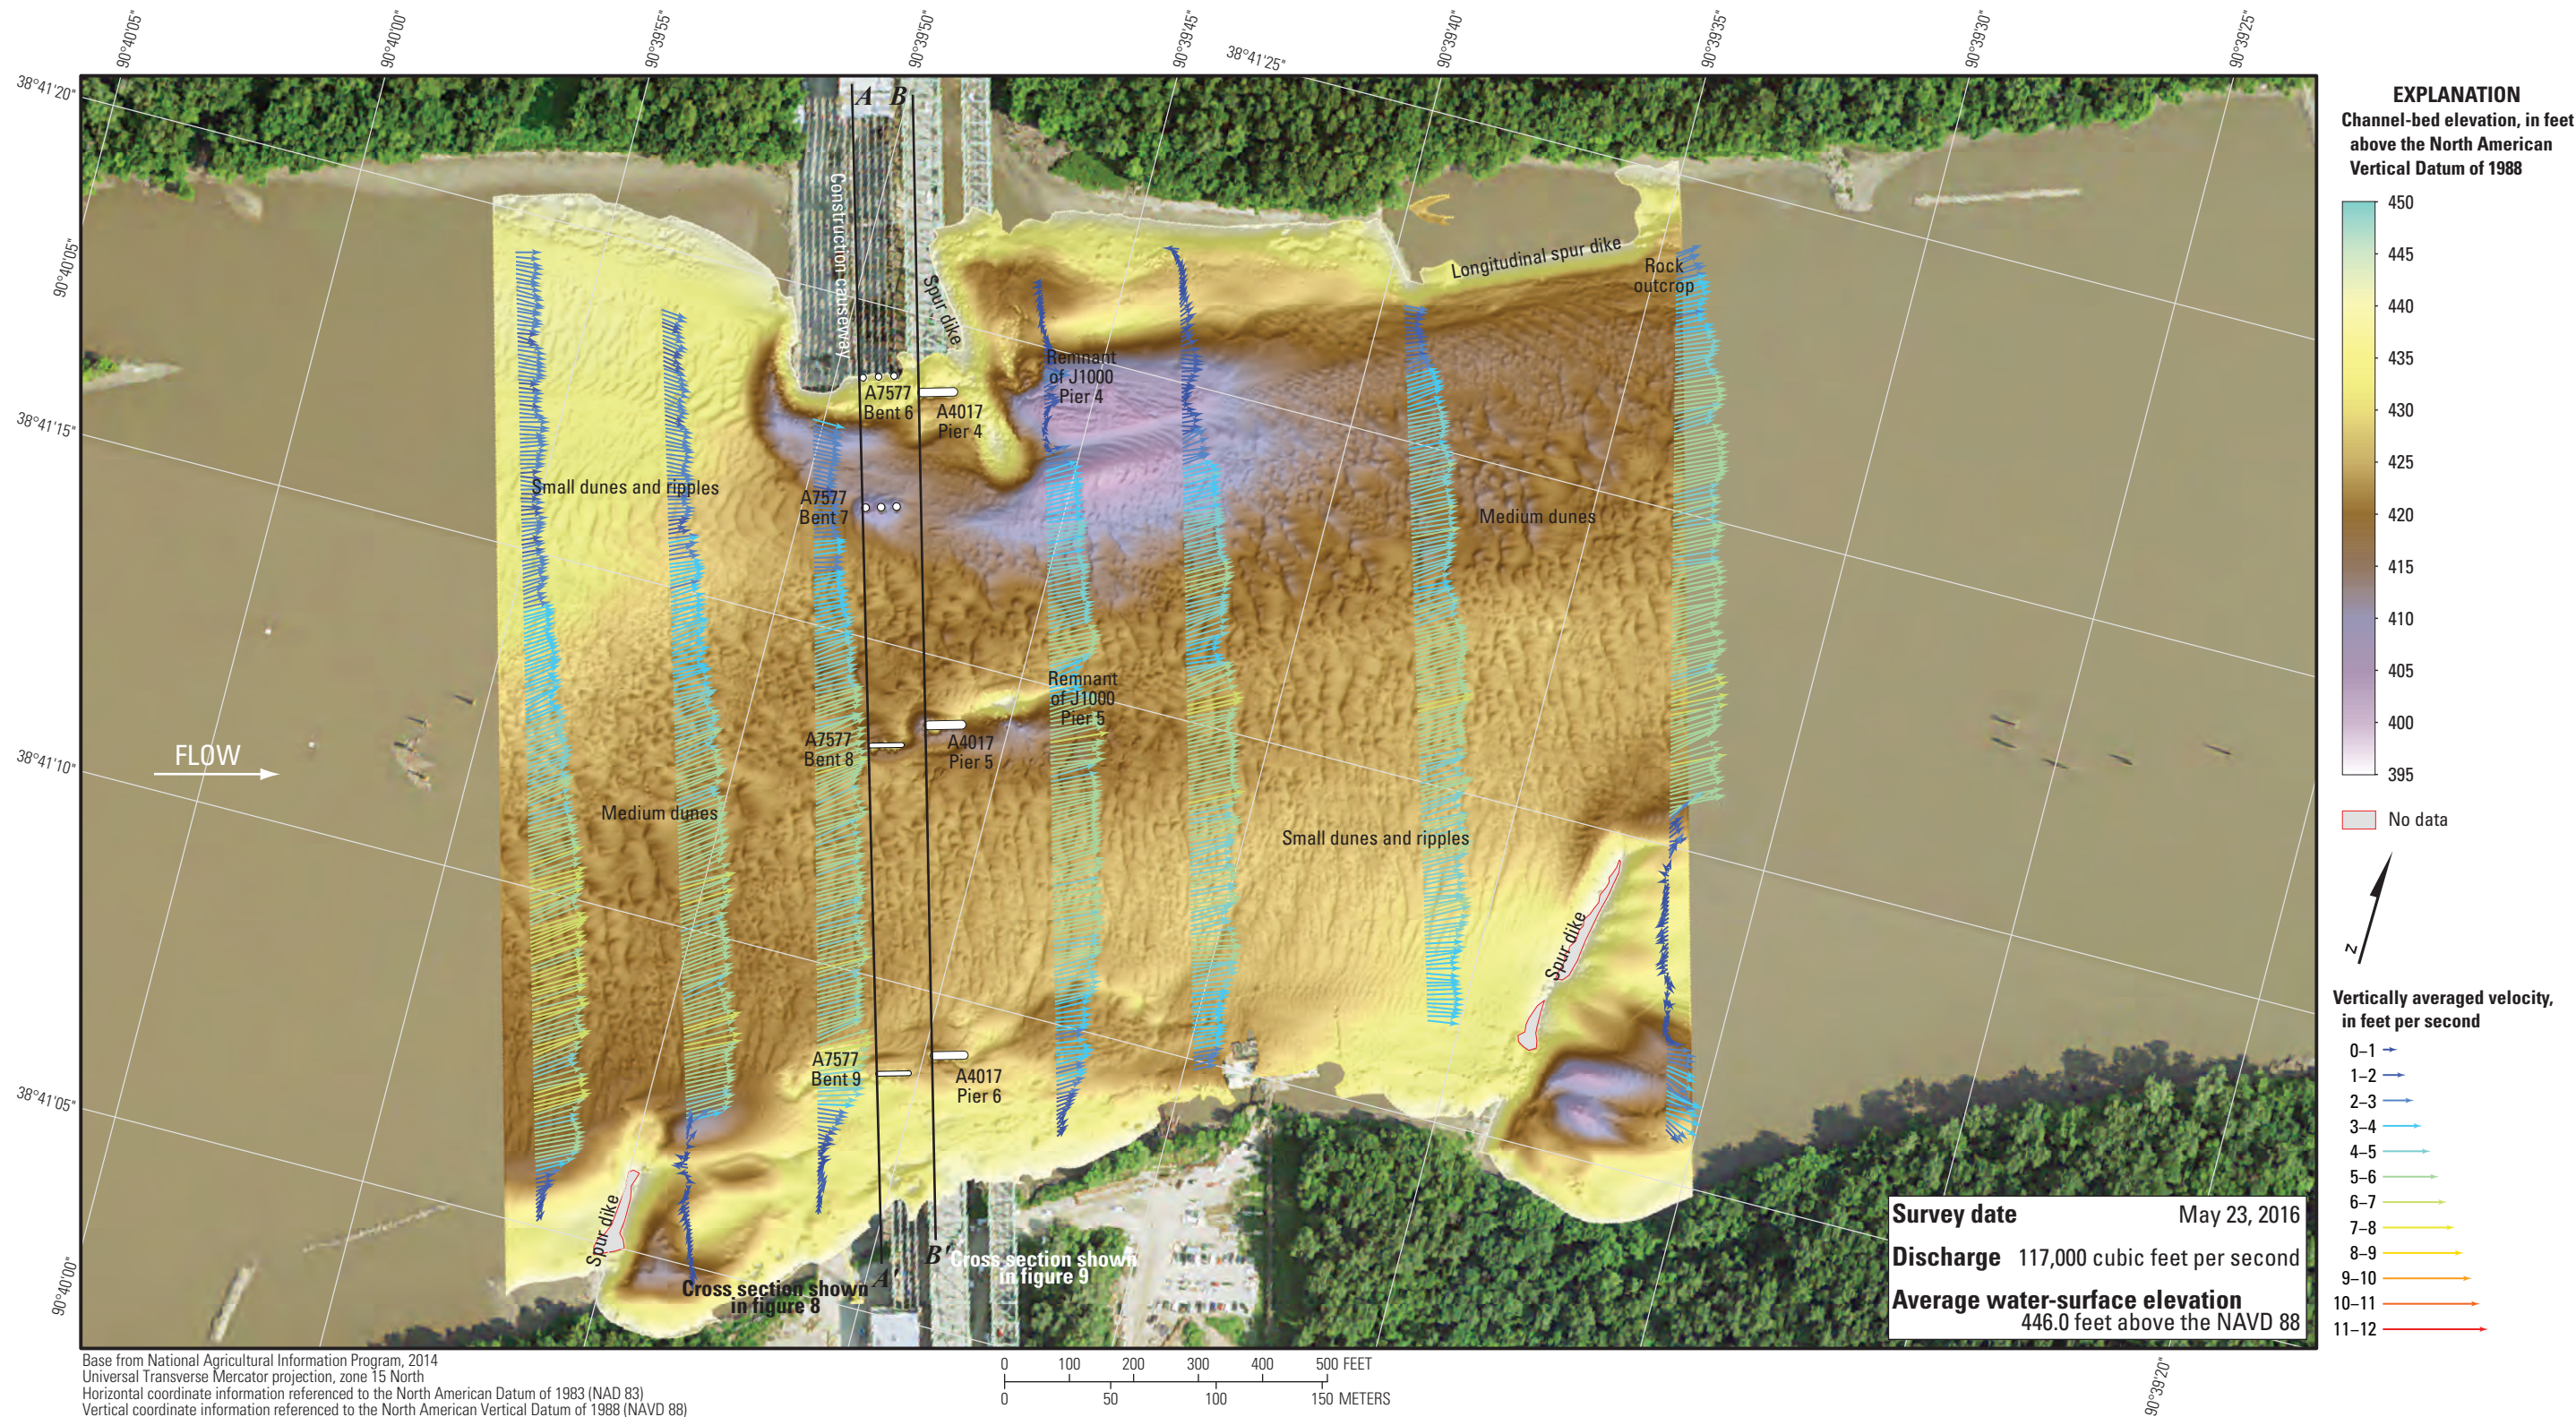
Figure 12. Bathymetry and vertically averaged velocities of the Missouri River channel near structures A7577 and A4017 on U.S. Highway 40 near St. Louis, Missouri.

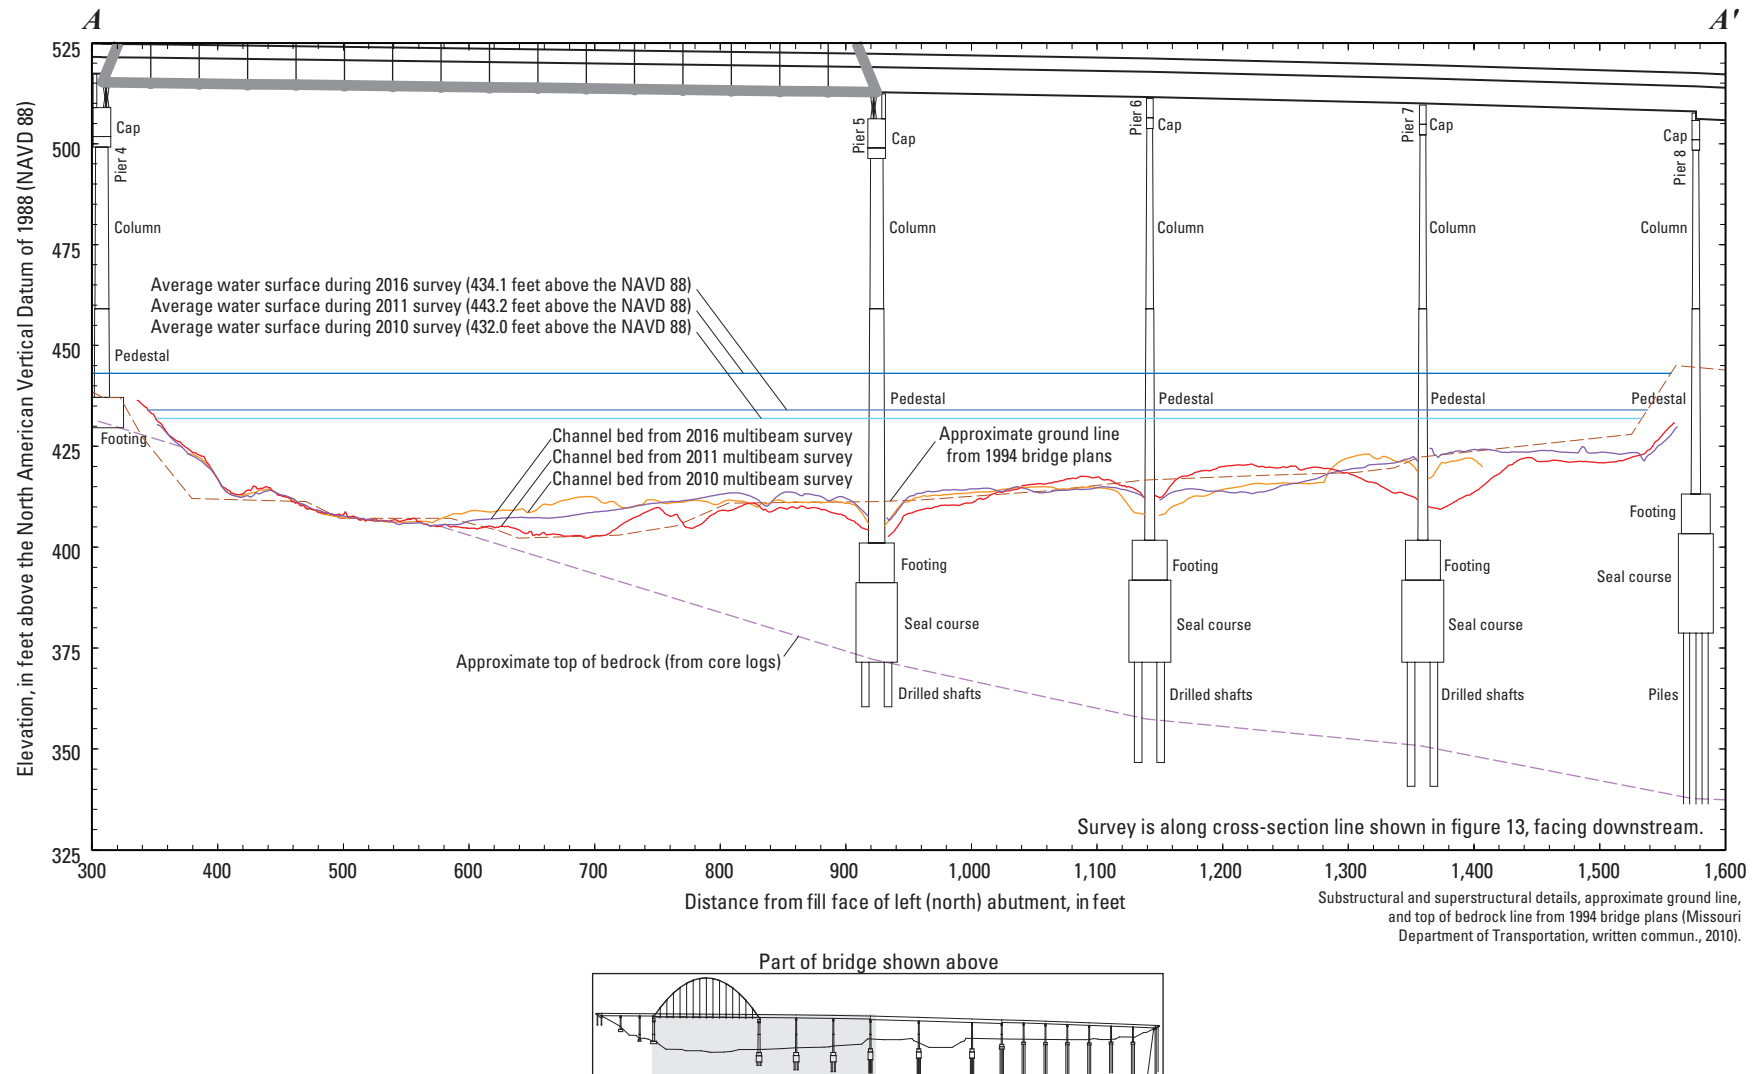
Information from bridge plans indicates that the main channel piers of both bridges of structure A5585 are founded on shafts drilled 11 ft into bedrock (figs. 15, 16; table 6). Depth of bed material between bedrock and the bottom of the various scour holes at dual bridge structure A5585 ranged from 34 to 69 ft because of the sloping bedrock in the area (figs. 15, 16; table 6). The approximate minimum channel-bed elevation in each of the scour holes was substantially higher than the bottom of the seal course elevation at each pier of 371.62 ft (figs. 15, 16; table 6).

Figure 15. Key features, substructural and superstructural details, and surveyed channel bed along the upstream face of the upstream bridge of dual bridge structure A5585 on State Highway 364 crossing the Missouri River near St. Louis, Missouri.

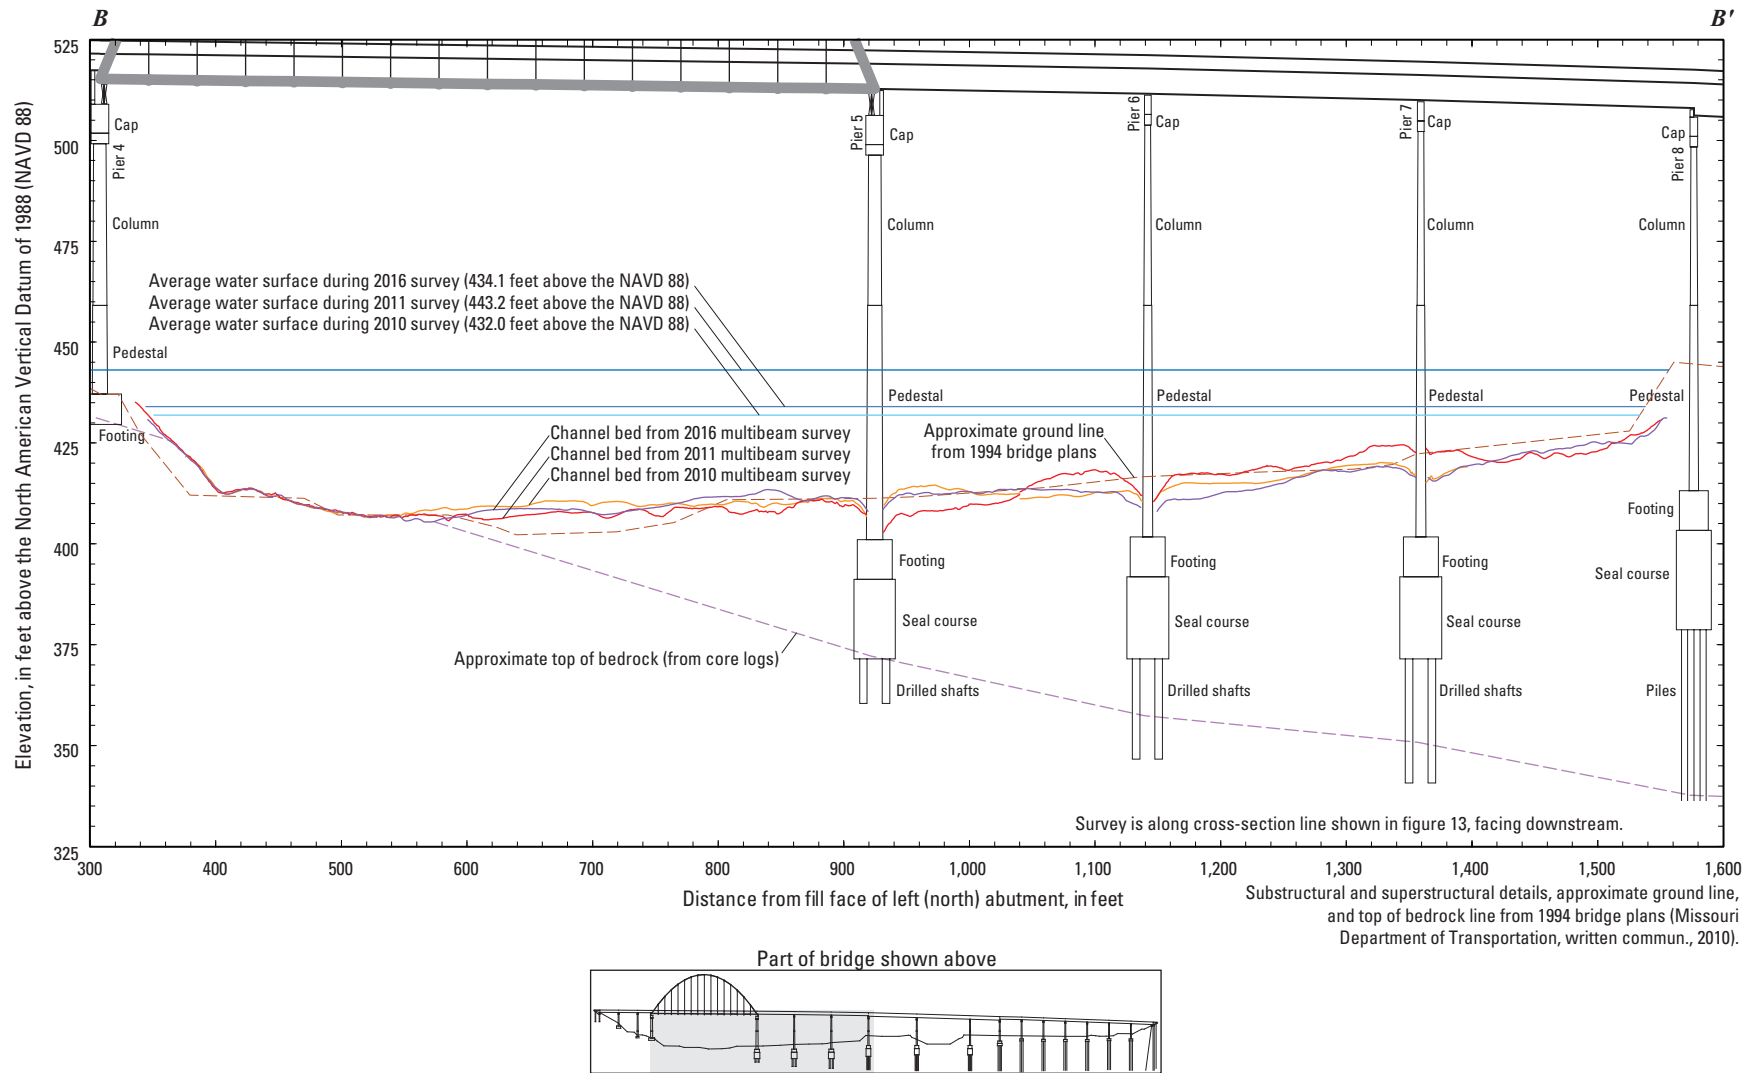
Figure 16. Key features, substructural and superstructural details, and surveyed channel bed along the upstream face of the downstream bridge of dual bridge structure A5585 on State Highway 364 crossing the Missouri River near St. Louis, Missouri.

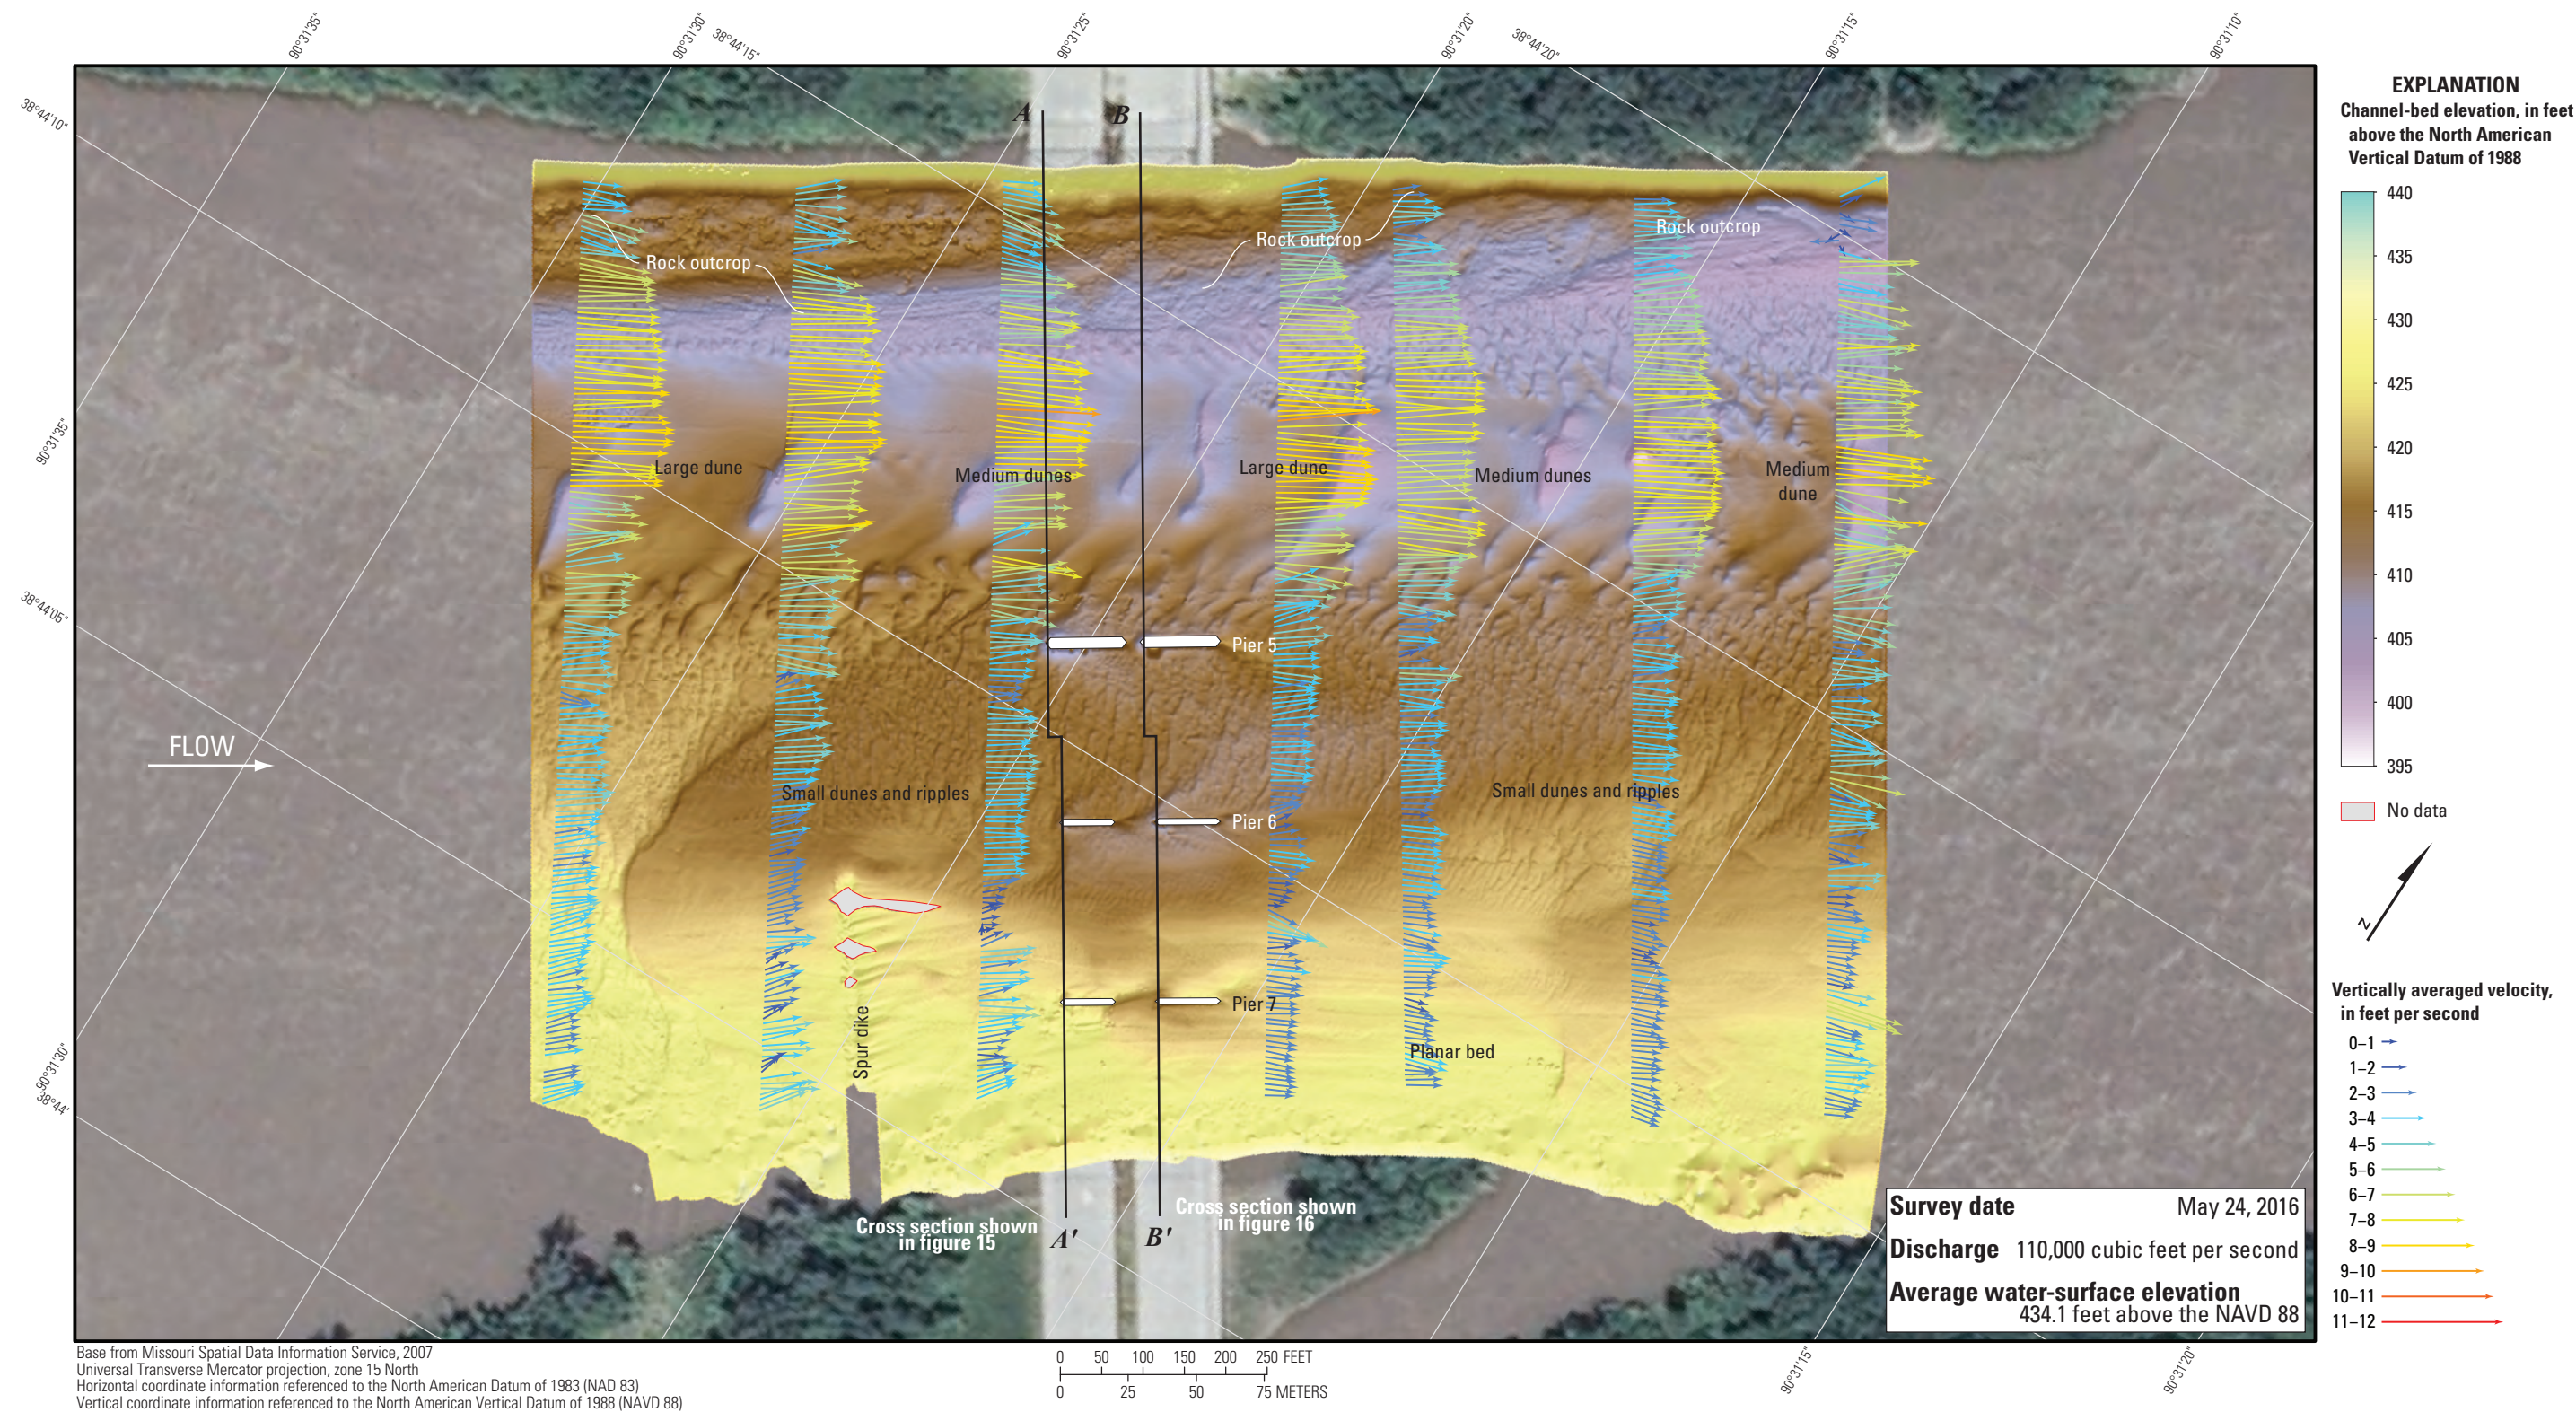
The vertically averaged velocity vectors indicate moderate to substantial turbulence throughout the reach, ranging from about 2 to 10 ft/s (fig. 19). Flow was angled to the left (north) in the upstream reach because of the bend in the river, and numerous local velocity minima were on the right (south) side of the channel (fig. 19). Substantial turbulence was observed in the channel thalweg, particularly downstream from the bridges (fig. 19). Piers 5 through 7 were aligned with flow, resulting in minimal additional turbulence downstream (fig. 19).

Figure 19. Bathymetry and vertically averaged velocities of the Missouri River channel near dual bridge structure A5585 on State Highway 364 near St. Louis, Missouri.

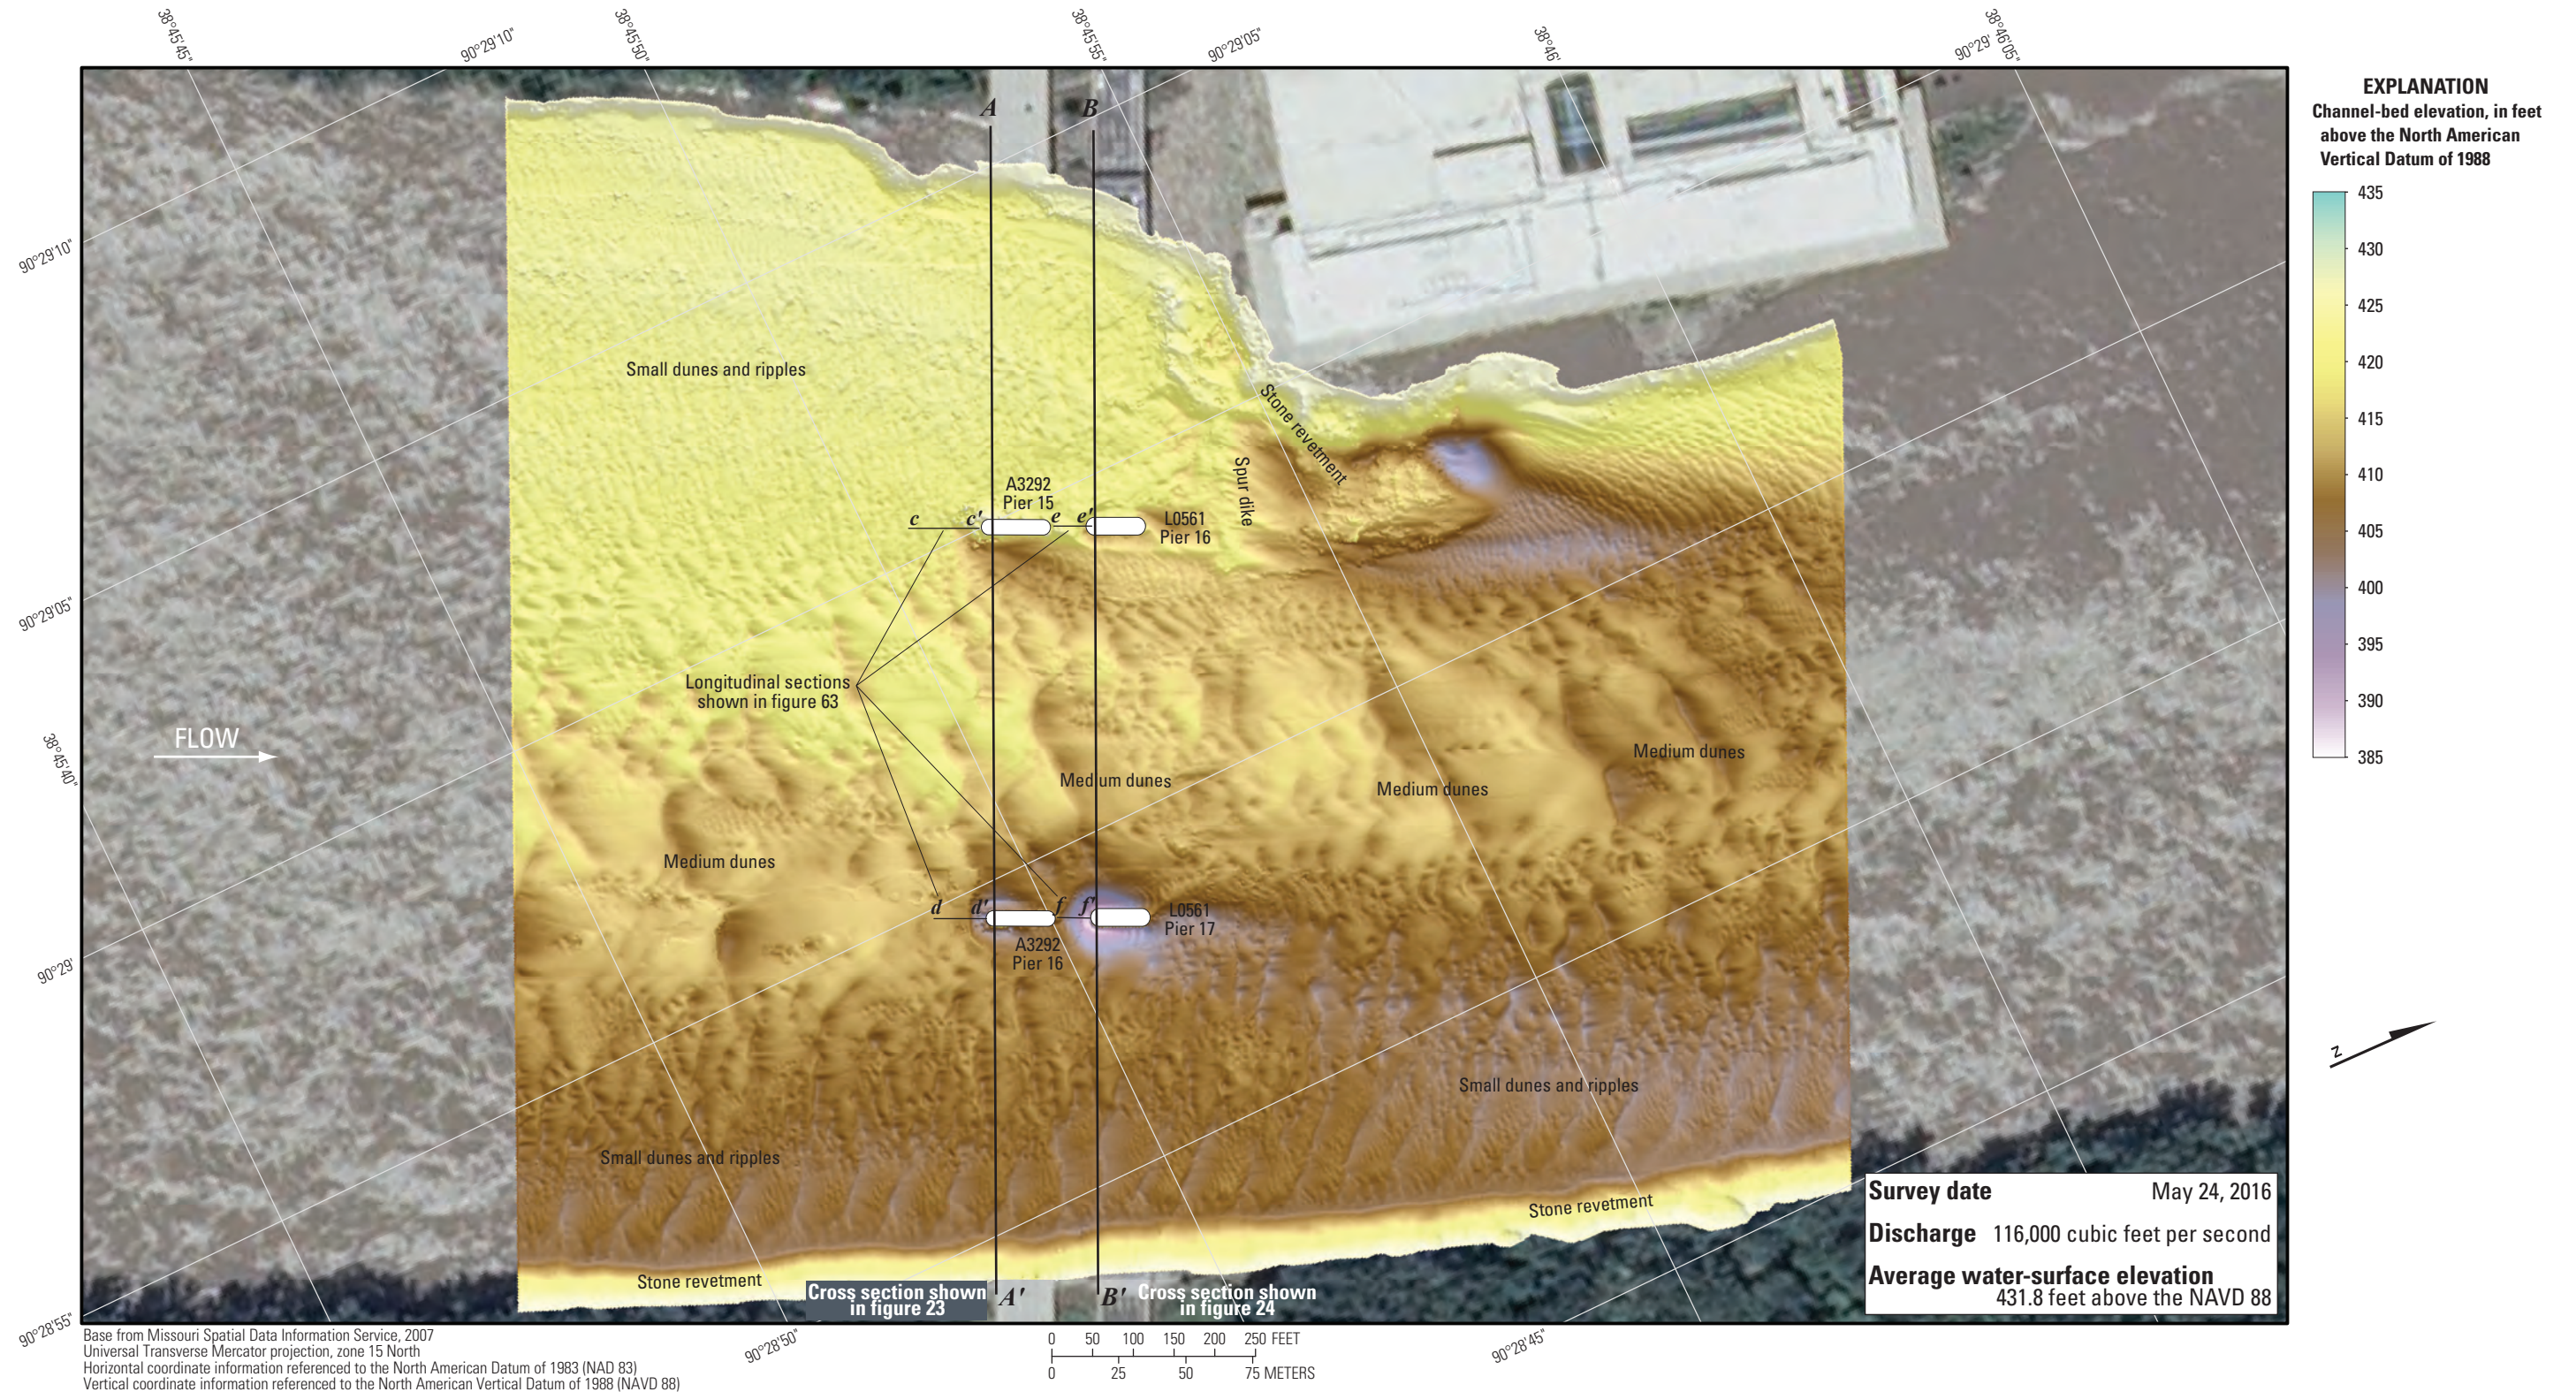
A minor scour hole near the left main channel piers (pier 15 of upstream structure A3292 and pier 16 of downstream structure L0561; fig. 20) had an approximate minimum channel-bed elevation of about 407 and 409 ft, respectively (table 6), about 13 ft below the average channel bed immediately upstream from pier 15 of structure A3292 (fig. 20; table 6). The scour hole was deeper on the right (southeast) side of pier 15 (fig. 20), likely exacerbated by the effects of a small debris raft trapped on the nose of that pier and the angled flow near the left main channel piers caused by the constriction downstream (fig. 22). Information from bridge plans indicates that pier 15 of upstream structure A3292 is founded on shafts drilled about 16 ft in bedrock (table 6), and

Larger scour holes were present near the right main channel piers of structures A3292 and L0561 (fig. 20). The scour hole at upstream pier 16 had an approximate minimum channel-bed elevation of about 399 ft (fig. 23; table 6), about 12 ft below the average channel bed immediately upstream from the pier, whereas the scour hole at downstream pier 17 had an approximate minimum channel-bed elevation of about 389 ft (fig. 24; table 6), about 18 ft below the average channel bed immediately upstream from that pier. Information from bridge plans indicates that pier 16 of upstream structure A3292 is founded on shafts drilled 17 ft into bedrock, and about 57 ft of bed material was present between the bottom of the scour hole and bedrock (fig. 23; table 6). Pier 17 of structure L0561 is founded on a caisson on bedrock, and about 46 ft of bed material was present between the bottom of the scour hole and bedrock (fig. 24; table 6).

Figure 20. Bathymetric survey of the Missouri River channel near structures A3292 and L0561 on Interstate 70 near St. Louis, Missouri.

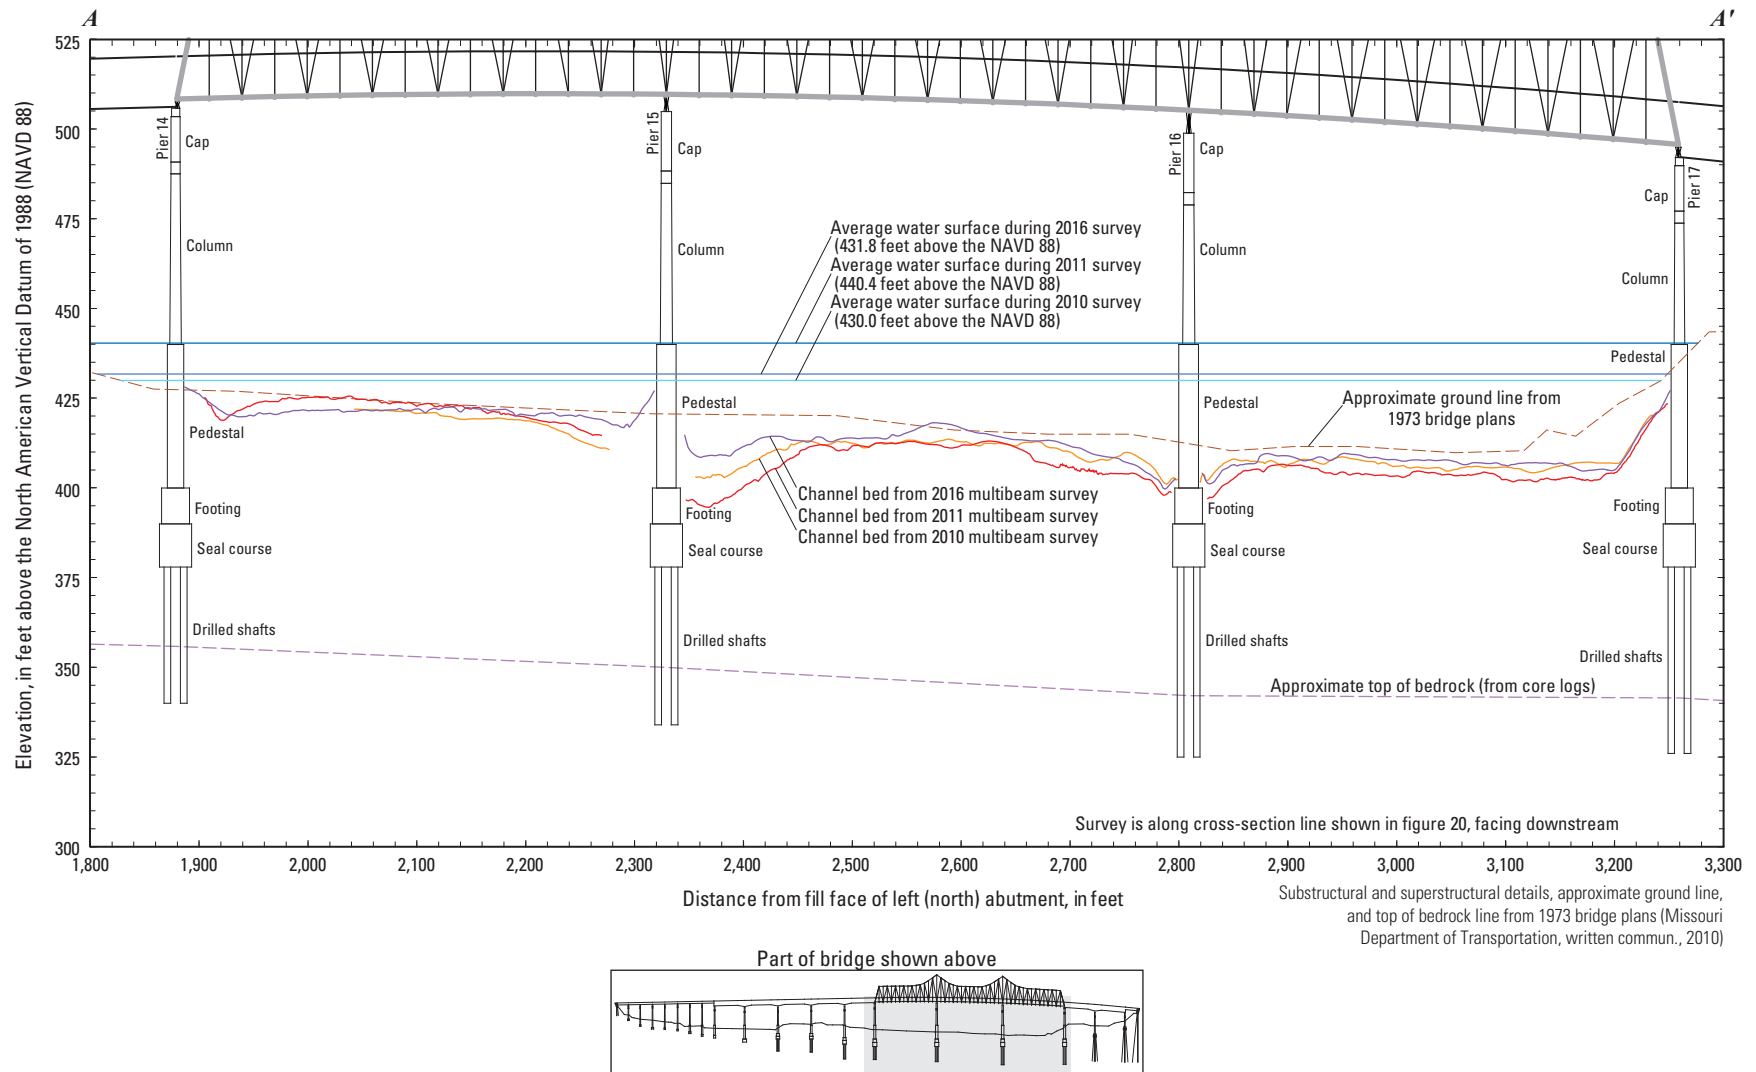
about 57 ft of bed material was present between the bottom of the scour hole and bedrock near the upstream pier (fig. 23; table 6). Pier 16 of downstream structure L0561 is founded on a caisson on bedrock, and the bottom of the minor local scour hole near this pier was about 58 ft above the bottom of the caisson and bedrock (fig. 24; table 6).

Figure 23. Key features, substructural and superstructural details, and surveyed channel bed of structure A3292 on Interstate 70 crossing the Missouri River near St. Louis, Missouri.

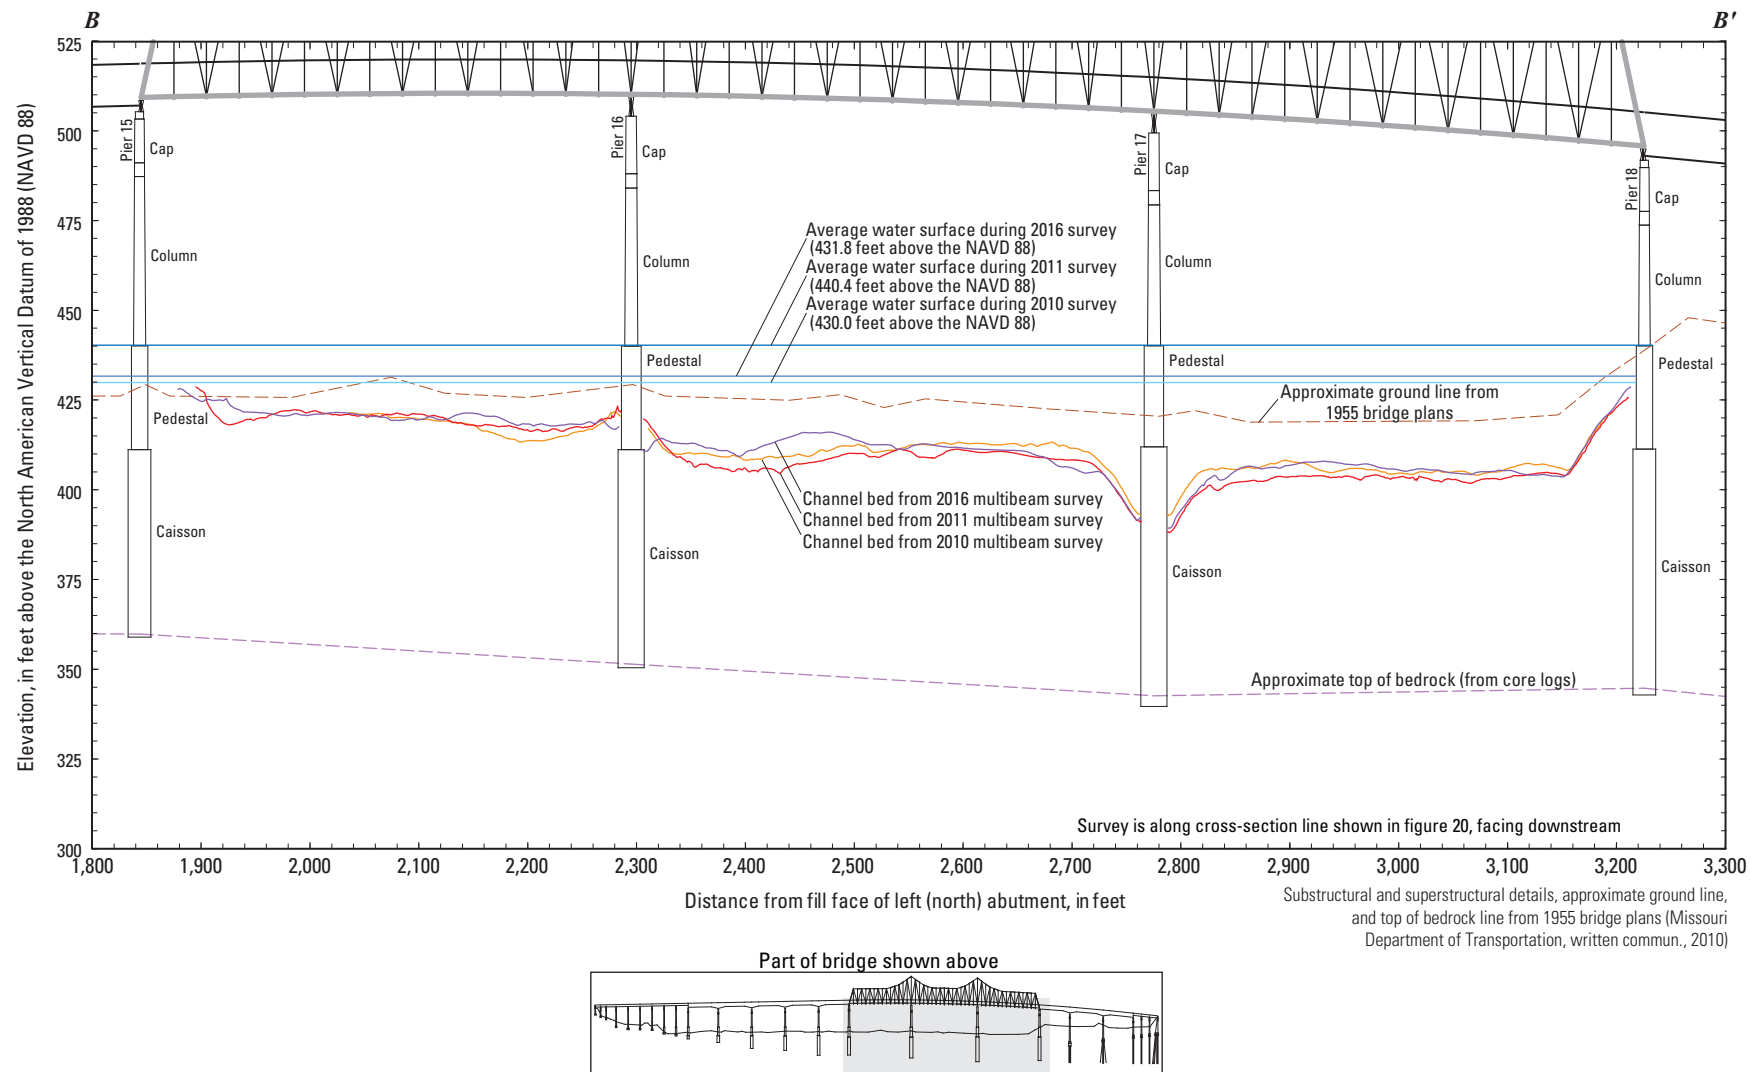
Figure 24. Key features, substructural and superstructural details, and surveyed channel bed of structure L0561 on Interstate 70 crossing the Missouri River near St. Louis, Missouri.
