Bathymetric and Velocimetric Surveys at Highway Bridges Crossing the Missouri and Mississippi Rivers near St. Louis, Missouri, May 23–27, 2016

Scientific Investigation Report 2017–5076

By Richard J. Huizinga

Prepared in cooperation with the Missouri Department of Transportation

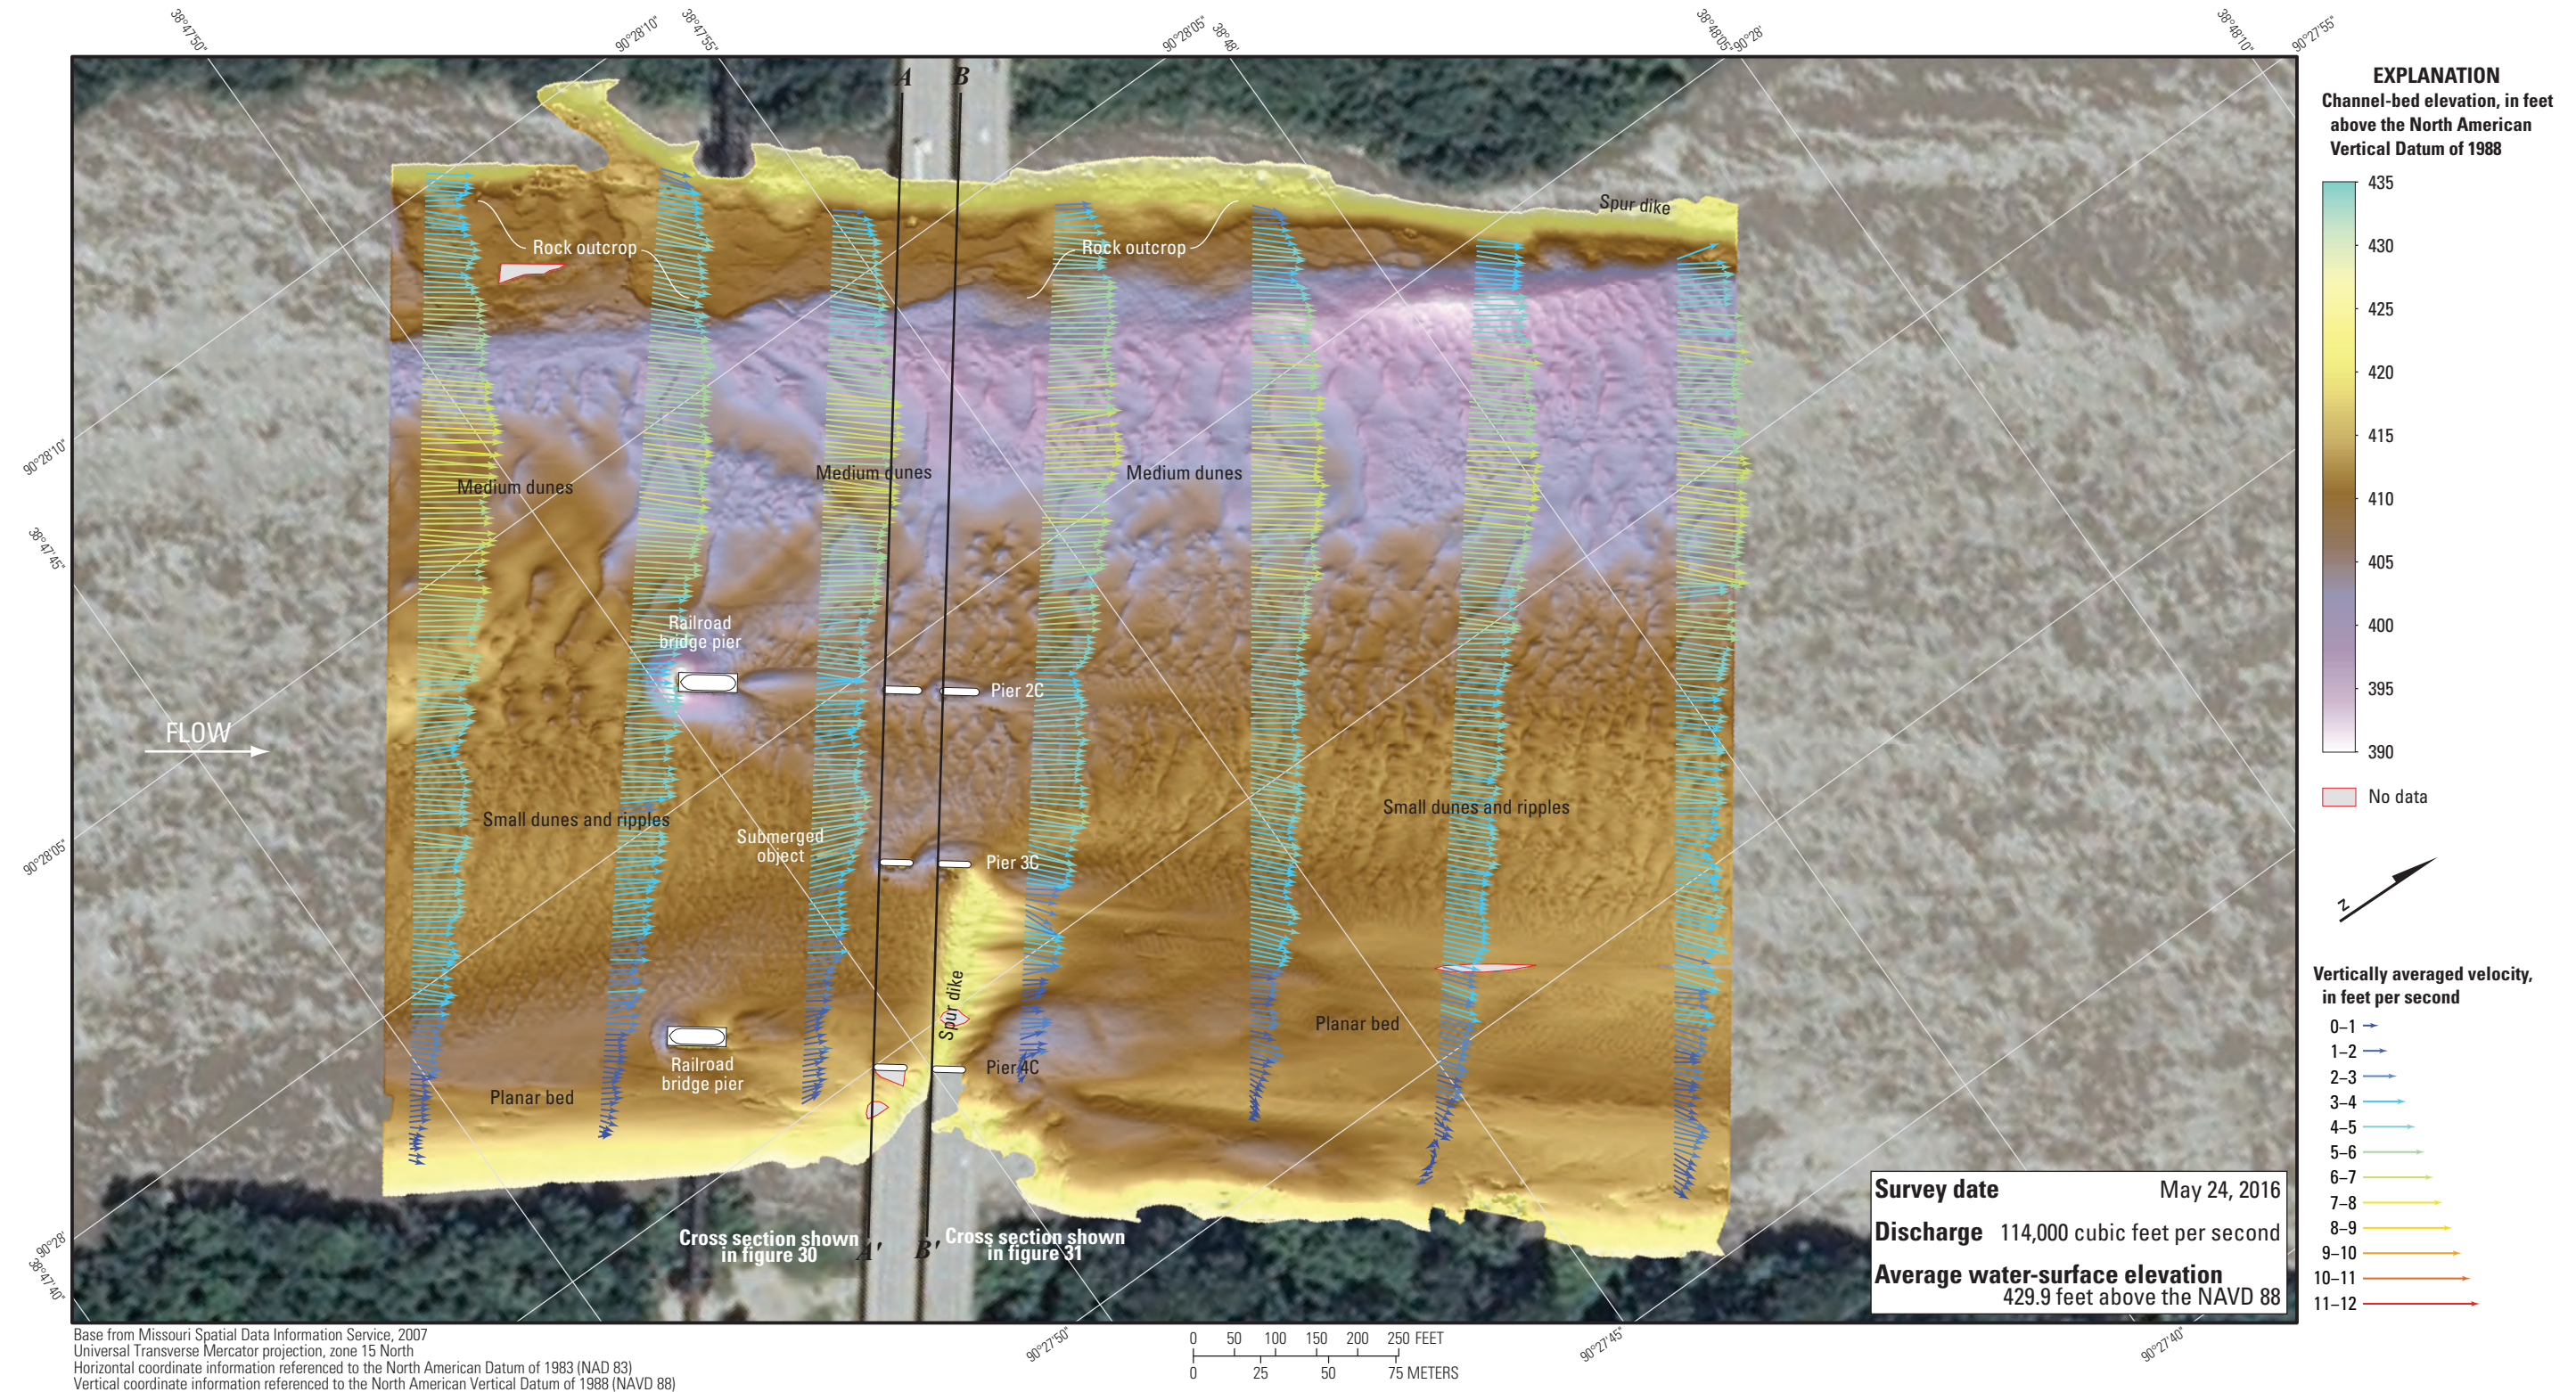
Figure 29. Bathymetry and vertically averaged velocities of the Missouri River channel near dual bridge structure A4557 on State Highway 370 near St. Louis, Missouri.

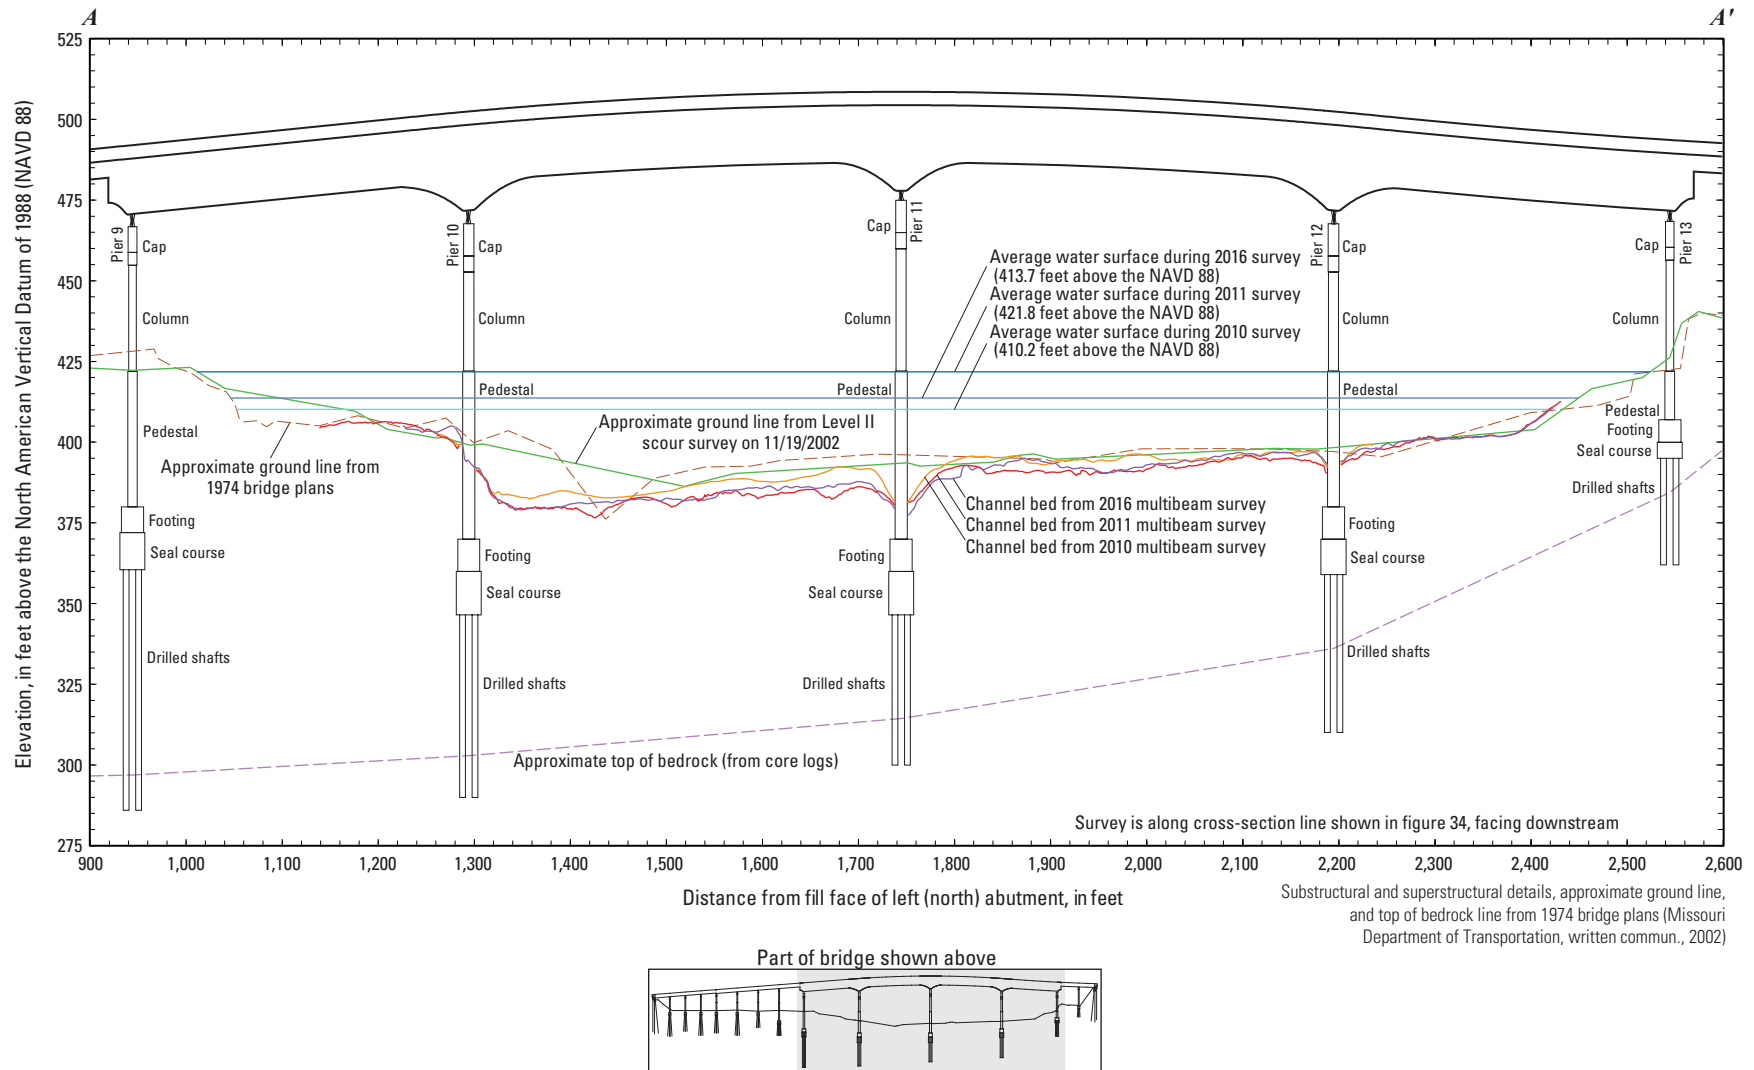
Figure 36. Key features, substructural and superstructural details, and surveyed channel bed of structure A3047 on U.S. Highway 67 crossing the Missouri River near St. Louis, Missouri.

Information from bridge plans indicates that pier 10 is founded on shafts drilled 13 ft into bedrock, and about 76 ft of bed material was present between the channel thalweg and bedrock at the bridge (table 6), and about 85 ft of bed material was present between the bed at the nose of the pier and bedrock (fig. 36; difference between “Approximate elevation

of scour hole at upstream pier/bent face” and “Approximate elevation of bedrock near pier/bent” in table 6). Pier 11 is founded on shafts drilled 15 ft into bedrock, and about 61 ft of bed material was present between the bottom of the scour hole and bedrock (fig. 36; table 6). Pier 12 is founded on shafts drilled 26 ft into bedrock, and about 56 ft of bed material was present between the bottom of the scour hole and bedrock (fig. 36; table 6).

from the two surveys are similar on the left and right sides of the channel, and indicate scour for most of the channel between piers 10 and 12 (fig. 36). The frequency distribution of bed elevations was of a similar shape but wider in 2016 than in 2010; a greater percentage of survey-grid cells was at elevations above 398 ft (fig. 35).

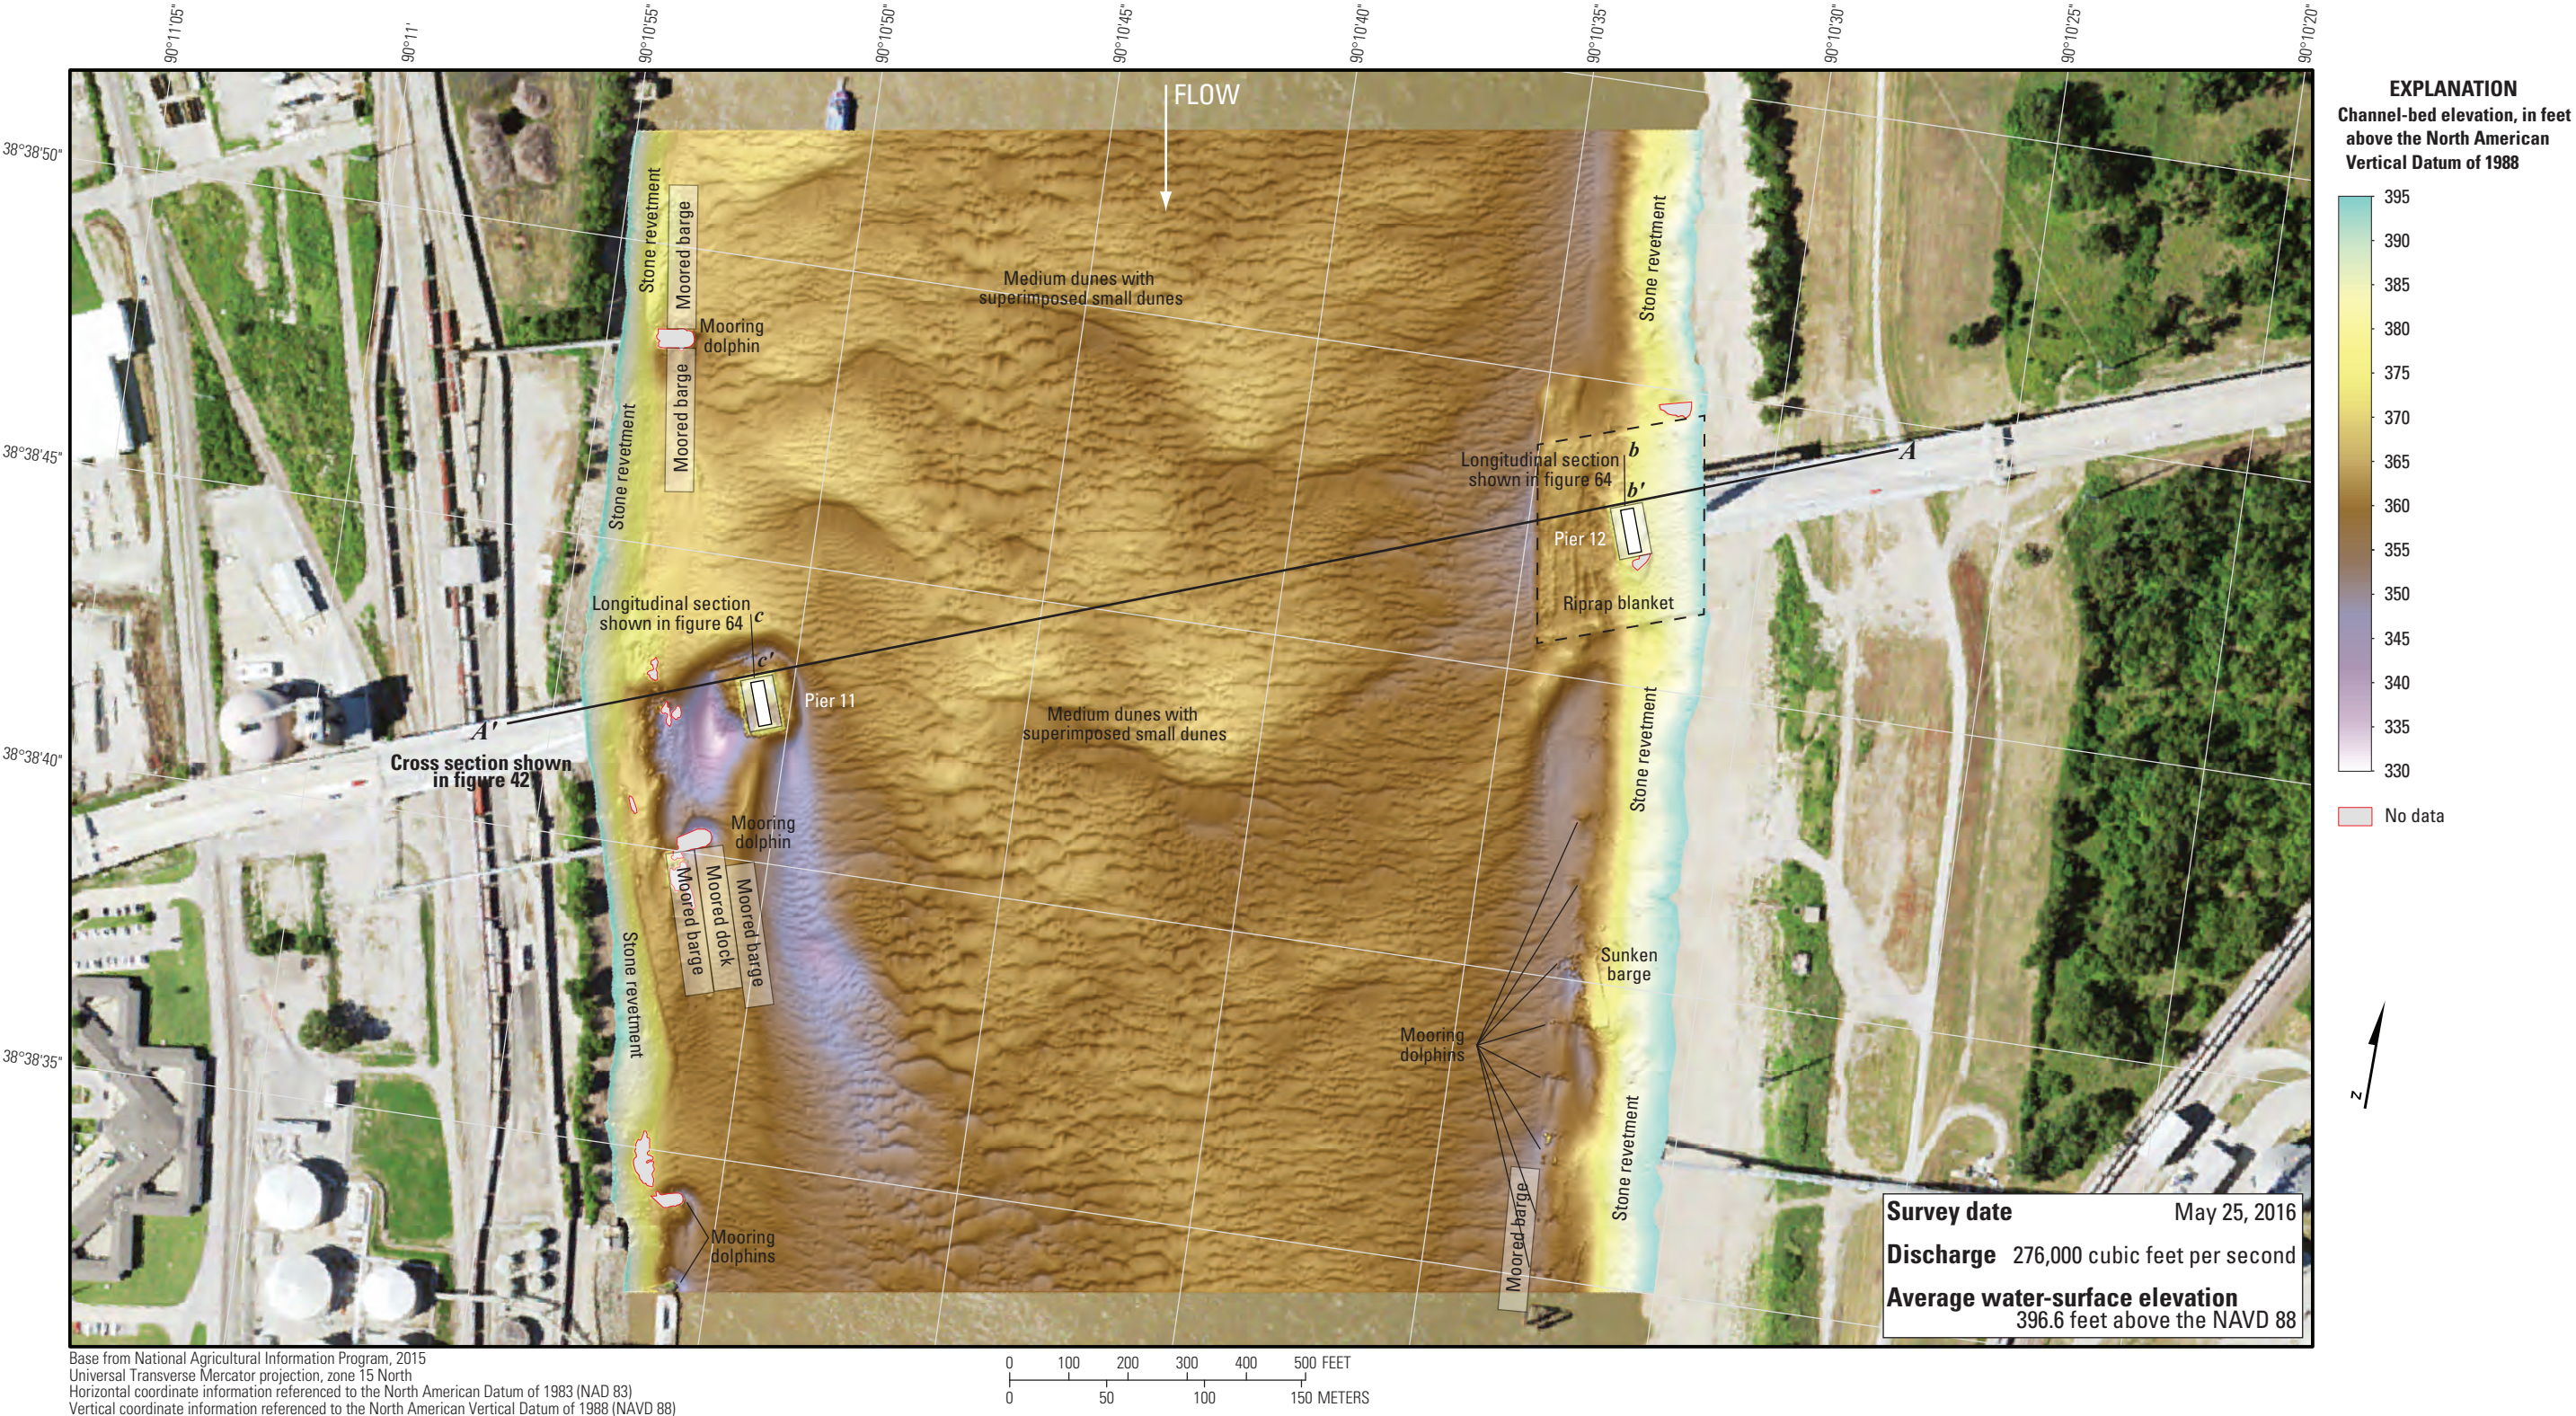
Figure 40. Bathymetric survey of the Mississippi River channel near structure A6500 on Interstate 70 in St. Louis, Missouri.

The survey area was about 1,970 ft long and about 1,480 ft wide, extending from bank to bank in the main channel (fig. 40). The upstream end of the survey area was about 860 ft upstream from the centerline of structure A6500 (fig. 40). The approximate channel-bed elevations ranged from about 354 to 383 ft for most of the surveyed area (5th to 95th percentile range of the bathymetric data; table 5; fig. 41), except downstream from the right (west) main channel pier, where the overall minimum channel-bed elevation was 334 ft (tables 5, 8; fig. 40). A poorly defined thalweg was present along the left (east) bank throughout the surveyed area. Numerous small dunes and ripples were detected throughout the channel, and a few medium dune features with superimposed small dunes and ripples were present in the middle of the channel (fig. 40). As in the previous survey (Huizinga and others, 2010), stone revetment was present on both banks throughout the reach (fig. 40).

There was no scour hole near left (east) main channel pier 12 because the pier is surrounded with a riprap blanket (figs. 40, 42; table 8). The top of the riprap blanket is slightly higher than the bottom of the pier seal course elevation of 361.5 ft (fig. 42; table 8). Main channel pier 11 seems to be partly surrounded with mounded riprap, but the top of the riprap pile is below the bottom of the seal course elevation on the downstream side of the pier (fig. 40; table 8). The approximate

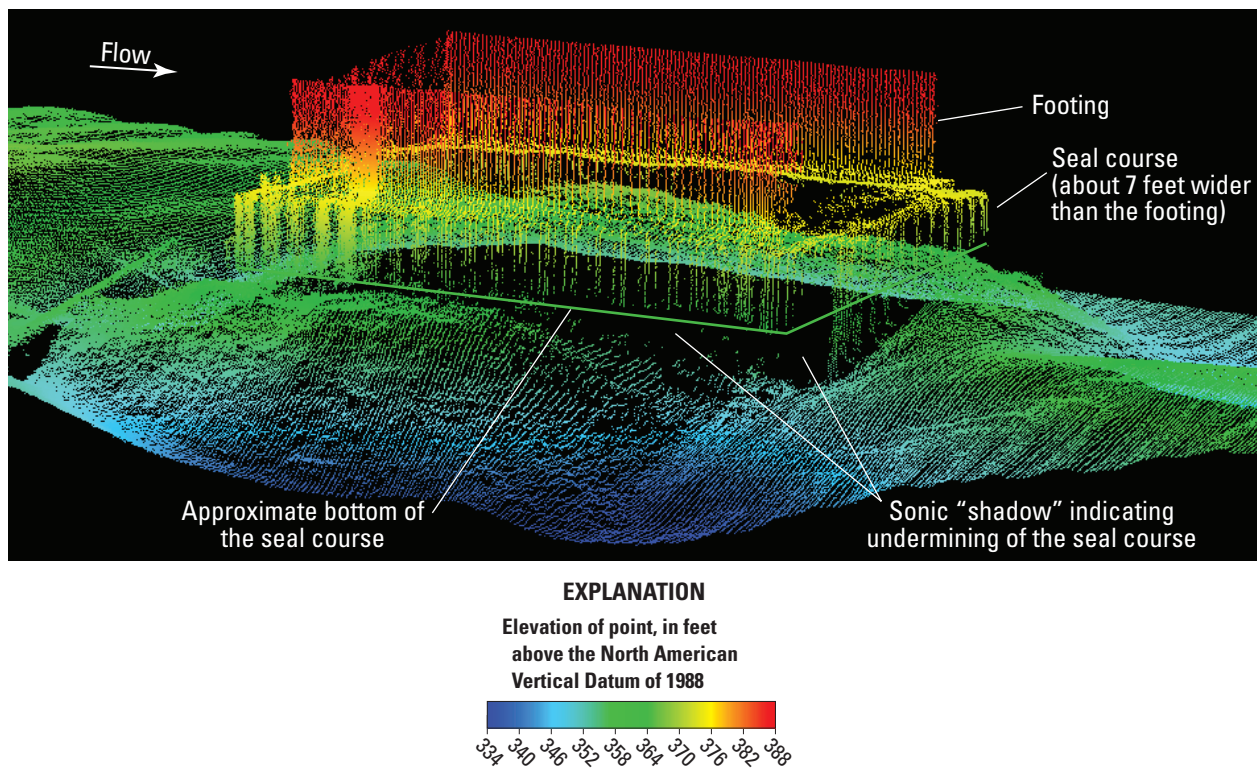
Figure 43. Point cloud visualization of the channel bed and right (west) side of main channel pier 11 of structure A6500 on Interstate 70 crossing the Mississippi River in St. Louis, Missouri.

elevation of the bottom of the scour hole on the upstream side of the pier is about 348 ft, about 13 ft below the bottom of the seal course (table 8). Information from bridge plans indicates that pier 11 is founded on shafts drilled 22 ft into bedrock, and about 15 ft of bed material was present between the bottom of the scour hole and bedrock (fig. 42; table 8). The undermined seal course is evident in a point cloud image of the right (west) side of pier 11 (fig. 43); furthermore, the seal course seems to be larger than the footing by about 7 ft on each side (fig. 43), which is not indicated in the plans (fig. 42). This is true for both piers (appendix 1, fig. 1–6). The approximate ground line from the 2010 bridge plans was digitized directly from the

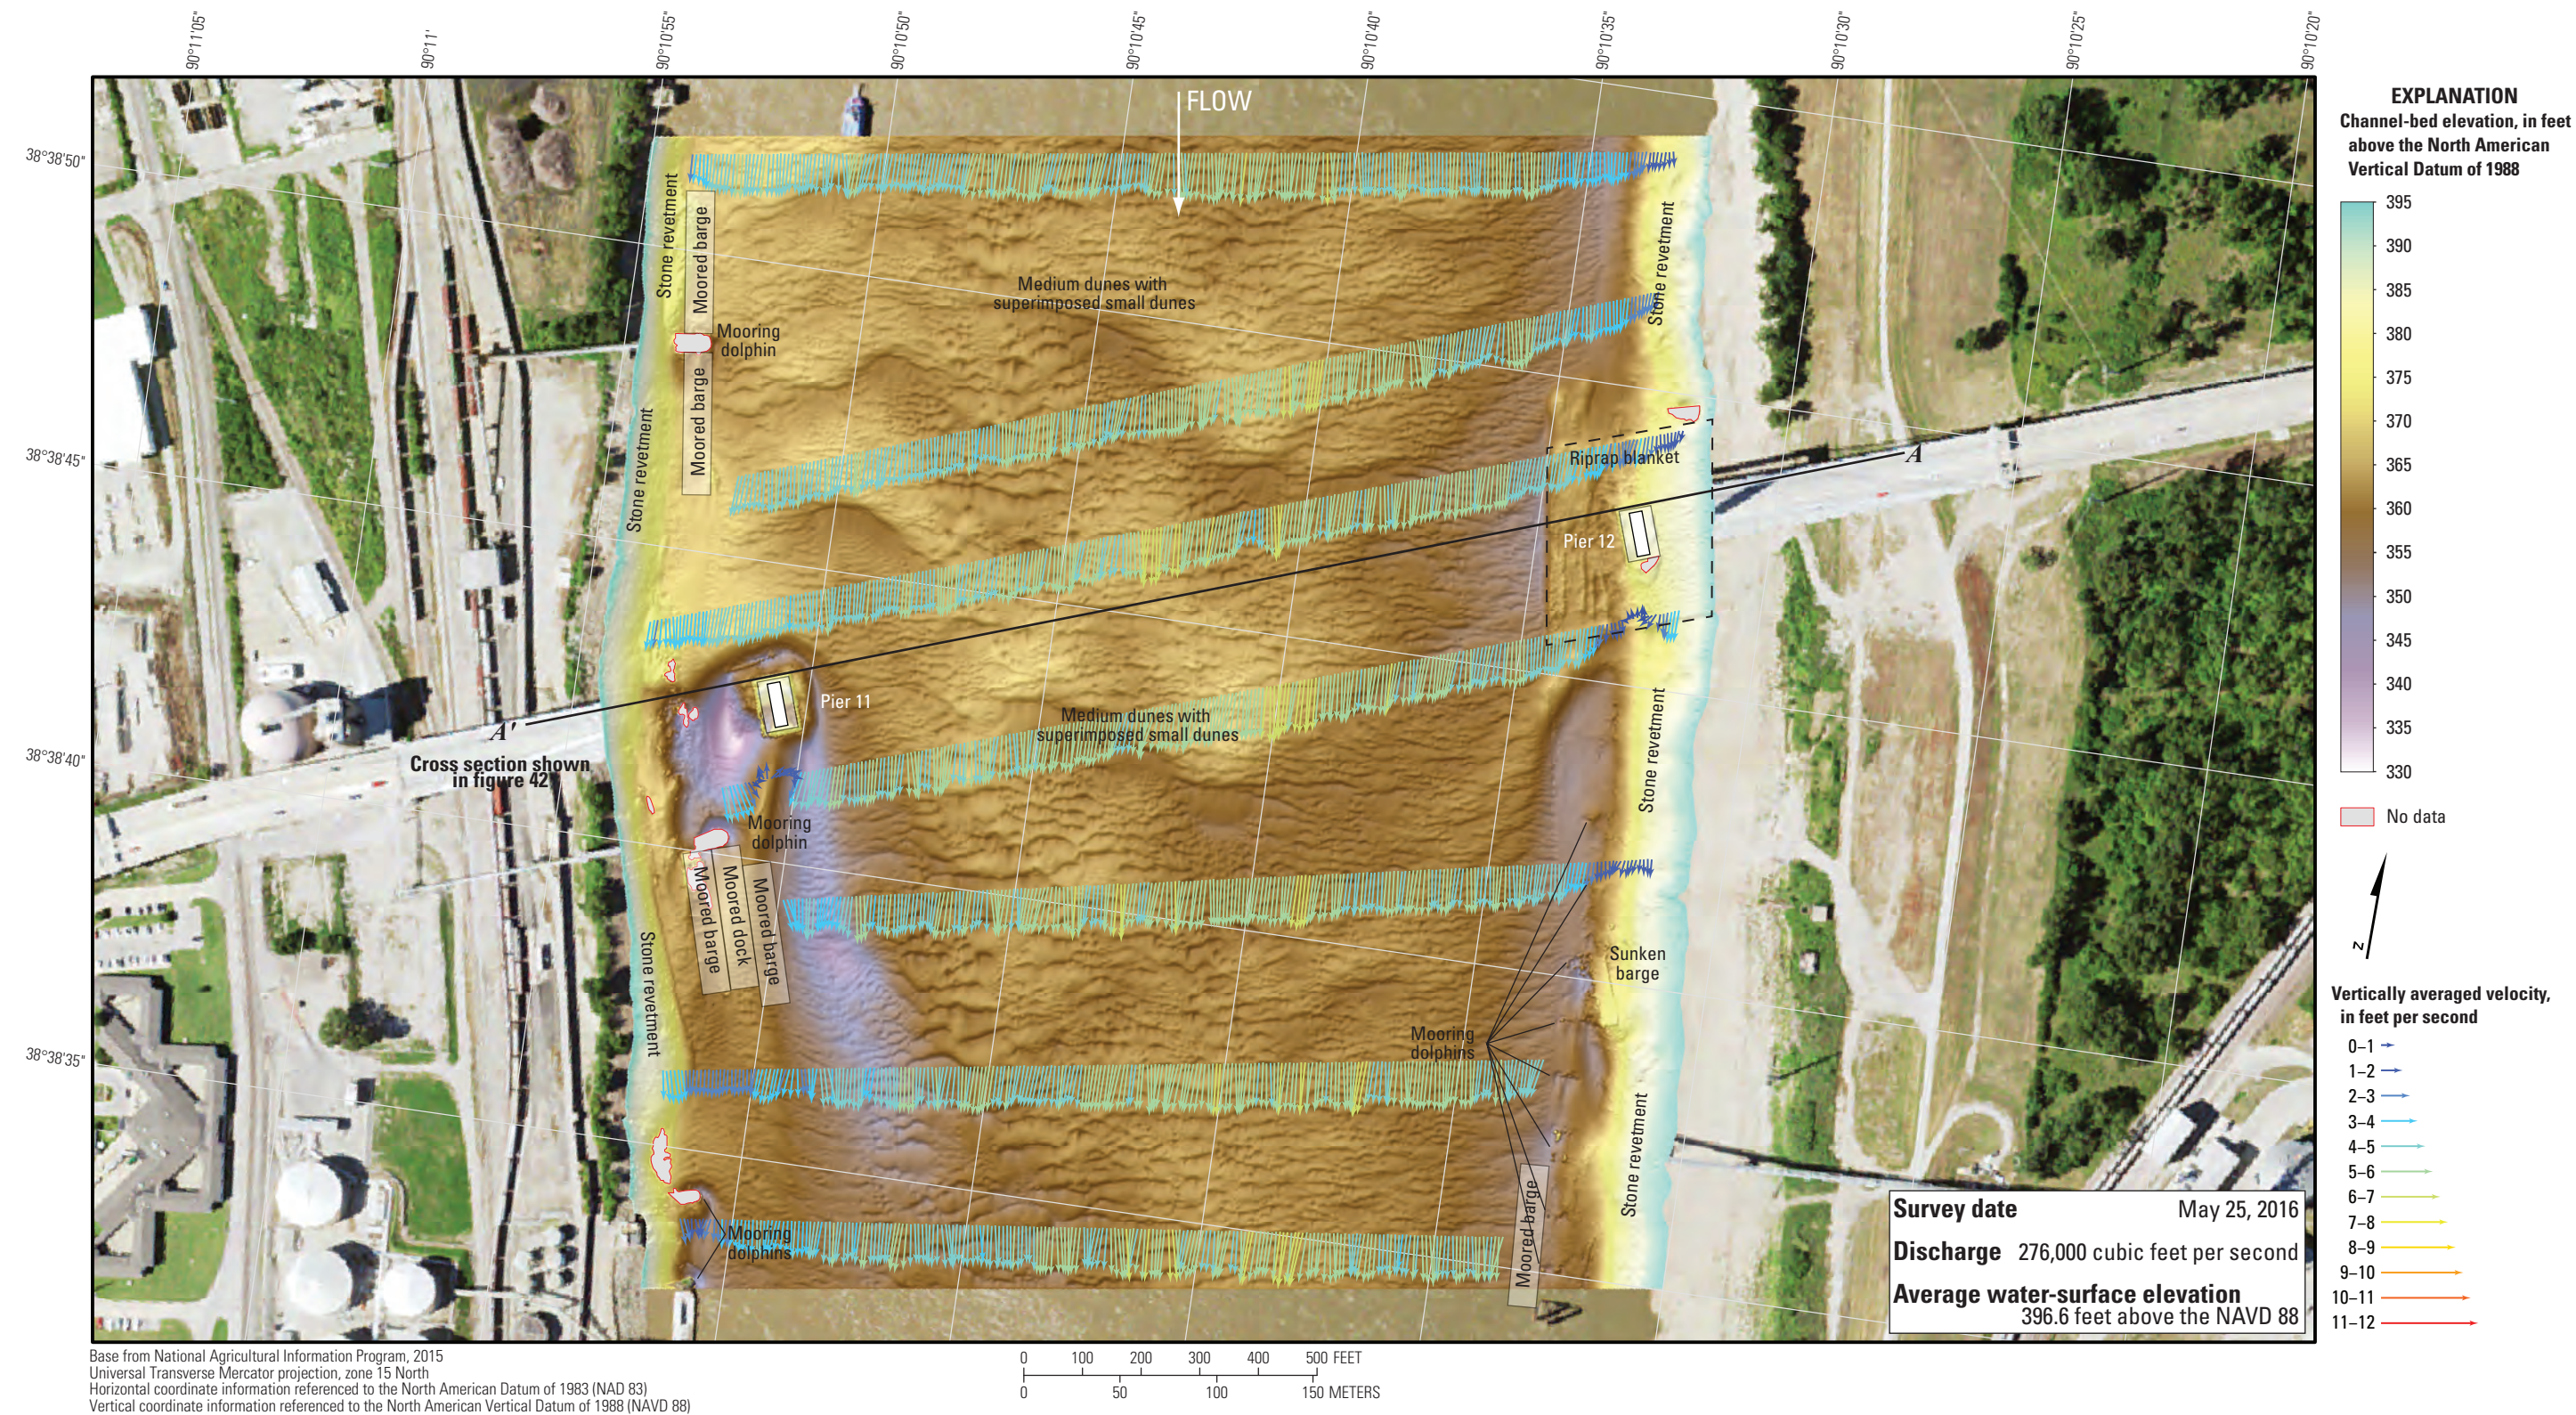
Figure 45. Bathymetry and vertically averaged velocities of the Mississippi River channel near structure A6500 on Interstate 70 in St. Louis, Missouri.

In the preconstruction survey in 2009, flow was observed to cross from the Illinois (east) side of the river to the Missouri (west) side through the reach, and generally this was reflected in the vertically averaged velocity vectors for the present (2016) survey (fig. 45). Both piers are skewed to approach flow, and the scour hole near pier 11 has the typical characteristics of a hole at a skewed pier, being longer on the side with impinging flow and an angled line of deposition on the leeward side (figs. 40, 45); however, the 55-ft-wide, square nose of pier 11, a mild constriction downstream from the pier, and the additional scour from adjacent mooring dolphins downstream likely have exacerbated the scour on the leeward side of the pier by increasing local turbulence and pulling sediment into suspension (figs. 40, 45). A similar situation was observed at the main channel pylon for structure A7650 in Kansas City in 2015 (Huizinga, 2016, fig. 24).

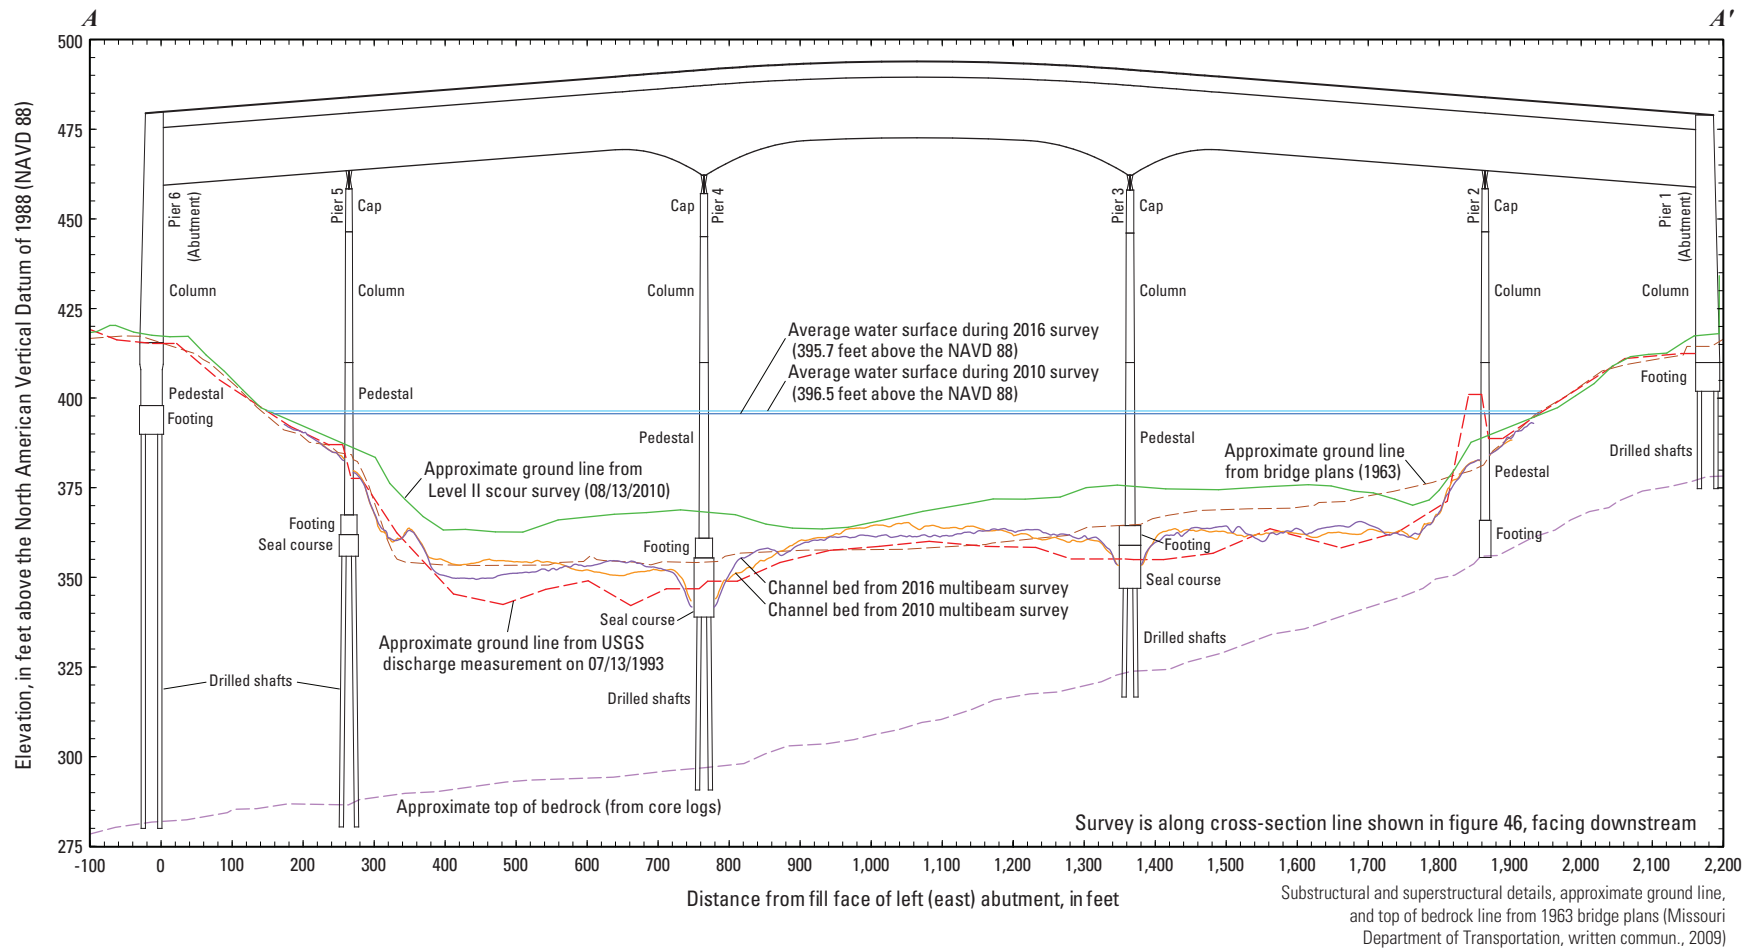
Figure 48. Profile showing key features, substructural and superstructural details, and surveyed channel bed of structure A1500 on Interstate 55 crossing the Mississippi River in St. Louis, Missouri.

There was no observed scour hole near the left bank pier (pier 5, fig. 46). The upper left bank is covered with gravel and cobble-sized revetment that seems to extend to the toe of the bank and will limit or prevent scour at this pier. The channel thalweg at the toe of the left bank had a minimum elevation of about 350 ft immediately downstream from pier 5 (fig. 46), which is about 6 ft below the bottom of the seal course elevation of 356.00 ft (fig. 48; table 8); however, the thalweg is more than 100 ft to the right from the pier (figs. 46, 48). Information from bridge plans indicates that pier 5 is founded on shafts drilled 7 ft into bedrock, and about 63 ft of bed material was present between the channel thalweg and bedrock near the bridge (fig. 48), and about 71 ft of bed material was present between the bed and bedrock at the upstream pier face (fig. 48; table 8).

only about 1 ft above the bottom of the seal course elevation (fig. 48; table 8). Information from bridge plans indicates that pier 4 is founded on shafts drilled 7 ft into bedrock, and about 43 ft of bed material was present between the bottom of the scour hole and bedrock (fig. 48; table 8). Similarly, a moderate scour hole was present near the right main channel pier (pier 3, fig. 46) with a minimum elevation of about 352 ft, about 12 ft below the average channel bed immediately upstream from the pier (fig. 46; table 8), and about 5 ft above the bottom of the seal course elevation (fig. 48; table 8). Information from bridge plans indicates that pier 3 also is founded on shafts drilled 7 ft into bedrock, and about 28 ft of bed material was present between the bottom of the scour hole and bedrock (fig. 48; table 8).

The difference between the survey on May 25, 2016, and the previous survey on October 20, 2010 (fig. 49), indicates a balance of scour and deposition (a mean difference of -0.38 ft between the bathymetric surfaces) throughout the reach from 2010 to 2016 (table 7). The net volume of cut in the reach from 2010 to 2016 was about 141,500 yd³, and the net volume of fill was about 105,700 yd³, resulting in a net loss of about 35,800 yd³ of sediment between 2010 and 2016. There was moderate deposition of more than 10 ft in the middle of the channel downstream from the bridge (fig. 49); however, substantial scour of as much as 10 ft was observed in the middle of the upstream channel, and moderate scour was observed along the left (east) side of the channel throughout the reach (fig. 49). The cross section from the 2016 survey alternates above and below the 2010 survey; however, the scour holes at piers 3 and 4 are similar in size and depth (fig. 48). The

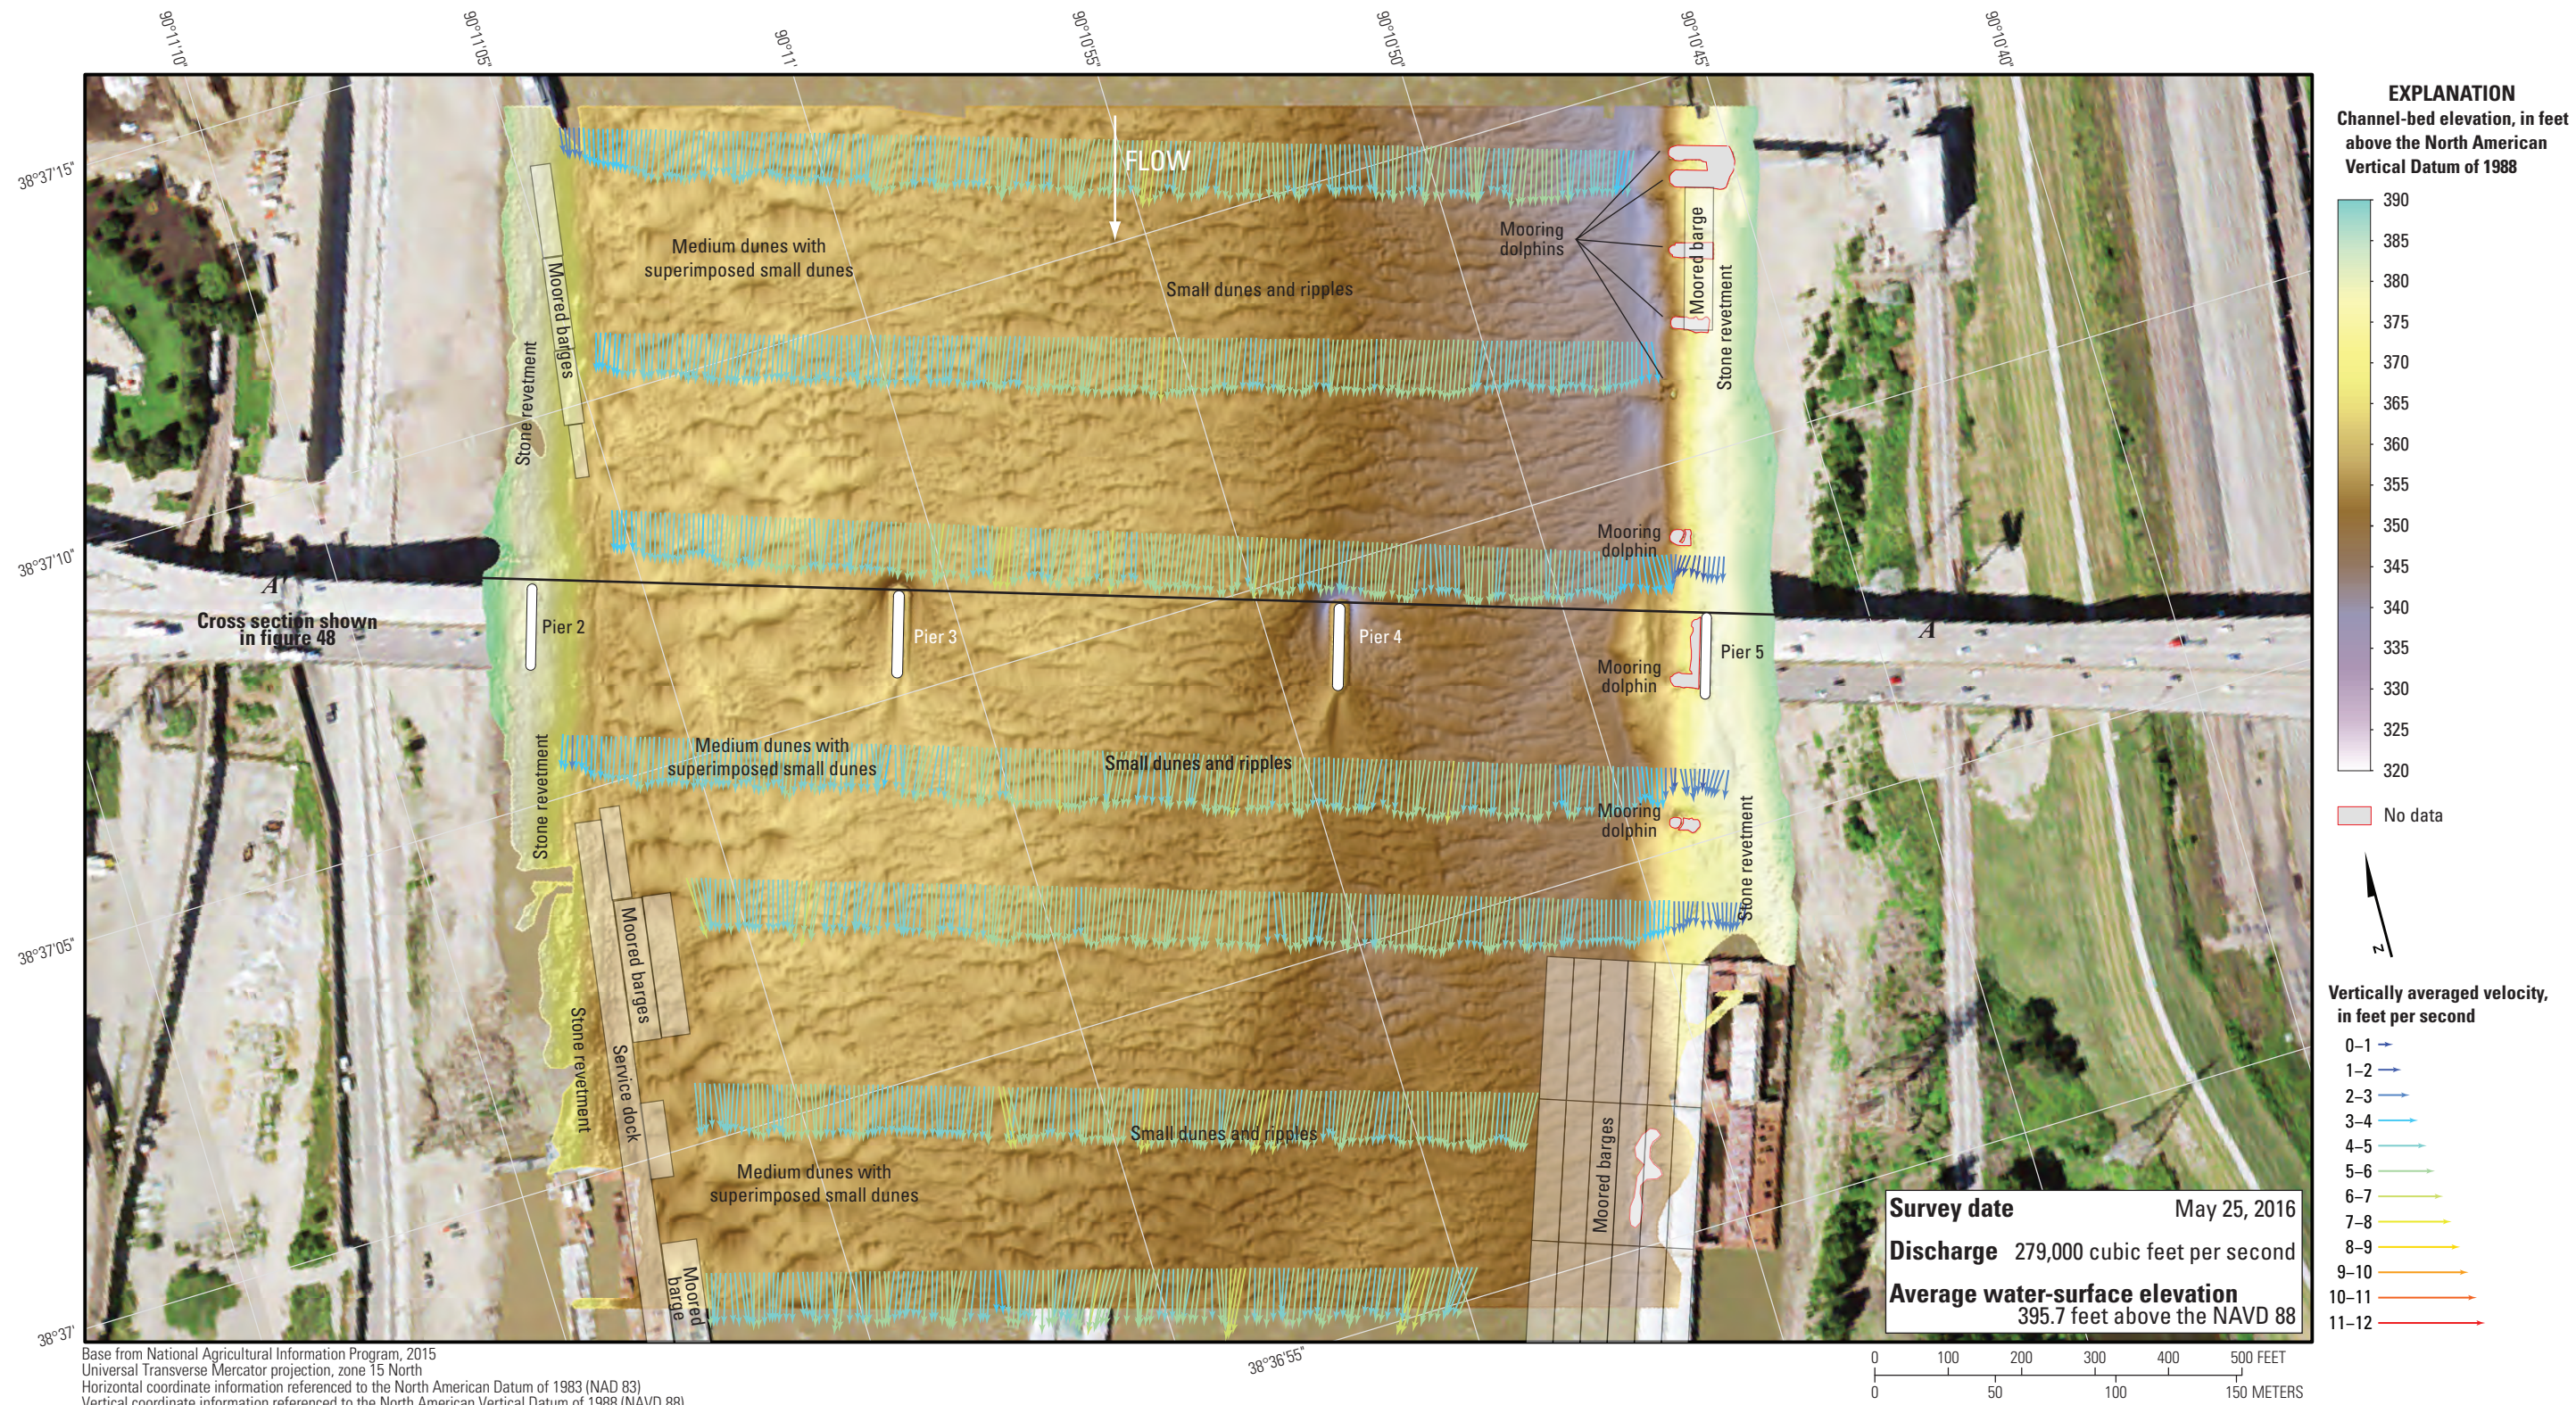
Figure 50. Bathymetry and vertically averaged velocities of the Mississippi River channel near structure A1500 on Interstate 55 in St. Louis, Missouri.

The vertically averaged velocity vectors indicate mostly uniform flow throughout the reach, ranging from about 3 to 8 ft/s (fig. 50). Exceptions to uniform flow include minor to moderate turbulence in several transects, particularly near the mooring dolphins along the left (east) bank, near the moored barges, and downstream from the bridge piers (fig. 50).
