Bathymetric and Velocimetric Surveys at Highway Bridges Crossing the Missouri and Mississippi Rivers near St. Louis, Missouri, May 23–27, 2016

Scientific Investigation Report 2017–5076

By Richard J. Huizinga

Prepared in cooperation with the Missouri Department of Transportation

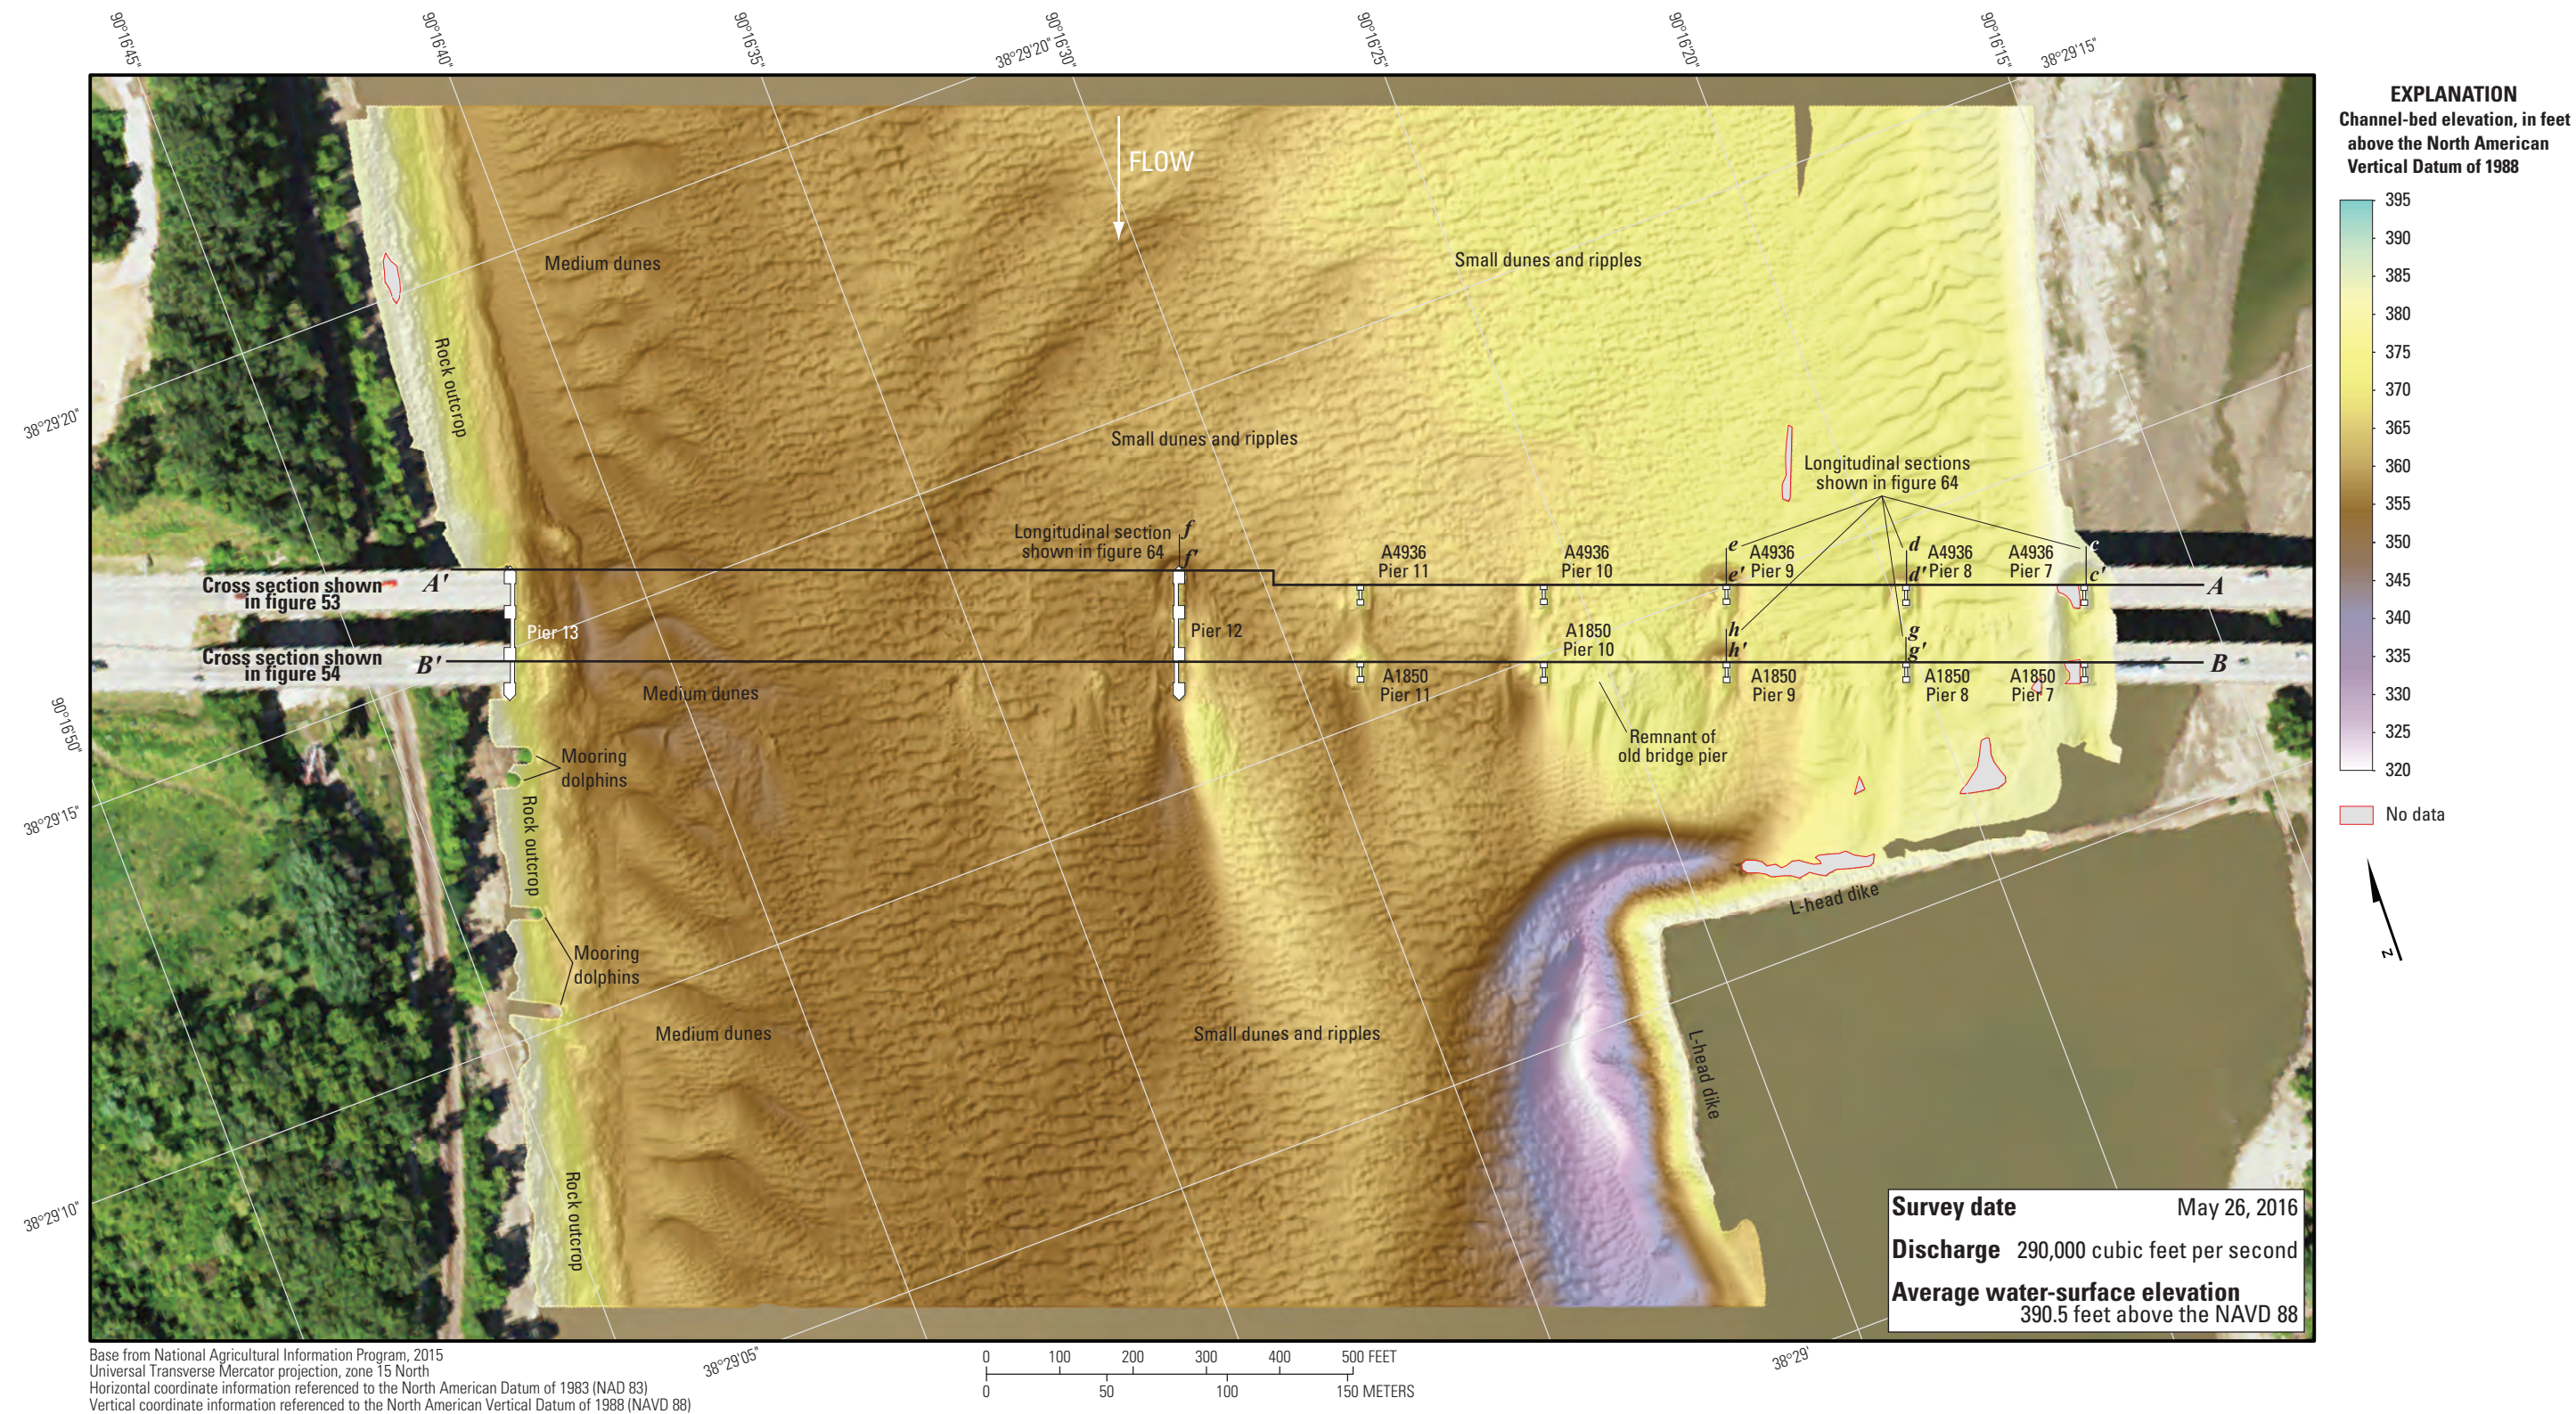
Figure 51. Bathymetric survey of the Mississippi River channel near structures A4936 and A1850 on Interstate 255 near St. Louis, Missouri.

Near pier 9 of upstream structure A4936, the scour hole had an approximate minimum channel-bed elevation of about 357 ft, about 10 ft below the average channel bed immediately upstream from the pier, and about 4 ft above the bottom of the seal course elevation of 353.00 ft (figs. 51, 53; table 8). At downstream structure A1850, the scour hole near pier 9 had a minimum channel-bed elevation of 357 ft, also about 10 ft below the average channel bed immediately upstream, and about 4 ft above the bottom of the seal course elevation of 353.00 ft (figs. 51, 54; table 8). Information from bridge plans indicates that pier 9 of structures A4936 and A1850 are founded on piles driven to refusal on bedrock at both structures, and about 60 ft of bed material was present between the bottom of the scour holes and bedrock (figs. 53, 54; table 8).

Scour holes were not observed upstream from piers 10 and 11 of either structure A4936 or A1850 (fig. 51); in fact, the surveyed channel bed seems to be aggraded near these piers (figs. 53, 54), which indicates riprap or some other scour-resistant material has been piled near the upstream faces of these piers; however, the side edges and downstream corners of the footings are apparent at pier 11 of both structures (appendix 1, figs. 1–9C, 1–9D), and a local scour hole with an approximate minimum channel-bed elevation of 352 ft was present near the downstream left corner of pier 11 of downstream structure A1850 (fig. 51; table 8). The remnant of an old bridge pier was observed between piers 9 and 10 of downstream structure A1850 (figs. 51, 54). Information from bridge plans indicates that piers 10 and 11 are founded on piles driven to refusal on

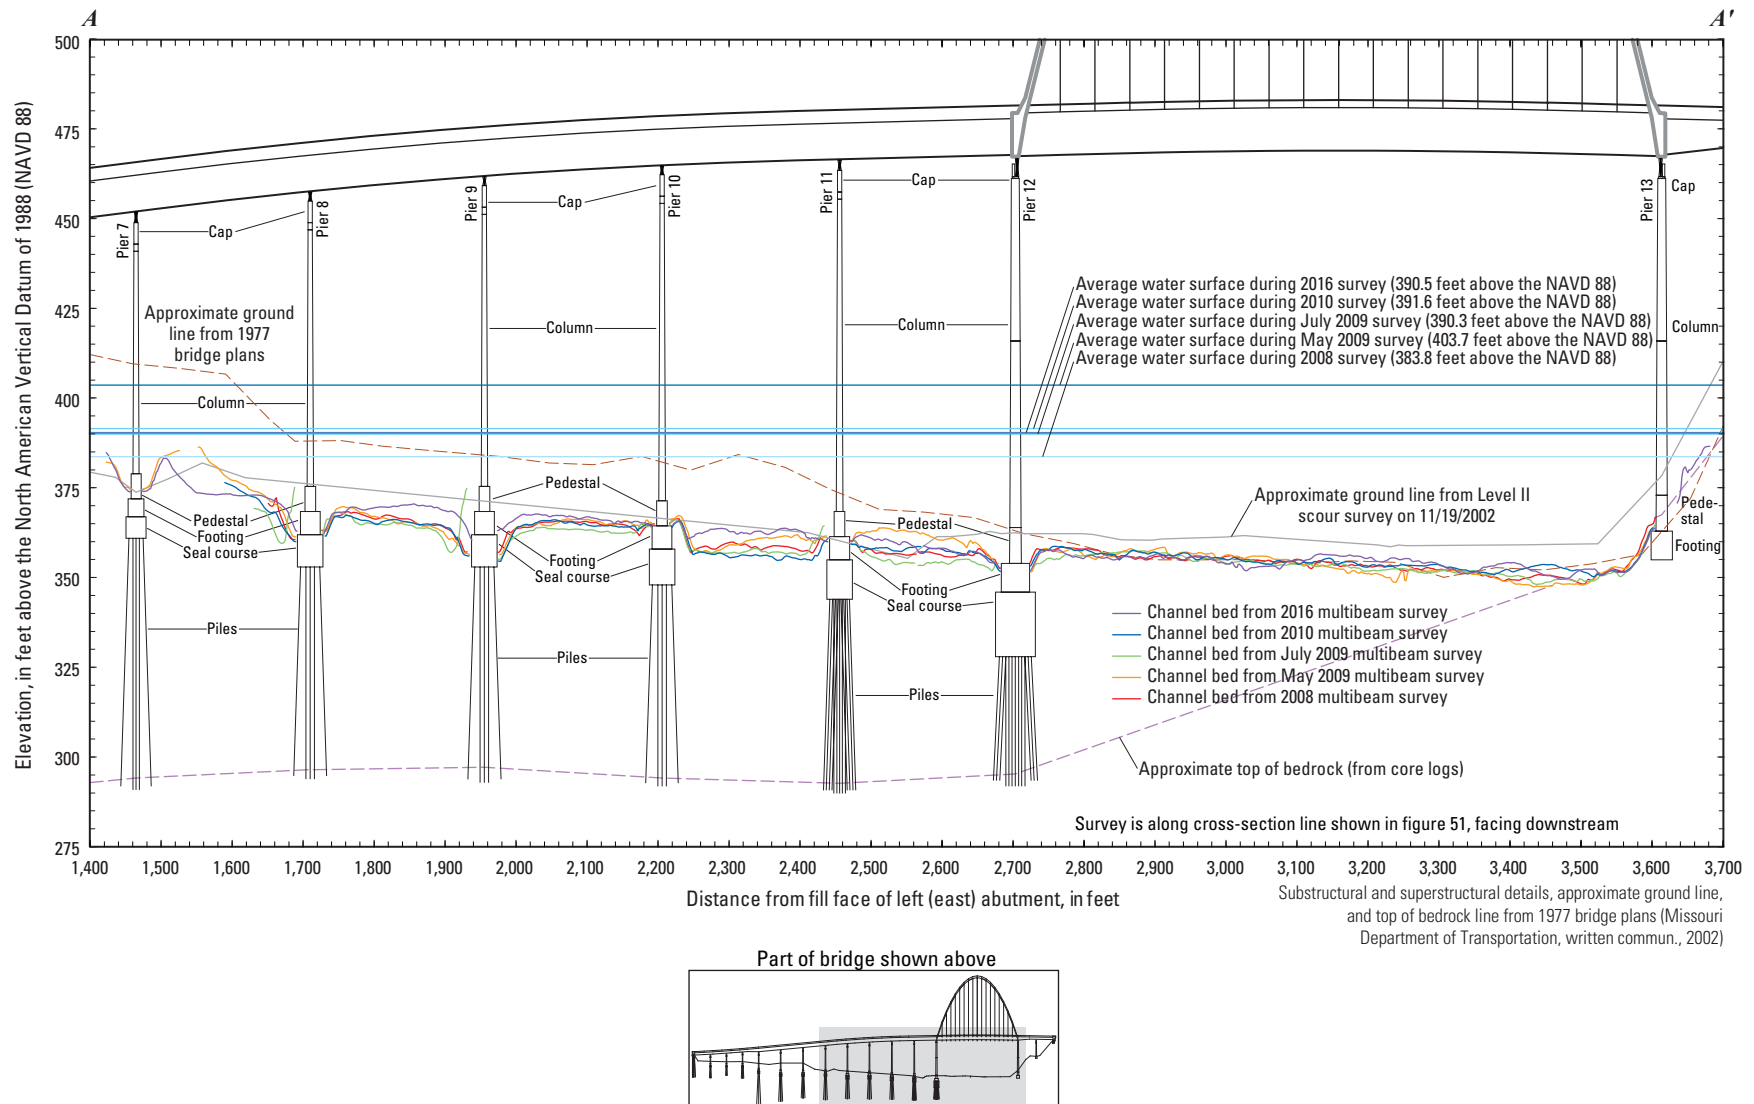
Figure 53. Key features, substructural and superstructural details, and surveyed channel bed of structure A4936 on Interstate 255 crossing the Mississippi River near St. Louis, Missouri.

7 of structures A4936 and A1850 are founded on piles driven to refusal on bedrock at both structures, and about 79 to 80 ft of bed material was present between the bottom of the scour holes and bedrock (figs. 53, 54; table 8).

bedrock at both structures, and about 59 to 66 ft of bed material was present between the approximate minimum channel-bed elevation near each pier and bedrock (figs. 53, 54; table 8).

A minor to moderate scour hole was present upstream from pier 12 with a minimum elevation of about 349 ft, about 6 ft below the average channel bed immediately upstream from the pier, but 21 ft above the bottom of the seal course elevation of 328.00 ft (figs. 51, 53, 54; table 8). Information from bridge plans indicates that pier 12 is founded on piles driven to refusal on bedrock, and about 56 ft of bed material was present between the bottom of the scour hole and bedrock (figs. 53, 54; table 8).

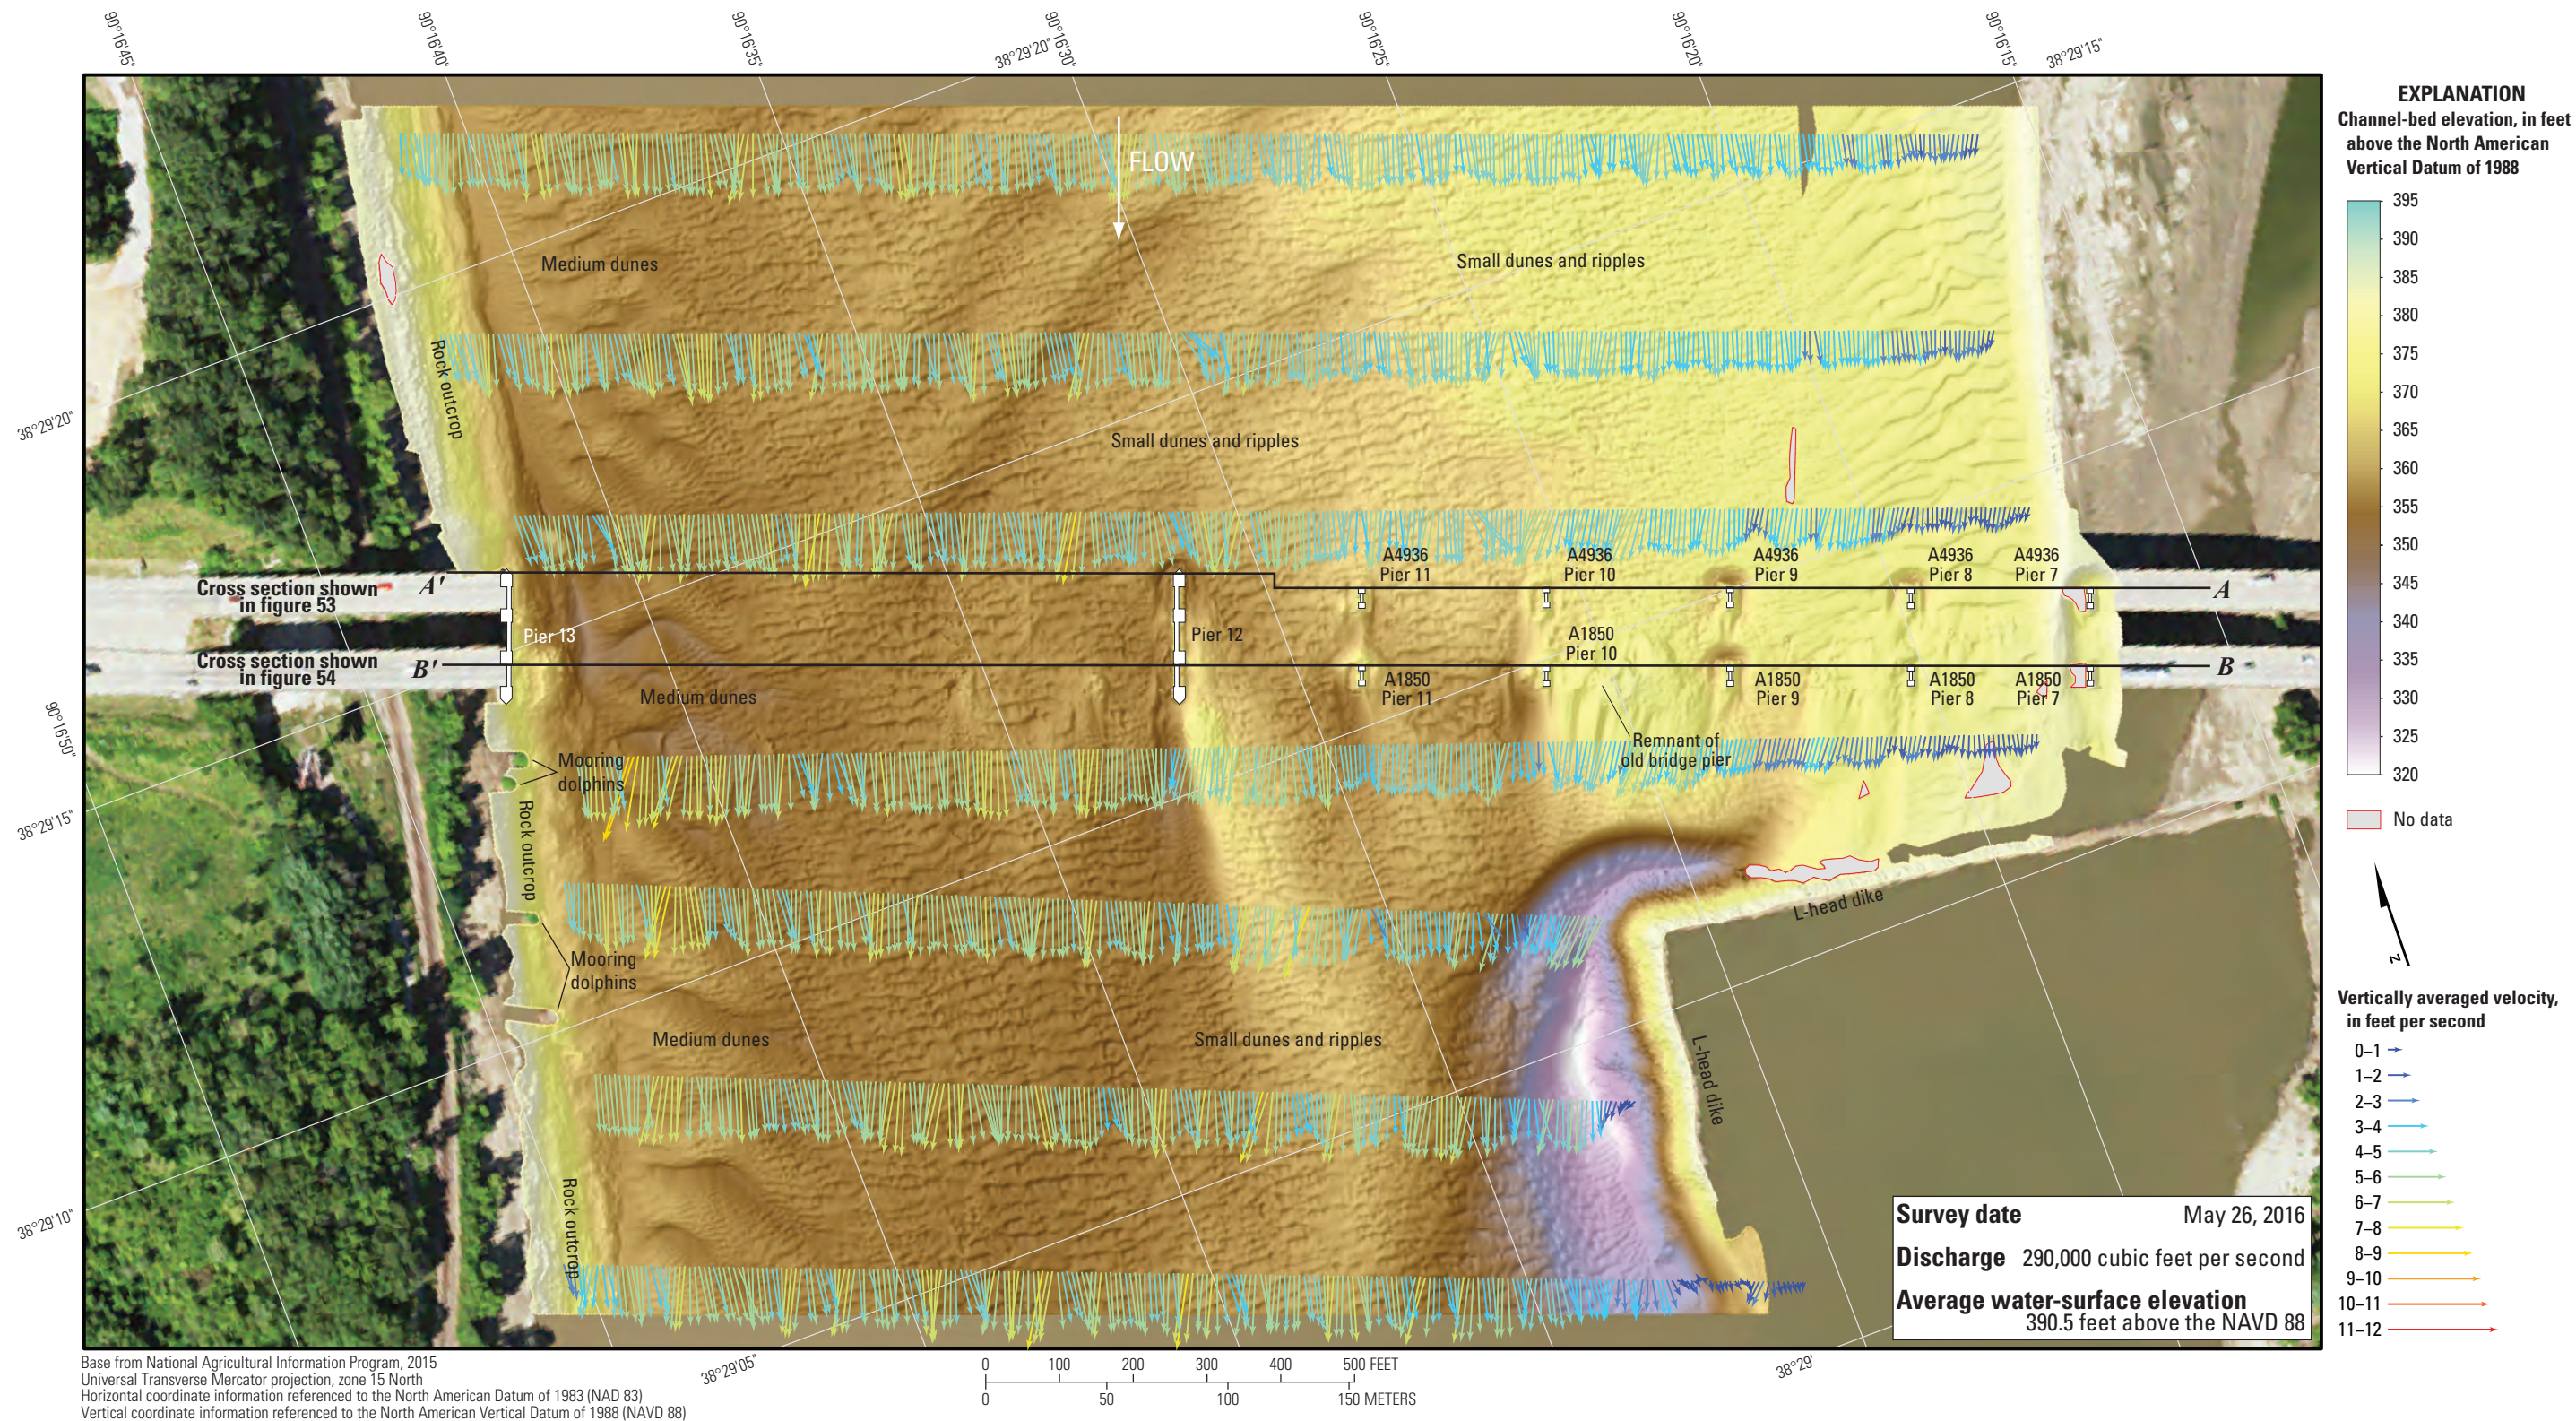
Figure 55. Bathymetry and vertically averaged velocities of the Mississippi River channel near structures A4936 and A1850 on Interstate 255 near St. Louis, Missouri.

The vertically averaged velocity vectors indicate mostly uniform flow throughout the channel, ranging from about 2 to 9 ft/s (fig. 55). Flow was angled to the right (west) in the transects immediately upstream and adjacent to the L-head dike because of the constricting effect of the dike (fig. 55). Exceptions to uniform conditions include moderate turbulence observed in all the transects, and substantial velocity gradients and flow reversal in the area adjacent to the L-head dike (fig. 55). The piers generally seem to be aligned with flow (fig. 55).

Given the generally low velocities observed along the left (east) bank in the upstream part of the reach, which obviously results in deposition in the area along the upstream left bank, the size of the scour holes around piers 7 through 9—and particularly near pier 7—perhaps are unexpected; however, velocities upstream from piers 8 and 9 were around

5 to 6 ft/s in the current (2016) survey (fig. 55), which are of sufficiently high magnitude to create a moderate to substantial scour hole in a sand-bed channel like the Mississippi River, dependent upon the cross-sectional size and shape of the pier (Richardson and Davis, 2001). Furthermore, during the survey on May 12–13, 2009, completed as part of the fixed scour-monitor study at this site (Rydland, 2009; full bathymetry shown in Huizinga and others [2010] and included with the data from this report), flow conditions were such that flow was over the L-head dike (Huizinga and others, 2010, fig. 11). Although velocity data were not collected during that survey, the researchers recollect experiencing substantial velocities around piers 7 through 9 of a magnitude similar to those observed further to the right in the channel when there was flow over the L-head dike.

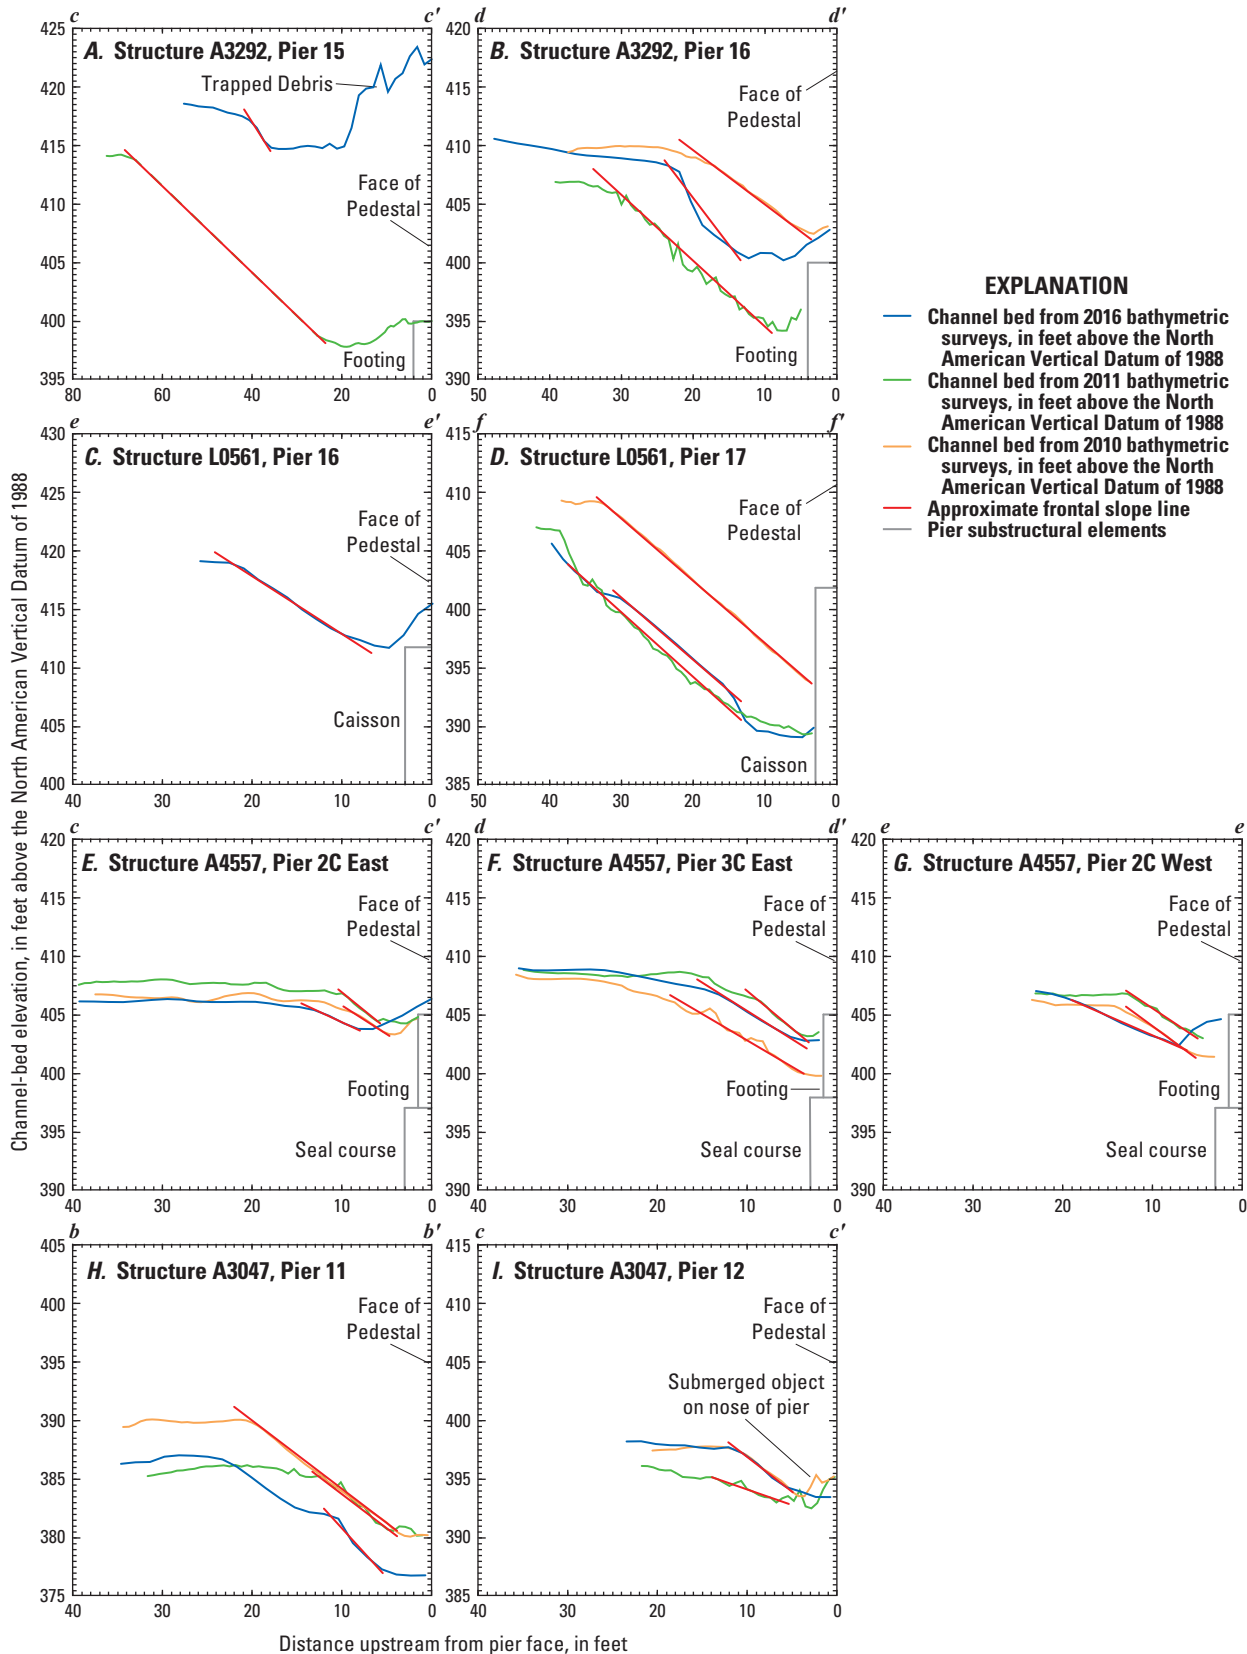
The approximate frontal slope of the well-defined scour holes for sites on the Missouri River ranged from 1.06 to 3.03 (figs. 62, 63; table 6). Several scour holes at the Missouri River sites had frontal slopes of values greater than 3.03, but generally scour holes near these piers were substantially affected by an upstream pier (table 6). The approximate frontal slope of the well-defined scour holes for sites on the Mississippi River ranged from 1.28 to 2.27 (fig. 64; table 8). The mean value of the frontal slopes at the Missouri River sites not affected by upstream piers was 2.09 (table 6), and the mean value at the Mississippi River sites was 1.79 (table 8). Richardson and Davis (2001) noted that the side slope of a scour hole in cohesionless sand in air could range from 1.0 to 1.8 depending on the composition of the bed material and its dry angle of repose, and suggest using a value of 2.0 for design purposes to account for the wet angle of repose. The slope values determined in the current (2016) study generally are similar to the values noted in Richardson and Davis (2001) and to values determined for scour holes in similar studies (Huizinga, 2010, 2011, 2015, 2016), and are similar to previous surveys at these sites (figs. 62–64).

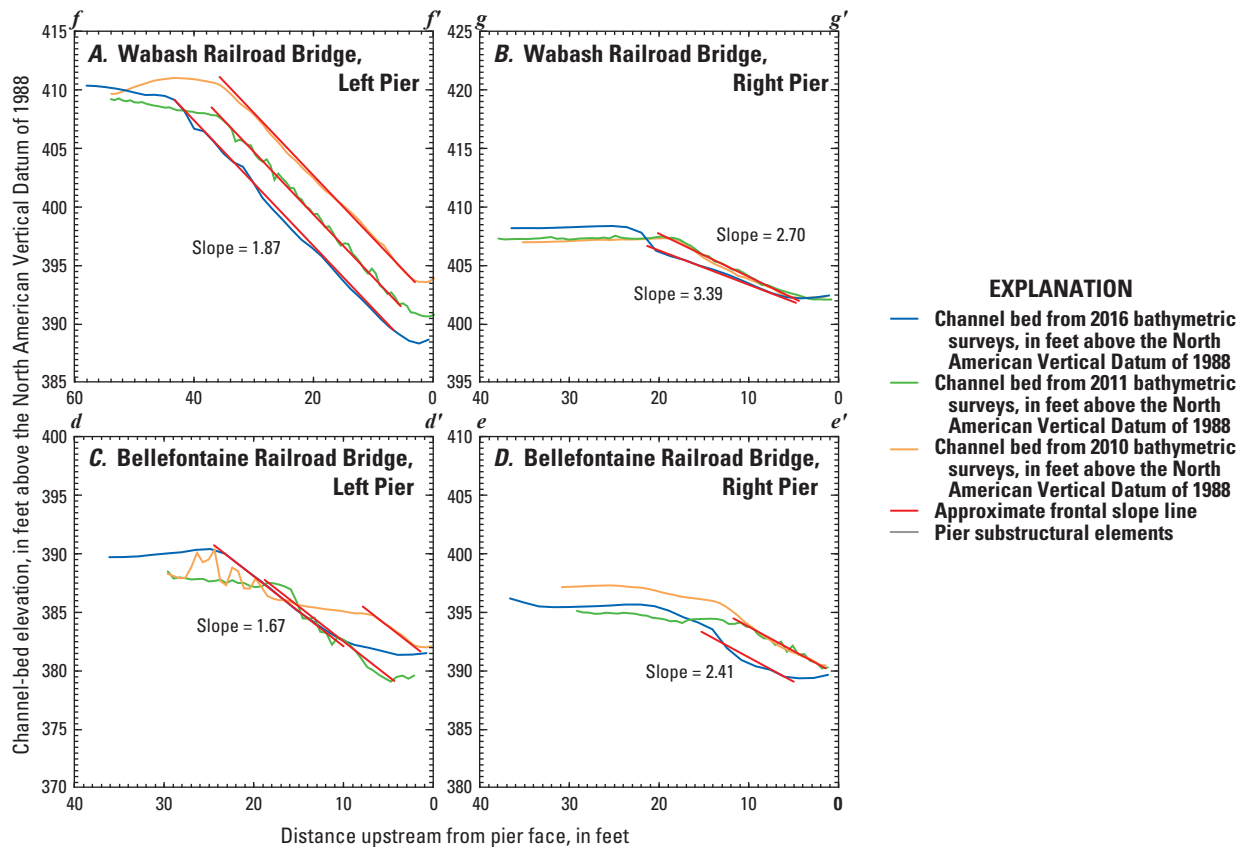
Figure 65. Longitudinal profiles upstream from railroad bridge piers near dual bridge structure A4557 on State Highway 370, and near structure A3047 on U.S. Highway 67, crossing the Missouri River near St. Louis, Missouri.

A longitudinal profile also was drawn upstream from the nose of the railroad bridge piers near dual bridge structure A4557 and near structure A3047, and the approximate frontal slope was determined for each hole (fig. 65). Although analysis of scour near the railroad bridges was not within the scope of the study, these railroad bridges were in close proximity to the highway bridges, and fell within the boundaries

of the survey at these highway bridge sites. The approximate frontal slope of the well-defined scour holes at the railroad bridge piers ranged from 1.67 to 3.39 (fig. 65); however, the hole with the largest slope value—or the shallowest frontal slope—(3.39 at the right main channel pier of the Wabash railroad bridge; figs. 27, 65*B*) was observed in an area with a nearly planar bed with low velocities (fig. 29), which indicate minimal sediment transport in that area. Piers in similar planar bed areas near dual bridge structure A5585 (pier 7 of both eastbound and westbound bridges; fig. 13) also demonstrated very shallow frontal slopes (figs. 62*H*, 62*K*; table 6).

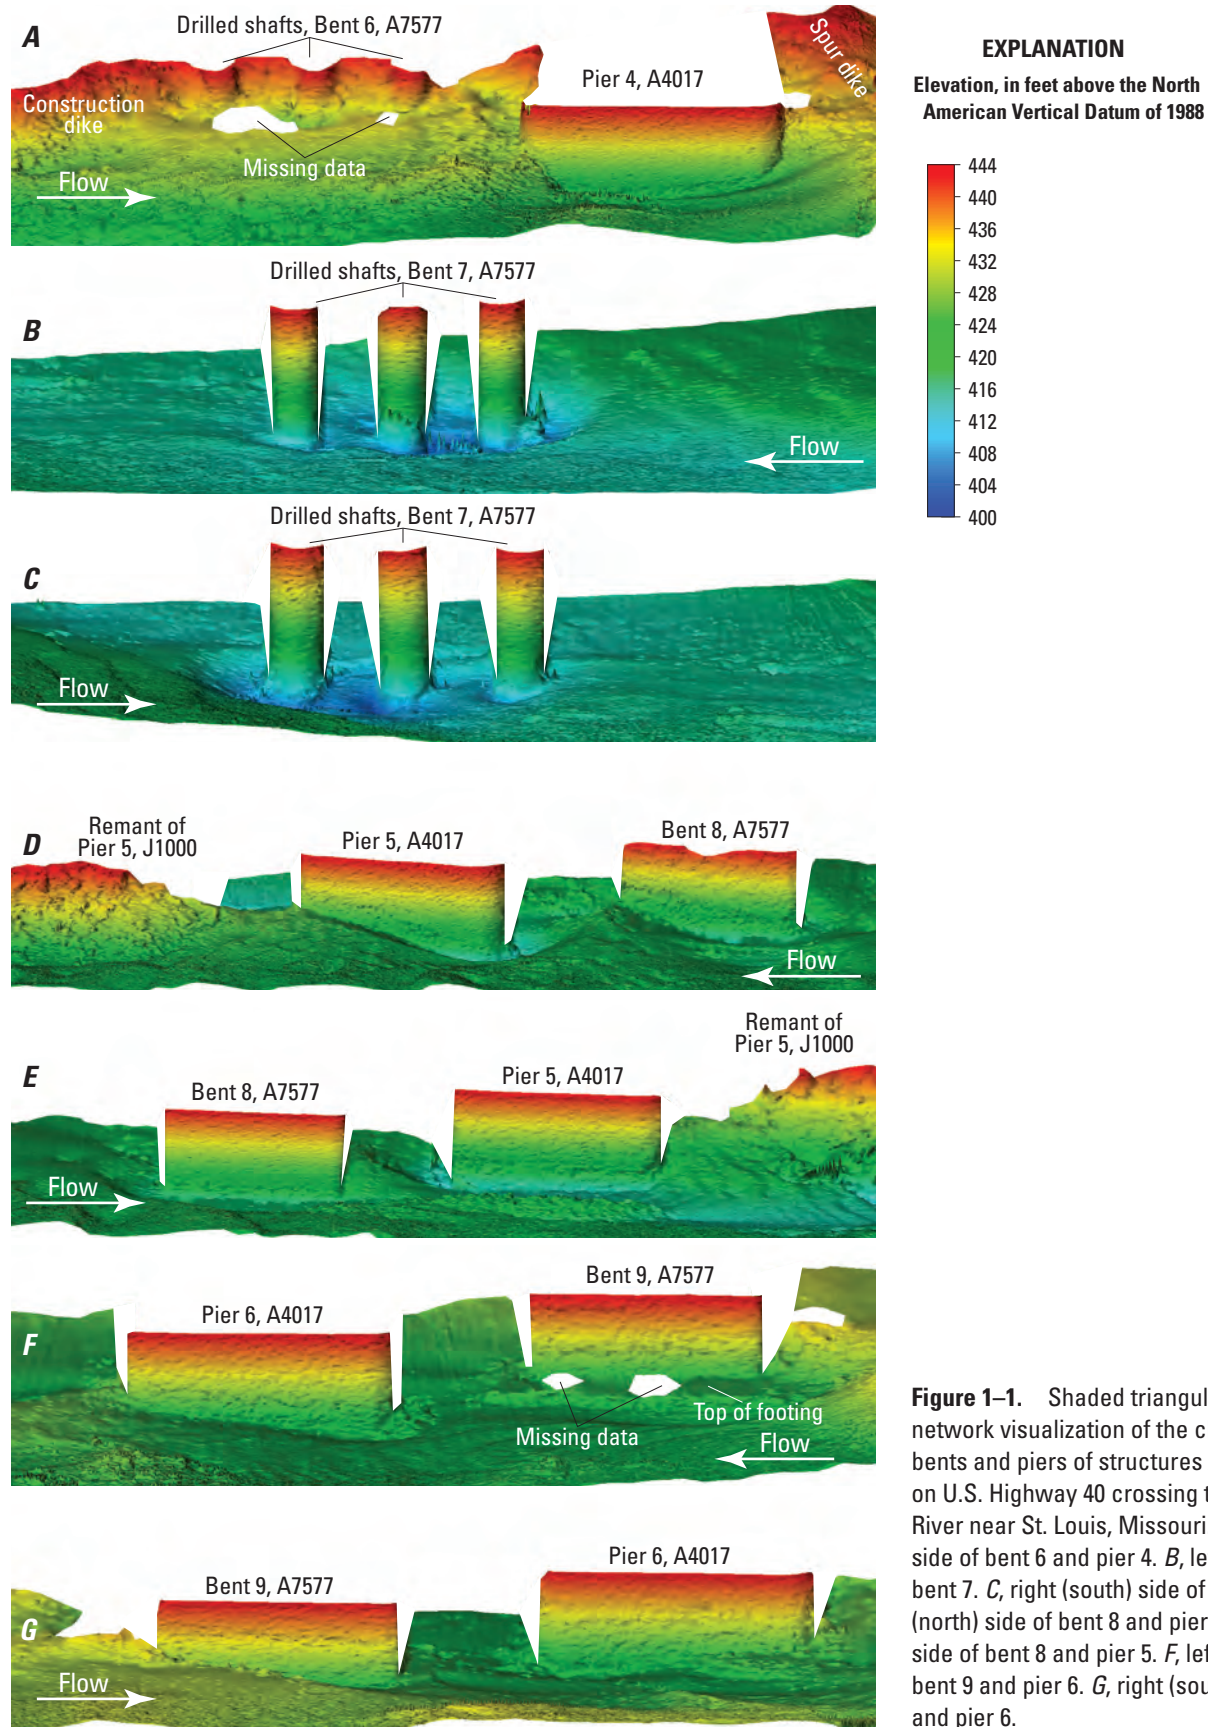
Figure 1-1. Shaded triangulated irregular network visualization of the channel bed and bents and piers of structures A7577 and A4017 on U.S. Highway 40 crossing the Missouri River near St. Louis, Missouri. *A*, right (south) side of bent 6 and pier 4. *B*, left (north) side of bent 7. *C*, right (south) side of bent 7. *D*, left (north) side of bent 8 and pier 5. *E*, right (south) side of bent 8 and pier 5. *F*, left (north) side of bent 9 and pier 6. *G*, right (south) side of bent 9 and pier 6.

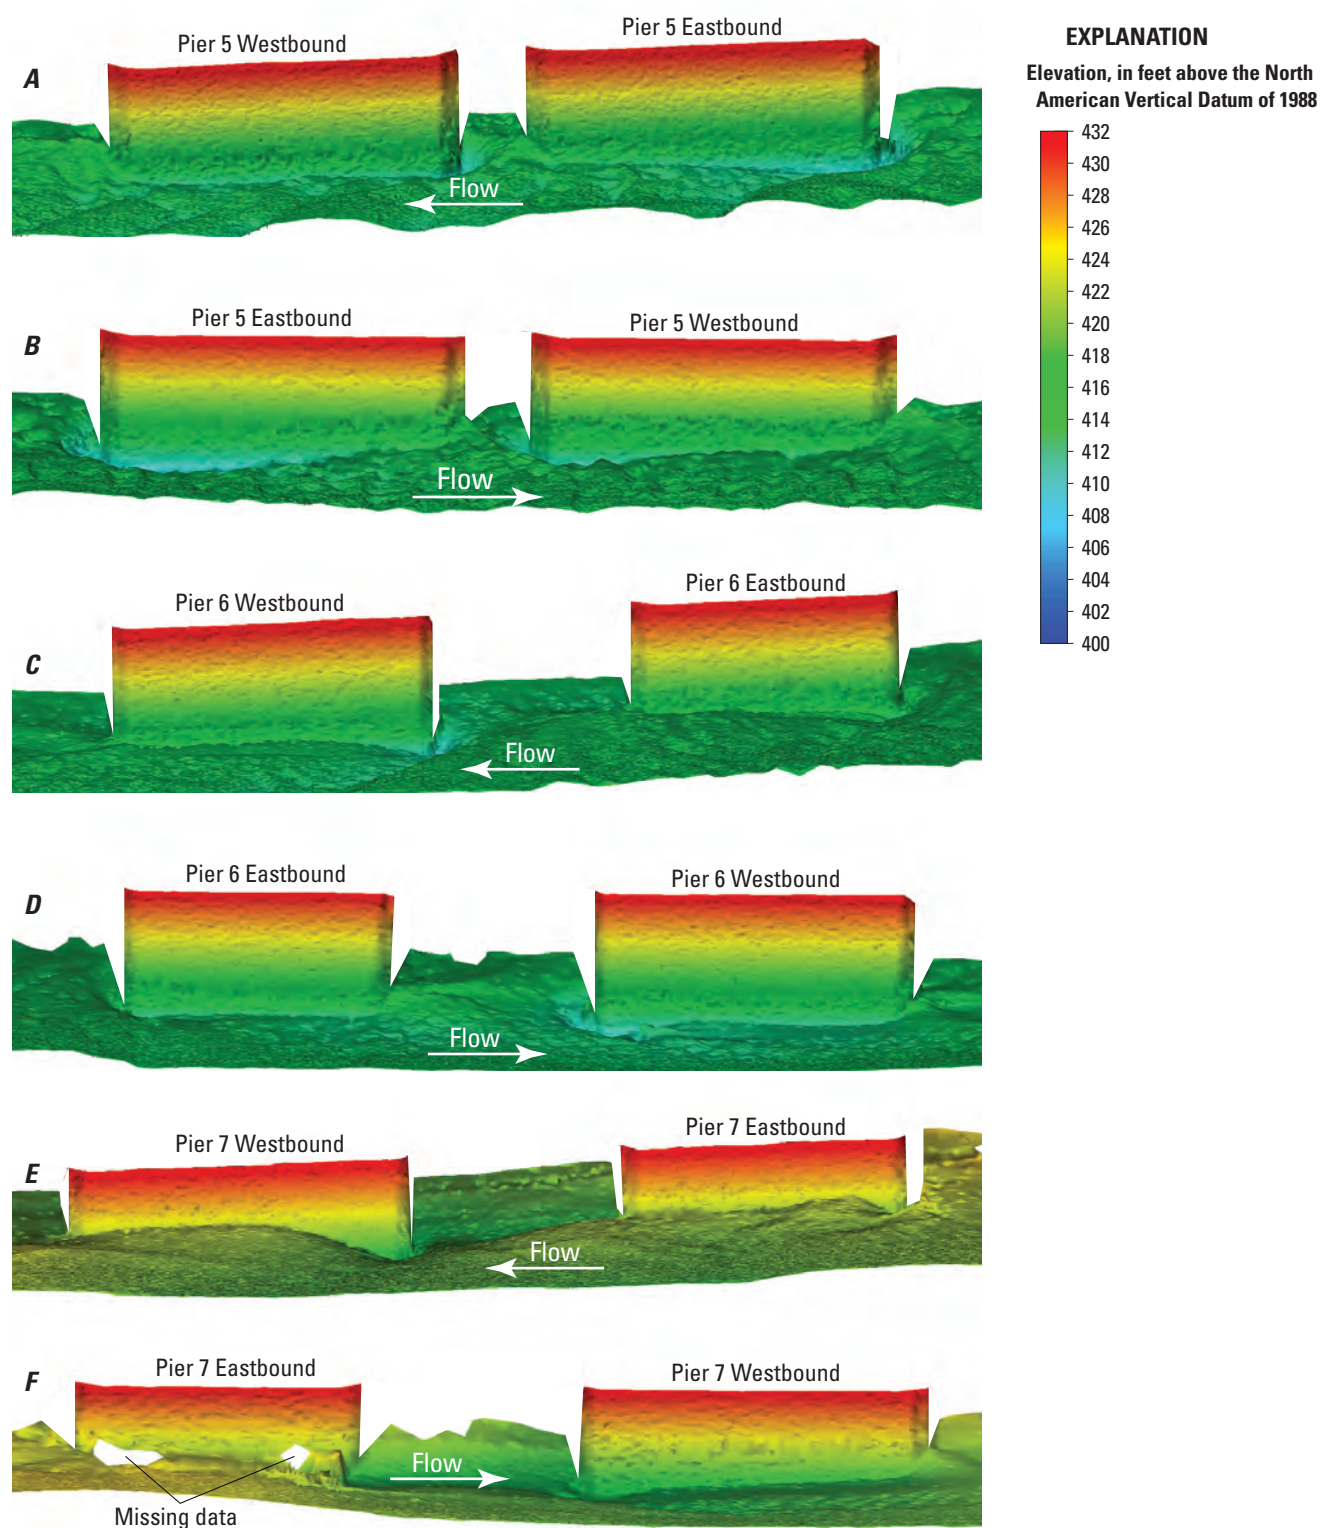
Figure 1–2. Shaded triangulated irregular network visualization of the channel bed and piers of dual bridge structure A5585 on State Highway 364 crossing the Missouri River near St. Louis, Missouri. *A*, left (north) side of pier 5. *B*, right (south) side of pier 5. *C*, left (north) side of pier 6. *D*, right (south) side of pier 6. *E*, left (north) side of pier 7. *F*, right (south) side of pier 7.

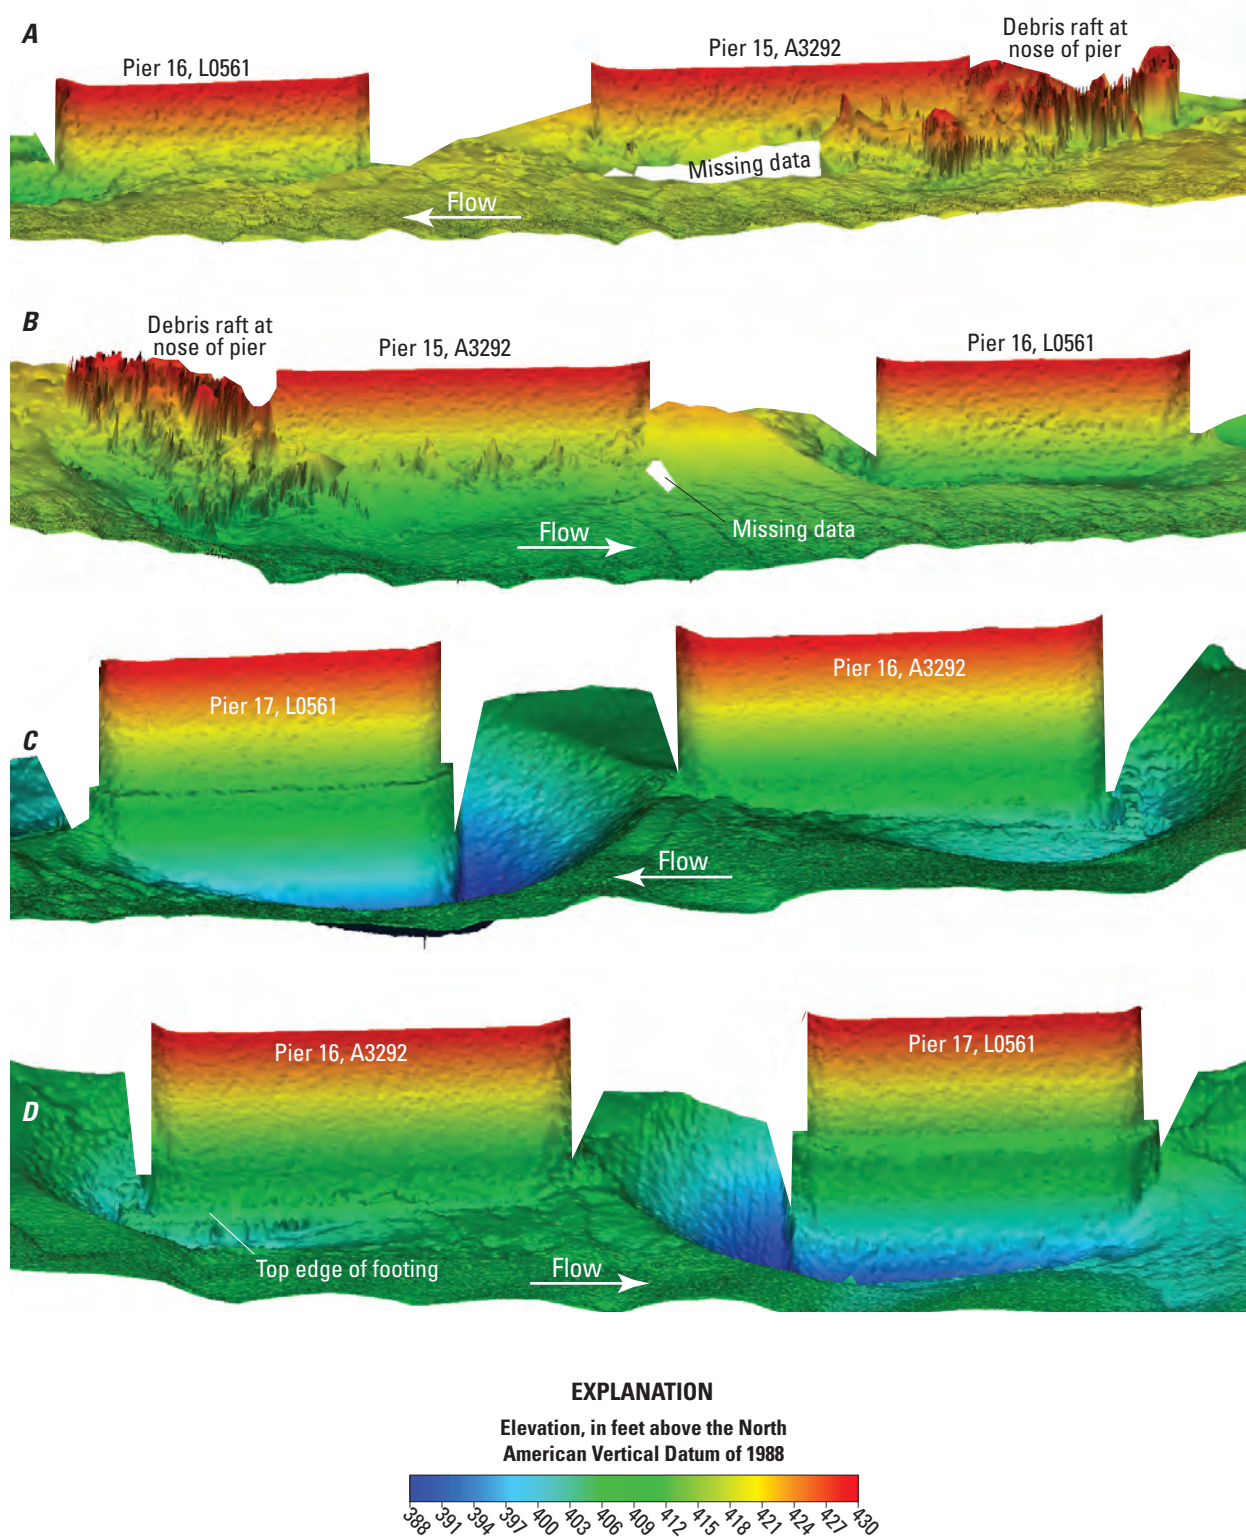
Figure 1-3. Shaded triangulated irregular network visualization of the channel bed and piers of structures A3292 and L0561 on Interstate 70 crossing the Missouri River near St. Louis, Missouri. *A*, left (northwest) side of piers 15 and 16. *B*, right (southeast) side of piers 15 and 16. *C*, left (northwest) side of piers 16 and 17. *D*, right (southeast) side of piers 16 and 17.

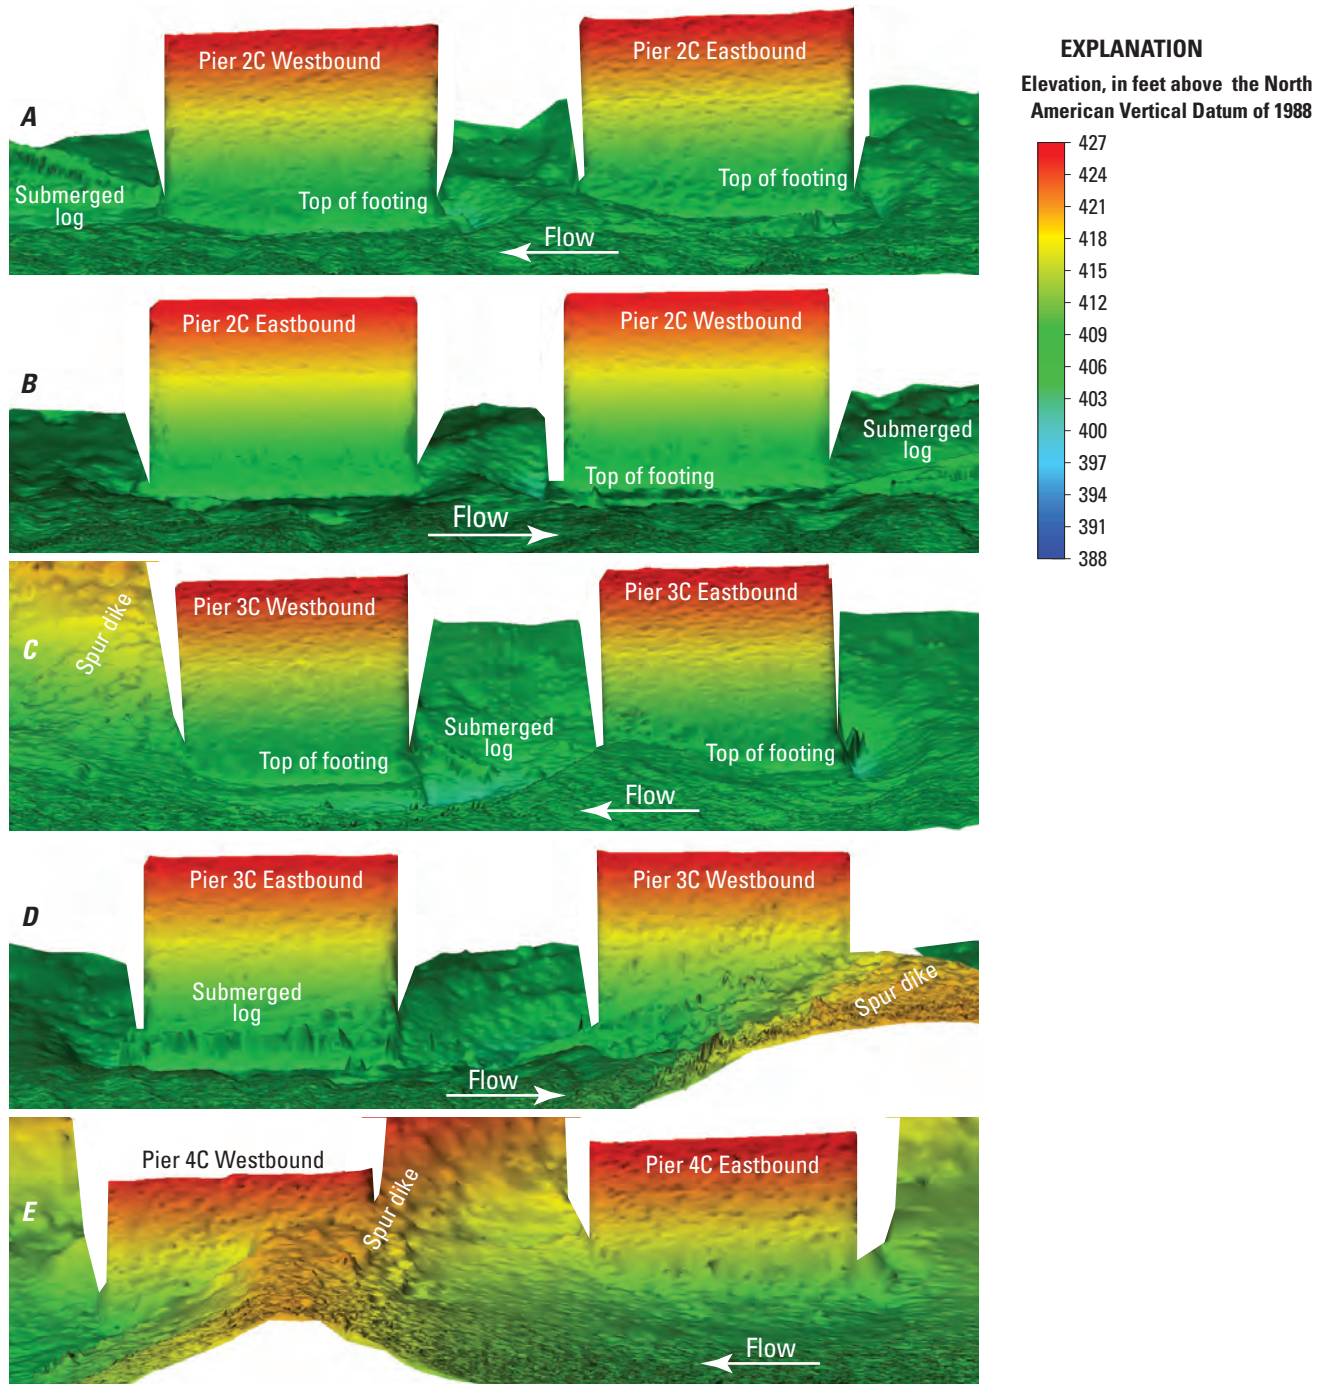
Figure 1-4. Shaded triangulated irregular network visualization of the channel bed and piers of dual bridge structure A4557 on State Highway 370 crossing the Missouri River near St. Louis, Missouri. *A*, left (northwest) side of pier 2C. *B*, right (southeast) side of pier 2C. *C*, left (northwest) side of pier 3C. *D*, right (southeast) side of pier 3C. *E*, left (northwest) side of pier 4C.
