Bathymetric and Velocimetric Surveys at Highway Bridges Crossing the Missouri and Mississippi Rivers near St. Louis, Missouri, May 23–27, 2016

Scientific Investigation Report 2017–5076

By Richard J. Huizinga

Prepared in cooperation with the Missouri Department of Transportation

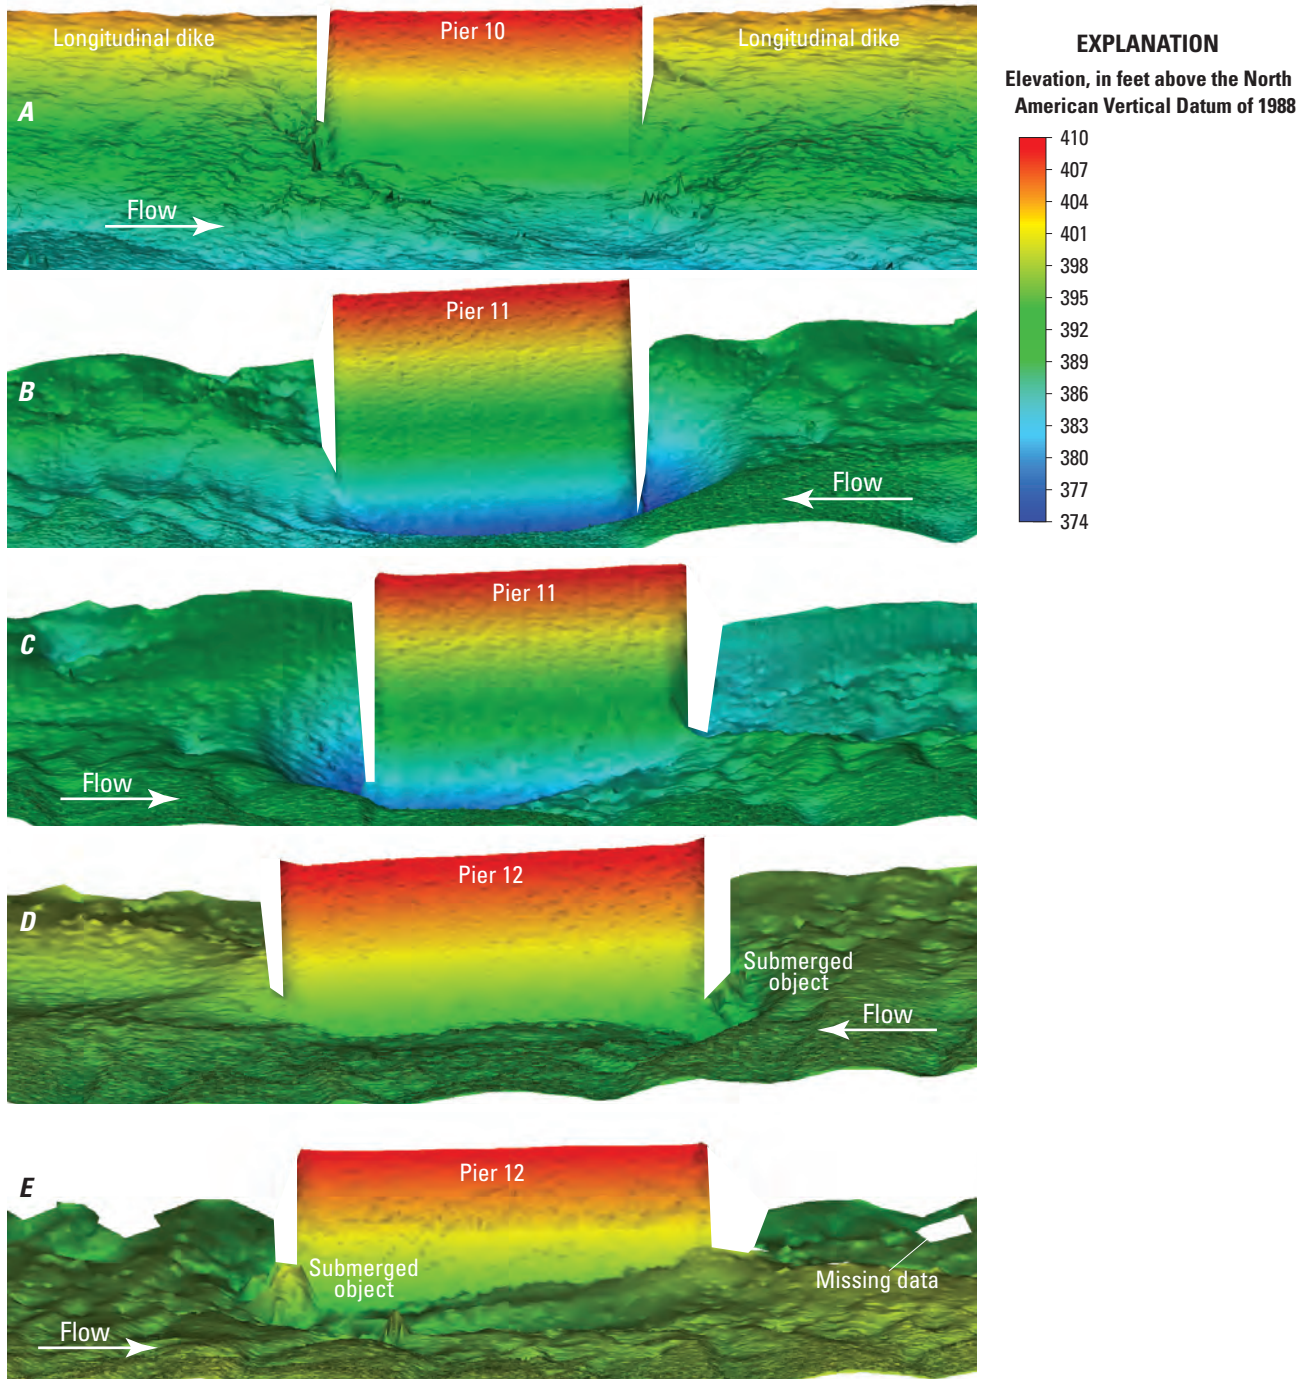
Figure 1-5. Shaded triangulated irregular network visualization of the channel bed and piers of structure A3047 on U.S. Highway 67 crossing the Missouri River near St. Louis, Missouri. *A*, right (south) side of pier 10. *B*, left (north) side of pier 11. *C*, right (south) side of pier 11. *D*, left (north) side of pier 12. *E*, right (south) side of pier 12.

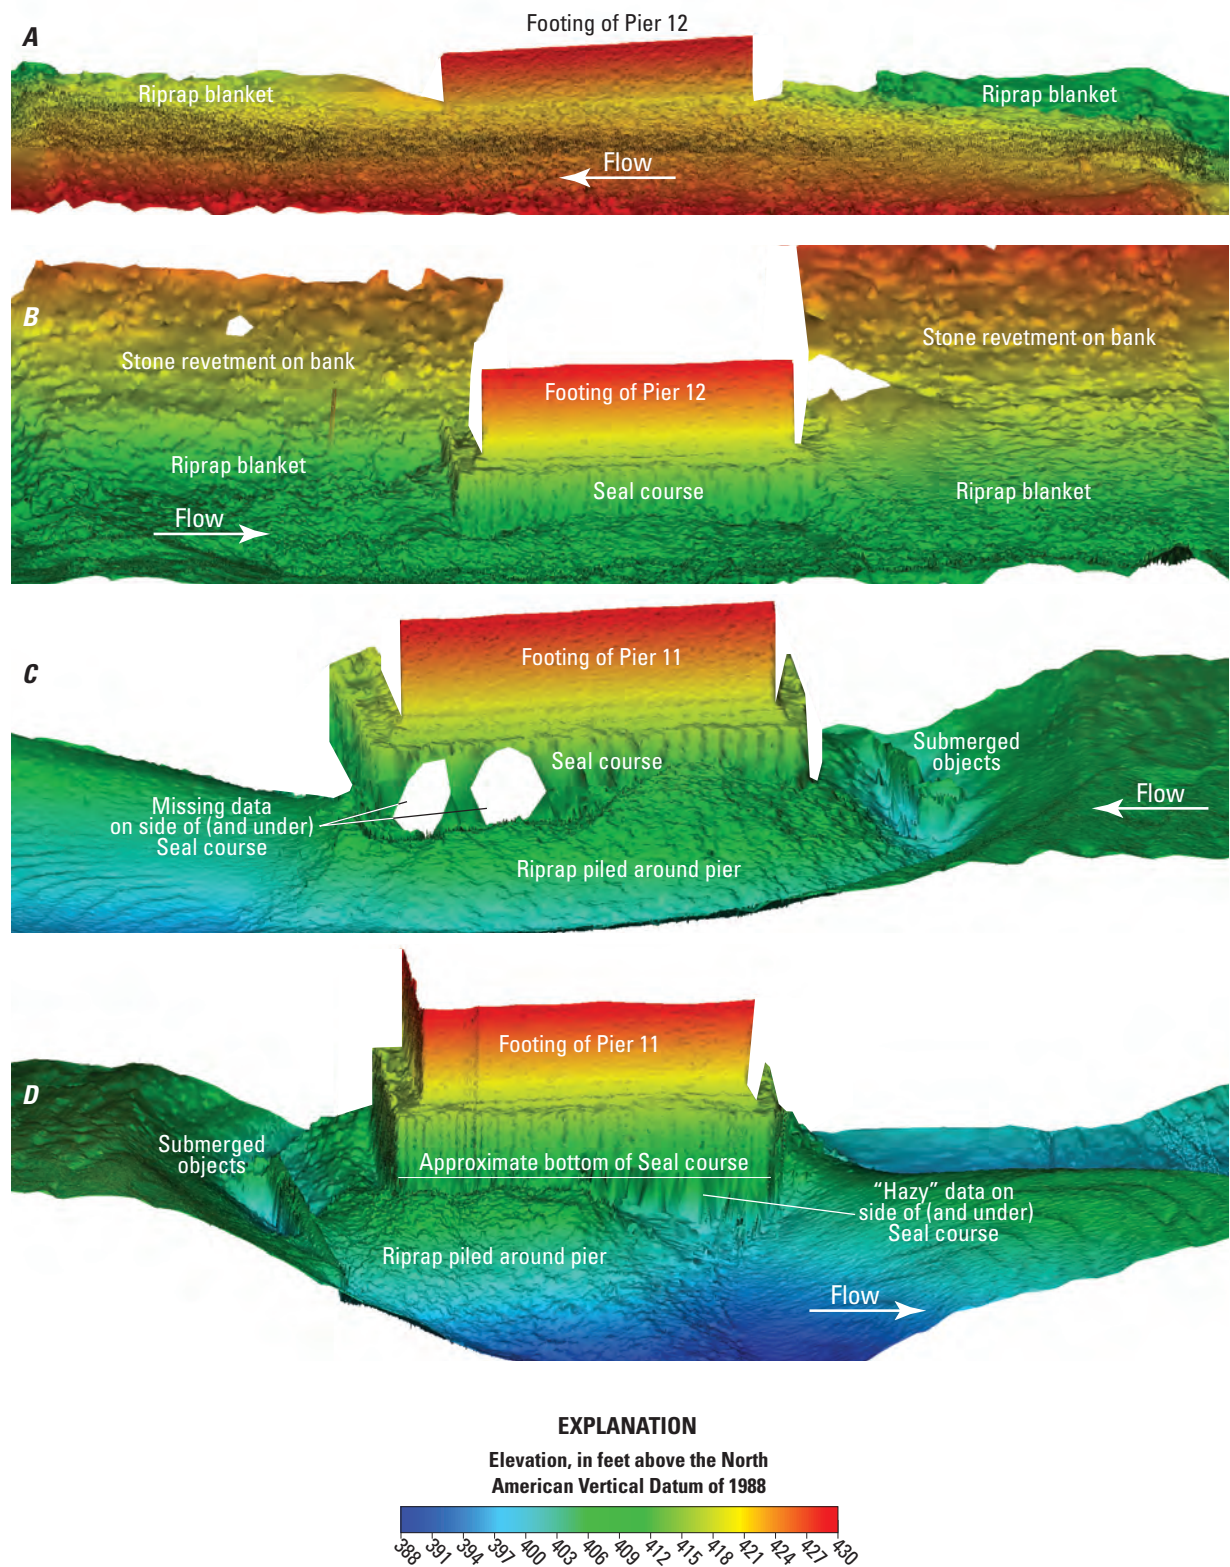
survey indicated moderate scour overall in the reach from 2009 to 2016, with an average difference of -1.36 ft between the bathymetric surfaces. Substantial scour of nearly 30 feet was observed at and downstream from pier 11. Both piers are skewed to approach flow, and the scour hole near pier 11 has the typical characteristics of a hole at a skewed pier, being longer on the side with impinging flow, and with a line of deposition on the leeward side. However, the wide, square nose of the pier, a mild constriction downstream from the pier, and additional scour from adjacent mooring dolphins downstream likely have exacerbated the scour on the leeward side of the pier by increasing local turbulence and pulling sediment into suspension. A riprap blanket surrounds pier 12, and seems to limit scour near that pier.

Figure 1-6. Shaded triangulated irregular network visualization of the channel bed and piers of structure A6500 on Interstate 70 crossing the Mississippi River in St. Louis, Missouri. *A*, left (east) side of pier 12. *B*, right (west) side of pier 12. *C*, left (east) side of pier 11. *D*, right (west) side of pier 11.

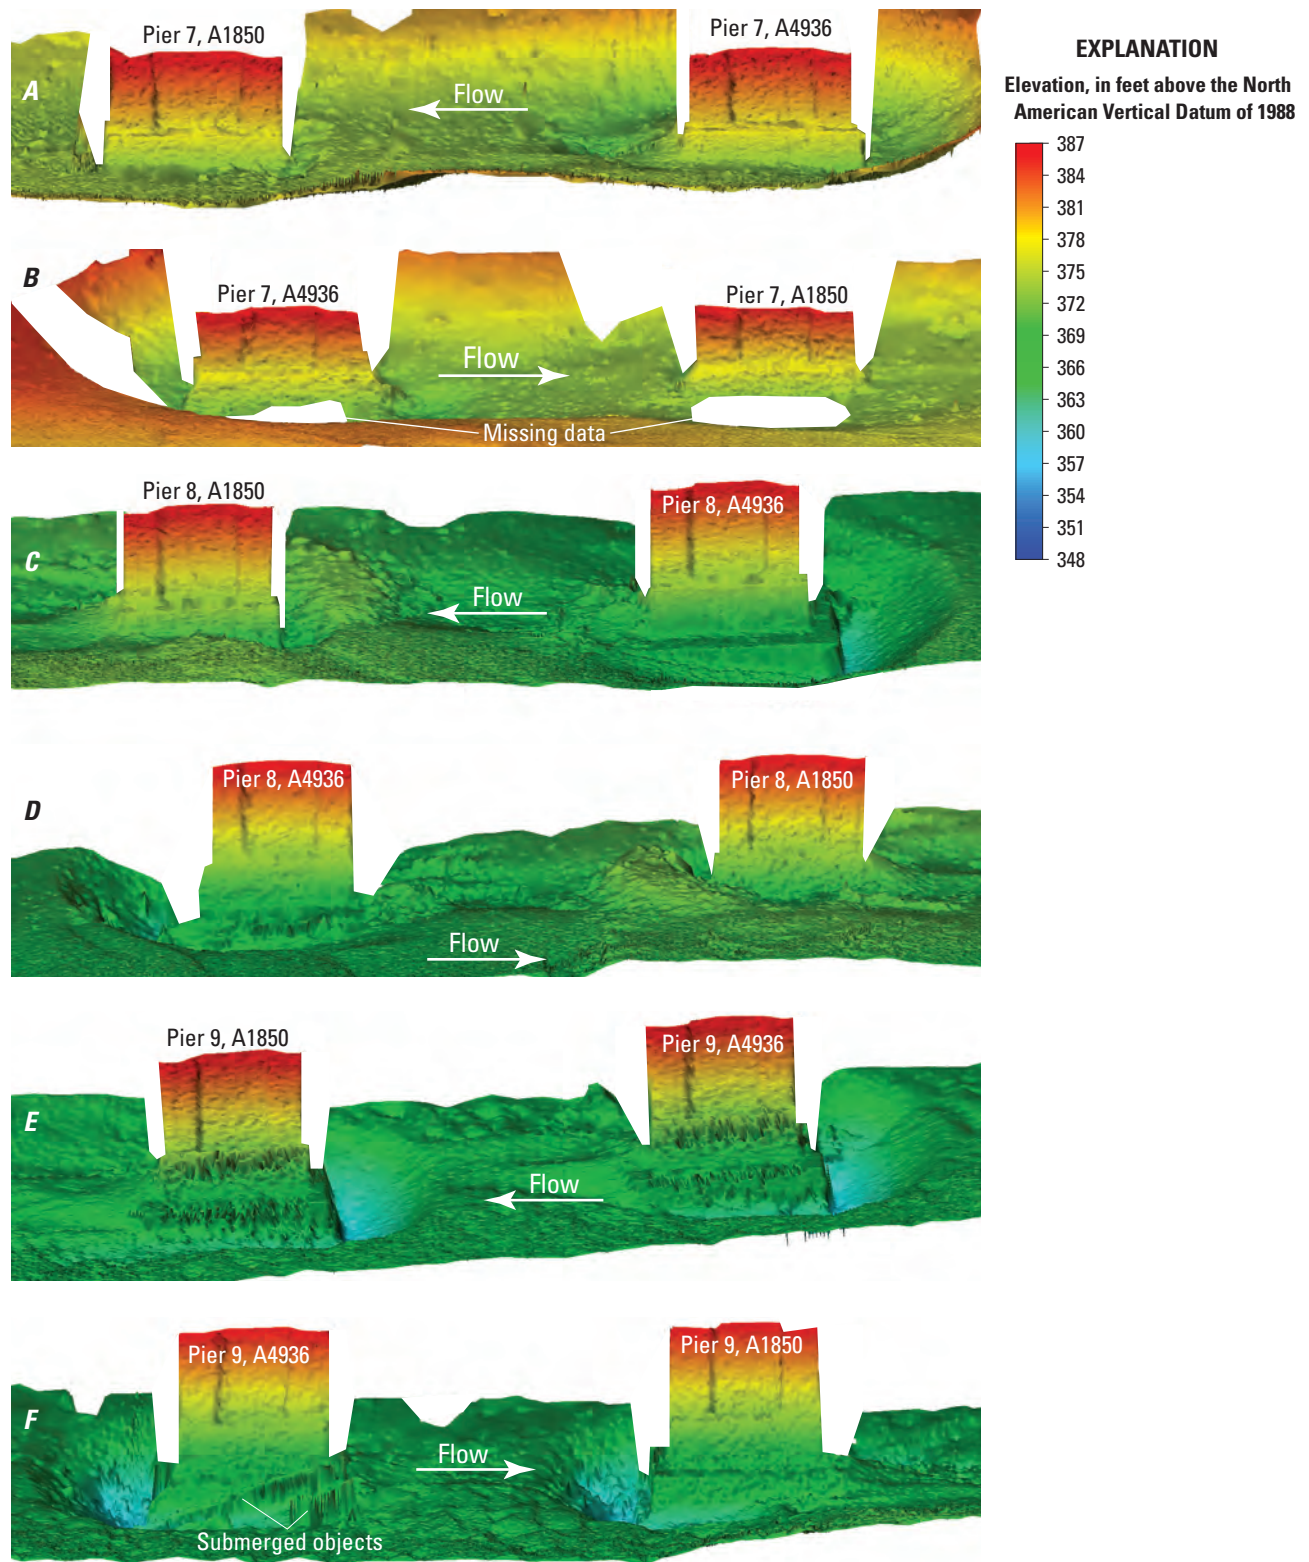
Figure 1–8. Shaded triangulated irregular network visualization of the channel bed and piers of structures A4936 and A1850 on Interstate 255 crossing the Mississippi River near St. Louis, Missouri. *A*, left (east) side of pier 7. *B*, right (west) side of pier 7. *C*, left (east) side of pier 8. *D*, right (west) side of pier 8. *E*, left (east) side of pier 9. *F*, right (west) side of pier 9.

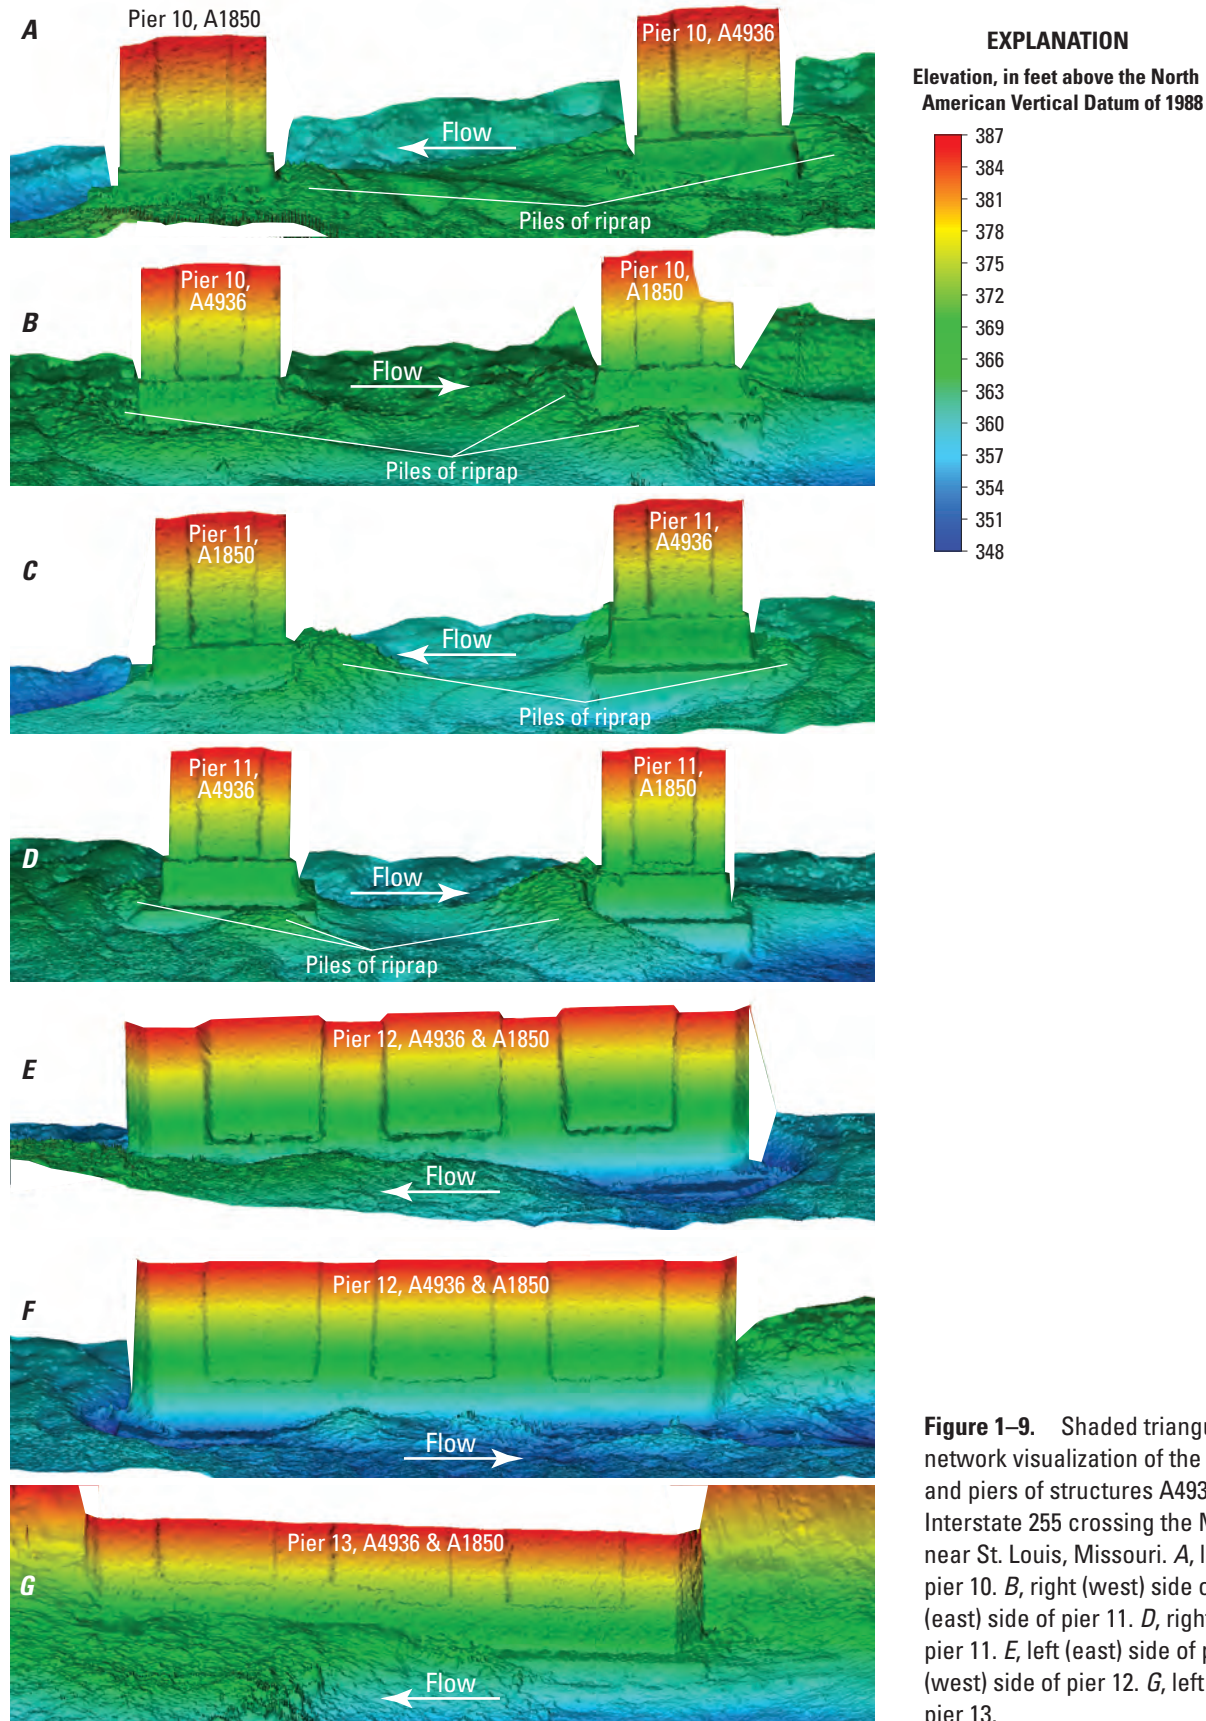
Figure 1-9. Shaded triangulated irregular network visualization of the channel bed and piers of structures A4936 and A1850 on Interstate 255 crossing the Mississippi River near St. Louis, Missouri. *A*, left (east) side of pier 10. *B*, right (west) side of pier 10. *C*, left (east) side of pier 11. *D*, right (west) side of pier 11. *E*, left (east) side of pier 12. *F*, right (west) side of pier 12. *G*, left (east) side of pier 13.
