# **Overview of the Geologic Effects of the November 14, 2016, $M_w$ 7.8 Kaikoura, New Zealand, Earthquake**

By Randall W. Jibson, Kate E. Allstadt, Francis K. Rengers, and Jonathan W. Godt

Scientific Investigations Report 2017–5146

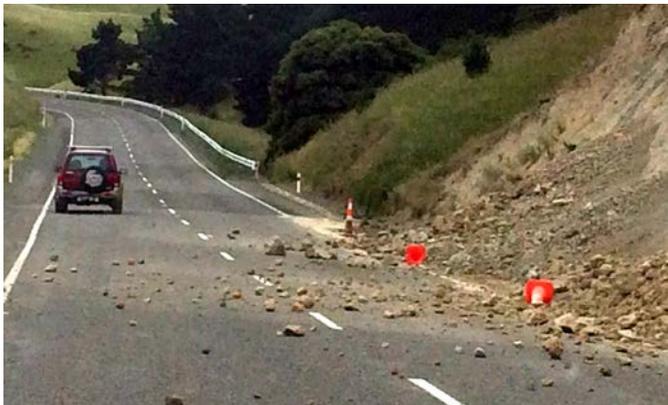
**Figure 4.** Photograph showing debris from a road cut that was shaken during the  $M_w$  5.5 aftershock of December 4, 2016, following the 2016 Kaikoura, New Zealand, earthquake. (See fig. 1B.)

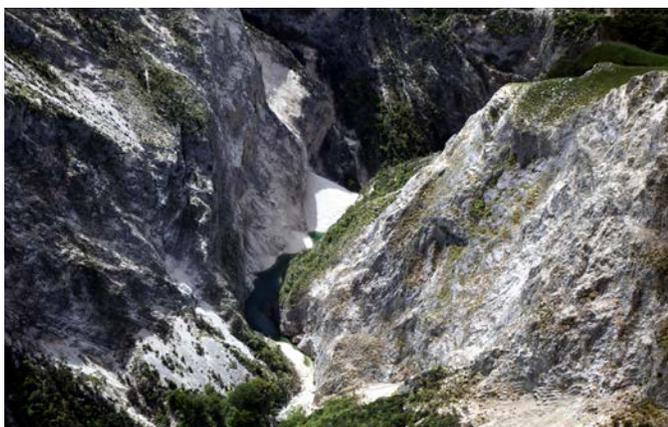
**Figure 9.** Photograph showing landslide debris blocking a channel in Sawcut Gorge. (See fig. 1E.)

Upstream, the river narrows into Sawcut Gorge, a resistant limestone block that has been narrowly incised. Landslides in this steep terrain created multiple in-channel dams that formed chains of ponds in the gorge (see fig. 9).

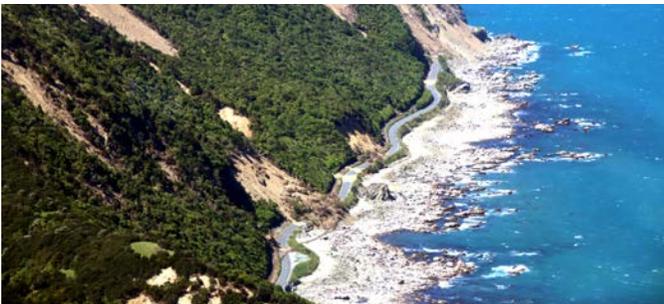
**Figure 26.** Photograph showing landslides blocking State Highway 1 between Waipapa Bay and Kaikoura. (See fig. 1B.)

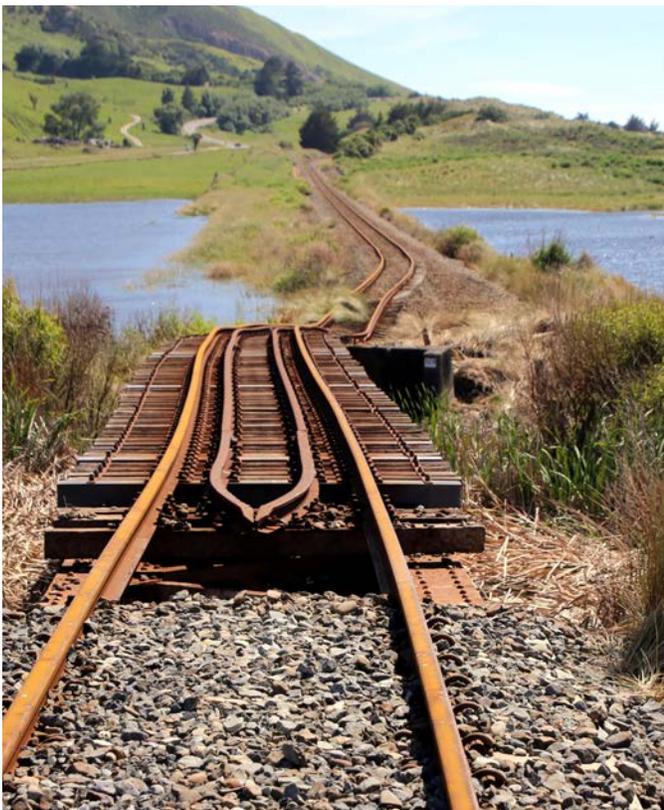
**Figure 33.** Photograph showing the South Island Main Trunk rail line offset laterally and vertically by the Kekerengu fault 15 kilometers southwest of Ward. (See fig. 1E.)

A few kilometers farther south, State Highway 1 was damaged from surface fault rupture, and a down-dropped block adjacent to the coast created a temporary lake (see fig. 32). Because the new lake is not connected to the ocean, it presumably is filled by groundwater seepage and surface drainage. This location also experienced significant damage to the railway (see fig. 33).

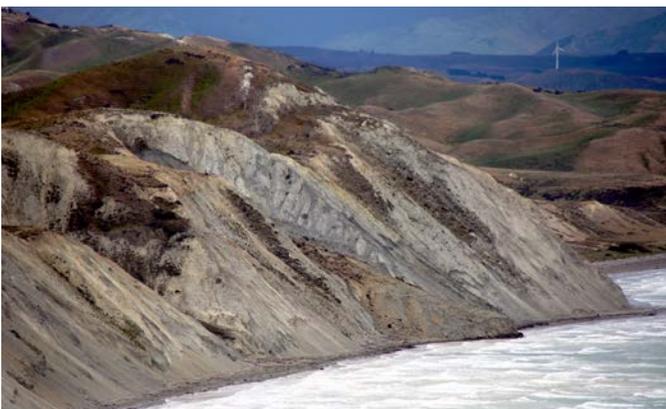
A large preexisting landslide on a hill composed of weak Neogene sandstone and siltstone was reactivated and significantly enlarged by the earthquake shaking (fig. 37). Extensive ground cracking on the crest of the hill indicates incipient failure of larger parts of the hillside (fig. 38). Numerous other preexisting landslides on steep slopes in weak sediment in the vicinity of Cape Campbell were reactivated and enlarged by strong shaking (fig. 39).

**Figure 39.** Photograph showing reactivated landslides on coastal bluffs west of Cape Campbell. (See fig. 1C.)

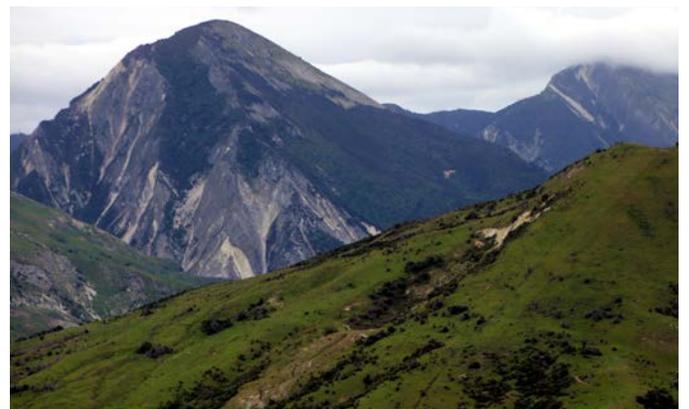
In the steeper Inland Kaikoura Range about 8 km west of Ward, we observed landslides that transitioned into steep debris flow-like channels (fig. 41). From a distance, we could not determine if these channels formed from rapid dry granular flow or if enough water was present to form a true debris flow.

**Figure 41.** Photograph showing debris slides about 8 kilometers west of Ward. (See fig. 1E.)

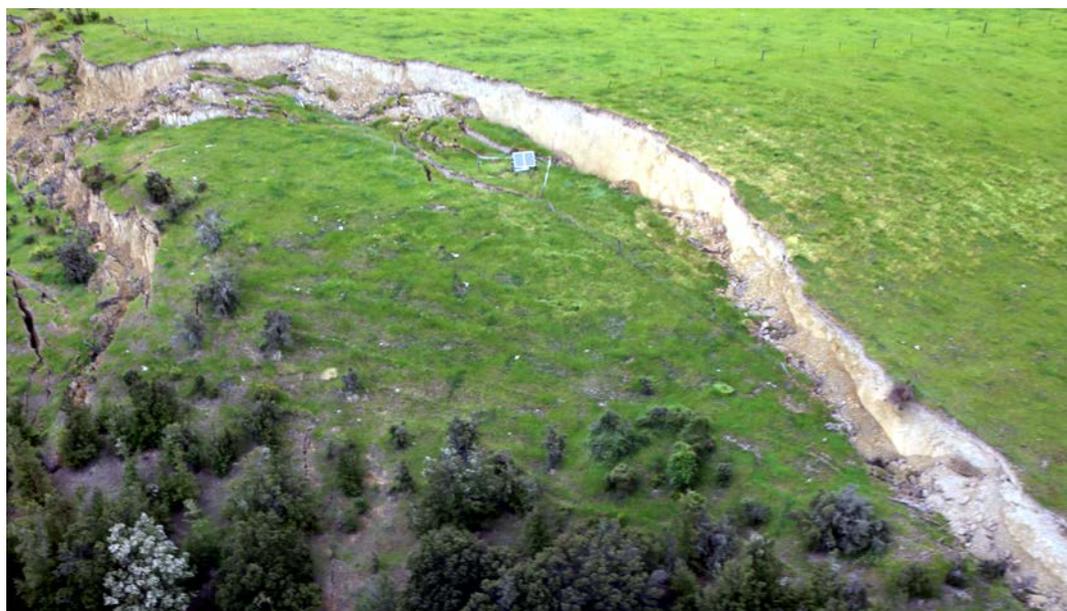
**Figure 68.** Photograph showing a landslide between Waiau and Mount Lyford with a near-vertical headscarp. (See fig. 1H.)
