Bathymetric and Velocimetric Surveys at Highway Bridges Crossing the Missouri and Mississippi Rivers on the Periphery of Missouri, July–August 2018

Scientific Investigations Report 2020–5088

By Richard J. Huizinga

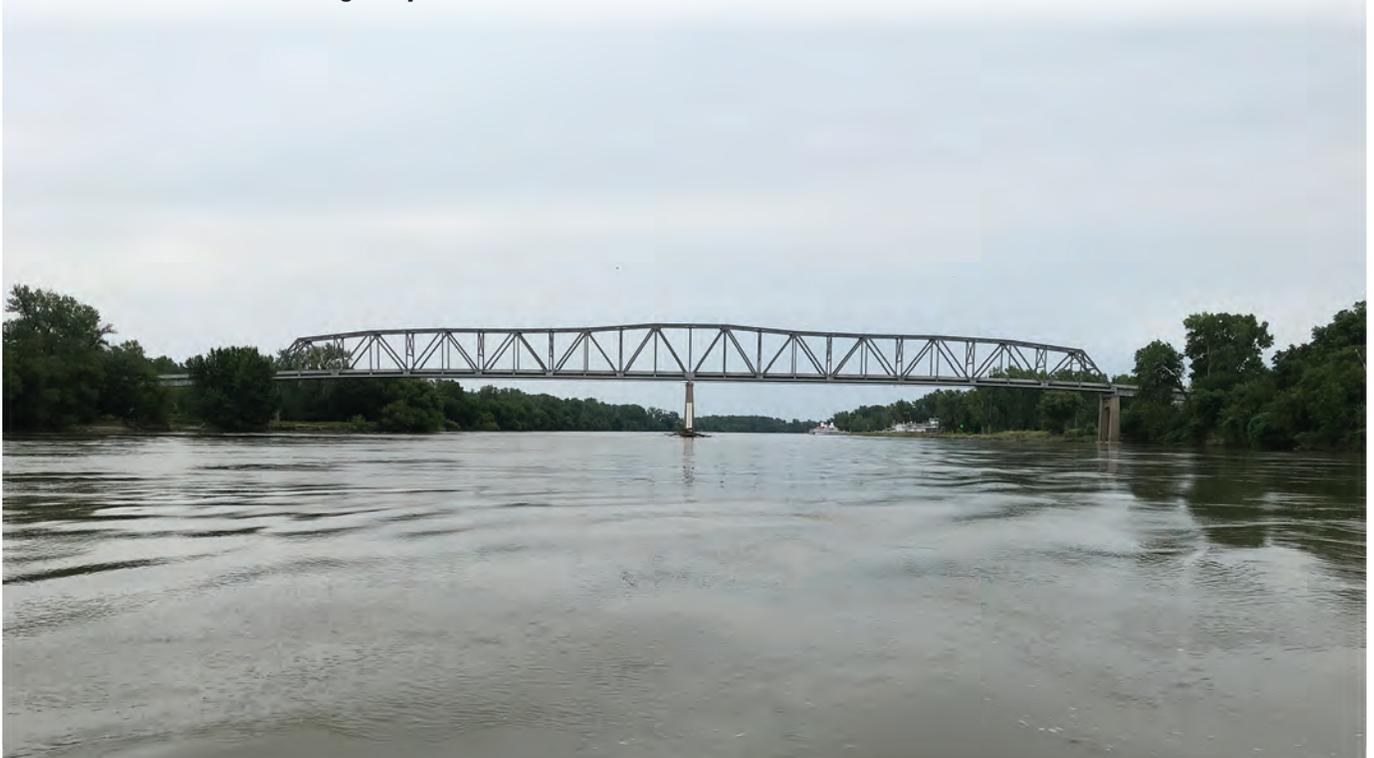
Structure L0098 on U.S. Highway 136

The survey area was about 1,640 ft long and about 740 ft wide, extending across the active channel from bank to bank (fig. 6). The upstream end of the survey area was about 740 ft upstream from the centerline of structure L0098. The channel-bed elevations ranged from about 863 to 881 ft for most of the surveyed area (5 to 95 percentile range of the bathymetric data; table 3; fig. 7), except near pier 3 and on the downstream sides of the various spur dikes on the left (east) bank (fig. 6). The channel bed was covered with medium and small dunes and ripples. As in previous surveys (Huizinga, 2012, 2015), a rock outcrop was present on the right (west) bank upstream from the bridge, and stone revetment was present on the right bank downstream from the bridge (fig. 6).

A local scour hole near pier 3 had a minimum channel-bed elevation of about 845 ft (table 7), about 20 ft below the average channel bed immediately upstream from the pier (fig. 6) and the overall minimum channel-bed elevation for the surveyed reach (table 3). Information from bridge plans

Figure 6. Bathymetric survey of the Missouri River channel near structure L0098 on U.S. Highway 136 at Brownville, Nebraska.

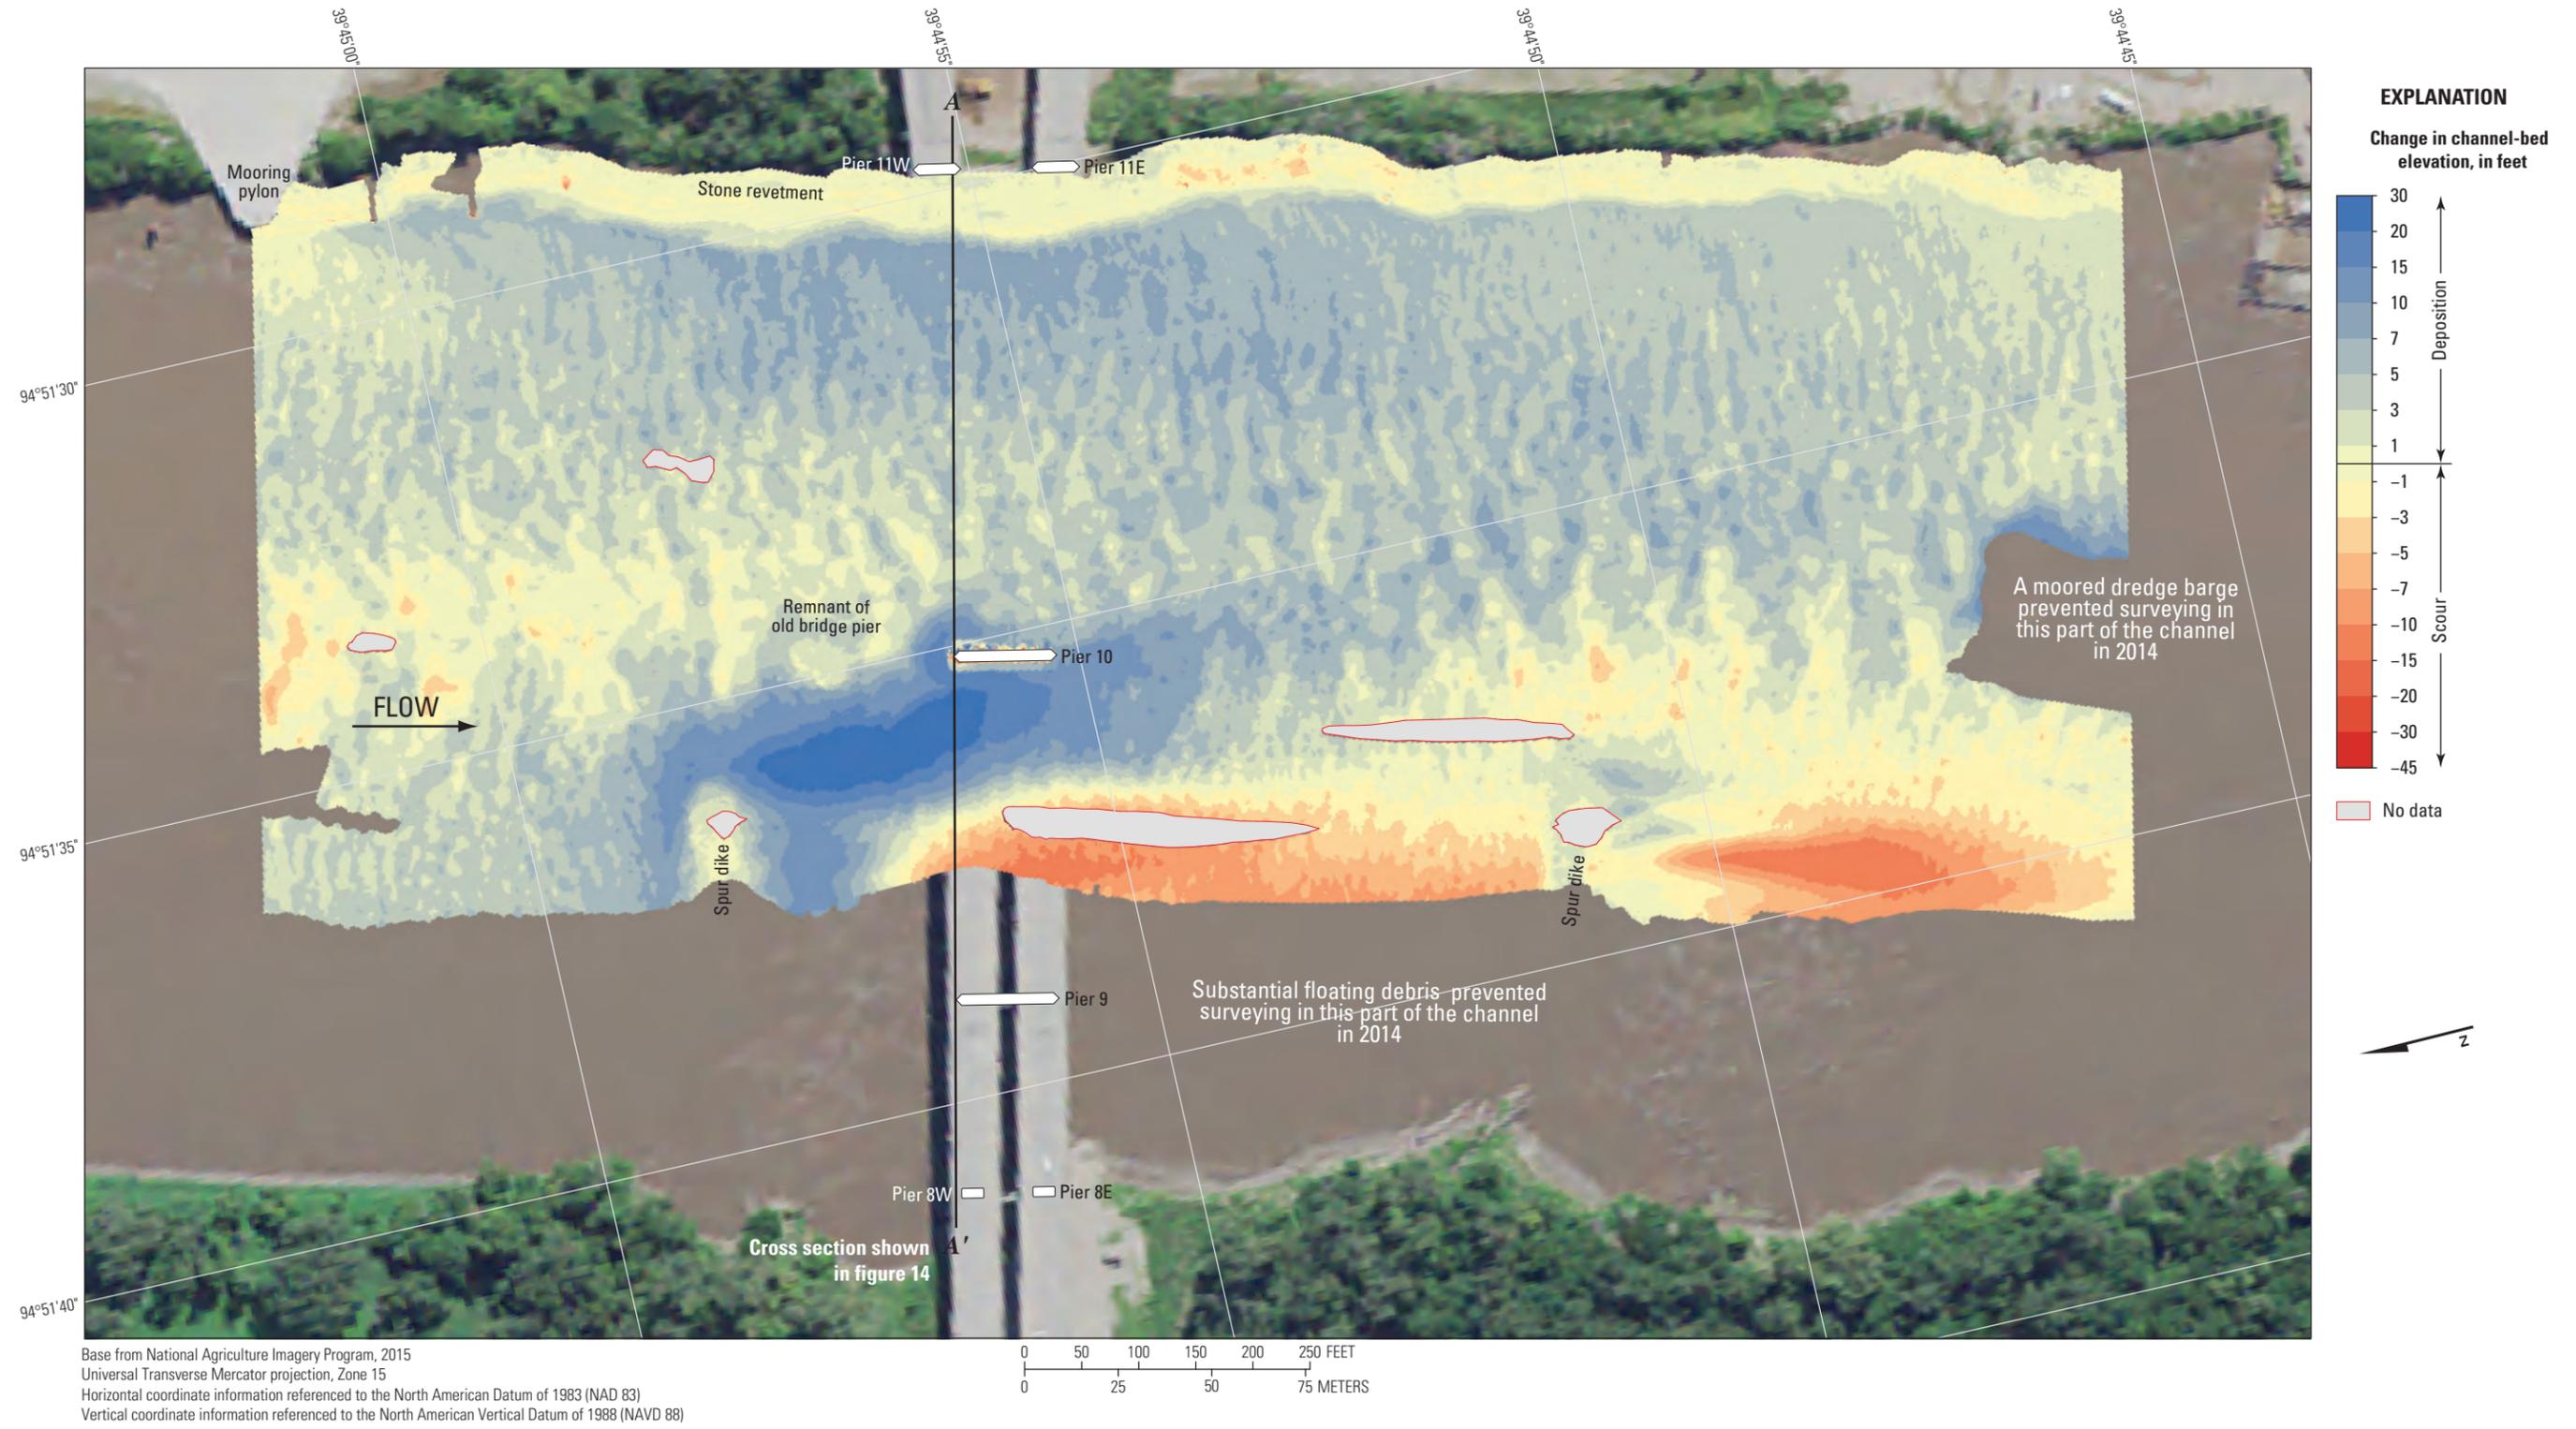
The difference between the survey on July 16, 2018, and the previous nonflood survey on June 4, 2014 (fig. 15), indicates substantial deposition of nearly 30 ft throughout the reach from the 2014 to 2018 surveys, resulting in an average difference of +3.15 ft between the bathymetric surfaces (table 8). The net volume of cut in the reach from 2014 to 2018 was about 21,200 yd³, and the net volume of fill was about 141,200 yd³, resulting in a net gain of about 120,000 yd³ of sediment. The frequency distribution of channel-bed elevations in 2018 was similar in shape to 2014, but with most of the survey-grid cells at elevations about 3 ft higher than in 2014 (fig. 13). The limited width extent of the 2014 survey

Figure 15. Difference between surfaces created from bathymetric surveys of the Missouri River channel near dual bridge structure A3664 on U.S. Highway 36 at St. Joseph, Missouri, on July 16, 2018, and June 4, 2014.

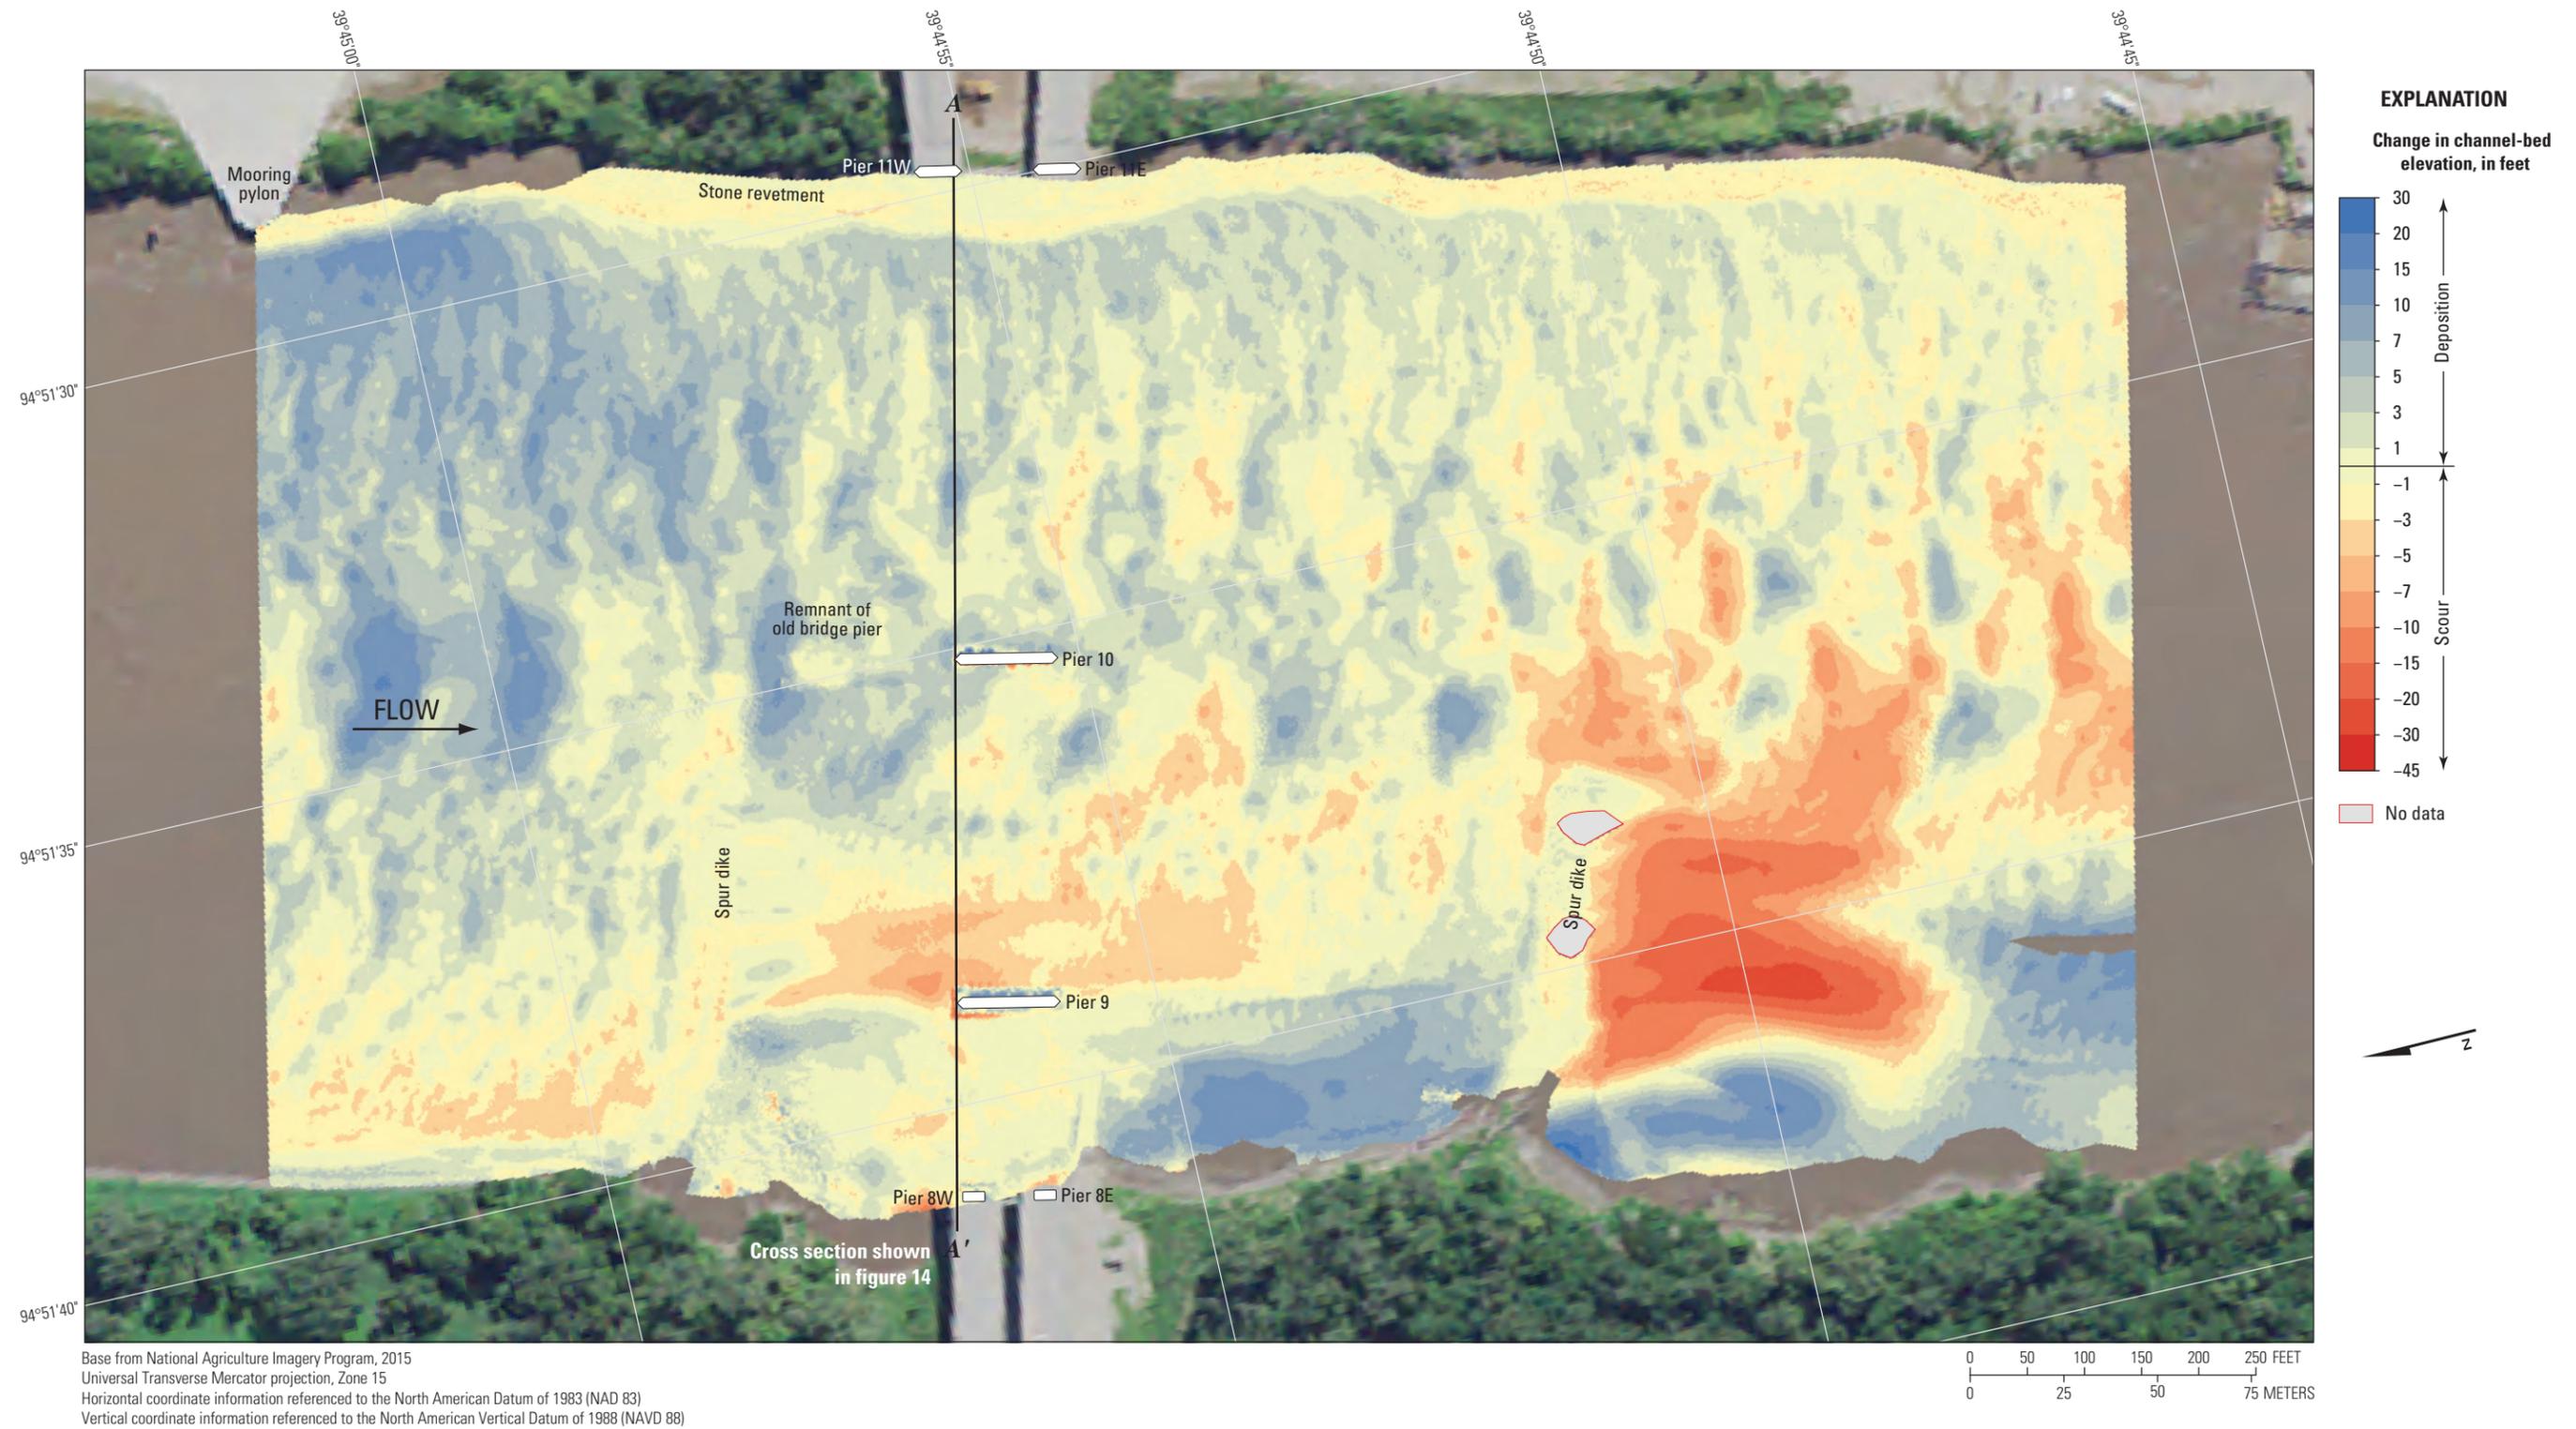
The difference between the survey on July 16, 2018, and the previous flood survey on July 14, 2011, indicates a general balance of scour and deposition throughout the reach between 2011 and 2018, except downstream from the downstream spur dike on the right (west) side of the channel where scour of as much as 20 ft was observed (fig. 16). The average difference between the bathymetric surfaces was +0.86 ft (table 8), indicating minor aggradation between the 2011 and 2018 surveys for the area common to both surveys. The net volume of cut in

Figure 16. Difference between surfaces created from bathymetric surveys of the Missouri River channel near dual bridge structure A3664 on U.S. Highway 36 at St. Joseph, Missouri, on July 16, 2018, and July 14, 2011.

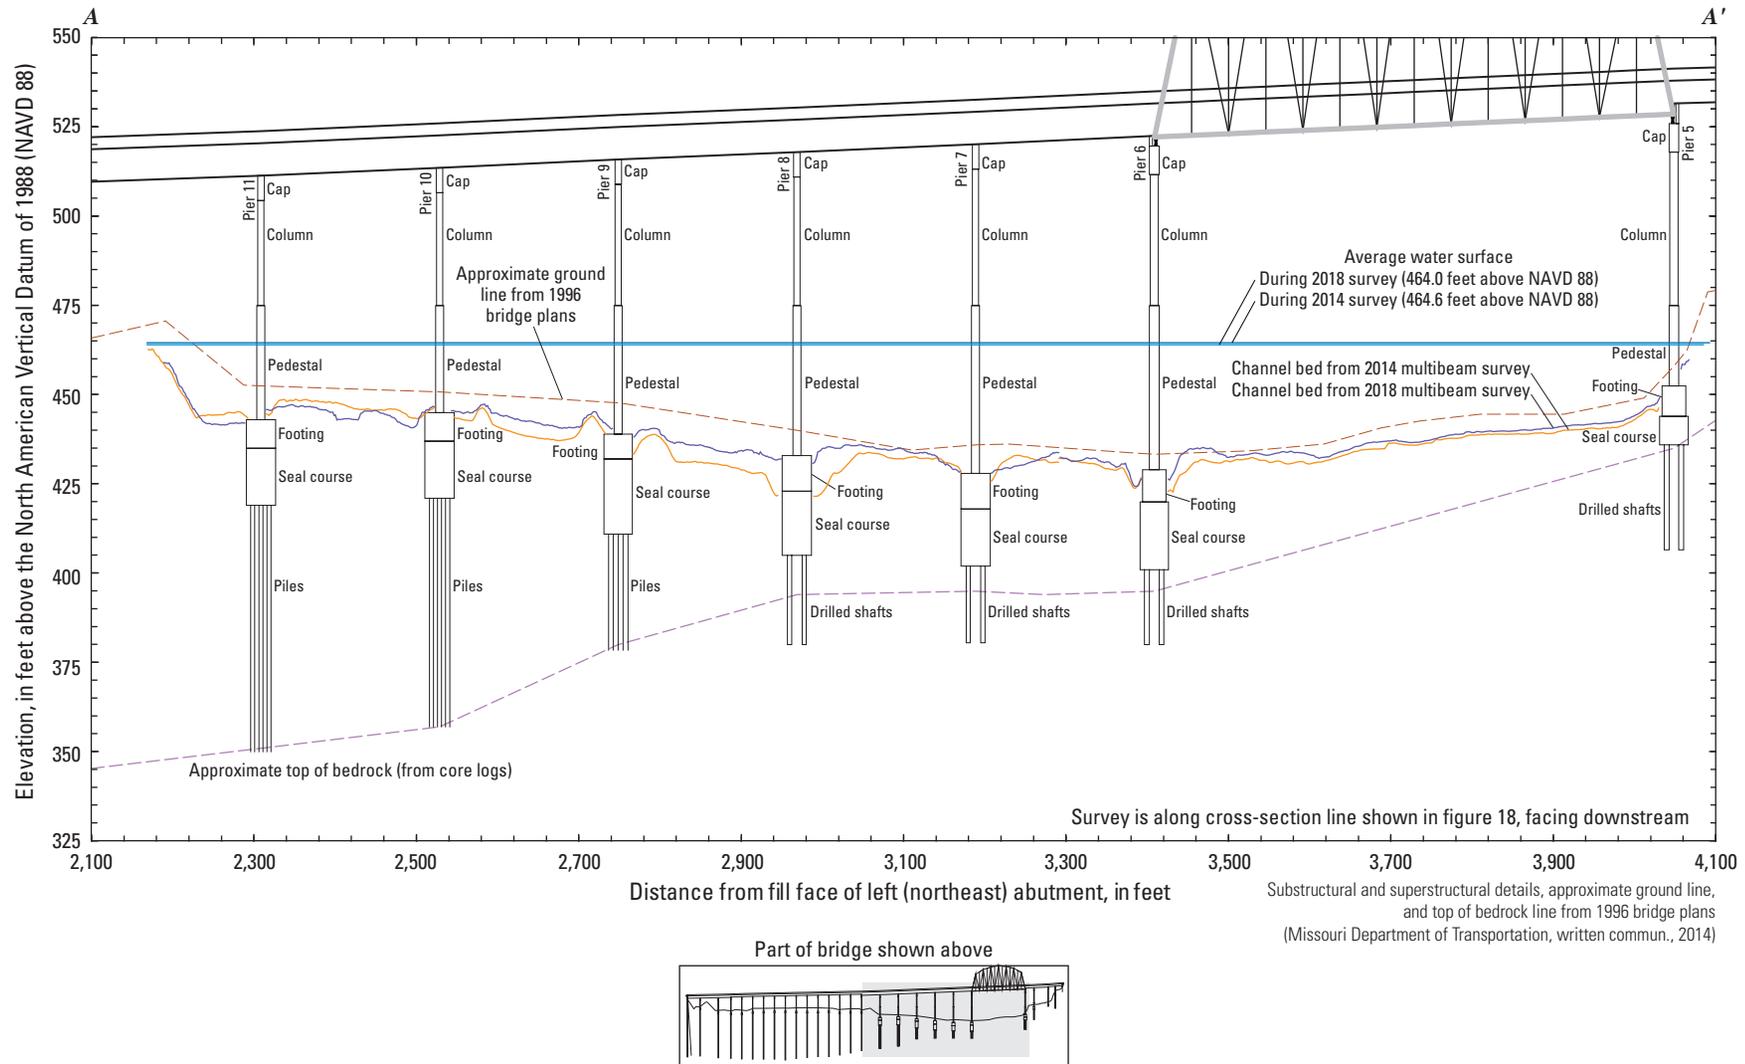
The minor scour holes near piers 10 and 11 were difficult to discern from nearby dunes and ripples, and there was no discernable hole near pier 5 on the right bank (figs. 18, 20). Alternatively, piers 6 through 8 had well-defined, asymmetric scour holes indicative of being skewed to approach flow. Pier 8 seems to have part of the footing exposed in the bathymetric map (figs. 18, 1.4A, 1.4B), and piers 9 and 10 seem to be surrounded by partial riprap blankets or piles of rock (figs. 18, 1.3C through 1.3F). Information from bridge plans

(Missouri Department of Transportation, written commun., 2014) indicates that piers 5 through 8 are founded on shafts drilled 15 to 28 ft into bedrock, having about 12 to 34 ft of bed material between the channel bottom and bedrock (fig. 20; table 7). Piers 9 through 11 are founded on steel H-piles driven to refusal on bedrock, having 56 ft of bed material between the channel bottom and bedrock at pier 9, 86 ft of bed material at pier 10, and 89 ft of bed material at pier 11 (fig. 20; table 7). The surveyed bed was 1 to 10 ft higher along the upstream bridge face than the previous survey in 2014, except between the left (northeast) bank and pier 10 (fig. 20). The cross section along the upstream bridge face indicates partial footing exposure at all the piers (fig. 20), although it is not readily evident on the bathymetry map (fig. 18). However, footing exposure is readily apparent in the shaded TIN images of pier 11 (figs. 1.3A, 1.3B) and piers 6 through 8 (fig. 1.4). The top of the footing is partially evident at pier 9 in the shaded TIN images (figs. 1.3F), but is mostly obscured by sediment or a partial riprap blanket.

Figure 20. Key features, substructural and superstructural details, and surveyed channel bed of structure A5054 on Interstate 72 crossing the Mississippi River at Hannibal, Missouri.

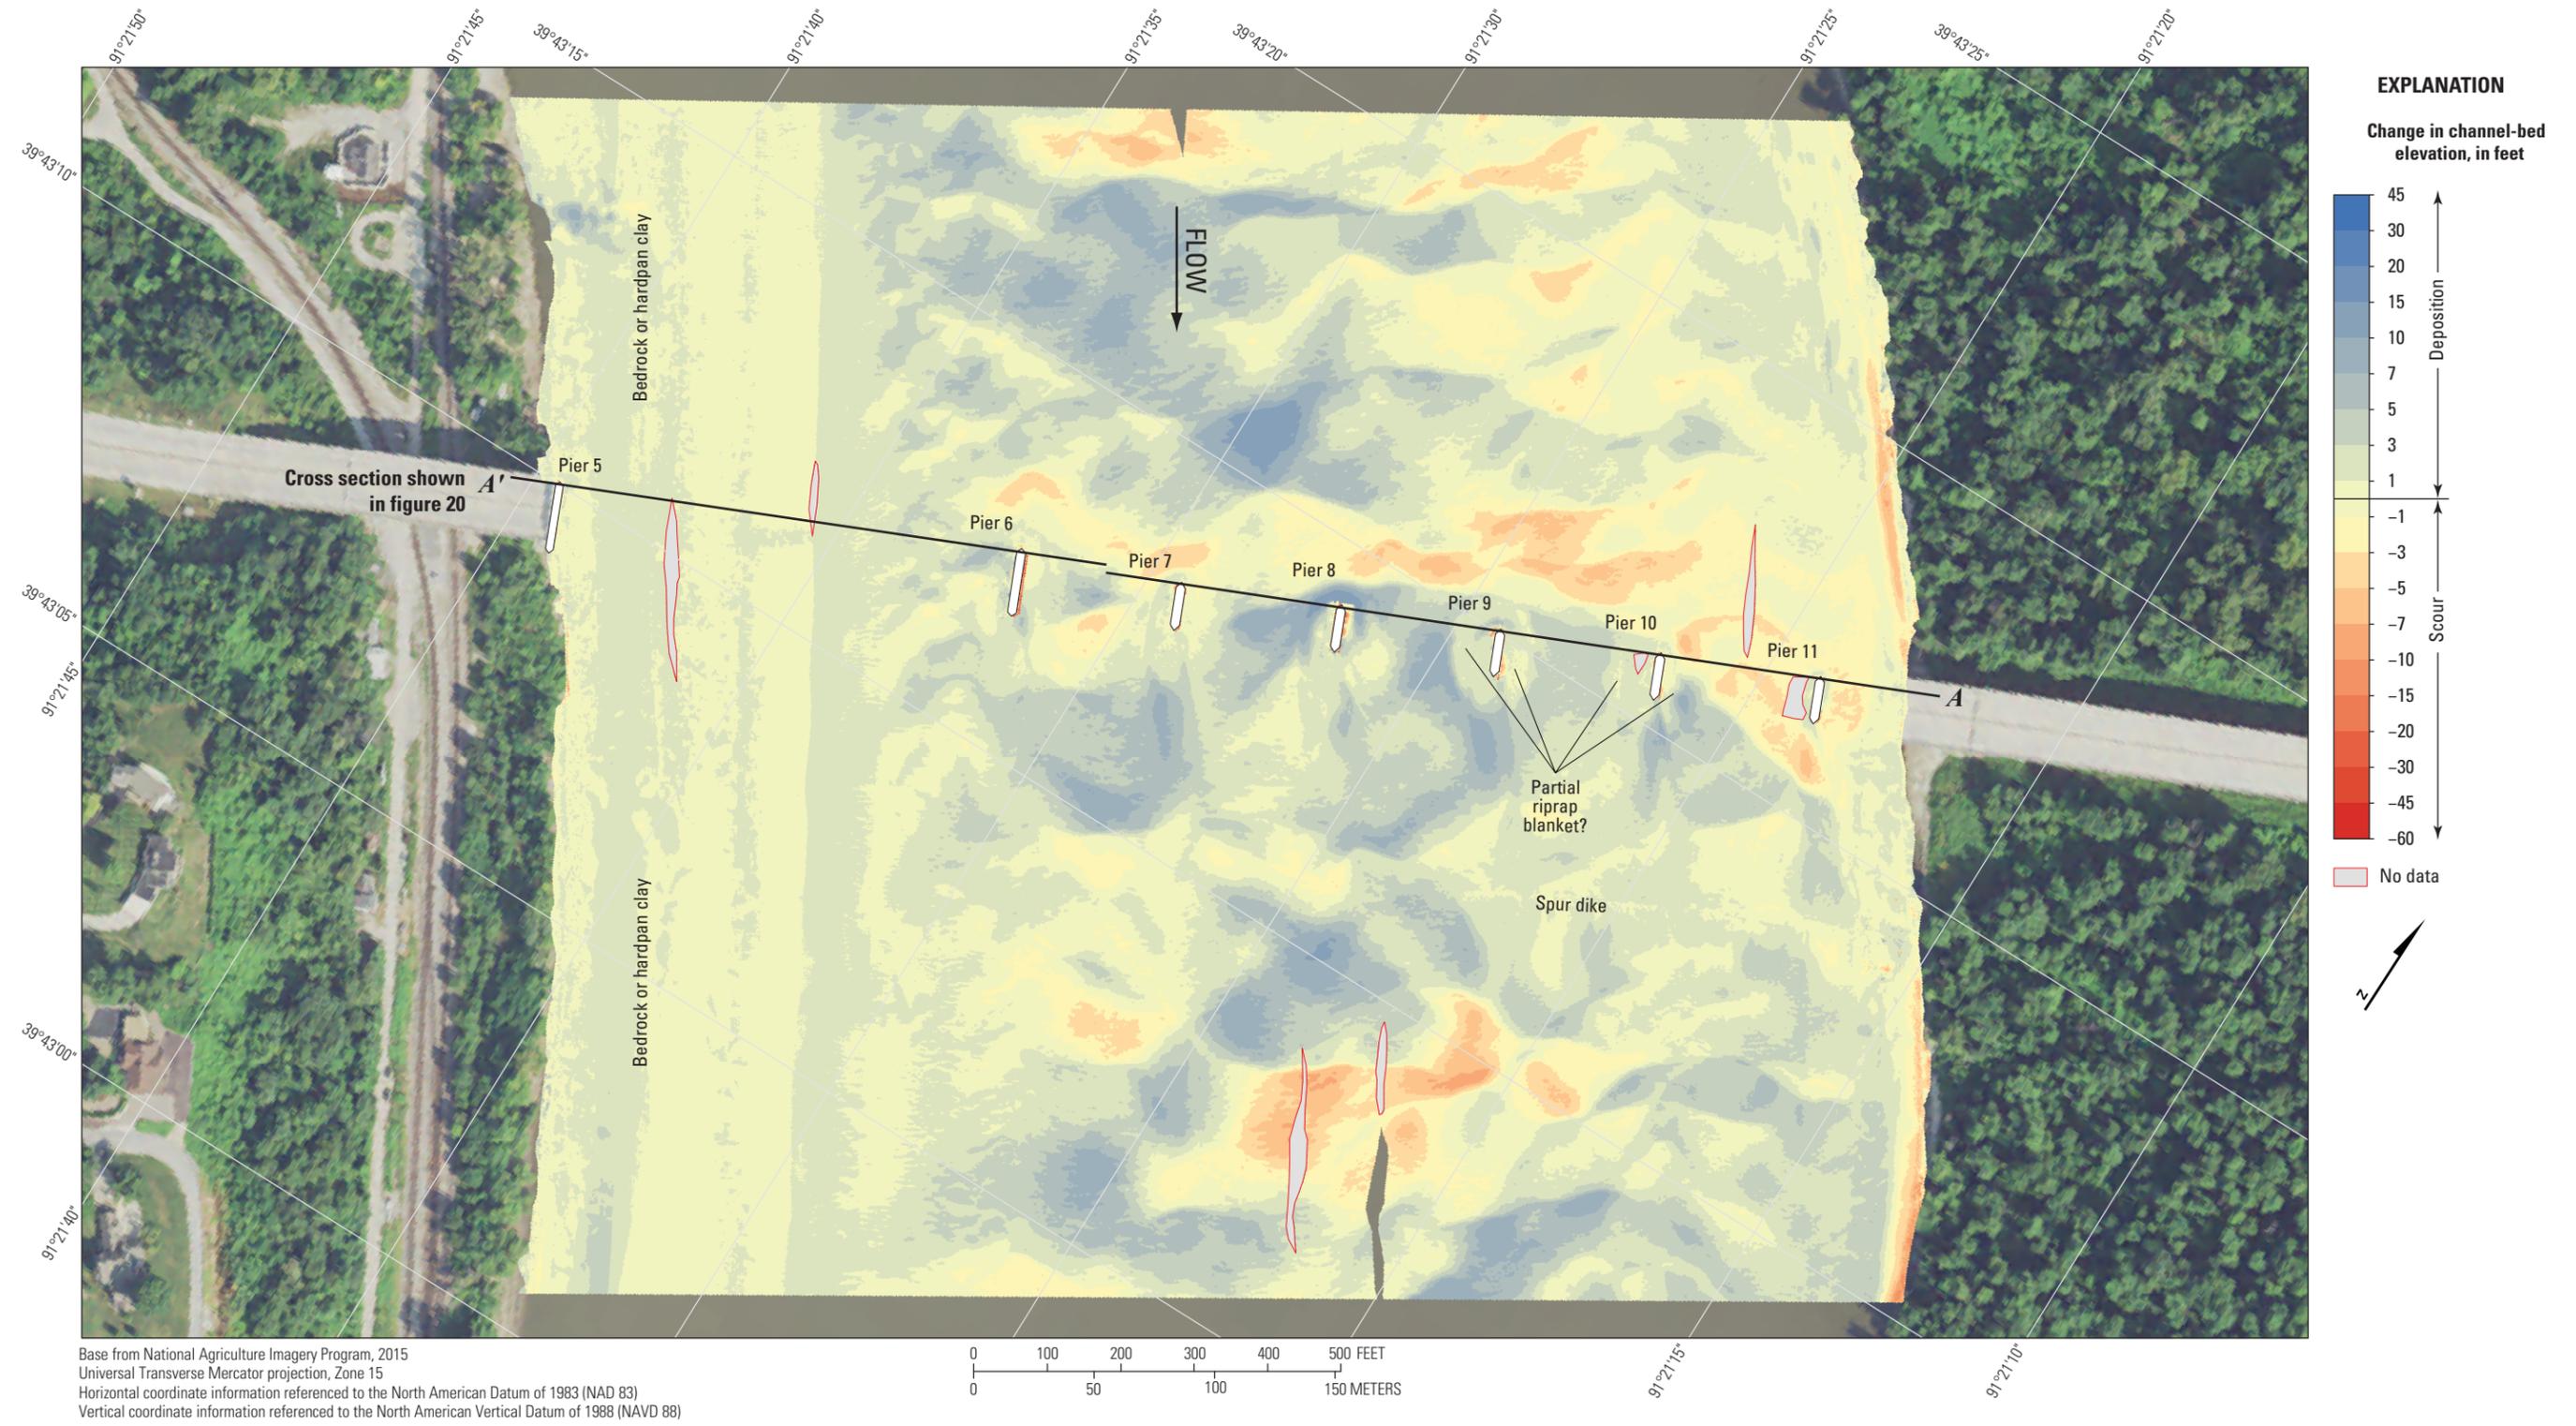
The difference between the survey on July 18, 2018, and the previous survey on June 5, 2014 (fig. 21), indicates moderate deposition of as much as 15 ft throughout the reach from the 2014 to 2018 surveys, resulting in an average difference

of +1.45 ft between the bathymetric surfaces (table 8). The net volume of cut in the reach from 2014 to 2018 was about 39,800 yd³, and the net volume of fill was about 200,000 yd³, resulting in a net gain of about 160,000 yd³ of sediment. There was minor deposition of as much as 5 ft along the right (southwest) bank, and a narrow bank of scour of as much as 10 ft along the left (northeast) bank compared to the 2018 survey (fig. 21). Moderate localized scour of as much as 10 ft was observed in various areas upstream, near the bridge piers, and downstream in the channel (fig. 21). The frequency distribution of bed elevations was similar in 2018 and 2014, but with a greater percentage of survey-grid cells at elevations below 432 ft in 2014 than 2018 (fig. 19).

Figure 21. Difference between surfaces created from bathymetric surveys of the Mississippi River channel near structure A5054 on Interstate 72 at Hannibal, Missouri, on July 18, 2018, and June 5, 2014.

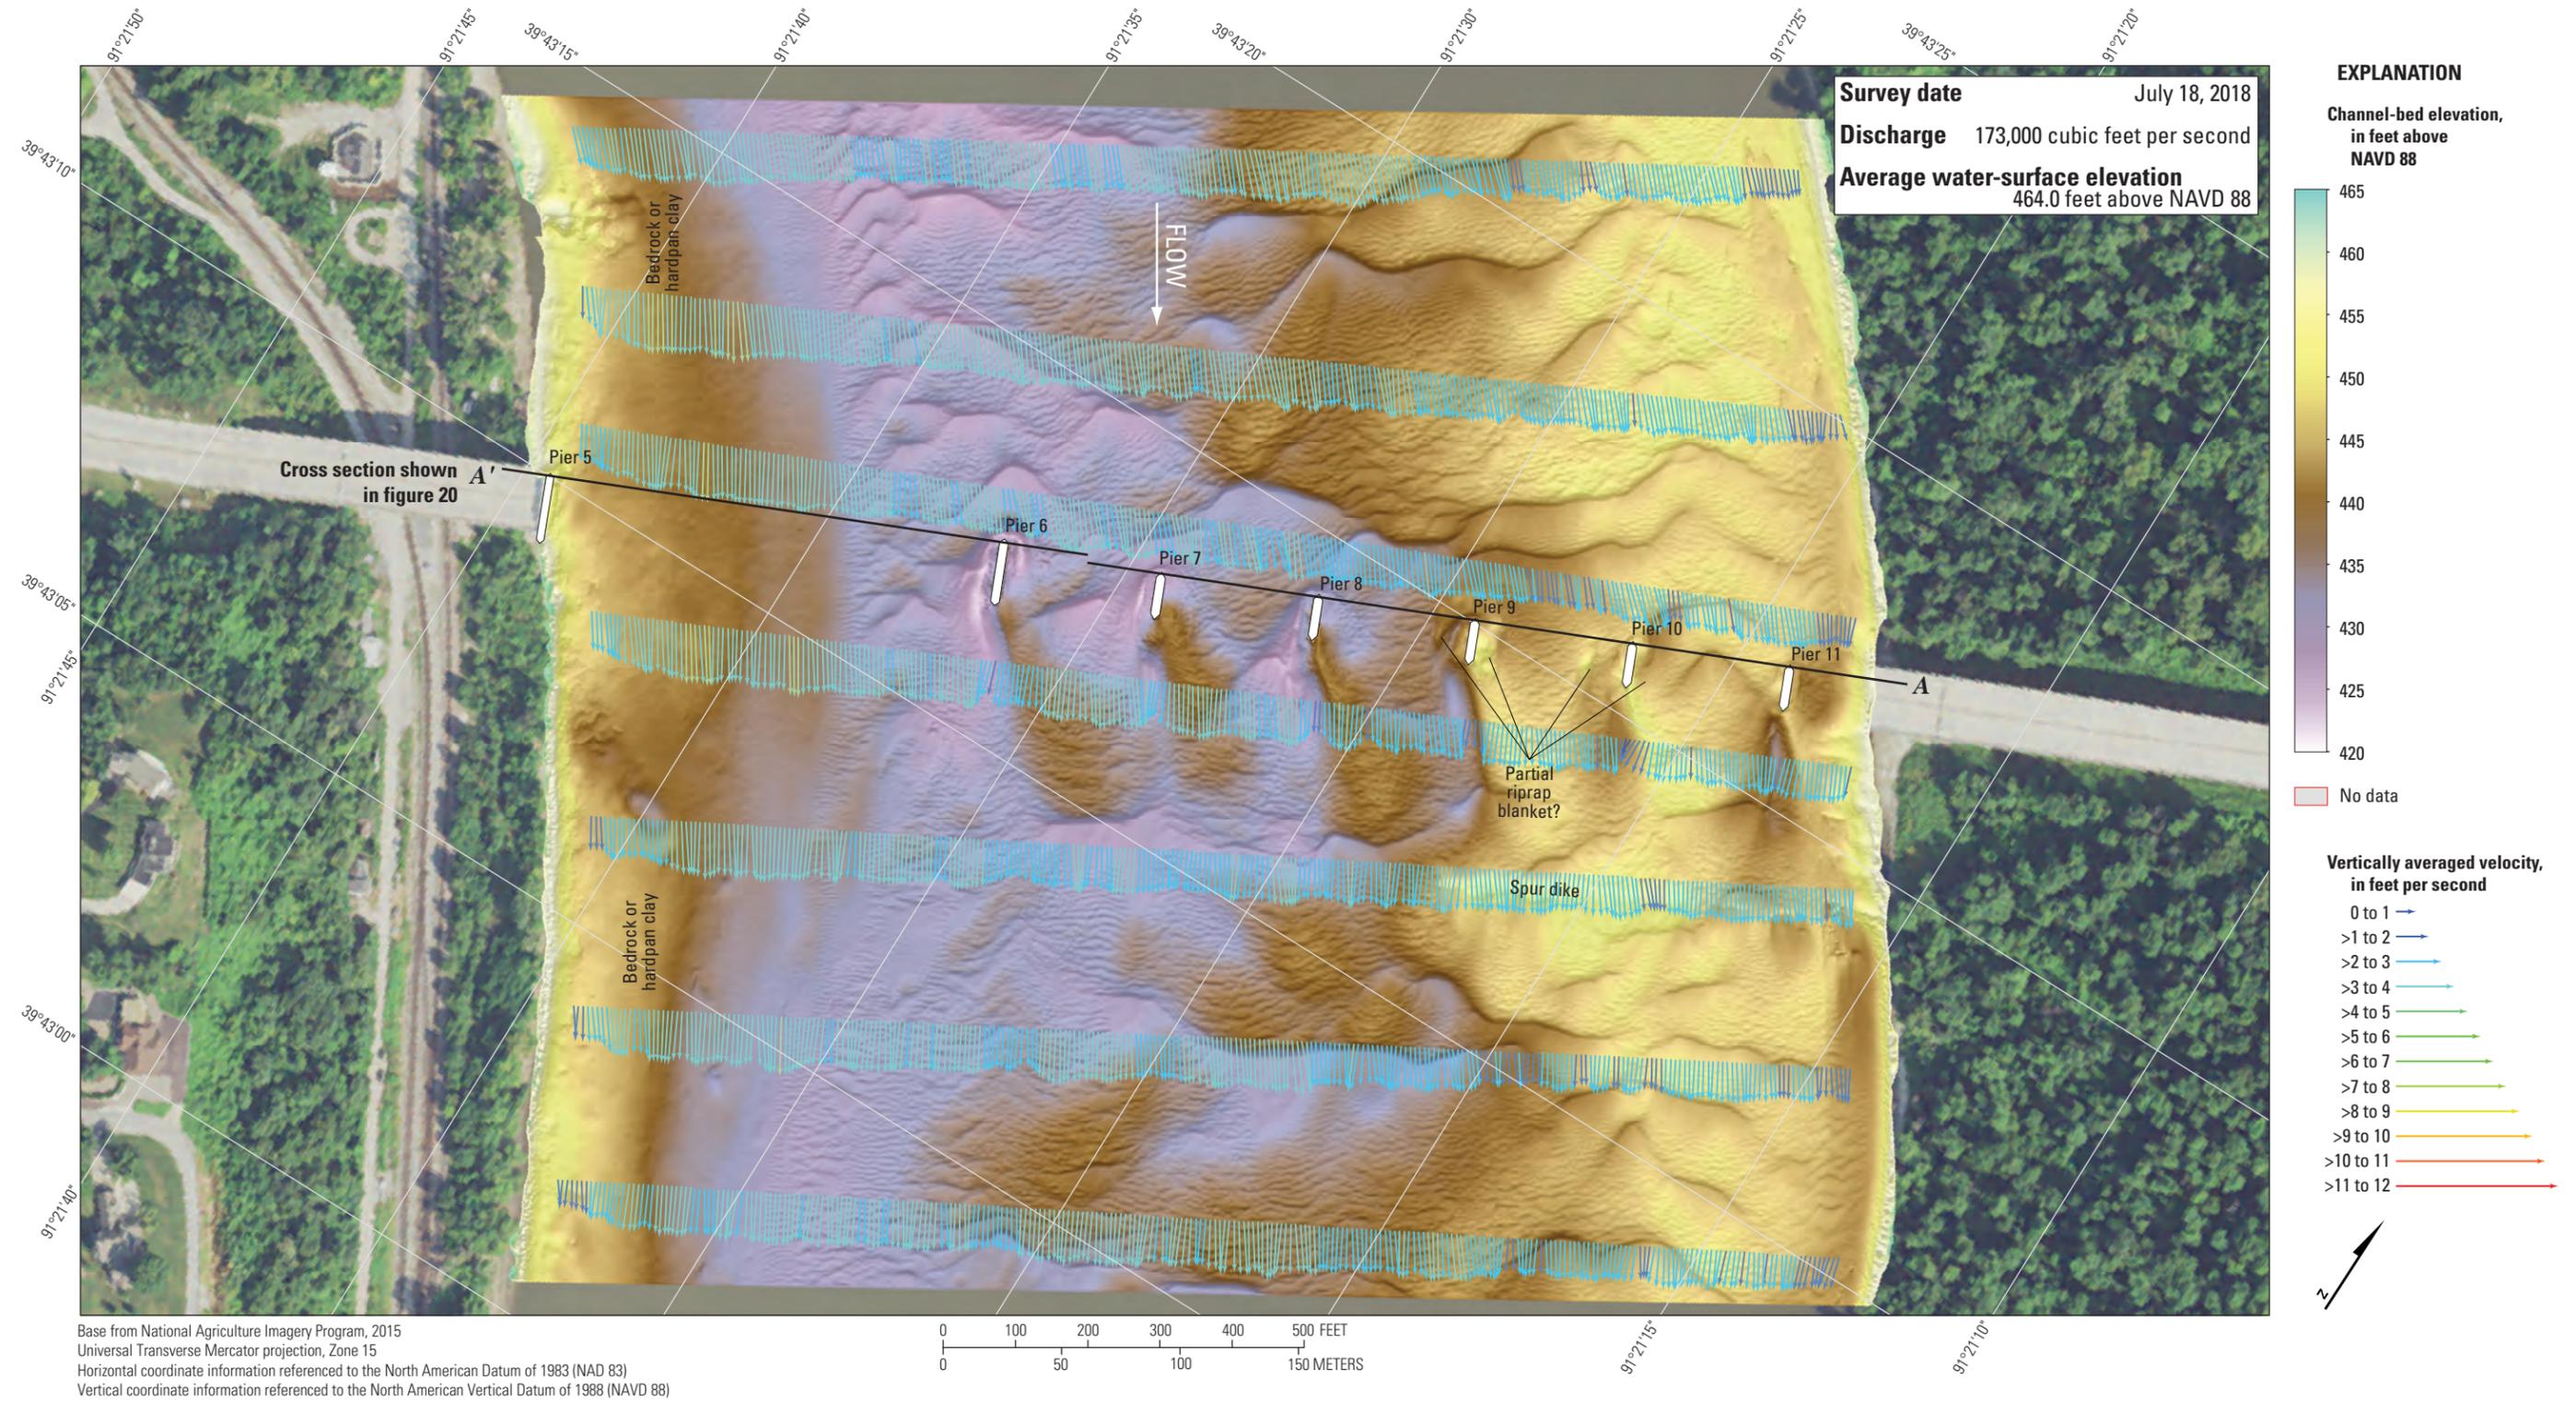
The vertically averaged velocity vectors indicate mostly uniform flow throughout most of the channel, ranging from about 3 to 7 ft/s (fig. 22). Areas of non-uniform flow caused by the skewed orientation of the piers is evident in the velocity sections downstream from the bridge, as well as near the spur dike on the left bank downstream from the bridge. Similar areas of non-uniform flow are apparent in the upstream sections as well, likely caused by a railroad bridge located about 1,130 ft upstream from the surveyed reach (fig. 22)

Figure 22. Bathymetry and vertically averaged velocities of the Mississippi River channel near structure A5054 on Interstate 72 at Hannibal, Missouri.

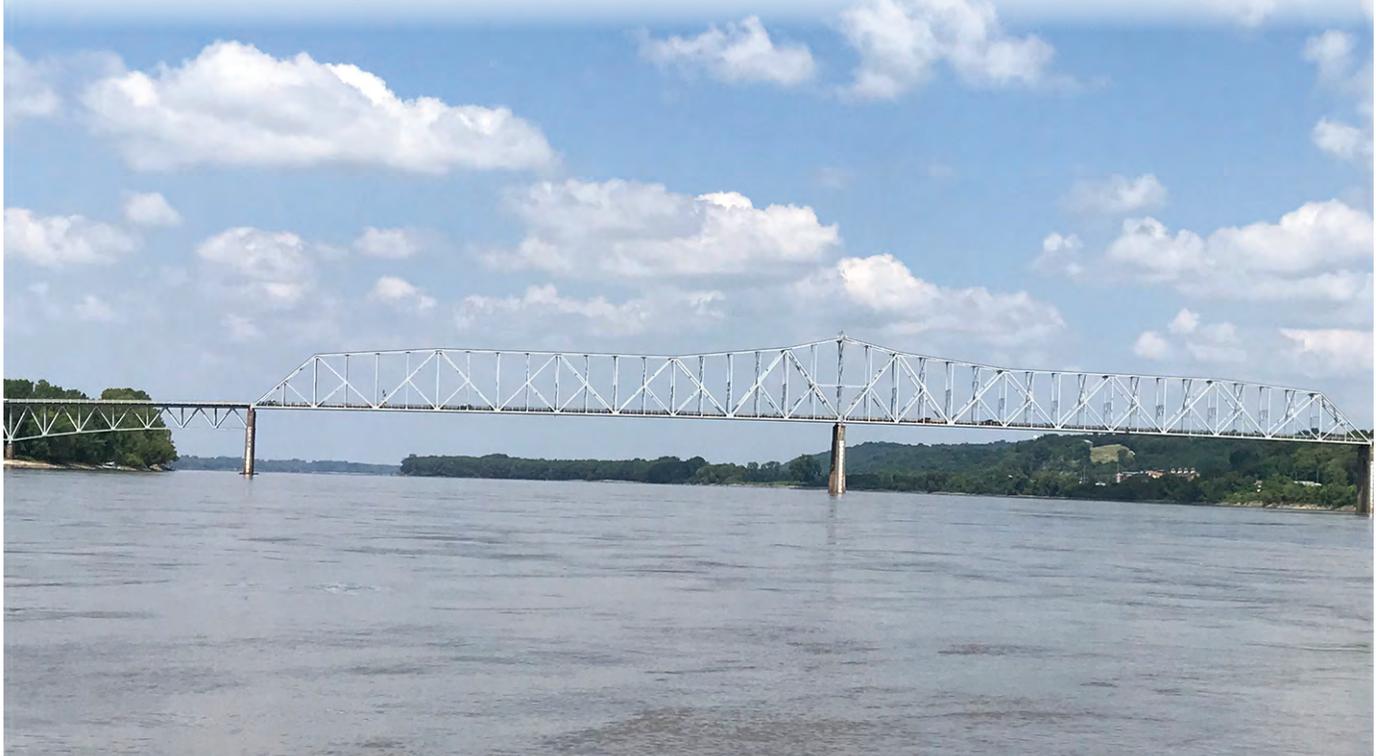
Structure L0135 on State Highway 51

Near pier 11 (fig. 23), a substantial scour hole had a minimum channel-bed elevation of about 306 ft (table 7), which is about 16 ft below the average channel elevation upstream from the pier (figs. 23, 25, 1.5C, 1.5D). Information from bridge plans (Missouri Department of Transportation, written commun., 2000) indicates that pier 11 is founded on a caisson on bedrock, having about 40 ft of bed material between the bottom of the scour hole and bedrock (fig. 25; table 7). Near pier 10 (fig. 23), a moderate scour hole had a minimum channel-bed elevation of about 330 ft (table 7), which is about 8 ft below the average channel elevation upstream from the pier (figs. 23, 25, 1.5E, 1.5F). Pier 10 also is founded on a caisson on bedrock, having about 85 ft of bed material between the bottom of the scour hole and bedrock (fig. 25; table 7). Pier 12 is founded on footings on the exposed bedrock on the right bank, with no apparent scour hole nearby (figs. 23, 25, 1.5A, 1.5B; table 7). Pier 13 also is founded on footings on the exposed bedrock on the right bank, and was near the surveyed water surface with no apparent scour hole nearby (figs. 23, 25; table 7). In modern construction, bridge substructural elements usually are pinned or socketed to bedrock (American Association of State Highway Transportation Officials, 2012; Brown and others, 2010), but full exposure of usually buried substructural elements warrants special consideration and

observation, even when designed to be exposed. The surveyed bed generally was lower than the original ground line from 1940 bridge plans (Missouri Department of Transportation, written commun., 2000) between piers 9 and 10 and between piers 11 and 13, and higher than the original ground line between piers 10 and 11 (fig. 25). The surveyed bed was approximately the same as the bed from the Level 2 scour survey in 2000 (Huizinga and Rydlund, 2004), except on the left bank (fig. 25); however, the ground line from the Level 2 bridge scour assessment was along the downstream side of the bridge and may have incorporated part of the downstream spur dike (fig. 23).

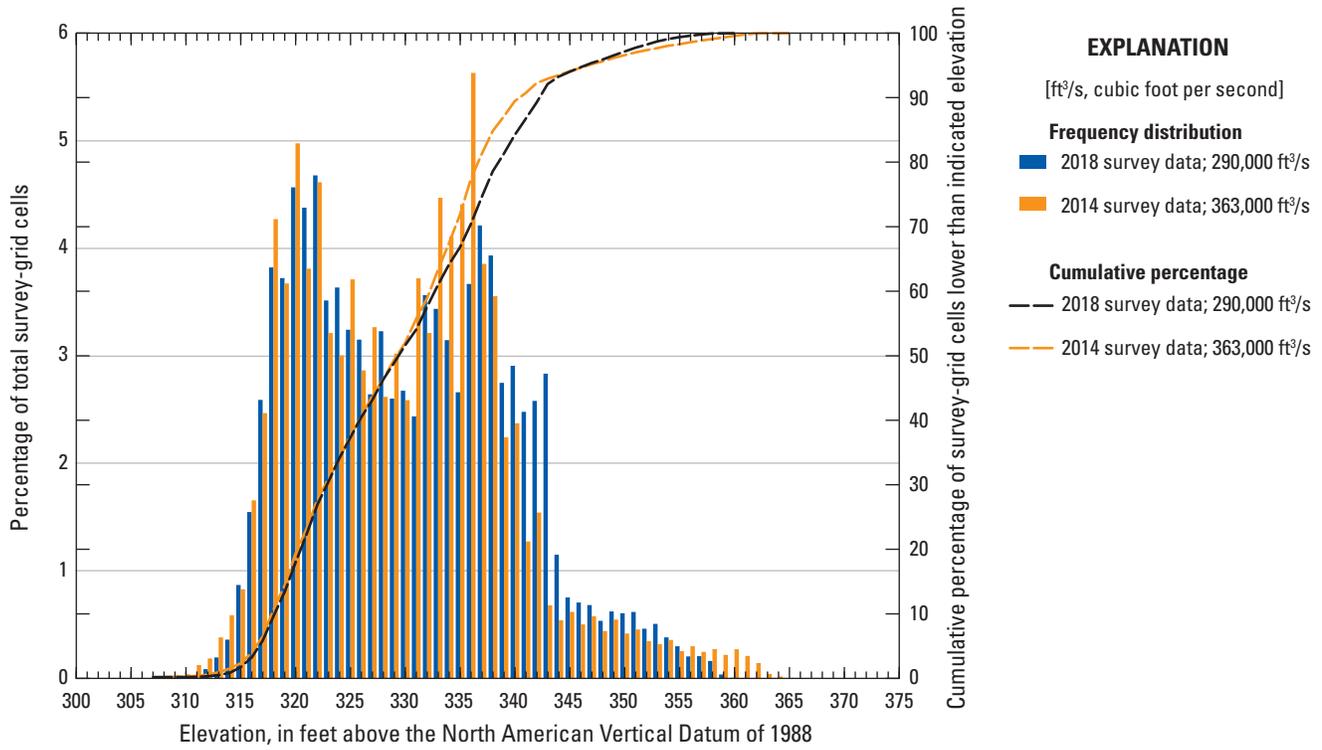
Figure 24. Frequency distribution of bed elevations for bathymetric survey-grid cells in 1-foot elevation bins on the Mississippi River near structure L0135 on State Highway 51 at Chester, Illinois, on July 24, 2018, compared to previous surveys (Huizinga, 2015).

An examination of the frequency distributions of bed elevations (figs. 7, 13, 19, 24, 29, and 34) indicate that the 2018 distributions generally are similar to the 2014 distributions, which might be expected given the generally similar flow conditions or flow regime between 2014 and 2018. However, there is a difference in the distributions at St. Joseph (site 2, fig. 13), which likely is the result of the dredging operation in progress in 2014 as mentioned earlier in this section. A difference in distribution at Caruthersville (site 38, fig. 34) may be the result of the timing of the 2018 survey after the longer-duration high flow on the Mississippi River, compared to being on the rising limb of a flood in 2014 (Huizinga, 2015). The 2018 accumulation curve generally falls between the 2011 distribution and the 2008 and 2014 distributions at Caruthersville (fig. 34); the 2014 distribution is very similar to the 2008 distribution (fig. 34), despite the substantially different flows.
