Bathymetric and Velocimetric Surveys at Highway Bridges Crossing the Missouri and Mississippi Rivers on the Periphery of Missouri, July–August 2018

Scientific Investigations Report 2020–5088

By Richard J. Huizinga

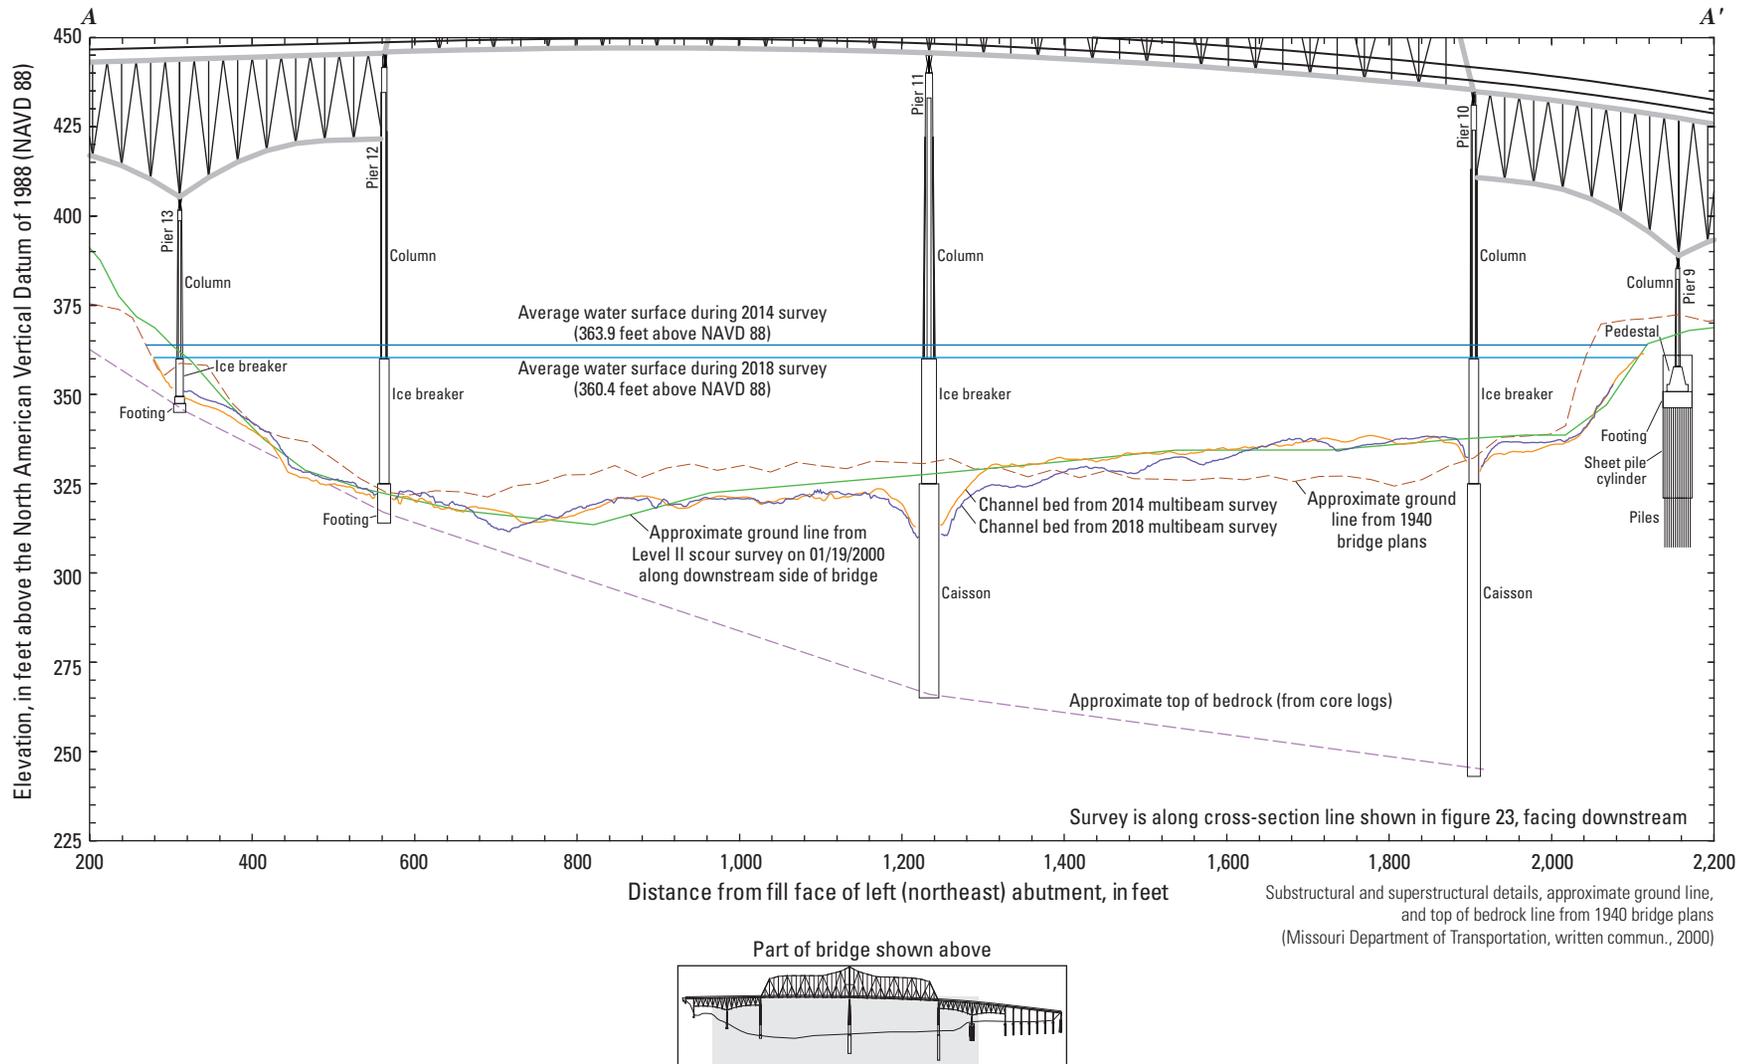
Near pier 11 (fig. 23), a substantial scour hole had a minimum channel-bed elevation of about 306 ft (table 7), which is about 16 ft below the average channel elevation upstream from the pier (figs. 23, 25, 1.5C, 1.5D). Information from bridge plans (Missouri Department of Transportation, written commun., 2000) indicates that pier 11 is founded on a caisson on bedrock, having about 40 ft of bed material between the bottom of the scour hole and bedrock (fig. 25; table 7). Near pier 10 (fig. 23), a moderate scour hole had a minimum channel-bed elevation of about 330 ft (table 7), which is about 8 ft below the average channel elevation upstream from the pier (figs. 23, 25, 1.5E, 1.5F). Pier 10 also is founded on a caisson on bedrock, having about 85 ft of bed material between the bottom of the scour hole and bedrock (fig. 25; table 7). Pier 12 is founded on footings on the exposed bedrock on the right bank, with no apparent scour hole nearby (figs. 23, 25, 1.5A, 1.5B; table 7). Pier 13 also is founded on footings on the exposed bedrock on the right bank, and was near the surveyed water surface with no apparent scour hole nearby (figs. 23, 25; table 7). In modern construction, bridge substructural elements usually are pinned or socketed to bedrock (American Association of State Highway Transportation Officials, 2012; Brown and others, 2010), but full exposure of usually buried substructural elements warrants special consideration and

Figure 25. Key features, substructural and superstructural details, and surveyed channel bed of structure L0135 on State Highway 51 crossing the Mississippi River at Chester, Illinois.

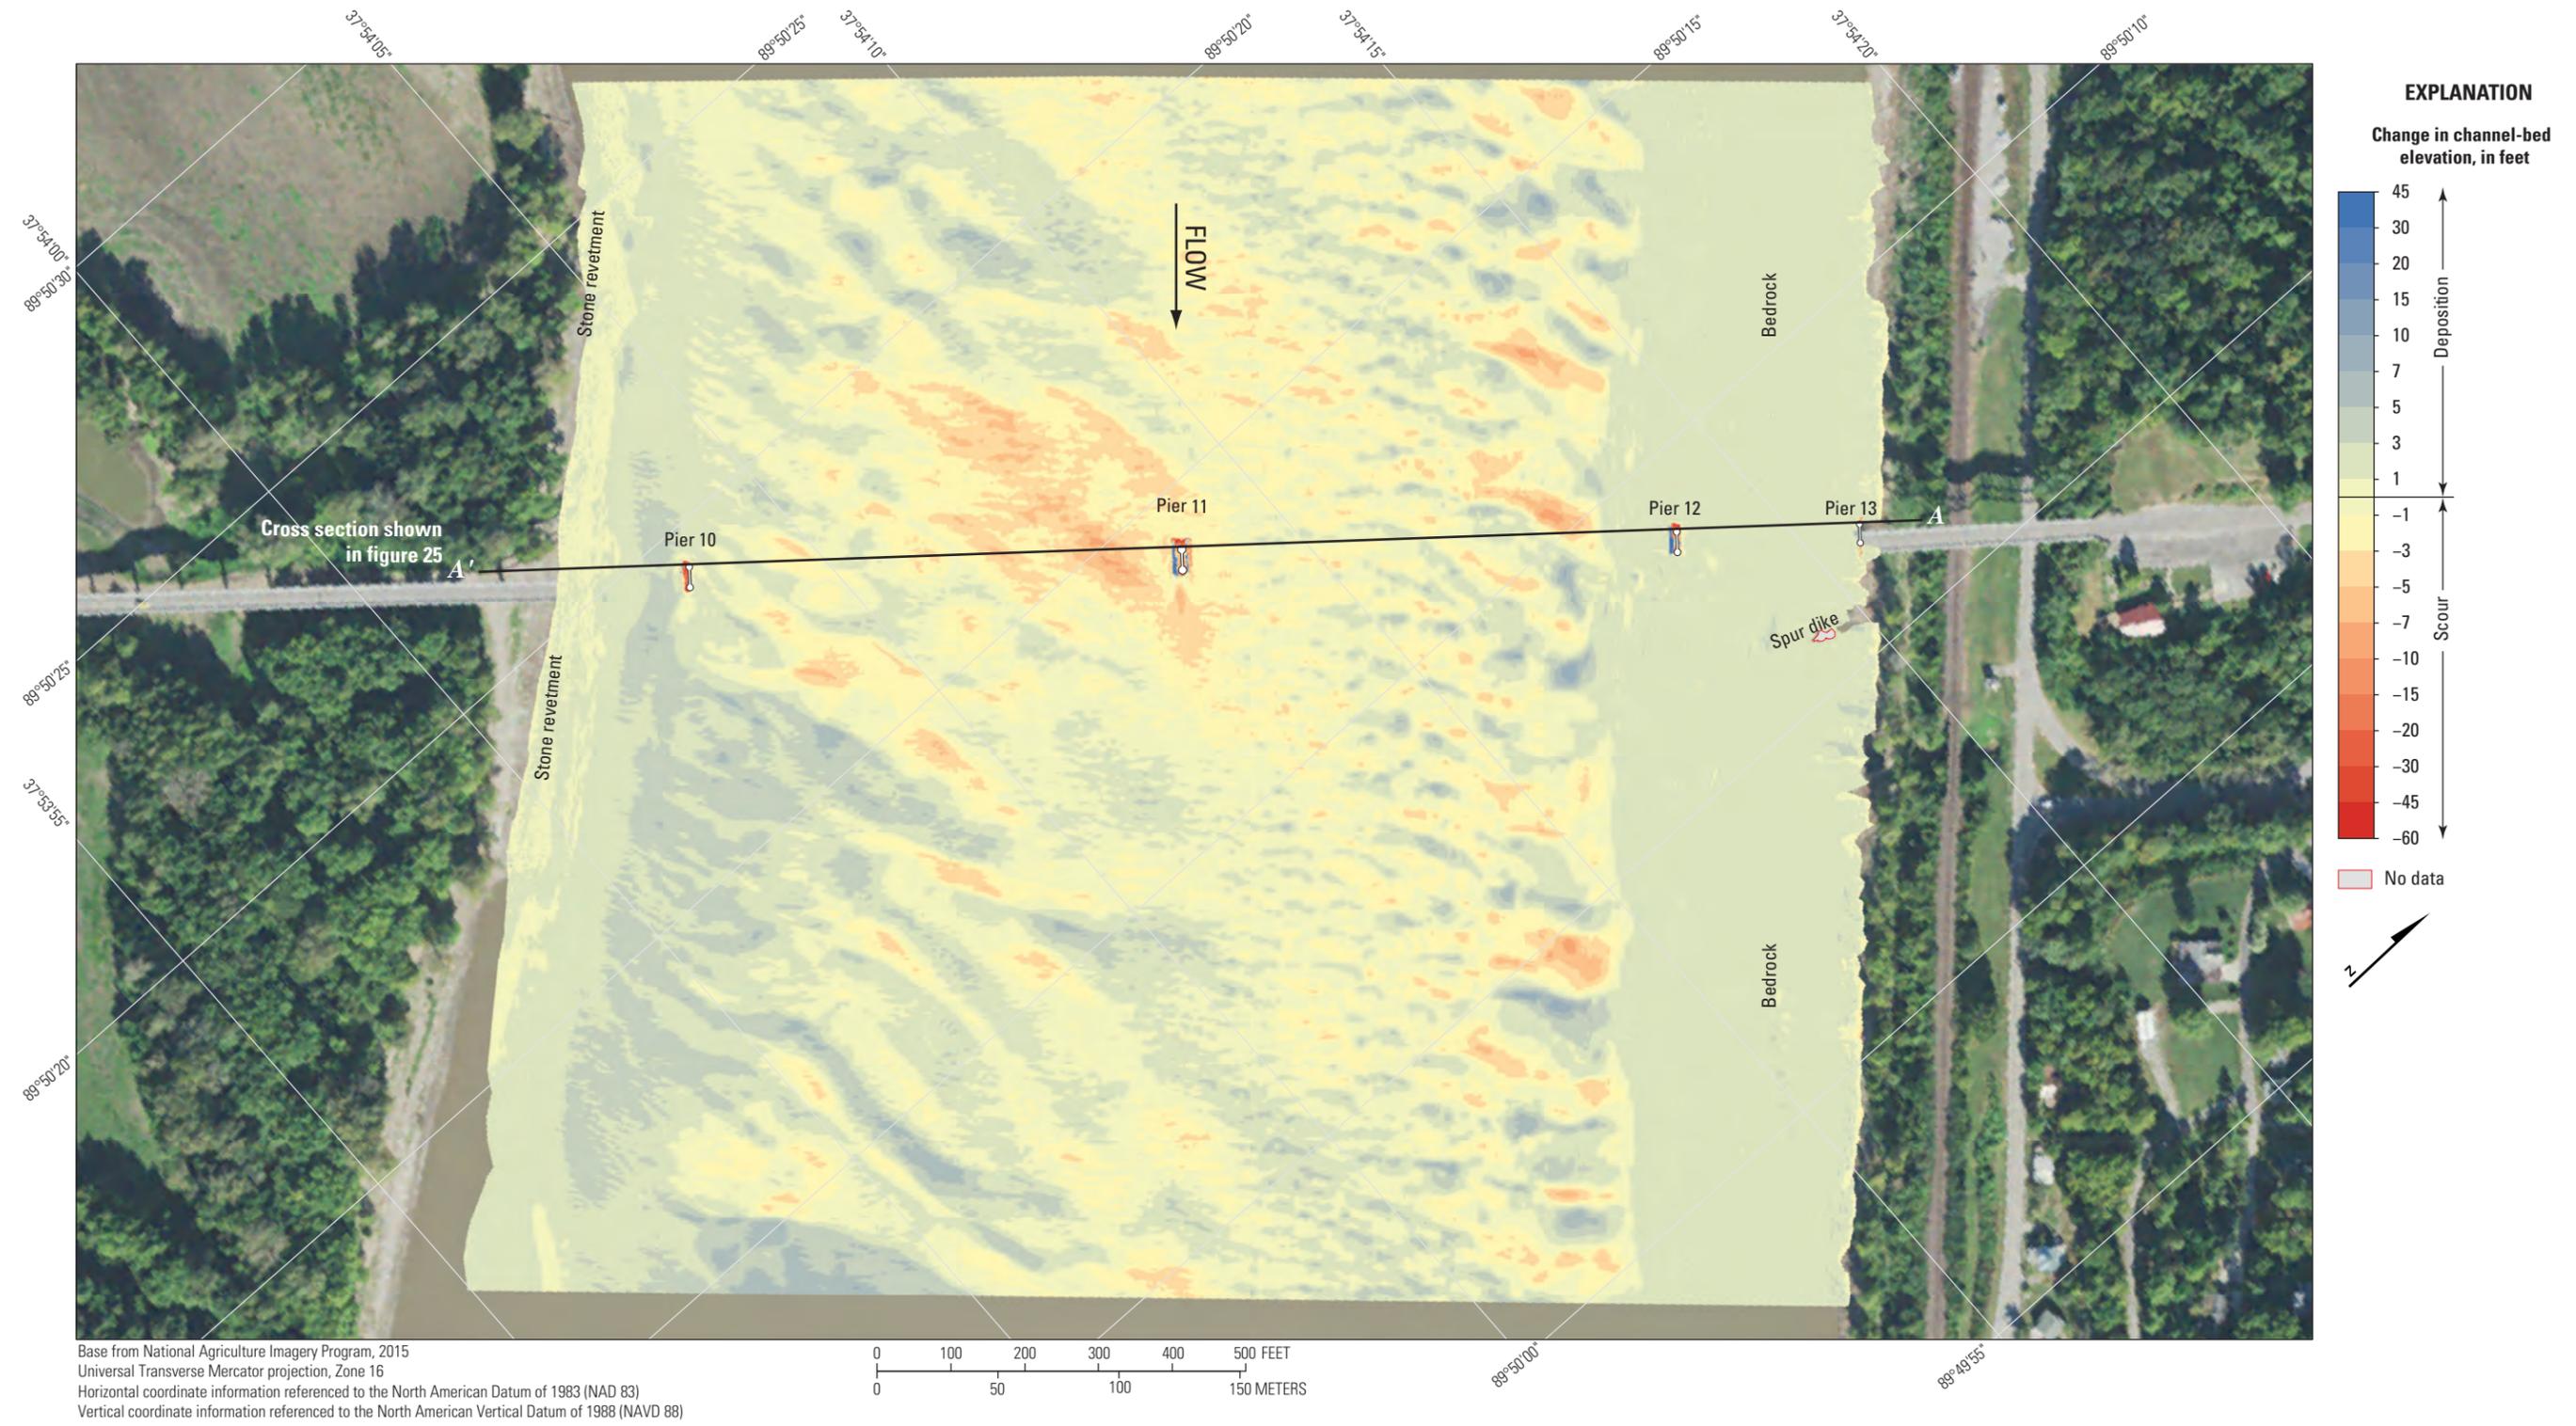
Figure 26. Difference between surfaces created from bathymetric surveys of the Mississippi River near structure L0135 on State Highway 51 at Chester, Illinois, on July 24, 2018, and June 9, 2014.

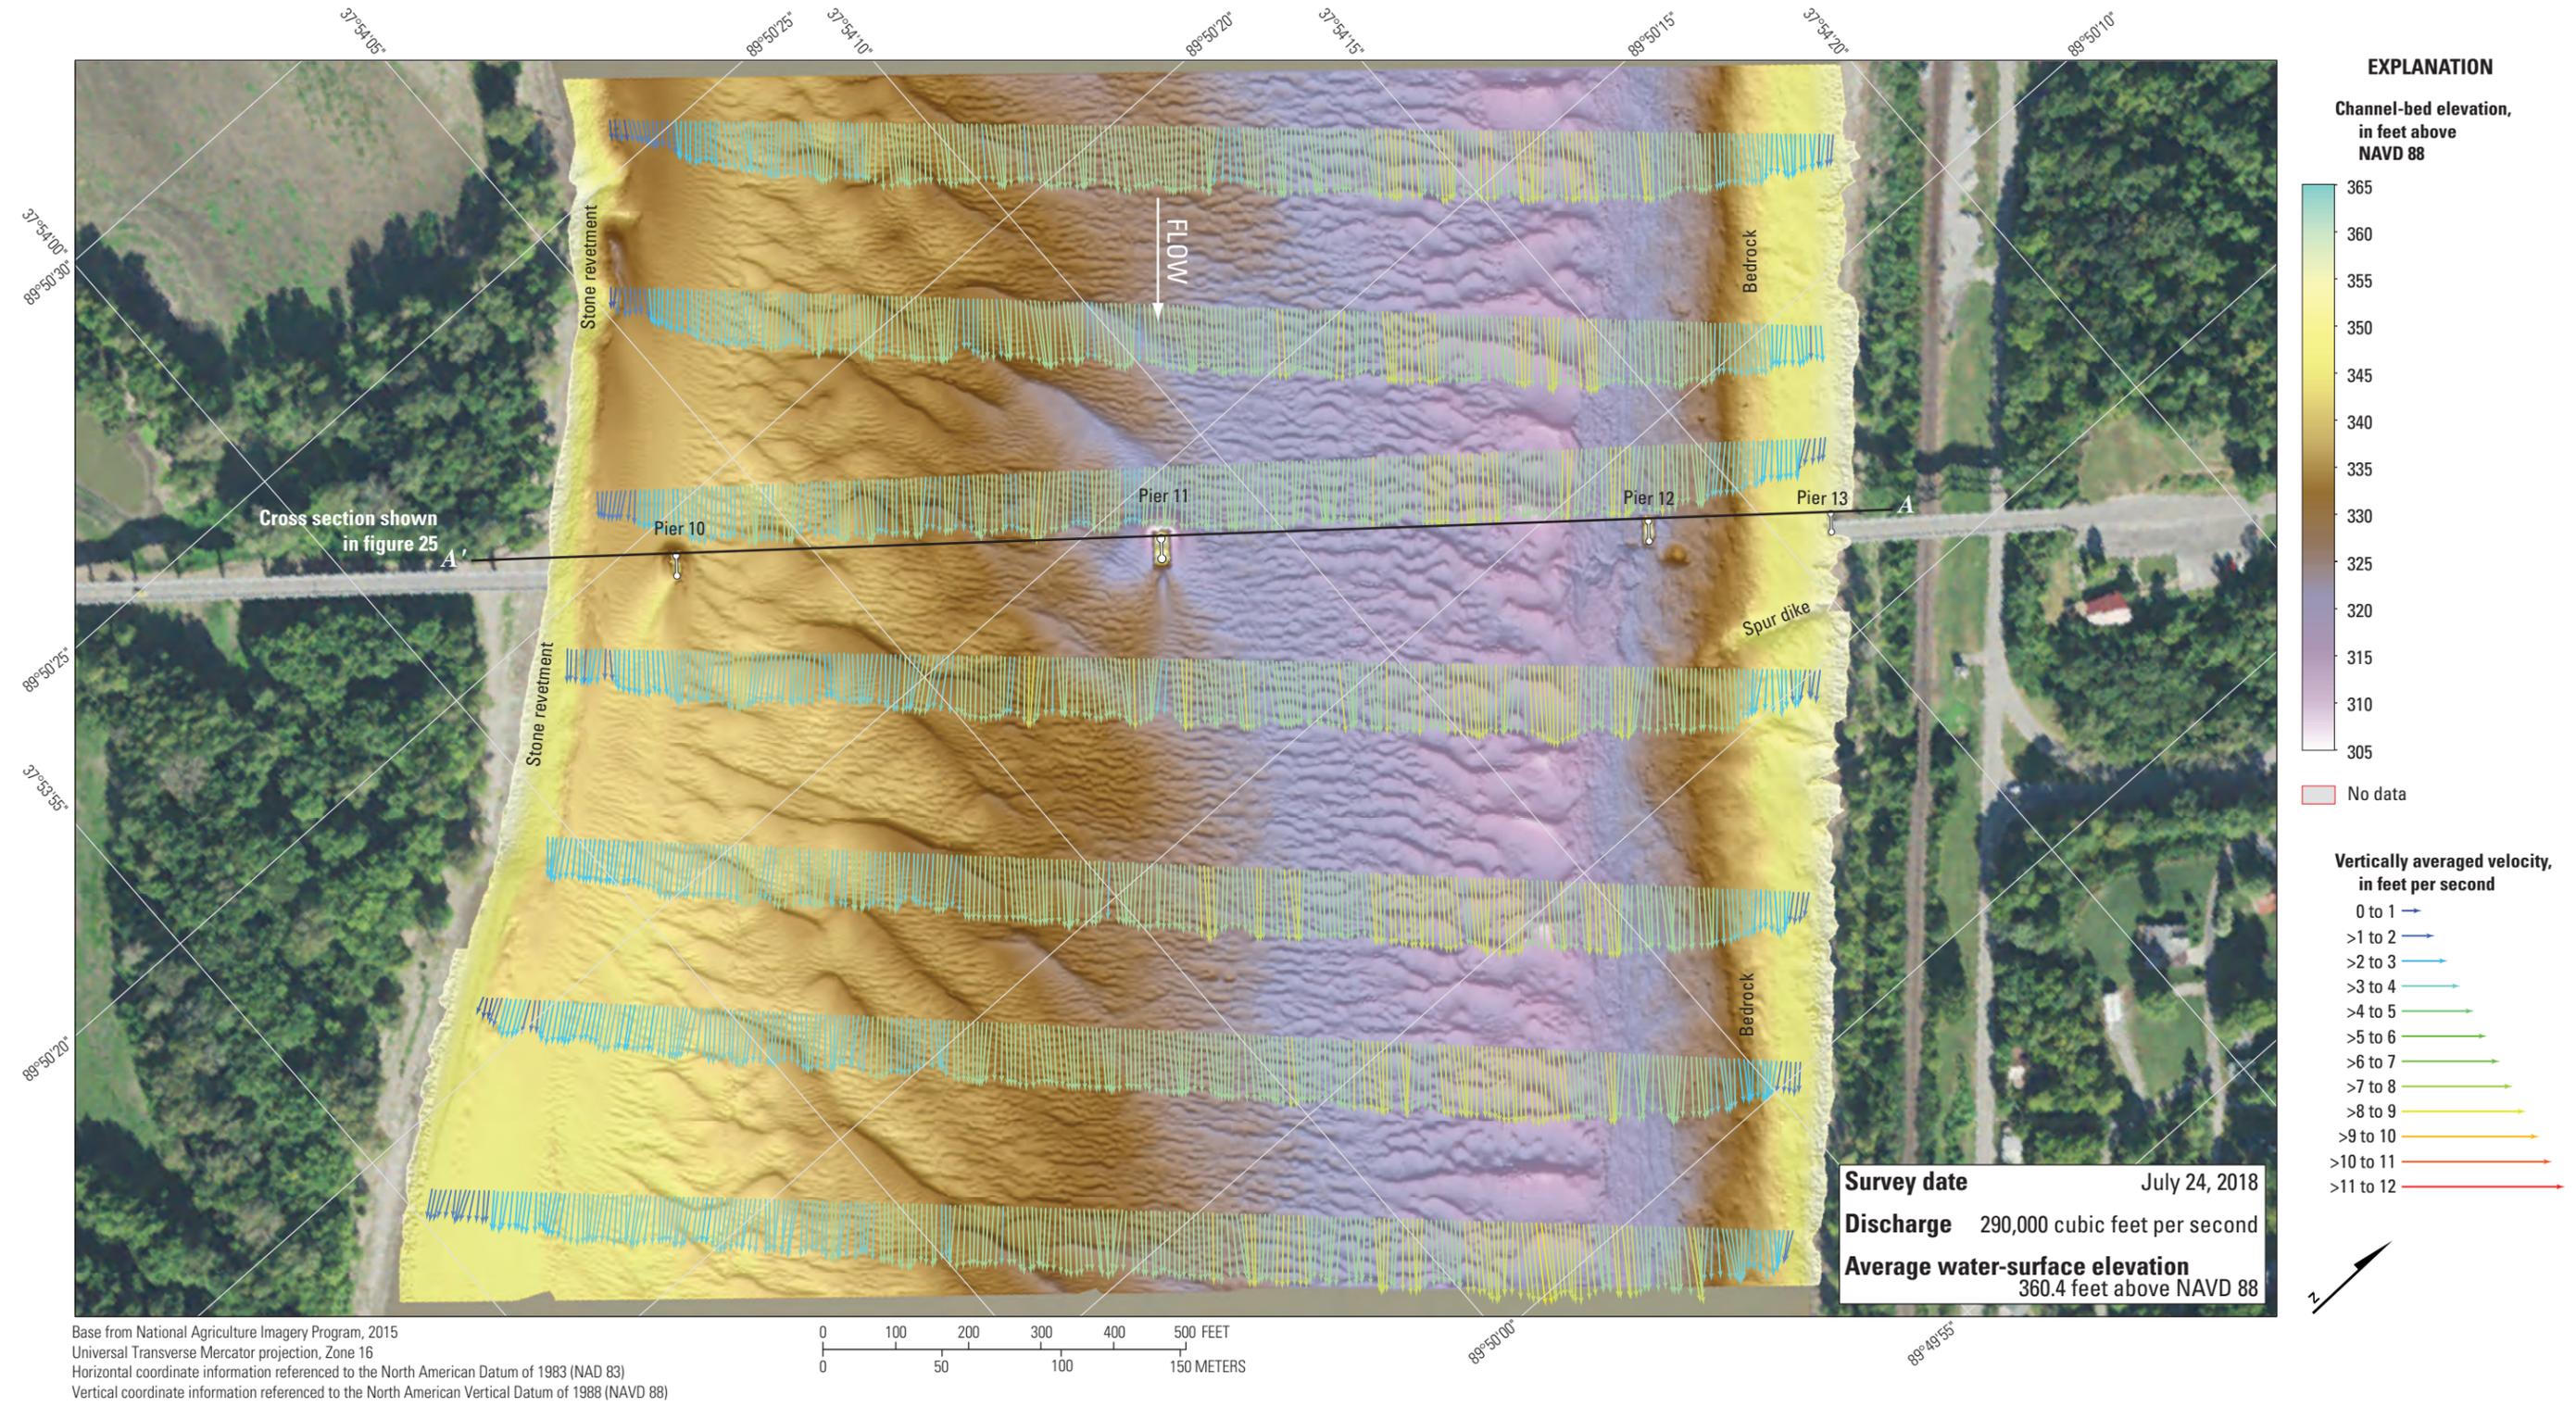
The vertically averaged velocity vectors indicate mostly uniform, expanding flow throughout most of the reach, ranging from about 2 to 9 ft/s, with areas of shear along the right side of the channel (fig. 27). All the piers were aligned with flow, as indicated by little to no turbulence observed downstream that can be directly attributed to the piers (fig. 27).

Figure 27. Bathymetry and vertically averaged velocities of the Mississippi River near structure L0135 on State Highway 51 at Chester, Illinois.

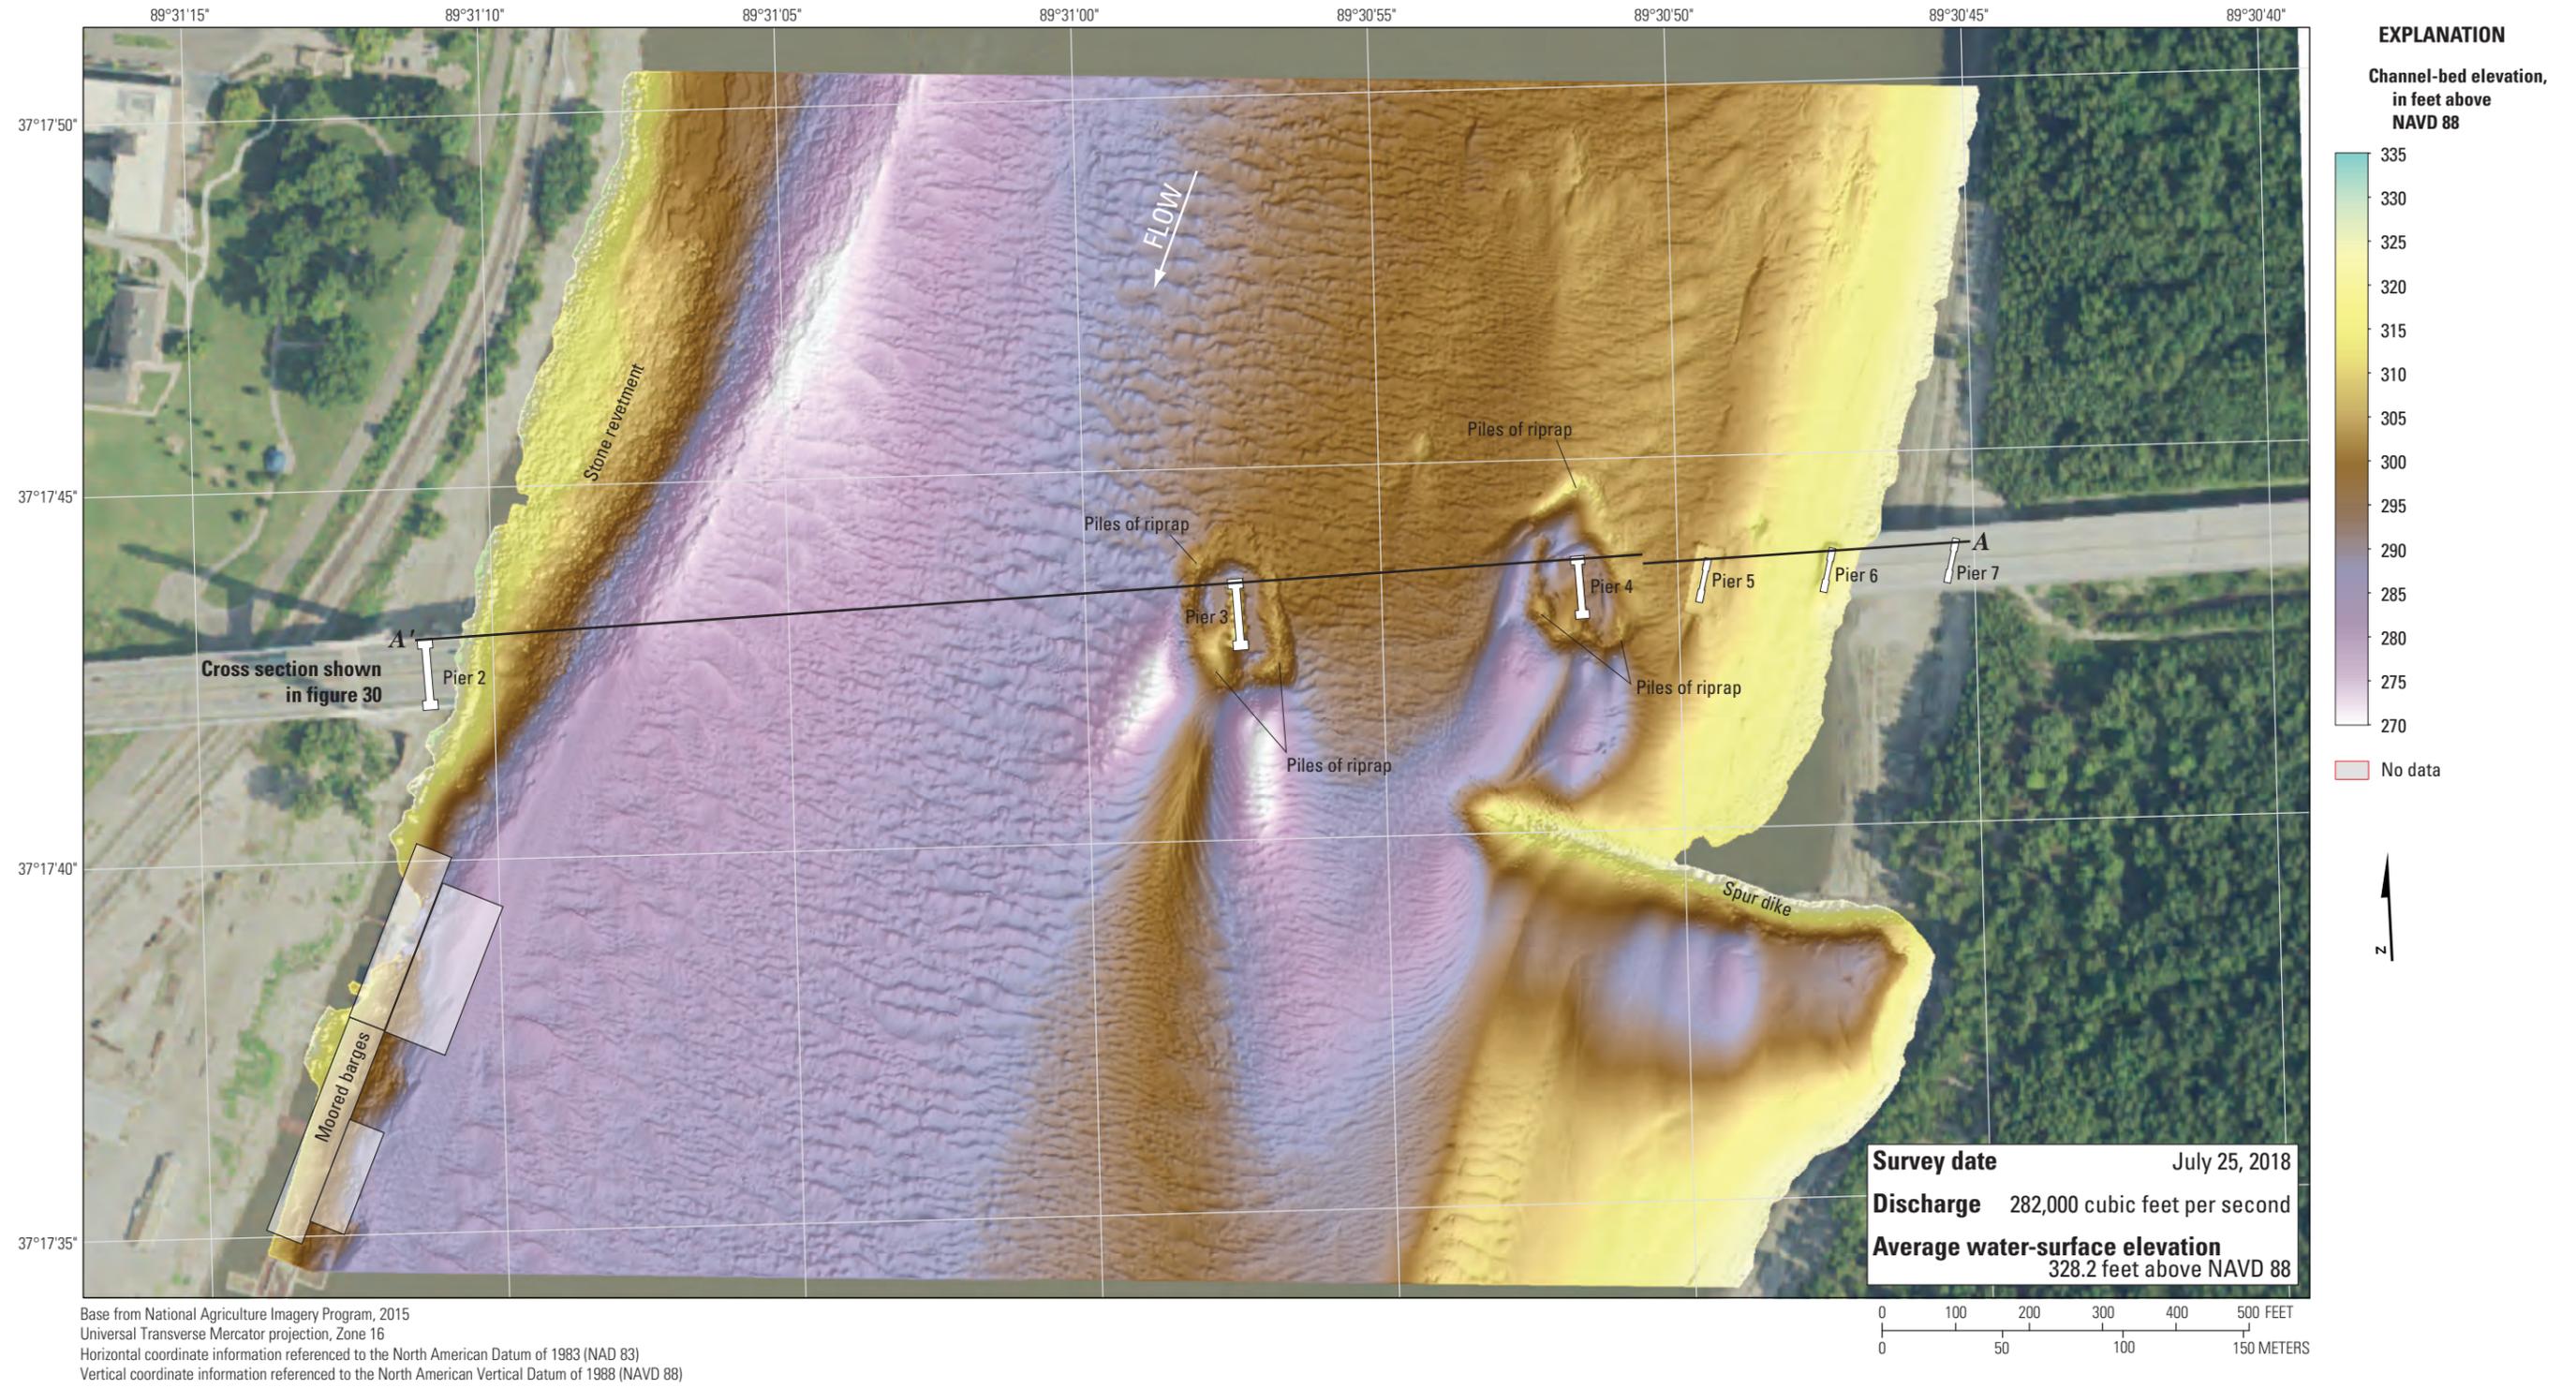
The survey area was about 1,640 ft long and about 1,970 ft wide (perpendicular to flow), extending across the active channel from the left (east) bank to the right (west) bank in the main channel (fig. 28). The upstream end of the survey area was about 730 ft upstream from the centerline of structure A5076 at pier 3, and piers 3 through 6 were in the water. Piers 2 and 7 were in very shallow water on the right and left banks, respectively, and were not surveyed. The channel-bed elevations ranged from about 278 to 314 ft for most of the surveyed area (5 to 95 percentile range of the bathymetric data; table 3; fig. 29), except in the well-defined channel thalweg along the right bank, and downstream from piers 3 and 4 (fig. 28). Numerous small dunes and ripples were present throughout the channel. The area near the left bank upstream from the bridge was about 20 to 25 ft shallower than on the right side of the channel (fig. 28).

Piers 3 and 4 seemed to be partially surrounded by piles of riprap or rock (figs. 28, 1.6E through 1.6H), with additional scour downstream from the piers reaching a minimum elevation of 270 ft near pier 3 and 285 near pier 4 (fig. 28; table 7). Poorly defined, minor scour holes were observed near piers 5 and 6 (figs. 28, 1.6A through 1.6D), having a minimum channel-bed elevation of about 300 ft at pier 5 and 311 ft at pier 6 (table 7); however, the top of the footing was visible at pier 5, and the top of the distribution cap was visible at piers 3 and 4 (figs. 28, 30). The minimum channel-bed elevation near pier 5 is about 15 ft above the elevation of the bottom of the pier seal course of 285.00 ft, and the minimum channel-bed elevation near pier 6 is about 19 ft above the elevation of the bottom of the pier seal course of 292.00 ft (fig. 30; table 7). Information from bridge plans (Missouri Department of Transportation, written commun., 2014) indicates that piers 3 and 4 are founded on caissons on bedrock, having about 20 ft of bed material between the bottom of the scour hole and bedrock at pier 3, and 41 ft of material at pier 4. Piers 5 through 7 are founded on shafts drilled as much as 22 ft into bedrock, having about 55 ft of bed material between the bottom of the scour hole and bedrock at pier 5, and about 66 ft of material at pier 6 (fig. 30; table 7). The surveyed bed generally was similar to the previous survey in 2014, and the original ground line in 1996 from bridge plans, except near pier 4 (fig. 30).

Figure 28. Bathymetric survey of the Mississippi River channel near structure A5076 on State Highway 34 at Cape Girardeau, Missouri.

either side that may be partial riprap blankets (fig. 18), and piers 3 and 4 of structure A5076 at Cape Girardeau, Mo. (site 37, fig. 1), seemed to be partially surrounded with piles of coarse material (fig. 28). However, the effectiveness of the scour mitigation is uncertain, because the placement seems random and non-uniform. Furthermore, there are no indications of designed scour countermeasures at these sites in the bridge plans. Scour immediately downstream from piers 3 and 4 of structure A5076 at Cape Girardeau, Mo., was substantial (fig. 28), but likely does not directly affect the stability of those piers.

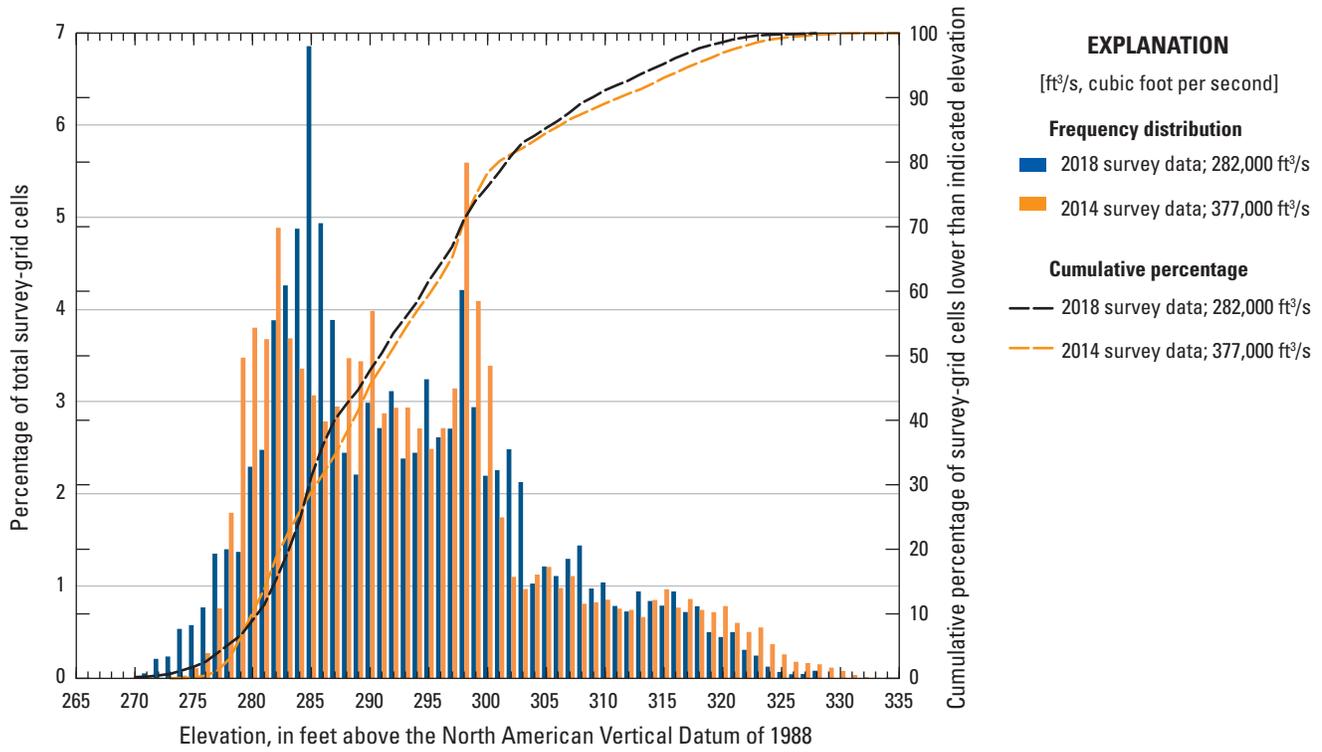
channel both upstream and downstream (fig. 31). The frequency distribution of bed elevations in 2018 was of a similar shape to 2014, with a higher percentage of grid cells at elevations from 278 to 283 ft, and around 300 ft (fig. 29).

Figure 29. Frequency distribution of bed elevations for bathymetric survey-grid cells in 1-foot elevation bins on the Mississippi River near structure A5076 on State Highway 34 at Cape Girardeau, Missouri, on July 25, 2018, compared to previous surveys (Huizinga, 2015).

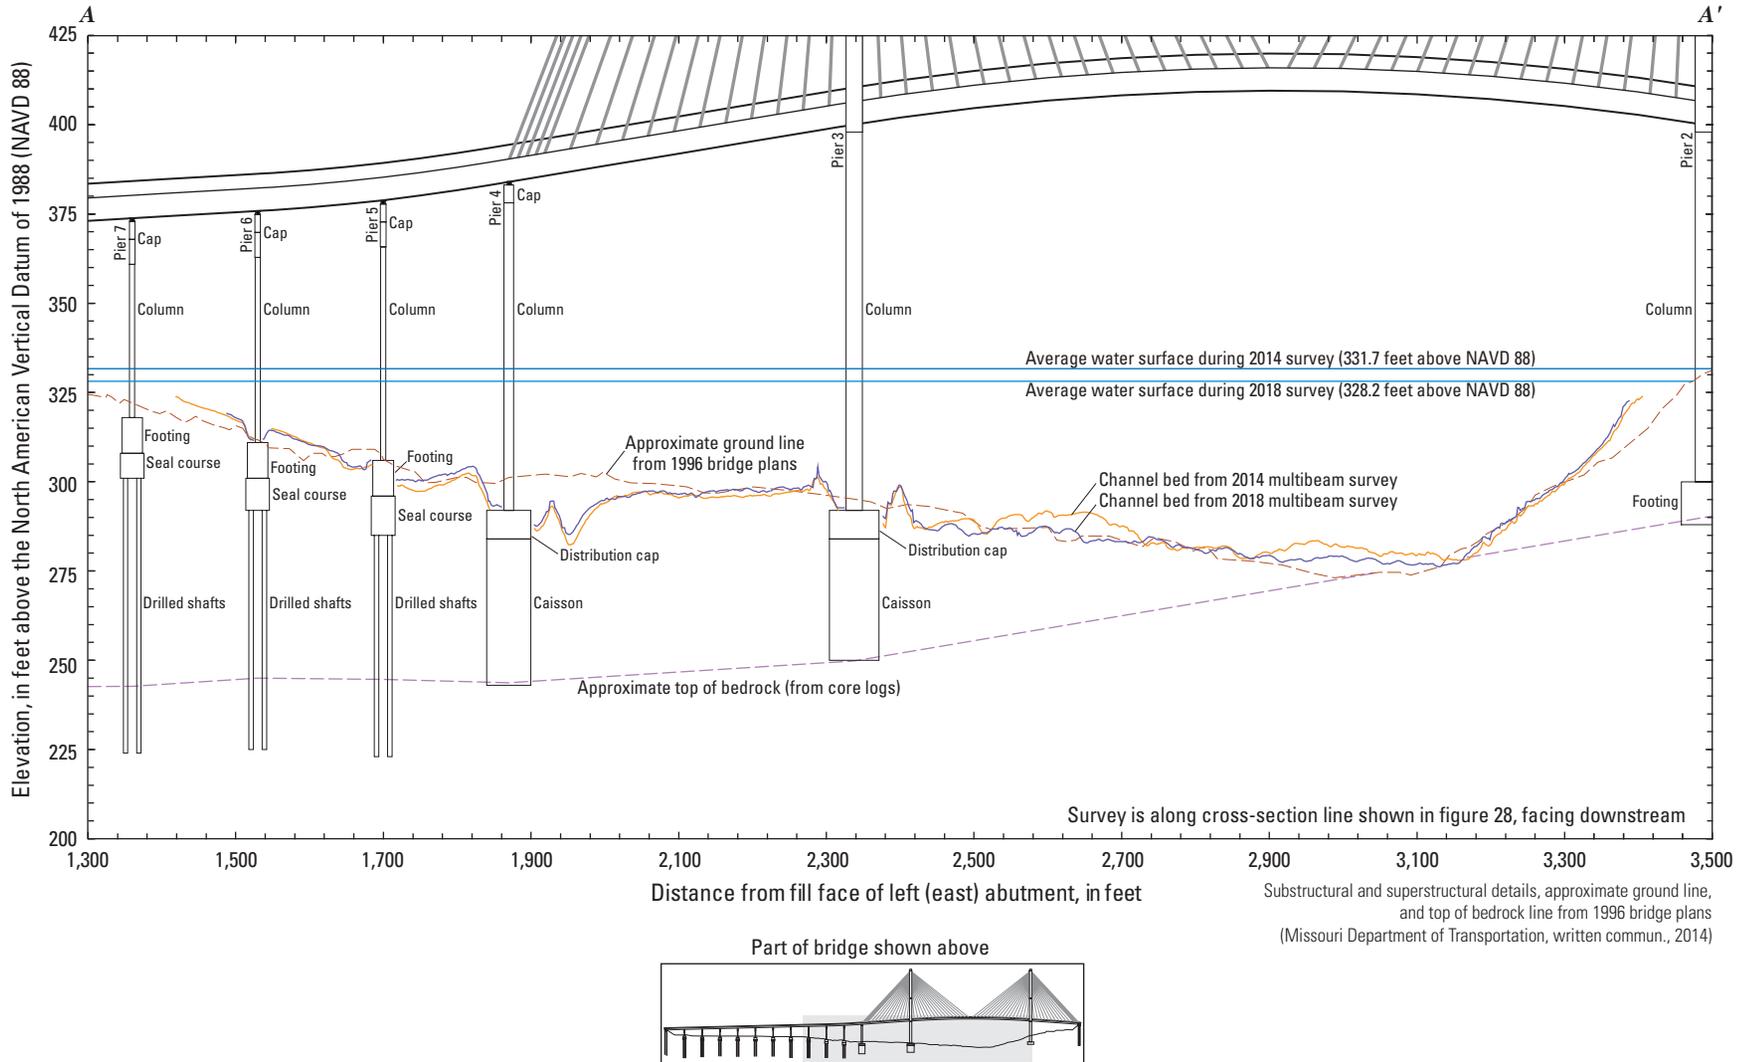
Figure 30. Key features, substructural and superstructural details, and surveyed channel bed of structure A5076 on State Highway 34 crossing the Mississippi River at Cape Girardeau, Missouri.

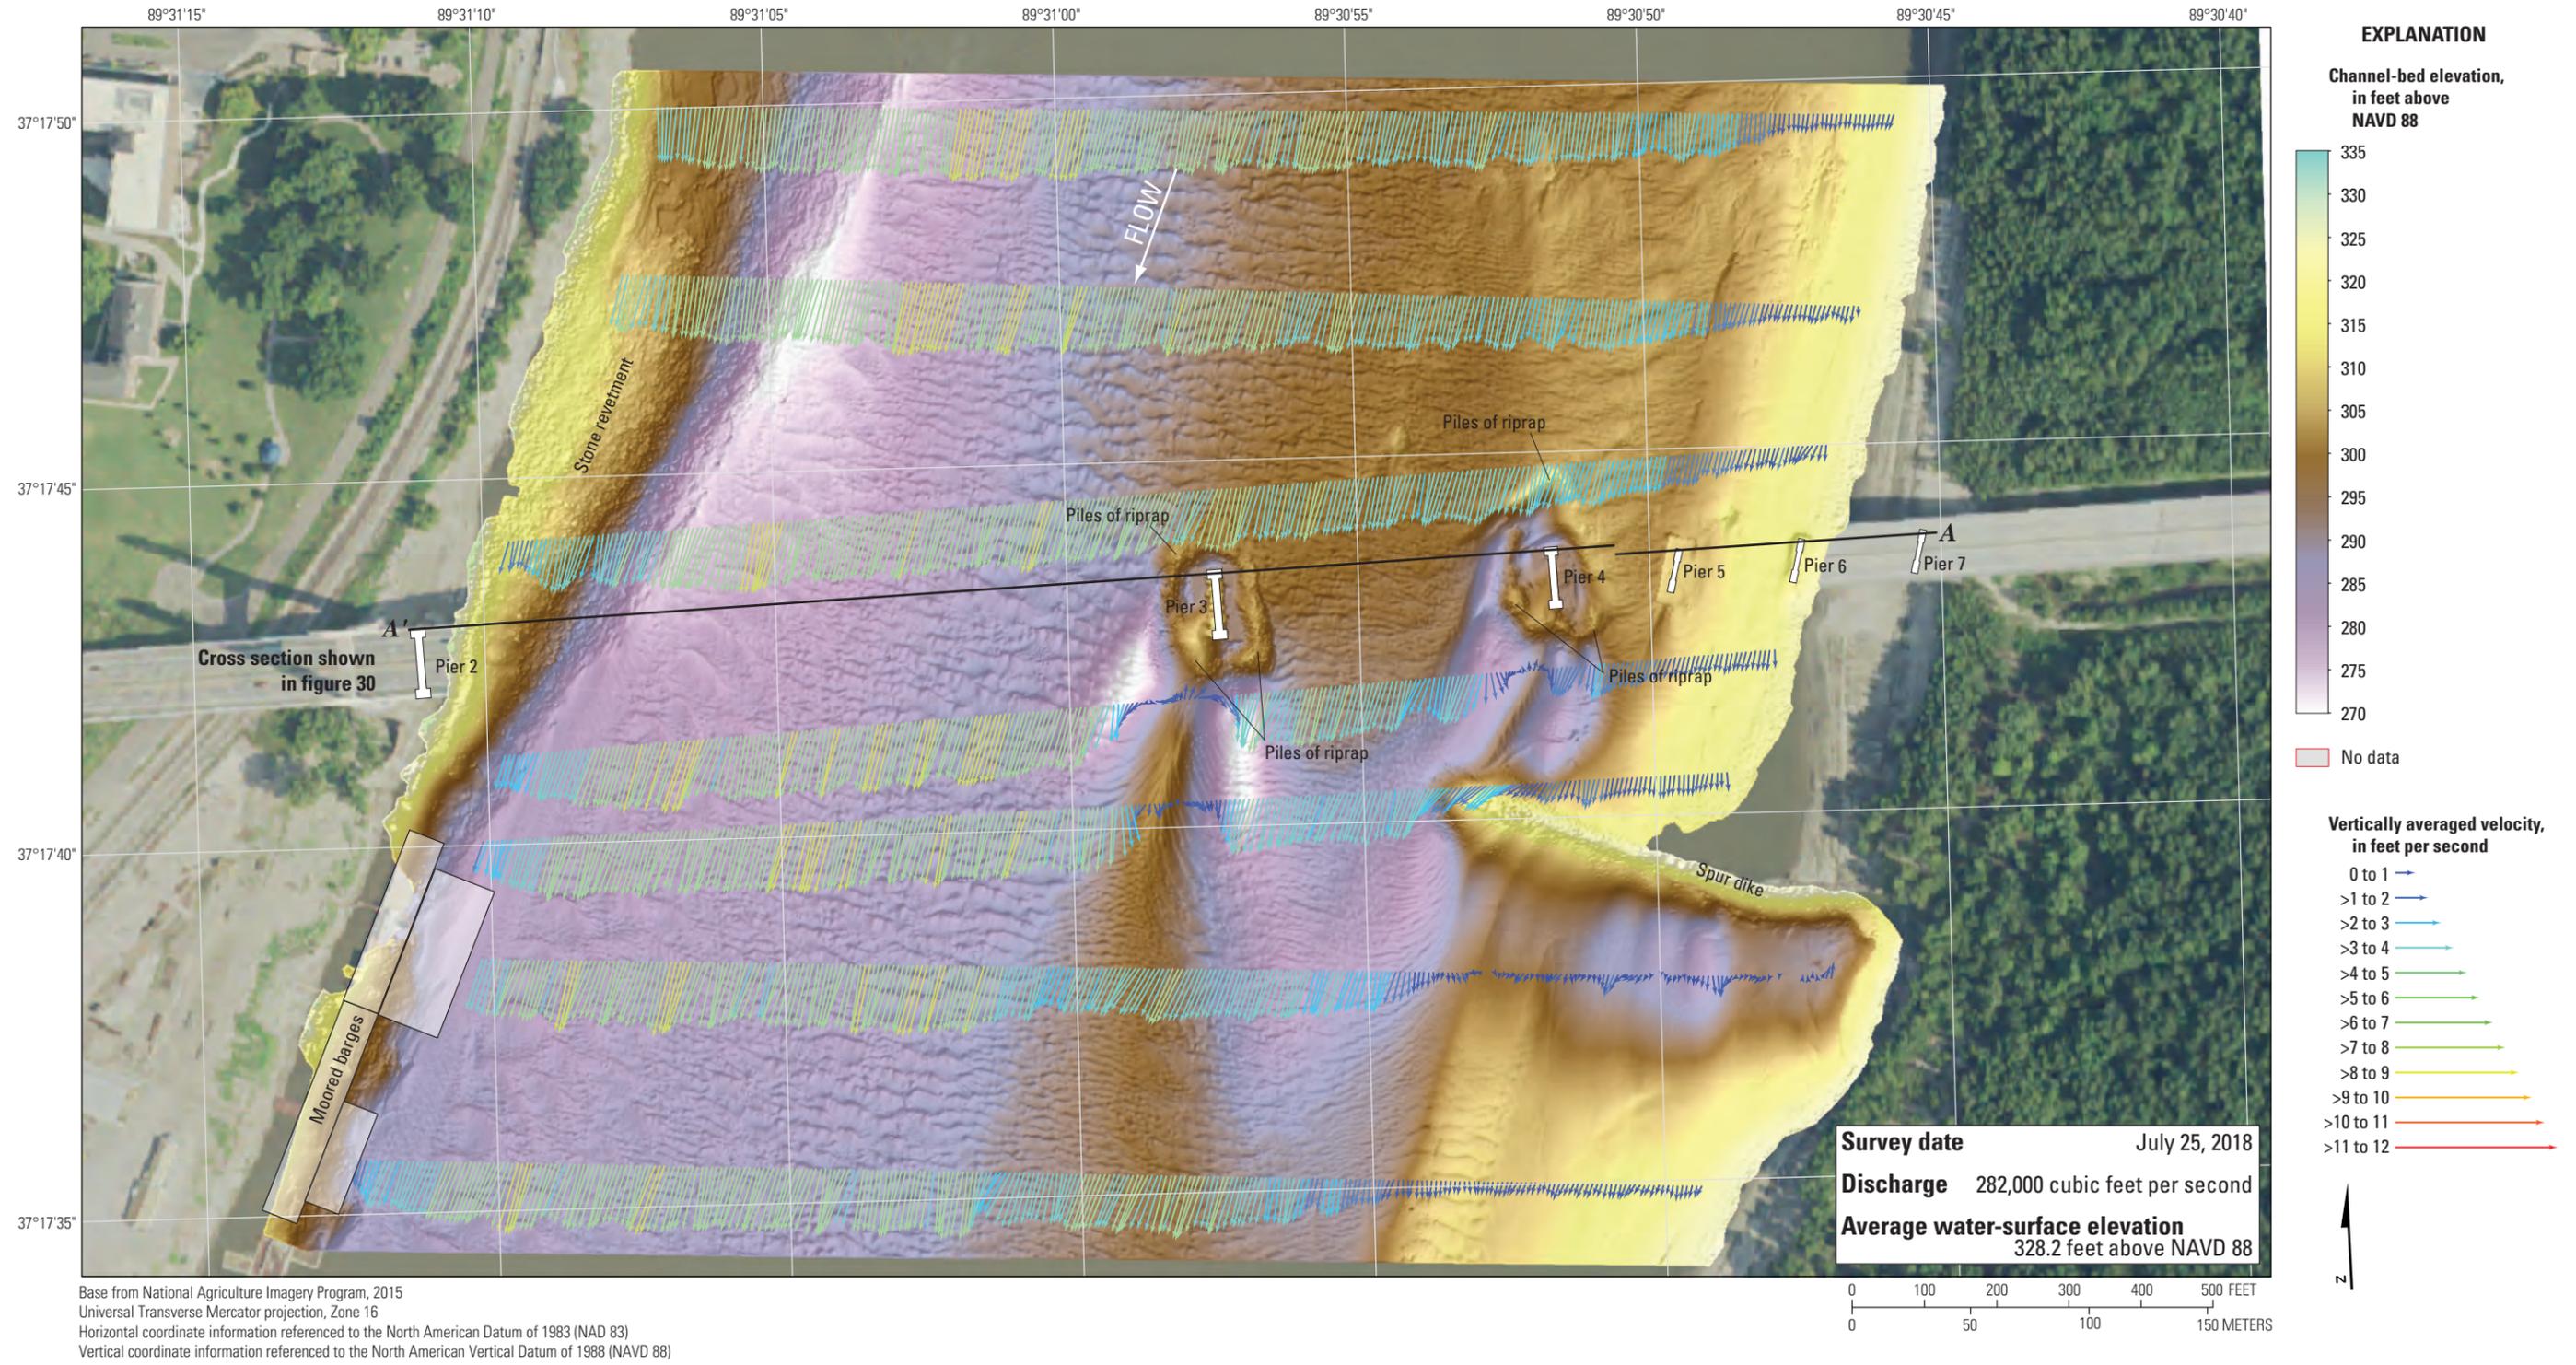
The vertically averaged velocity vectors indicate mostly uniform flow throughout the thalweg of the channel along the right bank, ranging from about 5 to 9 ft/s with minor variations in velocity across the sections (fig. 32). Moderate non-uniform flow was observed along the left side of the channel, particularly downstream from the spur dike on the left bank. Piers 3 and 4 were skewed to approach flow, causing substantial wake vortices with flow reversal and well-defined deposition ridges downstream (figs. 28, 32)

Figure 32. Bathymetry and vertically averaged velocities of the Mississippi River channel near structure A5076 on State Highway 34 at Cape Girardeau, Missouri.
