Bathymetric and Velocimetric Surveys at Highway Bridges Crossing the Missouri and Mississippi Rivers on the Periphery of Missouri, July–August 2018

Scientific Investigations Report 2020–5088

By Richard J. Huizinga

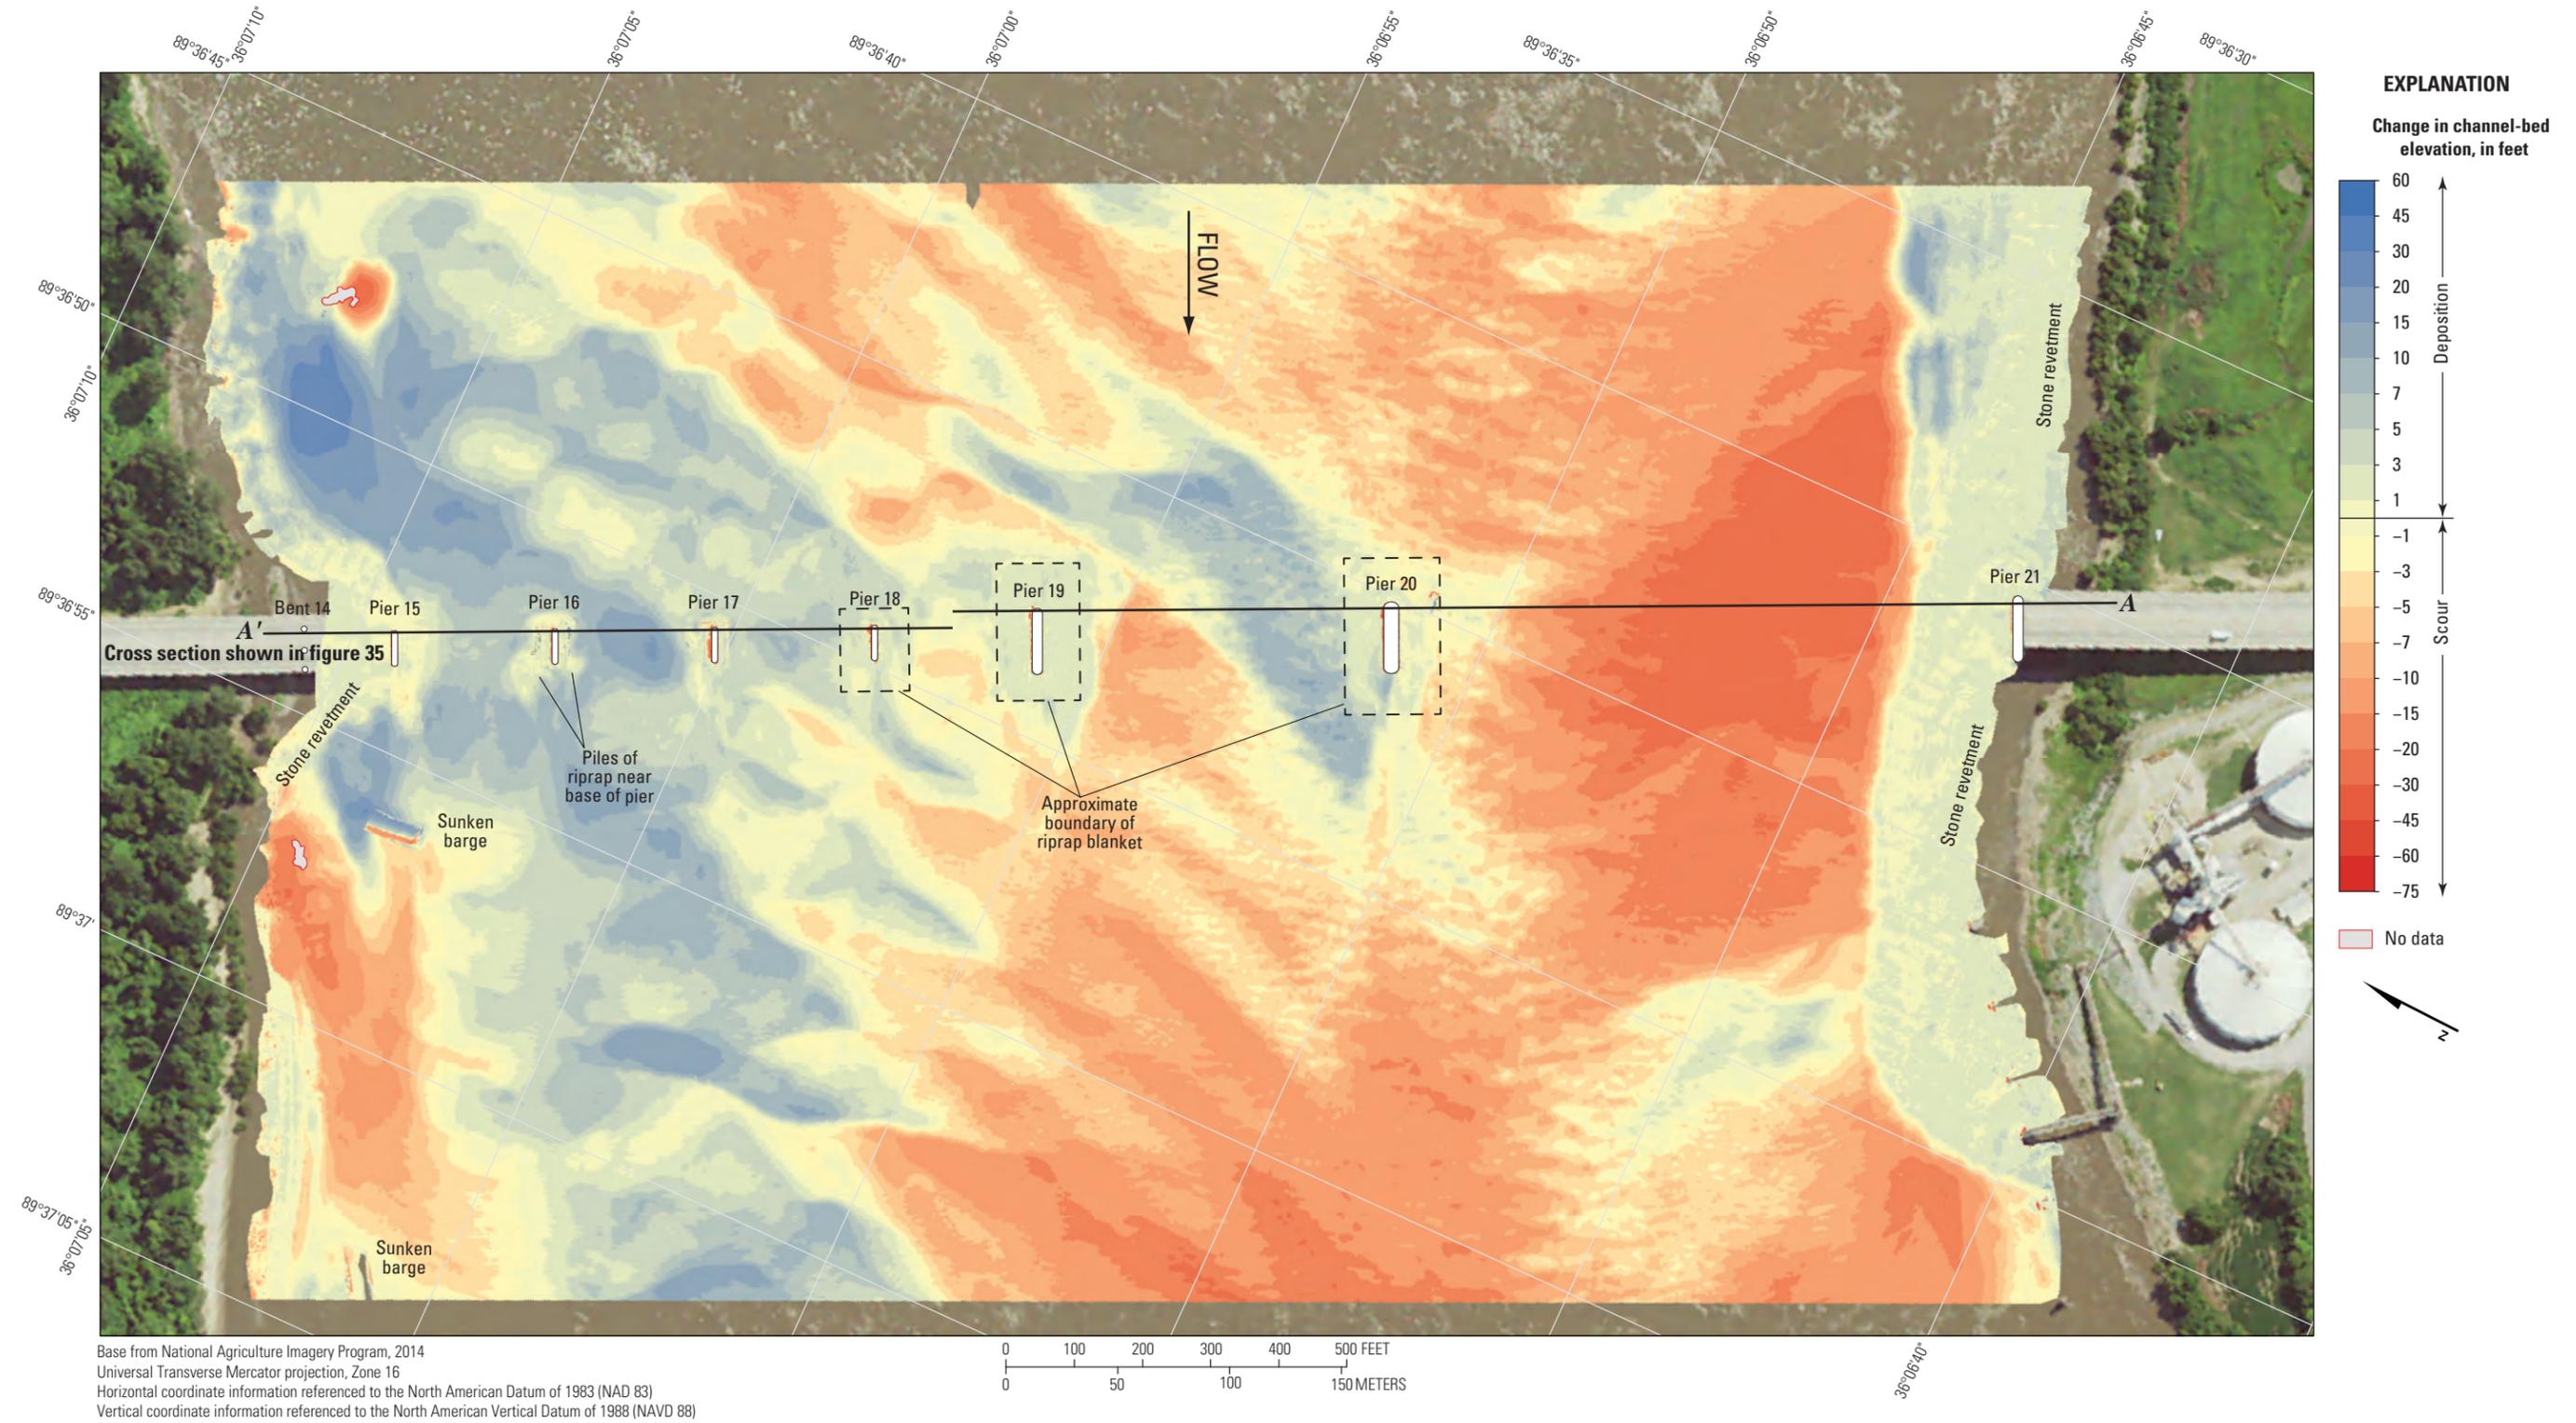
The difference between the survey on July 26, 2018, and the previous nonflood survey on June 11, 2014 (fig. 36), indicates more scour than deposition throughout the reach from 2014 to 2018, resulting in an average difference of -3.37 ft between the bathymetric surfaces (table 8). The net volume of cut in the reach from 2014 to 2018 was about 800,000 yd³, and the net volume of fill was about 265,000 yd³, resulting in a net loss of about 535,000 yd³ of sediment. Moderate to substantial scour of as much as 30 ft in the thalweg on the left (south) side is balanced with localized deposition of as much as 20 ft on the right (north) side of the channel, but the area of scour is more wide-spread than the deposition (fig. 36). A pile of rocks present upstream from the bridge near the right (north) bank in 2014 (see fig. 26 in Huizinga, 2015) was removed sometime after the 2014 survey, resulting in additional localized apparent scour there (fig. 36). Localized deposition along the toe of the left (south) bank upstream from the bridge implies additional stone revetment may have been placed there (fig. 36). The frequency distribution for 2018 has a higher percentage of grid cells between 176 and 190 ft than 2014, and a lower percentage between 194 and 204 ft (fig. 34). The cumulative percentage curve is between the 2011 and 2014/2008 curves below about 200 ft elevation (fig. 34).

Figure 36. Difference between surfaces created from bathymetric surveys of the Mississippi River channel near structure A1700 on Interstate 155 near Caruthersville, Missouri, on July 26, 2018, and June 11, 2014.

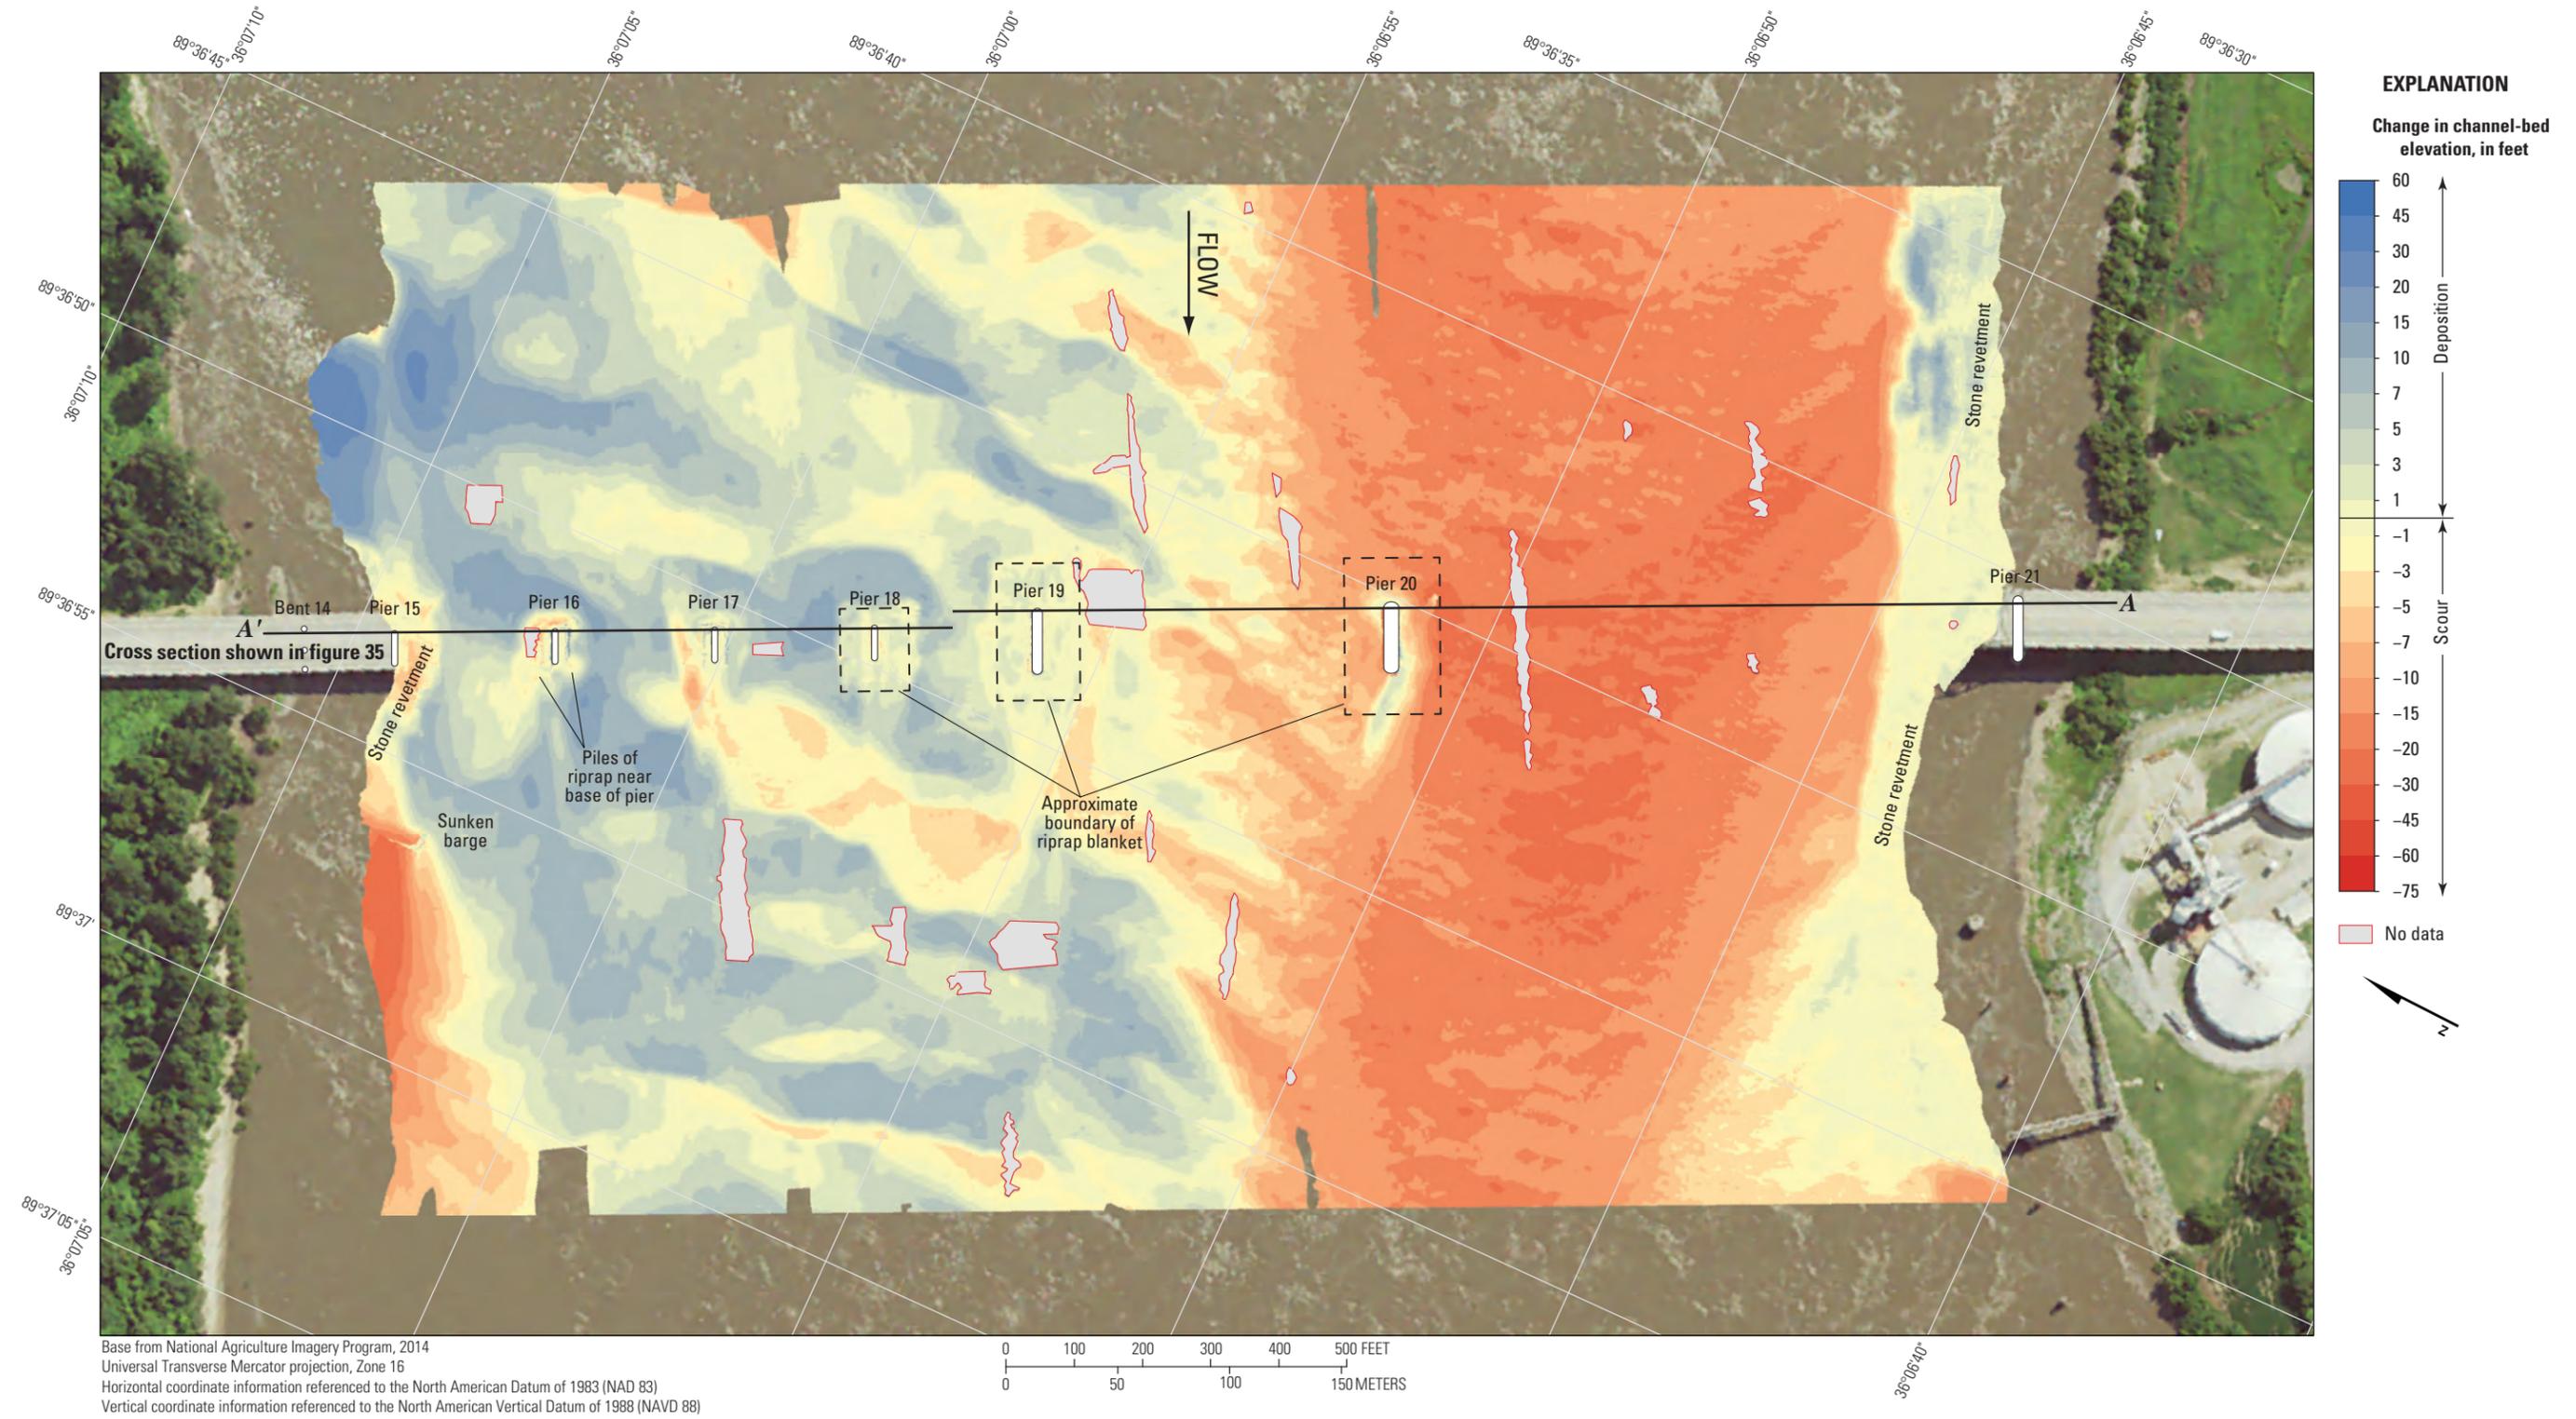
The difference between the survey on July 26, 2018, and the earliest survey on December 10, 2008 (fig. 38), indicates more scour than deposition throughout the reach from 2008 to 2018, resulting in an average difference of -3.98 ft between the bathymetric surfaces (table 8). The net volume of cut in the reach from 2008 to 2018 was about 766,000 yd³, and the net volume of fill was about 255,000 yd³, resulting in a net loss of about 511,000 yd³ of sediment. Moderate to substantial scour of as much as 30 ft in the thalweg on the left (south) side is balanced with localized deposition of as much as 20 ft on the right (north) side of the channel, but the area of scour is more widespread than the deposition (fig. 38). The frequency distribution for 2008 is similar to 2014, but does not extend as high up the banks because of the more limited surveyed area (fig. 34; table 8).

Figure 38. Difference between surfaces created from bathymetric surveys of the Mississippi River channel near structure A1700 on Interstate 155 near Caruthersville, Missouri, on July 26, 2018, and December 10, 2008.

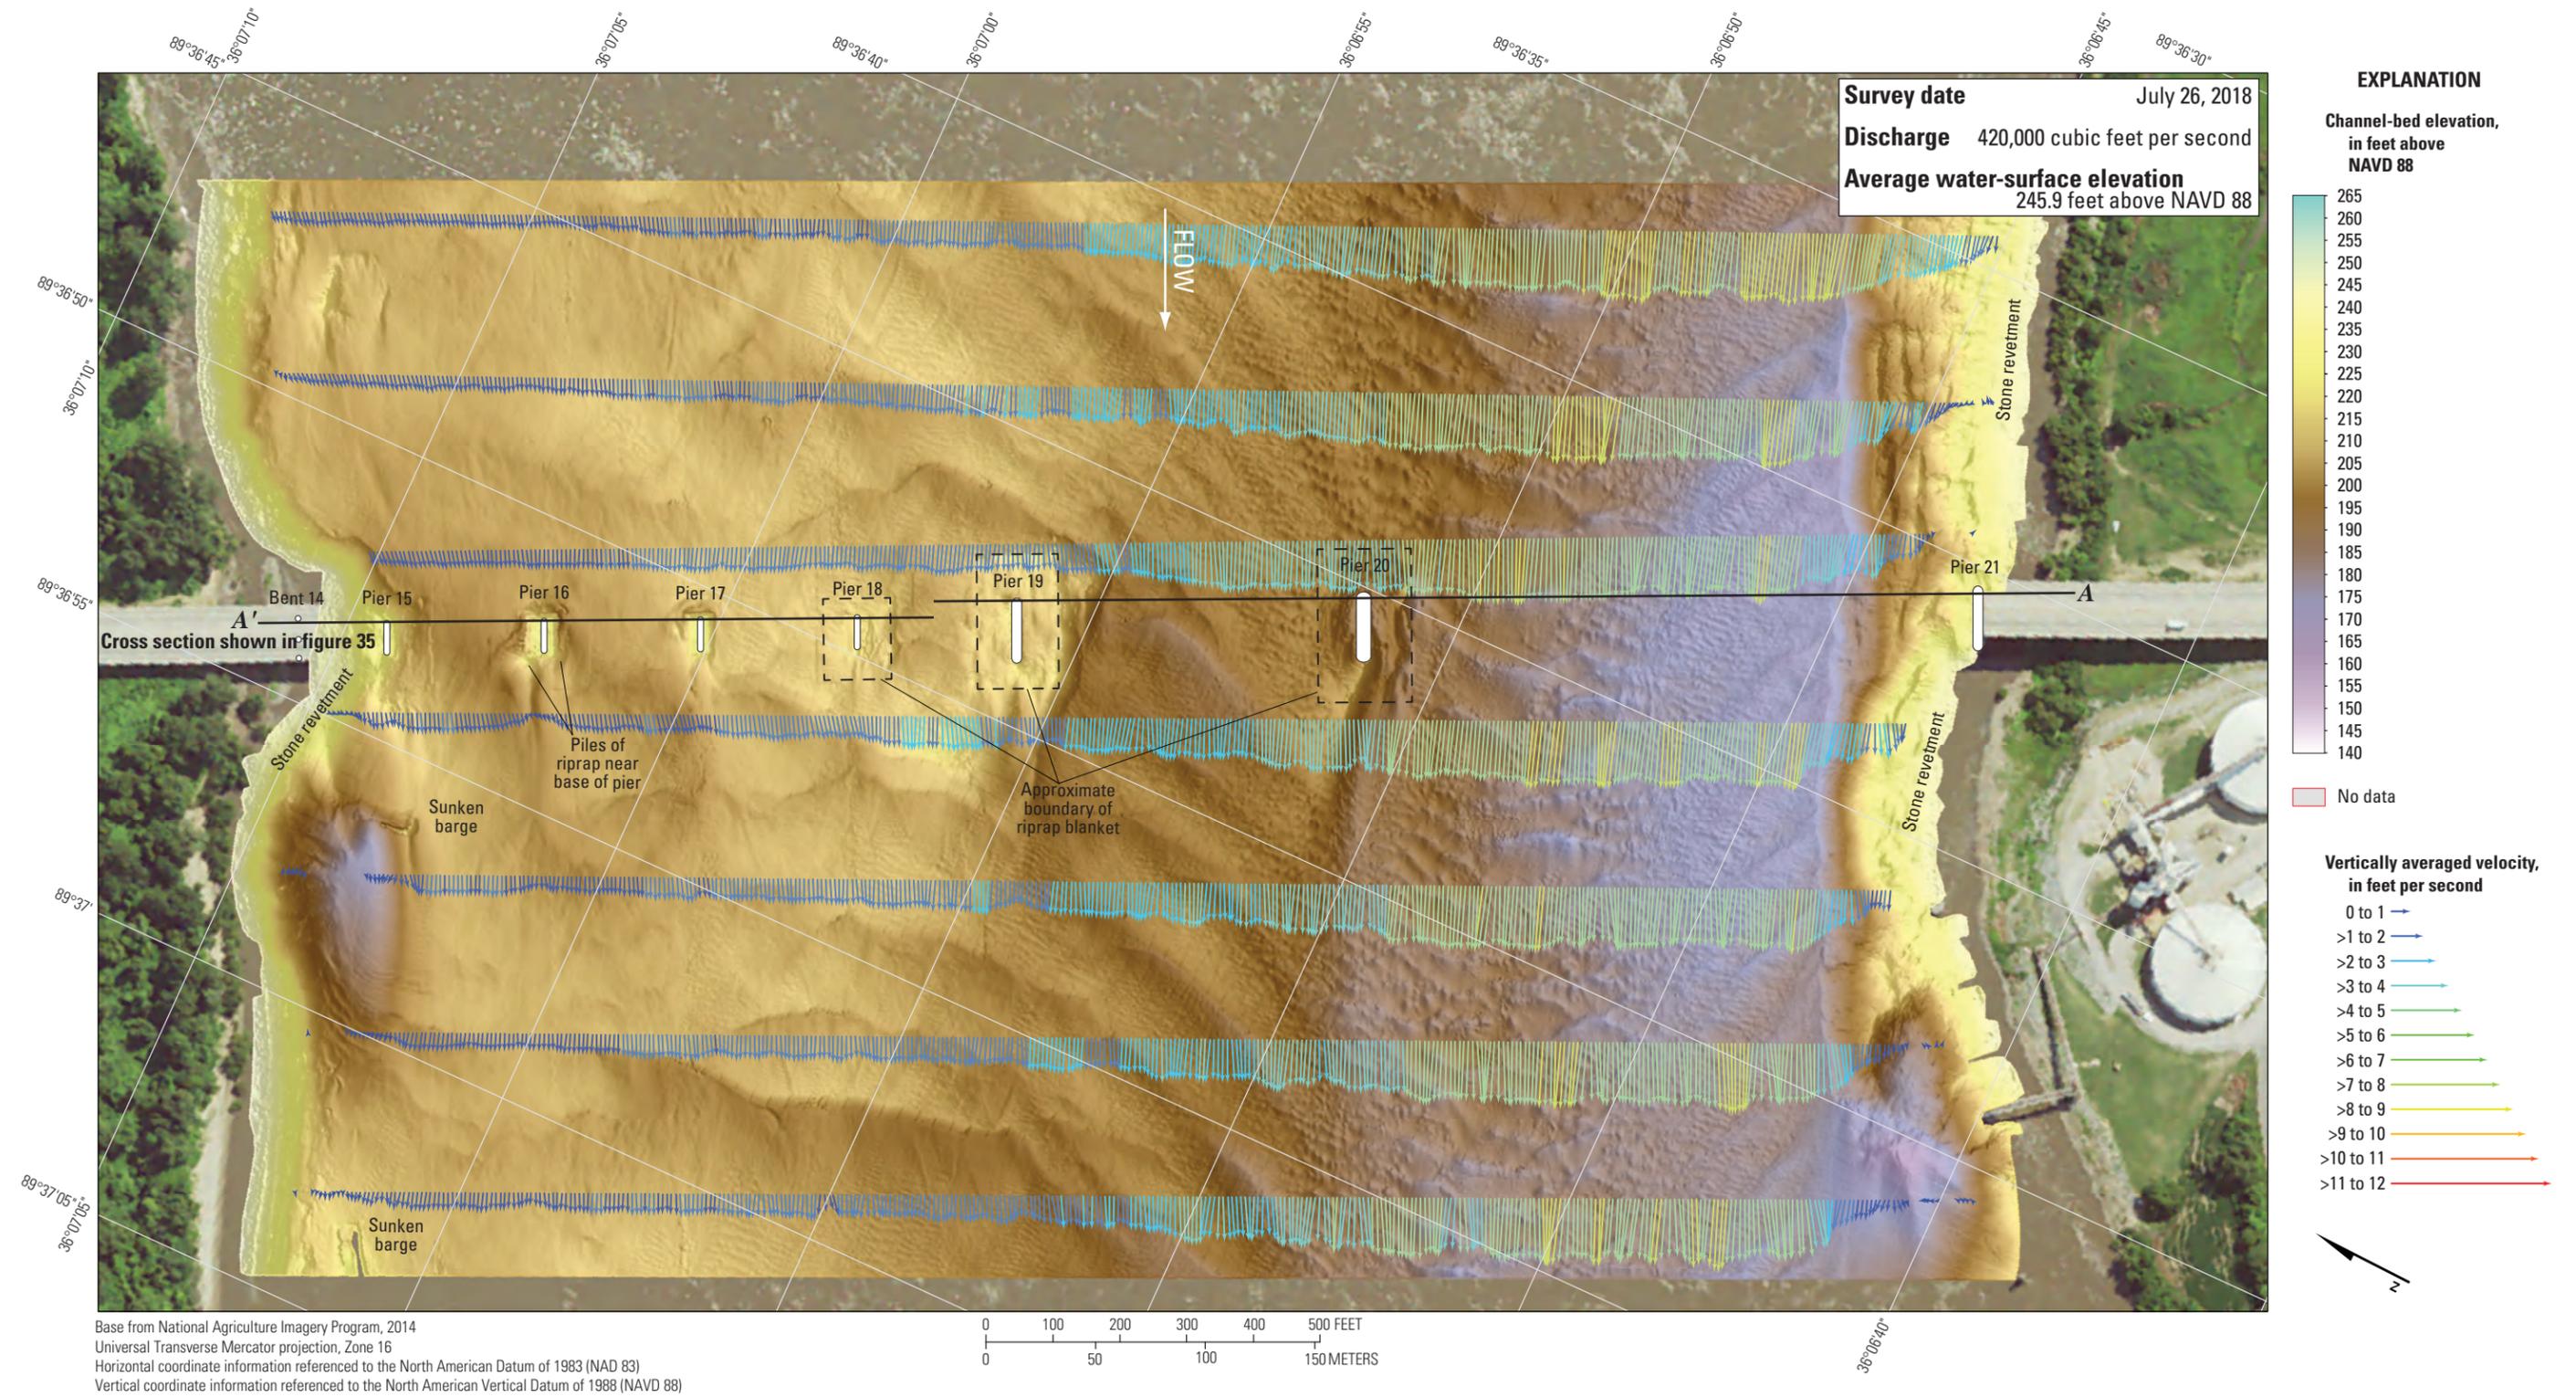
The vertically averaged velocity vectors for the 2018 survey indicate mostly uniform flow throughout a majority of the reach, with small areas of flow disturbance and shear flow, particularly along the banks near the constrictions at the bridge and downstream (fig. 39). Velocities ranged from about 5 to 9 ft/s for the left (south) side of the channel, and from 1 to 5 ft/s for the right (north) side of the channel, and low velocities and flow reversals were observed downstream from the bank constrictions at the bridge. The piers generally were aligned with flow, with minimal wake vortices observed downstream (fig. 39).

Figure 39. Bathymetry and vertically averaged velocities of the Mississippi River channel near structure A1700 on Interstate 155 near Caruthersville, Missouri.

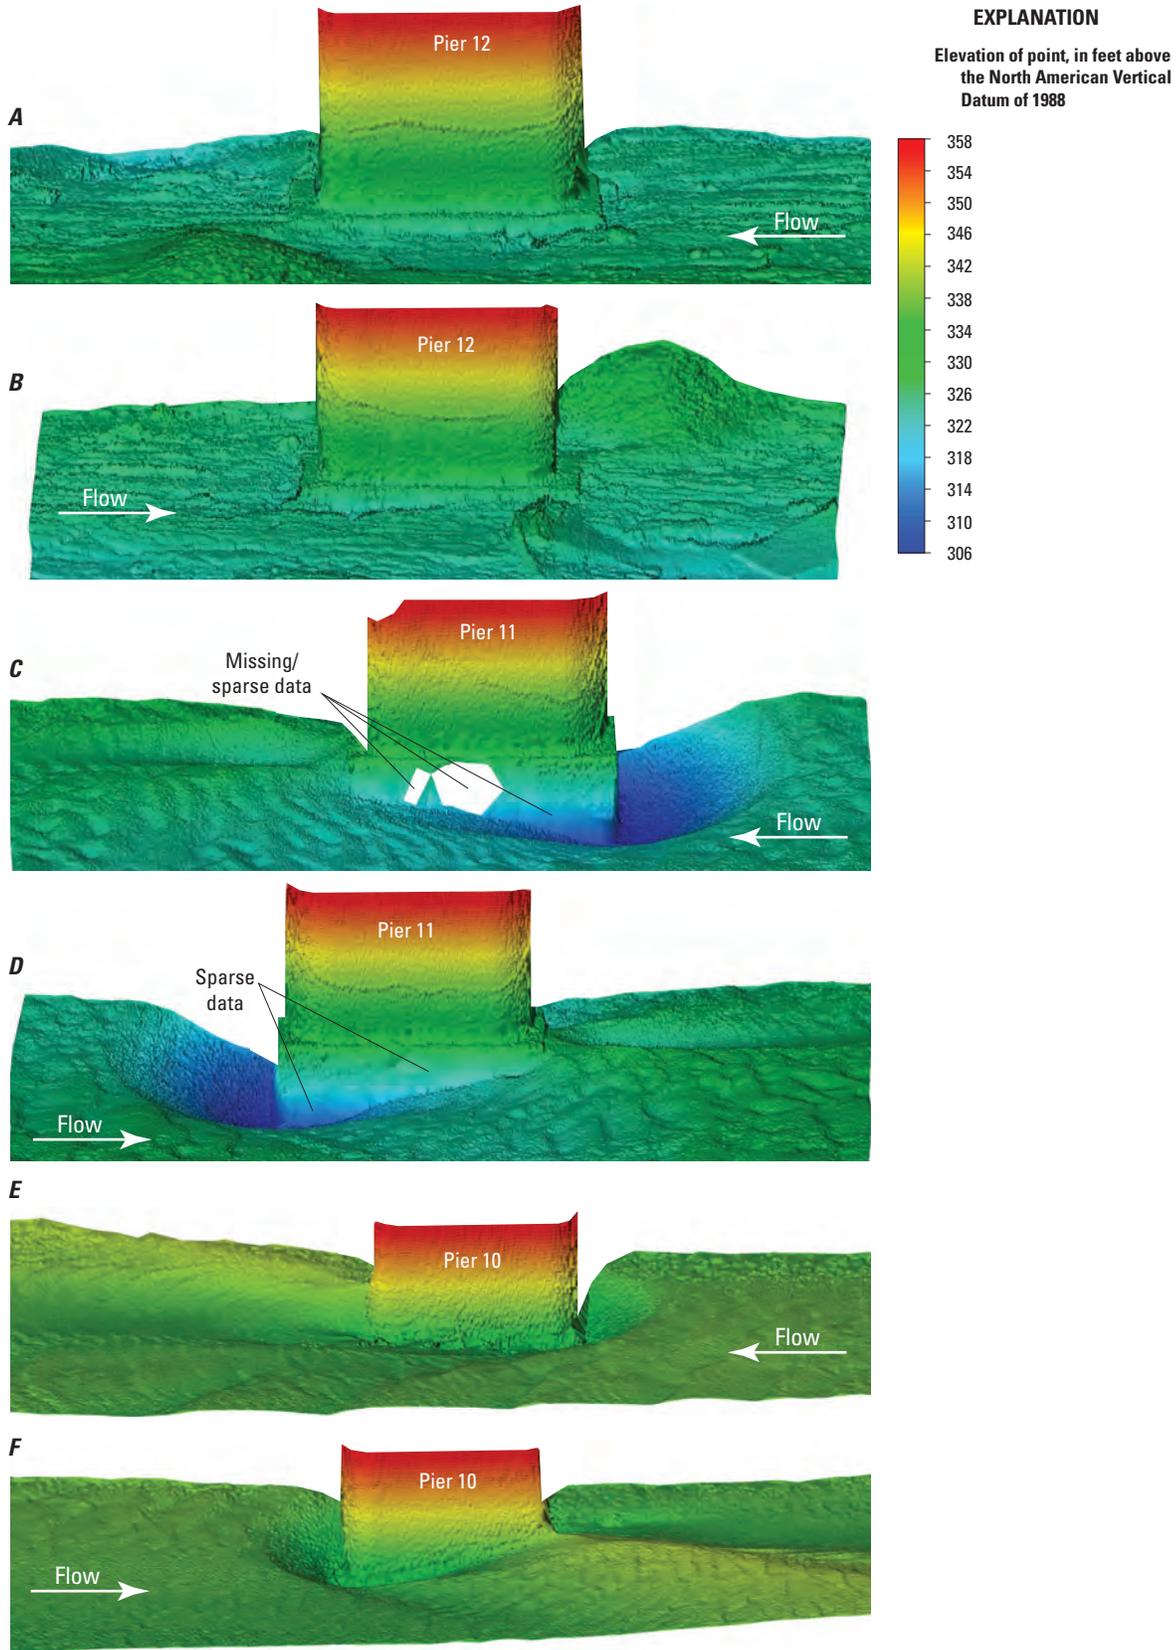
Near pier 11 (fig. 23), a substantial scour hole had a minimum channel-bed elevation of about 306 ft (table 7), which is about 16 ft below the average channel elevation upstream from the pier (figs. 23, 25, 1.5C, 1.5D). Information from bridge plans (Missouri Department of Transportation, written commun., 2000) indicates that pier 11 is founded on a caisson on bedrock, having about 40 ft of bed material between the bottom of the scour hole and bedrock (fig. 25; table 7). Near pier 10 (fig. 23), a moderate scour hole had a minimum channel-bed elevation of about 330 ft (table 7), which is about 8 ft below the average channel elevation upstream from the pier (figs. 23, 25, 1.5E, 1.5F). Pier 10 also is founded on a caisson on bedrock, having about 85 ft of bed material between the bottom of the scour hole and bedrock (fig. 25; table 7). Pier 12 is founded on footings on the exposed bedrock on the right bank, with no apparent scour hole nearby (figs. 23, 25, 1.5A, 1.5B; table 7). Pier 13 also is founded on footings on the exposed bedrock on the right bank, and was near the surveyed water surface with no apparent scour hole nearby (figs. 23, 25; table 7). In modern construction, bridge substructural elements usually are pinned or socketed to bedrock (American Association of State Highway Transportation Officials, 2012; Brown and others, 2010), but full exposure of usually buried substructural elements warrants special consideration and

Figure 1.5. Shaded triangulated irregular network visualization of the channel bed and main channel piers of structure L0135 on State Highway 51 over the Mississippi River at Chester, Illinois. *A*, left (northeast) side of pier 12. *B*, right (southwest) side of pier 12. *C*, left (northeast) side of pier 11. *D*, right (southwest) side of pier 11. *E*, left (northeast) side of pier 10. *F*, right (southwest) side of pier 10.

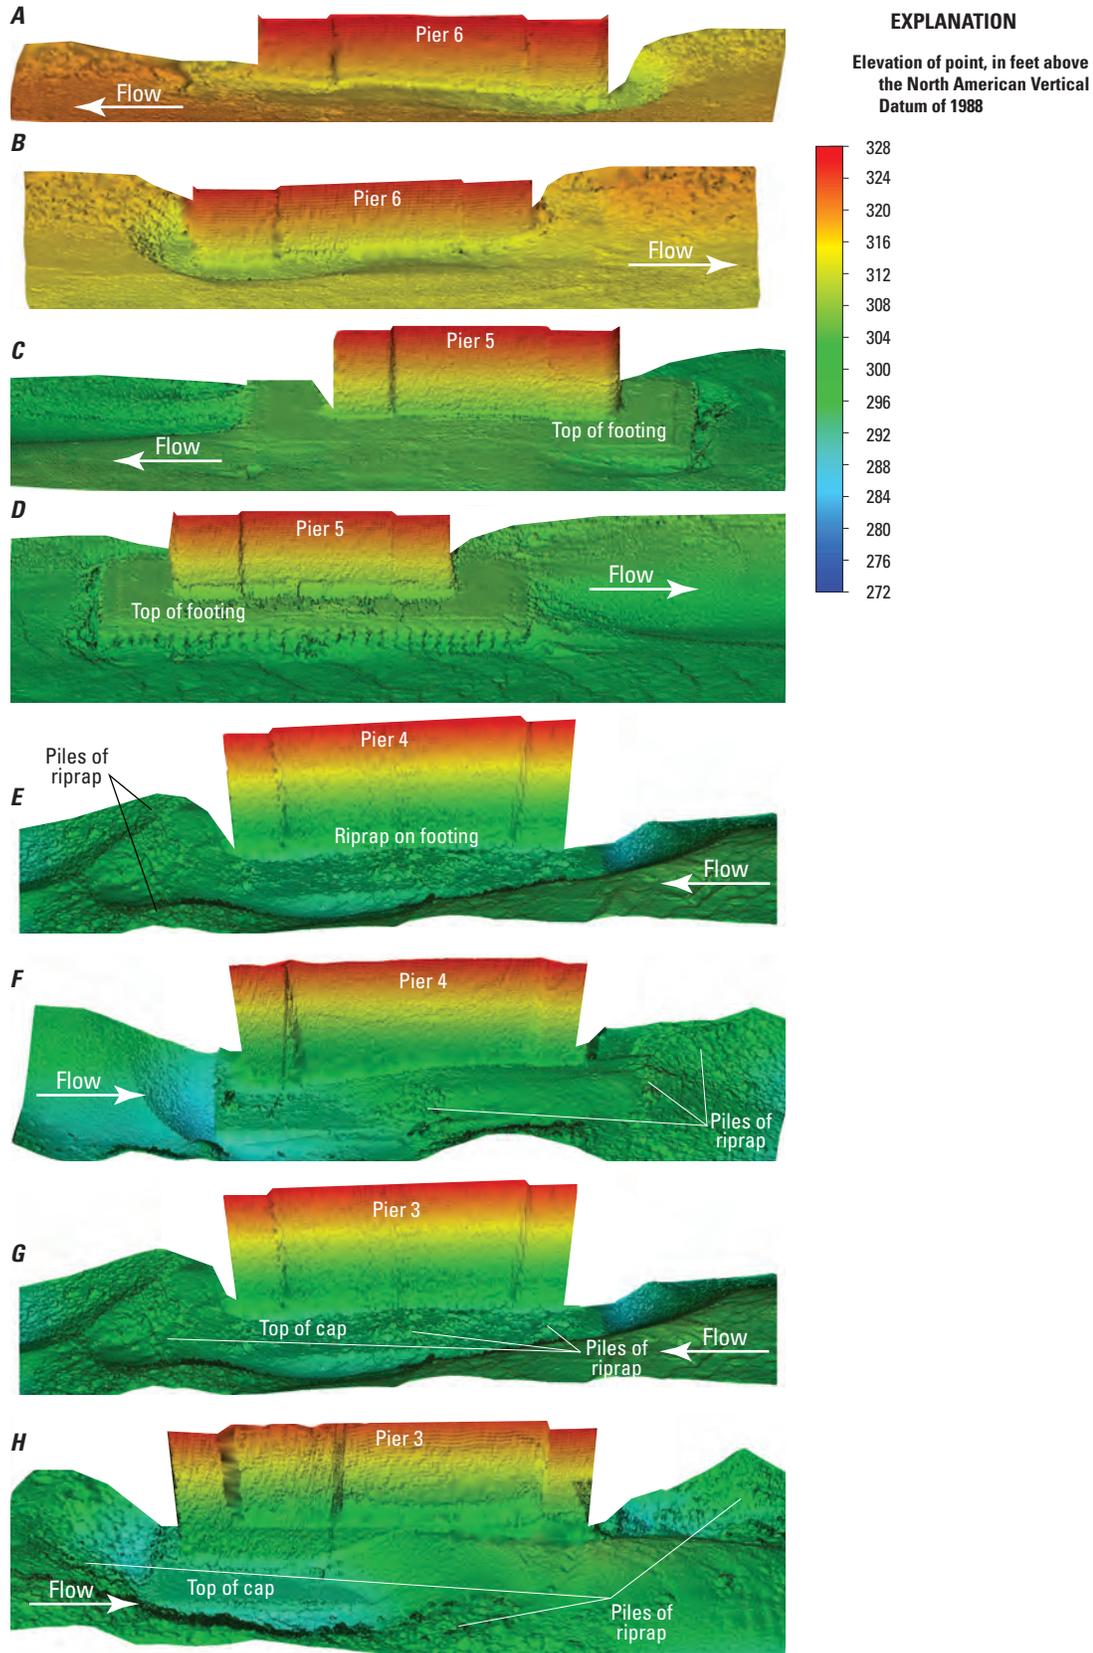
Piers 3 and 4 seemed to be partially surrounded by piles of riprap or rock (figs. 28, 1.6E through 1.6H), with additional scour downstream from the piers reaching a minimum elevation of 270 ft near pier 3 and 285 near pier 4 (fig. 28; table 7). Poorly defined, minor scour holes were observed near piers 5 and 6 (figs. 28, 1.6A through 1.6D), having a minimum channel-bed elevation of about 300 ft at pier 5 and 311 ft at pier 6 (table 7); however, the top of the footing was visible at pier 5, and the top of the distribution cap was visible at piers 3 and 4 (figs. 28, 30). The minimum channel-bed elevation near pier 5 is about 15 ft above the elevation of the bottom of the pier seal course of 285.00 ft, and the minimum channel-bed elevation near pier 6 is about 19 ft above the elevation of the bottom of the pier seal course of 292.00 ft (fig. 30; table 7). Information from bridge plans (Missouri Department of Transportation, written commun., 2014) indicates that piers 3 and 4 are founded on caissons on bedrock, having about 20 ft of bed material between the bottom of the scour hole and bedrock at pier 3, and 41 ft of material at pier 4. Piers 5 through 7 are founded on shafts drilled as much as 22 ft into bedrock, having about 55 ft of bed material between the bottom of the scour hole and bedrock at pier 5, and about 66 ft of material at pier 6 (fig. 30; table 7). The surveyed bed generally was similar to the previous survey in 2014, and the original ground line in 1996 from bridge plans, except near pier 4 (fig. 30).

Figure 1.6. Shaded triangulated irregular network visualization of the channel bed and main channel piers of structure A5076 on State Highway 34 over the Mississippi River at Cape Girardeau, Missouri. *A*, left (east) side of pier 6. *B*, right (west) side of pier 6. *C*, left (east) side of pier 5. *D*, right (west) side of pier 5. *E*, left (east) side of pier 4. *F*, right (west) side of pier 4. *G*, left (east) side of pier 3. *H*, right (west) side of pier 3.

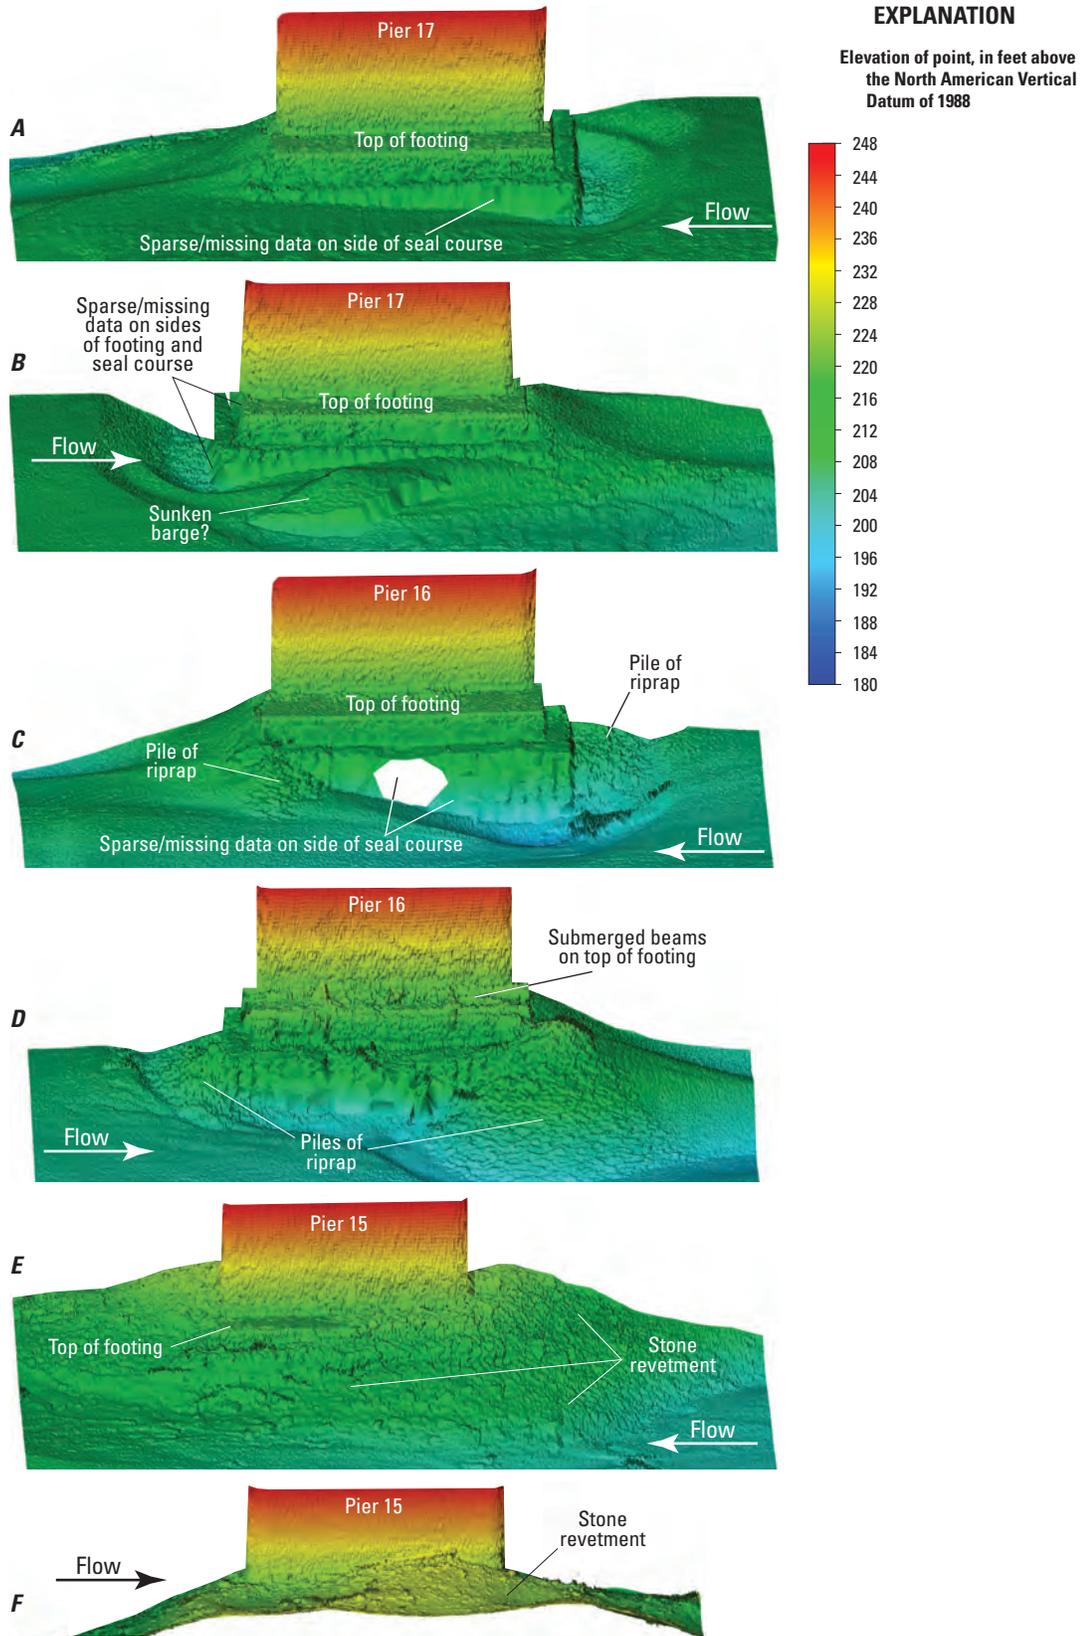
into flow. The cross section along the upstream bridge face (fig. 35) shows a localized high bed elevation near the left edge of the riprap blanket at pier 20 that coincides with the observed object. Pier 15 is embedded in the stone revetment along the right bank (figs. 33, 35, 1.8E, 1.8F), and pier 16 seems to be surrounded by several almost random piles of riprap, which may help mitigate scour (figs. 33, 35, 1.8C, 1.8D).

Figure 1.8. Shaded triangulated irregular network visualization of the channel bed and main channel piers of structure A1700 on Interstate 155 over the Mississippi River near Caruthersville, Missouri. *A*, left (southeast) side of pier 17. *B*, right (northwest) side of pier 17. *C*, left (southeast) side of pier 16. *D*, right (northwest) side of pier 16. *E*, left (southeast) side of pier 15. *F*, right (northwest) side of pier 15.
