Bathymetric and Velocimetric Surveys at Highway Bridges Crossing the Missouri River near Kansas City, Missouri, August 2019, August 2020, and October 2020

Scientific Investigations Report 2021–5098

By Richard J. Huizinga

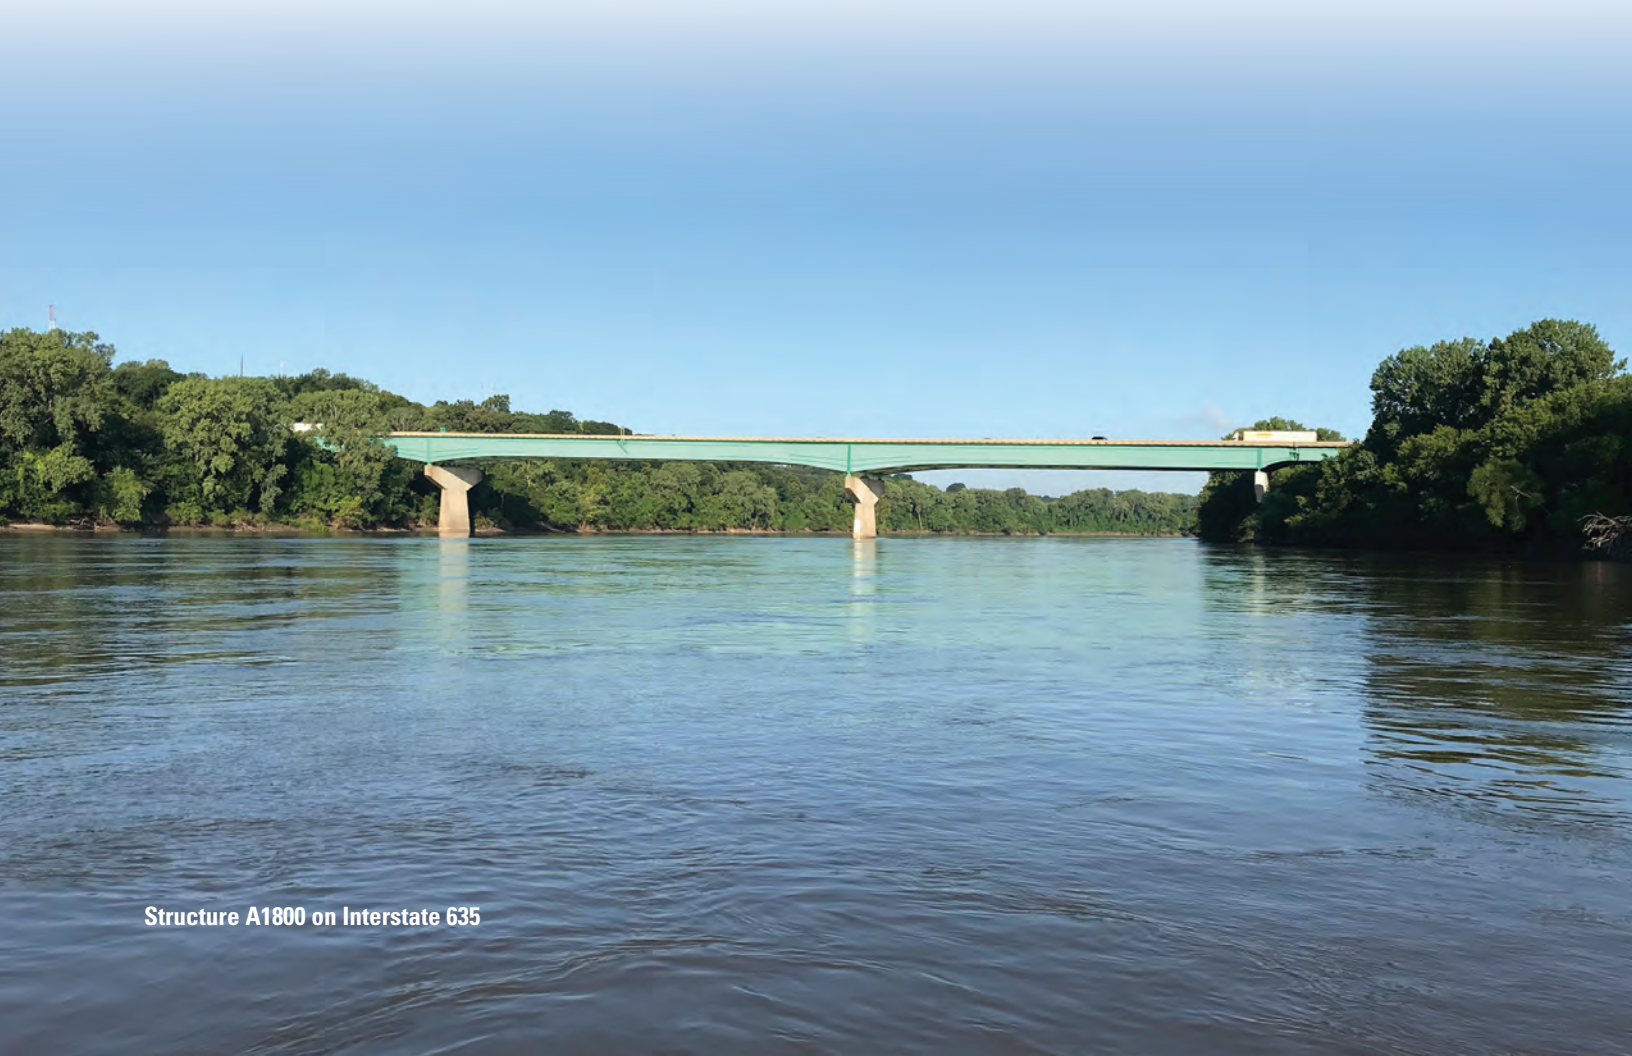
Structure A1800 on Interstate 635

The difference between the survey on August 13, 2019, and the previous flood survey on July 16, 2011 (fig. 10), indicates about 85 percent of the joint area of interest had detectable change, which means about 15 percent of the differences in the joint area of interest are equivocal and within the uncertainty. Substantial bed variation is apparent from 2011 to 2019 in the DoD map, particularly near the thalweg where large dune features were present in the 2011 survey (Huizinga, 2012). Whereas scour of as much as 15 ft seems dominant on the left (north) side of the channel in the DoD map, deposition of as much as 10 ft seems dominant in the thalweg (fig. 10). The average difference between the bathymetric surfaces was -1.77 ft (table 7), indicating moderate net channel degradation between the 2011 and 2019 surveys. The net volume of cut in the reach from 2011 to 2019 was about $110,500$ yd^3 , and the net volume of fill was about $43,500$ yd^3 , resulting in a net loss of about $67,000$ yd^3 of sediment between 2011 and 2019. As with the 2015 survey, the cross sections from the two surveys along the upstream face of the bridge are not substantially different from one another for most of the cross section, except near the left bank where the 2019 section is substantially lower than all the previous sections (fig. 8). The frequency distribution of bed elevations in 2019 also was similar in shape but narrower to 2011, and had a higher percentage of cells at the middle channel-bed elevations (fig. 7). As with the 2015 survey, the scour hole near pier 3 was of a very similar shape in 2019 and 2011 (fig. 8), again as evidenced by the overall

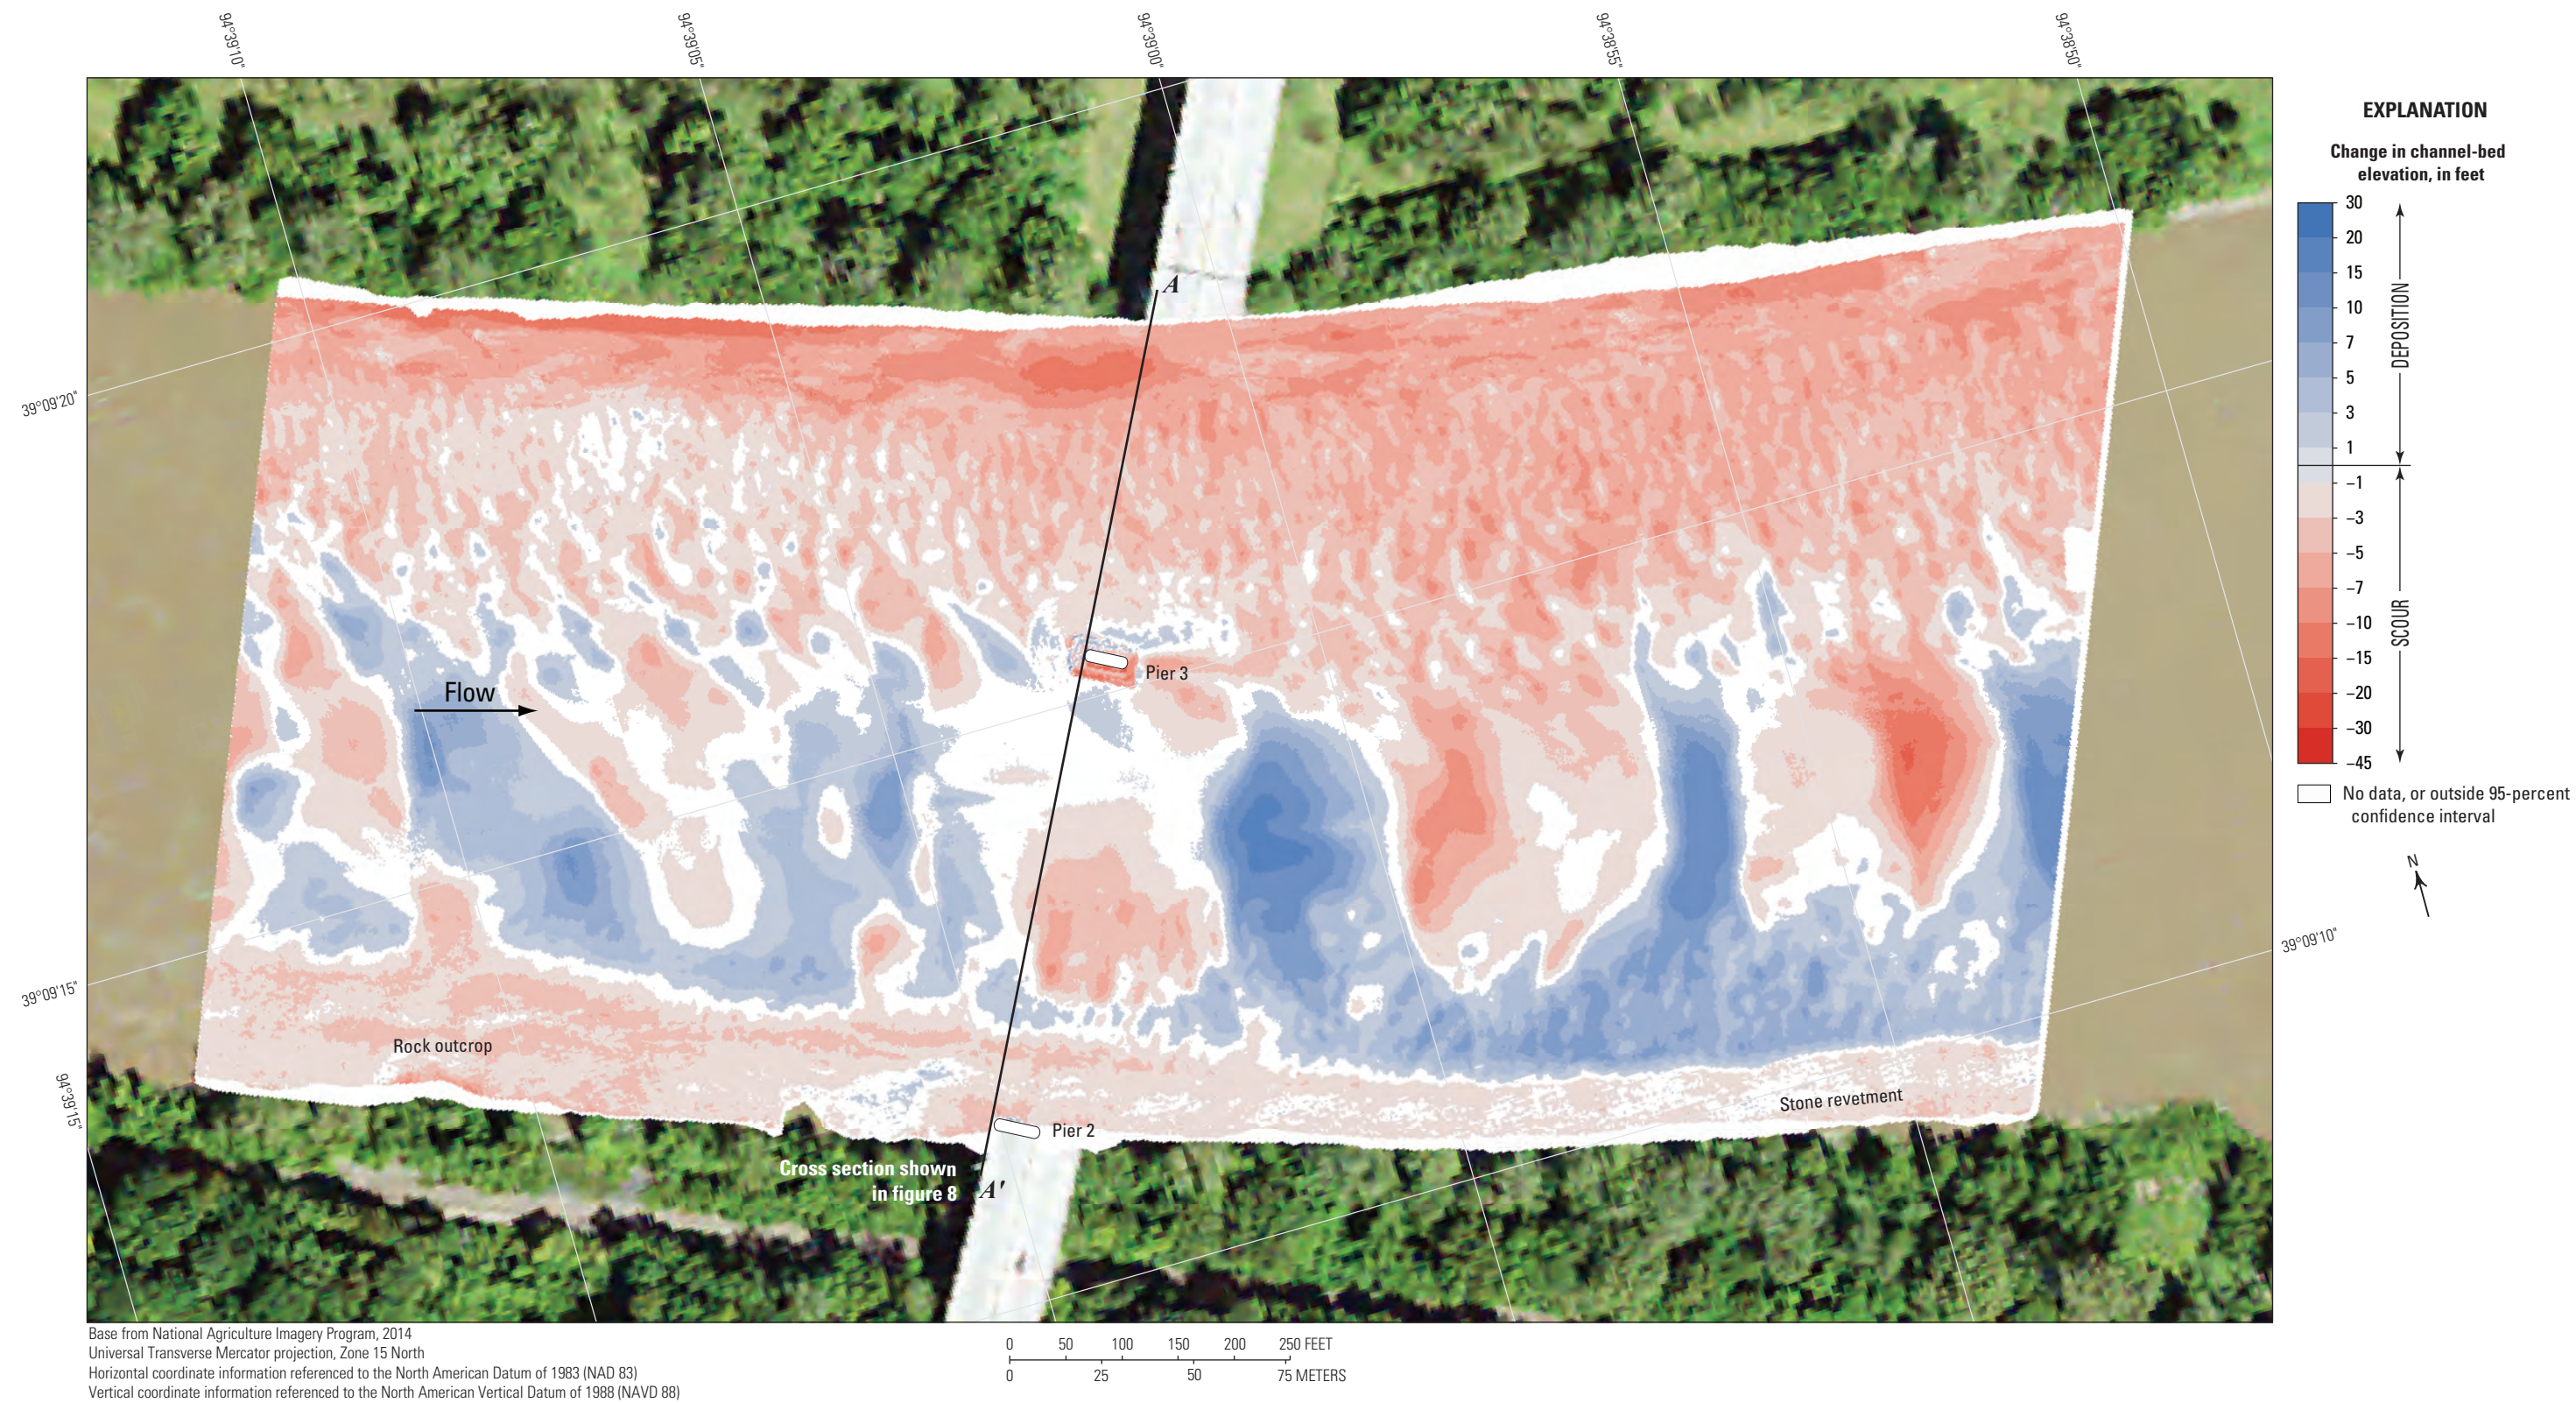
Figure 10. Difference between surfaces created from bathymetric surveys of the Missouri River channel near structure A1800 on Interstate 635 in Kansas City, Missouri, on August 13, 2019, and July 16, 2011.

area of “no data” or minimal change around the pier in the DoD map (fig. 10). The rock outcrop on the right (south) bank showed signs of more substantial scour upstream from the bridge, and the stone revetment on the downstream right (south) bank showed signs of minor scour (fig. 10). As with the previous DoD map, substantial deposition or scour apparent at the faces of the pier footing results from minor horizontal positional variances between the surveys (see “Uncertainty Estimation” section).

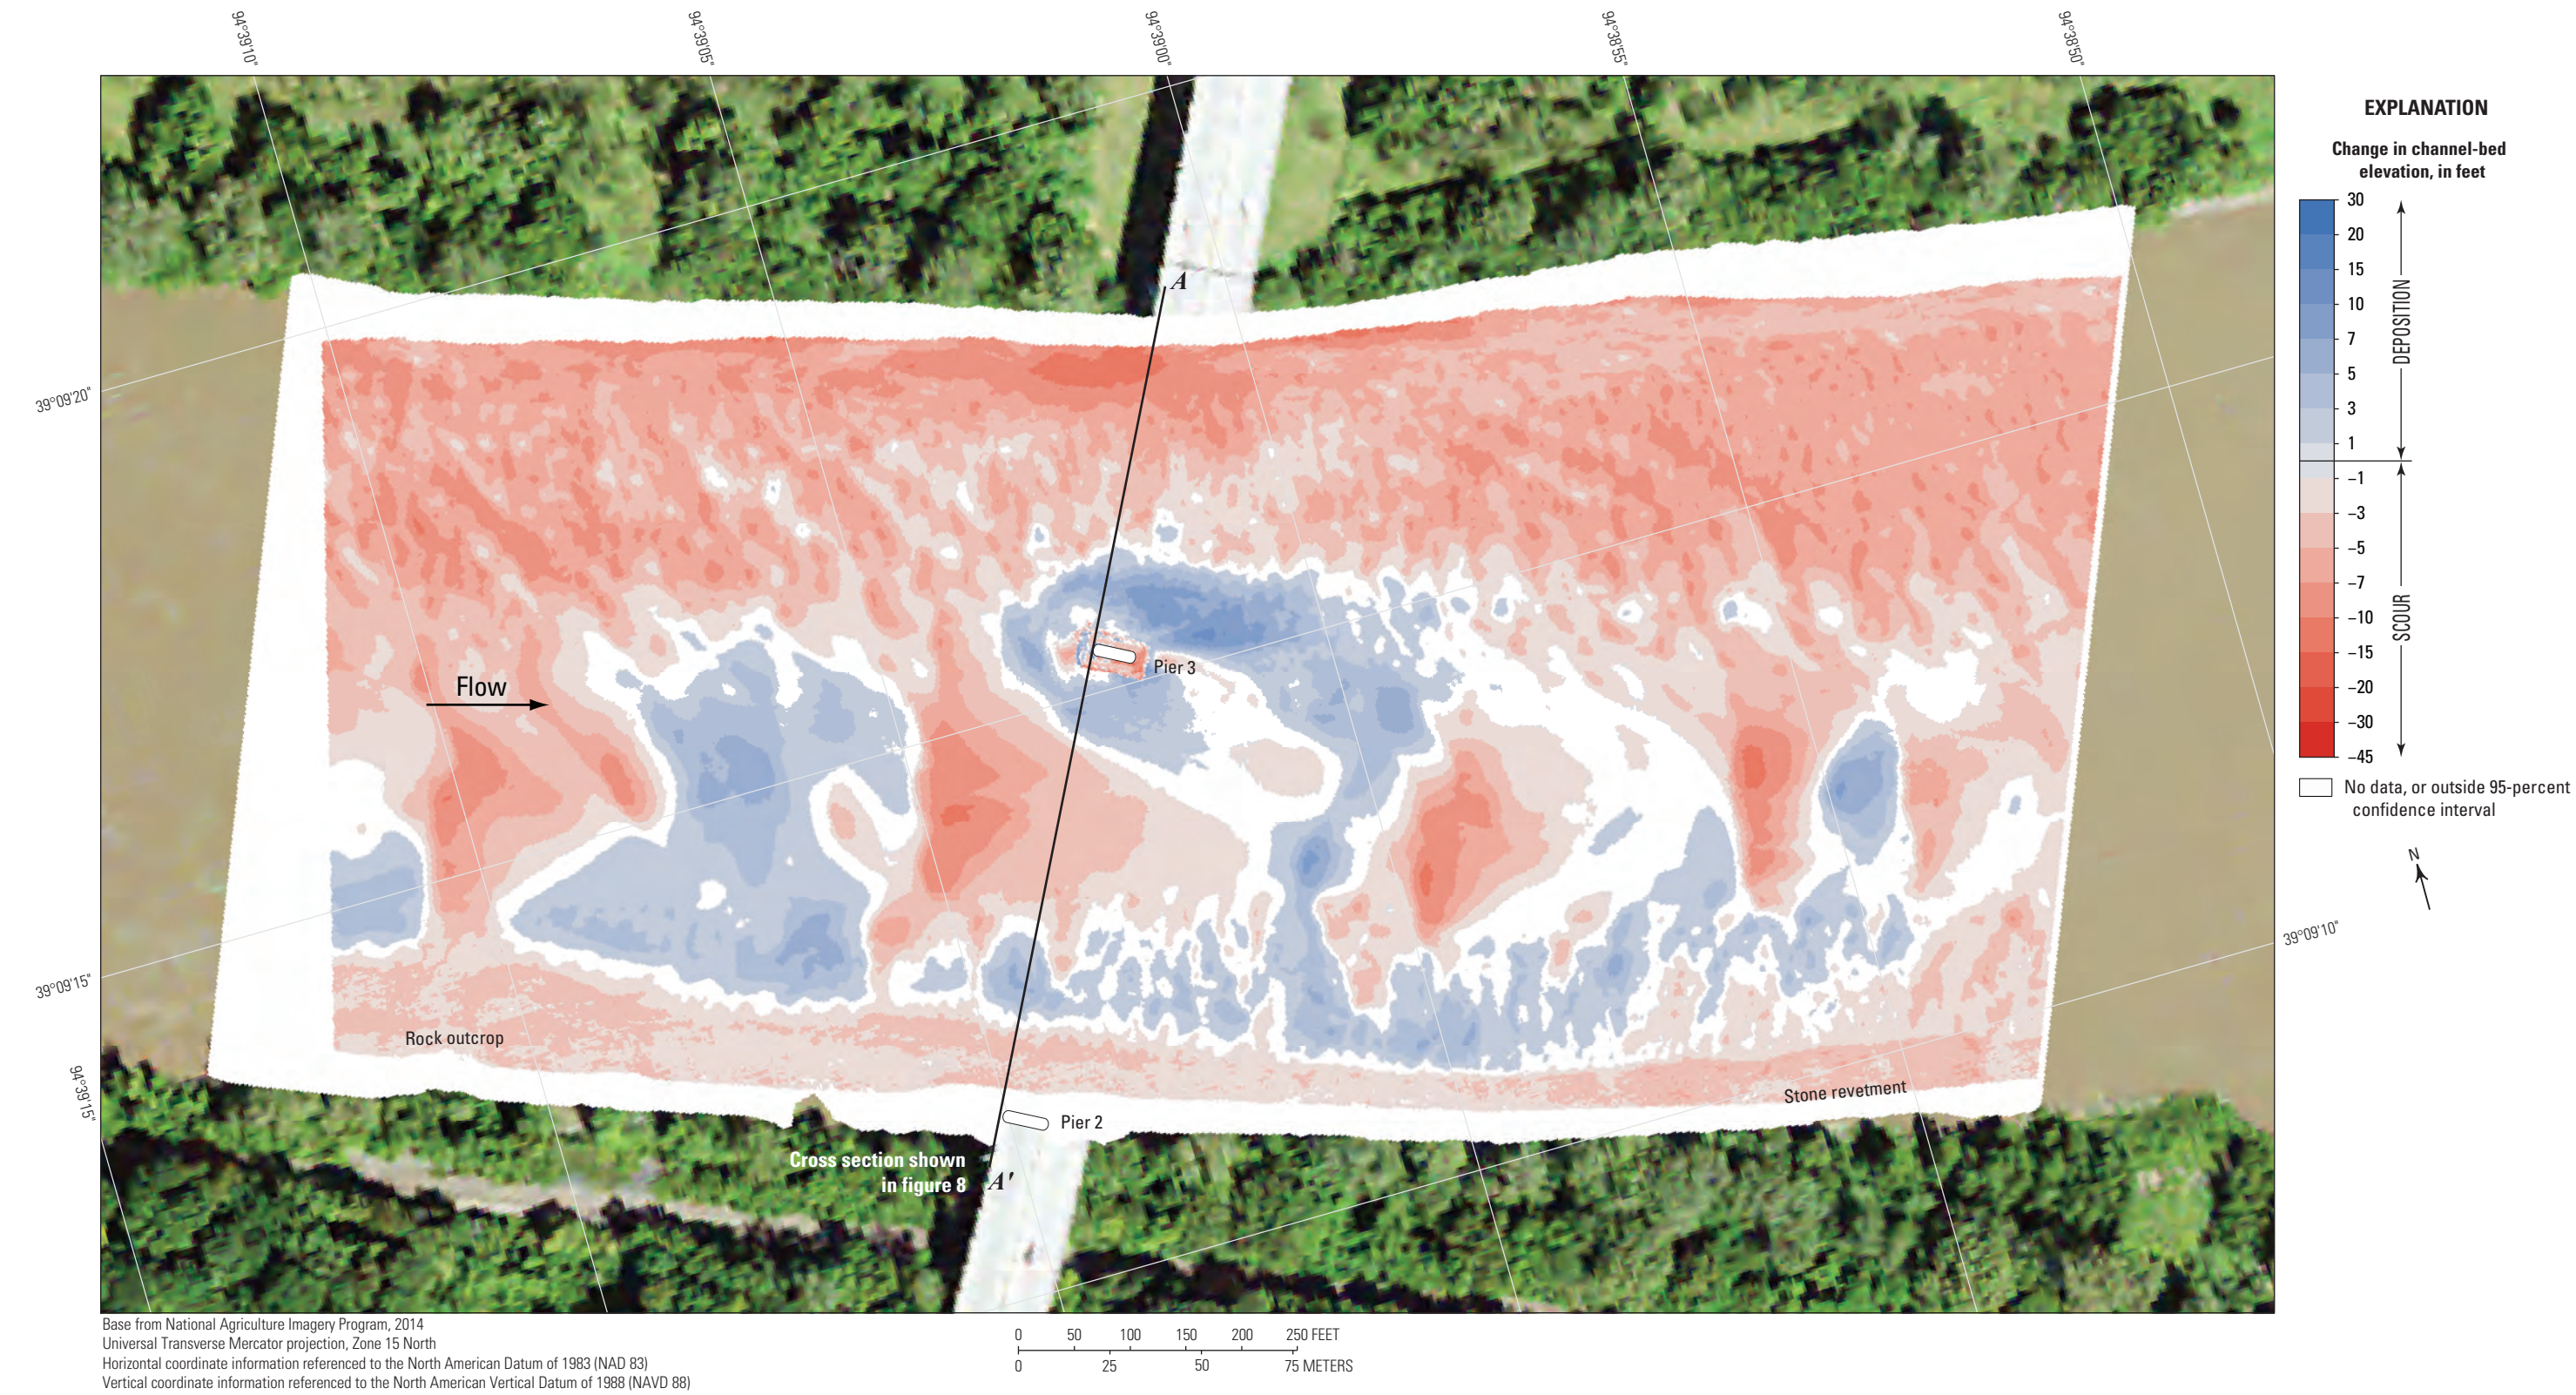
Figure 11. Difference between surfaces created from bathymetric surveys of the Missouri River channel near structure A1800 on Interstate 635 in Kansas City, Missouri, on August 13, 2019, and March 15, 2010.

The difference between the survey on August 13, 2019, and the earliest nonflood survey on March 15, 2010 (fig. 11), indicates about 87 percent of the joint area of interest had detectable change, which means about 13 percent of the differences in the joint area of interest are equivocal and within the uncertainty. Scour is dominant throughout most of the reach between 2010 and 2019 in the DoD map, except near some dune features present in the middle of the channel in 2010 and near pier 3 (Huizinga, 2010; fig. 11). The average difference between the bathymetric surfaces was -2.93 ft (table 7), indicating substantial channel degradation between the 2010 and 2019 surveys. The net volume of cut in the reach from 2010 to 2019 was about $122,700$ yd^3 , and the net volume of fill was about $20,500$ yd^3 , resulting in a net loss of about $102,200$ yd^3 of sediment between 2010 and 2019. Whereas the cross sections from the two surveys along the upstream face of the bridge are not substantially different from one another for most of the cross section, as with all the surveys the 2019 section is substantially lower than all the previous sections near the left bank (fig. 8). The frequency distribution of bed elevations in 2019 was very similar to 2010 for elevations below about 708 ft; however, above the 2019 distribution has a higher percentage of cells at a lower channel-bed elevation than 2010 (fig. 7). The scour hole near pier 3 was deeper and wider in 2010 than in 2019 (fig. 8), as evidenced by large horseshoe-shaped area of deposition around the pier in the DoD map (fig. 11). The rock outcrop on the right (south) bank showed signs of moderate scour upstream from the bridge, and the stone revetment on the downstream right (south) bank showed signs of minor scour (fig. 11). As with previous DoD maps, substantial deposition or scour apparent at the faces of the pier footing results from minor horizontal positional variances between the surveys (see “Uncertainty Estimation” section).

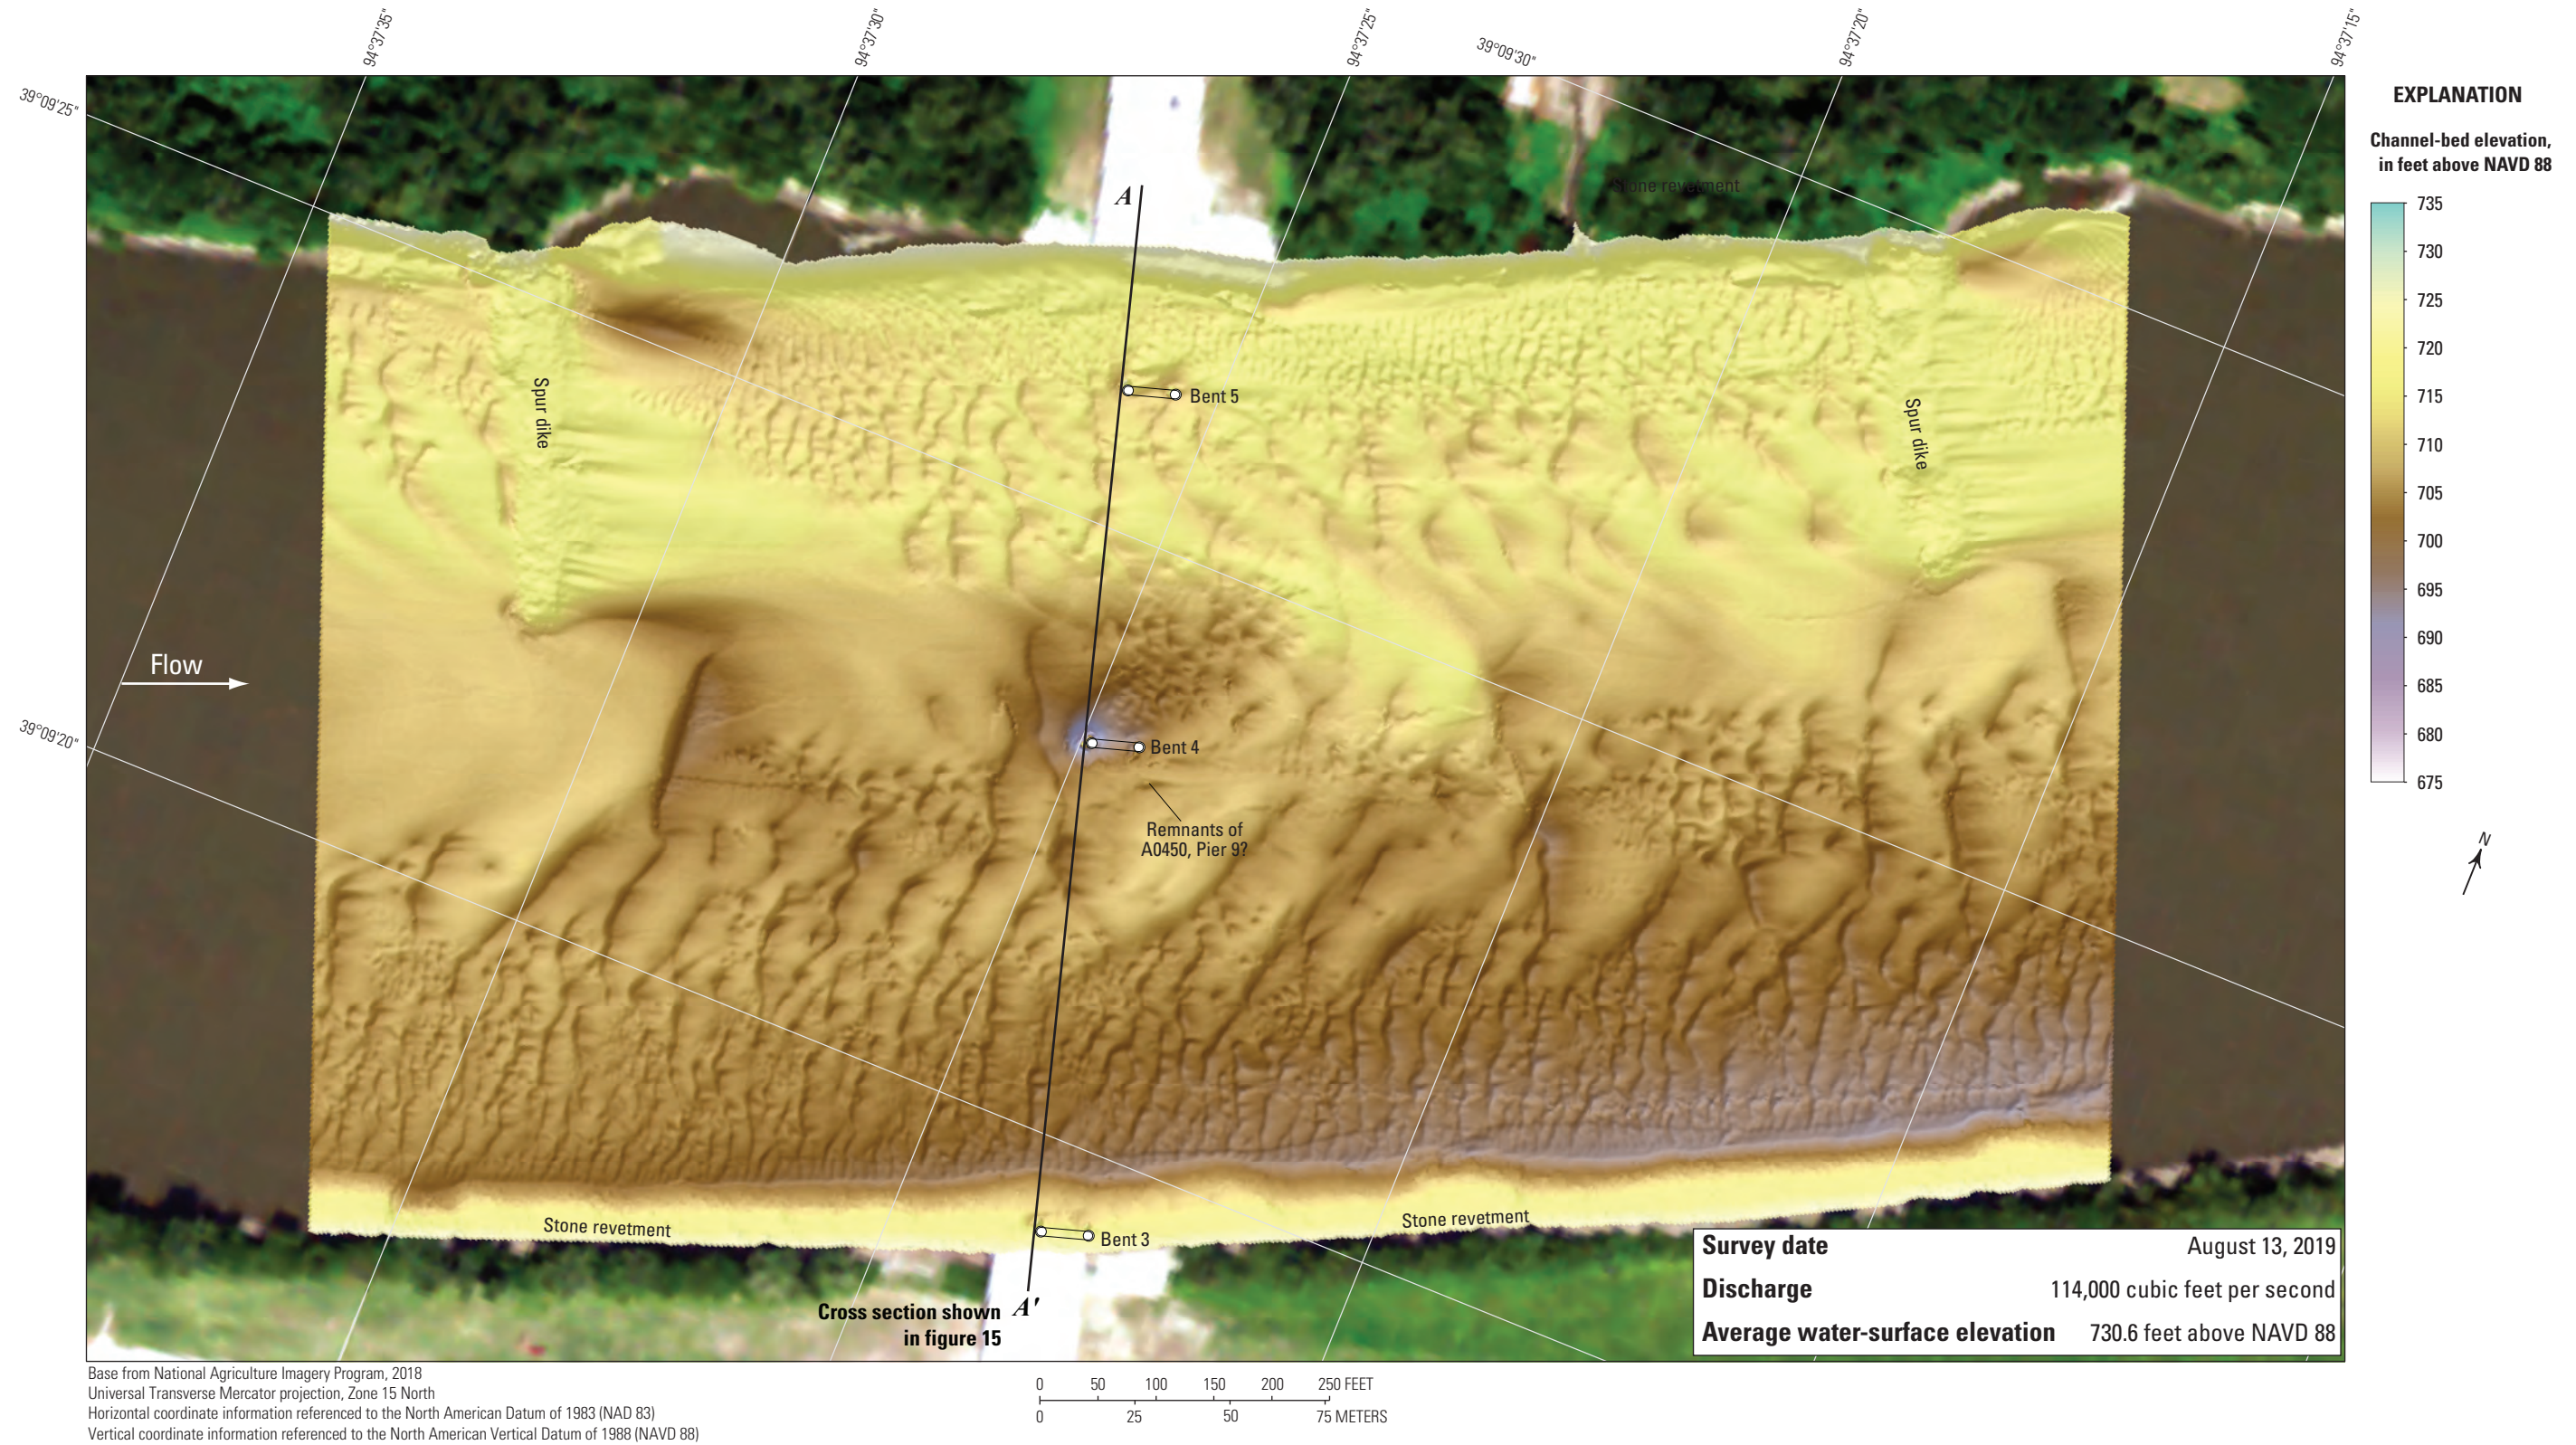
Figure 13. Bathymetric survey of the Missouri River channel near structure A8340 on U.S. Highway 69 in Kansas City, Missouri, on August 13, 2019.

The survey area was about 1,550 ft long and averaged about 875 ft wide, extending across the active channel from bank to bank ([fig. 13](#)). The upstream end of the survey area was about 680 ft upstream from the centerline of structure A8340 ([fig. 13](#)). The channel-bed elevations ranged from about 698 to 717 ft for most of the surveyed area (5th to 95th percentile range of the bathymetric data; [table 5](#); [fig. 14](#)), except near the central main channel bent 4 of structure A8340 ([fig. 13](#)). There was a defined thalweg along the toe of the right (south) bank, which was about 12 ft deeper than the channel bed in the middle of the channel ([fig. 13](#)). A series of medium dunes was present in the middle of the channel, and numerous other small dunes and ripples were present throughout the rest of the channel ([fig. 13](#)). As in previous surveys (Huizinga, 2010, 2012, 2020a), stone revetment was present on the right (south) bank throughout the reach, and two spur dikes were present on the left (north) bank ([fig. 13](#)). Partial remnants of the pier from old structure A0450 were evident to the right and downstream from bent 4 of structure A8340 ([fig. 13](#)).

A local scour hole near bent 4 had an approximate minimum channel-bed elevation of about 688 ft ([table 6](#)), the minimum elevation for the surveyed area ([table 5](#)), and about 17 ft below the average channel bed immediately upstream from the bent ([table 6](#); [fig. 13](#)). A local scour hole near bent 5 had a minimum elevation of 707 ft, about 5 ft below the average channel bed immediately upstream from the pier ([fig. 13](#); [table 6](#)). Bent 3 is surrounded by the rock revetment on the right (south) bank, but a very small depression of about 3 ft was present in the revetment near the upstream face of the upstream column ([fig. 13](#); [table 6](#)). Information from bridge plans indicates that all the main channel bents of structure A8340 are shafts drilled about 23 to 28 ft into bedrock and have about 50 ft of bed material between the bottom of the scour hole and bedrock at bent 4 ([fig. 15](#); [table 6](#)); bents 5 and 3 have about 69 and 82 ft of bed material between the bottom of the scour hole and bedrock, respectively ([fig. 15](#); [table 6](#)).

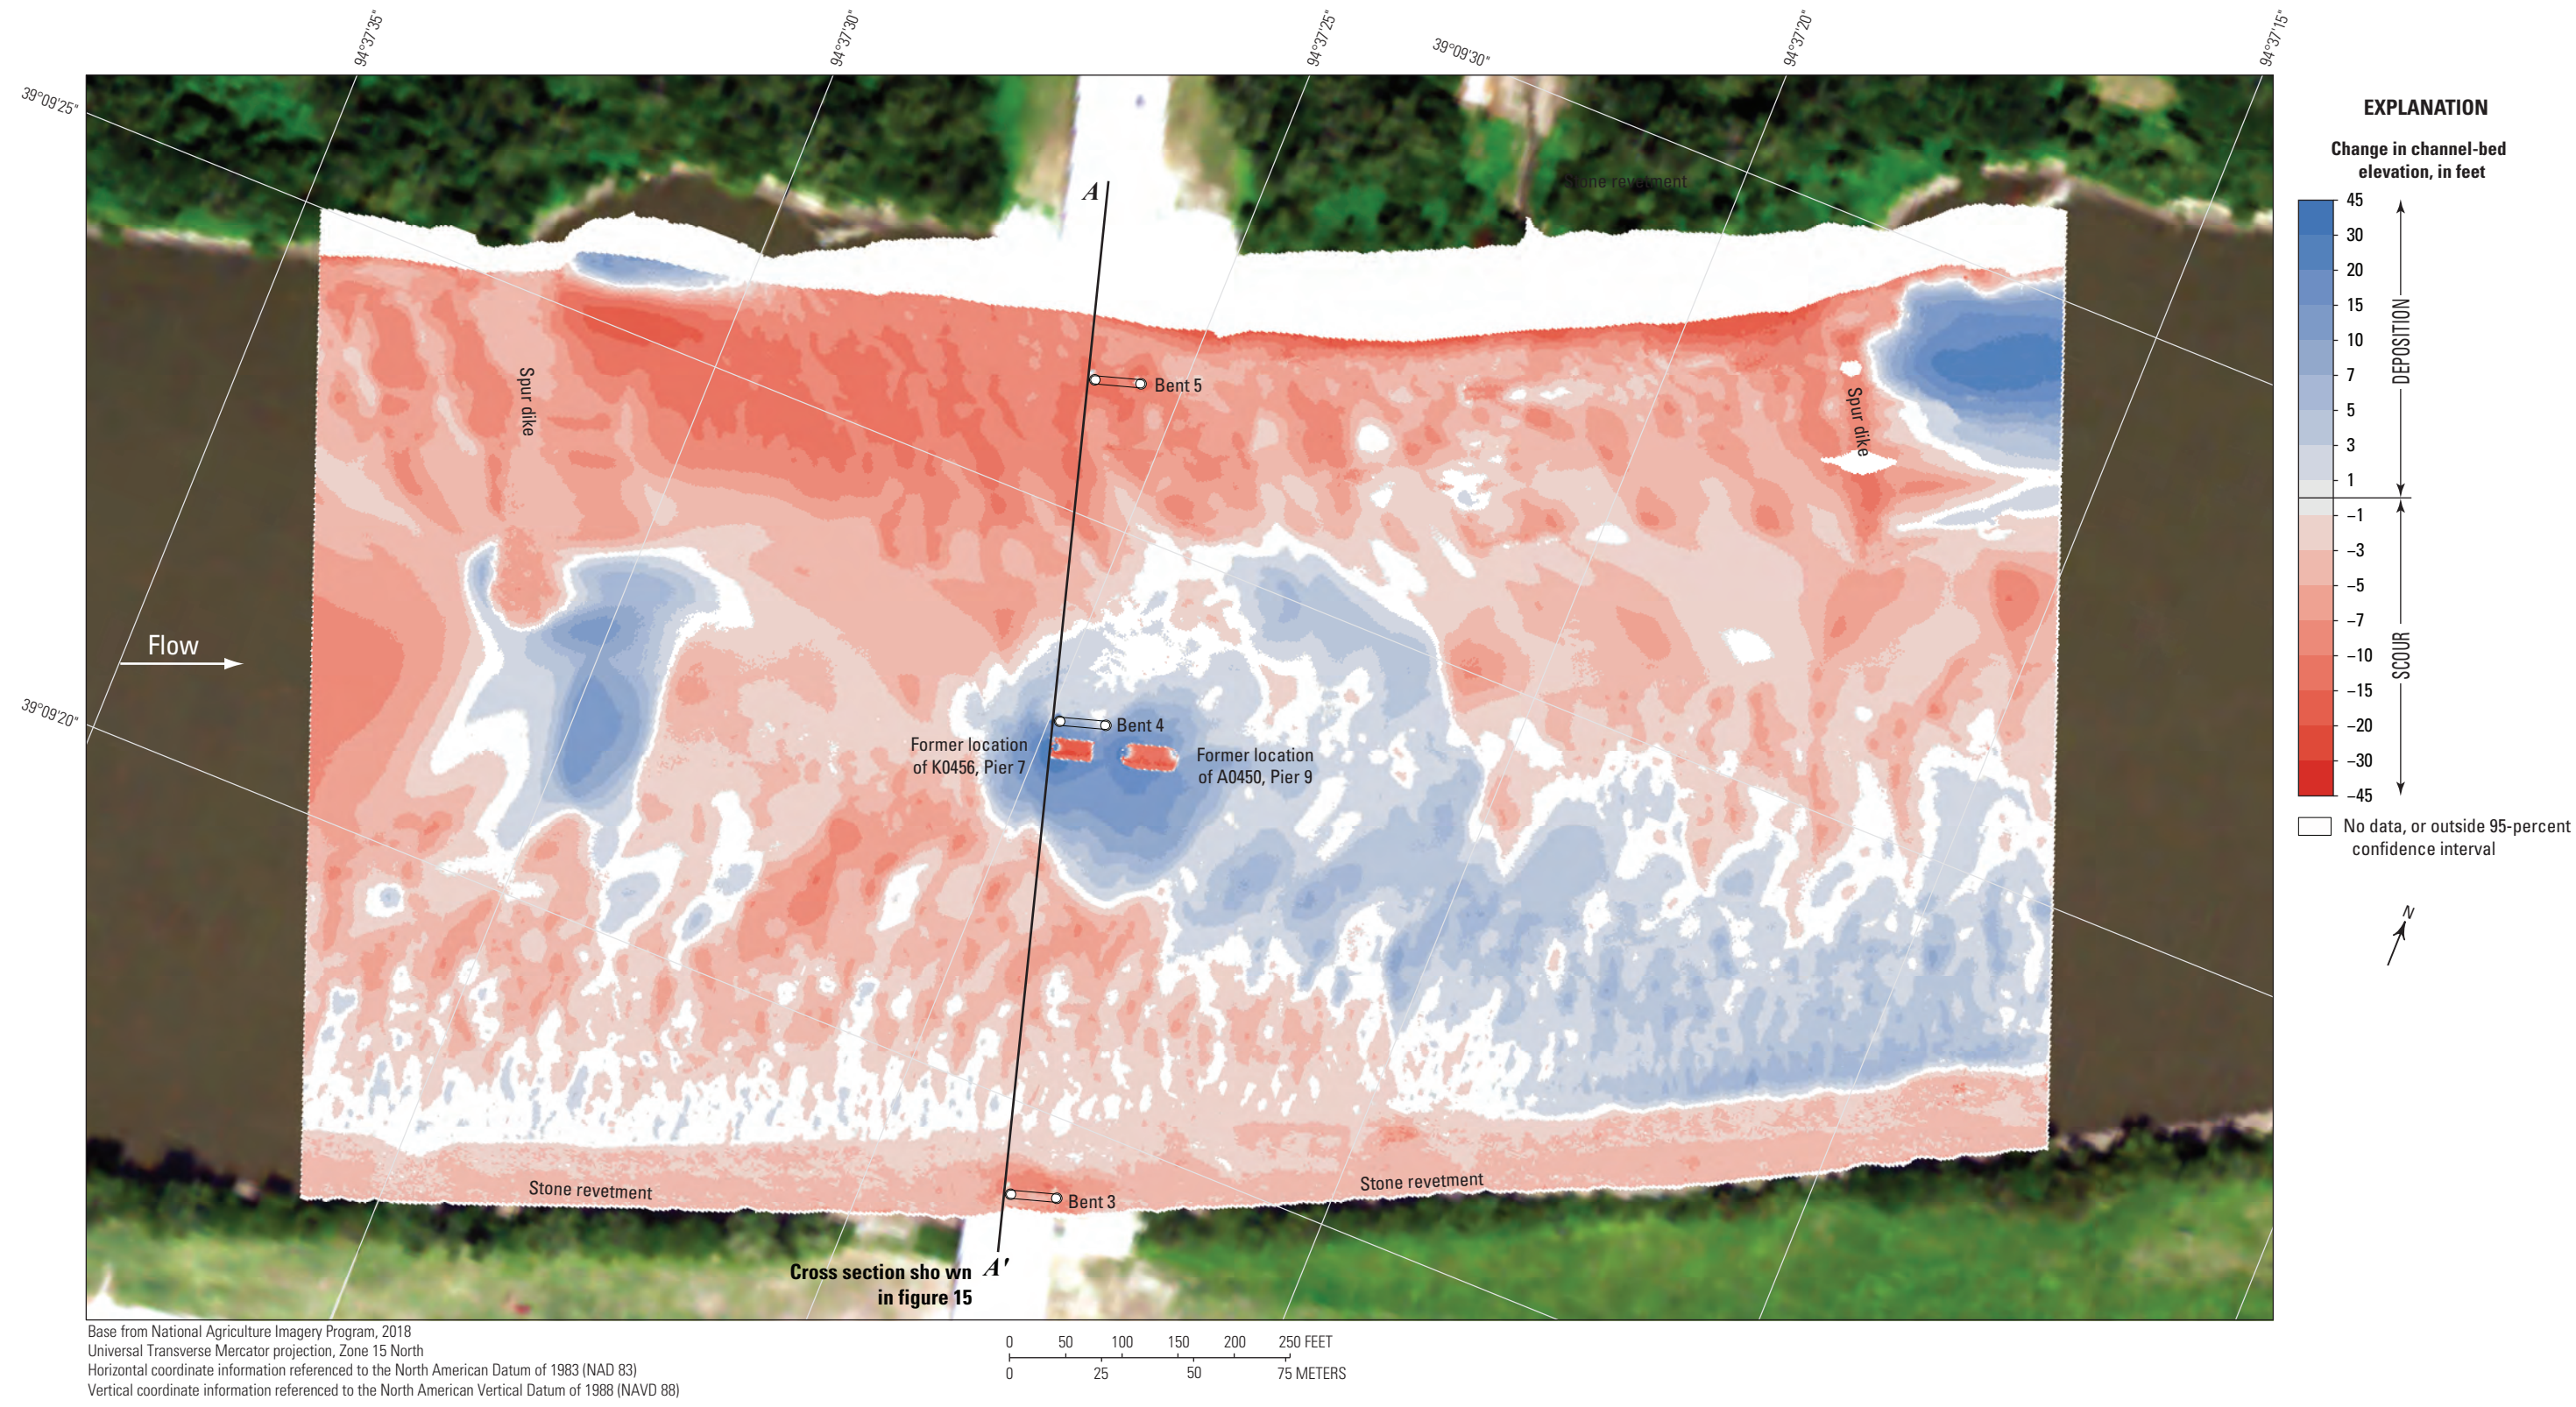
Figure 17. Difference between surfaces created from bathymetric surveys of the Missouri River channel near structure A8340 on U.S. Highway 69 in Kansas City, Missouri, on August 13, 2019, and July 16, 2011.

The difference between the survey on August 13, 2019, and the previous flood survey on July 16, 2011 ([fig. 17](#)), indicates about 88 percent of the joint area of interest had detectable change, which means about 12 percent of the differences in the joint area of interest are equivocal and within the uncertainty. Substantial bed variation is again apparent from 2011 to 2019 in the DoD map, with scour predominant throughout the reach except for substantial deposition at the former location of the old bridge piers near bent 4 and in the downstream thalweg and the troughs of dunes present in the 2011 survey (Huizinga, 2012). Whereas scour of greater than 10 ft appears dominant on the left (north) side of the channel in the DoD map, deposition of as much as 10 ft occurred in the thalweg, and deposition of more than 20 ft occurred downstream from the downstream spur dike ([fig. 17](#)). The average difference between the bathymetric surfaces was -2.27 ft ([table 7](#)), indicating substantial net channel degradation between the 2011 and 2019 surveys. The net volume of cut in the reach from 2011 to 2019 was about 137,700 yd³, and the net volume of fill was about 45,600 yd³, resulting in a net loss of about 92,100 yd³ of sediment between 2011 and 2019. As with the 2017 survey, the cross sections from the two surveys along the upstream face of the bridge indicate a nearly uniform lowering of 5 to 10 ft for most of the cross section except the location of the former pier ([fig. 15](#)). The frequency distribution of bed elevations in 2019 also was similar in shape but slightly narrower to 2011, with a higher percentage of cells at the middle channel-bed elevations ([fig. 14](#)). The differences in the frequency distribution of bed elevations in 2017 and 2019 from 2011 ([fig. 14](#)) likely are a direct result of the new bridge bents, which are designed to be more hydrodynamic and less scour-inducing than the old bridge piers. The stone revetment on the right (south) bank also showed signs of nearly uniform minor scour in the DoD map ([fig. 17](#)).
