Bathymetric and Velocimetric Surveys at Highway Bridges Crossing the Missouri River near Kansas City, Missouri, August 2019, August 2020, and October 2020

Scientific Investigations Report 2021–5098

By Richard J. Huizinga

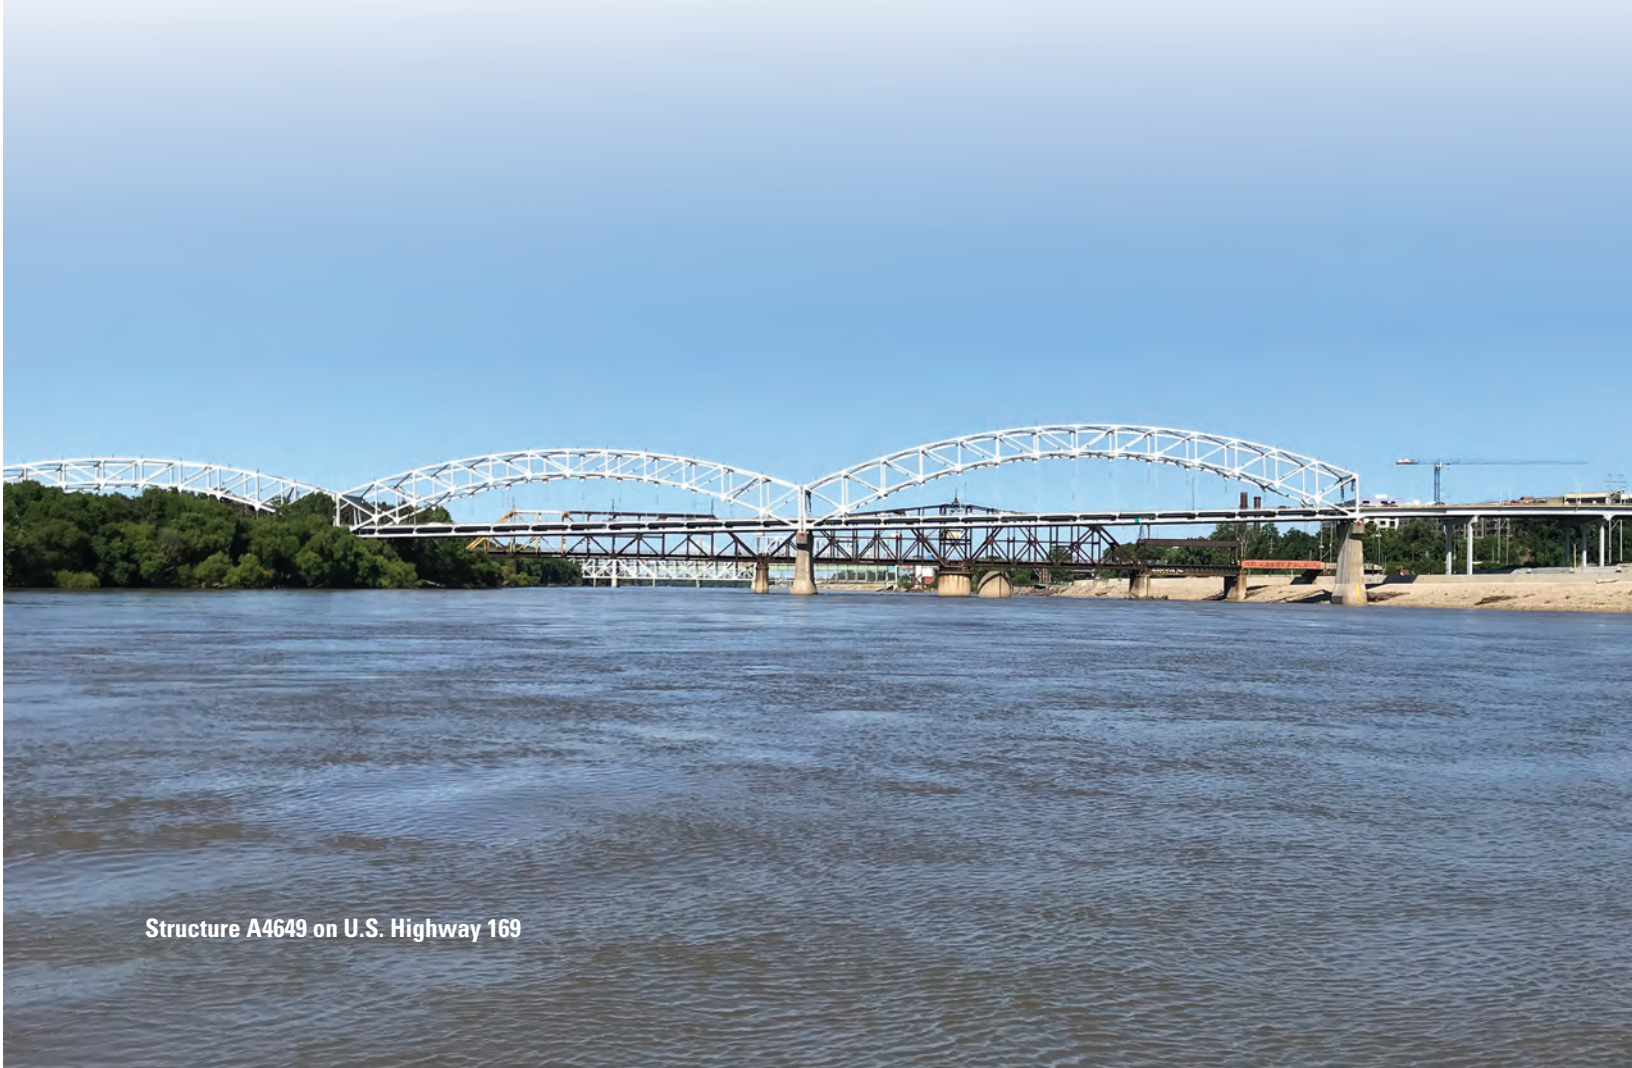
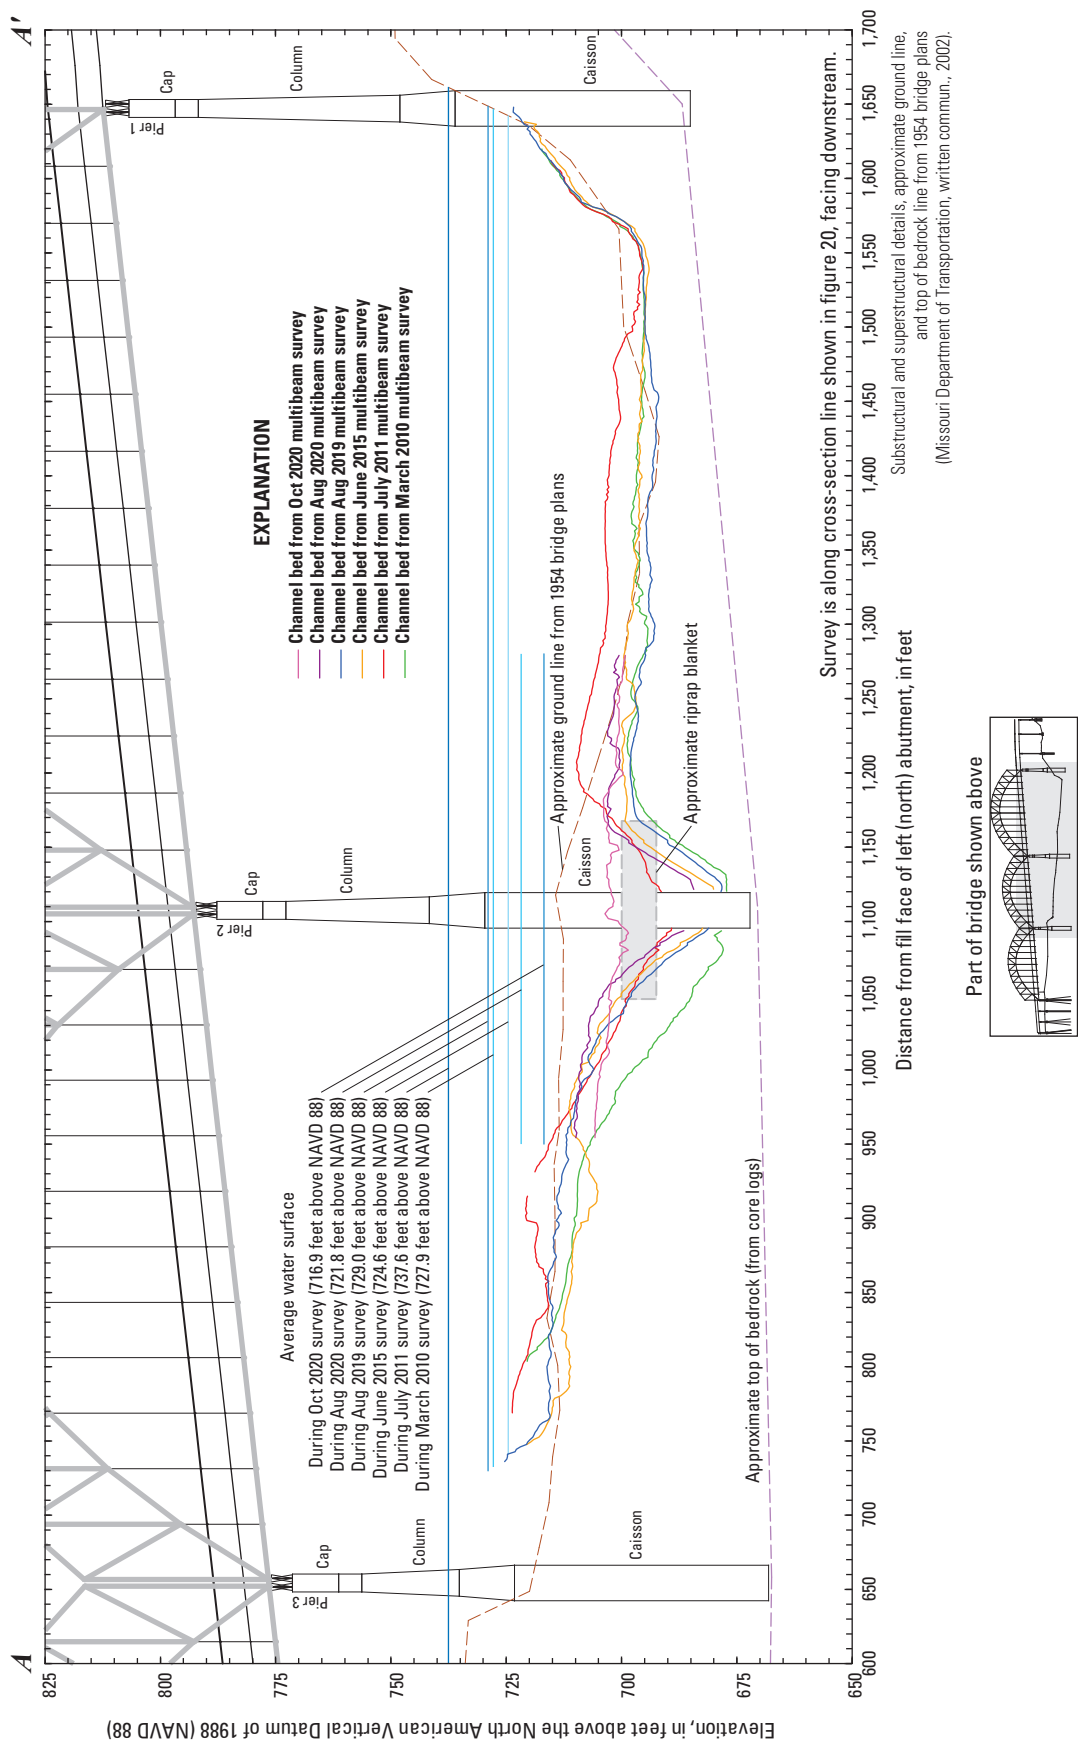
Figure 22. Key features, substructural and superstructural details, and surveyed channel bed of structure A4649 on U.S. Highway 169 crossing the Missouri River in Kansas City, Missouri.

channel pier 2 of structure A4649 is a caisson on bedrock, and has about 8 ft of bed material between the bottom of the scour hole and the bottom of the caisson ([fig. 22](#); [table 6](#)).

The history of scour observed near pier 2 (Huizinga, 2010, 2012, 2016), and the nature of caisson foundations generally not being embedded in bedrock led MoDOT to install scour countermeasures around pier 2 during August–October 2020. Partial surveys of the channel bed near pier 2 of structure A4649 were done before and after installation of these scour countermeasures to document and verify installation. The historical scour hole near pier 2 was clearly evident in the pre-installation survey on August 17, 2020 (fig. 27), but the difference between the survey on August 13, 2019, and the partial survey on August 17, 2020, indicates moderate deposition of 5 to 10 ft had occurred from 2019 to 2020 (fig. 28). The cross sections from the two surveys along the upstream face of the bridge also indicates this deposition from 2019 to 2020 (fig. 22). The downstream edge of riprap blanket countermeasures installed around pier 2 was clearly evident in the post-installation survey on October 23, 2020 (figs. 29, 1.4B), and the difference between the pre- and post-installation surveys indicate the changes resulting from the installation (fig. 30). The net volume of cut in the partial reach from August 2019 to August 2020 was about 750 yd³, and the net volume of fill was about 18,660 yd³, resulting in a net gain of about 17,910 yd³ of sediment between August 2019 and August 2020 (fig. 28). However, the net volume of cut in the partial reach from August to October 2020 was about 6,300 yd³, and the net volume of fill was about 5,000 yd³, resulting in a net loss of about 1,300 yd³ of sediment between August and October 2020 (fig. 30), despite installation of the countermeasures. The scour hole was effectively mitigated, with as much as 20 ft of deposition near the pier (fig. 30), including some deposition of material on top of the blanket upstream from the bridge (fig. 29); nevertheless, moderate scour occurred in much of the partial reach around the riprap blanket between August and October (fig. 30).

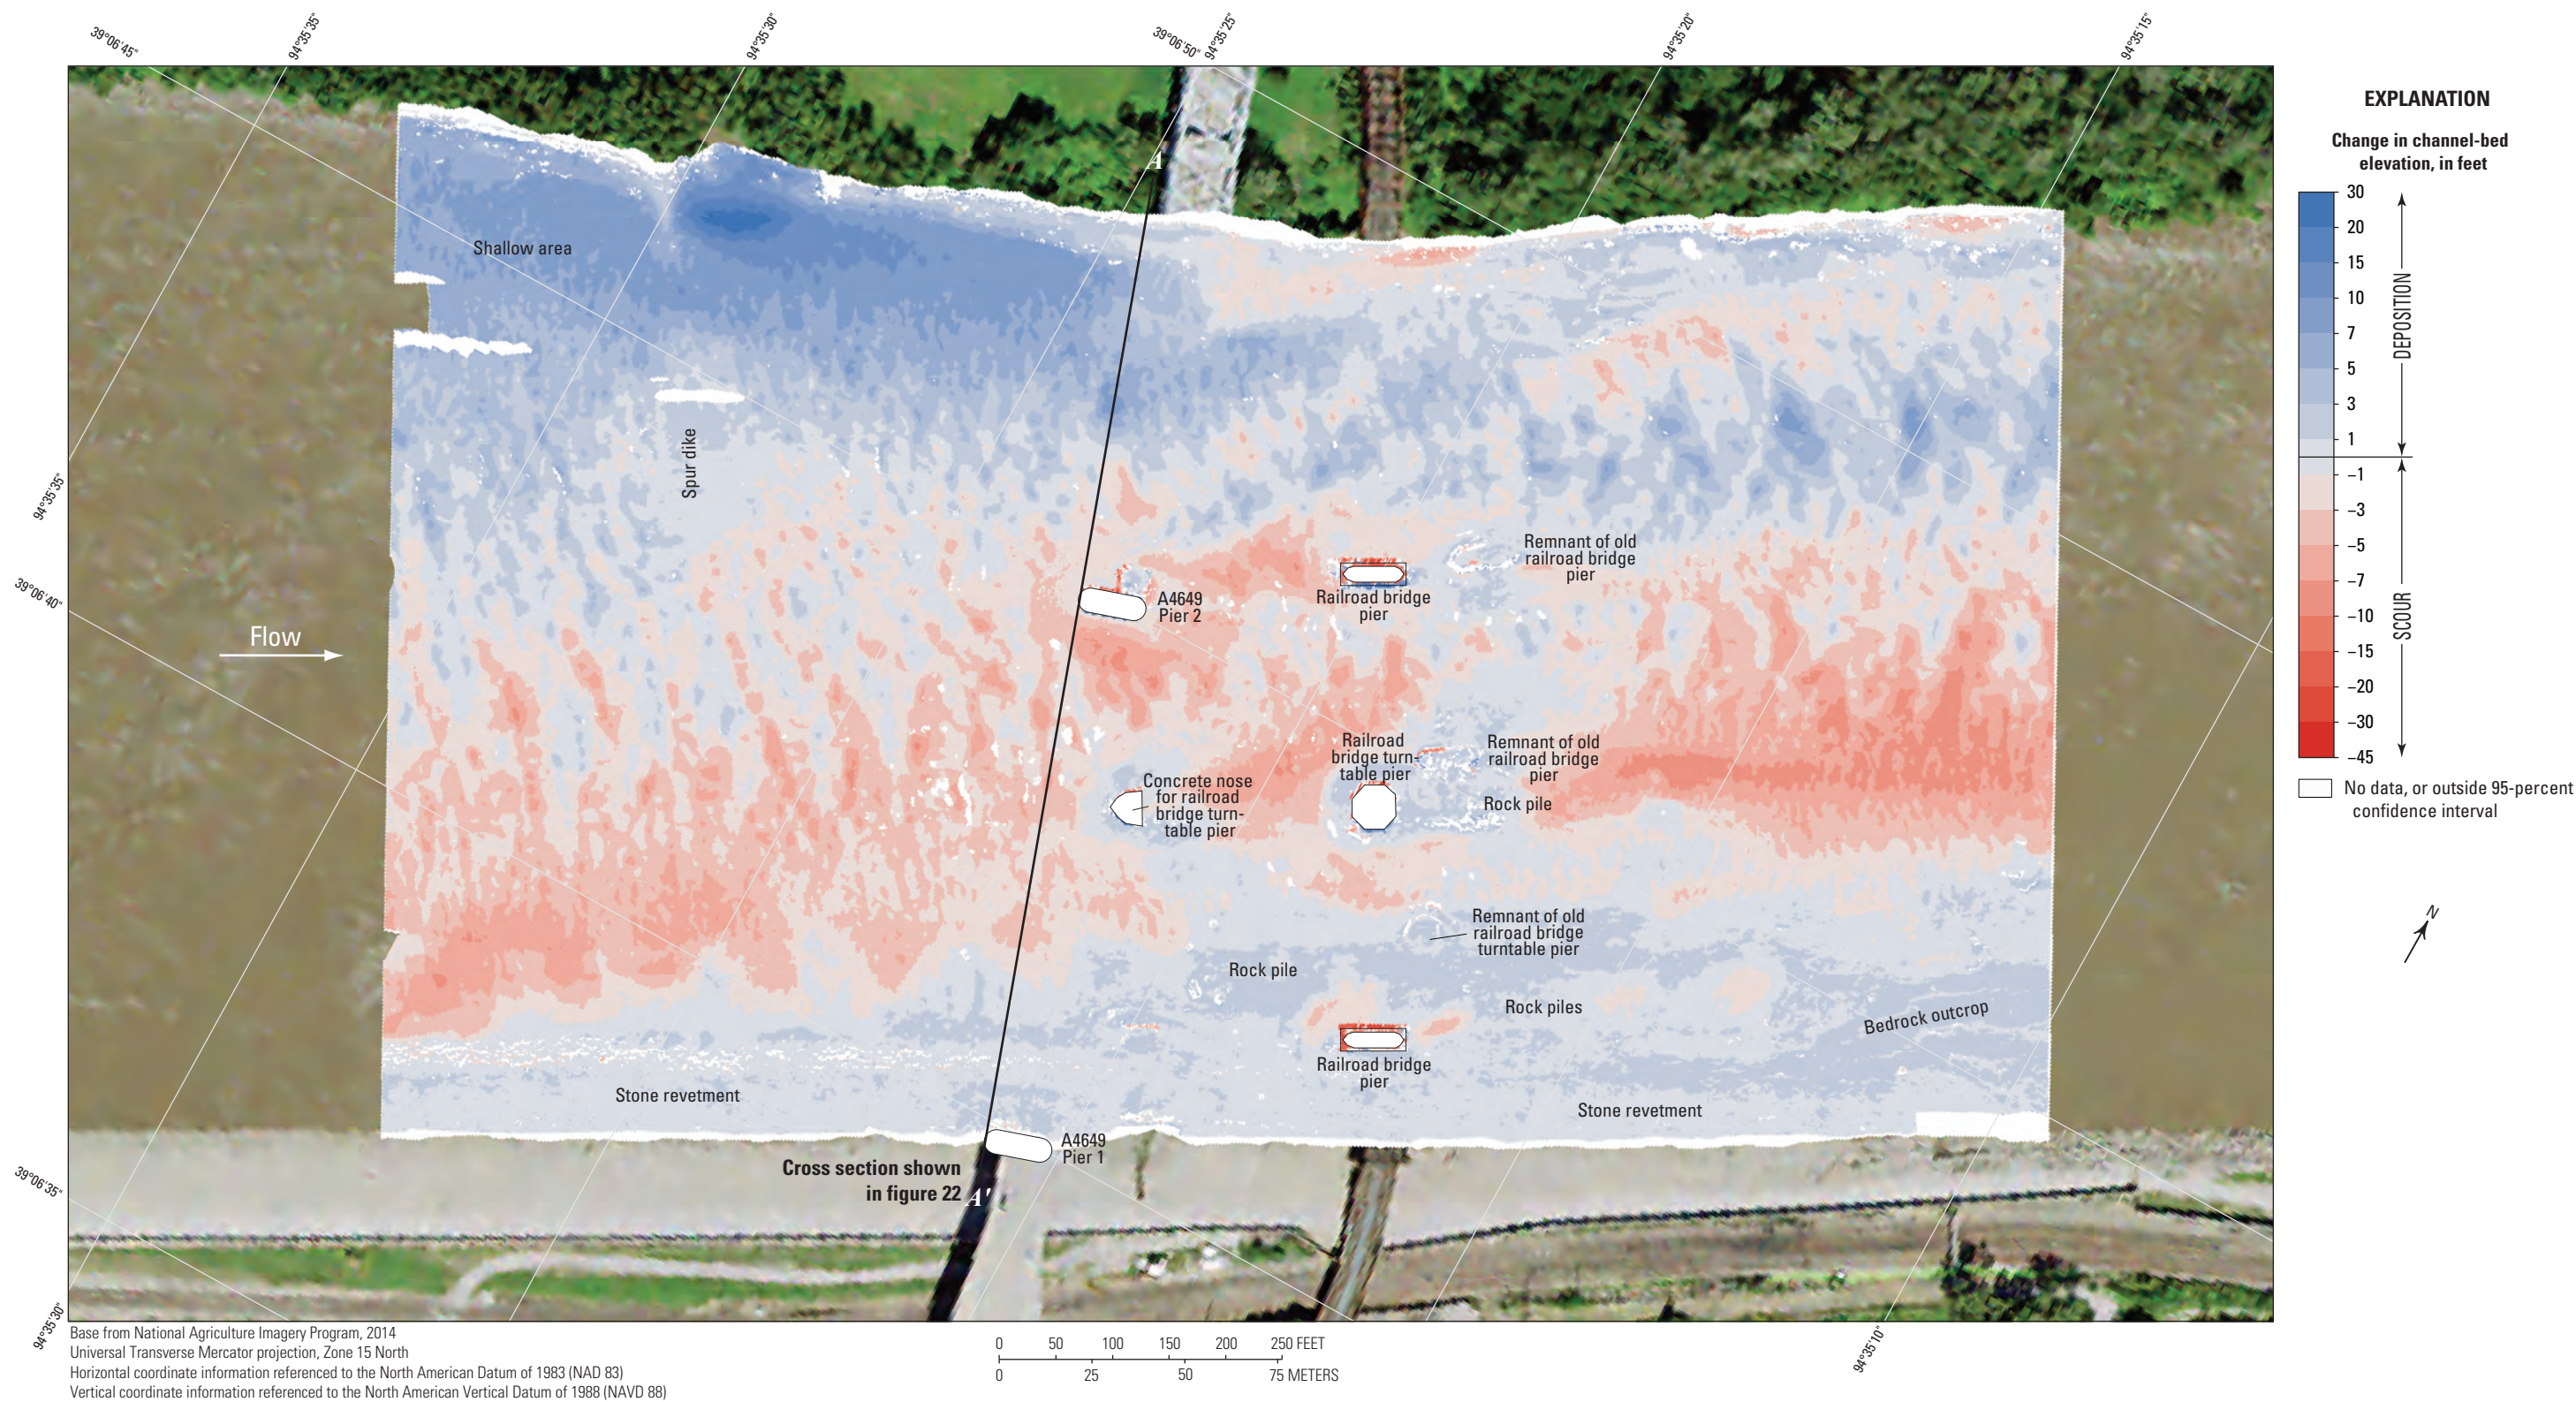
Figure 23. Difference between surfaces created from bathymetric surveys of the Missouri River channel near structure A4649 on U.S. Highway 169 in Kansas City, Missouri, on August 13, 2019, and June 22, 2015.

The difference between the survey on August 13, 2019, and the previous nonflood survey on June 2, 2015 ([fig. 23](#)), indicates about 99 percent of the joint area of interest had detectable change, which means only 1 percent of the differences in the joint area of interest are equivocal and within the uncertainty. However, bed variation seems about equal between scour and deposition throughout the channel from 2015 to 2019 in the DoD map because deposition on the upstream left (north) side is balanced with scour in the middle ([fig. 23](#)). The average difference between the bathymetric surfaces was -0.13 ft ([table 7](#)), indicating minimal channel degradation between the 2015 and 2019 surveys. The net volume of cut in the reach from 2015 to 2019 was about 74,200 yd³, and the net volume of fill was about 67,000 yd³, resulting in a net loss of about 7,200 yd³ of sediment between 2015 and 2019. The cross sections from the two surveys along the upstream face of the bridge are similar ([fig. 22](#)); there is deposition on the left end of the section and there is nearly uniform lowering of about 5 ft for most of the rest of the cross section. The frequency distribution of bed elevations in 2019 was wider than 2015 because a higher percentage of cells are at lower and higher channel-bed elevations ([fig. 21](#)). The scour hole near main channel pier 2 was of a similar shape in 2019 and 2015 ([fig. 22](#)) but slightly deeper on the right (south) side as evidenced by the area of scour around that side of the pier in the DoD map ([fig. 23](#)). The stone revetment and bedrock outcrops on the right (south) bank showed signs of nearly uniform minor deposition throughout the surveyed reach ([fig. 23](#)). As with previous DoD maps, substantial deposition or scour apparent at the faces of the pier footing results from minor horizontal positional variances between the surveys (see “Uncertainty Estimation” section).

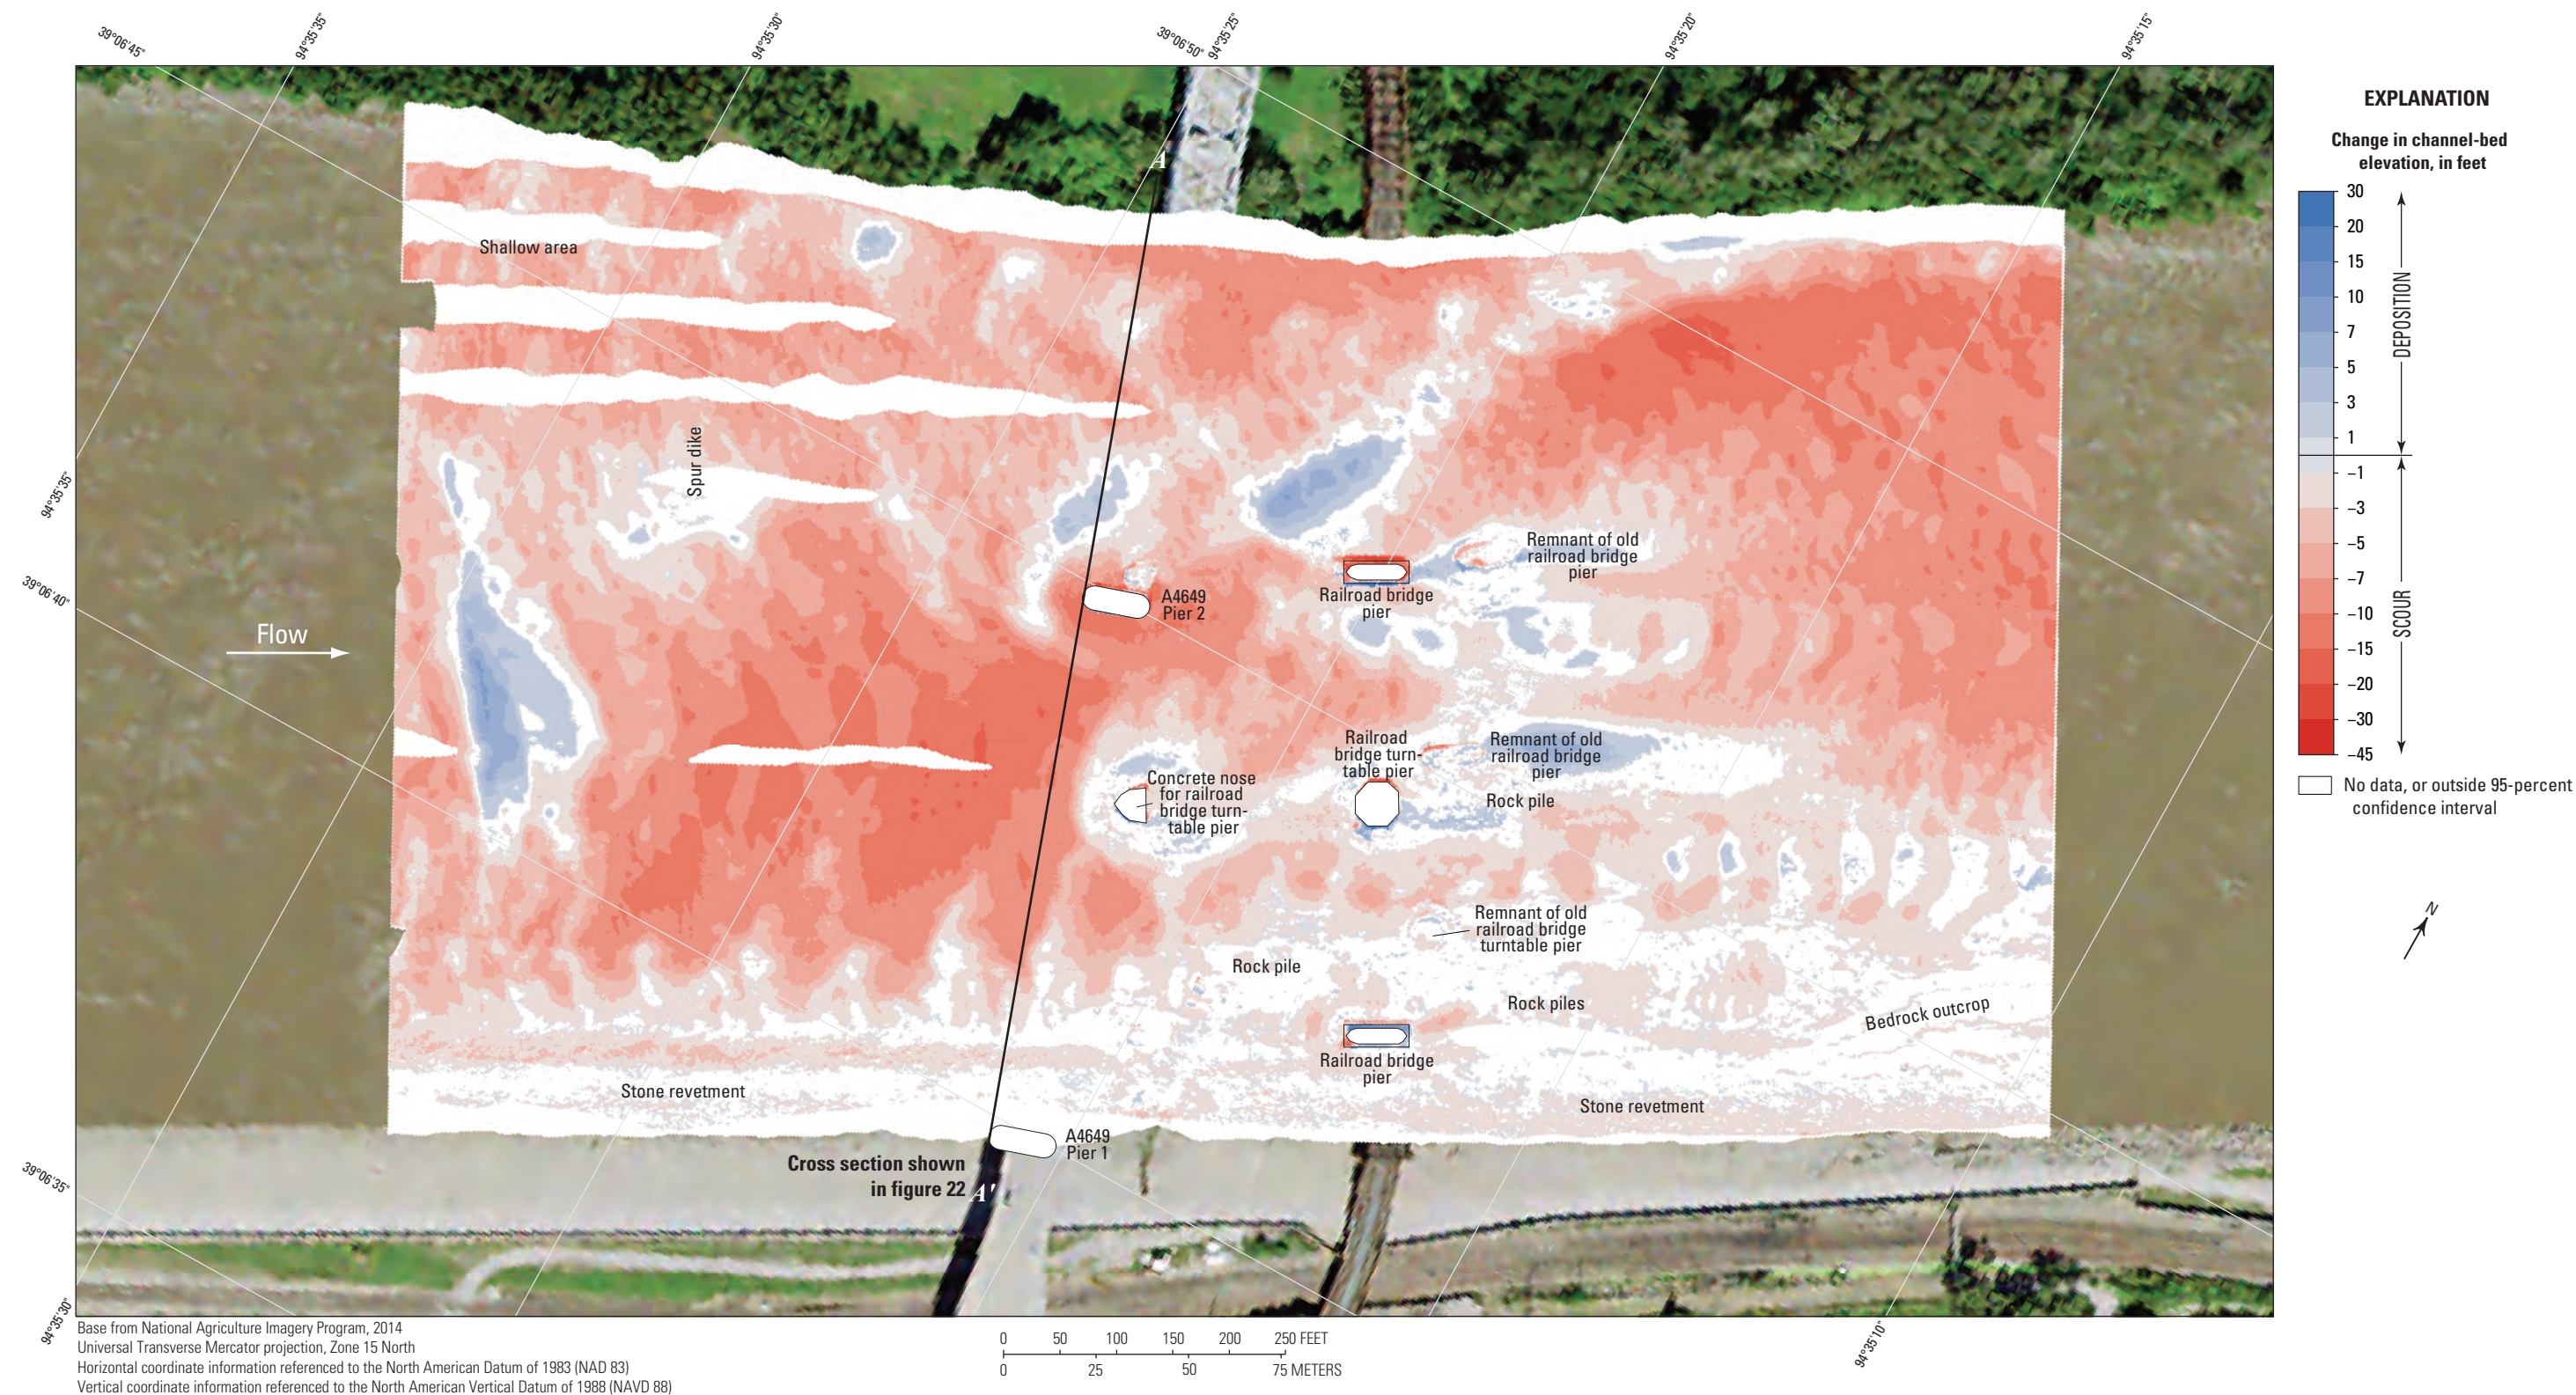
Figure 24. Difference between surfaces created from bathymetric surveys of the Missouri River channel near structure A4649 on U.S. Highway 169 in Kansas City, Missouri, on August 13, 2019, and July 17, 2011.

The difference between the survey on August 13, 2019, and the previous flood survey on July 17, 2011 ([fig. 24](#)), indicates about 83 percent of the joint area of interest had detectable change, which means about 17 percent of the differences in the joint area of interest are equivocal and within the uncertainty. Substantial bed variation is apparent from 2011 to 2019 in the DoD map, and scour was predominant throughout the reach except for moderate deposition in some localized scoured areas near the piers and the trough of a large dune present in the 2011 survey (Huizinga, 2012; [fig. 24](#)). The average difference between the bathymetric surfaces was -4.91 ft ([table 7](#)), indicating substantial net channel degradation between the 2011 and 2019 surveys. The net volume of cut in the reach from 2011 to 2019 was about 216,700 yd³, and the net volume of fill was about 6,000 yd³, resulting in a net loss of about 210,700 yd³ of sediment between 2011 and 2019. The cross sections from the two surveys along the upstream face of the bridge are substantially different except along the left side of the scour hole near pier 2 and on the right bank ([fig. 22](#)). The frequency distribution of bed elevations in 2019 was similar in shape to 2011 but with a higher percentage of cells

at lower elevations than in 2011 (fig. 21). The stone revetment and bedrock outcrops on the right (south) bank showed signs of localized scour in the DoD map, but much of the difference on the tops of the bedrock outcrop was within the uncertainties of the data (fig. 24). As with previous DoD maps, substantial deposition or scour apparent at the faces of the pier footing results from minor horizontal positional variances between the surveys (see “Uncertainty Estimation” section).

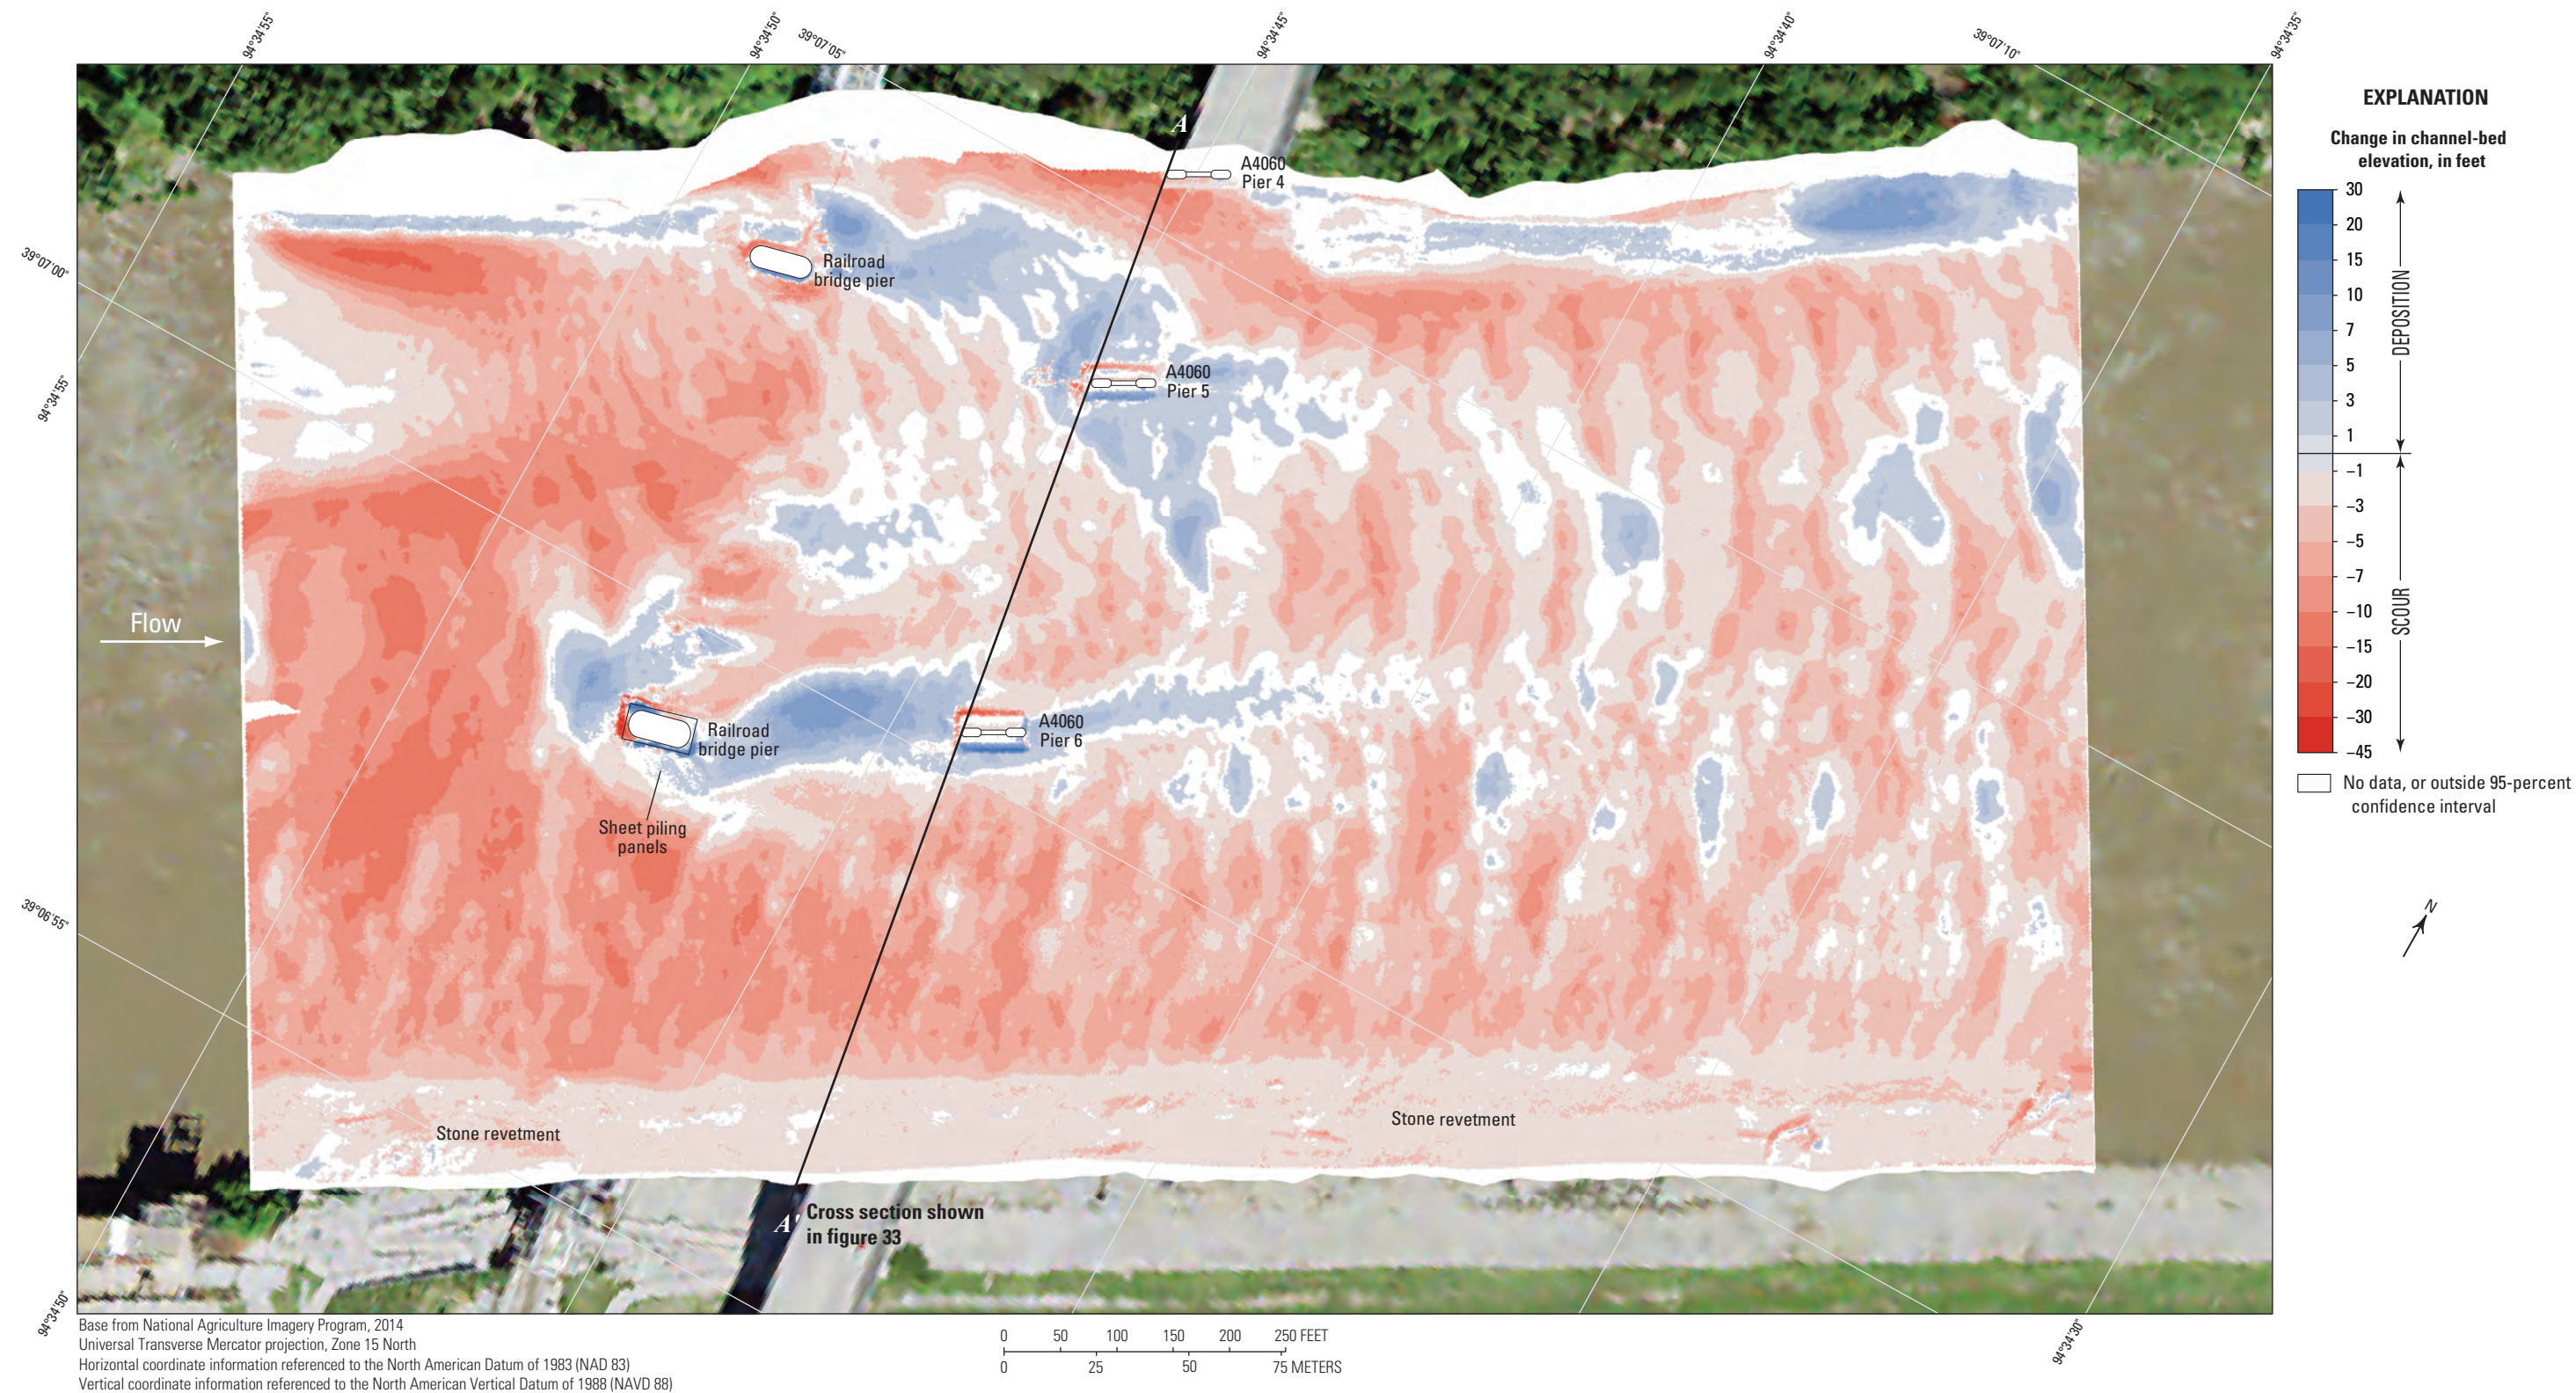
Figure 35. Difference between surfaces created from bathymetric surveys of the Missouri River channel near structure A4060 on State Highway 9 in Kansas City, Missouri, on August 13, 2019, and July 17, 2011.

2011 (fig. 32). The stone revetment on the right (south) bank showed signs of nearly uniform minor scour in the DoD map (fig. 35). As with previous DoD maps, substantial deposition or scour apparent at the faces of the pier footing results from minor horizontal positional variances between the surveys (see “Uncertainty Estimation” section).

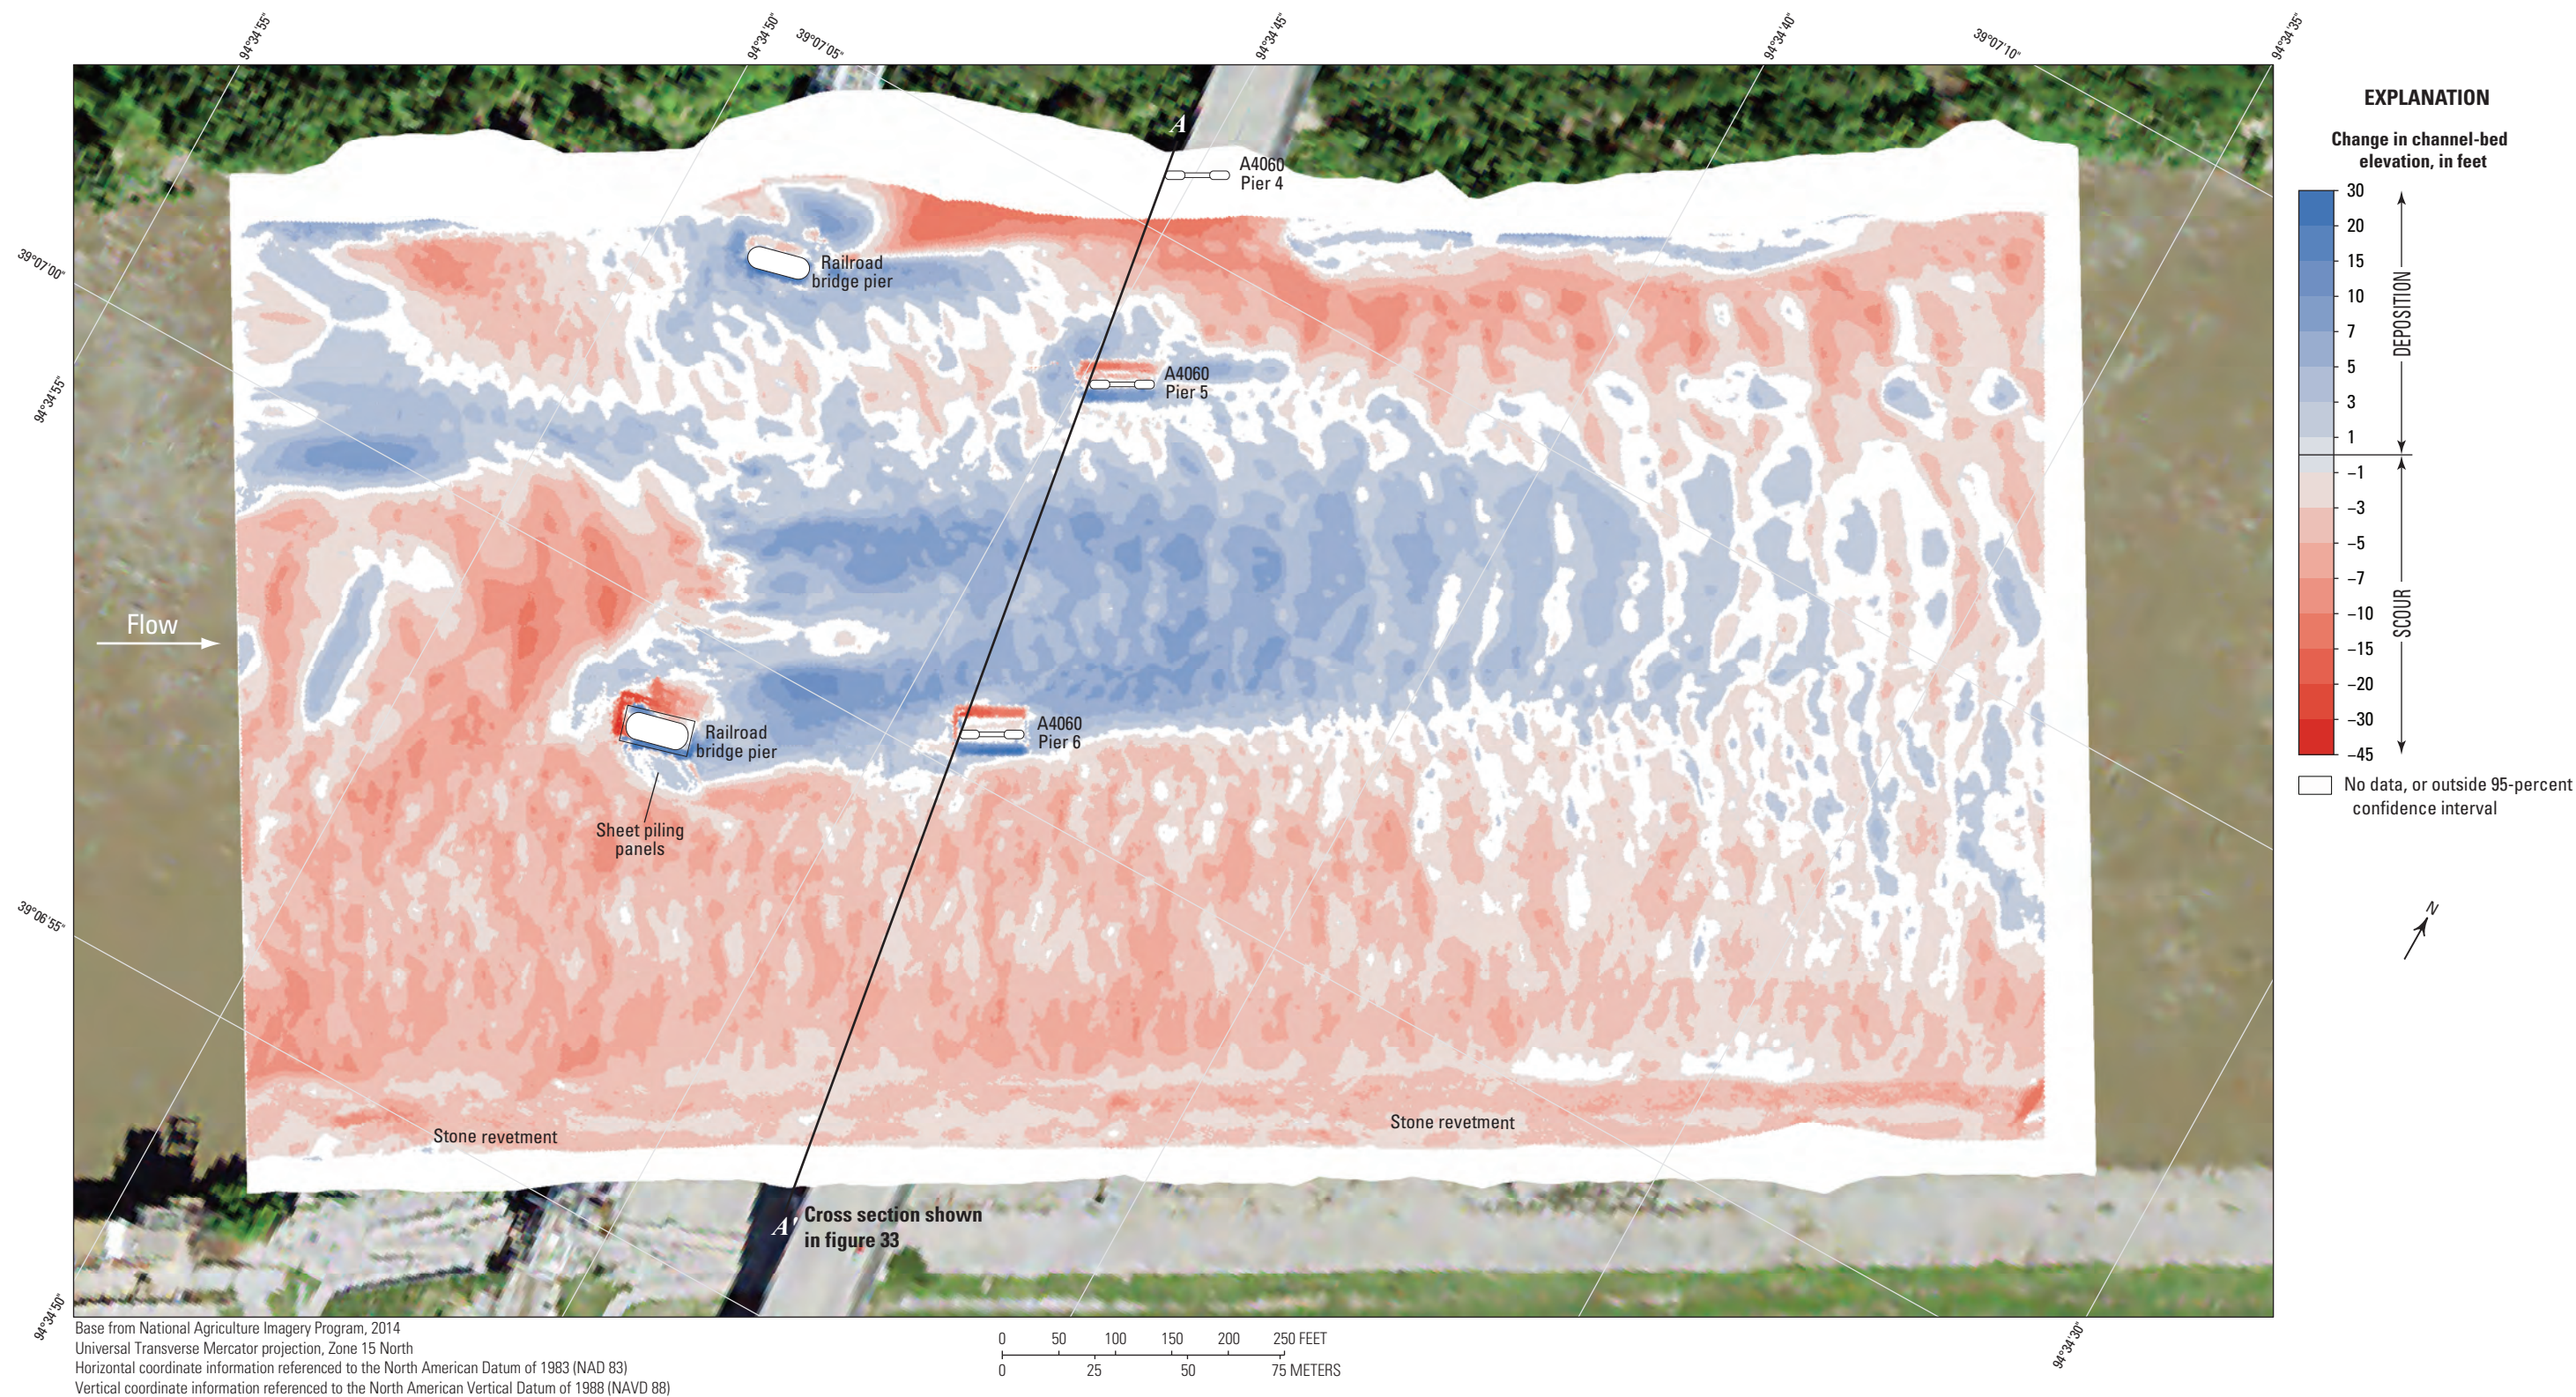
Figure 36. Difference between surfaces created from bathymetric surveys of the Missouri River channel near structure A4060 on State Highway 9 in Kansas City, Missouri, on August 13, 2019, and March 16, 2010.

The difference between the survey on August 13, 2019, and the earliest nonflood survey on March 16, 2010 (fig. 36), indicates about 85 percent of the joint area of interest had detectable change, which means about 15 percent of the differences in the joint area of interest are equivocal and within the uncertainty. Bed variation seemed more equal between scour and deposition from 2010 to 2019 in the DoD map than in the other DoD maps, deposition was predominant along the left (north) side of the channel, and scour was predominant along the right (south) side (fig. 36). However, the average difference between the bathymetric surfaces was -1.58 ft (table 7), indicating minor to moderate channel degradation between the 2010 and 2019 surveys. The net volume of cut in the reach from 2010 to 2019 was about $109,900$ yd³, and the net volume of fill was about $44,200$ yd³, resulting in a net loss of about
