Bathymetric and Velocimetric Surveys at Highway Bridges Crossing the Missouri River near Kansas City, Missouri, August 2019, August 2020, and October 2020

Scientific Investigations Report 2021–5098

By Richard J. Huizinga

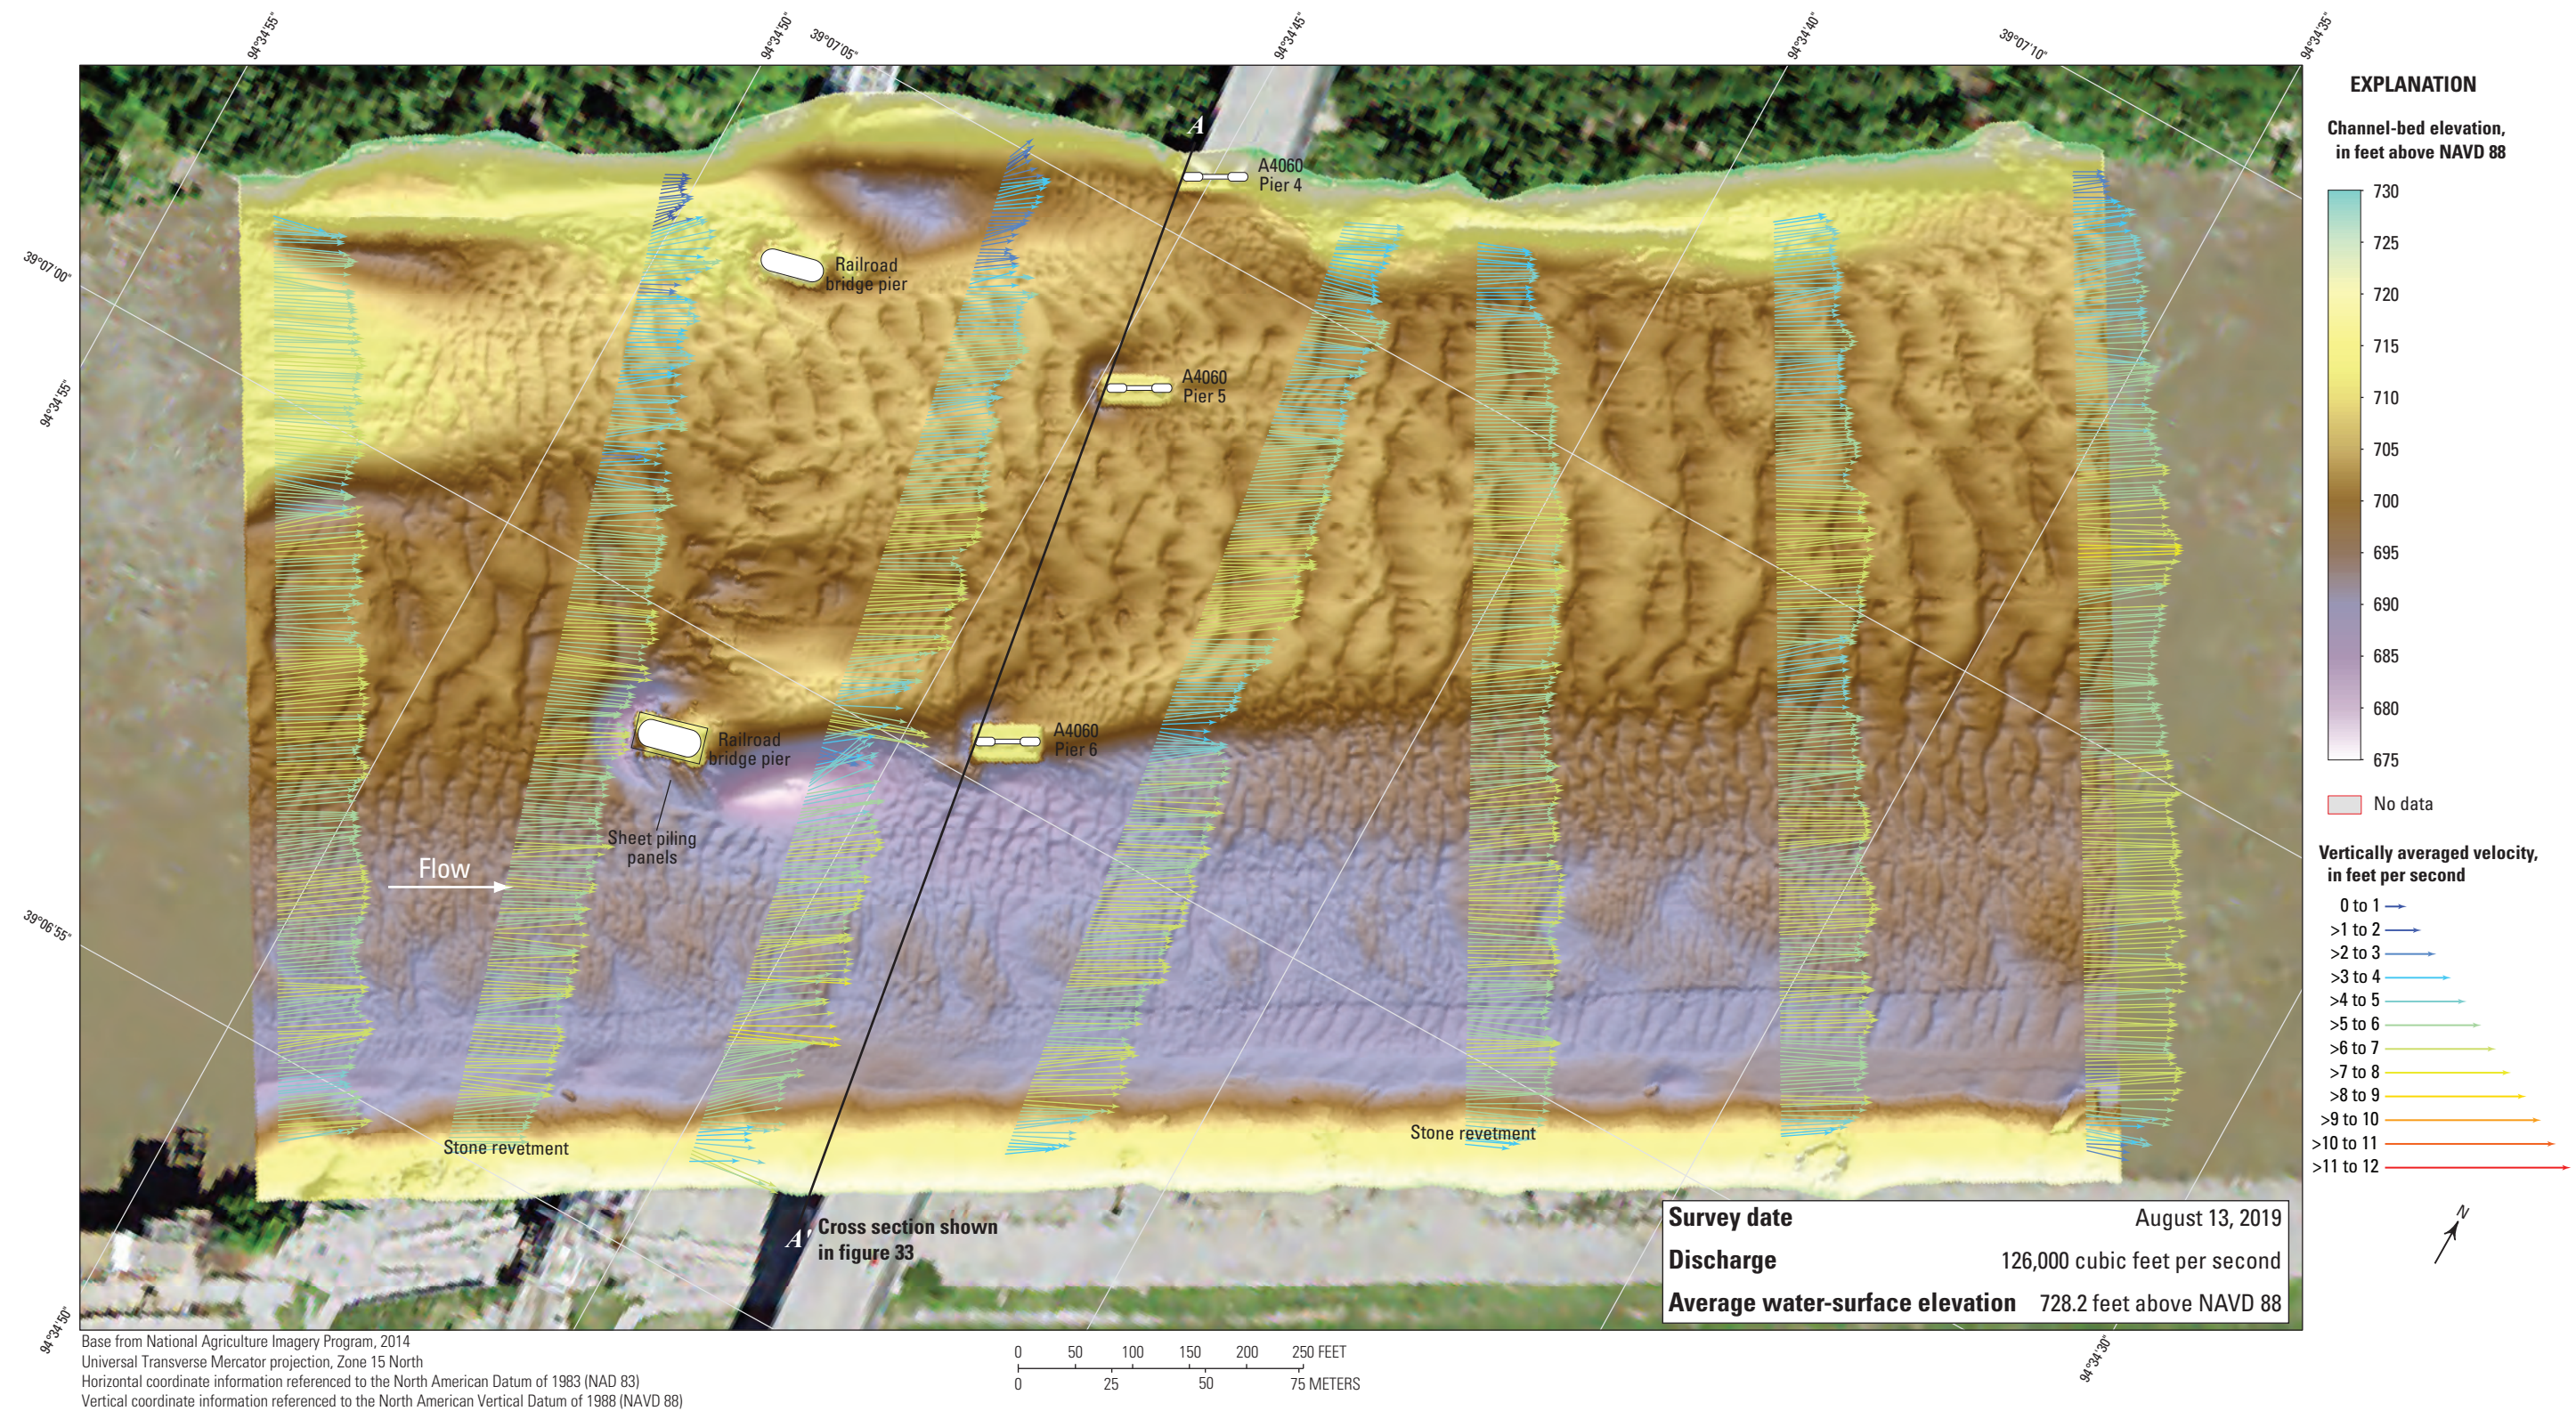
Figure 37. Bathymetry and vertically averaged velocities of the Missouri River channel near structure A4060 on State Highway 9 in Kansas City, Missouri, on August 13, 2019.

The vertically averaged velocity vectors indicate mostly uniform flow throughout the channel, ranging from about 1 to 9 ft/s (fig. 37). Exceptions to uniform conditions include substantial turbulence observed downstream from the railroad and highway bridge piers, and near the upstream left (north) bank (fig. 37).

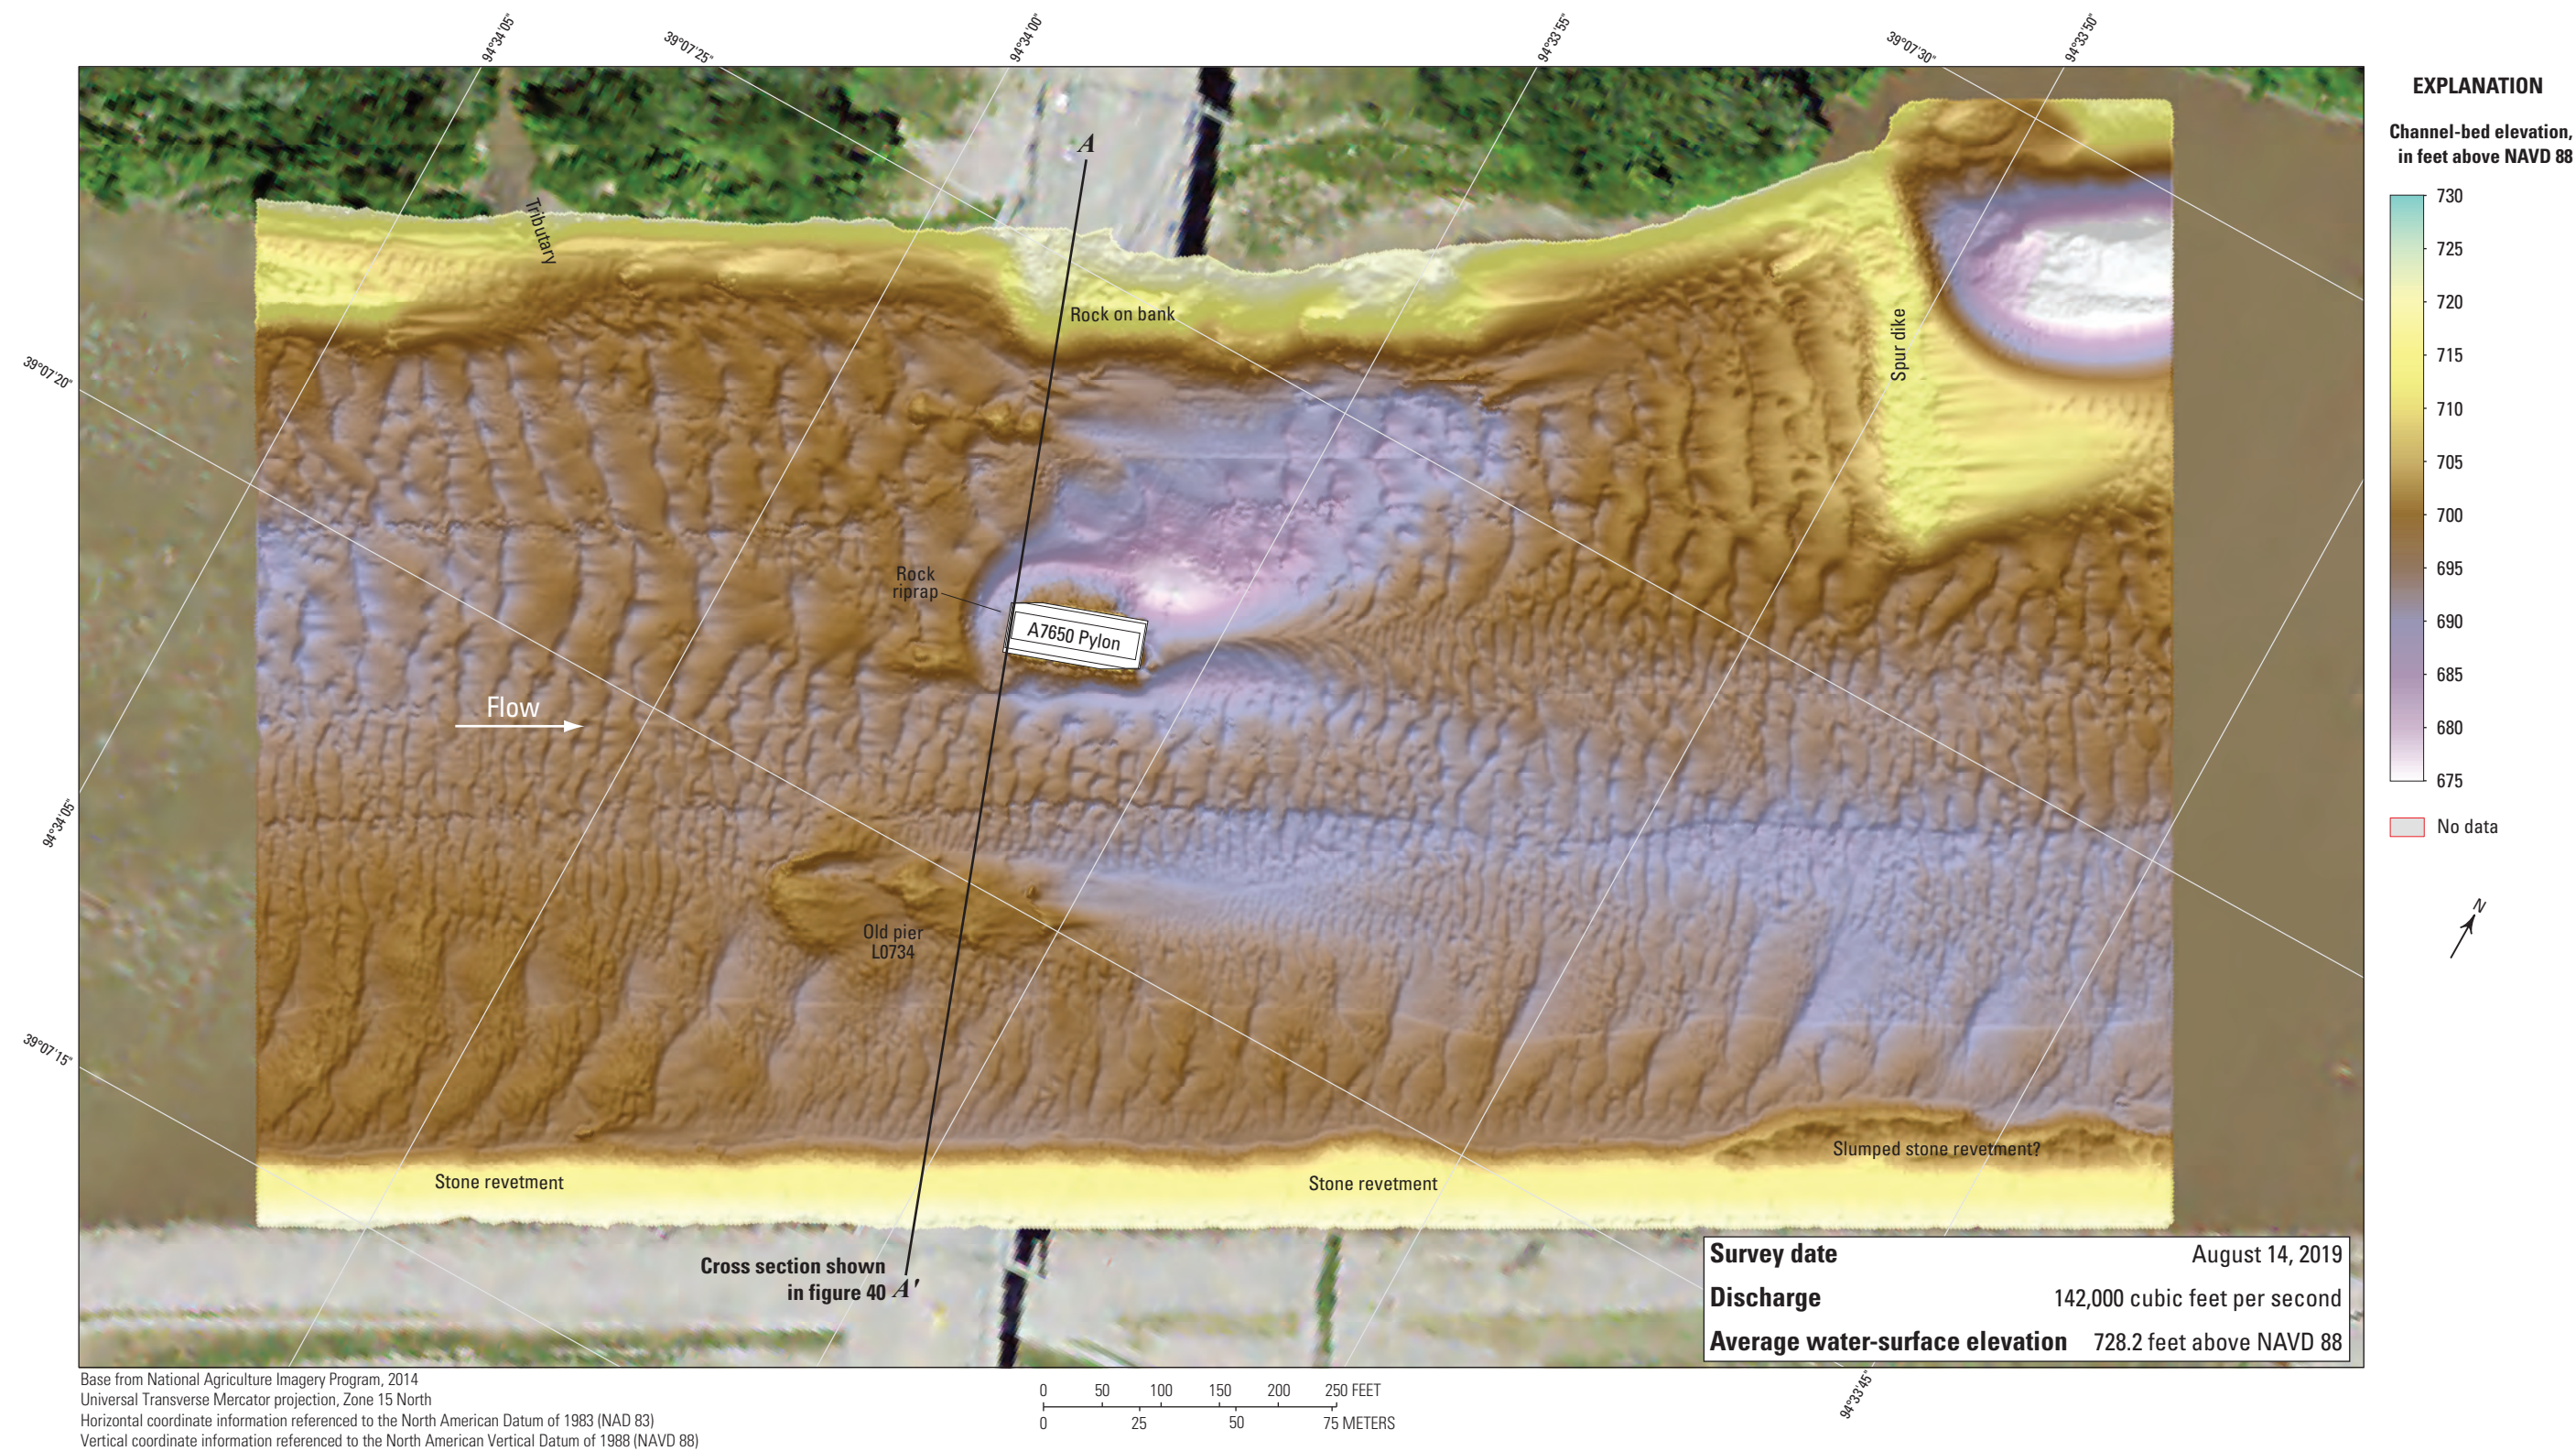
Figure 38. Bathymetric survey of the Missouri River channel near structure A7650 on Interstate 35 in Kansas City, Missouri, on August 14, 2019.

The survey area was about 1,640 ft long and averaged about 875 ft wide, extending from bank to bank in the main channel ([fig. 38](#)). The upstream end of the survey area was about 700 ft upstream from the centerline of structure A7650 at the main channel pylon ([fig. 38](#)). The channel-bed elevations ranged from about 690 to 714 ft for most of the surveyed area (5th to 95th percentile range of the bathymetric data; [table 5](#); [fig. 39](#)), except near the pylon and downstream from the spur dike on the downstream left (north) bank ([fig. 38](#)). The shallow thalweg in the channel at upstream structure A4060 diminished, such that there was no definitive thalweg along either side of the channel upstream from structure A7650 ([fig. 38](#)). Numerous small to medium dunes and ripples were present throughout the channel, and downstream translation of the smaller dunes and ripples between survey passes were more pronounced at this site than at the upstream sites ([fig. 38](#)). Downstream from the spur dike on the left (north) side of the downstream reach, the minimum channel-bed elevations of 671 ft was observed ([fig. 38](#); [table 5](#)). As in previous surveys at this site (Huizinga, 2012, 2016), stone revetment was present on the right (south) bank throughout the reach, including the apparent slumped area near the downstream end of the reach observed in the previous survey ([fig. 38](#)).

As in previous surveys at this site (Huizinga, 2012, 2016), the main channel pylon seemed to be surrounded by a mound of rock riprap as a scour countermeasure, with a local minimum channel-bed elevation of about 677 ft near the downstream left (north) corner ([fig. 38](#); [table 6](#)). The top of the riprap around the upstream face of the pylon was at an elevation of about 697 ft, which is slightly below the elevation of the bottom of the pylon seal course of 699.50 ft ([table 6](#)); the top of the riprap along the sides of the pylon is lower than at the upstream face ([figs. 38 and 40](#)). The minimum channel-bed elevation near the pylon was about 22 ft below the elevation of the bottom of the pylon seal course ([fig. 38](#); [table 6](#)). Information from bridge plans indicates that the pylon is founded on shafts drilled 32 ft into bedrock, with about 30 ft of bed material between the bottom of the scour hole and bedrock ([fig. 40](#); [table 6](#)).

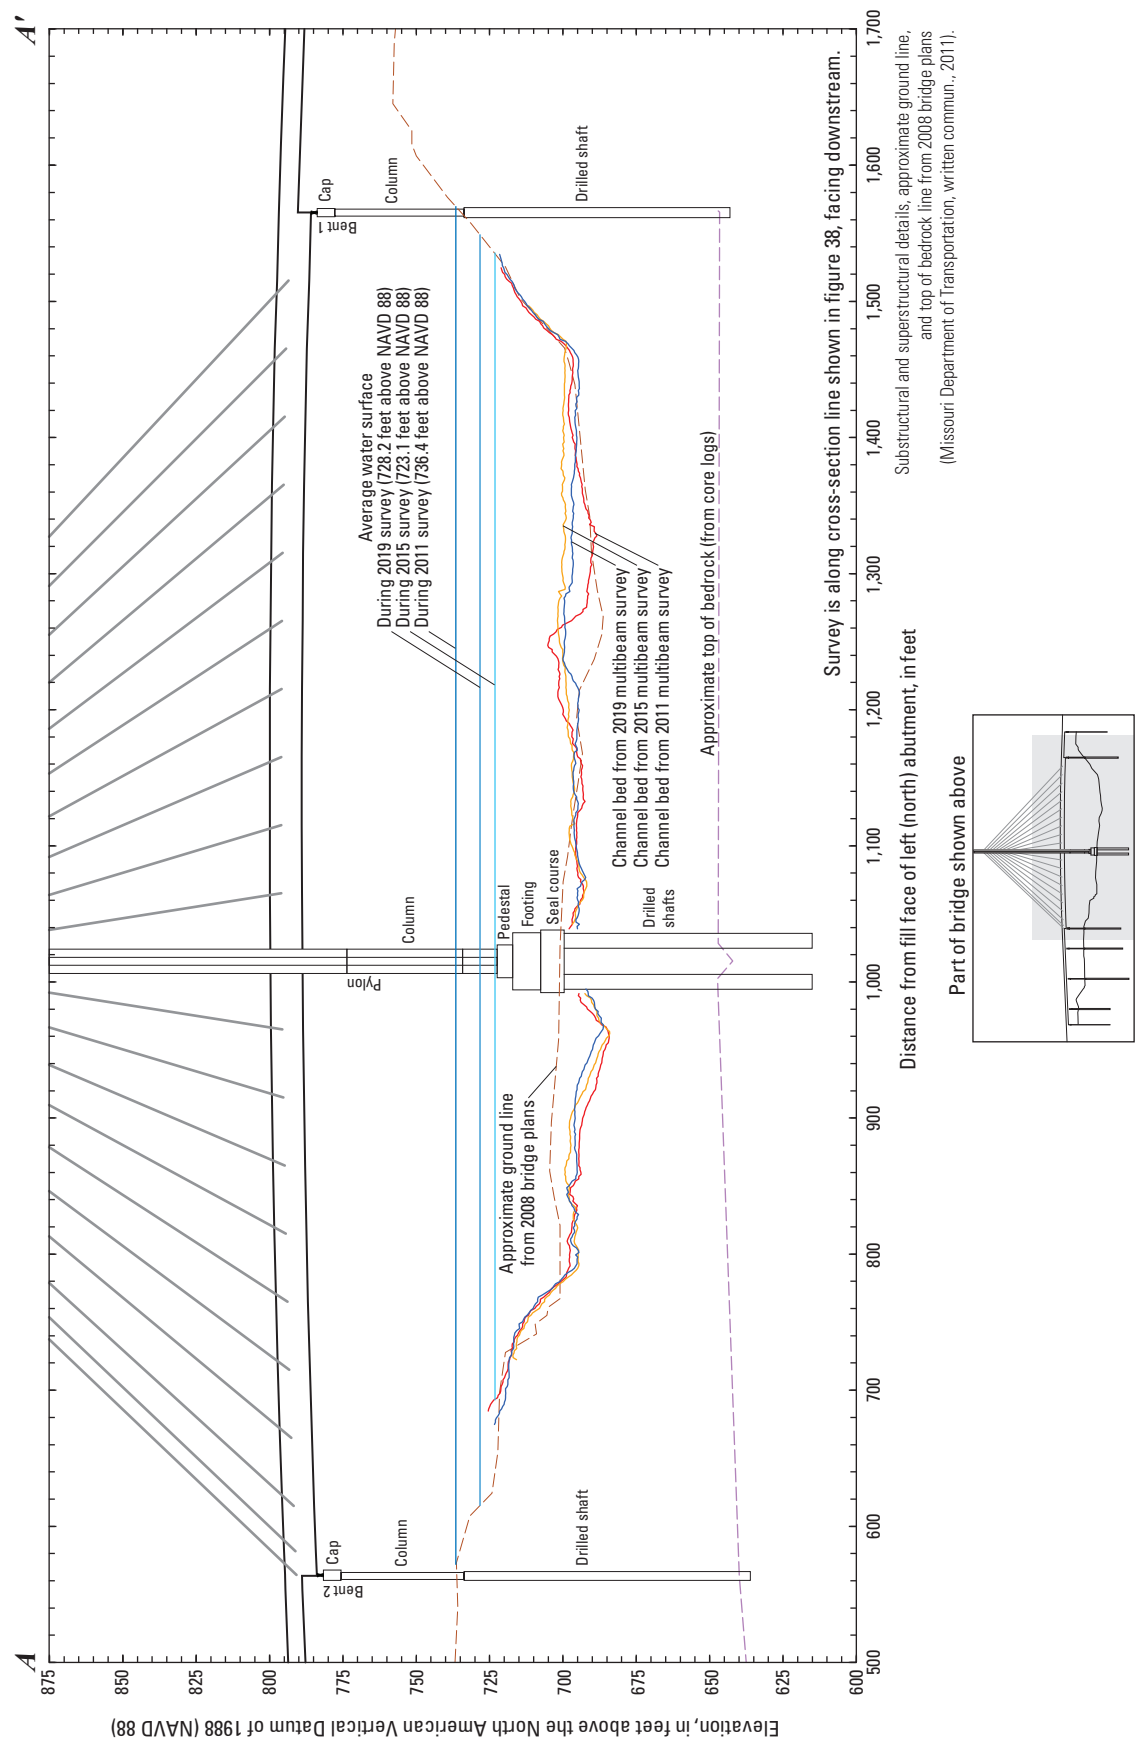
Figure 40. Key features, substructural and superstructural details, and surveyed channel bed of structure A7650 on Interstate 35 crossing the Missouri River in Kansas City, Missouri.

The difference between the survey on August 14, 2019, and the previous flood survey on July 17, 2011 ([fig. 42](#)), indicates about 74 percent of the joint area of interest had detectable change, which means about 26 percent of the differences in the joint area of interest are equivocal and within the uncertainty. Bed variation appeared about equal between scour and deposition from 2011 to 2019 in the DoD map, with substantial scour downstream from the spur dike on the downstream left (north) side and in the upstream left (north) and downstream right (south) parts of the reach, and moderate to substantial deposition near the pylon and location of the old pier of structure L0734 ([fig. 42](#)). The average difference between the bathymetric surfaces was -1.29 ft ([table 7](#)), indicating minor to moderate degradation between the 2011 and 2019 surveys. The net volume of cut in the reach from 2011 to 2019 was about 86,900 yd³, and the net volume of fill was about 39,600 yd³, resulting in a net loss of about 47,300 yd³ of sediment between 2011 and 2019. The cross sections from the two surveys along the upstream face of the bridge show the substantial variation in the surveyed sections ([fig. 40](#)). However, the frequency distribution of bed elevations in 2019 was remarkably similar in shape to 2011 ([fig. 39](#)). The scour hole near the main channel pylon was smaller and shallower upstream from the pylon, as evidenced by the area of deposition near the pylon in the DoD map ([fig. 42](#)). The rock riprap around the pylon base indicated moderate differences ([fig. 42](#)), and the cross-section along the upstream bridge face shows the riprap has lowered by as much as 7 ft since 2011 ([fig. 40](#)).

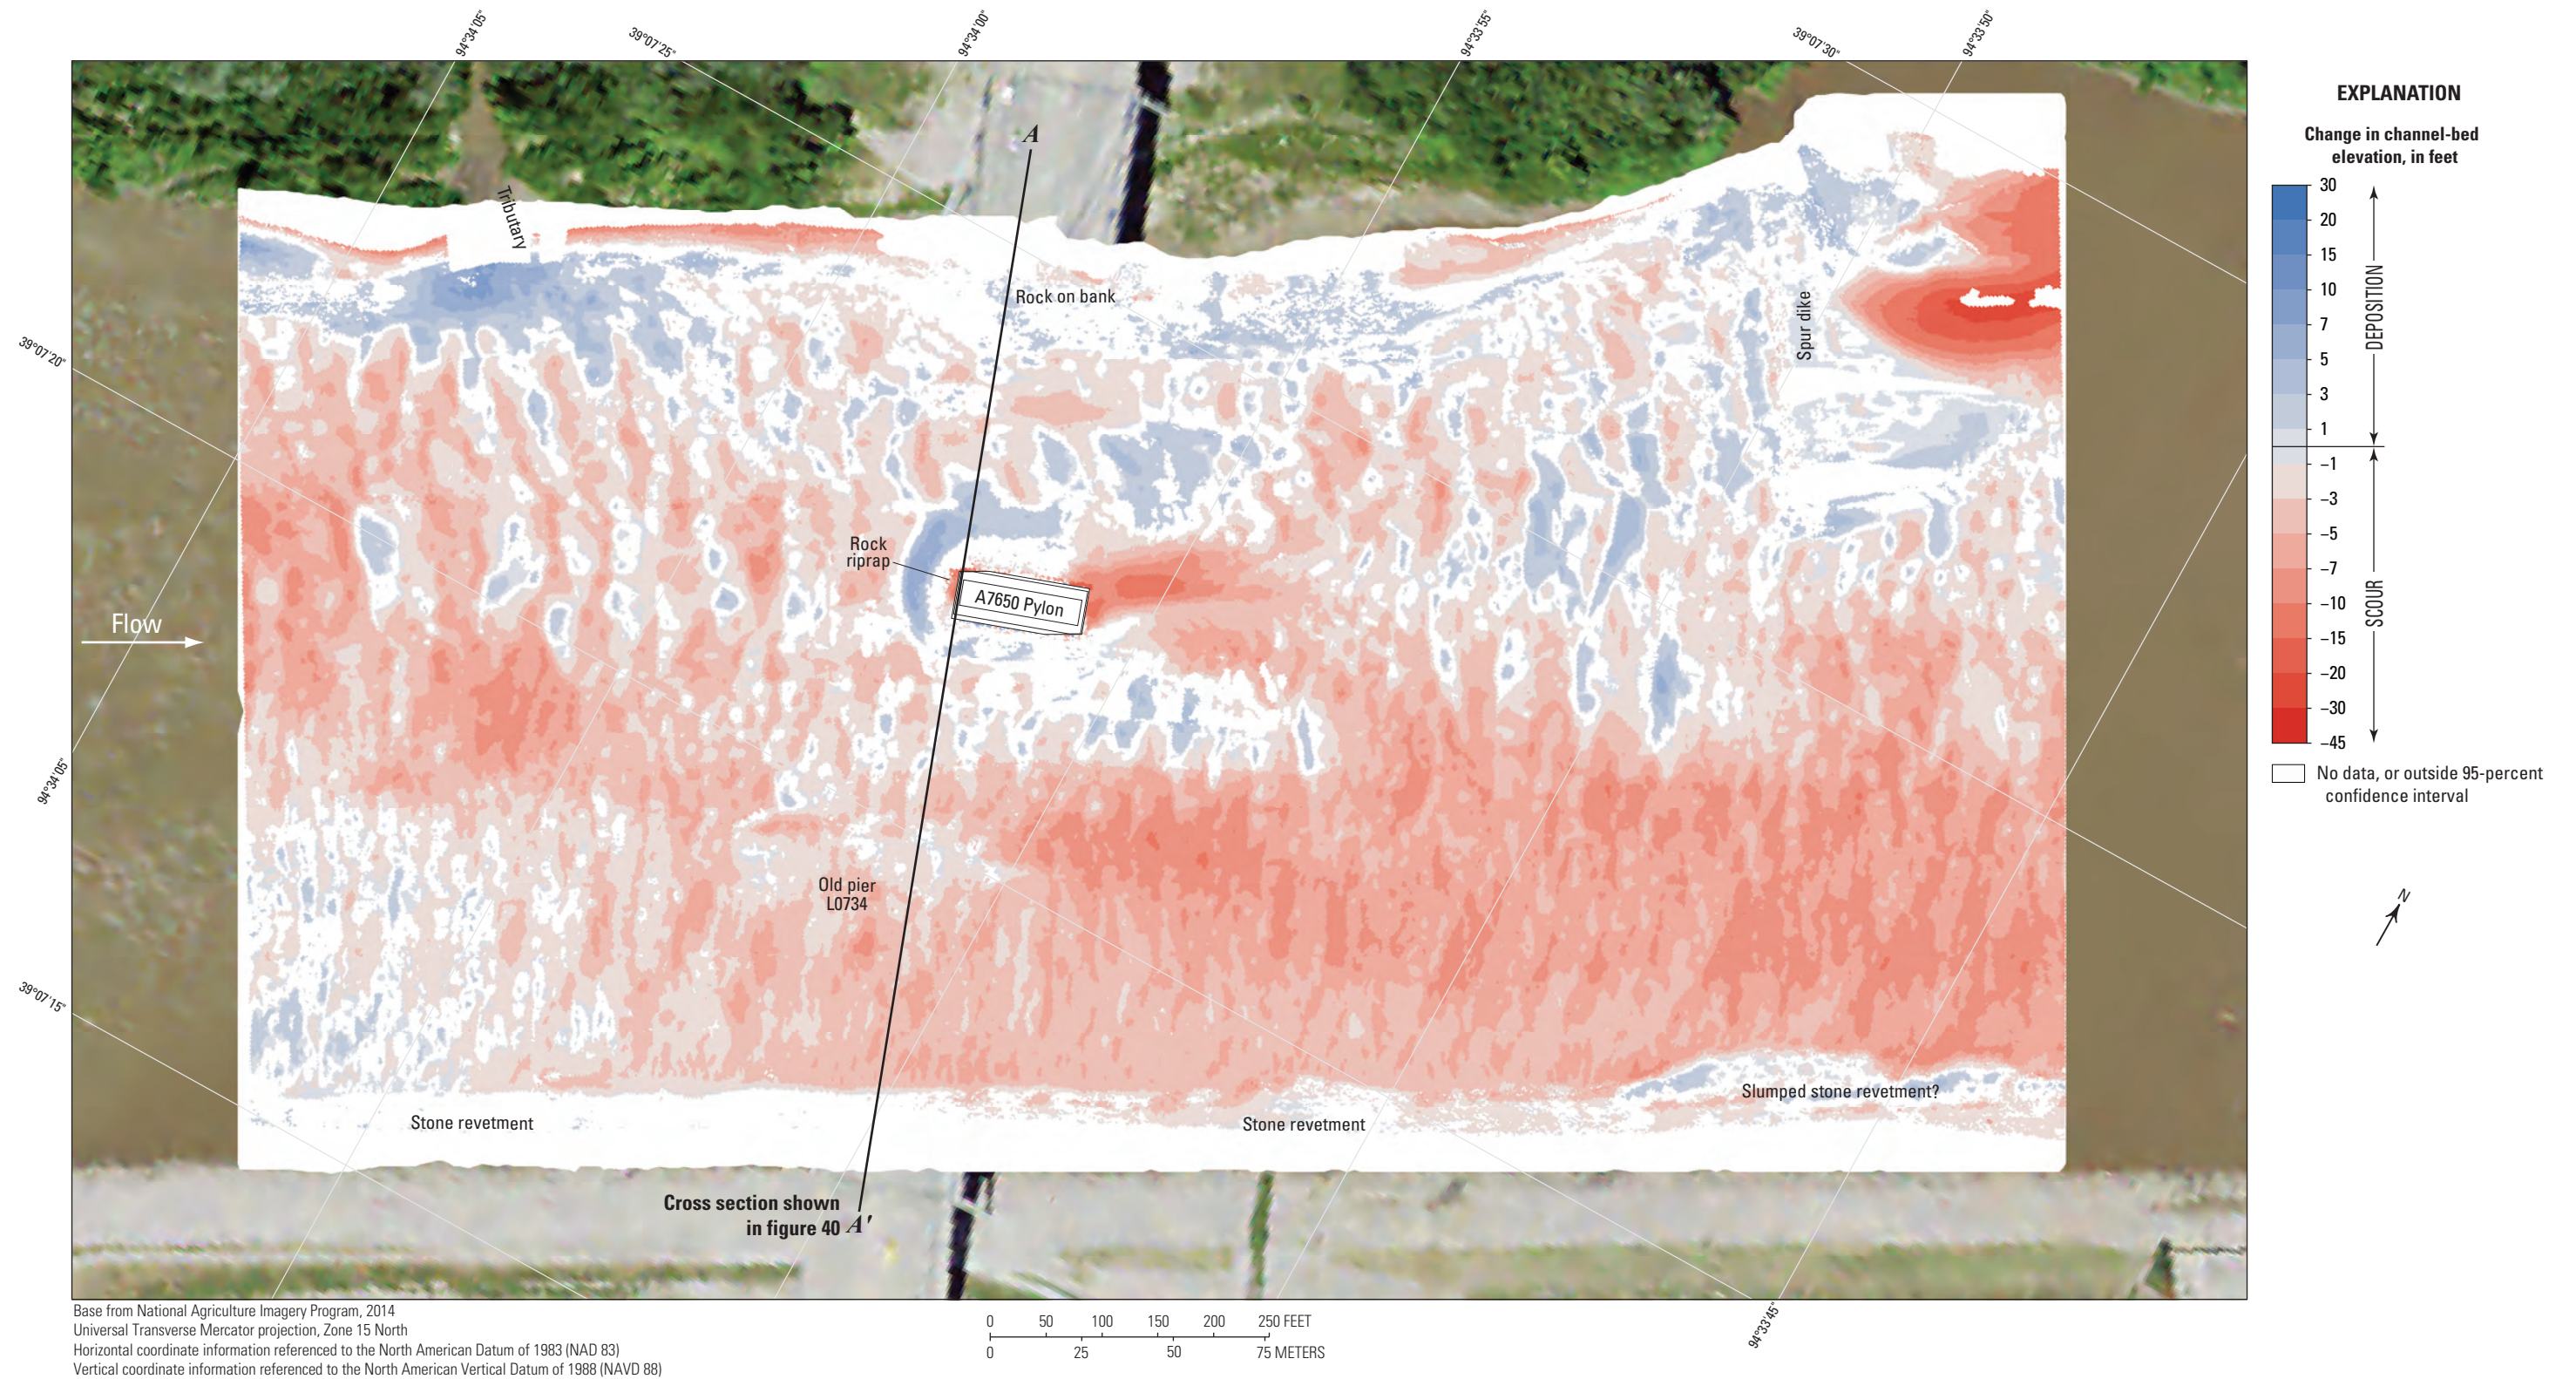
Figure 41. Difference between surfaces created from bathymetric surveys of the Missouri River channel near structure A7650 on Interstate 35 in Kansas City, Missouri, on August 14, 2019, and June 3, 2015.

The difference between the survey on August 14, 2019, and the previous nonflood survey on June 3, 2015 ([fig. 41](#)), indicates about 79 percent of the joint area of interest had detectable change, which means about 21 percent of the differences in the joint area of interest are equivocal and within the uncertainty. Bed variation from 2015 to 2019 is moderate to

substantial in the DoD map, and scour is predominant throughout the reach except small areas along the left (north) side of the channel and in the upstream right (south) part ([fig. 41](#)). The average difference between the bathymetric surfaces was -3.48 ft ([table 7](#)), indicating moderate to substantial degradation between the 2015 and 2019 surveys. The net volume of cut in the reach from 2015 to 2019 was about 141,200 yd³, and the net volume of fill was about 8,500 yd³, resulting in a net loss of about 132,700 yd³ of sediment between 2015 and 2019. The cross sections from the two surveys along the upstream face of the bridge are similar to each other but have uniform scour of about 5 ft between the pylon and the right (south) bank ([fig. 40](#)). The frequency distribution of bed elevations in 2019 was wider than 2015 because of a higher percentage of cells at lower channel-bed elevations ([fig. 39](#)). The scour hole near the main channel pylon was smaller and shallower upstream from the pylon but deeper downstream as evidenced by the areas of deposition and scour near the pylon in the DoD map ([fig. 41](#)). The rock riprap around the pylon base also indicated only minor differences, or differences within the uncertainty ([fig. 41](#)). As with previous DoD maps, substantial deposition or scour apparent at the faces of the pylon footing results from minor horizontal positional variances between the surveys (see “Uncertainty Estimation” section). The stone revetment on the right (south) bank showed signs of very minor localized deposition and scour, primarily downstream from the bridge ([fig. 41](#)); most of the differences on the right (south) bank were within the uncertainties of the data.

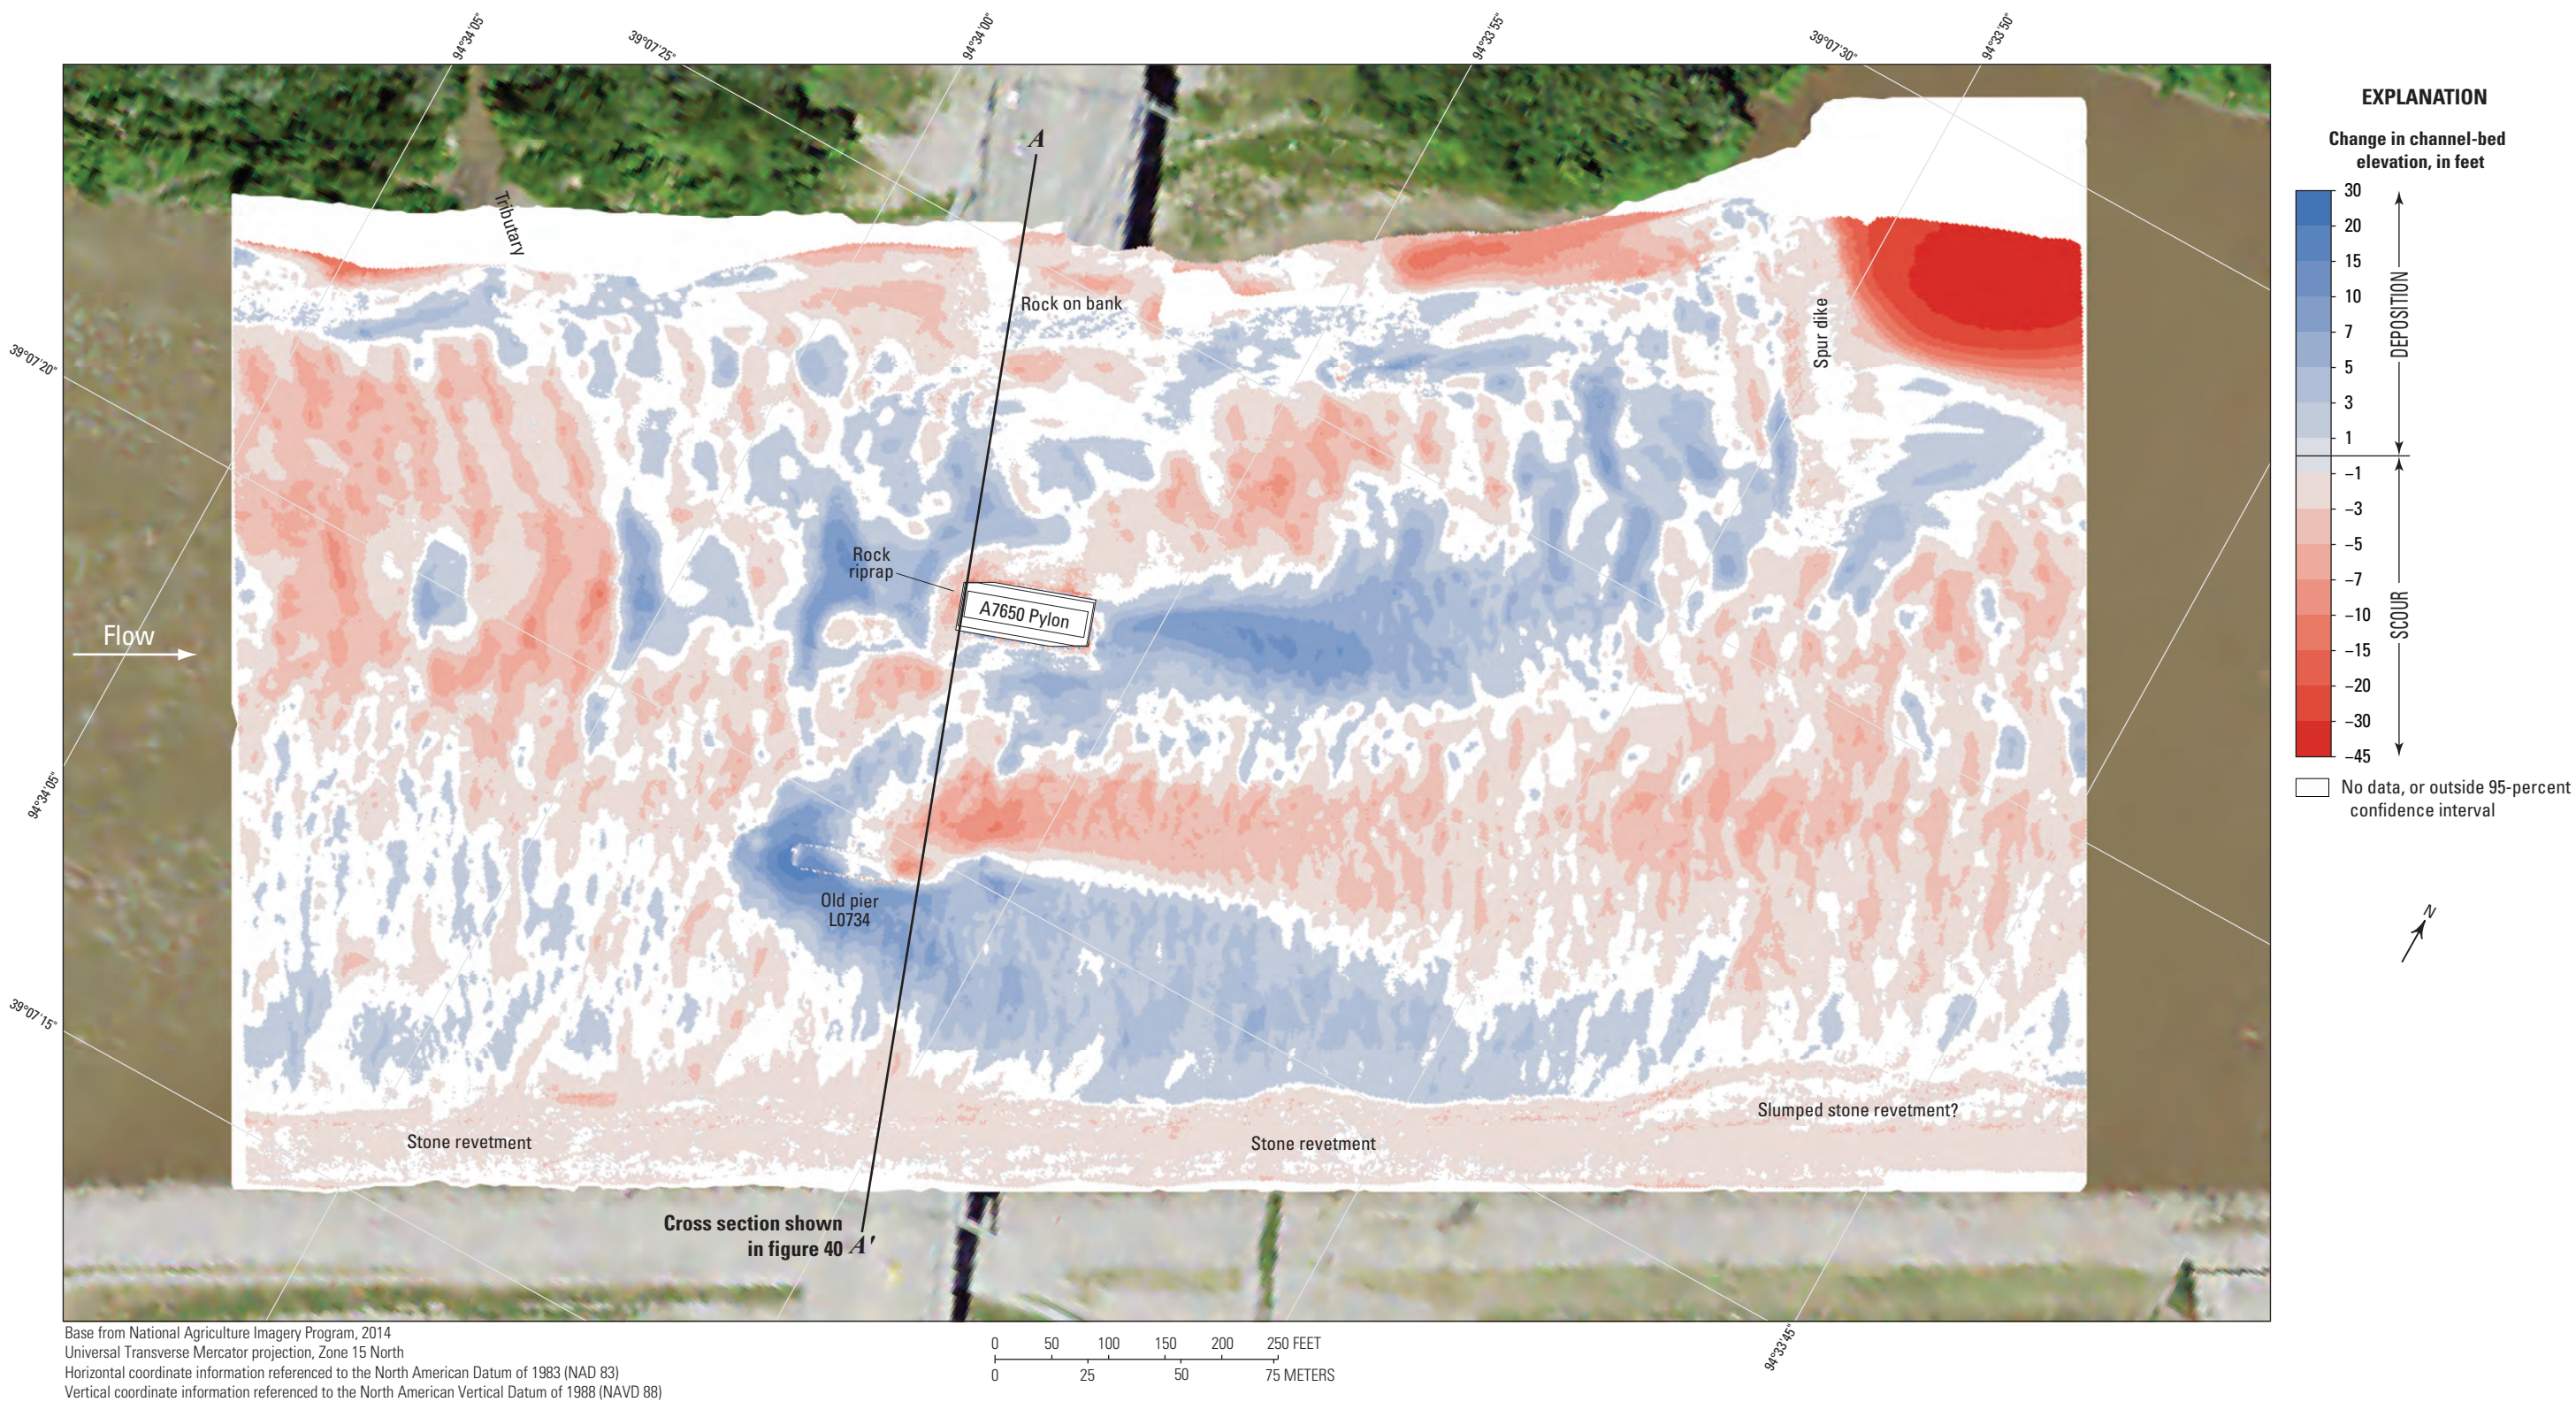
Figure 42. Difference between surfaces created from bathymetric surveys of the Missouri River channel near structure A7650 on Interstate 35 in Kansas City, Missouri, on August 14, 2019, and July 17, 2011.

As with previous DoD maps, substantial deposition or scour apparent at the faces of the pylon footing results from minor horizontal positional variances between the surveys (see “Uncertainty Estimation” section). The stone revetment on the right (south) bank showed signs of nearly uniform minor scour in the DoD map (fig. 42).

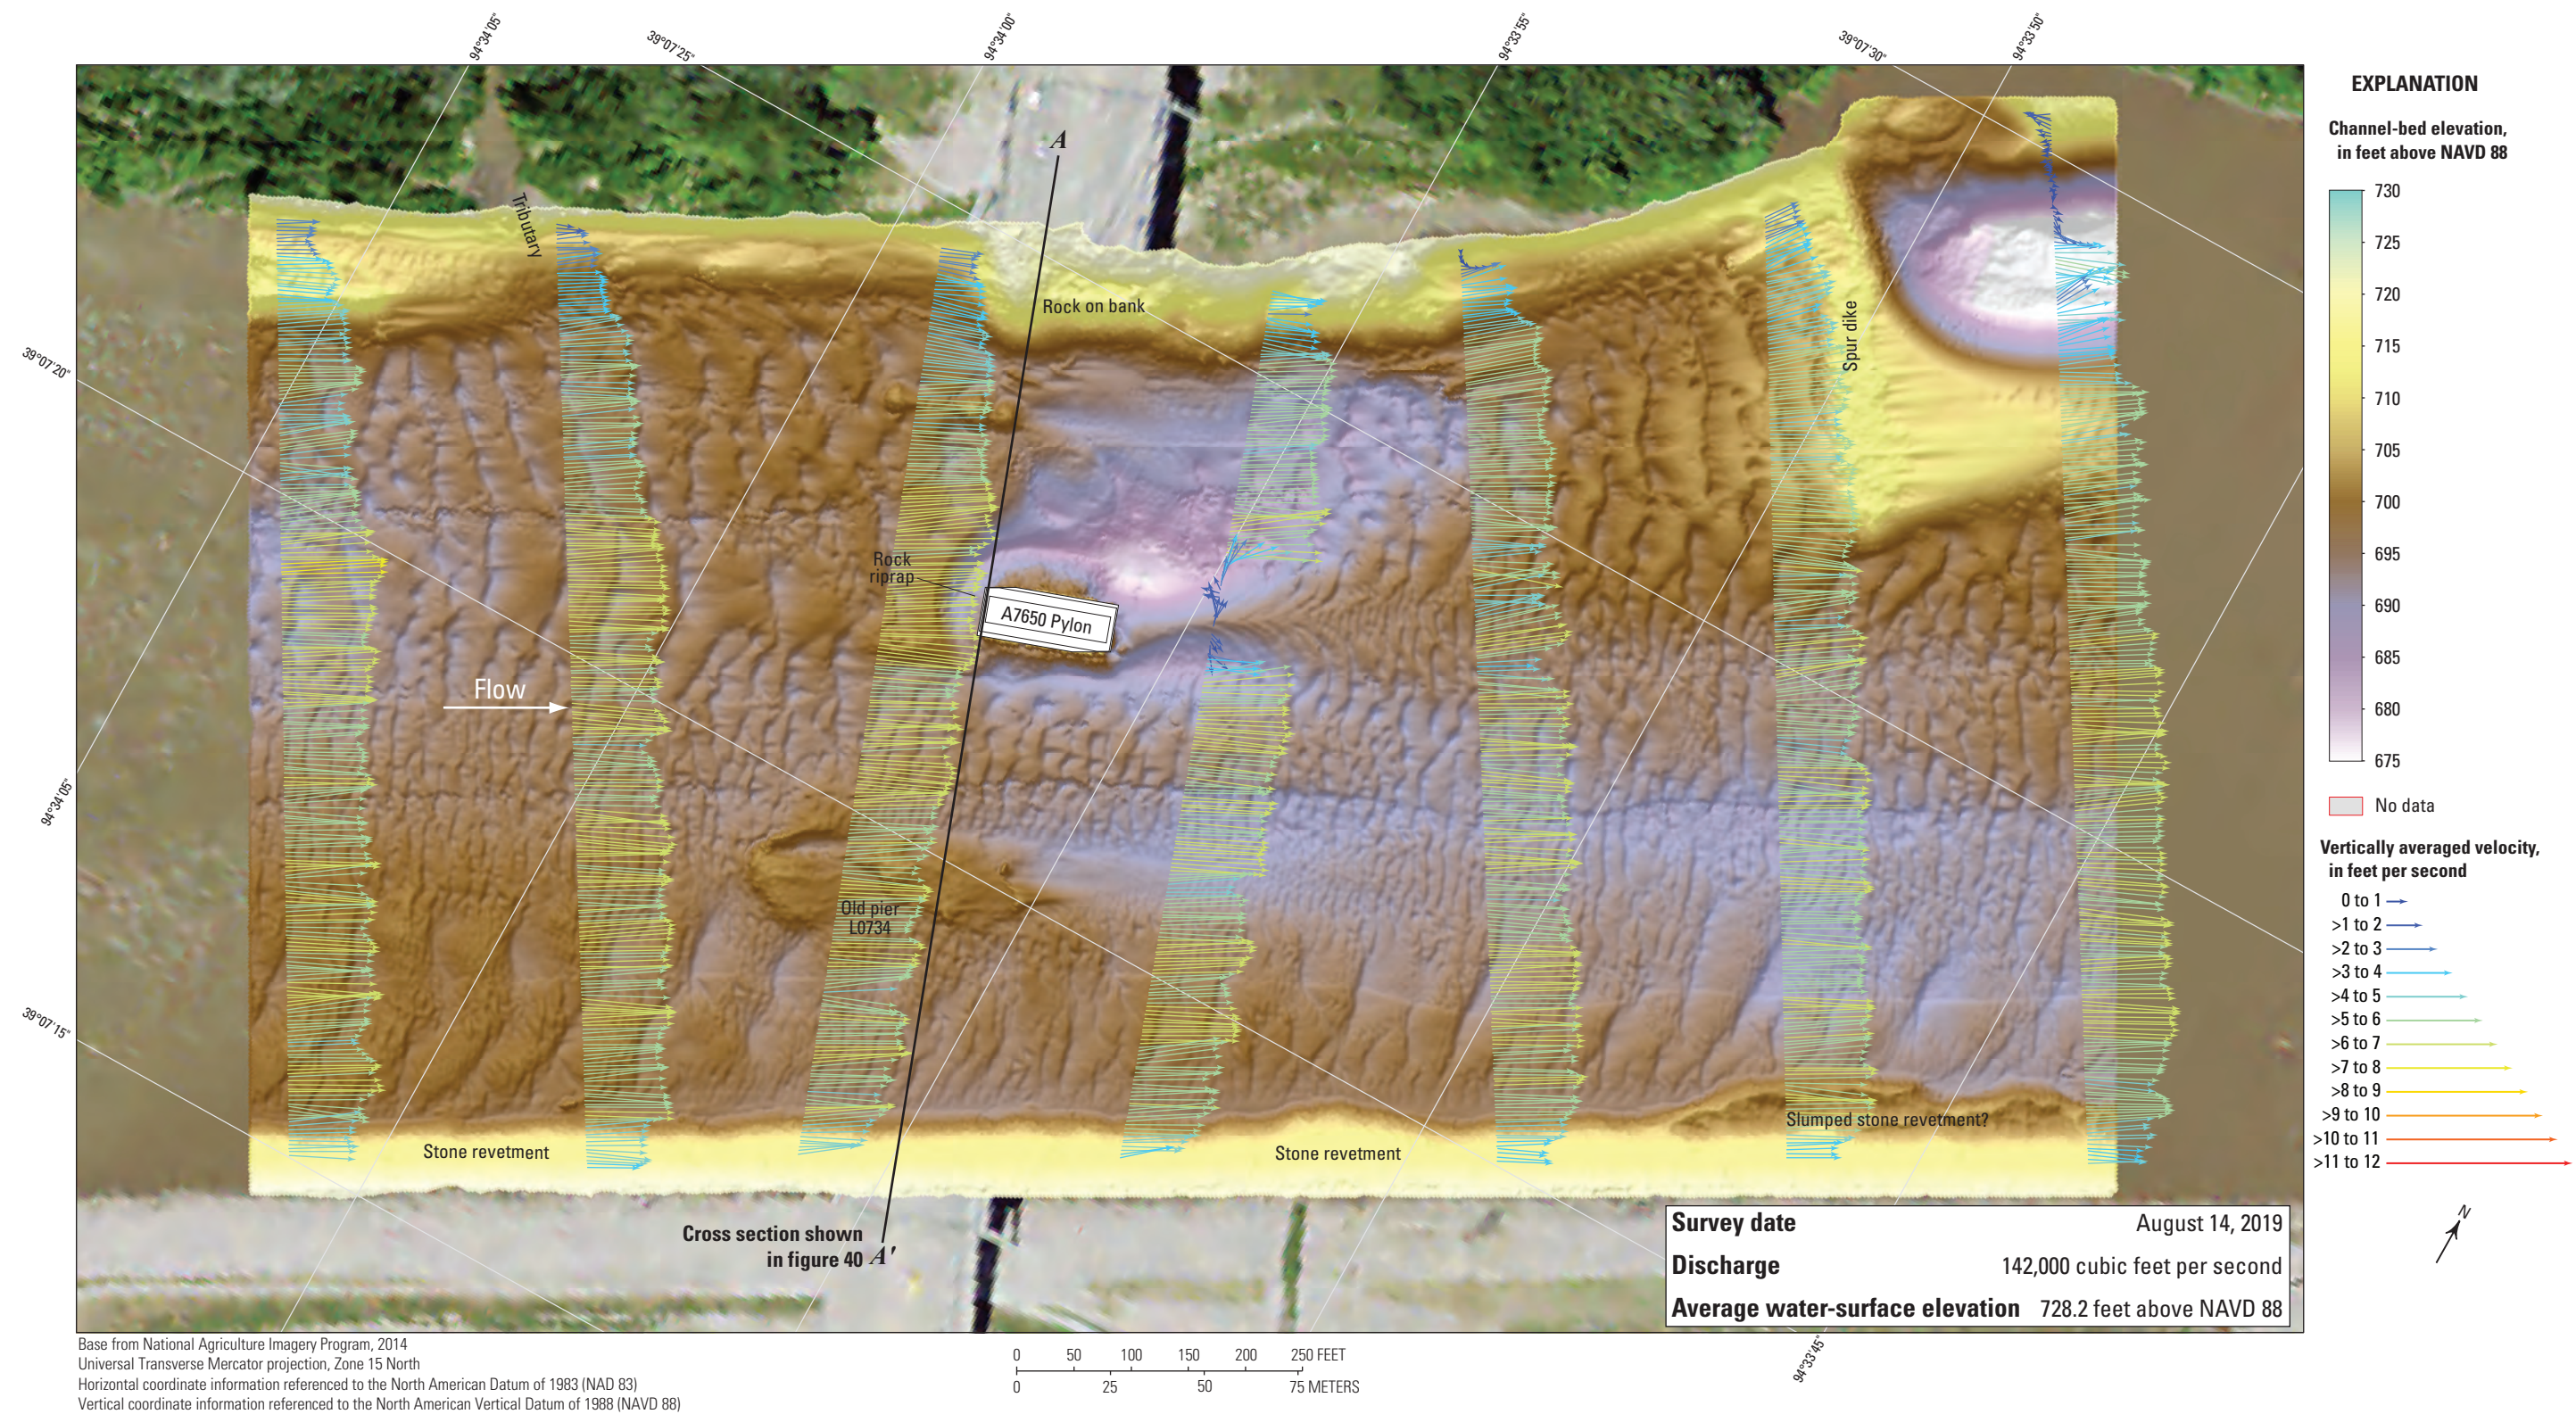
Figure 43. Bathymetry and vertically averaged velocities of the Missouri River channel near structure A7650 on Interstate 35 in Kansas City, Missouri, on August 14, 2019.

The vertically averaged velocity vectors indicate mostly uniform flow throughout most of the reach, with velocities

ranging from about 2 to 8 ft/s (fig. 43). Exceptions to uniform conditions include flow reversal along the left (north) bank near the upstream tributary and in the pool downstream from the spur dike (fig. 43). Substantial turbulence also was observed downstream from the main channel pylon (fig. 43), likely as a result of the pylon being skewed to flow. The velocities do not seem to be higher near the bulge in the left bank at the bridge.
