Bathymetric and Velocimetric Surveys at Highway Bridges Crossing the Missouri River near Kansas City, Missouri, August 2019, August 2020, and October 2020

Scientific Investigations Report 2021–5098

By Richard J. Huizinga

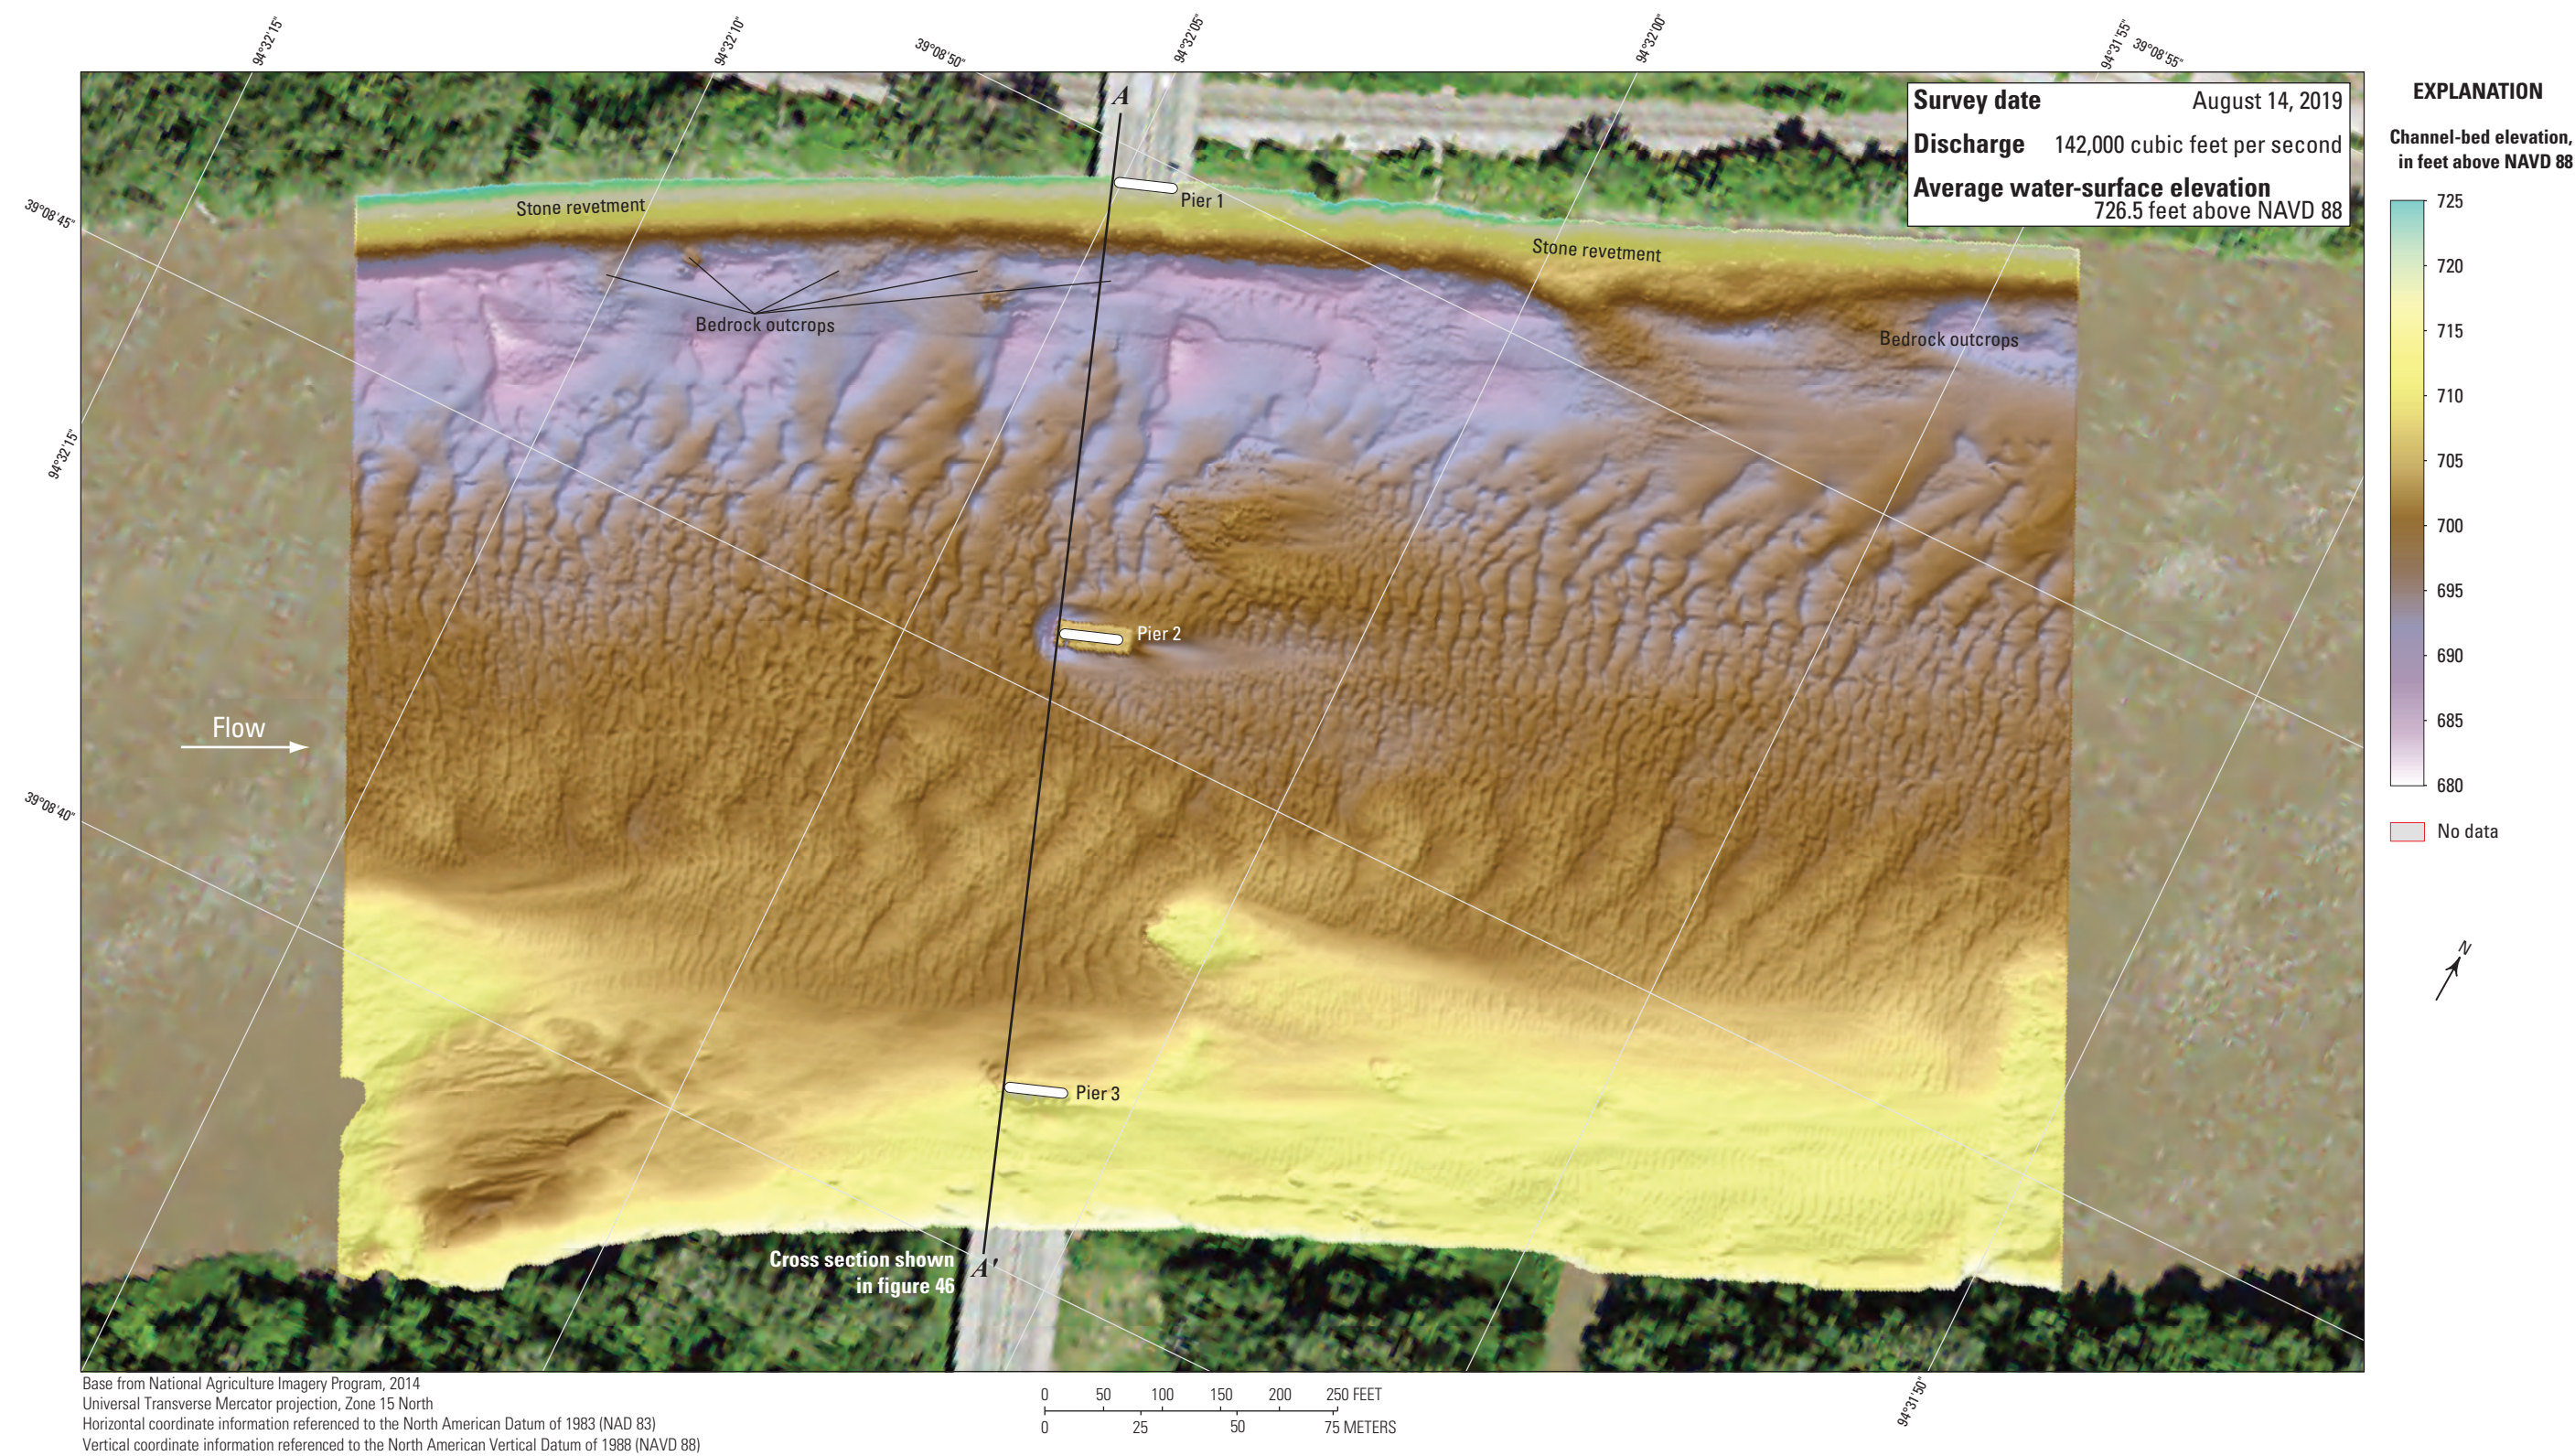
Figure 44. Bathymetric survey of the Missouri River channel near structure A5817 on State Highway 269 in Kansas City, Missouri, on August 14, 2019.

The survey area was about 1,640 ft long and averaged about 995 ft wide, extending from bank to bank in the main channel ([fig. 44](#)). Piers 2 and 3 were in the water and away from the banks, and the upstream end of the survey area was about 670 ft upstream from the centerline of structure A5817 at pier 2 ([fig. 44](#)). The channel-bed elevations ranged from about 691 to 712 ft for most of the surveyed area (5th to 95th percentile range of the bathymetric data; [table 5](#); [fig. 45](#)). A moderately deep thalweg along the left (north) bank throughout the surveyed area contained evidence of bedrock exposure and was about 12 to 14 ft deeper than the channel bed in the middle of the channel ([fig. 44](#)). Numerous medium dune features were observed in the channel thalweg, and numerous medium to small dunes and ripples were present throughout the rest of the channel, decreasing in size towards the right (south) bank ([fig. 44](#)). As in previous surveys at this site (Huizinga, 2010, 2012, 2016), stone revetment and bedrock outcrops were present on the left (north) bank throughout the reach ([fig. 44](#)).

A scour hole near main channel pier 2 ([fig. 44](#)) had a minimum channel-bed elevation of about 687 ft ([table 6](#)), which was about level with the elevation of the bottom of the pier seal course of 687.26 ft ([fig. 46](#); [table 6](#)). The top of the pier footing was evident during the survey ([fig. 44](#)). The minor scour hole near pier 3 was difficult to discern from nearby small dunes and ripples ([fig. 44](#)). Information from bridge plans indicates that piers 2 and 3 of structure A5817 are founded on shafts drilled 20 ft into bedrock, with about 10 ft of bed material between the bottom of the scour hole and bedrock at pier 2 and about 45 ft of material at pier 3 ([fig. 46](#); [table 6](#)).

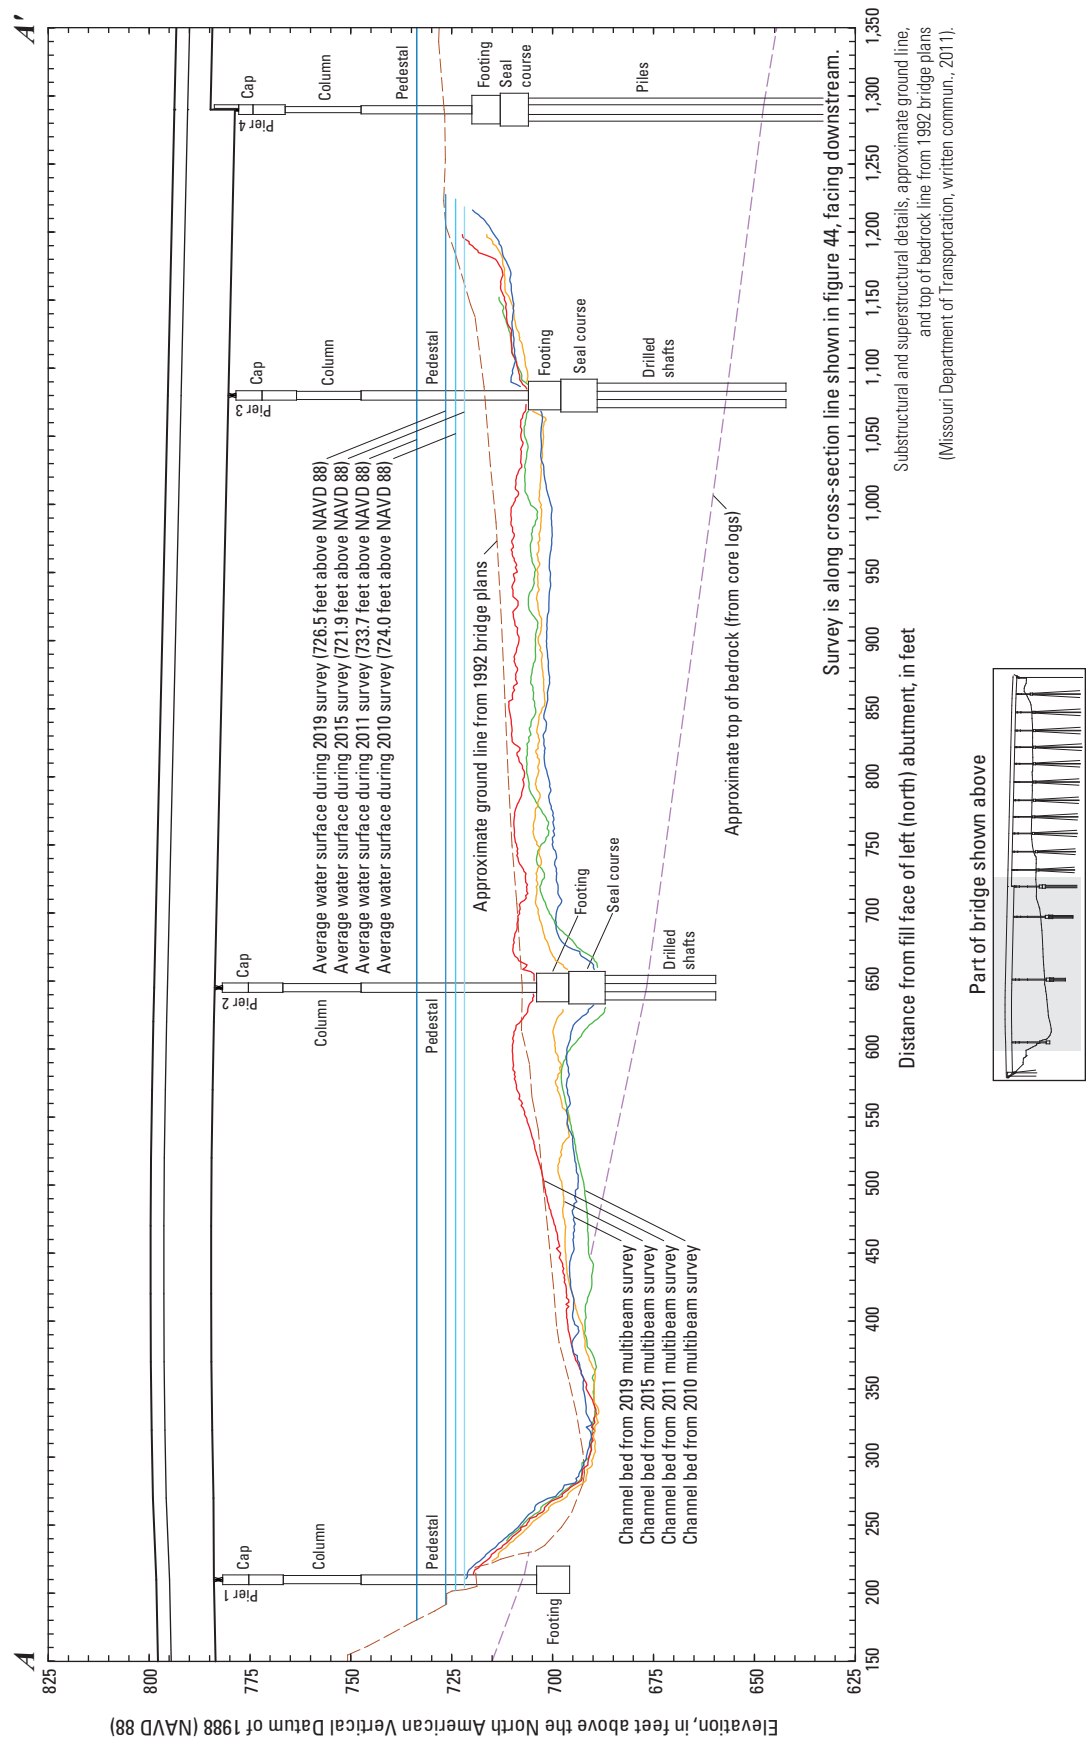
Figure 46. Key features, substructural and superstructural details, and surveyed channel bed of structure A5817 on State Highway 269 crossing the Missouri River in Kansas City, Missouri.

two surveys along the upstream face of the bridge are similar to each other but had deposition of 5 to 10 ft between the left (north) bank and pier 2 and scour of 5 to 10 ft between piers 2 and 3 (fig. 46). The frequency distribution of bed elevations in 2019 was different from 2010 because a higher percentage of cells was at lower channel-bed elevations (fig. 45); however, the surveyed area was substantially wider in 2019 than in 2010 and extended higher on the channel banks, particularly on the right (south) side (fig. 49). The bedrock outcrops and stone revetment on the left (north) bank showed signs of minor, localized deposition, particularly in the upstream reach in the DoD map (fig. 49); however, much of the differences on the left (north) side of the channel—and particularly the tops of the outcrops—were again within the uncertainties of the data, as would be expected. As with previous DoD maps, substantial deposition or scour is apparent at the faces of the pier footings resulting from minor horizontal positional variances between the surveys (see “Uncertainty Estimation” section).

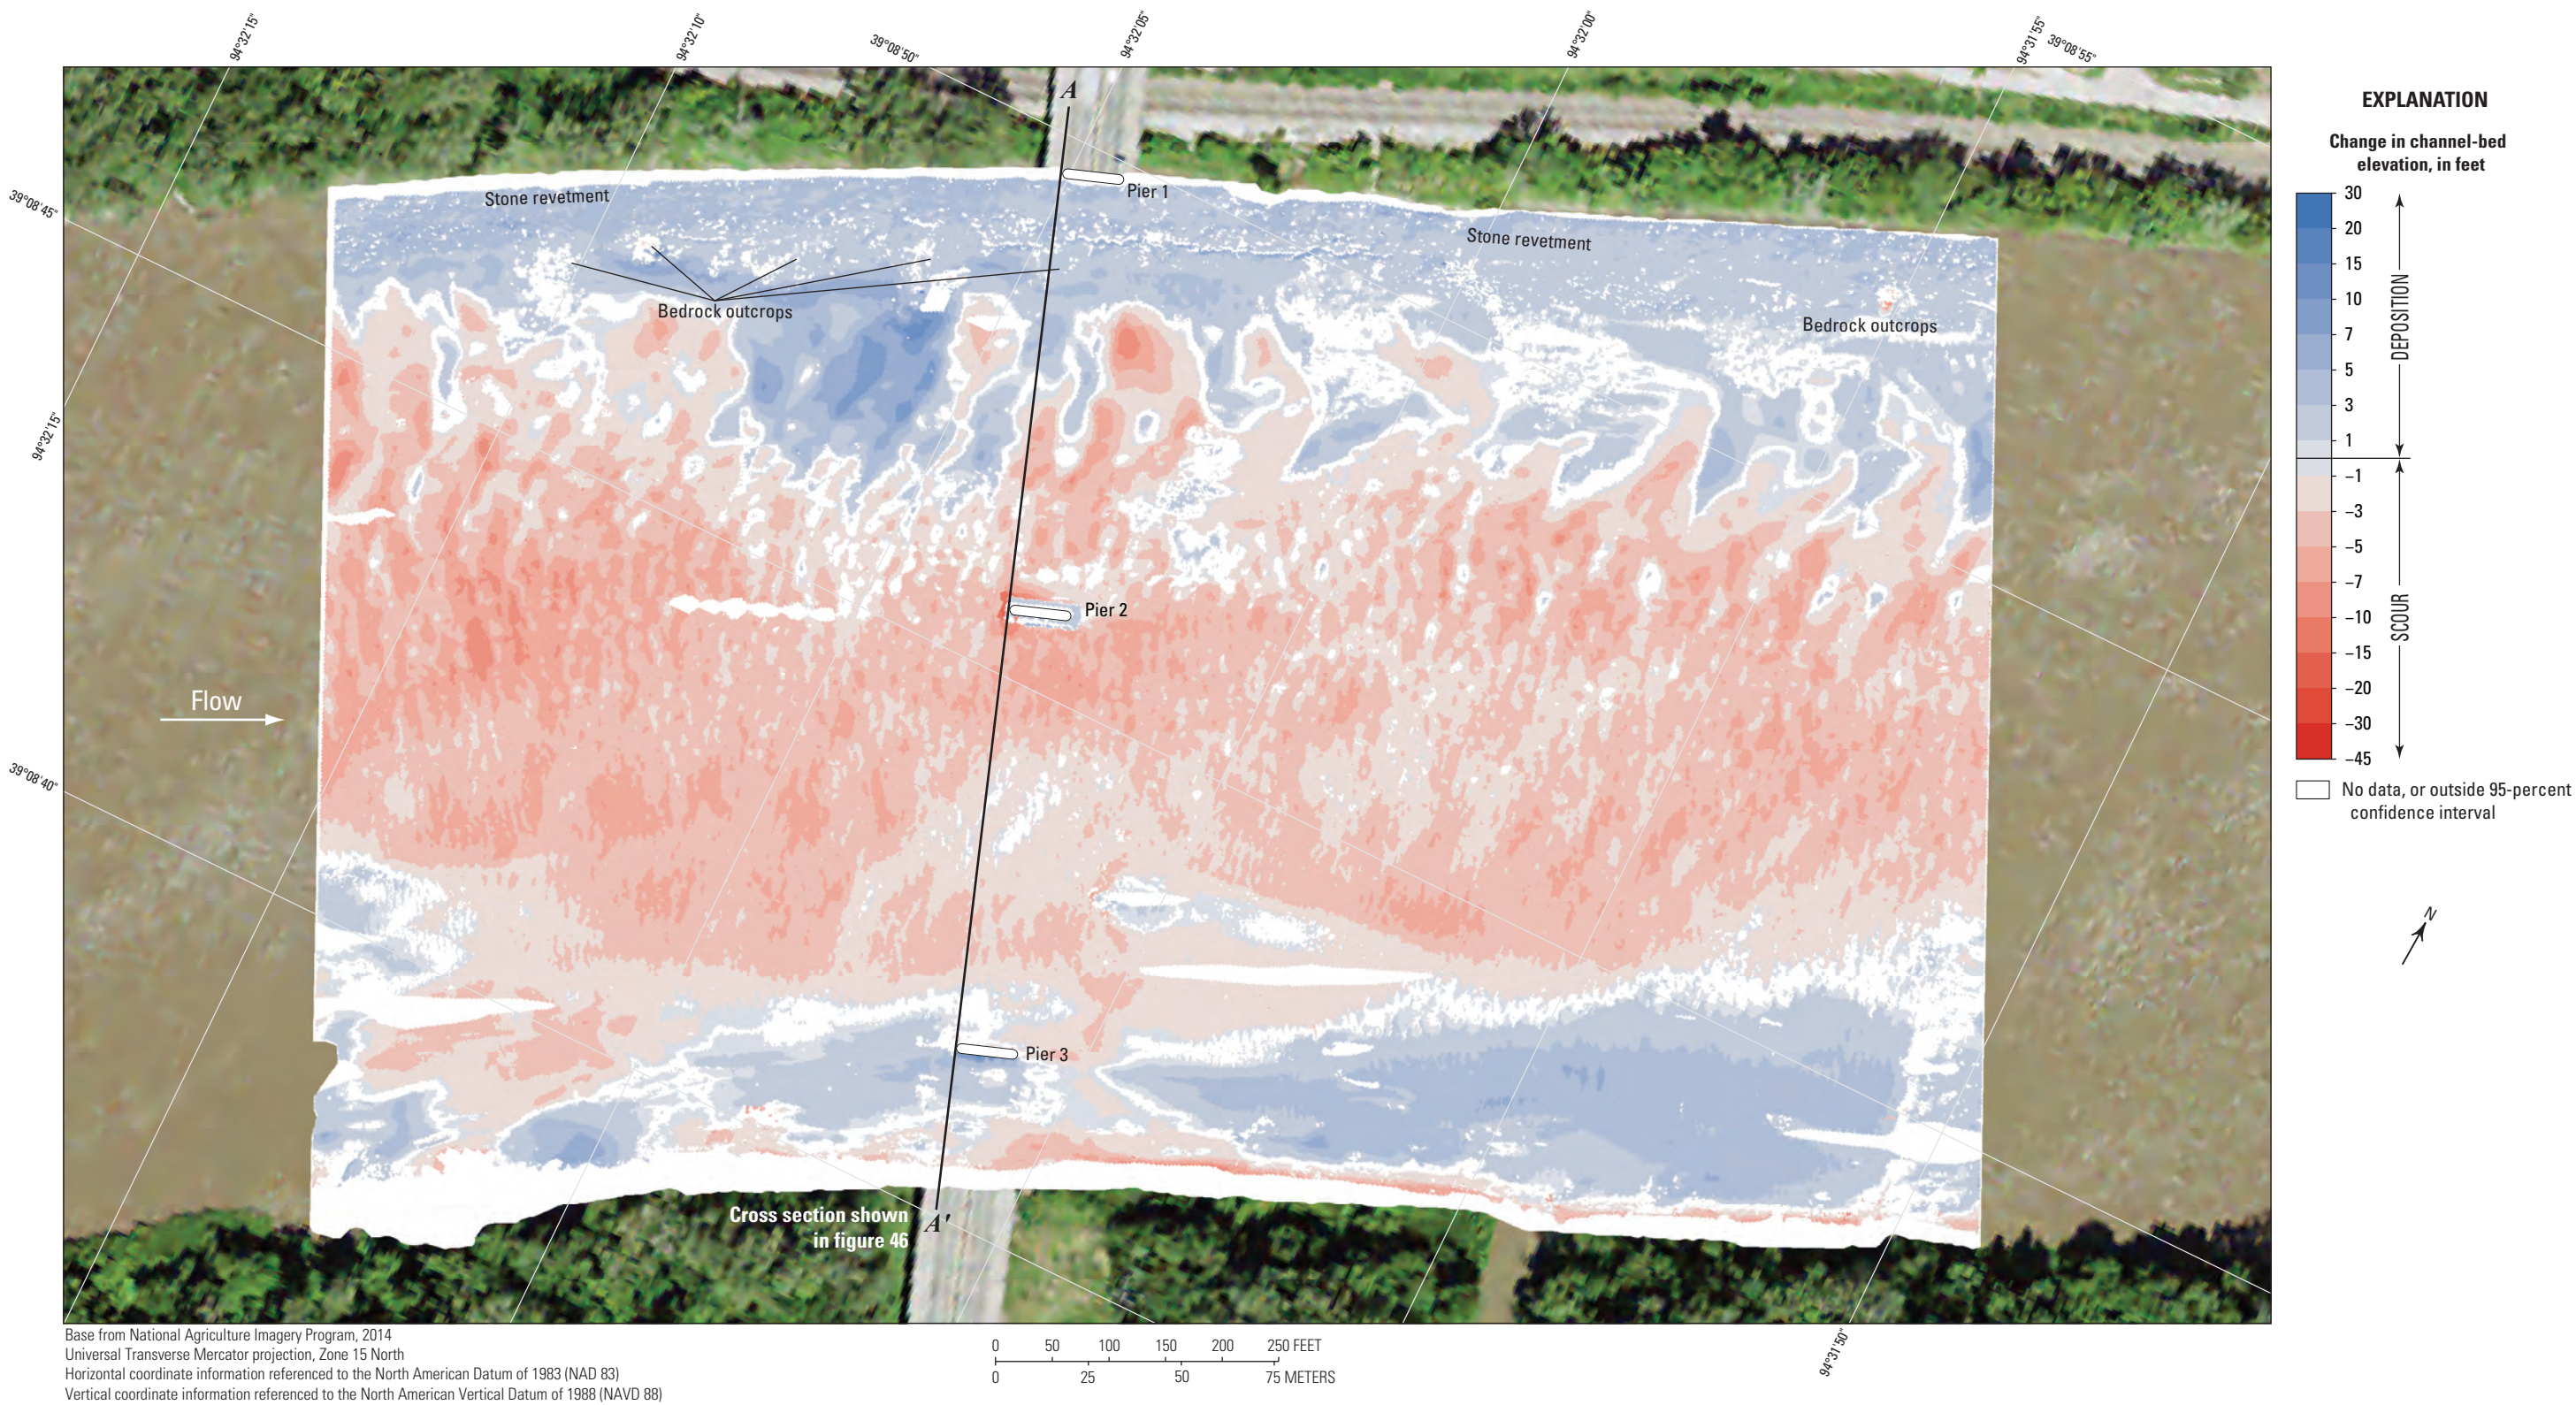
Figure 47. Difference between surfaces created from bathymetric surveys of the Missouri River channel near structure A5817 on State Highway 269 in Kansas City, Missouri, on August 14, 2019, and June 3, 2015.

The difference between the survey on August 14, 2019, and the previous nonflood survey on June 3, 2015 ([fig. 47](#)), indicates about 89 percent of the joint area of interest had detectable change, which means about 11 percent of the differences in the joint area of interest are equivocal and within the uncertainty. There is moderate to substantial bed variation from 2015 to

2019 in the DoD map, with scour predominant throughout the middle of the reach, and deposition on both banks ([fig. 47](#)). The average difference between the bathymetric surfaces was -1.44 ft ([table 7](#)), indicating minor to moderate degradation between the 2015 and 2019 surveys. The net volume of cut in the reach from 2015 to 2019 was about 114,200 yd³, and the net volume of fill was about 40,800 yd³, resulting in a net loss of about 73,400 yd³ of sediment between 2015 and 2019. The cross sections from the two surveys along the upstream face of the bridge are similar to each other but with uniform scour of 5 to 10 ft between the left (north) bank and pier 3 ([fig. 46](#)). The frequency distribution of bed elevations in 2019 was wider than 2015 because a higher percentage of cells were at lower and higher channel-bed elevations ([fig. 45](#)). The scour hole near the main channel pier 2 was deeper and wider than in 2015, as evidenced by the area of scour near that pier in the DoD map ([fig. 47](#)). Alternatively, the change from 2015 to 2019 near main channel pier 3 was equivocal to the uncertainty on the left side of the footing, and there was deposition along the right side ([fig. 47](#)). The bedrock outcrops and stone revetment on the left (north) bank showed signs of localized deposition throughout the reach between 2015 and 2019, which is somewhat unexpected ([fig. 47](#)); however, the differences on the tops of some of the outcrops were within the uncertainties of the data, which implies there may be a horizontal offset to the 2019 data on the bank that is creating the appearance of deposition.

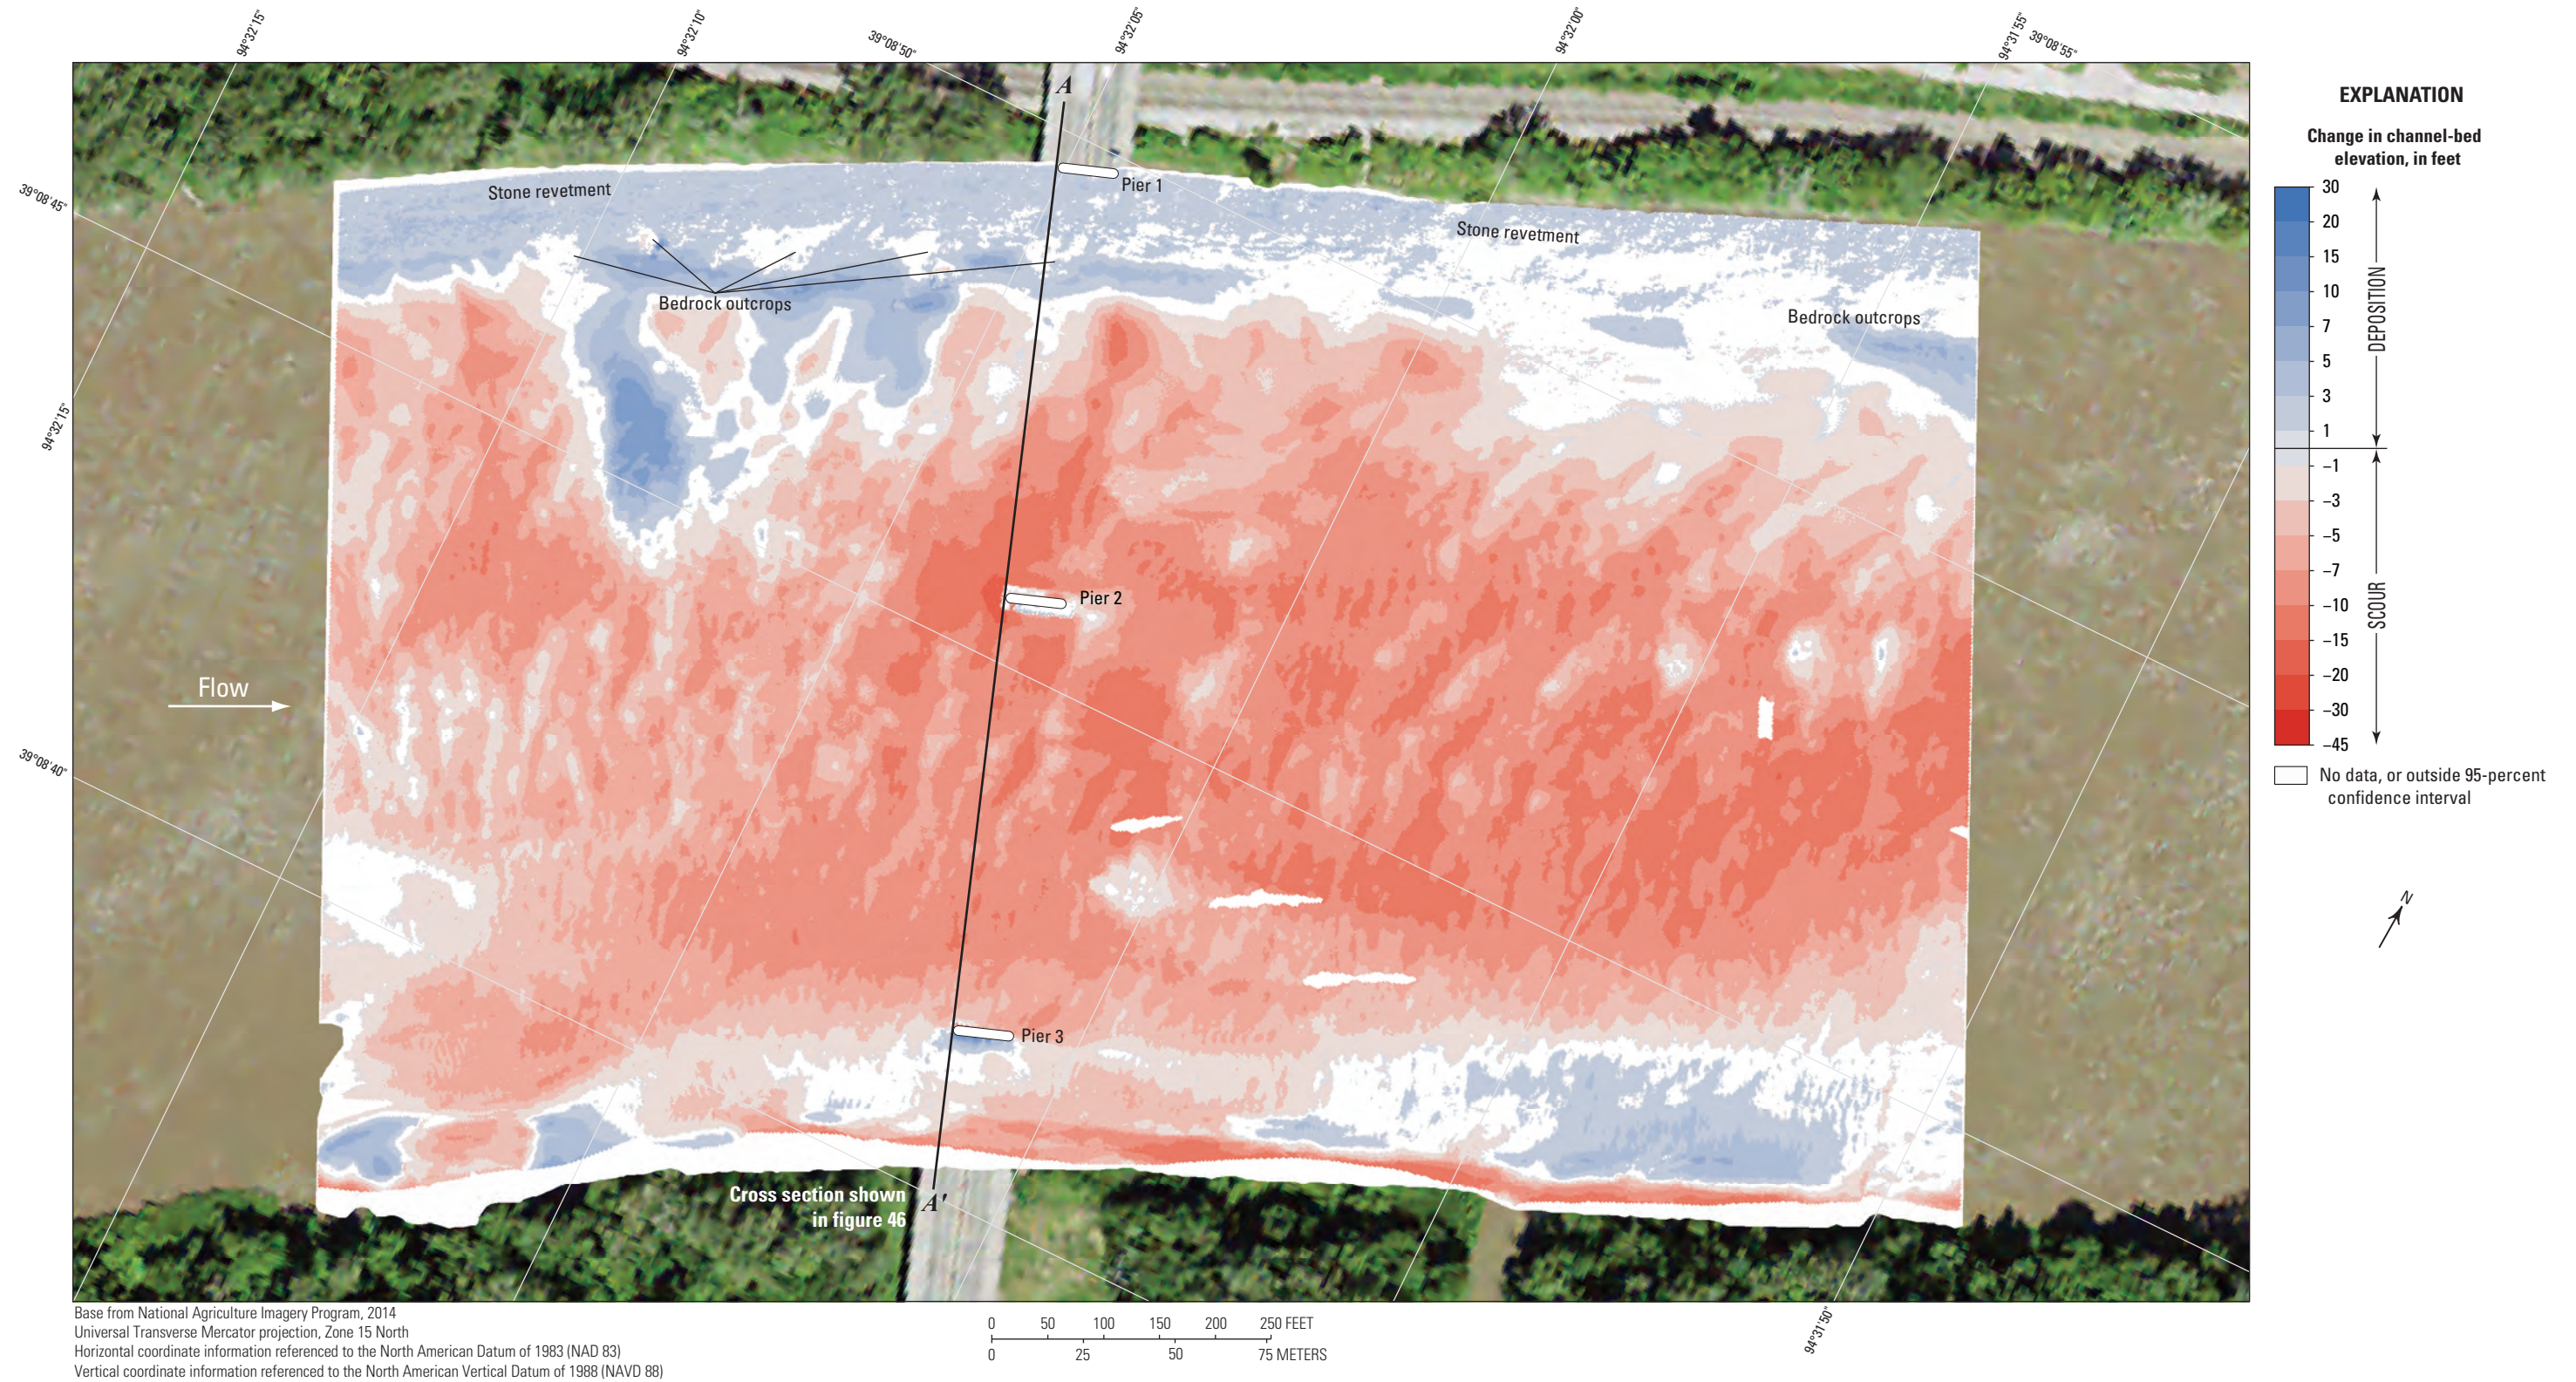
Figure 48. Difference between surfaces created from bathymetric surveys of the Missouri River channel near structure A5817 on State Highway 269 in Kansas City, Missouri, on August 14, 2019, and July 18, 2011.

The difference between the survey on August 14, 2019, and the previous flood survey on July 18, 2011 ([fig. 48](#)), indicates about 89 percent of the joint area of interest had detectable change, which means about 11 percent of the differences in the joint area of interest are equivocal and within the uncertainty. Substantial bed variation was apparent from 2011 to 2019 in the DoD map, with substantial scour throughout the reach except along the left (north) bank and in the troughs of substantial dunes present in the 2011 survey (Huizinga, 2012, [fig. 48](#)). The average difference between the bathymetric surfaces was -4.76 ft ([table 7](#)), indicating substantial degradation between the 2011 and 2019 surveys. The net volume of cut in the reach from 2011 to 2019 was about 268,900 yd³, and the net volume of fill was about 20,000 yd³, resulting in a net loss of about 248,900 yd³ of sediment in the reach between 2011 and 2019. The cross sections from the two surveys along the upstream face of the bridge show the substantial difference in the surveyed sections ([fig. 46](#)). The frequency distribution of bed

elevations in 2019 also was substantially different from 2011 (fig. 45). The DoD map shows the substantial scour throughout the reach, so the scour hole near main channel pier 2 is indistinguishable from the overall change between 2011 and 2019 (fig. 48). As with the DoD map for 2015 to 2019 (fig. 47), the bedrock outcrops and stone revetment on the left (north) bank showed signs of localized deposition throughout the reach between 2011 and 2019, which is somewhat unexpected (fig. 48); however, the differences on the tops of the outcrops were again within the uncertainties of the data, which implies there may be a horizontal offset to the 2019 data on the bank that is creating the appearance of deposition.

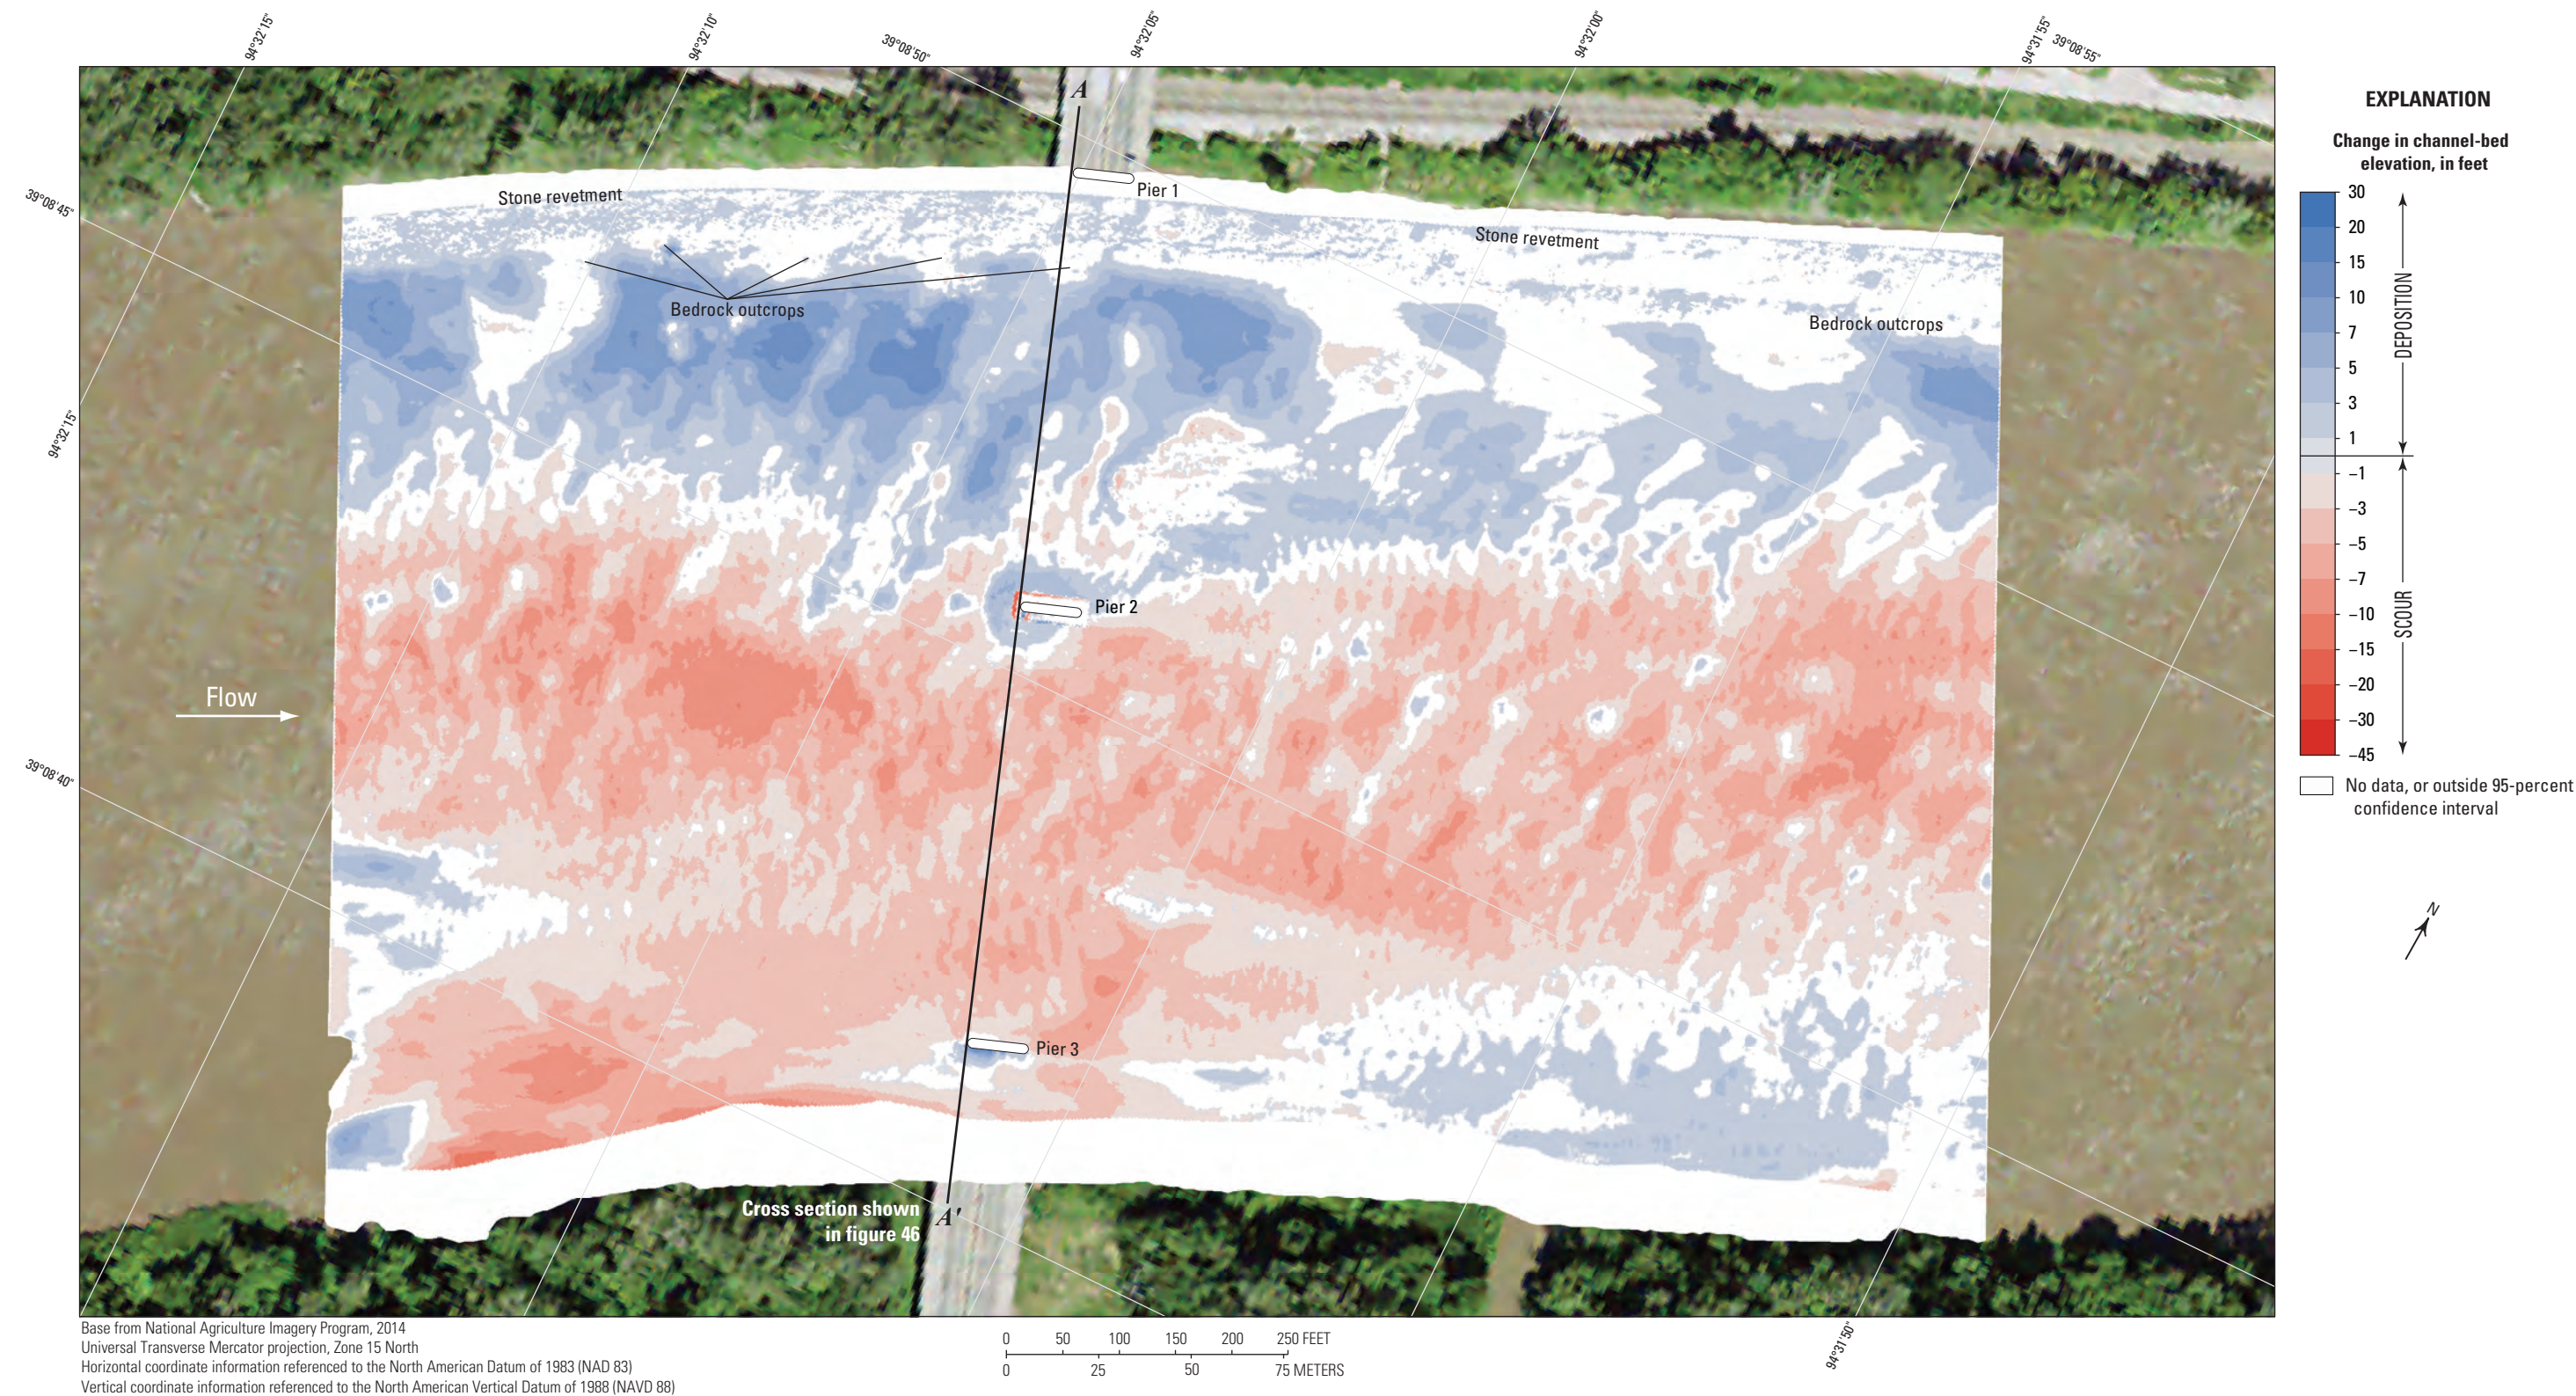
Figure 49. Difference between surfaces created from bathymetric surveys of the Missouri River channel near structure A5817 on State Highway 269 in Kansas City, Missouri, on August 14, 2019, and March 17, 2010.

The difference between the survey on August 14, 2019, and the earliest nonflood survey on March 17, 2010 (fig. 49), indicates about 80 percent of the joint area of interest had detectable change, which means about 20 percent of the differences in the joint area of interest are equivocal and within the uncertainty. Bed variation seemed nearly equal between scour and deposition from 2010 to 2019 in the DoD map, deposition was predominant along the thalweg on the left (north) side of the channel, and scour was predominant along the middle and right (south) side (fig. 49). However, the average difference between the bathymetric surfaces was -1.38 ft (table 7), indicating minor to moderate channel degradation between the 2010 and 2019 surveys. The net volume of cut in the reach from 2010 to 2019 was about 111,500 yd³, and the net volume of fill was about 50,100 yd³, resulting in a net loss of about 61,400 yd³ of sediment between 2010 and 2019. The cross sections from the

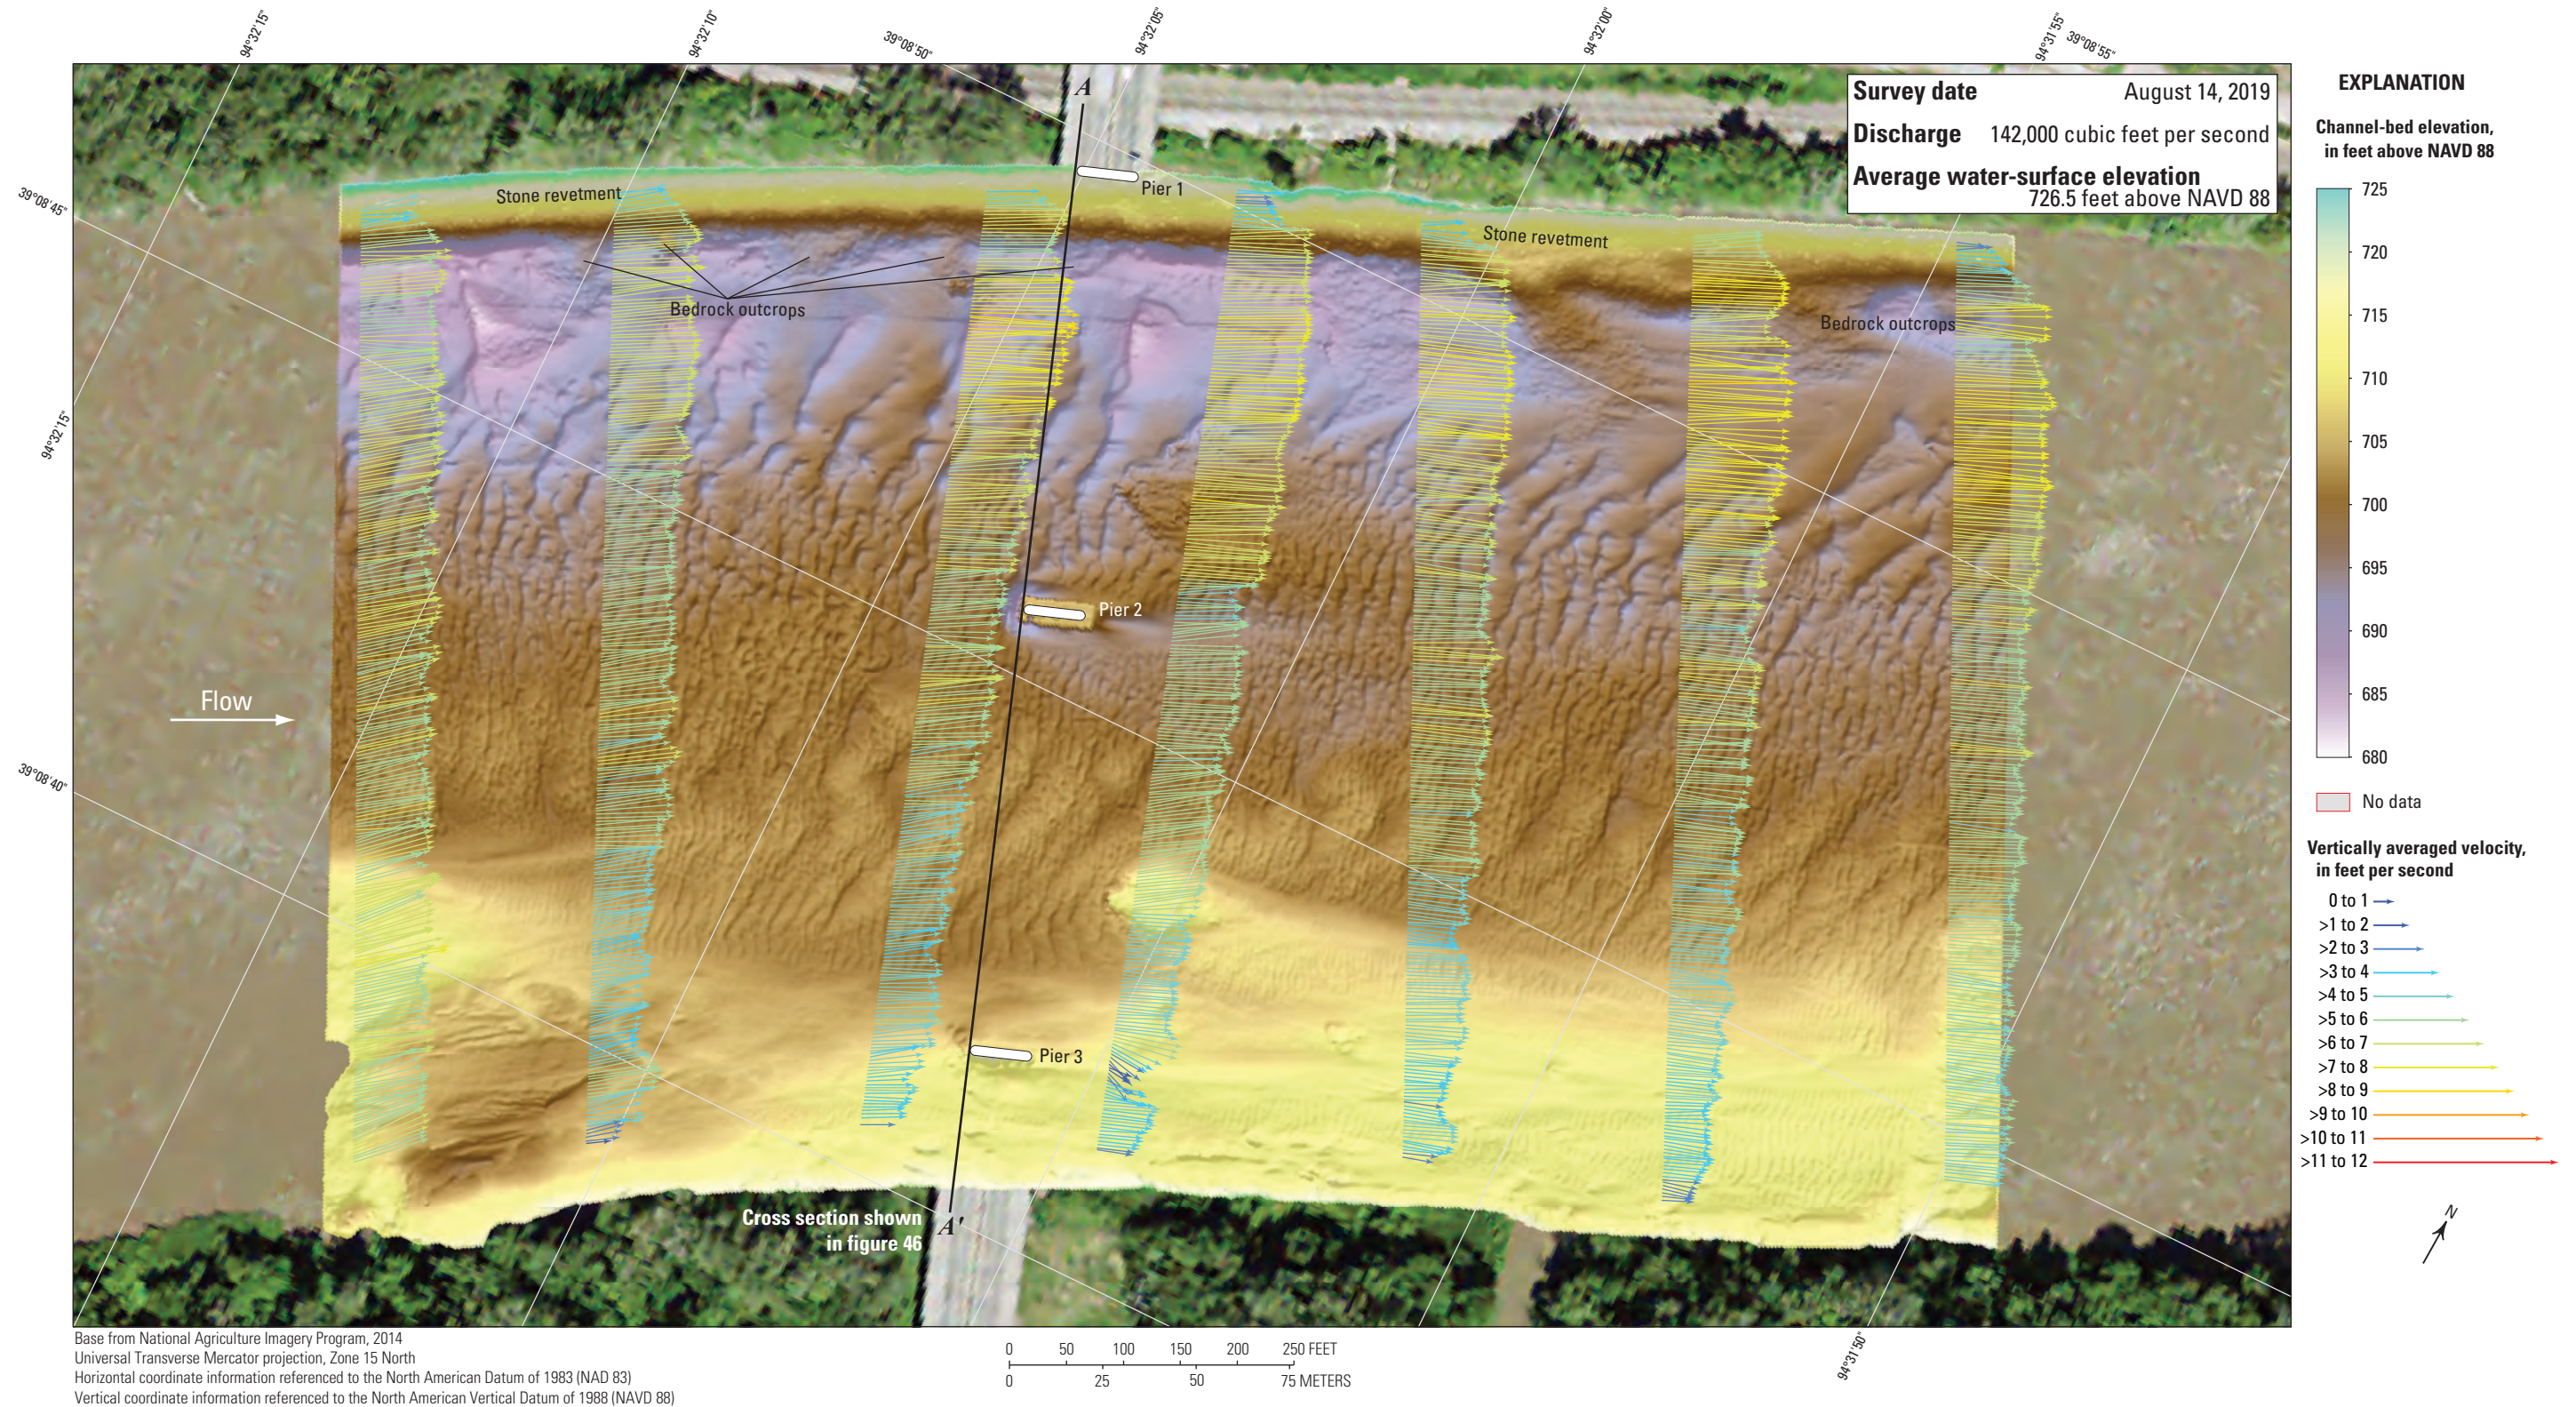
Figure 50. Bathymetry and vertically averaged velocities of the Missouri River channel near structure A5817 on State Highway 269 in Kansas City, Missouri, on August 14, 2019.

The vertically averaged velocity vectors indicate mostly uniform flow throughout the reach, ranging from about 3 ft/s along the inside of the bend on the right (south) bank to 9 ft/s in the thalweg along the left (north) bank (fig. 50). Exceptions to uniform flow include flows angled to the left (north) in the upstream part of the reach because of the bend in the channel (fig. 50). Moderate turbulence also was observed along the thalweg near the bedrock outcrops, along the inside of the bend along the right (south) bank, and downstream from pier 3 (fig. 50).
