Bathymetric and Velocimetric Surveys at Highway Bridges Crossing the Missouri River near Kansas City, Missouri, August 2019, August 2020, and October 2020

Scientific Investigations Report 2021–5098

By Richard J. Huizinga

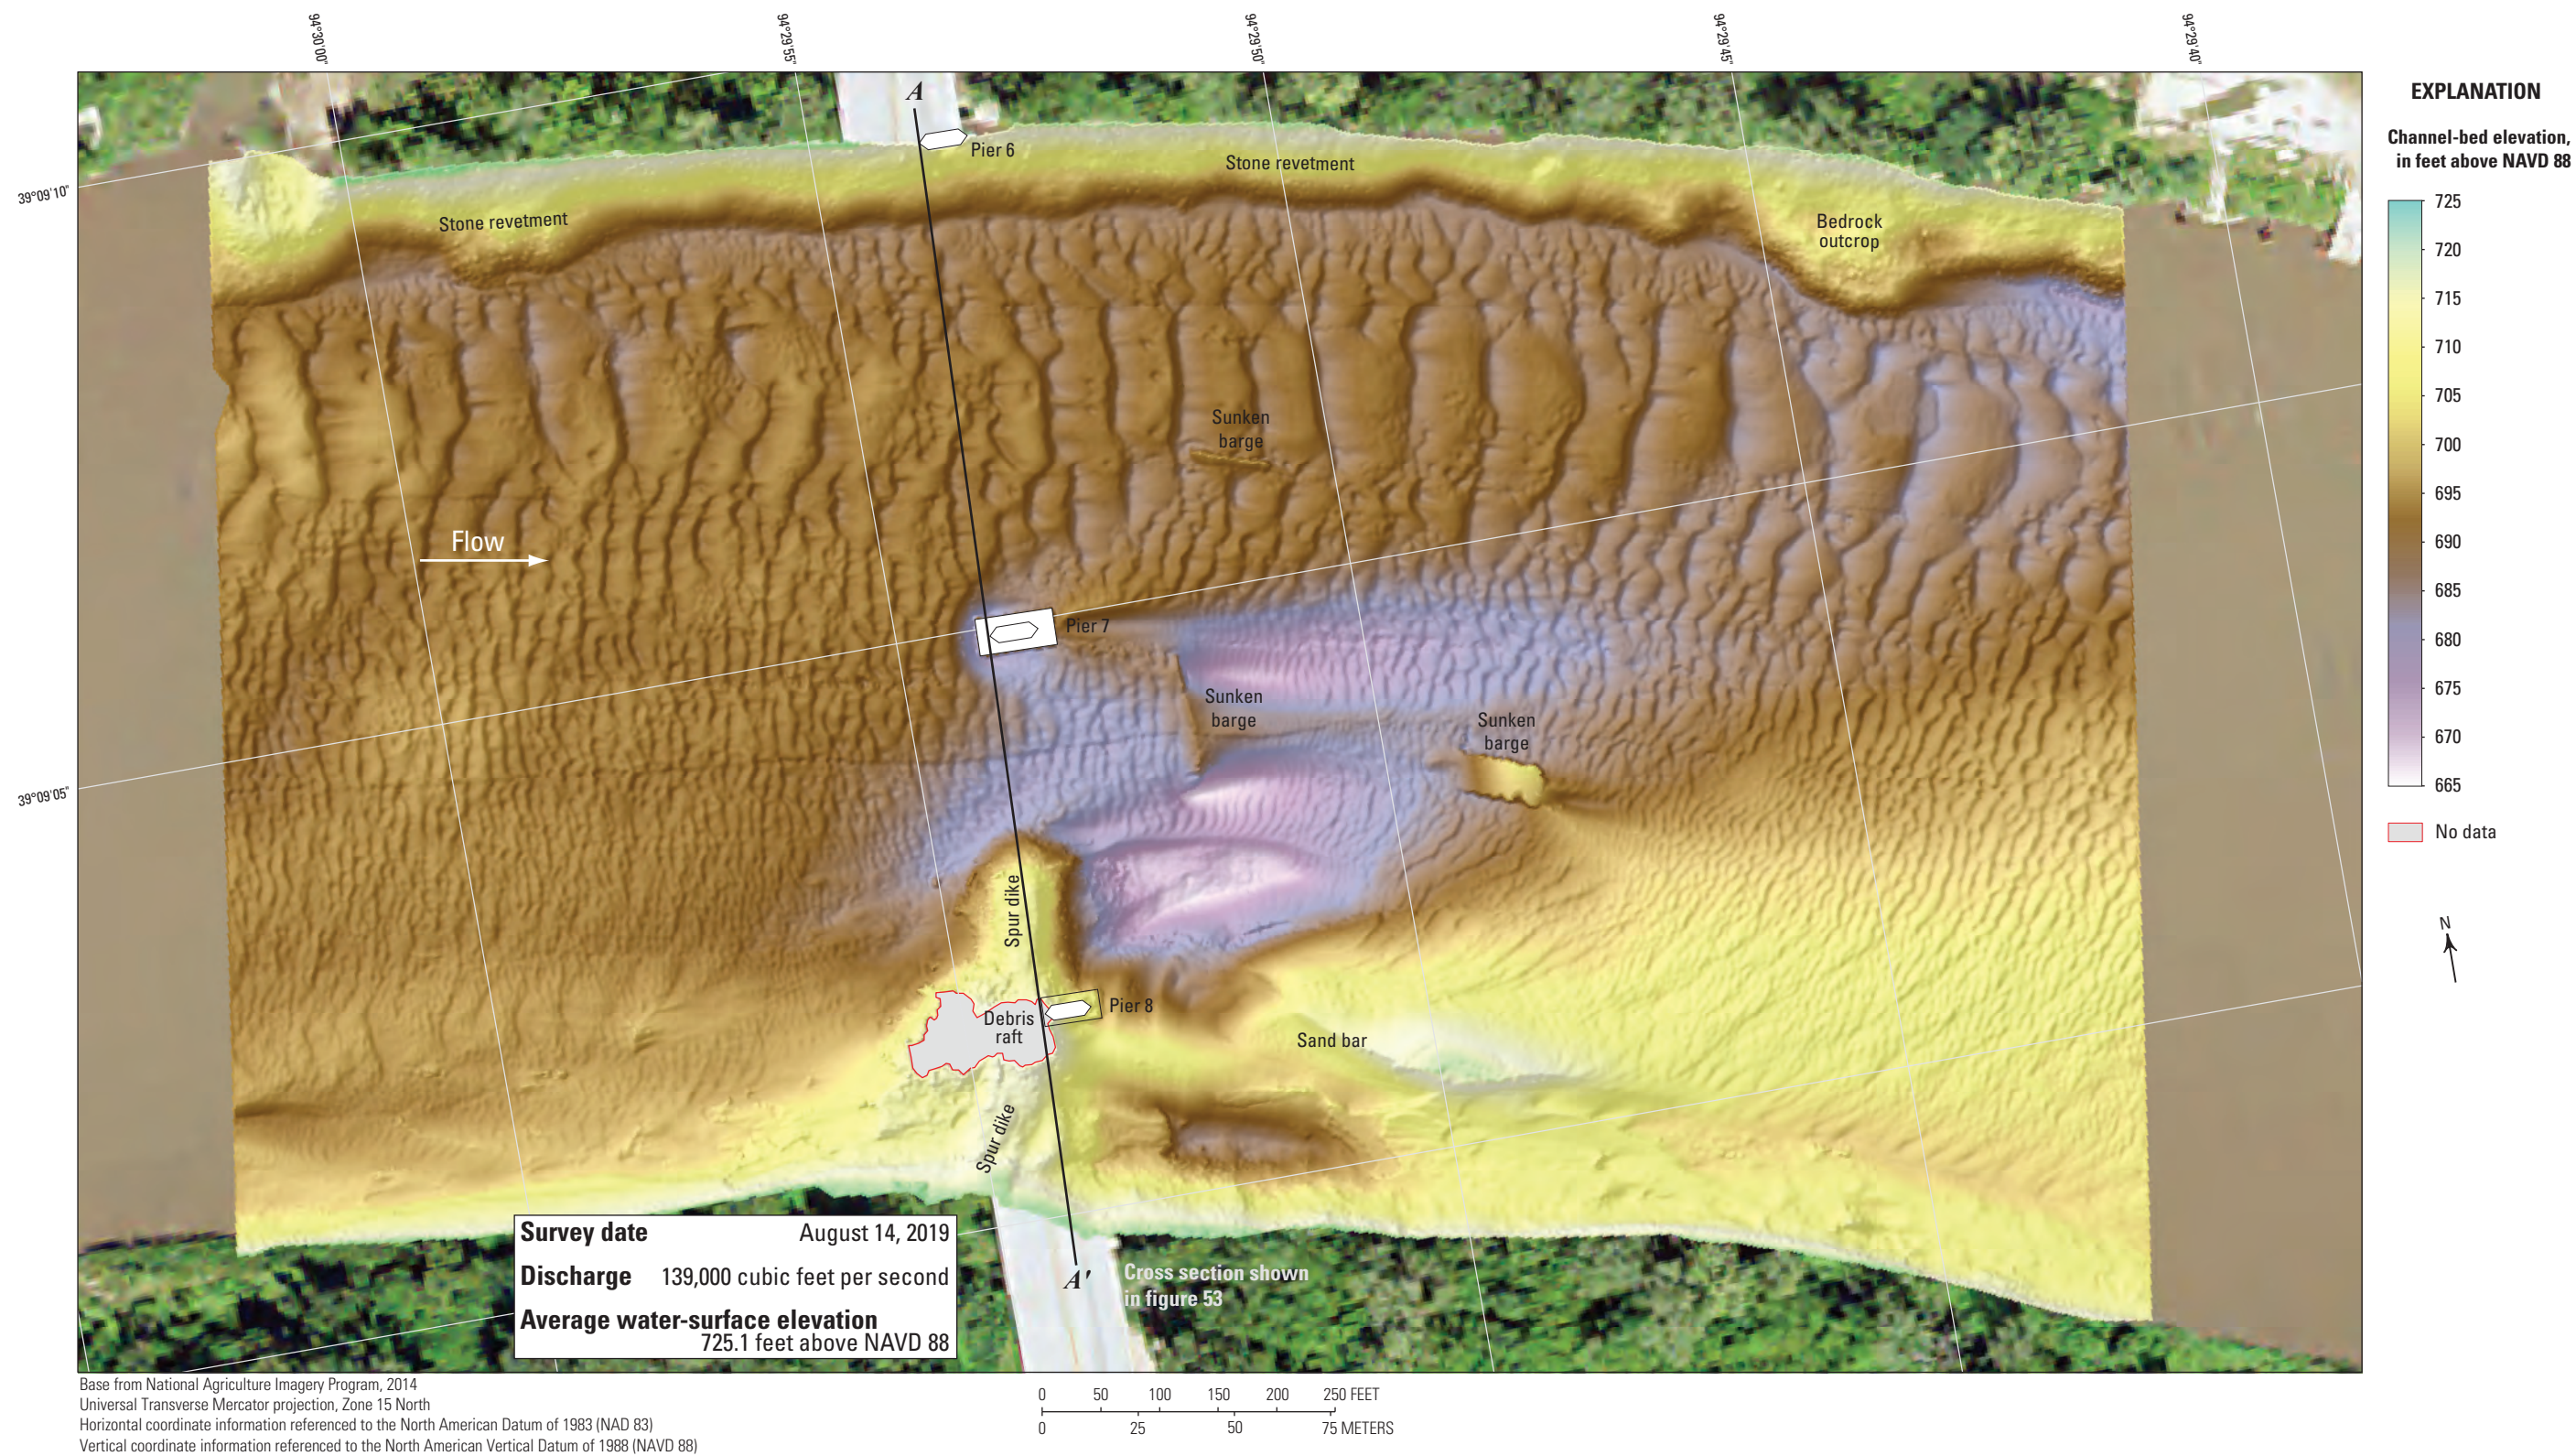
Figure 51. Bathymetric survey of the Missouri River channel near structure A0767 on Interstate 435 in Kansas City, Missouri, on August 14, 2019.

elevation in the surveyed area of 668 ft ([fig. 51](#); [table 5](#)); however, this hole was more than 50 ft away from pier 8, and substantial alluvial material was present between the hole and the pier.

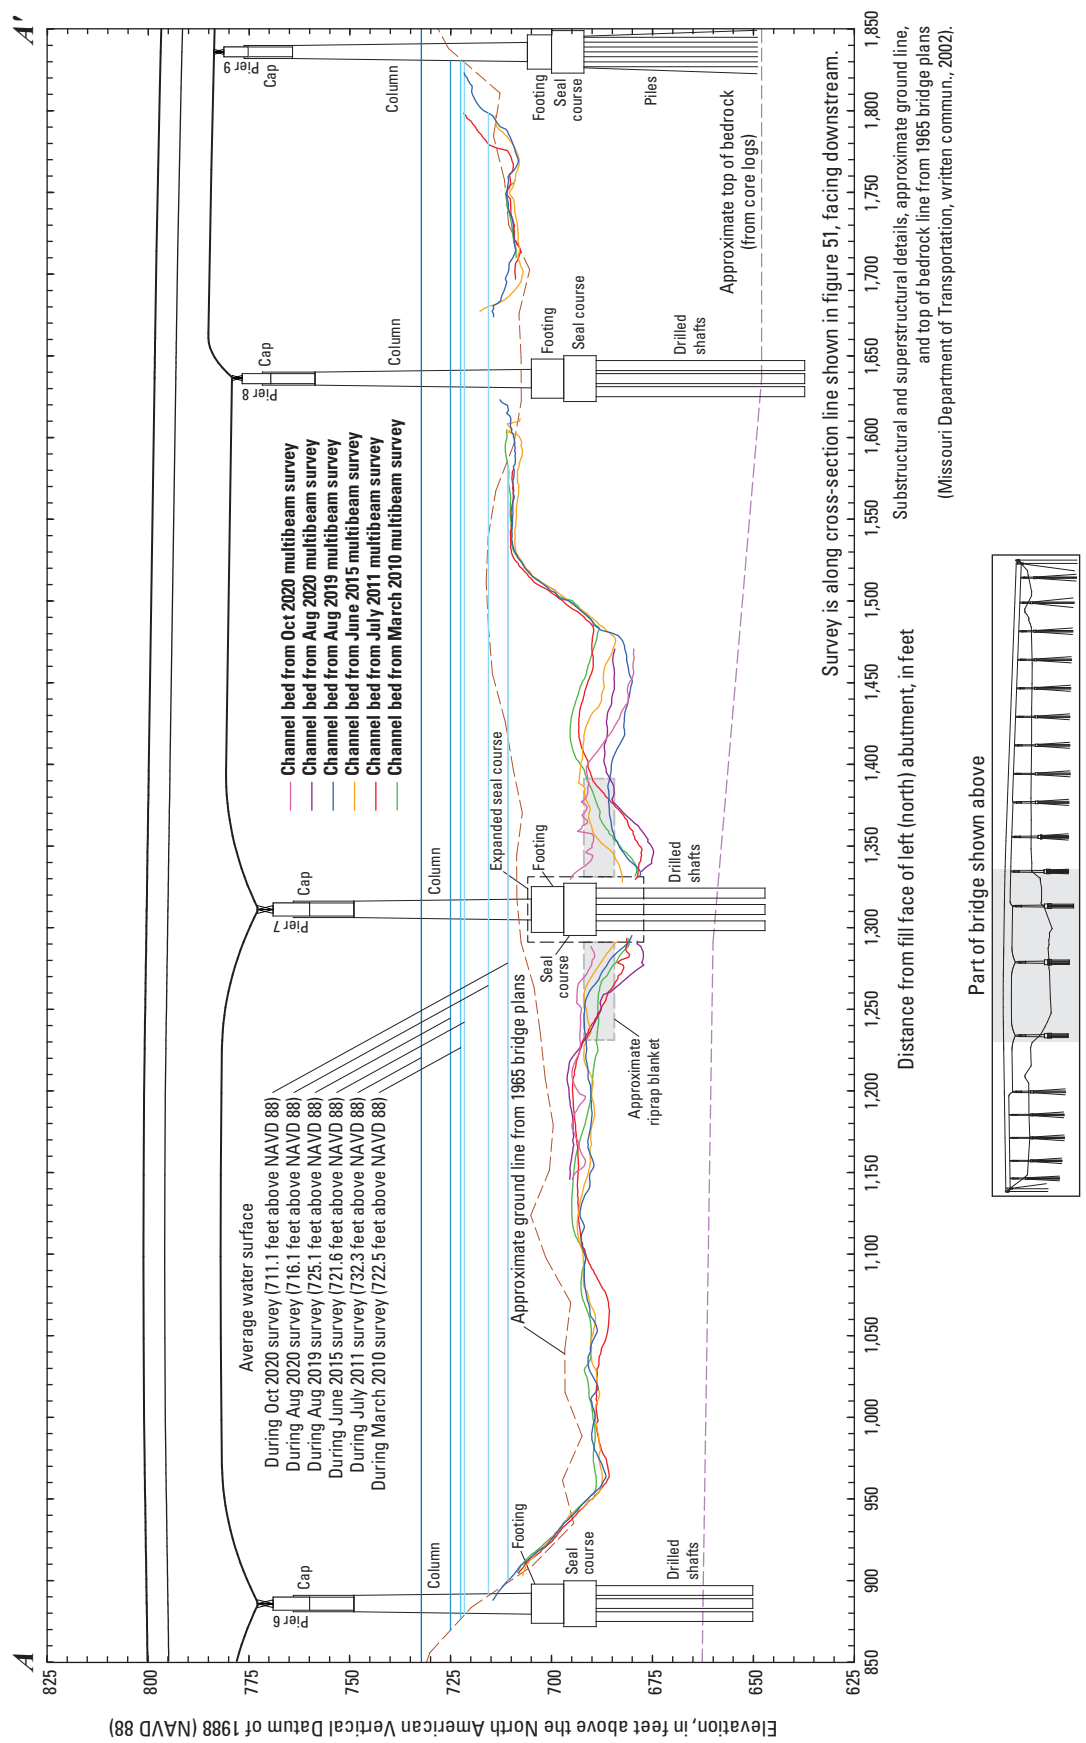
Figure 53. Key features, substructural and superstructural details, and surveyed channel bed of structure A0767 on Interstate 435 crossing the Missouri River in Kansas City, Missouri.

bridge show the substantial difference in the surveyed sections (fig. 53). The frequency distribution of bed elevations in 2019 was remarkably similar to 2011 (fig. 52), but a slightly higher percentage of cells was at a lower channel-bed elevation than 2011 in the middle of the range (fig. 52). The scour hole near main channel pier 7 is shallower and narrower than in 2015, as indicated by the area of deposition in a horseshoe shape around that pier (fig. 55). The bedrock outcrops and stone revetment on the left (north) bank showed signs of localized deposition throughout the reach between 2011 and 2019 (fig. 55); however, the differences on the tops of the outcrops were within the uncertainties of the data, which implies there may be a slight horizontal offset to the 2019 data on the bank that is creating the appearance of deposition on the bank.

The history of scour observed near pier 7 (Huizinga, 2010, 2012, 2016) led MoDOT to install scour countermeasures around pier 7 during August–October 2020. Partial surveys of the channel bed near pier 7 of structure A0767 were surveyed before and after installation of these scour countermeasures to document and verify installation. The historical scour hole near pier 7 was clearly evident in the pre-installation survey on August 17, 2020 (fig. 58), but the cofferdam for an expanded seal course had been partially installed, creating a partially widened footprint to the pier (fig. 58). The difference between the survey on August 13, 2019, and the partial survey on August 17, 2020, indicates moderate deposition of 3 to 7 ft had occurred in much of the partial reach from 2019 to 2020, but that scour of 15 to 20 ft had occurred near the pier (fig. 59). The cross sections from the two surveys along the upstream face of the bridge also indicates this deeper and wider scour hole at the pier in 2020

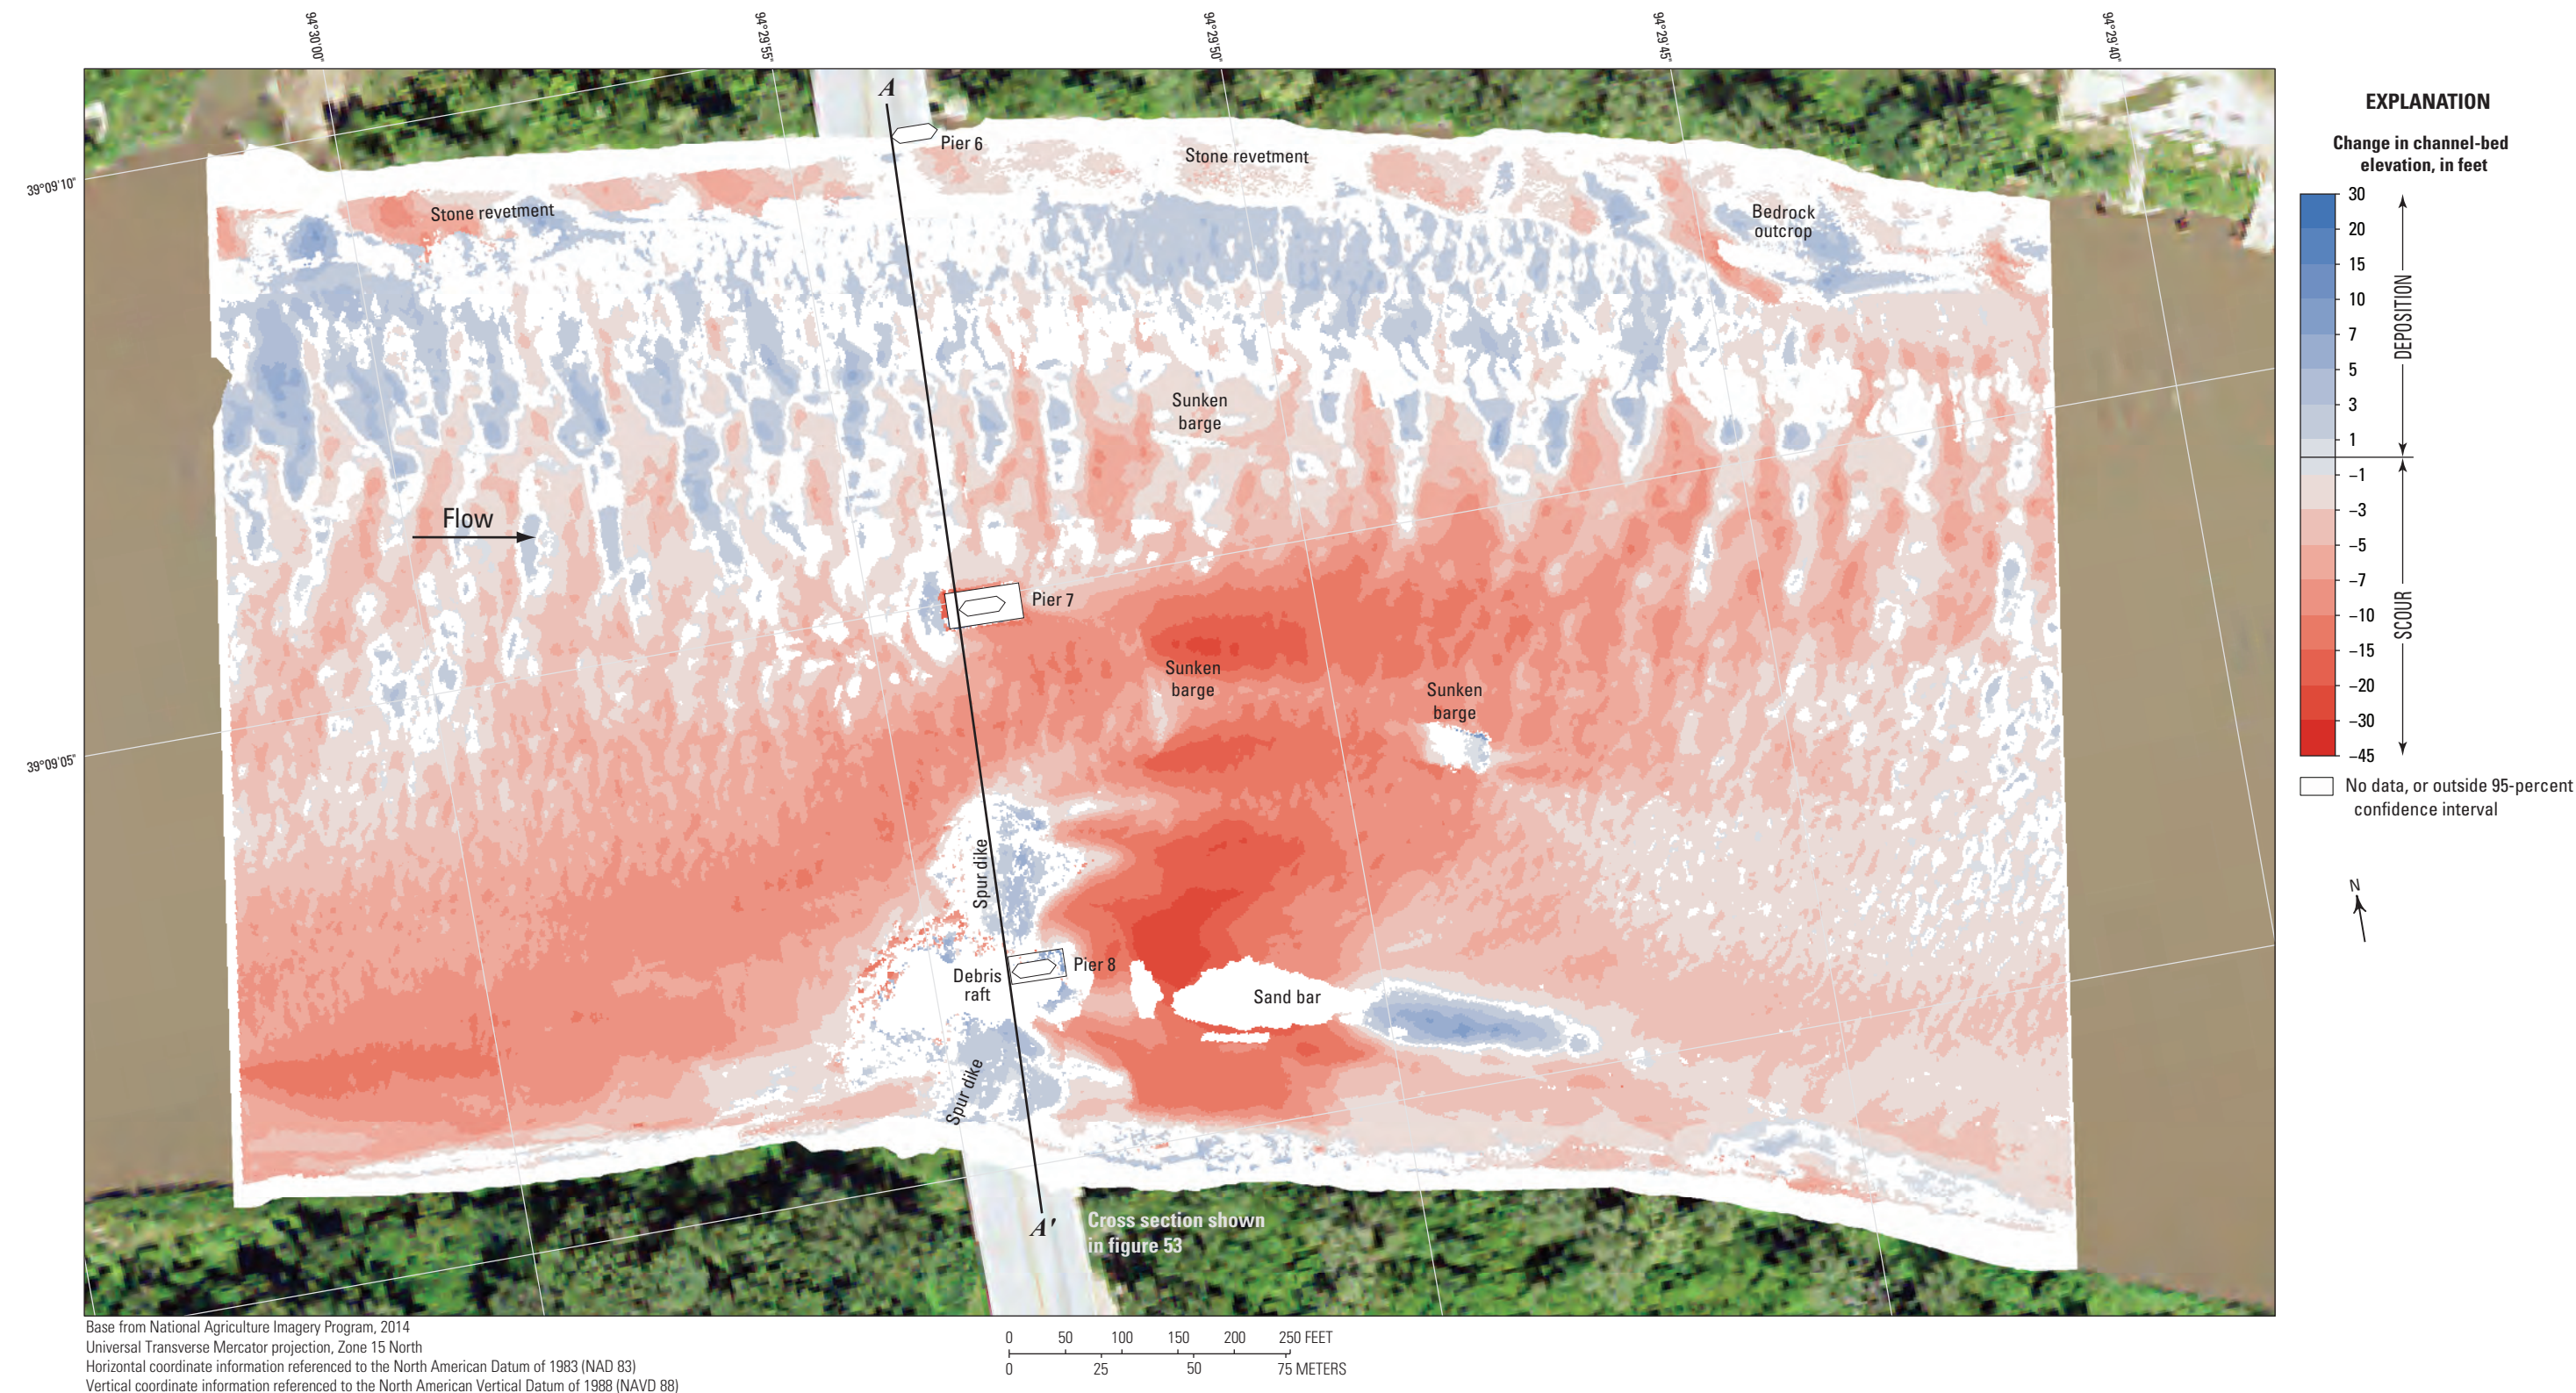
Figure 54. Difference between surfaces created from bathymetric surveys of the Missouri River channel near structure A0767 on Interstate 435 in Kansas City, Missouri, on August 14, 2019, and June 4, 2015.

The difference between the survey on August 14, 2019, and the previous nonflood survey on June 4, 2015 ([fig. 54](#)), indicates about 80 percent of the joint area of interest had detectable change, which means about 20 percent of the differences in the joint area of interest are equivocal and within the uncertainty. Bed variation from 2015 to 2019 was moderate to substantial in the DoD map, deposition was predominant in the thalweg on the left (north) side, and scour was predominant throughout the middle and right (south) side of the reach ([fig. 54](#)). The average difference between the bathymetric surfaces was -4.17 ft ([table 7](#)), indicating substantial degradation between the 2015 and 2019 surveys. The net volume of cut in the reach from 2015 to 2019 was about 187,700 yd³, and the net volume of fill was only about 11,200 yd³, resulting in a net loss of about 176,500 yd³ of sediment between 2015 and 2019. The cross sections from the two surveys along the upstream face of the bridge indicate the trends from the DoD map, and deposition in the thalweg and scour was as much as 20 ft between pier 7 and the spur dike ([fig. 53](#)). The frequency distribution of bed elevations in 2019 appeared similar to 2015 but had a higher percentage of cells at lower channel-bed elevations than 2015 ([fig. 52](#)). The scour hole near main channel pier 7 was similar to that in 2015, as evidenced by the area of equivocal data in a horseshoe shape around the upstream end of that pier in the DoD map ([fig. 54](#)). However, on the downstream side of piers 7 and 8, substantial scour had occurred between 2015 and 2019 ([fig. 54](#)). The bedrock outcrops and stone revetment on the left (north) bank showed signs of localized scour and deposition throughout the reach between 2015 and 2019 ([fig. 54](#)), which was expected because of erroneous positioning during data collection in the 2015 survey (Huizinga, 2016) that created an offset of the data along the upstream left (north) bank between surveys.

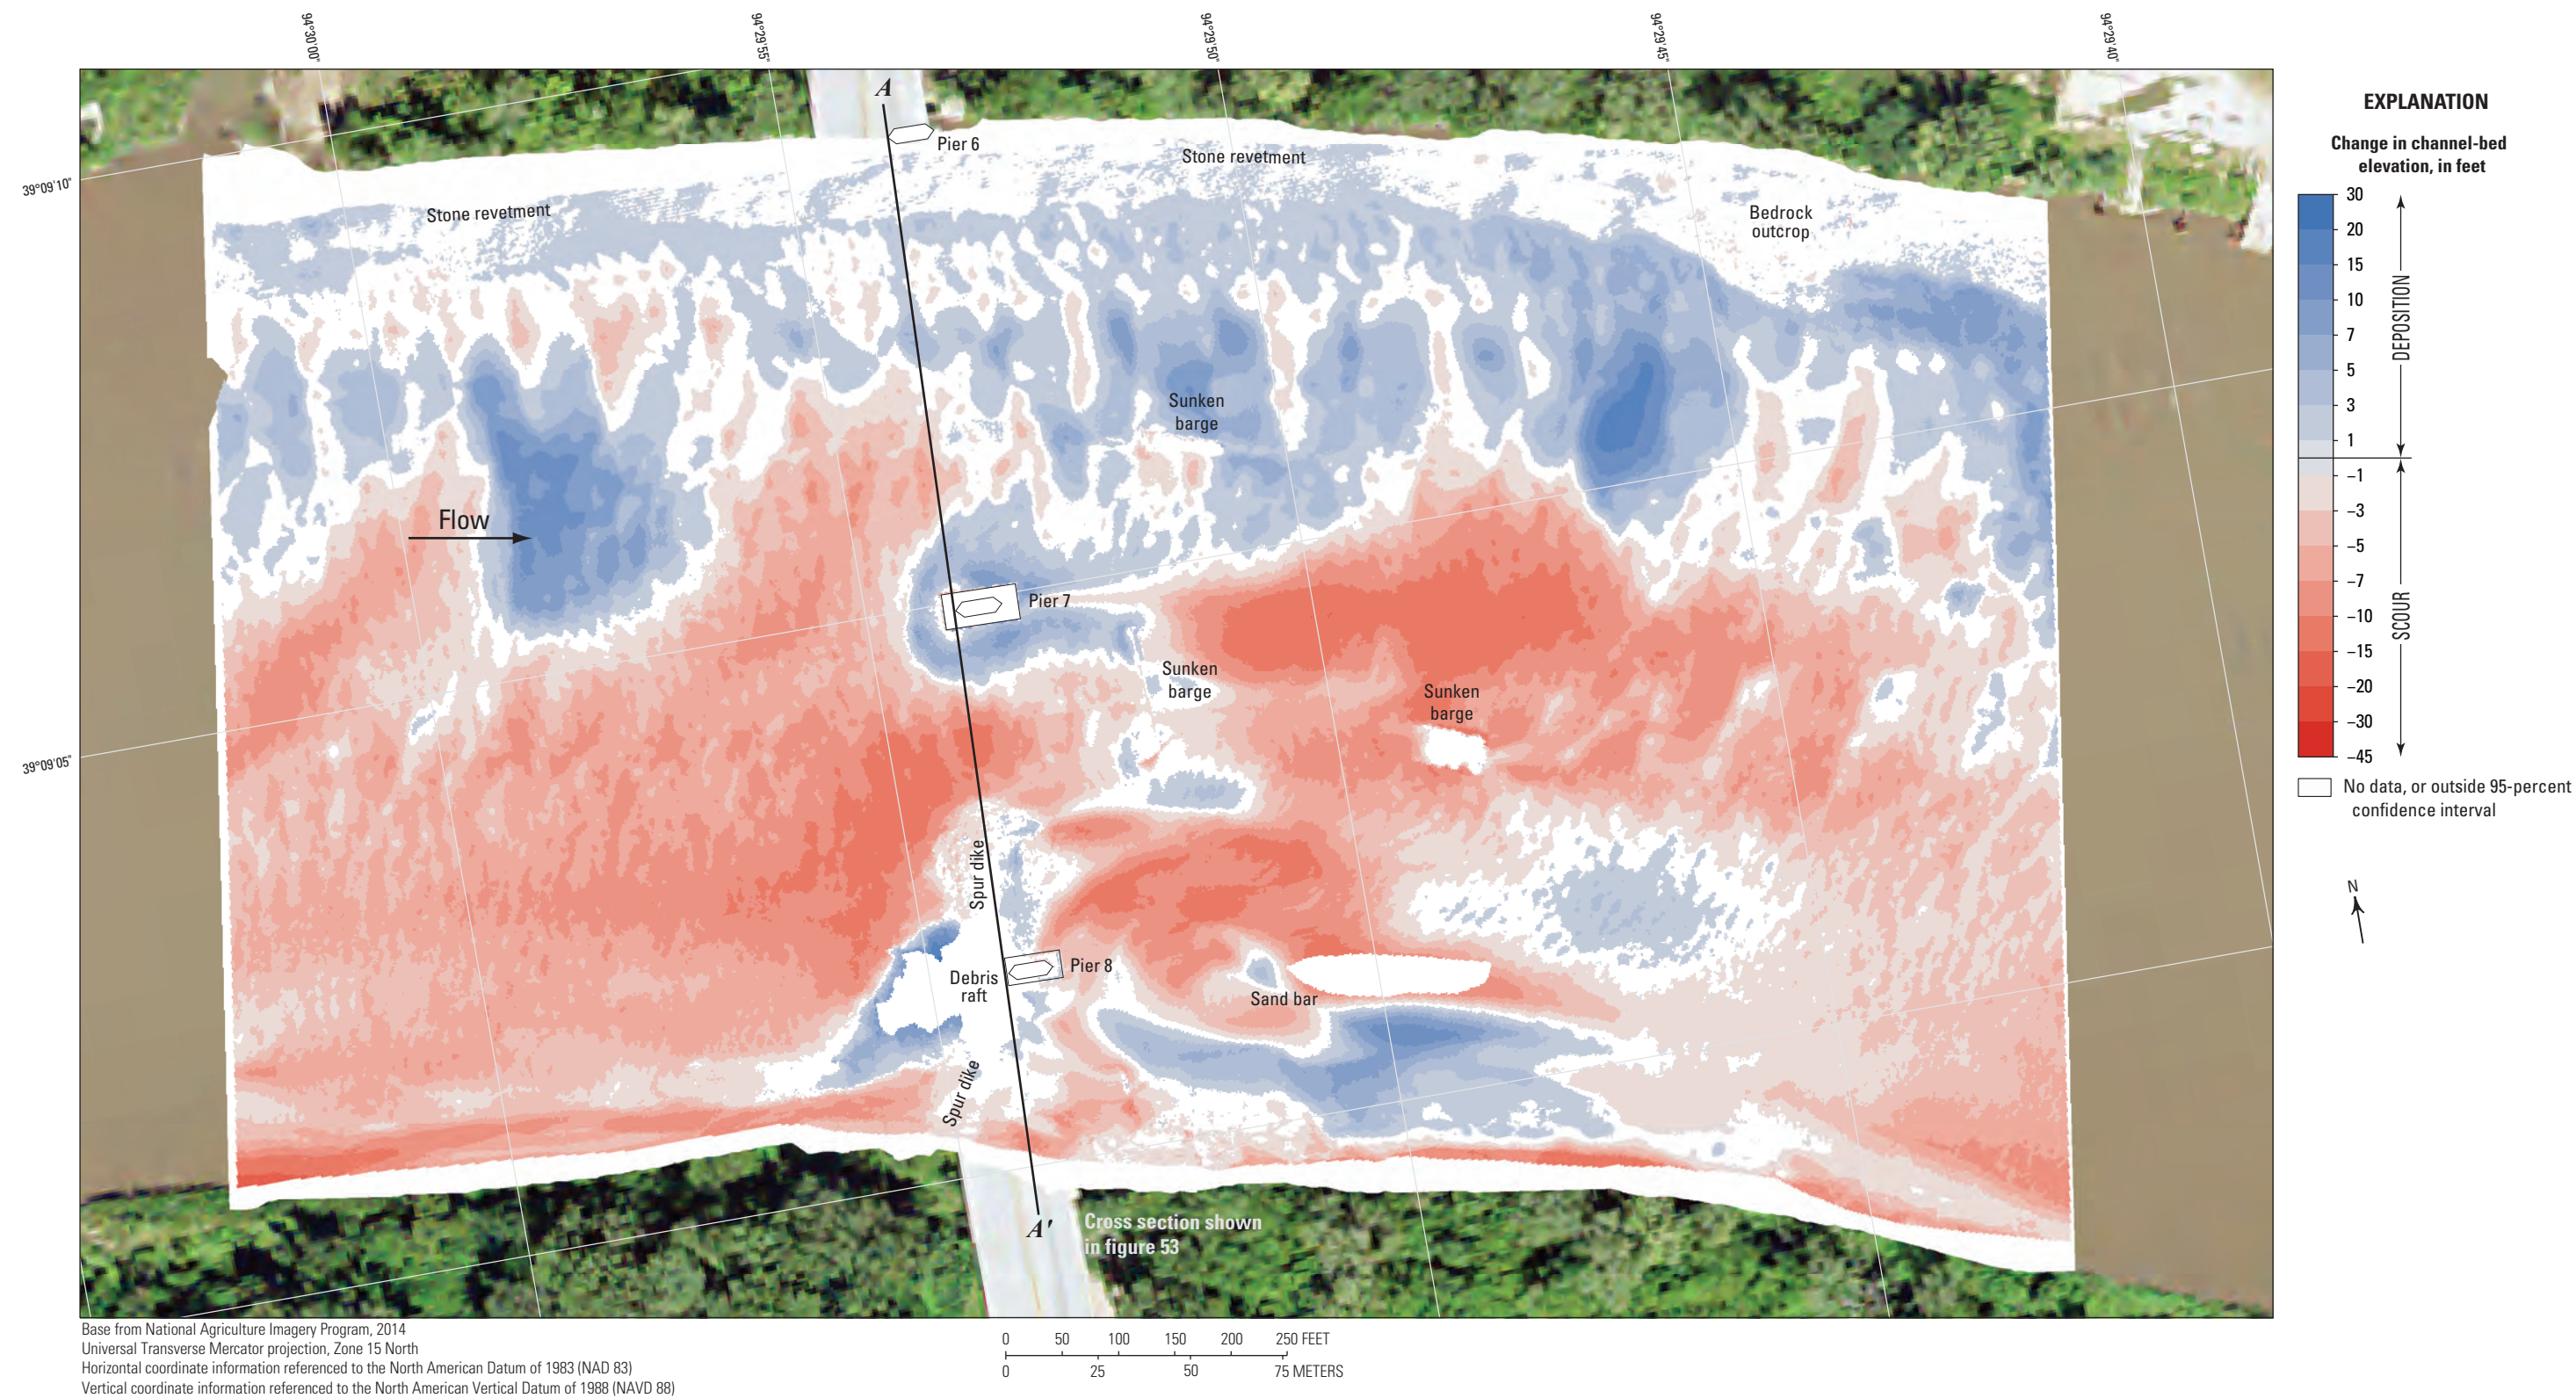
Figure 55. Difference between surfaces created from bathymetric surveys of the Missouri River channel near structure A0767 on Interstate 435 in Kansas City, Missouri, on August 14, 2019, and July 18, 2011.

The difference between the survey on August 14, 2019, and the previous flood survey on July 18, 2011 ([fig. 55](#)), indicates about 82 percent of the joint area of interest had detectable change, which means about 18 percent of the differences in the joint area of interest are equivocal and within the uncertainty. Bed variation from 2015 to 2019 was moderate to substantial in the DoD map, deposition was predominant in the thalweg on the left (north) side and in the troughs of substantial dunes present in the 2011 survey (Huizinga, 2012), and scour was predominant throughout the middle and right (south) side of the reach ([fig. 55](#)). The average difference between the bathymetric surfaces was -2.28 ft ([table 7](#)), indicating moderate degradation between the 2011 and 2019 surveys. The net volume of cut in the reach from 2011 to 2019 was about 147,800 yd³, and the net volume of fill was about 49,900 yd³, resulting in a net loss of about 97,900 yd³ of sediment in the reach between 2011 and 2019. The cross sections from the two surveys along the upstream face of the

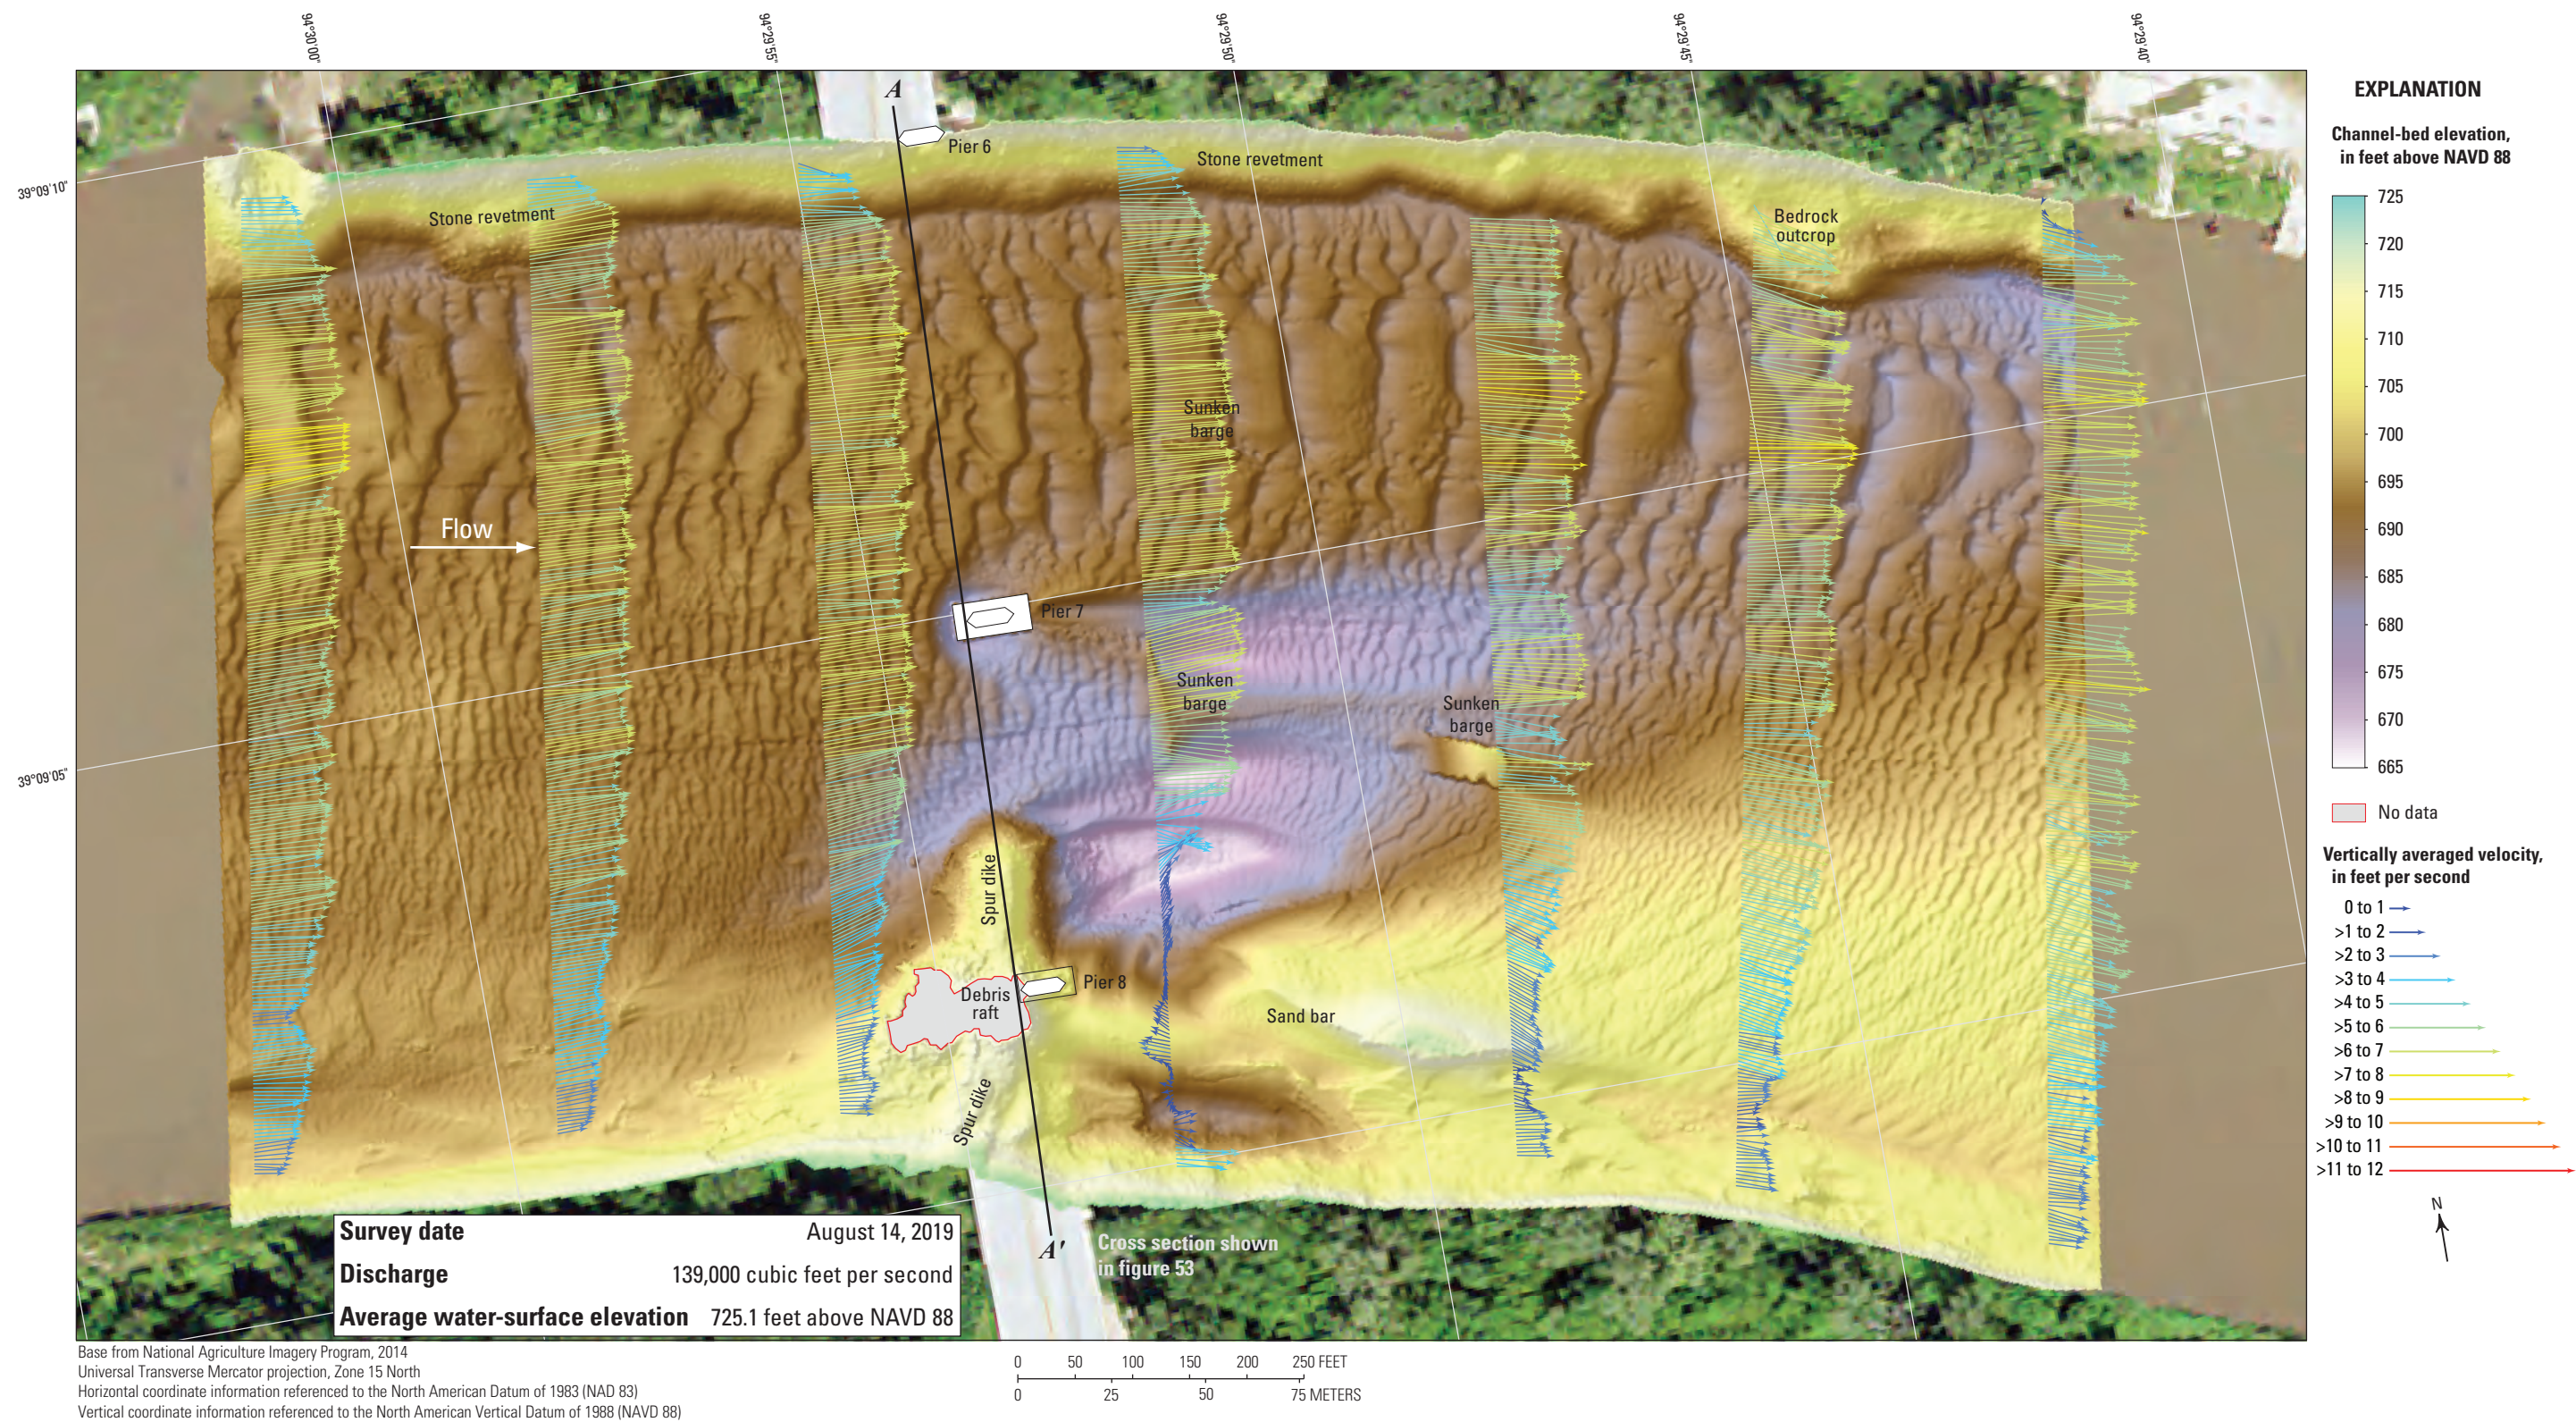
Figure 57. Bathymetry and vertically averaged velocities of the Missouri River channel near structure A0767 on Interstate 435 in Kansas City, Missouri, on August 14, 2019.

The vertically averaged velocity vectors indicate mostly uniform flow throughout the reach, ranging from about 2 ft/s along the inside of the bend on the right (south) bank to 9 ft/s in the thalweg (fig. 57); however, turbulence and velocity

reduction were observed downstream from the spur dike, debris raft, and pier 8, and moderate turbulence was observed in several transects (fig. 57).

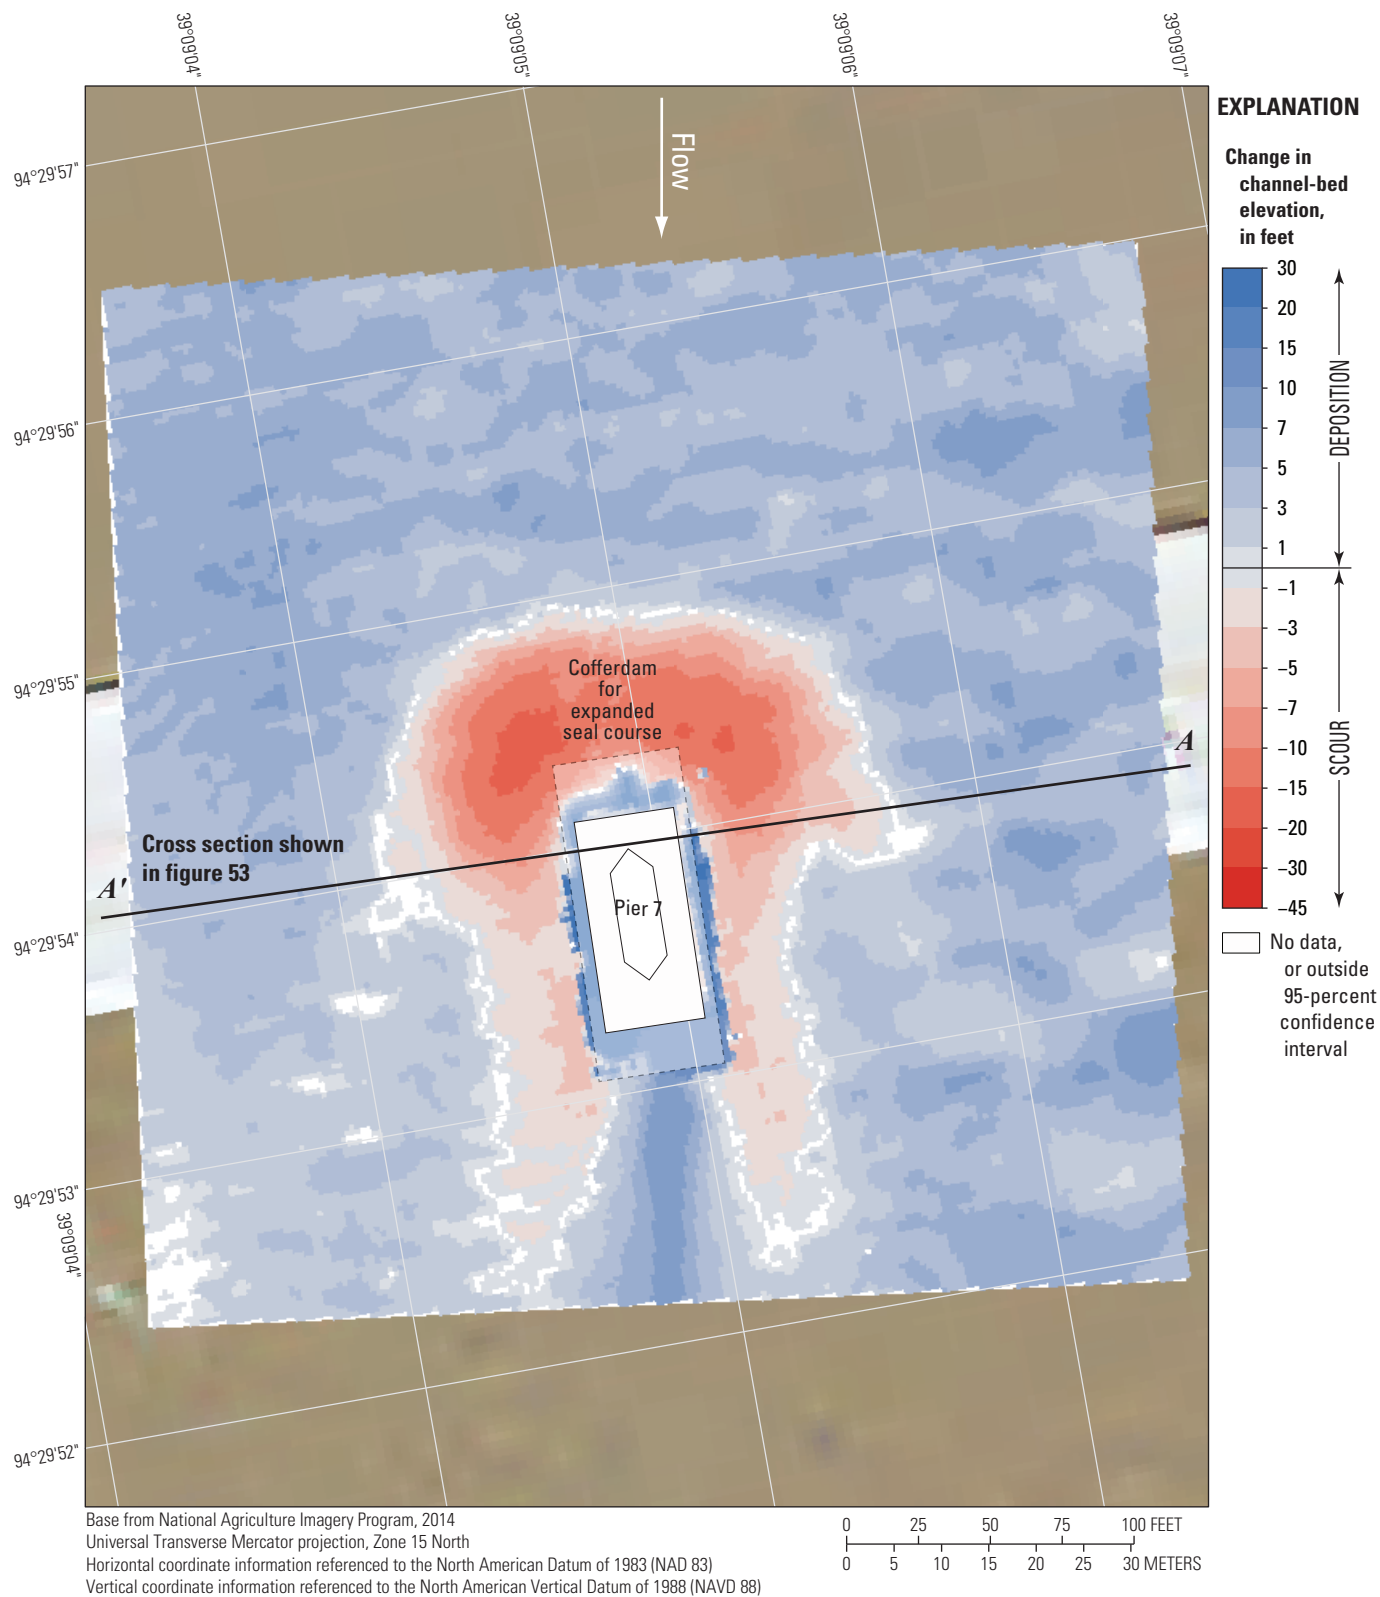
Figure 59. Difference between surfaces created from bathymetric surveys of the Missouri River channel near the main channel pier of structure A0767 on Interstate 435 in Kansas City, Missouri, on August 13, 2019, and August 17, 2020, before installation of scour countermeasures.
