Bathymetric and Velocimetric Surveys at Highway Bridges Crossing the Missouri River near Kansas City, Missouri, August 2019, August 2020, and October 2020

Scientific Investigations Report 2021–5098

By Richard J. Huizinga

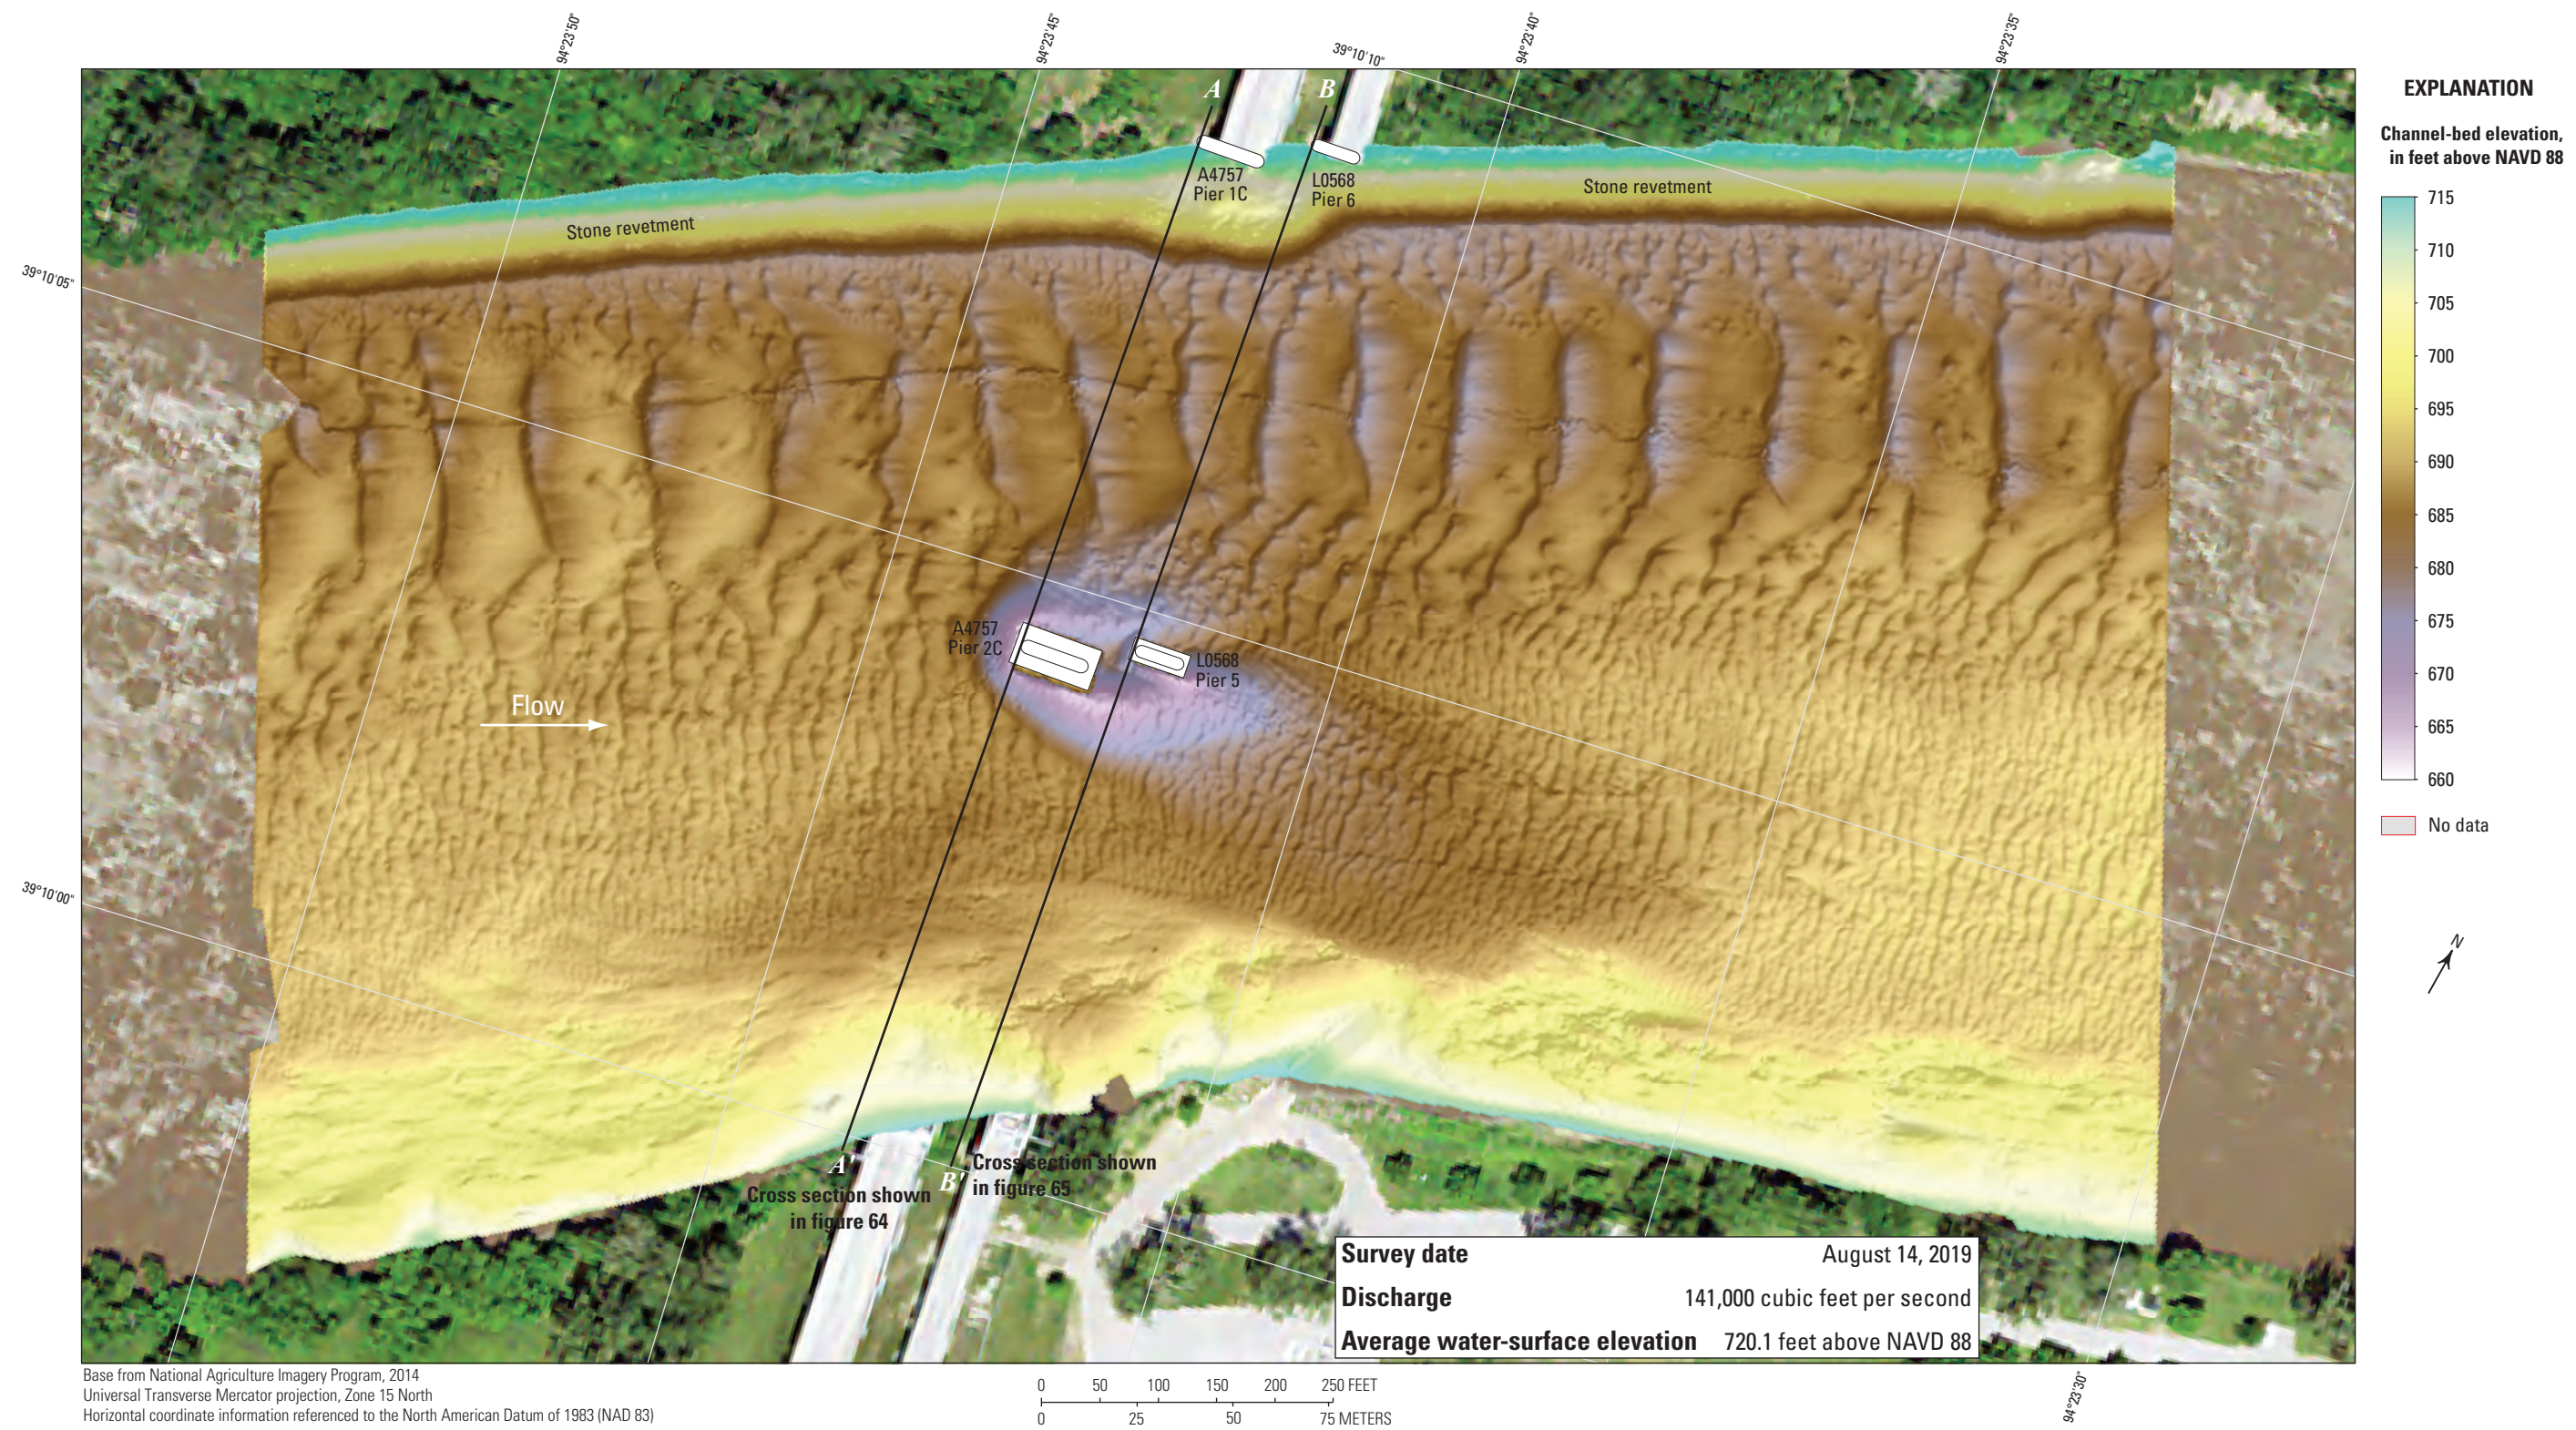
Structures A4757 and L0568 (site 13; [table 1](#)) are dual bridges on State Highway 291, crossing the Missouri River at RM 352.7 on the northeastern side of the Kansas City, Mo., metropolitan area ([fig. 1](#)). The site was surveyed on August 14, 2019, and the average water-surface elevation of the river in the survey area, determined by the RTK GPS tide solution, was 720.1 ft ([table 5](#); [fig. 62](#)). Streamflow on the Missouri River was about 141,000 ft³/s during the survey ([table 5](#)).

The survey area was about 1,640 ft long and averaged about 890 ft wide, extending from bank to bank in the main channel ([fig. 62](#)). The upstream end of the survey area was about 720 ft upstream from the centerline between structures A4757 and L0568 ([fig. 42](#)). The channel-bed elevations ranged from about 679 to 706 ft for most of the surveyed area (5th to 95th percentile range of the bathymetric data; [table 5](#); [fig. 63](#)), except near the main channel piers of structures A4757 and L0568 ([fig. 62](#)). A channel thalweg was along the left (north) bank throughout the channel and was about 10 ft deeper than the middle of the channel ([fig. 62](#)). A row of medium dune features were observed in the thalweg on the left side of the channel, as well as numerous small dunes and ripples throughout the rest of the channel ([fig. 62](#)). As in previous surveys at this site (Huizinga, 2010, 2012, 2016), a noticeable channel constriction was at and immediately downstream from the bridges, and the left (north) bank was covered with stone revetment ([fig. 62](#)).

A large scour hole near the main channel piers ([fig. 62](#)) that essentially encompasses both piers had a minimum channel-bed elevation of about 664 ft ([table 6](#)), which also was the minimum channel-bed elevation for the entire reach ([table 5](#)). The main channel piers were skewed to the approaching flow, which caused a wide scour hole with somewhat unique characteristics as compared to scour holes at the other surveyed bridges. Pier 5 of structure L0568 was in the wake of pier 2C of structure A4757 and, therefore, had a poorly defined scour hole near it ([fig. 62](#)). At the upstream end of pier 2C of structure A4757, the minimum channel-bed elevation was about 664 ft, and at the upstream end of pier 5 of structure L0568, the minimum channel-bed elevation was about 672 ft ([fig. 62](#); [table 6](#)). Information from bridge plans indicates that the main channel pier 2C of structure A4757 is founded on shafts drilled 20 ft into bedrock ([fig. 64](#)), and about 45 ft of bed material are between the bottom of the scour hole and bedrock at the point of minimum elevation of the scour hole near the upstream pier face ([fig. 64](#); [table 6](#)). At the point of minimum elevation, the surveyed channel bed was about 2 ft below the bottom of the seal course elevation of 666.26 ft ([table 6](#)). Information from bridge plans indicate that the main channel pier 5 of structure L0568 is a caisson on bedrock ([fig. 65](#)), and about 47 ft of bed material are between the bottom of the scour hole and bedrock at the point of minimum elevation of the scour hole near the downstream right (south) corner ([fig. 65](#); [table 6](#)).

Figure 62. Bathymetric survey of the Missouri River channel near structures A4757 and L0568 on State Highway 291 near Kansas City, Missouri, on August 14, 2019.

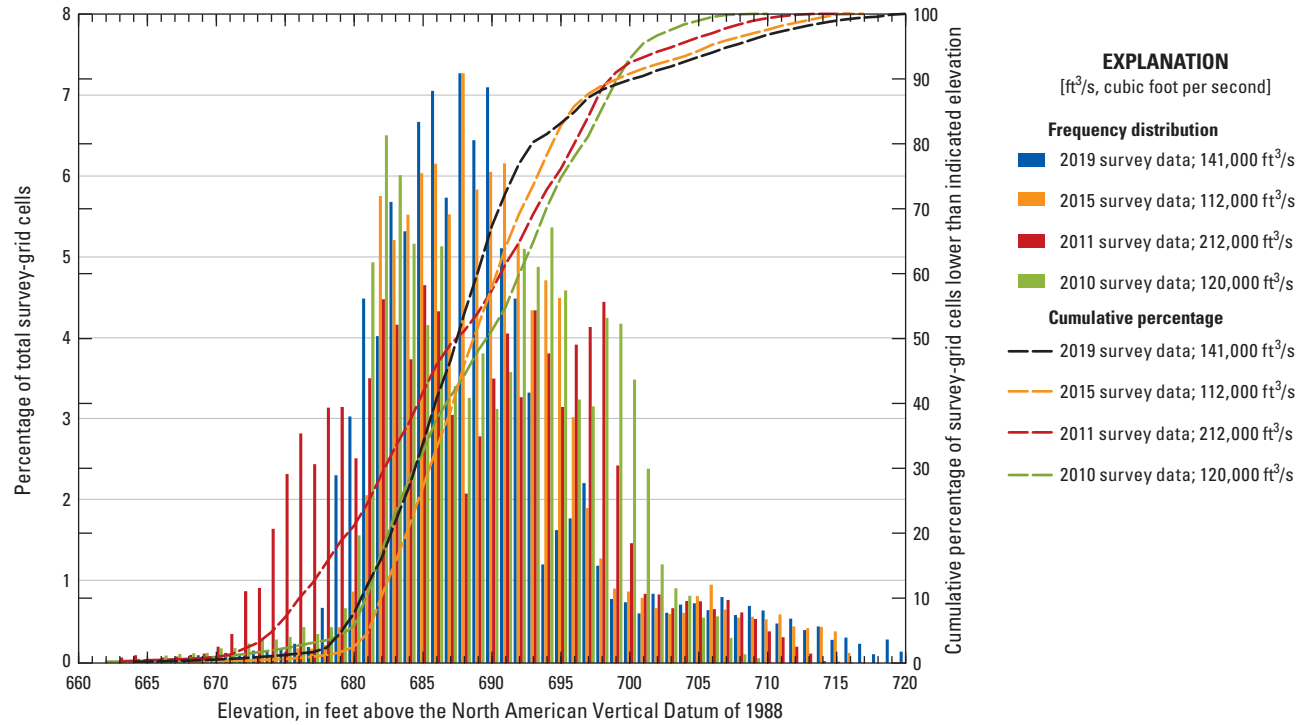
Figure 63. Frequency distribution of bed elevations for bathymetric survey-grid cells in 1-foot elevation bins on the Missouri River near structures A4757 and L0568 on State Highway 291 near Kansas City, Missouri, on August 14, 2019, compared to previous surveys in 2010, 2011, and 2015 (Huizinga, 2010, 2012, 2016, respectively).

The size and shape of the frequency distributions through time also may be an indication of the type of river reach the site is located upon. Sites 6 and 7 are both on the same gentle bend in the river, and the similarities of the curve shapes may be indicative of the channel bend characteristics (figs. 7, 14, 71). Sites 11 and 12 also are on gentle river bends and have distributions curves with a similar shape to sites 6 and 7 (figs. 45, 52, 71). Site 13 also is on a gentle river bend, but the frequency distribution is somewhat unique (figs. 63, 71), likely because of the size and alignment of the piers at that

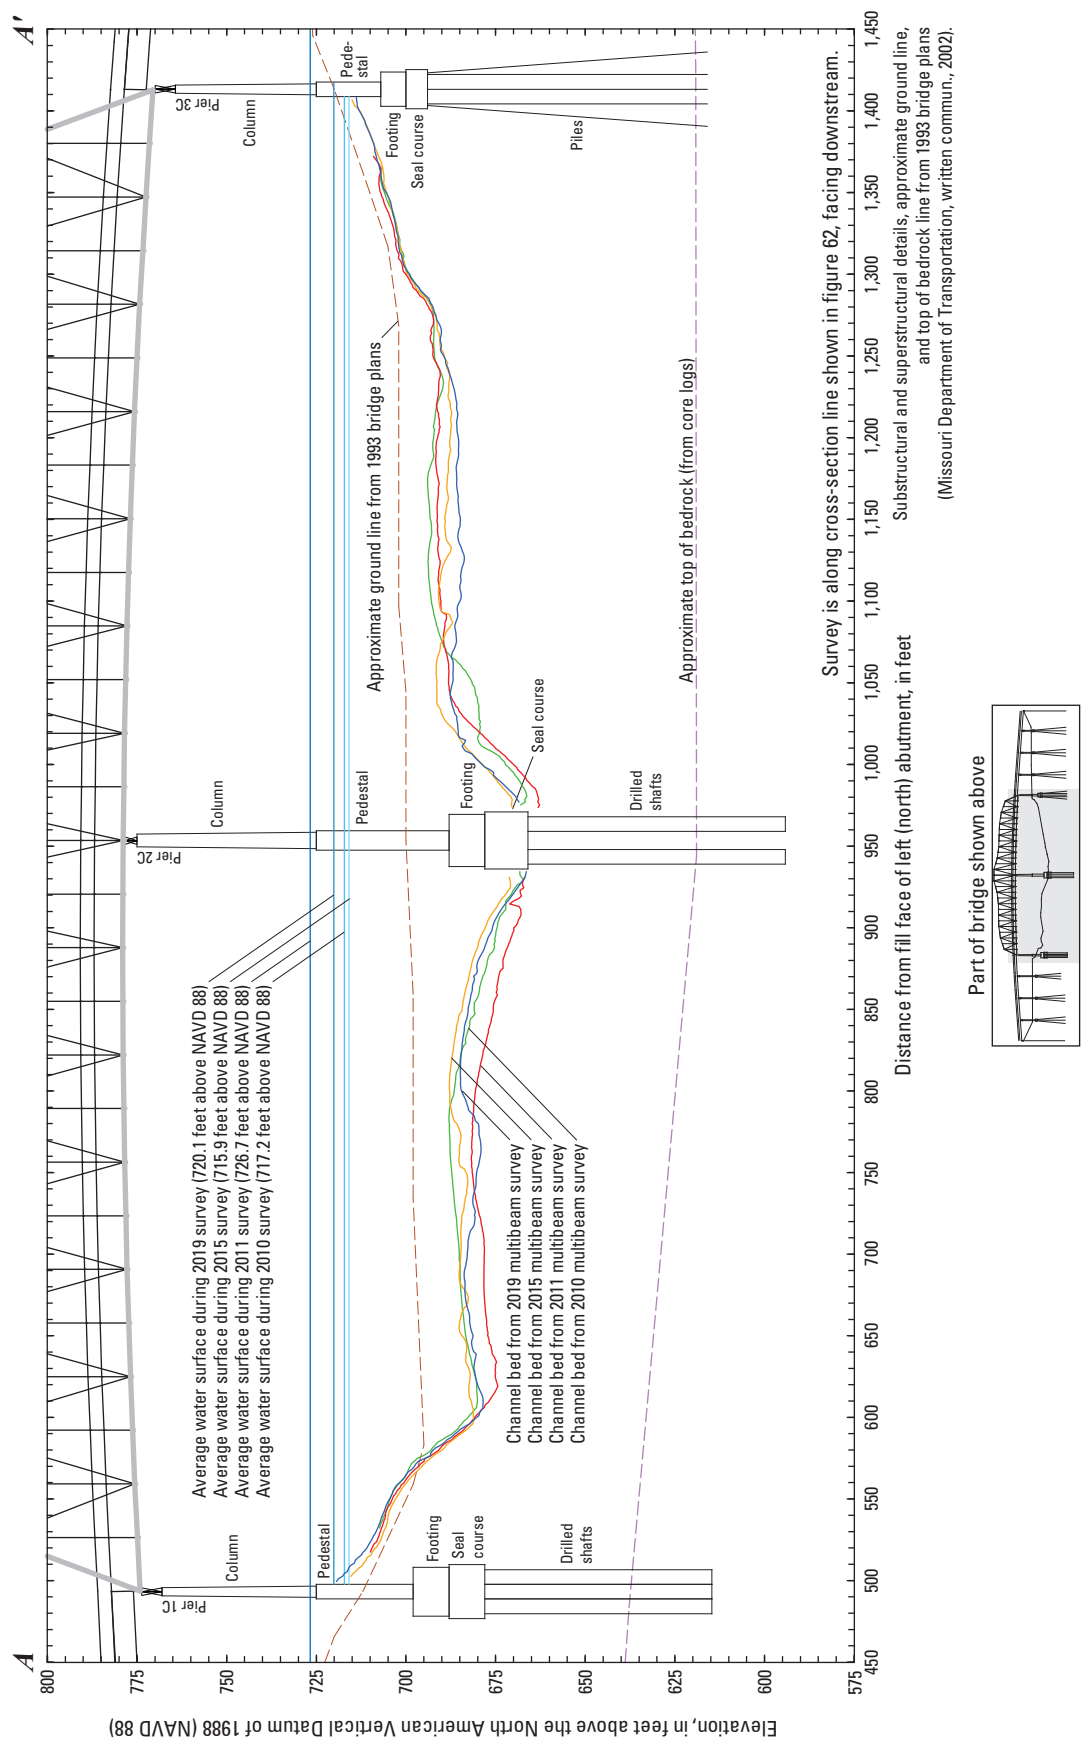
Figure 64. Key features, substructural and superstructural details, and surveyed channel bed of structure A4757 on State Highway 291 crossing the Missouri River near Kansas City, Missouri.

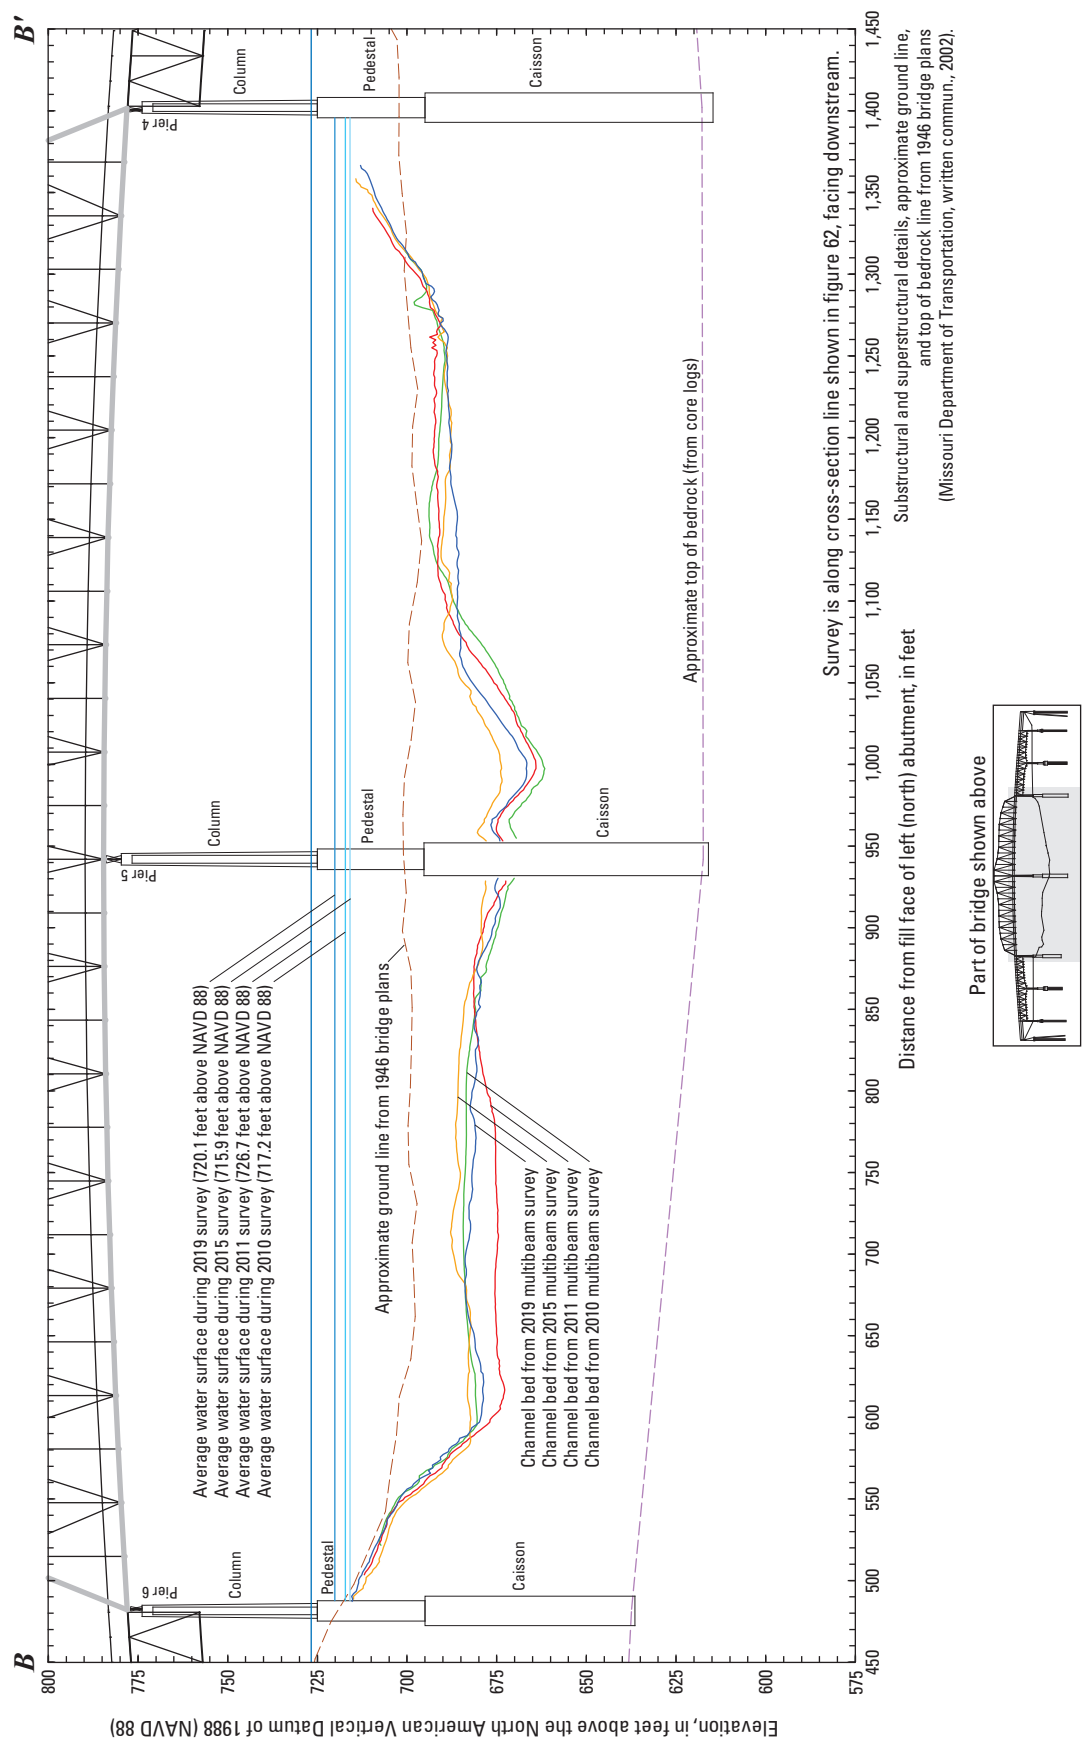
Figure 65. Key features, substructural and superstructural details, and surveyed channel bed of structure L0568 on State Highway 291 crossing the Missouri River near Kansas City, Missouri.

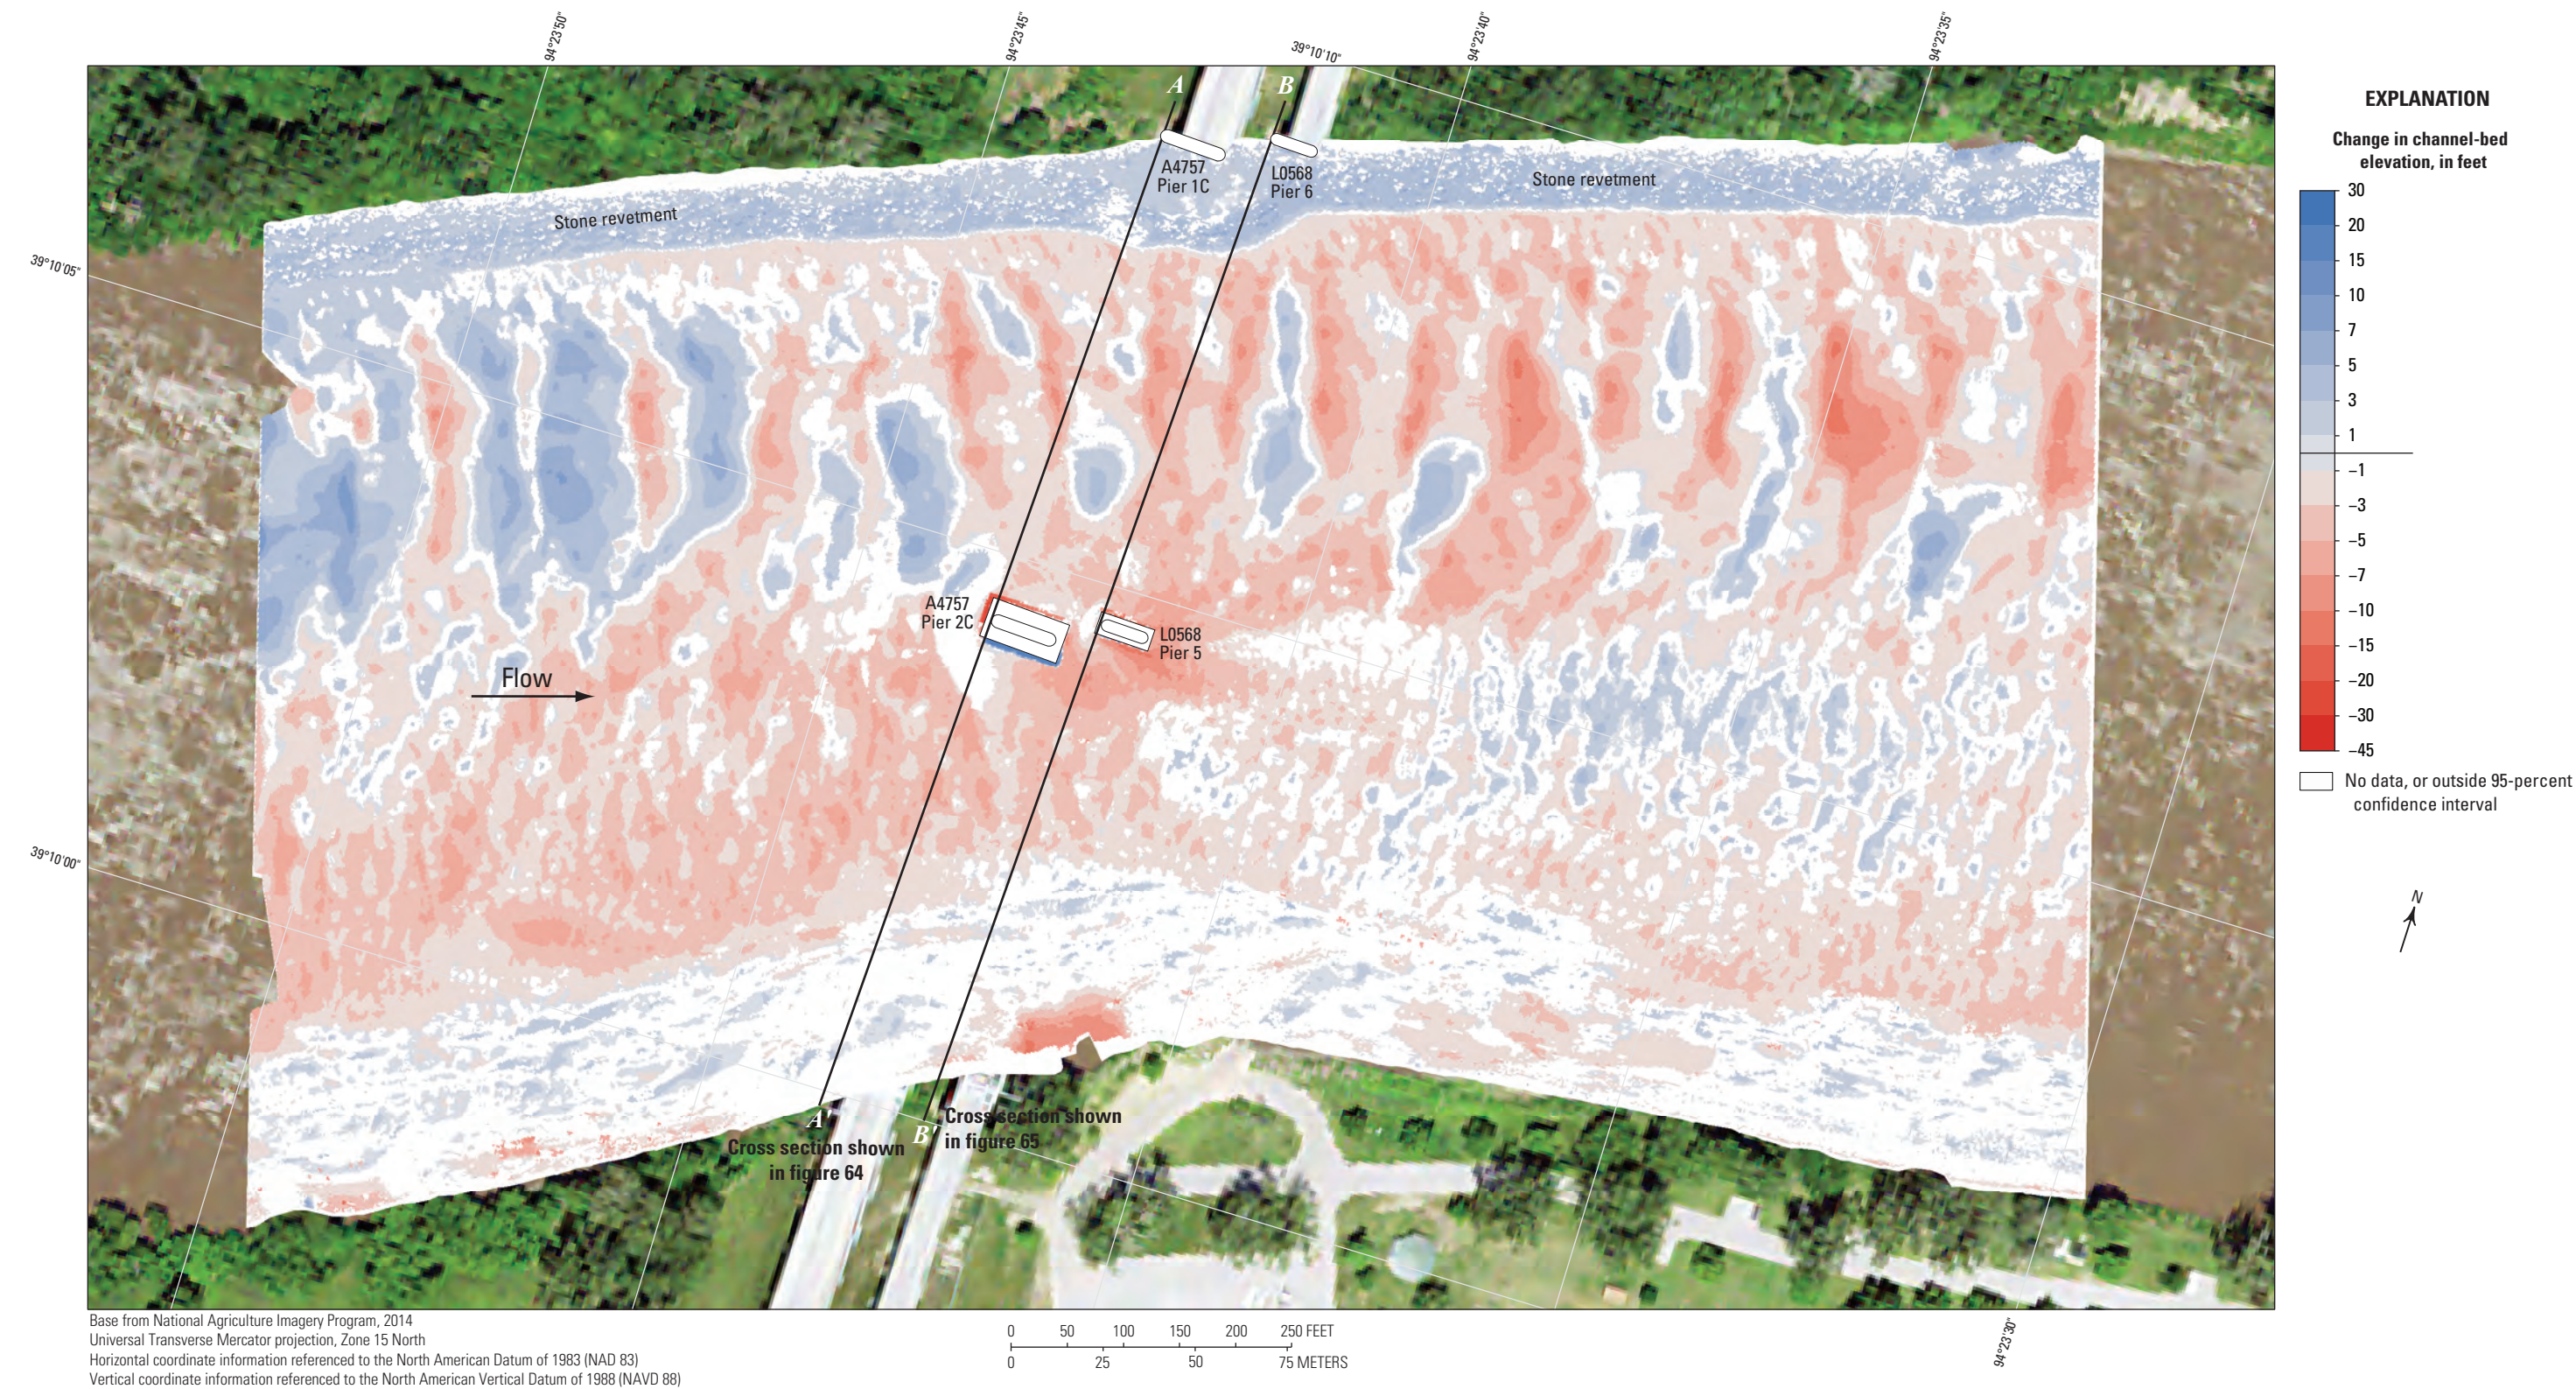
The difference between the survey on August 14, 2019, and the previous nonflood survey on June 4, 2015 ([fig. 66](#)), indicates about 74 percent of the joint area of interest had detectable change, which means about 26 percent of the differences in the joint area of interest are equivocal and within the uncertainty. Bed variation seemed nearly equal between scour and deposition from 2015 to 2019 in the DoD map, deposition was predominant from the upstream left through the downstream right of the reach, and scour was predominant from the upstream right to the downstream left ([fig. 66](#)). The average difference between the bathymetric surfaces was -1.51 ft ([table 7](#)), indicating minor to moderate degradation between the 2015 and 2019 surveys. The net volume of cut in the reach from 2015 to 2019 was about 82,100 yd³, and the net volume of fill was about 25,100 yd³, resulting in a net loss of about 57,000 yd³ of sediment between 2015 and 2019. The cross sections from the two surveys along the upstream face of the upstream bridge are similar to each other but generally with uniform scour of 5 to 10 ft across the section ([fig. 64](#)). The cross sections from the two surveys along the upstream face of the downstream bridge also are similar to each other but generally with uniform scour of 10 ft across the section ([fig. 65](#)). The frequency distribution of bed elevations in 2019 was very similar to 2015, but a higher percentage of cells were at slightly lower channel-bed elevations in 2019 ([fig. 63](#)). The scour hole near upstream pier 2C was similar to 2015, as evidenced by the area of equivocal data in a horseshoe shape around the upstream end of that pier in the DoD map ([fig. 66](#)). However, the scour hole was slightly deeper near downstream pier 5 than in 2015, as evidenced by the area of scour starting at the downstream side of upstream pier 2C and extending downstream around pier 5 in the DoD map ([fig. 66](#)). The stone revetment on the left (north) bank showed signs of nearly uniform deposition throughout the reach between 2015 and 2019, which is somewhat unexpected ([fig. 66](#)); as indicated with others surveys in the current study, there may be a horizontal offset to the 2019 data on the bank that is creating the appearance of deposition. The potential for a horizontal offset is substantiated by the appearance of substantial scour on the left (north) faces and deposition on the right (south) faces of the footing and caisson that likely results from minor horizontal positional variances between the surveys (see "Uncertainty Estimation" section).

Figure 66. Difference between surfaces created from bathymetric surveys of the Missouri River channel near structures A4757 and L0568 on State Highway 291 near Kansas City, Missouri, on August 14, 2019, and June 4, 2015.

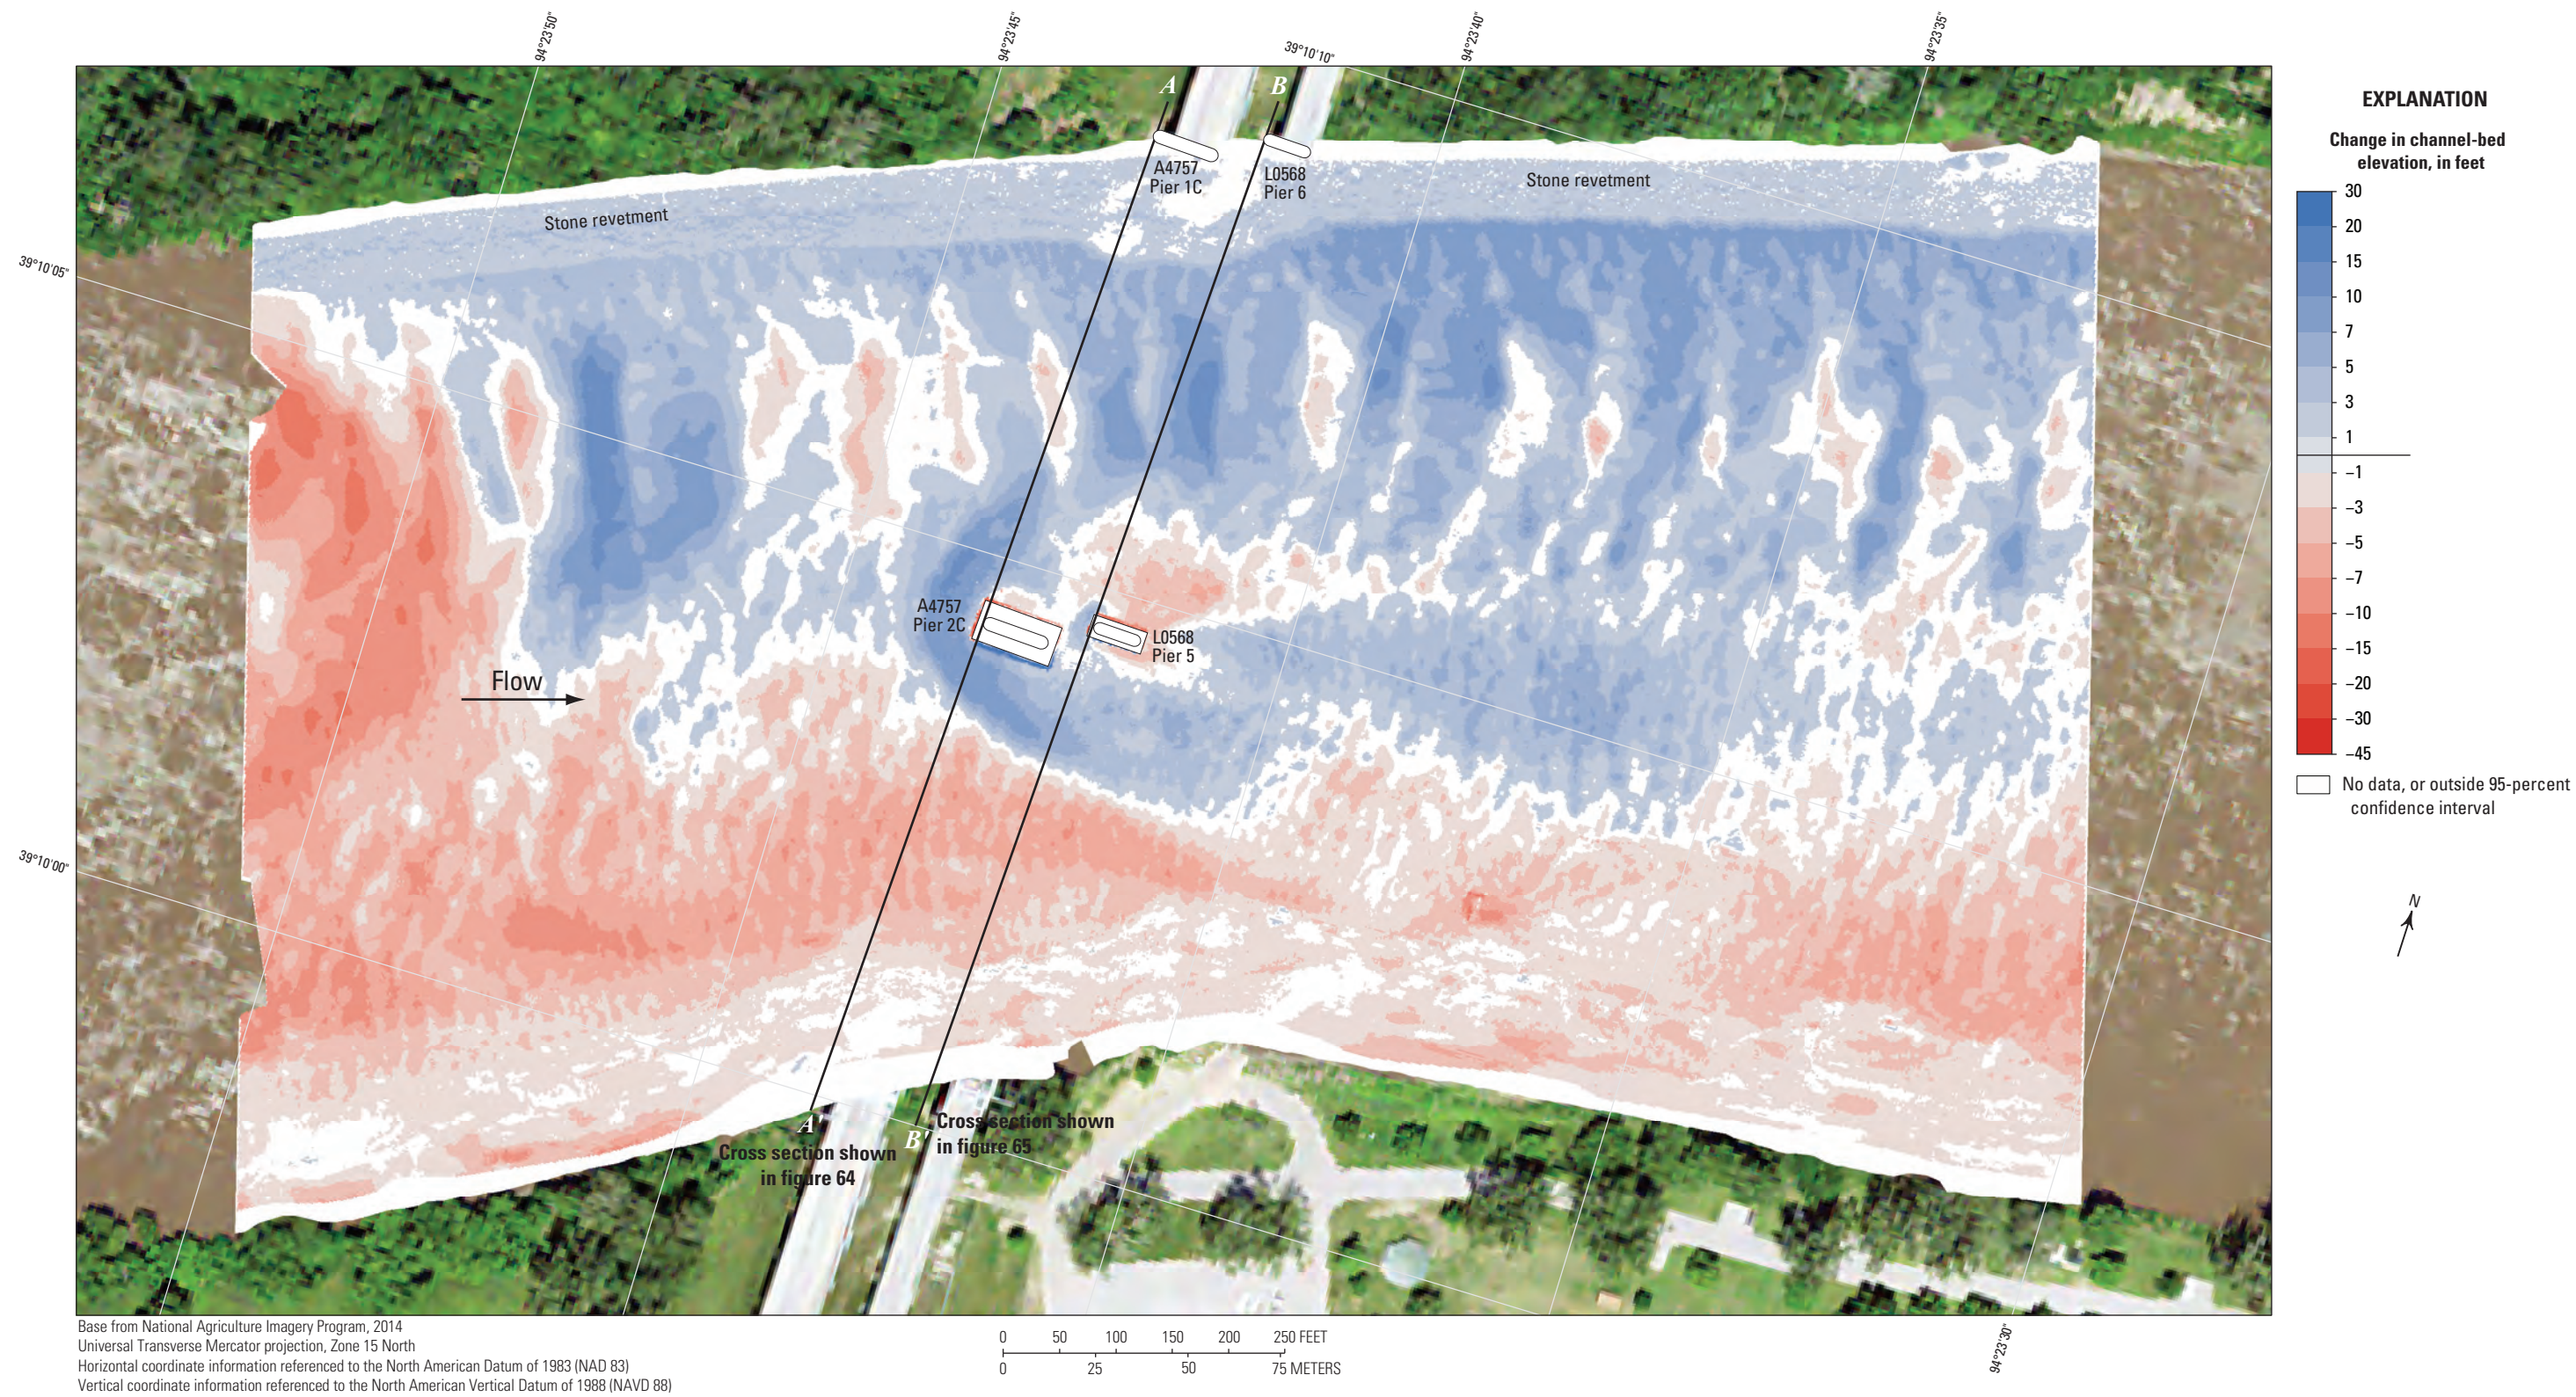
The difference between the survey on August 14, 2019, and the previous flood survey on July 19, 2011 ([fig. 67](#)), indicates about 85 percent of the joint area of interest had detectable change, which means about 15 percent of the differences in the joint area of interest are equivocal and within the uncertainty. Substantial but approximately balanced bed variation was apparent from 2011 to 2019 in the DoD map, substantial scour was throughout the upstream part and along the right side of the reach, and substantial deposition was along the thalweg along the left (north) side and in the troughs of substantial dunes present in the 2011 survey (Huizinga, 2012, [fig. 67](#)). The average difference between the bathymetric

Figure 67. Difference between surfaces created from bathymetric surveys of the Missouri River channel near structures A4757 and L0568 on State Highway 291 near Kansas City, Missouri, on August 14, 2019, and July 19, 2011.

surfaces was +0.22 ft (table 7), indicating little net difference between the 2011 and 2019 surveys. The net volume of cut in the reach from 2011 to 2019 was about 77,900 yd³, and the net volume of fill was about 87,400 yd³, resulting in a net gain of about 9,500 yd³ of sediment in the reach between 2011 and 2019. However, the cross sections from the two surveys along the upstream faces of the bridges show the substantial difference in the surveyed sections (figs. 64, 65). The frequency distribution of bed elevations in 2019 also was substantially narrower than 2011 because a higher percentage of cells was at the middle range of elevations (fig. 63). The DoD map shows that the substantial scour hole at upstream pier 2C was smaller and shallower in 2019, as evidenced by the horseshoe-shaped deposition around the nose of the pier (fig. 67). As with the DoD map for 2015 to 2019 (fig. 66), the stone revetment on the left (north) bank showed signs of localized deposition throughout the reach between 2011 and 2019, which is somewhat unexpected (fig. 67); however, the differences on the tops of steps in the bank were within the uncertainties of the data, which implies there may be a horizontal offset to the 2019 data on the bank that is creating the appearance of deposition. The appearance of substantial scour on the left (north) faces and deposition on the right (south) faces of the footing and caisson also likely results from minor horizontal positional variances between the surveys (see “Uncertainty Estimation” section).

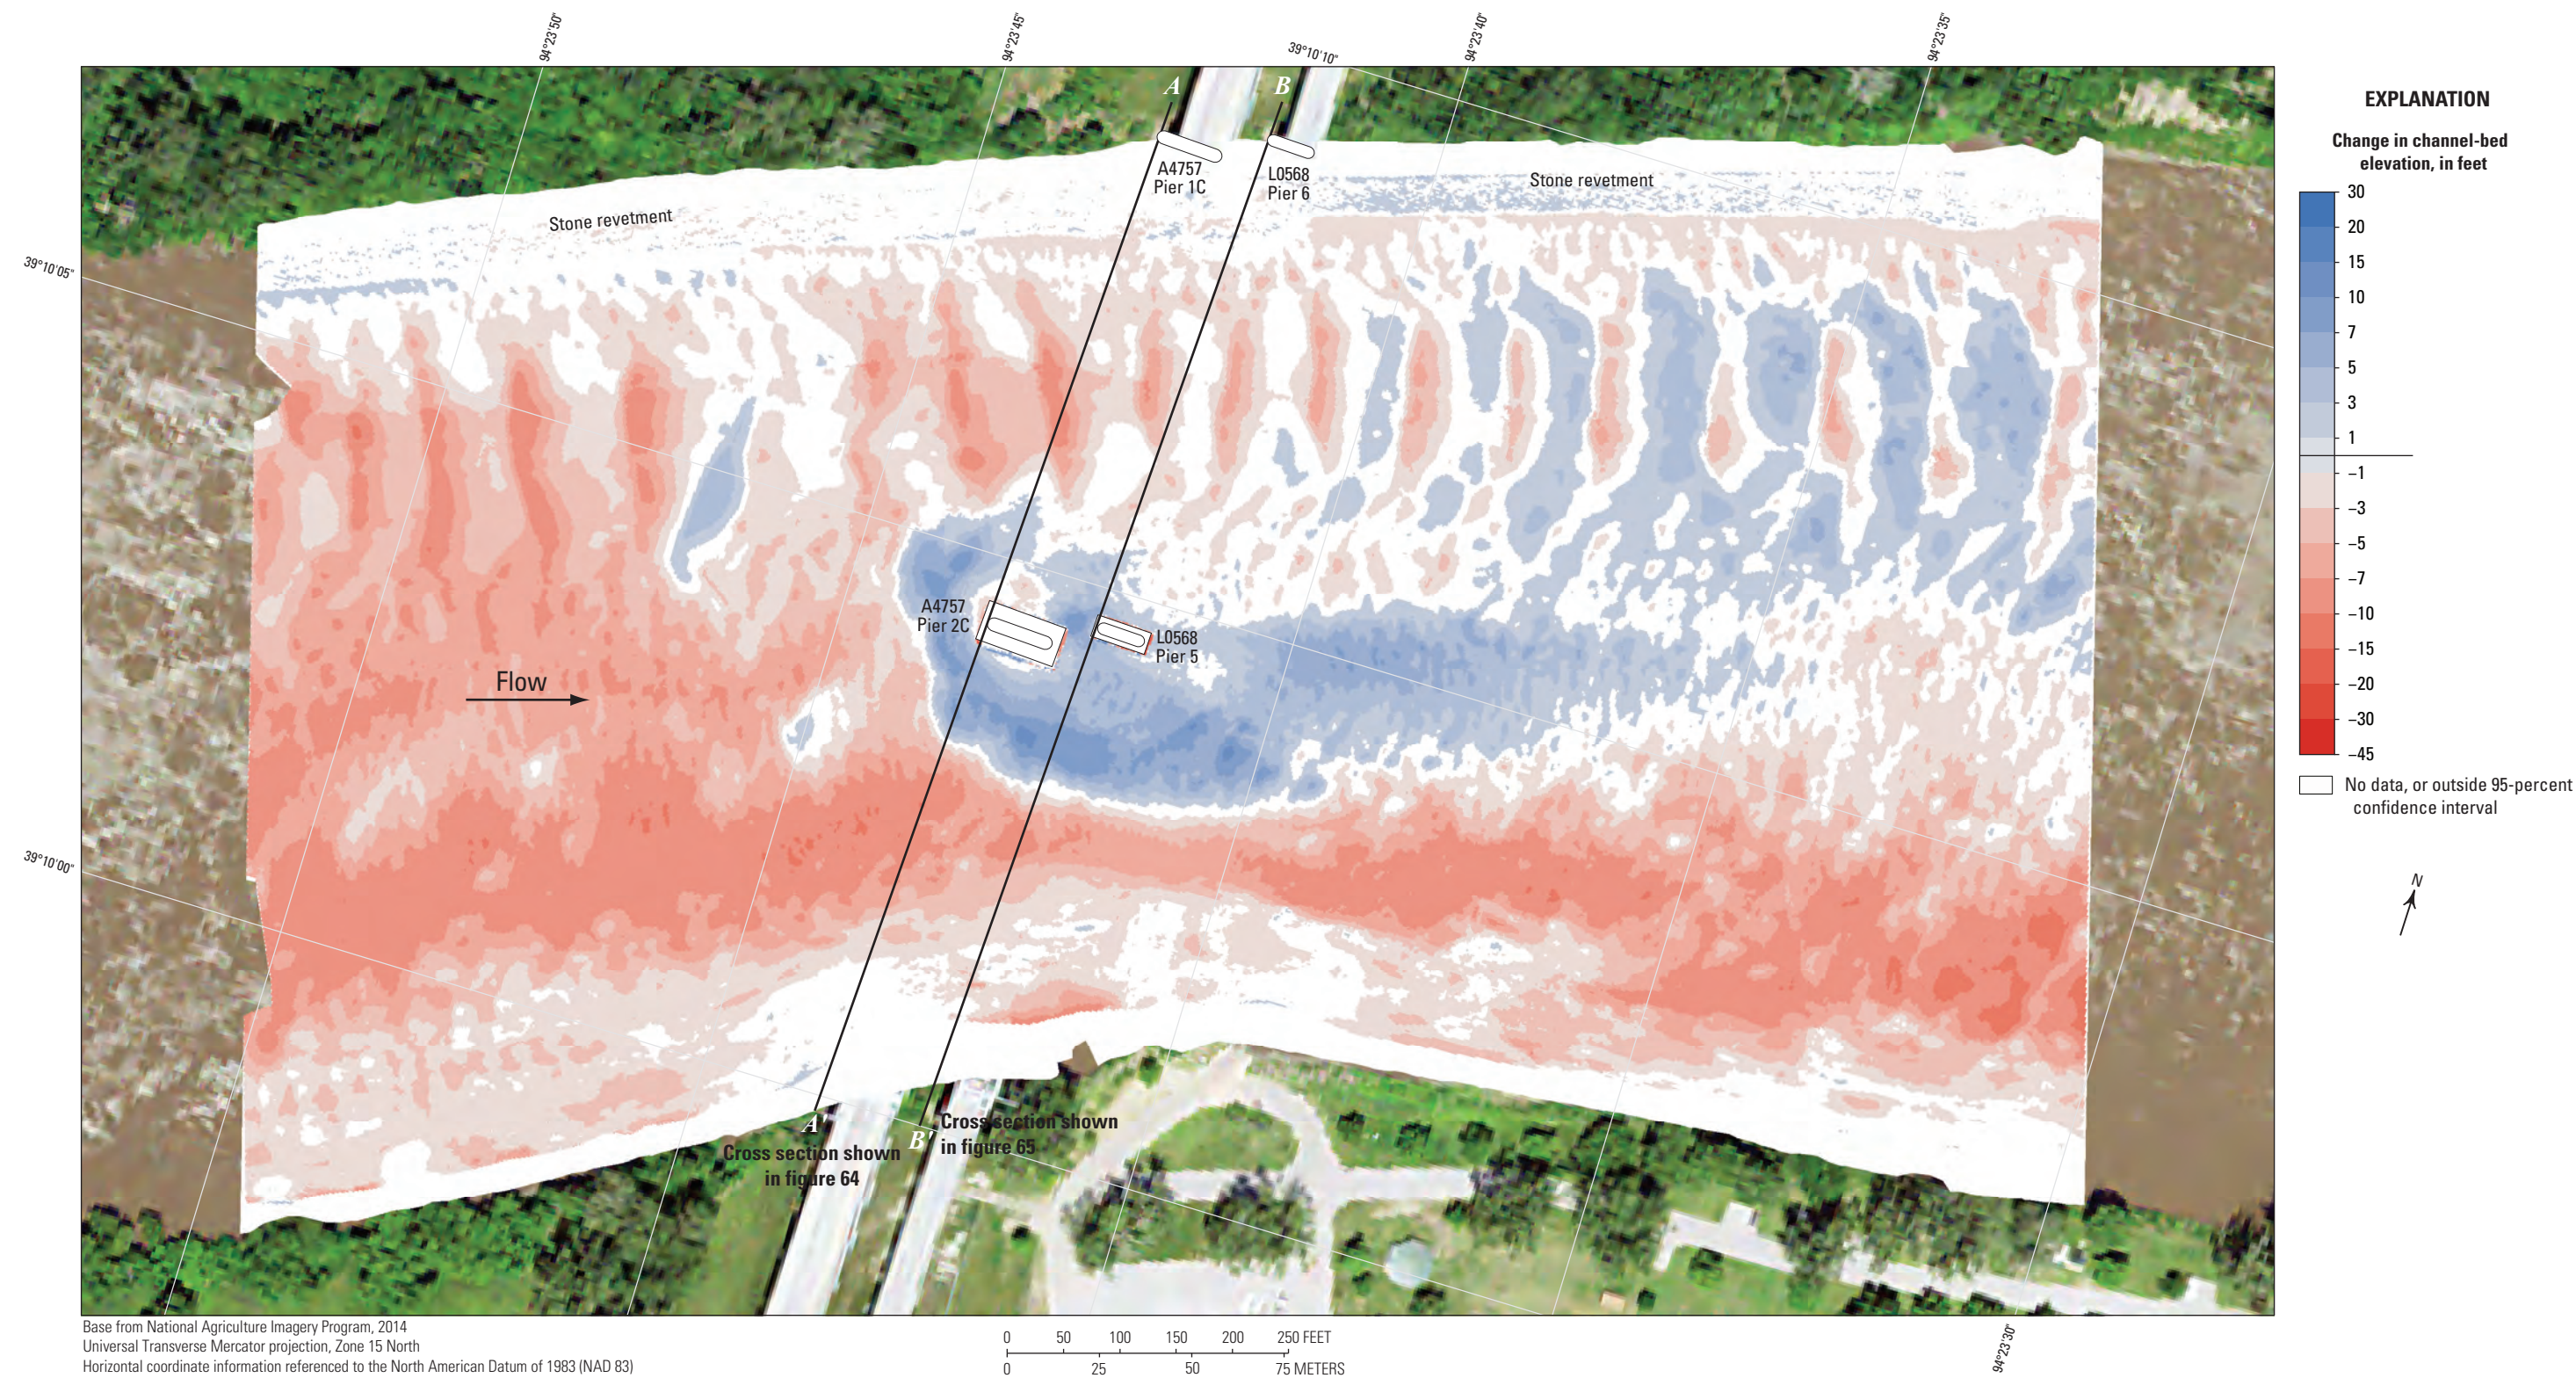
The difference between the survey on August 14, 2019, and the earliest nonflood survey on March 18, 2010 (fig. 68), indicates about 75 percent of the joint area of interest had detectable change, which means about 25 percent of the differences in the joint area of interest are equivocal and within the uncertainty. Substantial but approximately balanced bed variation was apparent from 2010 to 2019 in the DoD map, scour was predominant in the upstream area and along the right (south) bank downstream, and deposition was in the substantial scour hole near the piers and troughs of large dunes in

the downstream channel present in the 2010 survey (Huizinga, 2010; fig. 68). The average difference between the bathymetric surfaces was -2.82 ft (table 7), indicating moderate channel degradation between the 2010 and 2019 surveys. The net volume of cut in the reach from 2010 to 2019 was about 127,200 yd³, and the net volume of fill was about 24,600 yd³, resulting in a net loss of about 102,600 yd³ of sediment between 2010 and 2019. The cross sections from the two surveys along the upstream face of the bridge are similar to each other, except near the piers and between the piers and the right (south) banks (figs. 64, 65). The frequency distribution of bed elevations in 2019 was similar to 2010 at lower elevations but became different with increasing elevation, and a lower percentage of cells was at higher channel-bed elevations (fig. 63); however, the surveyed area was substantially wider in 2019 than in 2010 and extended higher on the channel banks, particularly on the right (south) side (fig. 68). The stone revetment on the left (north) bank showed signs of minor, localized scour and deposition, and much of the difference was within the uncertainties of the data, as would be expected. As with previous DoD maps, and substantial deposition or scour apparent at the faces of the pier footing results from minor horizontal positional variances between the surveys (see “Uncertainty Estimation” section).

Figure 68. Difference between surfaces created from bathymetric surveys of the Missouri River channel near structures A4757 and L0568 on State Highway 291 near Kansas City, Missouri, on August 14, 2019, and March 18, 2010.
