Bathymetric and Velocimetric Surveys at Highway Bridges Crossing the Missouri River near Kansas City, Missouri, August 2019, August 2020, and October 2020

Scientific Investigations Report 2021–5098

By Richard J. Huizinga

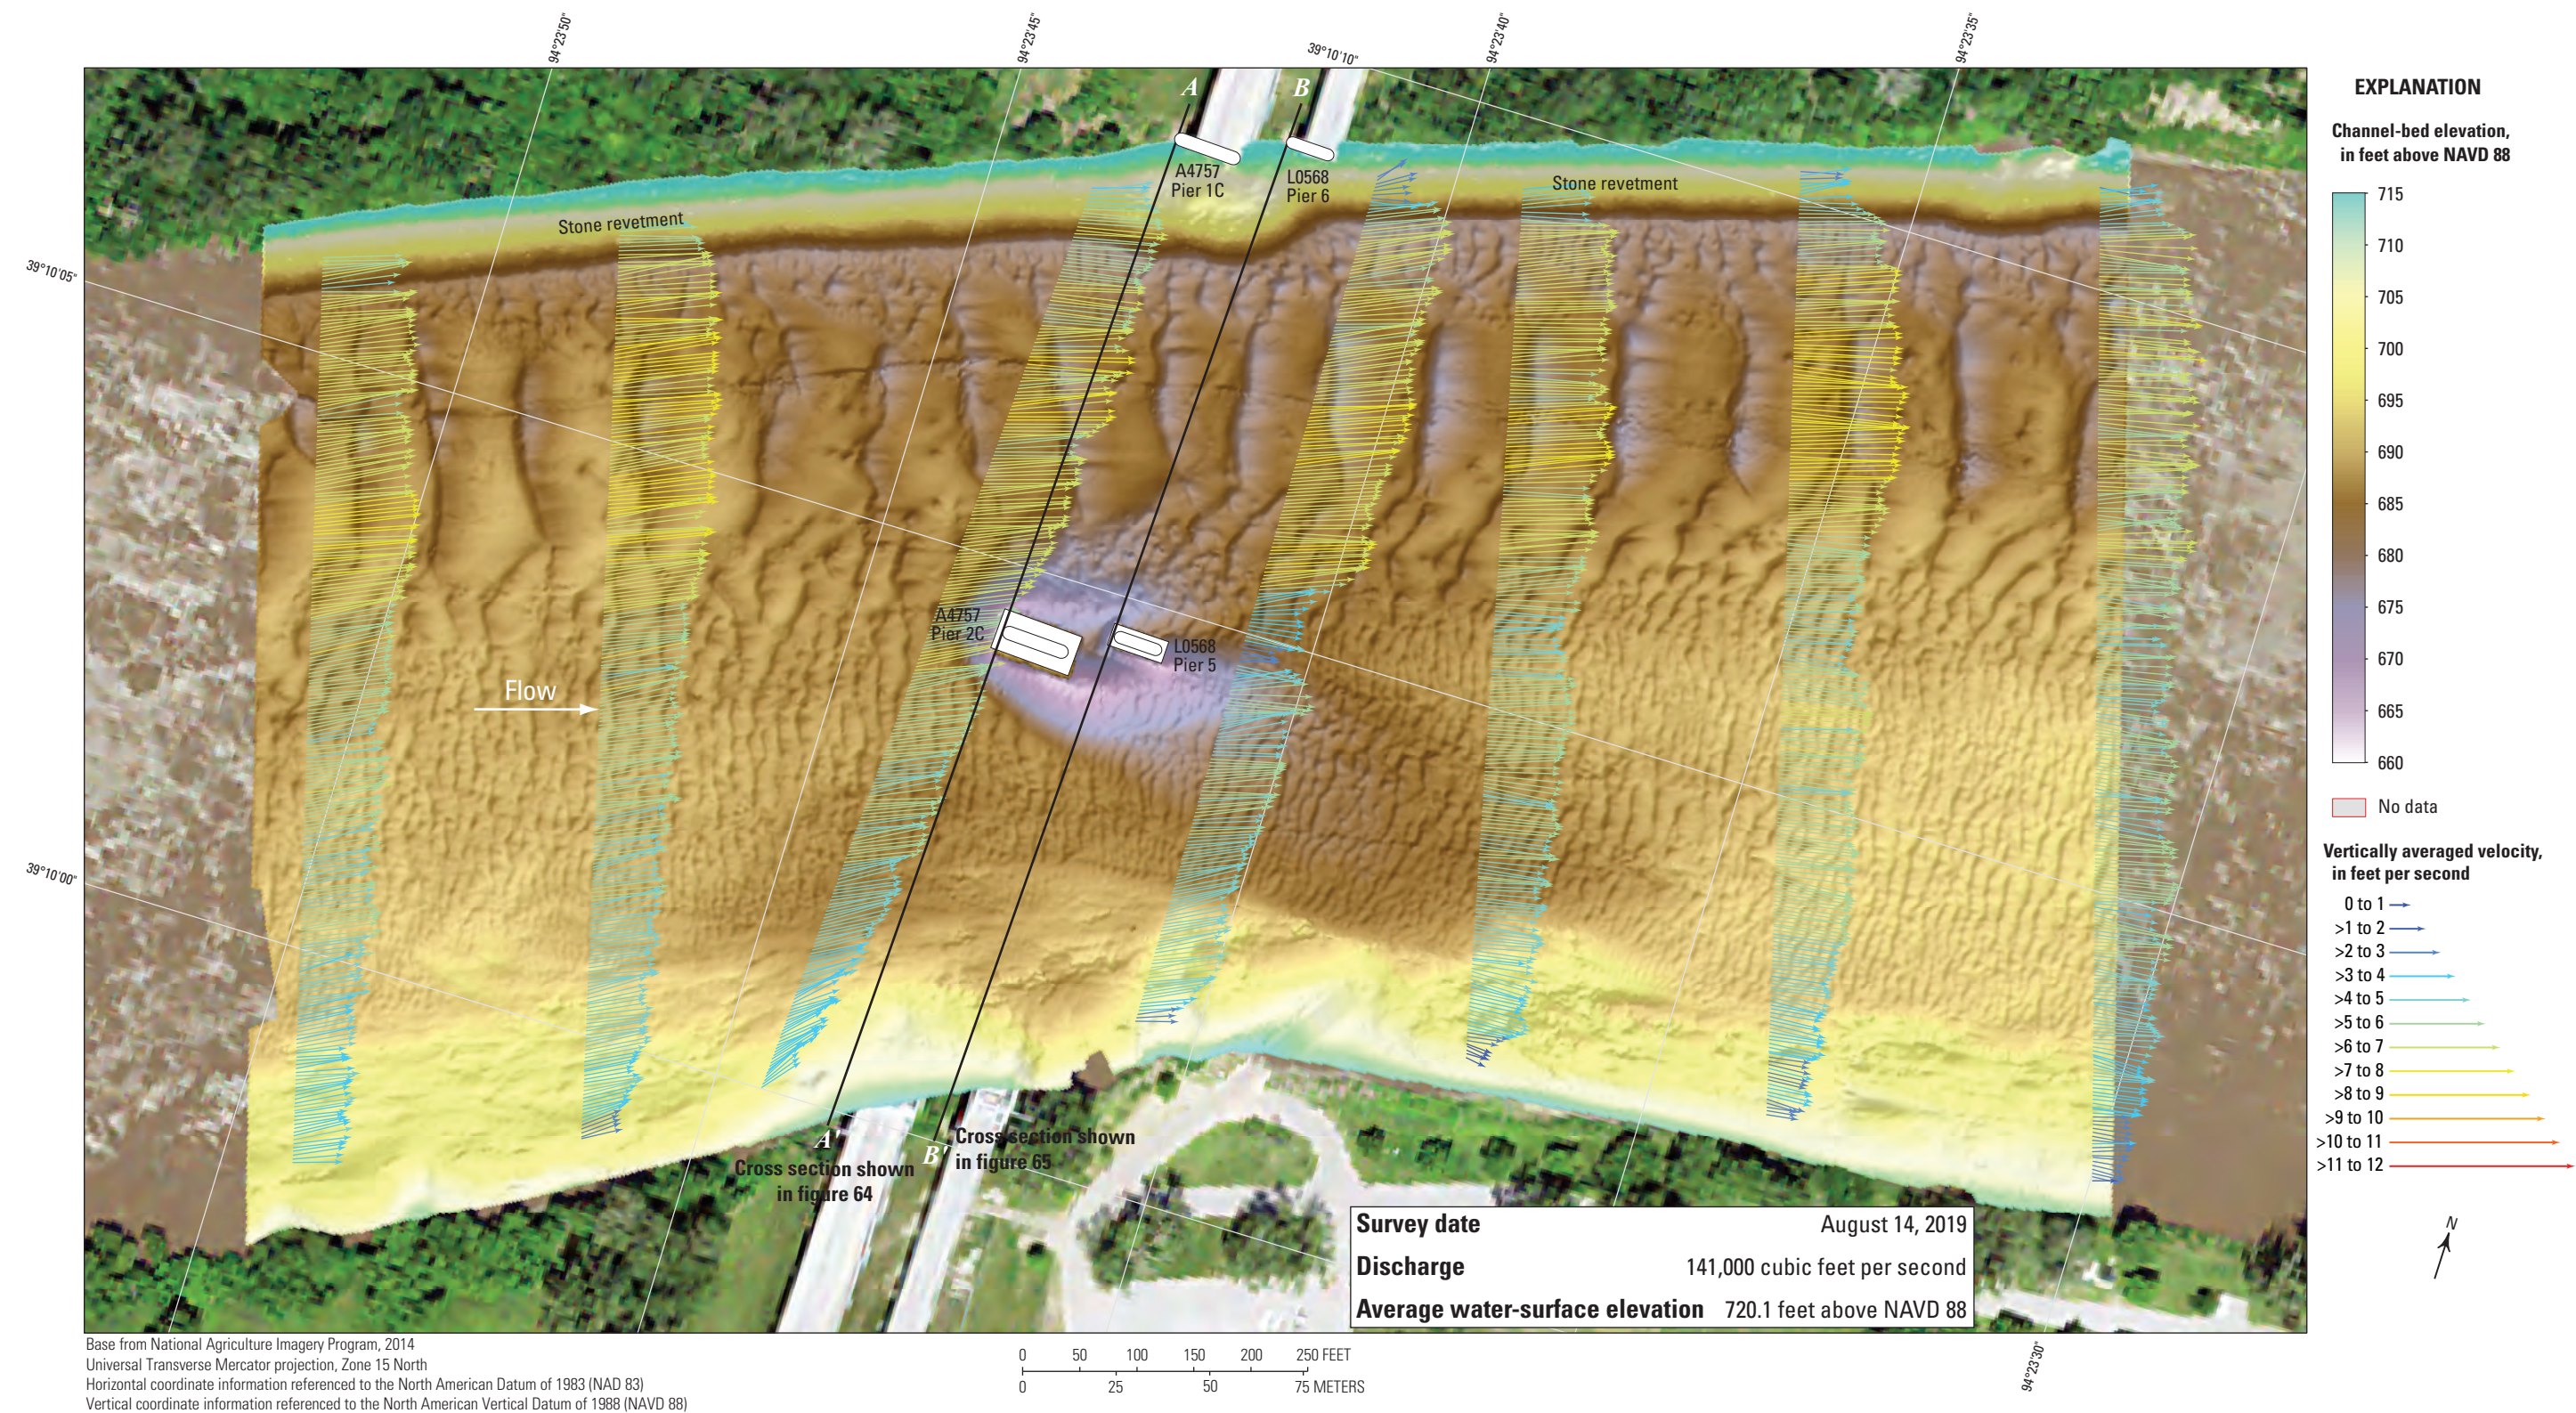
The vertically averaged velocity vectors indicate mostly uniform flow throughout the reach, ranging from about 2 ft/s along the inside of the bend on the right (south) bank to about 9 ft/s in the thalweg (fig. 69). Exceptions to uniform flow include flows angled to the left (north) near the upstream and downstream faces of the bridges (fig. 69). Moderate turbulence also was observed in several transects, particularly near the bank protrusions near the bridges and downstream from the main channel piers (fig. 69). Velocities were slightly lower downstream from the bridges, likely caused by the flow expansion downstream from the constriction at the bridges (fig. 69).

Figure 69. Bathymetry and vertically averaged velocities of the Missouri River channel near structures A4757 and L0568 on State Highway 291 near Kansas City, Missouri, on August 14, 2019.

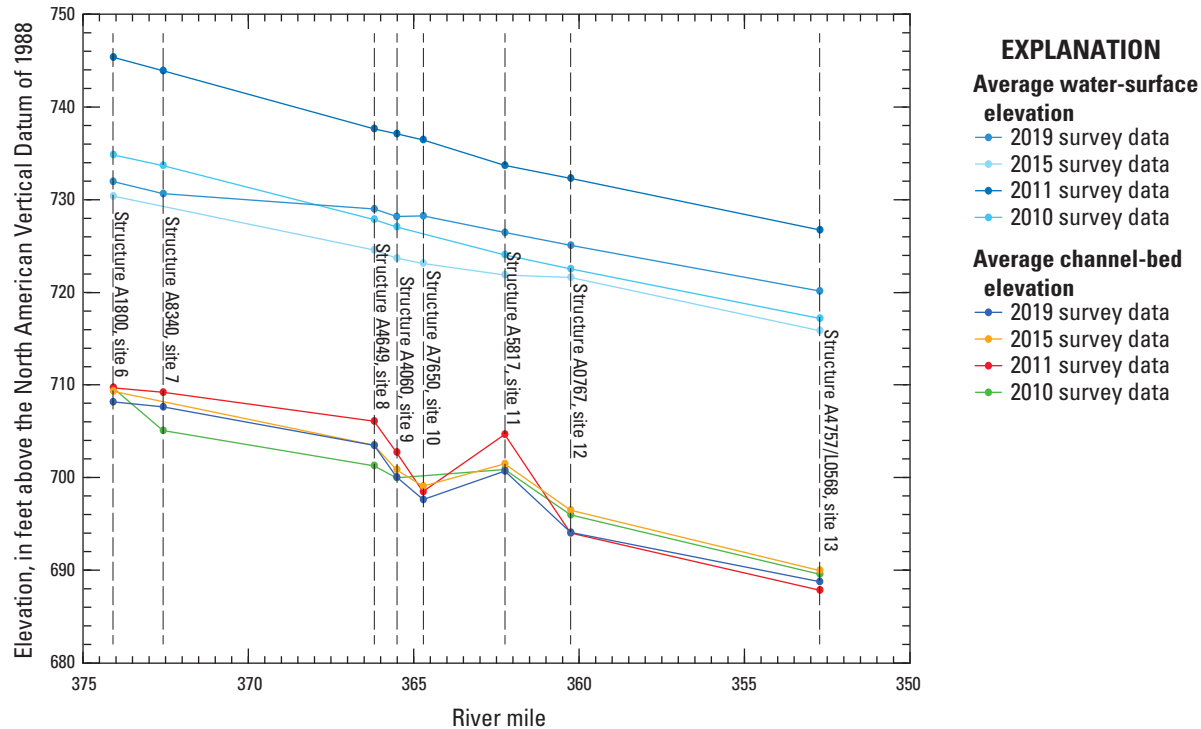
Examining the average channel-bed and water-surface elevations with time (fig. 70), the water-surface elevations during the 2019 surveys were the second-lowest of the four surveys at the two upstream-most structures A1800 (site 6) and A8340 (site 7), whereas the water-surface elevation during the 2019 surveys were the second-highest of the four surveys at the sites from structure A4649 (site 8) downstream. At sites 7, 8, 9 and 11, the channel bed was at a temporal maximum in 2011, and at sites 7 and 8, the channel bed was at a temporal minimum in 2010. The 2015 and 2019 average channel-bed elevations fell between the 2010 and 2011 surveys at sites 7 and 8. In contrast, the 2019 survey set or matched the temporal minimum at sites 6 and 9 through 12 (fig. 70). The Kansas River joins the Missouri River immediately upstream from structure A4649 (site 8; fig. 1), and additional inflow from the Kansas River likely accounts for the increased water-surface

Figure 70. Average channel-bed and water-surface elevations near bridges on the Missouri River near Kansas City, Missouri, from surveys in 2010, 2011, 2015, and 2019 (Huizinga, 2010, 2012, 2016, and this report, respectively).

elevations at site 8 and downstream. The additional inflow may also account for why the average channel-bed elevations are at a temporal minimum in 2019 for nearly all the sites downstream from structure A4649 (site 8; [fig. 70](#)). This configuration of average channel-bed elevations and average differences indicates that greater streamflow at the time of the survey alone does not necessarily result in more scour at a site (as would be evidenced by lower average channel-bed elevations with increased streamflow). It was hypothesized in the 2011 flood study at Kansas City (Huizinga, 2012) that a slug of sediment may have been traveling through the upstream part of the Kansas City area at that time, given the substantial increase in channel-bed elevation from 2010 to 2011 at the upstream sites; it was further hypothesized after the 2015 surveys that this slug of sediment had been eroded away between 2011 and 2015 (Huizinga, 2016). The results of the 2019 surveys seem to substantiate that if a slug of sediment indeed was present in 2011, it had eroded away from the upstream sites; furthermore, additional erosion has occurred at nearly all the sites downstream from structure A4649 (site 8) since 2015 ([fig. 70](#)). Again, it seems reasonable to assume that the higher streamflows in March and June had a substantial scouring effect in the reach, and the 2019 surveys captured a partial rebound.

The local spatial minimum observed at structure A7650 (site 10) in the 2015 surveys (Huizinga, 2016) persisted in the 2019 surveys ([fig. 70](#)) and likely indicates this site is at or near a local feature that controls sediment deposition and scour.

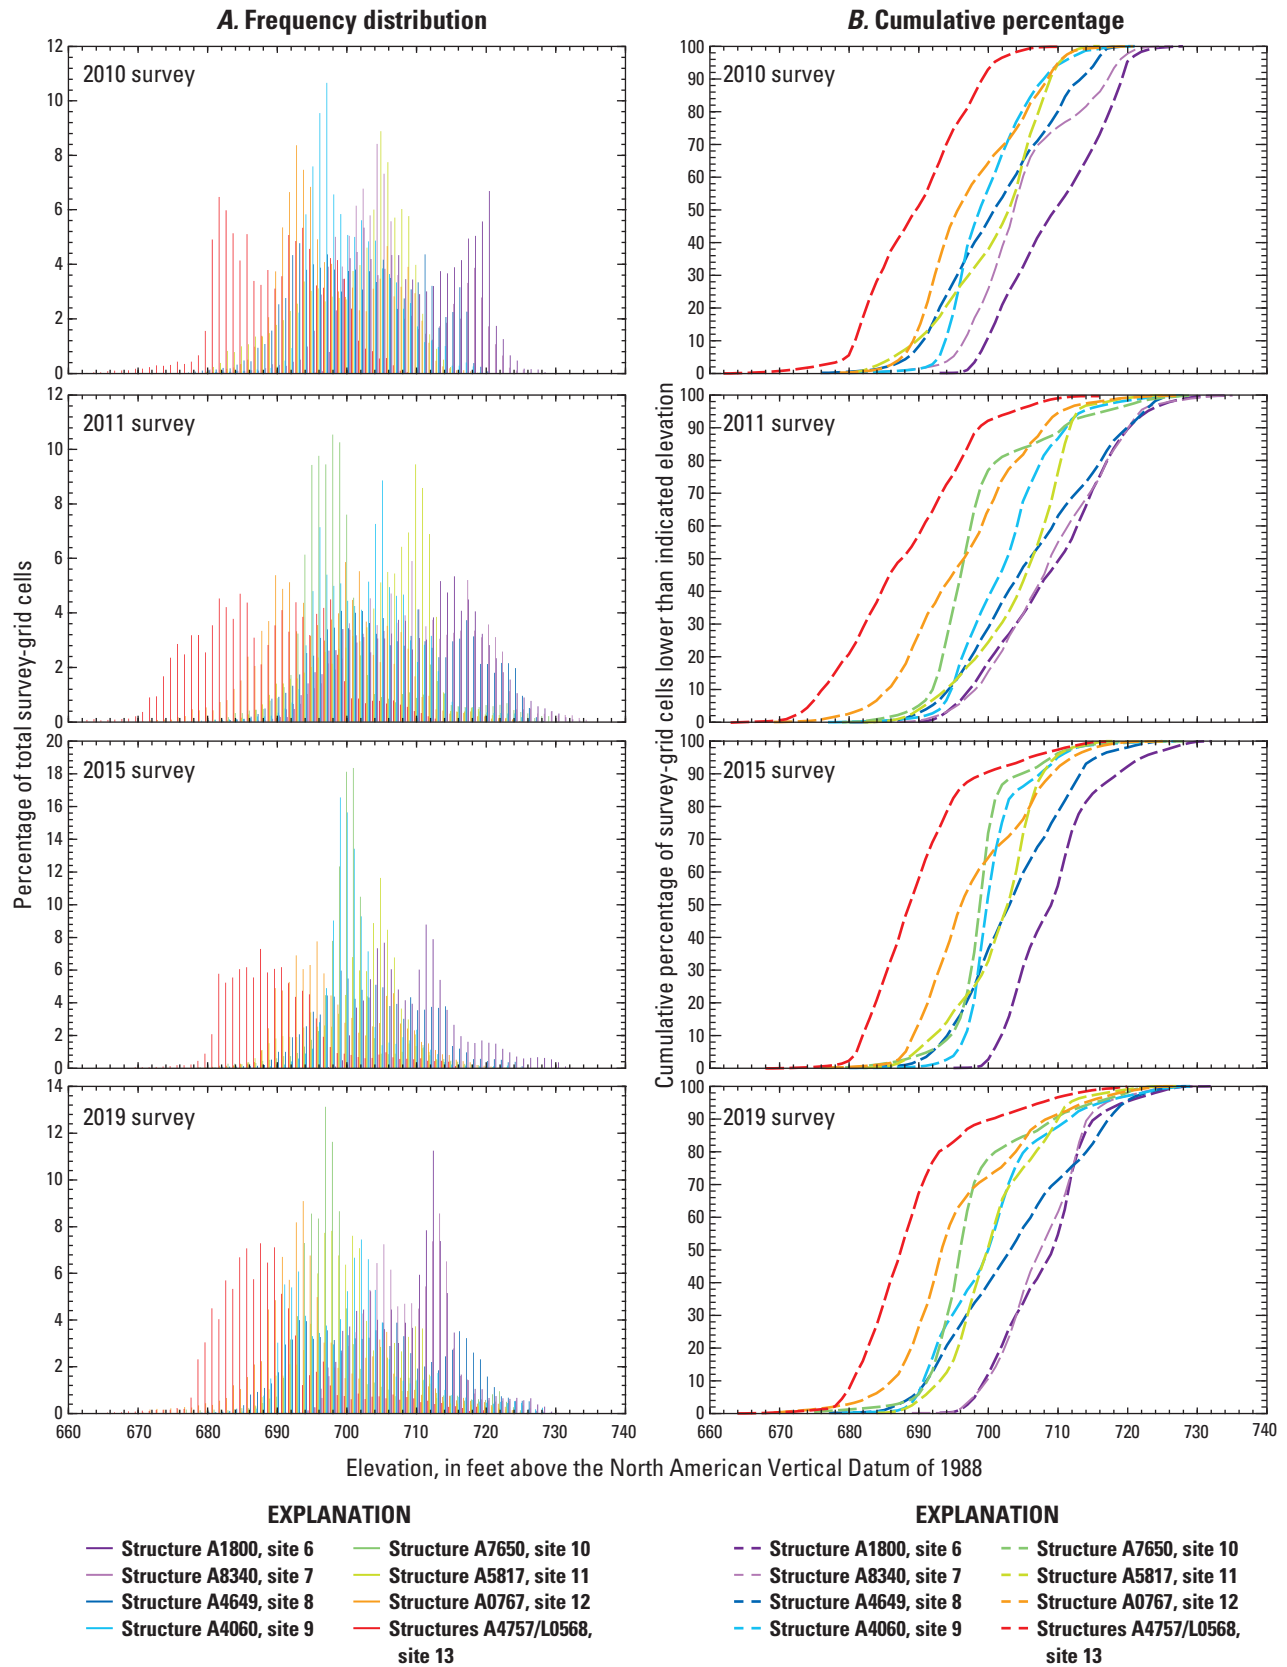
Figure 71. Comparison of frequency distribution and cumulative percentage of bed elevations for bathymetric survey-grid cells in 1-foot elevation bins from various surveys on the Missouri River near Kansas City, Missouri, in 2010, 2011, 2015, and 2019 (Huizinga, 2010, 2012, 2016, and this report, respectively). *A*, frequency distribution. *B*, cumulative percentage.

sites, and the accumulation curve is to the right of (implying a higher elevation than) several of the upstream sites in the surveys (fig. 71B).

Further examination of the frequency distributions of the 2019 surveys in relation to the others in 2019 indicates the similarity of several of the sites with a neighboring site or the uniqueness of a given site (fig. 71). For example, sites 6 and 7 (structures A1800 and A8340) have remarkably similar distributions and cumulative percentage curves in 2019. Sites 6 and 7 also were similar in the 2011 surveys and also relatively similar to site 8 (structure A4649) in 2011. Sites 9 and 10 (structures A4060 and A7650) were similar to one another in 2015, but site 9 was more similar to site 11 (structure A5817) in 2019. Site 13 (structures A4757/L0568) is likely too far removed from the other sites to have any similarity. The distributions at site 12 (structure A0767) historically have been remarkably similar during the various surveys (fig. 52) but unique from the other sites (fig. 71B); the cumulative percentage curve above 70 percent was at a higher elevation than several sites upstream, including site 9 (structure A4060) in 2010 and 2015 (fig. 71B). Site 8 (structure A4649) also has a wider range of elevations than other sites (figs. 21, 71A), indicated by the more gradual slope of the cumulative percent curve which often crosses the downstream sites at the lower percentages and crosses the two upstream sites at the upper percentages in the various surveys (fig. 71B).

Furthermore, the frequency distributions of the 2019 surveys compared to the previous surveys reveals additional differences that may be the result of streamflow conditions during the 2019 surveys (fig. 71). Whereas the frequency distributions generally were narrower in the 2015 survey than in either the 2010 or 2011 survey at each site with a higher percentage of survey-grid cells in a particular elevation range (fig. 71A), the distributions for the 2019 survey generally were slightly wider, similar to 2011 and indicative of a wider spread of elevations in the surveys at a given site. Similarly, whereas the narrower distributions in 2015 resulted in generally steeper accumulation curves, the 2019 accumulation curves were more similar to 2010 (figs. 71B). Accumulation curves that are steep indicate a channel bed with a narrower range of elevations (more level throughout the reach), whereas those that are less steep indicate a wider variation of elevations. Accumulation curves with “steps” indicate a channel with distinct groups of elevations, such as a thalweg on one side and a shallow area on the opposite side of the channel (such as structure A1800, figs. 6 and 7).

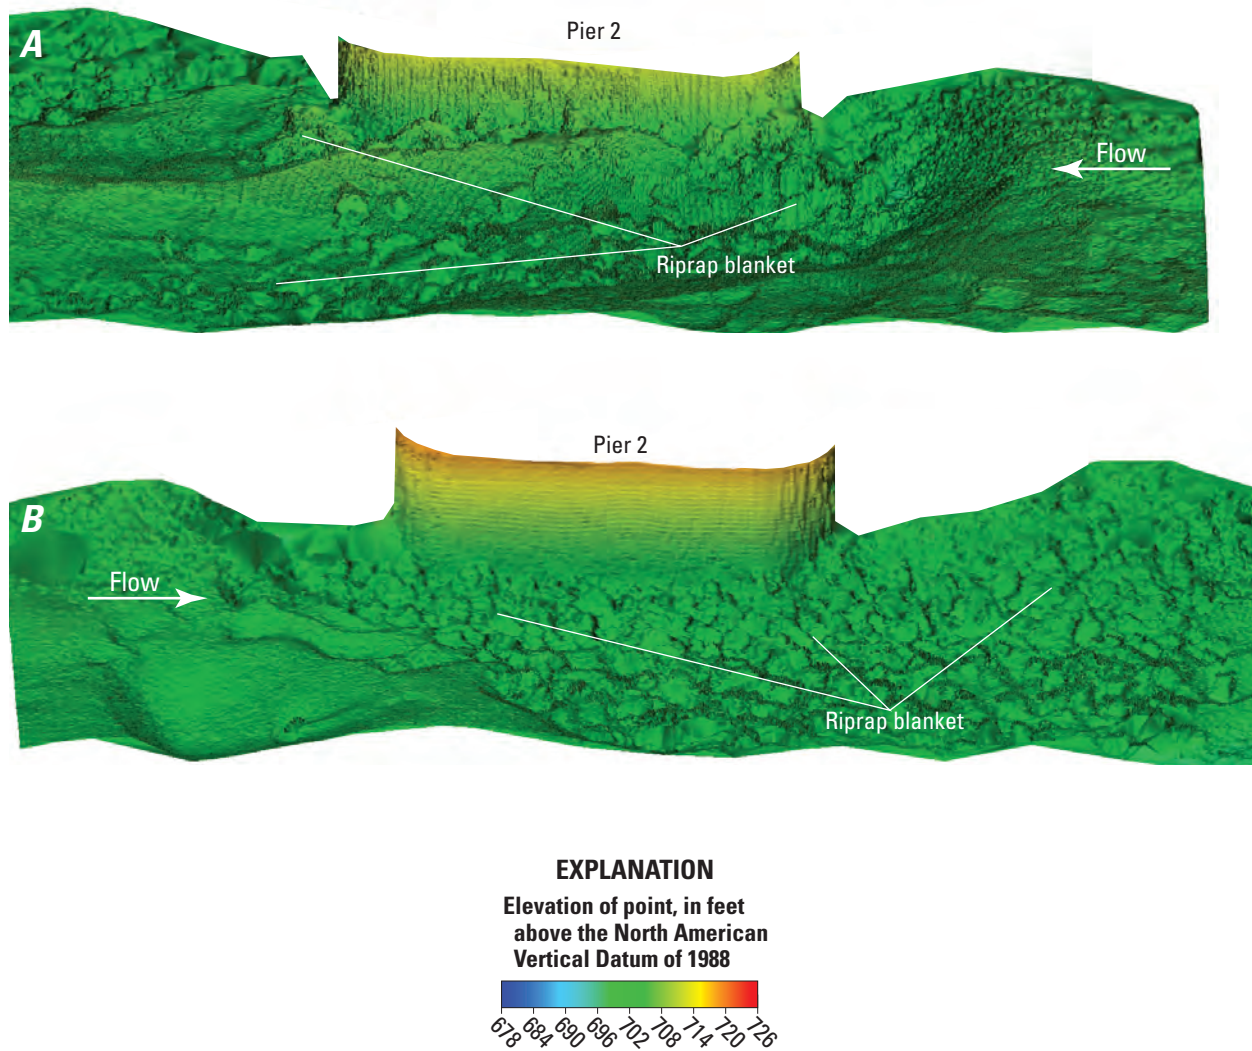
Two piers had scour countermeasures in the form of a riprap blanket installed between August and October 2020. Survey results from before and after installation of these countermeasures show these features had a substantial effect on mitigating the observed scour at these piers, particularly when compared to other piers at other sites without such a feature.

Figure 1.4. Shaded triangulated irregular network visualization of the channel bed and main channel pier 2 of structure A4649 on U.S. Highway 169 crossing the Missouri River in Kansas City, Missouri, on October 23, 2020, after installation of scour countermeasures. *A*, left (northwest) side of pier 2. *B*, right (southeast) side of pier 2.

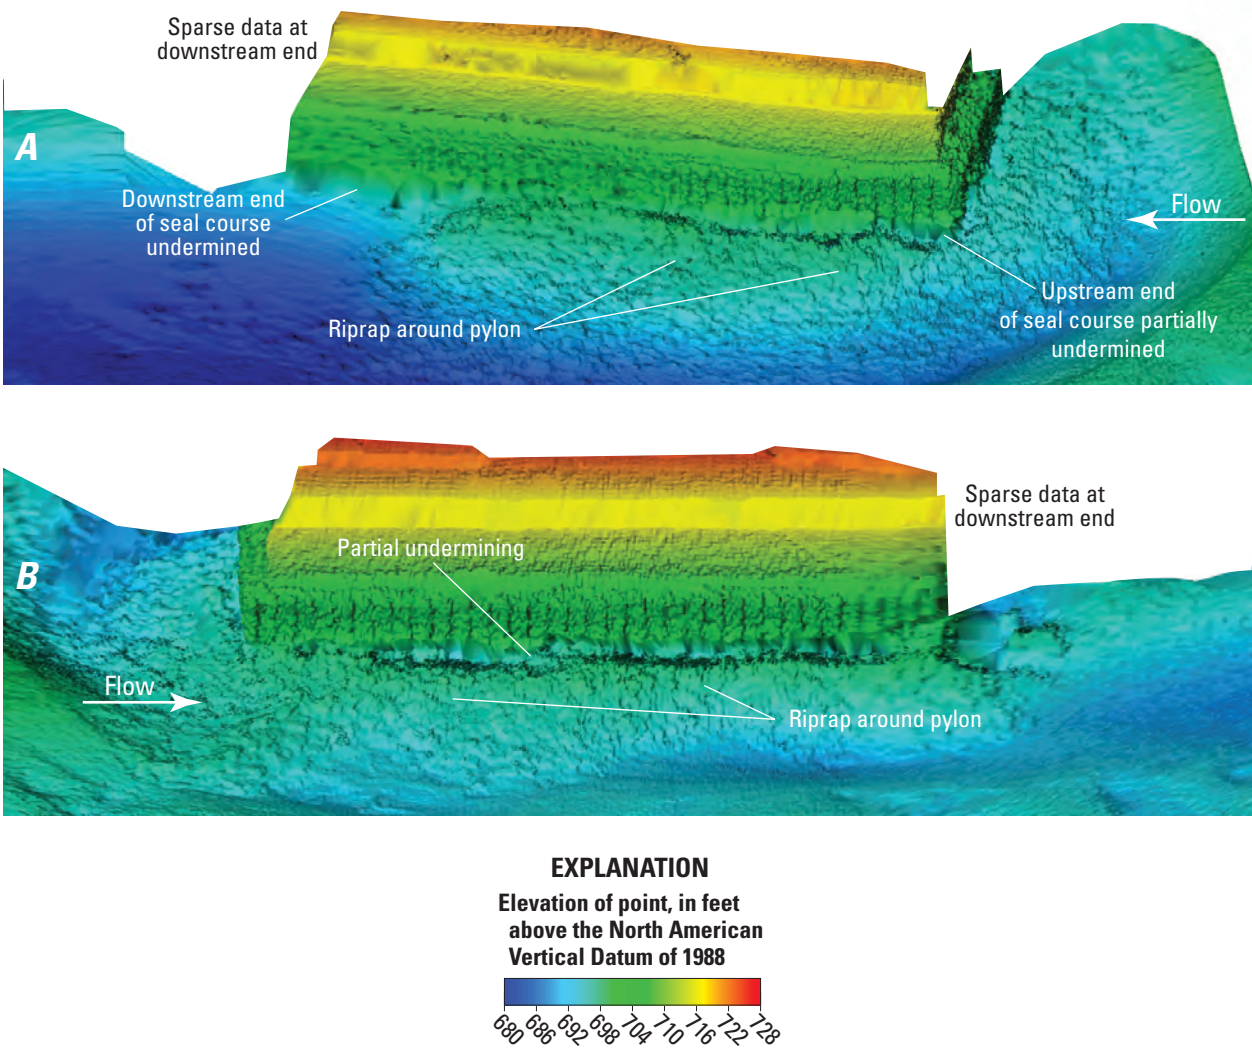
The main channel pylon of structure A7650 (site 10) seemed to be partially surrounded with piles of coarse material (figs. 38, 40, 1.6). Bridge plans do not indicate that these piles are a designed scour countermeasure. Some settling of the piles was observed in the 2019 survey compared to the previous surveys in 2015 and 2011 (figs. 41, 42) such that the bottom of the seal course was exposed by 5 to 10 ft along the upstream face of the bridge (fig. 40). Nevertheless, these piles seem to effectively divert most of the scour near the pylon away from the pylon base. Scour immediately downstream from the pylon was substantial (fig. 38) but likely does not directly affect the stability of the pylon.

Figure 1.6. Shaded triangulated irregular network visualization of the channel bed and main channel pylon of structure A7650 on Interstate 35 over the Missouri River in Kansas City, Missouri. *A*, left (northwest) side. *B*, right (southeast) side.

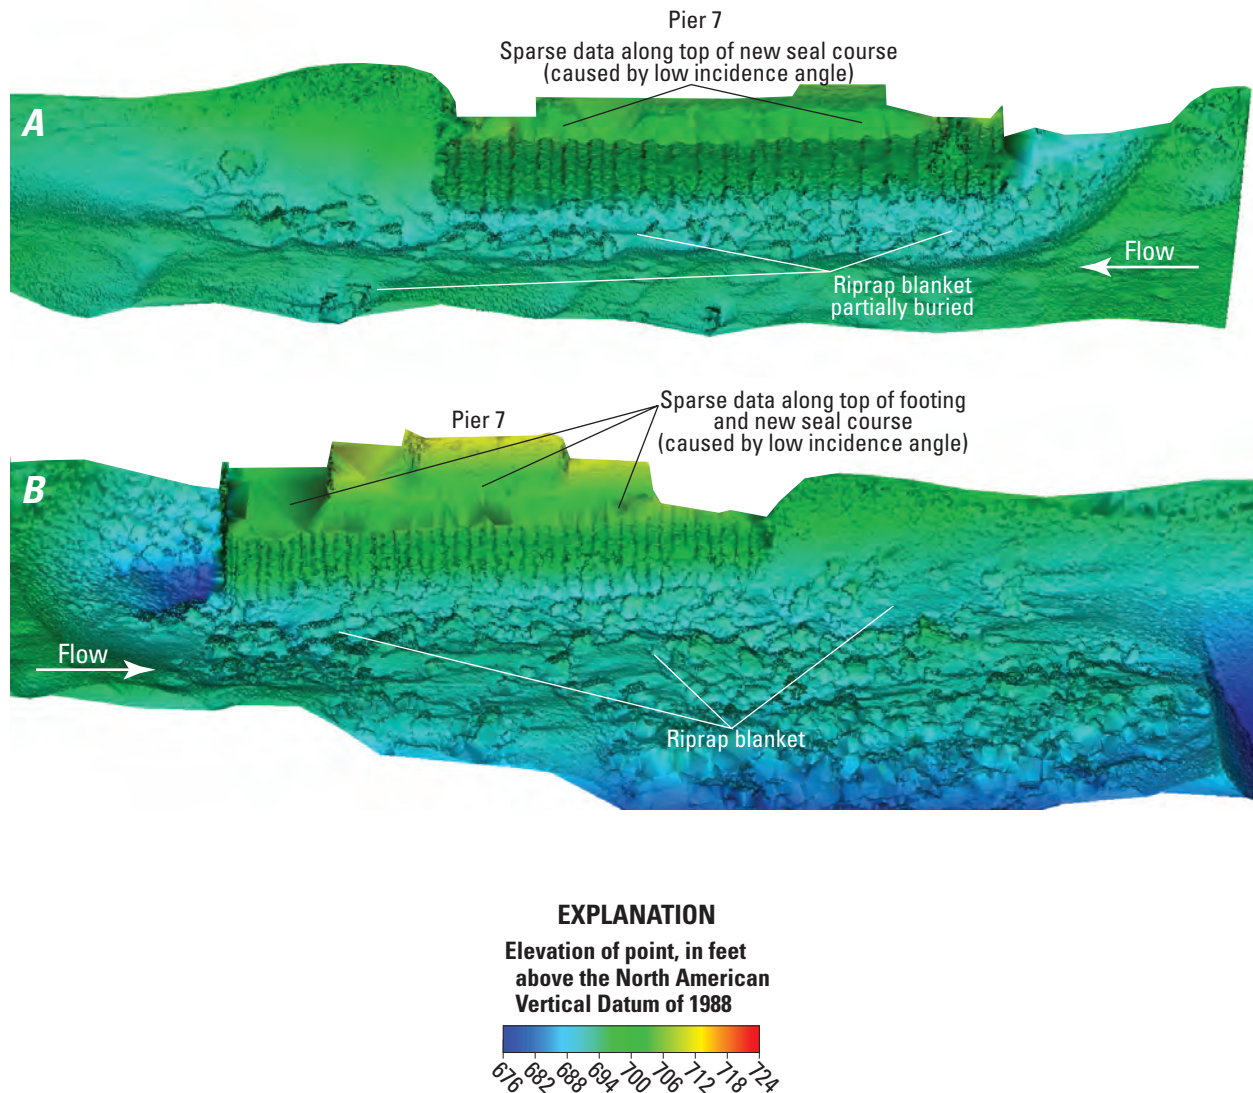
Figure 1.9. Shaded triangulated irregular network visualization of the channel bed and main channel pier 7 of structure A0767 on Interstate 435 over the Missouri River in Kansas City, Missouri, on October 23, 2020, after installation of scour countermeasures. *A*, left (north) side of pier 7. *B*, right (south) side of pier 7.
