Bathymetric and Velocimetric Surveys at Highway Bridges Crossing the Missouri and Mississippi Rivers on the Periphery of Missouri, June 13–22, 2022

Scientific Investigations Report 2024–5032

By Richard J. Huizinga

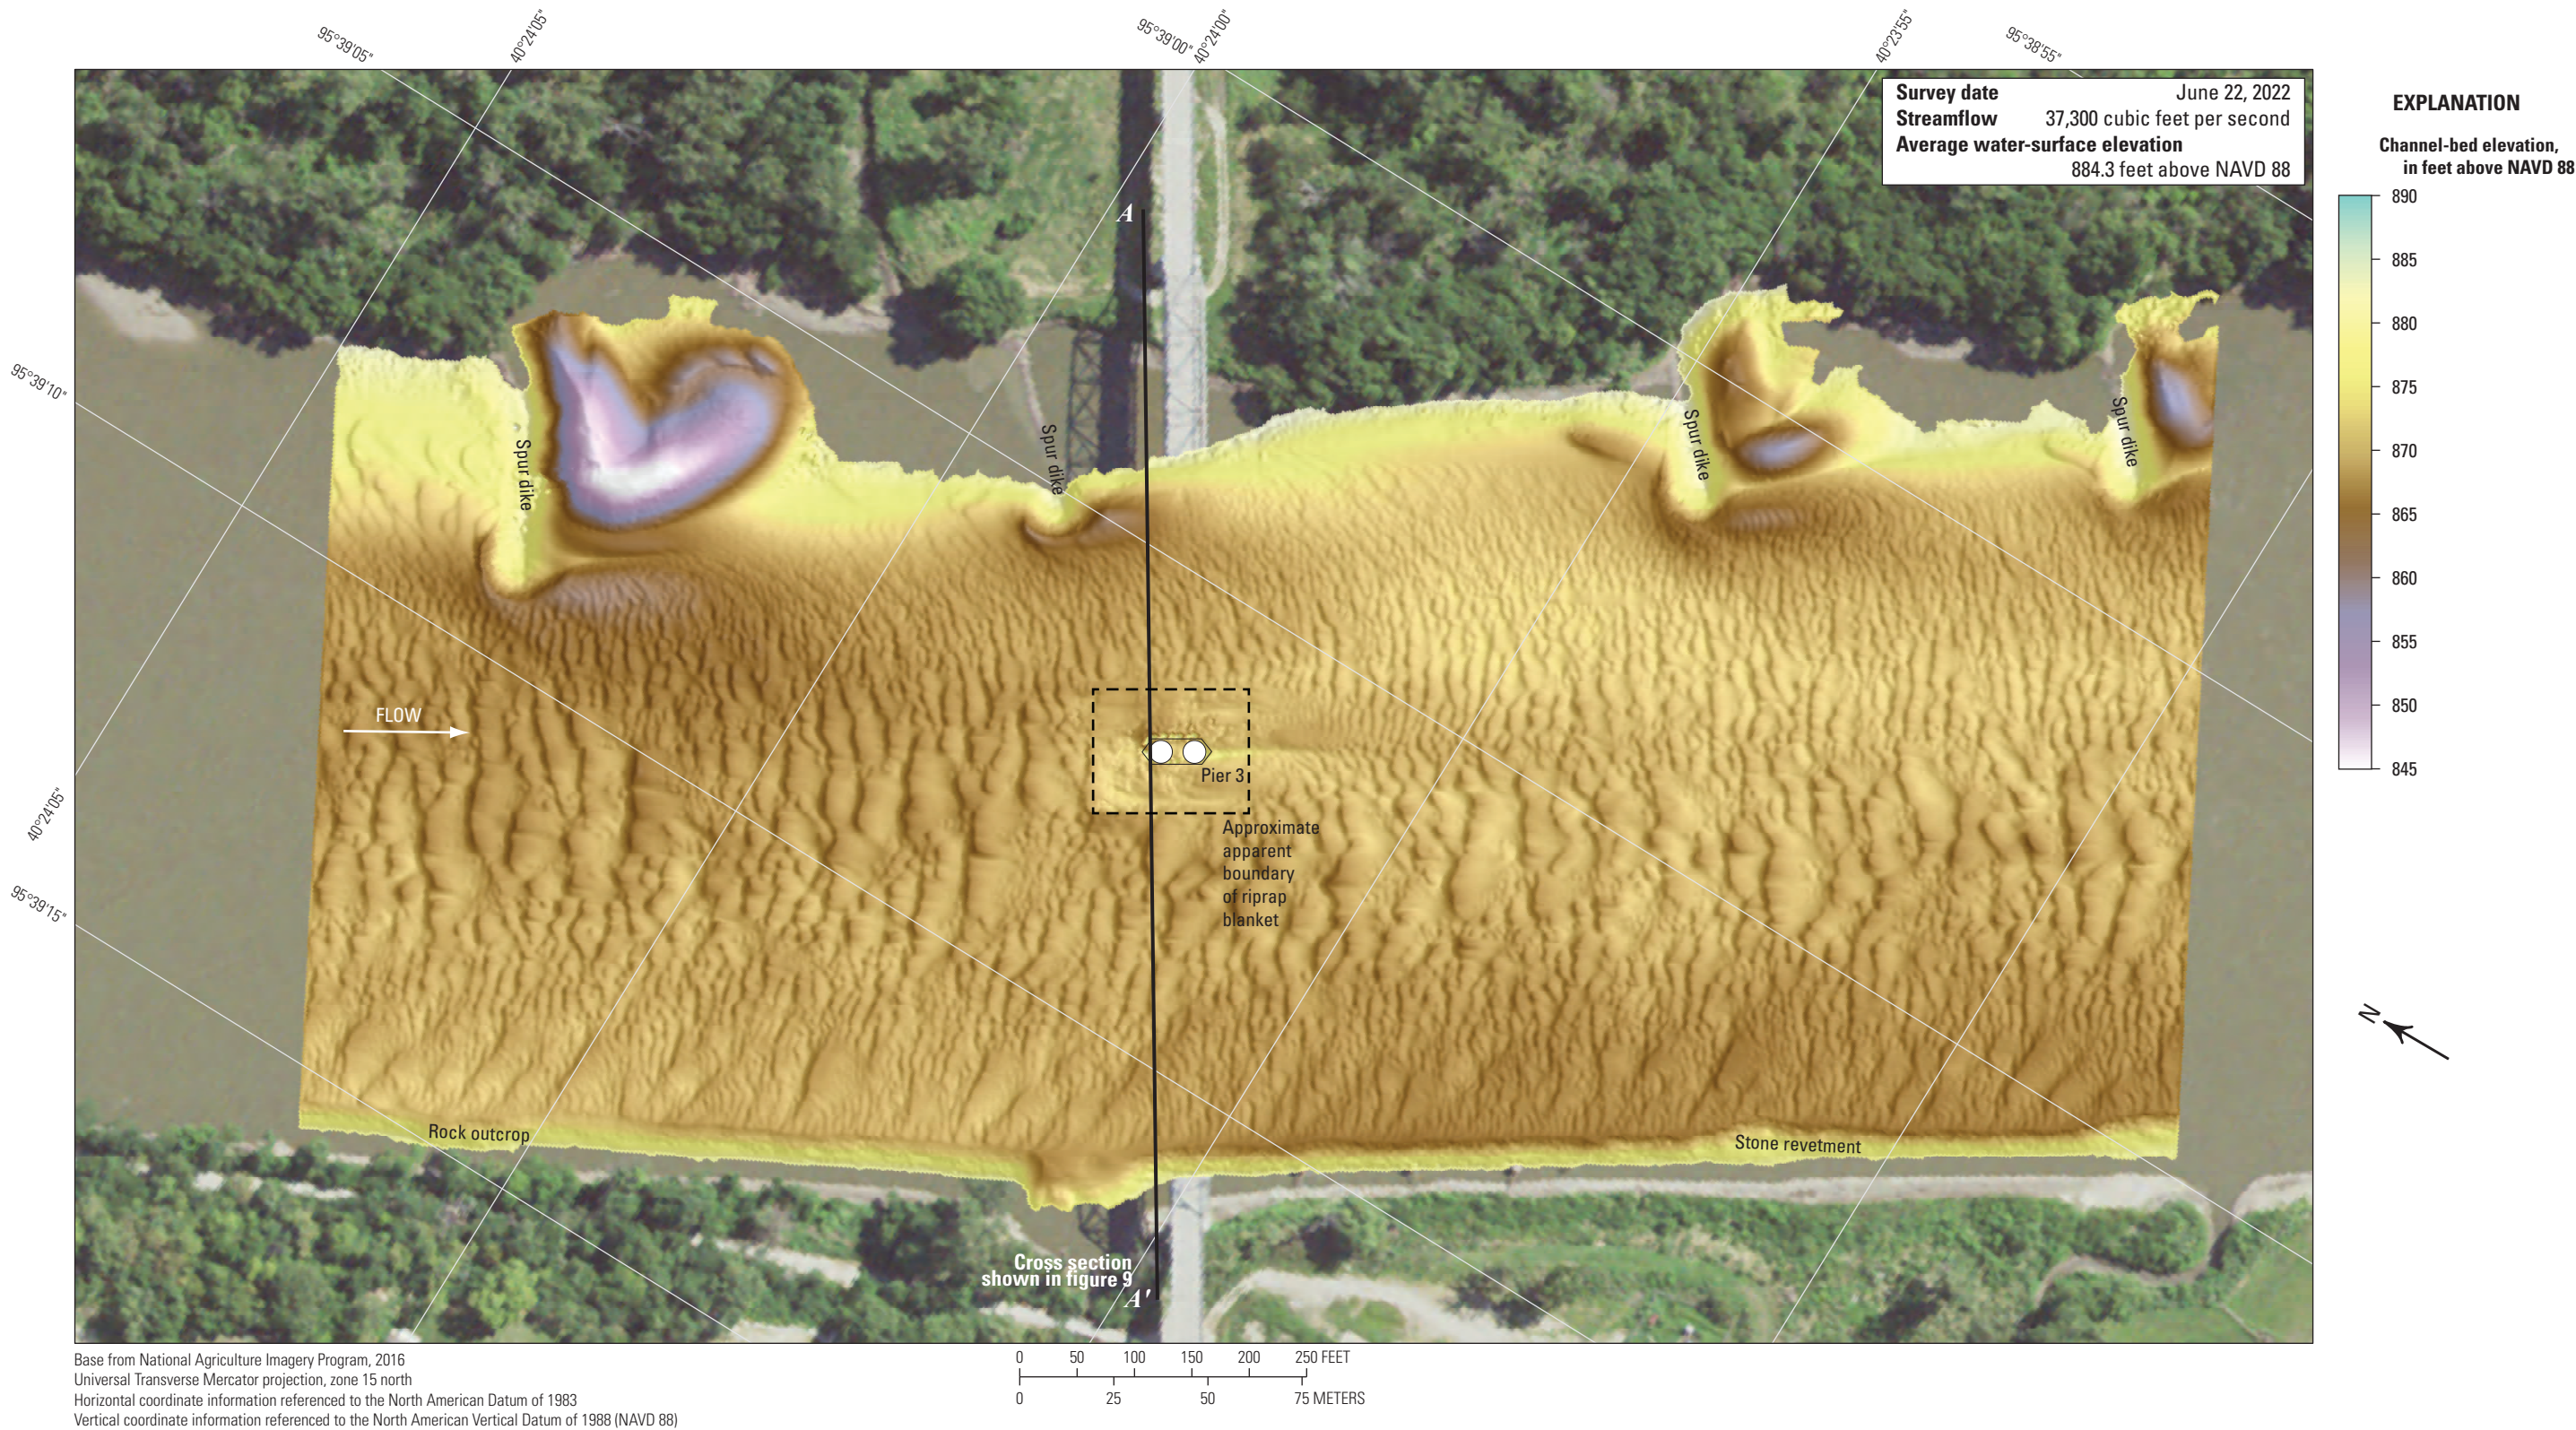
The survey area was about 1,640 ft long and about 740 ft wide, extending across the active channel from bank to bank, except for a shallow area between the spur dikes on the left (eastern) bank (fig. 7). The survey area extended about 740 ft upstream from the centerline of structure L0098. The channel-bed elevations ranged from about 864 to 876 ft for most of the surveyed area (5th to 95th percentile range of the bathymetric data; fig. 8), on the downstream sides of the various spur dikes on the left (east) bank (fig. 7; table 3). The channel bed was covered with small to medium dunes and ripples. As in previous surveys (Huizinga, 2012, 2015, 2020e), a rock outcrop was present on the right (west) bank upstream from the bridge, and a stone revetment was present on the right bank downstream from the bridge (fig. 7).

The scour hole that historically had been observed near pier 3 in previous surveys (refer to fig. 6 in Huizinga [2020e]) was conspicuously absent in the 2022 survey, having been mitigated by the apparent installation of a riprap blanket scour countermeasure around the pier sometime since the most-recent previous survey in 2018 (figs. 7, 1.1A, 1.1B). Information from bridge plans indicates that pier 3 is founded on sheet piling caissons on bedrock, with about 51 ft of bed material between the bottom of the scour hole and bedrock at the upstream face of the pier (fig. 9; difference between “Approximate minimum elevation in scour hole near pier/bent” and “Approximate elevation of bedrock near pier/bent” in table 7). The unique configuration of the sheet pile caissons and ice breaker of the pier are clearly seen in the shaded TIN images for pier 3 (fig. 1.1). The surveyed bed generally was similar to the most-recent previous multibeam surveys in 2014 and 2018, except near pier 3 where the riprap blanket scour countermeasures now exist (fig. 9).

Figure 7. Bathymetric survey of the Missouri River channel near structure L0098 on U.S. Highway 136 at Brownville, Nebraska.

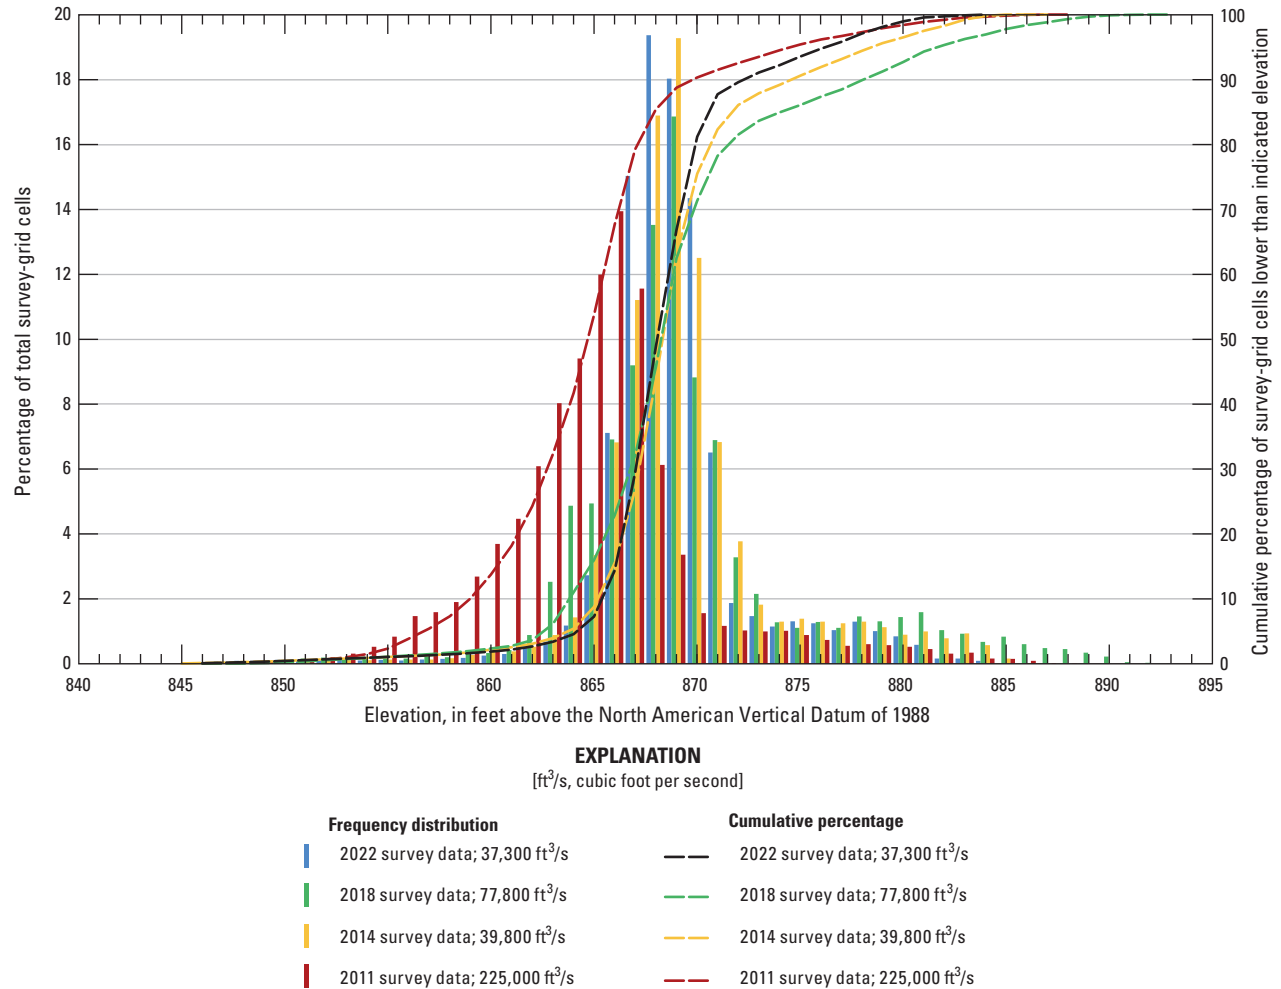
Figure 8. Frequency distribution of bed elevations for bathymetric survey-grid cells in 1-foot elevation bins on the Missouri River near structure L0098 on U.S. Highway 136 at Brownville, Nebraska, on June 22, 2022, compared to previous surveys in 2011, 2014, and 2018 (Huizinga, 2012, 2015, and 2020e, respectively).

(fig. 9). The frequency distribution of bed elevations in 2011 is unique compared to the other distributions at this site, with a substantially higher percentage of cells at channel-bed elevations 8–10 ft lower than the other surveys (fig. 8). The stone revetment on the right (west) bank showed signs of localized substantial deposition, whereas the spur dikes on the left (east) bank showed minor scour (fig. 12). As with the previous DoD, deposition or scour apparent on opposing faces of a feature (such as a pier or spur dike) likely resulted from minor horizontal positional variances between the surveys (fig. 6).

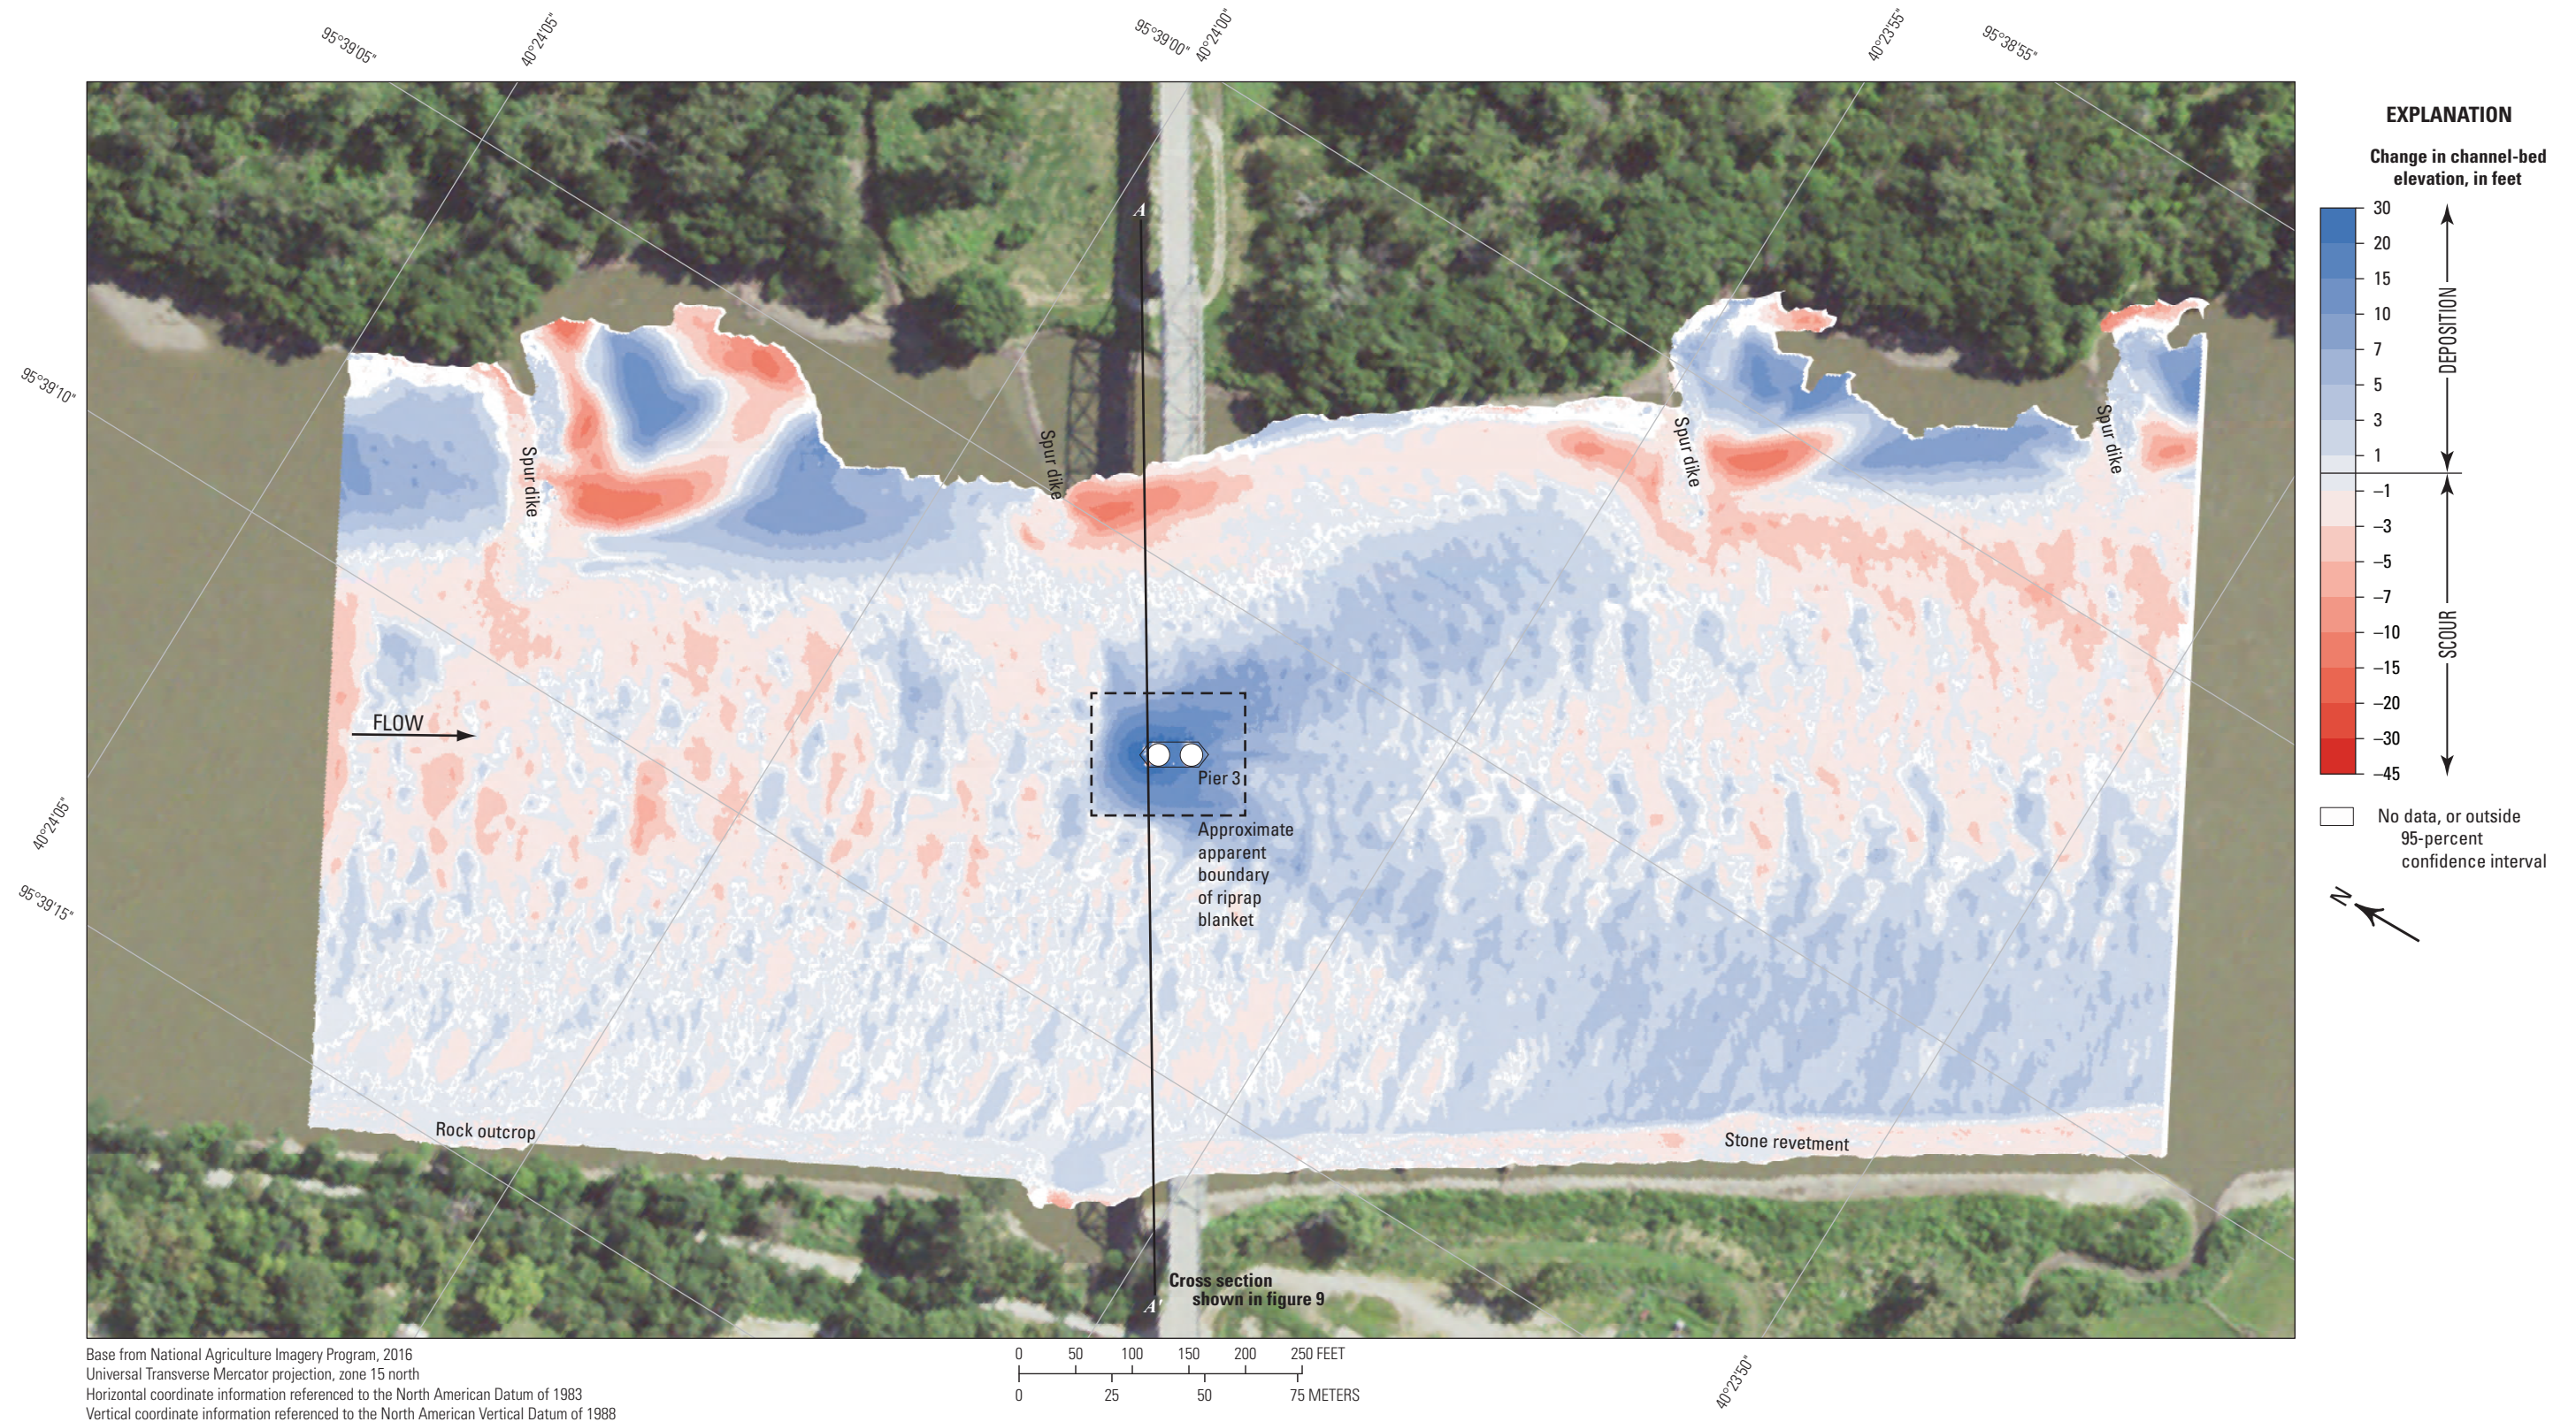
difference”) from the survey on June 22, 2022, and the previous survey on August 13, 2018 (fig. 10), indicated about 93 percent of the joint area of interest had change greater than the 95-percent confidence interval of uncertainty (hereinafter referred to as “detectable change”), which means only about 7 percent of the differences in the joint area of interest were equivocal and within the bounds of uncertainty (table 8). Bed variation seemed about equal between scour and deposition from 2018 to 2022 in the DoD (fig. 10); however, erosion was dominant in the upstream part of the reach and along the tips of the spur dikes on the left (east) bank throughout the reach, whereas substantial deposition was apparent near the pier, in the wake vortex area downstream, and between the spur dikes on the left side of the channel near the left (east) bank (fig. 10). The average difference between the bathymetric surfaces (the statistical mean value of the gridded raster surface [fig. 10] created from the thresholded difference between the 2022 and 2018 gridded raster bathymetric surfaces) was +0.41 ft (table 8), indicating minor to moderate channel aggradation between the 2018 and 2022 surveys. The net volume of cut in the reach from 2018 to 2022 was about 34,500 cubic yards (yd³), and the net volume of fill was about 50,100 yd³, resulting in a net gain of about 15,600 yd³ of sediment between 2018 and 2022 (table 8). The cross sections from the two surveys along the upstream face of the bridge are not substantially different from one another for most of the cross section, except pier 3 (fig. 9). The frequency distribution of bed elevations in 2022 also was similar to 2018 and 2014 (fig. 8). The stone revetment on the right (west) bank showed areas of minor scour and deposition, and the spur dike on the left (east) bank showed minor erosion on one side and deposition on the other (fig. 10); however, deposition or scour apparent on opposing faces of a feature likely resulted from minor horizontal positional variances between the surveys (fig. 6).

Figure 10. Difference between surfaces created from bathymetric surveys of the Missouri River channel near structure L0098 on U.S. Highway 136 at Brownville, Nebraska, on June 22, 2022, and August 13, 2018, with probabilistic thresholding.

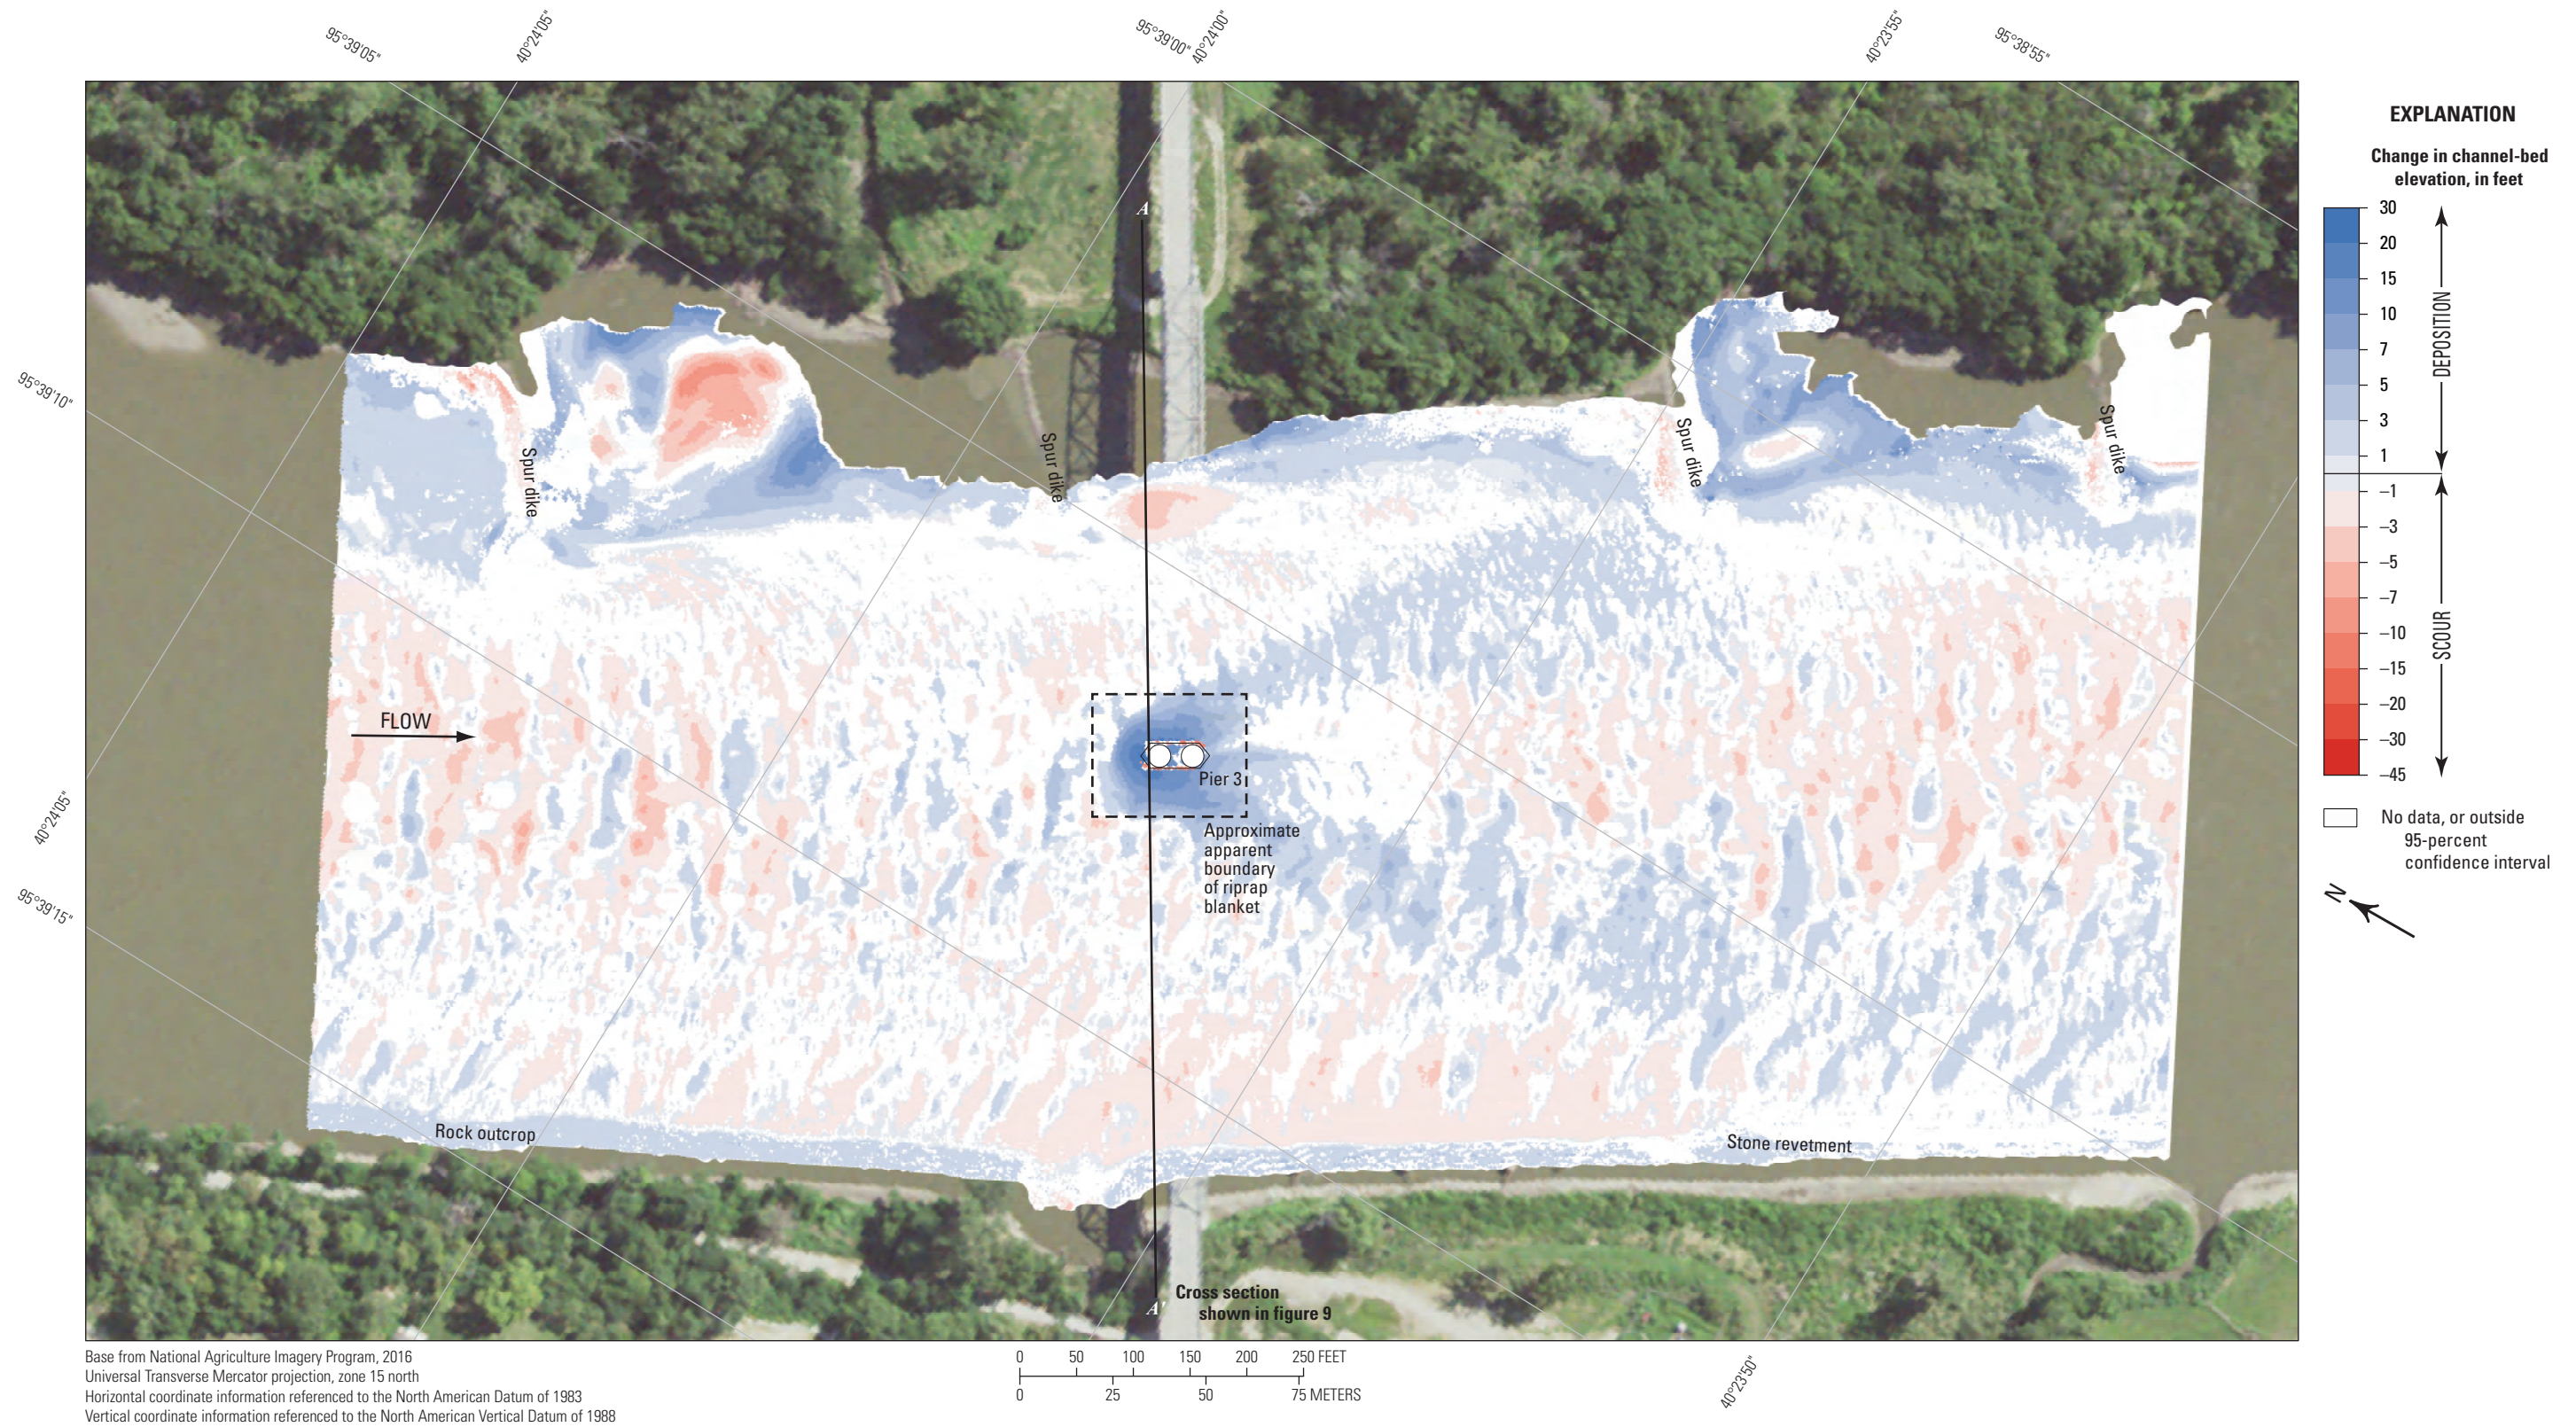
The difference between the survey on June 22, 2022, and the survey on June 3, 2014, (fig. 11), indicates about 57 percent of the joint area of interest had detectable change, which means about 43 percent of the differences in the joint area of interest are equivocal and within the bounds of uncertainty (table 8). Scour and deposition are roughly balanced throughout most of the reach between 2014 and 2022 in the DoD, except along the left (east) bank near the spur dikes, and near pier 3 (fig. 11). The average difference between the bathymetric surfaces was +0.27 ft (table 8), indicating minor overall channel aggradation between the 2014 and 2022 surveys. The net loss of sediment between 2014 and 2022 was about 19,700 yd³, and the net volume of fill was about 26,000 yd³, resulting in a net gain of only about 6,300 yd³ of sediment between 2018 and 2022 (table 8). Streamflow in 2022 was very similar to 2014 (table 8), which may account for the similarity in overall characteristics between the surveys (figs. 9 and 11). The stone revetment and rock outcrop on the right (west) bank has localized areas of deposition (fig. 11). As with the previous DoD, deposition or scour apparent on opposing faces of a feature (such as a pier or spur dike) likely results from minor horizontal positional variances between the surveys (fig. 6).

Figure 11. Difference between surfaces created from bathymetric surveys of the Missouri River channel near structure L0098 on U.S. Highway 136 at Brownville, Nebraska, on June 22, 2022, and June 3, 2014, with probabilistic thresholding.

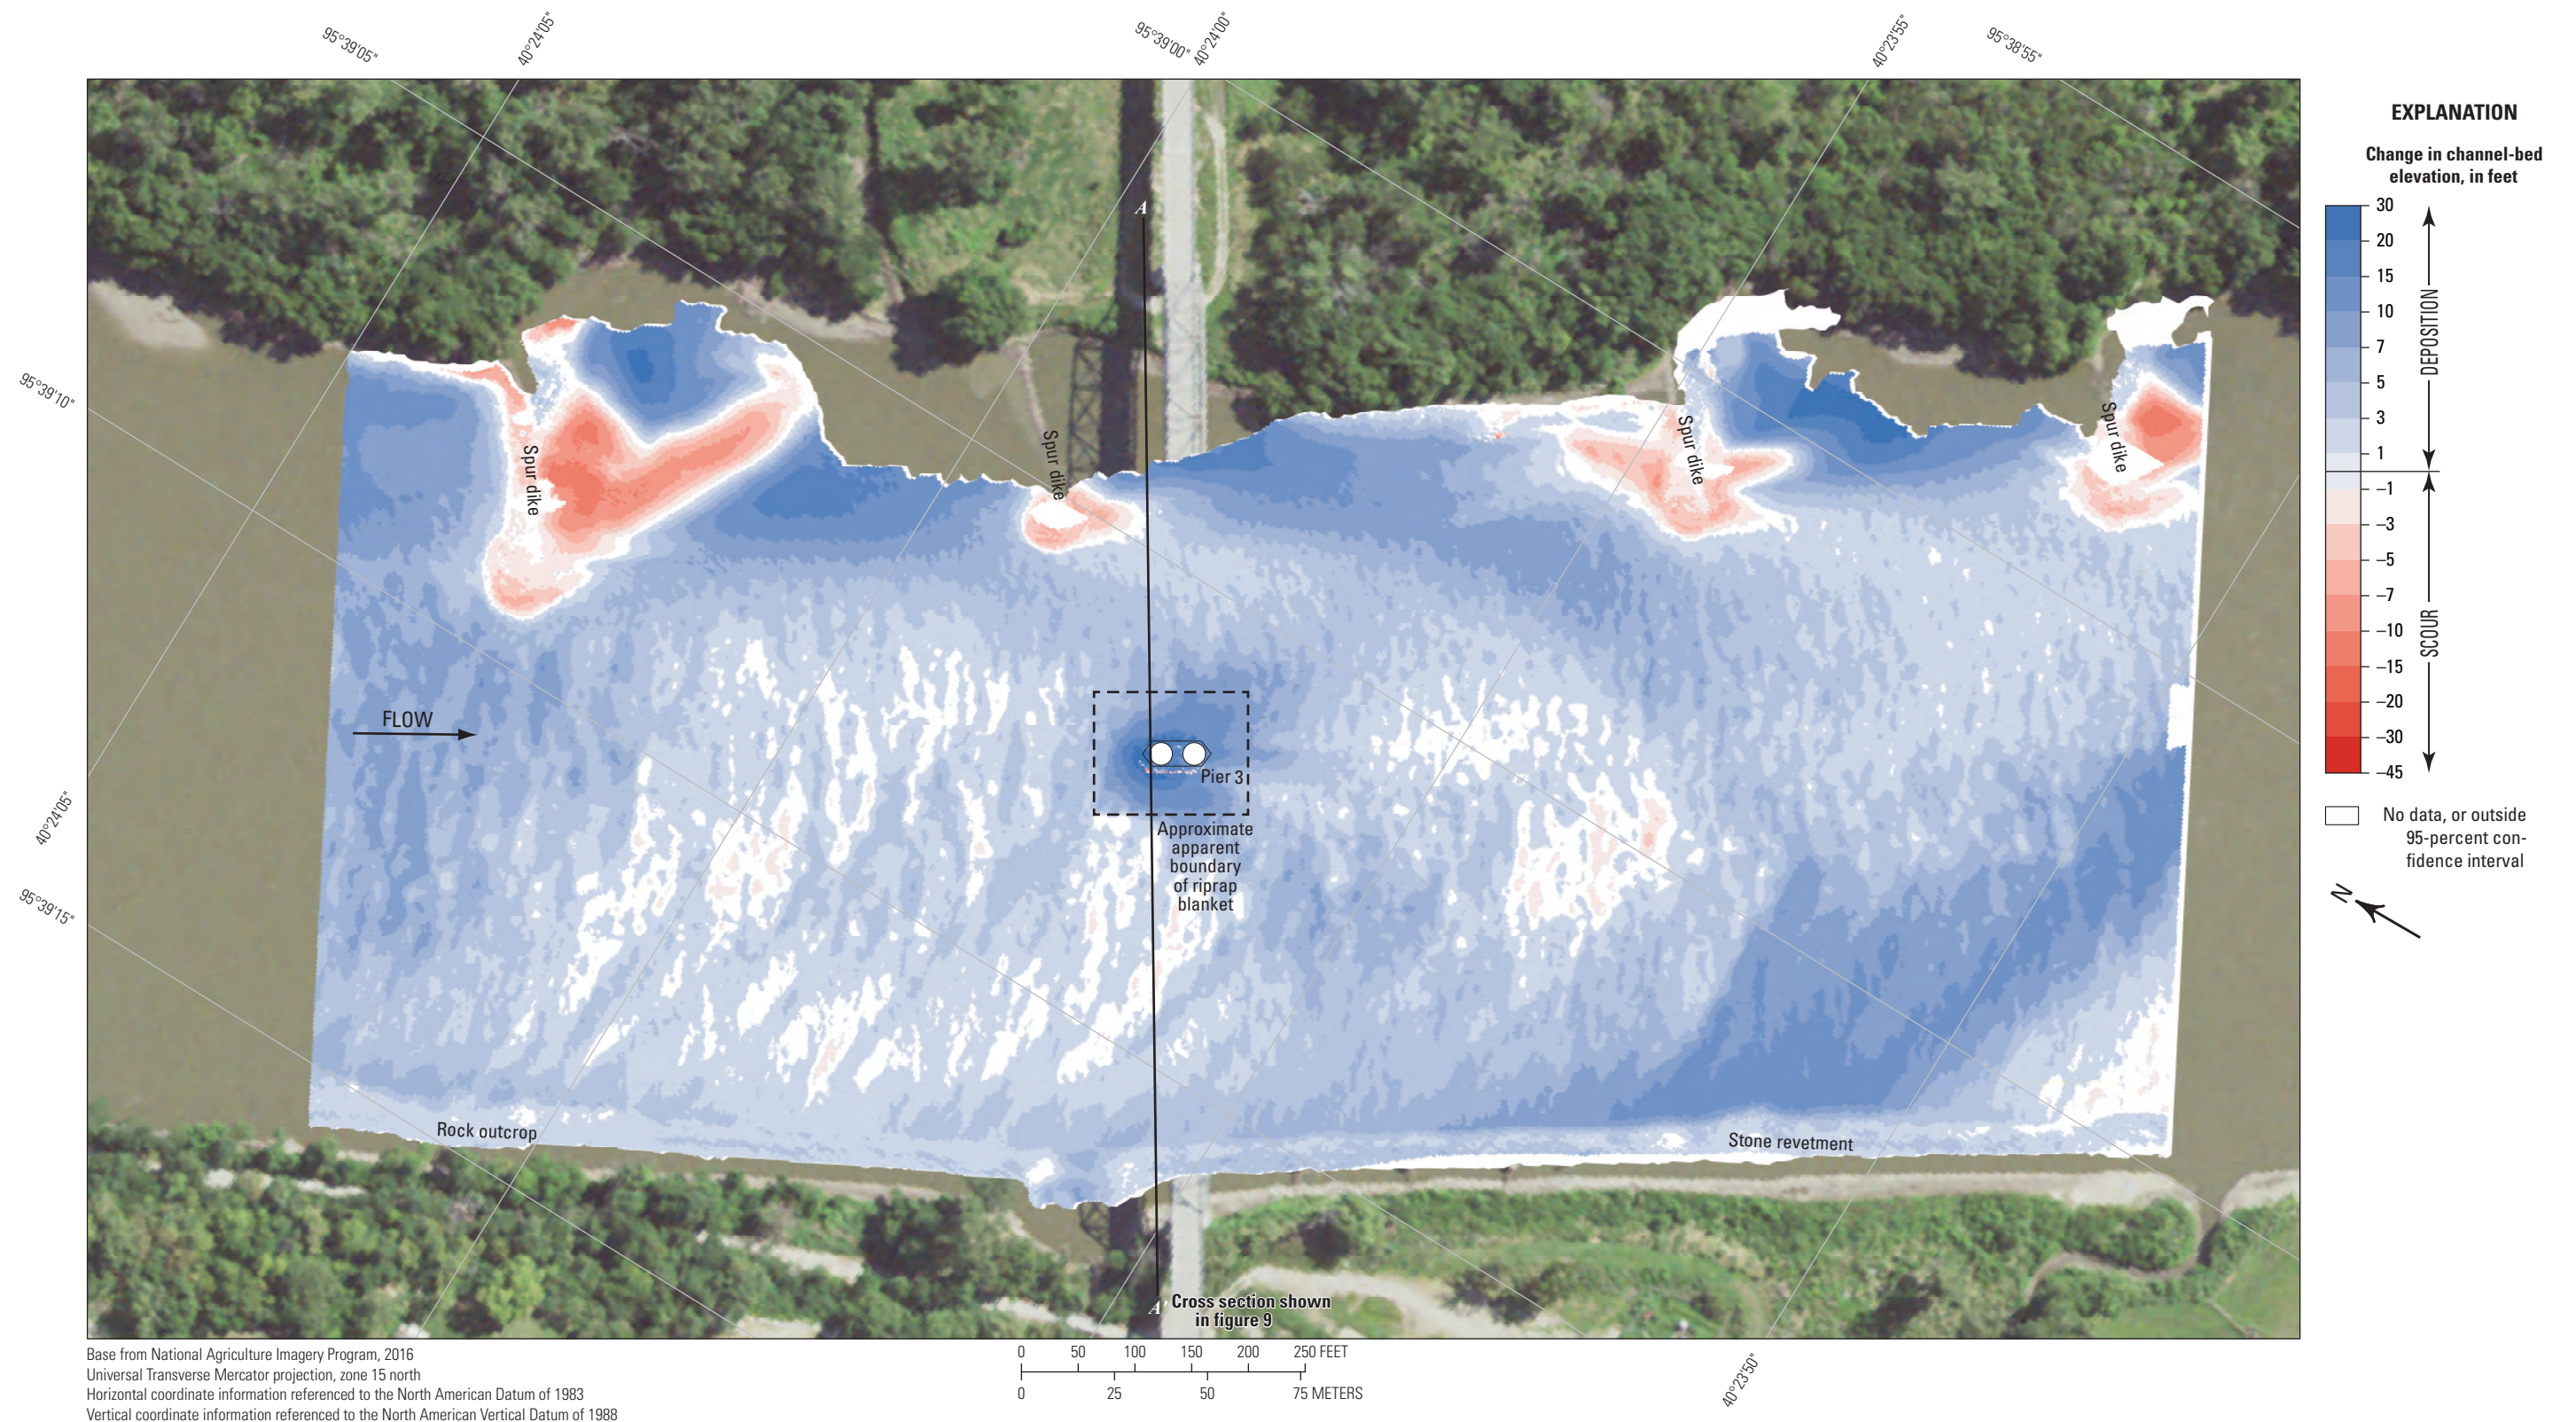
The difference between the survey on June 22, 2022, and the earliest survey during flooding on July 13, 2011 (fig. 12), indicates about 92 percent of the joint area of interest had detectable change, which means only about 8 percent of the differences in the joint area of interest are equivocal and within the bounds of uncertainty (table 8). Deposition is dominant throughout most of the reach between 2011 and 2022 in the DoD, except in localized areas near the tips of the spur dikes on the left (east) bank (fig. 12). The average difference between the bathymetric surfaces was +4.43 ft (table 8), indicating substantial channel aggradation between the 2011 and 2022 surveys. The net gain of sediment in the reach between 2011 and 2022 was about 165,100 yd³, which is by far the largest net gain of the two sites on the Missouri River, as well as the second largest net gain of all the sites surveyed in 2022 (table 8). The cross section from the 2011 survey along the upstream face of the bridge varies from 5 to 15 ft below the other survey sections, with a substantially lower bed near the left (east) bank downstream from the spur dike there

Figure 12. Difference between surfaces created from bathymetric surveys of the Missouri River channel near structure L0098 on U.S. Highway 136 at Brownville, Nebraska, on June 22, 2022, and July 13, 2011, with probabilistic thresholding.

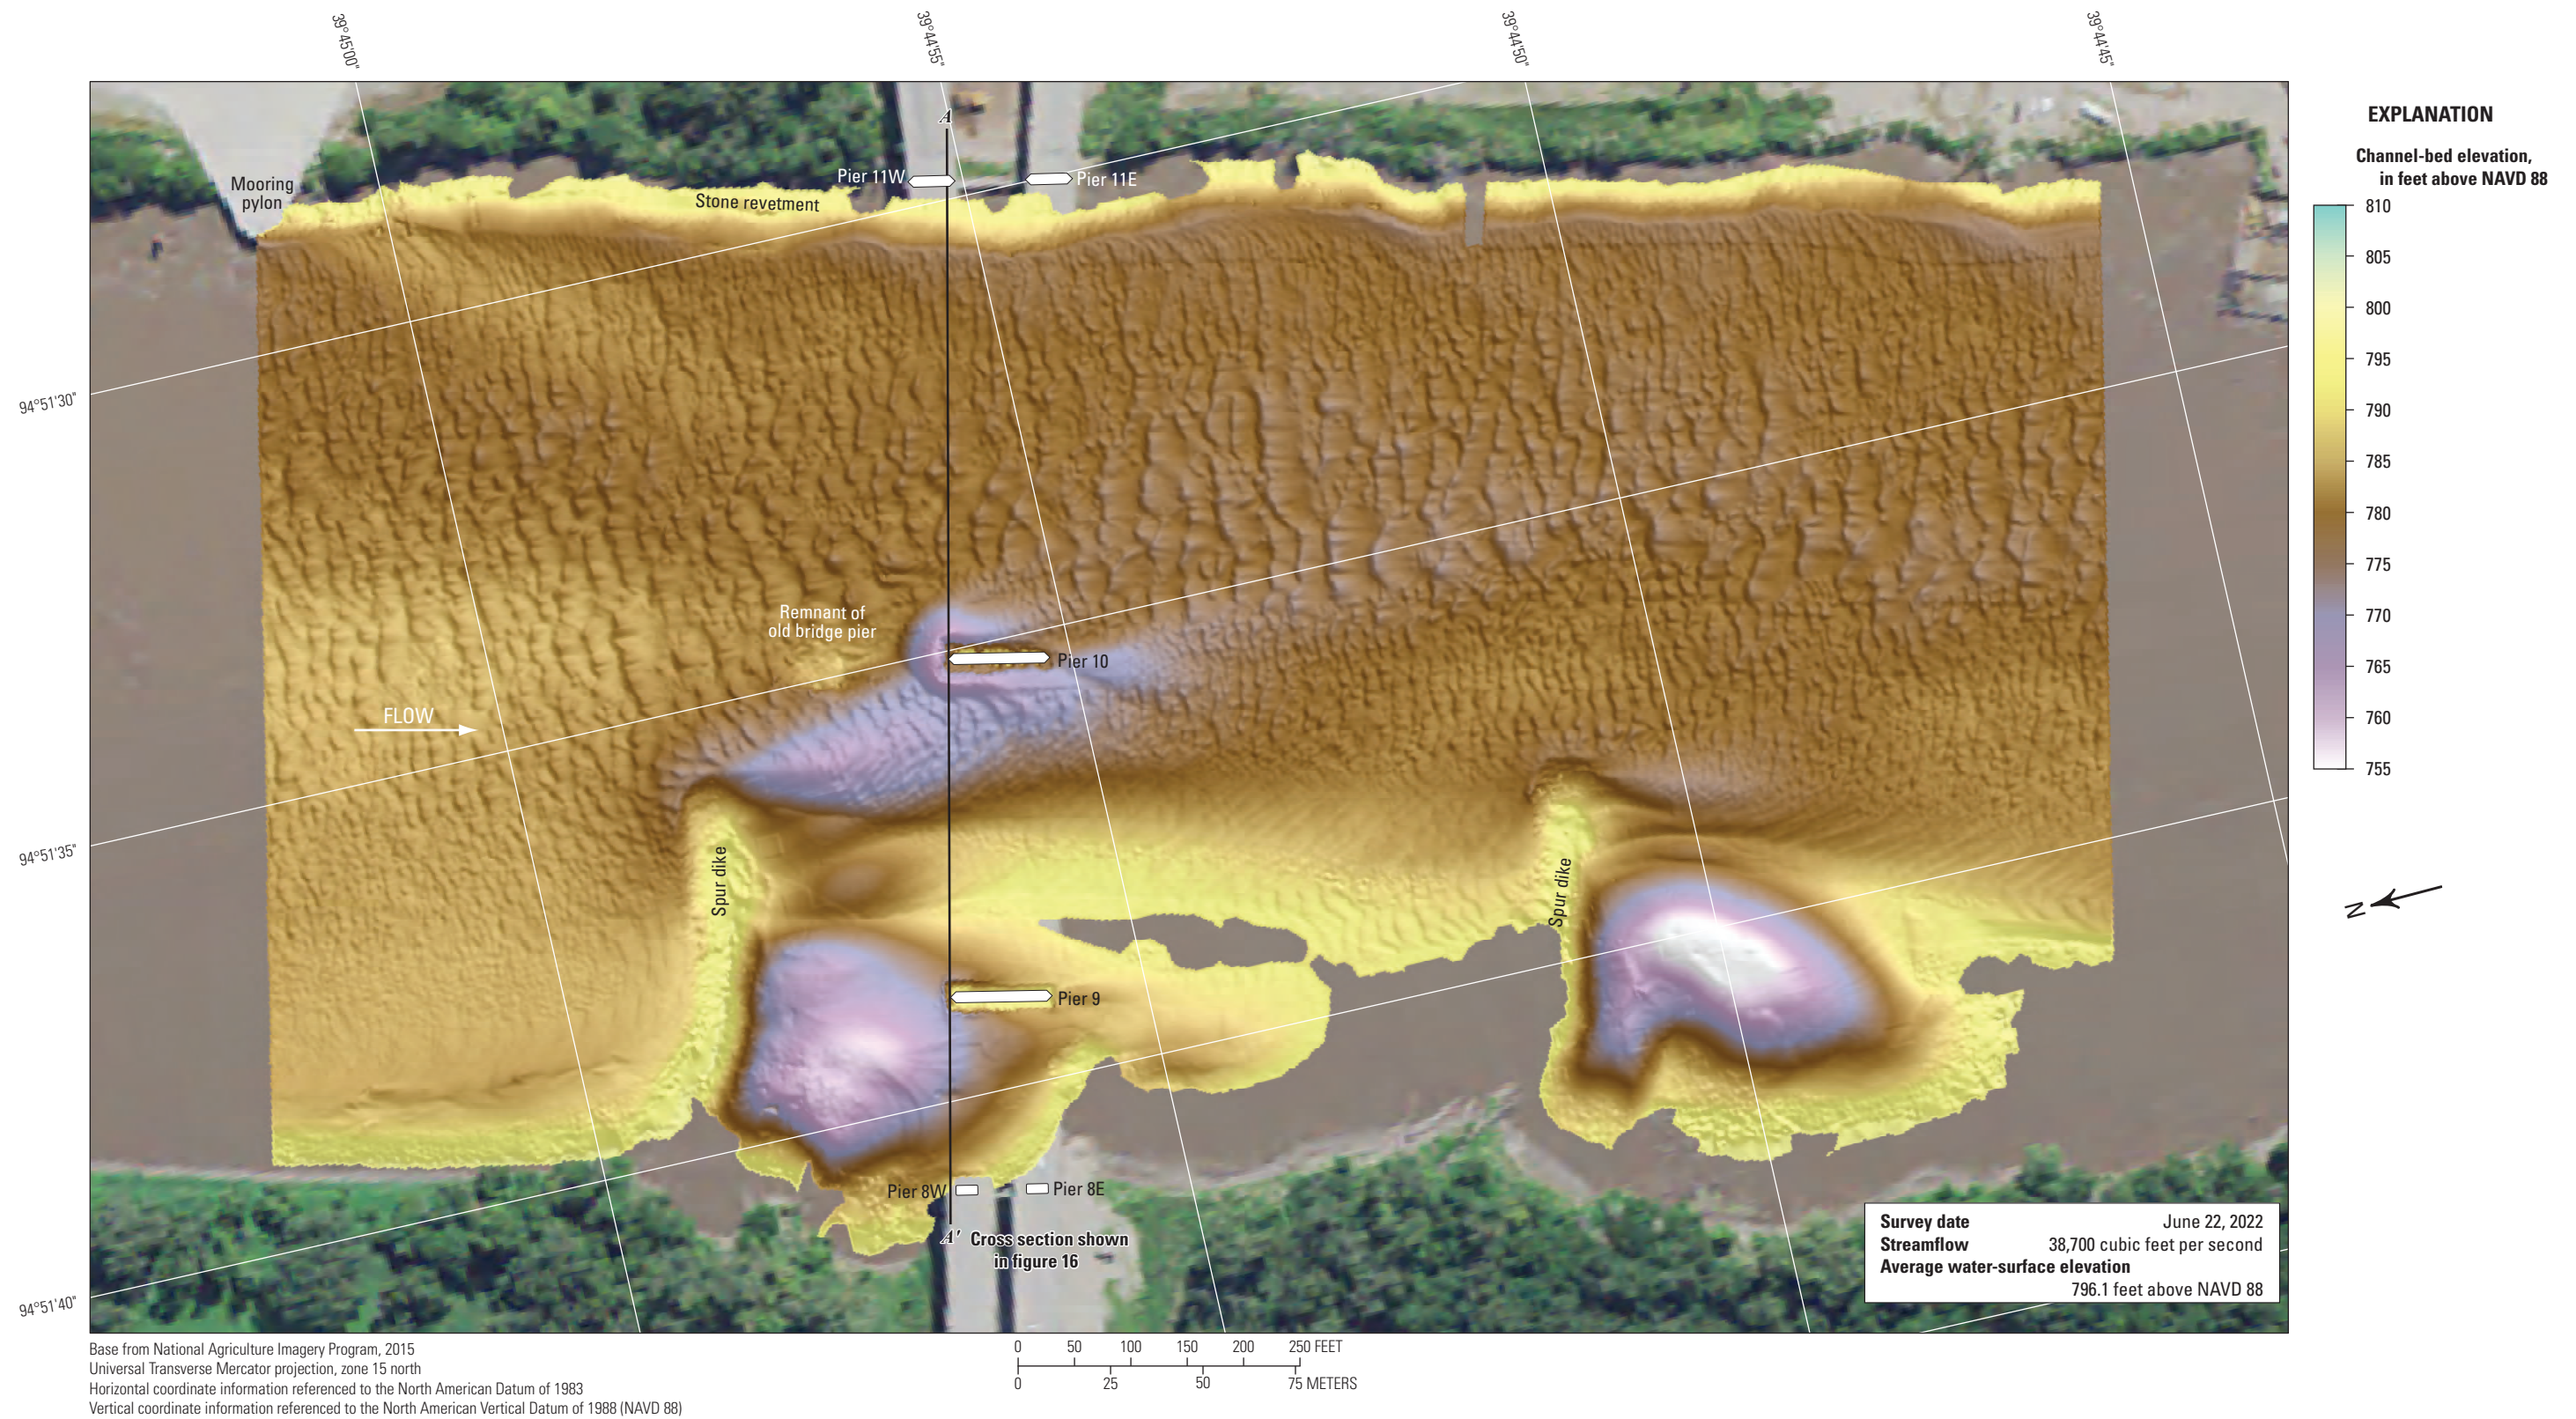
Figure 14. Bathymetric survey of the Missouri River channel near dual bridge structure A3664 on U.S. Highway 36 at St. Joseph, Missouri.
