Bathymetric and Velocimetric Surveys at Highway Bridges Crossing the Missouri and Mississippi Rivers on the Periphery of Missouri, June 13–22, 2022

Scientific Investigations Report 2024–5032

By Richard J. Huizinga

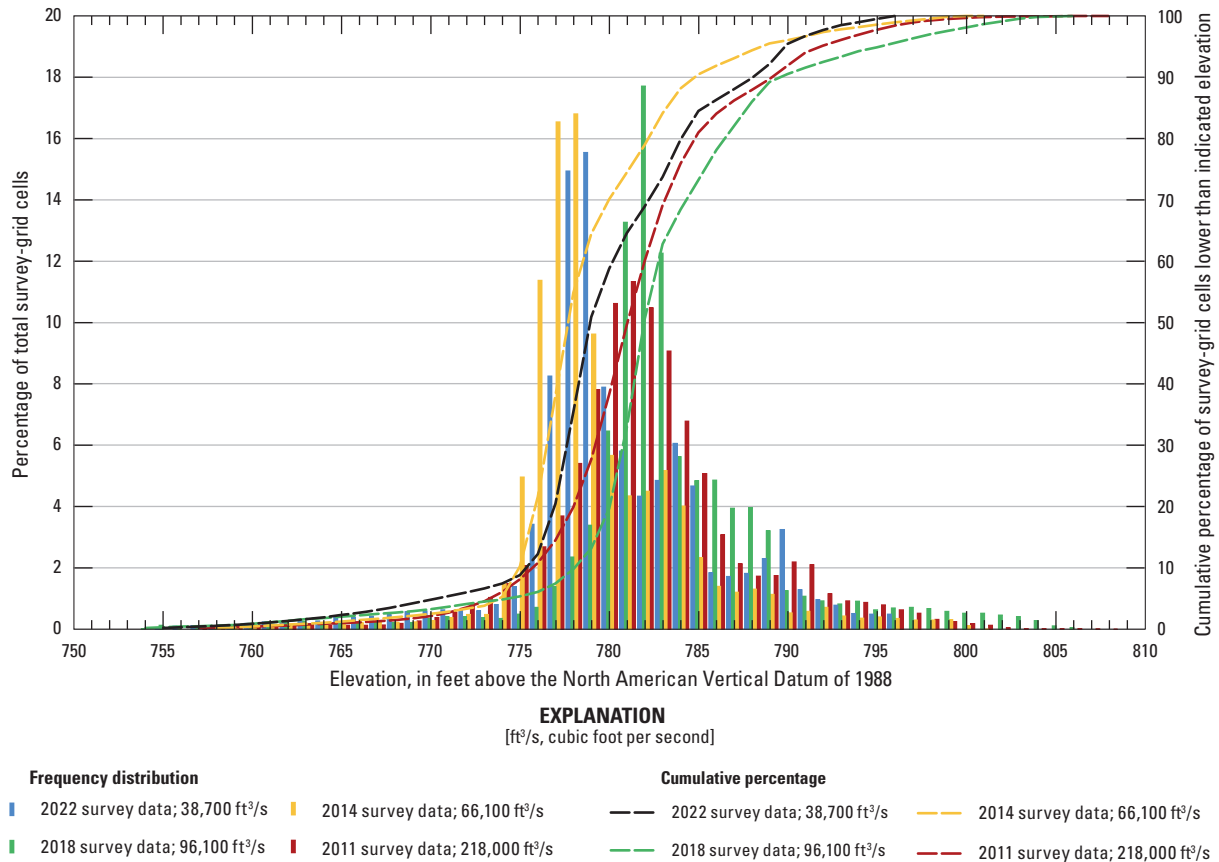
Figure 15. Frequency distribution of bed elevations for bathymetric survey-grid cells in 1-foot elevation bins on the Missouri River near structure A3664 on U.S. Highway 36 at St. Joseph, Missouri, on June 22, 2022, compared to previous surveys in 2011, 2014, and 2018 (Huizinga, 2012, 2015, and 2020e, respectively).

section (fig. 16). The frequency distribution of bed elevations in 2022 appeared similar in shape to 2014 but shifted about 1–2 ft higher in channel-bed elevations than 2014 (fig. 15). Streamflow in 2022 was most similar to 2014 (table 8), which may account for the similarity in overall characteristics between the surveys (figs. 16 and 18). The stone revetment on the left (east) banks shows a similar area of erosion to the 2018 comparison, again indicating possibly higher uncertainties of the outer beams in the 2022 survey, but most of the left bank is within the bounds of uncertainty (fig. 18). A substantial part of the channel on the right (west) side was not surveyed in 2014 because of substantial floating debris (table 8). As with previous DoDs, deposition or scour apparent on opposing faces of pier 10 likely resulted from minor horizontal positional variances between the surveys (fig. 6).

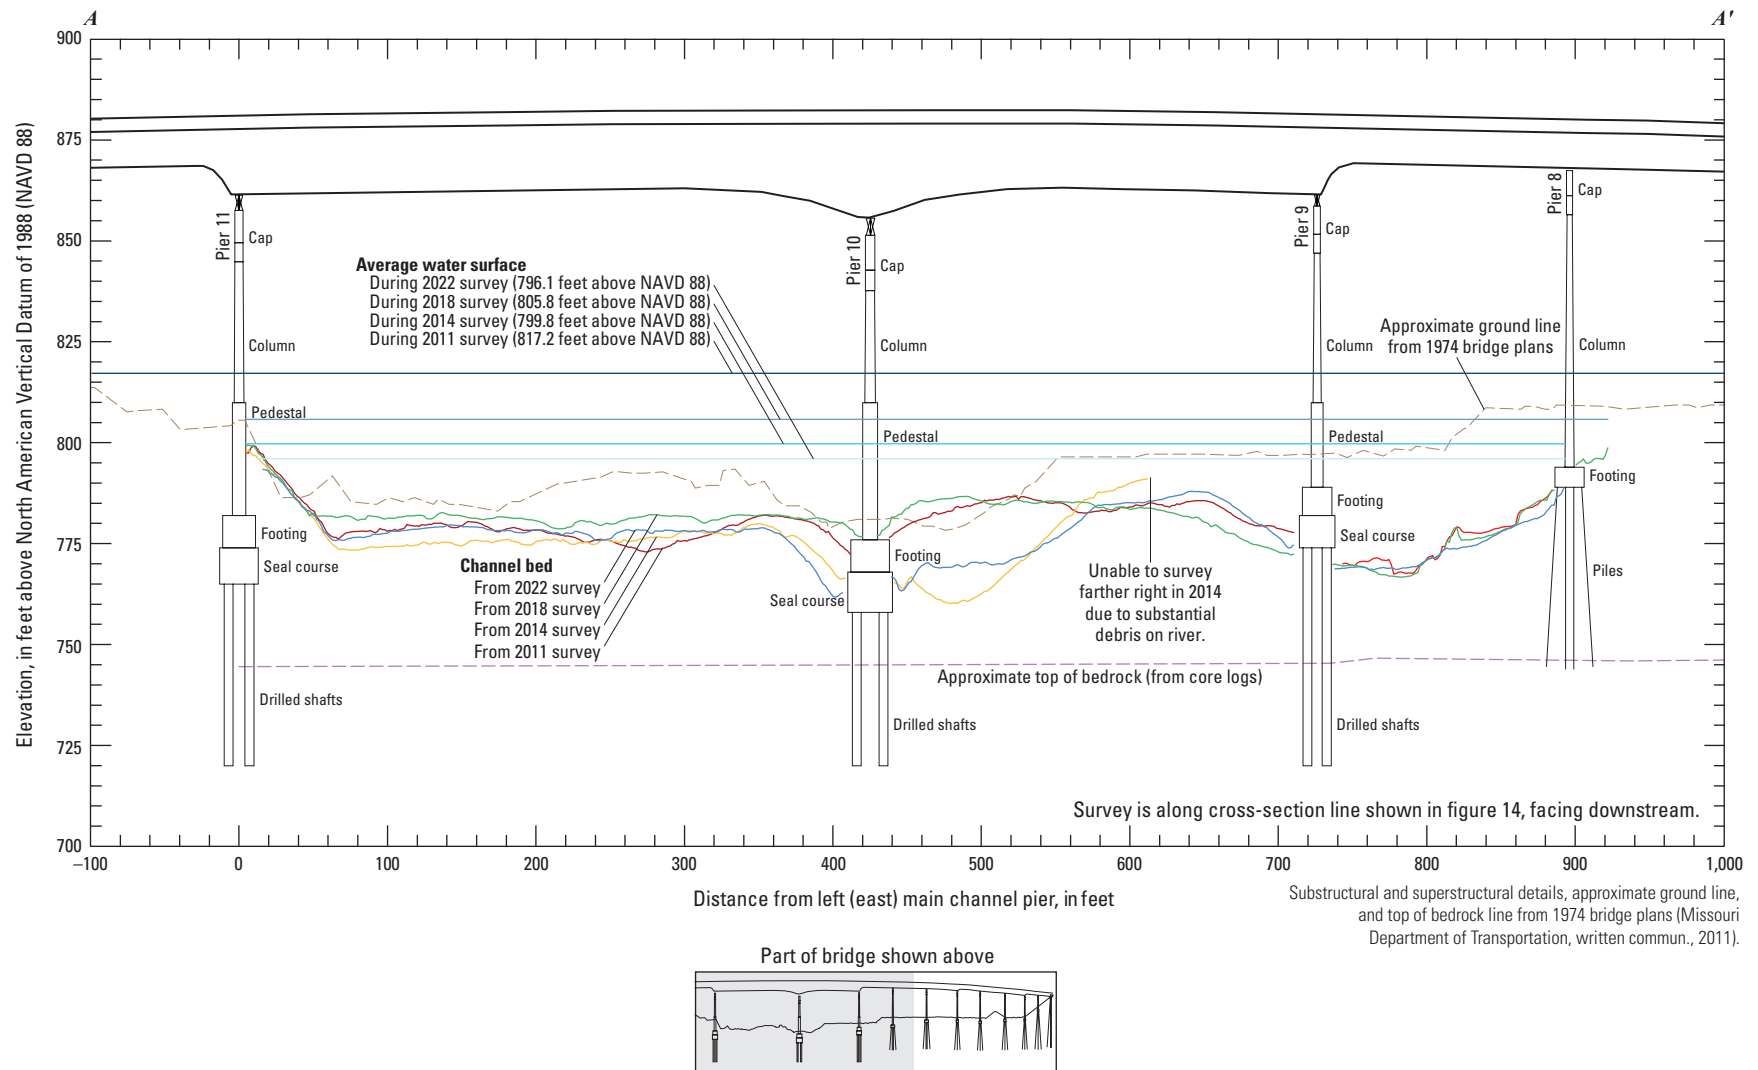
range of elevations observed in previous multibeam surveys, except near pier 10 where the 2022 cross section most closely mimics the 2014 survey ([fig. 16](#)).

Figure 16. Key features, substructural and superstructural details, and surveyed channel bed of dual bridge structure A3664 on U.S. Highway 36 crossing the Missouri River at St. Joseph, Missouri.

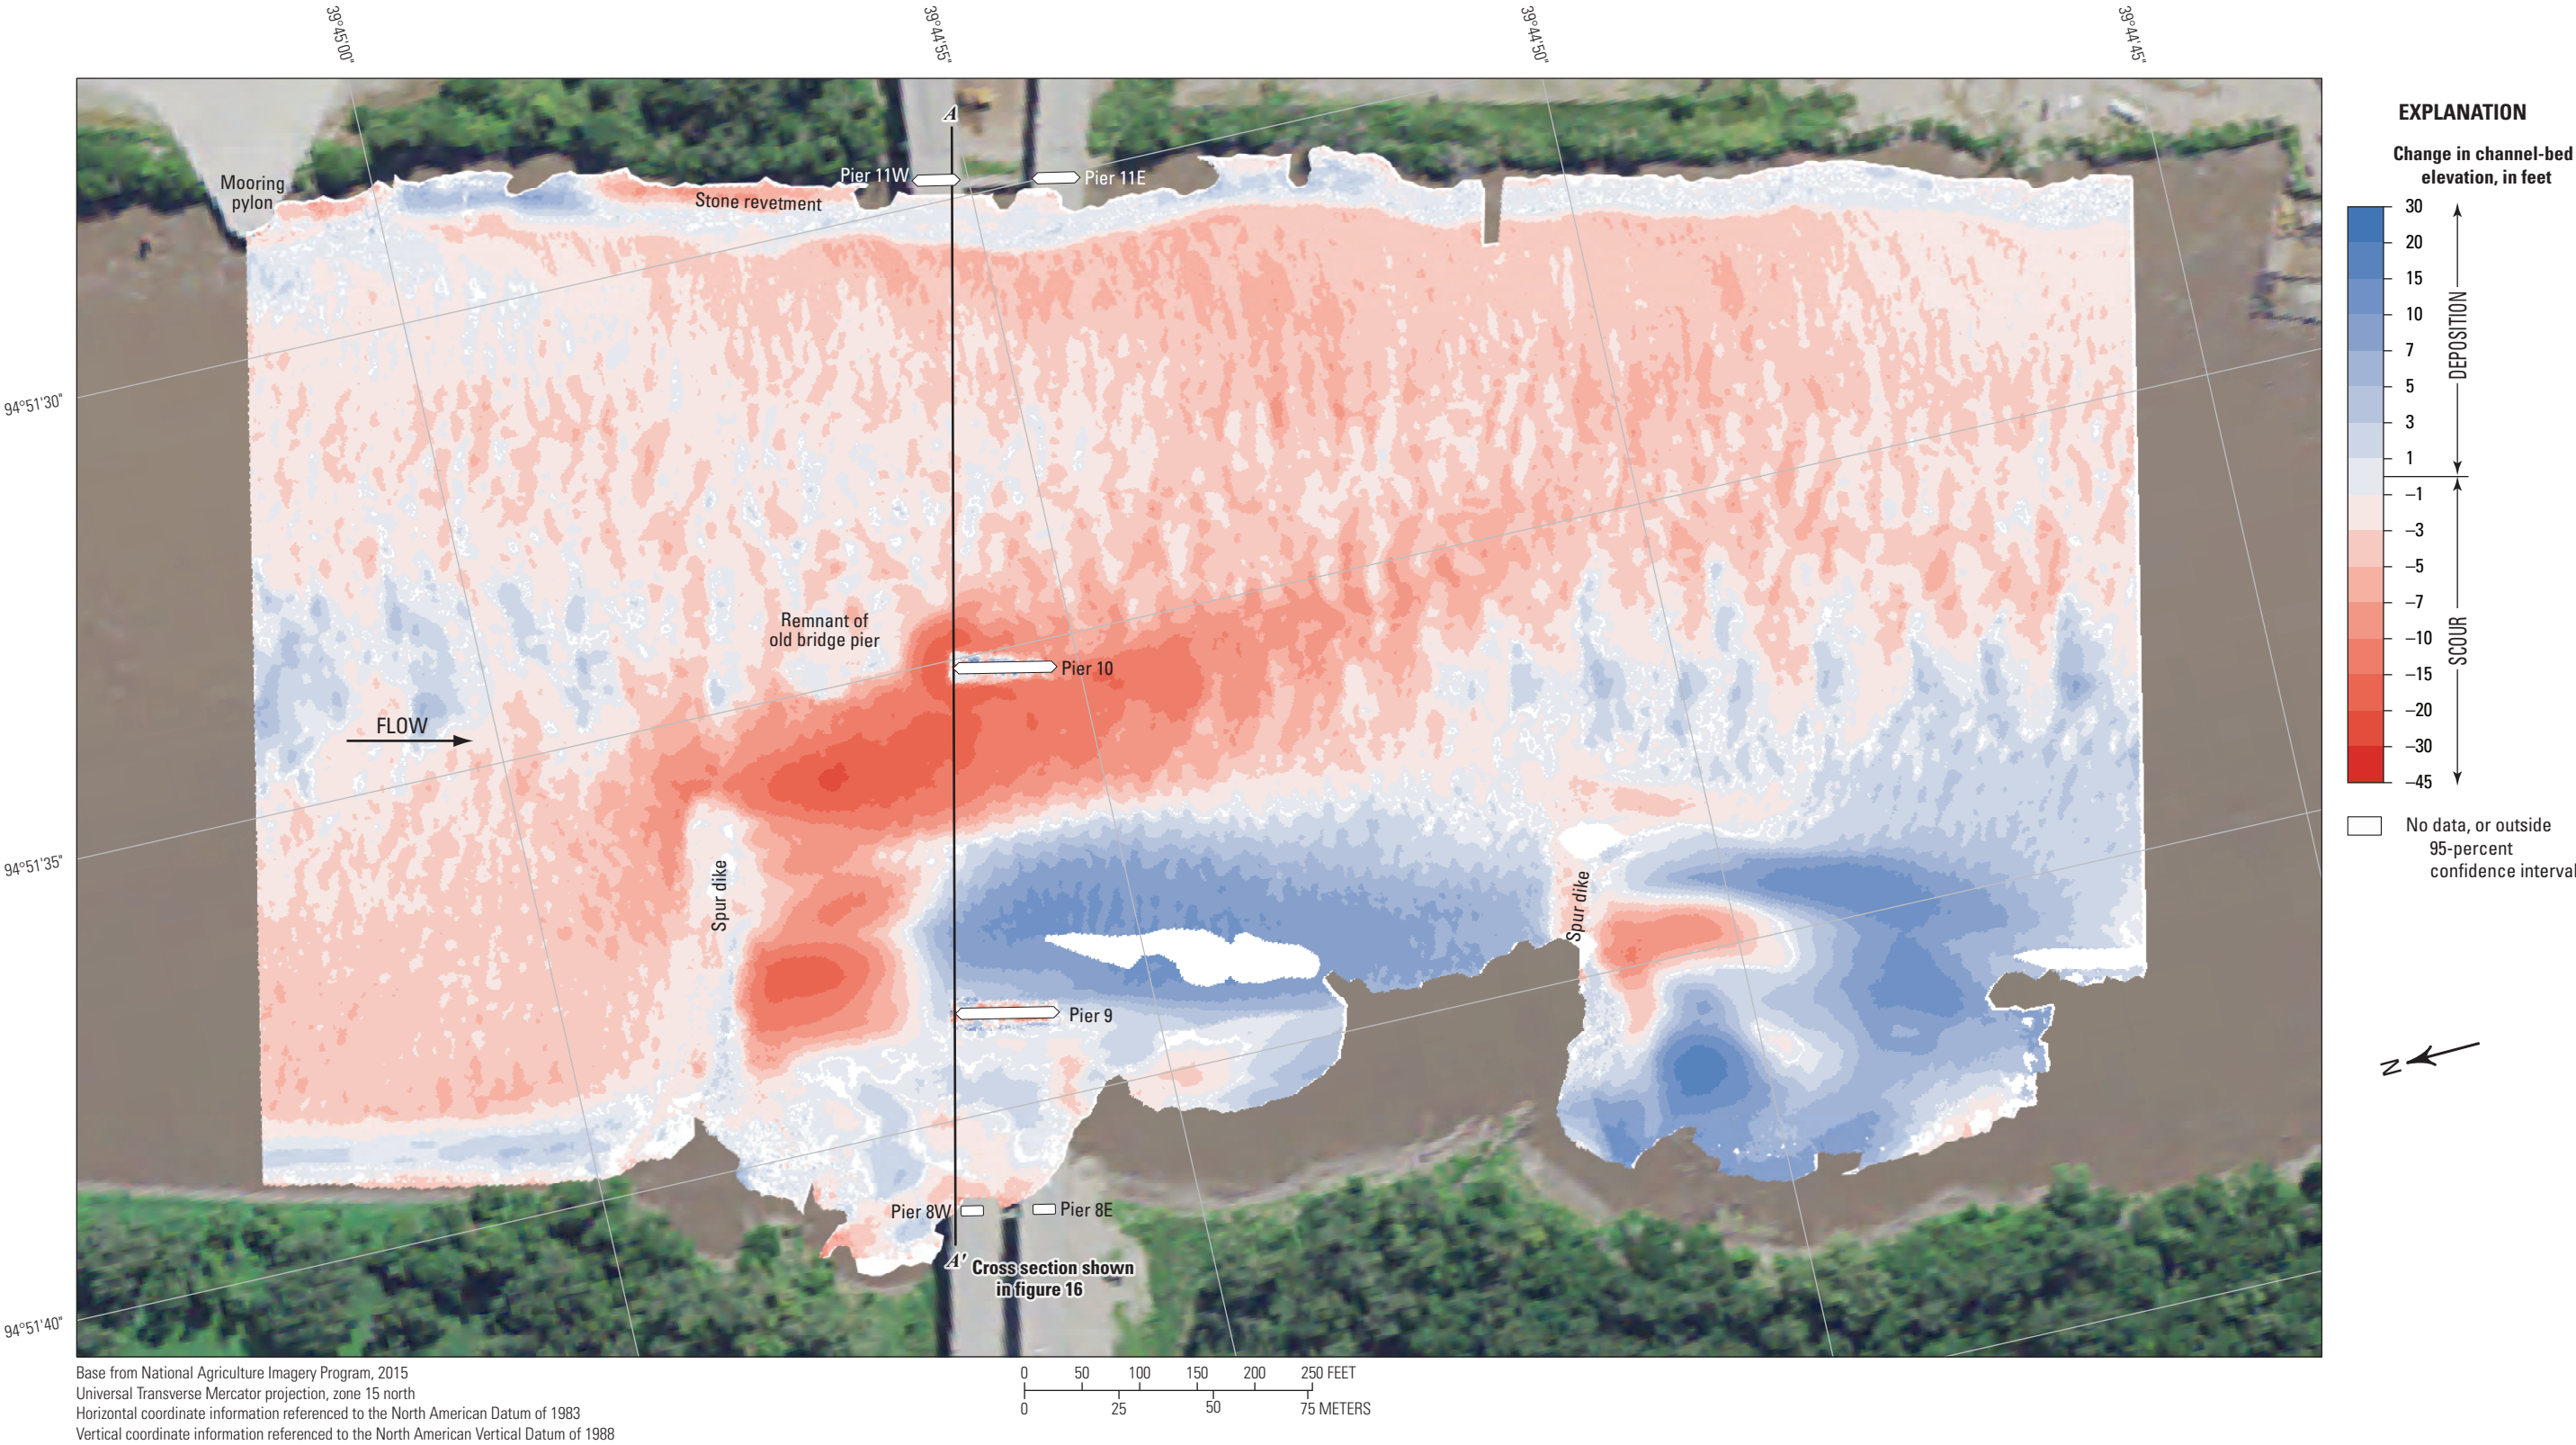
The difference between the survey on June 22, 2022, and the previous survey on July 16, 2018 ([fig. 17](#)), indicates about 98 percent of the joint area of interest had detectable change, which means only about 2 percent of the differences in the joint area of interest are equivocal and within the bounds of uncertainty ([table 8](#)). Erosion appears dominant throughout the reach between 2018 and 2022 in the DoD, except localized areas of substantial deposition downstream from the spur dikes on the right (west) bank and minor to moderate deposition in the middle of the upstream channel ([fig. 17](#)). The average difference between the bathymetric surfaces was -1.83 ft ([table 8](#)), indicating moderate channel degradation between the 2018 and 2022 surveys. The net volume of cut in the reach from 2018 to 2022 was about 134,200 yd³, and the net volume of fill was about 46,400 yd³, resulting in a net loss of about 87,800 yd³ of sediment between 2018 and 2022 ([table 8](#)). The bed surface in the cross section from the 2022 survey along the upstream face of the bridge was below the 2018 survey section, except near pier 9 ([fig. 16](#)). The water-surface elevation in 2022 also was substantially lower than in 2018 ([table 8](#); [fig. 16](#)). The frequency distribution of bed elevations in 2022 is similar in shape to the 2018 distribution, but with a higher percentage of cells at channel-bed elevations about 4–5 ft lower than 2018 ([fig. 15](#)). The area downstream from the spur dike on the upstream right bank showed substantial erosion of as much as 30 ft and deposition of as much as 20 ft ([fig. 17](#)), and the erosion likely affected the scour observed near pier 10 ([figs. 16 and 17](#)). The stone revetment on the left (east) bank showed localized signs of minor erosion and deposition, and the various spur dikes throughout the channel showed minor scour on one face and deposition on the other ([fig. 17](#)). As with previous DoDs, deposition or scour apparent on opposing faces of a feature likely results from minor horizontal positional variances between the surveys ([fig. 6](#)). The areas of apparent erosion of the stone revetment tend to be near the upper edges of the banks and may be the result of larger uncertainty in the outer beams in the 2022 survey, particularly near the water surface ([fig. 5](#)).

Figure 17. Difference between surfaces created from bathymetric surveys of the Missouri River channel near dual bridge structure A3664 on U.S. Highway 36 at St. Joseph, Missouri, on June 22, 2022, and July 16, 2018, with probabilistic thresholding.

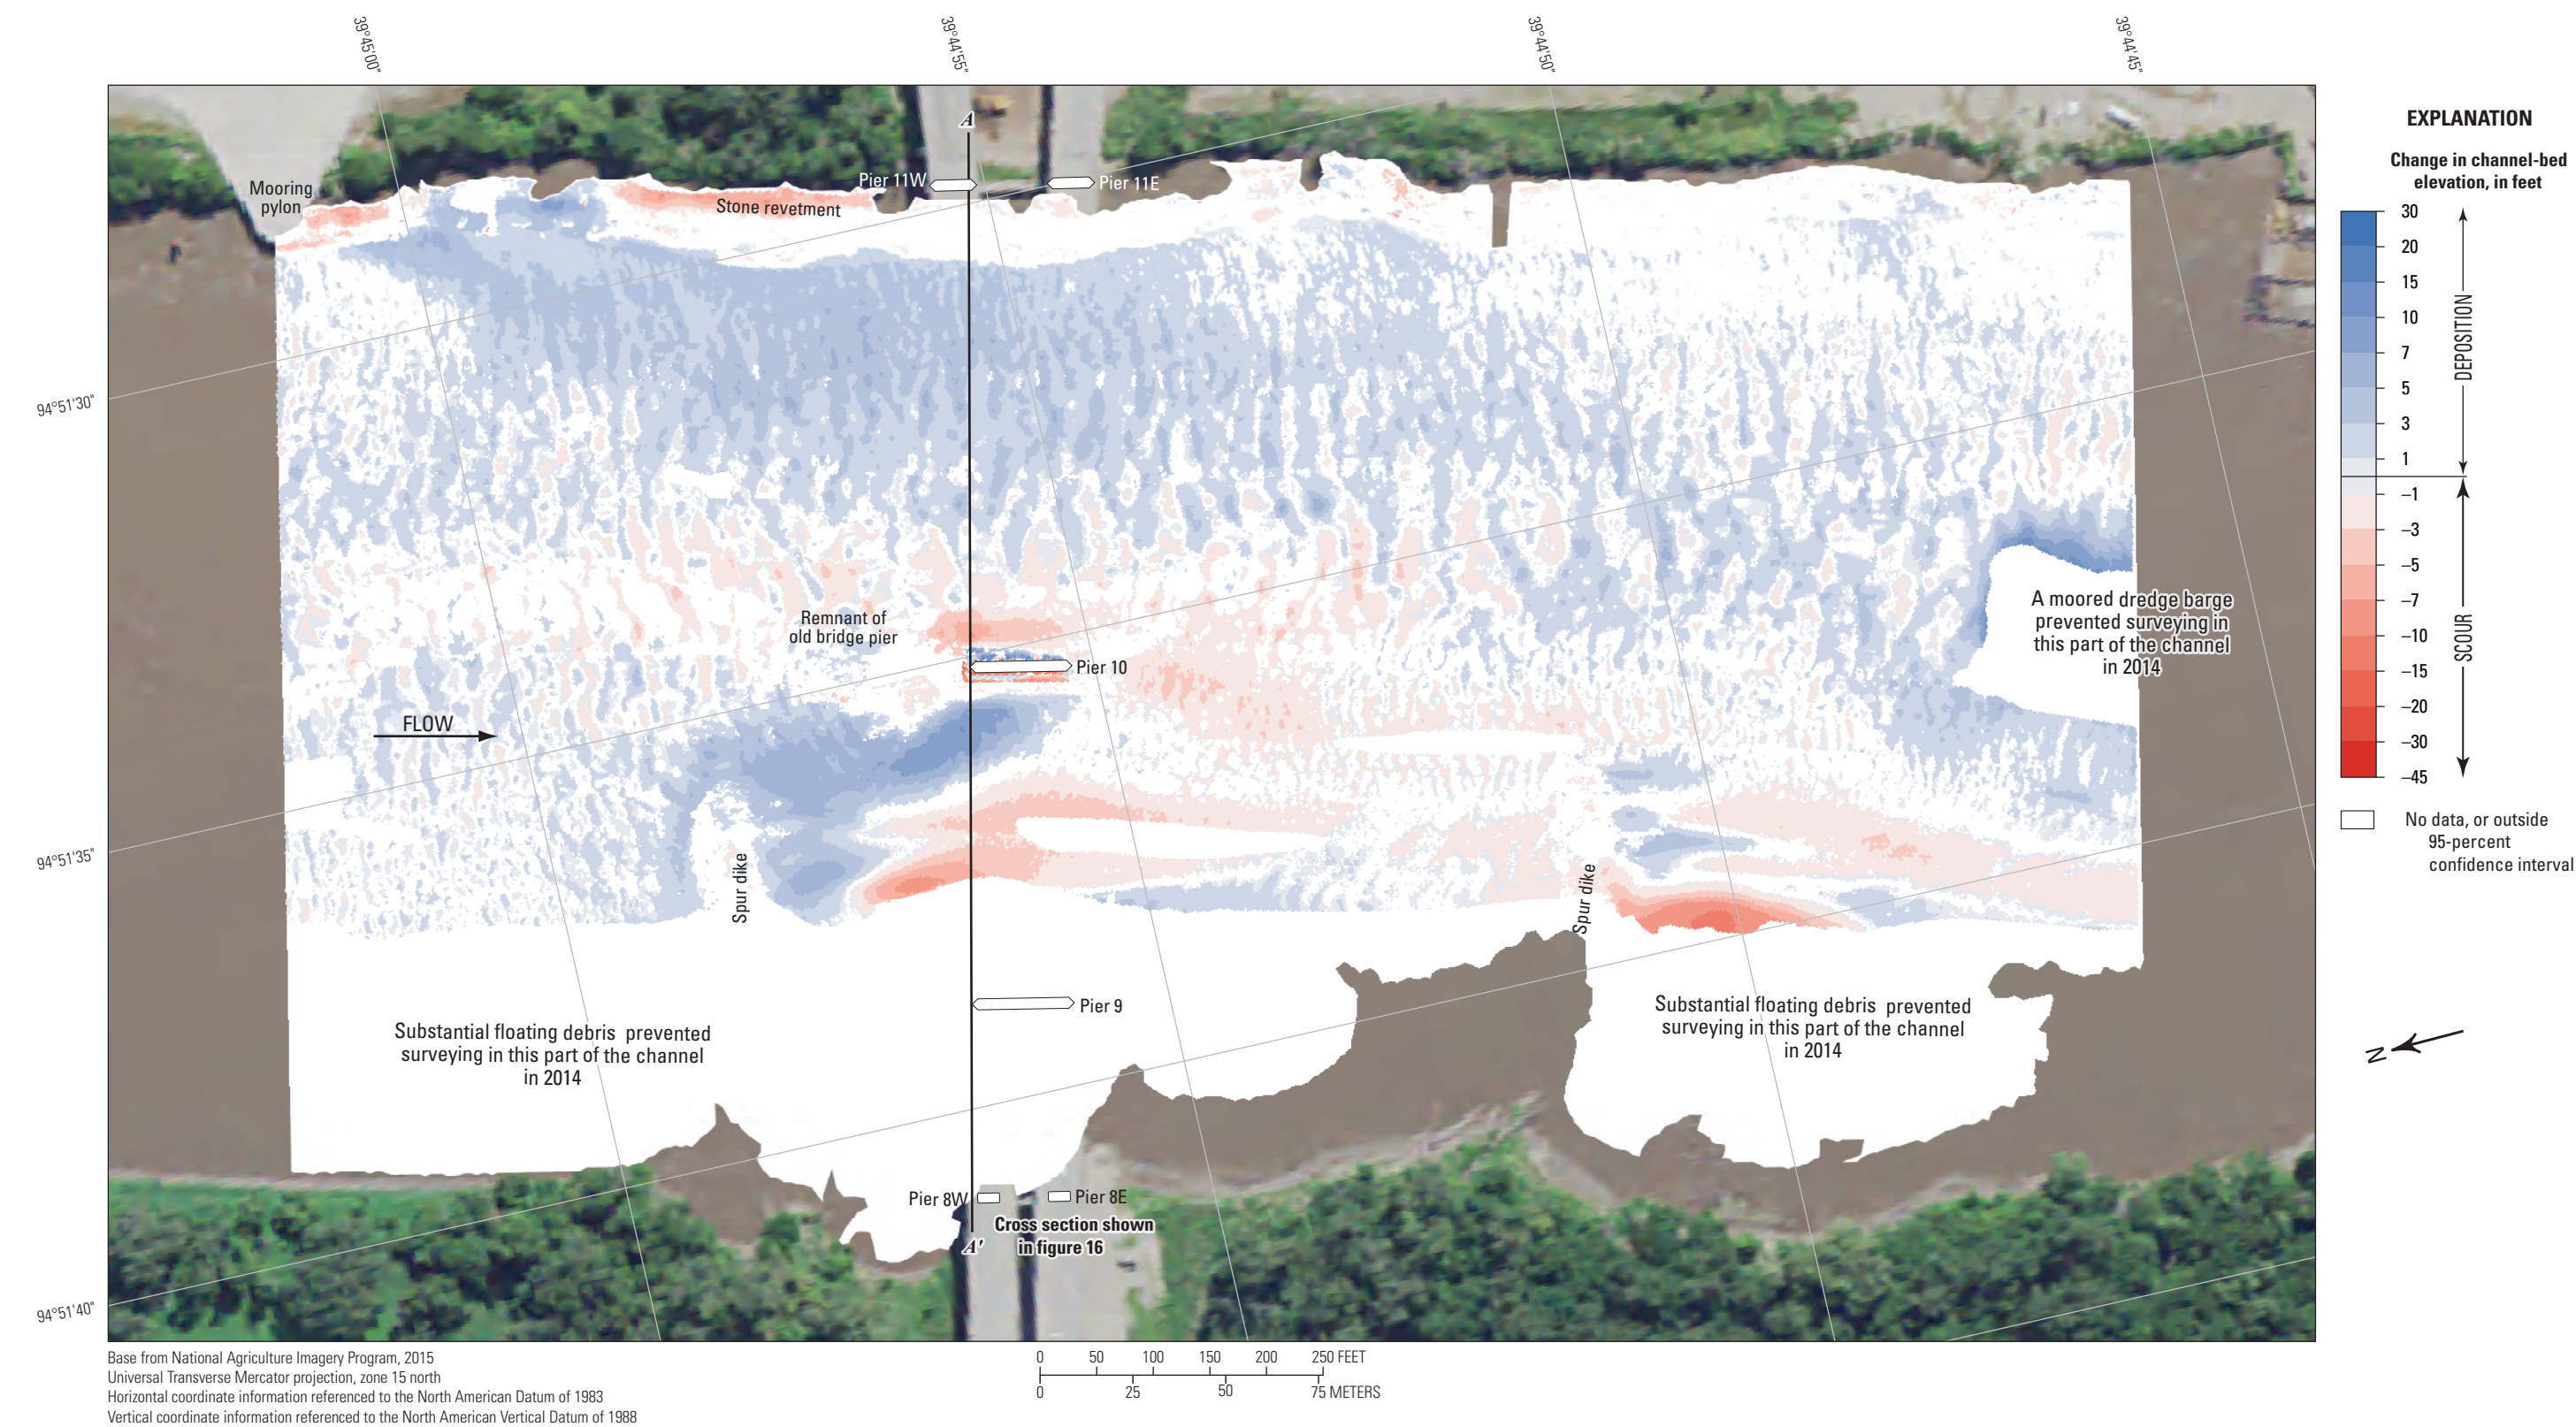
The difference between the survey on June 22, 2022, and the survey on June 4, 2014 ([fig. 18](#)), indicates about 60 percent of the joint area of interest had detectable change, which means about 40 percent of the differences in the joint area of interest are equivocal and within the bounds of uncertainty ([table 8](#)). Minor erosion and deposition appear nearly balanced throughout the reach between 2014 and 2022 in the DoD, with deposition slightly more dominant and with localized substantial erosion and deposition near the ends and downstream from the spur dikes ([fig. 18](#)). However, the average difference between the bathymetric surfaces was $+1.02$ ft ([table 8](#)), indicating moderate channel aggradation between the 2014 and 2022 surveys, and the net gain of sediment between 2014 and 2024 was about 22,900 yd³ ([table 8](#)). The cross section from the 2022 survey along the upstream face of the bridge is most like the 2014 survey section, varying 5 to 10 ft above and below the 2014

Figure 18. Difference between surfaces created from bathymetric surveys of the Missouri River channel near dual bridge structure A3664 on U.S. Highway 36 at St. Joseph, Missouri, on June 22, 2022, and June 4, 2014, with probabilistic thresholding.

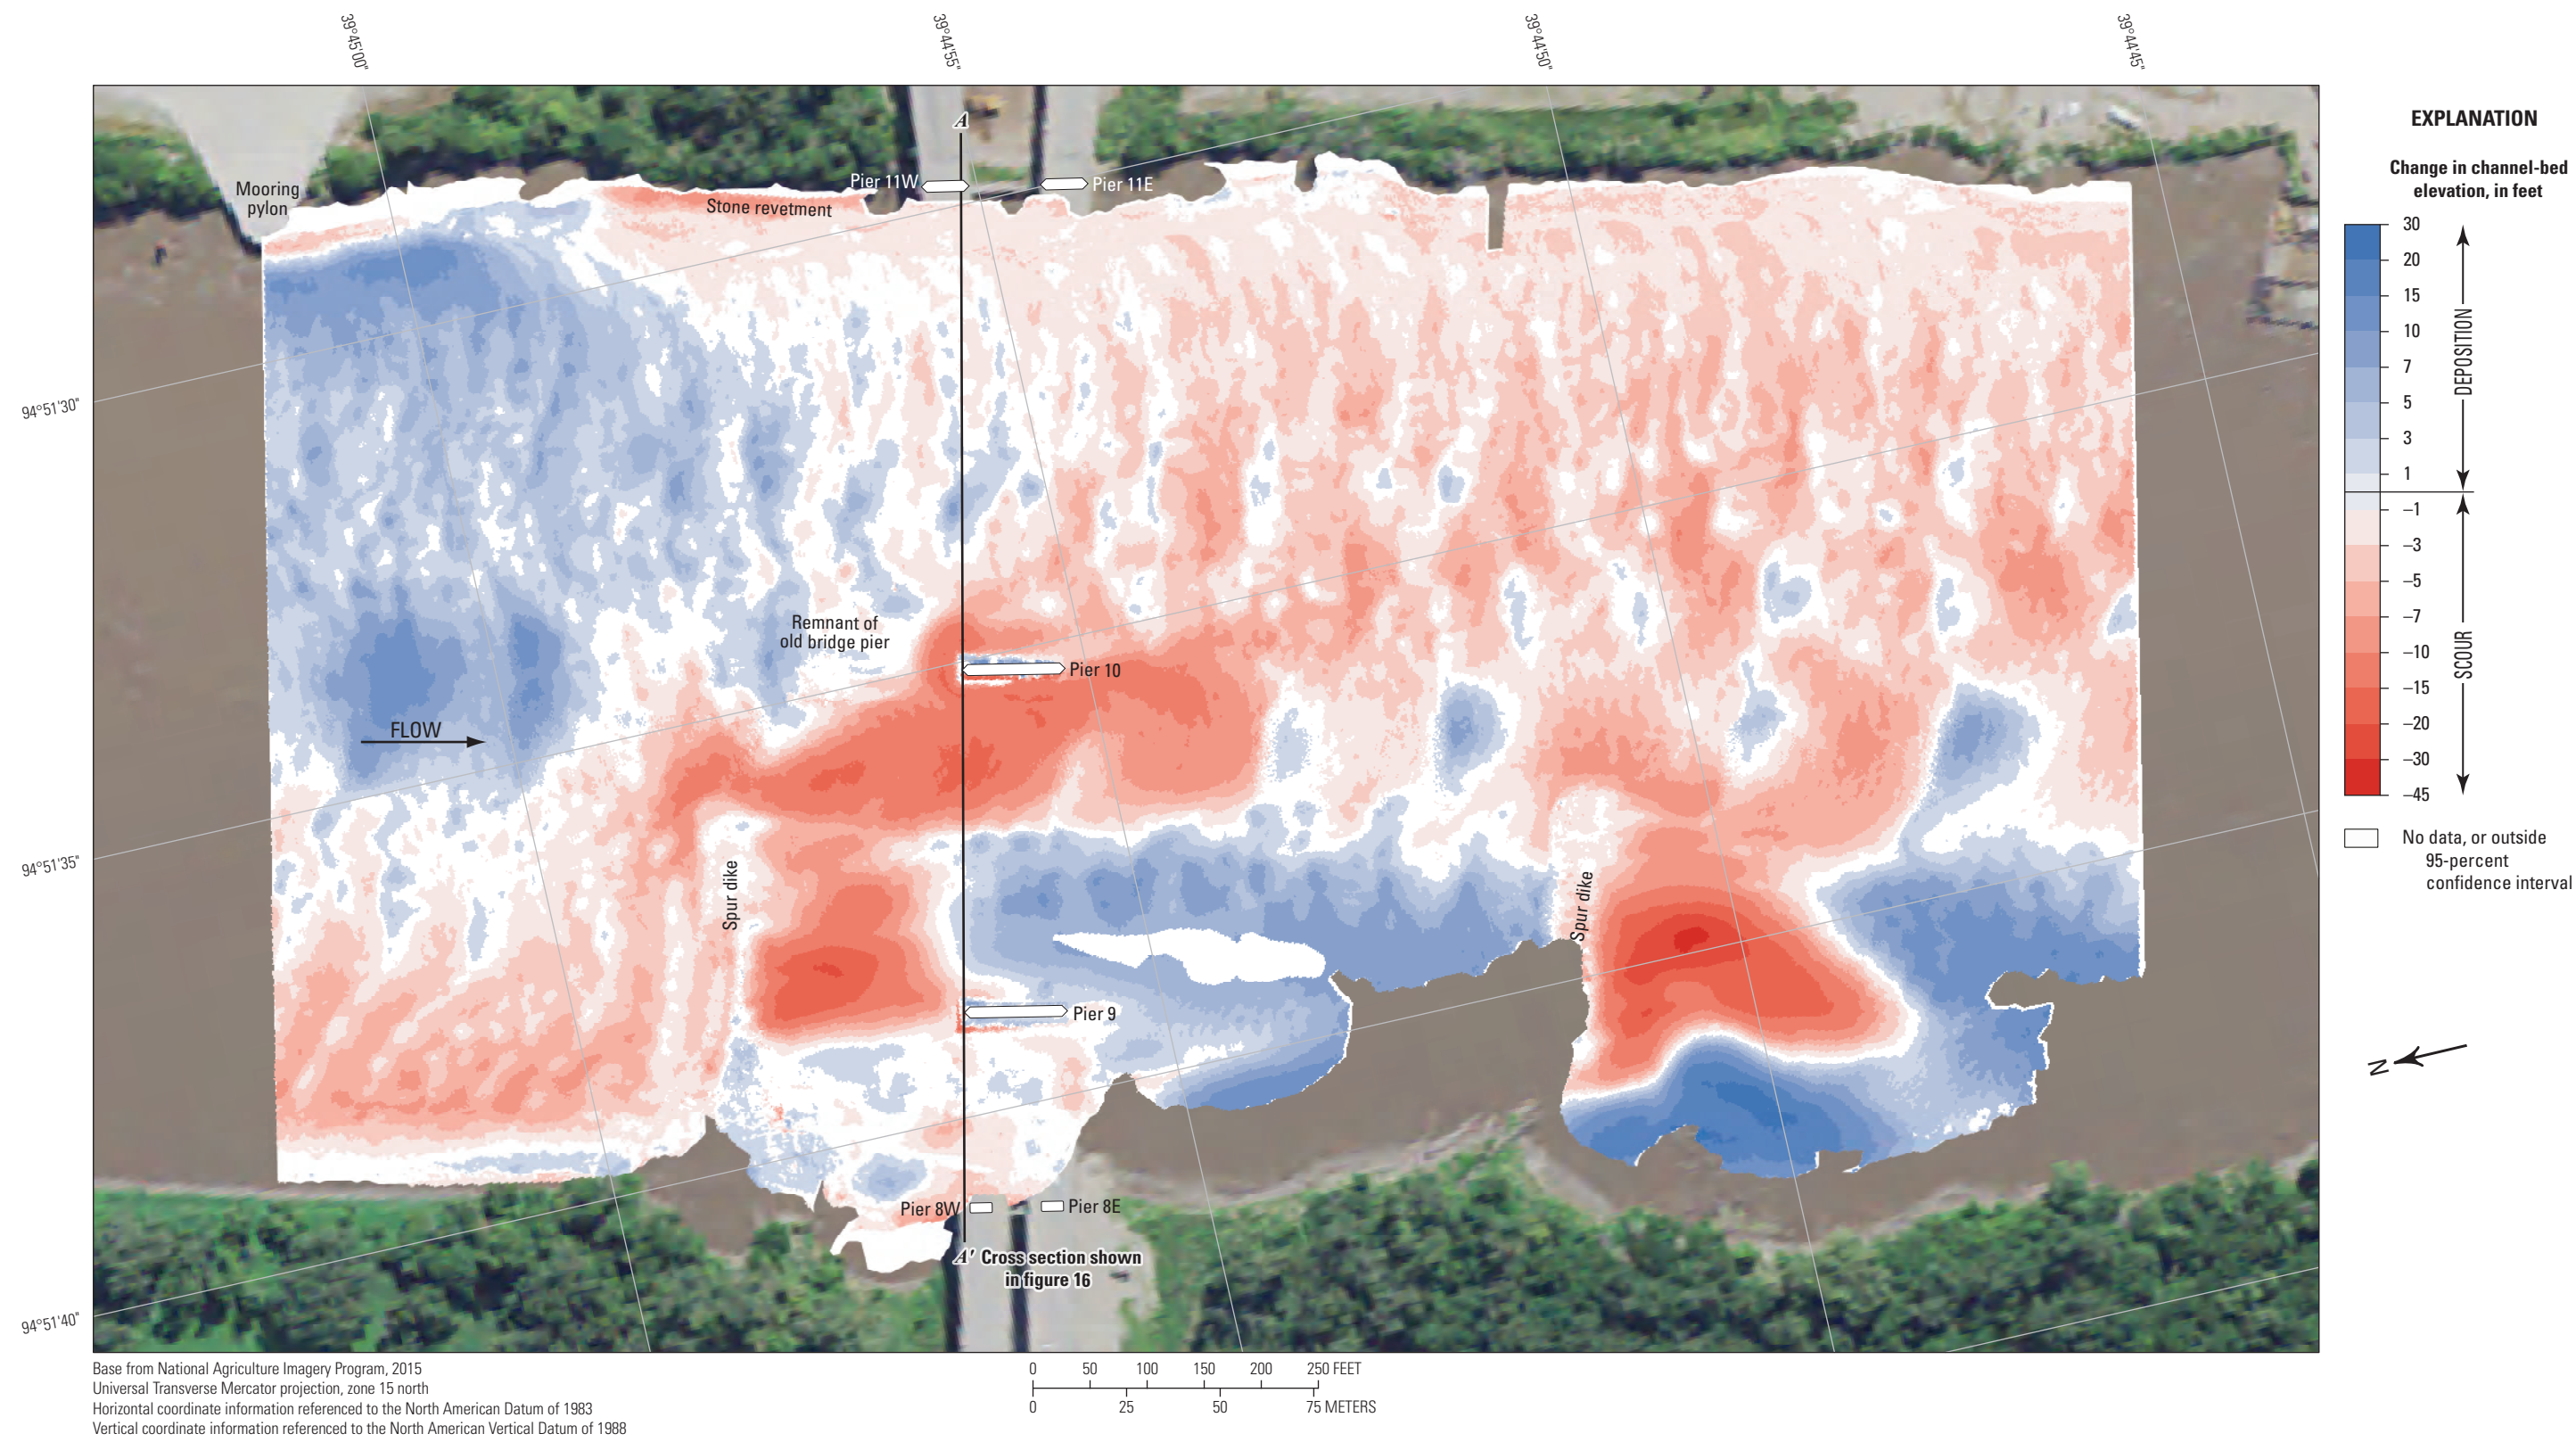
The difference between the survey on June 22, 2022, and the earliest survey during flooding on July 14, 2011 (fig. 19), indicates about 85 percent of the joint area of interest had detectable change, which means about 15 percent of the differences in the joint area of interest are equivocal and within the bounds of uncertainty (table 8). Erosion appears dominant between 2011 and 2022 in the DoD, with substantial erosion balanced with moderate to substantial deposition in the upstream channel and downstream from the spur dikes (fig. 19). The average difference between the bathymetric surfaces was –1.34 ft (table 8), indicating moderate degradation

between the 2011 and 2022 surveys, with a net loss of sediment of about 55,800 yd³ (table 8). The frequency distribution of bed elevations in 2011 was very similar to 2022 (and the other surveys) but shifted about 2–3 ft higher in channel-bed elevations than 2022 (fig. 15). The stone revetment on the left (east) bank showed localized signs of minor scour and deposition, with the same area of moderate erosion as the other DoDs for this site (fig. 19). The piers and various spur dikes throughout the channel showed minor scour on one face and deposition on the other (fig. 19). As with previous DoDs, deposition or scour apparent on opposing faces of a feature likely resulted from minor horizontal positional variances between the surveys (fig. 6).

Figure 19. Difference between surfaces created from bathymetric surveys of the Missouri River channel near dual bridge structure A3664 on U.S. Highway 36 at St. Joseph, Missouri, on June 22, 2022, and July 14, 2011, with probabilistic thresholding.

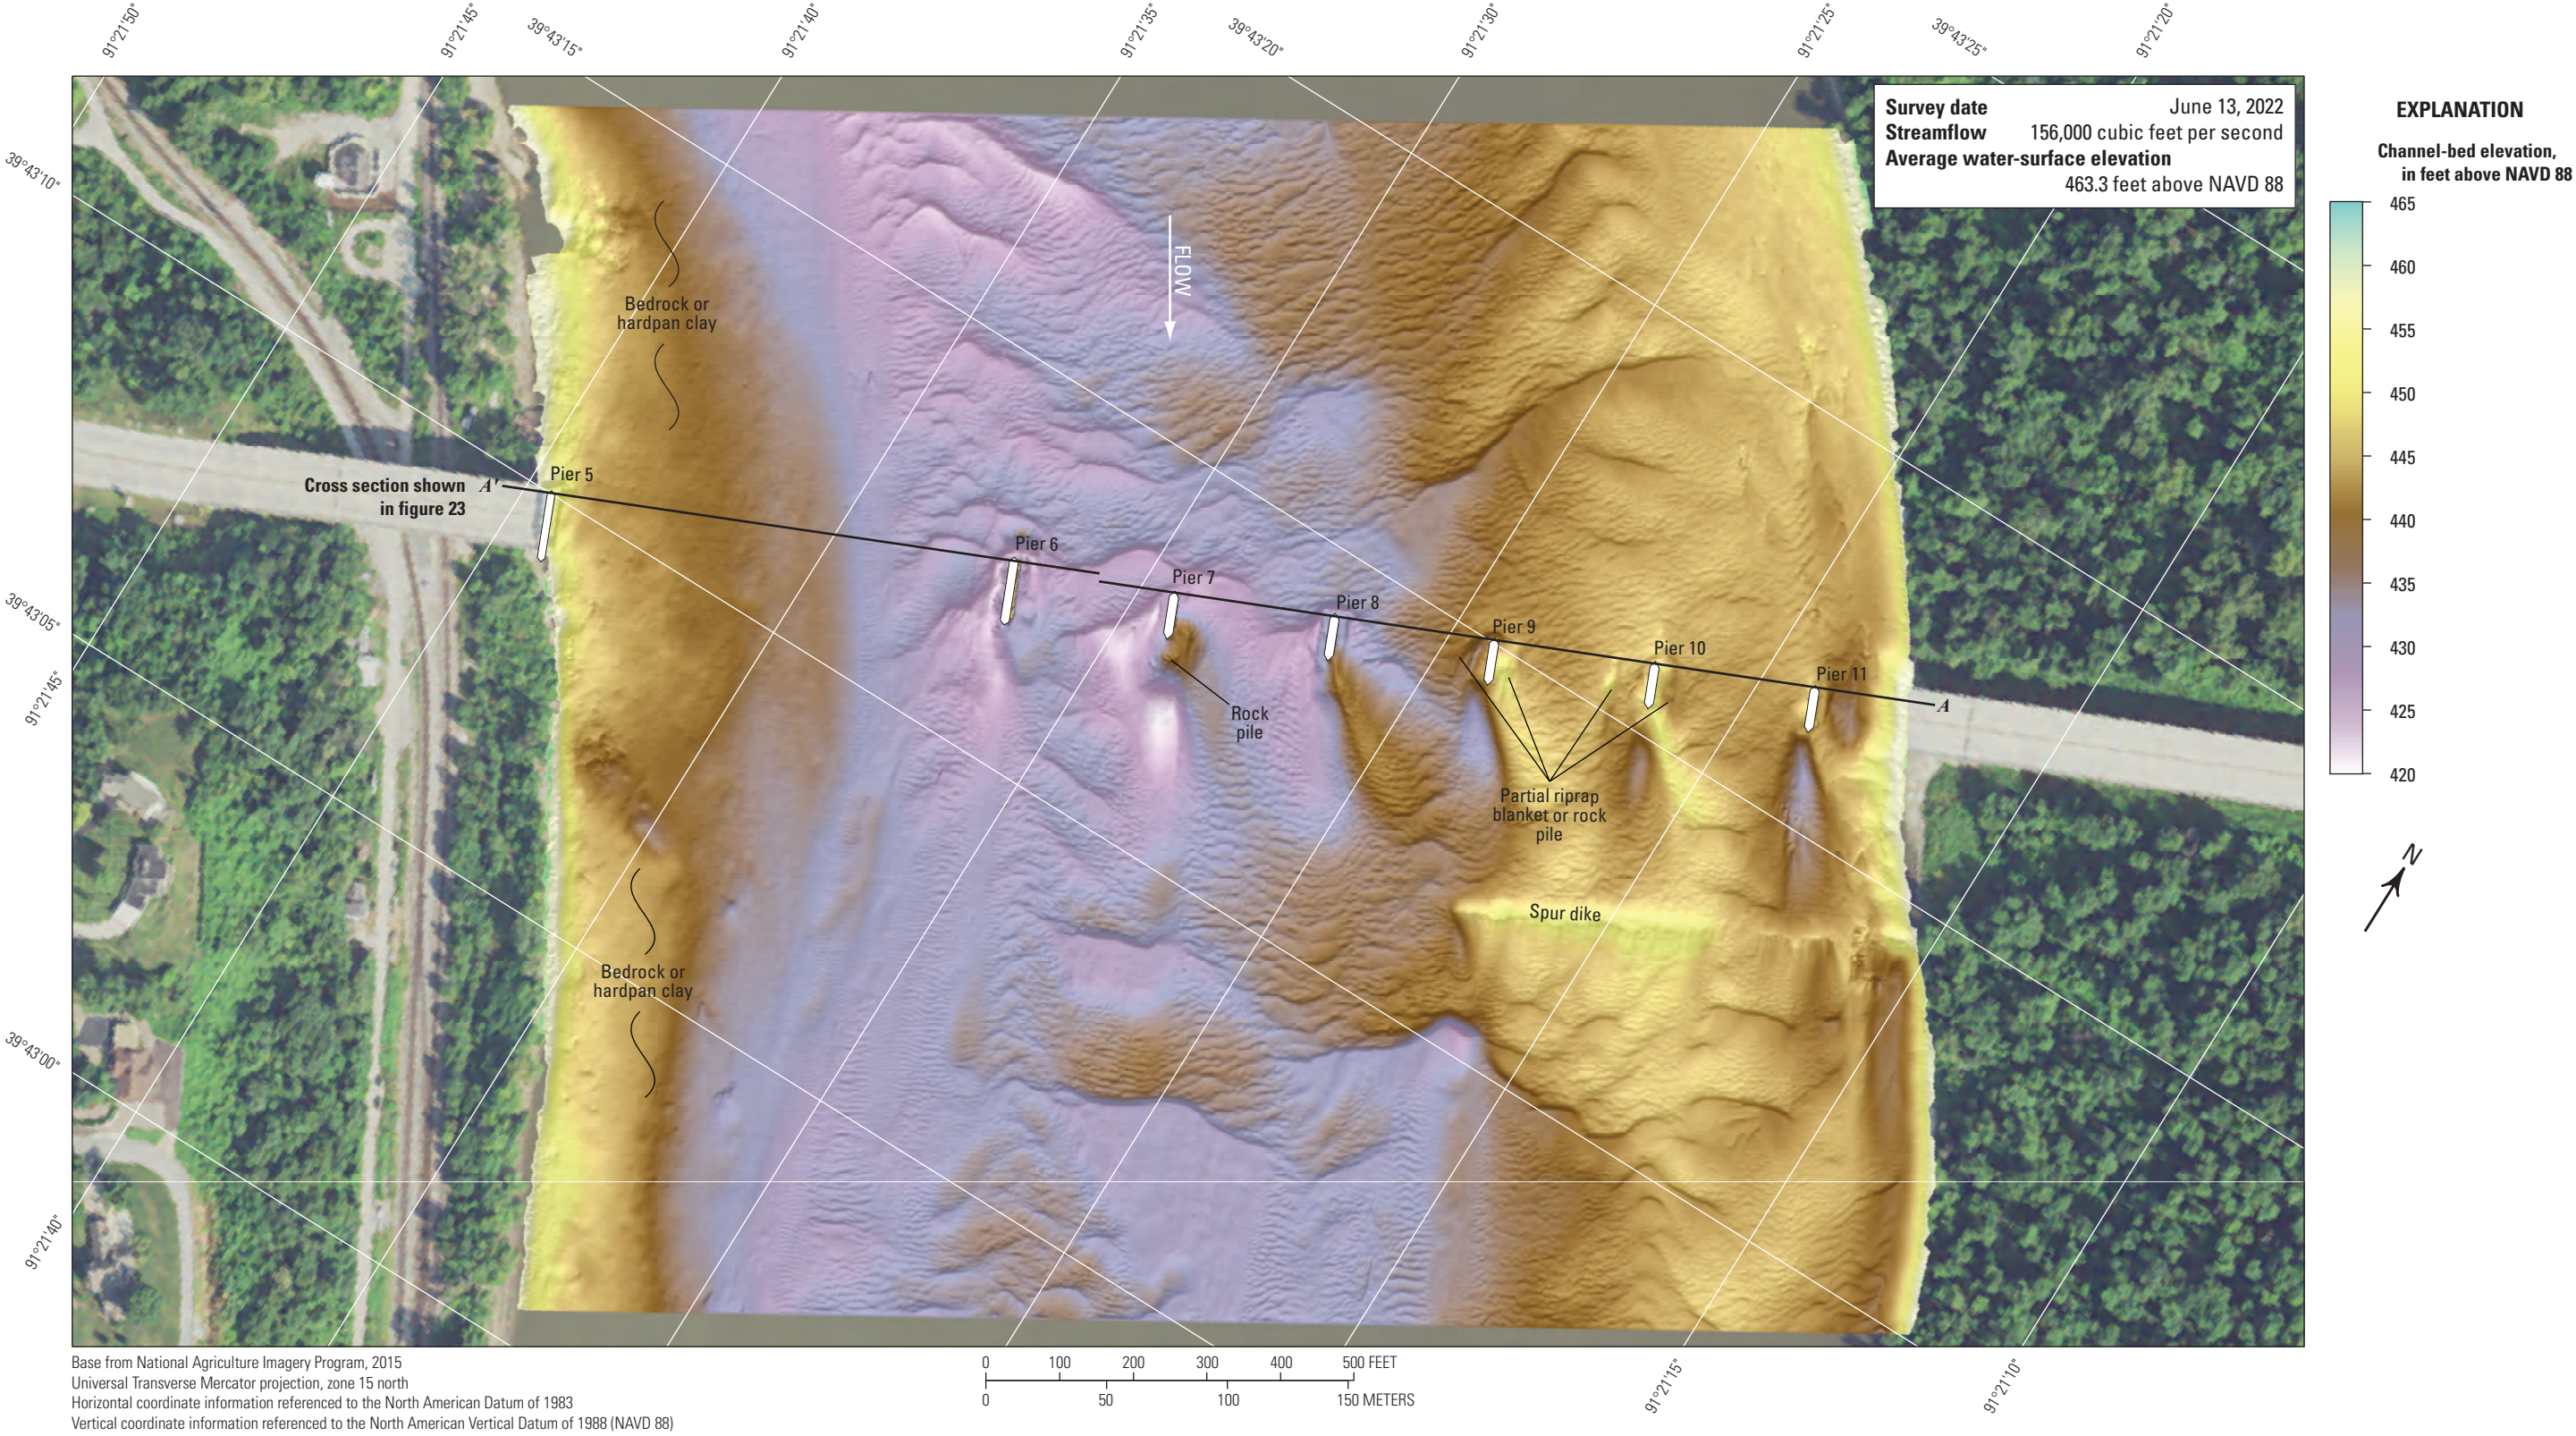
The survey area was about 1,640 ft long and about 1,870 ft wide, extending from bank to bank in the main channel (fig. 21). The survey area extended about 700 ft upstream from the centerline of structure A5054 (fig. 21). The approximate channel-bed elevations ranged from about 428 to 447 ft for most of the surveyed area (5th to 95th percentile range of the bathymetric data; table 3; fig. 22), except near piers 6 through 8 and the thalweg of the channel along the base of the right (southwest) bank (fig. 21; table 3). The left side of the channel between the left (northeast) bank and the channel thalweg was filled with small and medium dune features with superimposed ripples. A spur dike on the left side downstream from the bridge was barely visible above the average bed nearby. As in previous surveys (Huizinga, 2015, 2020e), the right bank consisted of smooth rock or hardpan clay throughout the reach, with no discernable dune features (fig. 21).

The minor scour holes near the upstream end of piers 10 and 11 were difficult to discern from nearby dunes and ripples, and no hole was discernable near pier 5 on the right bank (figs. 21, 1.3A–D, 1.4G). Alternatively, piers 6 through 8 had well-defined, asymmetric scour holes indicative of being skewed to approach flow. Parts of the footing appear exposed for all the piers in the bathymetric map and in the shaded TIN images (figs. 21, 1.3, 1.4), and piers 6, 7, 9, and 10 seem to be surrounded by partial piles of riprap (figs. 21, 1.3, 1.4). Information from bridge plans indicates that piers 5 through 8 are founded on shafts drilled 15 to 28 ft into bedrock, having about 13 to 32 ft of bed material between the channel bottom and bedrock (table 7; fig. 23). Piers 9 through 11 are founded on steel H-piles driven to refusal on bedrock, having 54 ft of

Figure 21. Bathymetric survey of the Mississippi River channel near structure A5054 on Interstate 72 at Hannibal, Missouri.

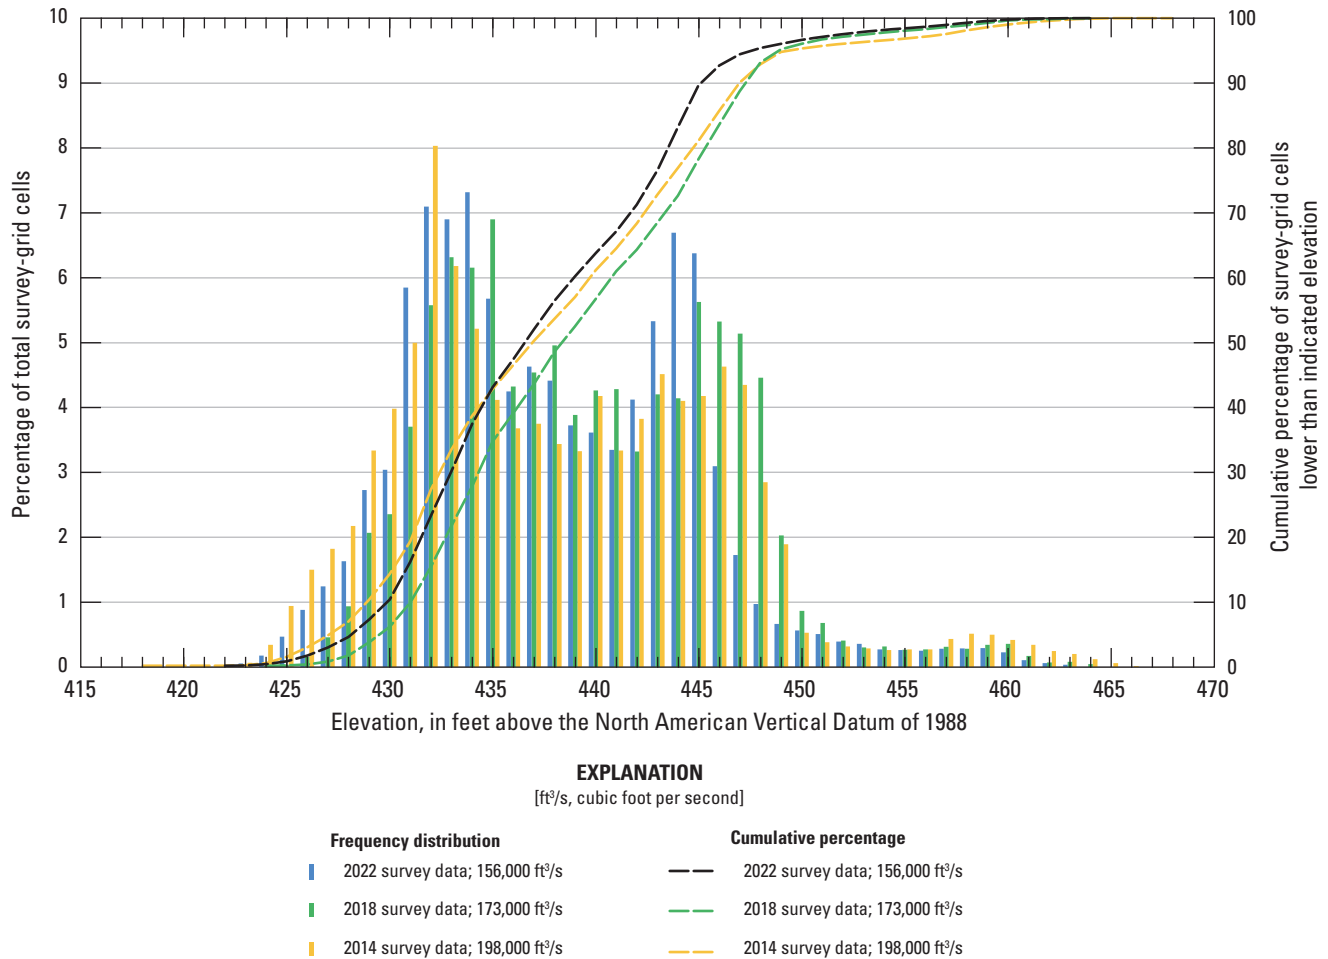
Figure 22. Frequency distribution of bed elevations for bathymetric survey-grid cells in 1-foot elevation bins on the Mississippi River near dual bridge structure A5054 on Interstate 72 at Hannibal, Missouri, on June 13, 2022, compared to previous surveys in 2014 and 2018 (Huizinga, 2015, and 2020e, respectively).
