Bathymetric and Velocimetric Surveys at Highway Bridges Crossing the Missouri and Mississippi Rivers on the Periphery of Missouri, June 13–22, 2022

Scientific Investigations Report 2024–5032

By Richard J. Huizinga

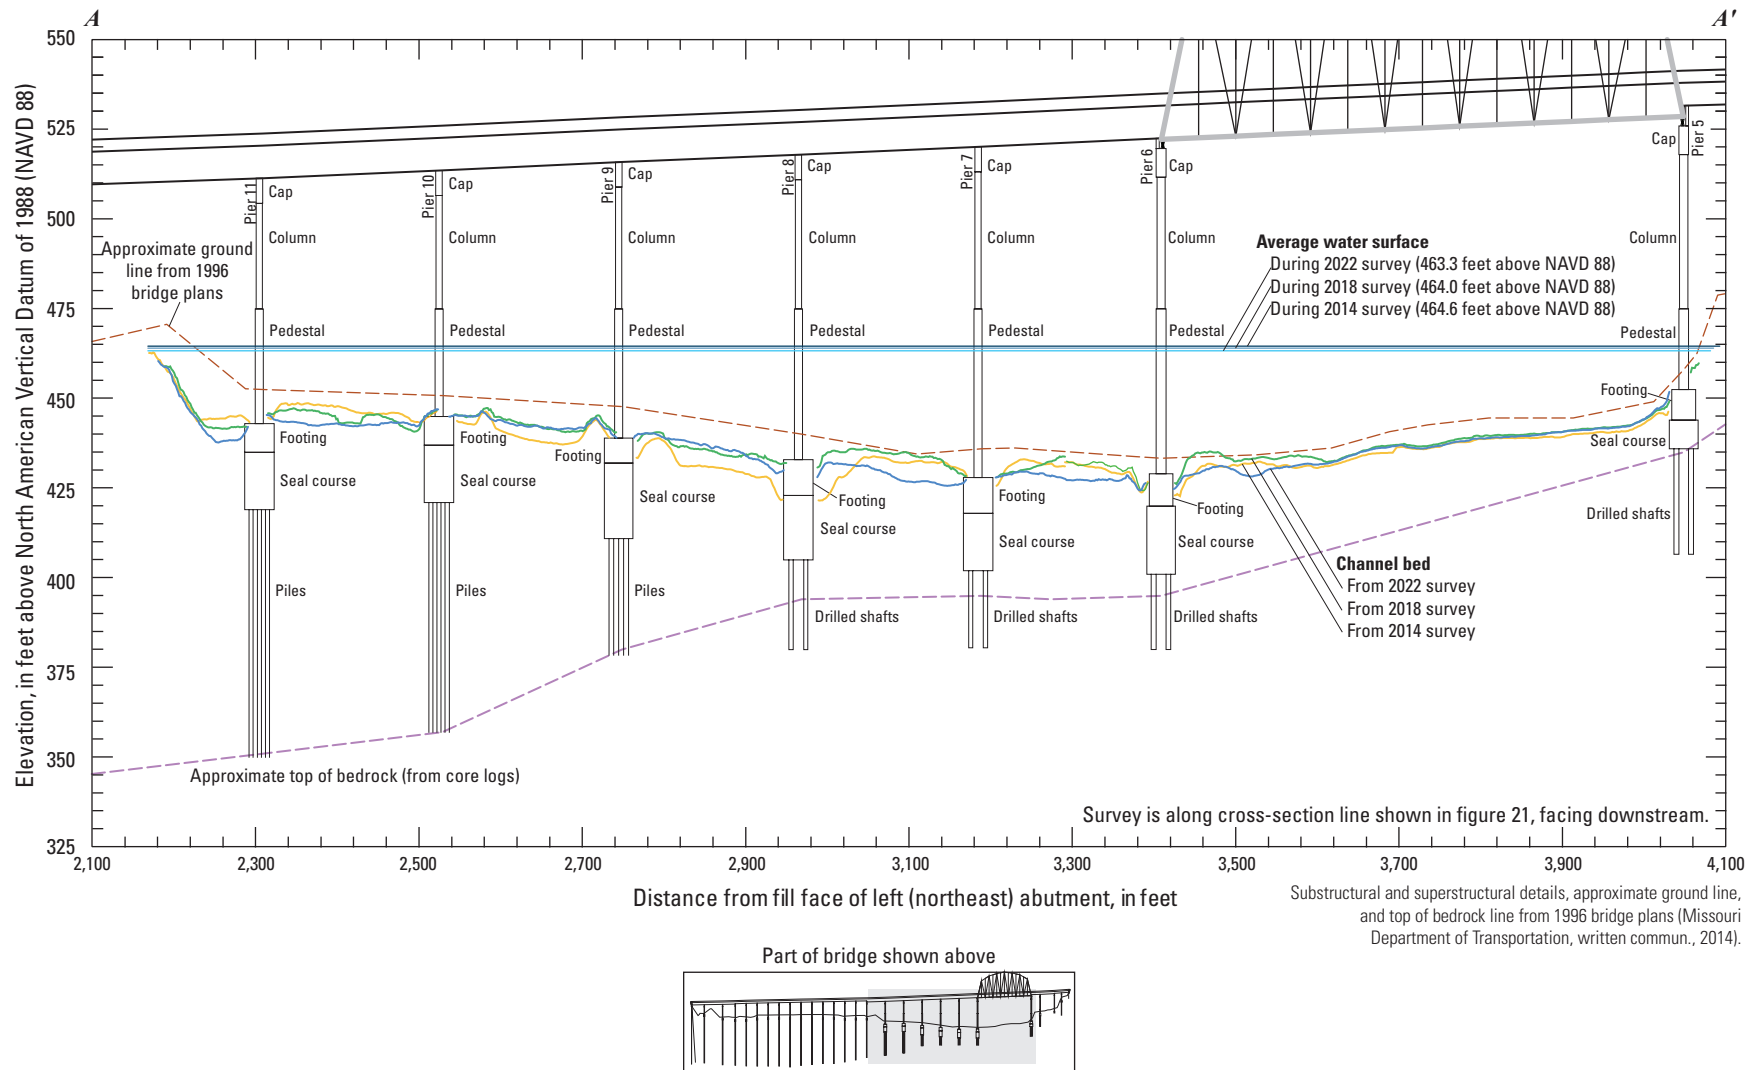
Figure 23. Key features, substructural and superstructural details, and surveyed channel bed of structure A5054 on Interstate 72 crossing the Mississippi River at Hannibal, Missouri.

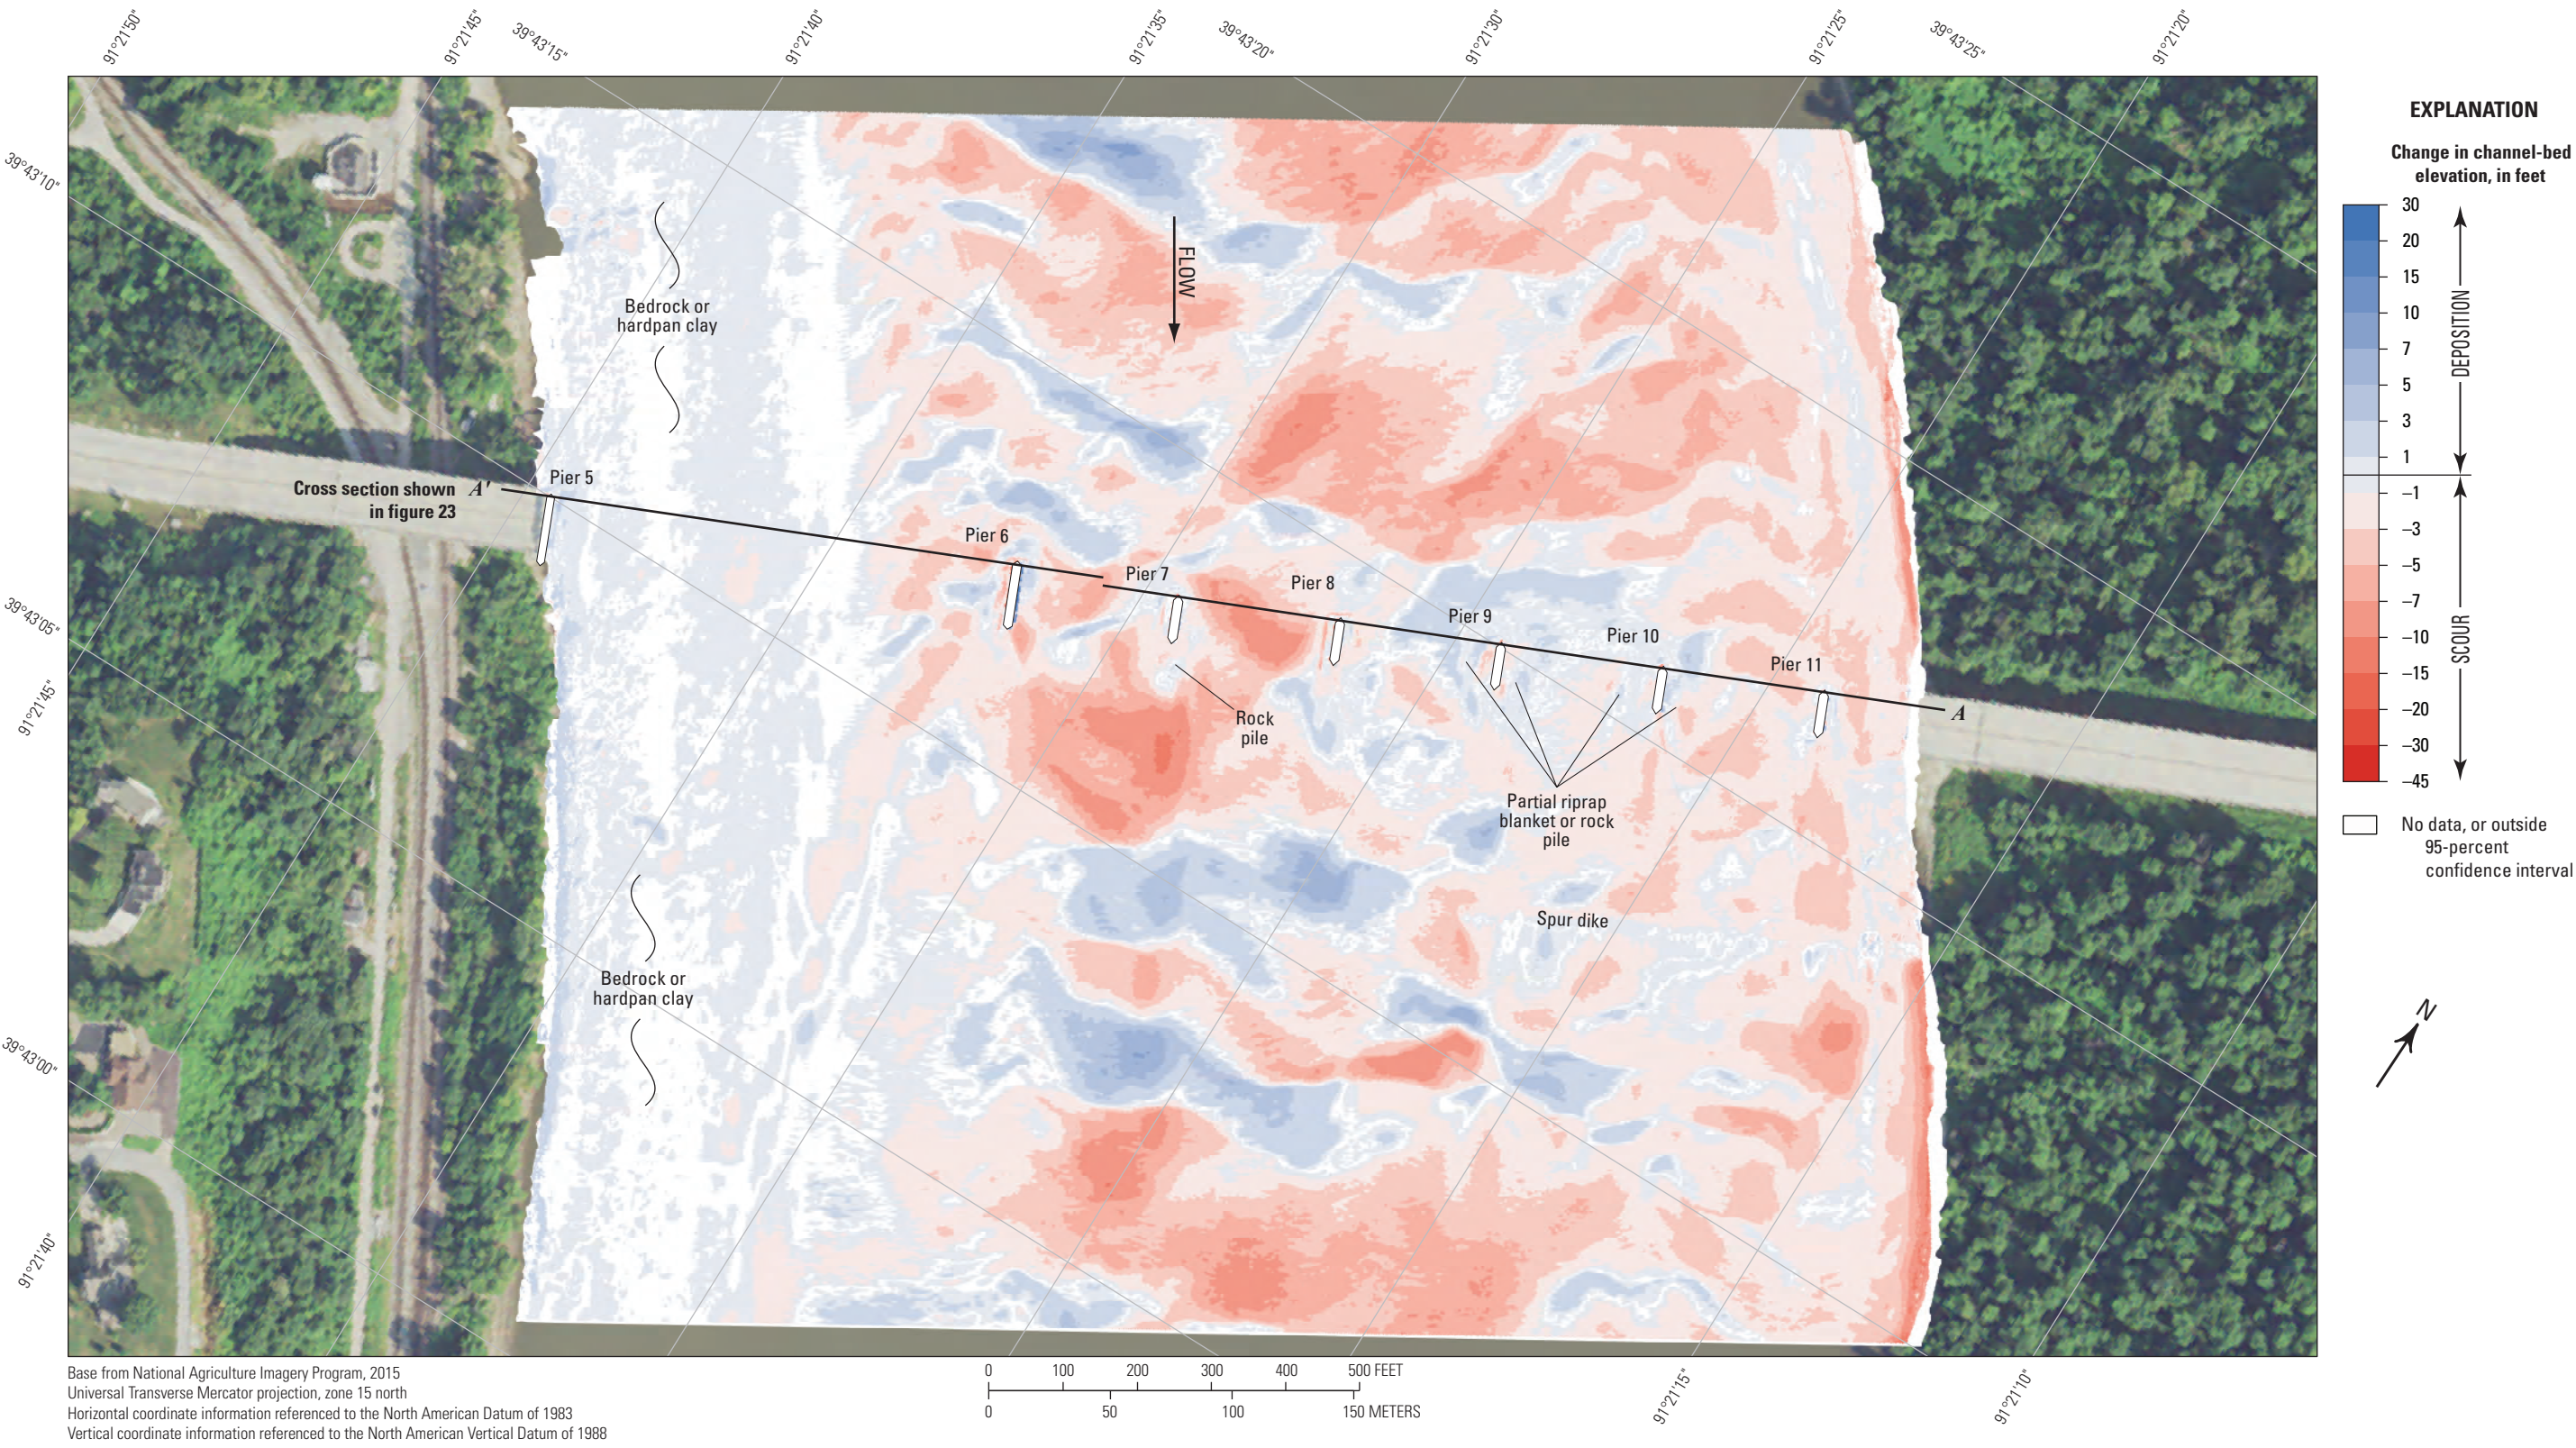
Figure 24. Difference between surfaces created from bathymetric surveys of the Mississippi River channel near structure A5054 on Interstate 72 at Hannibal, Missouri, on June 13, 2022, and July 18, 2018, with probabilistic thresholding.

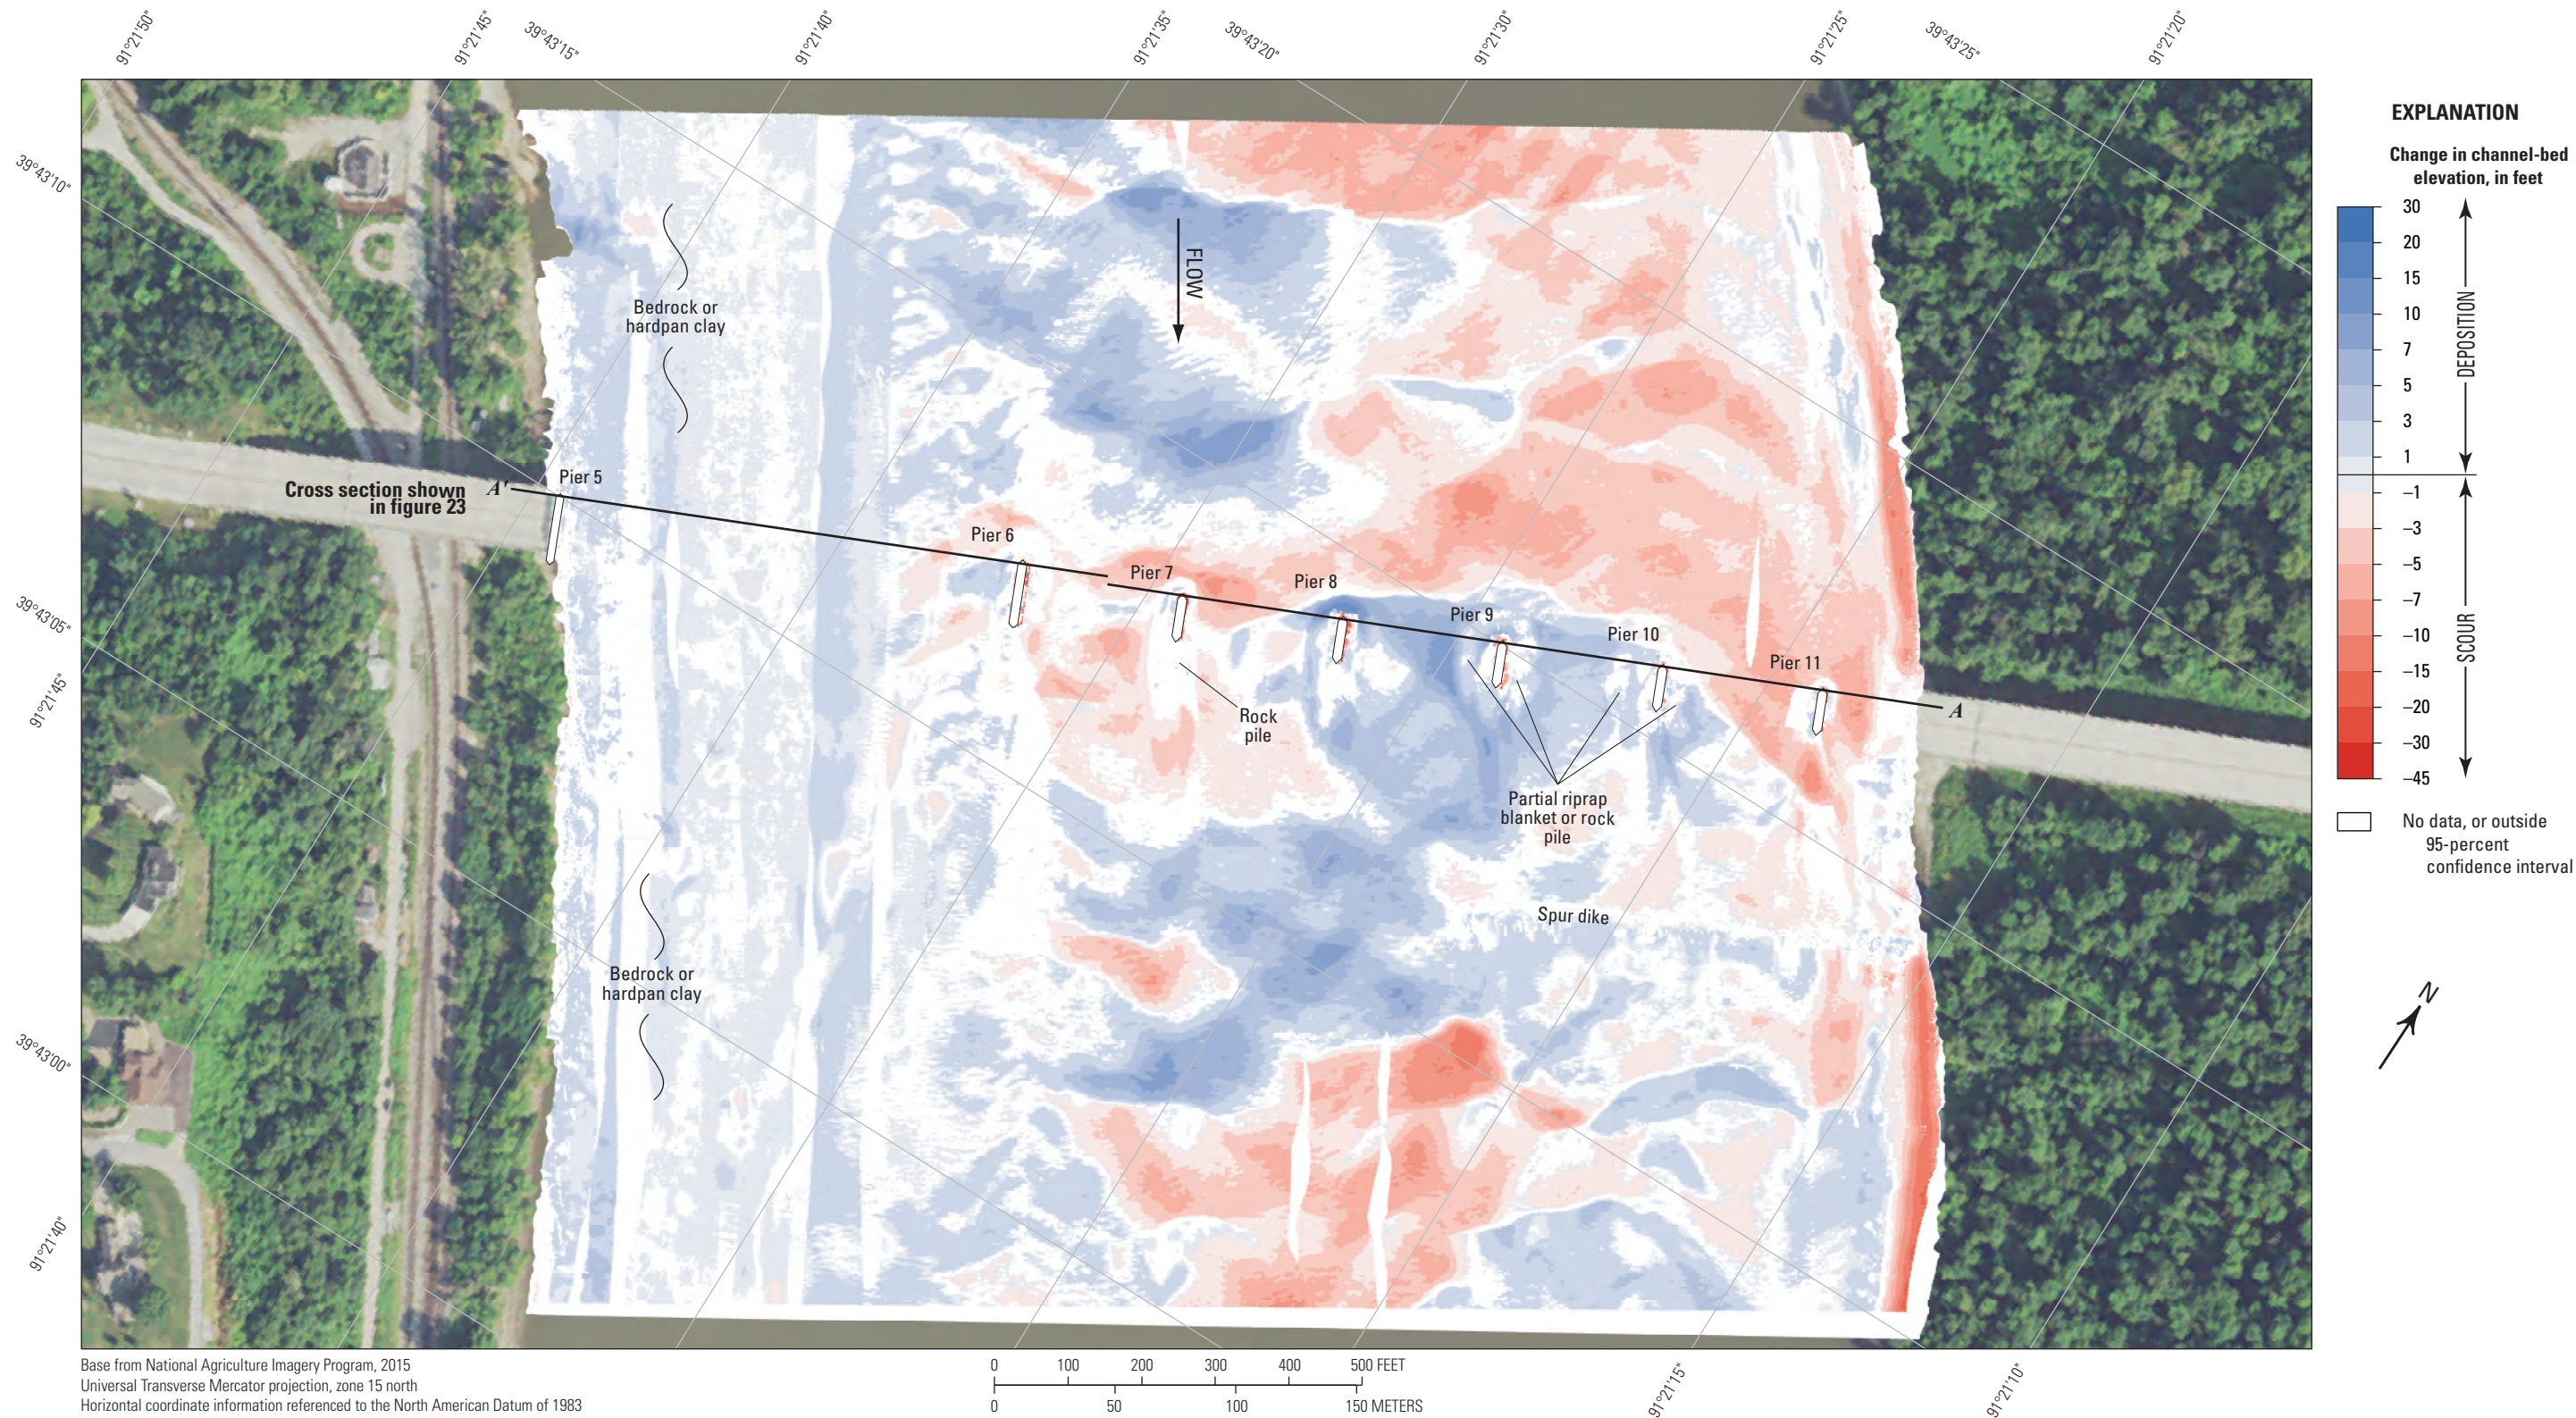
resulting in substantial erosion along that bank upstream and downstream from the bridge (fig. 25). As with previous DoDs, deposition or scour apparent on opposing faces of a feature likely results from minor horizontal positional variances between the surveys (fig. 6).

Figure 25. Difference between surfaces created from bathymetric surveys of the Mississippi River channel near structure A5054 on Interstate 72 at Hannibal, Missouri, on June 13, 2022, and June 5, 2014, with probabilistic thresholding.

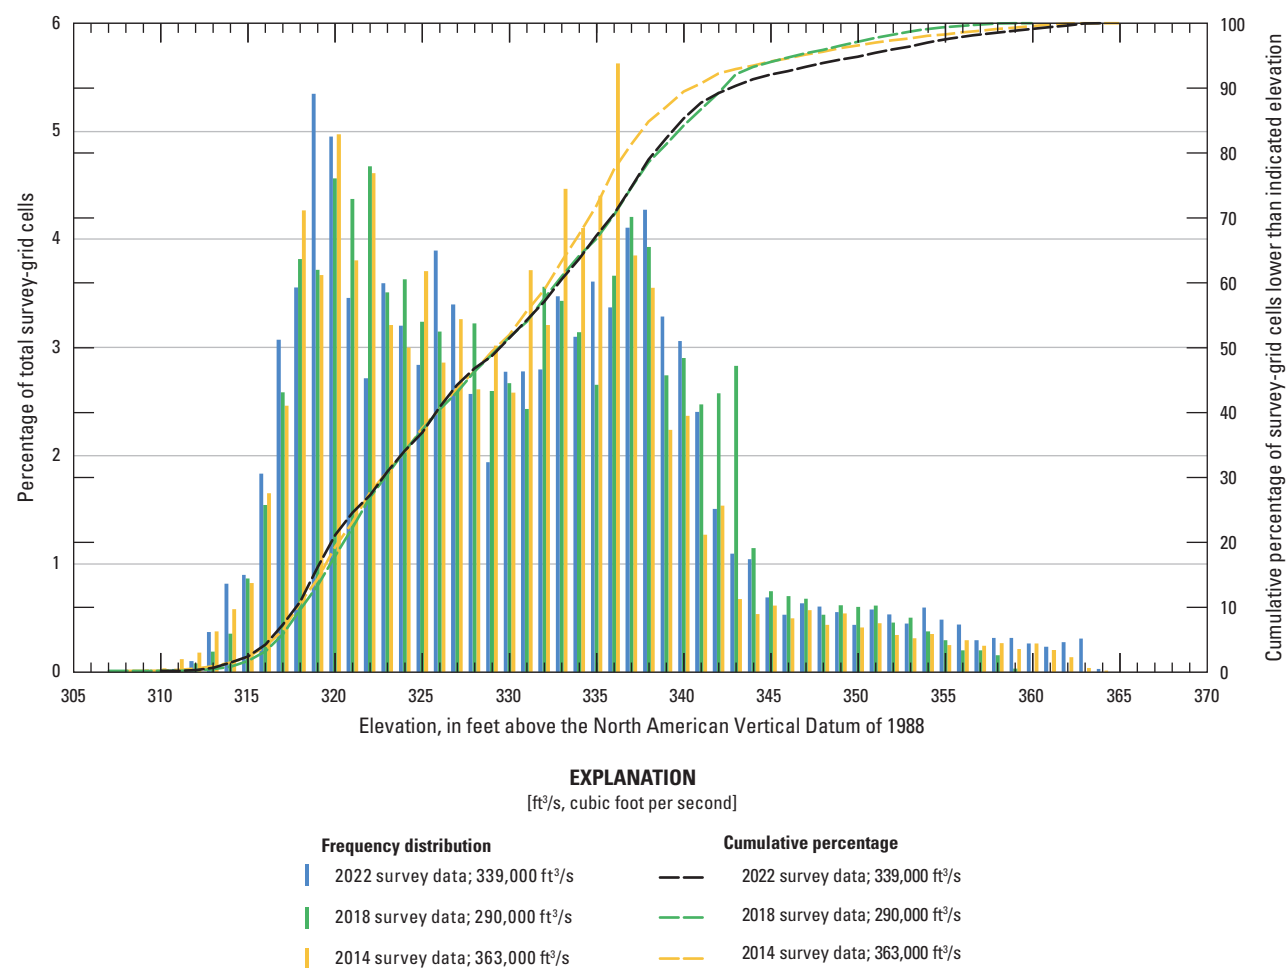
Figure 28. Frequency distribution of bed elevations for bathymetric survey-grid cells in 1-foot elevation bins on the Mississippi River near structure L0135 on State Highway 51 at Chester, Illinois, on June 14, 2022, compared to previous surveys in 2014 and 2018 (Huizinga, 2015, and 2020e, respectively).

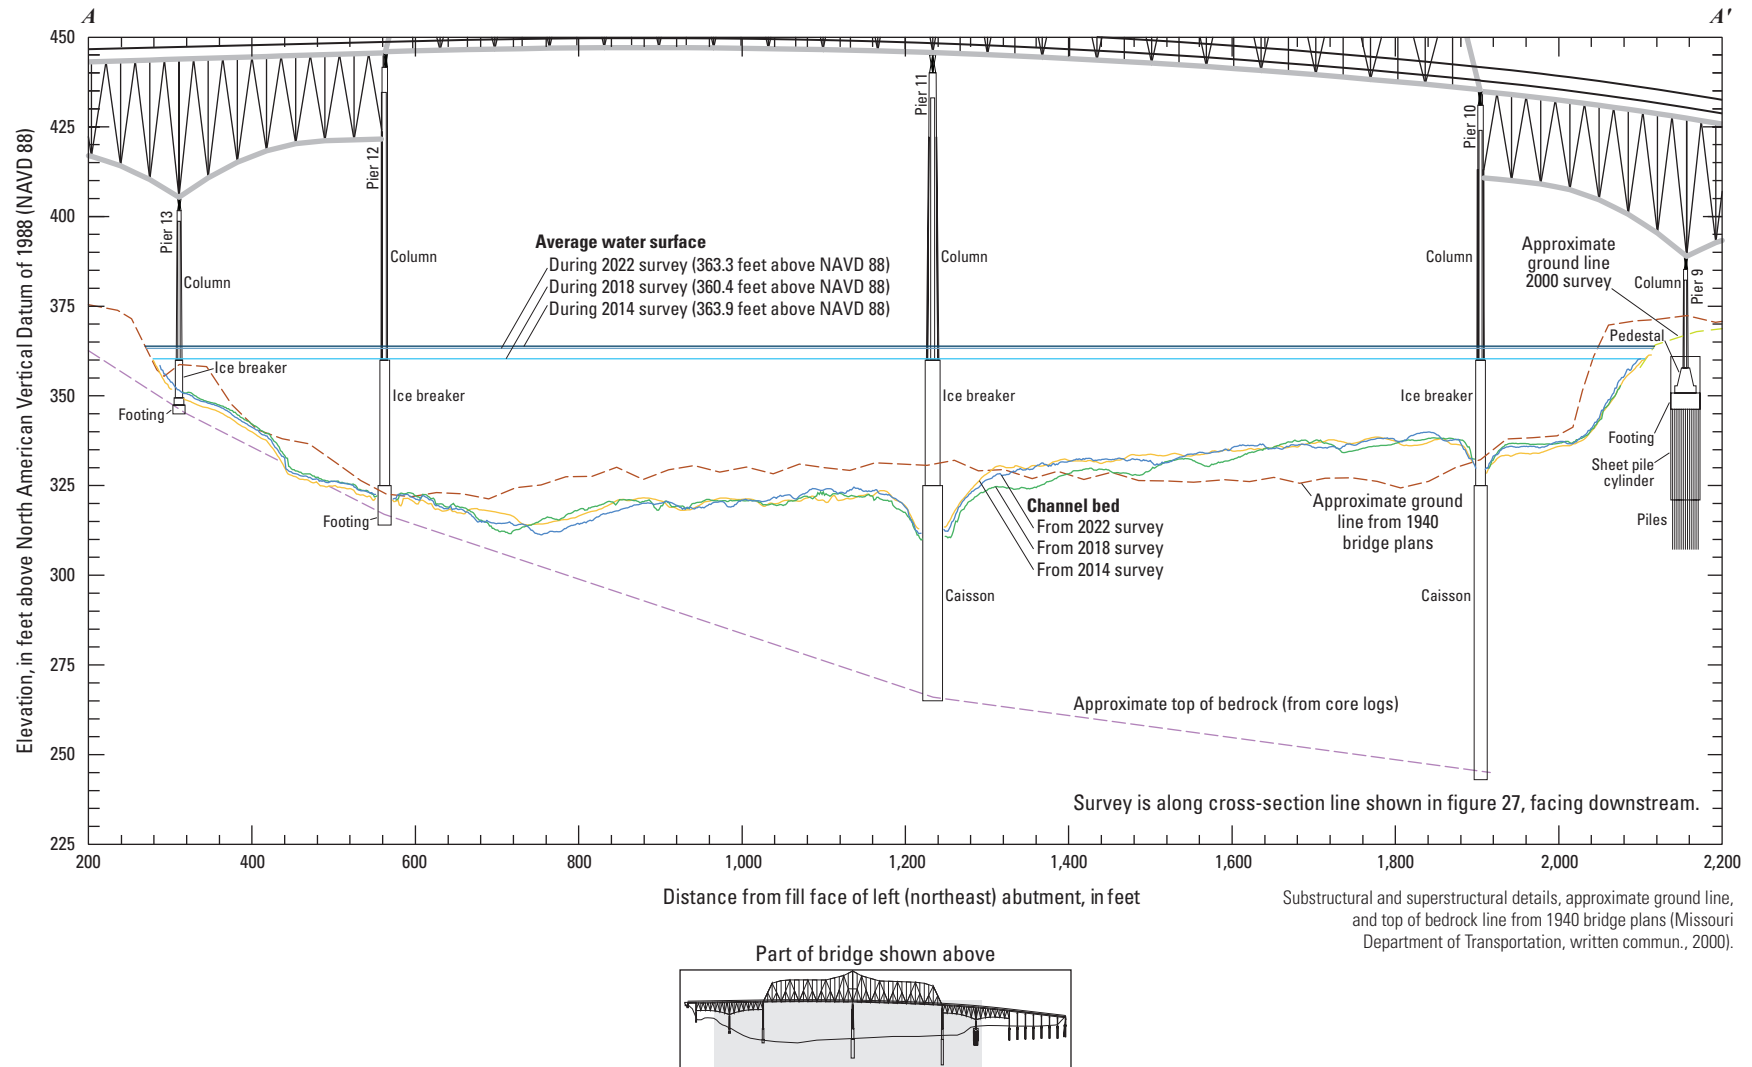
Figure 29. Key features, substructural and superstructural details, and surveyed channel bed of structure L0135 on State Highway 51 crossing the Mississippi River at Chester, Illinois.

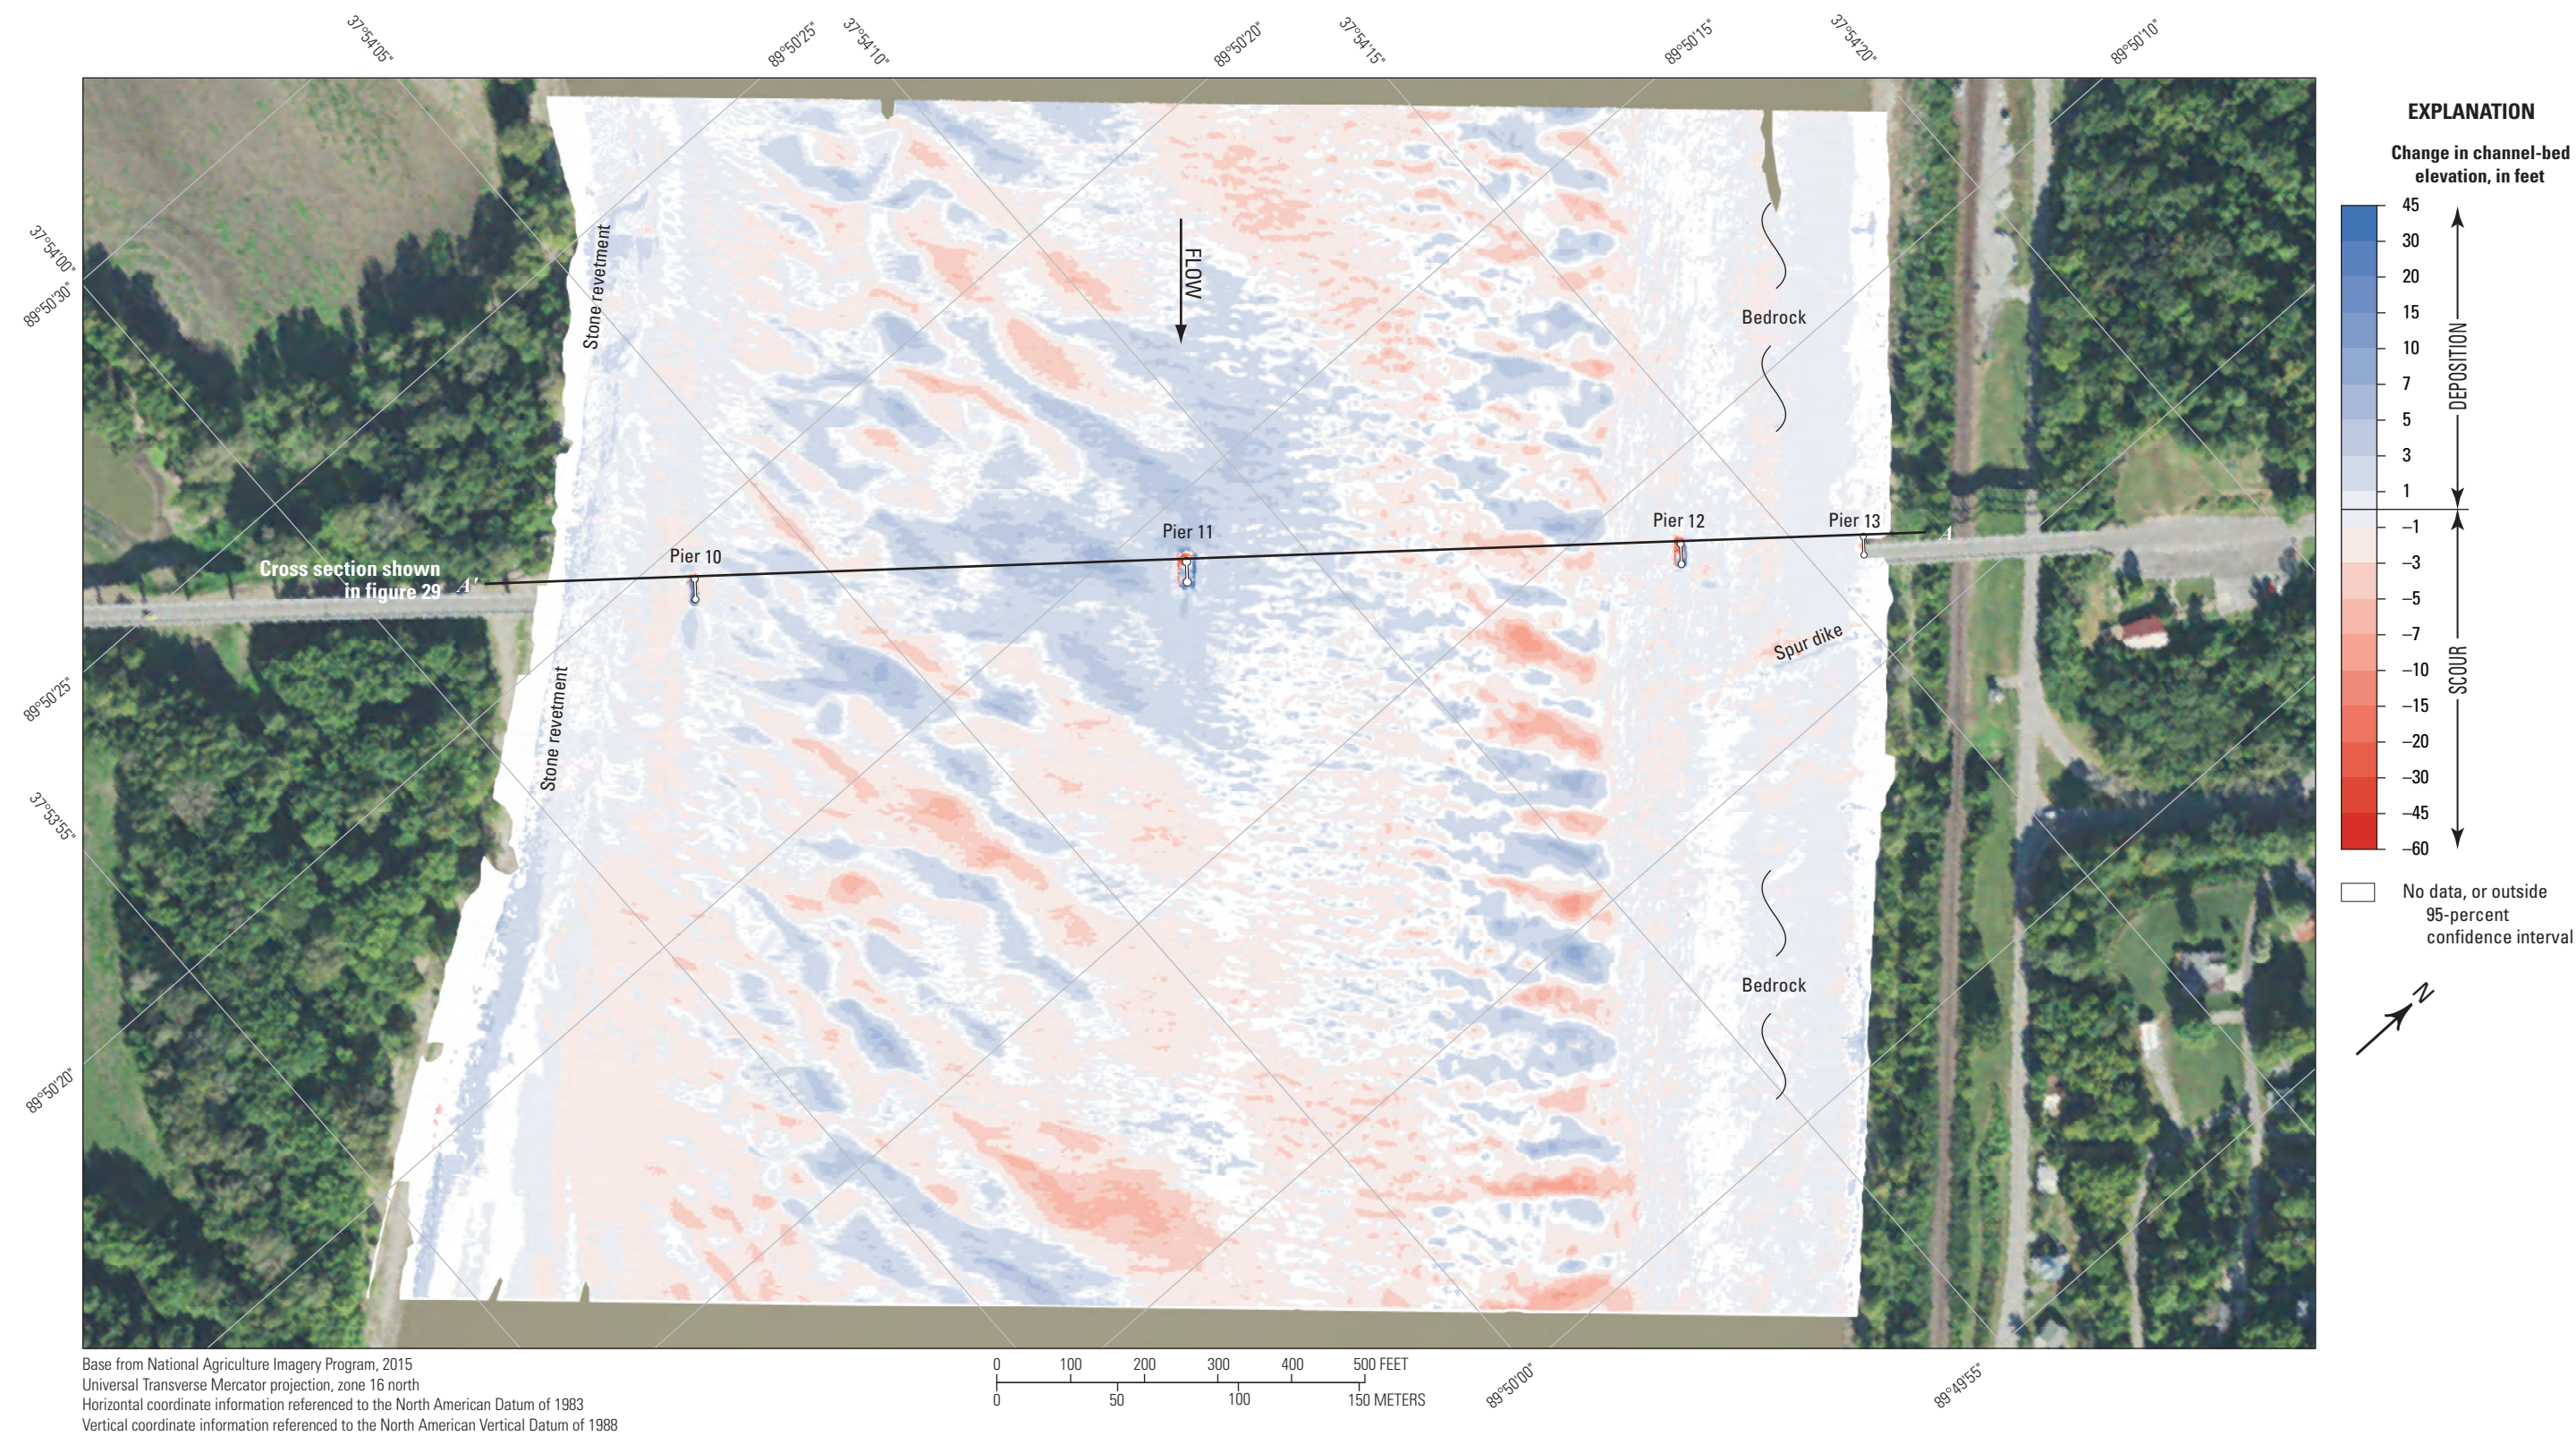
The difference between the survey on June 14, 2022, and the previous survey on July 24, 2018 ([fig. 30](#)), indicates about 81 percent of the joint area of interest had detectable change, which means about 19 percent of the differences in the joint area of interest are equivocal and within the bounds of uncertainty ([table 8](#)). Scour and deposition appear roughly balanced throughout the reach between 2018 and 2022 in the DoD, with apparent scour and deposition alternating in the troughs of the medium dune features in the thalweg and right side of the channel ([fig. 30](#)). The average difference between the bathymetric surfaces was –0.52 ft ([table 8](#)), indicating minor degradation of the reach between the 2018 and 2022 surveys. The net volume of cut in the reach from 2018 to 2022 was about 92,600 yd³, and the net volume of fill was about 46,100 yd³, resulting in a net loss of about 46,500 yd³ of sediment between 2018 and 2022 ([table 8](#)). The scour holes near piers 10 and 11 are shallower and slightly narrower in 2022 than in 2018 ([figs. 29 and 30](#)). The frequency distribution of bed elevations in 2022 appears very similar to 2018, with a slightly higher percentage of cells at the highest elevations than 2018 ([fig. 28](#)). The bedrock outcrop along the left (northeast) bank showed localized signs of minor scour, but most of the rock outcrop indicated changes within 1–3 ft of the 2018 elevation, or changes outside the 95-percent confidence interval ([fig. 30](#)). As with previous DoDs, deposition or scour apparent on opposing faces of a feature likely results from minor horizontal positional variances between the surveys ([fig. 6](#)).

Figure 30. Difference between surfaces created from bathymetric surveys of the Mississippi River channel near structure L0135 on State Highway 51 at Chester, Illinois, on June 14, 2022, and July 24, 2018, with probabilistic thresholding.

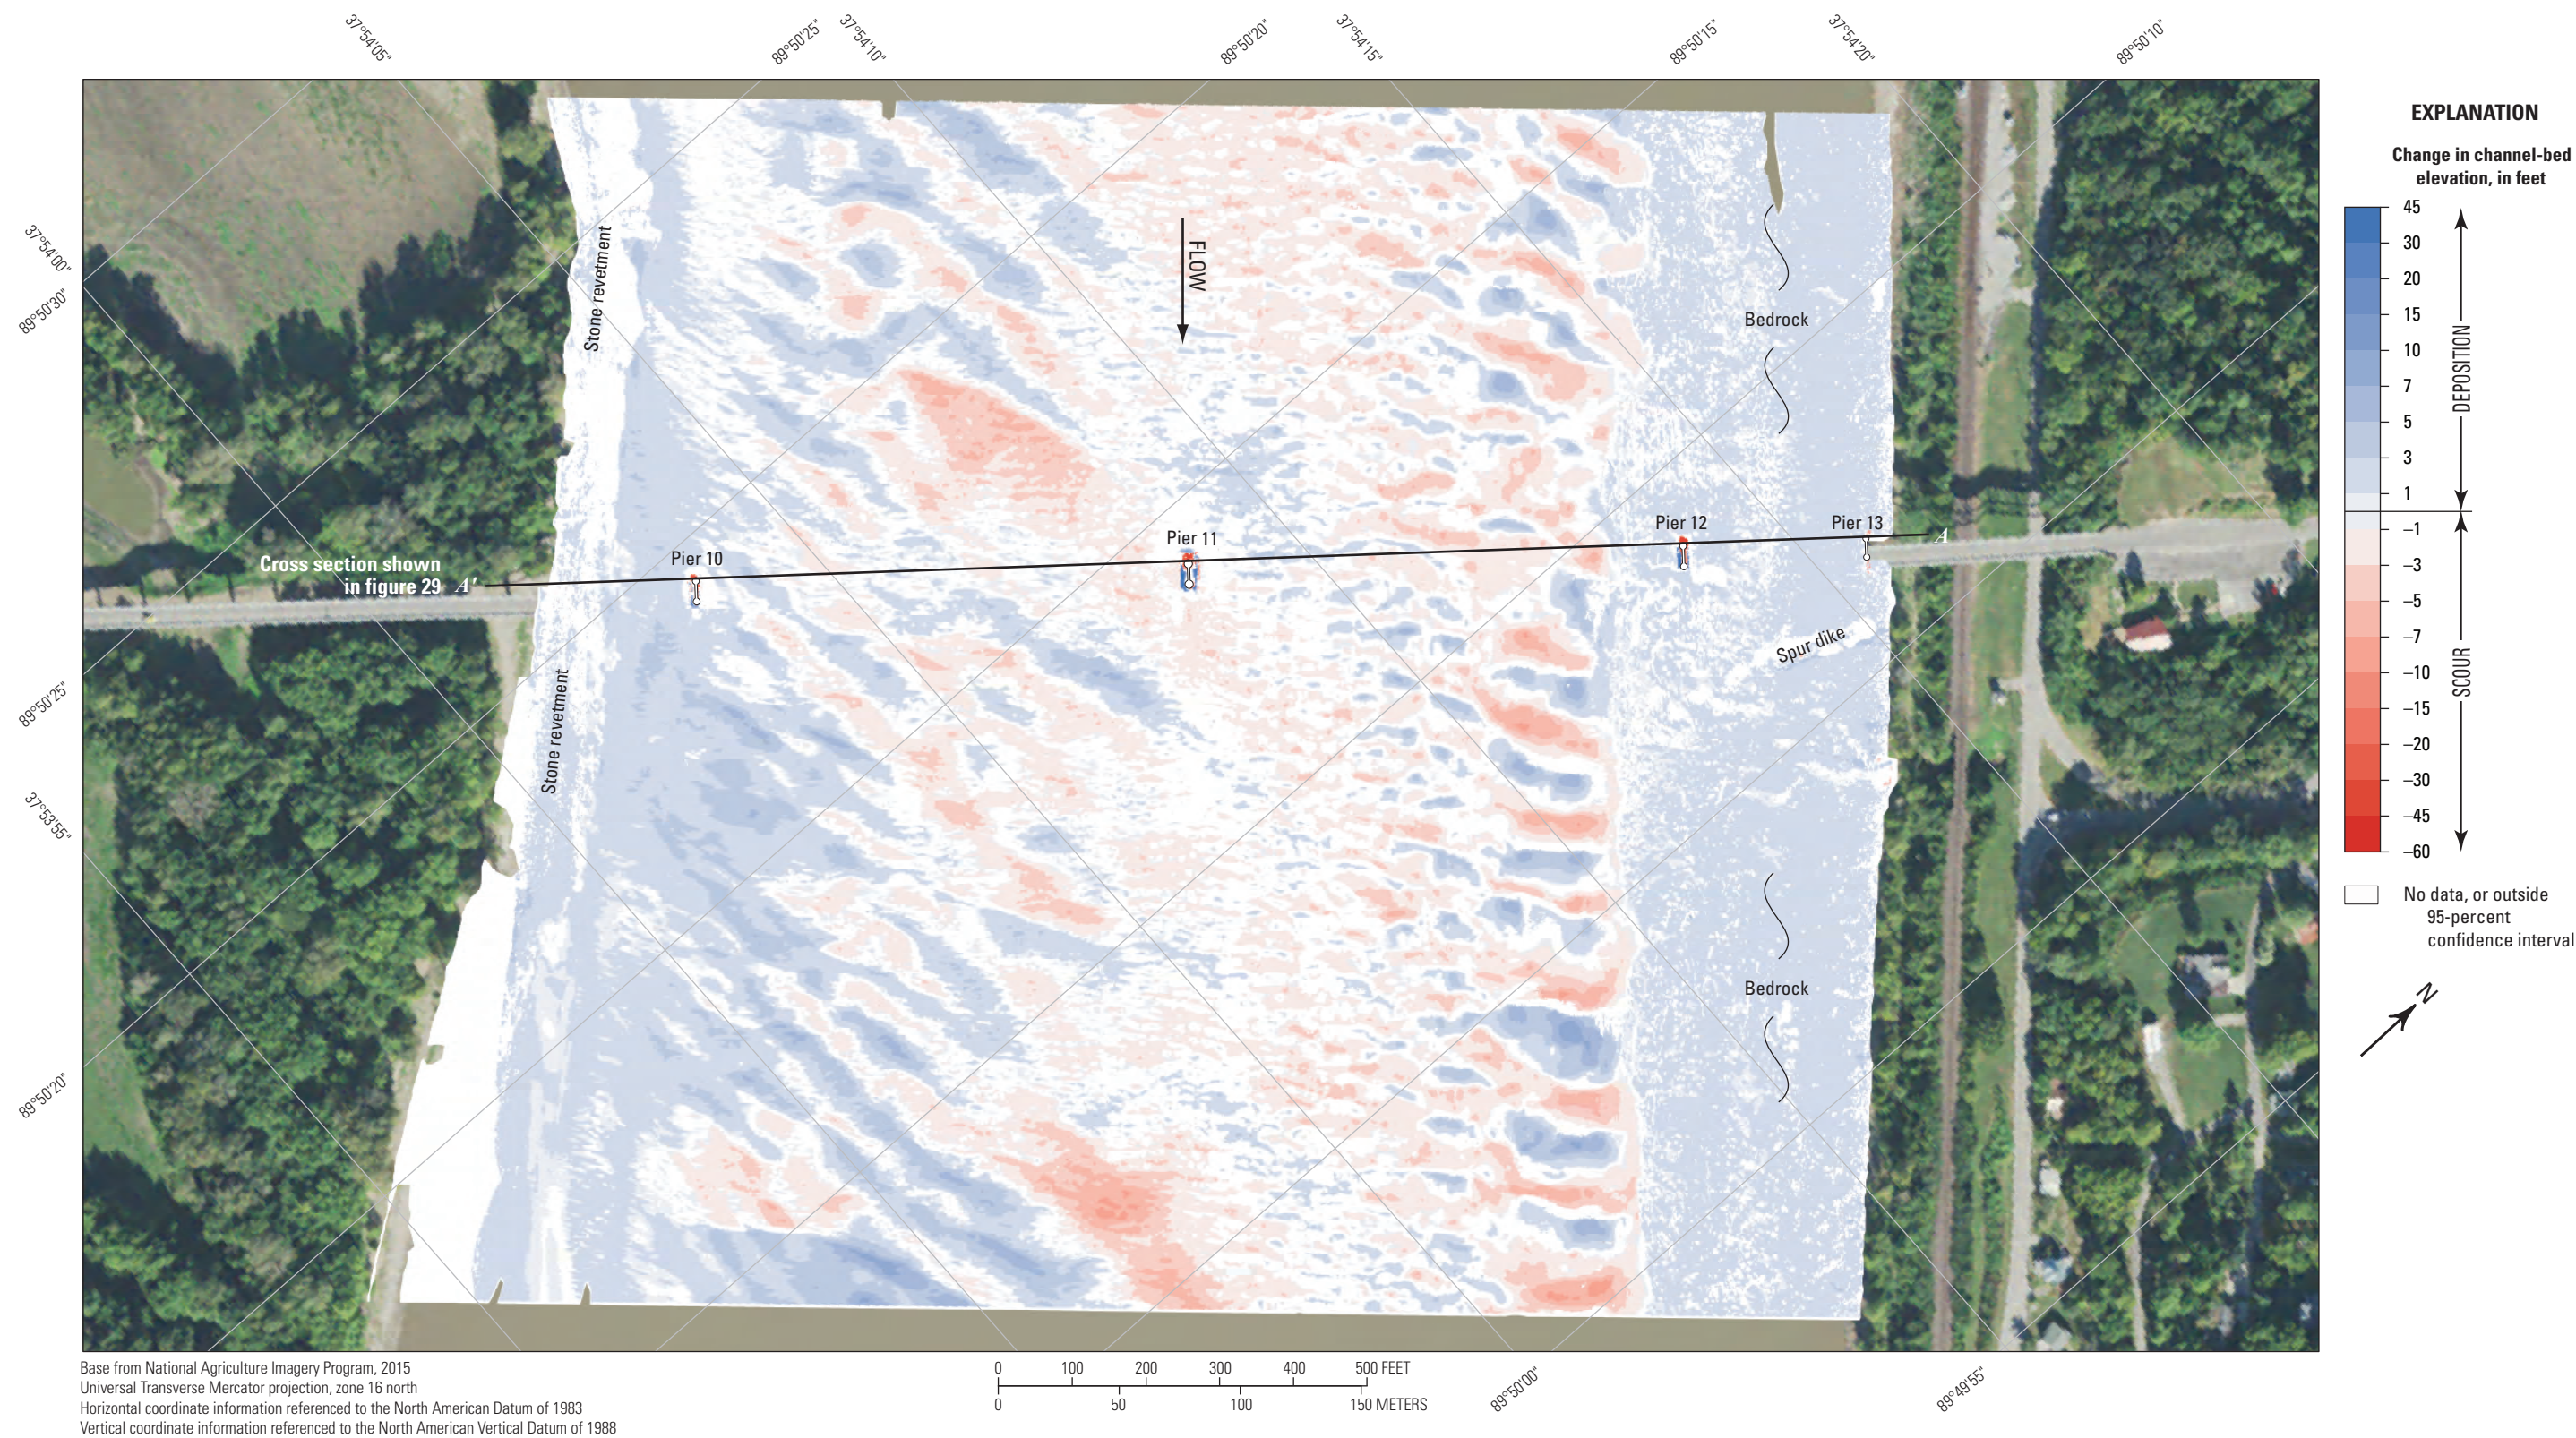
The difference between the survey on June 14, 2022, and the earliest survey on June 9, 2014 ([fig. 31](#)), indicates about 70 percent of the joint area of interest had detectable change, which means about 30 percent of the differences in the joint area of interest are equivocal and within the bounds of uncertainty ([table 8](#)). Deposition appears dominant throughout most of the reach between 2014 and 2022 in the DoD, with scour and deposition alternating in the troughs of the medium dune features in the thalweg and middle of the channel ([fig. 31](#)). The average difference between the bathymetric surfaces was +0.35 ft ([table 8](#)), indicating minor channel aggradation between the 2014 and 2022 surveys, and the net gain of sediment between 2014 and 2022 was about 27,300 yd³ ([table 8](#)). The scour holes near piers 10 and 11 are nearly identical in 2014 and 2022 ([figs. 29 and 31](#)). As with 2018, the frequency distribution of bed elevations in 2022 is very similar to 2014, with a slightly lower percentage of cells at elevations above 330 ft than in 2014 ([fig. 28](#)). Changes to the stone revetment along the right (southwest) bank is mostly equivocal, with localized signs of deposition downstream from the bridge ([fig. 31](#)). The bedrock outcrop on the left (northeast) bank showed localized signs of minor to moderate deposition ([fig. 31](#)); however, the differences near the rock outcrop would be most affected by minor horizontal positional variances between the surveys. As with previous DoDs, deposition or scour apparent on opposing faces of a feature likely results from minor horizontal positional variances between the surveys ([fig. 6](#)).
