Bathymetric and Velocimetric Surveys at Highway Bridges Crossing the Missouri and Mississippi Rivers on the Periphery of Missouri, June 13–22, 2022

Scientific Investigations Report 2024–5032

By Richard J. Huizinga

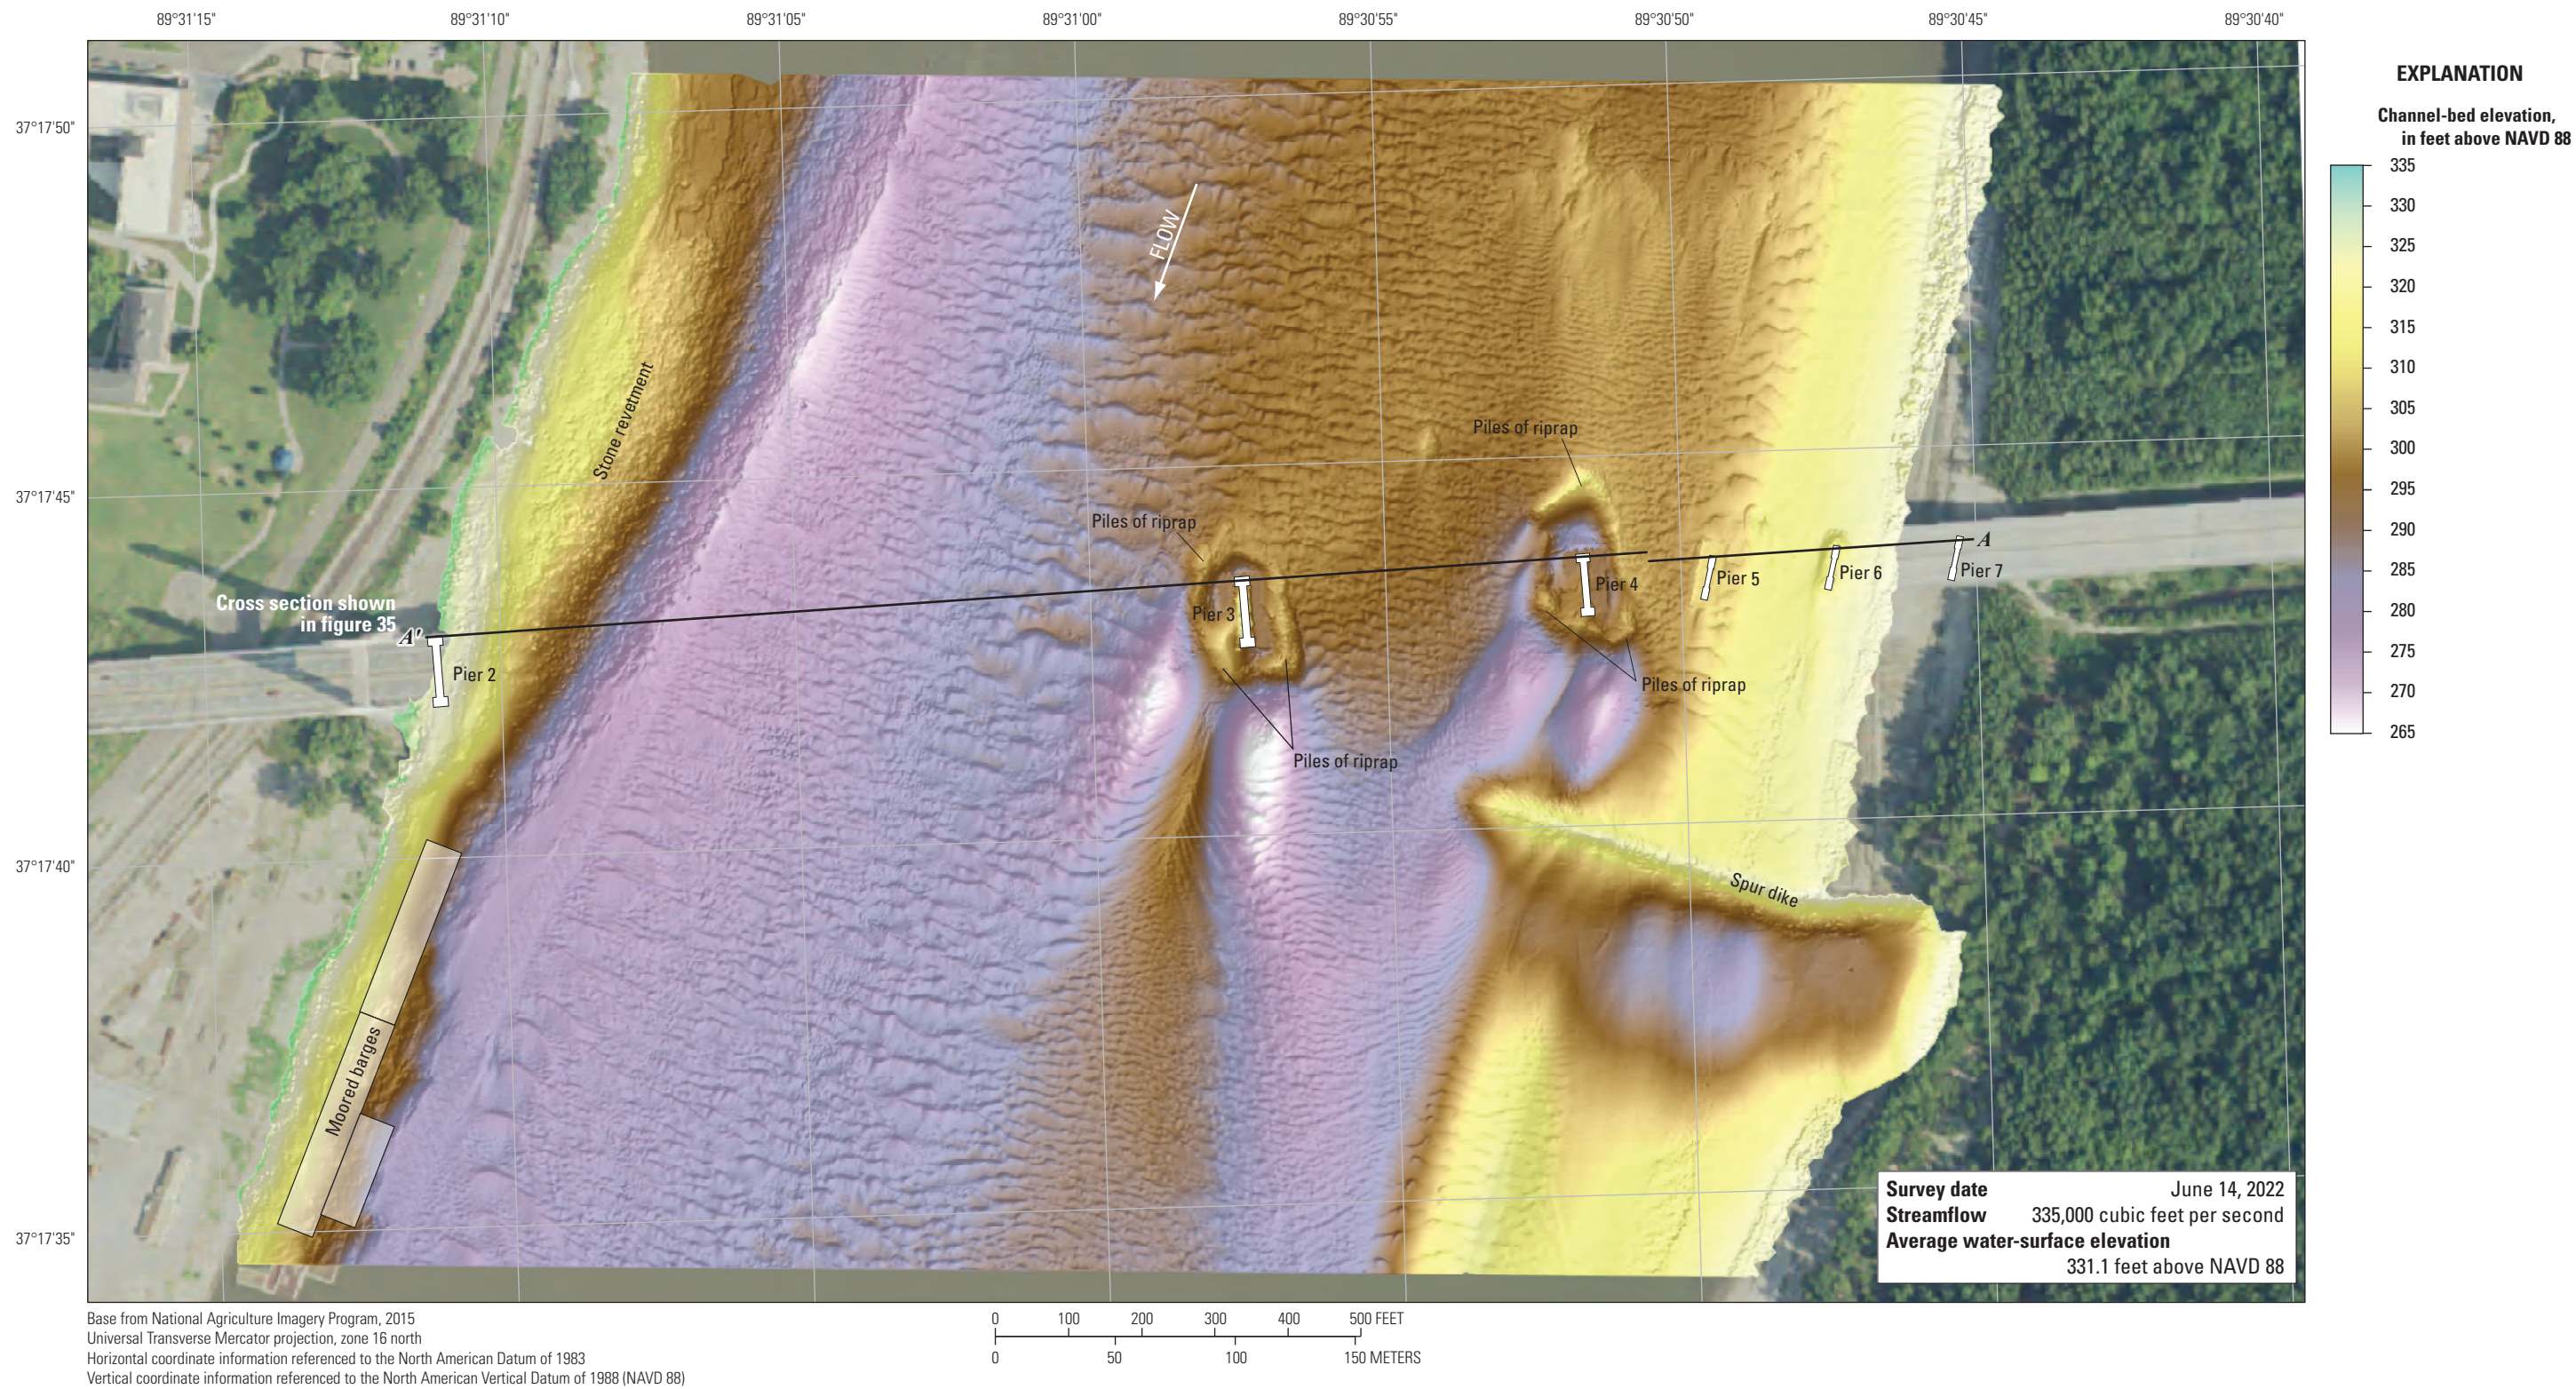
As in previous surveys, piers 3 and 4 seemed to be partially surrounded by piles of riprap or rock ([figs. 33, 1.6E–H](#)). Scour downstream from the piers in 2022 reached a minimum elevation of 264 ft near pier 3 ([table 7](#); [fig. 33](#)) and 270 near pier 4 ([fig. 33](#)). A poorly defined, minor scour hole difficult to discern from nearby ripples existed near pier 5 ([figs. 33, 1.6D](#)), having a minimum channel-bed elevation of about 300 ft ([table 7](#)). A minor scour hole also existed near pier 6 ([figs. 33, 1.6A–B](#)). The top of the footing was visible at pier 5, and the top of the distribution cap was visible at piers 3 and 4 ([figs. 33, 1.6C–H](#)). The minimum channel-bed elevation near pier 5 is about 15 ft above the elevation of the bottom of the pier seal course of 285.00 ft, and the minimum channel-bed elevation near pier 6 is about 20 ft above the elevation of the bottom of the pier seal course of 292.00 ft ([fig. 35](#); [table 7](#)). Information from bridge plans indicates that piers 3 and 4 are founded on caissons on bedrock, having about 14 ft of bed material between the bottom of the scour hole and bedrock at pier 3, and 38 ft of material at pier 4 ([fig. 35](#); [table 7](#)). Piers 5 through 7 are founded on shafts drilled as much as 22 ft into bedrock, having about 56 ft of bed material between the bottom of the scour hole and bedrock at pier 5, and about 67 ft of material at pier 6 ([fig. 35](#); [table 7](#)). The exposed tops of the footing and distribution caps at piers 3 through 5 ([figs. 33 and 35](#)) might

Figure 33. Bathymetric survey of the Mississippi River channel near structure A5076 on State Highway 34 at Cape Girardeau, Missouri.

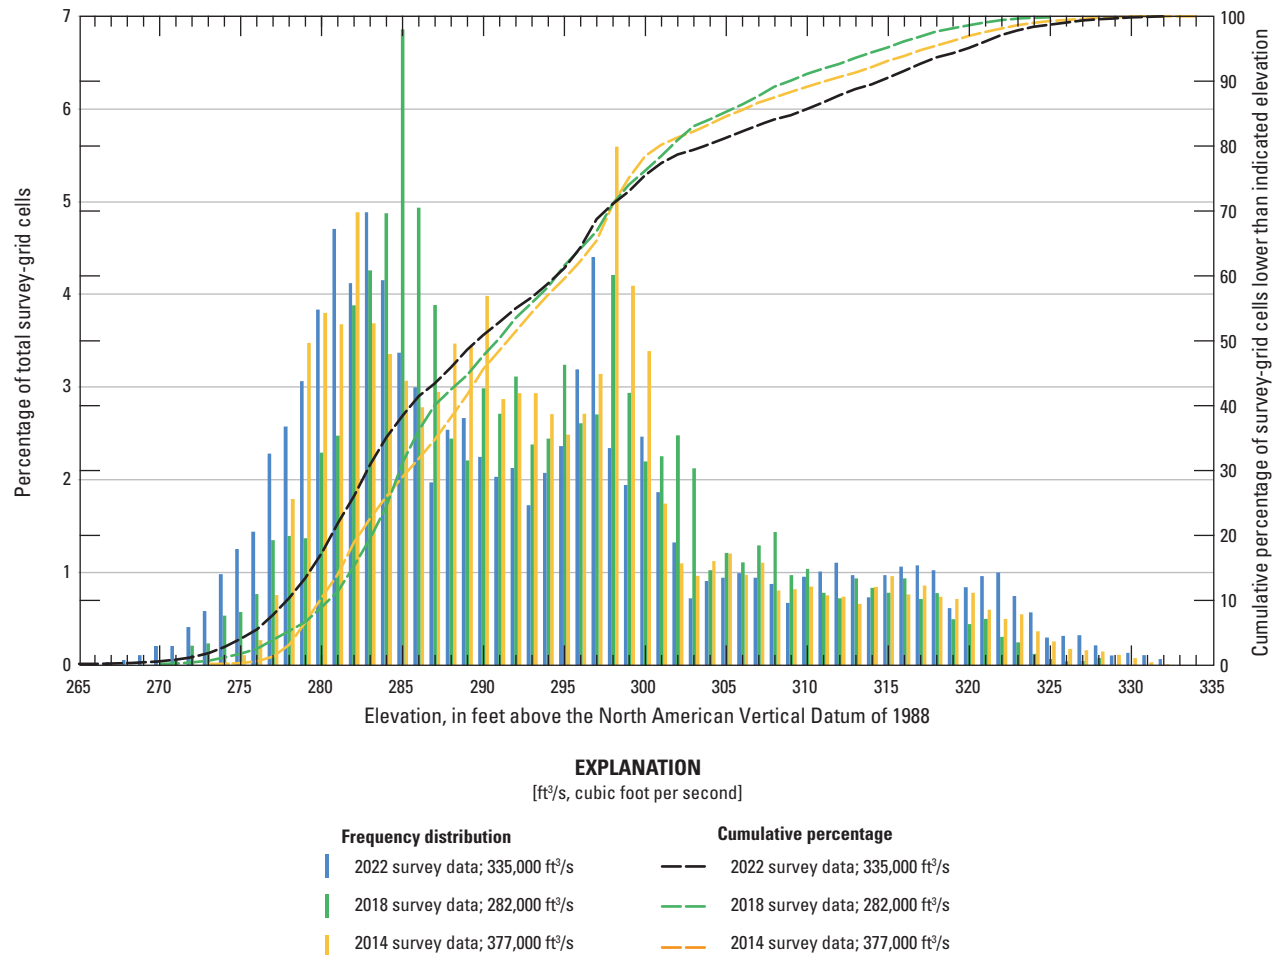
Figure 34. Frequency distribution of bed elevations for bathymetric survey-grid cells in 1-foot elevation bins on the Mississippi River near structure A5076 on State Highway 34 at Cape Girardeau, Missouri, on June 14, 2022, compared to previous surveys in 2014 and 2018 (Huizinga, 2015, 2020e, respectively).

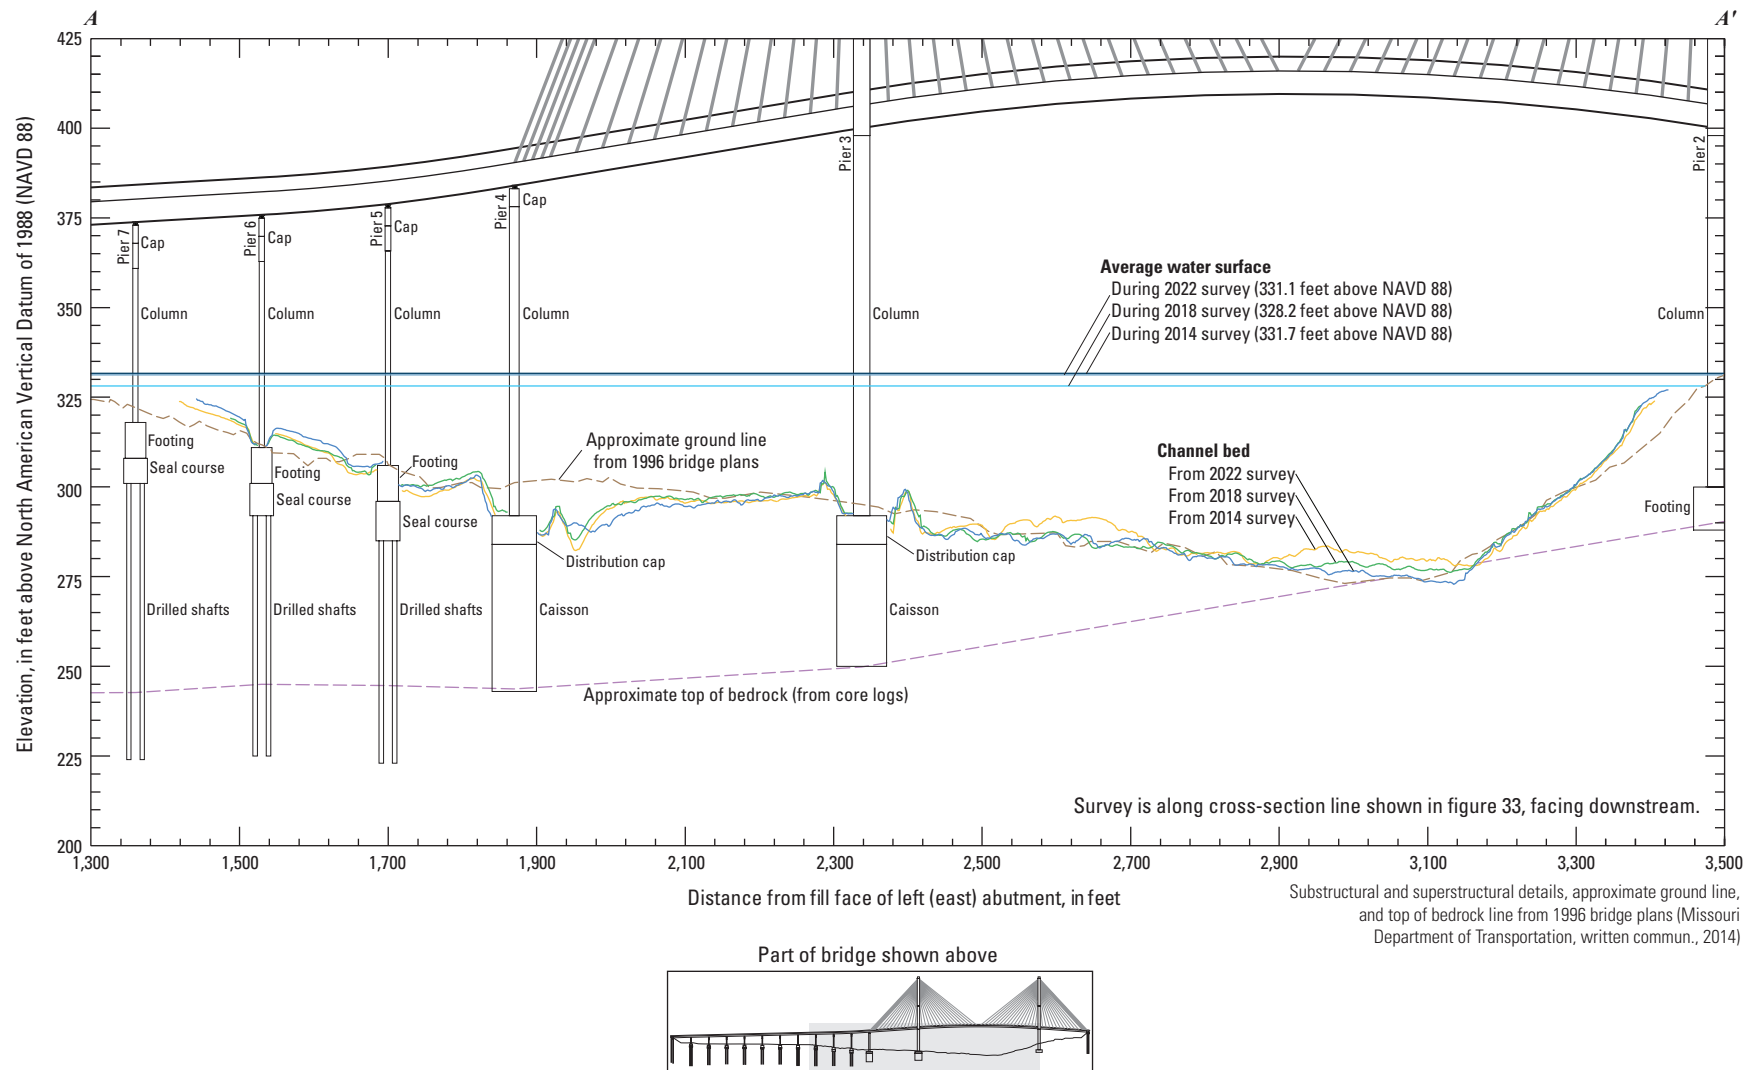
Figure 35. Key features, substructural and superstructural details, and surveyed channel bed of structure A5076 on State Highway 34 crossing the Mississippi River at Cape Girardeau, Missouri.

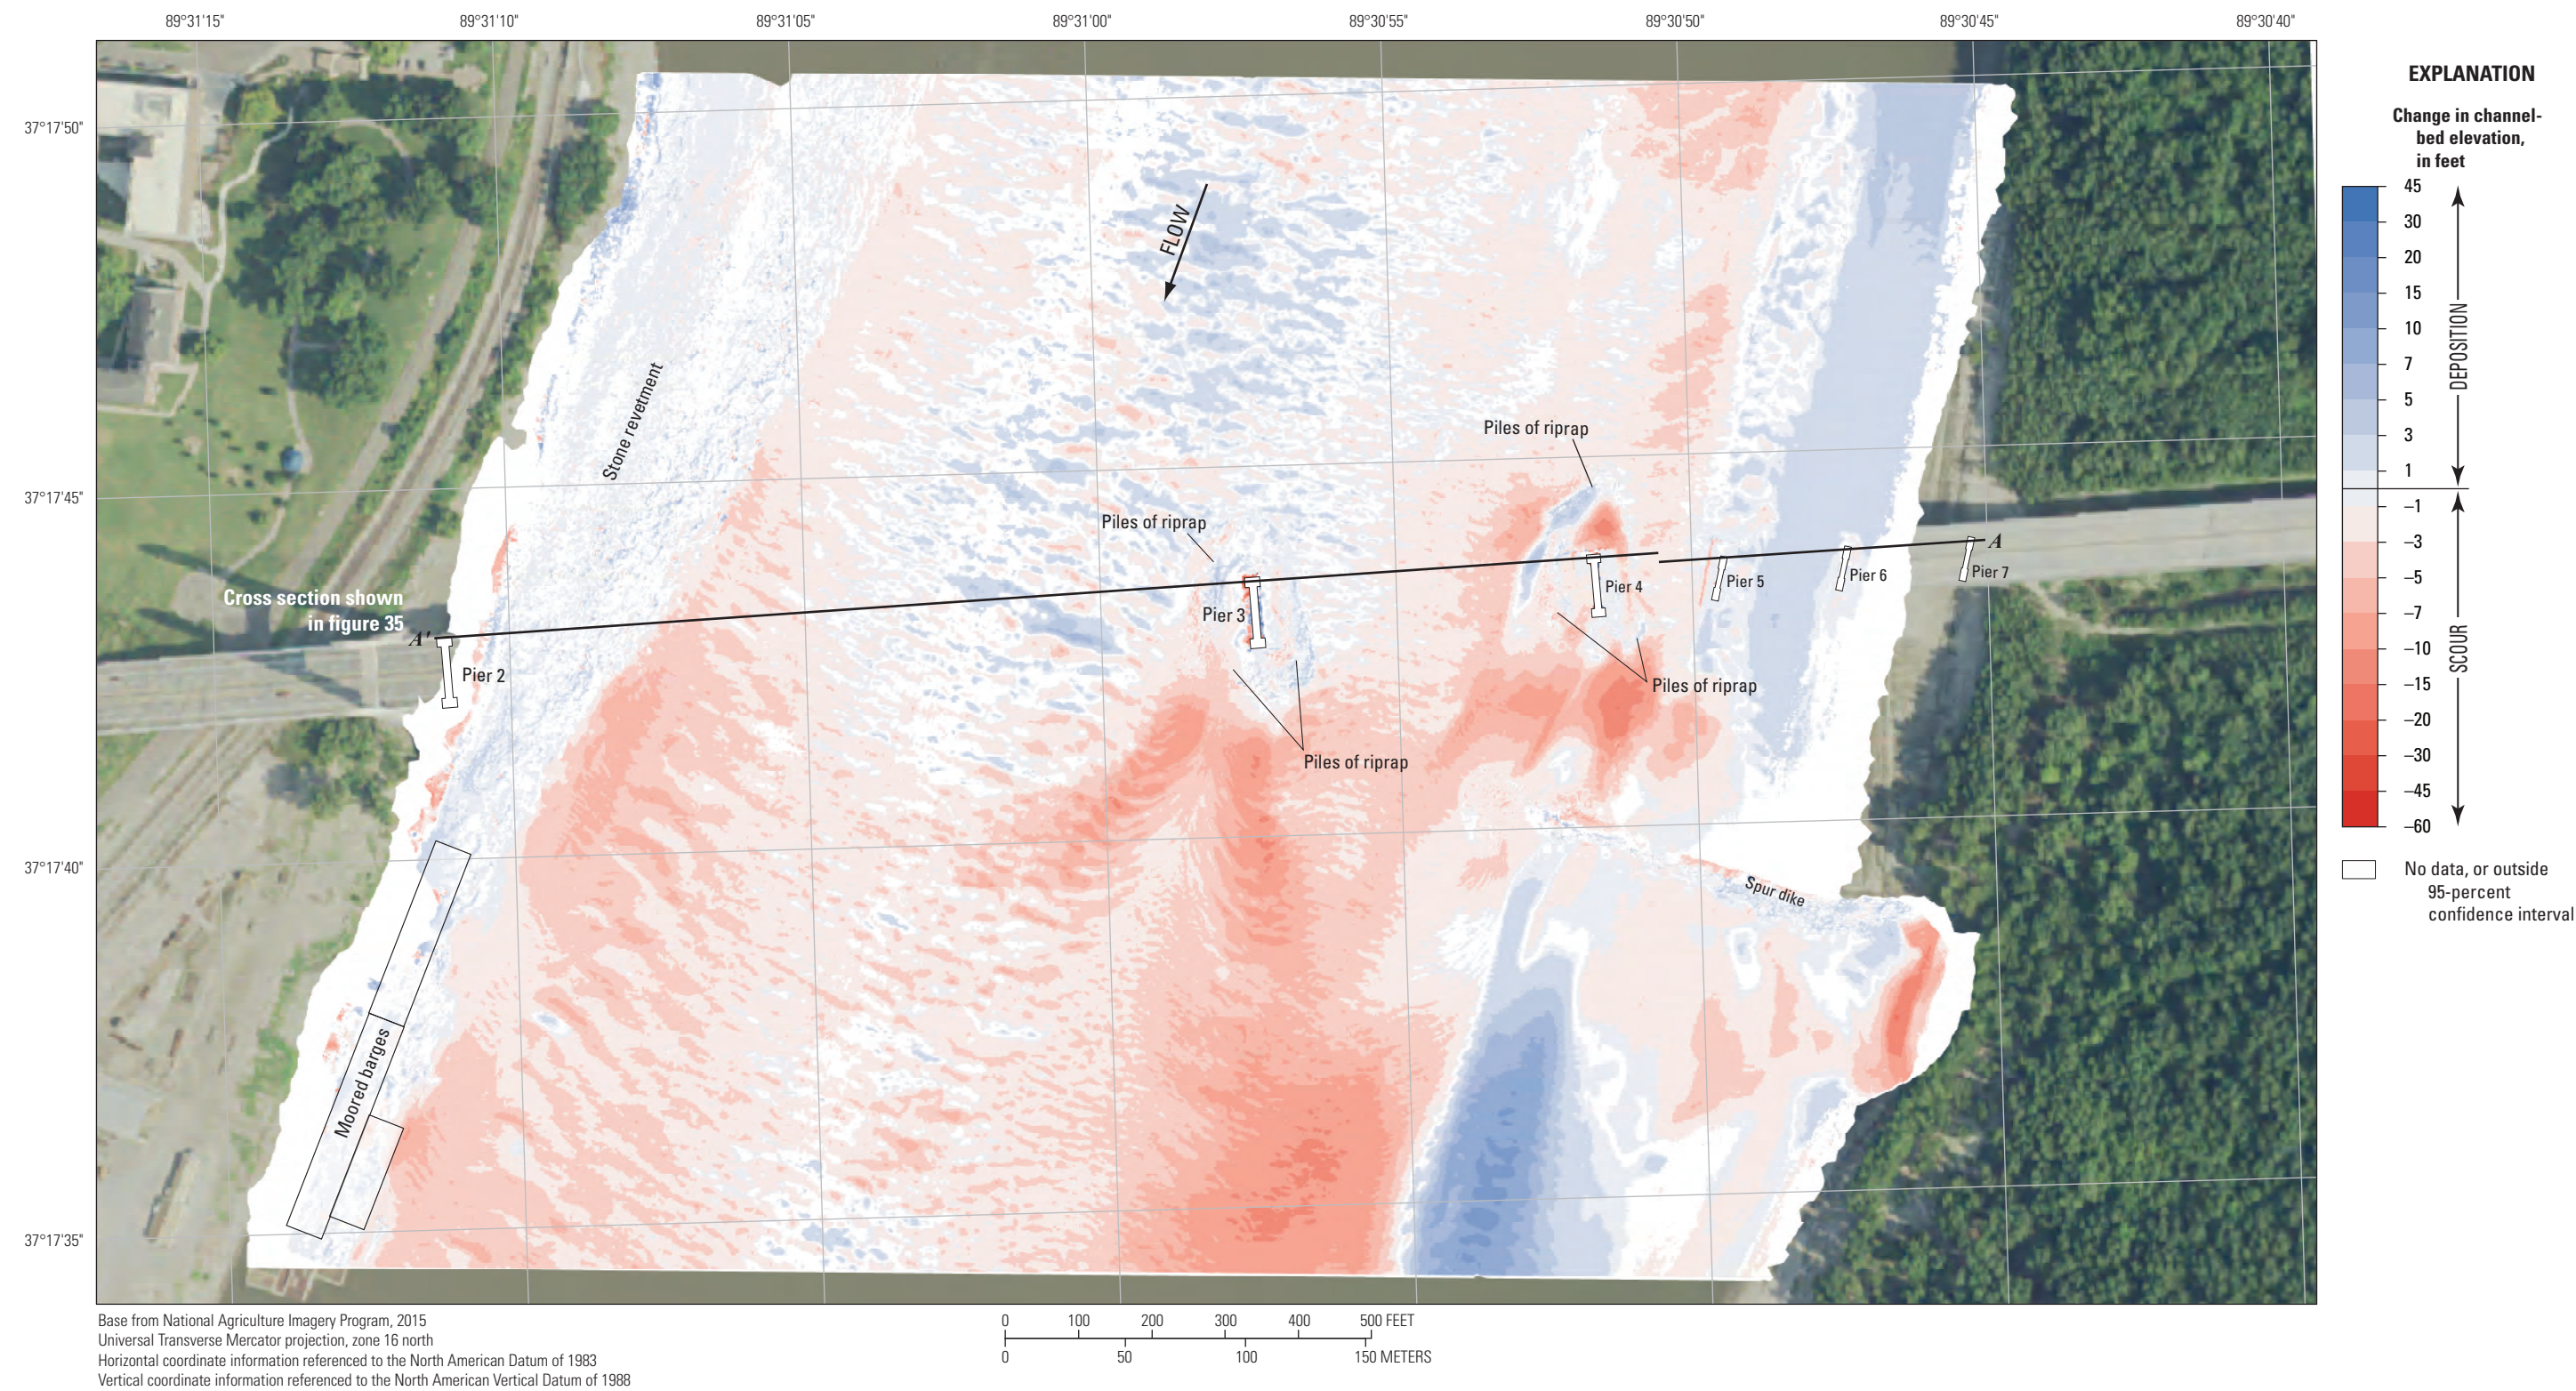
The difference between the survey on June 14, 2022, and the previous survey on July 25, 2018 ([fig. 36](#)), indicates about 83 percent of the joint area of interest had detectable change, which means about 17 percent of the differences in the joint area of interest are equivocal and within the bounds of uncertainty ([table 8](#)). Erosion appears predominant throughout the reach between 2018 and 2022 in the DoD, except near the left (east) bank where deposition is more dominant ([fig. 36](#)). The average difference between the bathymetric surfaces was –1.79 ft ([table 8](#)), indicating moderate to substantial channel degradation between the 2018 and 2022 surveys. The net volume of cut in the reach from 2018 to 2022 was about 215,200 yd³, and the net volume of fill was about 42,300 yd³, resulting in a net loss of about 172,900 yd³ of sediment between 2018 and 2022 ([table 8](#)). The cross section from the 2022 survey along the upstream face of the bridge generally varies above and below the 2018 survey section ([fig. 35](#)). The frequency distribution of bed elevations in 2022 has a slightly wider elevation range than either the surveys in 2018 or 2014 ([fig. 34](#)). The stone revetment on the right (west) bank showed localized areas of deposition, but nearly all the indicated changes are within 1 ft of the 2018 elevation, or outside the 95-percent confidence interval ([fig. 36](#)). Areas of localized erosion of the stone revetment tend to be near the upper edges of the banks and may be the result of larger uncertainty in the outer beams in the 2022 survey, particularly near the water surface (refer to [fig. 5](#) in “Uncertainty Estimation” section). The scour hole downstream from the spur dike on the left (east) bank has widened to the east since 2018, resulting in substantial erosion there ([fig. 36](#)).

Figure 36. Difference between surfaces created from bathymetric surveys of the Mississippi River channel near structure A5076 on State Highway 34 at Cape Girardeau, Missouri, on June 14, 2022, and July 25, 2018, with probabilistic thresholding.

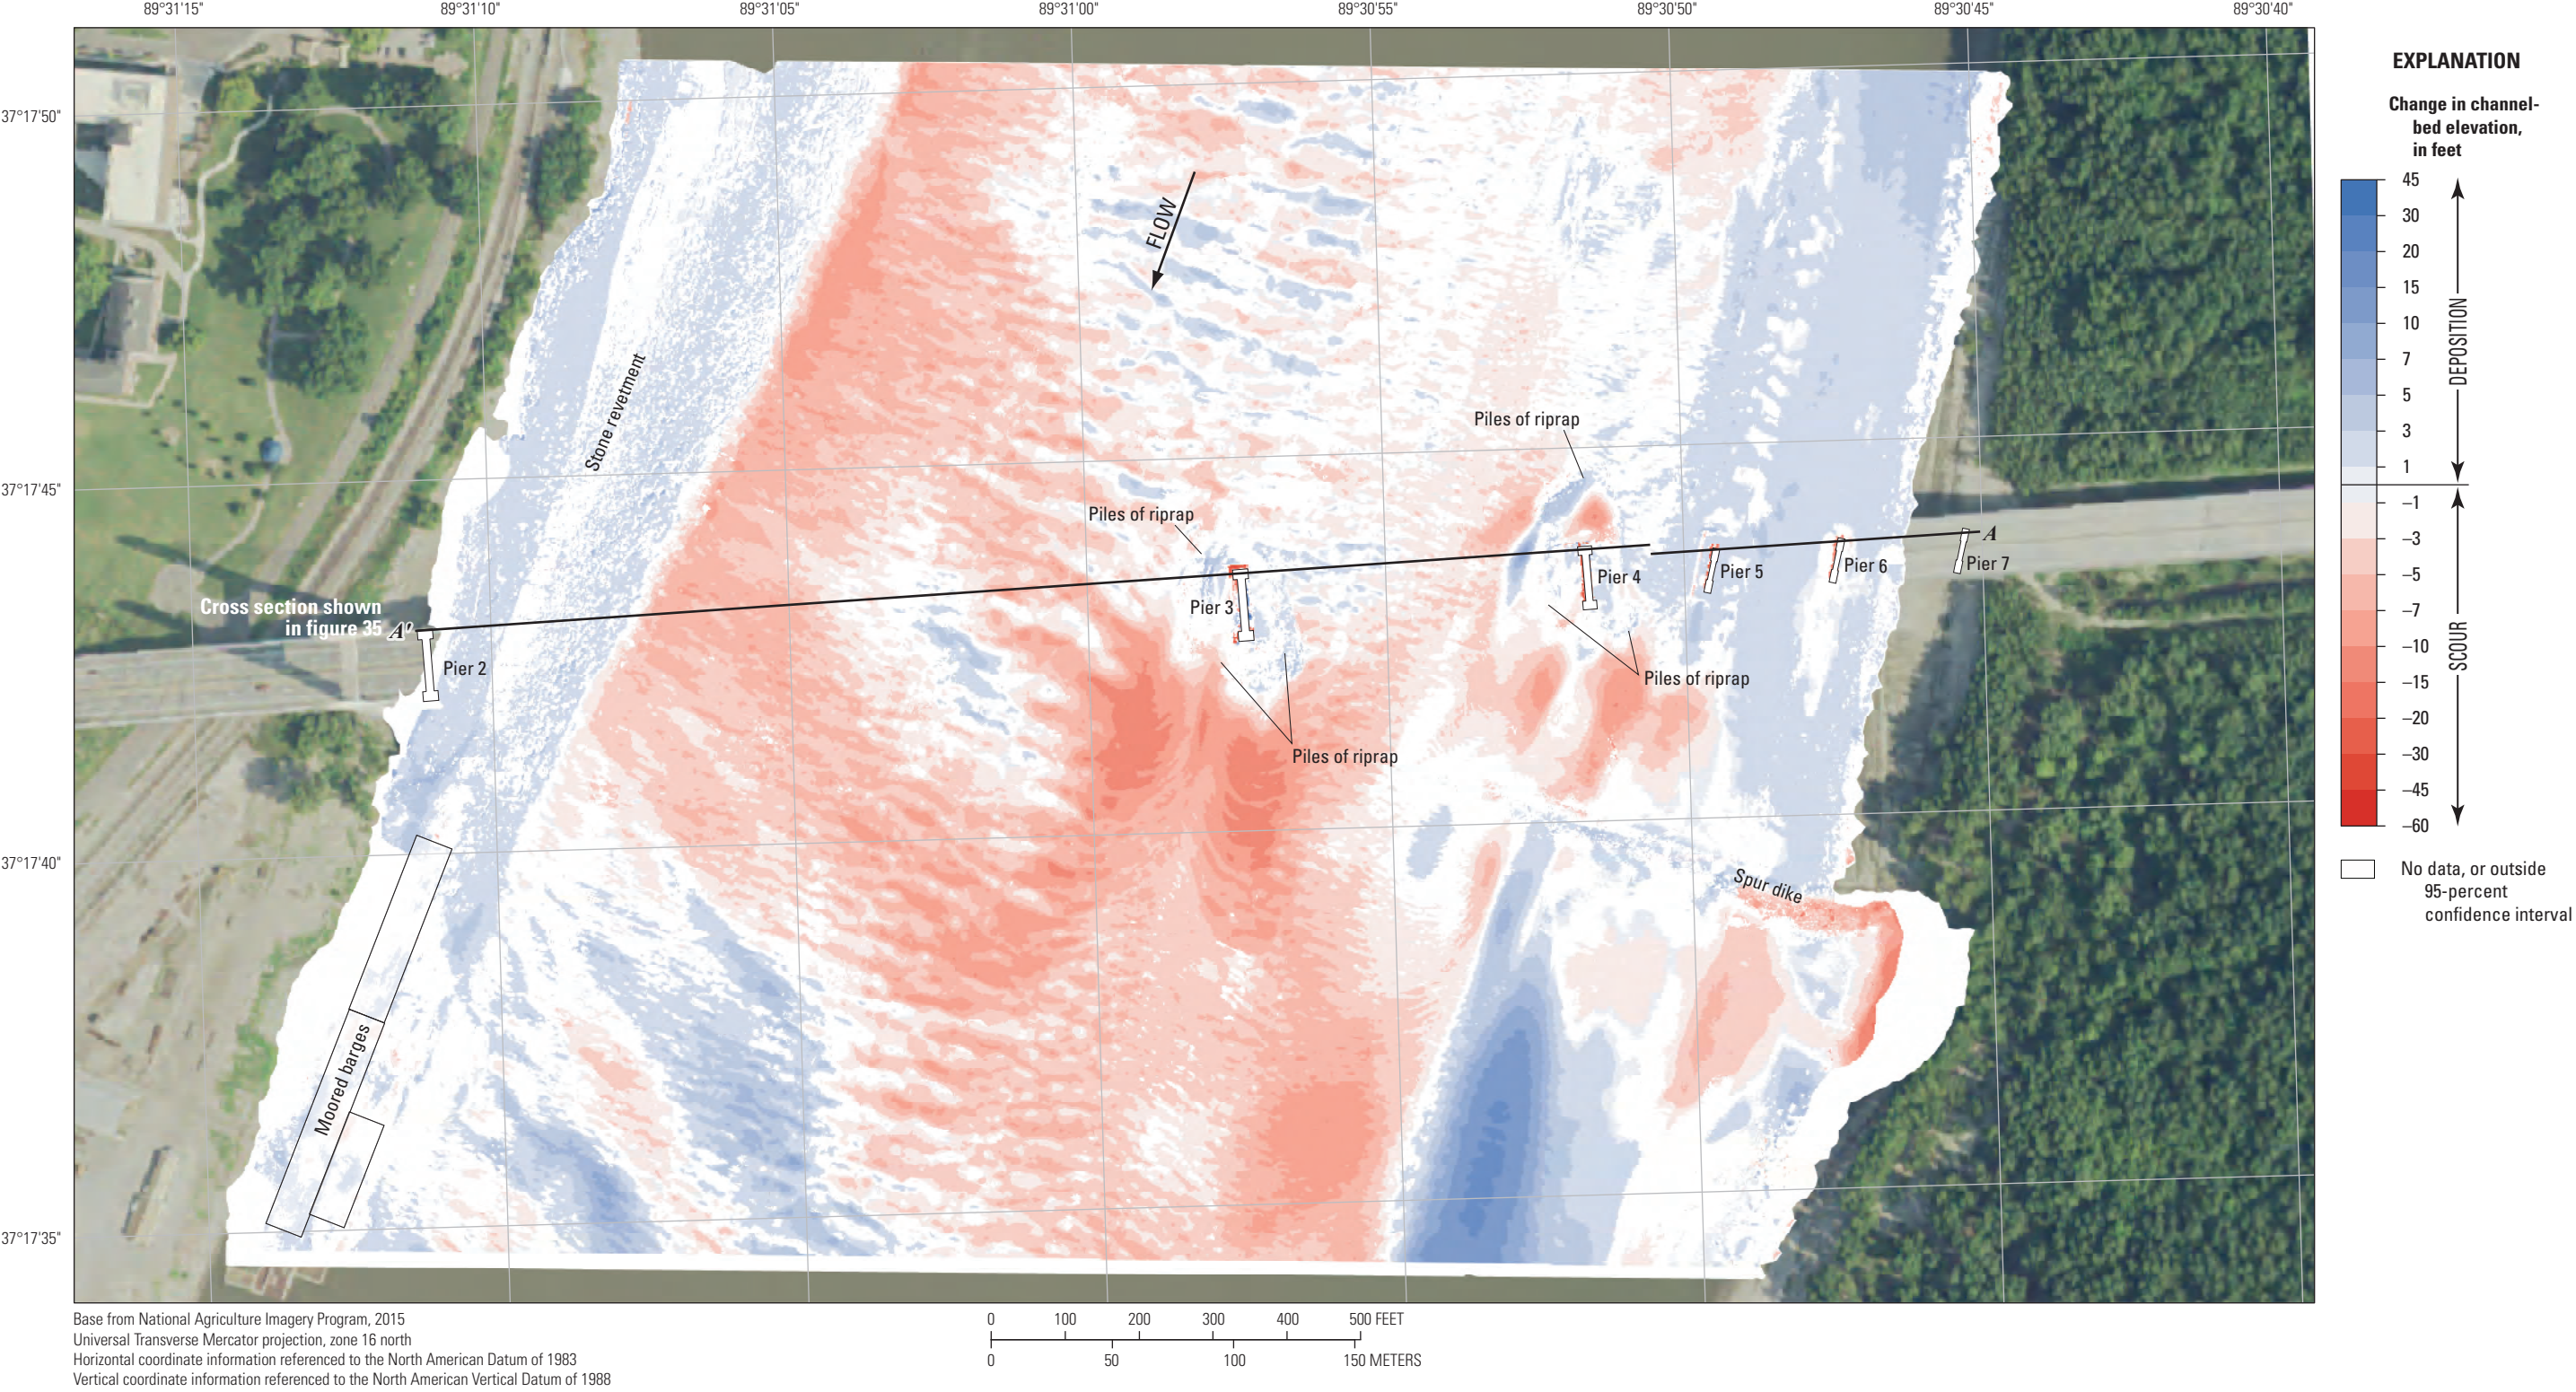
The difference between the survey on June 14, 2022, and the earliest survey on June 10, 2014 ([fig. 37](#)), indicates about 71 percent of the joint area of interest had detectable change, which means about 29 percent of the differences in the joint area of interest are equivocal and within the bounds of uncertainty ([table 8](#)). Erosion again appears predominant throughout the reach between 2014 and 2022 in the DoD, except near the left (east) bank throughout the reach, and localized areas on the right (west) bank downstream from the bridge where deposition is more dominant ([fig. 37](#)). The average difference between the bathymetric surfaces was –1.71 ft ([table 8](#)), similar to 2018 and again indicating moderate to substantial channel degradation between the 2014 and 2022 surveys. The net loss of sediment between 2014 and 2022 was about 142,900 yd³, which is less than but consistent with the net loss of sediment between 2018 and 2022 ([table 8](#)). As mentioned in the previous paragraph, the frequency distribution of bed elevations in 2022 has a slightly wider elevation range than either the survey in 2018 or 2014 ([fig. 34](#)). The stone revetment on the right (west) bank again showed localized areas of deposition ([fig. 37](#)); however, nearly all the indicated changes are within 1 ft of the 2014 elevation or are equivocal with uncertainty, and the apparent deposition likely results from

minor horizontal positional variances between the surveys (fig. 6). The scour hole downstream from the spur dike on the left (east) bank had widened eastward between 2014 and 2022 (likely since 2018, refer to preceding paragraph), resulting in substantial erosion (fig. 37). Deposition of as much as 15 ft also was observed downstream from the tip of the spur dike (fig. 37). As with previous DoDs, deposition or scour apparent on opposing faces of a feature likely results from minor horizontal positional variances between the surveys (fig. 6).

Figure 37. Difference between surfaces created from bathymetric surveys of the Mississippi River channel near structure A5076 on State Highway 34 at Cape Girardeau, Missouri, on June 14, 2022, and June 10, 2014, with probabilistic thresholding.

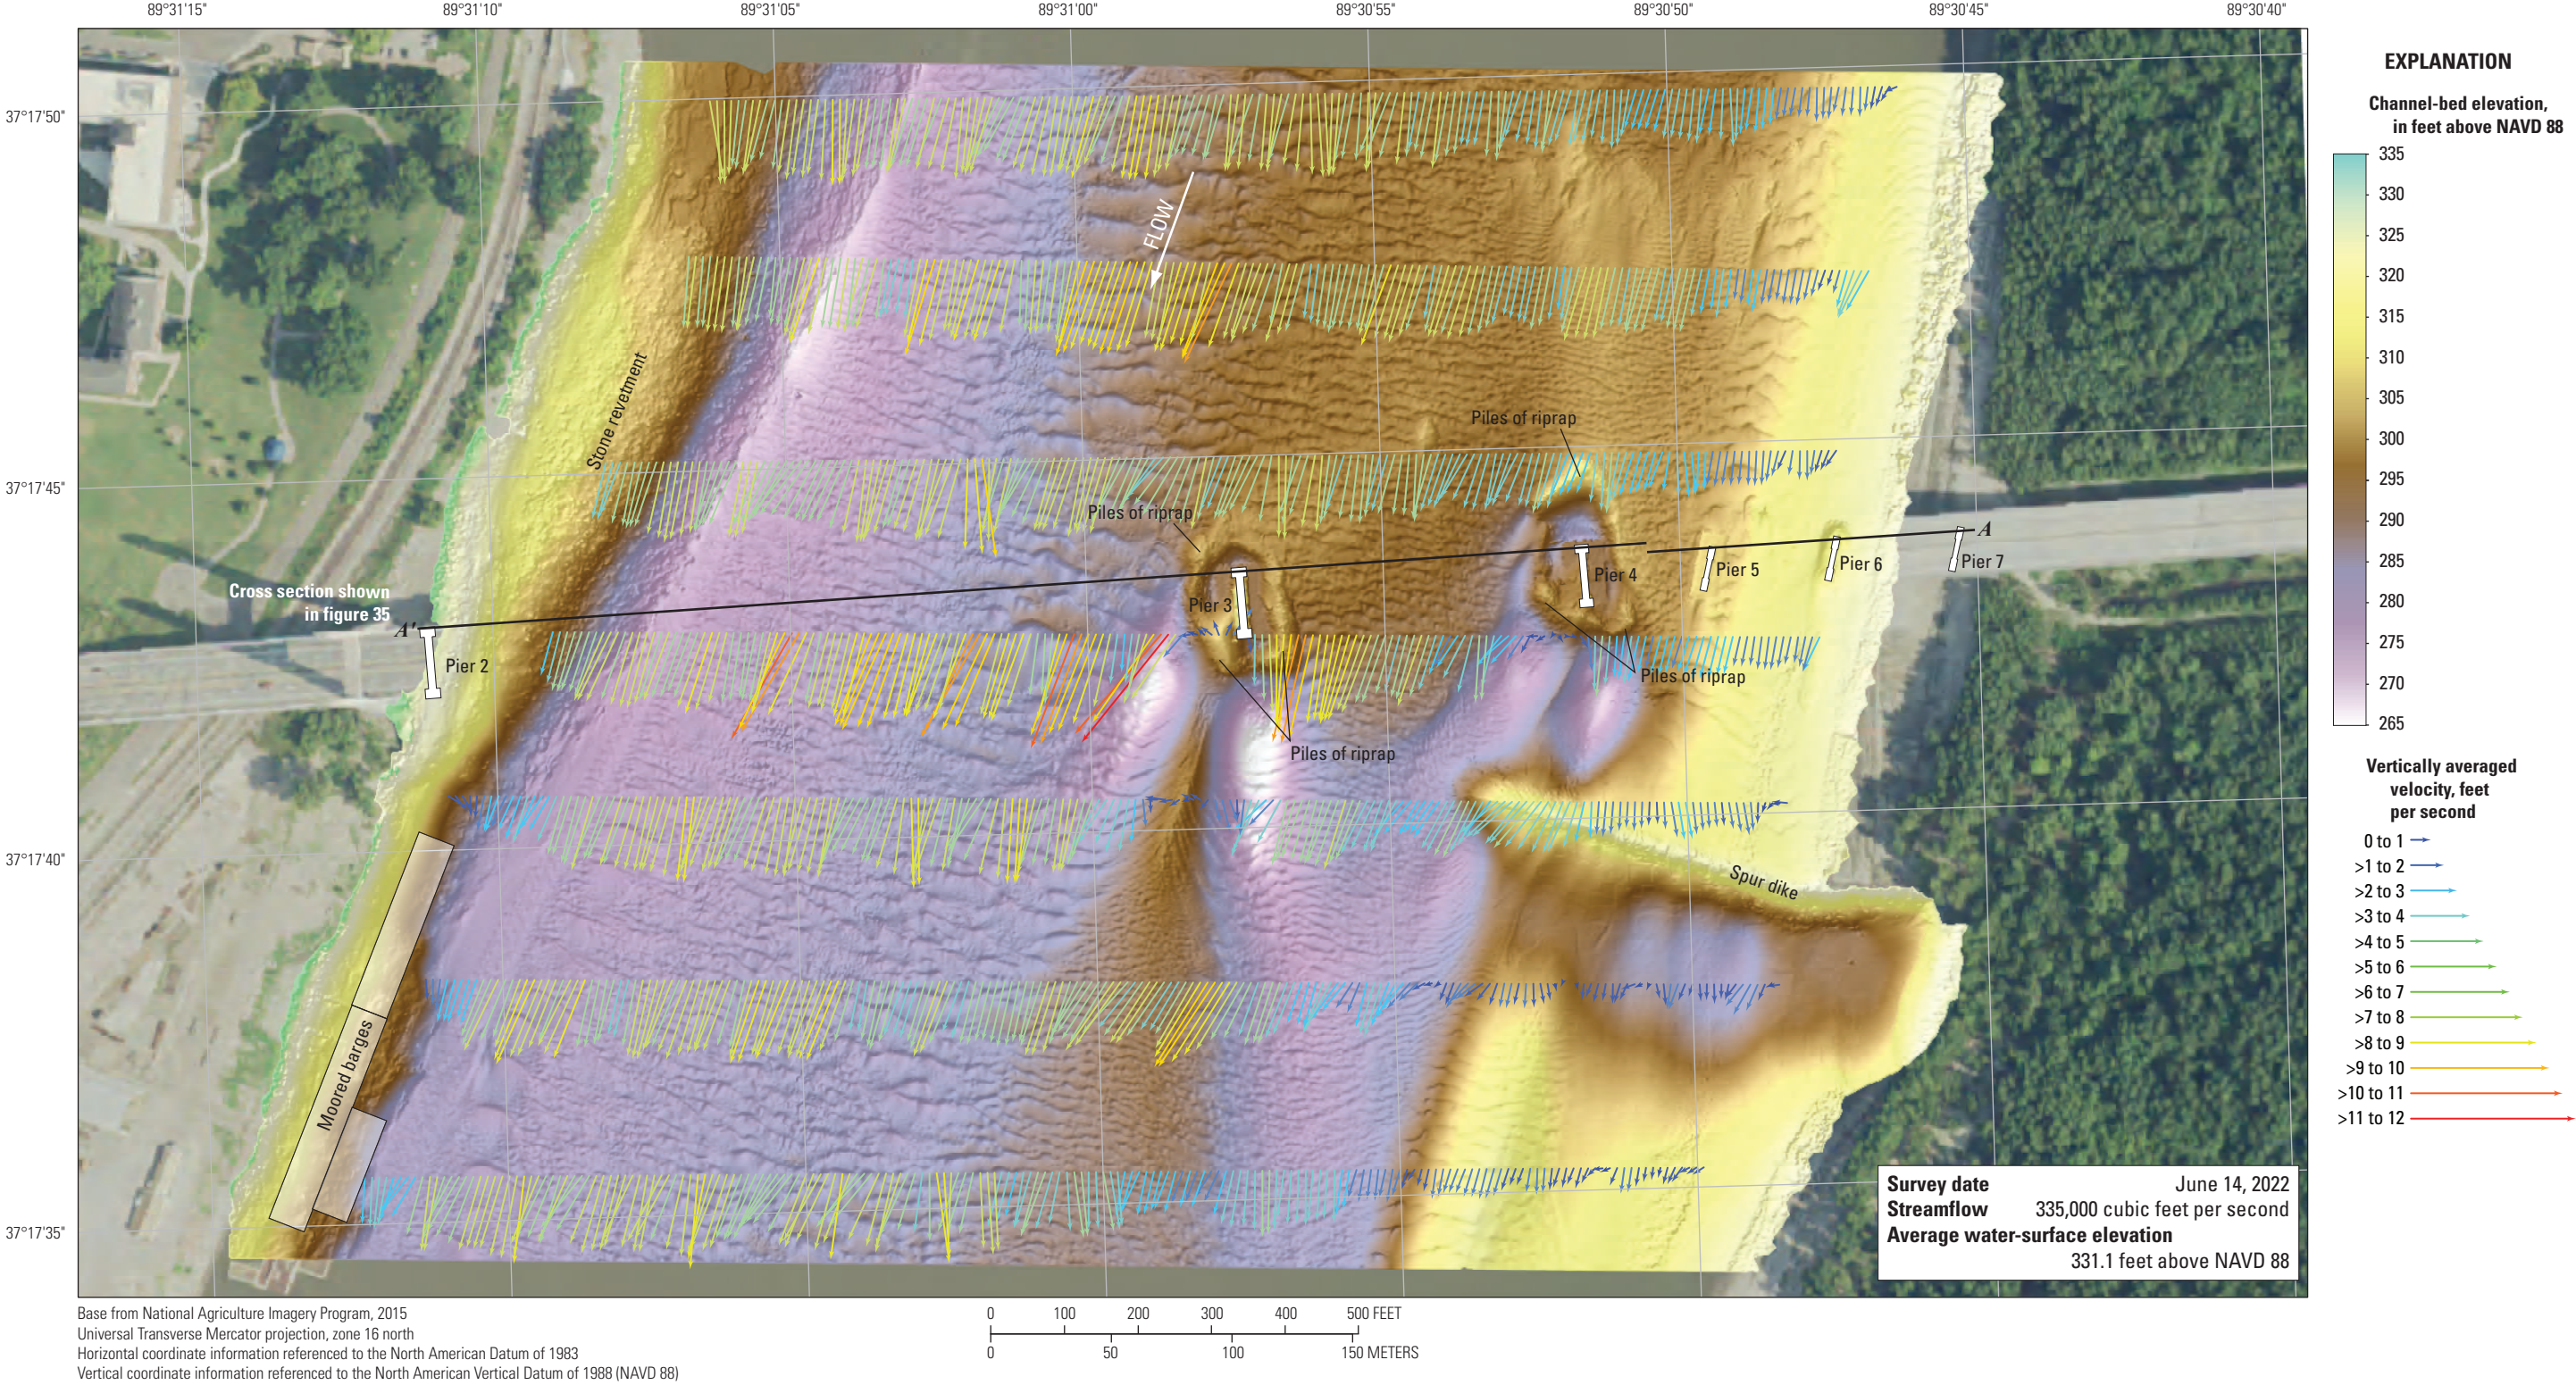
The vertically averaged velocity vectors indicate mostly uniform flow throughout most of the reach, with localized moderate to substantial turbulence and flow reversals near the piers and the spur dike on the downstream left (east) bank (fig. 38). Velocities generally ranging from about 3 to 9 ft/s, except in these turbulent areas where velocities of as much as 12 ft/s were observed (fig. 38). Piers 3 and 4 were skewed to approach flow by about 30 degrees (table 7), causing substantial wake vortices with flow reversal and well-defined deposition ridges downstream (fig. 38).

Figure 38. Bathymetry and vertically averaged velocities of the Mississippi River channel near structure A5076 on State Highway 34 at Cape Girardeau, Missouri.

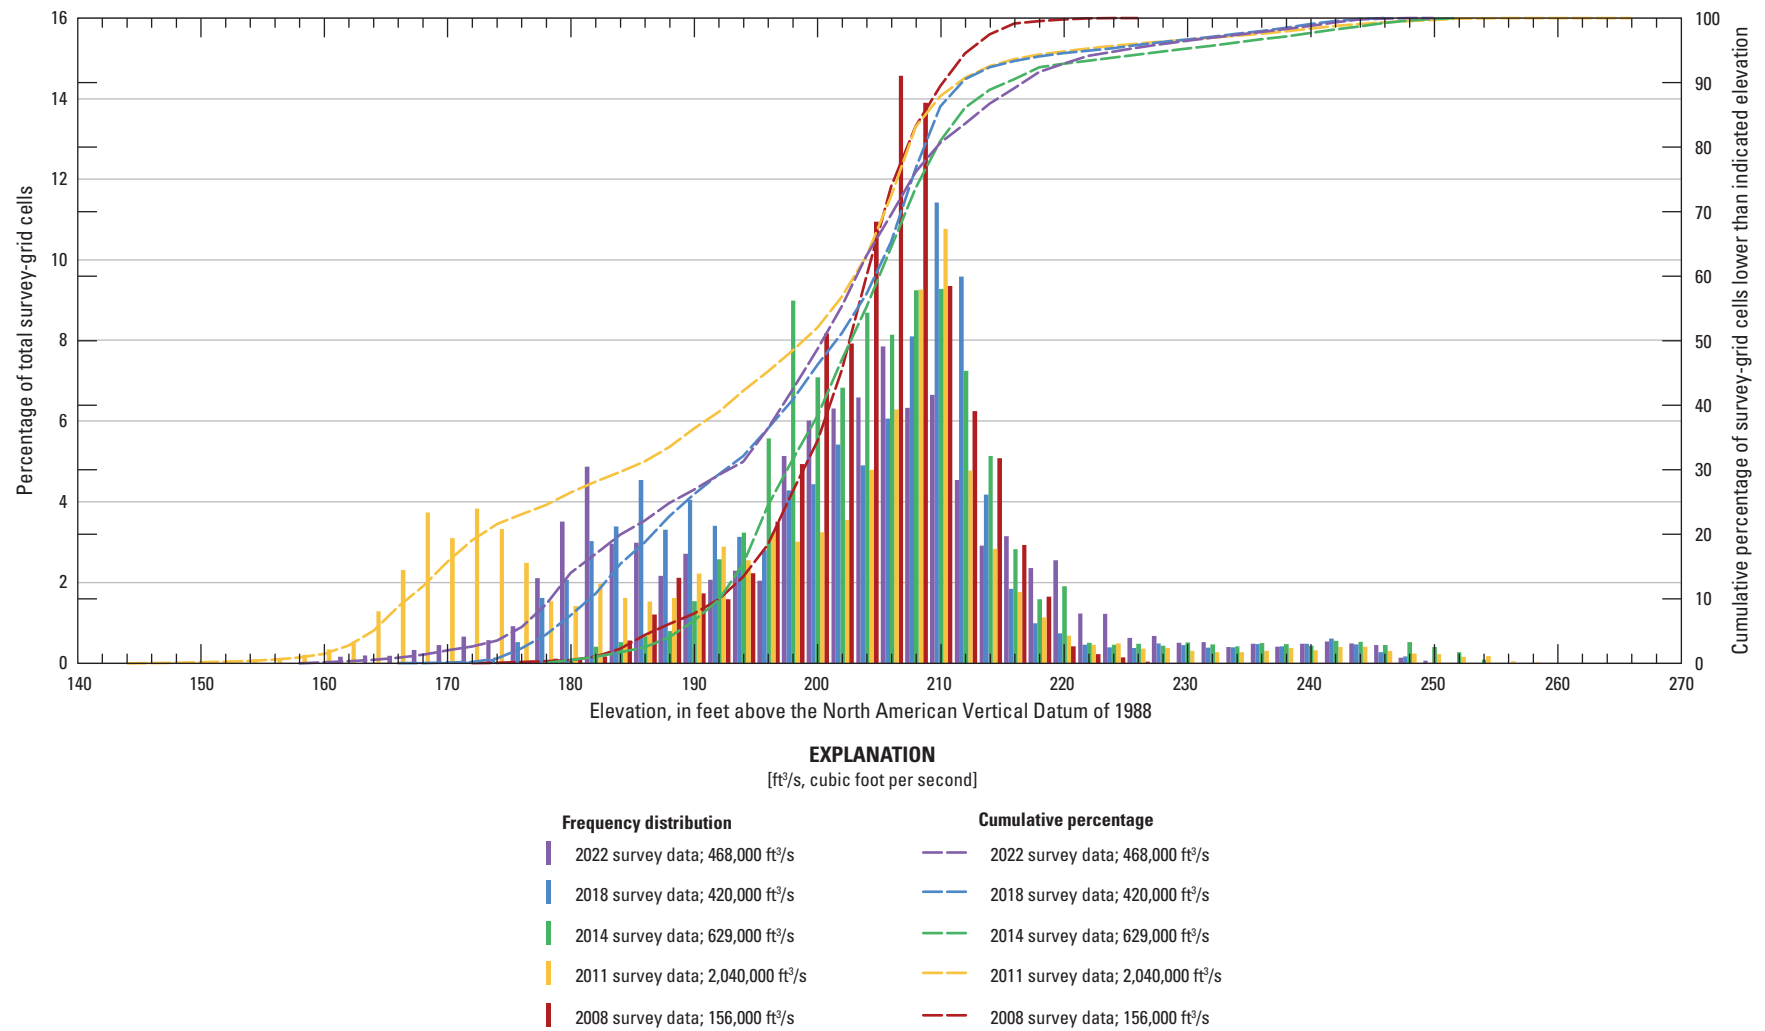
Figure 40. Frequency distribution of bed elevations for bathymetric survey-grid cells in 2-foot elevation bins on the Mississippi River near structure A1700 on Interstate 155 near Caruthersville, Missouri, on June 15, 2022, compared to previous surveys in 2008, 2011, 2014, and 2018 (Huizinga, 2014, 2020a).
