Bathymetric and Velocimetric Surveys at Highway Bridges Crossing the Missouri and Mississippi Rivers on the Periphery of Missouri, June 13–22, 2022

Scientific Investigations Report 2024–5032

By Richard J. Huizinga

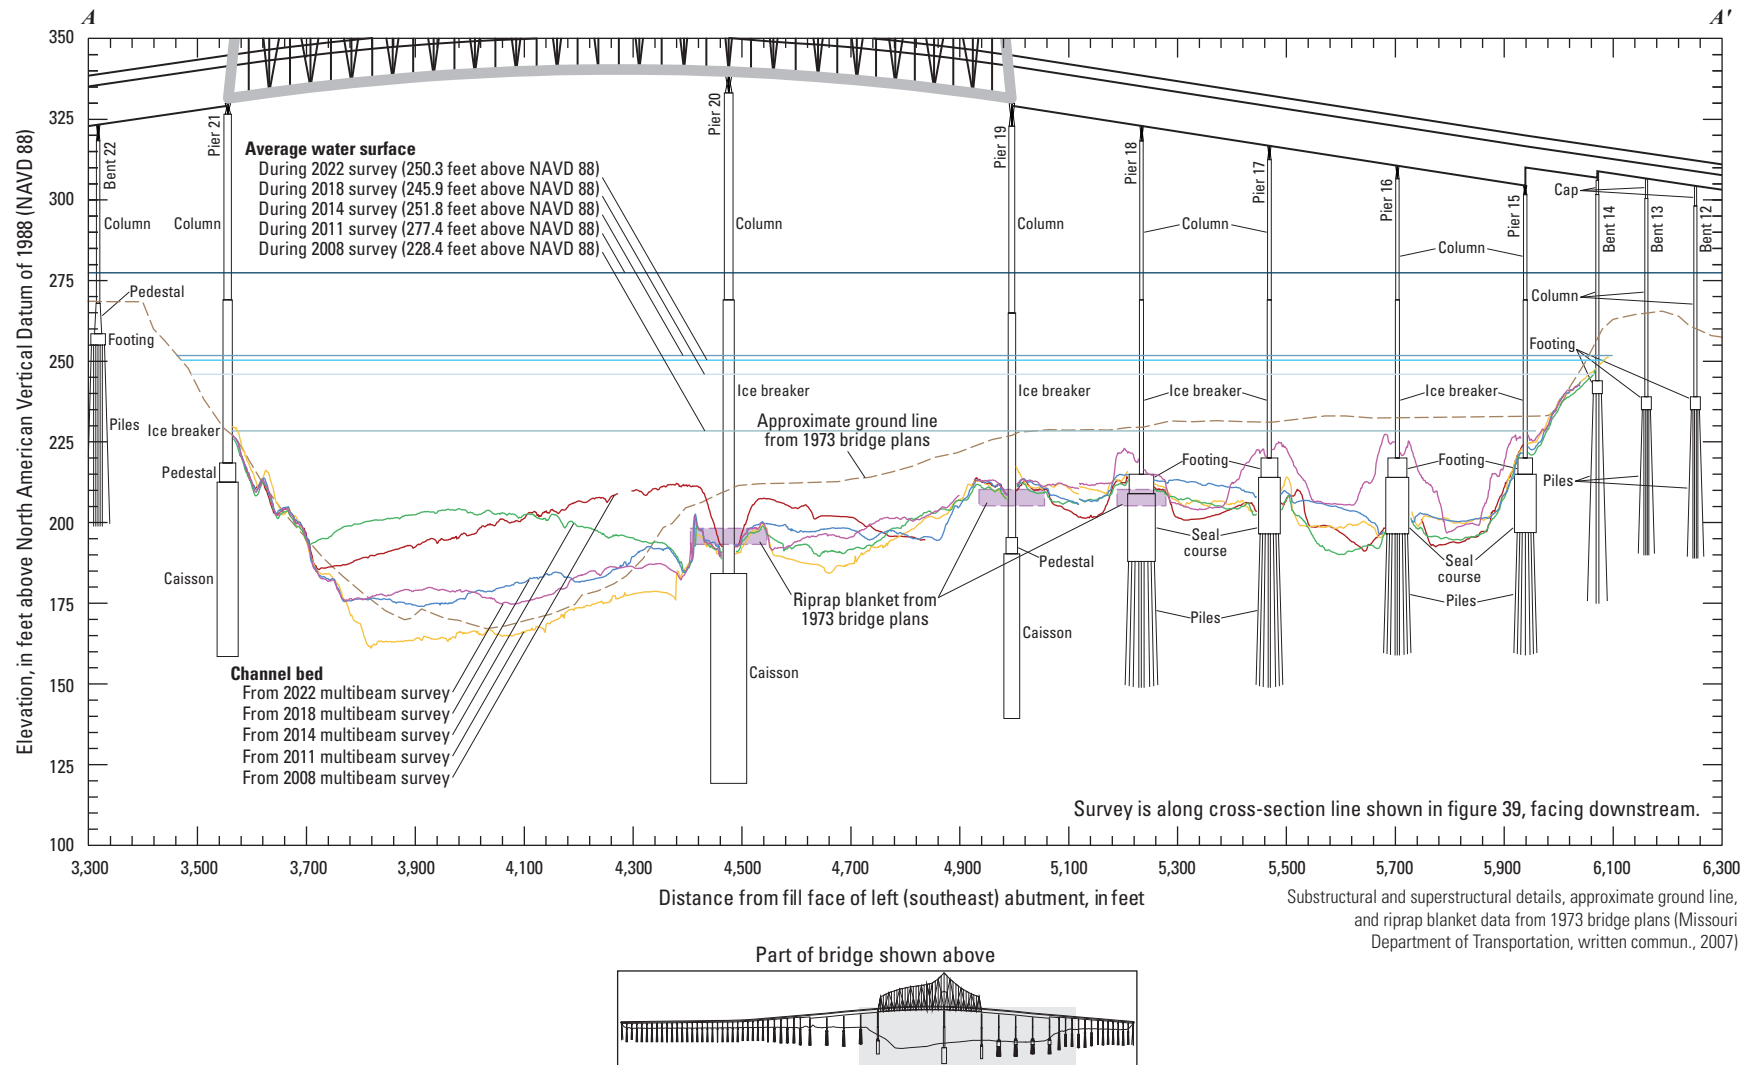
Figure 41. Key features, substructural and superstructural details, and surveyed channel bed of structure A1700 on Interstate 155 crossing the Mississippi River near Caruthersville, Missouri.

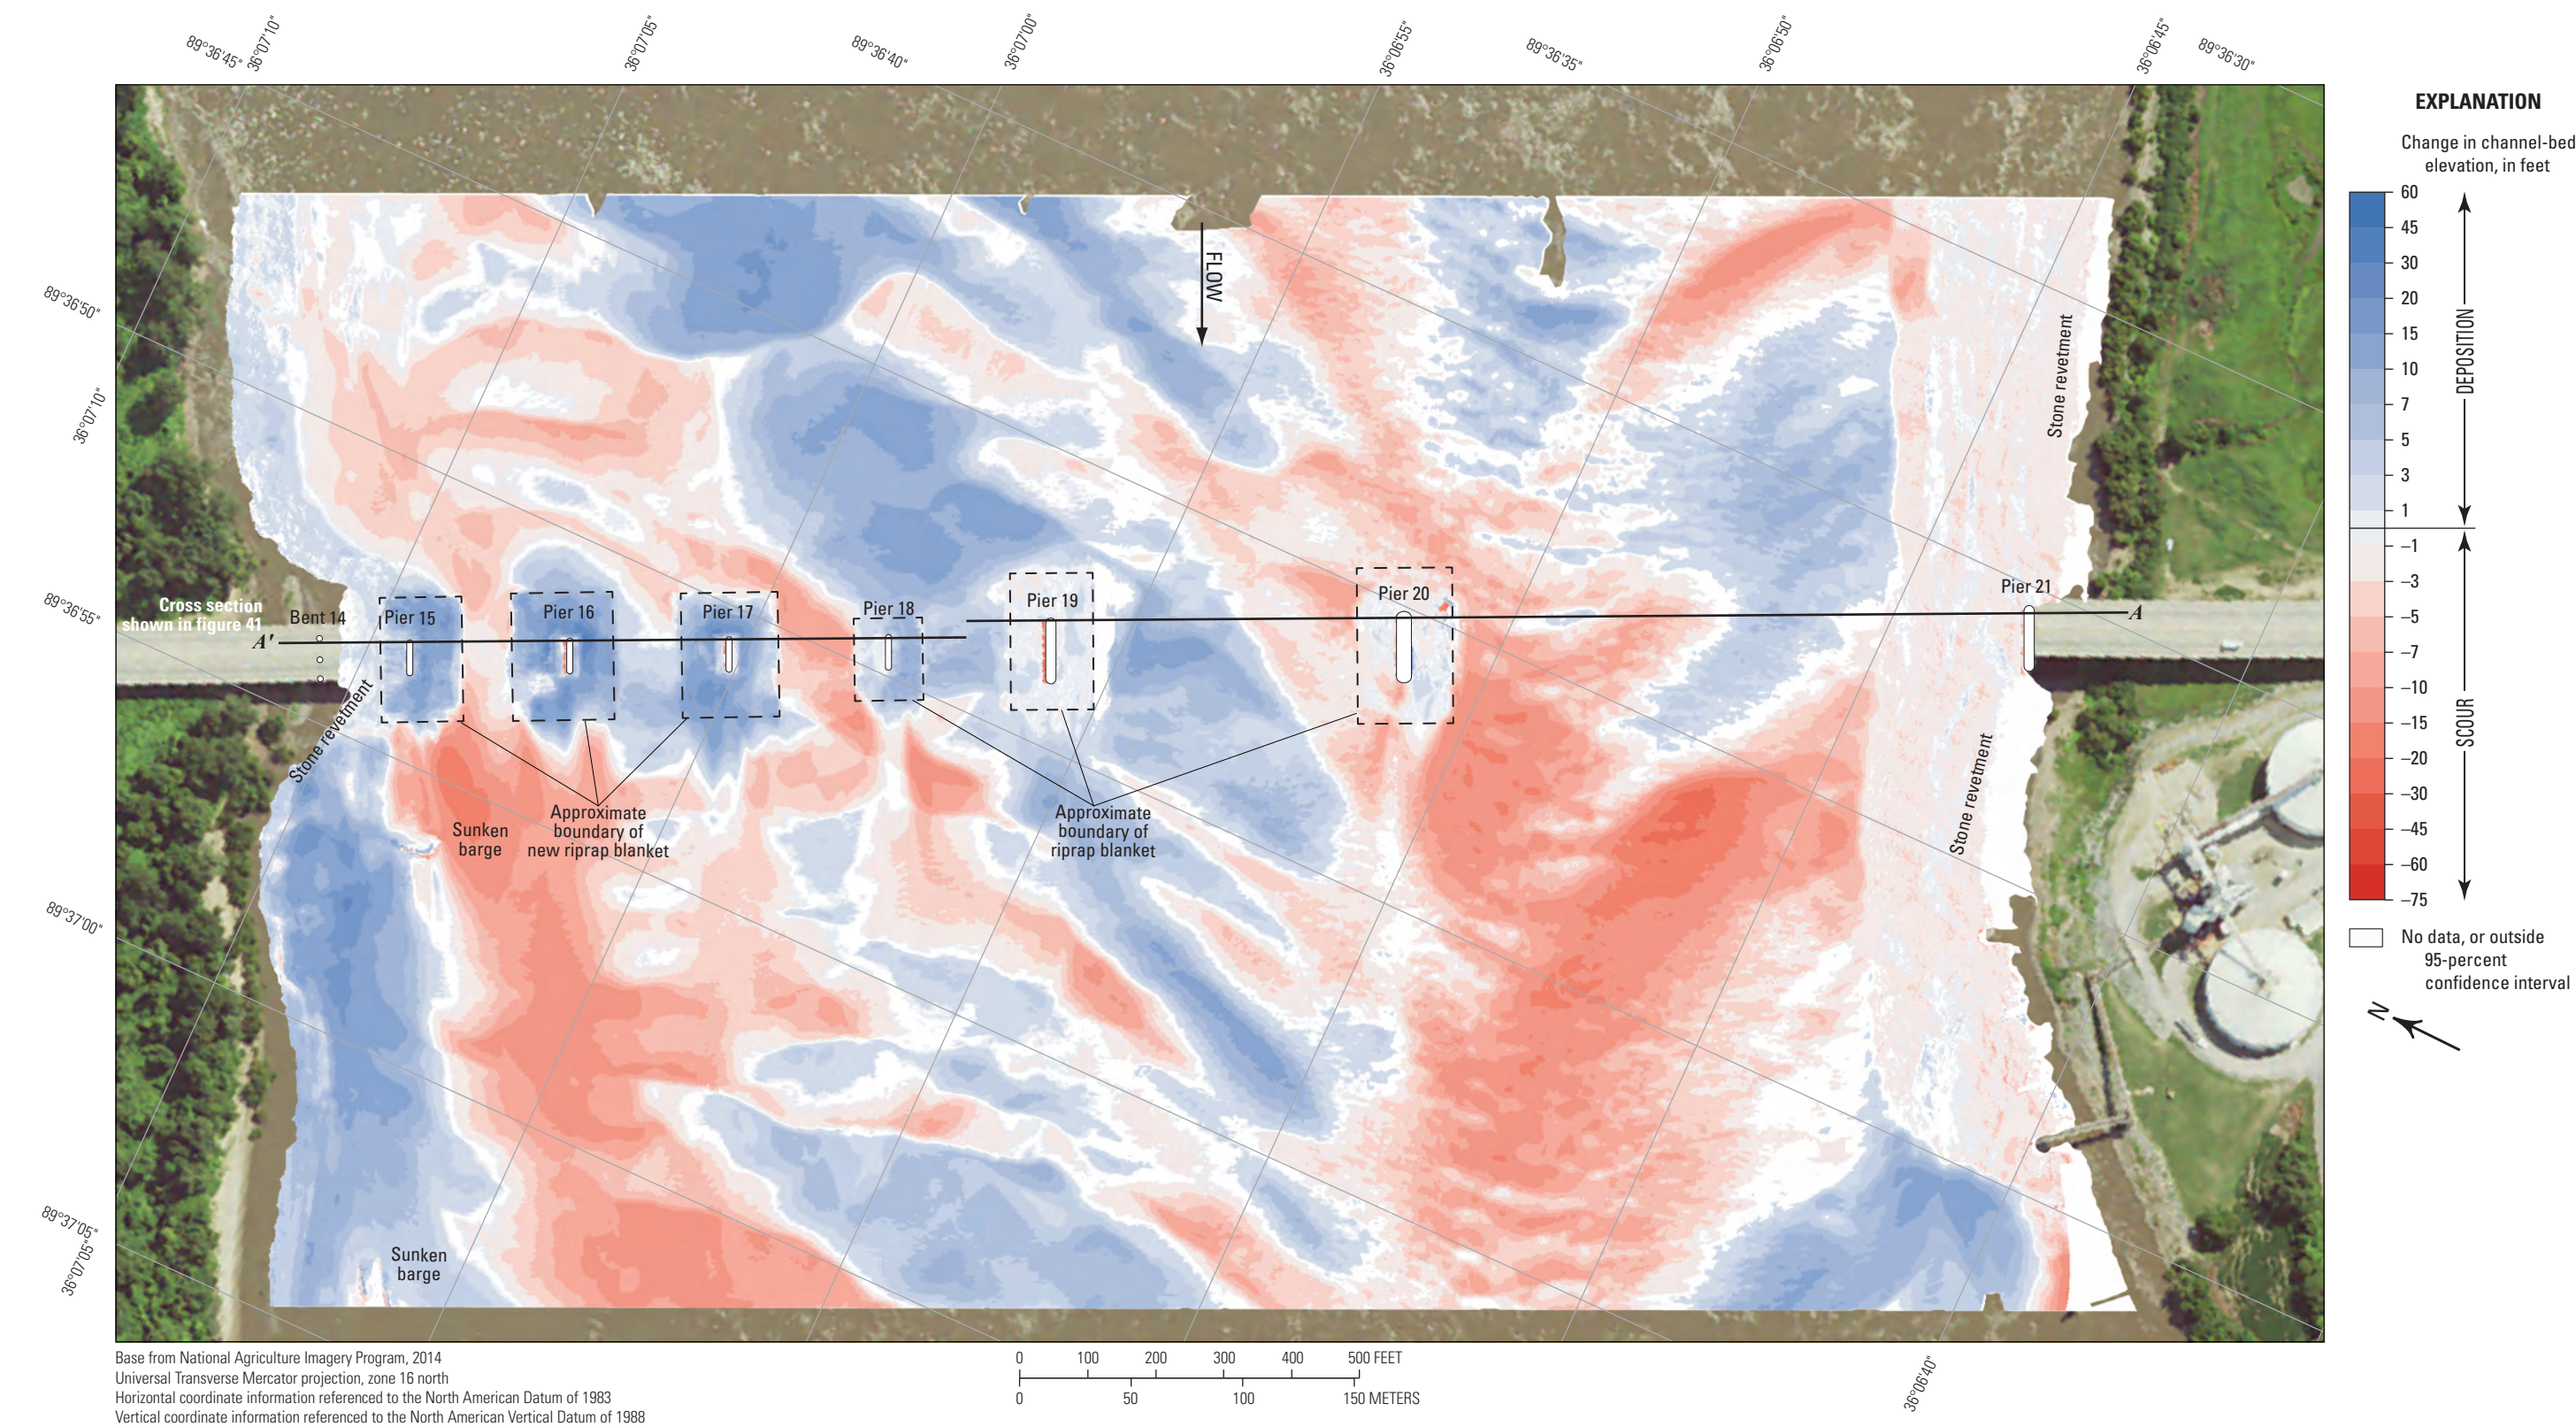
The difference between the survey on June 15, 2022, and the previous survey on July 26, 2018 ([fig. 42](#)), indicates about 90 percent of the joint area of interest had detectable change, which means about 10 percent of the differences in the joint area of interest are equivocal and within the bounds of uncertainty ([table 8](#)). Erosion and deposition appear roughly balanced throughout most of the reach between 2018 and 2022 in the DoD ([fig. 42](#)). Substantial deposition of more than 20 ft was observed along the right (northwest) bank downstream from the bridge, with a corresponding area of as much as 20 ft of erosion adjacent to the left (southeast; [fig. 42](#)). The change in the channel-bed elevations from the new and modified riprap blankets near piers 15 through 18 is evident in the DoD, including the material added to the left side of the pre-existing blanket near pier 18 ([fig. 42](#)). The average difference between the bathymetric surfaces was −0.71 ft ([table 8](#)), indicating minor to moderate channel degradation between the 2018 and 2022 surveys. The net volume of cut in the reach from 2018 to 2022 was about 405,600 yd³, and the net volume of fill was about 305,600 yd³, resulting in a net loss of about 100,000 yd³ of sediment between 2018 and 2022 ([table 8](#)). The frequency distribution of bed elevations in 2022 is most similar to the 2018 distribution, but with a slightly higher percentage of channel-bed elevations in the ranges between 182 and 194 ft, and 208 and 212 ft ([fig. 40](#)). The cross section along the upstream bridge face for 2022 also is most like the 2018 cross section, except near the new riprap blankets near piers 15 through 18, which are substantially built up ([fig. 41](#)). There is some localized erosion between piers 17 and 18, as well as erosion between piers 15 and 16 that extends to the downstream end of the reach ([figs. 41](#) and [42](#)). The stone revetment on the banks showed localized areas of erosion and deposition, but nearly all the indicated changes are within 3 ft of the 2018 elevation, or outside the 95-percent confidence interval ([fig. 42](#)). The left bank showed predominantly erosion, whereas the right bank showed predominantly deposition ([fig. 42](#)); however, deposition or scour apparent on opposing faces of a feature (or opposite banks) may result from minor horizontal positional variances between the surveys ([fig. 6](#)).

Figure 42. Difference between surfaces created from bathymetric surveys of the Mississippi River channel near structure A1700 on Interstate 155 near Caruthersville, Missouri, on June 15, 2022, and July 26, 2018, with probabilistic thresholding.

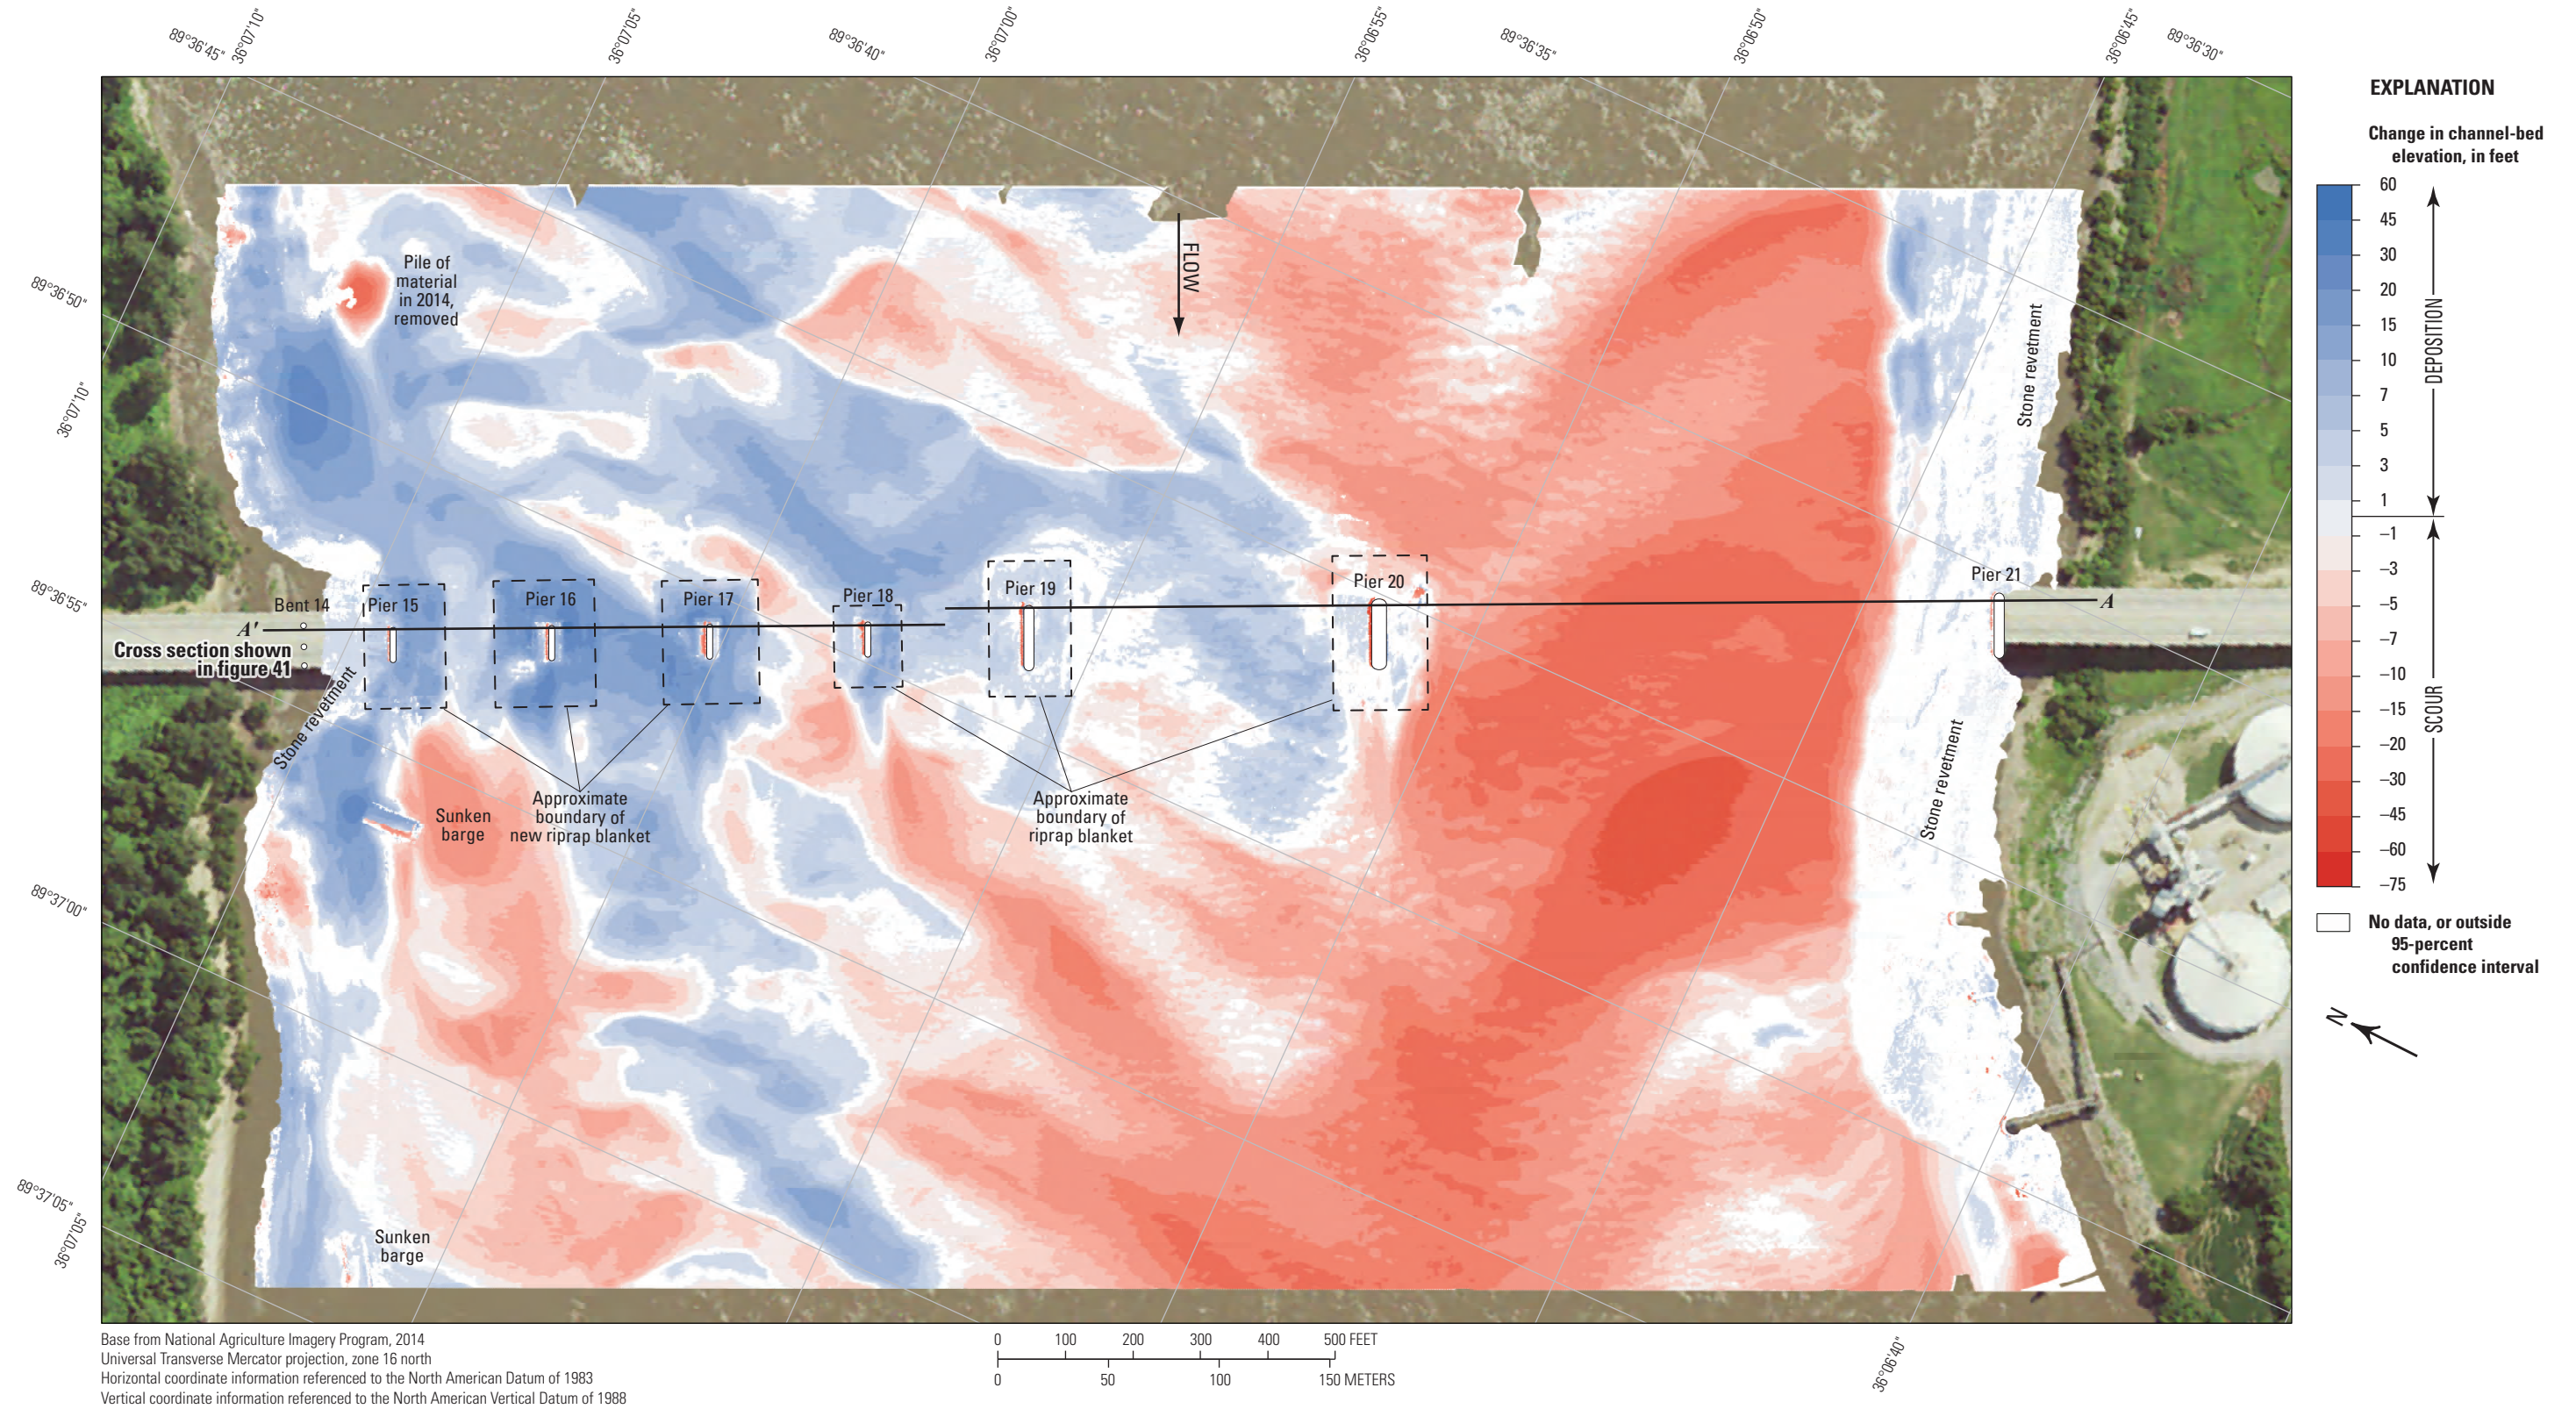
The difference between the survey on June 15, 2022, and the survey on June 11, 2014 ([fig. 43](#)), indicates about 86 percent of the joint area of interest had detectable change, which means about 14 percent of the differences in the joint area of interest are equivocal and within the bounds of uncertainty ([table 8](#)). Substantial erosion appears dominant throughout most of the reach between 2014 and 2022 in the DoD, with as much as 40 ft of erosion from the area near the trough of the very large dune in the thalweg near the bridge ([fig. 43](#)). As with 2018, the change in the channel-bed elevations from the new and modified riprap blankets near piers 15 through 18 is evident in the DoD, and there is additional deposition on the right side of the channel upstream from the bridge ([fig. 43](#)). Again, there is some localized erosion between piers 17 and 18, as well as erosion downstream from piers 15 and 16 that extends to the downstream end of the reach ([figs. 41](#) and [43](#)). The average difference between the bathymetric

Figure 43. Difference between surfaces created from bathymetric surveys of the Mississippi River channel near structure A1700 on Interstate 155 near Caruthersville, Missouri, on June 15, 2022, and June 11, 2014, with probabilistic thresholding.

surfaces was -4.69 ft (table 8), indicating substantial channel degradation between the 2014 and 2022 surveys with a net loss of sediment of about $636,400$ yd³ between 2014 and 2022, which was the largest net loss of material of all the sites surveyed in 2022 (table 8). The frequency distribution of bed elevations in 2014 had been similar to 2008, with a narrower range of elevations than 2022 (fig. 40). The stone revetment on the left (southeast) bank showed localized areas of deposition, but much of the difference is equivocal (fig. 43). Deposition of as much as 15 ft at the base of the upstream left bank and on the right bank upstream from the bridge likely resulted from material added in these areas after the 2014 survey; the left bank deposition had been noted in Huizinga (2020e; fig. 43). As with previous DoDs, deposition or scour apparent on opposing faces of a feature (such as the piers and sunken barges, fig. 43) likely results from minor horizontal positional variances between the surveys (fig. 6).

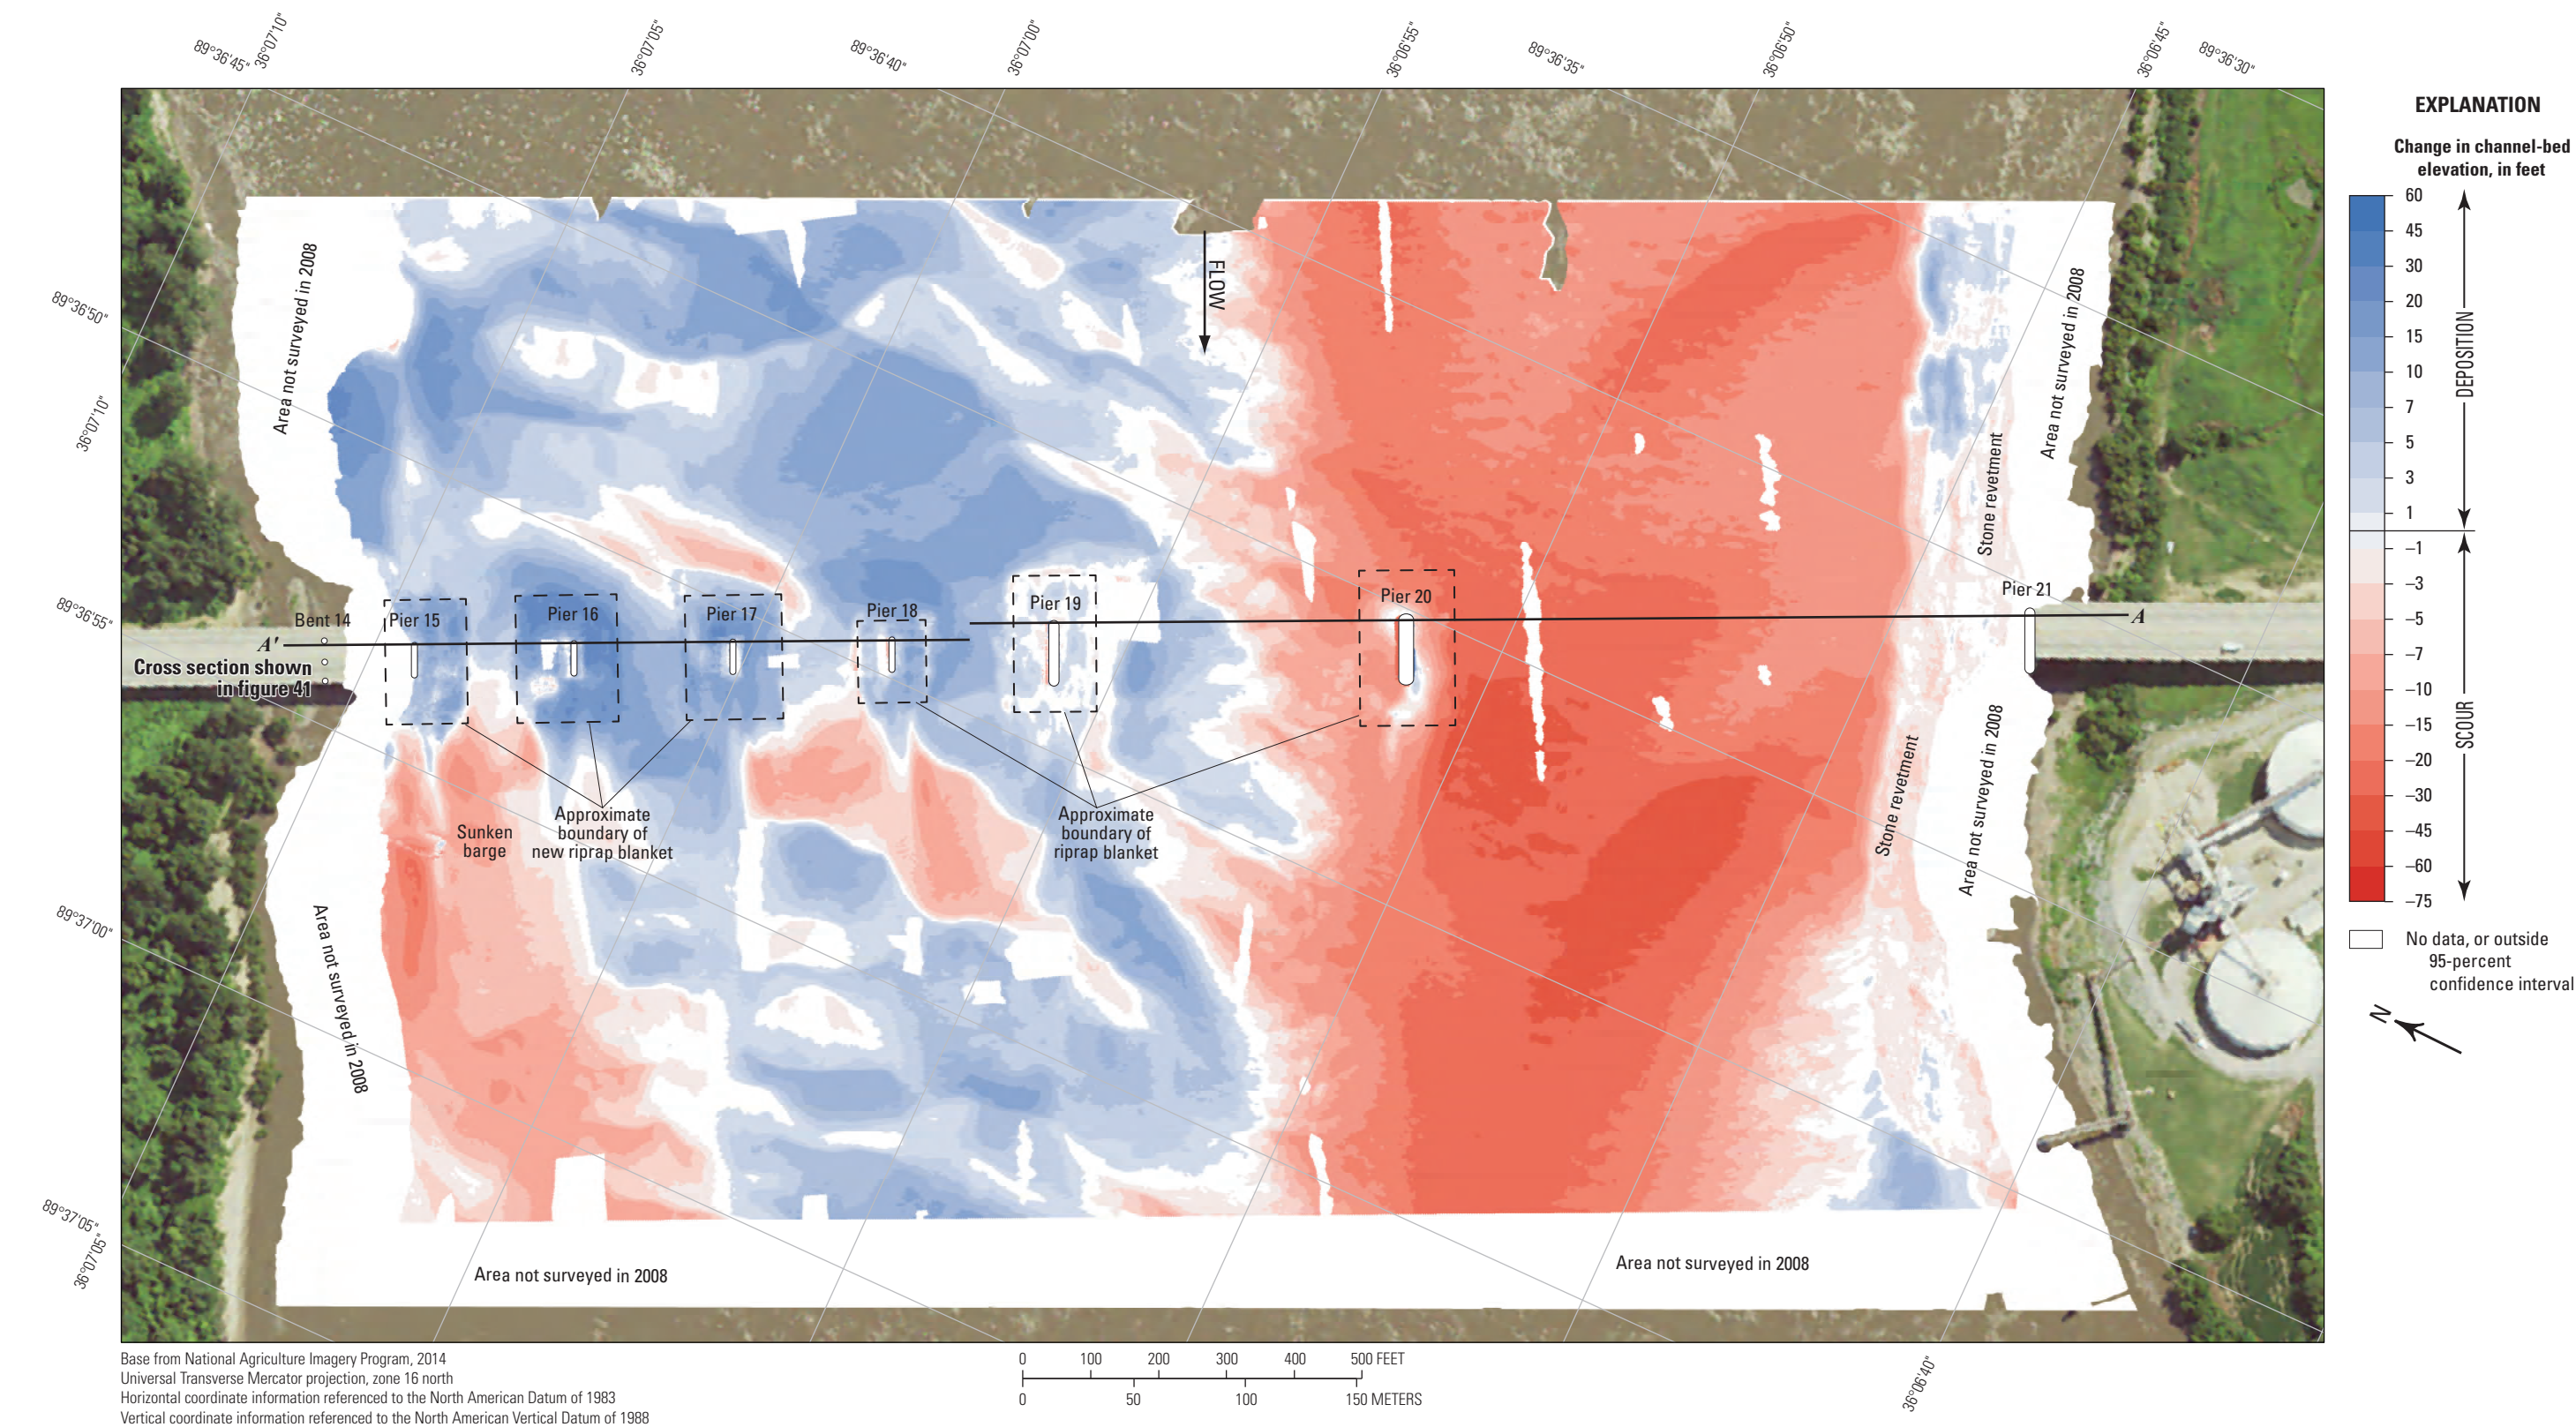
The difference between the survey on June 15, 2022, and the earliest survey on December 10, 2008 (fig. 45), indicates about 91 percent of the joint area of interest had detectable change, which means only about 9 percent of the differences in the joint area of interest are equivocal and within the bounds of uncertainty (table 8). Substantial erosion appears dominant throughout most of the reach between 2008 and 2022 in the DoD, with as much as 40 ft of erosion from the area near the trough of the very large dune in the thalweg near the bridge and erosion along the toe of the right bank downstream from piers 15 and 16 (fig. 45). The average difference between the 2008 and 2022 bathymetric surfaces was -5.47 ft (table 8), which was the largest negative average change and indicated substantial channel degradation with a net loss of sediment between 2008 and 2022 of about $636,300$ yd³ (table 8). This average difference was very similar to 2014 and was the second largest net loss of material of all the sites surveyed in 2022. The frequency distribution of bed elevations in 2008 also was similar to 2014, with a narrower range of elevations than 2022 (fig. 40). The stone revetment on the left (southeast) bank showed localized areas of moderate erosion and deposition (fig. 45). As noted in the preceding paragraphs, substantial deposition at the base of the upstream left bank likely results from material added in that area after the 2014 survey; however, much of the apparent erosion and deposition likely results from minor horizontal positional variances between the surveys, particularly because an SBET correction was not used in this earliest survey (refer to the “Uncertainty Estimation” section; fig. 6).

Figure 45. Difference between surfaces created from bathymetric surveys of the Mississippi River channel near structure A1700 on Interstate 155 near Caruthersville, Missouri, on June 15, 2022, and December 10, 2008, with probabilistic thresholding.

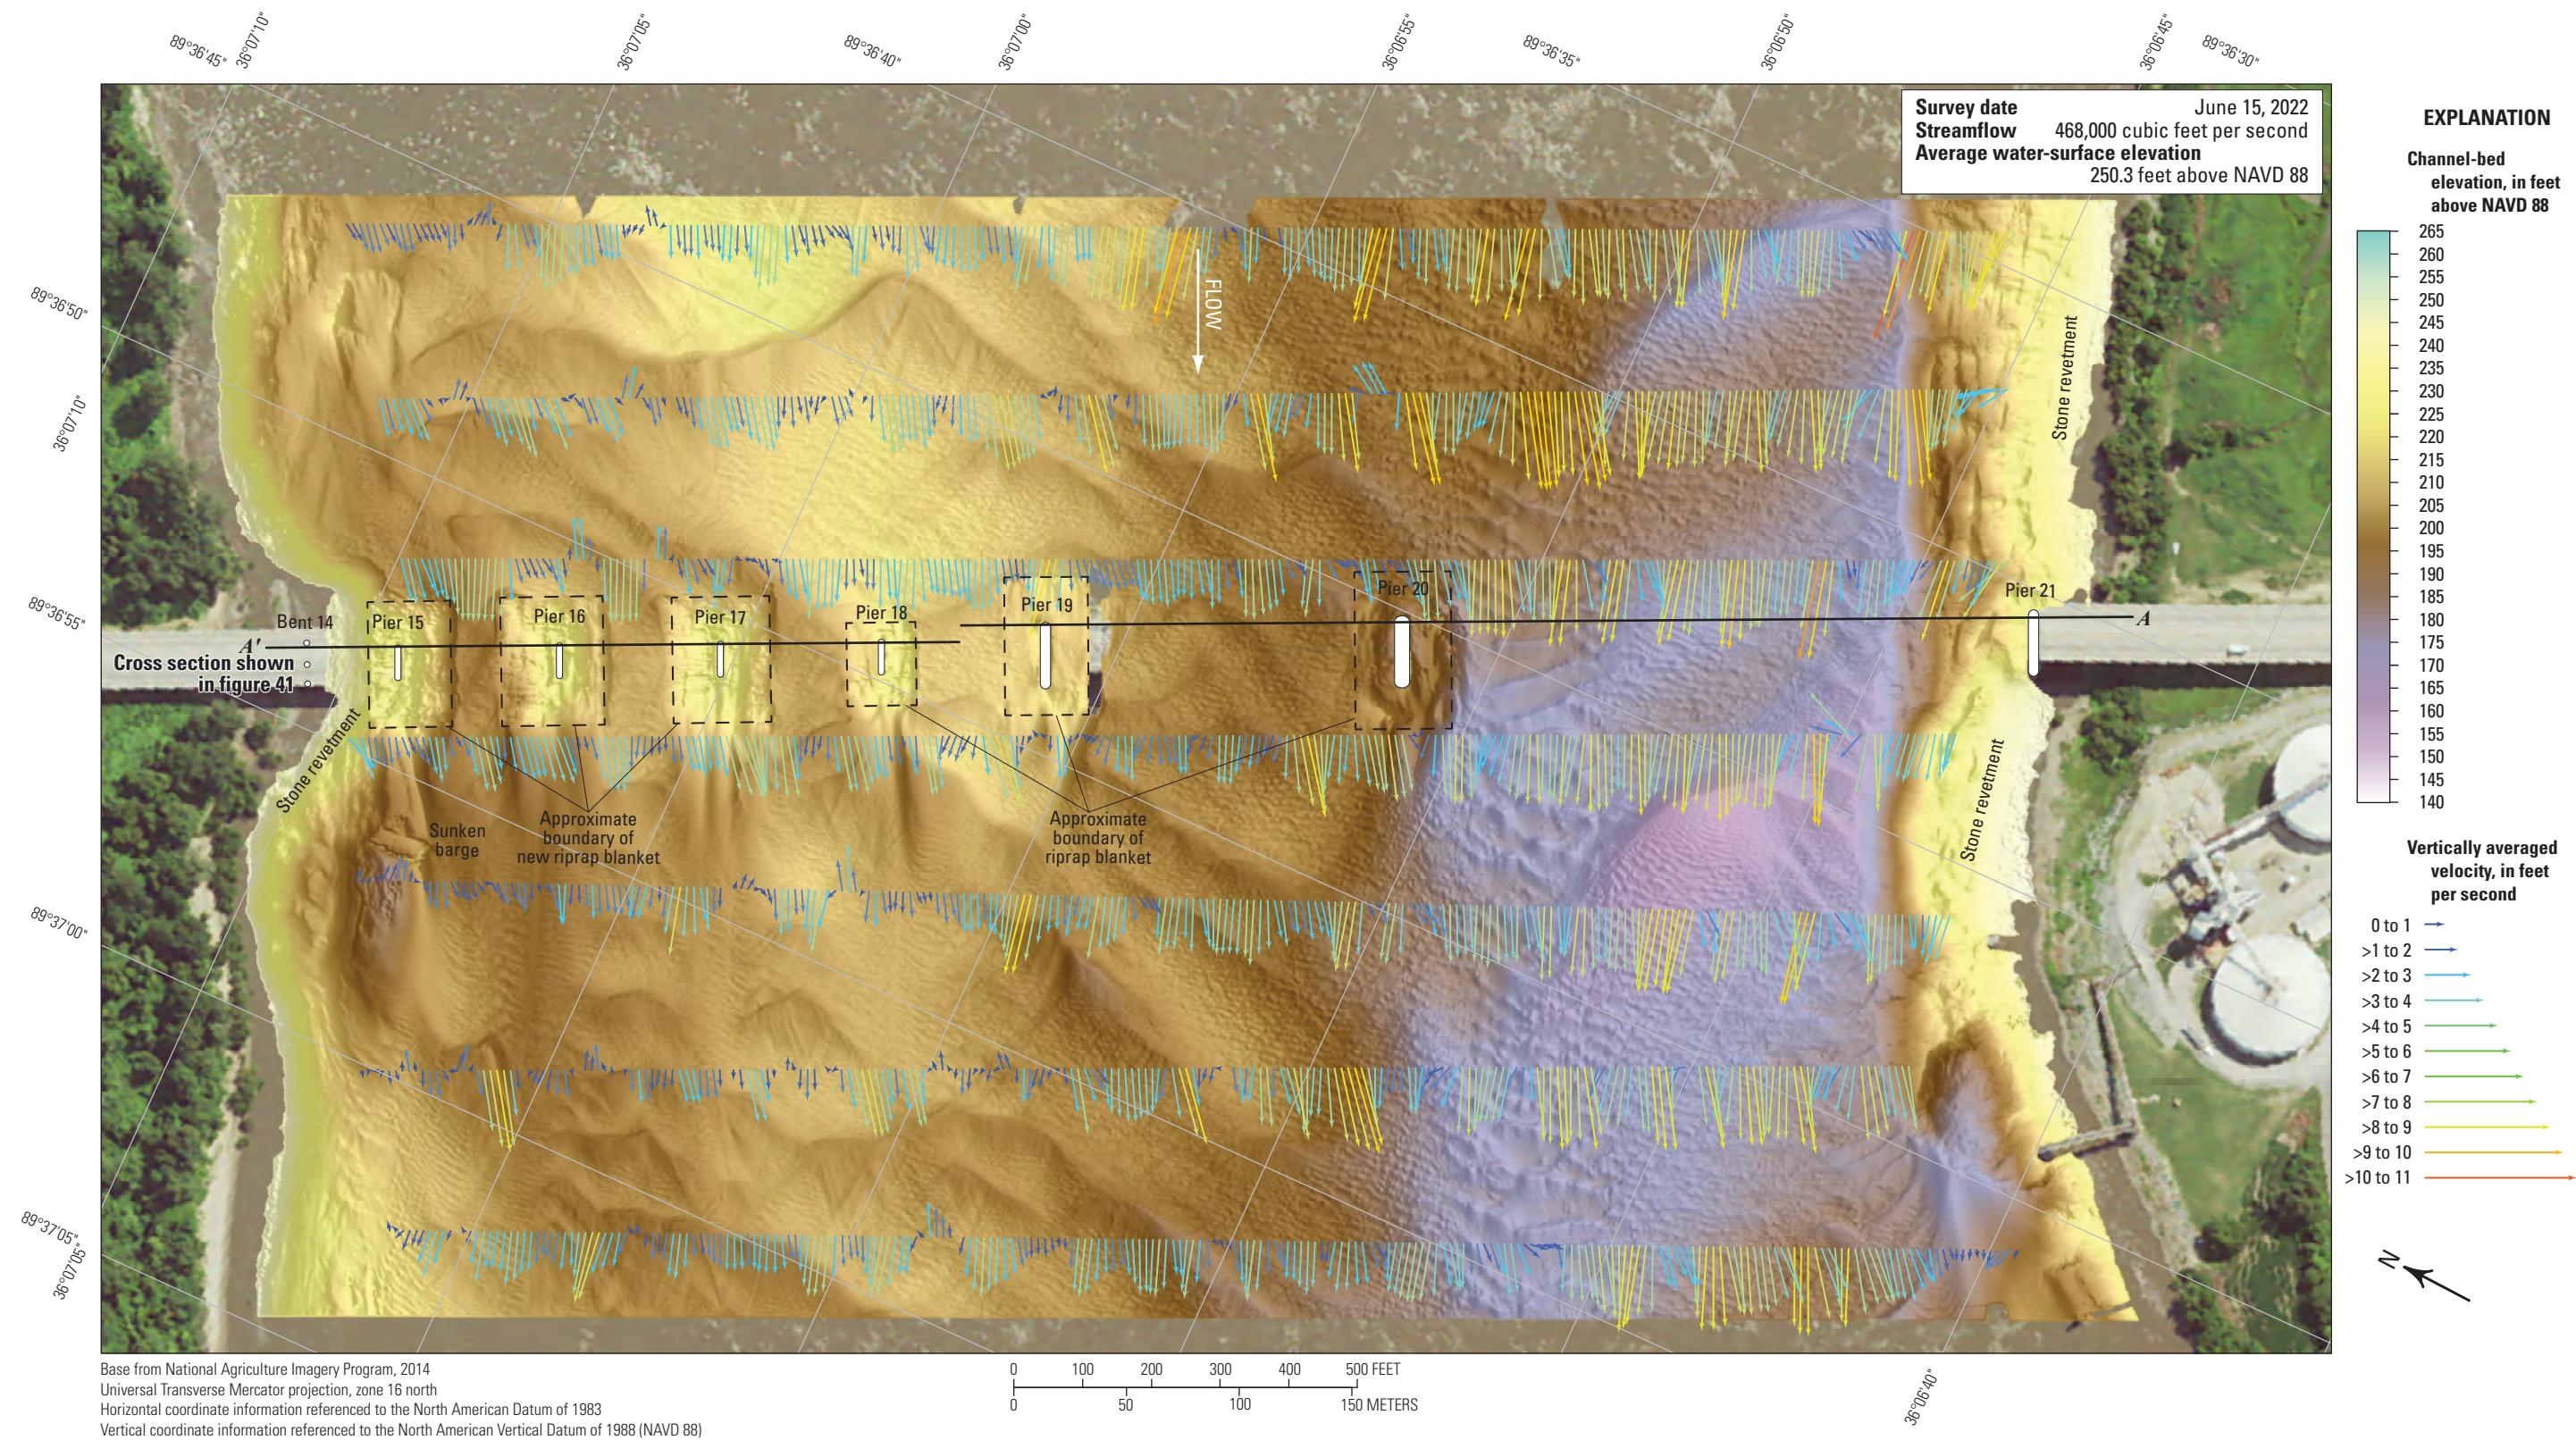
The vertically averaged velocity vectors indicate substantial variability of flow throughout the channel at this site (fig. 46). Velocities ranged from about 2 to 10 ft/s, with locally lower velocities and flow reversal in numerous locations along the banks, downstream from the bank constrictions near the bridge, and downstream from the piers. The new riprap blankets near piers 15 through 17 appear to cause localized flow disturbances upstream, downstream, and between the piers (fig. 46). Additional flow disturbance may result from upwelling of flow caused by the numerous medium to large dune features present throughout the channel (Best, 2005; fig. 46).

Figure 46. Bathymetry and vertically averaged velocities of the Mississippi River channel near structure A1700 on Interstate 155 near Caruthersville, Missouri.

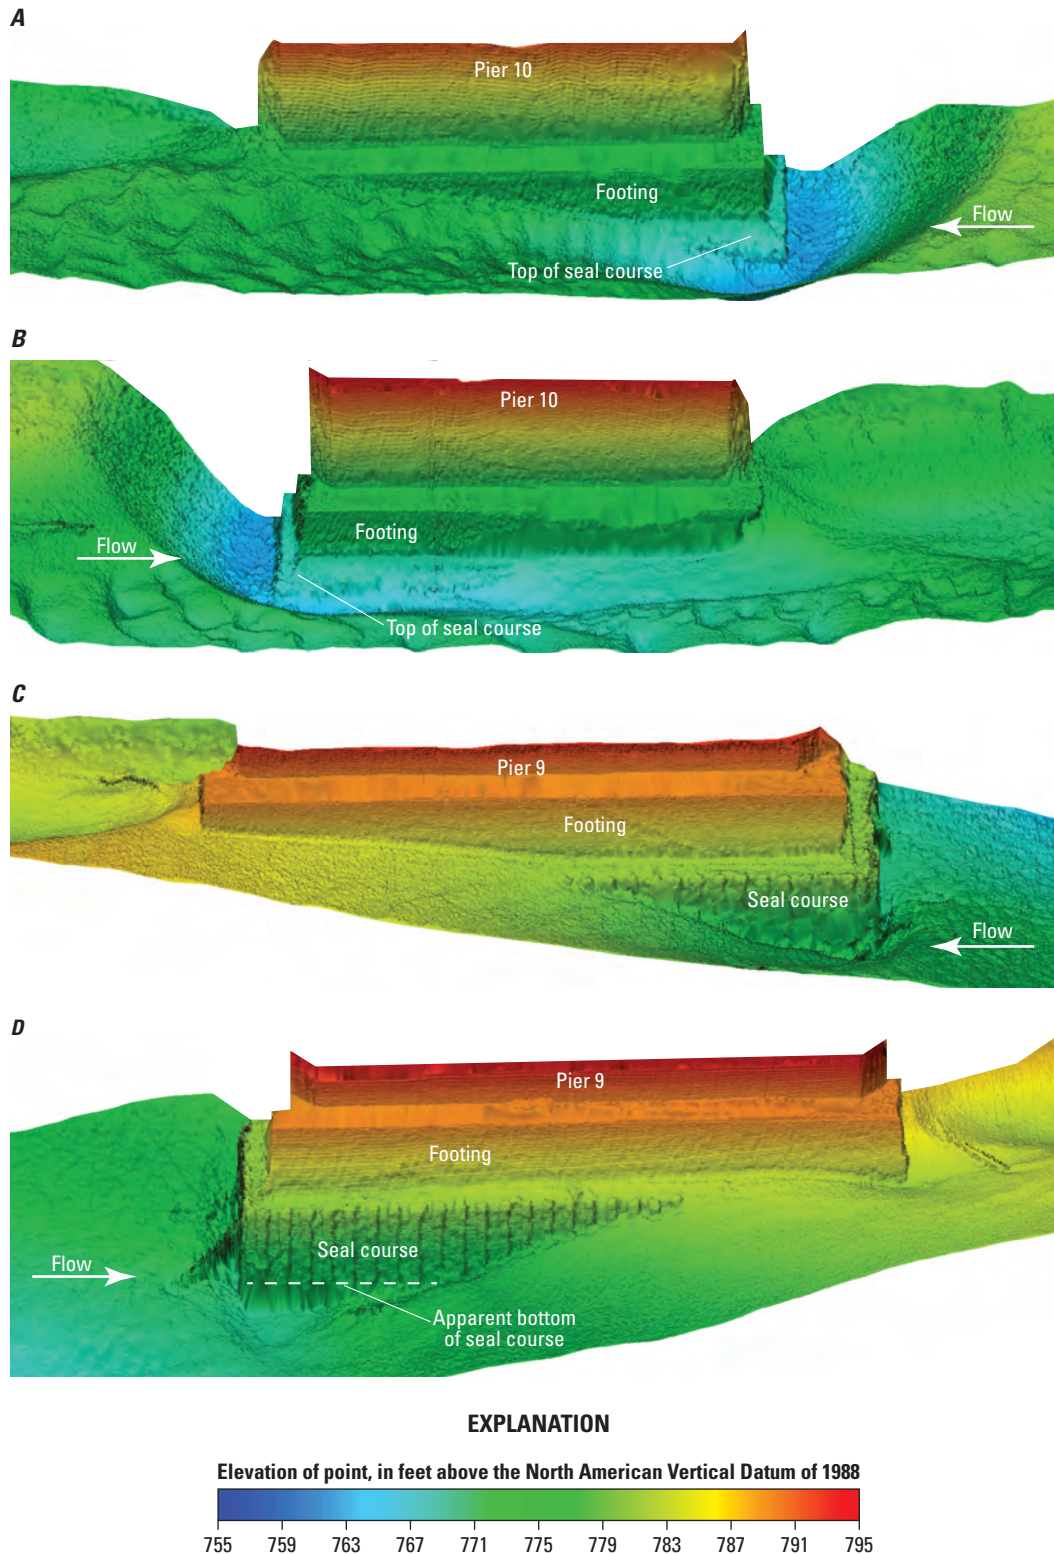
Figure 1.2. Shaded triangulated irregular network visualization of the channel bed and piers of dual bridge structure A3664 on U.S. Highway 36 over the Missouri River at St. Joseph, Missouri. *A*, Left (east) side of pier 10. *B*, Right (west) side of pier 10. *C*, Left (east) side of pier 9. *D*, Right (west) side of pier 9. (Note: point cloud data for pier 8 were too sparse to create a visualization).

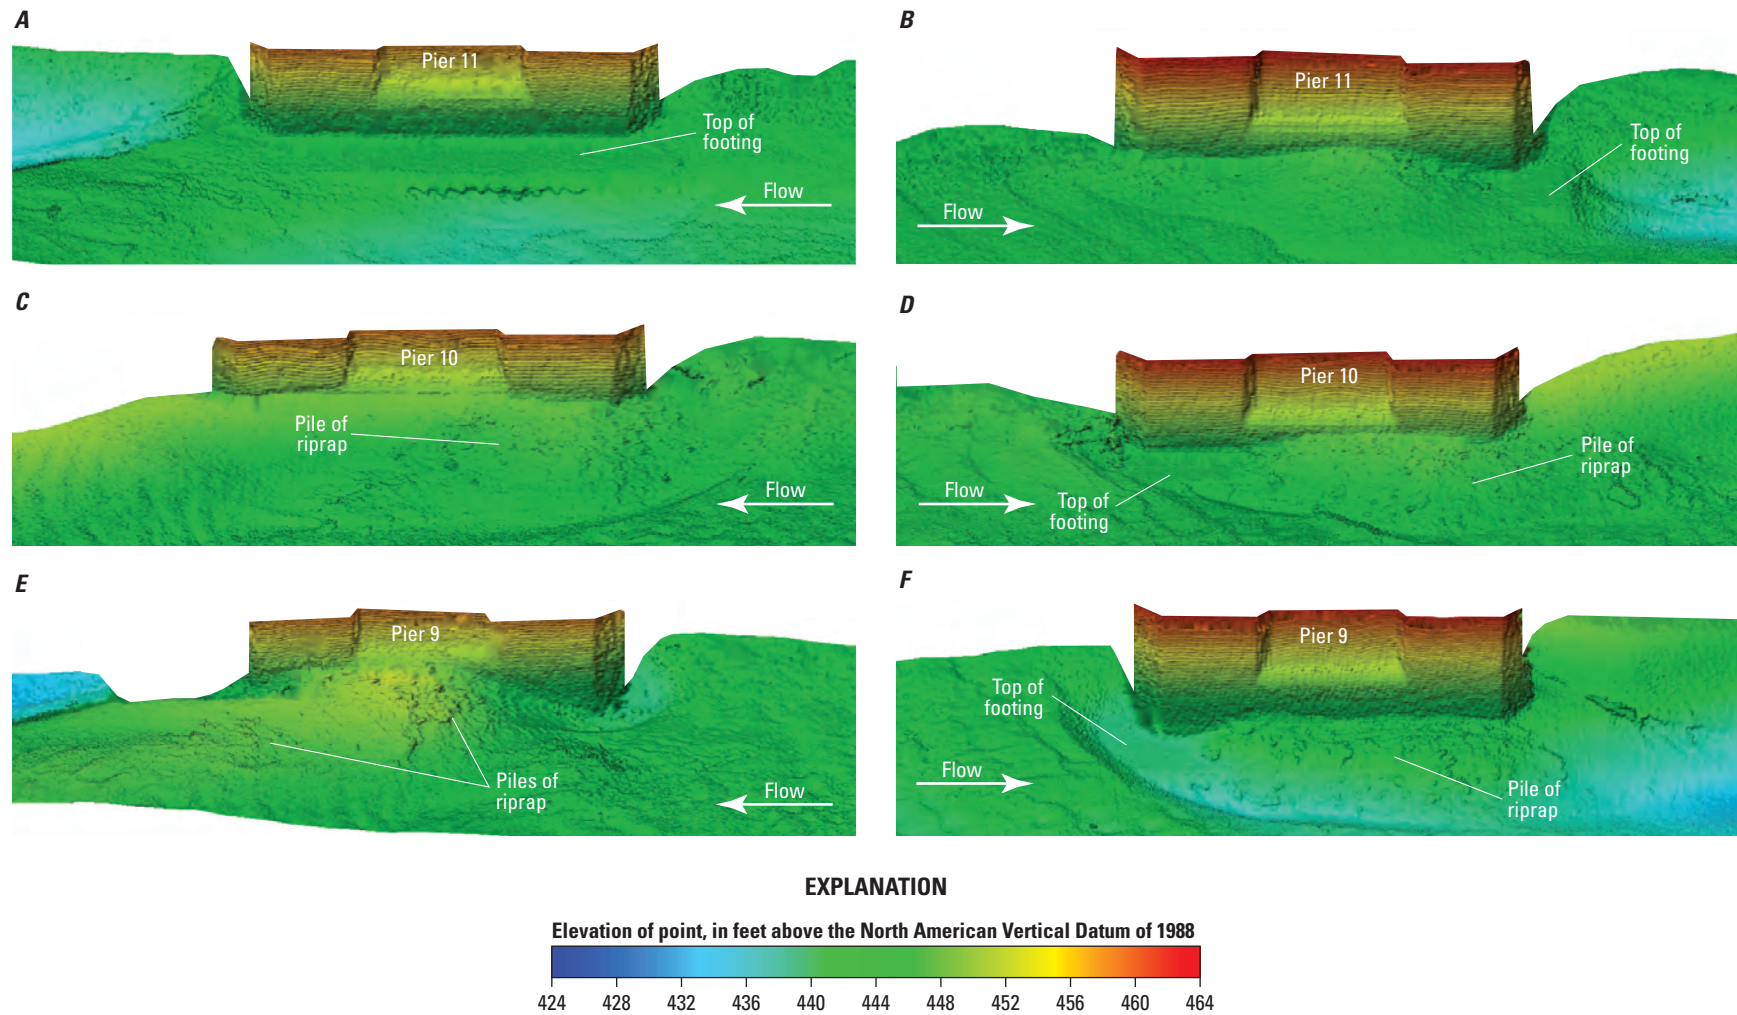
Figure 1.3. Shaded triangulated irregular network visualization of the channel bed and left main channel piers of structure A5054 on Interstate 72 over the Mississippi River at Hannibal, Missouri. *A*, Left (northeast) side of pier 11. *B*, Right (southwest) side of pier 11. *C*, Left (northeast) side of pier 10. *D*, Right (southwest) side of pier 10. *E*, Left (northeast) side of pier 9. *F*, Right (southwest) side of pier 9.
