Bathymetric and Velocimetric Surveys at Highway Bridges Crossing the Missouri and Mississippi Rivers on the Periphery of Missouri, June 13–22, 2022

Scientific Investigations Report 2024–5032

By Richard J. Huizinga

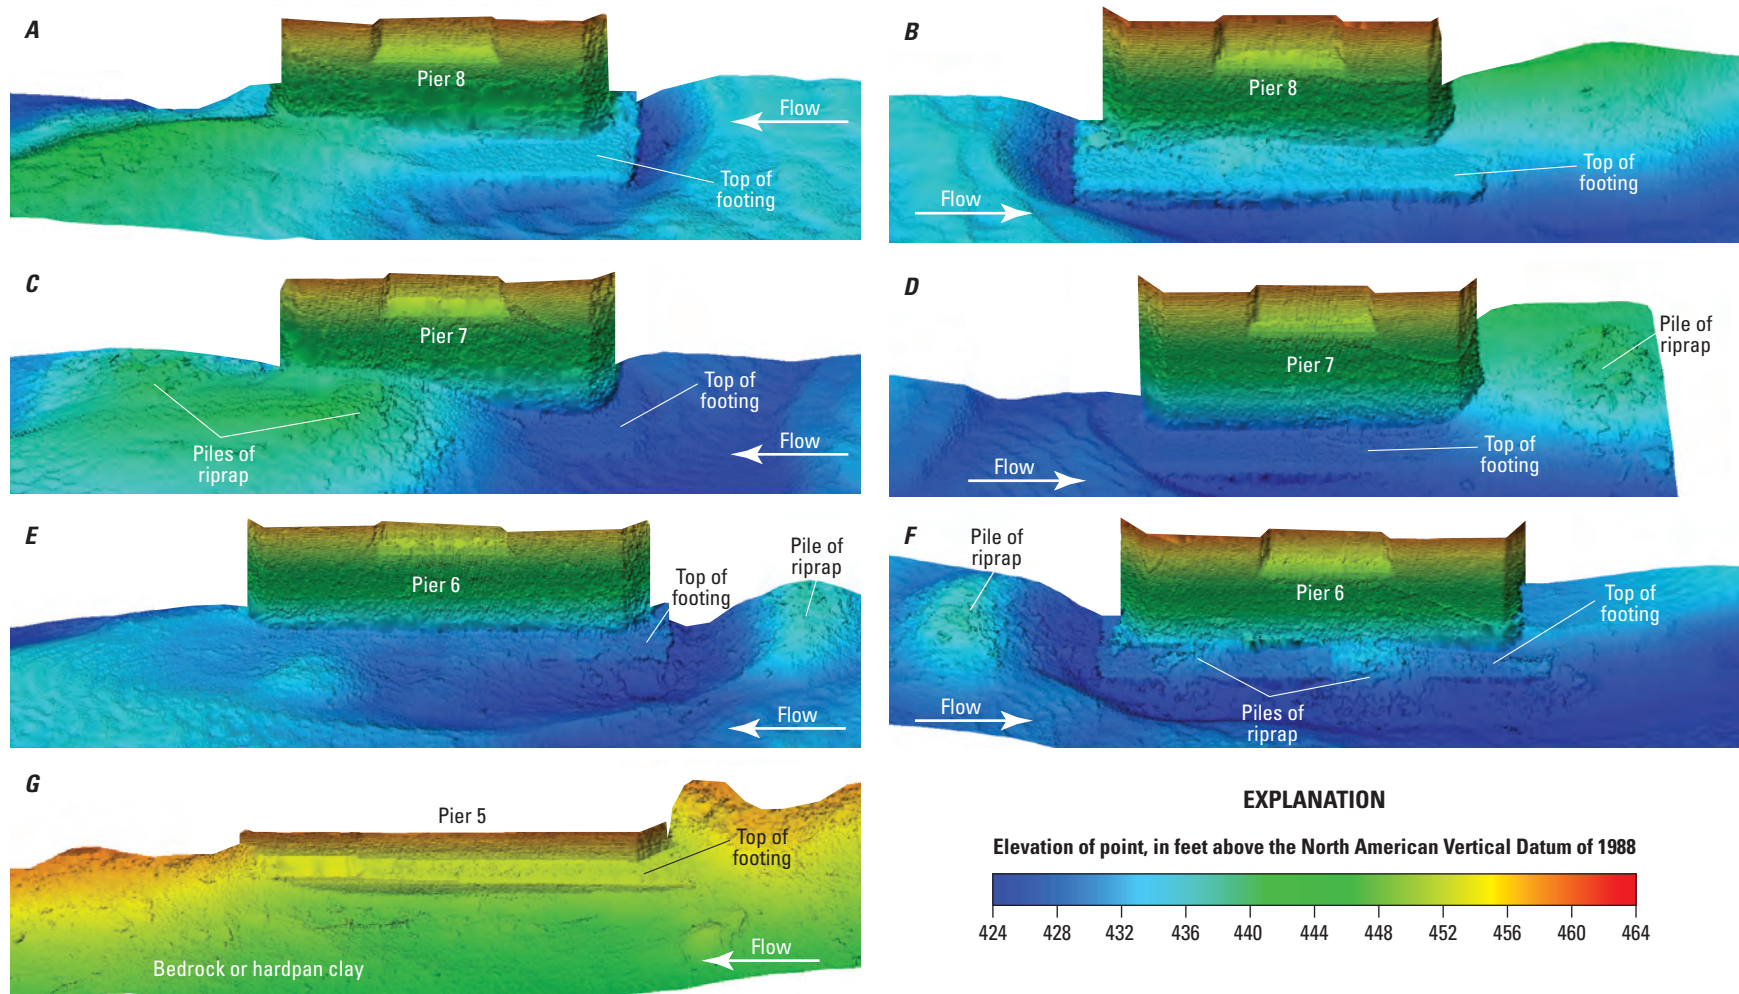
Figure 1.4. Shaded triangulated irregular network visualization of the channel bed and right main channel piers of structure A5054 on Interstate 72 over the Mississippi River at Hannibal, Missouri. *A*, Left (northeast) side of pier 8. *B*, Right (southwest) side of pier 8. *C*, Left (northeast) side of pier 7. *D*, Right (southwest) side of pier 7. *E*, Left (northeast) side of pier 6. *F*, Right (southwest) side of pier 6. *G*, Left (northeast) side of pier 5.

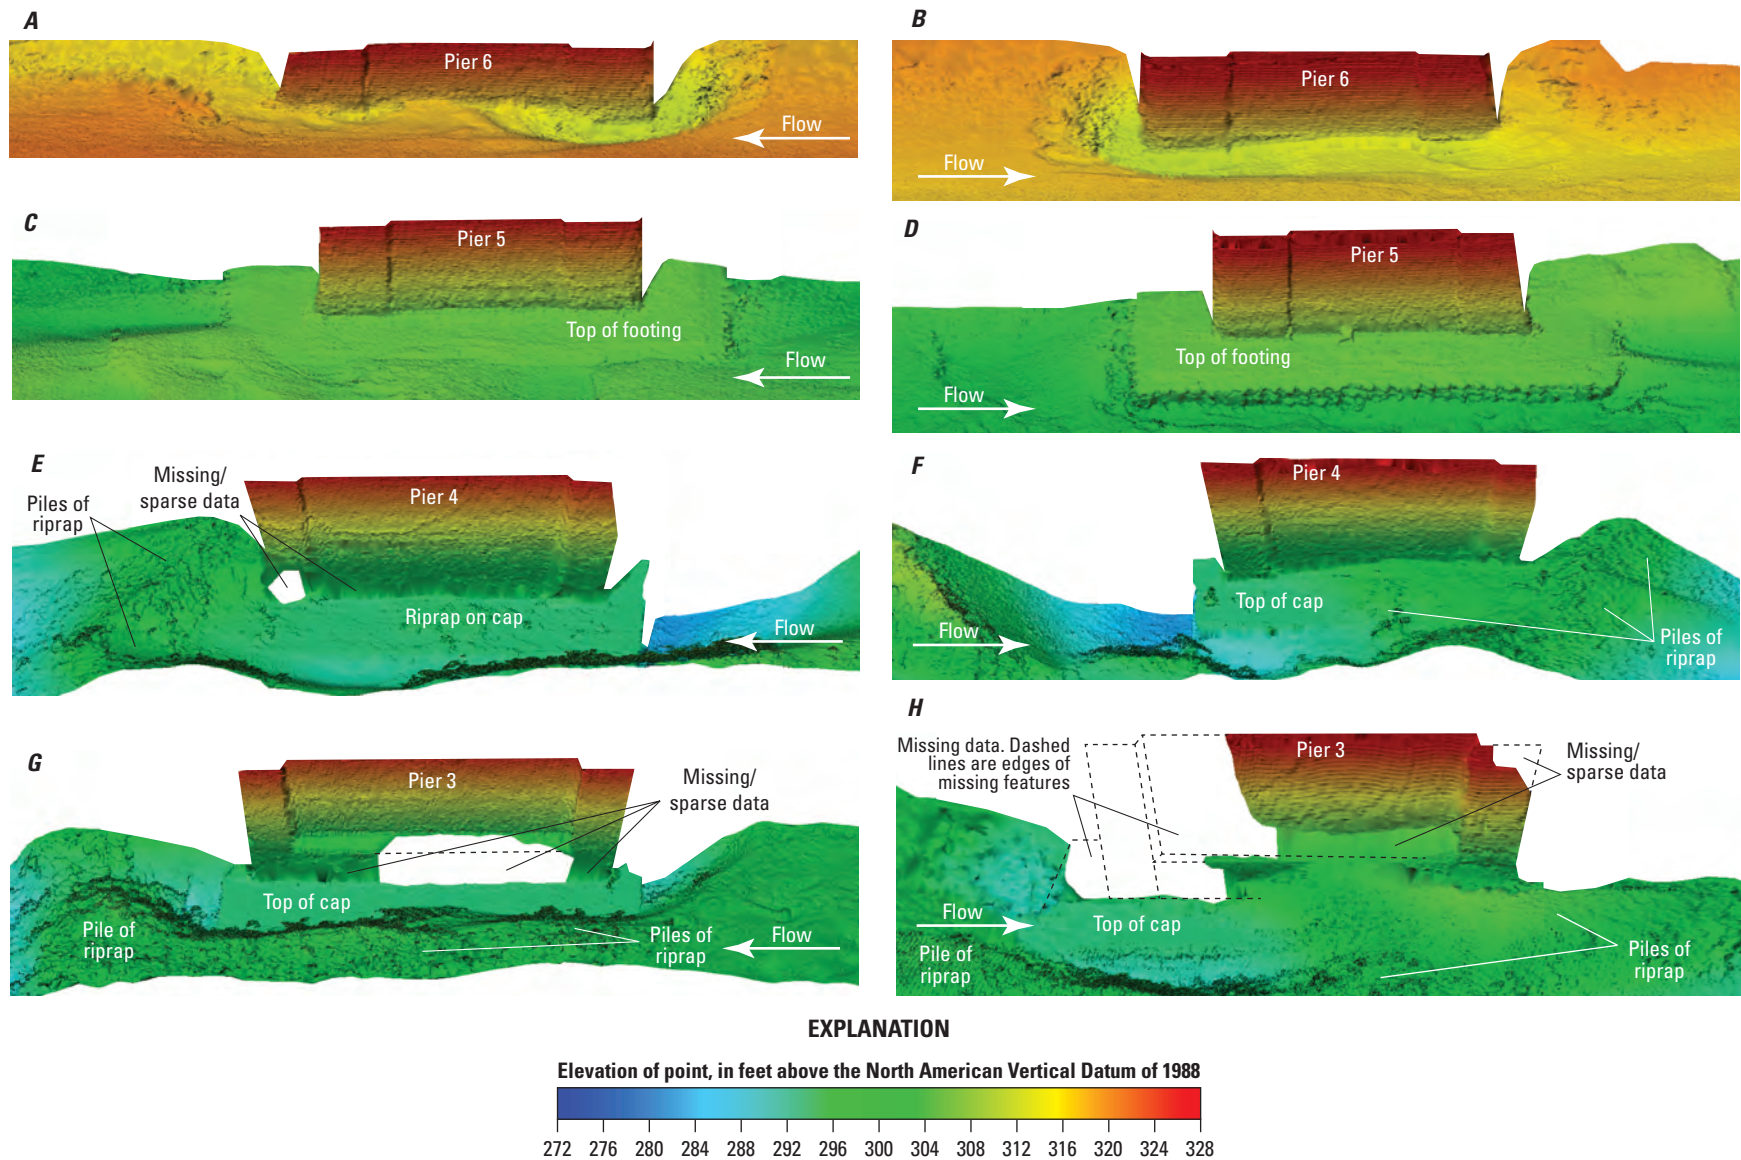
As in previous surveys, piers 3 and 4 seemed to be partially surrounded by piles of riprap or rock ([figs. 33, 1.6E–H](#)). Scour downstream from the piers in 2022 reached a minimum elevation of 264 ft near pier 3 ([table 7](#); [fig. 33](#)) and 270 near pier 4 ([fig. 33](#)). A poorly defined, minor scour hole difficult to discern from nearby ripples existed near pier 5 ([figs. 33, 1.6D](#)), having a minimum channel-bed elevation of about 300 ft ([table 7](#)). A minor scour hole also existed near pier 6 ([figs. 33, 1.6A–B](#)). The top of the footing was visible at pier 5, and the top of the distribution cap was visible at piers 3 and 4 ([figs. 33, 1.6C–H](#)). The minimum channel-bed elevation near pier 5 is about 15 ft above the elevation of the bottom of the pier seal course of 285.00 ft, and the minimum channel-bed elevation near pier 6 is about 20 ft above the elevation of the bottom of the pier seal course of 292.00 ft ([fig. 35](#); [table 7](#)). Information from bridge plans indicates that piers 3 and 4 are founded on caissons on bedrock, having about 14 ft of bed material between the bottom of the scour hole and bedrock at pier 3, and 38 ft of material at pier 4 ([fig. 35](#); [table 7](#)). Piers 5 through 7 are founded on shafts drilled as much as 22 ft into bedrock, having about 56 ft of bed material between the bottom of the scour hole and bedrock at pier 5, and about 67 ft of material at pier 6 ([fig. 35](#); [table 7](#)). The exposed tops of the footing and distribution caps at piers 3 through 5 ([figs. 33 and 35](#)) might

Figure 1.6. Shaded triangulated irregular network visualization of the channel bed and main channel piers of structure A5076 on State Highway 34 over the Mississippi River at Cape Girardeau, Missouri. *A*, Left (east) side of pier 6. *B*, Right (west) side of pier 6. *C*, Left (east) side of pier 5. *D*, Right (west) side of pier 5. *E*, Left (east) side of pier 4. *F*, Right (west) side of pier 4. *G*, Left (east) side of pier 3. *H*, Right (west) side of pier 3.

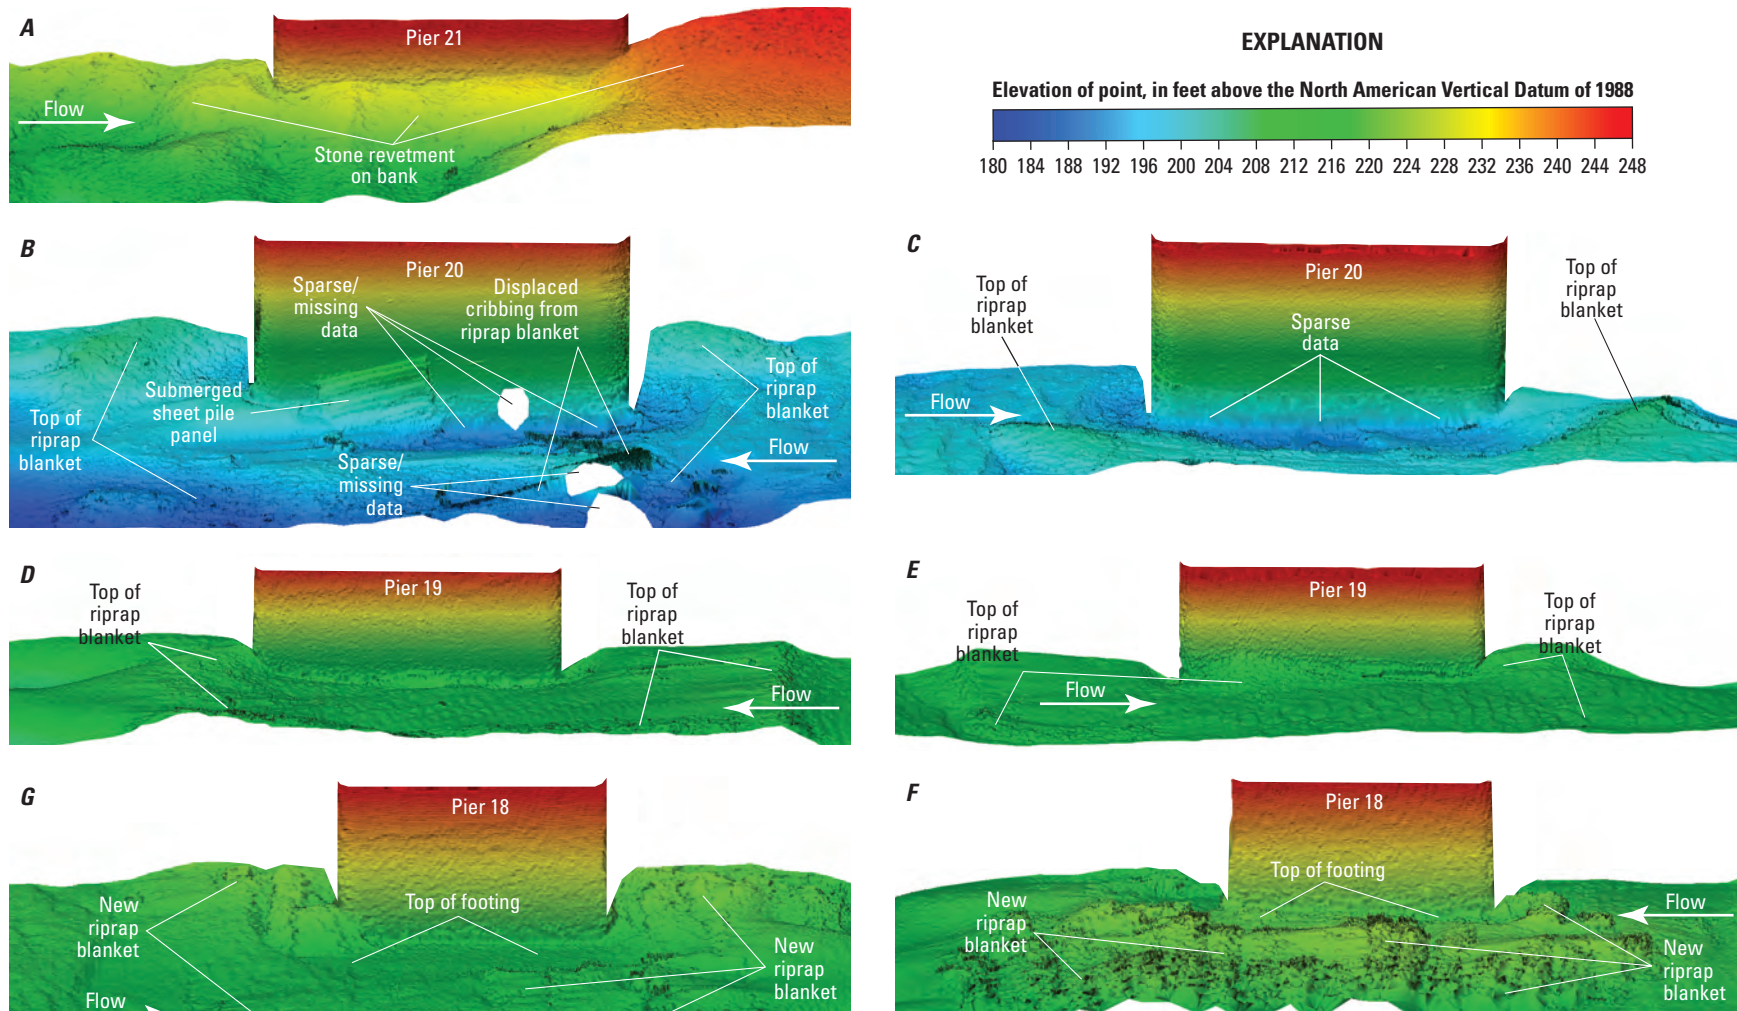
Figure 1.7. Shaded triangulated irregular network visualization of the channel bed and left main channel piers of structure A1700 on Interstate 155 over the Mississippi River near Caruthersville, Missouri. *A*, Right (northwest) side of pier 21. *B*, Left (southeast) side of pier 20. *C*, Right (northwest) side of pier 20. *D*, Left (southeast) side of pier 19. *E*, Right (northwest) side of pier 19. *F*, Left (southeast) side of pier 18. *G*, Right (northwest) side of pier 18.

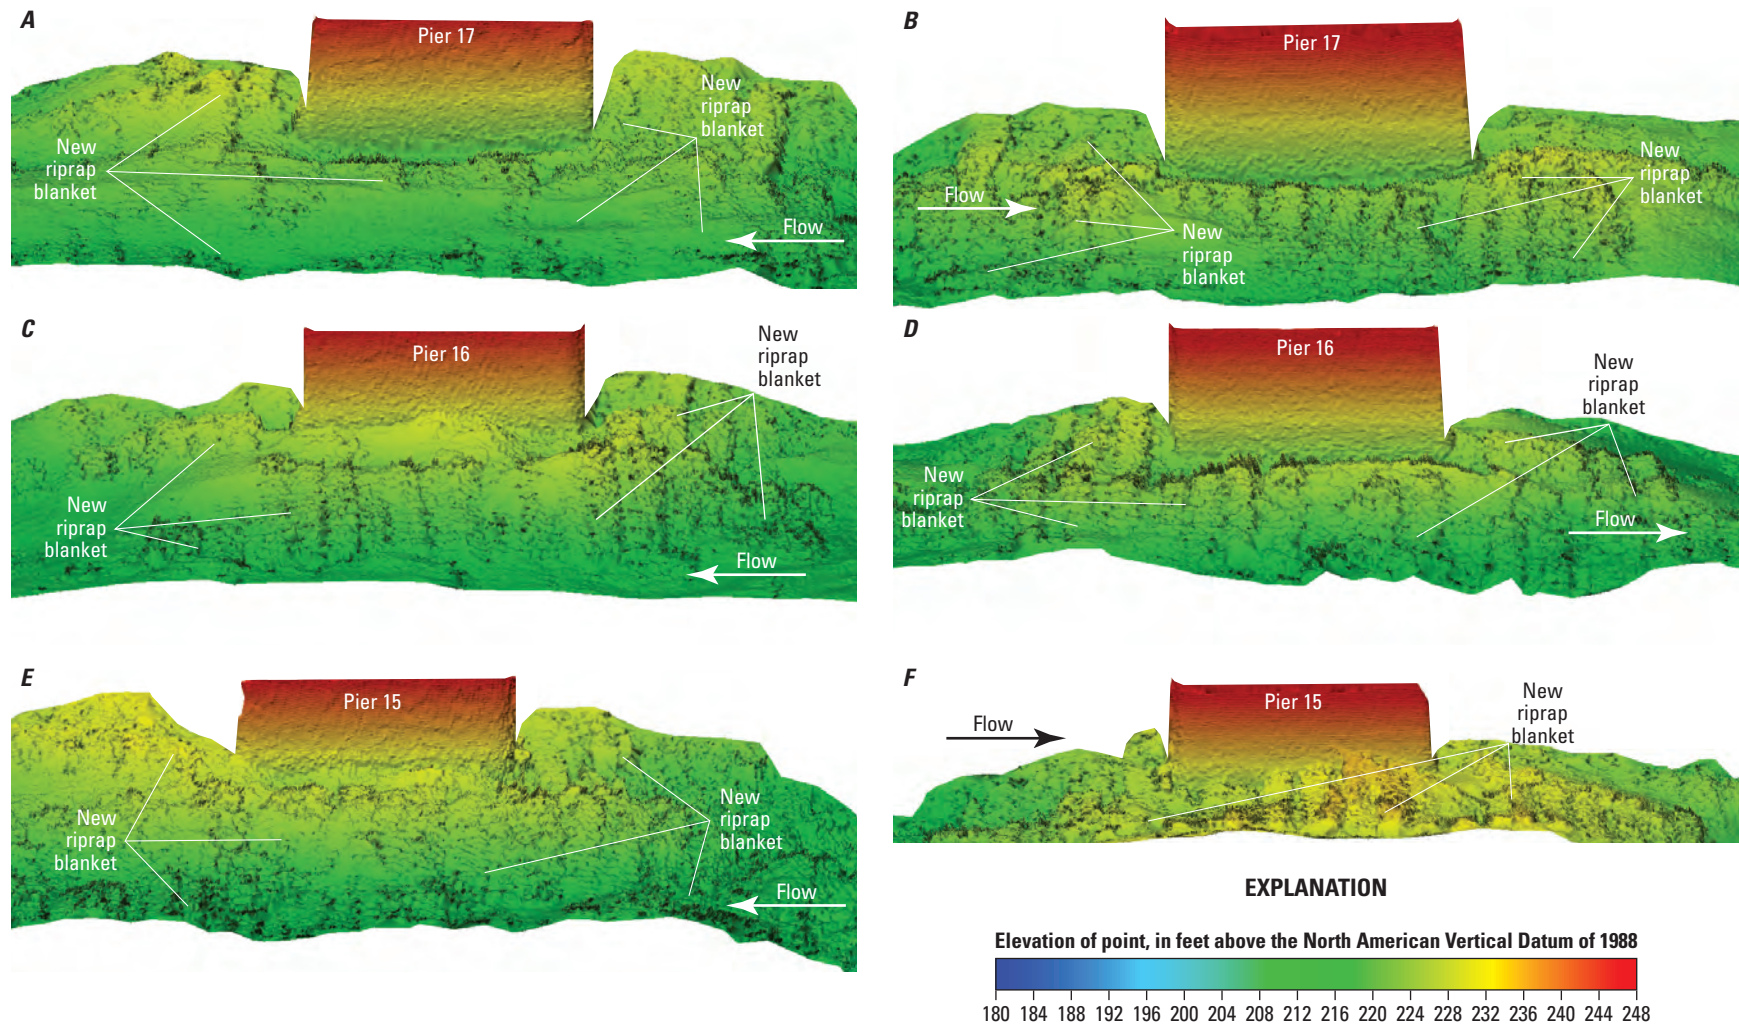
New riprap blankets were observed at pier 3 of structure L0098 at Brownville, Nebr. (site 1), and piers 15–18 of structure A1700 near Caruthersville, Mo. (site 38). The presence of these features had a substantial effect on the observed scour and velocities at and near a given pier, particularly compared to elevations from previous surveys at these sites. Several other piers seemed partially surrounded by random piles of riprap or rock, which may or may not help mitigate scour near those piers. Piers 9 and 10 of structure A5054 at Hannibal, Mo. (site 31), have hummocks on either side that may be partial riprap blankets, and piers 3 and 4 of structure A5076 at Cape Girardeau, Mo. (site 37), seemed to be partially surrounded with piles of coarse material. However, the effectiveness of the scour mitigation is uncertain because the placement seems random and nonuniform.

Figure 1.8. Shaded triangulated irregular network visualization of the channel bed and right main channel piers of structure A1700 on Interstate 155 over the Mississippi River near Caruthersville, Missouri. *A*, Left (southeast) side of pier 17. *B*, Right (northwest) side of pier 17. *C*, Left (southeast) side of pier 16. *D*, Right (northwest) side of pier 16. *E*, Left (southeast) side of pier 15. *F*, Right (northwest) side of pier 15.
