CHANNEL EROSION SURVEYS ALONG TAPS ROUTE, ALASKA, 1974

UNITED STATES DEPARTMENT OF THE INTERIOR
GEOLOGICAL SURVEY

Joseph M. Childers and Stanley H. Jones

OPEN-FILE REPORT

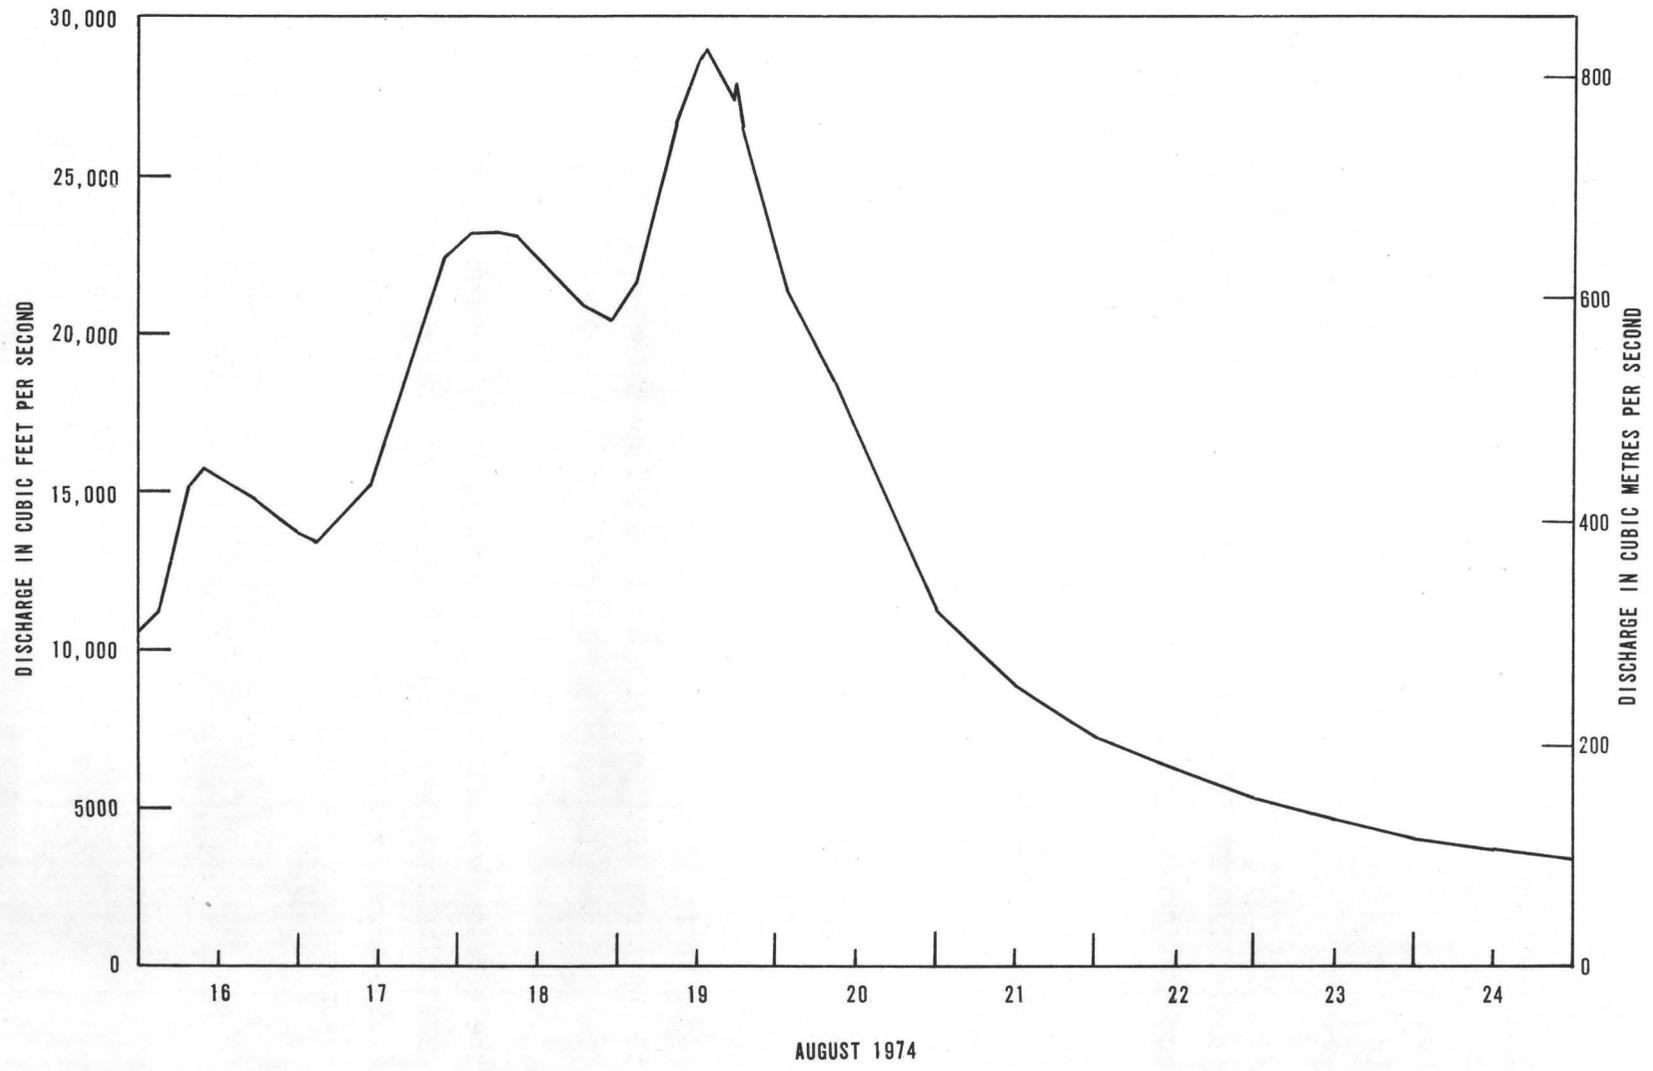
Figure 5.-- Discharge hydrograph for Sagavanirktok River near Sagwon.

Floods.--No significant overbank floods occurred during the period of the erosion investigation October 17, 1969, through September 6, 1974. The maximum observed discharge for the period, 28,900 ft³/s (818 m³/s) (fig. 5), was confined to the main channel far below the maximum evident flood and bankfull stage.

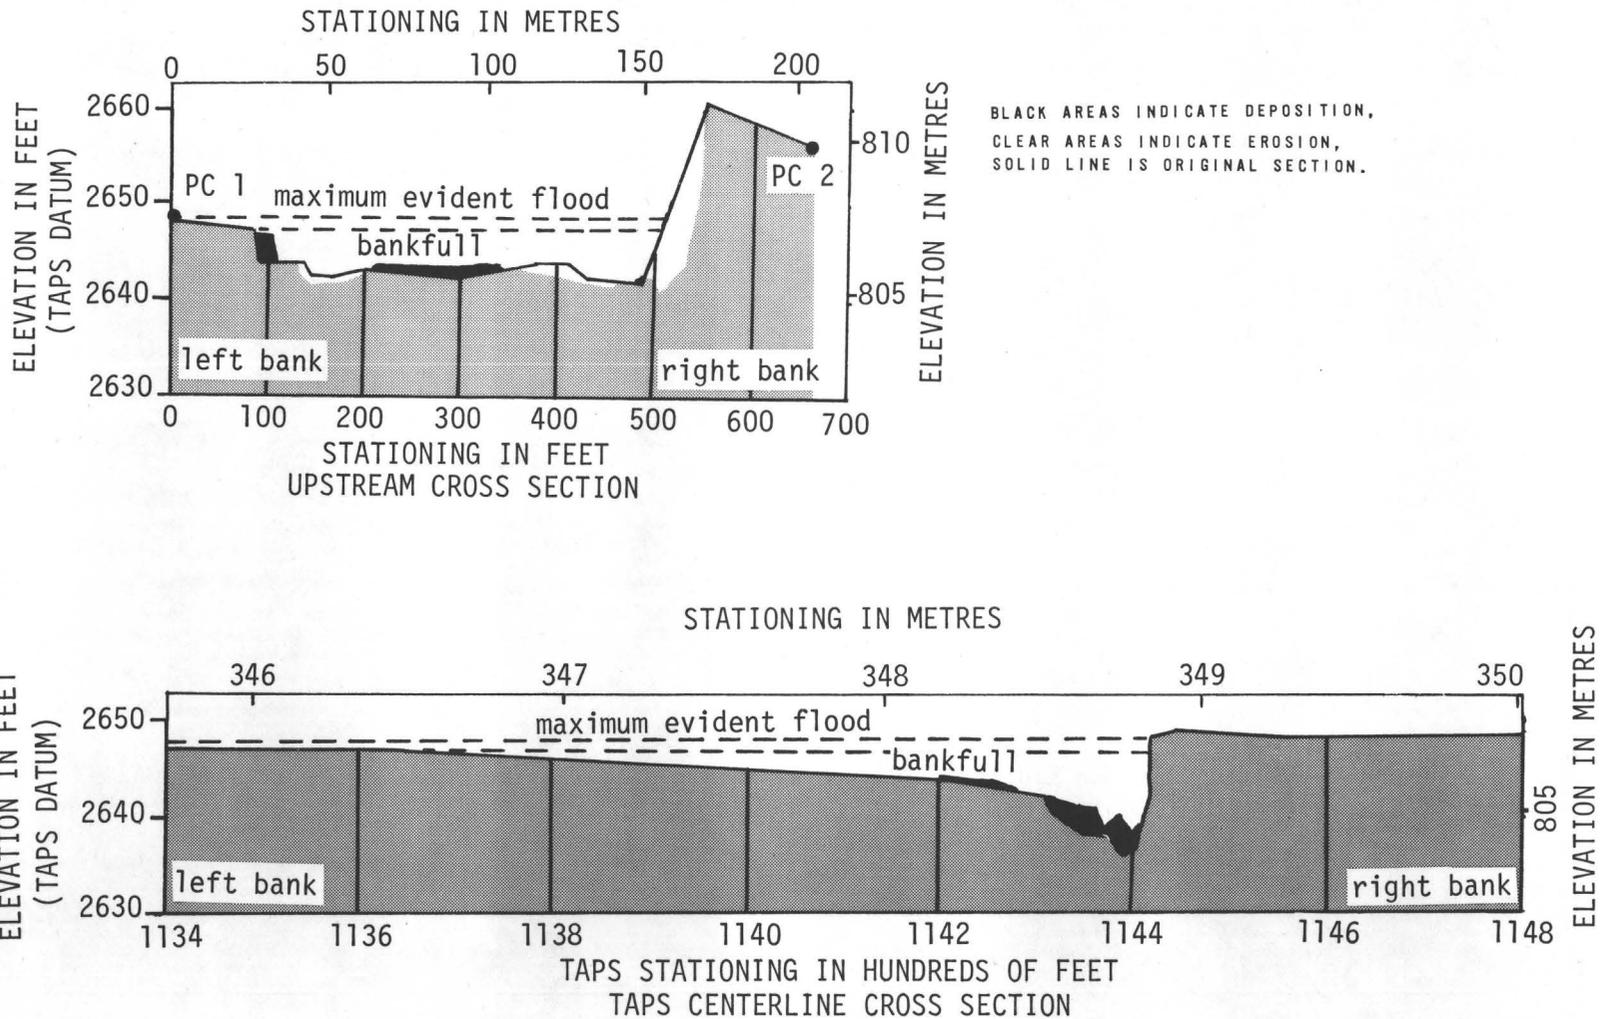
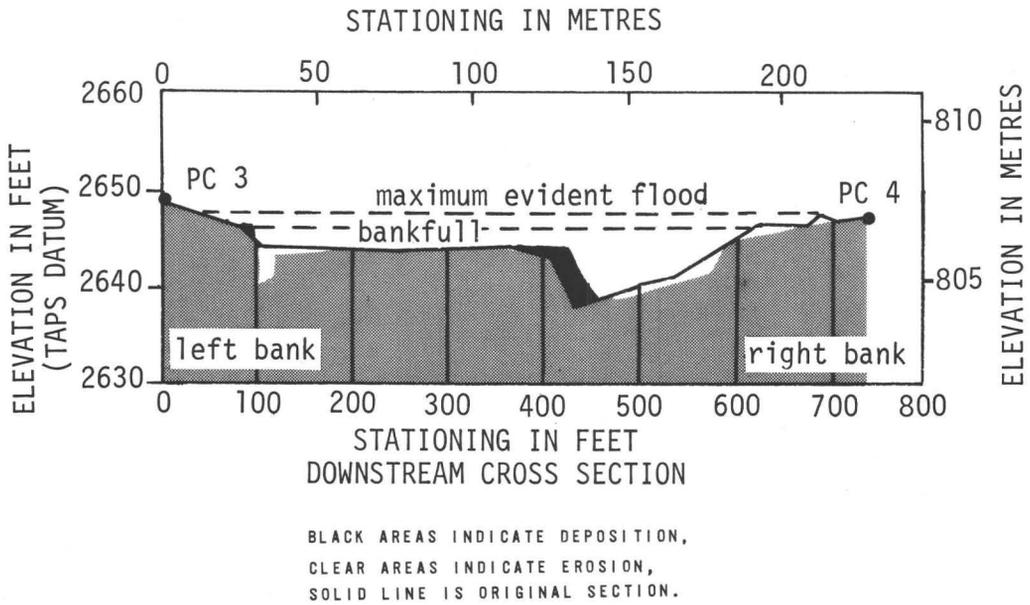
Figure 8.-- Cross sections of Atigun River near Galbraith Lake, July 31, 1971 and September 6, 1974.

Channel conditions.--High-altitude vertical aerial stereophotography (scale 1:24,000) was obtained October 17, 1969, (fig. 6) to document preconstruction topography at the site. Vertical aerial stereophotography (scale 1:6,000) taken August 24, 1974, (fig. 7) shows lateral bank erosion of 20 ft (6 m) along the right bank of the upstream section and a small overflow channel has developed along the left bank of the downstream section. No significant erosion has occurred in the TAPS centerline section. There was no construction activity in the crossing reach since October 17, 1969. Three cross sections (fig. 8) were surveyed July 31, 1971, to define preconstruction ground profiles in the crossing reach. On September 6, 1974, a channel survey of the three cross sections found 20 ft (6 m) of lateral bank erosion along the right bank of the upstream section and a small overflow channel about 4 ft (1 m) deep has developed along the left bank of the downstream section.

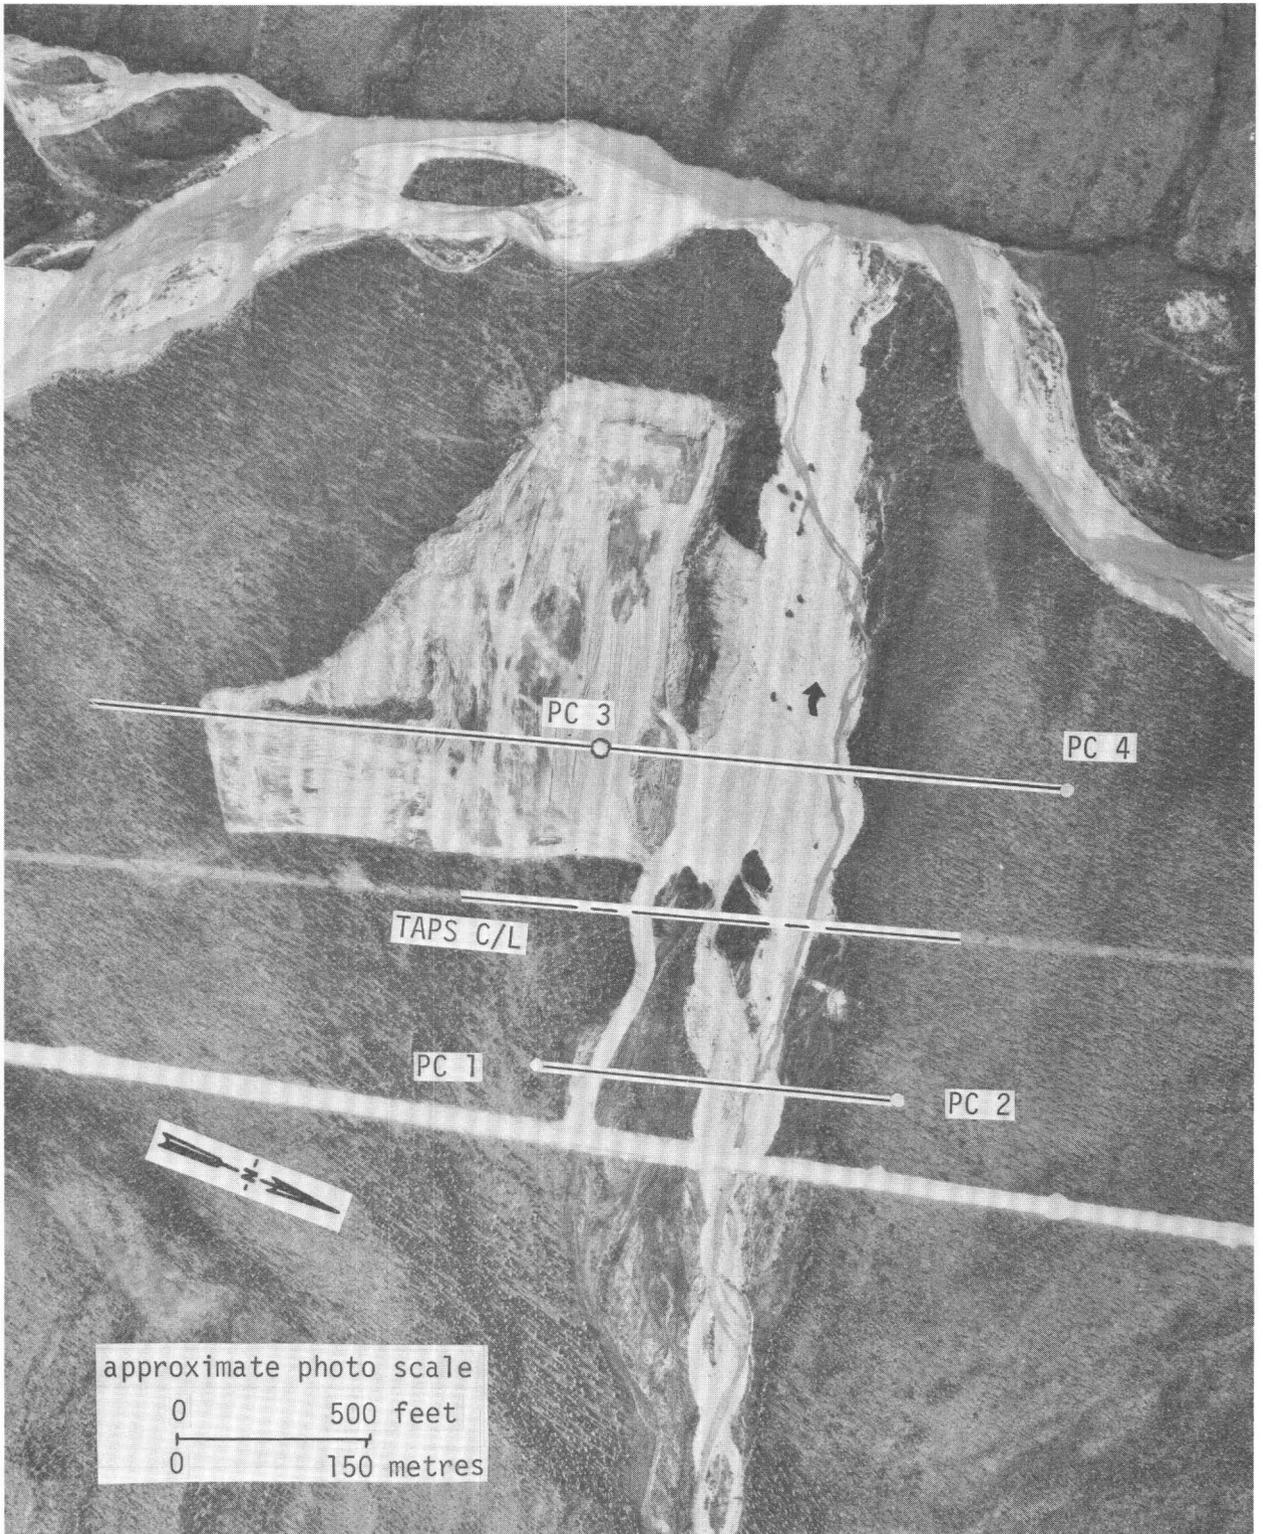
Figure 11. -- Snowden Creek near Dietrich Camp, August 6, 1974.
AIR PHOTO TECH.

Channel conditions.--Low-altitude vertical aerial stereophotography (scale 1:2,400) was obtained September 28, 1971, (fig. 9) to document preconstruction topography at the site. Vertical aerial stereophotography (scale 1:6,000) taken August 6, 1974, (figs. 10 and 11) shows significant change throughout the crossing reach. A large material-removal site is located in the stream channel and on the left bank of the flood fan at the pipeline crossing. A culvert and road fill have been installed across the Snowden Creek flood fan 800 ft (240 m) above the pipeline crossing. Three cross sections (fig. 12) were surveyed July 26, 1971, to define preconstruction ground profiles in the crossing reach. On September 5, 1974, a channel survey of the upstream and downstream sections (fig. 12) showed significant change. The upstream section shows about 20 ft (6 m) of lateral erosion along the left bank of the main channel. The downstream section shows about 20 ft (6 m) of lateral erosion along the right bank and a large quantity of flood-fan material removed from the left bank flood plain.

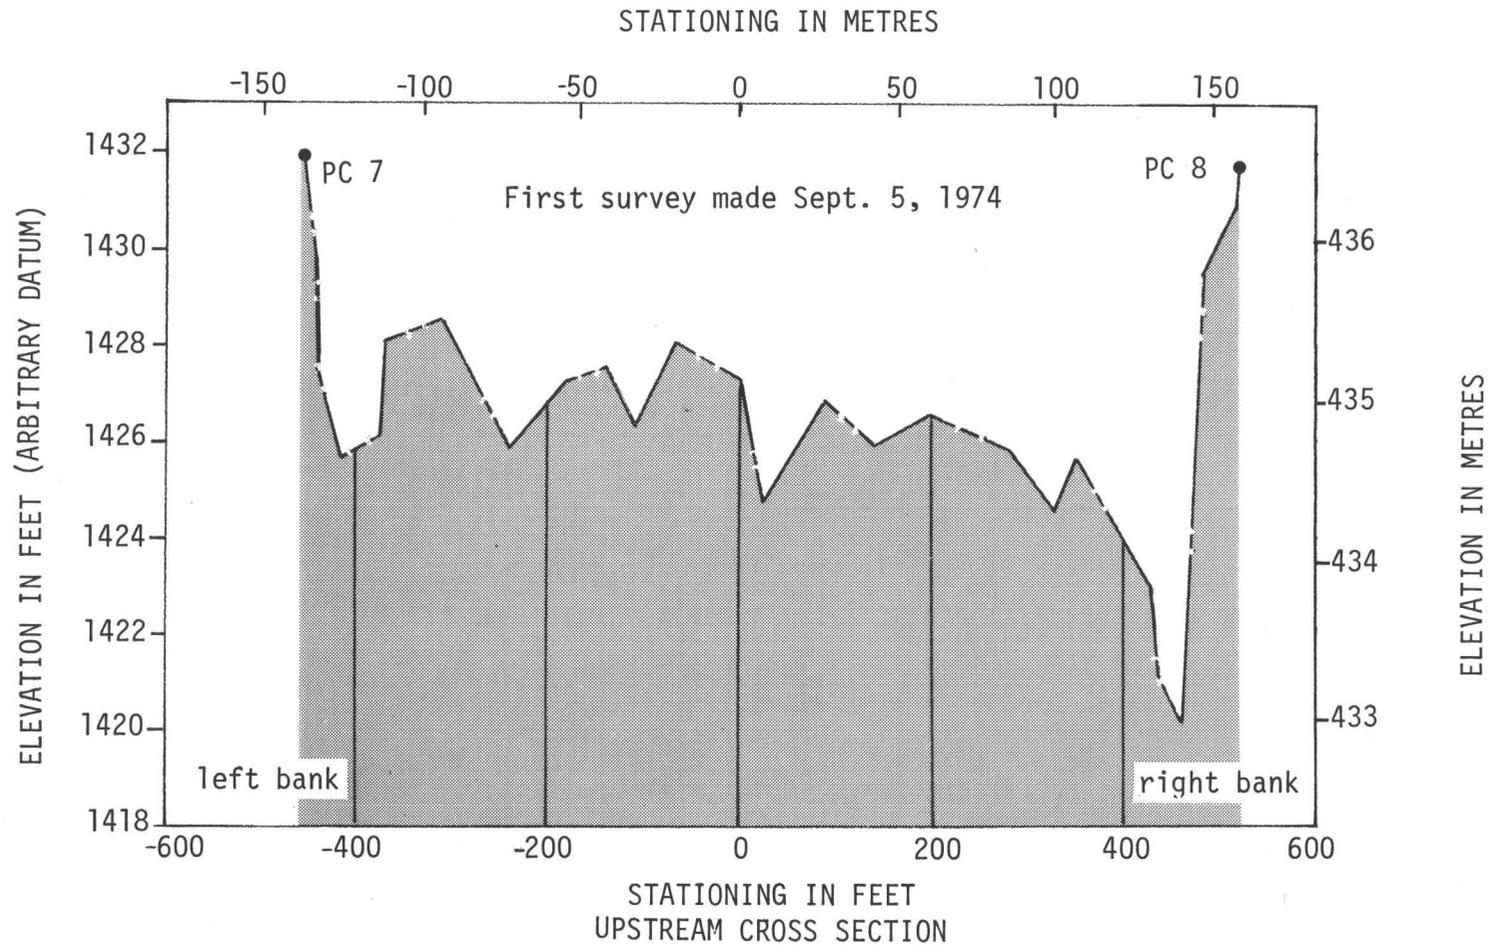
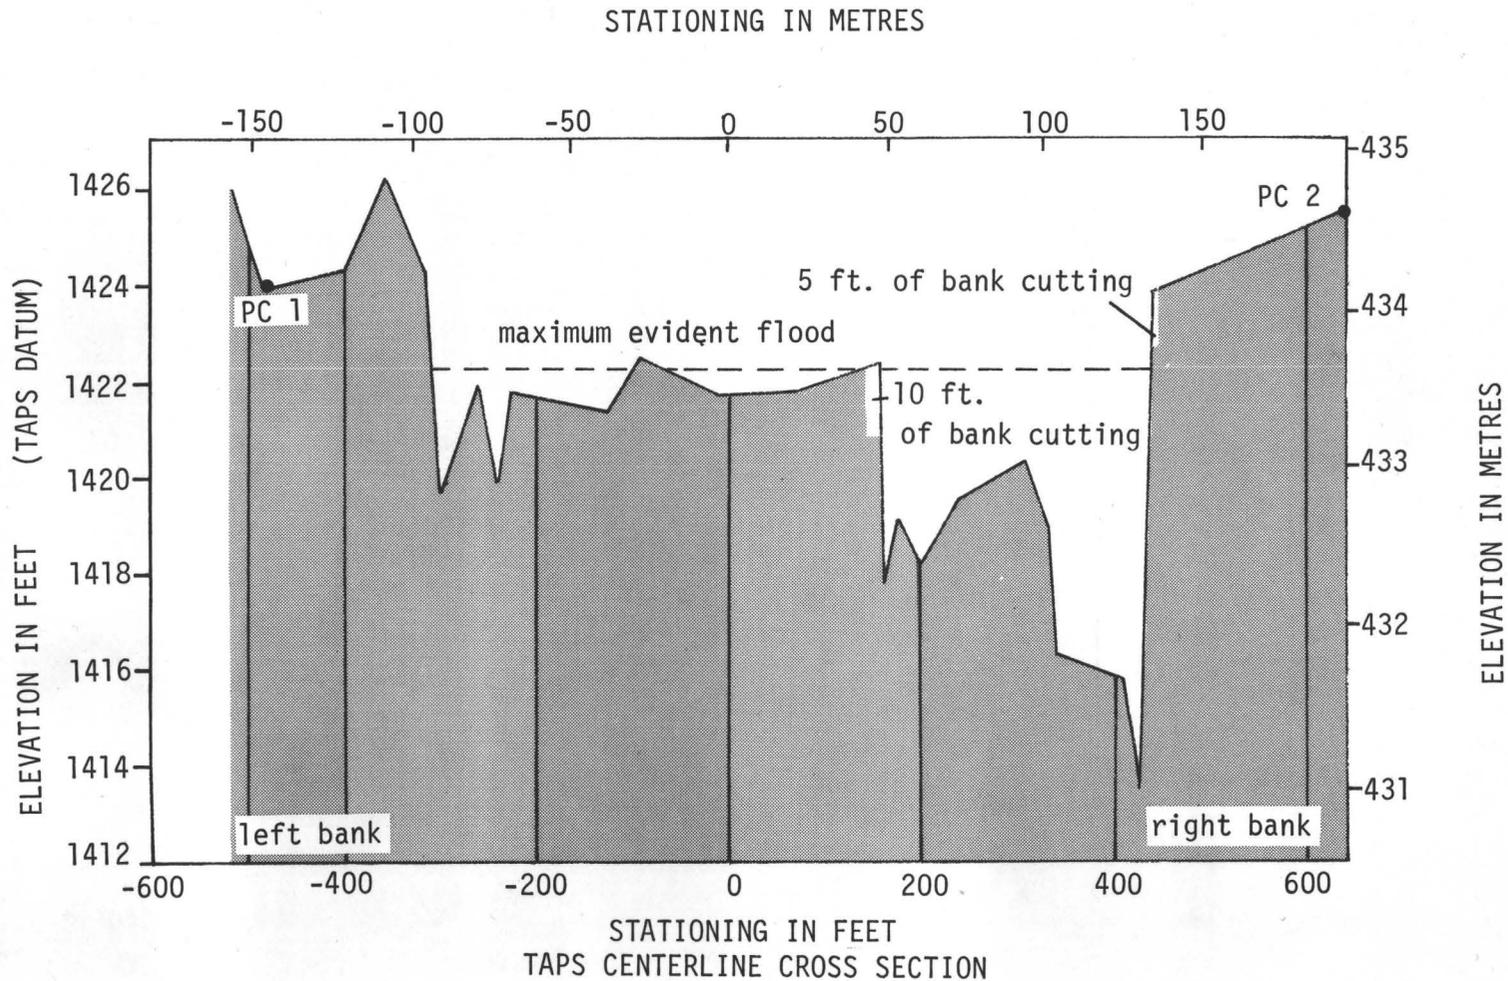
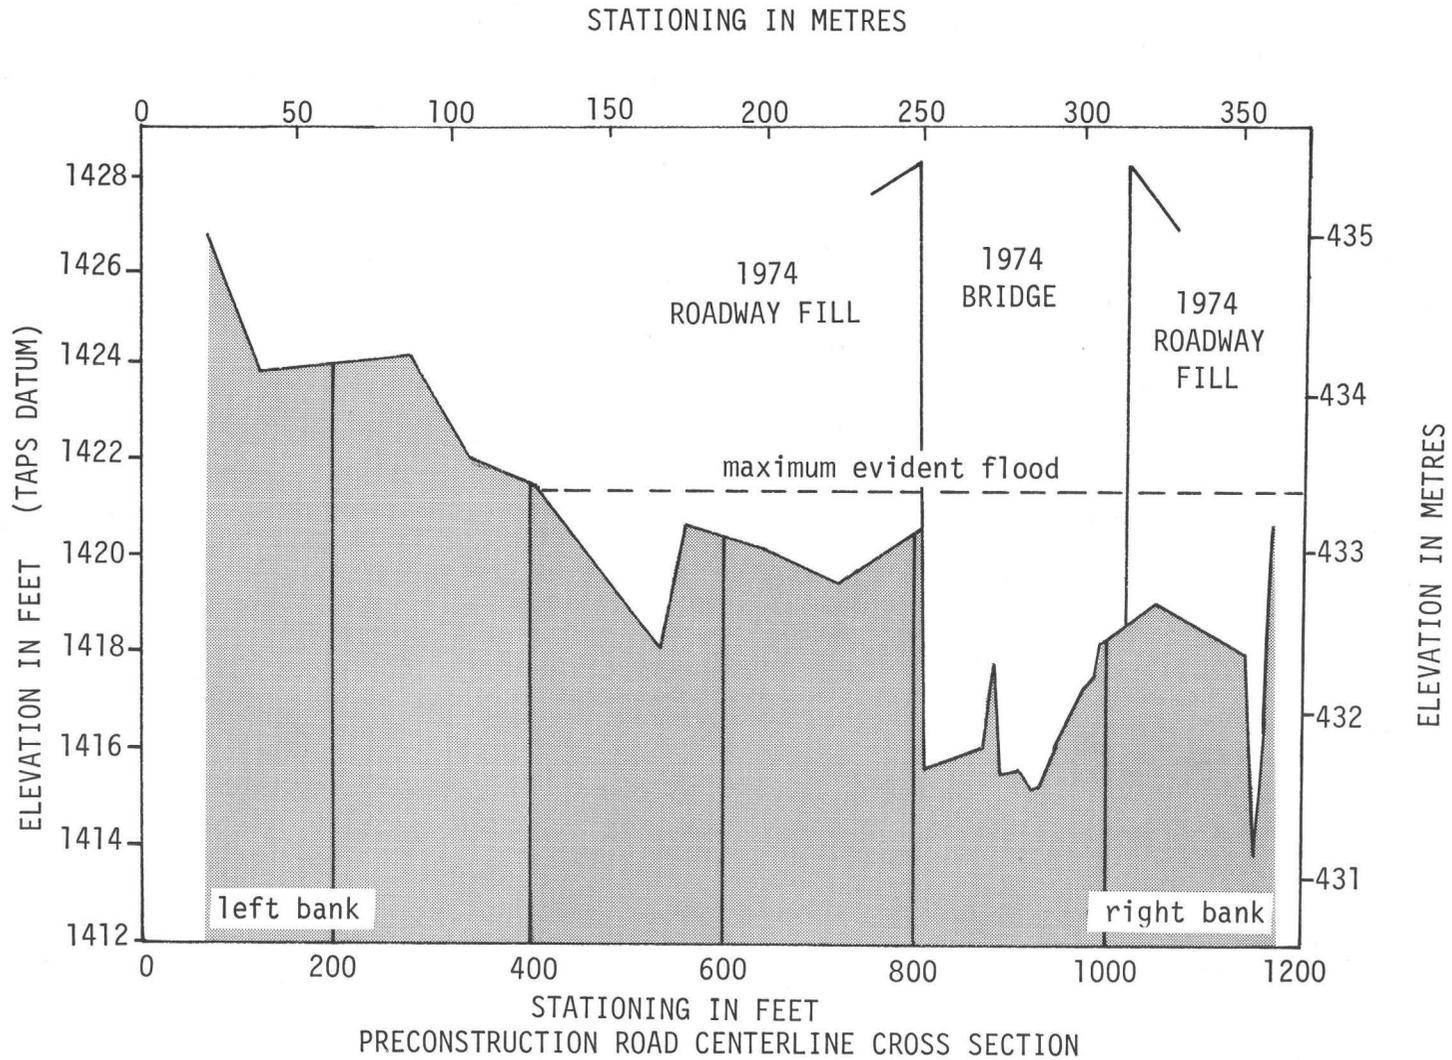
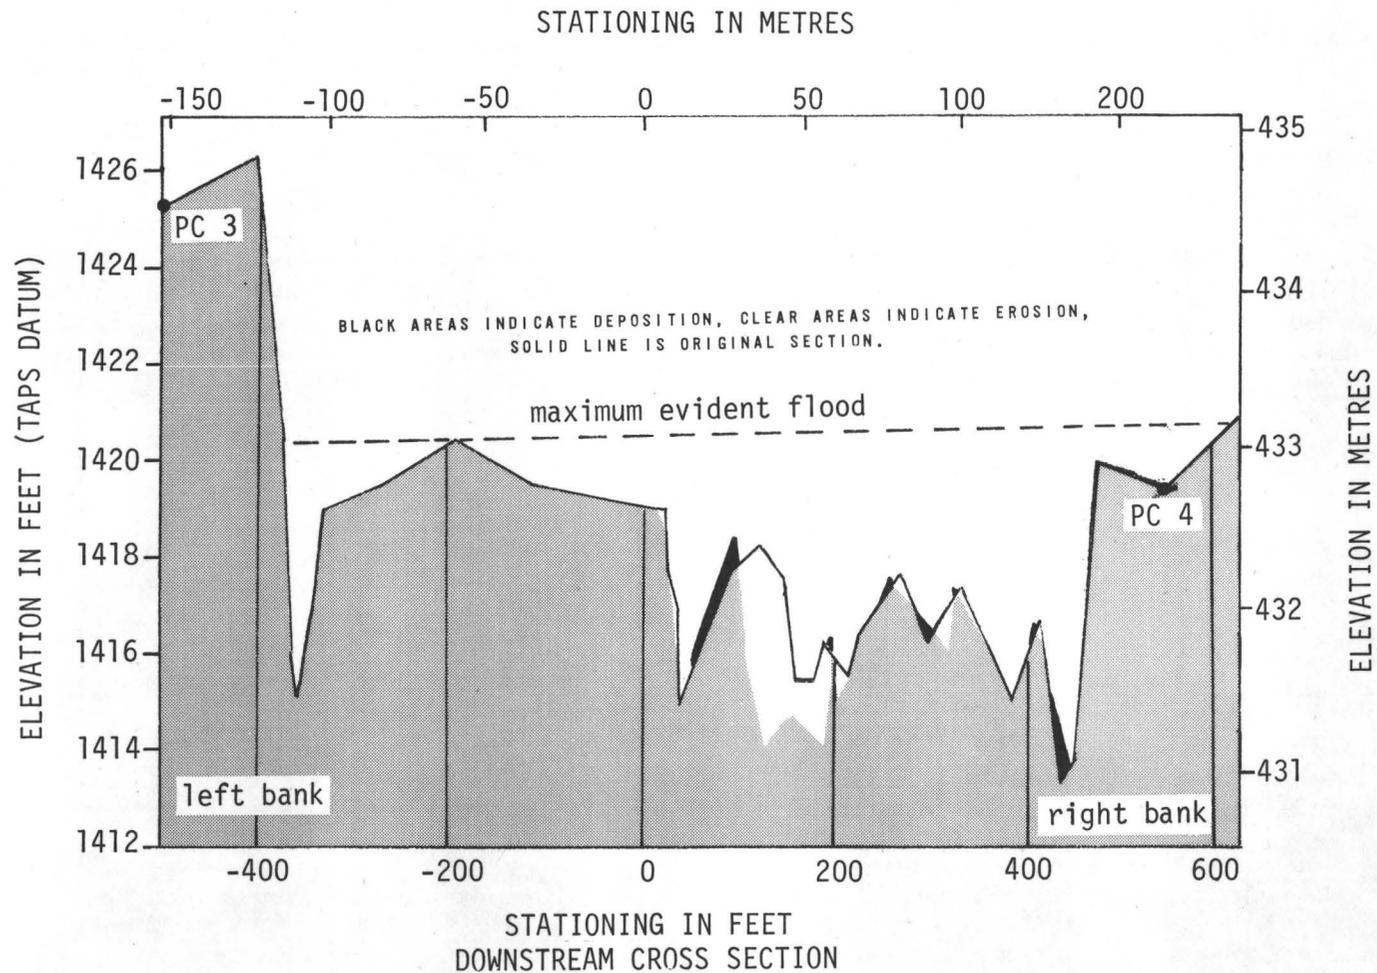
Figure 15.-- Cross sections of Dietrich River at Bettles River, July 29, 1971 and September 5, 1974.

Channel conditions.--Low-altitude vertical aerial stereophotography (scale 1:2,400) was obtained September 28, 1971, (fig. 13) to document preconstruction topography at the site. Vertical aerial stereophotography (scale 1:6,000) taken August 6, 1974, (fig. 14) shows a bridge and roadway fill construction encroaching into the flood plain along the preconstruction road centerline section. The three cross sections (fig. 15) surveyed July 29, 1971, showed significant changes when they were resurveyed on September 5, 1974. The upstream section shows 10 ft (3 m) of lateral bank erosion. The preconstruction road centerline section was significantly changed by bridge and roadway fill construction encroaching into the flood plain. Although no overbank flooding occurred during the period July 29, 1971, through September 5, 1974, about 50 ft (15 m) of lateral erosion was detected in the main channel of the downstream section. The bridge upstream of this section has constricted the floodflow and concentrated streamflow in the main channel below the bridge.

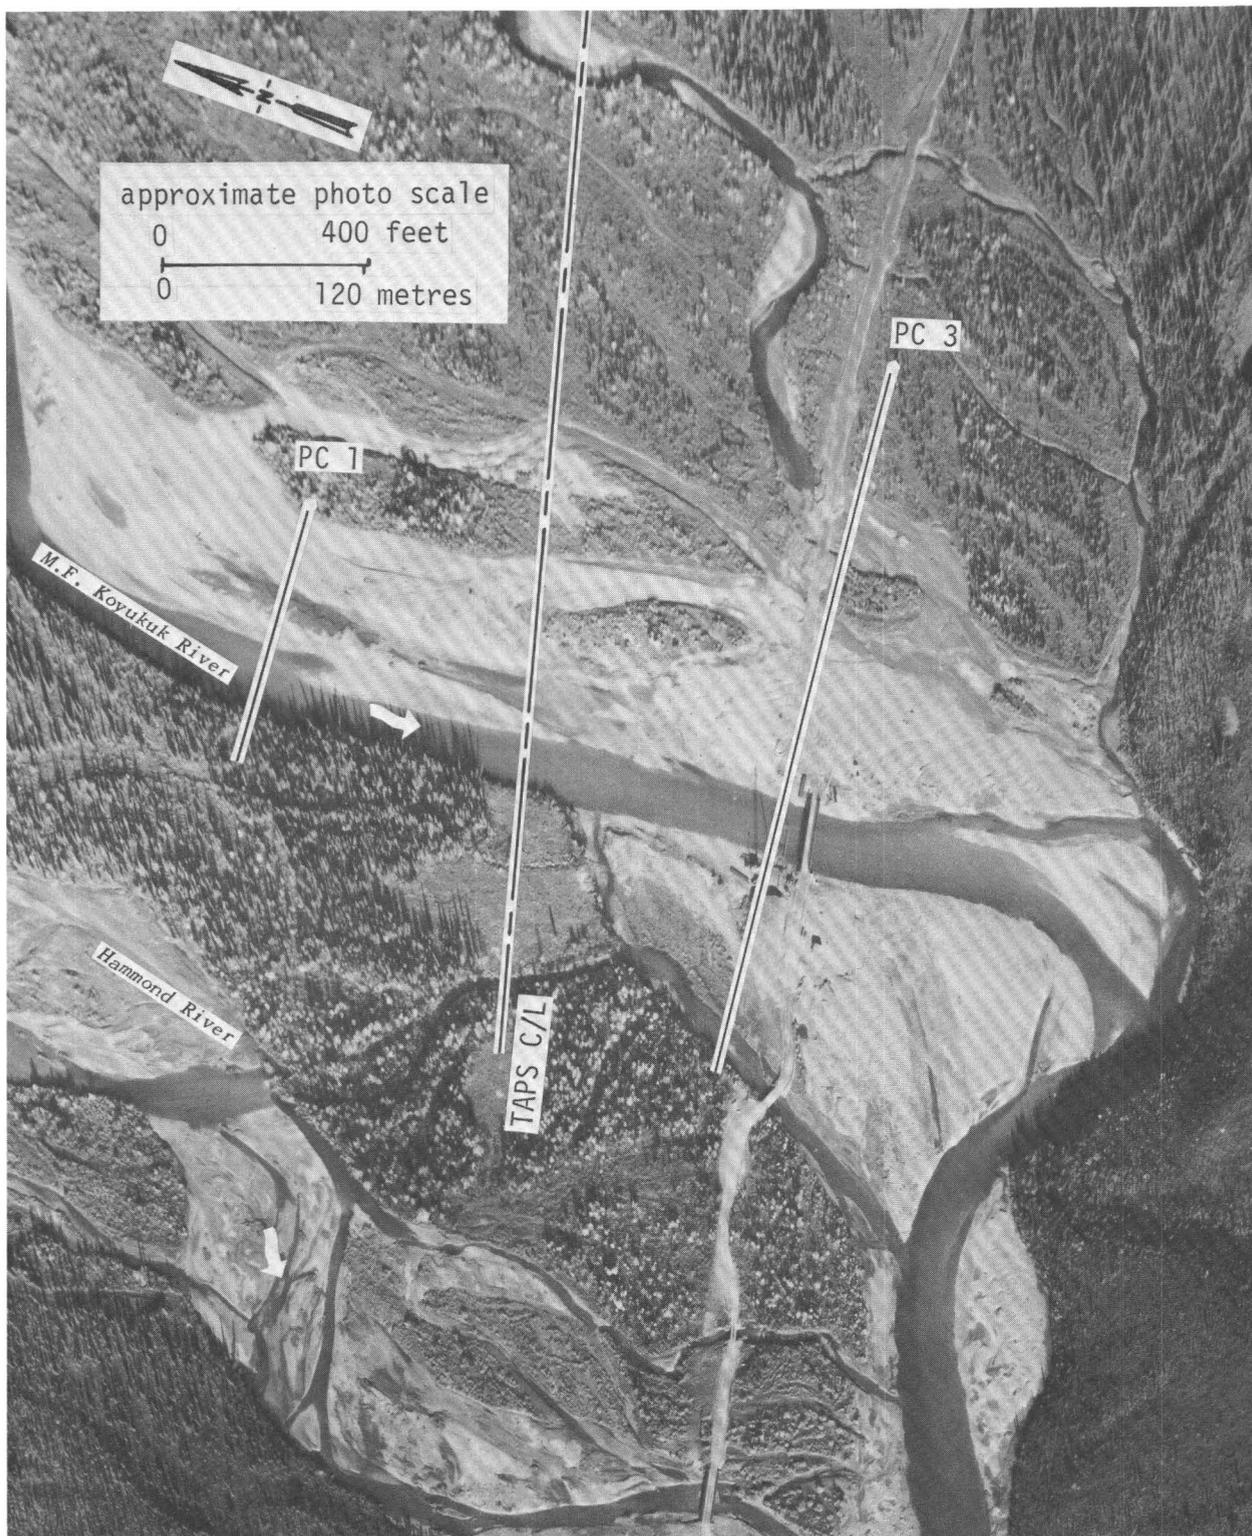
Figure 17. -- Middle Fork Koyuk River at Hammond River, September 1, 1974.
ALYESKA PIPELINE SERVICE CO.-AIR PHOTO TECH.

Channel conditions.--Low-altitude vertical aerial stereophotography (scale 1:4,800) was obtained September 28, 1971, (fig. 16) to document preconstruction topography at the site. Vertical aerial strip photography (scale 1:6,000) taken September 1, 1974, (fig. 17) shows a bridge and roadway fill being constructed at the downstream cross section below the TAPS centerline cross section. The overflow channel on the far left bank of the TAPS centerline cross section has been diked off upstream at the material-removal site and by the road embankment. Three cross sections (fig. 18) were surveyed July 27, 1971, to define preconstruction ground profiles in the crossing reach. On September 5, 1974, a channel survey of the upstream cross section found no significant lateral erosion.

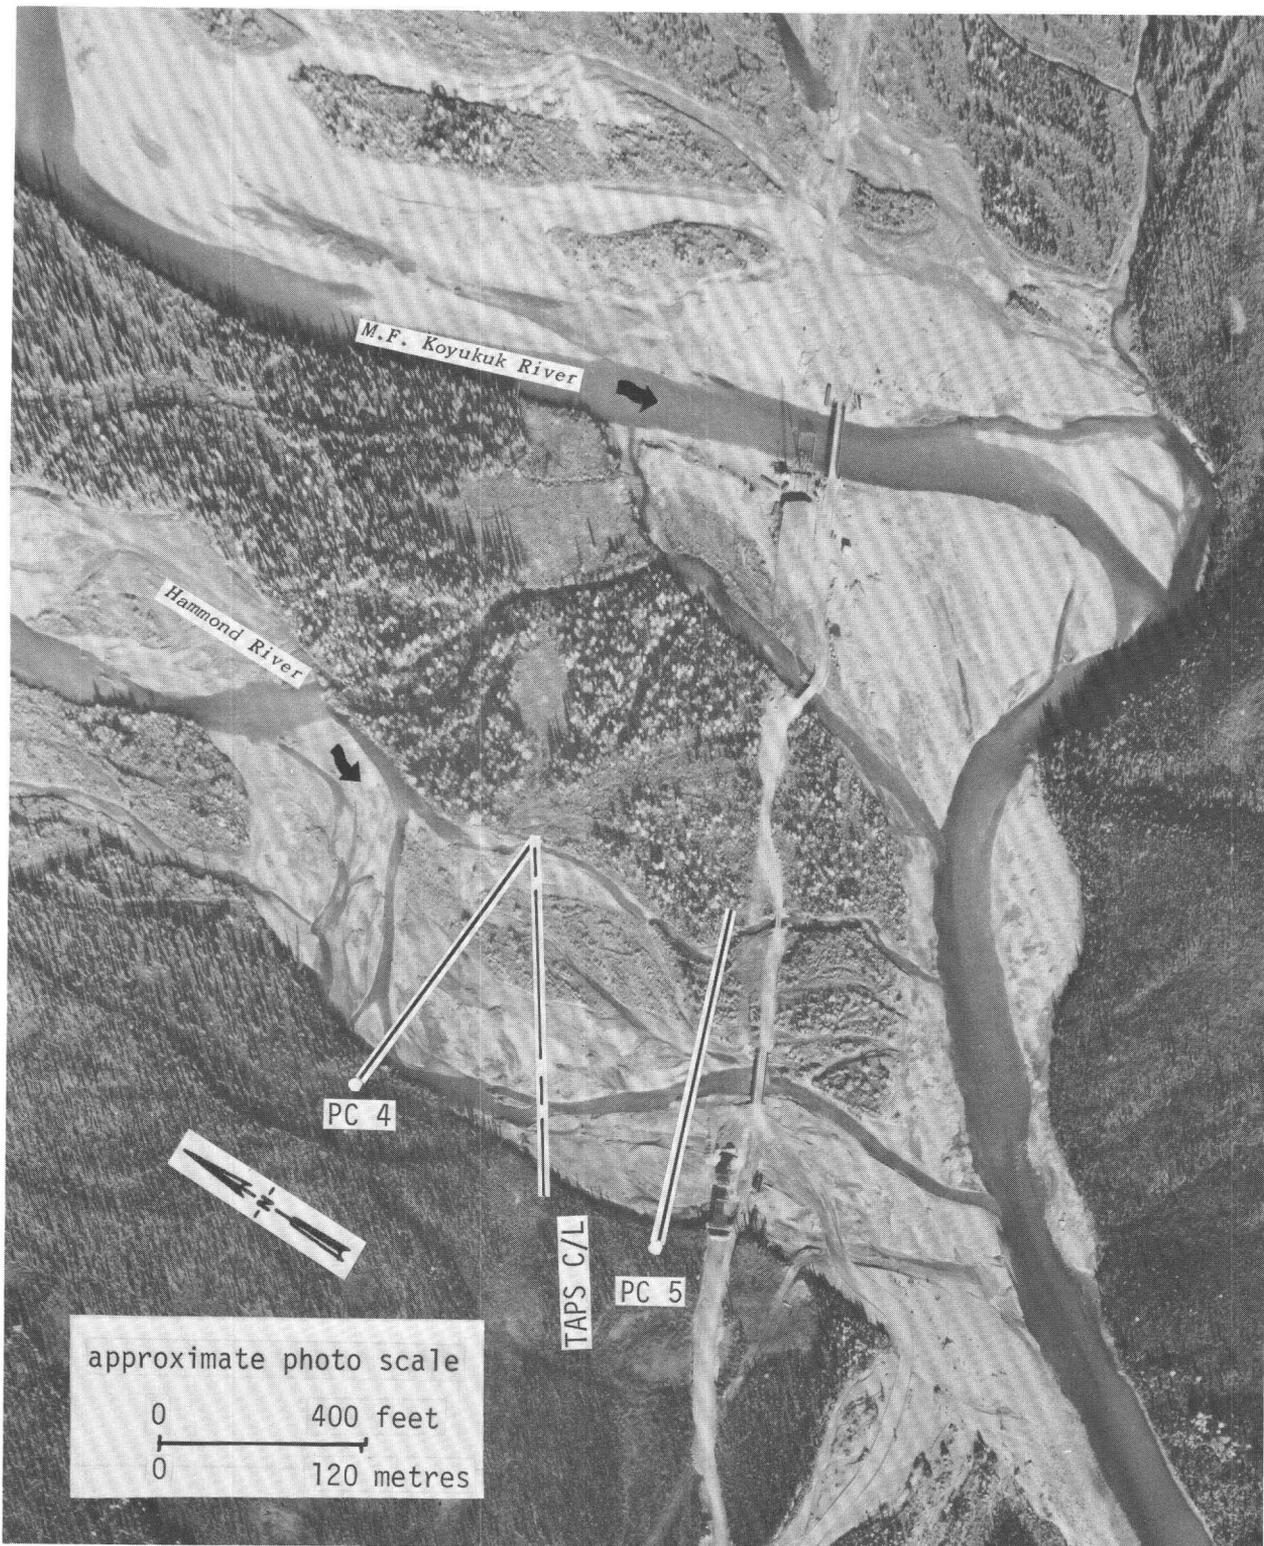
Figure 20. -- Hammond River near Wiseman, September 1, 1974.
ALYESKA PIPELINE SERVICE CO.-AIR PHOTO TECH.

Channel conditions.--Low-altitude vertical aerial stereophotography (scale 1:4,800) was obtained September 28, 1971, (fig. 19) to document preconstruction topography at the site. Vertical aerial strip photography (scale 1:6,000) taken September 1, 1974, (fig. 20) shows bridge and roadway fill being constructed near the downstream cross section below the TAPS centerline cross section. Three cross sections (fig. 21) were surveyed July 25, 1971, to define preconstruction ground profiles in the crossing reach. On September 5, 1974, a channel survey showed about 20 ft (6 m) of lateral bank erosion in the upstream section and 20 ft (6 m) of lateral bank erosion in the downstream section along the right bank. About 2 ft (0.6 m) of scour has occurred along the right cutbank in the upstream section.

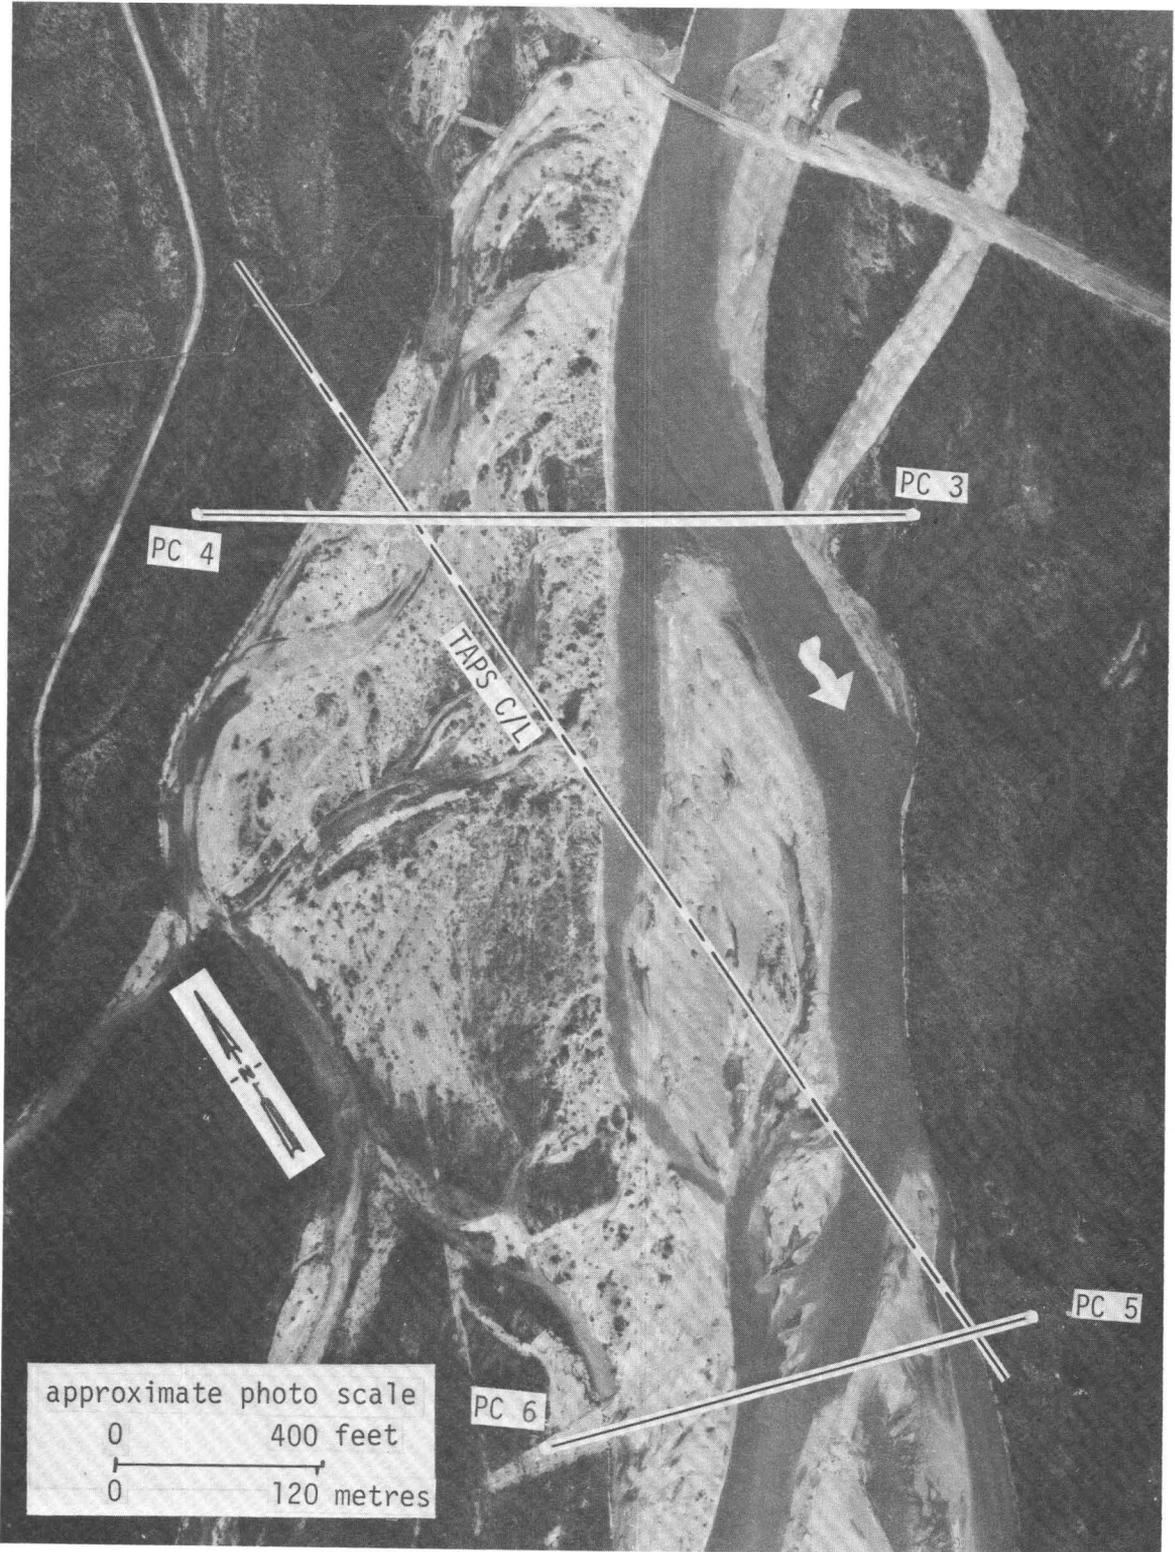
Figure 23. -- Middle Fork Koyukuk River near Wiseman, August 6, 1974.
AIR PHOTO TECH.

(scale 1:4,800) was obtained September 28, 1971, (fig. 22) to document preconstruction topography at the site. Vertical aerial stereophotography (scale 1:6,000) taken August 6, 1974, (fig. 23) shows bridge and roadway fill being constructed 800 ft (240 m) above the upstream cross section. The roadway fill encroaches on the flood plain on both banks and forms a dike along the left bank overflow channel. Three cross sections (fig. 24) were surveyed July 27, 1971, to define preconstruction ground profiles in the crossing reach. The channel survey of September 4, 1974, of the upstream and downstream cross sections found no significant lateral bank erosion and about 2 ft (0.6 m) of scour.

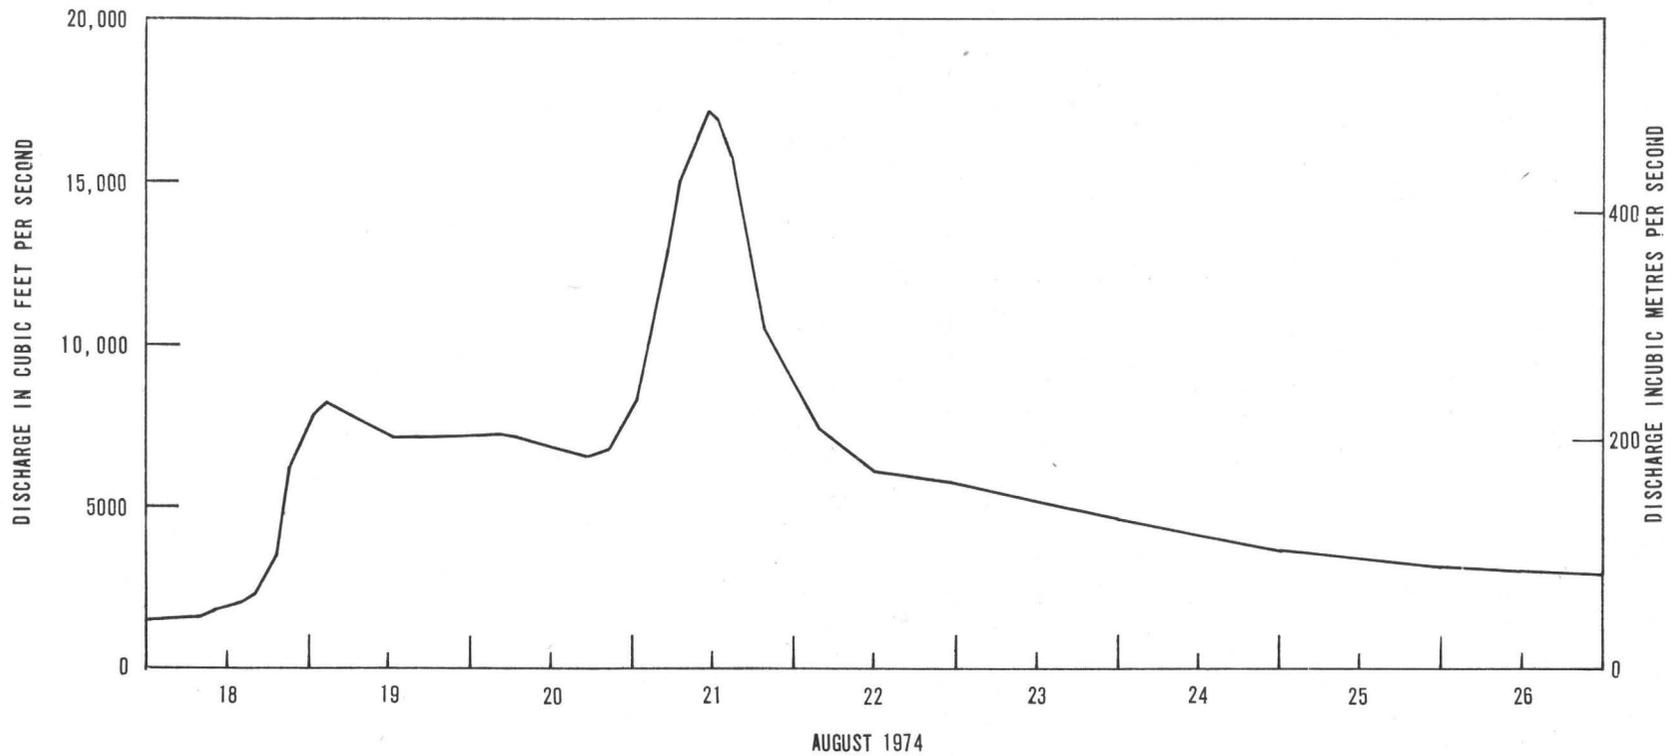
Figure 25.-- Discharge hydrograph for Middle Fork Koyukuk River near Wiseman.

Floods.--On August 21, 1974, a floodpeak discharge, 17,100 ft³/s (484 m³/s) (fig. 25), occurred at a stage of about 2 ft (0.6 m) below the maximum evident flood.

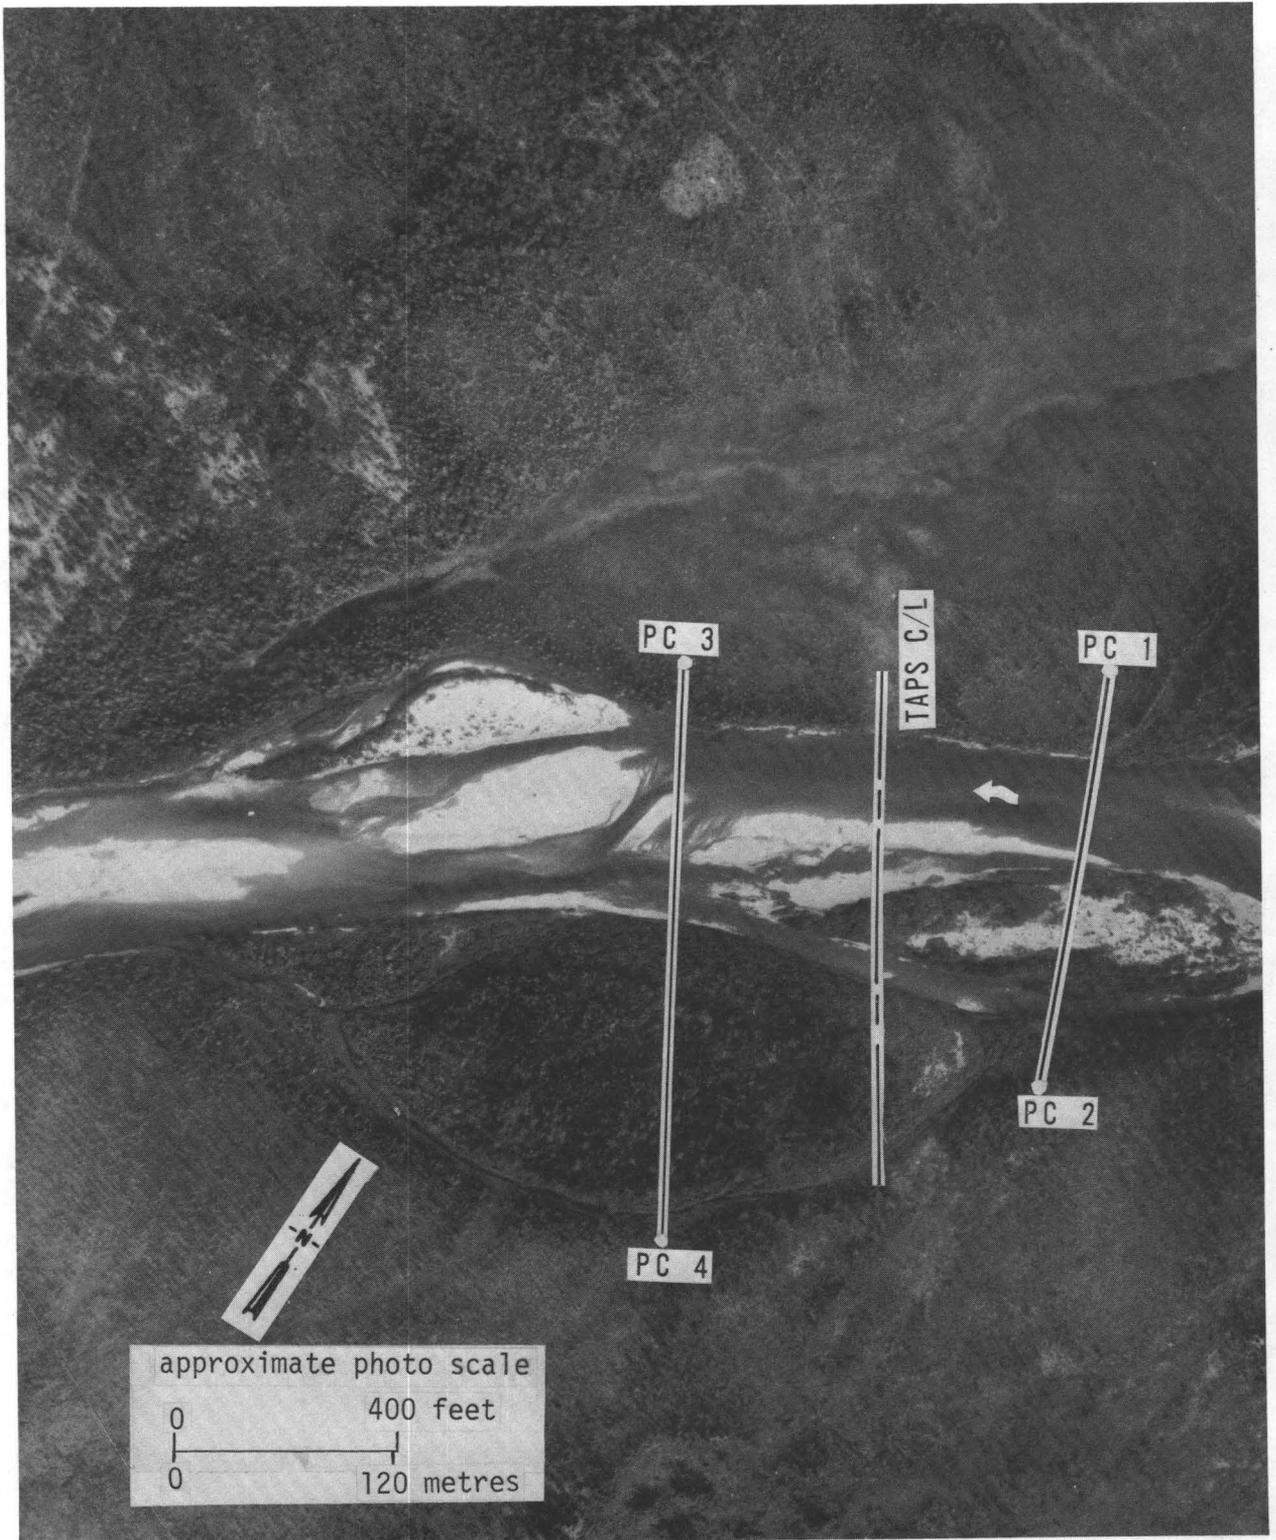
Figure 27. -- South Fork Koyukuk River near Wiseman, August 6, 1974.
AIR PHOTO TECH.

Channel conditions.--Low-altitude vertical aerial stereophotography (scale 1:4,800) was obtained September 28, 1971, (fig. 26) to document preconstruction topography at the site. Vertical aerial stereophotography (scale 1:6,000) taken August 6, 1974, (fig. 27) shows no significant channel erosion or construction activities have occurred in the proposed crossing reach since September 28, 1971. Three cross sections (fig. 28) were surveyed July 22, 1971, and September 26, 1973, to define preconstruction ground profiles in the crossing reach. In September 1974 a channel survey of the three cross sections found no significant lateral erosion.
