CHANNEL EROSION SURVEYS ALONG TAPS ROUTE, ALASKA, 1974

UNITED STATES DEPARTMENT OF THE INTERIOR
GEOLOGICAL SURVEY

Joseph M. Childers and Stanley H. Jones

OPEN-FILE REPORT

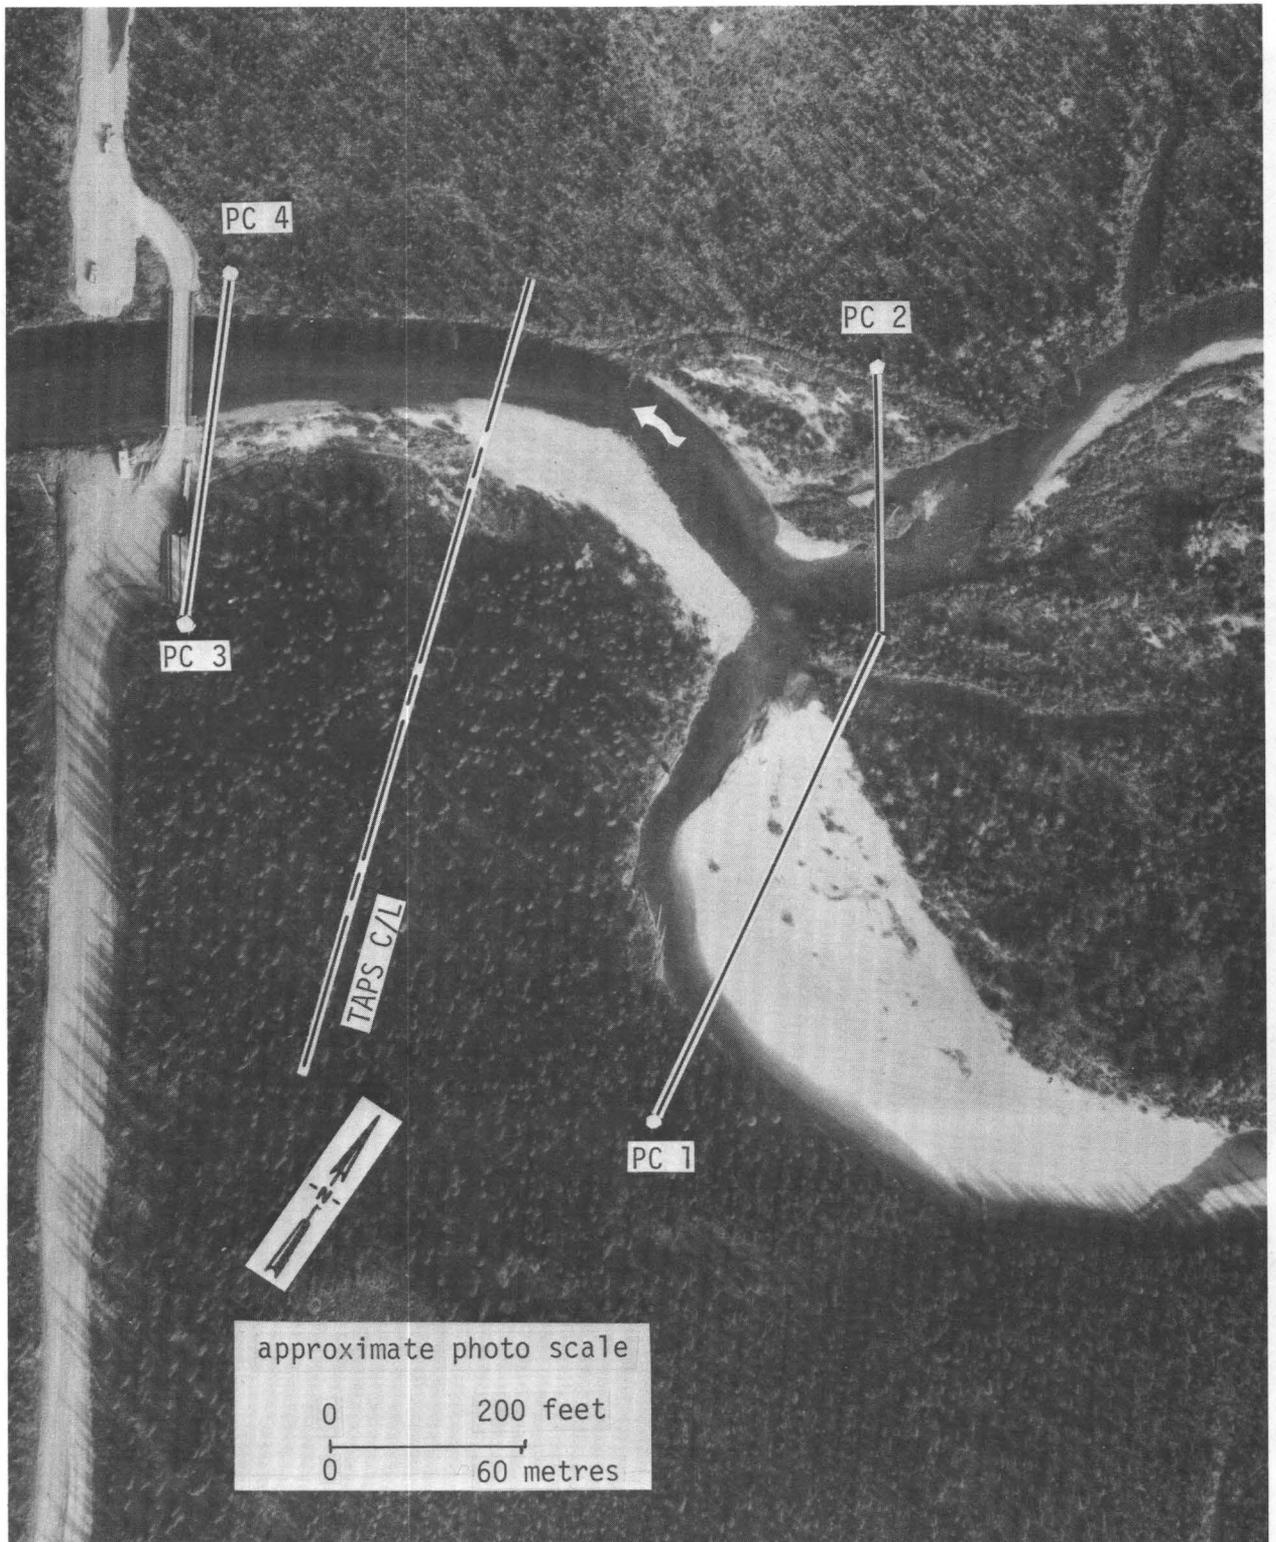
Figure 30. -- Jim River near Prospect Creek Camp, August 25, 1974.
AIR PHOTO TECH.

Channel conditions.--Low-altitude vertical aerial stereophotography (scale 1:2,400) was obtained September 28, 1971, (fig. 29) to document preconstruction topography at the site. Vertical aerial stereophotography (scale 1:6,000) taken August 25, 1974, (fig. 30) shows bridge and road fill being constructed near the downstream cross section. The photographs show no significant lateral erosion. Three cross sections (fig. 31) were surveyed July 20, 1971, to define preconstruction ground profiles in the crossing reach. On September 1974 a channel survey of the preconstruction cross sections showed no significant change.

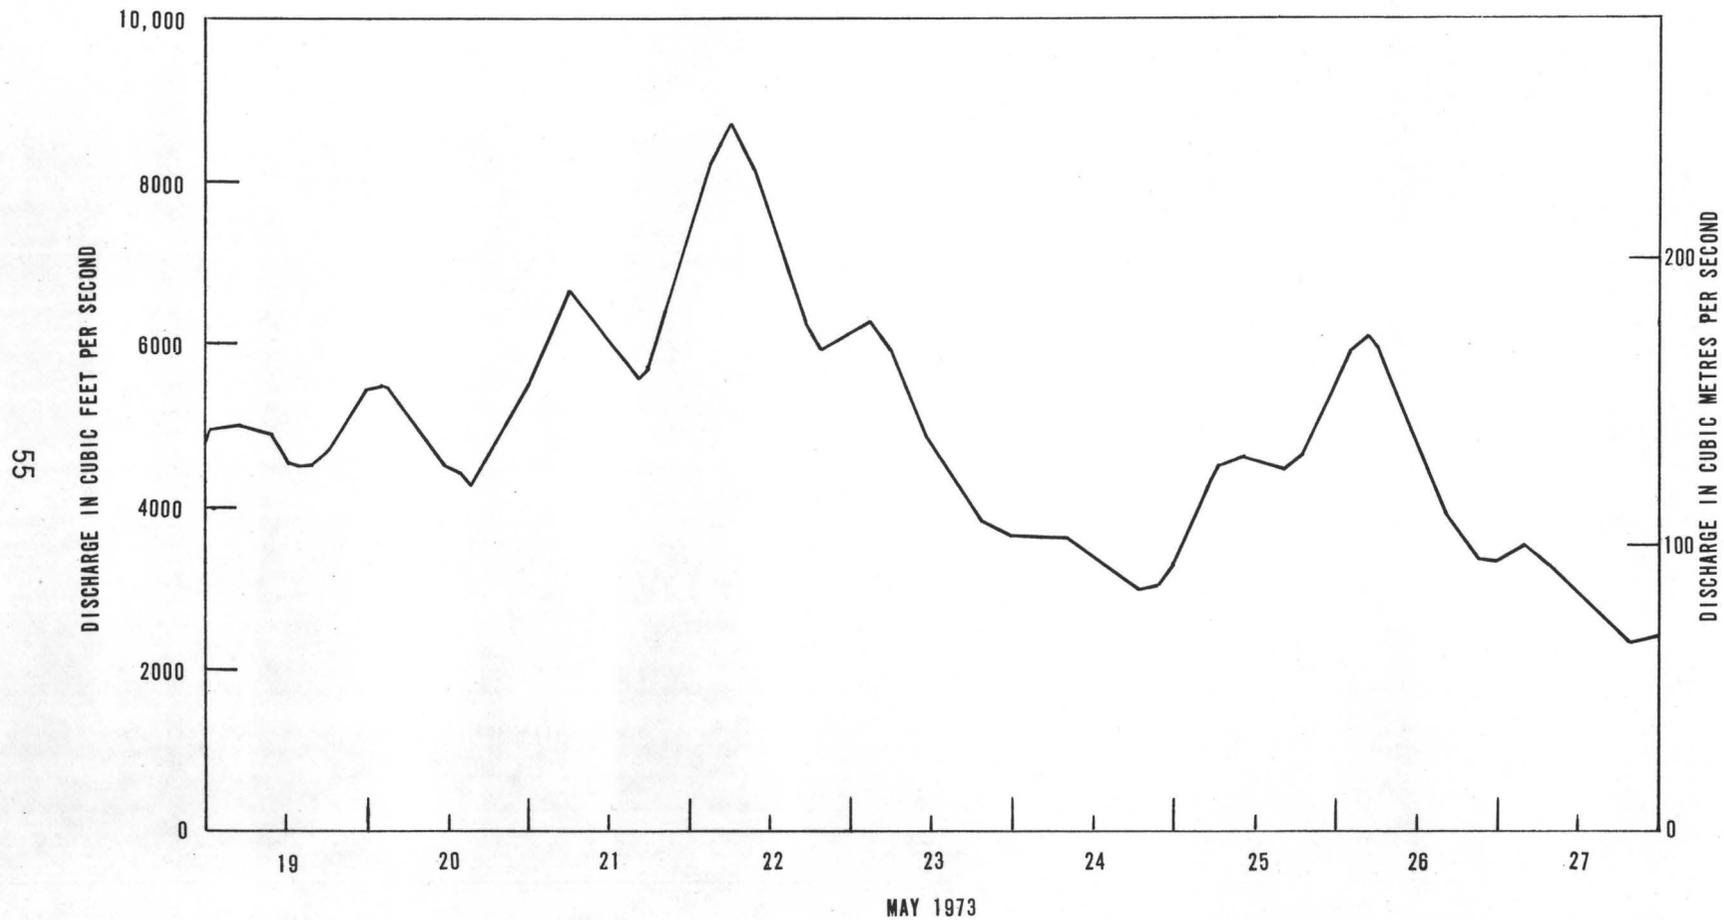
Figure 32. -- Discharge hydrograph at gaging station for Jim River near Prospect Creek Camp.

Floods.--No significant overbank flooding occurred during the period July 20, 1971, through September 1974. The maximum observed discharge for the period was confined to the main channel and below the maximum evident flood discharge. A discharge of 8,700 ft³/s (245 m³/s) (fig. 32) occurred May 22, 1973, at the gaging station about 15 mi (24 km) downstream. Drainage area at the gage is about twice that at the pipeline crossing.

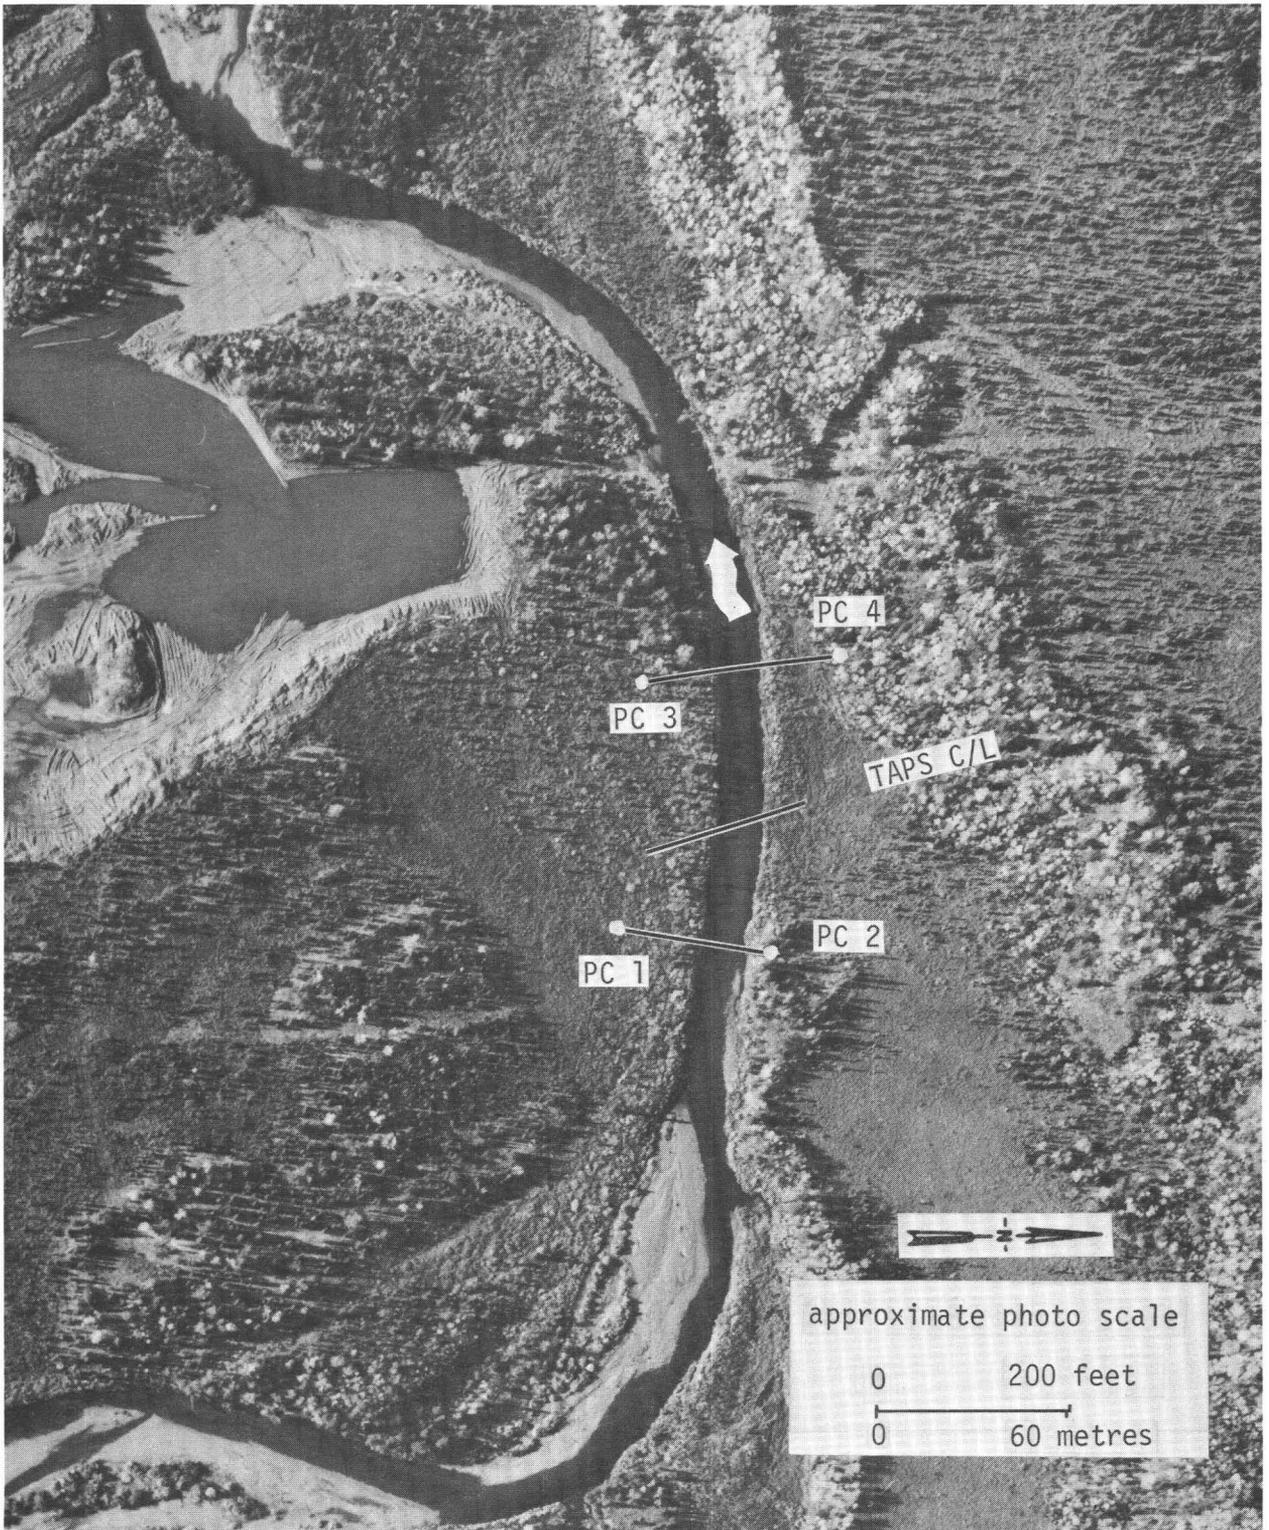
Figure 34. -- Prospect Creek near Prospect Creek Camp, September 1, 1974.
ALYESKA PIPELINE SERVICE CO.-AIR PHOTO TECH.

Channel conditions.--Low-altitude vertical aerial stereophotography (scale 1:2,400) was obtained September 28, 1971, (fig. 33) to document preconstruction topography at the site. Vertical aerial strip photography (scale 1:6,000) taken September 1, 1974, (figs. 34 and 35) shows a large gravel-removal site, roadway fill, and bridge about 500 ft (150 m) downstream of the TAPS centerline. The photographs show no significant lateral erosion. Three cross sections (fig. 36) were surveyed July 21, 1971, to define preconstruction ground profiles in the crossing reach. In September 1974 a channel survey of the preconstruction cross sections showed no significant erosion.

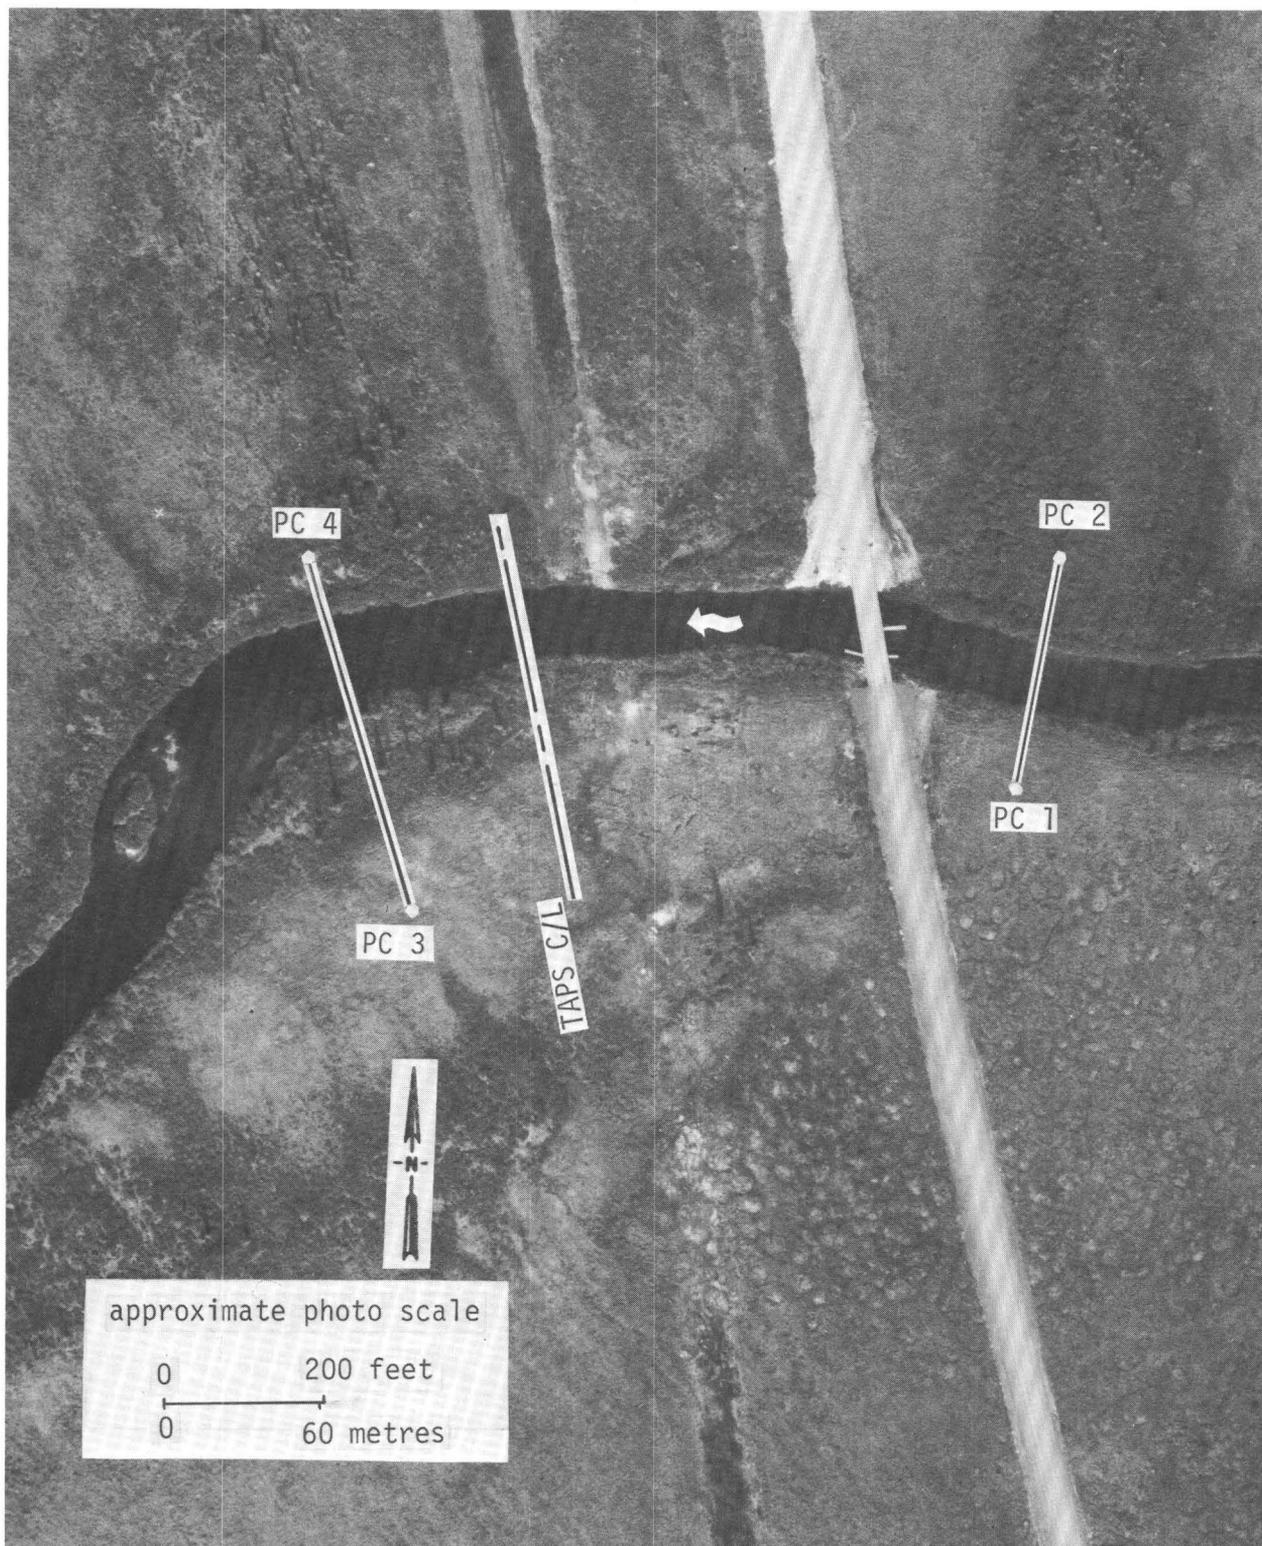
Figure 38. -- Kanuti River near Bettles, August 6, 1974.
AIR PHOTO TECH.

Channel conditions.--Low-altitude vertical aerial stereophotography (scale 1:2,400) was obtained September 28, 1971, (fig. 37) to document preconstruction topography at the site. Vertical aerial stereophotography (scale 1:6,000) taken August 6, 1974, (fig. 38) shows a roadway and bridge constructed 300 ft (91 m) above the TAPS centerline. There was no significant erosion in the crossing reach. Three cross sections (fig. 39) were surveyed July 22, 1971, to define preconstruction ground profiles in the crossing reach. In September 1974 a channel survey of the preconstruction cross sections showed no significant erosion.

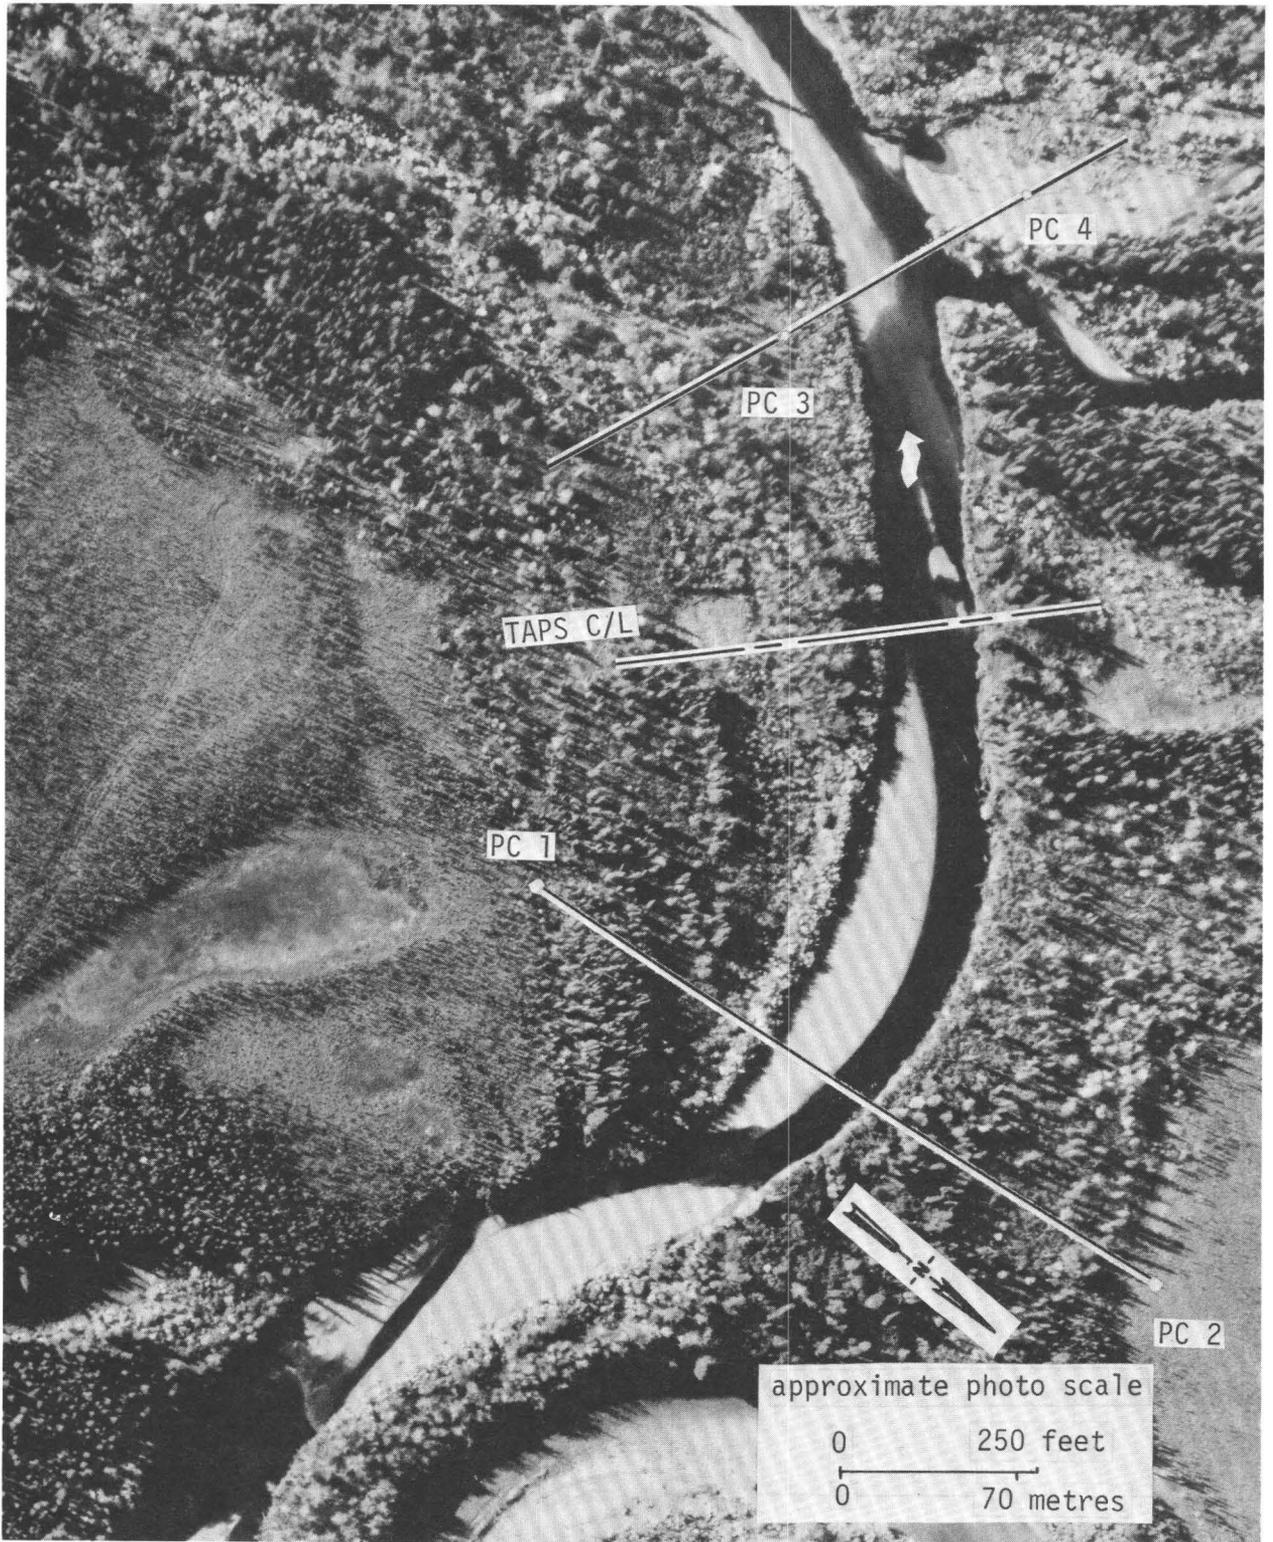
Figure 41. -- Hess Creek near Livengood, September 1, 1974.
ALYESKA PIPELINE SERVICE CO.-AIR PHOTO TECH.

Channel conditions.--Low-altitude vertical aerial stereophotography (scale 1:2,400) was obtained September 28, 1971, (fig. 40) to document preconstruction topography at the site. Vertical aerial strip photography (scale 1:6,000) taken September 1, 1974, (fig. 41) shows no significant channel erosion or construction activities have occurred in the proposed crossing reach since August 3, 1971. Three cross sections (fig. 42) were surveyed August 3, 1971, to define preconstruction ground profiles in the crossing reach. In September 1974 a channel survey of the three cross sections found 5 ft (2 m) of lateral bank erosion in the upstream section.

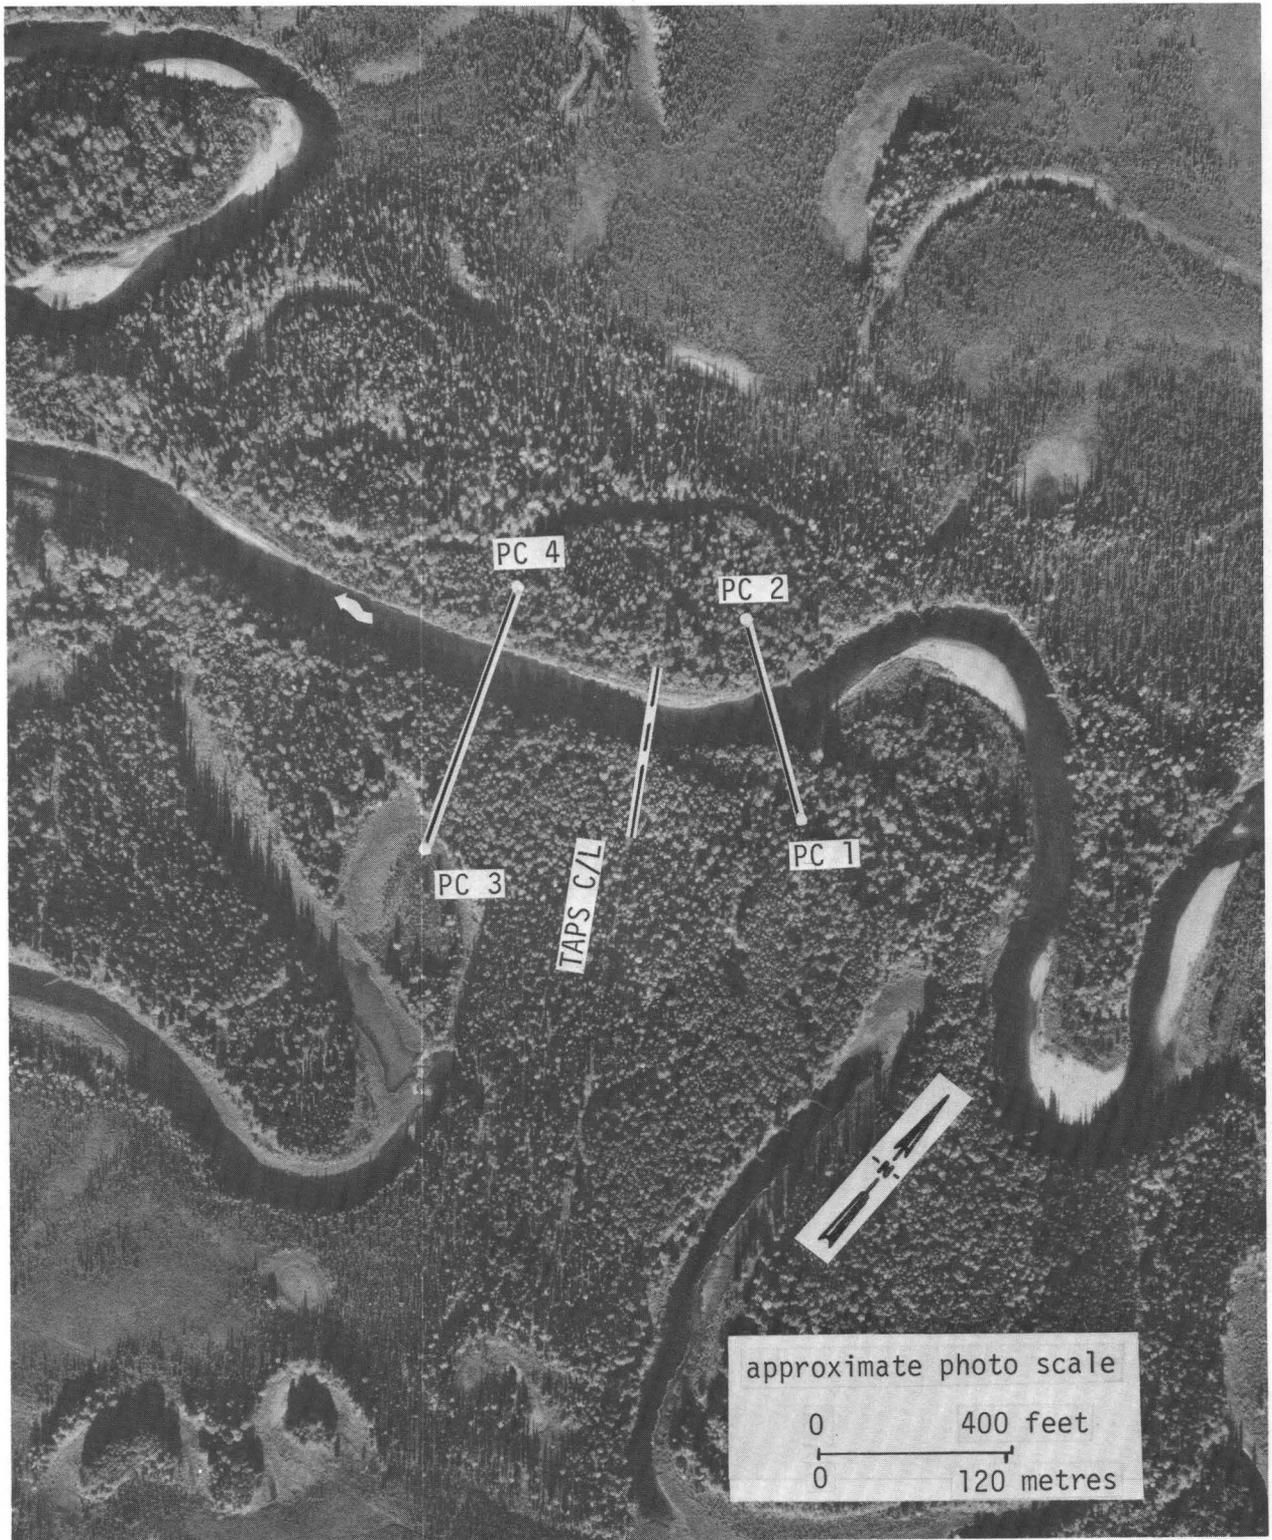
Figure 45. -- Chatanika River near Olnes, September 4, 1974.
ALYESKA PIPELINE SERVICE CO.-AIR PHOTO TECH.

Channel conditions.--High-altitude vertical aerial stereophotography (scale 1:15,840) was obtained August 18, 1969, (fig. 44) to document preconstruction topography at the site. Vertical aerial strip photography (scale 1:6,000) taken September 4, 1974, (fig. 45) shows no significant channel erosion or construction activities have occurred in the proposed crossing reach since August 18, 1969. Three cross sections (fig. 46) were surveyed August 3, 1971, to define preconstruction ground profiles in the crossing reach. In June 1974 a channel survey of measurements from photograph control points found no significant lateral erosion.

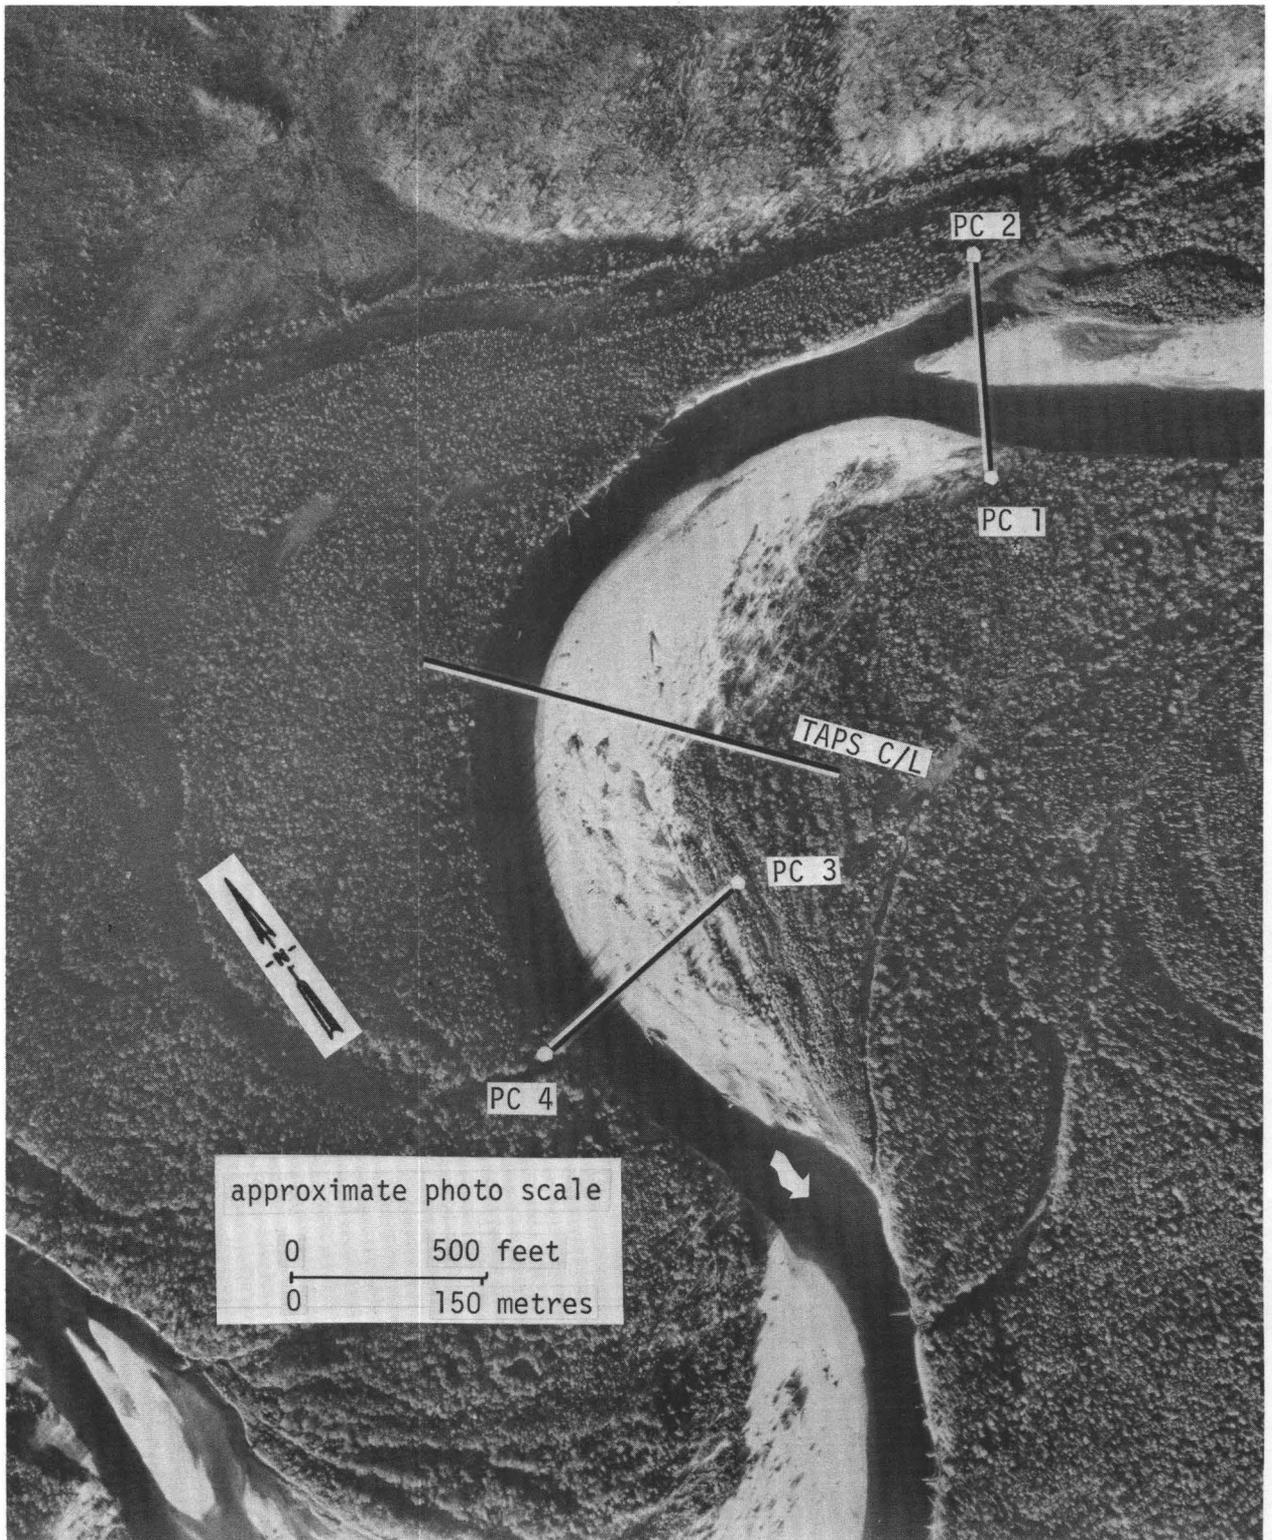
Figure 48. -- Salcha River near Salchaket, August 31, 1974.
 ALYESKA PIPELINE SERVICE CO.-AIR PHOTO TECH.

Channel conditions.--High-altitude vertical aerial stereophotography (scale 1:24,000) was obtained August 14, 1969, (fig. 47) to document preconstruction topography at the site. Vertical aerial strip photography (scale 1:6,000) taken August 31, 1974, (fig. 48) shows no significant channel erosion or construction activities have occurred in the proposed crossing reach since August 14, 1969. Three cross sections (fig. 49) were surveyed August 5, 1971, to define preconstruction ground profiles in the crossing reach. On September 16, 1974, a channel survey of the three cross sections found no significant lateral erosion.

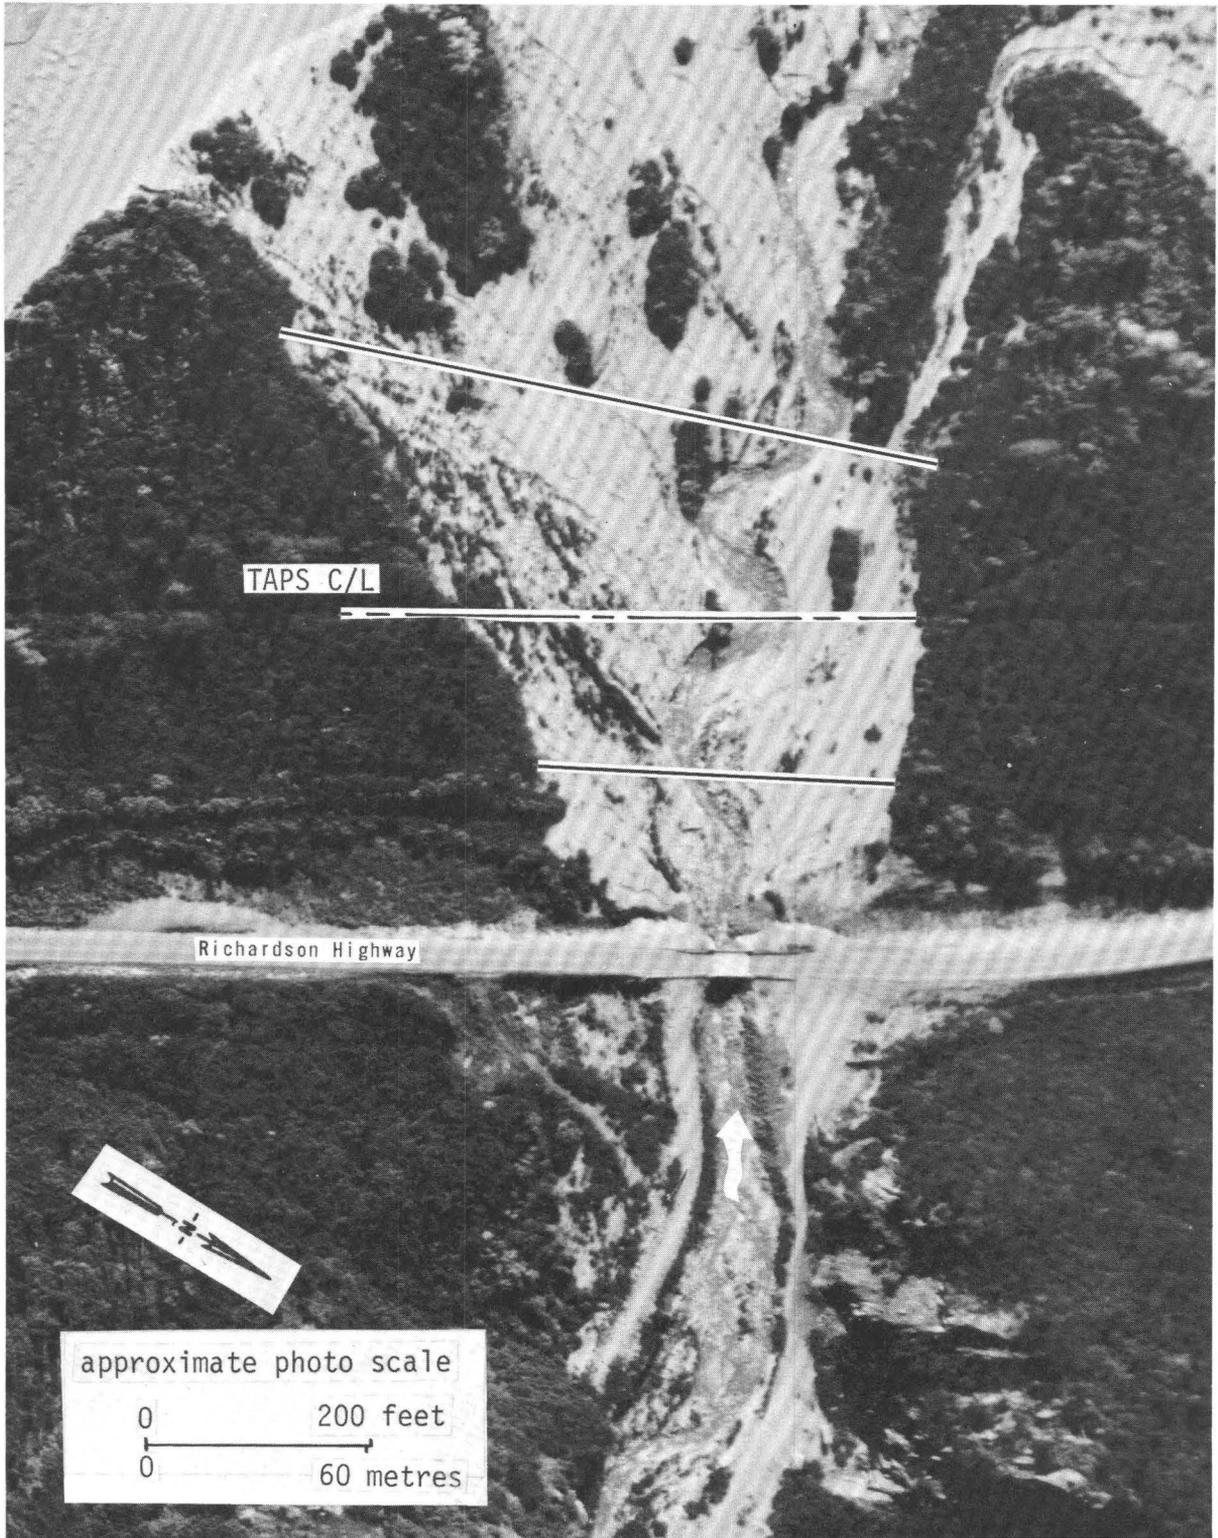
Figure 52. -- Flood Creek near Rapids, August 31, 1974.
ALYESKA PIPELINE SERVICE CO.-AIR PHOTO TECH.

Channel conditions.--Low-altitude vertical aerial stereophotography (scale 1:2,400) was obtained September 23, 1972, (fig. 51) to document preconstruction topography at the site. Vertical aerial strip photography (scale 1:6,000) taken August 31, 1974, (fig. 52) shows no significant channel erosion or construction activities have occurred in the crossing reach since September 23, 1972. Three cross sections (fig. 53) were surveyed in September 1972 to define preconstruction ground profiles in the crossing reach. In September 1974 a channel survey of the three cross sections found no significant lateral erosion.

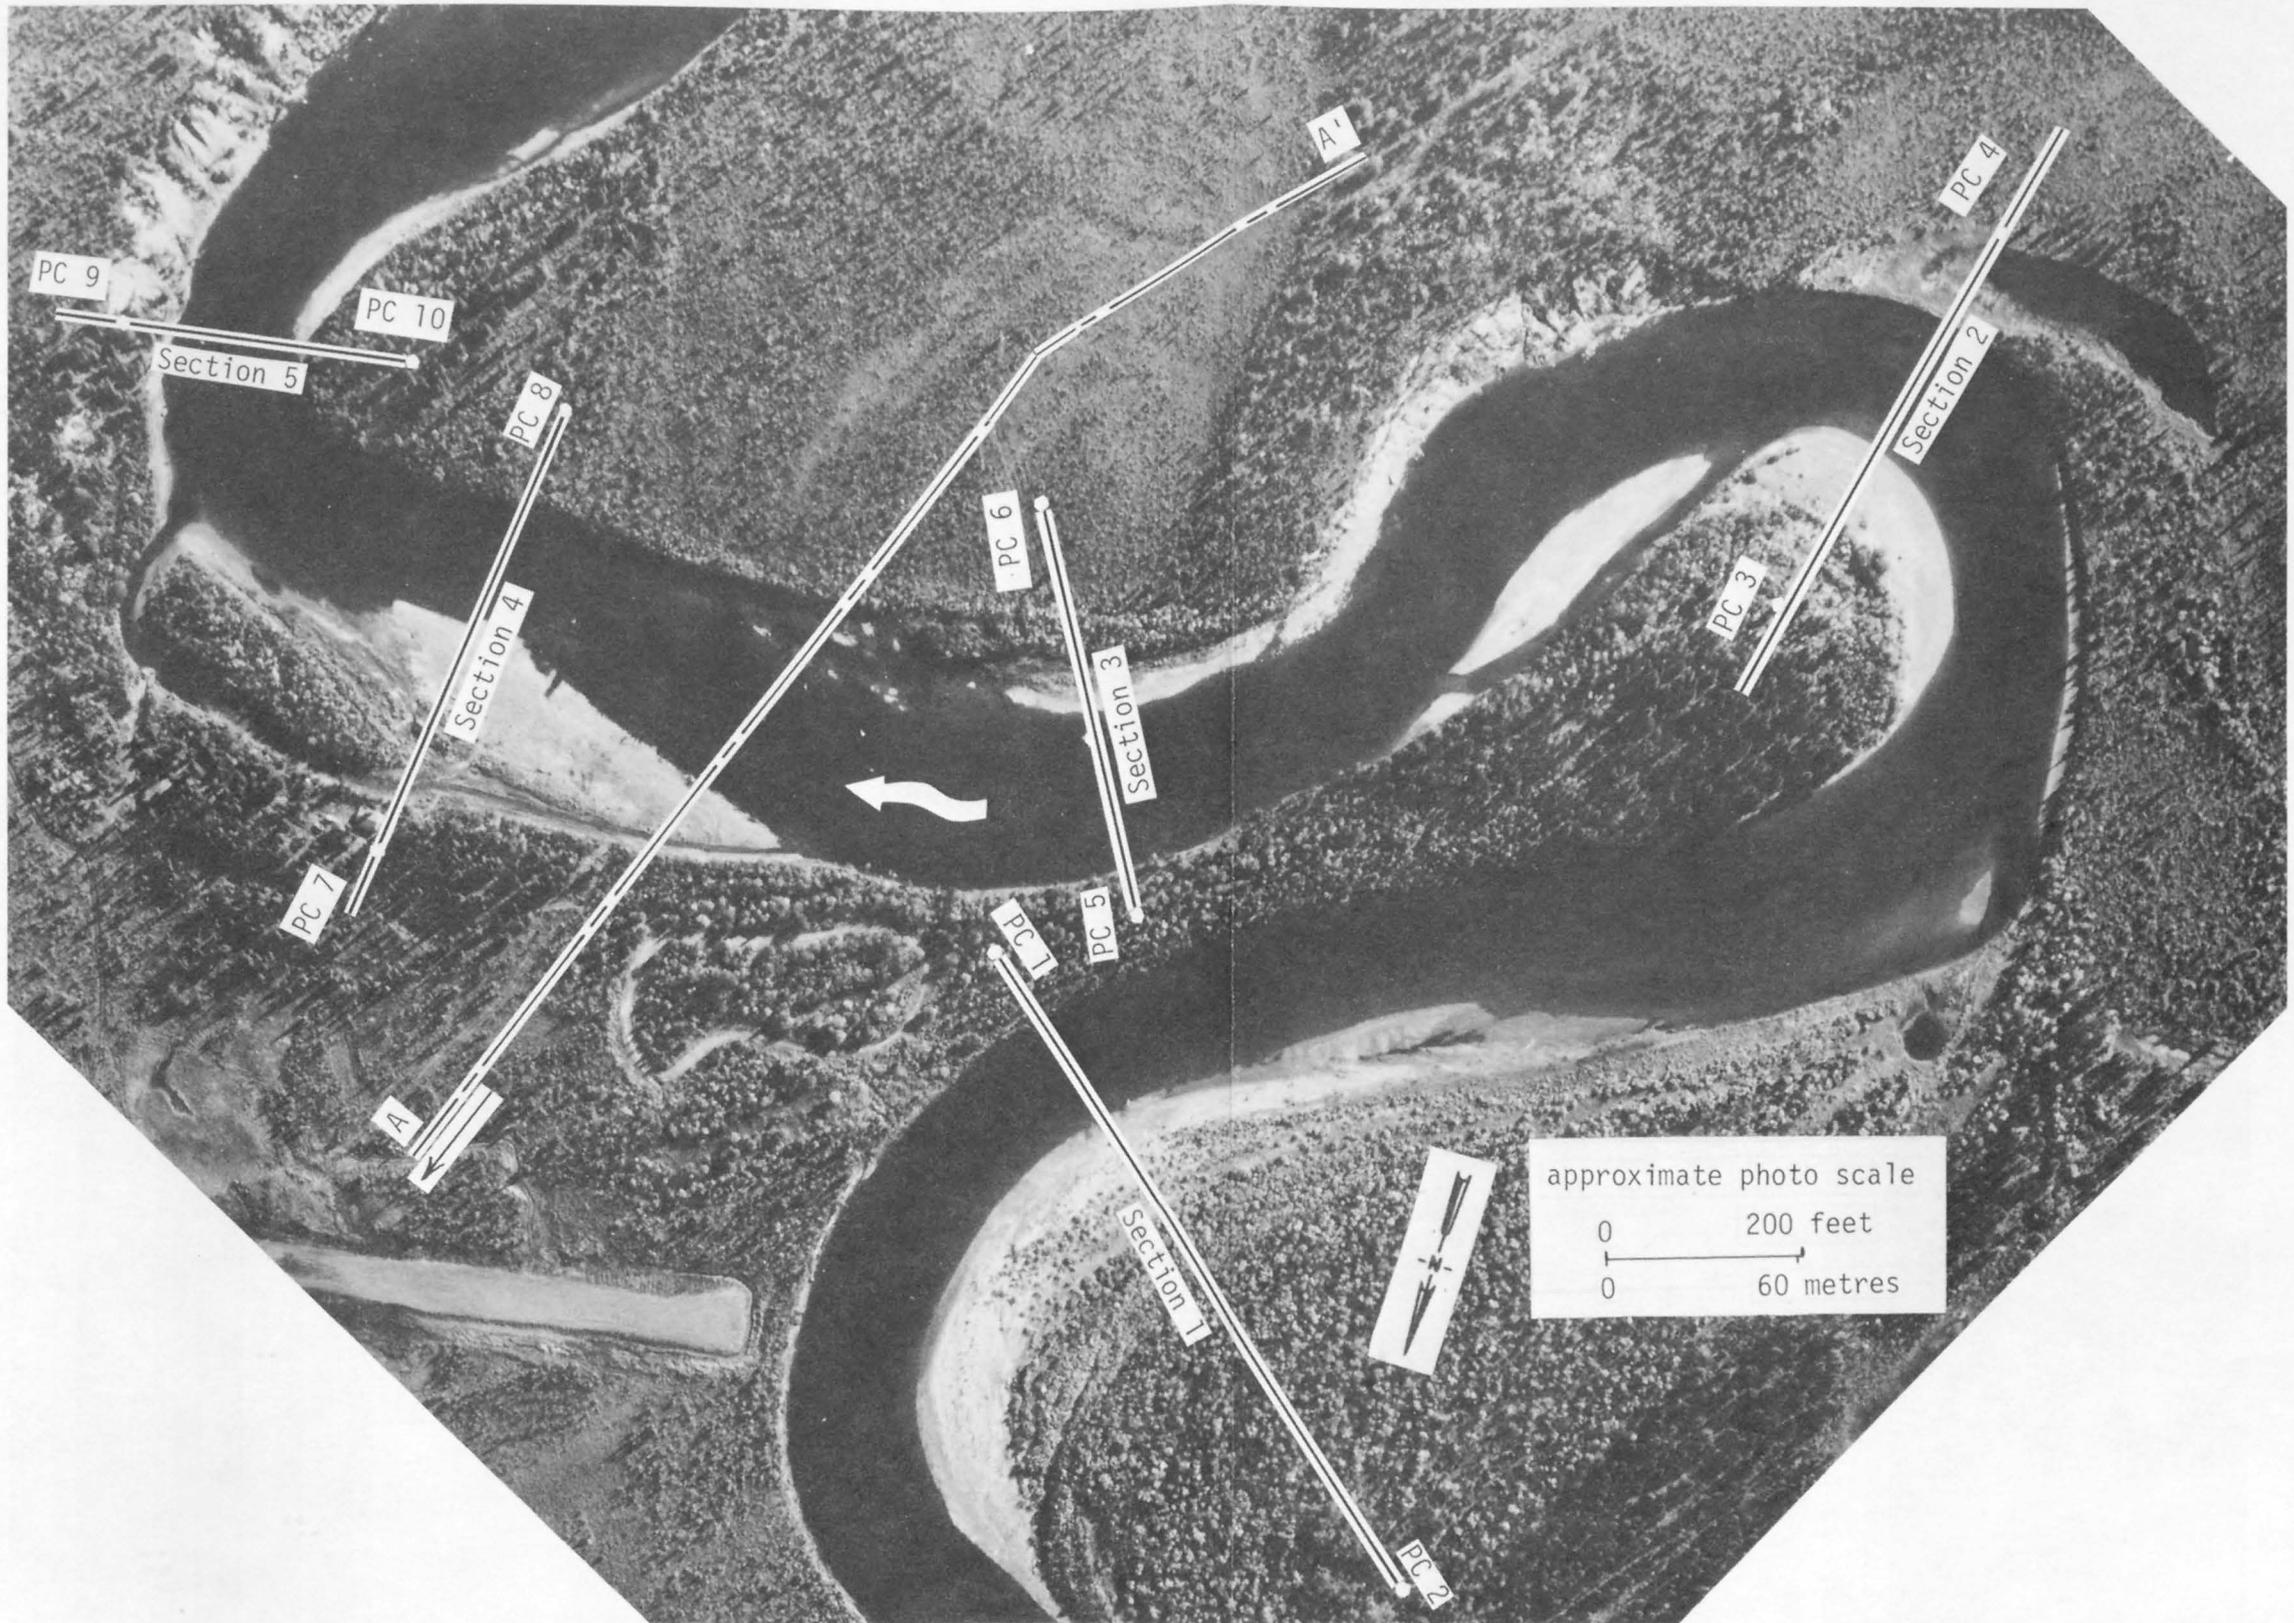
Figure 55. -- Gulkana River near Sourdough, August 31, 1974. ALYESKA PIPELINE SERVICE CO.-AIR PHOTO TECH.

Channel conditions.--Low-altitude vertical aerial stereophotography (scale 1:2,400) was obtained September 23, 1972, (fig. 54) to document preconstruction topography at the site. Vertical aerial strip photography (scale 1:6,000) taken August 31, 1974, (fig. 55) shows no significant channel erosion or construction activities have occurred in the crossing reach since September 23, 1972. Six cross sections (fig. 56) were surveyed May 15, 1973, to define preconstruction ground profiles in the crossing reach. On May 23, 1974, a channel erosion survey was made at a stream-flow discharge of 6,430 ft³/s (182 m³/s), gage height, 6.72 ft (205 m) at gaging station just downstream from Sourdough Creek, to determine maximum streambed scour at the cross sections.

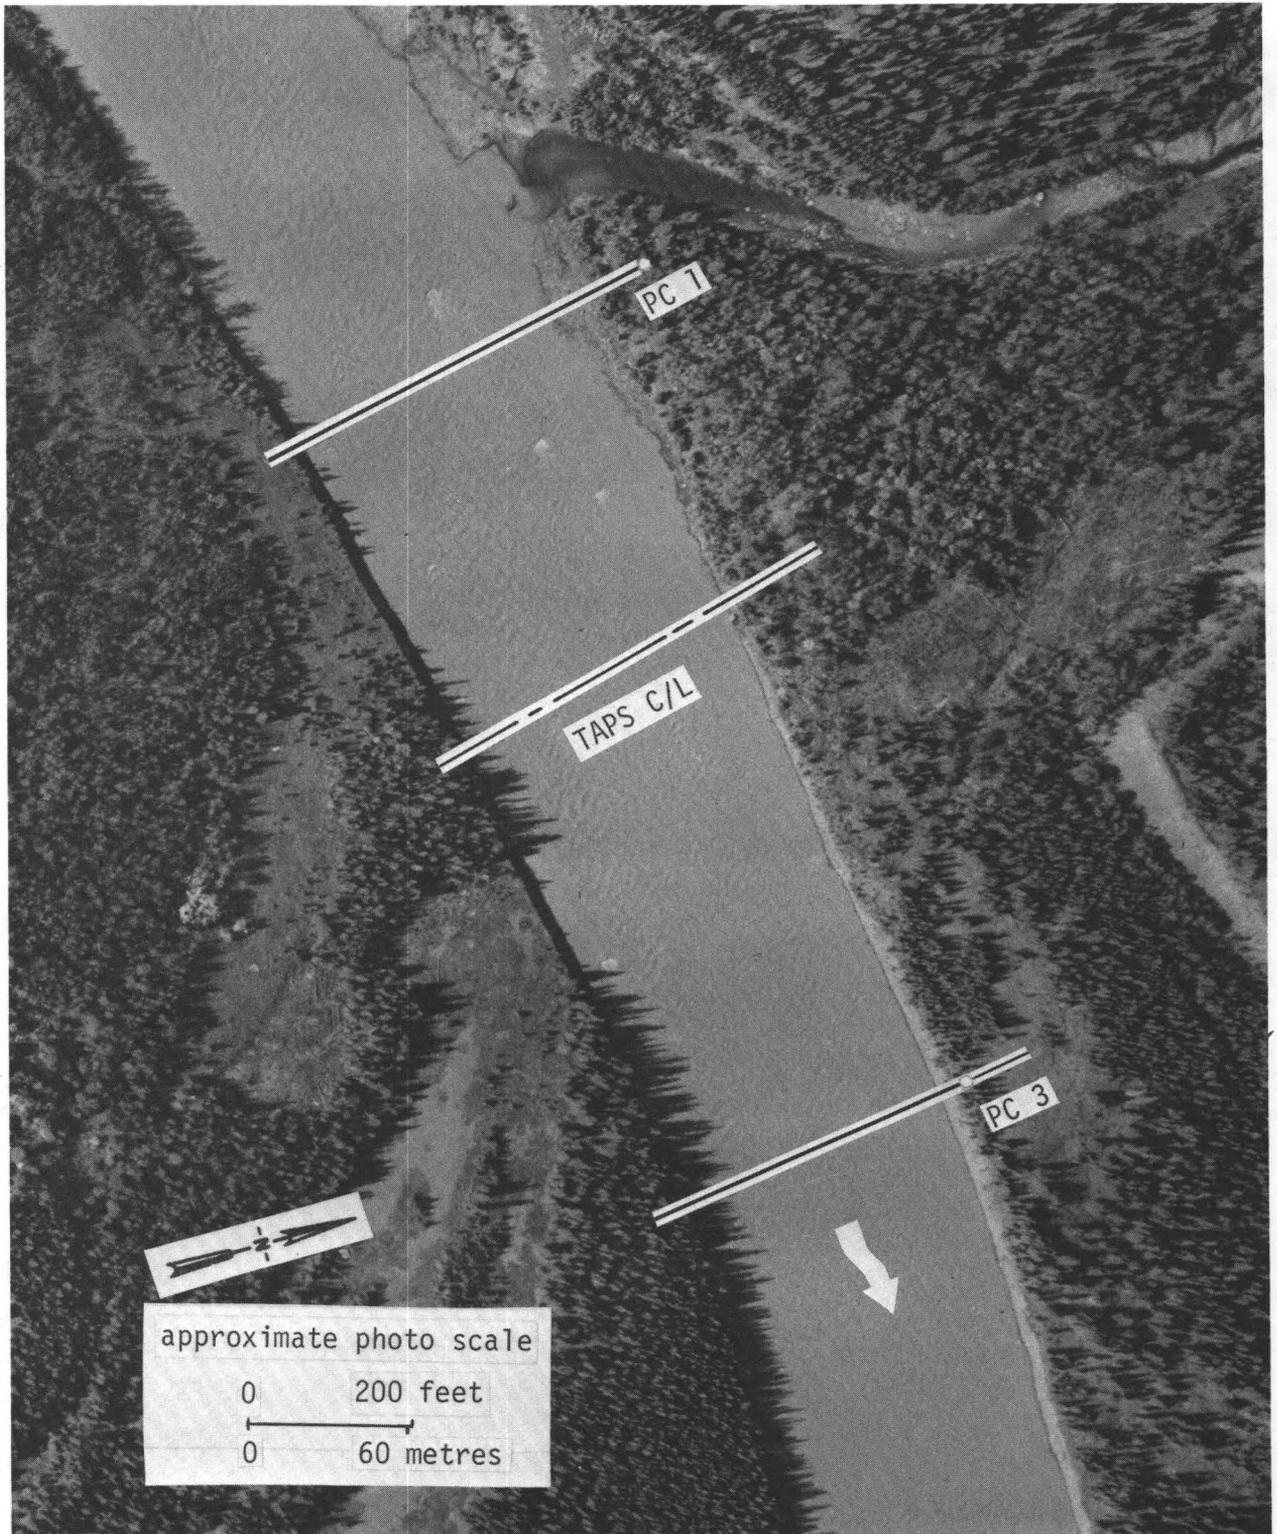
Figure 59. -- Tazlina River near Glennallen, August 31, 1974.
ALYESKA PIPELINE SERVICE CO.-AIR PHOTO TECH.

Channel conditions.--Low-altitude vertical aerial stereophotography (scale 1:2,400) was obtained September 23, 1972, (fig. 58) to document preconstruction topography of the site. Vertical aerial strip photography (scale 1:6,000) taken August 31, 1974, (fig. 59) shows no significant channel erosion or construction activities have occurred in the proposed crossing reach since September 23, 1972. Three cross sections (fig. 60) were surveyed September 22, 1973, to define preconstruction ground profiles in the crossing reach. On September 18, 1974, a channel survey of the original cross sections following the flood of August 15, 1974, shows 1 ft (0.3 m) of general scour in the crossing reach. There were no construction activities at the crossing.
