CHANNEL EROSION SURVEYS ALONG TAPS ROUTE, ALASKA, 1974

UNITED STATES DEPARTMENT OF THE INTERIOR
GEOLOGICAL SURVEY

Joseph M. Childers and Stanley H. Jones

OPEN-FILE REPORT

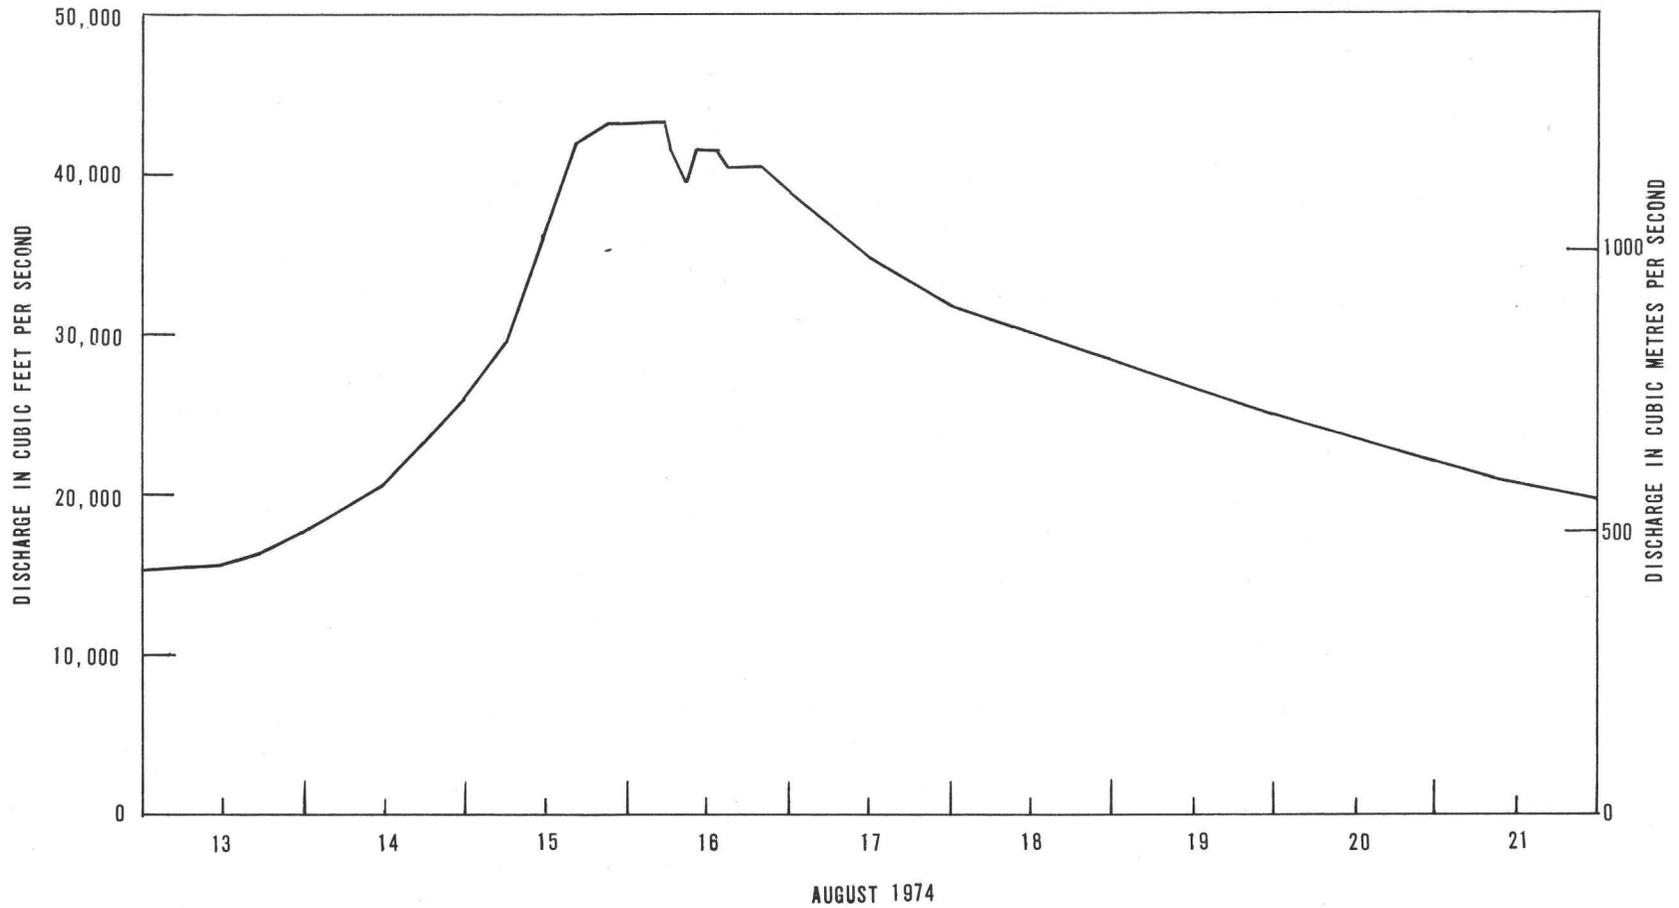
Figure 61.-- Discharge hydrograph for Tazlina River near Glennallen.

Floods.--Tazlina Lake's glacier-dammed outburst flood peaked at a discharge of 43,100 ft³/s (1,221 m³/s) (fig. 61) at the crossing reach.

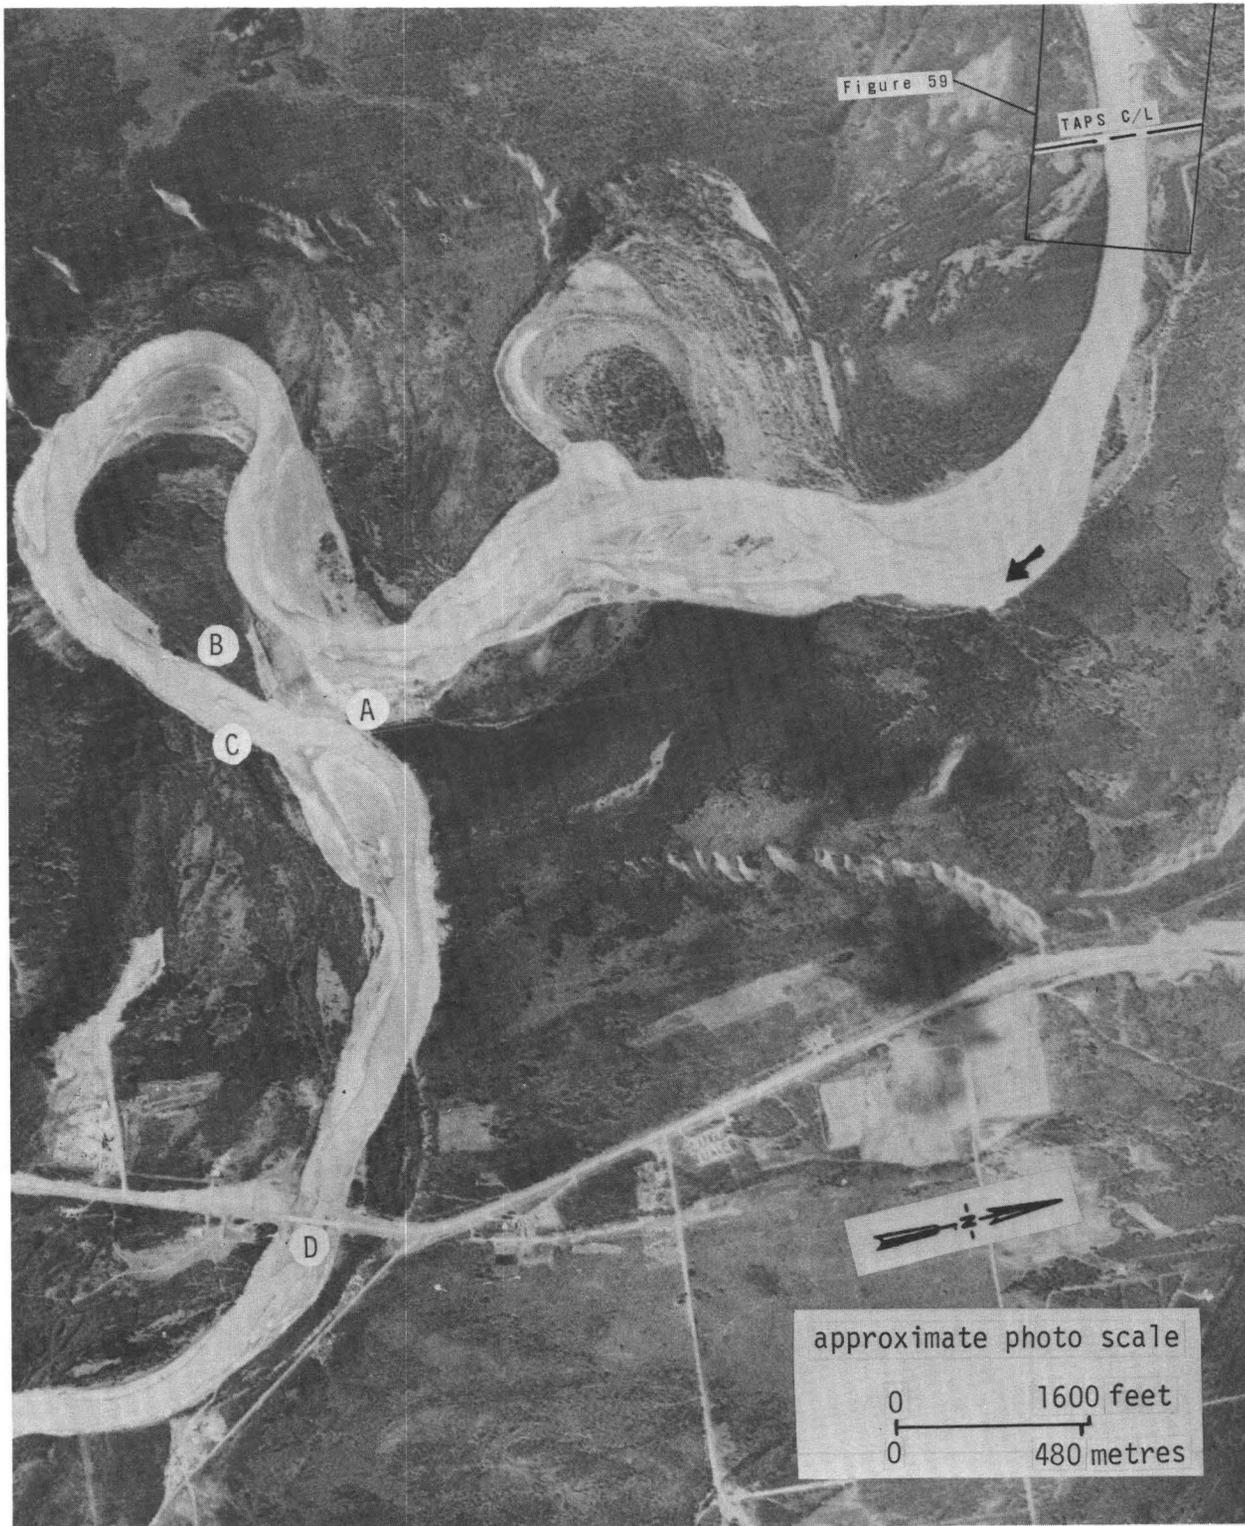
Figure 62. -- Tazlina River near Glennallen, June 15, 1974.
NORTH PACIFIC AERIAL SURVEYS

Comparison of aerial stereophotographs of September 23, 1972, (Childers, 1975, fig. 12) and June 15, 1974, of the meander downstream from the crossing shows no channel change at the meander neck A (fig. 62). (See discussion in Childers, 1975, p. 19.) The flood of August 15, 1974, overflowed the meander loop B, has begun to cut a channel there, and overflowed the bank along the area at C. Figure 63 shows the changes in the cross section at the bridge, site D.

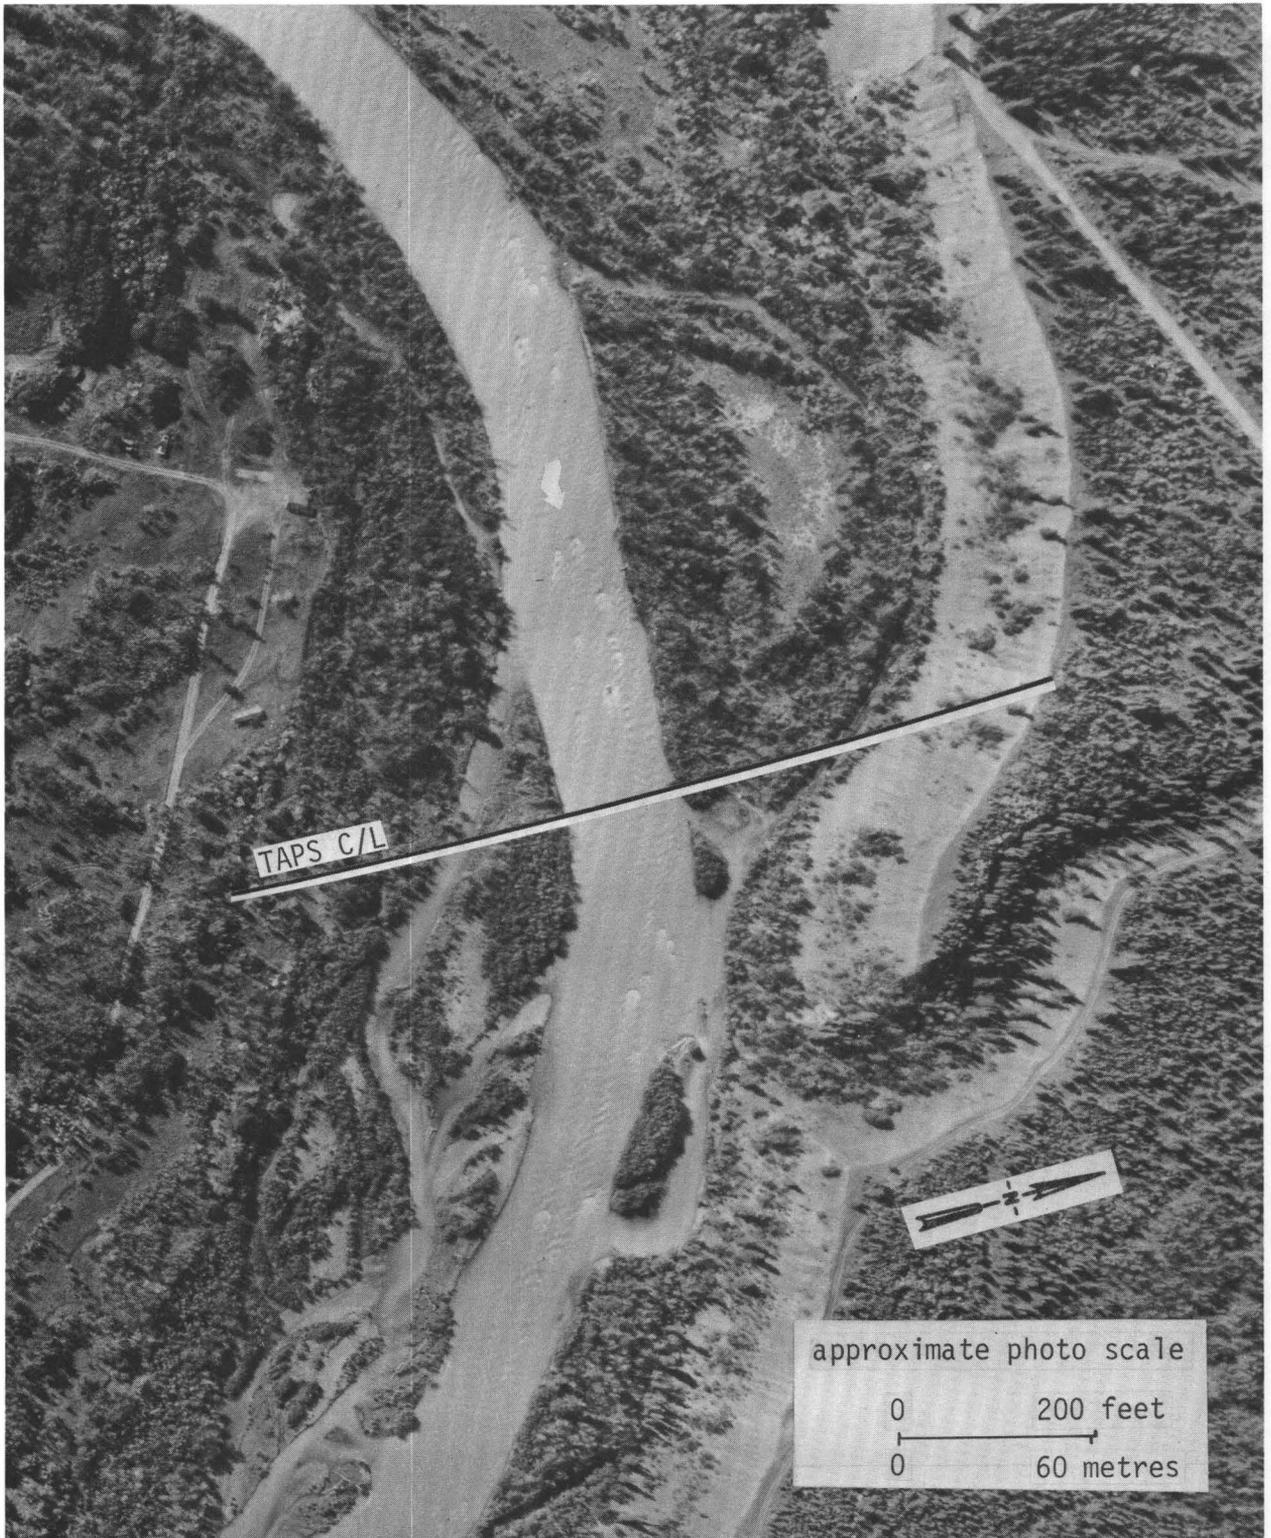
Figure 65. -- Klutina River near Copper Center, August 31, 1974.
ALYESKA PIPELINE SERVICE CO.-AIR PHOTO TECH.

Channel conditions.--Low-altitude vertical aerial stereophotography (scale 1:6,000) was obtained May 22, 1973, (fig. 64) to document preconstruction topography at the site. Vertical aerial strip photography (scale 1:6,000) taken August 31, 1974, (fig. 65) shows no significant channel erosion or construction activities have occurred in the crossing reach since May 22, 1973. The TAPS centerline section surveyed by Alyeska Pipeline Service Company on August 14, 1970, is shown in figure 66.

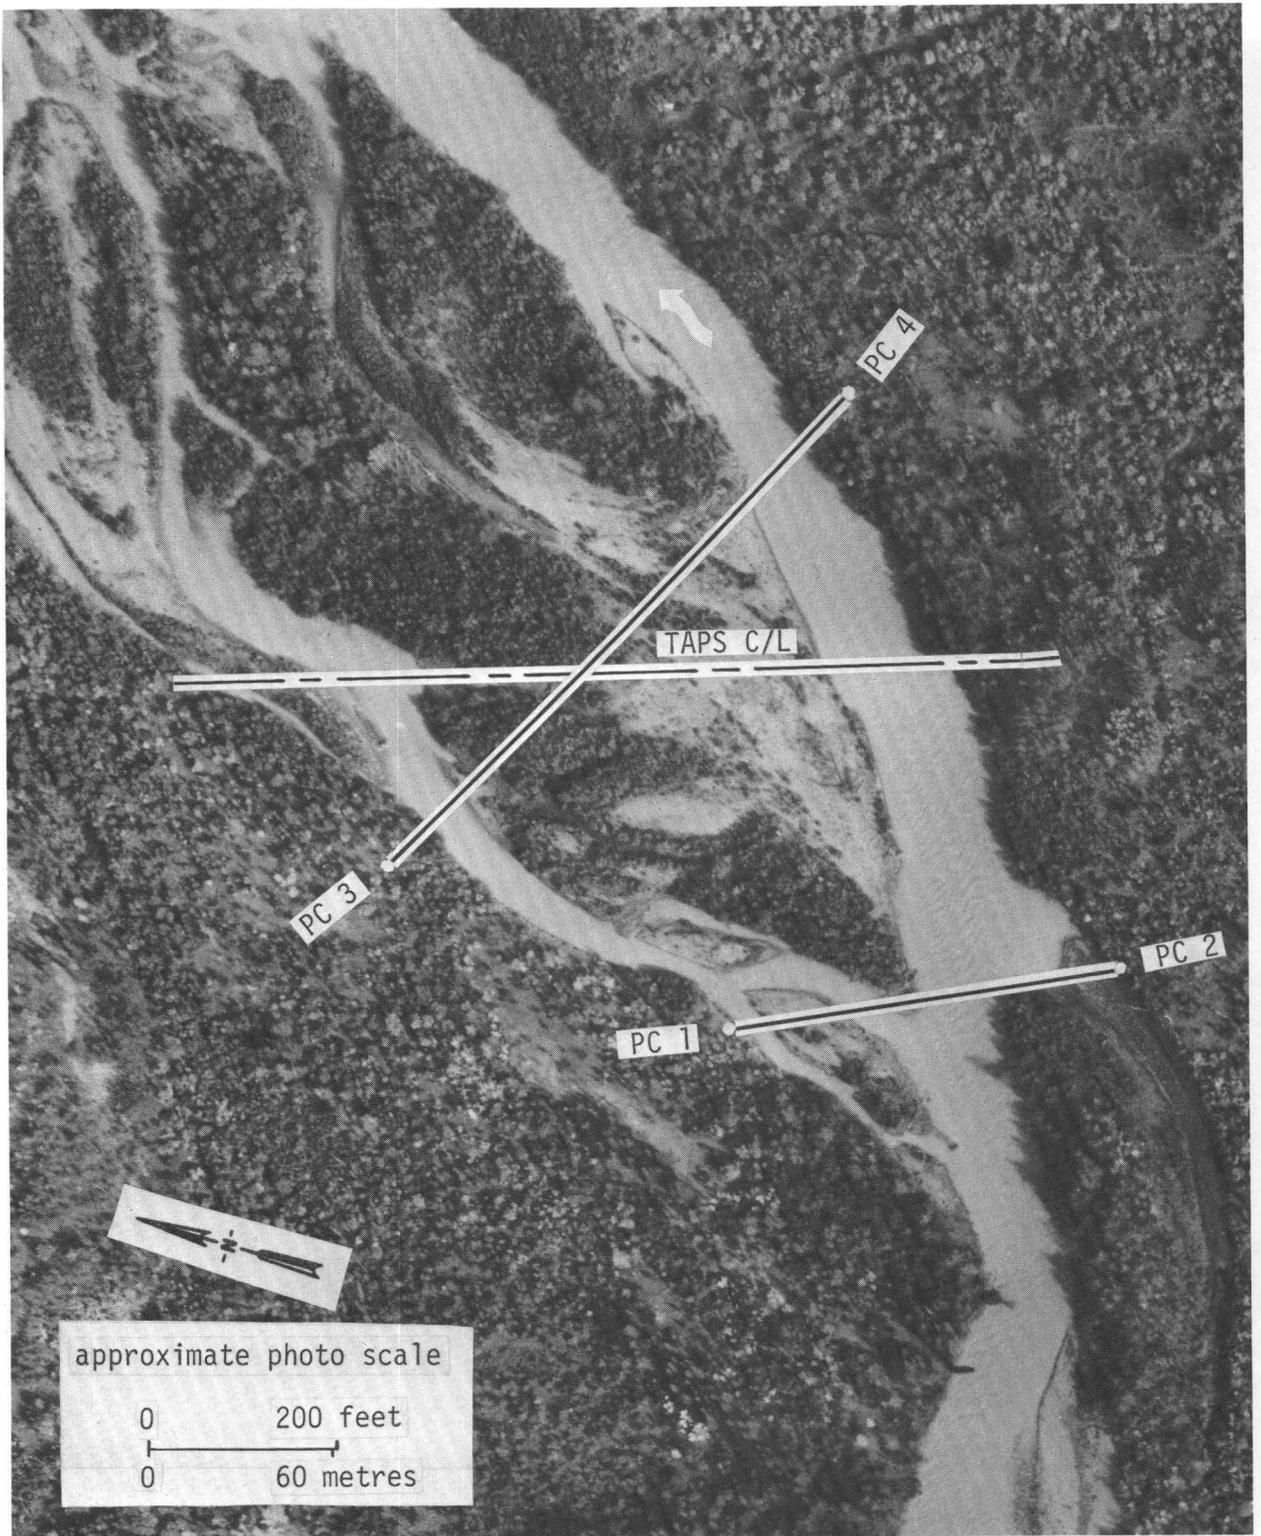
Figure 68. -- Tonsina River near Tonsina, August 31, 1974.
 ALYESKA PIPELINE SERVICE CO.-AIR PHOTO TECH.

Channel conditions.--Low-altitude vertical aerial stereophotography (scale 1:2,400) was obtained September 23, 1972, (fig. 67) to document preconstruction topography at the site. Vertical aerial strip photography (scale 1:6,000) taken August 31, 1974, (fig. 68) shows no significant channel erosion or construction activities have occurred in the crossing reach since September 23, 1972. Three cross sections (fig. 69) were surveyed September 28, 1972, to define preconstruction ground profiles in the crossing reach. On September 1974 a channel survey of the three cross sections found no significant lateral erosion.

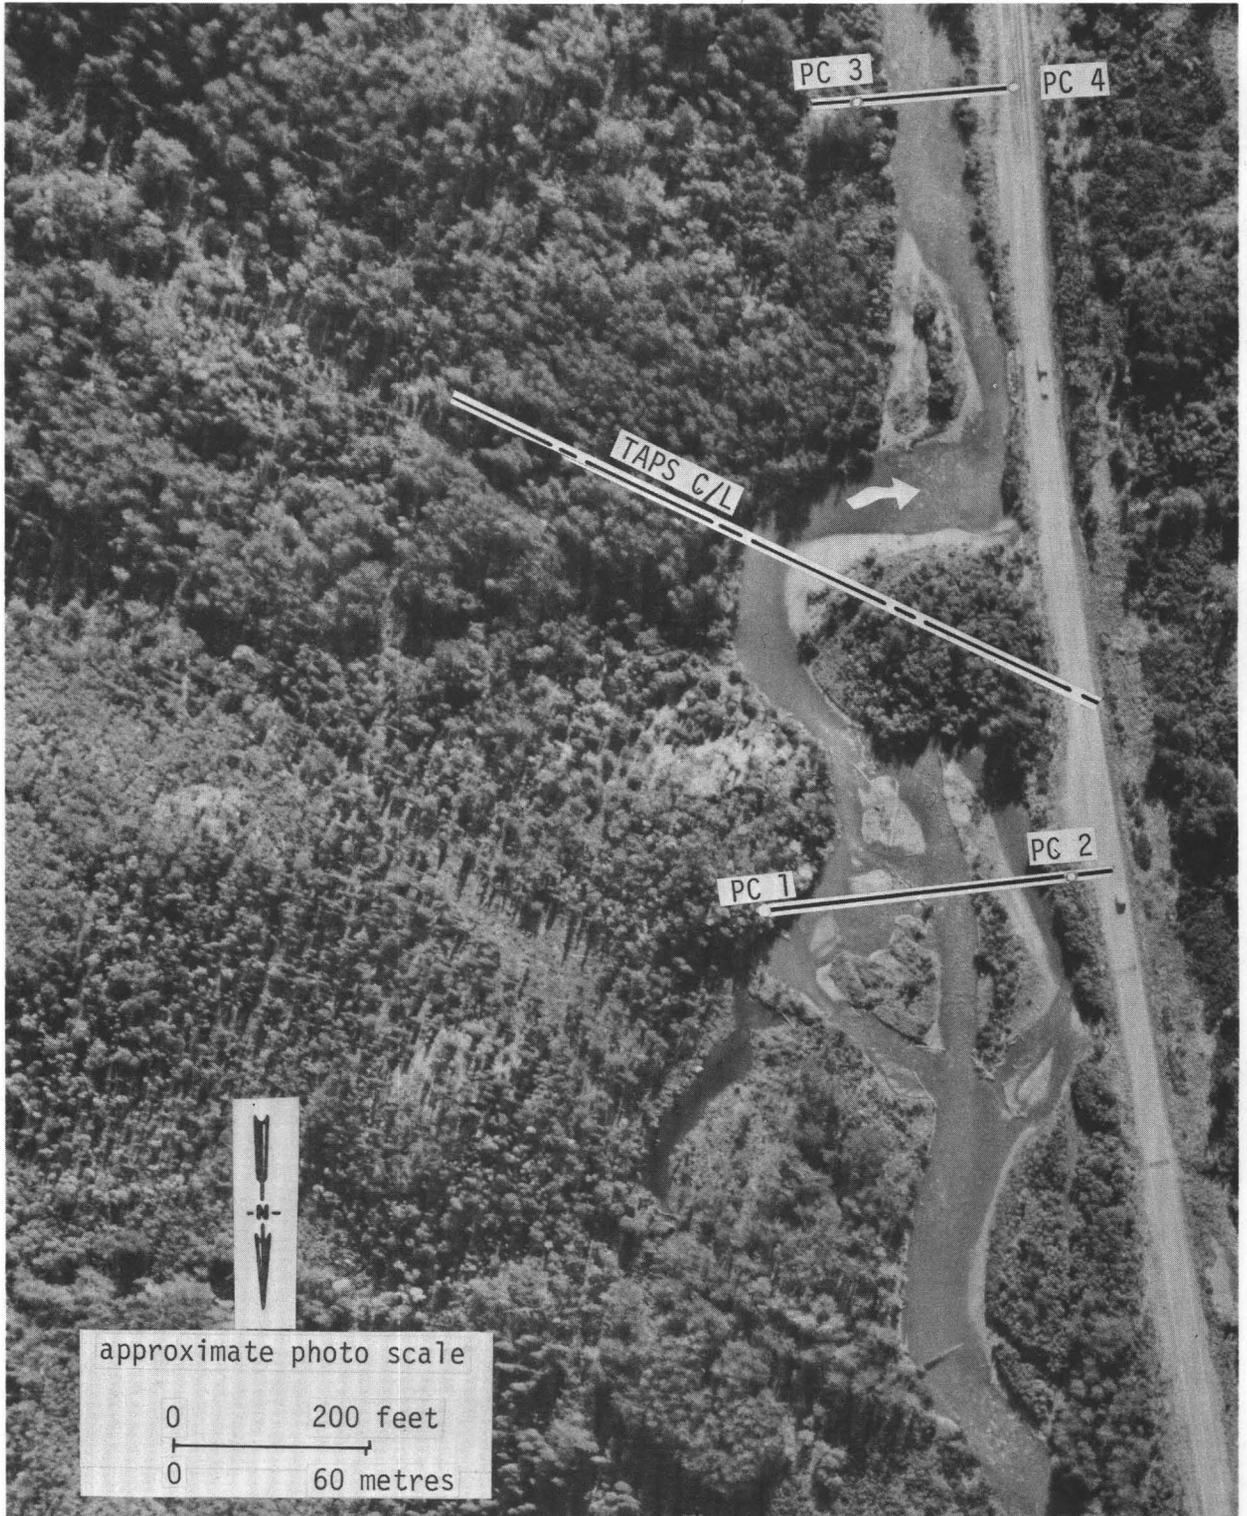
Figure 72. -- Tiekel River at Tiekel, August 31, 1974.
ALYESKA PIPELINE SERVICE CO.-AIR PHOTO TECH.

Channel conditions.--Low-altitude vertical aerial stereophotography (scale 1:2,400) was obtained September 23, 1972, (fig. 71) to document preconstruction topography at the site. Vertical aerial strip photography (scale 1:6,000) taken August 31, 1974, (fig. 72) shows no significant channel erosion or construction activities have occurred in the crossing reach since September 23, 1972. Three cross sections (fig. 73) were surveyed May 13, 1973, to define preconstruction ground profiles in the crossing reach. On August 1974, a channel survey of the three cross sections found no significant lateral erosion.

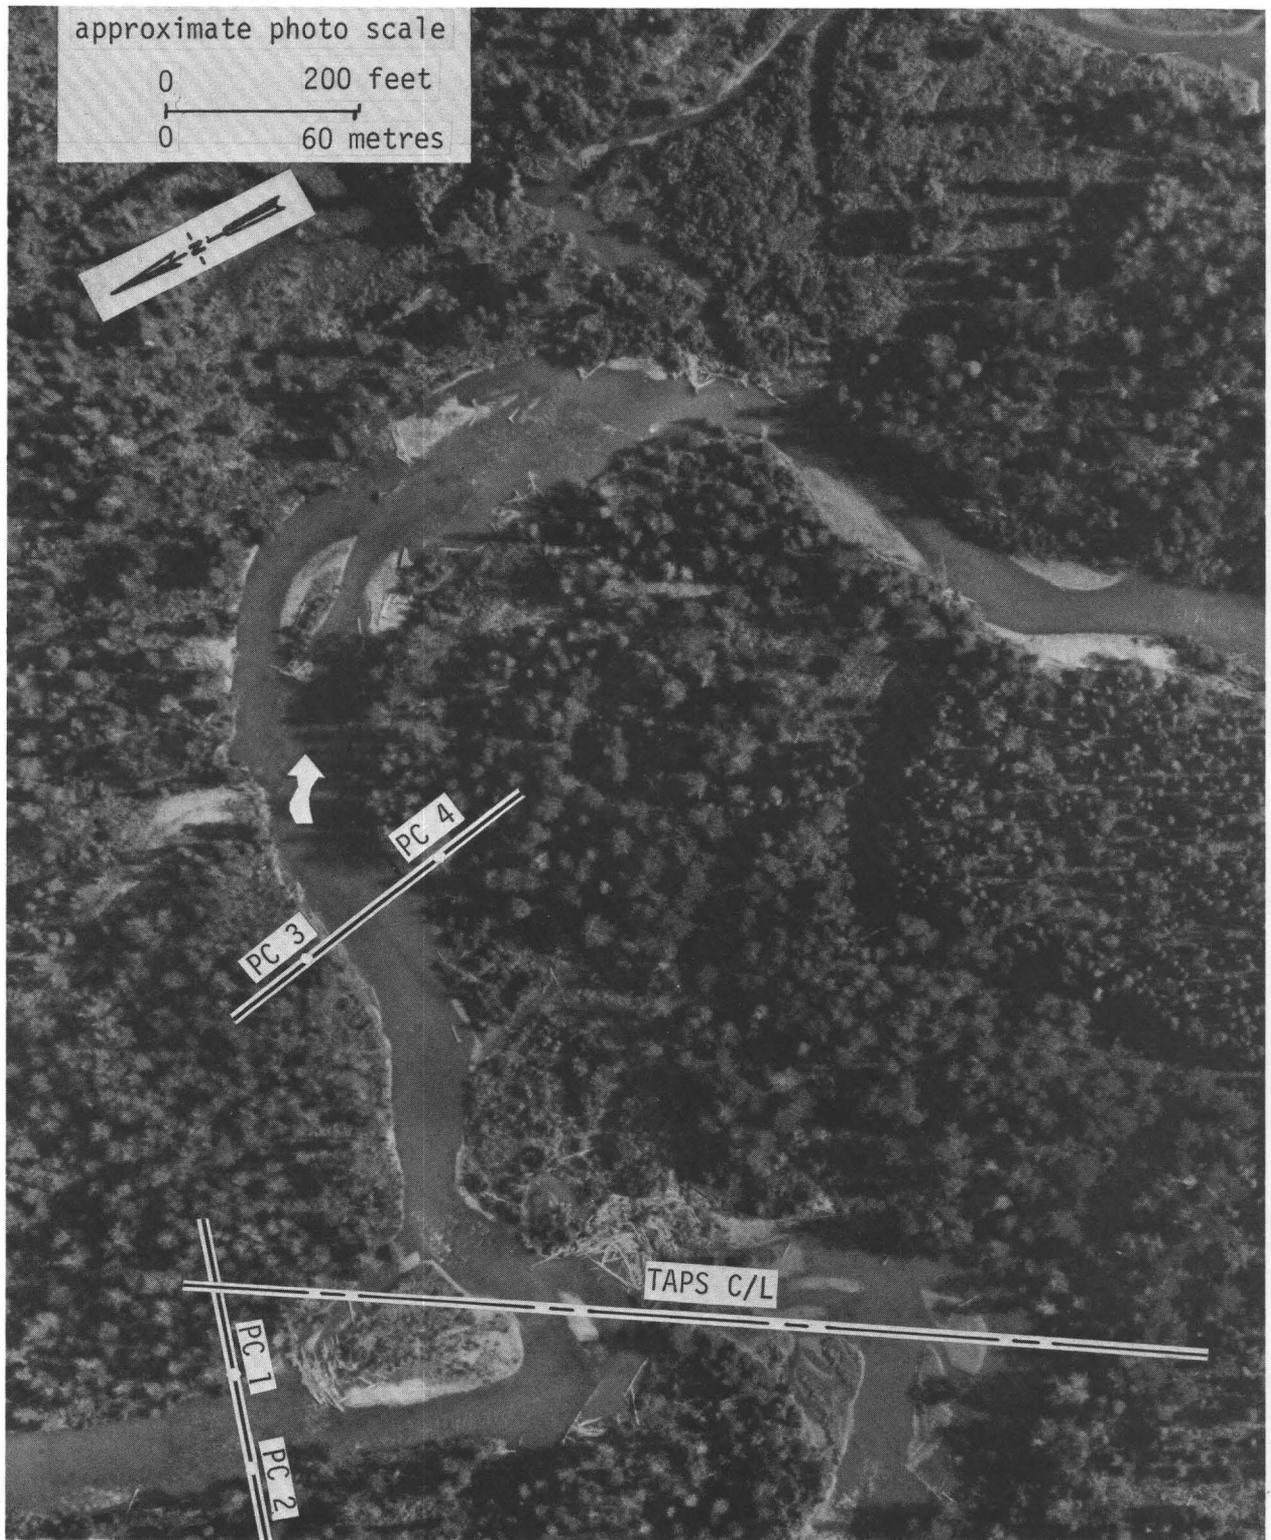
Figure 75. -- Tiekel River near Tiekel, August 31, 1974.
ALYESKA PIPELINE SERVICE CO.-AIR PHOTO TECH.

Channel conditions.--Low-altitude vertical aerial stereophotography (scale 1:2,400) was obtained September 23, 1972, (fig. 74) to document preconstruction topography at the site. Vertical aerial strip photography (scale 1:6,000) taken August 31, 1974, (fig. 75) shows no significant channel erosion or construction activities have occurred in the crossing reach since September 23, 1972. Three cross sections (fig. 76) were surveyed May 19, 1973, to define preconstruction ground profiles in the crossing reach. On August 1974, a channel survey of the three cross sections found no significant lateral erosion.

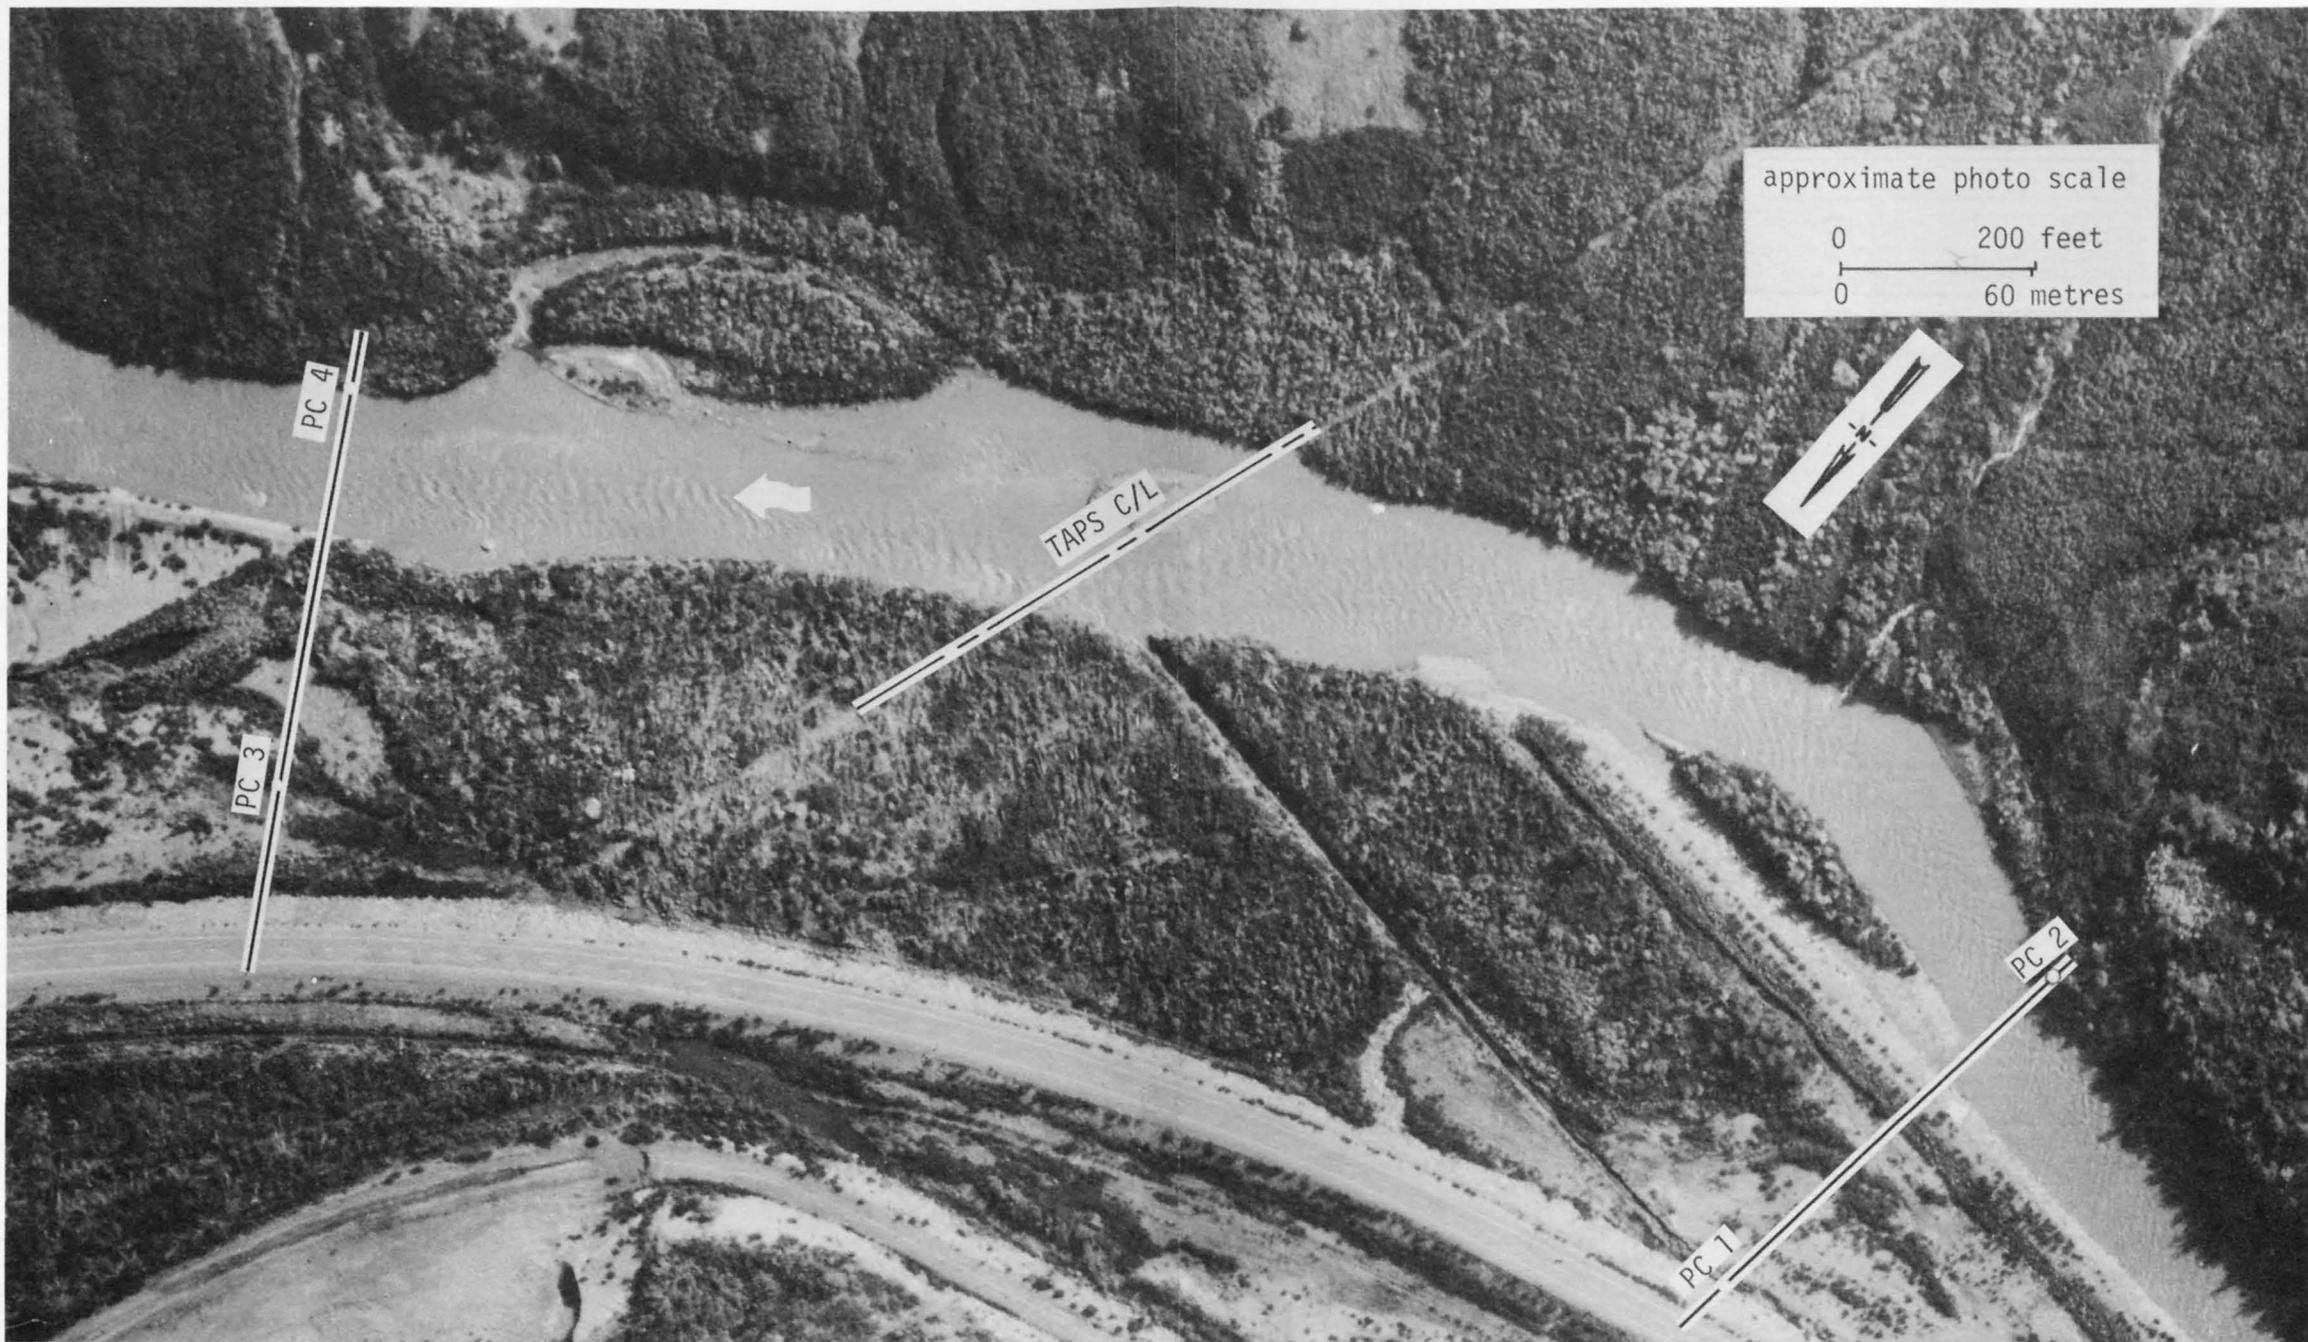
Figure 78. -- Tsina River near Tiekel, August 31, 1974.
ALYESKA PIPELINE SERVICE CO.-AIR PHOTO TECH.

Channel conditions.--Low-altitude vertical aerial stereophotography (scale 1:2,400) was obtained September 23, 1972, (fig. 77) to document preconstruction topography at the site. Vertical aerial strip photography (scale 1:6,000) taken August 31, 1974, (fig. 78) shows no significant channel erosion or construction activities have occurred in the crossing reach since September 23, 1972. Three cross sections (fig. 79) were surveyed May 17, 1973, to determine preconstruction ground profiles in the crossing reach. On August 1974, a channel survey of the three cross sections found no significant lateral erosion.

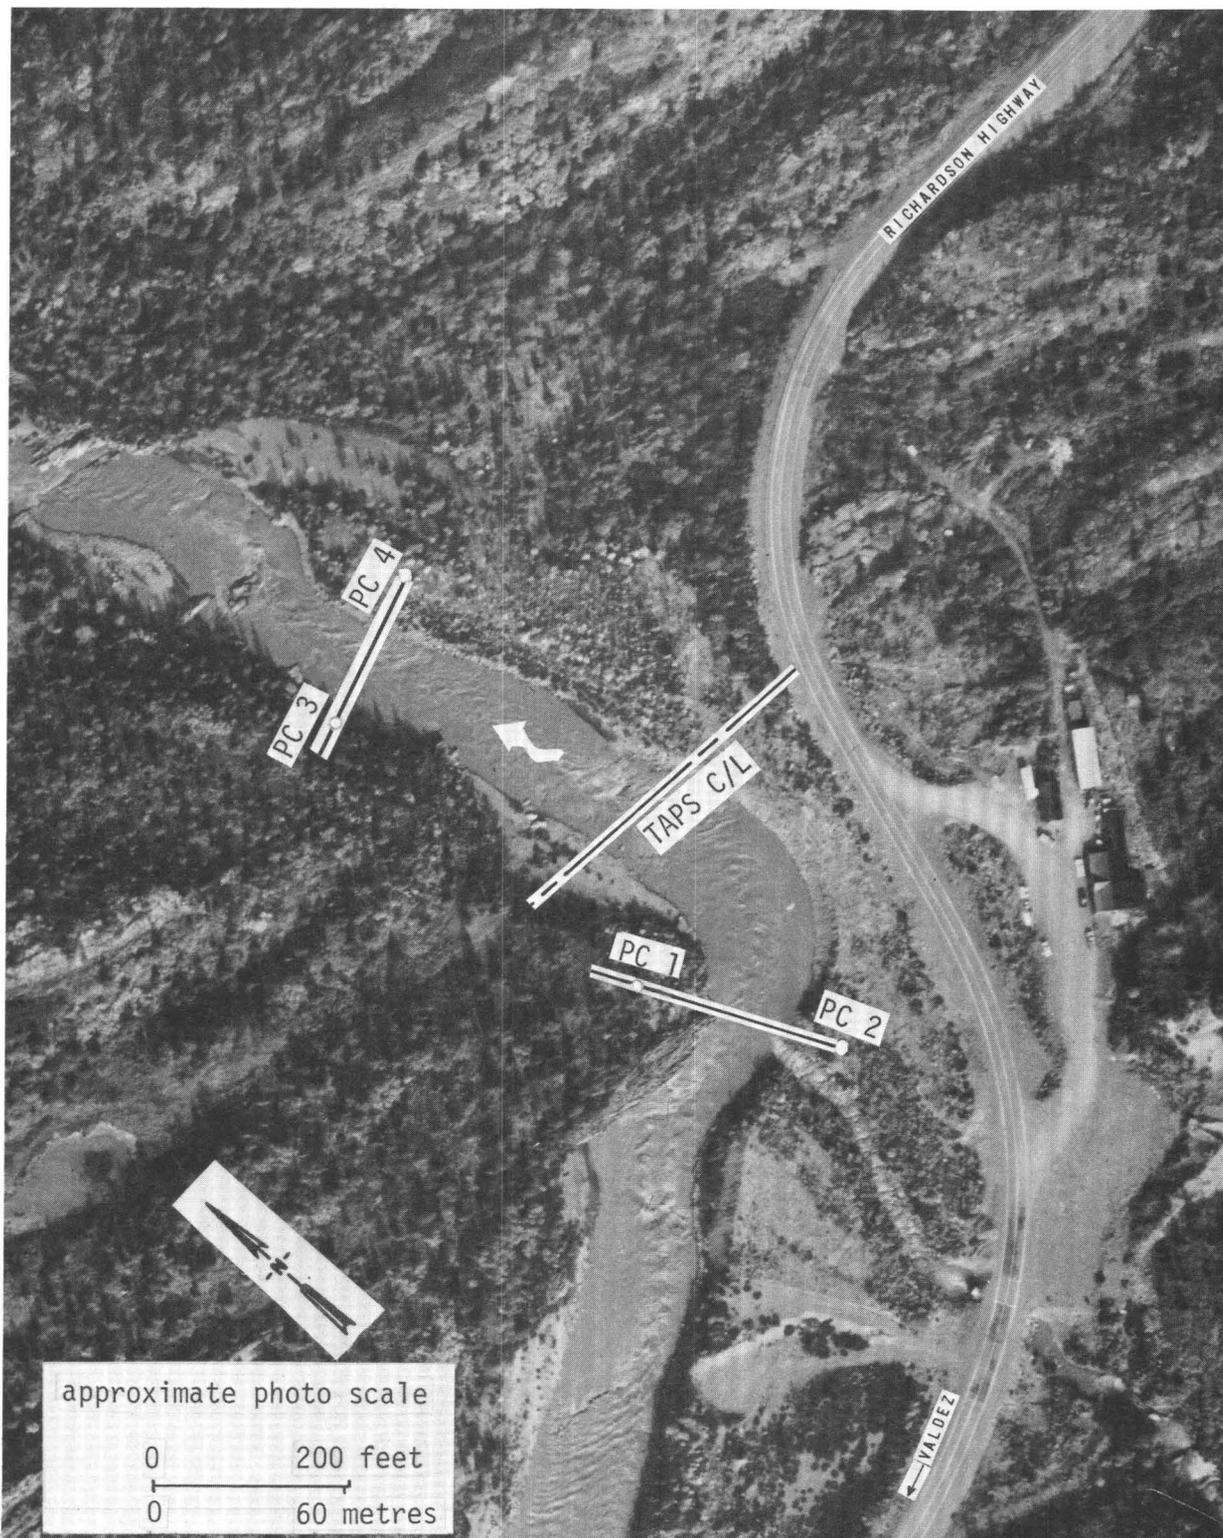
Figure 81. -- Tsina River near Ptarmigan, August 31, 1974.
 ALYESKA PIPELINE SERVICE CO.-AIR PHOTO TECH.

Channel conditions.--Low-altitude vertical aerial stereophotography (scale 1:2,400) was obtained September 23, 1972, (fig. 80) to document preconstruction topography at the site. Vertical aerial strip photography (scale 1:6,000) taken August 31, 1974, (fig. 81) shows no significant channel erosion or construction activities have occurred in the crossing reach since September 23, 1972. Three cross sections (fig. 82) were surveyed May 17, 1973, to define preconstruction ground profiles in the crossing reach. On August 17, 1974, a channel survey of the three cross sections found no significant lateral erosion.

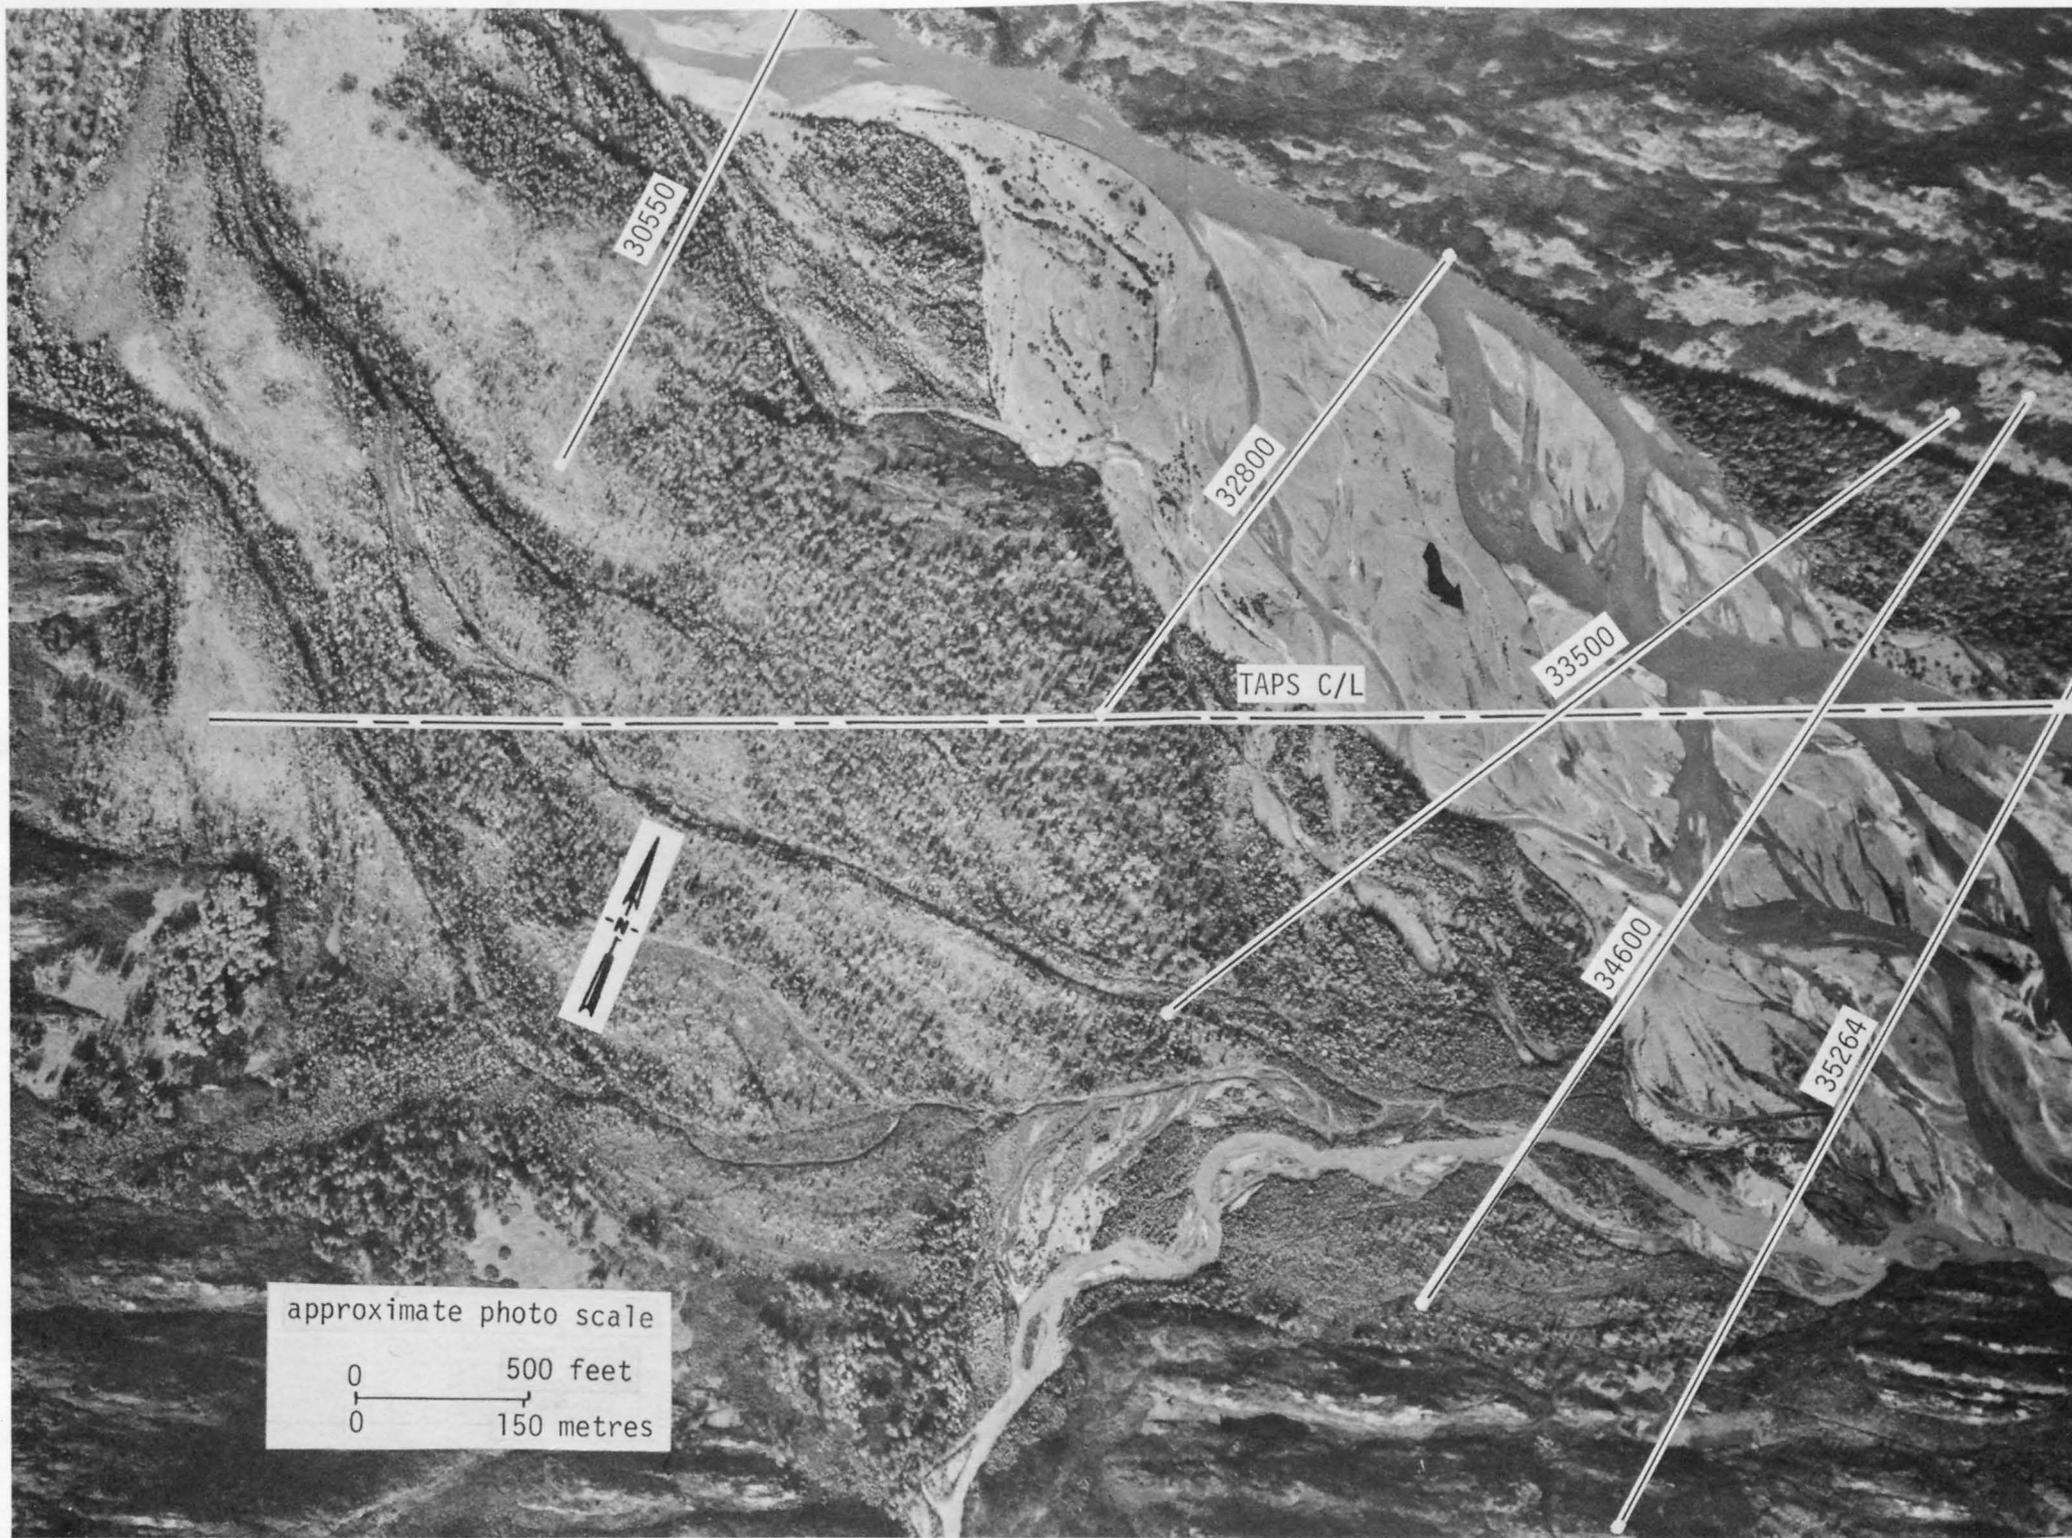
Figure 84. -- Tsina River at Ptarmigan, August 31, 1974.
ALYESKA PIPELINE SERVICE CO.-AIR PHOTO TECH.

Channel conditions.--Low-altitude vertical aerial stereophotography (scale 1:6,000) was obtained September 23, 1972, (fig. 83) to document preconstruction topography at the site. Vertical aerial strip photography (scale 1:6,000) taken August 31, 1974, (fig. 84) shows the main channel flow has concentrated along the left bank in sections 34600 and 35264. No significant channel erosion or construction activities have occurred since September 23, 1972. The six cross sections shown in figure 85 were surveyed by Alyeska Pipeline Service Company to define preconstruction ground profiles for the purpose of pipeline design.

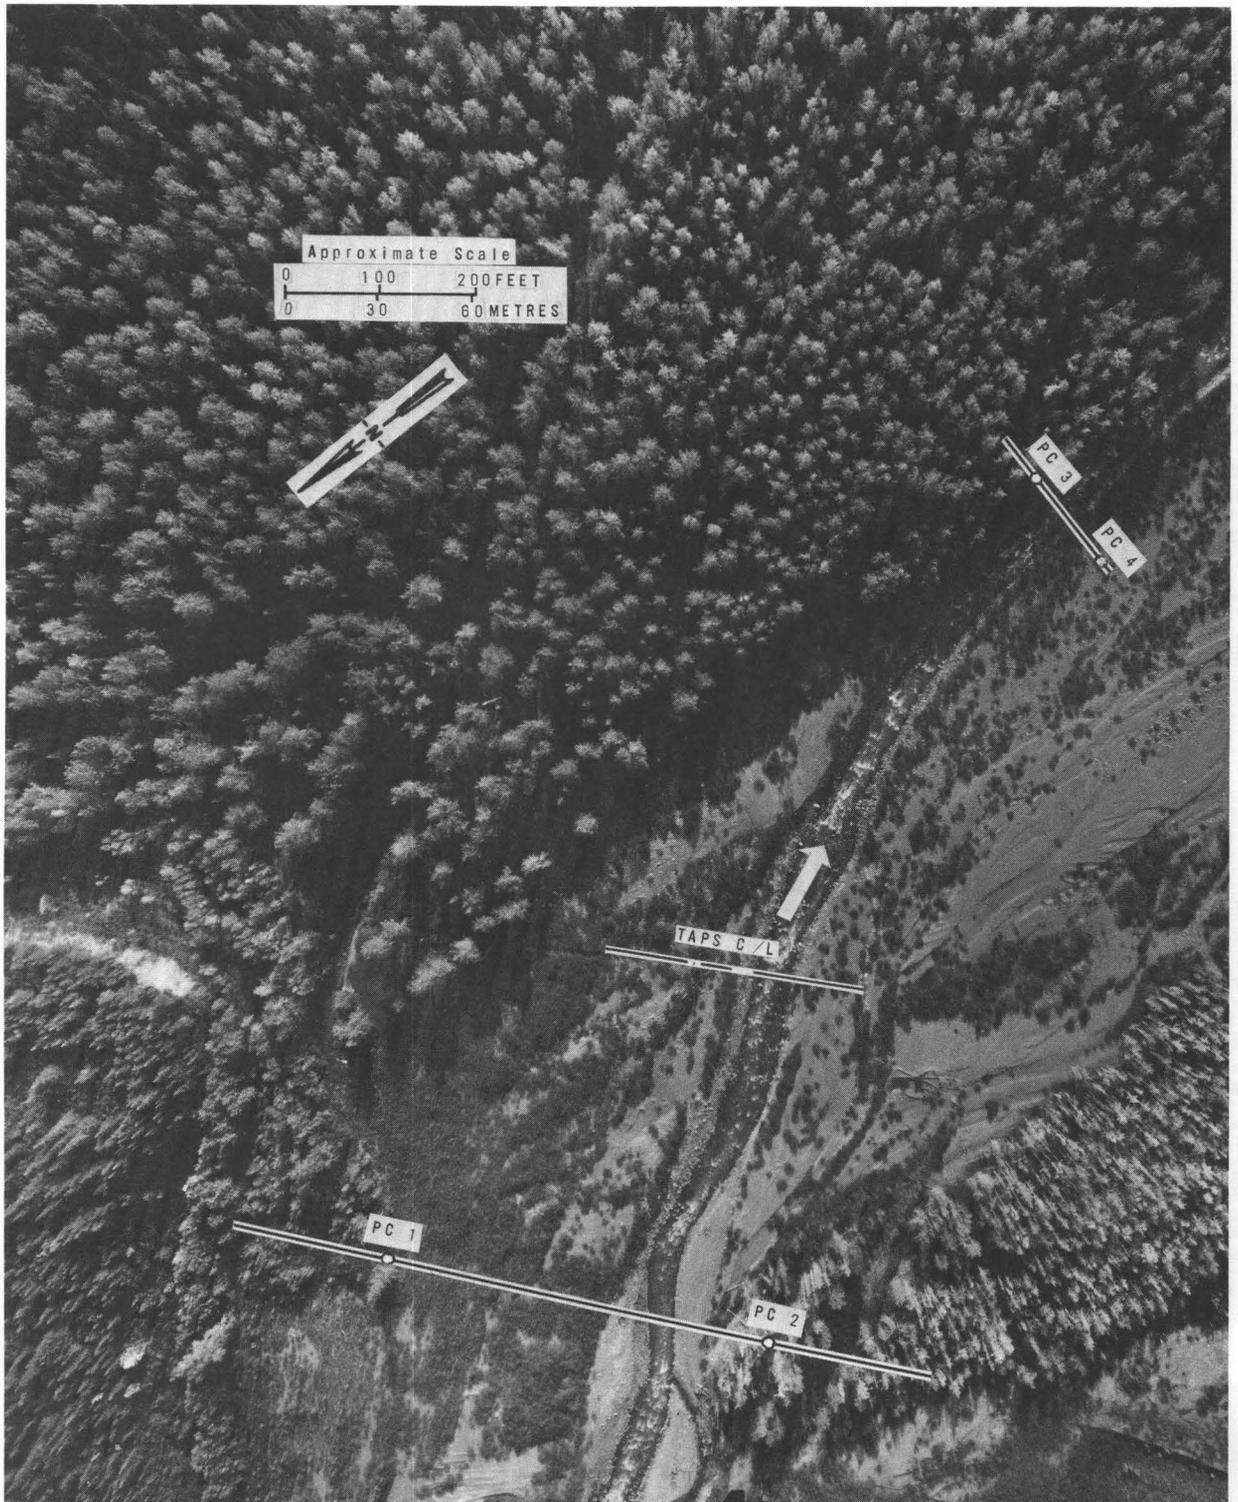
Figure 86. -- Sheep Creek near Valdez, September 23, 1972.
NORTH PACIFIC AERIAL SURVEYS

Channel conditions.--Low-altitude vertical aerial stereophotography (scale 1:2,400) was obtained September 23, 1972, (fig. 86) to document preconstruction topography at the site. Vertical aerial strip photography (scale 1:6,000) obtained August 31, 1974, (fig. 87) shows no significant channel erosion or construction activities have occurred in the immediate vicinity of the crossing reach since September 23, 1972. A large removal site is located 800 ft (240 m) north of the crossing reach. Three cross sections (fig. 88) were surveyed May 19, 1973, to define preconstruction ground profiles in the crossing reach.
