CHANNEL EROSION SURVEYS ALONG TAPS ROUTE, ALASKA, 1974

UNITED STATES DEPARTMENT OF THE INTERIOR
GEOLOGICAL SURVEY

Joseph M. Childers and Stanley H. Jones

OPEN-FILE REPORT

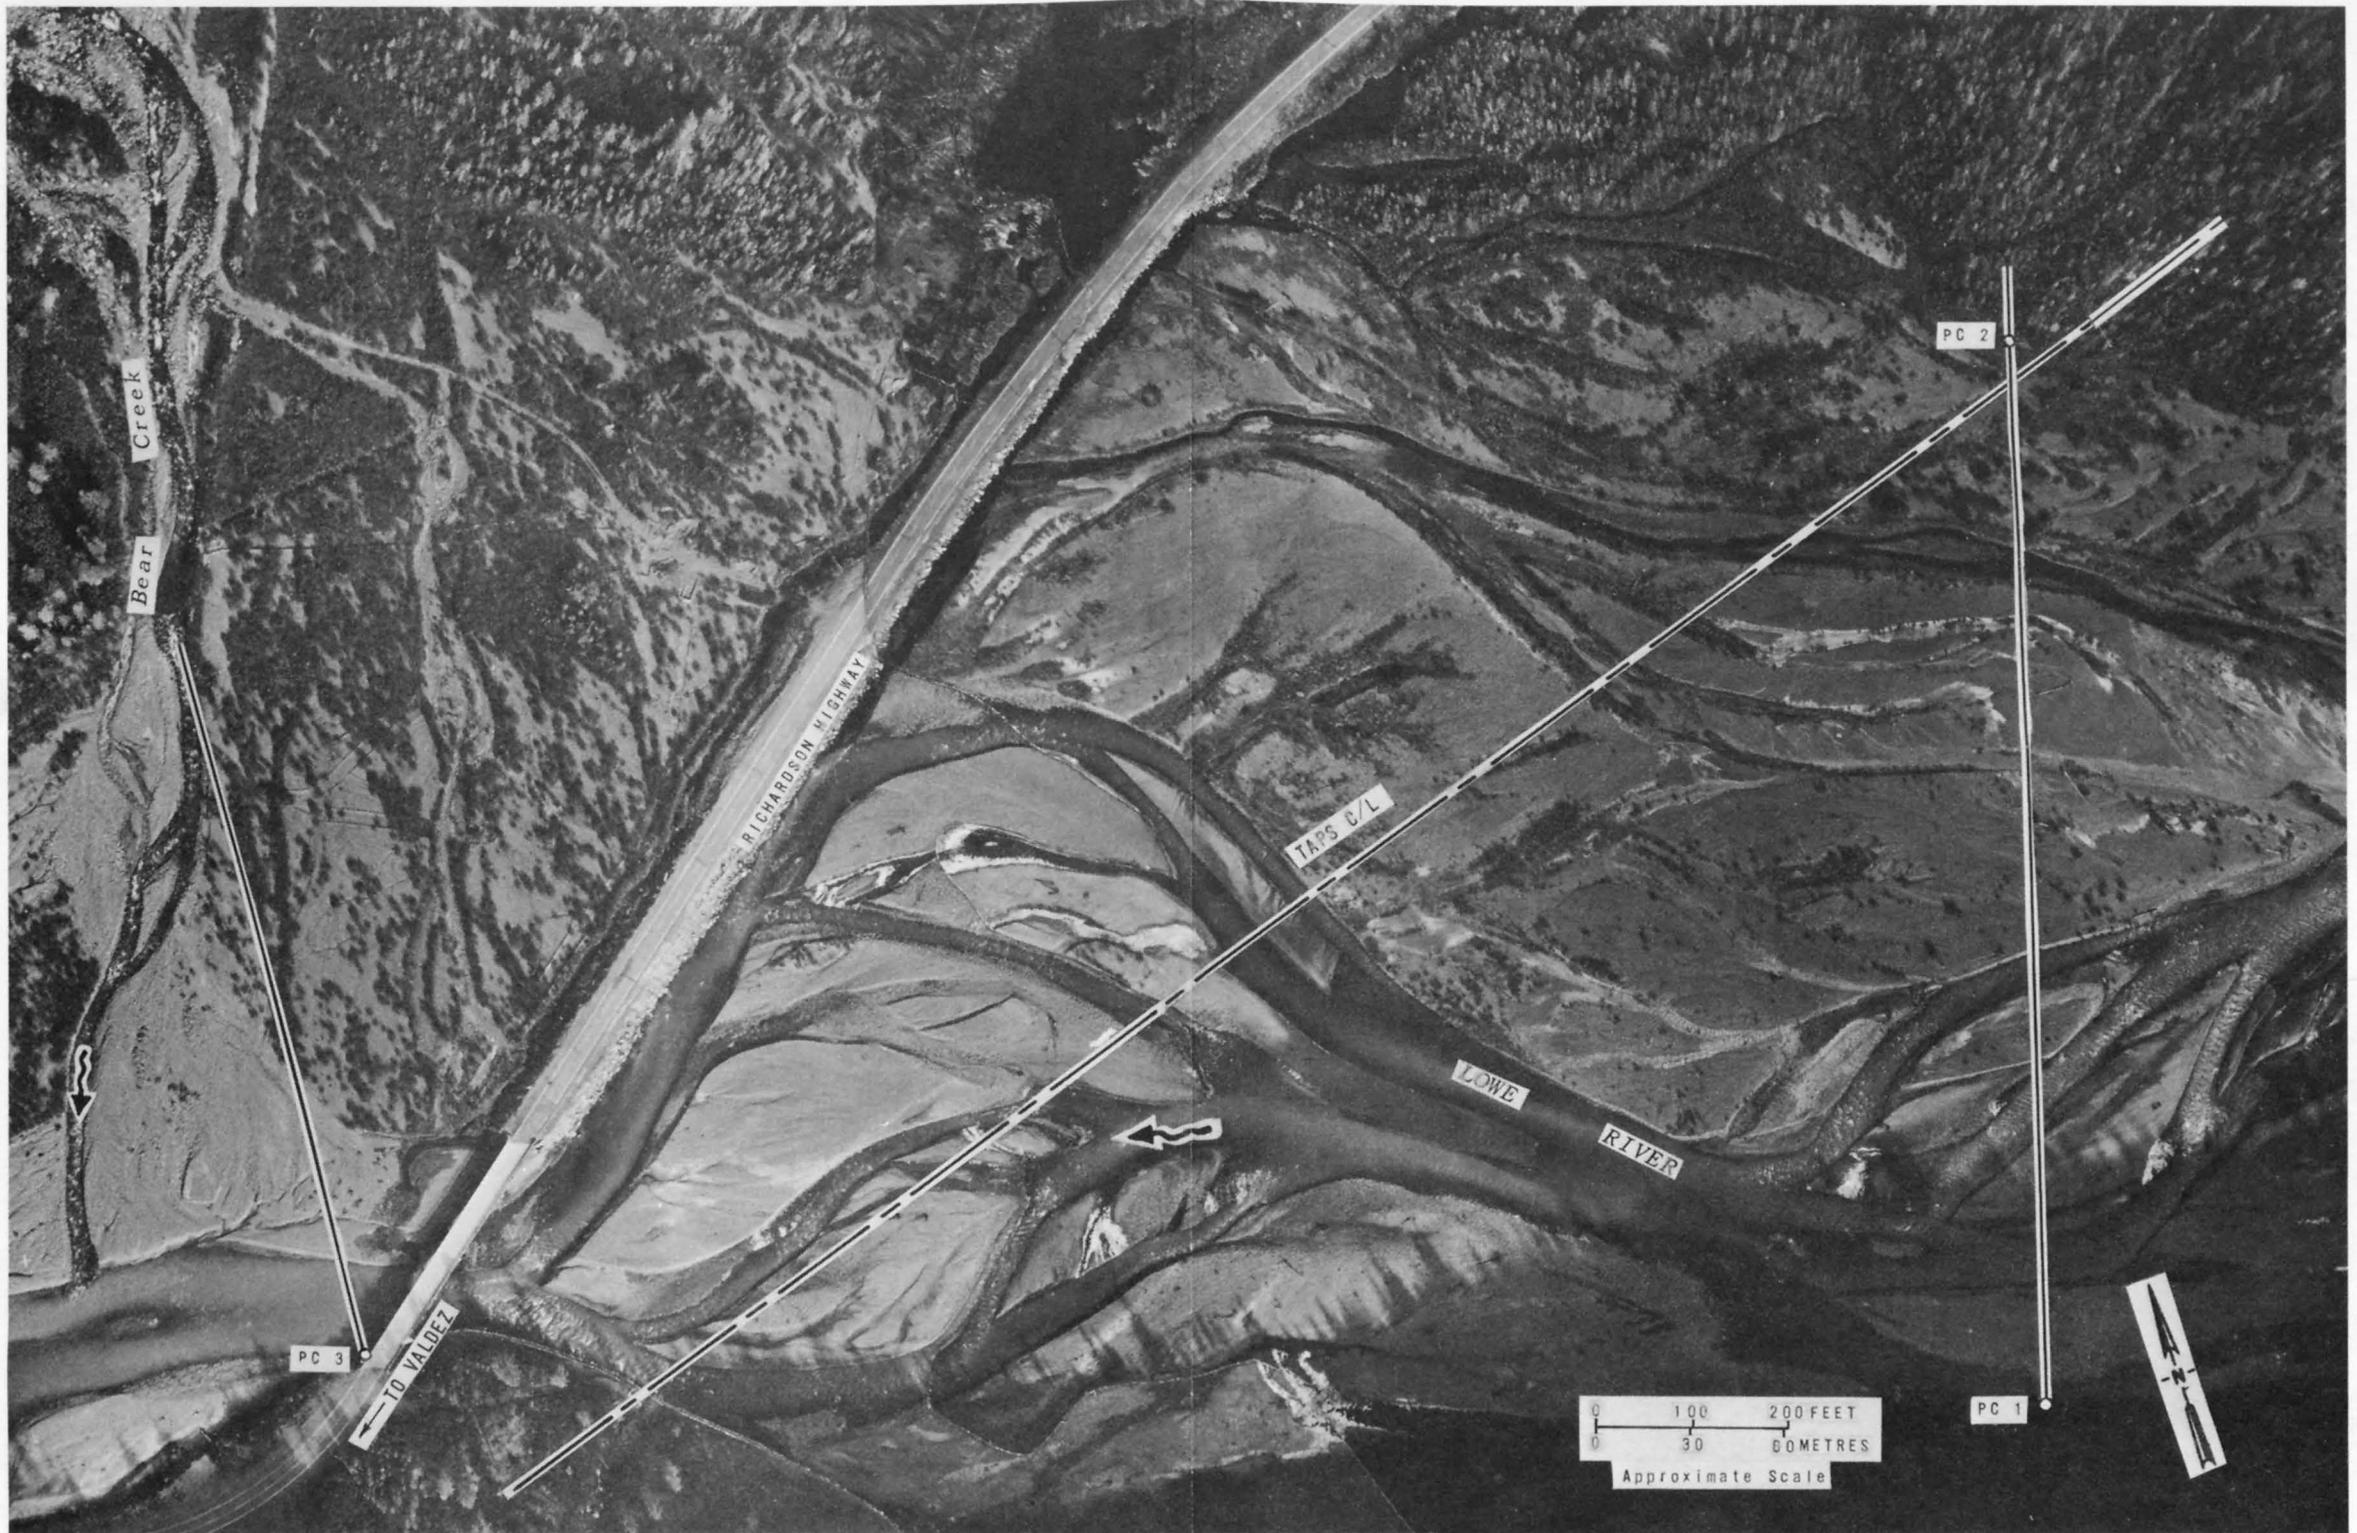
Figure 89. -- Lowe River near Valdez, September 23, 1972.
NORTH PACIFIC AERIAL SURVEYS

Channel conditions.--Low-altitude vertical aerial stereophotography (scale 1:2,400) was obtained September 23, 1972, (fig. 89) to document preconstruction topography of the site. Vertical aerial strip photography (scale 1:6,000) taken August 31, 1974, (fig. 90) shows the channel at moderately high flow. Comparison of the two photographs shows considerable streambed change both on Low River and Bear Creek. Two cross sections (fig. 91) were surveyed May 18, 1973, to define preconstruction ground profiles in the crossing reach. The TAPS centerline cross section (fig. 91, from Alyeska Pipeline Service Co. survey) was surveyed November 10, 1970. There were no construction activities in the immediate vicinity of the crossing reach for the period of erosion investigation September 23, 1972, through August 31, 1974. The construction of Sheep Creek camp in the Sheep Creek fan began in September 1974. Camp construction required a material-removal site and some diking on the main channel of the Low River 0.6 mi (0.1 km) above the pipeline crossing.

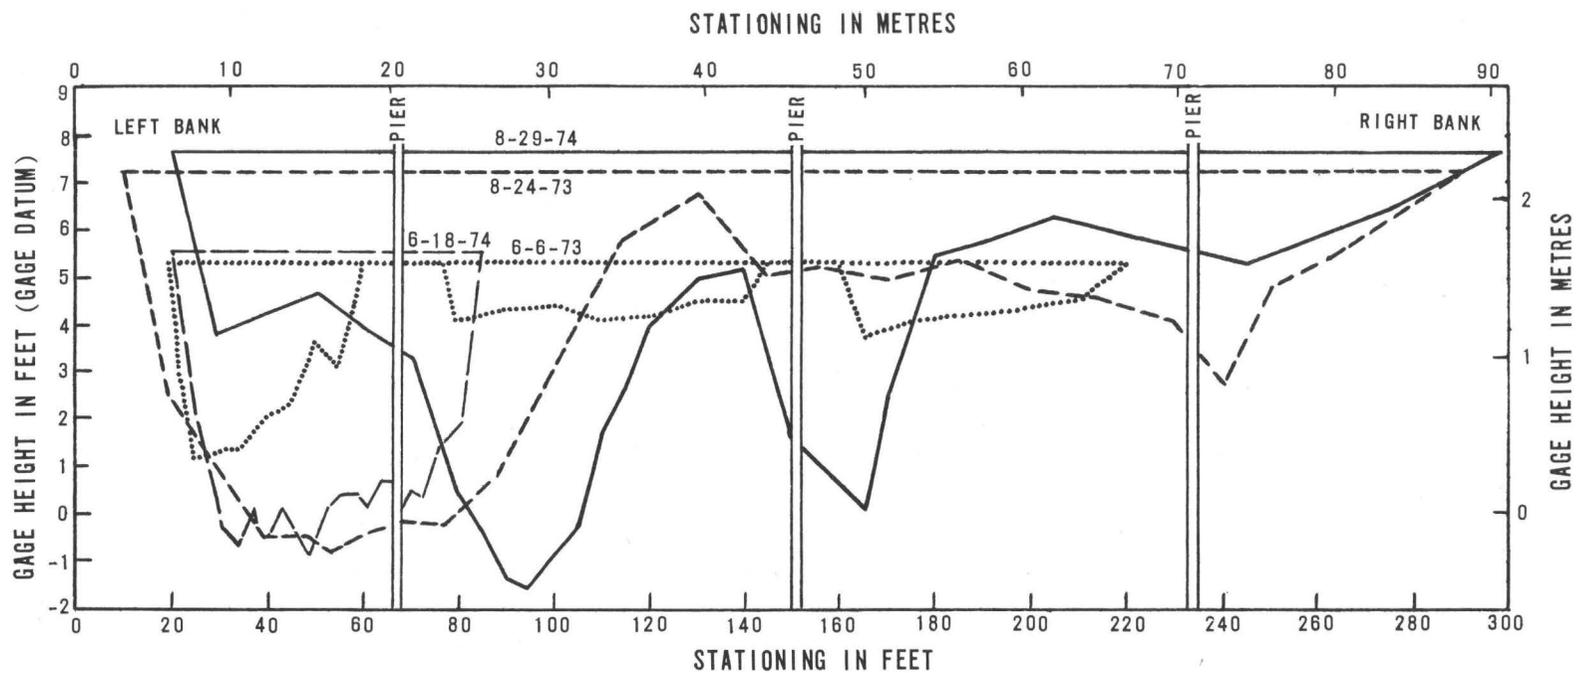
Figure 92.-- Cross section of Low River near Valdez, June 6, 1973, August 24, 1973, June 18, 1974, and August 29, 1974.

Floods.--A U.S. Geological Survey stream-gaging station was operated on the highway bridge at this site. Stream discharge measurements were made from the downstream side of the bridge. Figure 92 shows cross sections plotted from selected discharge measurements. The cross sections show the unstable streambed conditions at the site. The maximum discharge for the period of stream-gaging station record 1971 through September 1974 of 12,200 ft³/s (345 m³/s) (fig. 93) occurred August 30, 1974. The flow at flood stage inundated the gravel bars in the upstream section and TAPS centerline cross section and concentrated flow along the left bank. Floodflow in the downstream section was about bankfull.
