DEBRIS FLOW HAZARD ASSESSMENT FOR THE OREGON CAVES NATIONAL MONUMENT

U.S. GEOLOGICAL SURVEY
Water Resources Investigations Report 83-4100

Prepared in cooperation with
NATIONAL PARK SERVICE

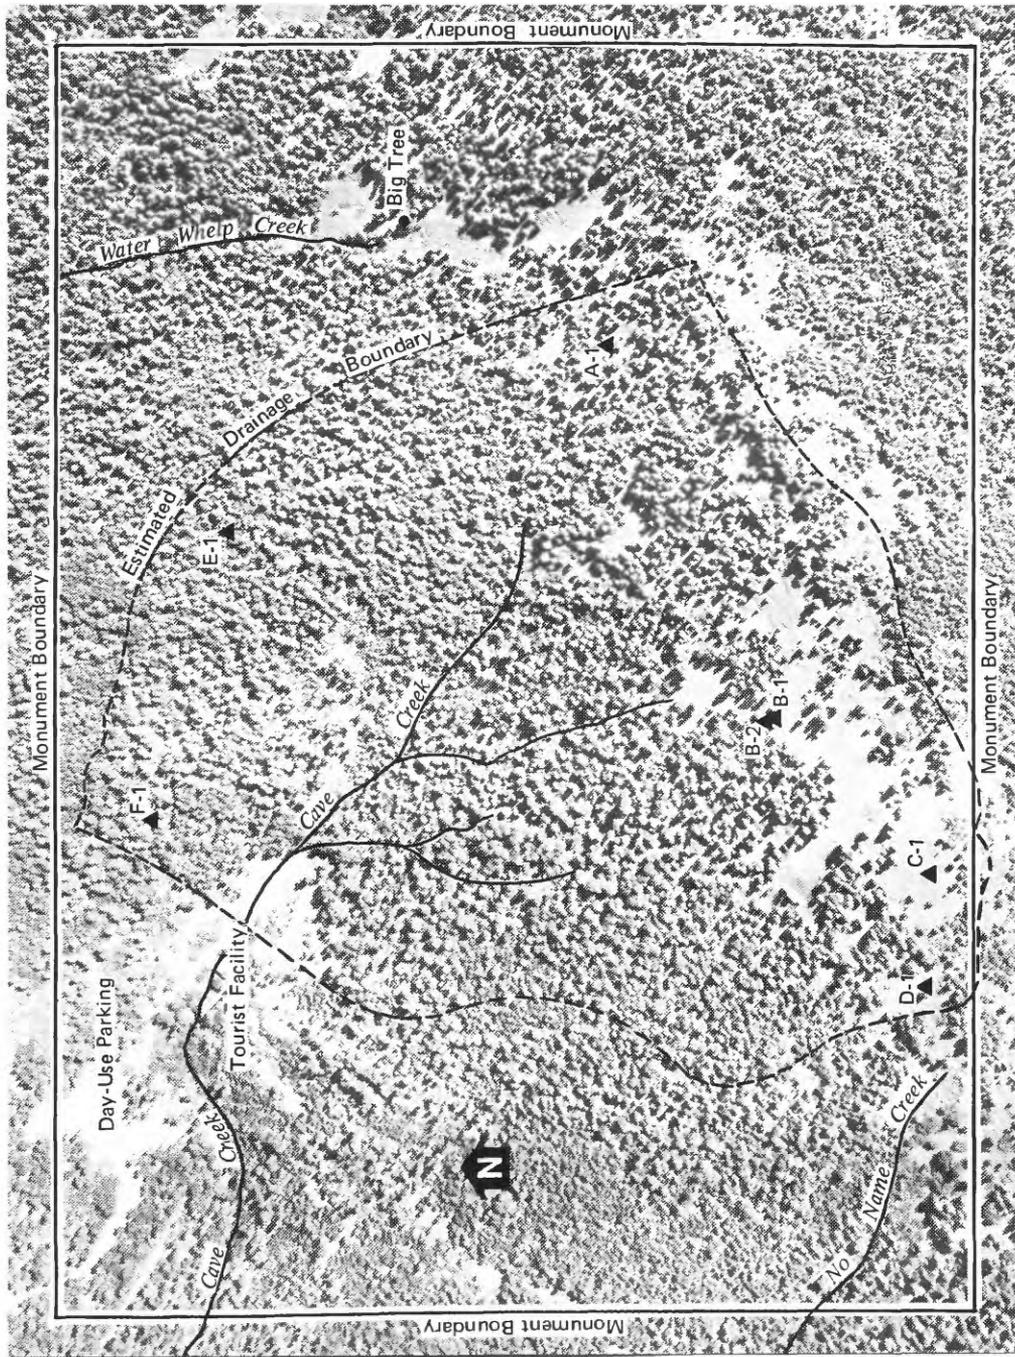
Figure 7. – Location of sampling sites. Aerial photograph dated July 7, 1964.

Another sidehill scar is evident upslope (north) from the day-use parking lot near the park entrance. Little information is available as to the date of occurrence or the magnitude of this failure. It appears that the movement might have been a slump caused by undercutting the supporting base when the parking lot was widened. This scar can be seen in figure 7.

Soil samples were taken at seven sites; one was at the scar of the 1964 debris flow. The other six sites were selected where ground slopes equalled or exceeded the slope at the scar. The location of the sites is shown in figure 7. Some locations are estimated because of orientation problems in the heavily forested areas. The samples were obtained by augering down into the overburden until a firm resistance was met at about the same depth in two or more holes (presumably at the bedrock interface). Samples were taken at various depths wherever there appeared to be a change in color or texture. A description of each site is as follows;

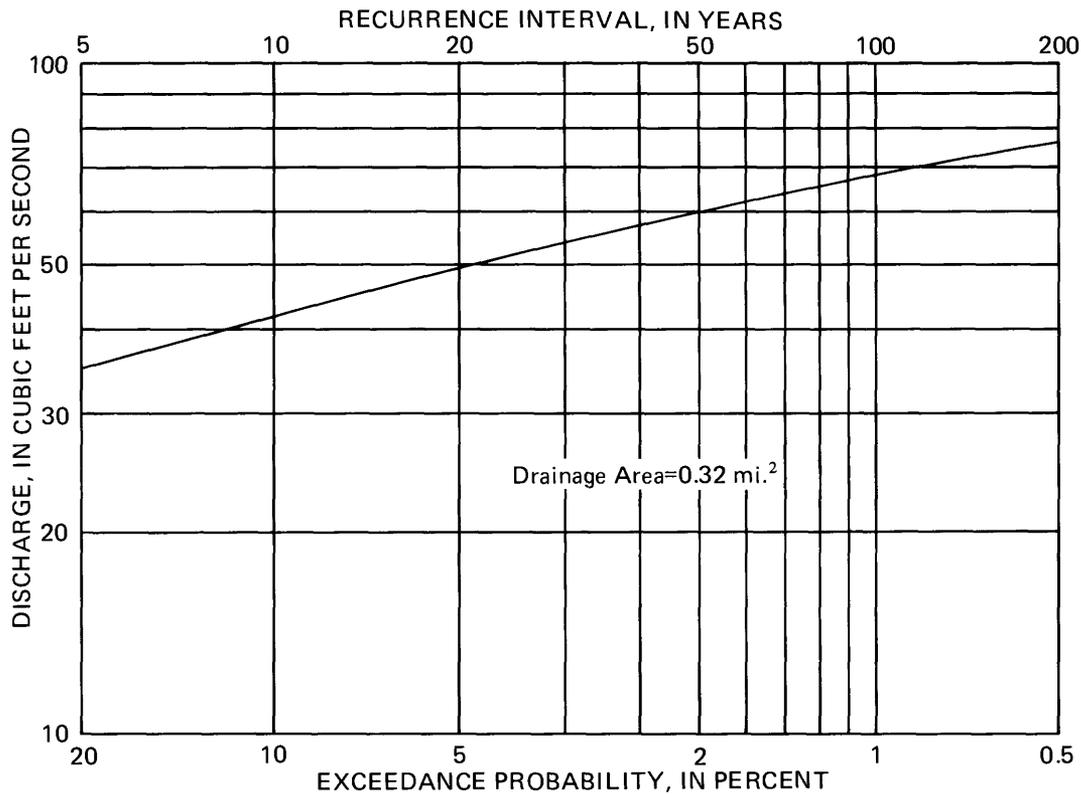
Figure 8. — Estimated flood-frequency curve for Cave Creek at the chalet.

The peak flow in Cave Creek prior to the arrival of the debris is estimated to be about $75 \text{ ft}^3/\text{s}$. The estimate is based on observed flow depths in the breezeway and assuming critical flow with a one-third reduction in effective width due to the placement of sandbags at the chalet doors.

An estimated flood-frequency relation for Cave Creek is shown in figure 8. The curve is based on flood equations computed for the coast region in a western Oregon flood-frequency analysis (Harris and others, 1979). Equations presented in that report for the Rogue and Umpqua Rivers region could not be used because the equations do not apply to streams as small as Cave Creek. The curve indicates that the estimated December 1964 peak on Cave Creek would also have a 0.5 percent chance of being equalled or exceeded in any given year.
