GEOMORPHIC RESPONSE TO CHANNEL MODIFICATIONS OF SKUNA RIVER AT THE STATE HIGHWAY 9 CROSSING AT BRUCE, CALHOUN COUNTY, MISSISSIPPI

by K. Van Wilson, Jr. and D. Phil Turnipseed

U.S. GEOLOGICAL SURVEY
Water-Resources Investigations Report 94-4000

Prepared in cooperation with the
MISSISSIPPI DEPARTMENT OF TRANSPORTATION

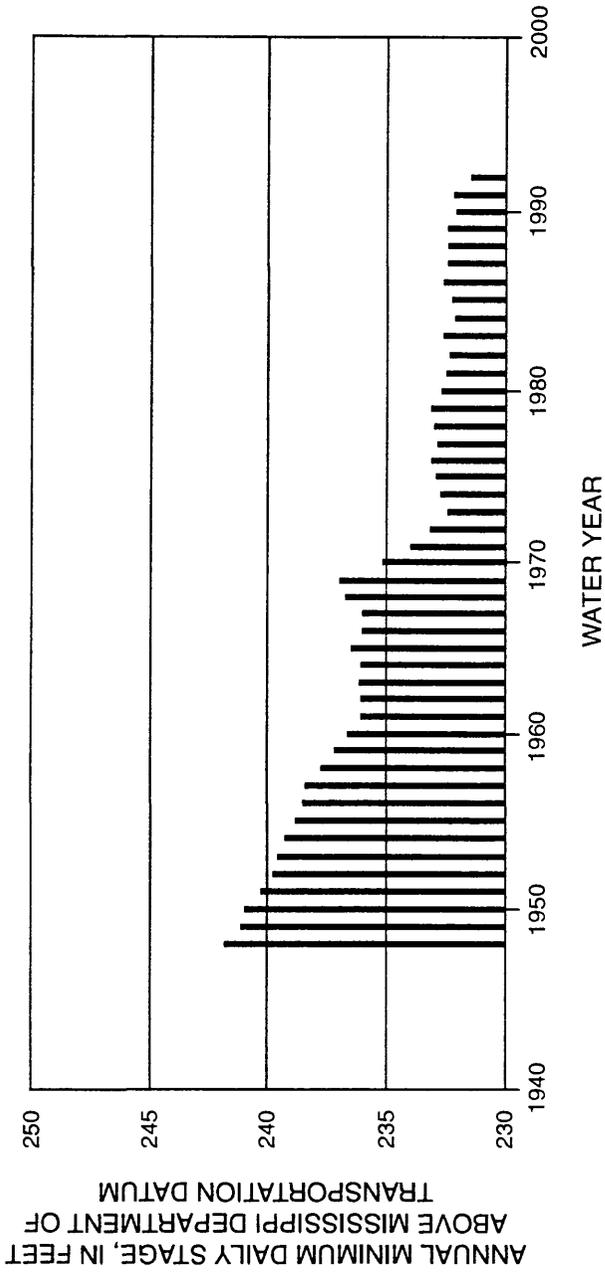
distorted by climatology, because minimum discharge did not vary enough to significantly affect the corresponding stage through the years of record (1948-92) as shown in figure 5. From 1925 to 1992, the canal degraded about 16.5 ft in the vicinity of State Highway 9, based on minimum-stage data, but scoured and degraded as much as 31.2 ft at the State Highway 9 bridge, based on minimum-bed data (fig. 4). The difference between 31.2 ft and 16.5 ft is 14.7 ft, which represents the sum of local and constriction scour that occurred at the State Highway 9 bridge.

Figure 5.-- Annual minimum daily stage and discharge for Skuna River Canal at State Highway 9 at Bruce, Mississippi.

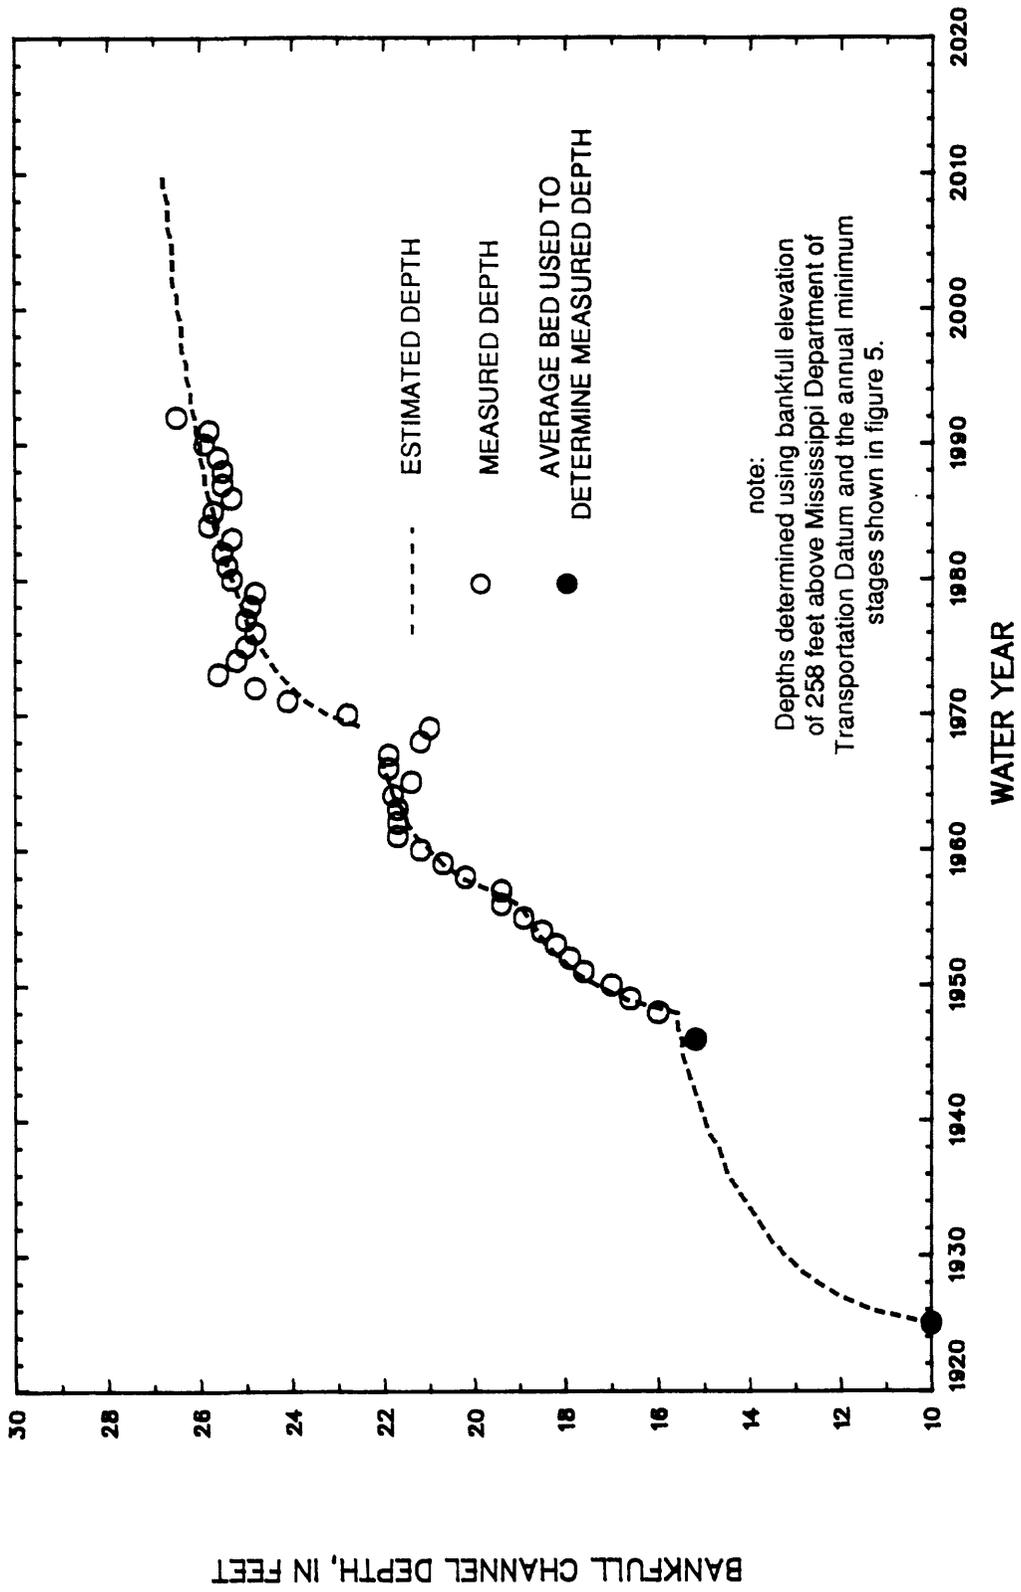
Figure 7.--Estimated patterns of channel deepening on Skuna River Canal at State Highway 9 at Bruce, Mississippi.

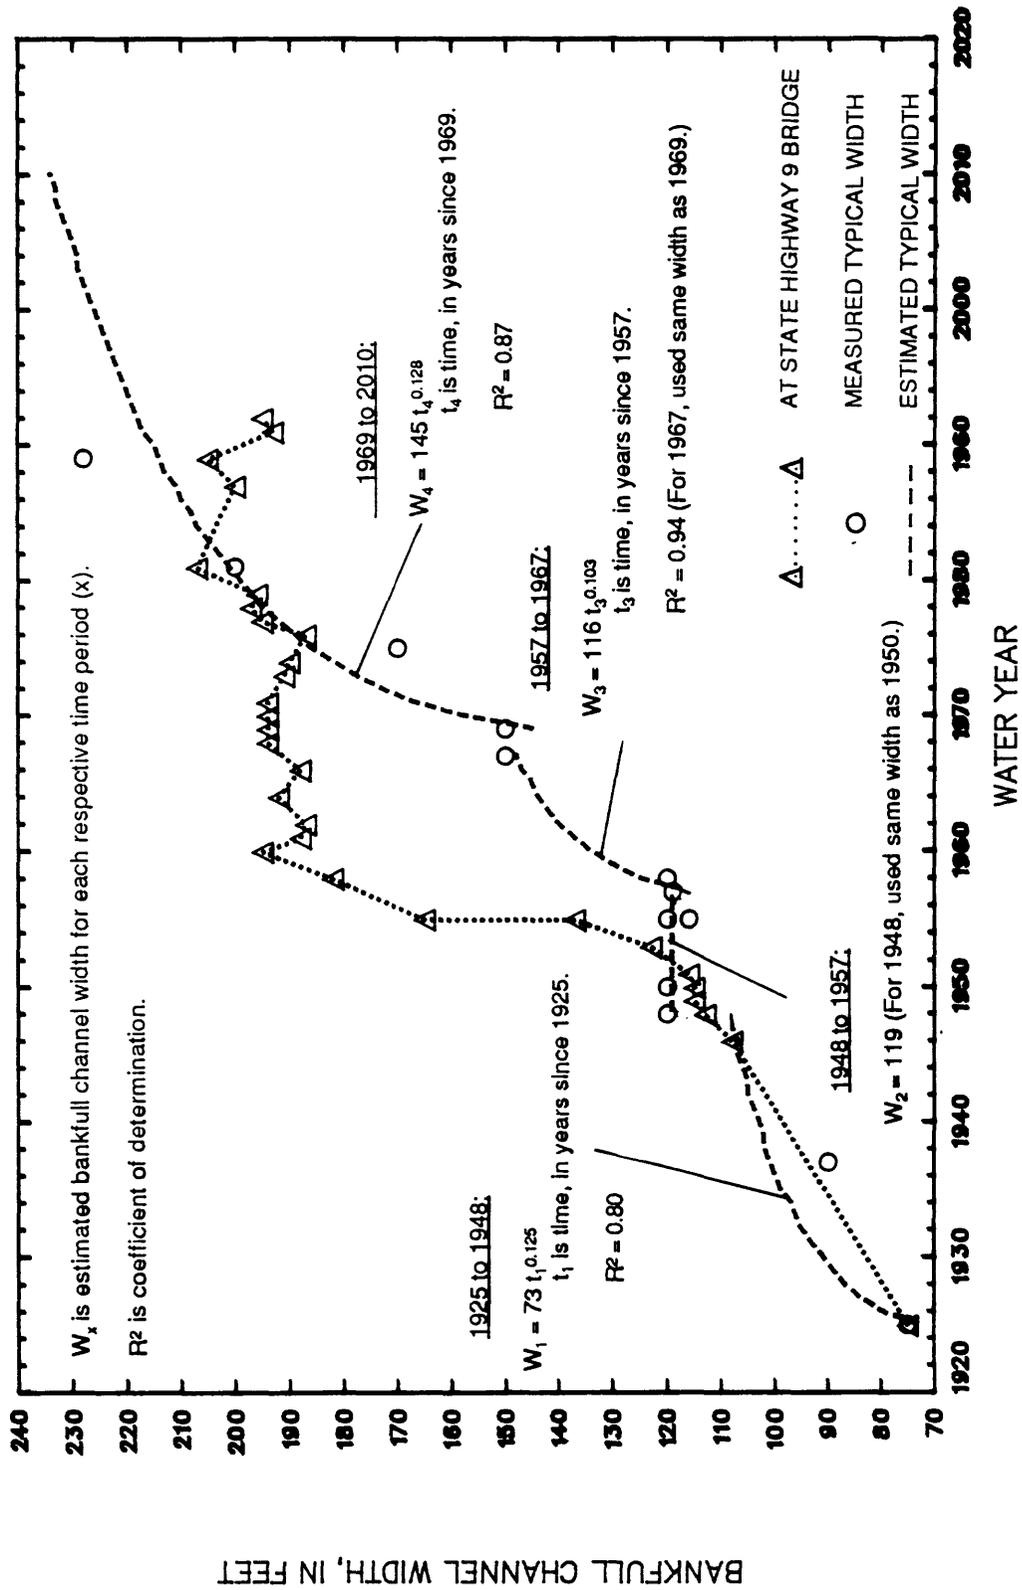
Figure 8.--Estimated patterns of channel-widening on Skuna River Canal at State Highway 9 at Bruce, Mississippi.

The canal widening relations were approximated using the same time periods as used for the bed-level and depth relations. Bankfull channel width typically has increased from about 75 ft in 1925 to 228 ft in 1989 for a total widening of about 150 ft (rounded to nearest 10 ft). The average channel width in the vicinity of State Highway 9 increased about 45 ft from 1925 to 1948, did not significantly increase from 1948 to 1957, increased about 30 ft from 1957 to 1967, and increased about 78 ft from 1969 to 1989 (reasonably representative of 1993 width). For the State Highway 9 bridge, the channel width increase of about 50 ft (fig. 8) was induced during the March 1955 flood, when debris caught on the bridge and the bridge collapsed. The bridge collapsed due to past degradation and widening and the additional local and constriction scour caused by the debris within the bridge opening. As shown in figure 8, there has not been a significant increase in width at the bridge since about 1960. The MDOT placed riprap and old car bodies on the left (south) bank at the bridge in about 1980, and the bank seems to have held in place fairly well (fig. 9). The log-linear relation of channel width with time for 1969 to 2010 indicates about 6 ft of additional widening will occur on the average by 2010 (fig. 8). The relation of width with time from 1969 to 1989 appears to be linear with an average widening rate of 4.0 ft/yr (fig. 8). On this basis, as much as 90 ft of additional widening could occur by 2010. This estimate is likely conservative because widening processes have been shown to decrease with time.

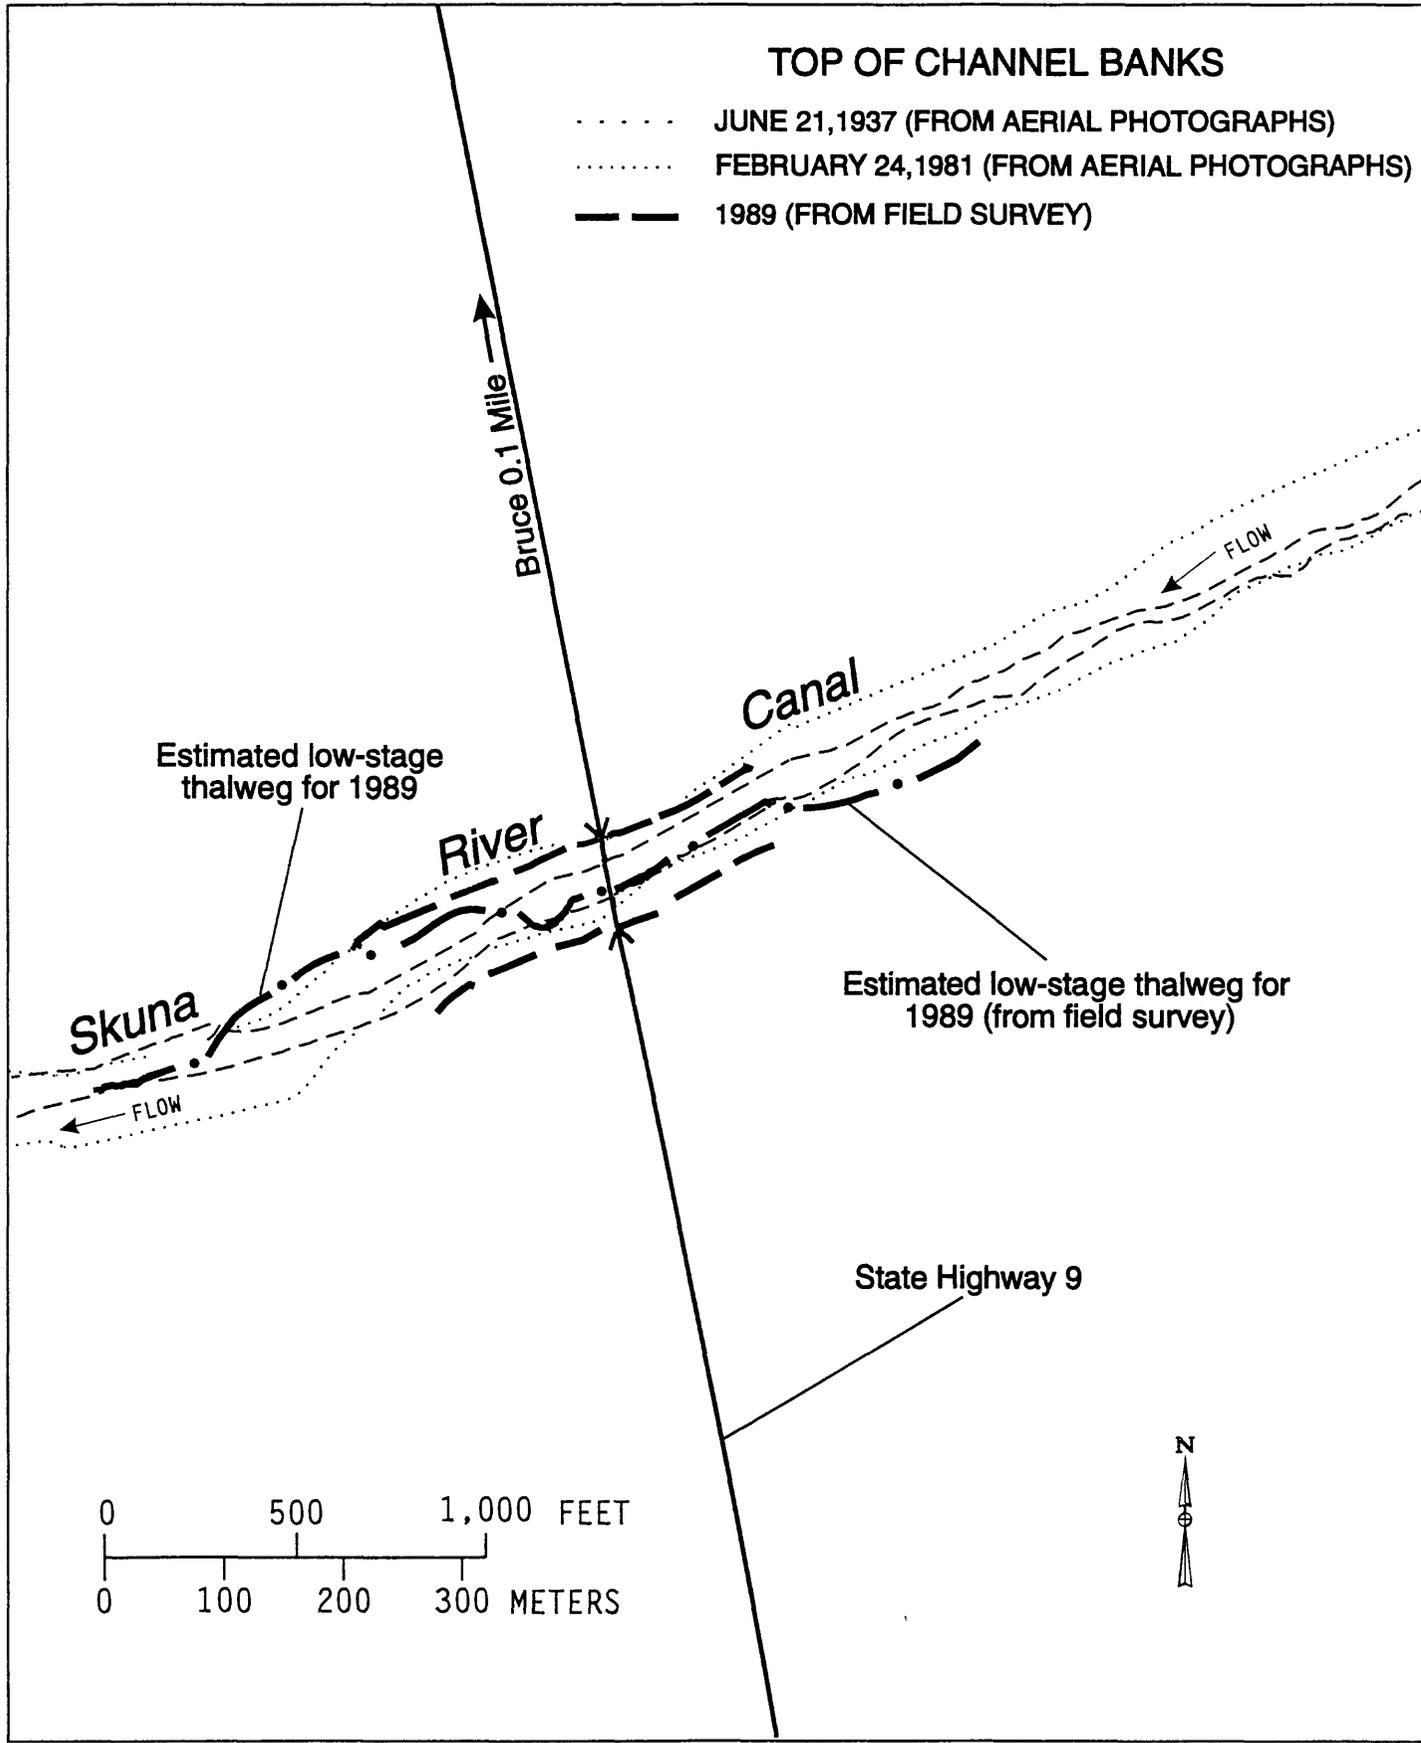
Channel pattern is used in this report to describe the plan view of a reach of river as seen from above, and includes meandering, braiding, or relatively straight channels. The changes of channel pattern through time for Skuna River Canal were determined using a technique used by Turnipseed and Smith (1992) in their study of the Pearl River in Mississippi. Tops of the canal's banks were delineated on historical black-and-white aerial photographs and transferred with an Aus Jena Sketchmaster to scale-stable material overlain on acetate-film positives of USGS 7.5-minute quadrangle maps. A geographic information system (GIS) provided a means of storing, referencing, and displaying the tops of channel banks through time and, therefore, displaying the changes of channel pattern through time. Skuna River Canal at bankfull stage presently (1993) remains relatively straight (small sinuosity) in the vicinity of the State Highway 9 bridge. However, the low-stage channel is developing alternate sandbars and the low-stage thalweg, defined by field surveys in 1989, meanders around the sandbars in a sinuous fashion (fig. 12). The meandering of the channel thalweg causes lateral erosion of the base of outside banks, which steepens and causes localized bank instability. According to Osman and Thorne (1988), the relative amount of lateral erosion is a function of bank material properties, bank geometry, type of bed material, and streamflow characteristics. As with other geomorphic responses to channel modifications, channel patterns will adjust to the changes in stream power.

Figure 12. --Historical changes in channel pattern of Skuna River Canal in the vicinity of State Highway 9 at Bruce, Mississippi.

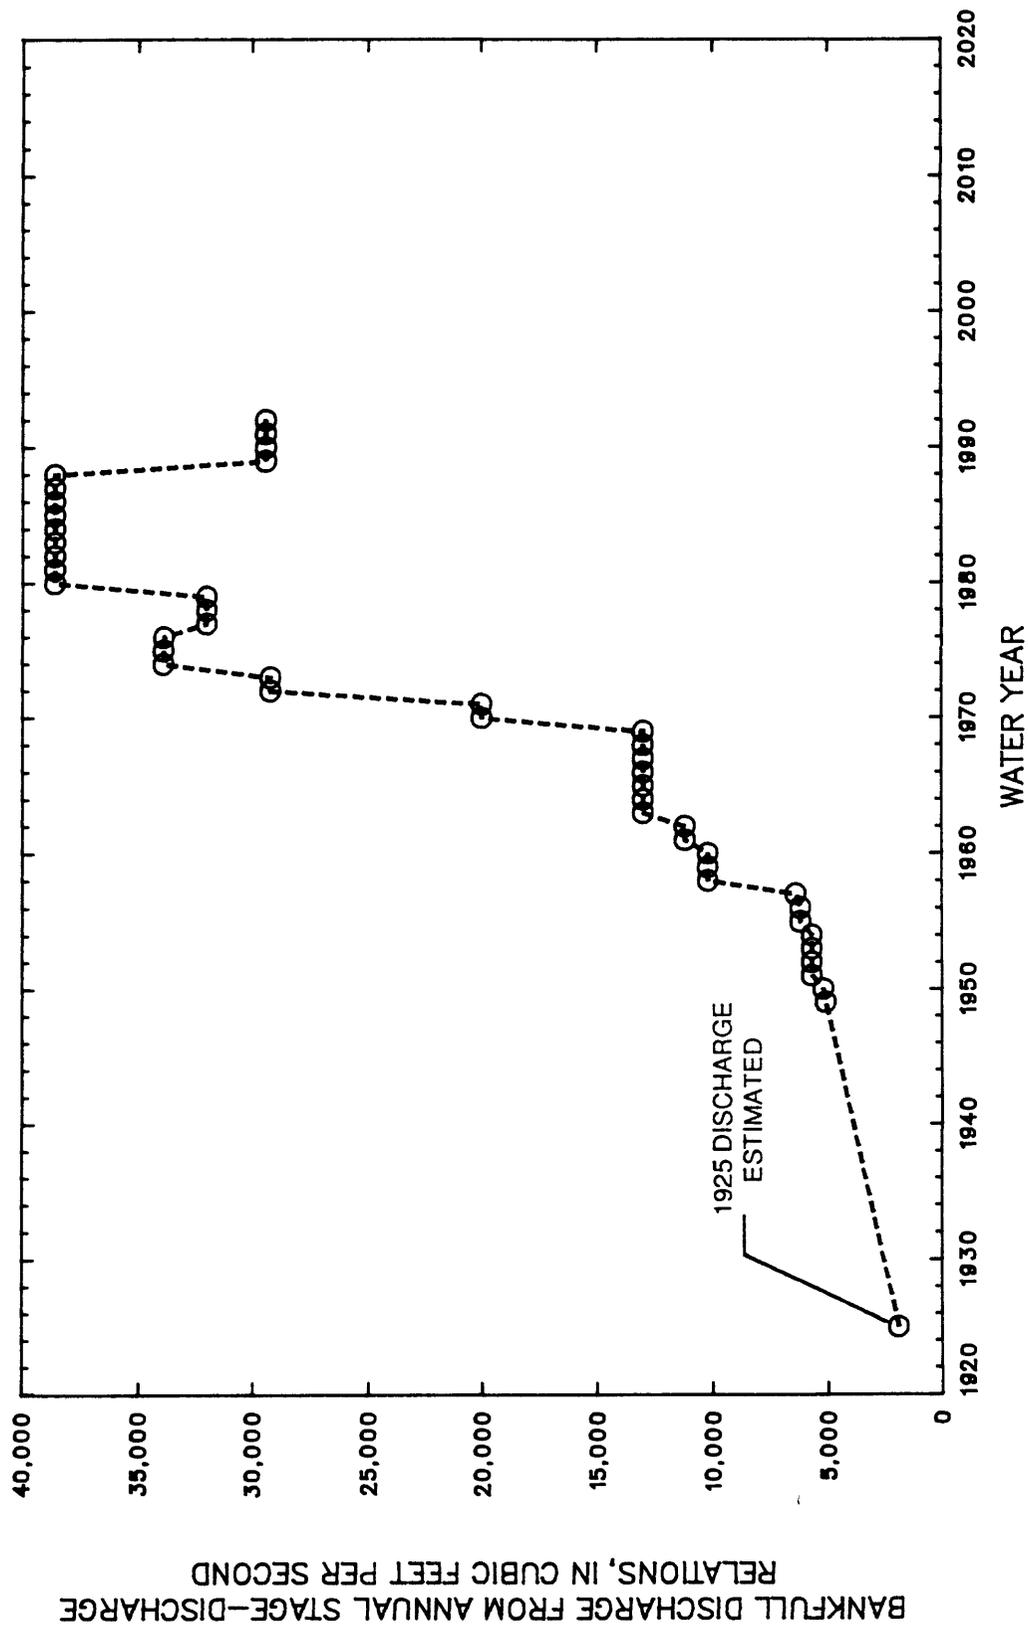
The geomorphic response to channel modification has a significant effect on the bankfull discharge capacity, which, in turn, affects overbank flooding. The bankfull discharge of the Skuna River Canal was determined for each year of gage record by using a stage of 258 ft (about bankfull stage near State Highway 9) with the stage-discharge relation for each year. As illustrated in figure 13, the capacity of the canal has substantially changed since its construction in about 1925. From 1925 to 1992, bankfull discharge increased about 1,450 percent. Bankfull discharge increased from about 1,900 to 5,000 ft³/s from 1925 to 1948, about 5,000 to 6,370 ft³/s from 1948 to 1957, and about 6,370 to 13,000 ft³/s from 1957 to 1969. However, for the period of record 1969-92, the bankfull discharge increased from 13,000 to 38,600 ft³/s from 1969 to 1980, remained at about 38,600 ft³/s from 1980 to 1988, and based on recent measurements, decreased from 38,600 to 29,400 ft³/s from 1988 to 1992. During the period 1980-88, no discharge measurements were obtained at stages above 250 ft to determine a revision of bankfull discharge; therefore, the bankfull discharge was assumed constant. The bankfull discharge probably was decreasing from 1980 to 1988. The combination of change in cross-sectional area, velocity, hydraulic radius, slope, and roughness has affected the discharge capacity of the channel. Through the years, the occurrence of overbank flooding on Skuna River has been reduced (fig. 14). For the period 1949-68, the annual peak stage exceeded bankfull stage of 258 ft for 15 of 20 years; however, for the period 1969-92, the annual peak stage exceeded bankfull stage

Figure 13.--Bankfull discharge from annual stage-discharge relations for Skuna River Canal at State Highway 9 at Bruce, Mississippi.

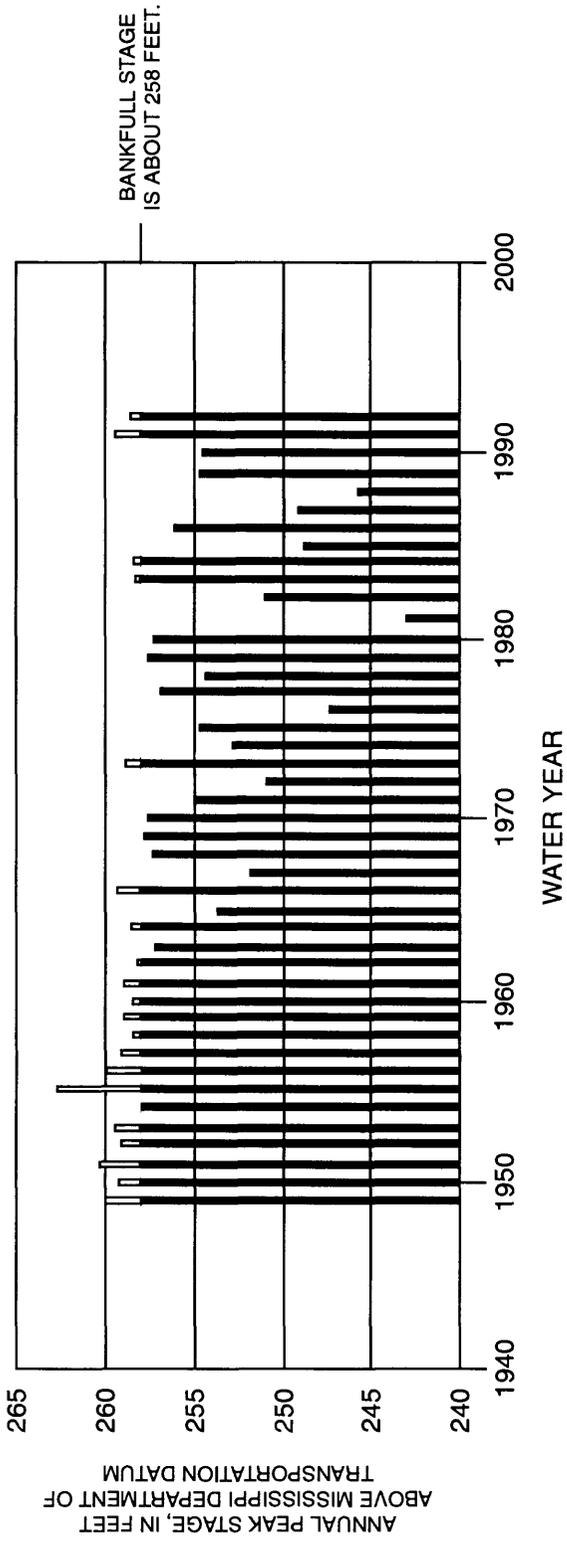
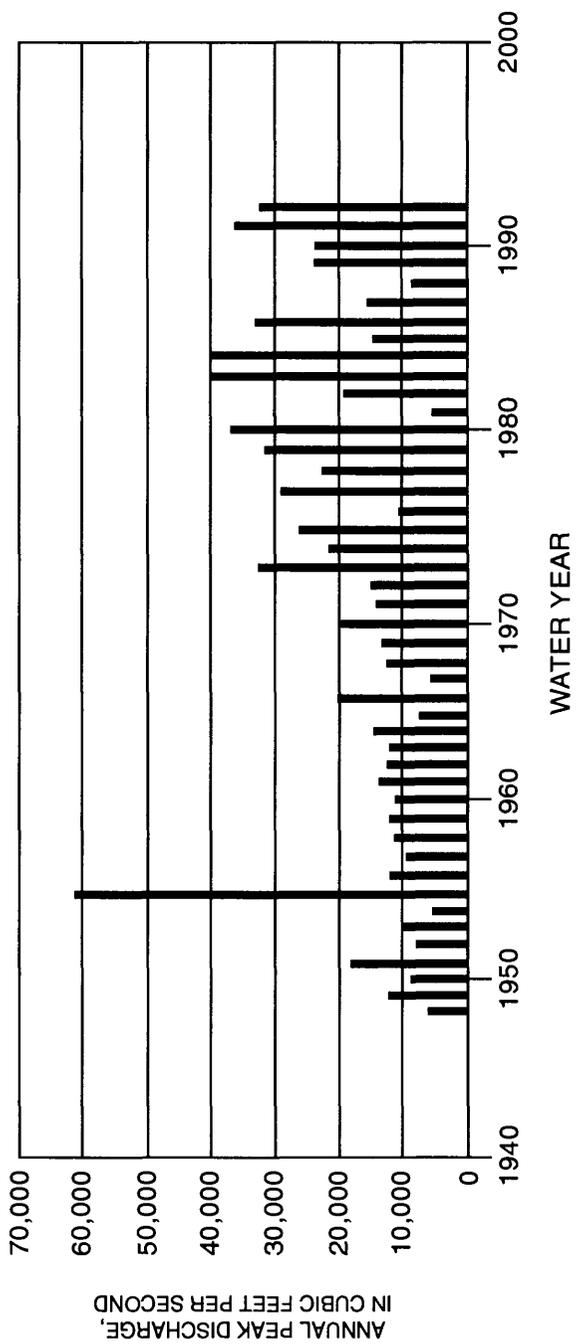
Figure 14.-- Annual peak stage and discharge for Skuna River at State Highway 9 at Bruce, Mississippi.

only 5 of 24 years. The corresponding peak discharges for the annual peak stages that exceeded bankfull stage ranged from 8,050 to 61,400 ft³/s for the period 1949-68 and ranged from 31,800 to 39,300 ft³/s for the period 1969-92.

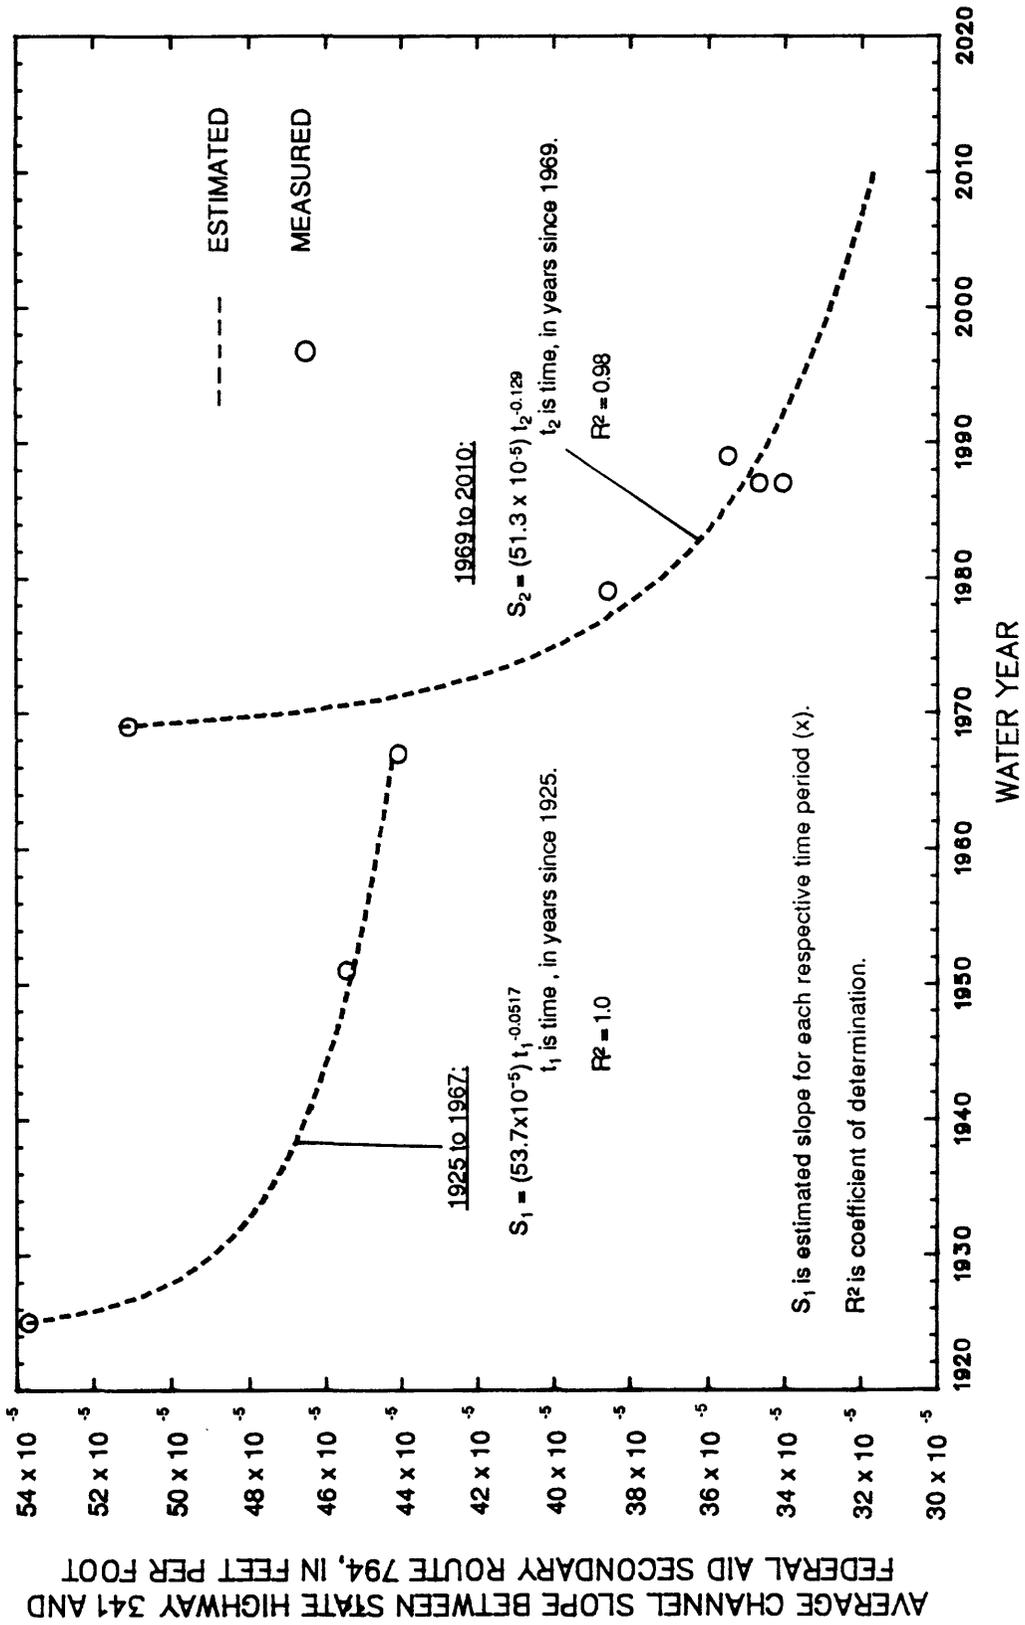
has significantly increased (fig. 13), and the channel slope has been reduced (fig. 15). In this report, adjustments of channel slope are described using a power function in the general form:

Figure 15.--Average channel slope of Skuna River Canal between State Highway 341 and Federal Aid Secondary Route 794.
