EROSION ASSESSMENT AT THE PETROGLYPH NATIONAL MONUMENT AREA, ALBUQUERQUE, NEW MEXICO

U.S. GEOLOGICAL SURVEY

Water-Resources Investigations Report 94-4205

Prepared in cooperation with the
NATIONAL PARK SERVICE

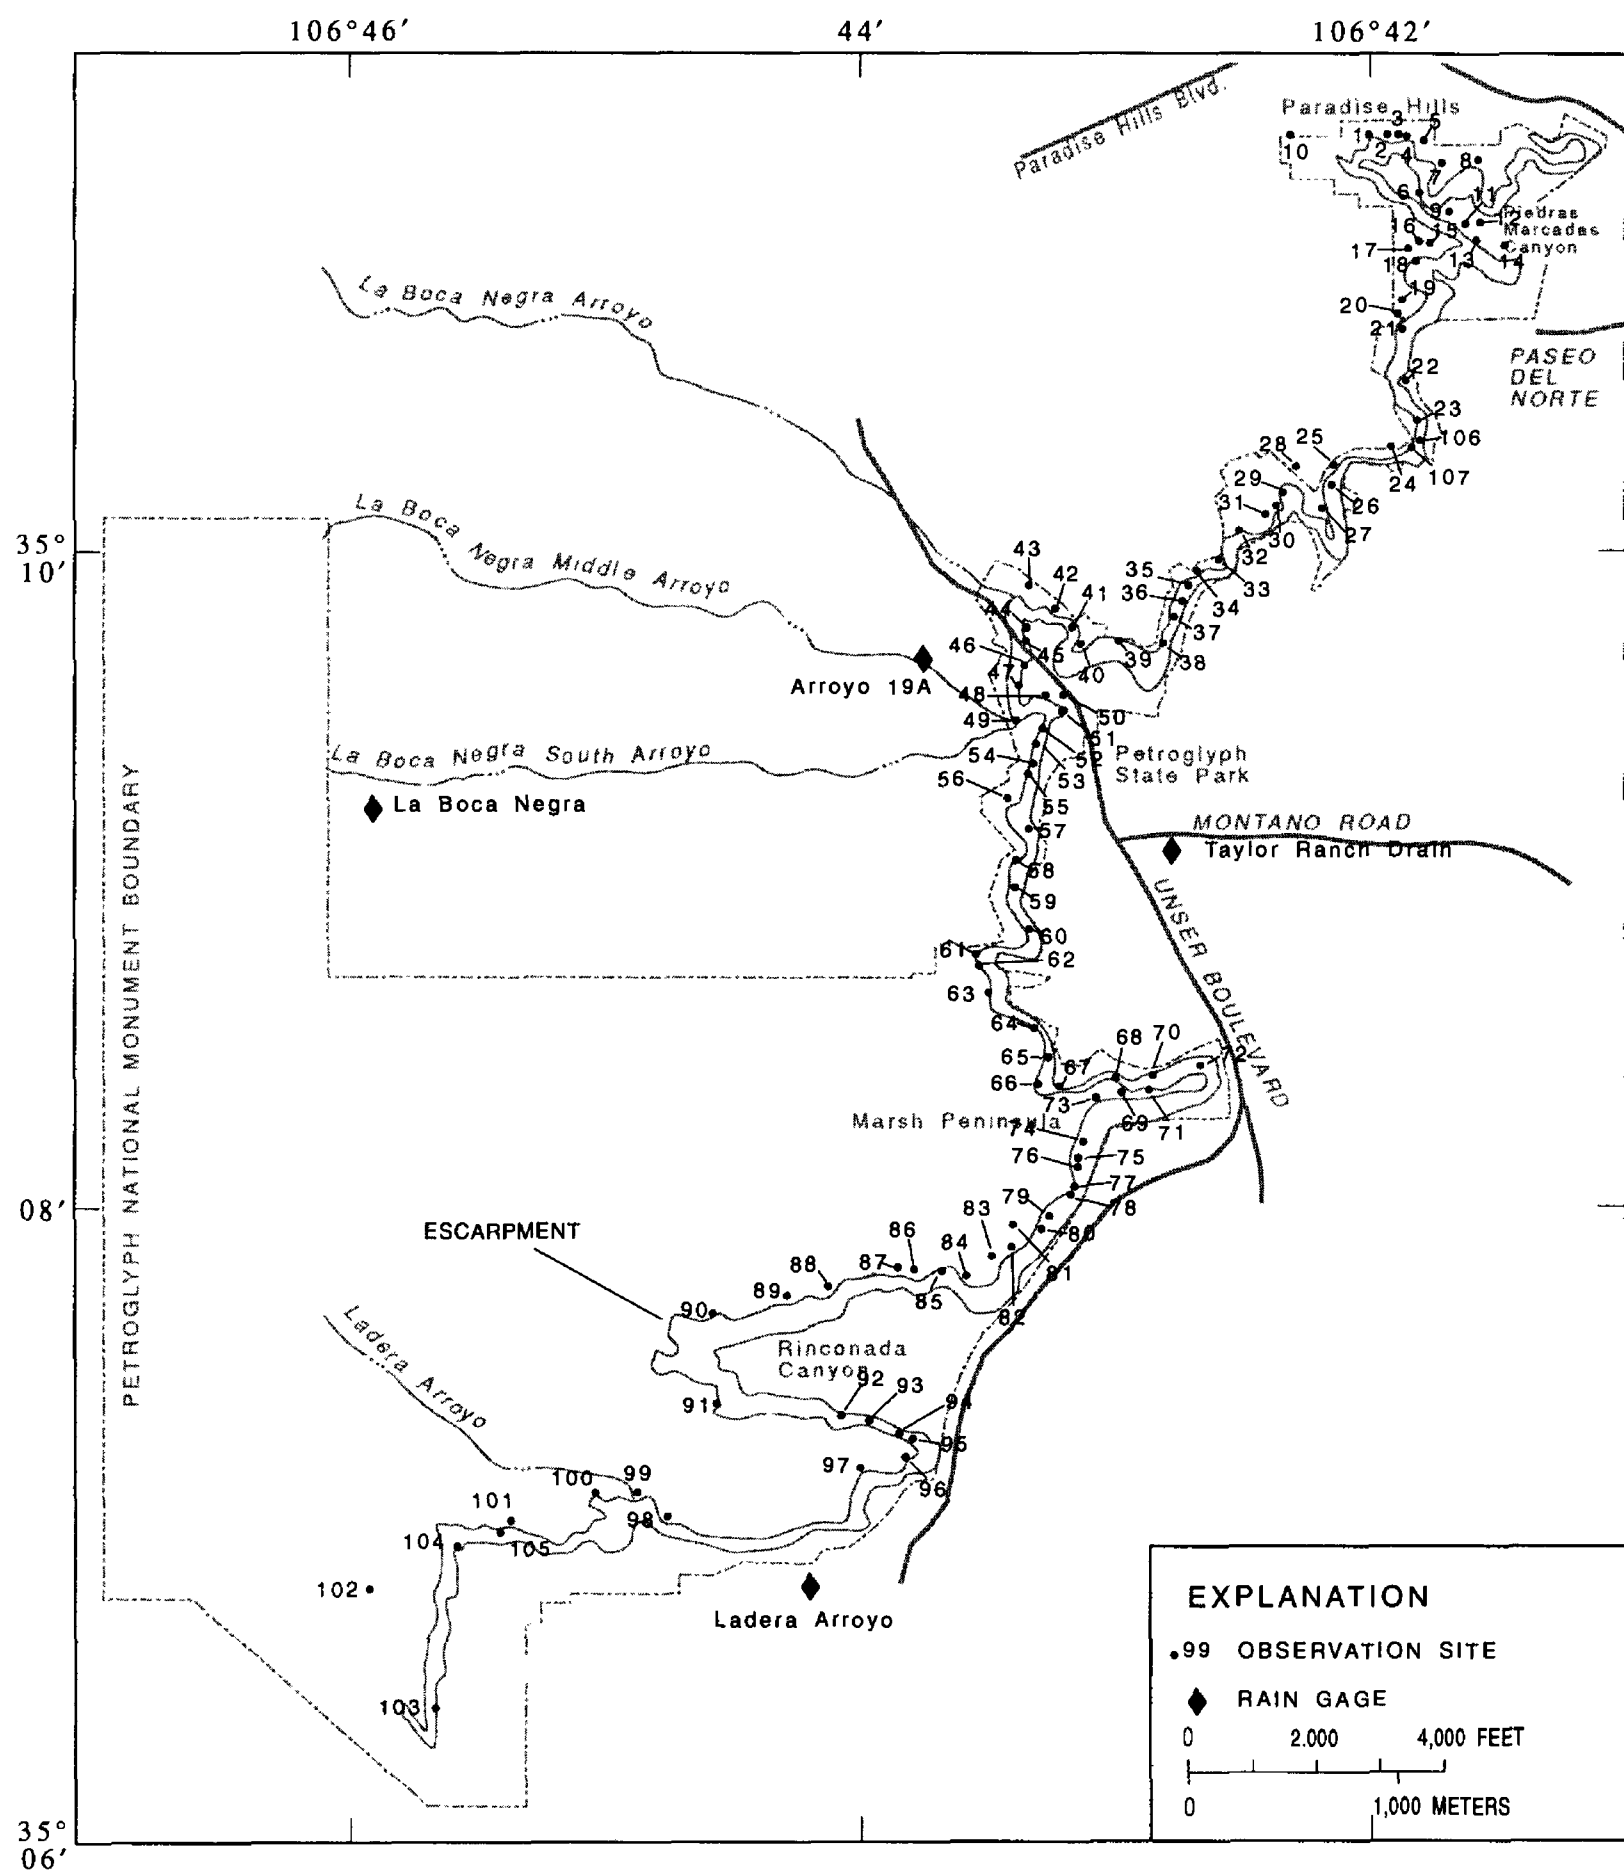
A total of 107 observation sites were selected along the West Mesa escarpment (fig. 5; table 1; tables are in the back of the report). A site was selected if erosion was occurring on the site. At random intervals a site was identified even if no erosion was occurring. Of the 107 observation sites, 50 were identified as having a gully (fig. 6). Because some gullies possibly were overlooked during the reconnaissance, 50 gullies might not be the total number of gullies in the area. All of the gullies were incised into unconsolidated loamy sand. For this report, gullies were classified for magnitude of erosion as follows:

Figure 5.--Location of observation sites selected for study of the Petroglyph National Monument. [For characteristics of each site see table 1.]

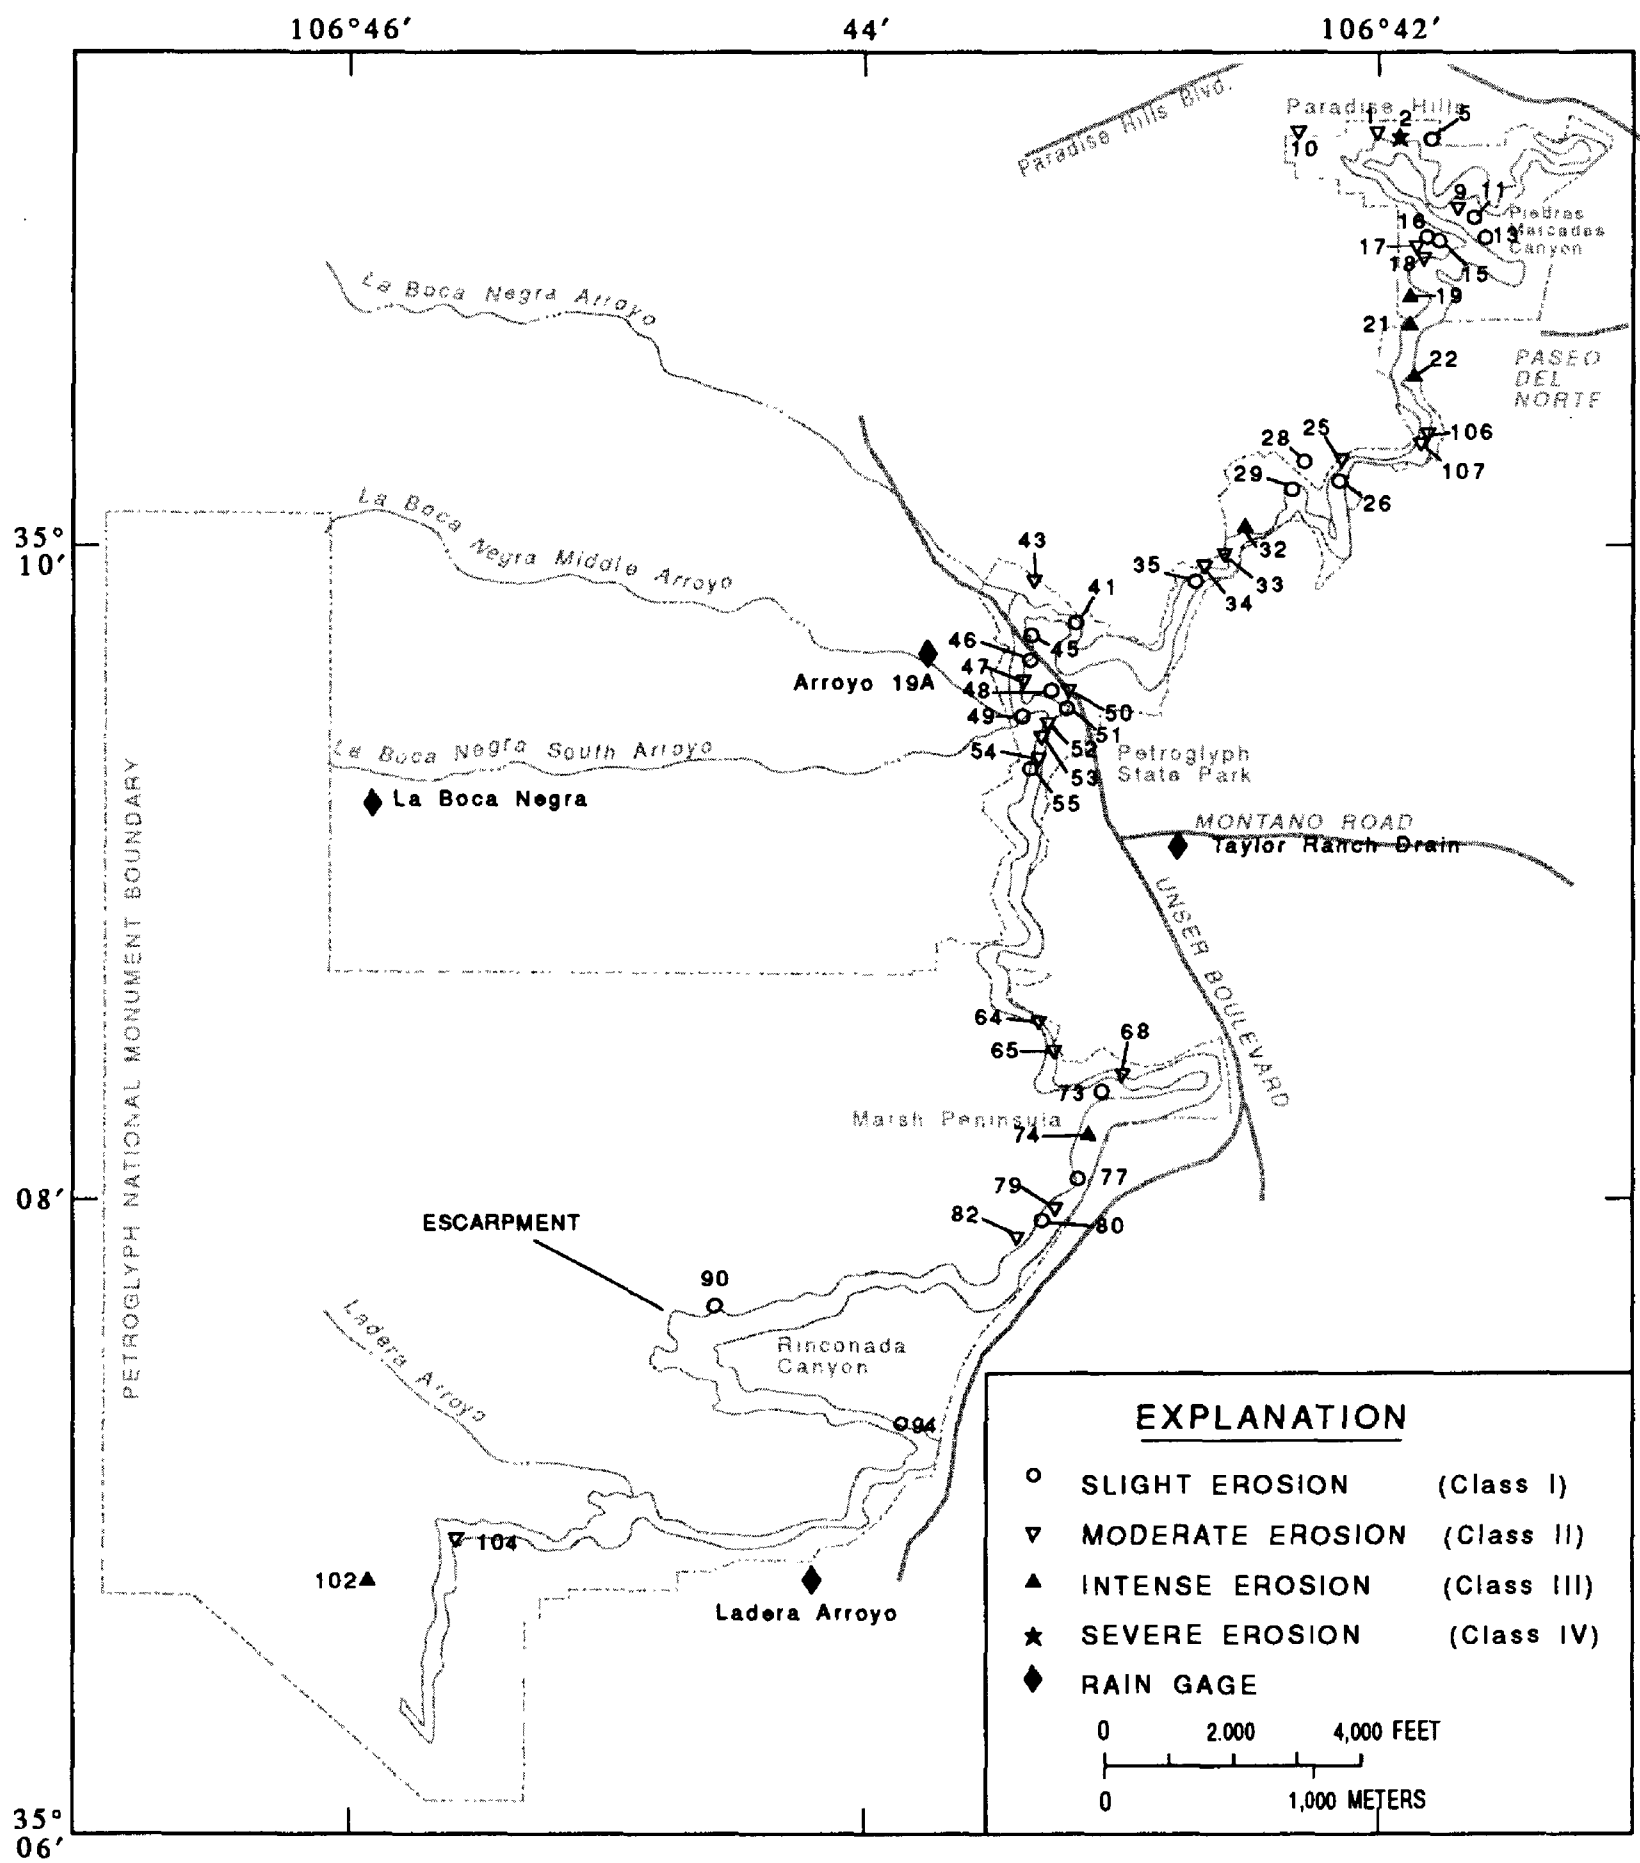
Of the 50 gullies identified along the escarpment in the Petroglyph National Monument, 21 were identified as Class I, 22 as Class II, 6 as Class III, and 1 as Class IV (fig. 6). Fourteen of the gullies were eroding dirt roads, 7 were eroding foot or bike trails, 11 were associated with a permanent channel or drainage, and 18 were located on hillslopes that were not affected by the aforementioned features.

Figure 6.--Location of selected gullies and magnitude of erosion.

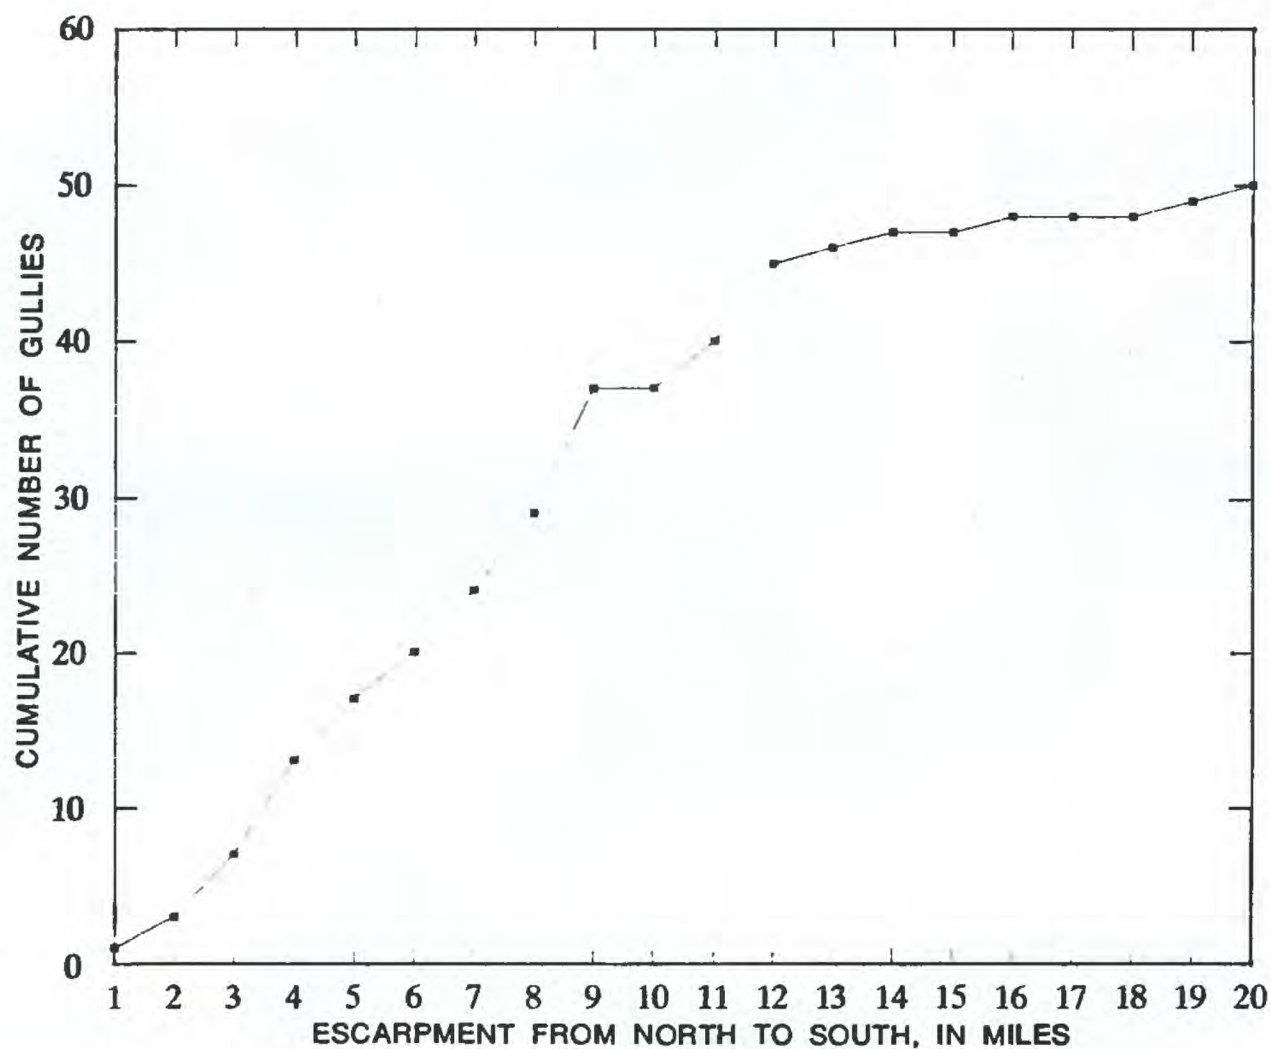
In the West Mesa escarpment there may be a relation between gully density and vegetative cover. The northern areas of the escarpment have less dense vegetative cover than the southern areas and a higher occurrence of gullies (figs. 7 and 8). Of the 50 gullies identified, 37 gullies, or about 75 percent, are located in the northern area of the escarpment between escarpment mile 0 and mile 9 (fig. 7). Housing communities are adjacent to and downgradient from the northern areas of the escarpment. Local residents use the foot and bike trails to reach the top of the mesa. Many of the gullies described in table 1 are located on these trails. Foot and bike traffic on the vegetation in northern parts of the escarpment might be decreasing the vegetative cover and promoting gullying. The number of gullies per square mile decreases slightly around escarpment mile 9; however, the density of gullies decreases even more around escarpment mile 12 (fig. 7). Mile 12 is south of the Marsh Peninsula (fig. 1) where there are fewer housing subdivisions.

Figure 7.--Cumulative plot of number of gullies per escarpment mile.

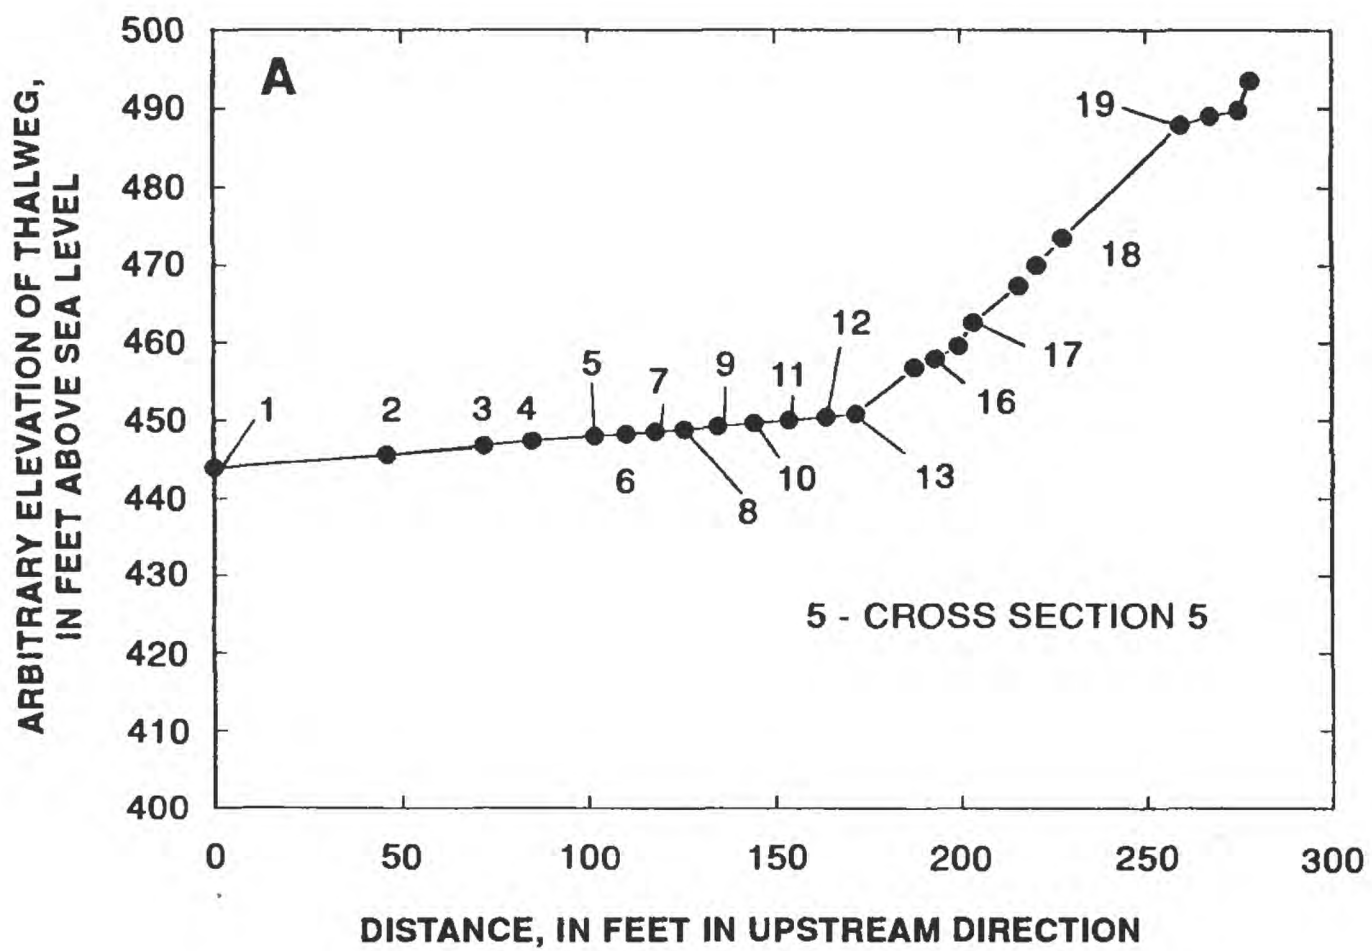
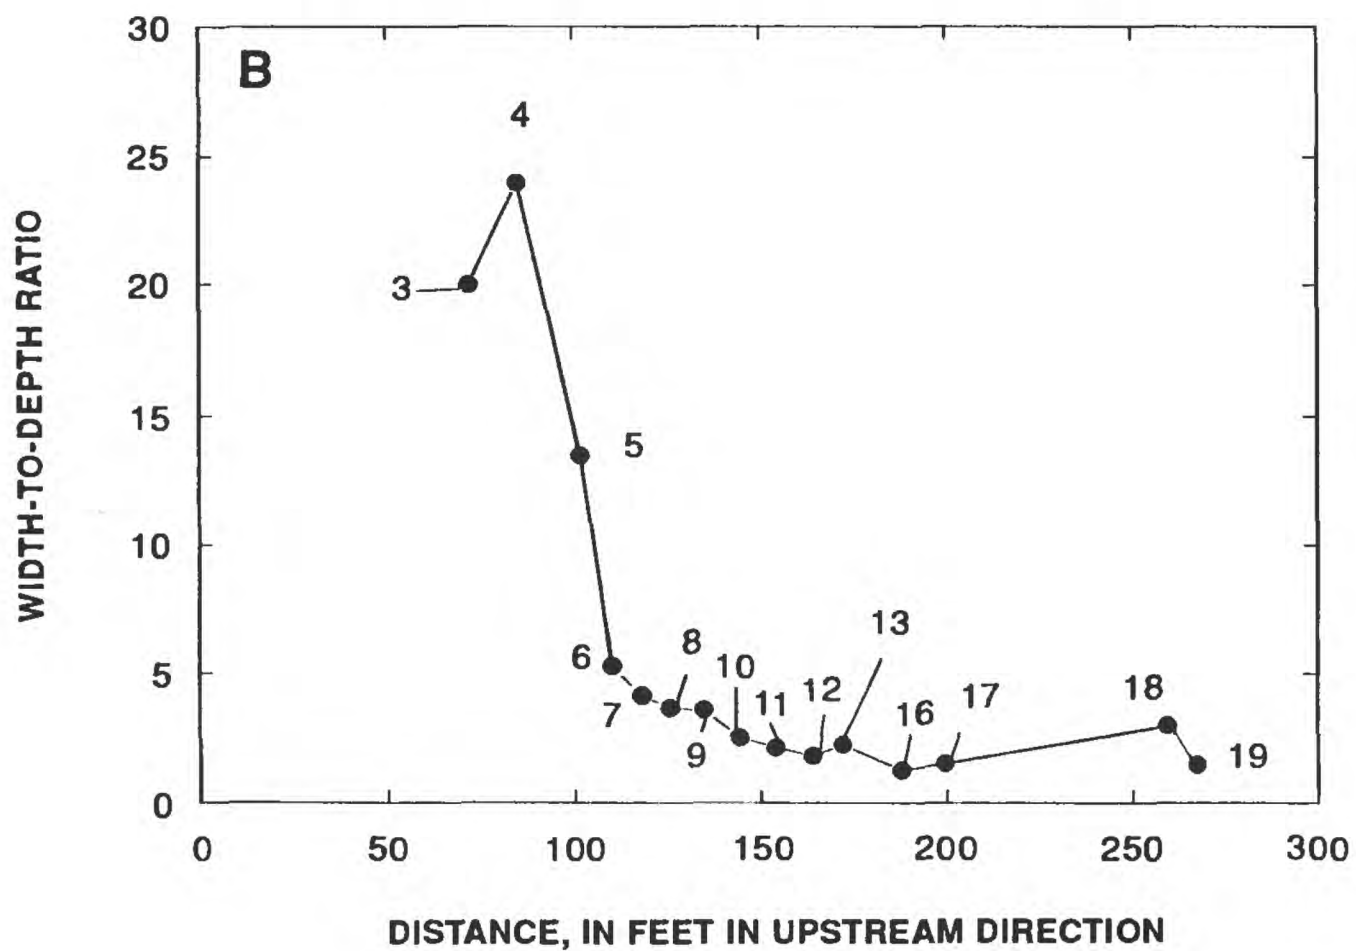
The gully at site 1 (fig. 6) in Piedras Marcadas Canyon is approximately 300 feet long (fig. 10). Nineteen cross sections were surveyed and two cross sections, 12 and 19, had elevation-reference marks emplaced for the purpose of resurveys (fig. 11). The lower reaches of the gully, from cross sections 1 to 5, have a relatively flat slope and a poorly defined channel. From cross section 6 to 16 the gully is incised into a loamy-sandy soil, and an active headcut is located upgradient from cross section 13. Cross section 14 is at the mouth of a tributary gully on the left bank and cross section 15 is at a tributary on the right bank. Upgradient from cross section 15 to just downgradient from cross section 19, the gully loses its form. Gullying is absent in this portion of the drainage because soils are lacking and bedrock and boulder outcroppings line the hillslope. On top of the mesa, at cross section 19, the gully is again incised into a loamy-sandy soil. A longitudinal profile of the gully (fig. 12A) shows an increase in gully gradient in an upstream direction. Width-to-depth ratios along the profile indicate a general widening in a downstream direction (fig. 12B). Reaches that are further downstream and away from the headcut might be closer to obtaining a new equilibrium condition than reaches immediately downstream from the headcut. Gully 1 was assigned an erosion classification of Class II (fig. 6; table 1).

Figure 12.--Longitudinal profile, in distance upstream from the gully mouth (A), and width-to-depth ratios (B) of a gully at site 1.

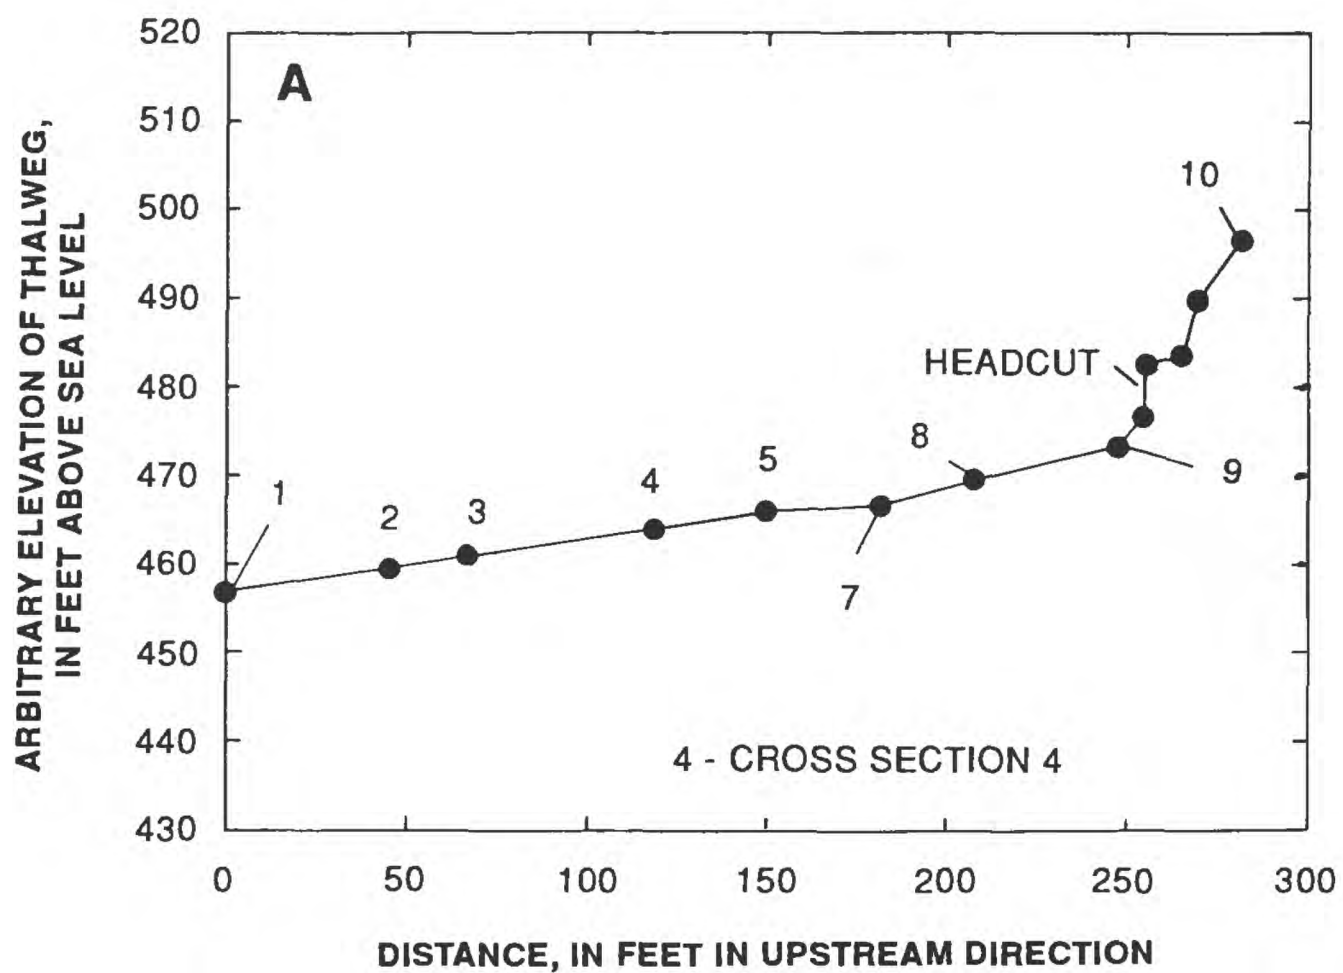
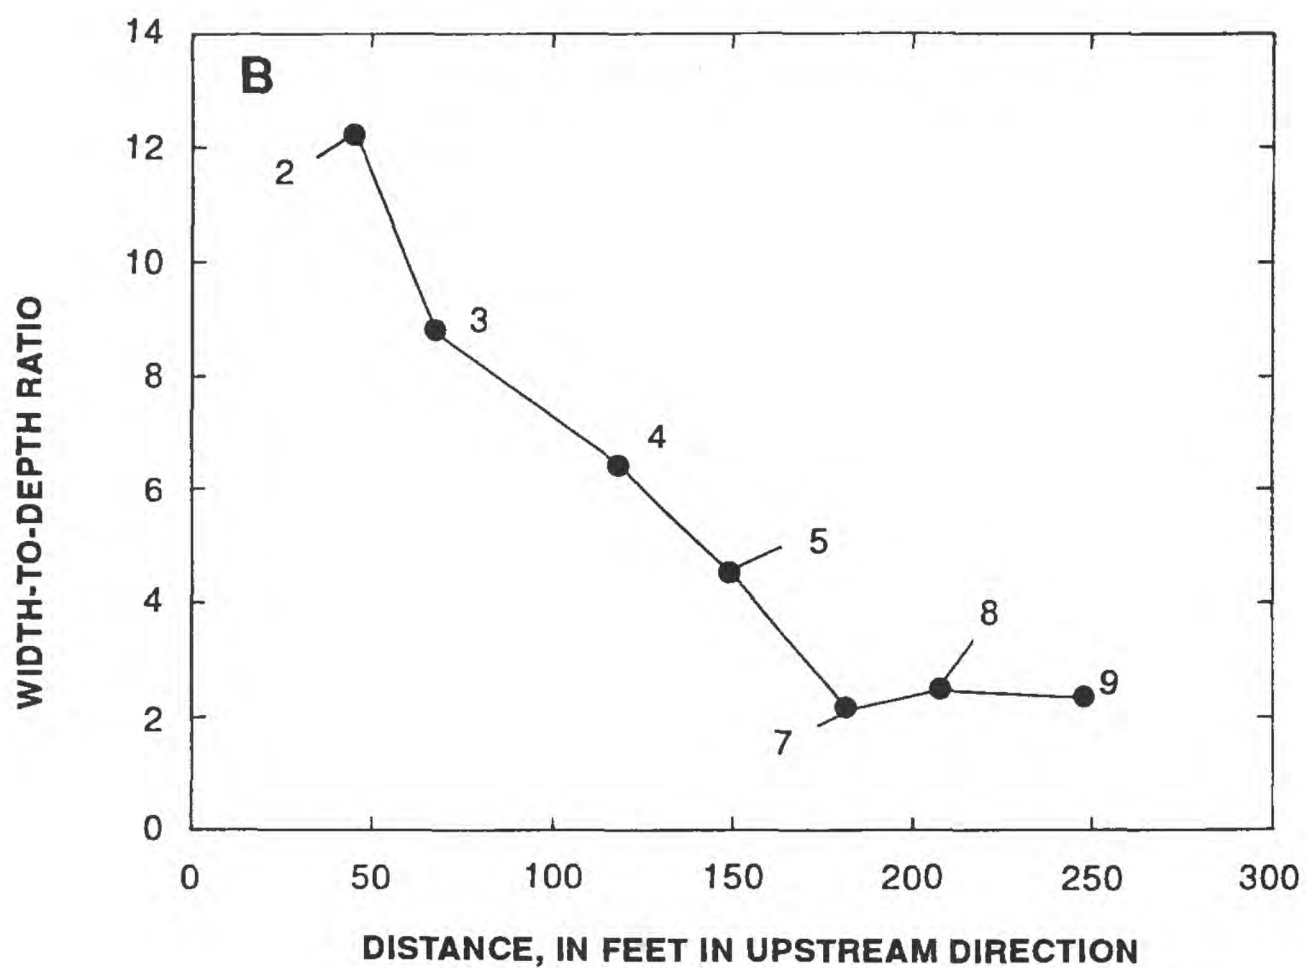
Figure 15.--Longitudinal profile, in distance upstream from the gully mouth (A), and width-to-depth ratios (B) of a gully at site 2.

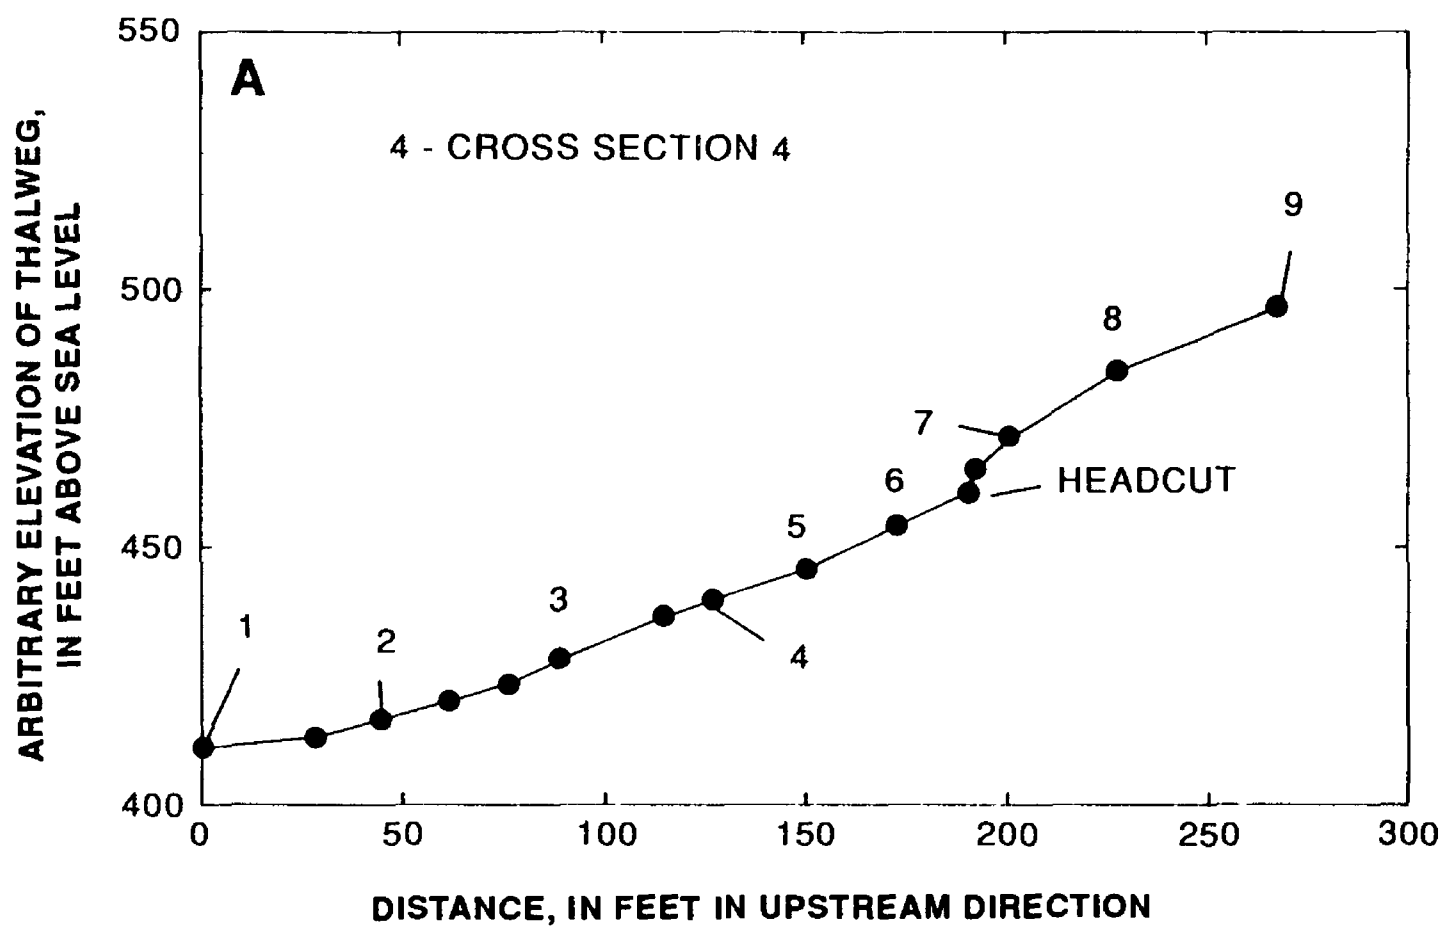
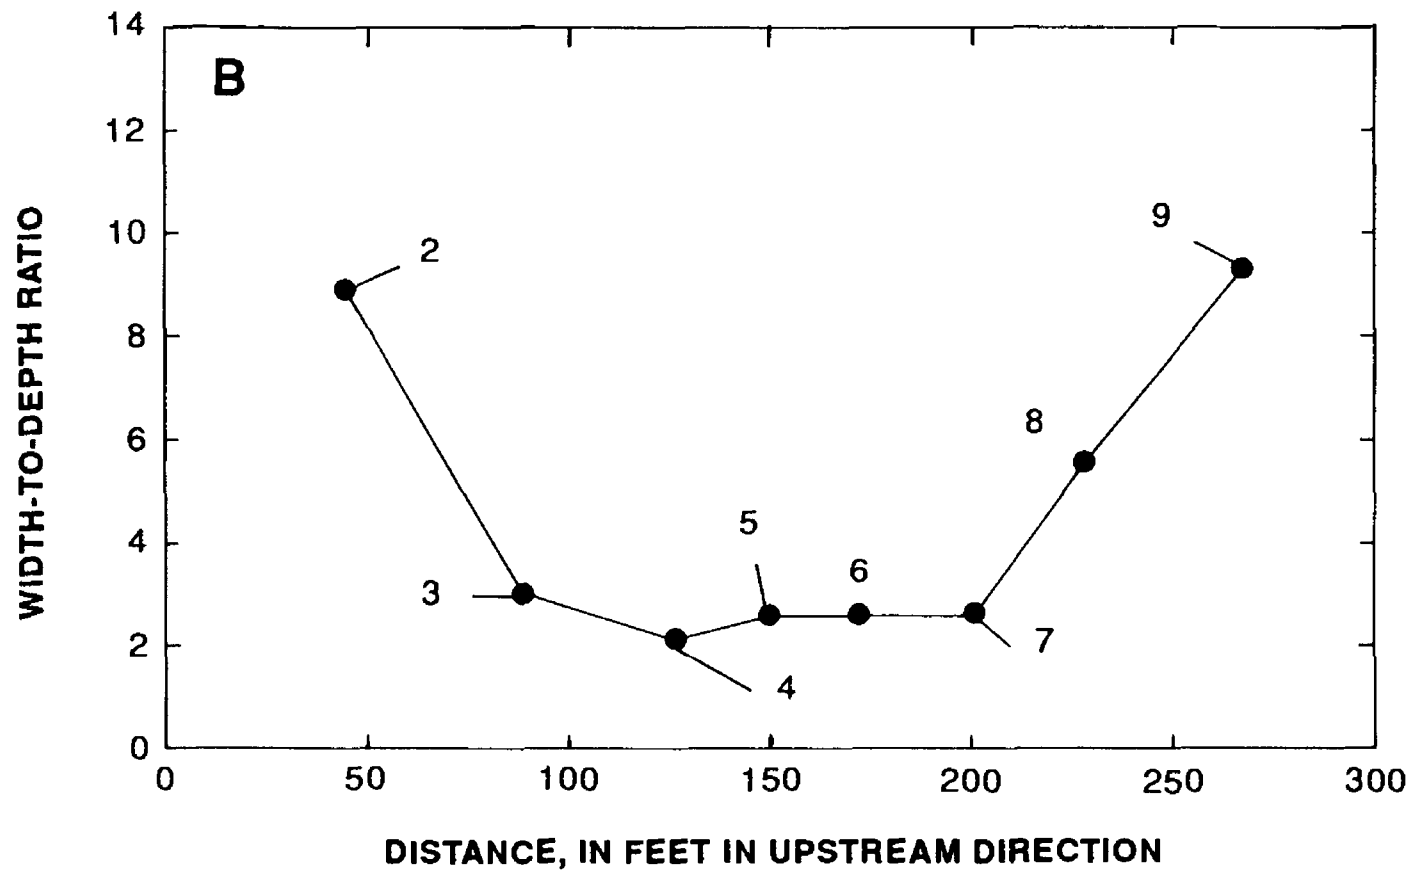
Figure 18.--Longitudinal profile, in distance upstream from the gully mouth (A), and width-to-depth ratios (B) of a gully at site 32.
