# Hydrogeology and Deformation of Sandbars in Response to Fluctuations in Flow of the Colorado River in the Grand Canyon, Arizona

U.S. GEOLOGICAL SURVEY  
Water-Resources Investigations Report 95—4010

Prepared in cooperation with the  
BUREAU OF RECLAMATION

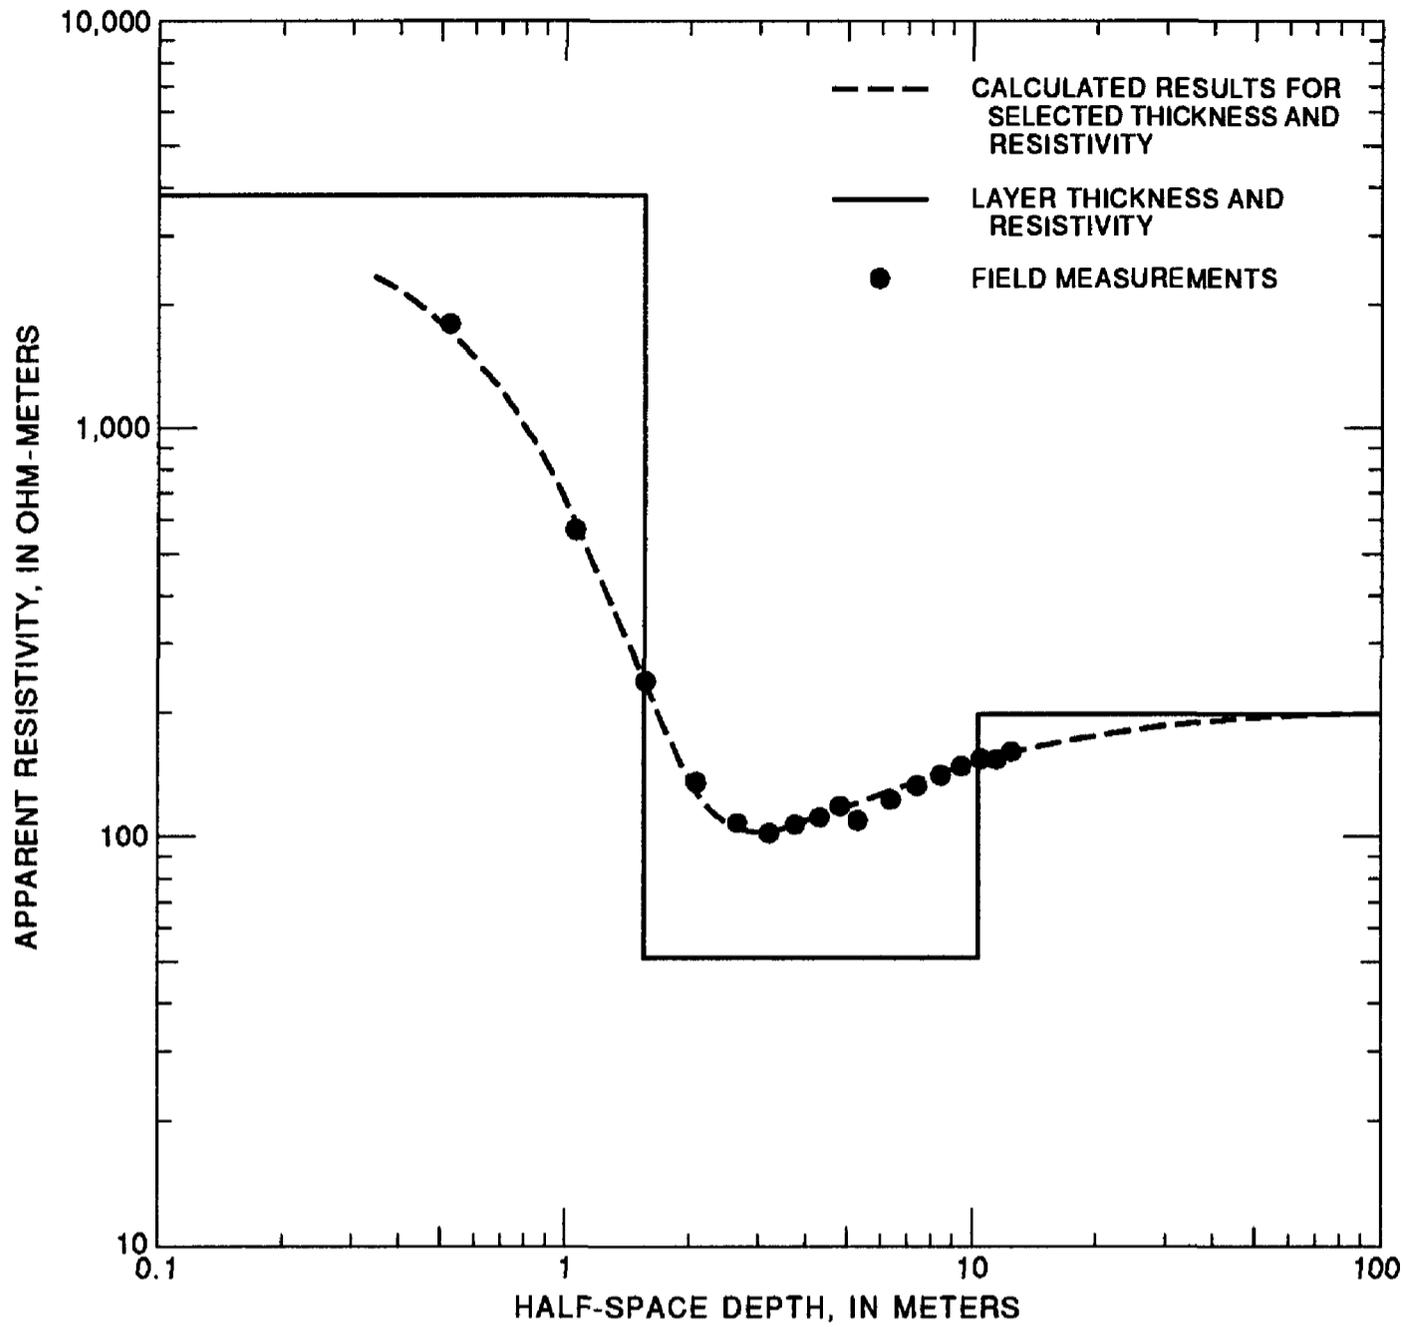
resistivities were related to the dry-sand part of the sandbar that underlay approximately 18 m of the line. Data from the central part of the line were block-averaged and modeled using one-dimensional methods. Modeling results indicated that the dry sand had a true resistivity of about 3,800  $\Omega$ -m and a thickness of about 1.6 m (fig. 5, table 1). This thickness correlated well with the elevation of the dry-sand part of the sandbar above the average stage of the river during the measurement period. Low apparent resistivities occurred on both ends of the line where electrodes were either occasionally submerged in the river or in the return channel. Apparent resistivities in these areas ranged from 40 to 50  $\Omega$ -m, suggesting that the river-water resistivity was not any greater than

Modeling yielded a higher true resistivity for the third layer that may represent electrical bedrock. The maximum depth penetrated by any of the piezometers was approximately 10 m. Bedrock was not encountered nor was there any significant change observed in grain size that might indicate penetration of a basal gravel or talus. On the basis of the resistivity data, bedrock may have been just

below the limit of drilling at an estimated depth of 10 to 15 m.

**Figure 5.** Block-averaged, apparent resistivity from sandbar 43.1L, opposite Anasazi Bridge, in relation to theoretical half-space depth of investigation.

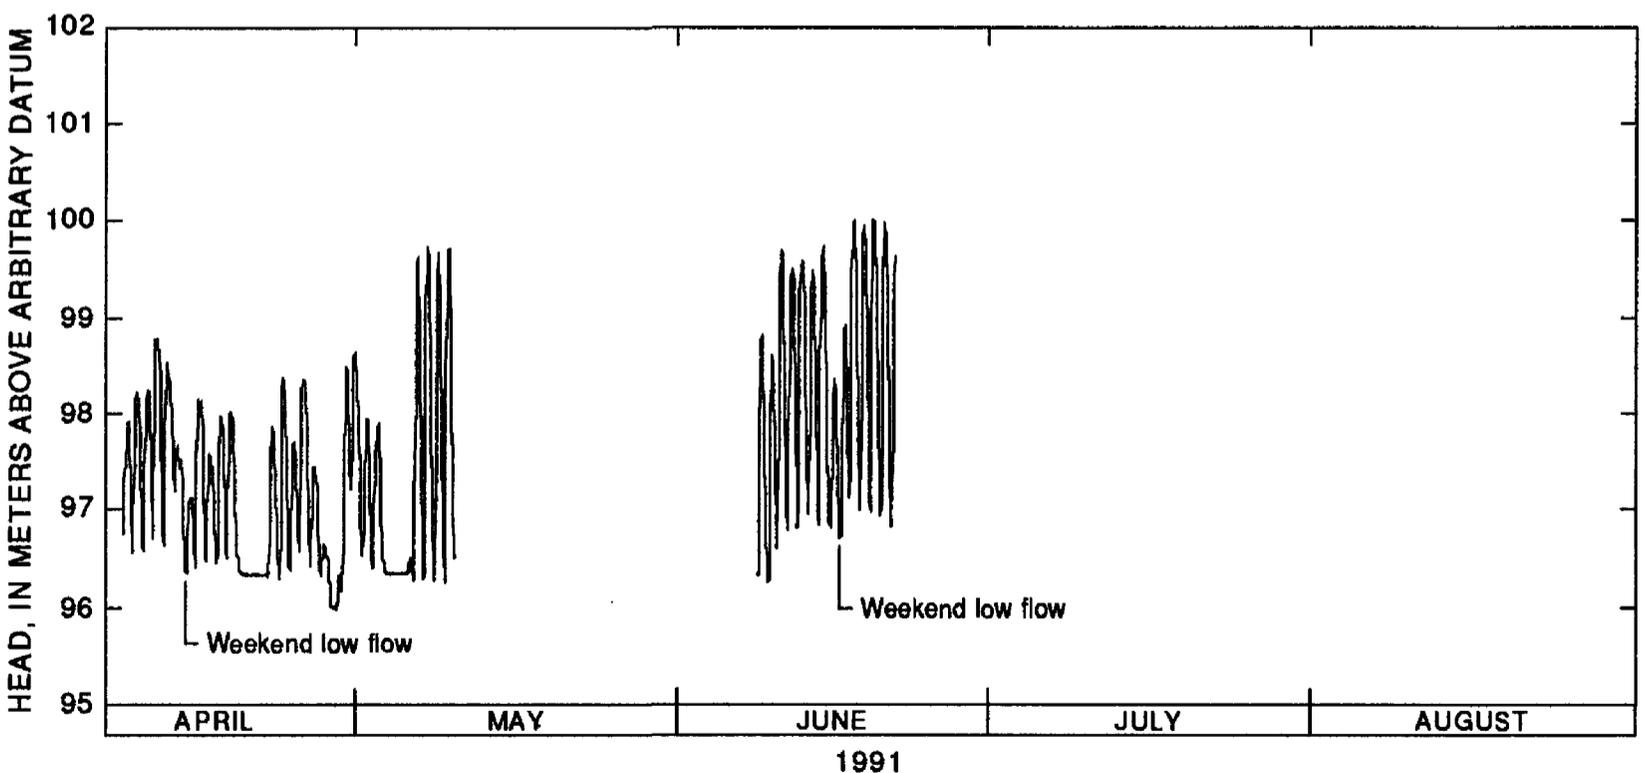
Figure 7. River stage at sandbar 43.1L, opposite Anasazi Bridge, April 8 through June 21, 1991.

failure on this sandbar was oversteepening of the lower part of the slope in the zone of fluctuating river stage. This conclusion was supported by evidence of rill erosion in daily photographs taken automatically from the opposite bank (Cluer, 1991). Rilling was enhanced during fluctuating weekend low flows (fig. 7). Rilling was intense after about 1.5 days during research steady low flows.

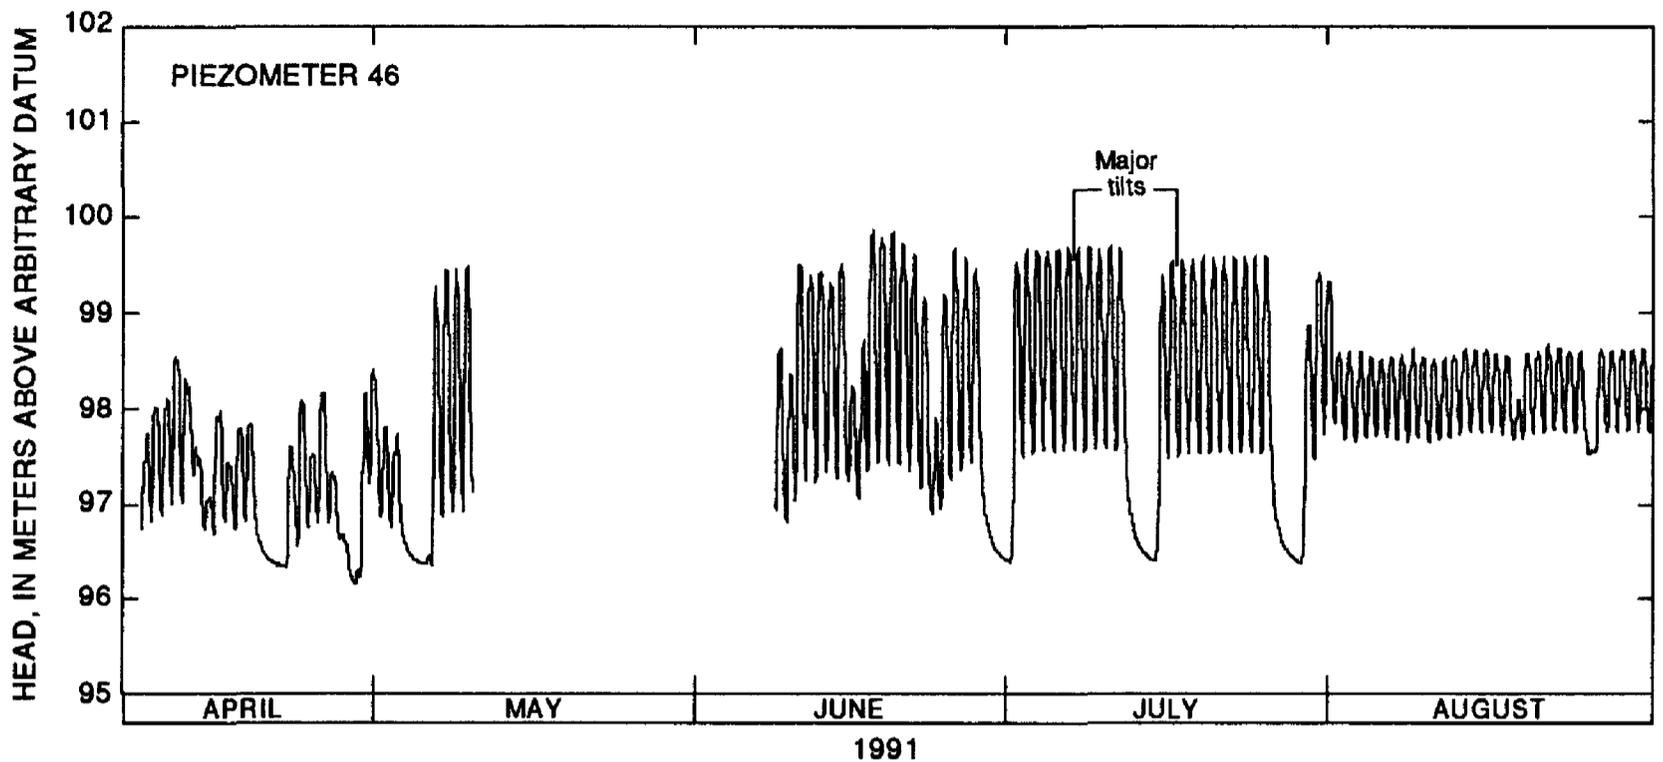
**Figure 8.** Water level in piezometer 46 at sandbar 43.1L, opposite Anasazi Bridge, April 8 through August 31, 1991.

Attenuation of water-level fluctuation from the front to the back of sandbar 43.1L was evident at piezometers 46, 40, 37, and 42 (figs. 9–11). From piezometer 46 to piezometer 42, the attenuation of fluctuating July flows was 30 percent over a distance of 30 m. The particularly high water level in piezometer 42 beginning on June 17, 1991, (fig. 11) may have been caused by hydraulic

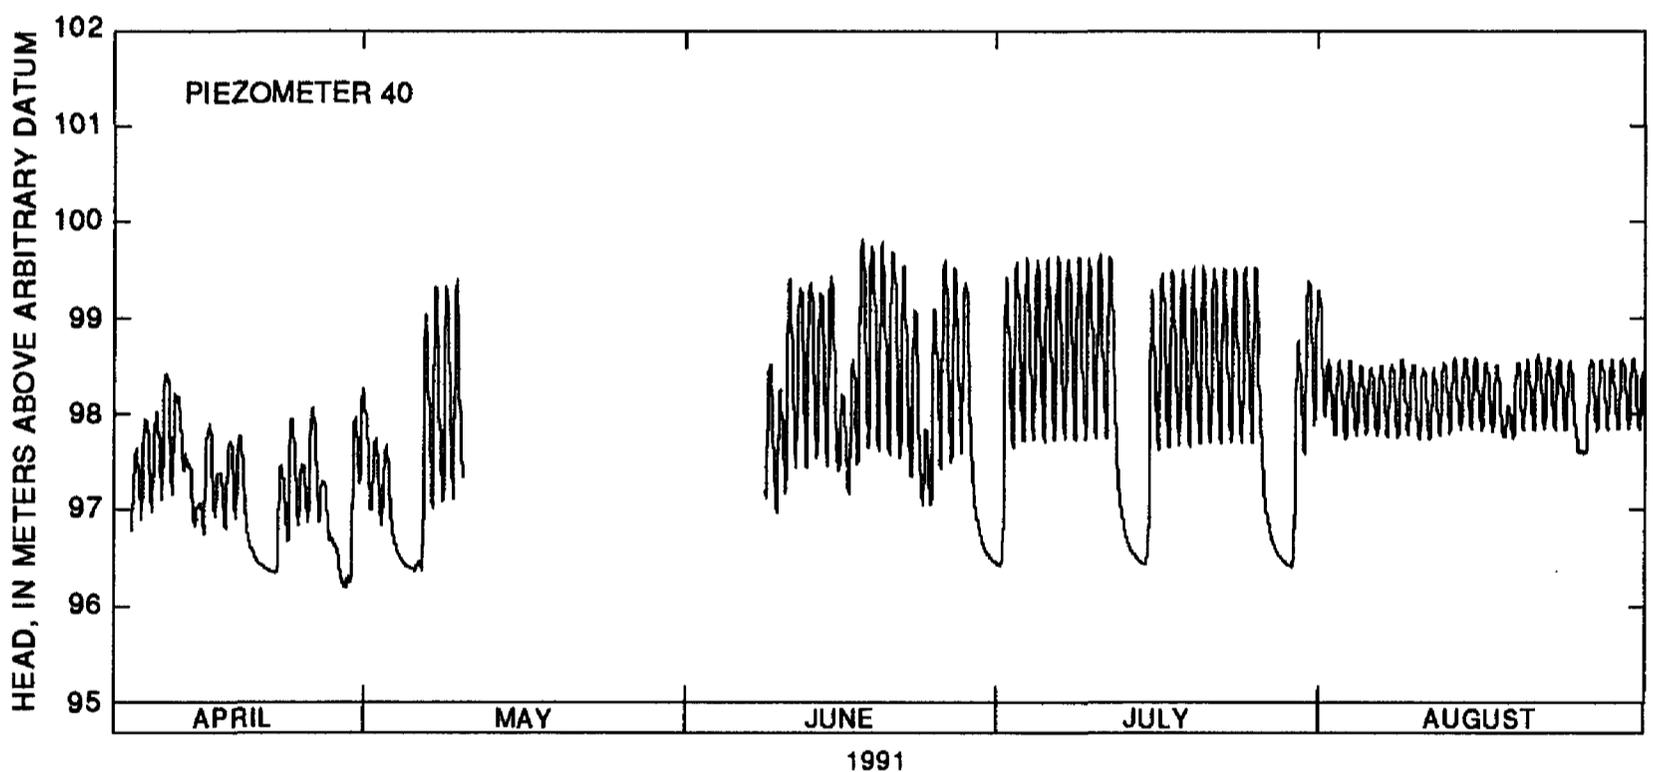
**Figure 9.** Water level in piezometer 40 at sandbar 43.1L, opposite Anasazi Bridge, April 8 through August 31, 1991.

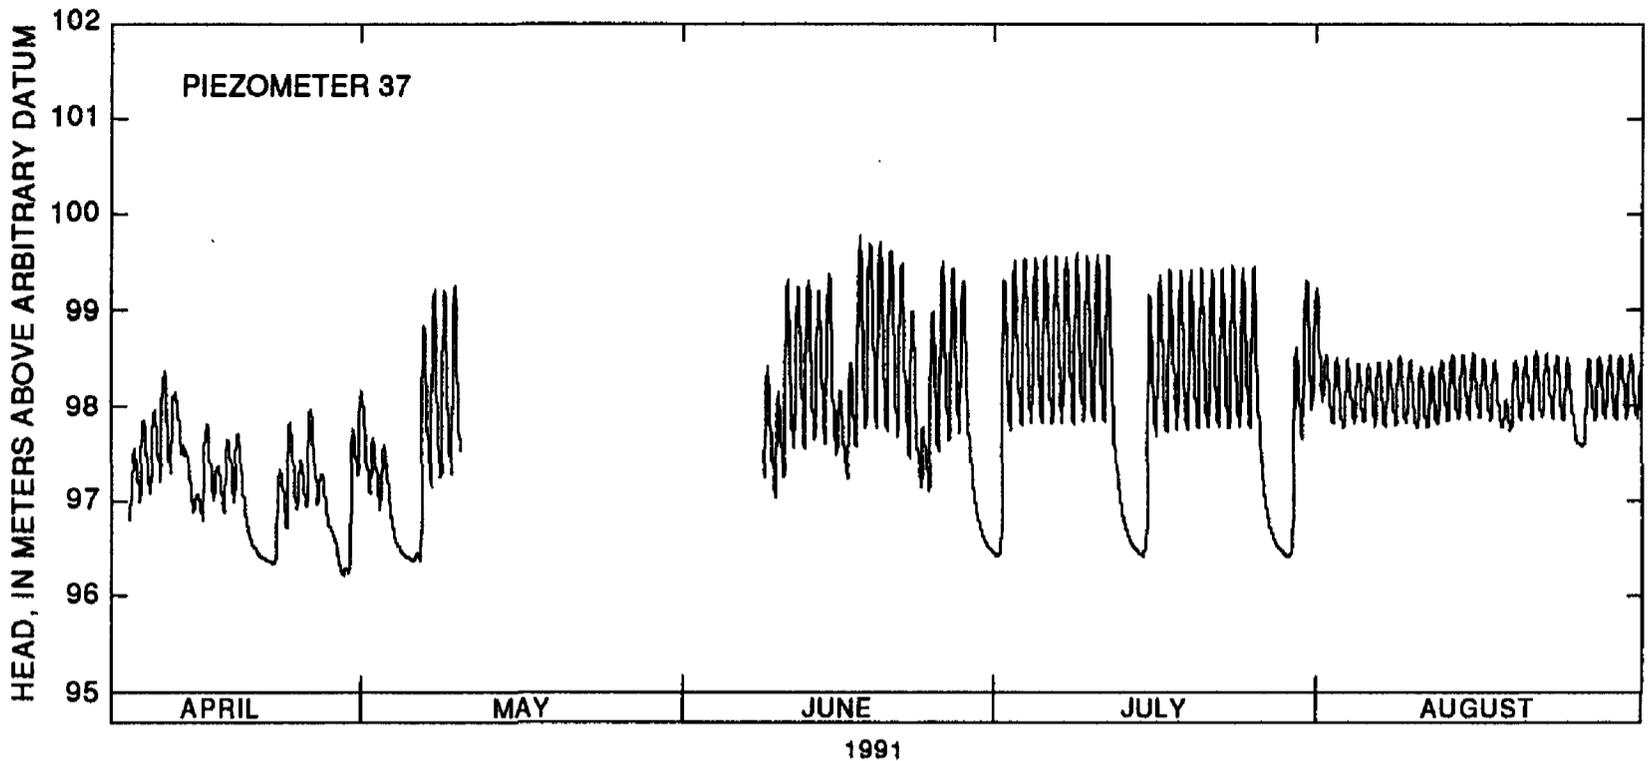
**Figure 10.** Water level in piezometer 37 at sandbar 43.1L, opposite Anasazi Bridge, April 8 through August 31, 1991.

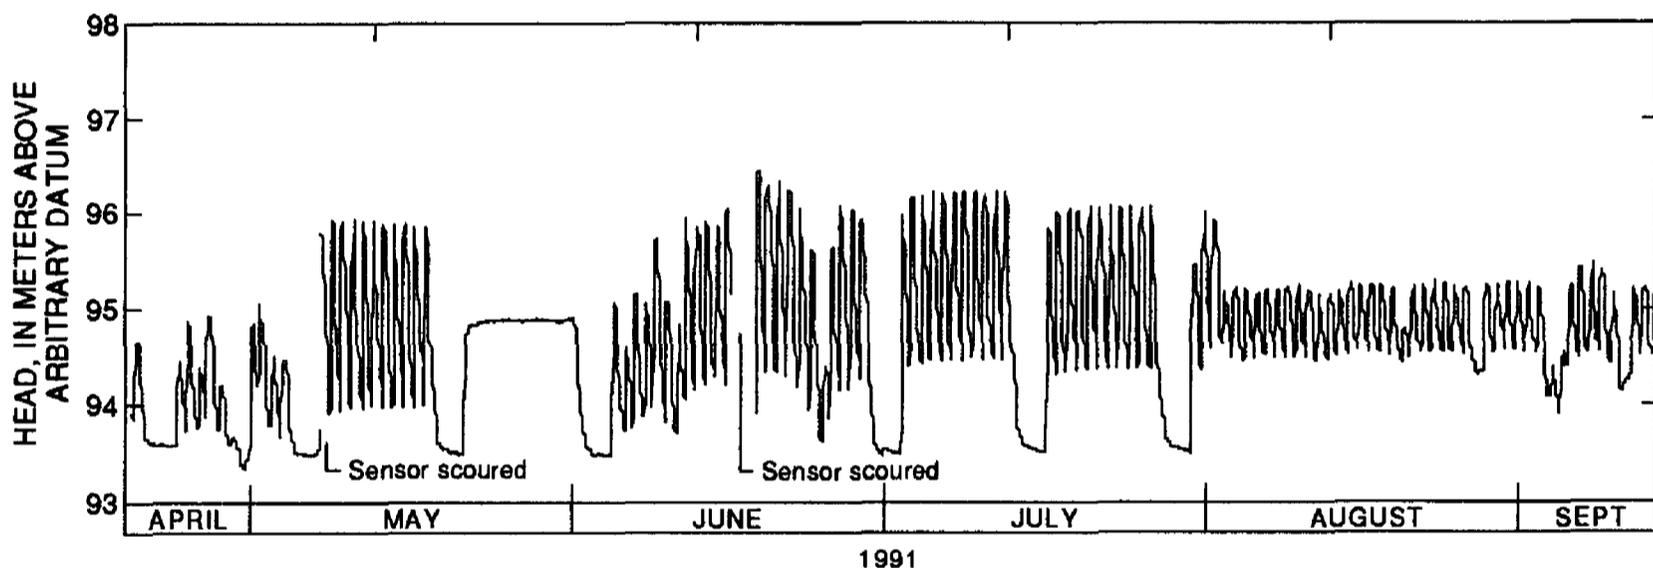
At sandbar 172.3L, attenuation of water-level fluctuation was about 30 percent from the stage sensor to piezometer 56 and 65 percent from the stage sensor to piezometer 64 over a distance of 35 m (figs. 15–17). Water-level fluctuations were less attenuated at piezometer 56 after the June 18, 1991, scour that deepened the stage sensor. The stage sensor was scoured and buried successively 1.3 m and 1.8 m on May 7 and June 18, 1991. The change in attenuation from the stage sensor to piezometer 56 probably was caused by the

**Figure 15.** River stage at sandbar 172.3L, downstream from the mouth of National Canyon, April 19 through September 12, 1991.
