Geology of Waterpower Sites on Scenery, Cascade, and Delta Creeks near Petersburg, Alaska

GEOLOGICAL SURVEY BULLETIN 1031-E

*A preliminary examination of the
geologic feasibility of proposed
damsites*

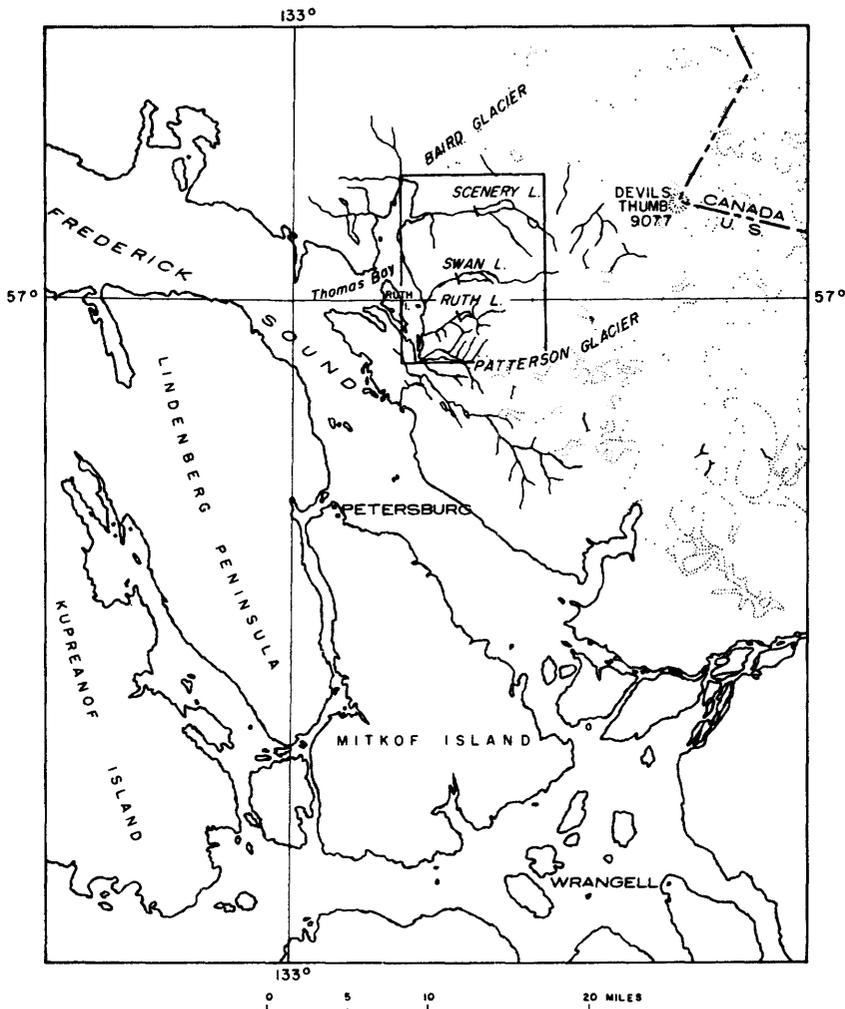
FIGURE 23.—Index map showing location of powersites.

The area investigated is on the mainland about 20 miles northeast of Petersburg on the east side of Thomas Bay, an arm of Frederick Sound, and is about 100 miles southeast of Juneau. Scenery, Cascade, and Delta Creeks, which flow westward into Thomas Bay, are effluents of Scenery, Swan, and Ruth Lakes, respectively. The location of these lakes and streams is shown on figure 23.
