GEOLOGICAL SURVEY CIRCULAR 147

GEOLOGY OF PROPOSED BLUE LAKE DAM SITE AND TUNNEL NEAR SITKA, ALASKA

By
William S. Twenhofel

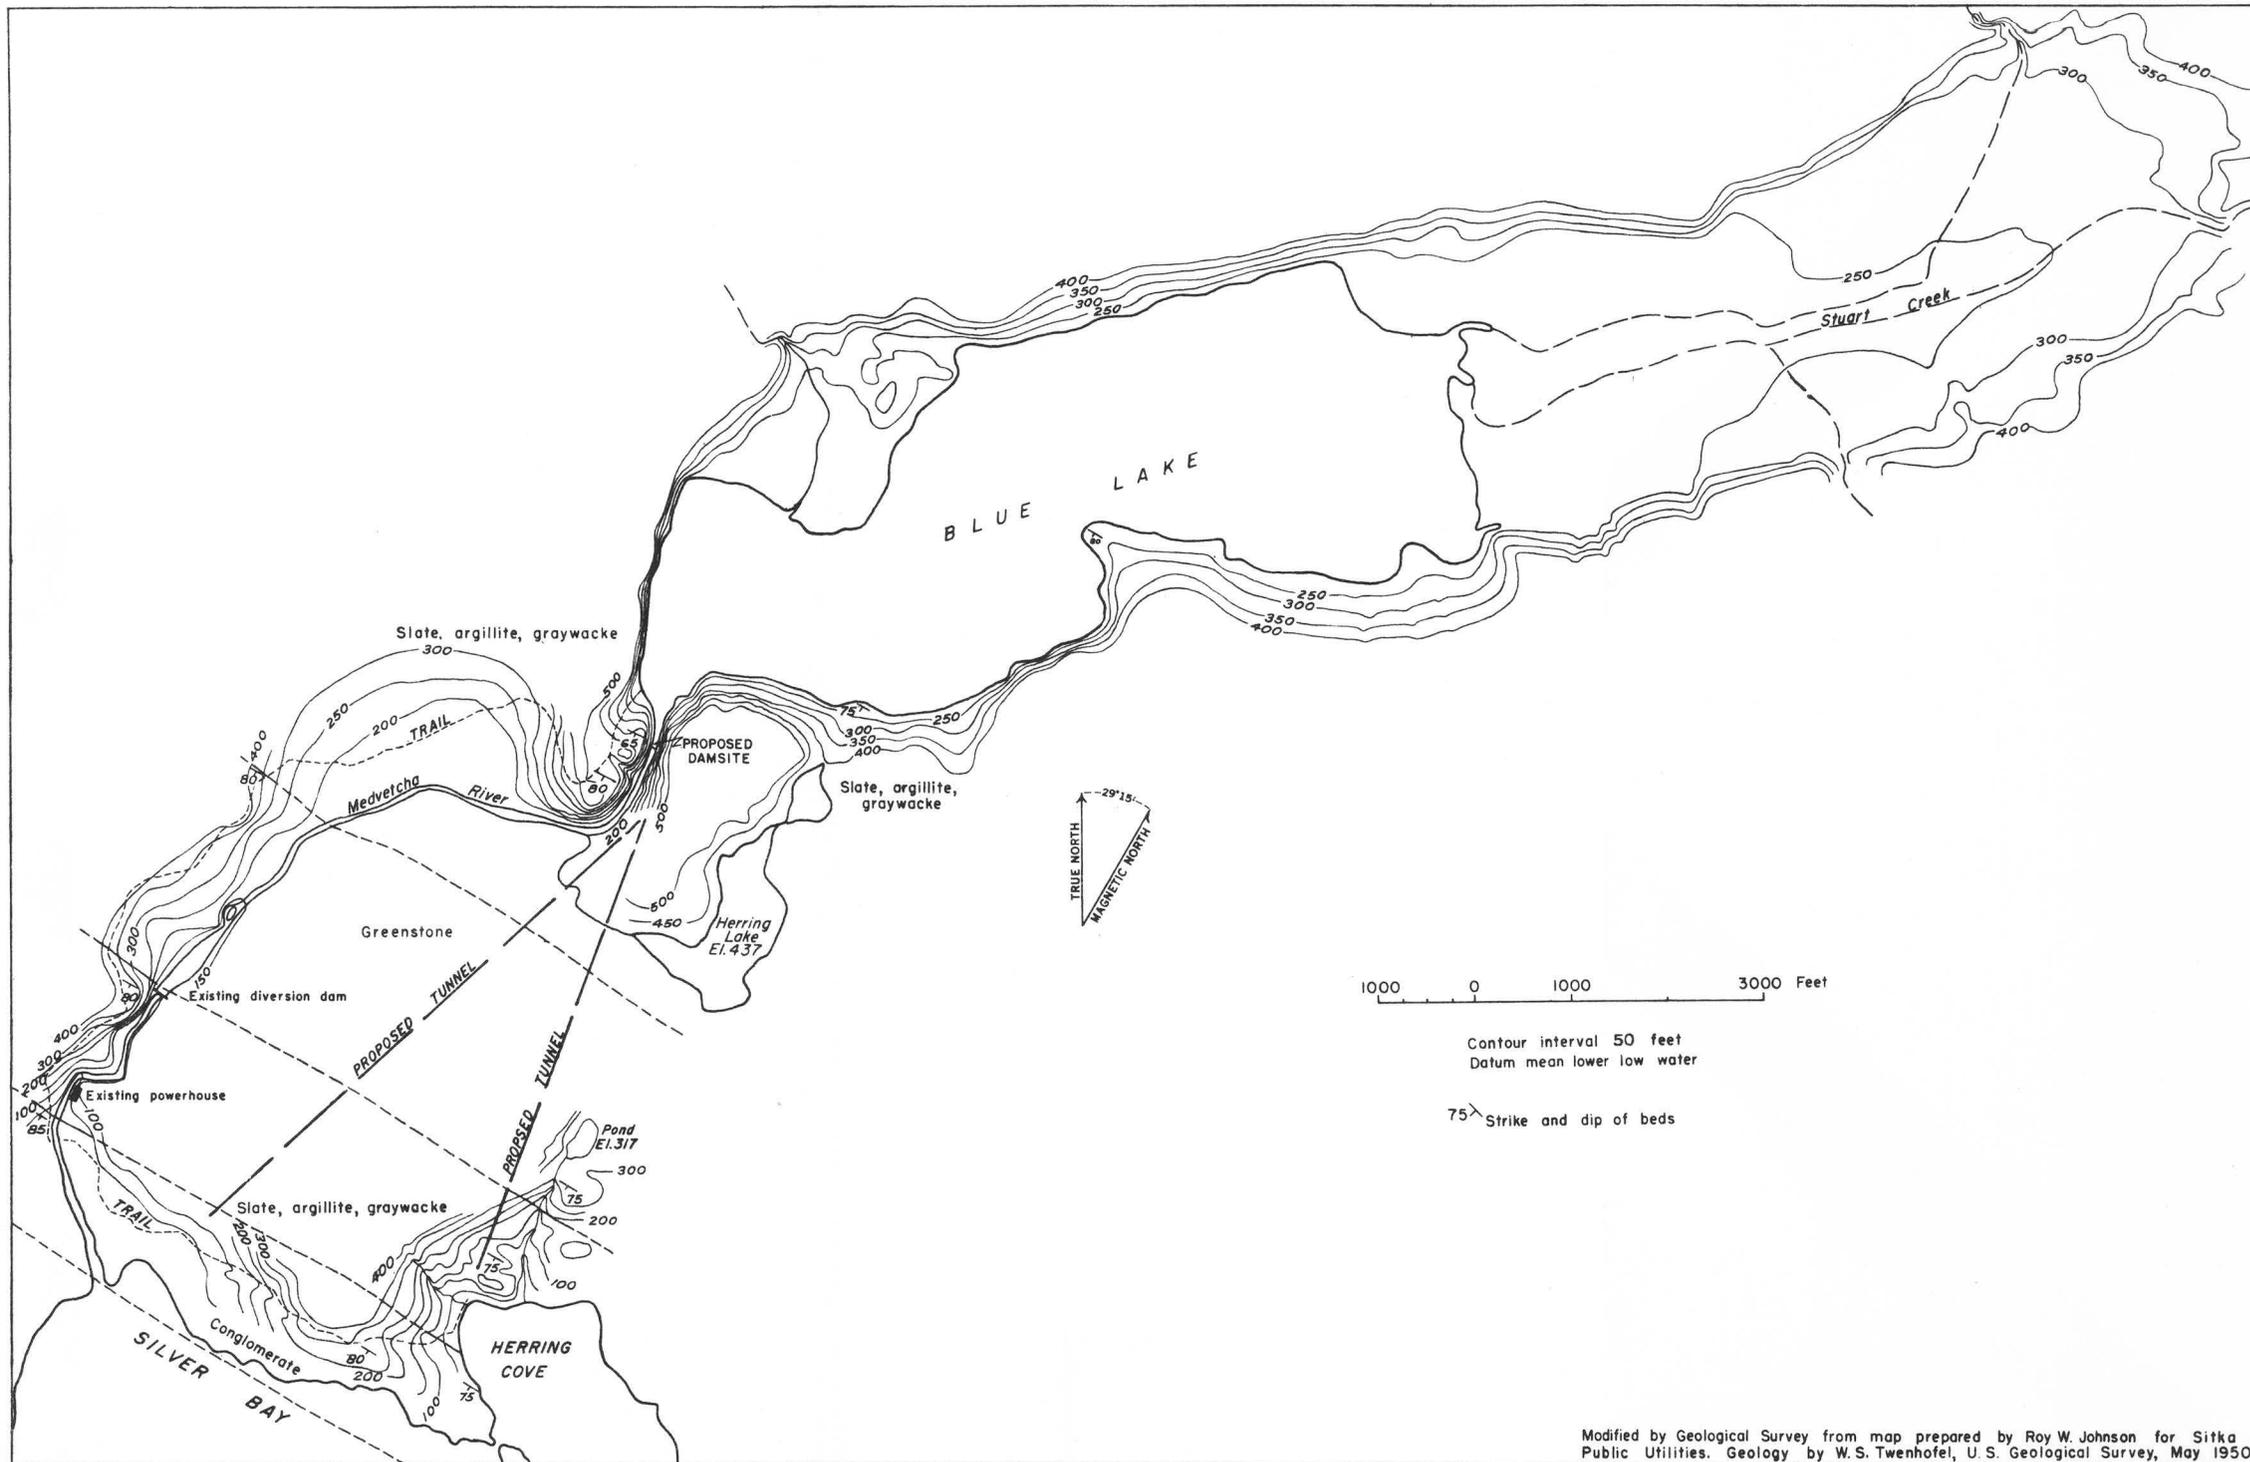
Figure 2. Blue Lake and vicinity, Baranof Island, Alaska.

Modified by Geological Survey from map prepared by Roy W. Johnson for Sitka Public Utilities. Geology by W. S. Twenhofel, U. S. Geological Survey, May 1950

1. Chichagof-Baranof Island, Alaska map no. 8, scale 1:250,000; published by U. S. Geological Survey.
2. Crawfish Inlet to Sitka, Baranof Island, chart no. 8255, scale 1:40,000; published by U. S. Coast and Geodetic Survey.
3. Figure 2 of this report; Blue Lake and vicinity, modified from map prepared by Roy W. Johnson for Sitka Public Utilities.

For this report four distinct units of rock are described (See fig. 2): conglomerate, slate, argillite, and graywacke; greenstone; and slate, argillite, and graywacke. All of these rocks strike uniformly northwest and either are vertical or dip steeply to the southwest. They are apparently conformable.

It is generally considered that the best dam site is in the canyon immediately below the outlet of Blue Lake. (See fig. 2) Here the canyon walls extend steeply upward from river level for 200 to 250 ft and a relatively small amount of material would be needed for dam construction. The canyon walls are stripped of all vegetation and loose rock, and the stream flows over bedrock. Very little stripping of material at the dam site would be necessary. The rock exposed is fresh argillite and slate, intensely fractured, but otherwise firm and solid. It is thought that removal of this fractured rock to a depth of 2 or 3 ft would expose less fractured rock and would provide firm dam foundation and abutments. No faults were seen in the area of the dam site.
