THE IMPLICATIONS OF RECENT FLOODPLAIN EVOLUTION ON HABITAT WITHIN THE MIDDLE RIO GRANDE, NEW MEXICO

Paul Tashjian, Hydrologist, Fish and Wildlife Service, Albuquerque, NM,
[Paul Tashjian@fws.gov](mailto:Paul.Tashjian@fws.gov); Tamara Massong, Hydrologist, Bureau of Reclamation,
Albuquerque, NM, tmassong@uc.usbr.gov

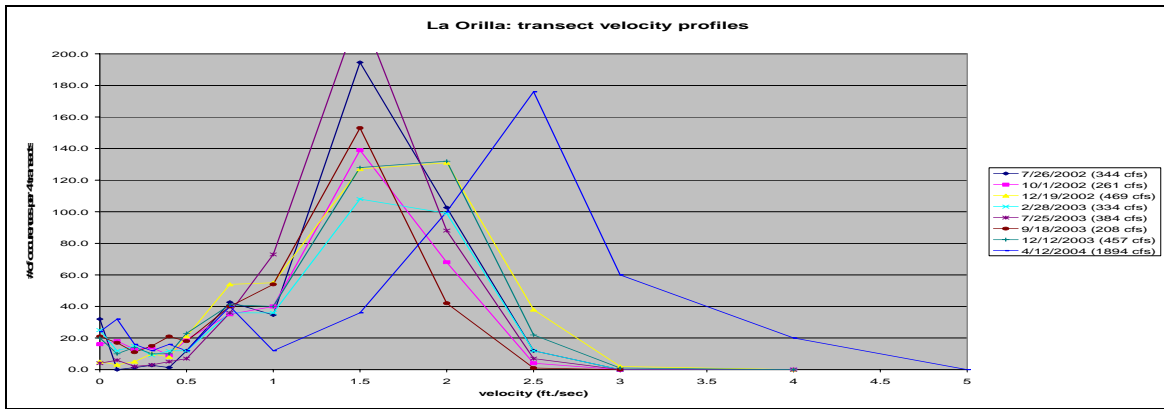
Figure 5: Velocity profiles for the La Orilla Site at various flow levels. These types of profiles are associated with poor habitat since there are very little in-channel velocity diversity at all flow levels.

The La Orilla Site which has a moderate-high incision character (Reach 3 from Massong et al., 2006) is located near Albuquerque, NM in the Albuquerque Valley Habitat Reach (Remshardt and Tashjian, 2005). This Site is typified by banks that are frozen in place by jetty jack lines (Figure 2), and a relatively tall abandoned floodplain. The site receives only a moderate amount of sediment supply and has a limited hydrograph. During the calendar years of 2000 through 2004, daily mean flows were between 100cfs and 1000cfs 95% of the days. Due to the frozen bank positions in this reach and an abandoned floodplain, flows in this range supply the in-channel habitat with very homogeneous velocity habitat availabilities (Figure 5). This site is considered poor habitat (Remshardt and Tashjian, 2005).

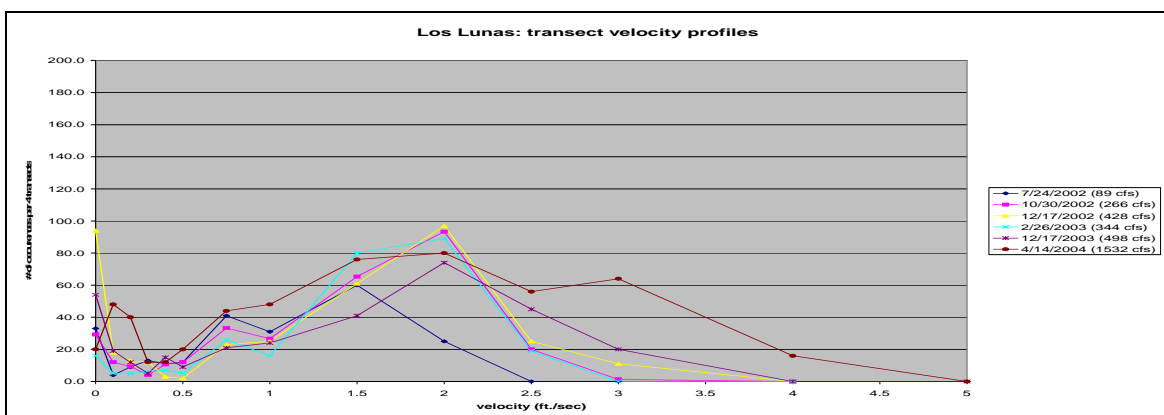
Figure 7: Velocity profiles for the Los Lunas Site at various flow levels. These types of profiles are associated with good habitat since there are diverse in-channel velocity diversity at all flow levels.

The primary difference between the La Orilla and Los Lunas Sites is that there is greater hydrographic diversity in the low and mid flow ranges at the Los Lunas Site. This diversity in the hydrograph, barring intermittence, has led to complex in channel habitats and modern bar and island floodplain surfaces, components of quality habitat.
