Geology and availability of ground water in the
vicinity of Gila Cliff Dwellings National
Monument, Catron County, New Mexico

By
Frederick D. Trauger

Open-file report 63-122
January 1963

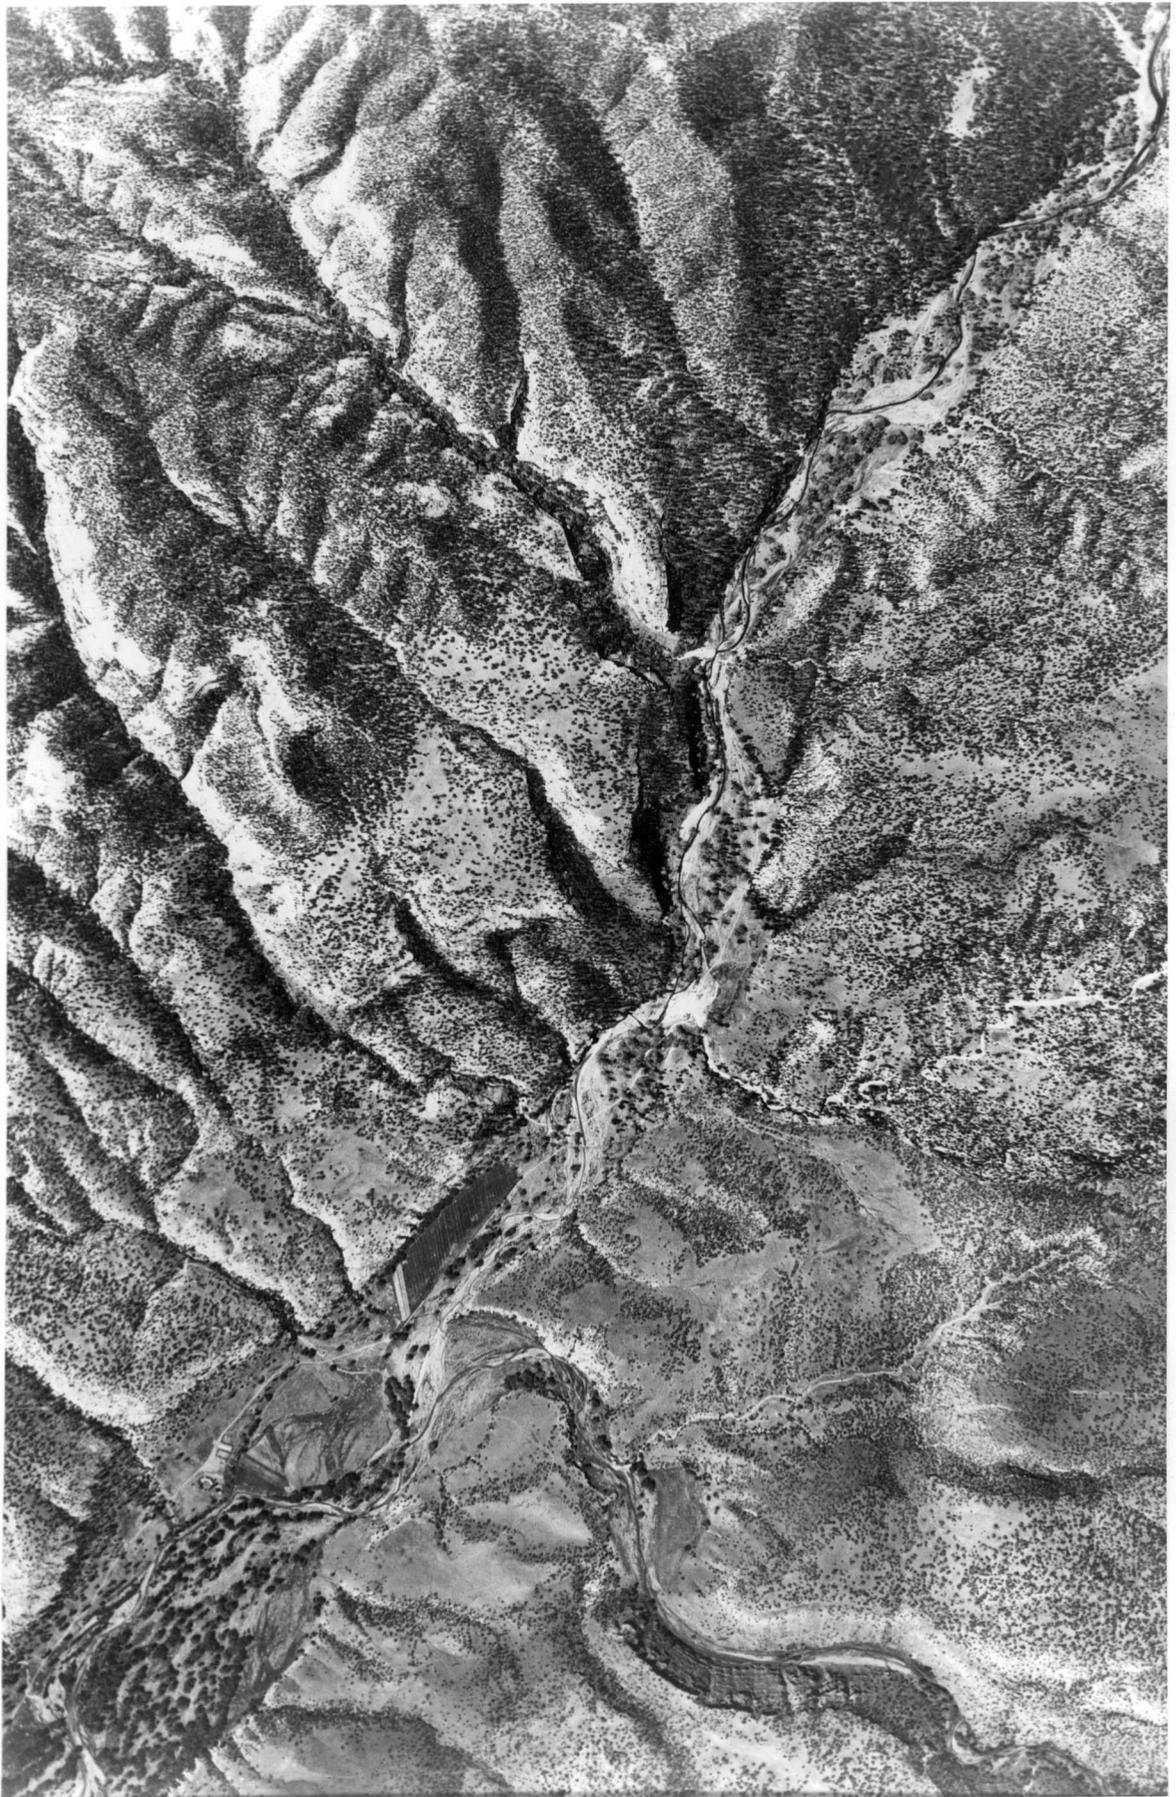
Figure 1.--Aerial mosaic and overlay of the Gila Cliff Dwellings National Monument and environs, Catron County, N. Mex.

Site A, T. J. Ruins area.--A six-level system of stream terraces (fig. 1) has been cut by the Middle Fork of the Gila River, in the central part of sec. 25, T. 12 S., R. 14 W., just north of the junction with the West Fork. The Middle Fork has truncated all the terraces on the north and west and has exposed the rocks underlying the terrace levels.

Site D, Doc's Cienaga and Site E, Pine Flat.--A flat area 0.1 to 0.2 mile wide at one time extended along the north side of the Gila River from about a quarter of a mile west to 1 mile west from the Visitors' Center (fig. 1). The river swept across the valley during a comparatively recent flood, cut away part of the flat and a small alluvial fan at the mouth of a side canyon, and left a bouldery channel which now divides the flat into two parts. The eastern part of about 12 acres is referred to as Doc's Cienaga (Site D); the western part of about 15 acres is referred to as Pine Flat (Site E).

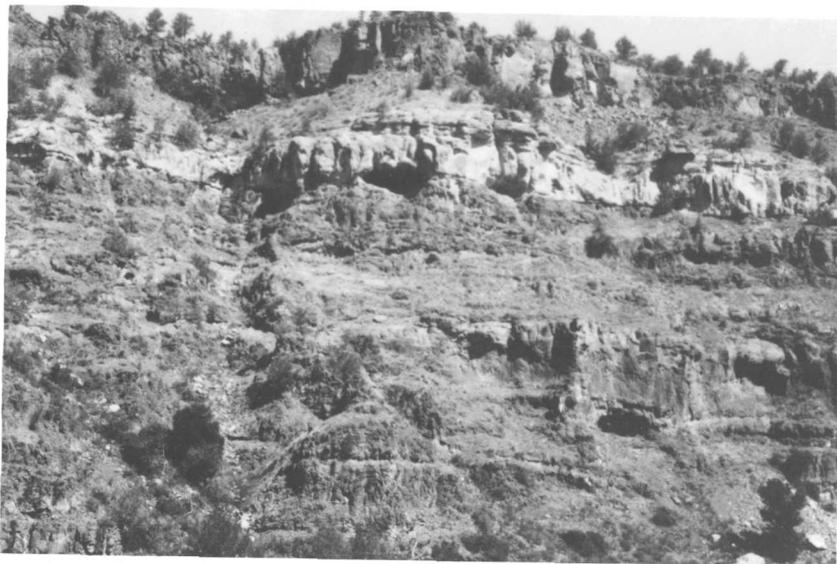
Figure 4.--North wall of the canyon of the Middle Fork of the Gila River, opposite Boundary Hot Spring. Rimrock is dense gray basalt underlain by buff sandstone (slope) and conglomerate (light colored cliff-rock) of the Gila Conglomerate. Reddish to dark-gray intricately jointed basalt underlies the Gila.
SW $\frac{1}{4}$ NE $\frac{1}{4}$ SE $\frac{1}{4}$ sec. 24, T. 12 S., R. 14 W.

The basalt rimrock at the top of the cliffs (fig. 4) is underlain by conglomerate and also overlain by conglomerate a short distance back from the rim. The contacts with the overlying and underlying conglomerate are concealed but the basalt is believed to be the same basalt that is exposed at river level below the T. J. Ruins, and there the contact shows the basalt to be intrusive into the conglomerate.

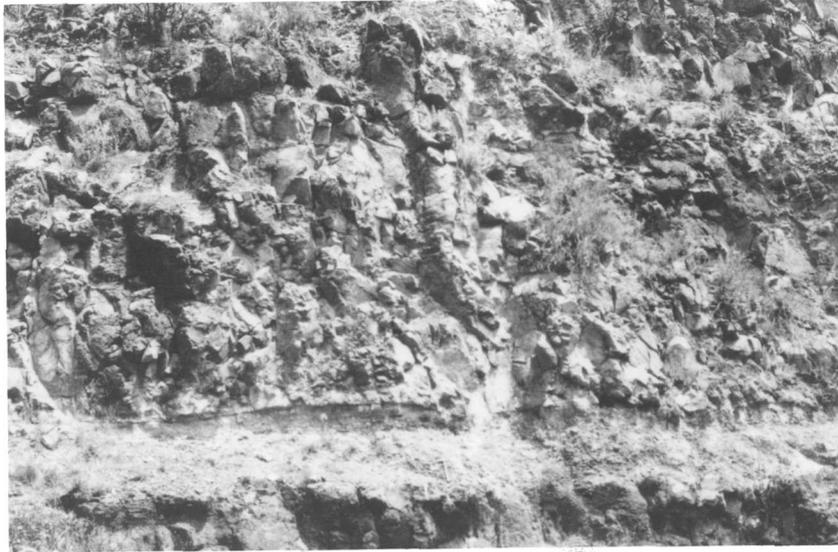
a

Figure 5a.--Reddish-brown basalt, intricately jointed, showing intense zeolitic zone, inflation pipe, and crude pillow structure.

Several flows, all intricately jointed, can be seen in the canyon wall. The intricate close-jointed structure and intense zeolitic development are both conspicuous in the east wall of the canyon at the river crossing in the SW $\frac{1}{4}$ SE $\frac{1}{4}$ SE $\frac{1}{4}$ sec. 24, T. 12 S., R. 14 W. (fig. 5a, b).

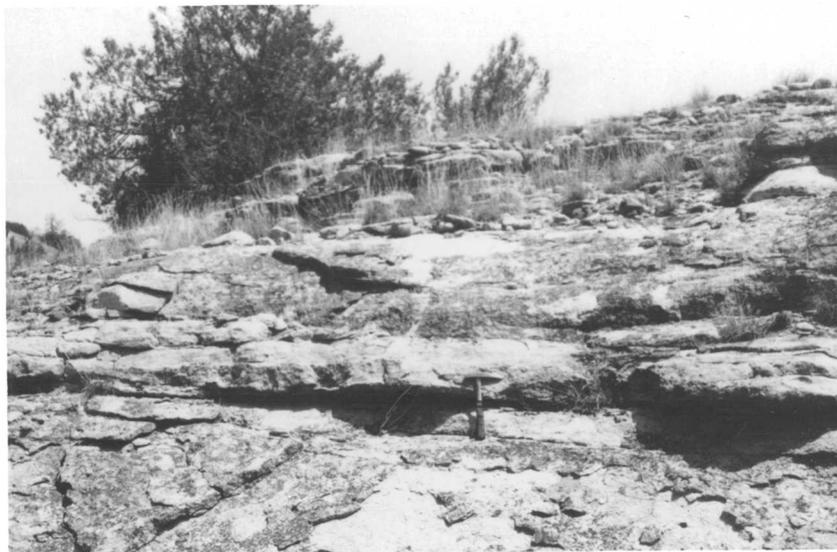
Figure 6a.--Gila Conglomerate showing well-defined bedding and strong cementation.

The sediments in general are poorly sorted, dense, massive to well bedded, and moderately well to very well consolidated (fig. 6a, b).

The surface of the fifth terrace is about 100 feet above the present level of the river, and is underlain by a veneer of unconsolidated gravel left by the river when the terrace was cut. Beds of the Gila Conglomerate (fig. 6) underlie the veneer of gravel to a depth of about 25 feet. Below these beds is a hard, dense, gray basalt sill in the Gila that may be as much as 75 feet thick. This rock extends down to river level and is exposed along the river at the foot of the slope up to the terraces. The base of the gray basalt is not exposed. The basalt probably is equivalent to the approximately 75 feet of gray basalt interbedded with the sandstone and conglomerate that is exposed in the cliffs high up on the canyon wall to the northeast, on the upthrown side of the fault.

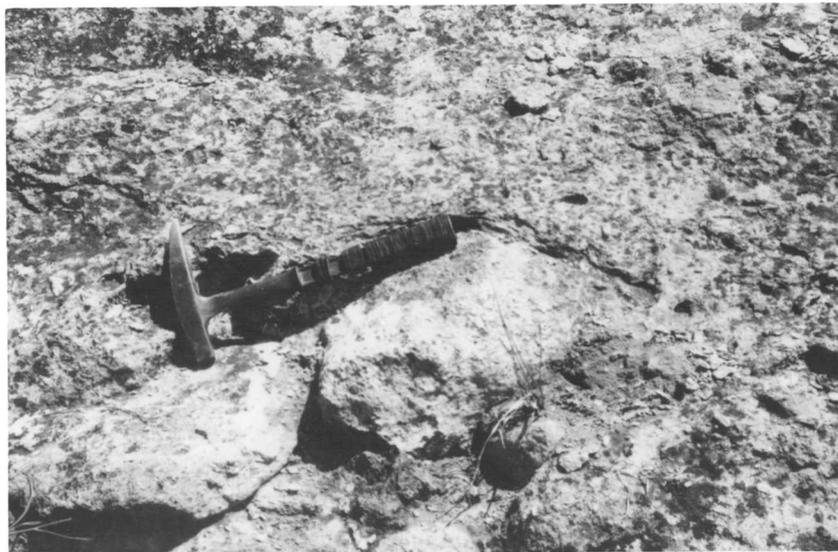
b

b.--Large boulders of dense hard volcanic rock in matrix of tuffaceous sandstone and smaller rocks. Terrace slope, SW $\frac{1}{4}$ SE $\frac{1}{4}$ NW $\frac{1}{4}$ sec. 25, T. 12 S., R. 14 W.

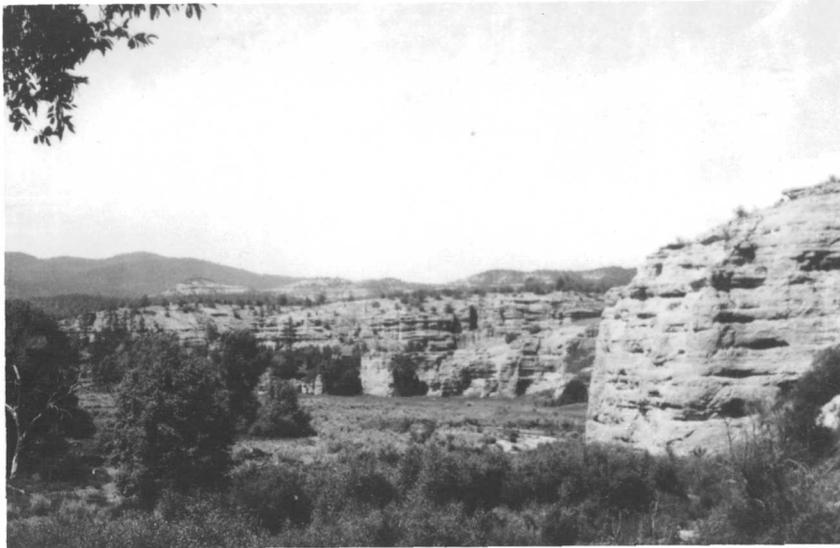
Figure 7.--Gila Conglomerate exposed in bluffs on west side of the Middle Fork of the Gila River, at the junction with the West Fork. Differential erosion and weathering have etched the face of the bluffs and accentuated the bedding planes. The valley floor is underlain by alluvial fill to a depth of 30 to 50 feet.

NW $\frac{1}{4}$ sec. 25, T. 12 S., R. 14 W.

The Gila Conglomerate forms the prominent bluffs that border the river at the junction of the West Fork and the Middle Fork of the Gila River (fig. 7). Characteristic and prominent features of the Gila
