Preliminary Geologic Report for the Alenaio Stream
Flood Damage Reduction Study Area, Hilo, Hawaii

Open-File Report 81-791

Report prepared for the
U. S. Army Corps of Engineers,
Honolulu District, September, 1980.
Revised March, 1981.

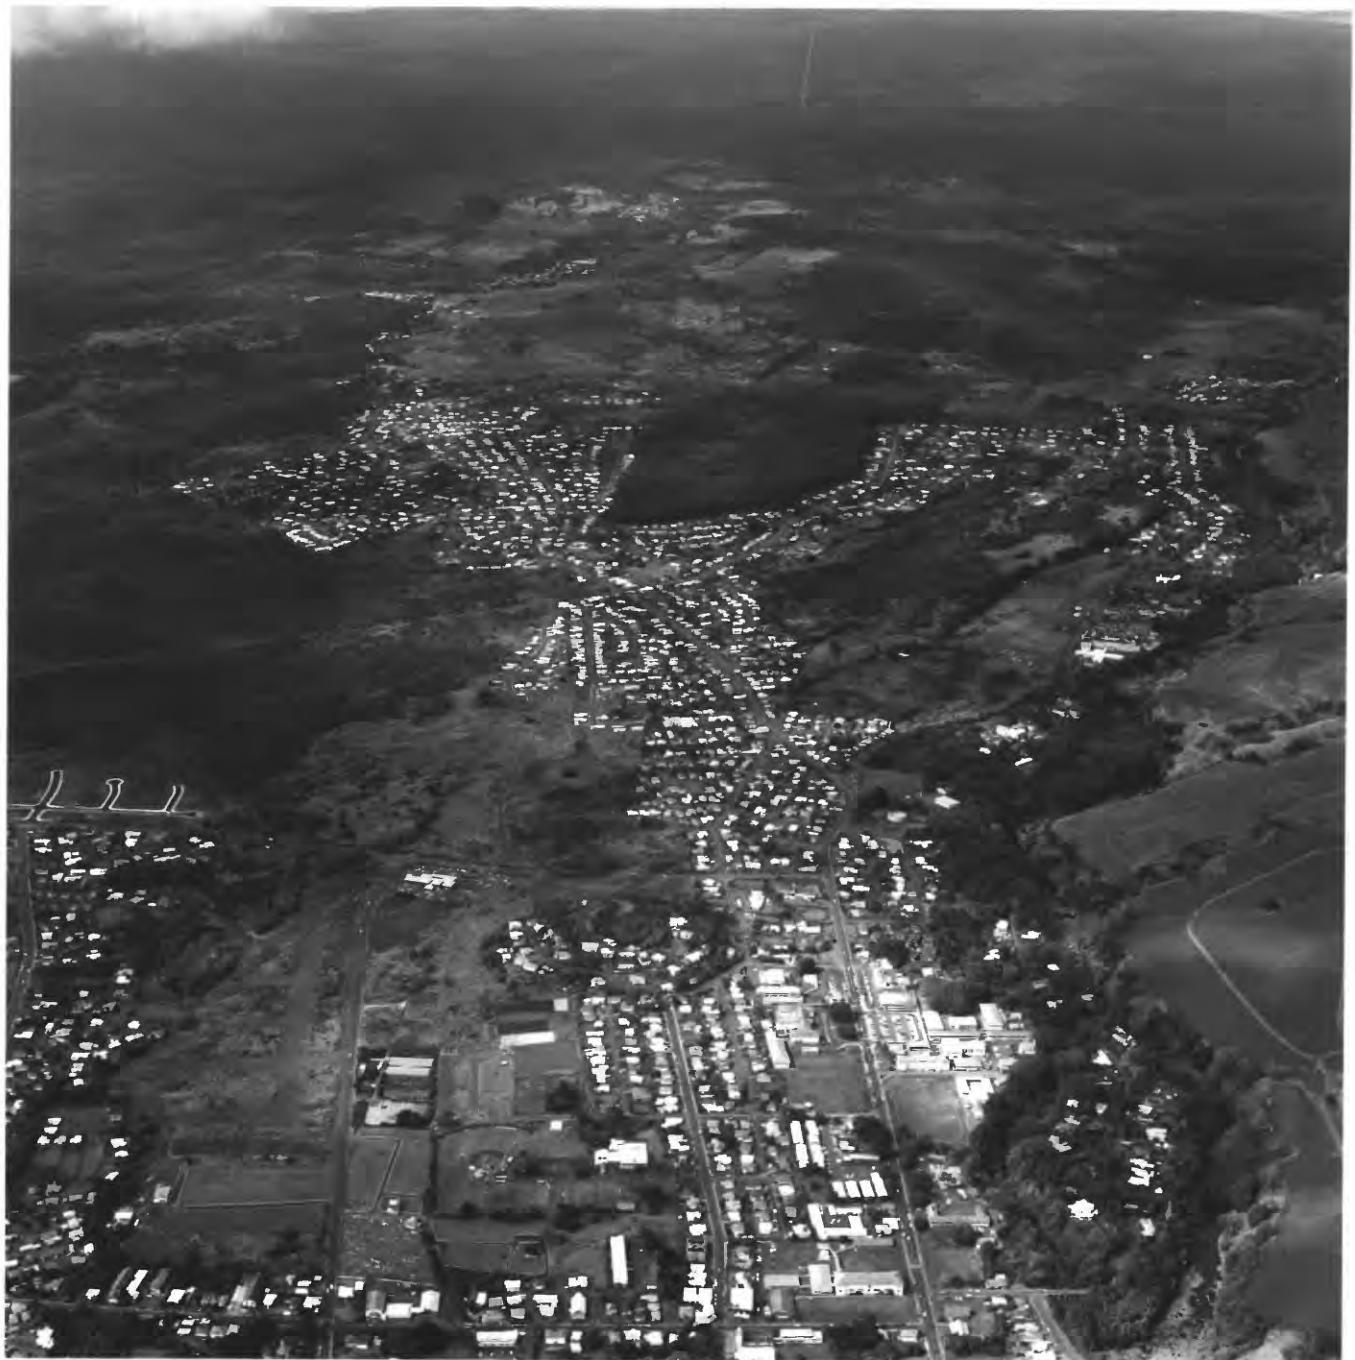
Figure 3.--Aerial view of the central Hilo area from the northeast showing the area of the "missing" channel between the Alenaio and Waipahoehoe Streams. The three principal pahoehoe flows that dominate the surface (left to right: Kulaloa, 1881, Punahoa) are seen as dark forested areas separated by light-colored grassland. Photograph by J. R. Griggs, U.S. Geological Survey.

Alenaio Stream lies directly downslope from Waipahoehoe Stream, yet in a 1-mi-long stretch midway between Chong's Bridge and Komohana Street, no well-defined channel connects the two streams (fig. 3). Substantial surface water travels directly from the Waipahoehoe Stream to the Alenaio Stream only during periods of very heavy rainfall. In times of normal rainfall, water carried in the Waipahoehoe Stream at Chong's Bridge seems to disappear in the area above Komohana Street and does not reach the Alenaio Stream directly. Yet, despite the lack of a well-developed stream channel upslope, water continues to flow in the middle and lower reaches of the Alenaio Stream except during periods of low rainfall. Much of the water passing below Chong's Bridge is lost directly into the bed of Waipahoehoe Stream, comprised mainly of the Punahoa and 1881 pahoehoe flows. There are numerous constriction points in the lower Waipahoehoe Stream, however, and during periods of abundant waterflow the carrying capacity of the stream is exceeded. The excess water is diverted out of the normal channel into well-defined flood channels that conduct the water southward, over the 1881 pahoehoe flow (fig. 4). Some of these flood channels lead directly to large lava tube openings (fig. 5), whereas others lead to the relatively flat area above Komohana Street, an area underlain by the 1881 and Kulaloa pahoehoe flows. Floodwaters accumulate in this area during periods of abundant rainfall, and it is clear that much of this water seeps into the underlying flows. Numerous small, wet, depressions where water collected and undoubtedly percolated downward were observed in this area during a recent relatively dry period. It is assumed that most of this water eventually reached lava tubes within the 1881 and Kulaloa flows. Some of this water doubtless continues to percolate downward beneath these flows, but much is clearly transported laterally towards the central Hilo area. The lava tube shown in figure 5 measured 8 ft in average diameter and had transported large amounts of water during recent heavy rains. Debris lodged in the tube roof indicated it had been completely water filled (fig. 6).

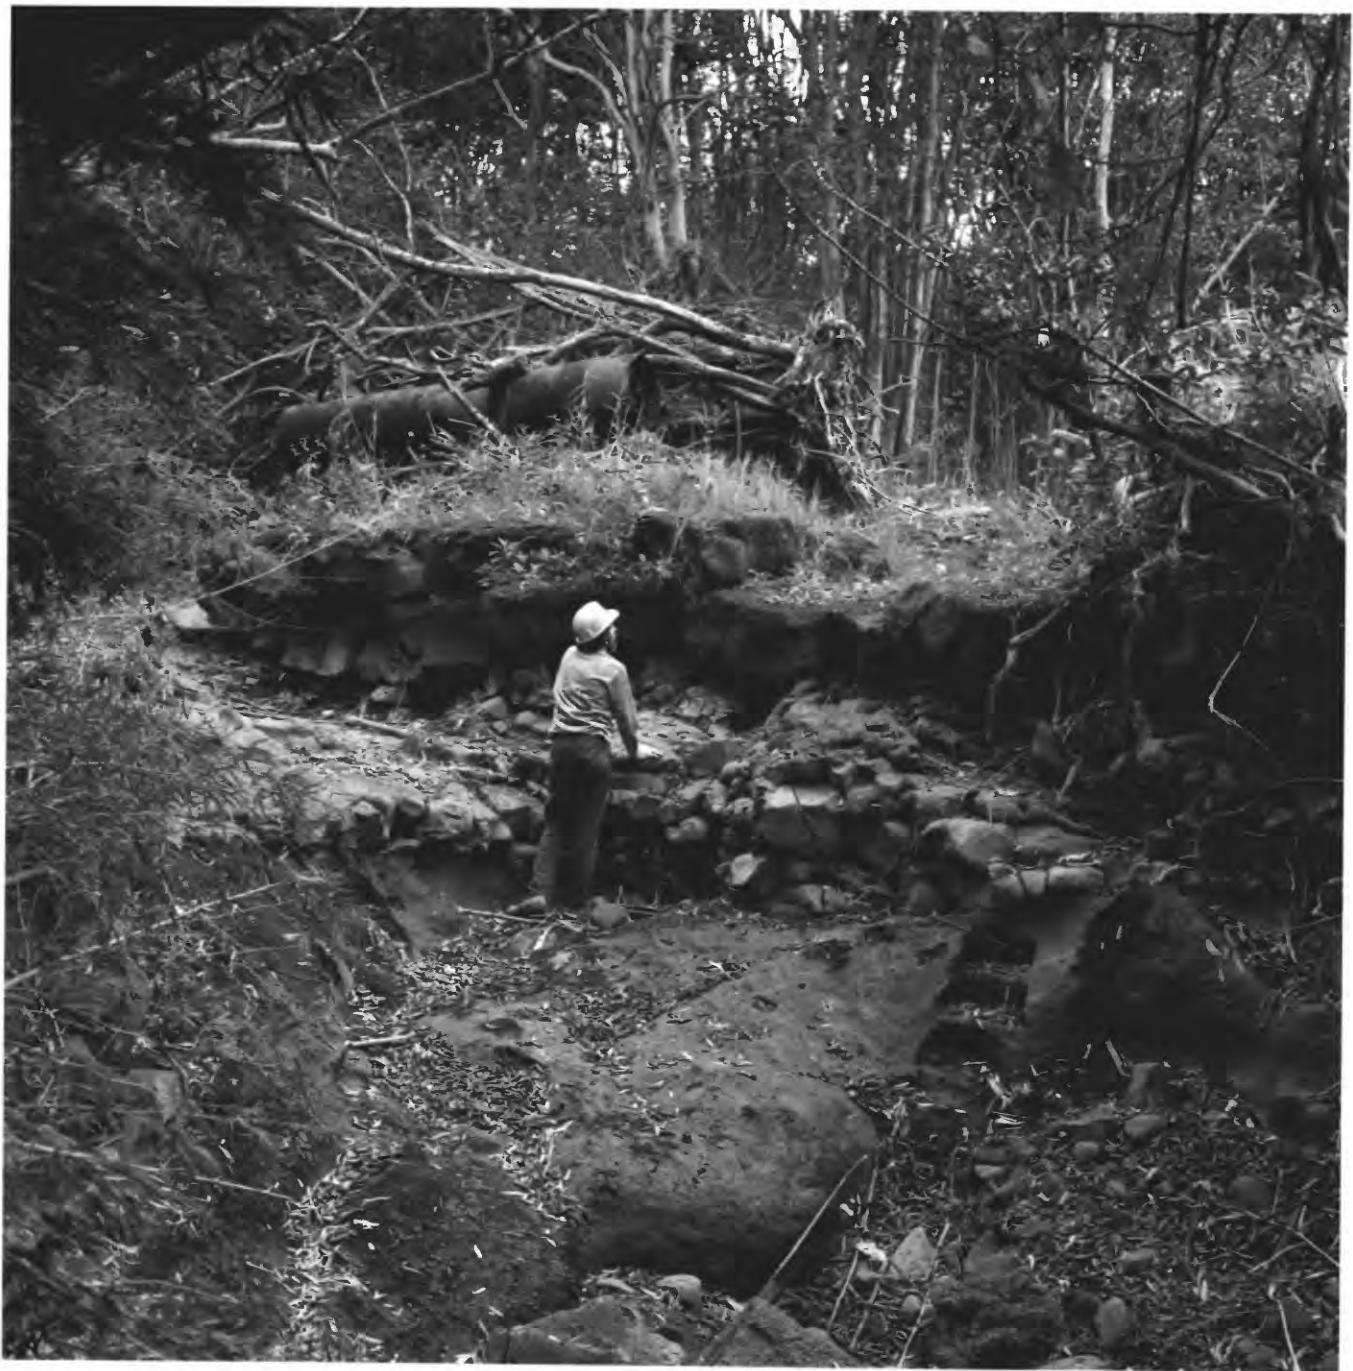
Figure 4.--Lower Waipahoehoe Stream showing constriction point where floodwaters are diverted into a south-flowing channel. Photograph by J. R. Griggs, U.S. Geological Survey.

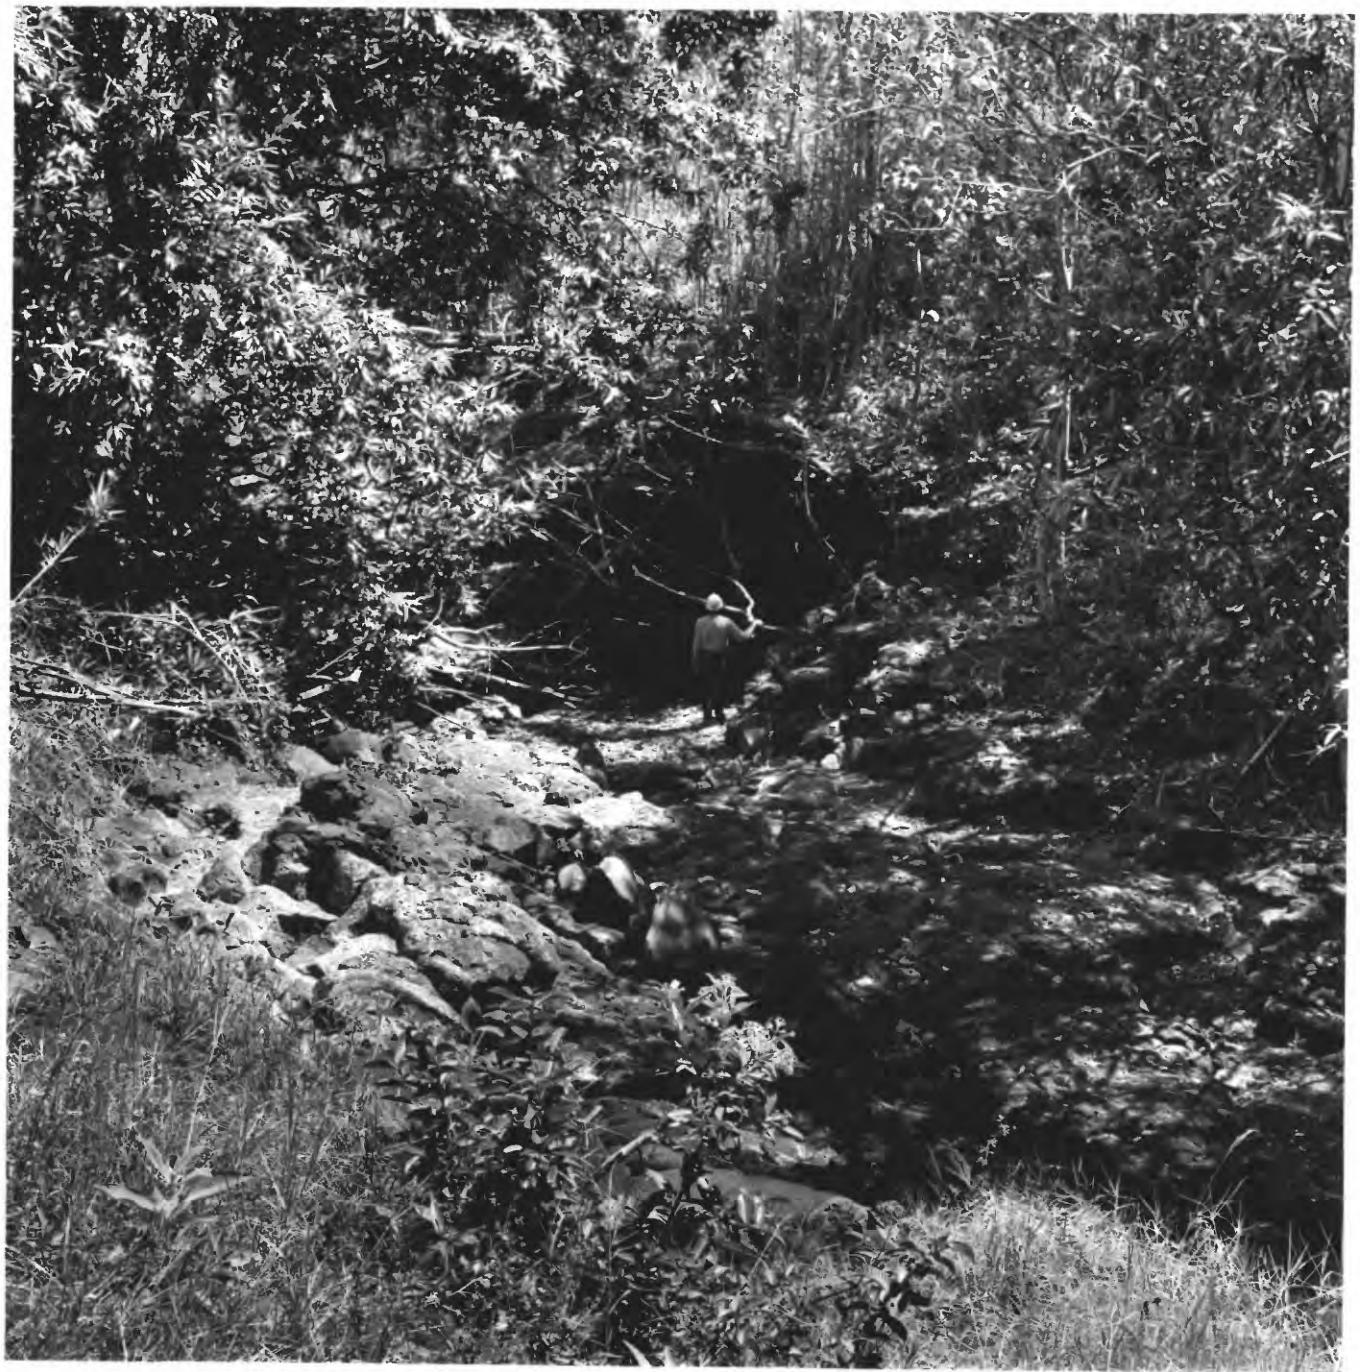
Figure 5.--Flood channel emptying into lava tube south of the lower Waipahoehoe Stream. Photograph by J. R. Griggs, U.S. Geological Survey.
