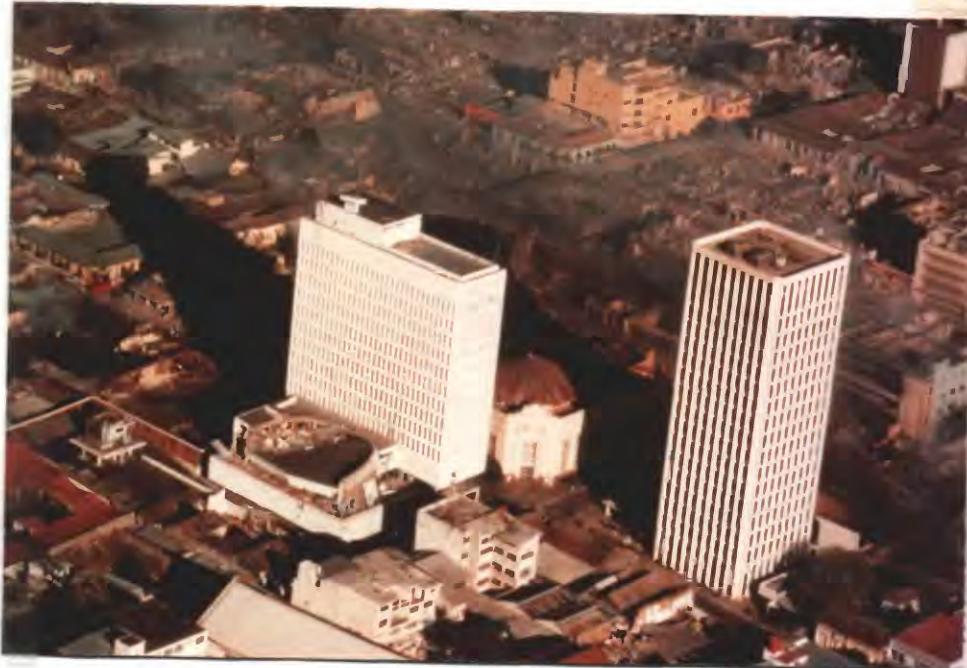
**Figure 1**

**View of downtown Managua after the 1972 earthquake showing the 15-story Banco Central building on the left and the 17-story Banco de America building on the right. The Banco Central, a reinforced-concrete, moment-resisting-frame structure, experienced severe structural damage, but large interstory drift caused severe nonstructural damage. The Banco de America, a shear-wall structure, experienced minor structural damage, and only minimal non-structural damage.**

Recognition of the need for reducing the earthquake response deformations has resulted primarily from postearthquake investigations. Implementation of this observation has been a long and arduous process. The relationship between drift and damage was recognized long ago, but it was not until 1976 that seismic drift limits were included in the Uniform Building Code. Note that this followed as quickly as was possible after the 1972 Managua, Nicaragua earthquake.

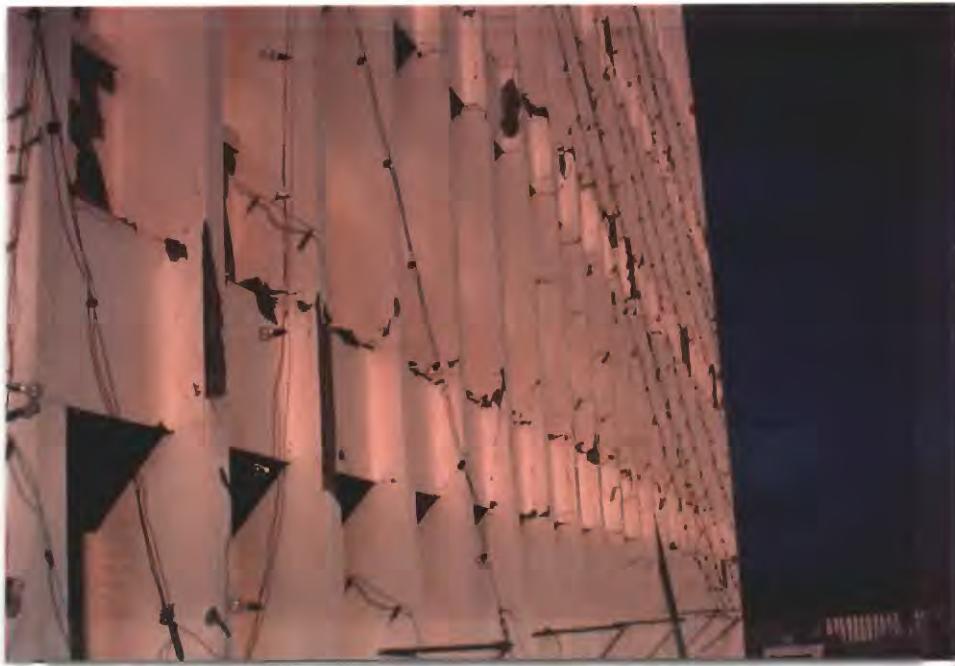
a. Banco Central building. Note the extensive concrete spalling at the beam-column joints. ( Photo by L. Wyllie )

**Exterior views of the Banco Central and Banco de America Buildings following the 1972 Managua, Nicaragua Earthquake.**

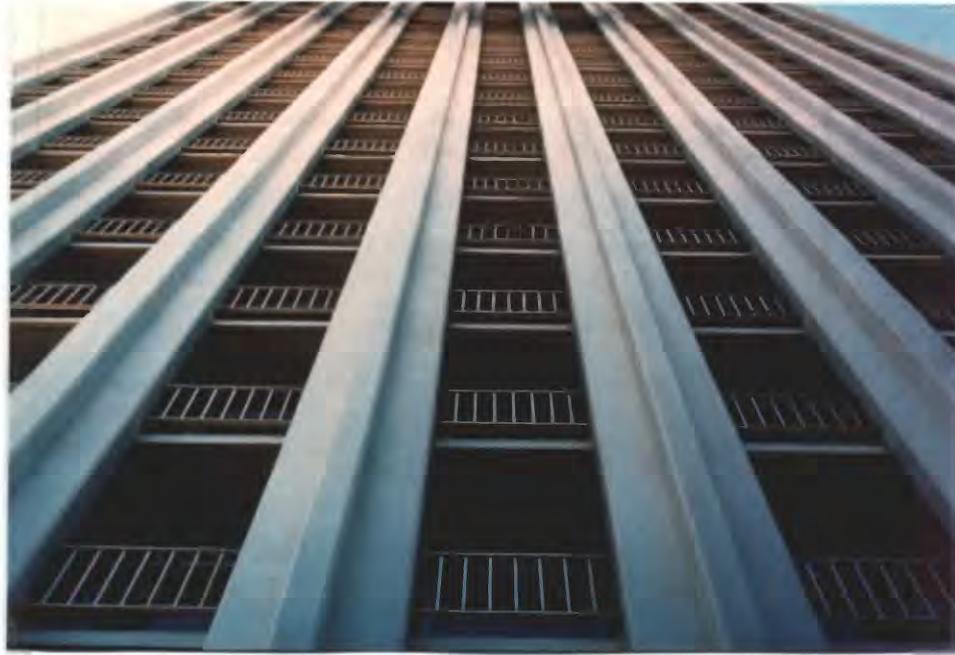
b. Banco de America building. ( Photo by L. Selna )

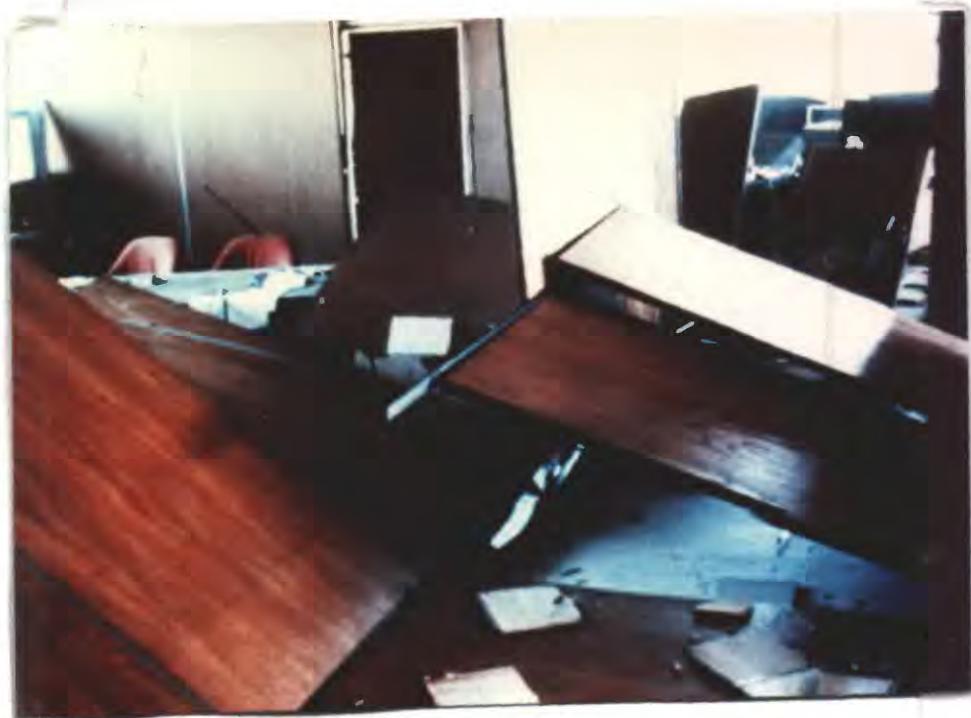
a. Typical office in the Banco Central showing the extensive ie.) nonstructural and contents damage. ( Photo by L. Wyllie )

**Photos of Offices in the Banco Central and Banco de America Buildings following the 1972 Managua Nicaragua Earthquake.**

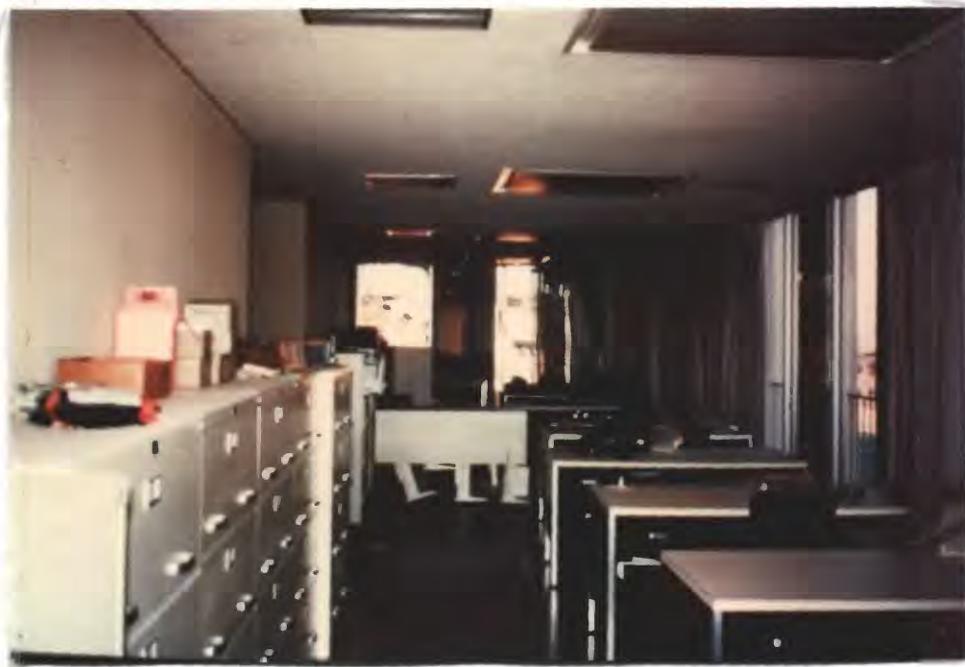
b. Typical Office in the Banco de America showing negligible nonstructural and contents damage. ( Photo by H. Degenkolb )

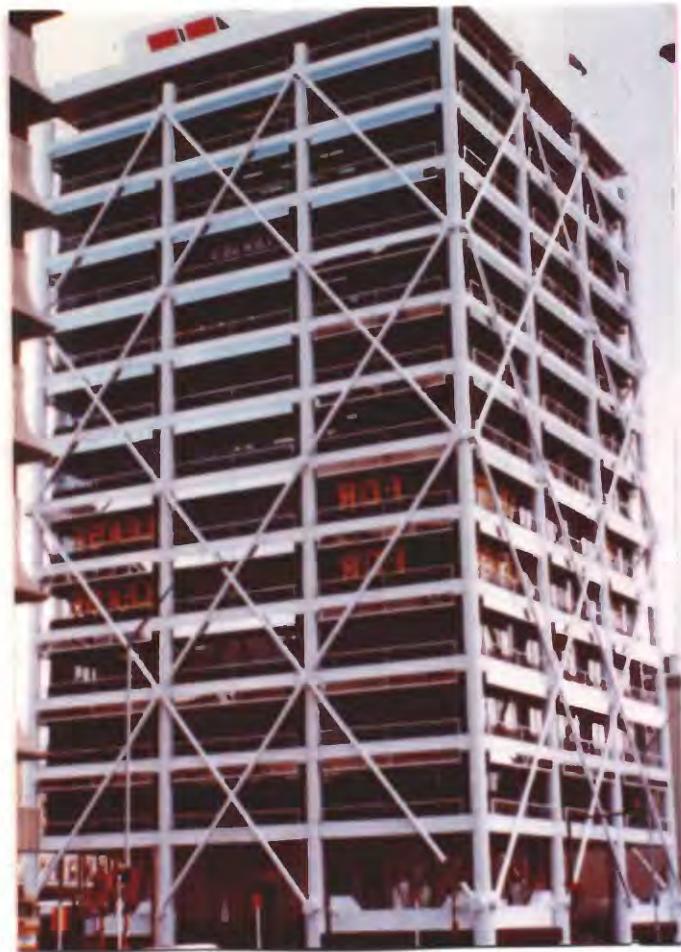
**Figure 10**

**Twelve – Story Union House Office Building in  
Aukland, New Zealand constructed base isolation and  
steel plate energy dissipators. ( Photo by C. Arnold )**

isolation system used is somewhat novel and is laterally very flexible. Added stiffness at the ground floor of the structure, using the energy-absorber concept, was provided to resist wind and earthquake forces. A total of 16 massive triangle-shaped steel plate energy absorbers, 4 on each side of the square building, were used. The plates are 75 mm. thick, and have a base width and triangle height of 600 mm. Figure 11 shows the installation of the energy absorber. Construction of the building has proved the system to be advantageous in terms of both cost and construction time (Boardman, et. al., 1986).

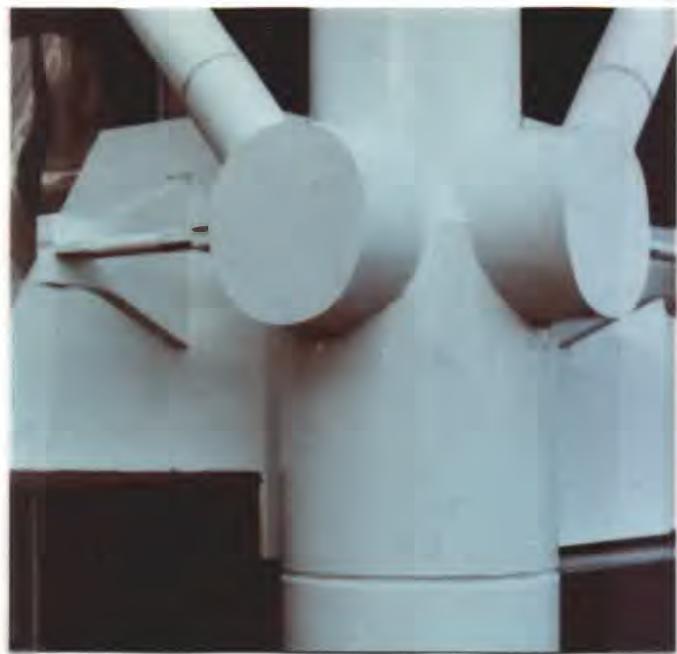
**Figure 11**

a. Finished appearance of energy dissipation.

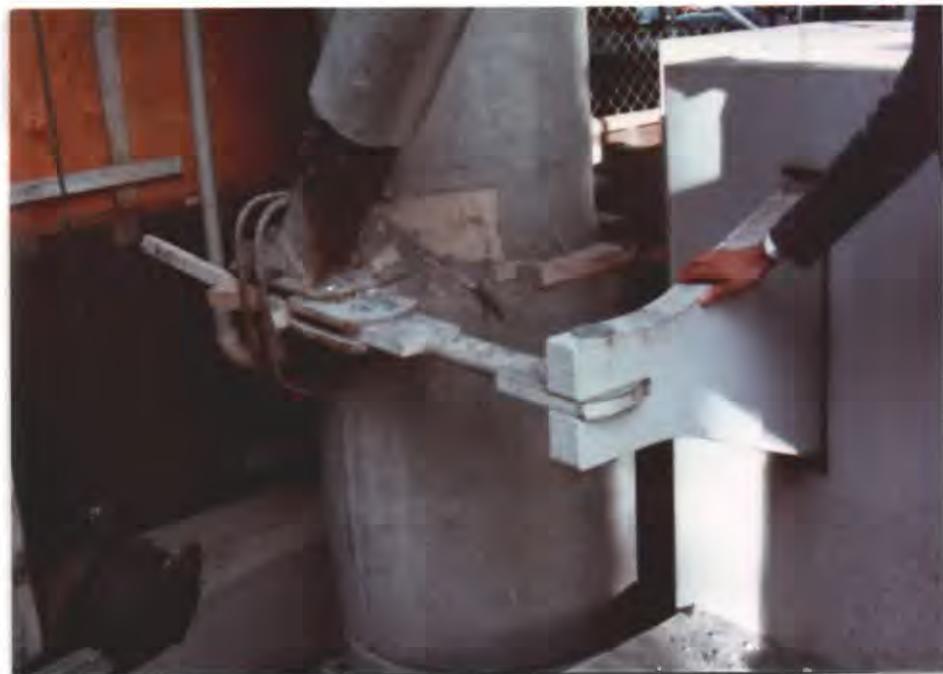
b. Energy dissipator connections exposed during construction.
