Data on Quantity and Quality of Water Flowing in  
Drainage Systems of Dry Docks at Puget Sound  
Naval Shipyard, Bremerton, Washington, 1994

U.S. GEOLOGICAL SURVEY  
Open-File Report 95-361

By Edmund A. Prych

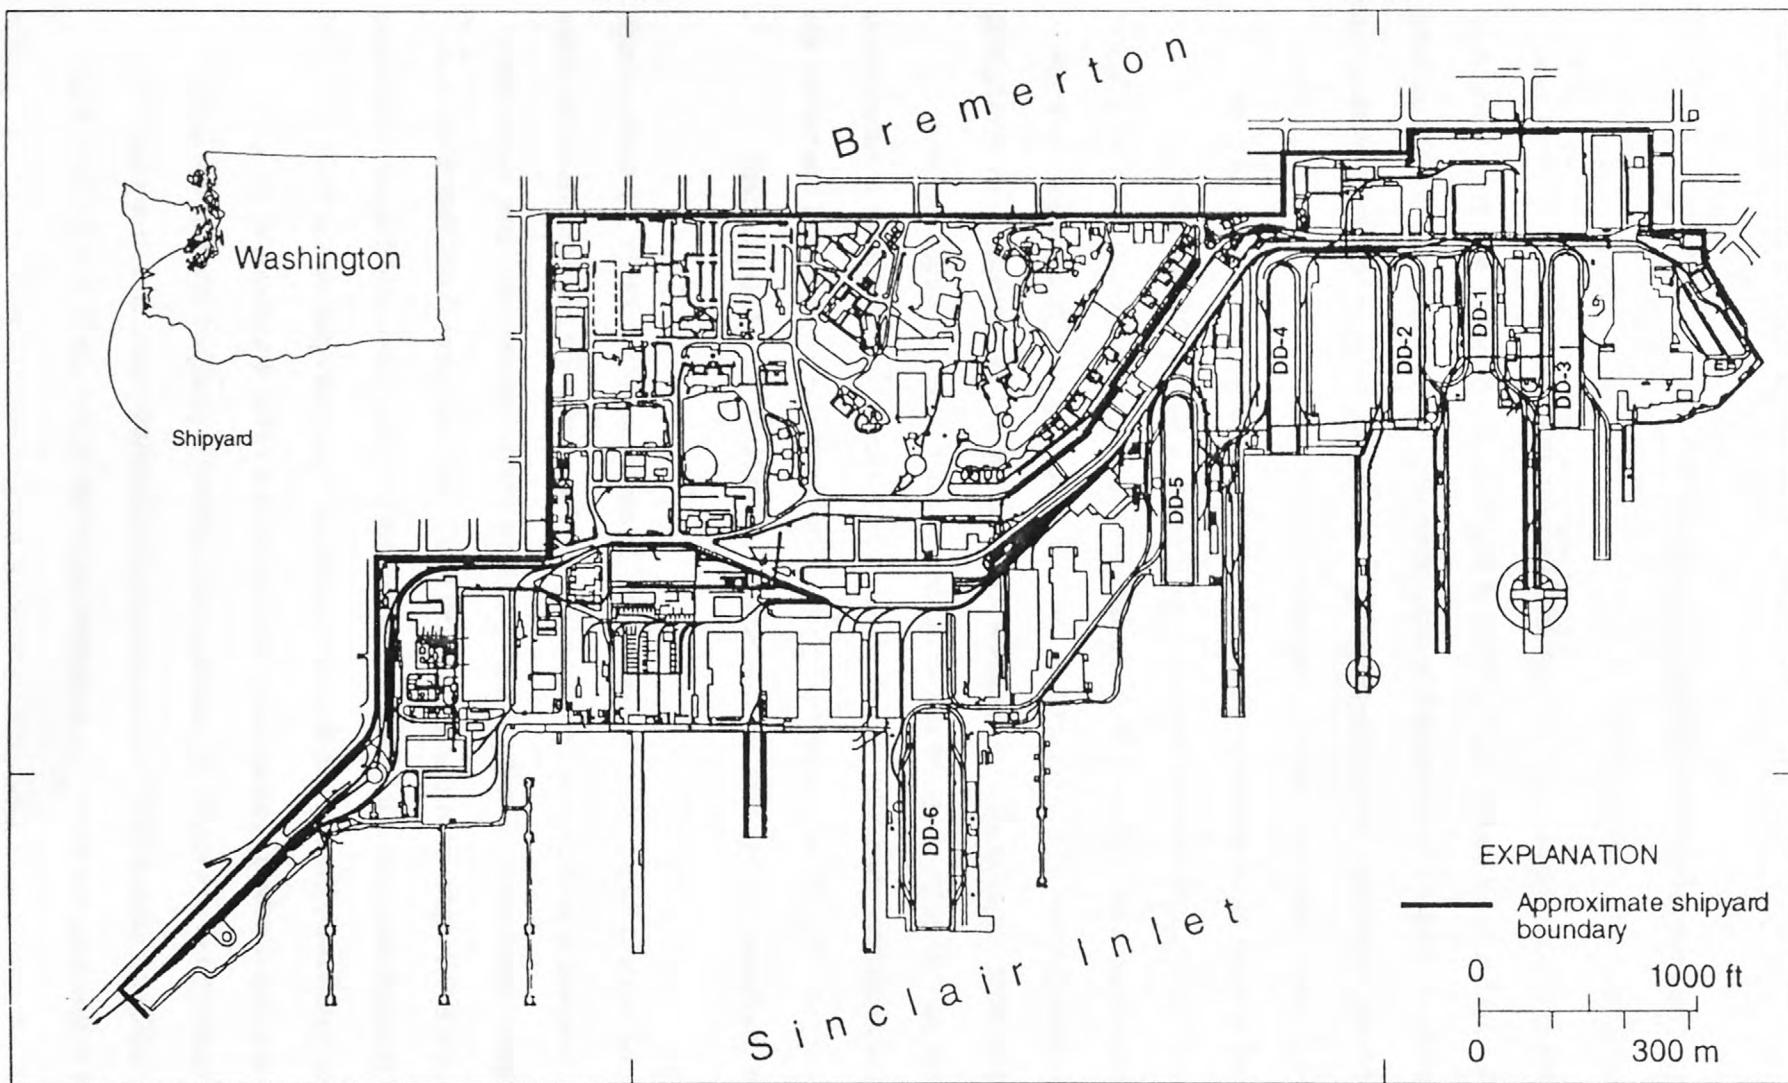
Figure 1. Puget Sound Naval Shipyard and locations of dry docks (DD).

All six dry docks are parallel and are oriented in a north-south direction along the north shoreline of Sinclair Inlet (fig. 1). The entrance to each dry dock, except DD-6, is approximately in line with or set back from the present shore line. Most of DD-6 protrudes into Sinclair Inlet. The fill behind the sidewalls and headwall (north wall) and beneath the floor of each dry dock, except DD-2, is coarse-grained material with imbedded drain pipes or crushed-rock drainage courses. Both fresh and saline ground water in the fill flows by gravity into these drains, which discharge into longitudinal concrete collection culverts within the dry docks. The invert elevations of the culverts (lowest points in culvert cross sections) are below the elevations of the dry-dock floors, and consequently help maintain a dry working environment in the dry docks. In addition to ground-water drainage, leakage by the cofferdams at the entrances to the dry docks, leakage from floodgates, cooling water used by ships in the dry docks, and process water is sometimes discharged to the culverts.

The following subsections give additional descriptions of the drainage systems of individual dry docks, and describe and give the results of the discharge measurements. The order in which the dry docks are described is from east to west (fig. 1). Information on water quality is given in a latter section titled "Water Quality". However, salinity data also are included with the water-discharge data.

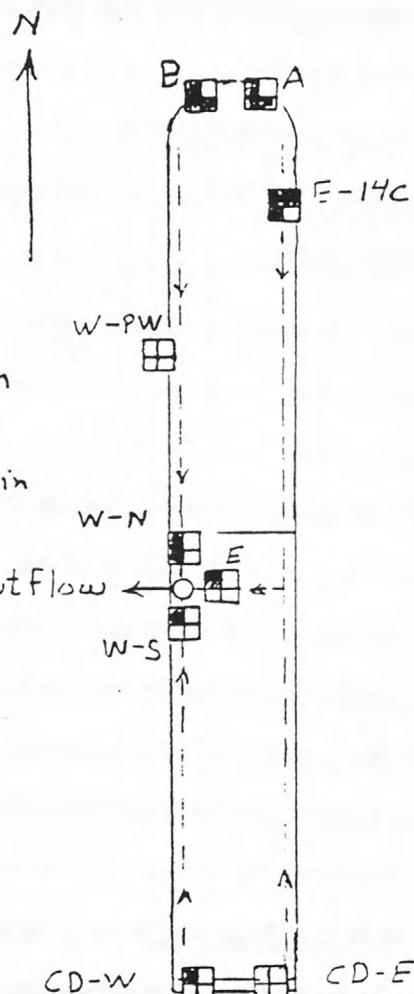
Figure 2.--Drain-water collection culverts and data-collection sites in dry dock no. 3.

For measuring discharge and taking water samples, the culverts were accessed through grate-covered openings spaced about 25 ft apart along the culverts and from the collection basin on the west side. However, most of the grates are rusted in their frames and were not removed during the present study. Discharge measurements were made at one location near the upstream end of the north part of the east-side culvert (site E-14C), at the ends of the three culverts that discharge directly into the collection basin (sites E, W-N and W-S), of the leakage from the cofferdam at the dry dock entrance into the east- and west-side culverts (sites CD-E and CD-W), and of a process-water line that was flowing into the north part of the east-side culvert (W-PW) (see table 1 and fig. 2). Measurements in the north part of the east culvert were made by constricting the flow cross section to less than 1 ft wide and measuring water velocities with a current meter. Discharges at the other locations were measured volumetrically. The estimated accuracy of the discharge measurements in DD-3 ranged from about 10 to 30 percent. Because of potential hazards, project personnel did not enter the culverts in this dry dock to measure discharges of individual drains that flow into the culverts. Discharges of drains in the head wall were not measured because the discharges were too small to be measured with a current meter and the drain lines were too close to the dry-dock floor to be caught in a bucket.

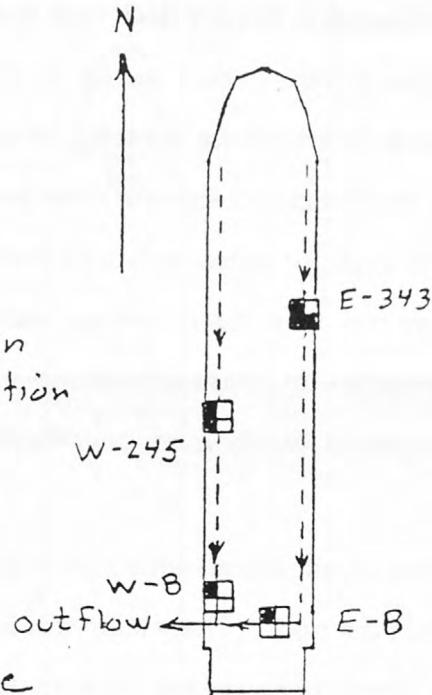
Figure 3.--Drain-water collection culverts and data-collection sites  
in dry dock no. 1.

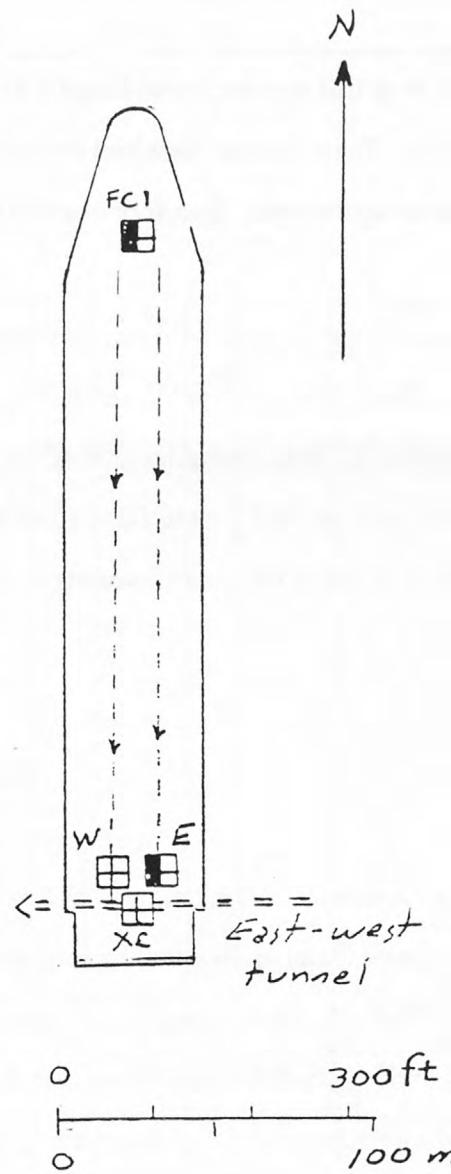
Figure 4.--Drain-water collection culverts and data-collection sites in dry dock no. 2.

Discharge in the east-west tunnel was measured near the center of DD-2 between the ends of the longitudinal culverts (site XC on table 1 and fig. 4). The accuracy of this measurement was about 10 percent. This discharge ( $0.76 \text{ ft}^3/\text{s}$ ) was 17 percent larger than the sum of outflows from DD-3, DD-1 and the east part of DD-2 ( $0.65 \text{ ft}^3/\text{s}$ ). The difference could be due to either low accuracies in some of the measurements or direct leakage to the tunnel east of the measurement site.

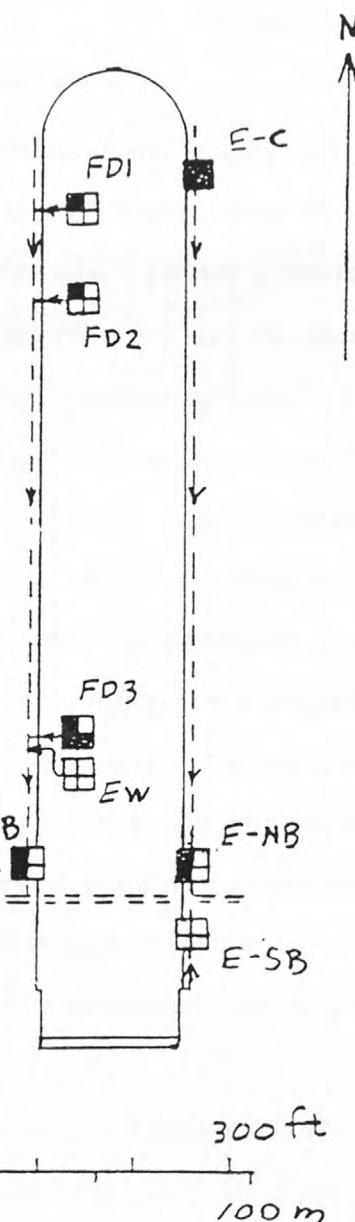
Figure 5.--Drain-water collection culverts and data-collection sites in dry dock no. 4.

Discharges were measured at or near where the north parts of both culverts flow into the east-west tunnel (sites E-NB and W-NB in table 1 and fig. 5). The accuracy of these measurements was about 20 percent. Water velocities in the south part of the east-side culvert could not be measured because the water was too shallow; therefore, the outflow from this section of culvert (site E-SB) was calculated by summing measured discharges from the individual wall drains. The discharges from these and other wall drains into the culvert (table 2) were measured volumetrically. The accuracy of the volumetrically measured discharges from individual drains in DD-4 probably was 10 percent or better; however, because small, unmeasureable quantities of water from drains beneath the dry-dock floor also were flowing into the culvert, the accuracy of the discharge that was computed by summing individual wall-drain discharges was probably also about 20 percent. The discharge in the few transverse 0.4 ft-wide slots in the floor on the west side of the dry dock that appeared to be conveying most of the water from the floor drains was determined by measuring the velocity at one location in each slot with a current meter (table 1). The accuracy of these measurements was about 30 percent. The pipes that convey water from the gutters to the culverts enter the culverts too low for the flow to be caught in a bucket.

<sup>1</sup> Numbers identify drain pipes or channels and were assigned by personnel in Puget Sound Naval Shipyard Environmental Group. "Un" denotes unnumbered drain; numbers increase from north to south. "W", "E" and "C" denote drain pipes discharging into culvert from west and east walls, and from ceiling, respectively; identifier in parenthesis is same as in figure 5 and table 1.

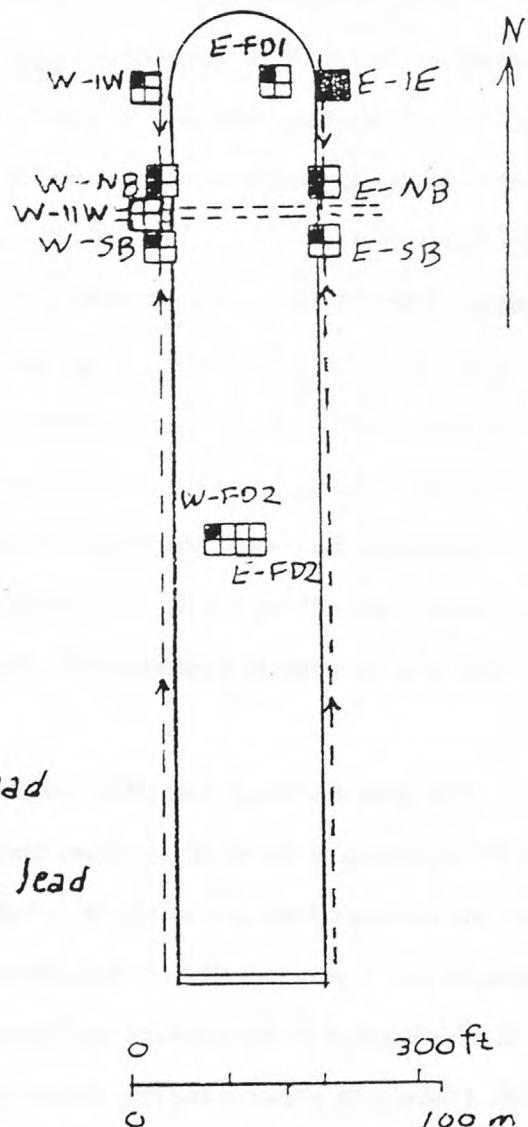
Figure 6.--Drain-water collection culverts and data-collection sites in dry dock no. 5.

The size and geometry of DD-5 and the configuration of its drainage system (fig. 6) are nearly identical to that of DD-4. An exception is that the east-west tunnel crosses DD-5 near its north end, and the both east- and west-side longitudinal culverts extend both north and south of the east-west tunnel. Water discharges were measured in both culverts at the four locations where they flow into the cross tunnel (sites E-NB, E-SB, W-NB and W-SB in table 1 and fig. 6). The discharge rates of the nearly 100 individual drains that flow into each of the culverts also were measured (table 3). The accuracy of all these discharge measurements ranged from about 5 to 10 percent. The discharge of water from floor drains in the transverse slots in the dry-dock floor were measured by the same method as in DD-4. There was no obvious leakage from the cofferdam at the time of the measurements. However, there was a small process-water discharge, and there was some discharge over spillways at the south ends of the longitudinal culverts that was leakage from Sinclair Inlet by gates in tunnels used to flood the dry dock (table 3).

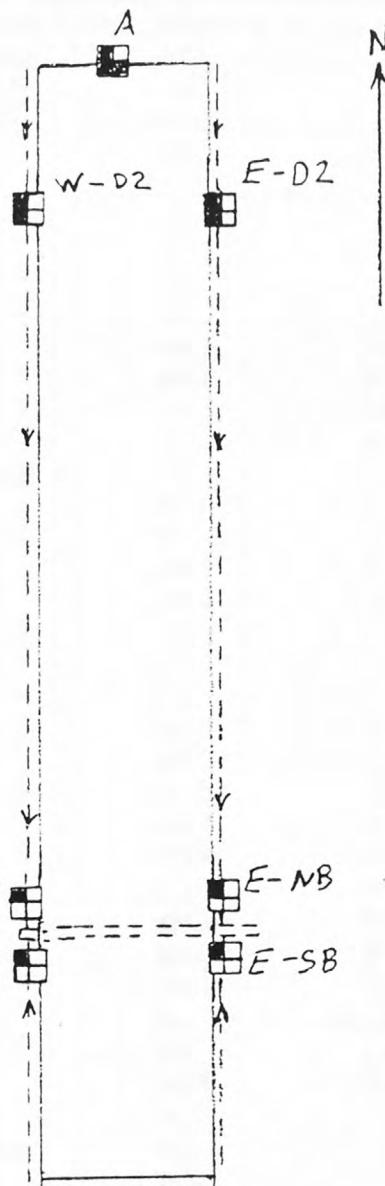
Figure 7.--Drain-water collection culverts and data-collection sites in dry dock no. 6.

Discharge in the culverts was measured at the four locations where they flow into the tunnel to the pump well (sites E-NB, E-SB, W-NB and W-SB in table 1 and fig. 7). Discharge in the culverts also was measured at 10 other locations and discharge from each of the more than 70 individual drains that flow into each culvert also was measured (table 5). Most of the discharge measurements were made on June 29 and 30, 1994; however, measurements in the south part of the west-side culvert were delayed until August 11 while a safety issue was being resolved. On August 11 discharge measurements also were made at some of the same sites where measurements were made on June 29 or 30. The estimated accuracy of most of these measurements was 5 to 10 percent.
