Side-scan Sonar Imaging of the Colorado River, Grand Canyon

Open-File Report 2007-1216

U.S. Department of the Interior
U.S. Geological Survey

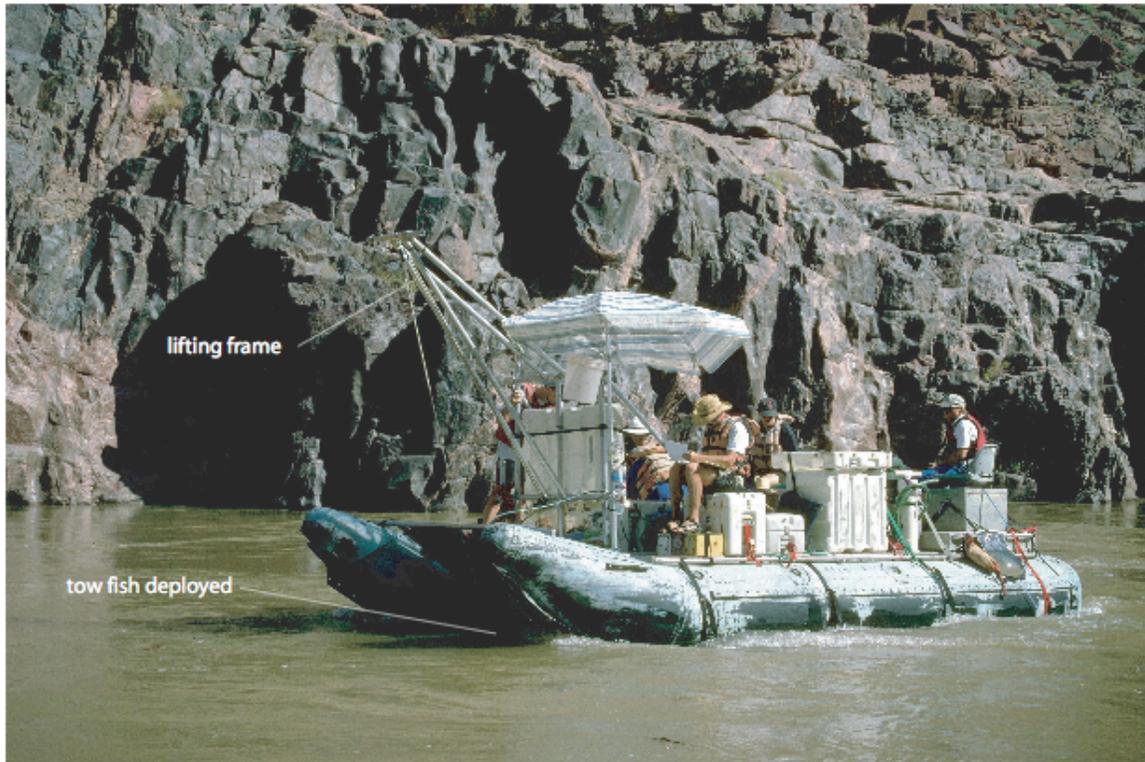
Figure 2. A 22-ft snout rig inflatable boat was used to collect side-scan data. White plastic waterproof boxes housed all electronics. The side-scan tow fish was raised and lowered using the lifting frame at the bow of the vessel.

A 22-foot inflatable river raft (snout rig) was used to collect the data (Figure 2). A Klein 500 kHz side-scan sonar tow fish was used to conduct the surveys above the Little Colorado River (LCR). The pre-LSSF (R3) survey found the Little Colorado discharging a large quantity of fine-grained sediment that attenuated the outgoing signal so much that operations were stopped. The survey switched to a 100 kHz tow fish for reaches between the LCR and Diamond Creek. The next survey (R4) used the Klein 500 kHz tow fish for the entire survey.

Because of the extreme heat conditions in the canyon required steps to be taken to keep the electronics needed to complete the surveys cool. This was achieved by building cases that were able to use the cold river water as a cooling medium for the electronics.

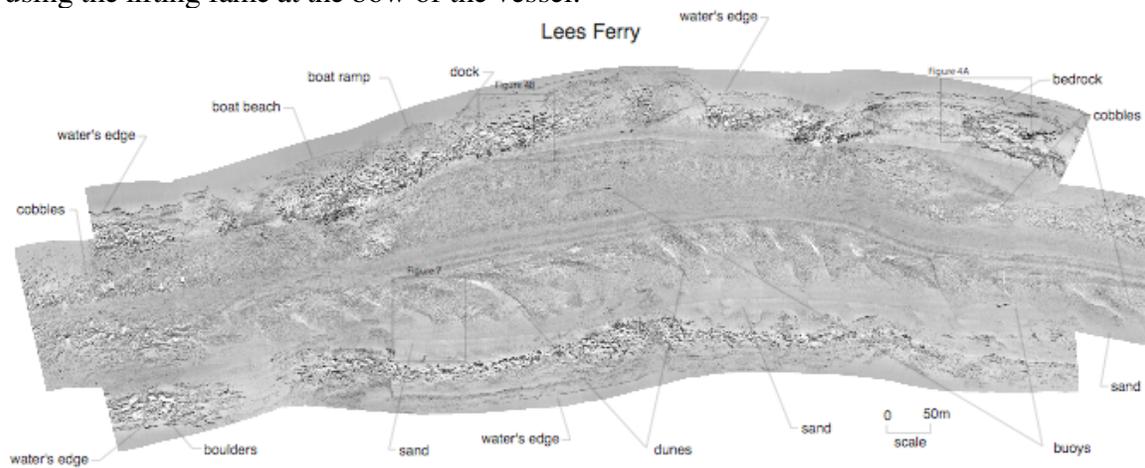
Figure 3. Three side-scan lines were merged to make this mosaic of the Lees Ferry reach (miles 0 to -0.3). Lines were merged using MIPS software. Variations in reflectivity of riverbed features create the differing textural patterns. Refer to Figures 4 and 7 for additional details of each area enclosed in the boxes.

The accompanying DVD contains files with pre- and post- high flow images side by side. The pre-flow image is on the left with the post-flow image on the right. The river miles are based on river miles posted on the GCMRC web site. The Lees Ferry area (Figure 3) shows nearly all the various features found along the river bottom.

Sand (diameter between 0.625 and 2.0 mm), pebbles (diameter between 2 and 64 mm), and cobbles (diameter between 64 and 256 mm) are smaller than the sonar pixels and therefore cannot be resolved individually. In the sonar images, sand appears as very nearly white or grey in color (Figures 3, 6, and 7). Sand often occurs as sub-aqueous dunes, with pebbles or cobbles exposed in the dune troughs (Figure 5).

Dunes up to 40 m in wavelength and 1 m in height were found in reaches that contained large amounts of sand (Figures 3, 6, and 7). In underwater video surveys (Anima, et. al., 1998), small-scale ripples are often observed superimposed on dunes, but such ripples are too small to be resolved by the sonar system used in this work.

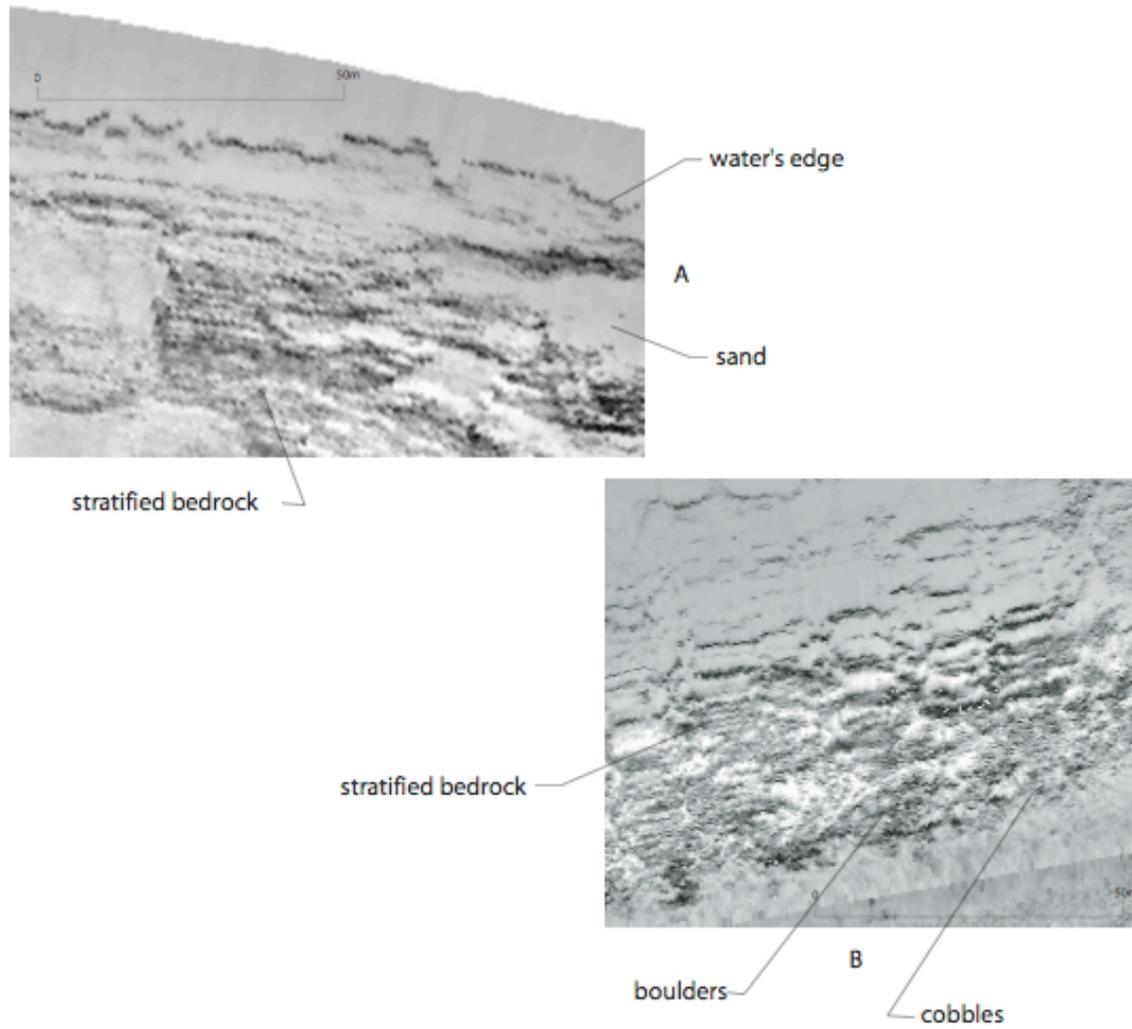
Figure 4. Images of bedrock. A. Bedrock with clear stratification. B. Bedrock partially covered with boulders and other sediment.

The reflectivity of bedrock exposures is dark to black, typically exhibiting discernable parallel bedding planes (Figure 4). In many reaches, bedrock is partially overlain by boulders, cobbles, pebbles, or sand (Figure 5).

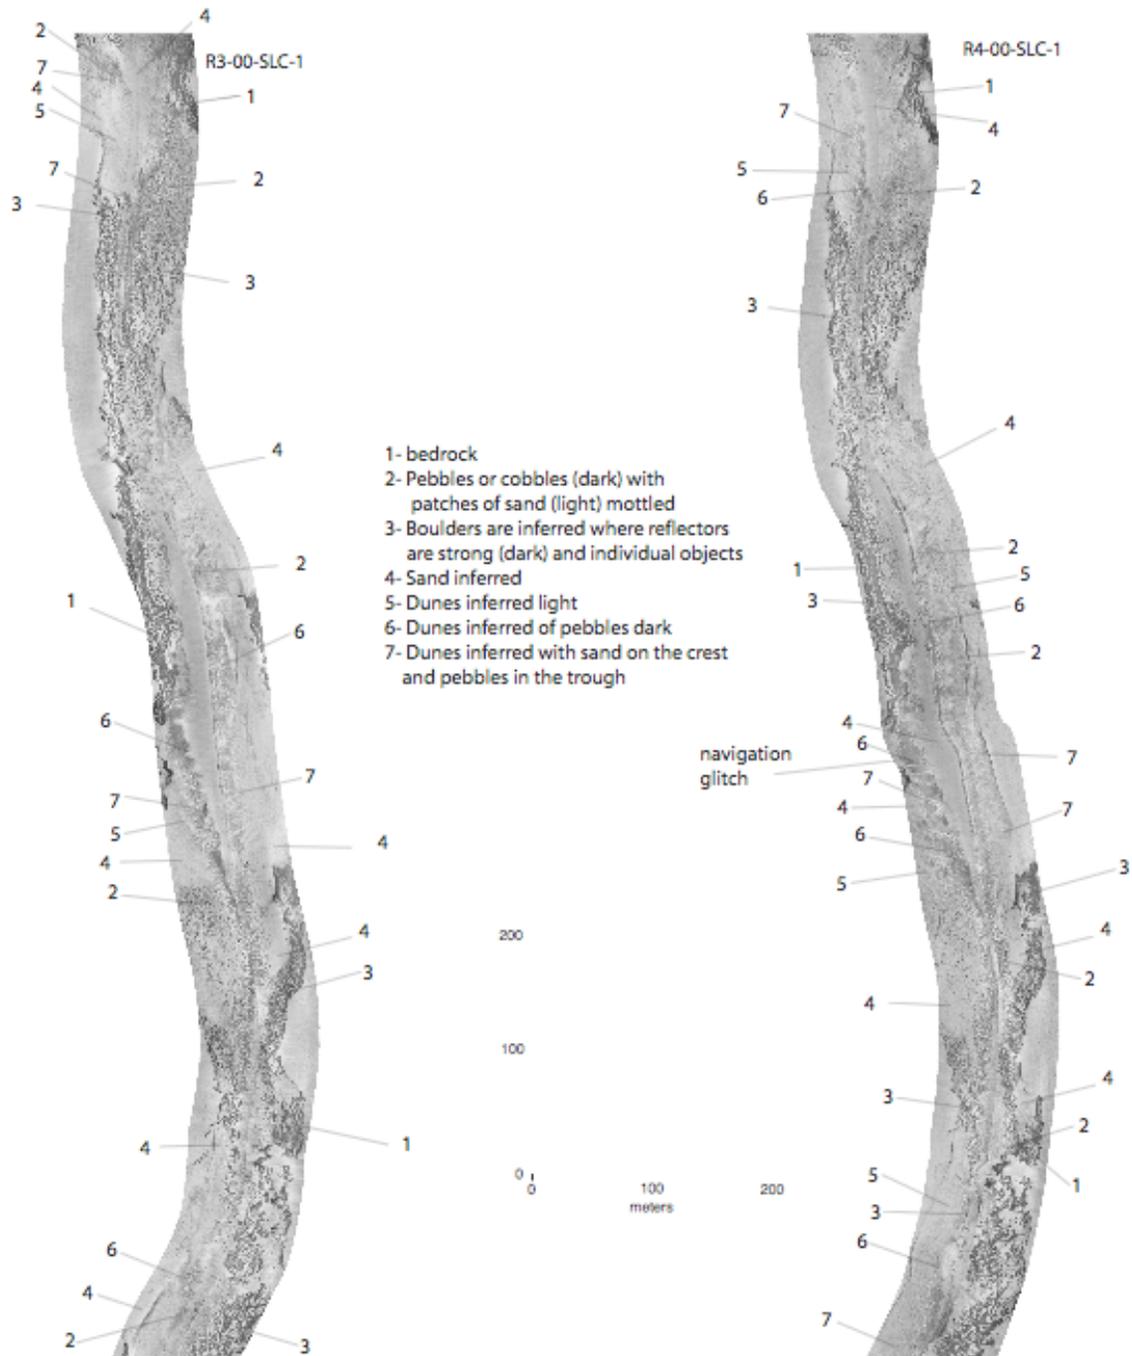
Figure 5. Sections of lines R3-00-SLC-1 and R4-00-SLC1 (between miles 60 and 61). Numbers identify the following bed features: (1) Bedrock with bedding planes is inferred from strong reflections (dark) and parallel continuous structure. (2) Pebbles or cobbles (dark) with patches of sand (light) are inferred to make a mottled pattern. (3) Boulders are inferred where reflectors are strong (dark) and individual objects can be resolved. (4) Sand is inferred where the bed appears light in color and uniformly smooth in texture. (5) Dunes composed of sand are inferred where dunes are relatively light. (6) Dunes composed of pebbles are inferred where dunes are relatively dark. (7) Dunes with sand crests and pebble or cobble troughs are inferred where troughs are dark.

Boulders (grain diameter > 256 mm) appear as large discontinuous features in talus and debris fans. The smallest boulders are comparable in size to a single sonar pixel and are perhaps too small to be resolved clearly, but larger boulders can be resolved individually (Figure 5). Larger boulders commonly have a “sonar shadow” (white area) behind them due to the rock deterring any imaging beyond the rock reflector.

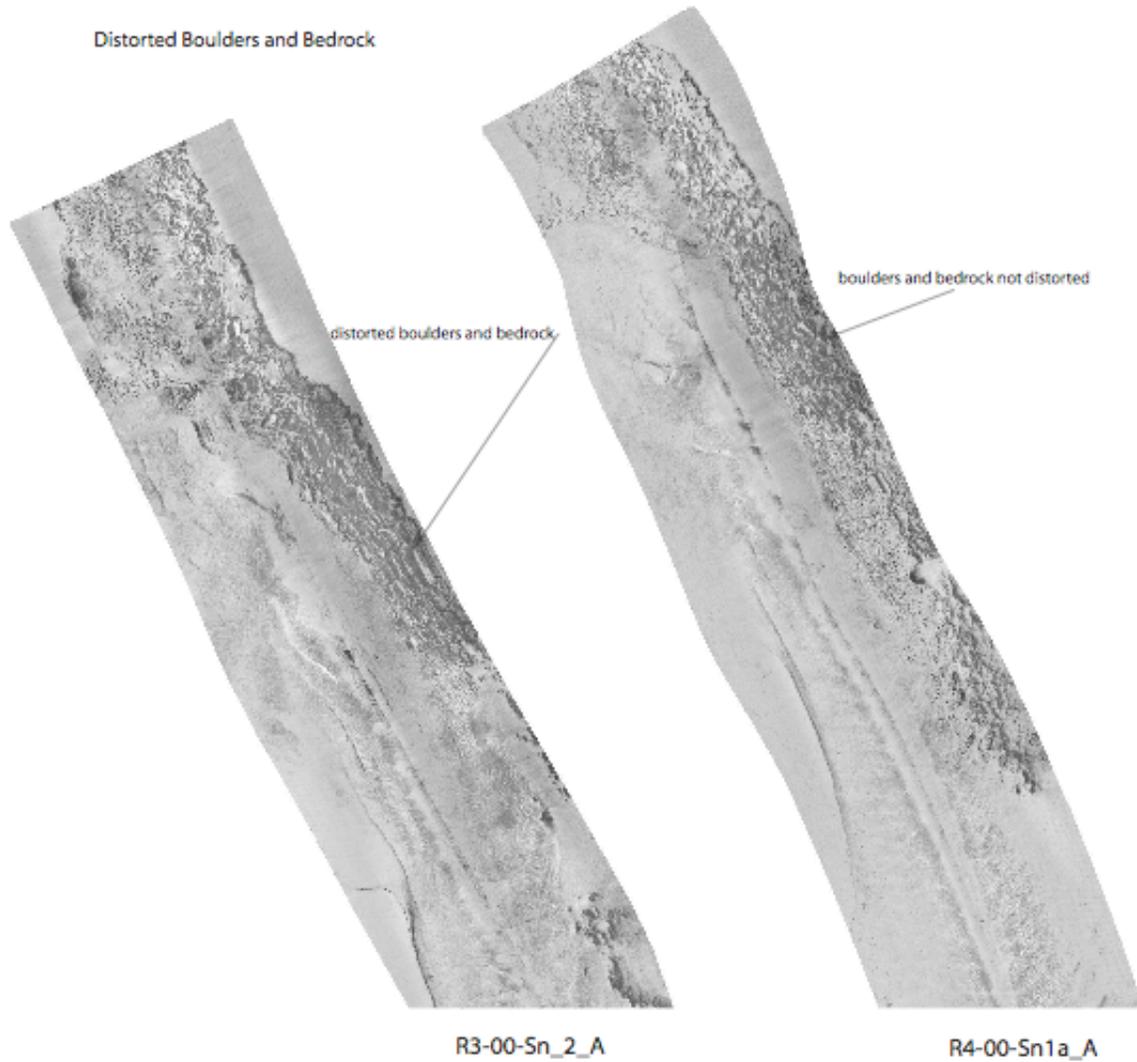
Figure 6. Sections of lines R3-00-Sn_2_A and R4-00-Sn_1_A exhibit examples of an area of distorted boulders and bedrock due to yawing of the side-scan tow fish.

Boulders may look like layered bedrock where boulders become distorted in linear bands as a result of current-induced heave and yaw of the side-scan sonar tow fish, a change in boat speed, or a combination of both (Figure 6). Bedrock and boulders can be distinguished in undistorted images, because boulders and cobbles appear as individual objects, whereas bedding planes in the bedrock are clearly exposed as continuous features (Figure 6).

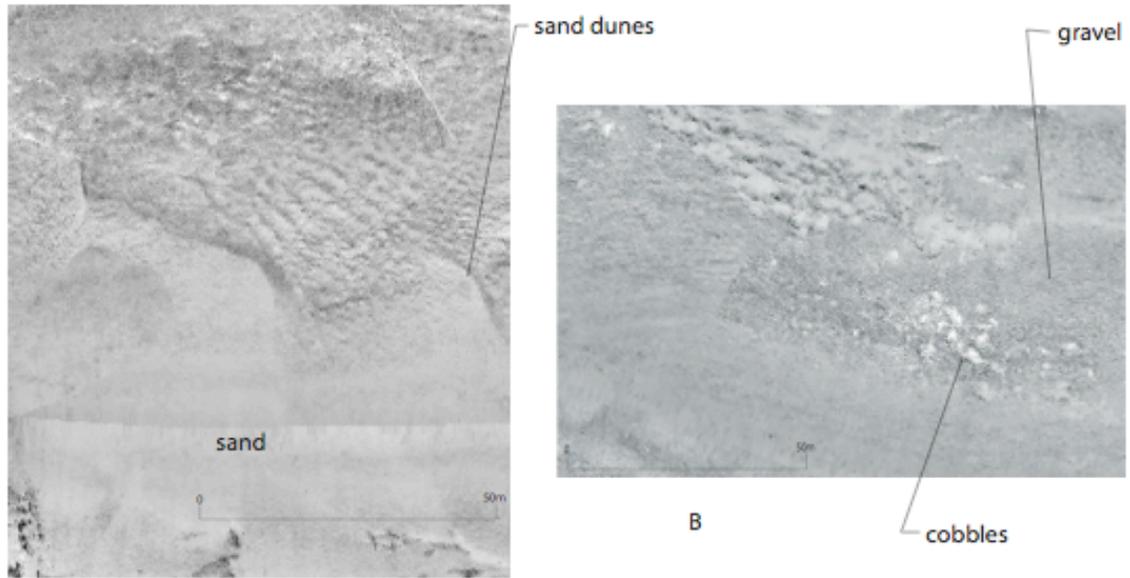
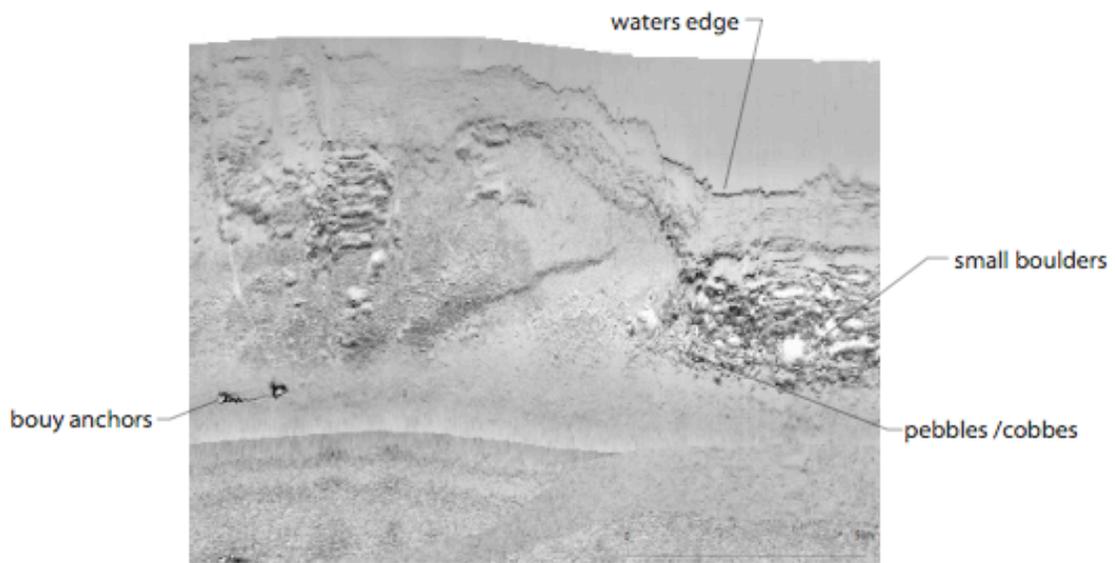
Figure 7. Sonar image containing features interpreted as dunes composed of sand, flat or rippled bed of sand, and flat bed of pebbles or cobbles.

Pebbles and cobbles have stronger acoustic reflections than sand and therefore appear darker (Figure 7). In some cases, pebbles and cobbles have a mottled texture, perhaps due to spatial variations in grain size, topography, or the presence of sand patches partially covering the coarser bed material. Some dunes have a dark reflectance suggesting that they are composed of pebbles. Underwater video also shows that some dunes are composed of gravel, confirming that dune morphology is not sufficient to identify a sand bed. Pebbles are widespread and are the predominant bed type in some reaches of the river. Pebbles and cobbles are the predominant feature along the tail waters section of the river above Lees Ferry.

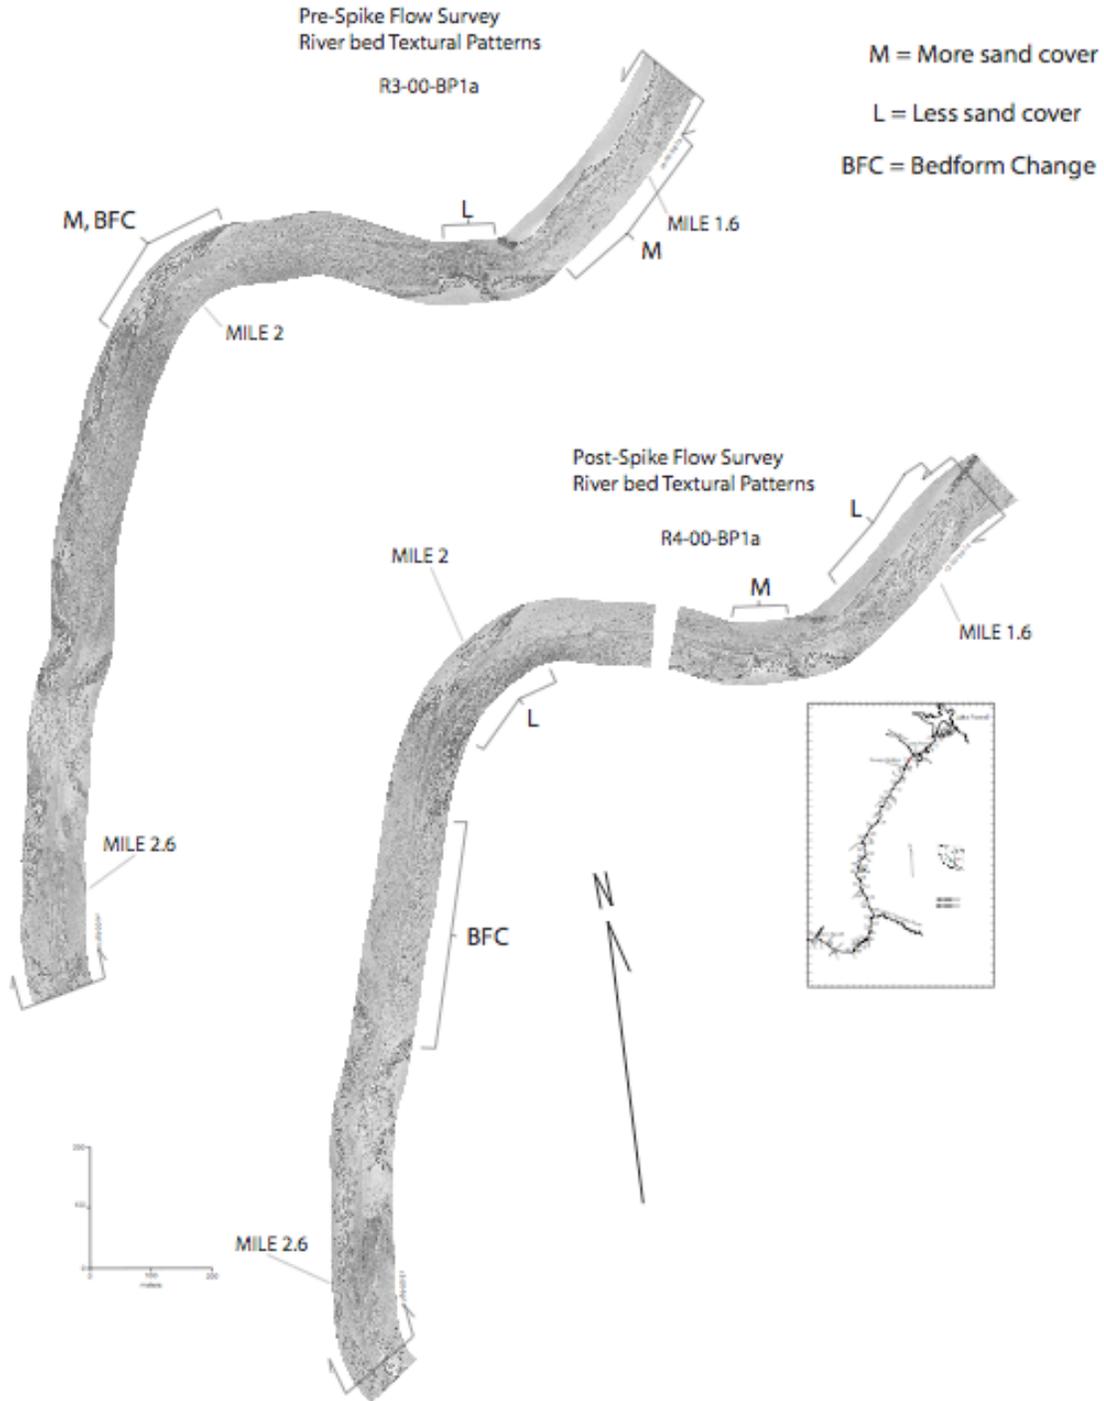
Figure 8. Lees Ferry to Cathedral Wash reaches showing areas of change in bed texture and bedforms in the pre- and post-LSSF. M represents more sand cover; L represents less sand cover; and BFC represents areas of bedform change.

The September 2000 LSSF experiment caused the bed material to change at some sites. We observed a number of such changes including: areas where a fine-grained veneer of sand was removed; large areas of change from sand to pebbles and cobbles; and areas of change from pebbles and cobbles to sand; and changes in dune size (fig. 8 & 9). Figures 8 & 9 show examples of changes observed along the riverbed and can be seen along most segments of the river.

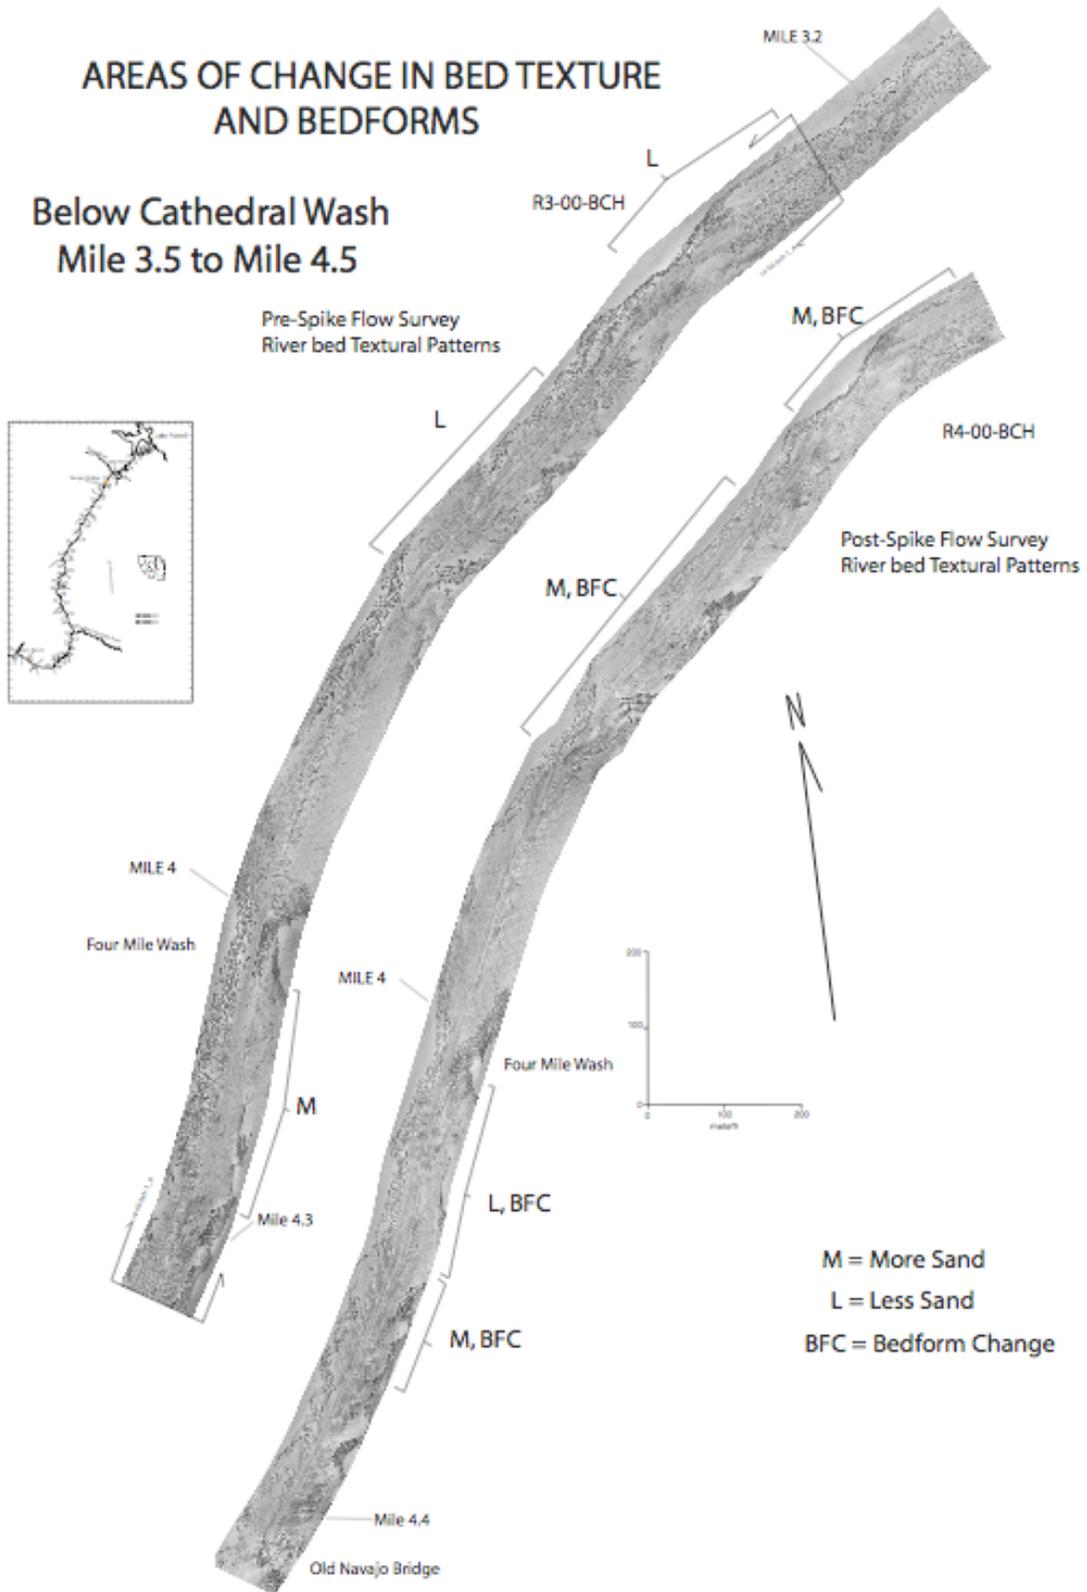
Figure 9. Below Cathedral Wash reaches also showing areas of change in bed texture and bedforms in the pre- and post-LSSF. M represents more sand cover; L represents less sand cover; and BFC represents areas of bedform change.
