## Floods of August 21–24, 2007, in Northwestern and North-Central Ohio

Open-File Report 2009–1094

By David E. Straub, Andrew D. Ebner, and Brian M. Astifan

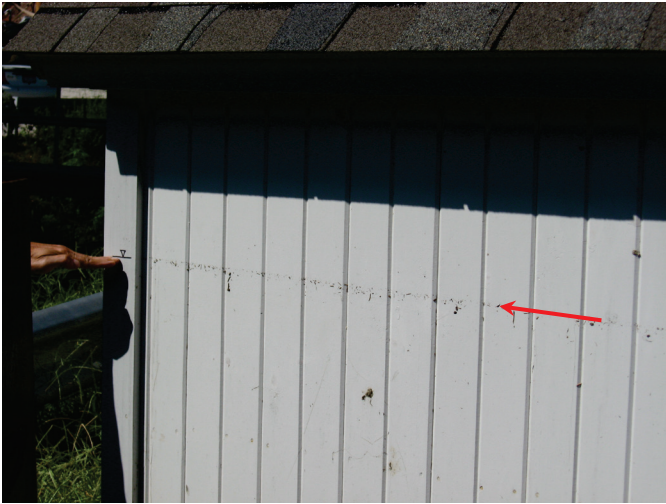
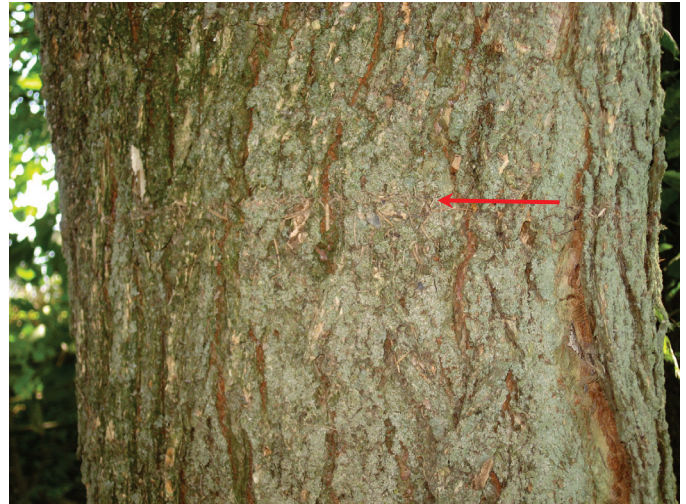
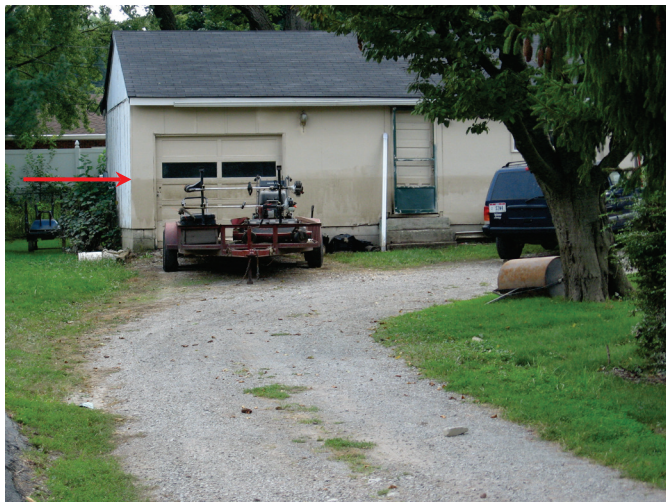
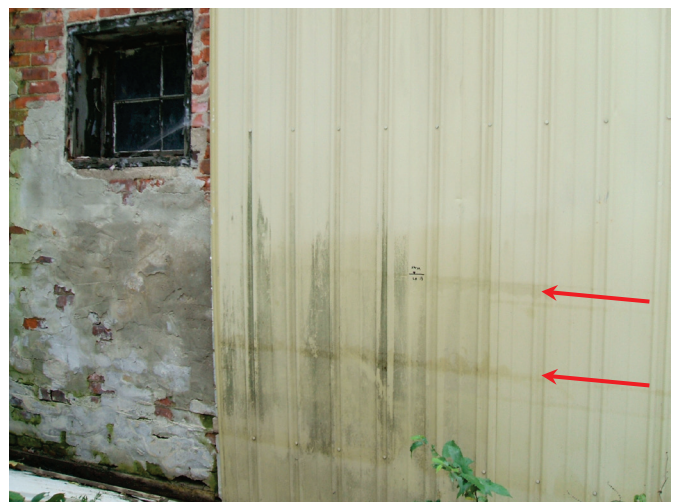
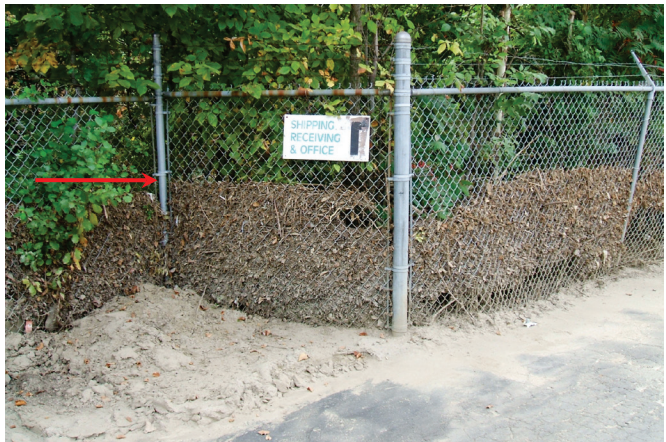
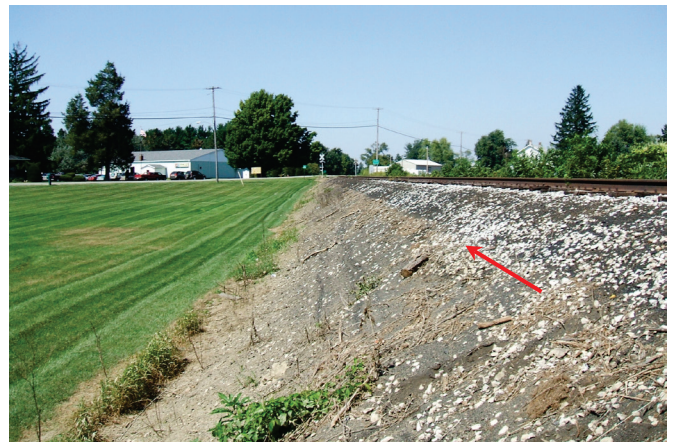
**Figure 5.** Examples of lines used as high-water marks at selected locations in the flooded area. *A*, Seed line on buildings or trees. *B*, Mud lines on buildings. *C*, Debris lines on fence or ground.

High-water marks are an indication of the water level at peak stage of a river during a flood event. They can be used to determine the peak streamflow or to calibrate peak-flow models used to determine flood-inundation areas. High-water marks are usually determined from mud, seed, or debris lines (or a combination thereof) left behind as the floodwaters receded. Examples of seed, mud, and or debris lines that indicated water elevations for this flood are shown in figure 5. Trees are generally a good place to find high-water marks because seeds and small debris get caught in the bark. Several distinct lines can be left after an event as floodwaters recede. For example, a flood with a secondary peak or an upstream bank failure can leave a distinct debris or mud line below the actual peak high-water mark (right picture figure 5B). The accuracy of the high-water marks is subjectively rated by the USGS personnel locating the mark, as outlined in Lumia and others (1986). High-water marks can be rated “excellent” (within 0.02 ft of the true high-water mark), “good” (within 0.05 ft), “fair” (within 0.10 ft), or “poor” (greater than 0.10 ft).
