The Loma Prieta, California, Earthquake of October 17, 1989—Building Structures

U.S. GEOLOGICAL SURVEY PROFESSIONAL PAPER 1552-C

BUILDING STRUCTURES

INTRODUCTION

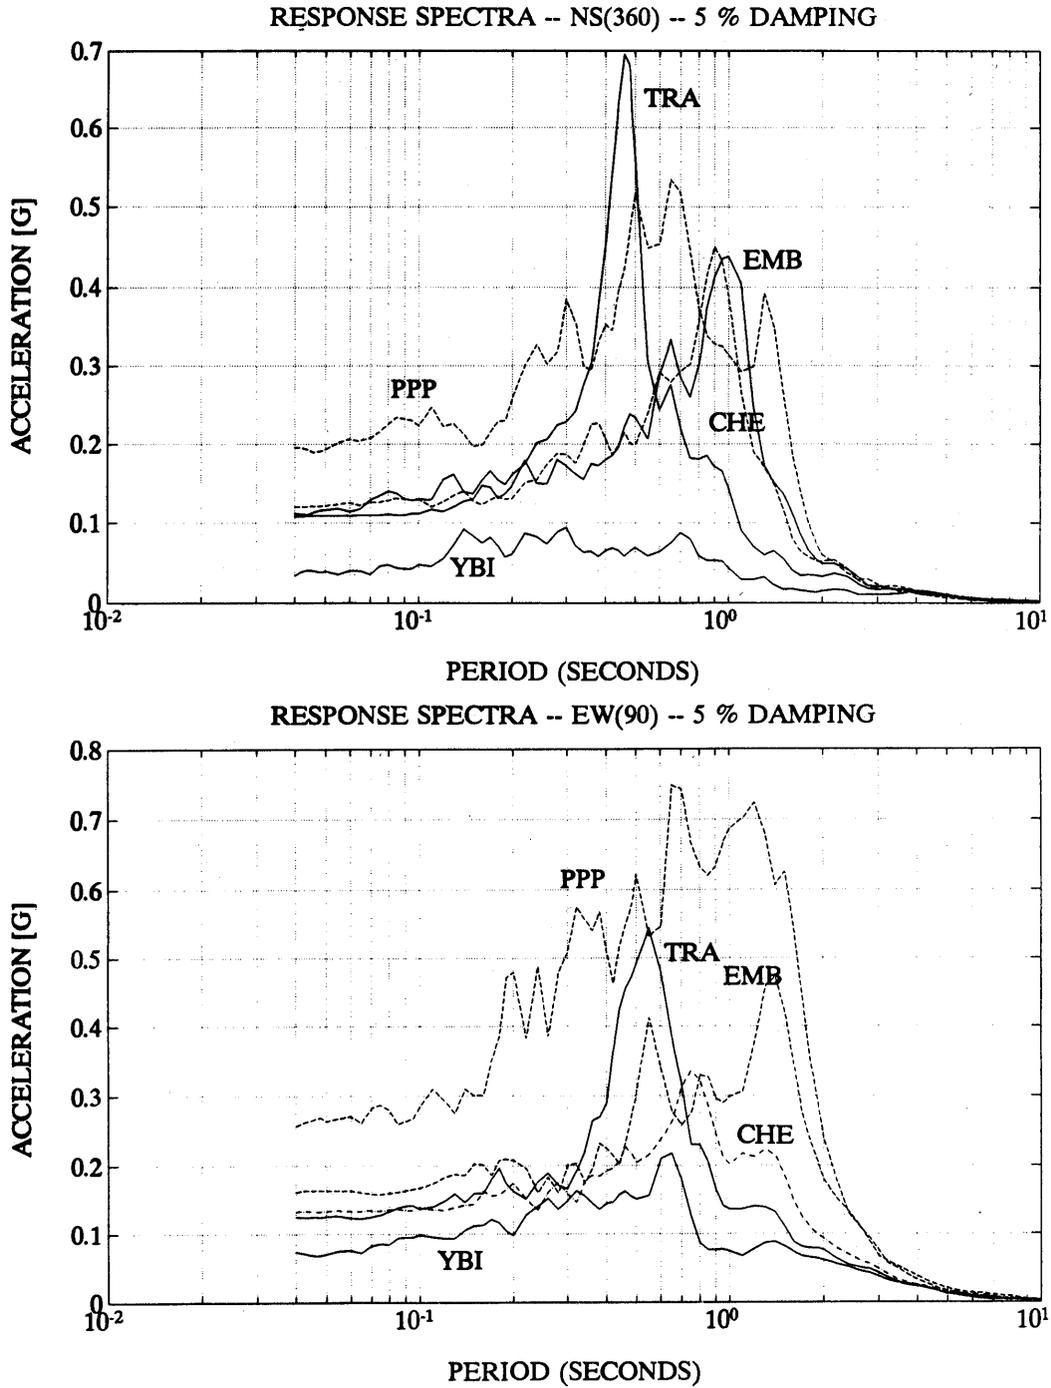
Figure 2.—Response spectra of free-field Emeryville site of Pacific Park Plaza (PPP), Transamerica Building (TRA), Embarcadero Building (EMB), and Chevron Building (CHE) compared to response spectrum of rock site Yerba Buena Island (YBI).

at dedicated free-field stations in the vicinity or at the ground floor or basement of the four tall buildings are compared (fig. 2) to the spectrum from the station on

Yerba Buena Island, a rock site, also located at approximately 100 km from the epicenter. While the largest peak acceleration at Yerba Buena Island was 0.06 g, the amplified peak accelerations at the soft soil sites of some of these tall buildings varied between 0.12 and 0.26 g. The response spectra depict the degree of amplification of peak acceleration, represented by zero-period accelerations as well as the frequency (period)-dependent spectral acceleration. Particularly between the periods 0.1 and 2 seconds, which is of engineering interest, the spectral amplification ratio is as high as 5 or 6.

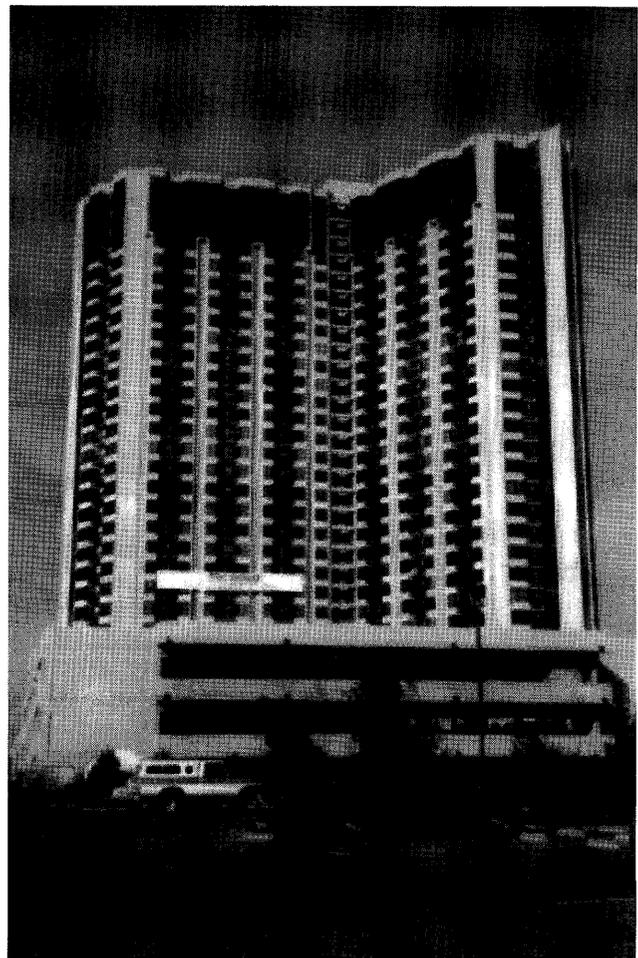
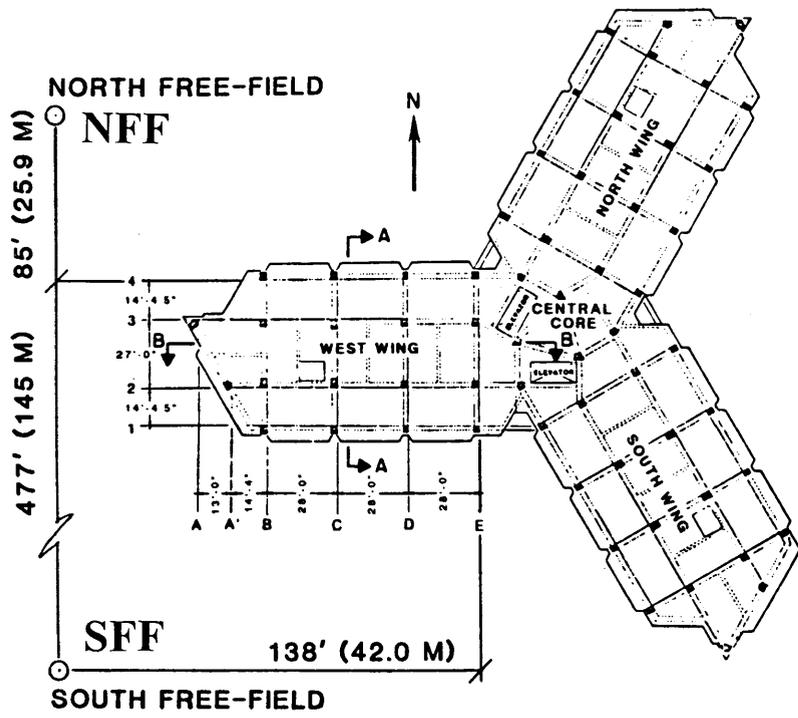
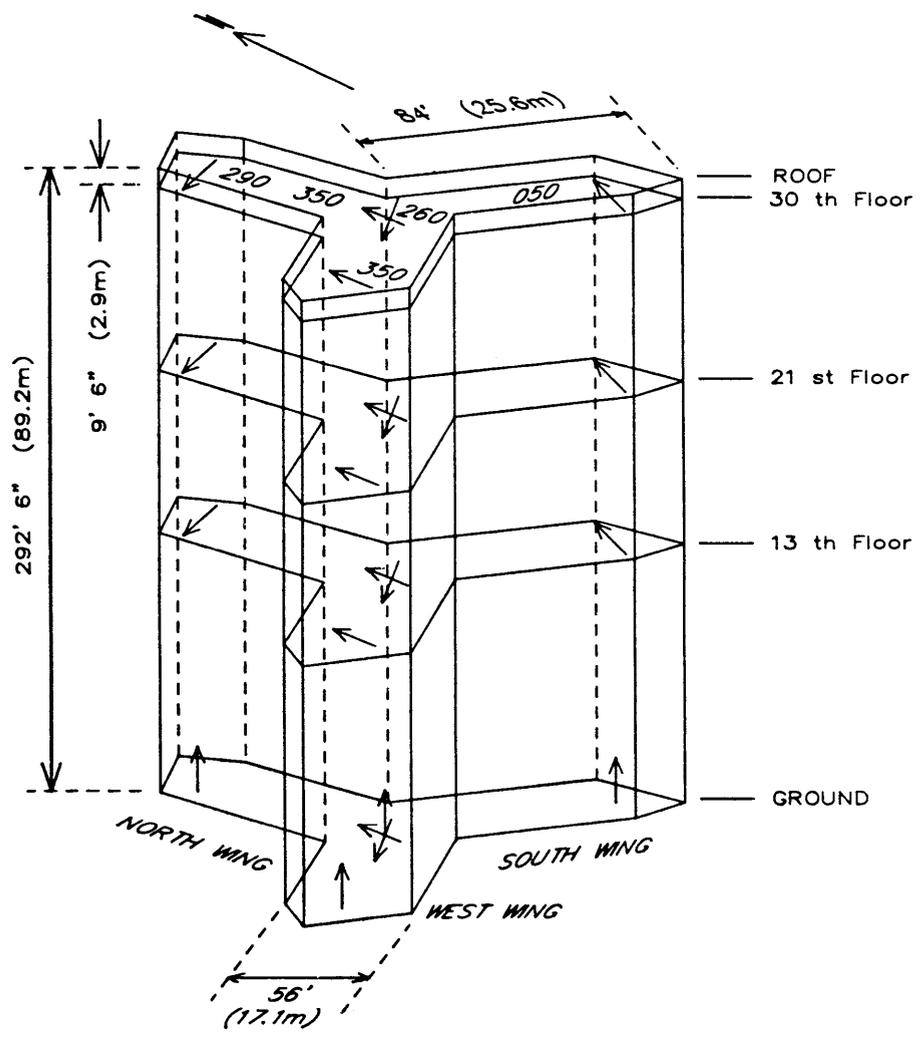
Figure 3.—A, Pacific Park Plaza. B, Plan layout and three-dimensional schematic of Pacific Park Plaza showing dimensions and strong-motion instrumentation (Çelebi, 1992, 1996).

The set of records from Pacific Park Plaza is possibly the most studied building response data during this earthquake. The building was constructed in 1983 and instrumented in 1985, is 30 stories, and is the tallest reinforced concrete building in northern California. A general view, a plan view, a three-dimensional schematic, and its instrumentation are shown in figure 3 (Çelebi, 1992, 1996). Twenty-one channels of synchronized uniaxial accelerometers are deployed throughout this structure, with an additional three channels of accelerometers located at the north free-field outside the building. All are connected to central recording systems. In addition, a triaxial strong-motion accelerograph is deployed at a free-field site on the south side of the building (SFF or EMV¹).

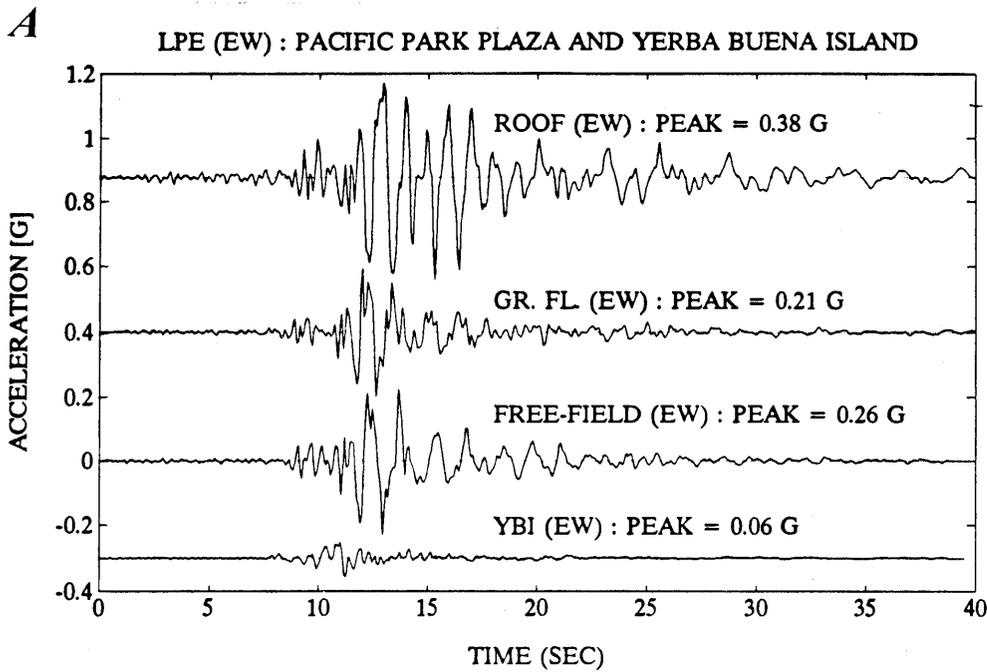
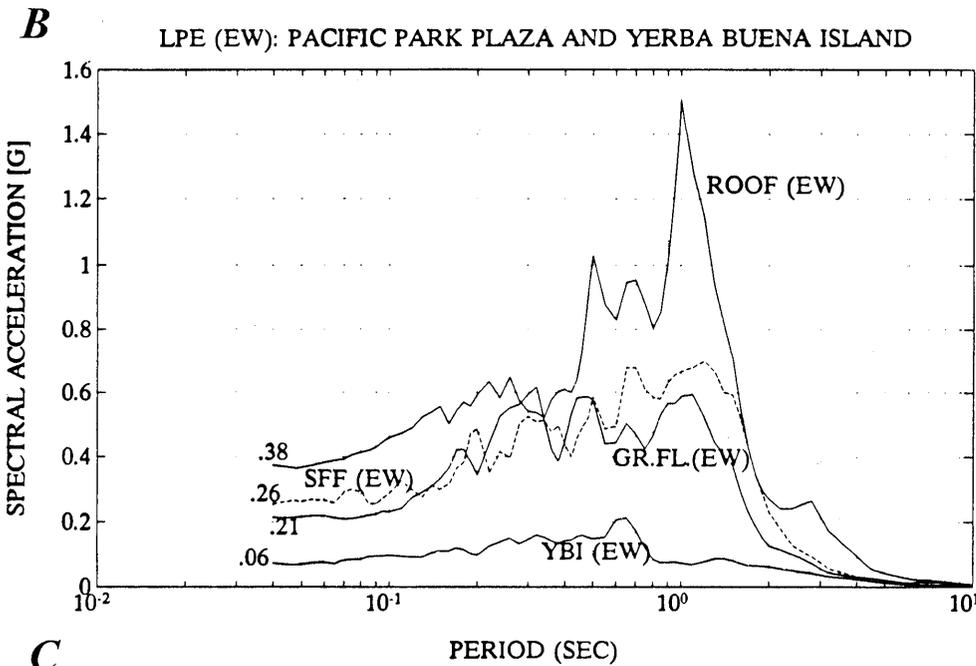
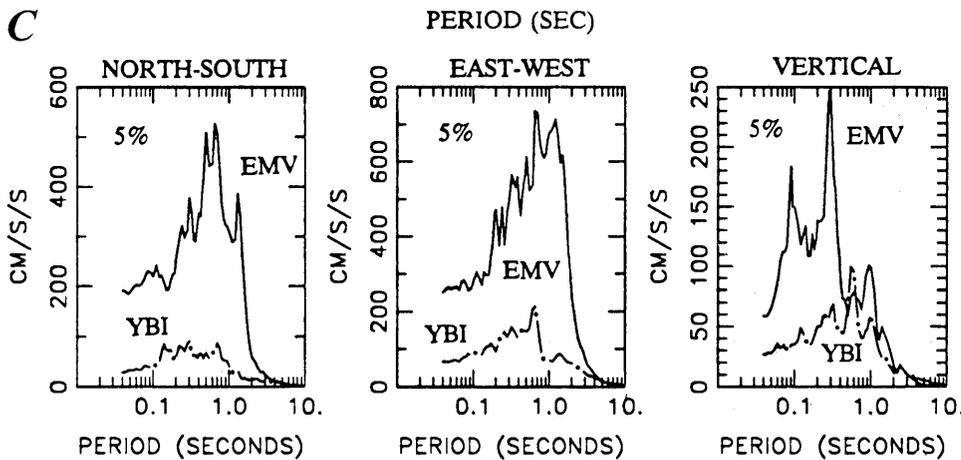
Figure 4.—A, Loma Prieta earthquake (LPE) east-west components of acceleration recorded at roof, ground floor, and south free-field (SFF) station of Pacific Park Plaza. Also shown is east-west component of acceleration at Yerba Buena Island (YBI). B, Response spectra of motions. C, response spectra of all three components of acceleration at south free-field (EMV) compared with YBI.

The building is an equally spaced three-winged, cast-in-place, ductile, moment-resistant reinforced concrete framed structure. The foundation is a 5-foot-thick concrete mat supported by 828 (14-inch-square) prestressed concrete friction piles, each 20-25 m in length, in a primarily soft-soil environment, with an average shear-wave velocity between 250 and 300 m/s and a depth of approximately 150 m to harder soil. The building had considerably amplified input motions but was not damaged during the earthquake. The east-west components of acceleration recorded at the roof and the ground floor of the structure and at the associated free-field station (SFF in fig. 3B), all at approximately 100 km from the epicenter, are shown in figure 4A. The motion at Yerba Buena Island (YBI), the closest rock site, had a peak acceleration of 0.06 g and is shown in figure 4 to indicate the level of amplified shaking at the free-field site and at the ground floor of the building. The corresponding response spectra are shown in figure 4B. For all three components of acceleration, the calculated response spectra of the south free-field site (SFF or EMV) of Pacific Park Plaza and Yerba Buena Island are compared in figure 4C (Çelebi, 1992). These response spectra show that the motions at EMV were amplified by as much as five times when compared with YBI. This is also inferred by the amplitude of the peak accelerations (0.26 g for EMV and 0.06 g for YBI). Furthermore, the differences in peak acceleration at the free-field station (0.26 g) and that at the ground floor of the building (0.21

g) (fig. 4A) suggest the possibility of significant soil-structure interaction.

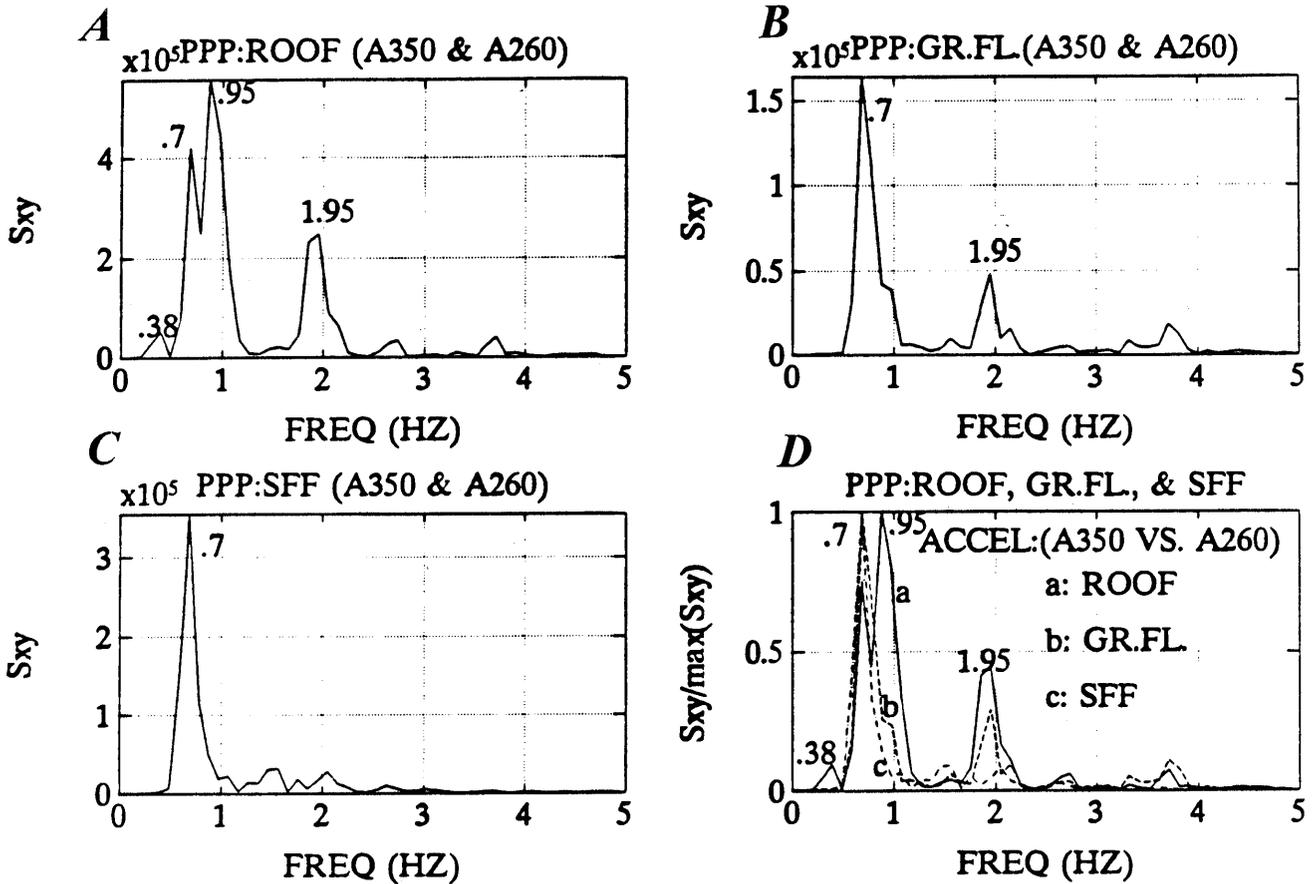
Figure 5.—Cross-spectra of accelerations at (A) roof, (B) ground floor, and (C) south free-field (SFF). Normalized cross spectra (D) show site frequency 0.7 Hz at ground floor and SFF but not at roof.

The building has been studied in detail by Çelebi and Şafak (1992), Şafak and Çelebi (1992), Anderson and Bertero (1994), Anderson and others (1991), Bertero and others (1992), Kagawa and others (1993), Kagawa and Al-Khatib (1993), Aktan and others (1992), and Kambhatla and others (1992). The predominant response modes of the building and the associated frequencies (periods) [0.38 Hz (2.63 s), 0.95 Hz (1.05 s), and 1.95 Hz (0.51 s)] are identified by all these investigators using different methods, including spectral analyses, system identification techniques, and mathematical models. These three modes of the building are torsionally-translationally coupled (Çelebi, 1996). The frequencies are clearly identified in the cross-spectra (S_{xy}) of the orthogonal records obtained from the roof and ground floor (fig. 5A, B), the south free-field site (SFF) (fig. 5C), and the normalized cross-spectra of the orthogonal records (fig. 5D). A site

frequency at 0.7 Hz (1.43 s) is also identified. The peak at 0.7 Hz that appears in the cross-spectrum of the roof (fig. 5A) appears as the dominant peak in the cross-spectra of the ground floor and the south free-field (SFF) (figs. 5B, C). When the normalized cross-spectra are calculated for the ground floor and free-field, the site frequency at 0.7 Hz is distinguishable from the structural frequencies in the normalized cross-spectrum of the roof (fig. 5D). The

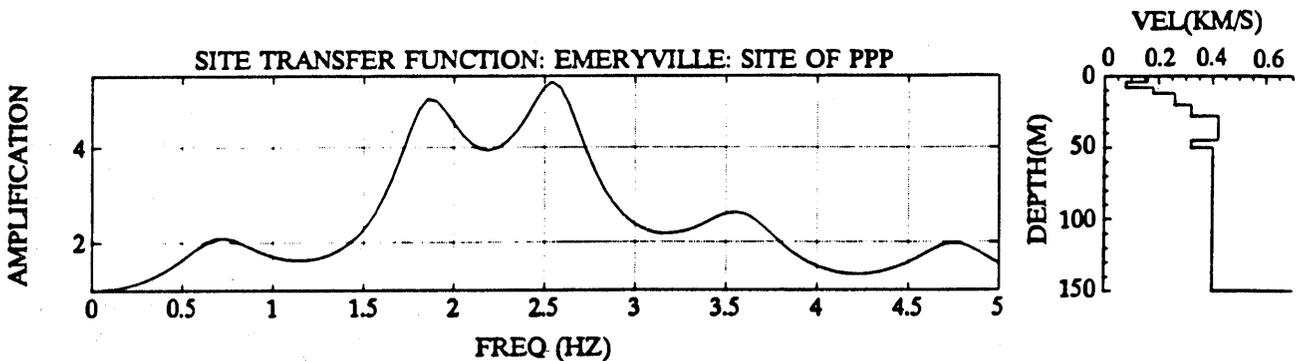
Figure 6.—Site transfer function of Pacific Park Plaza indicates first peak at 0.7 Hz.

0.7-Hz site frequency is further confirmed by the transfer function (fig. 6) calculated by using Haskell's shear-wave propagation method (Haskell, 1953, 1960) and site characterization information by Gibbs and others (1994). The figure shows the transfer function and the variation of shear-wave velocities with depth. The depth to bedrock has been adopted from a map by Hensolt and Brabb (1990) as 150 m (~500 ft).

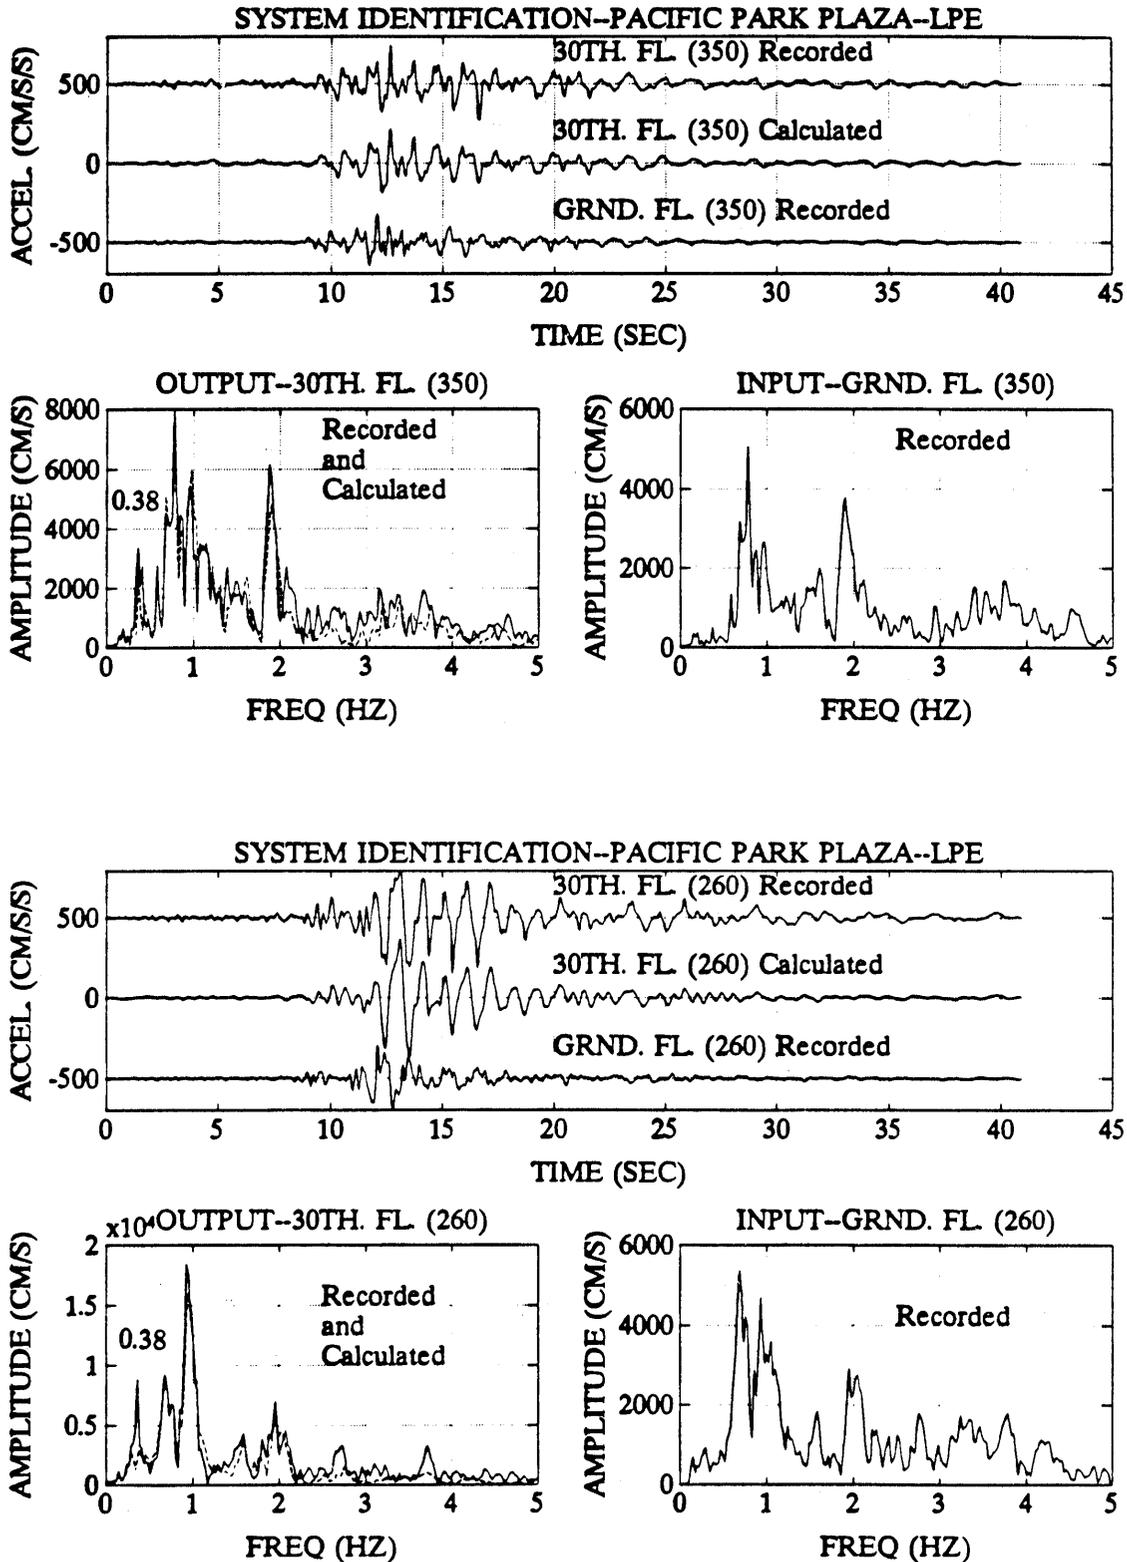
Figure 7.—System identification applied with accelerations recorded at roof and ground floor of Pacific Park Plaza.

Figure 7 shows the results of applying the system identification technique. The match between the observed and calculated response is excellent, as evidenced by comparison of the calculated and observed responses at the

top floor and by comparison of the amplitude spectra of these responses. The damping ratios extracted from the system identification analyses corresponding to the 0.38-Hz first-mode frequency are 11.6 percent (north-south)

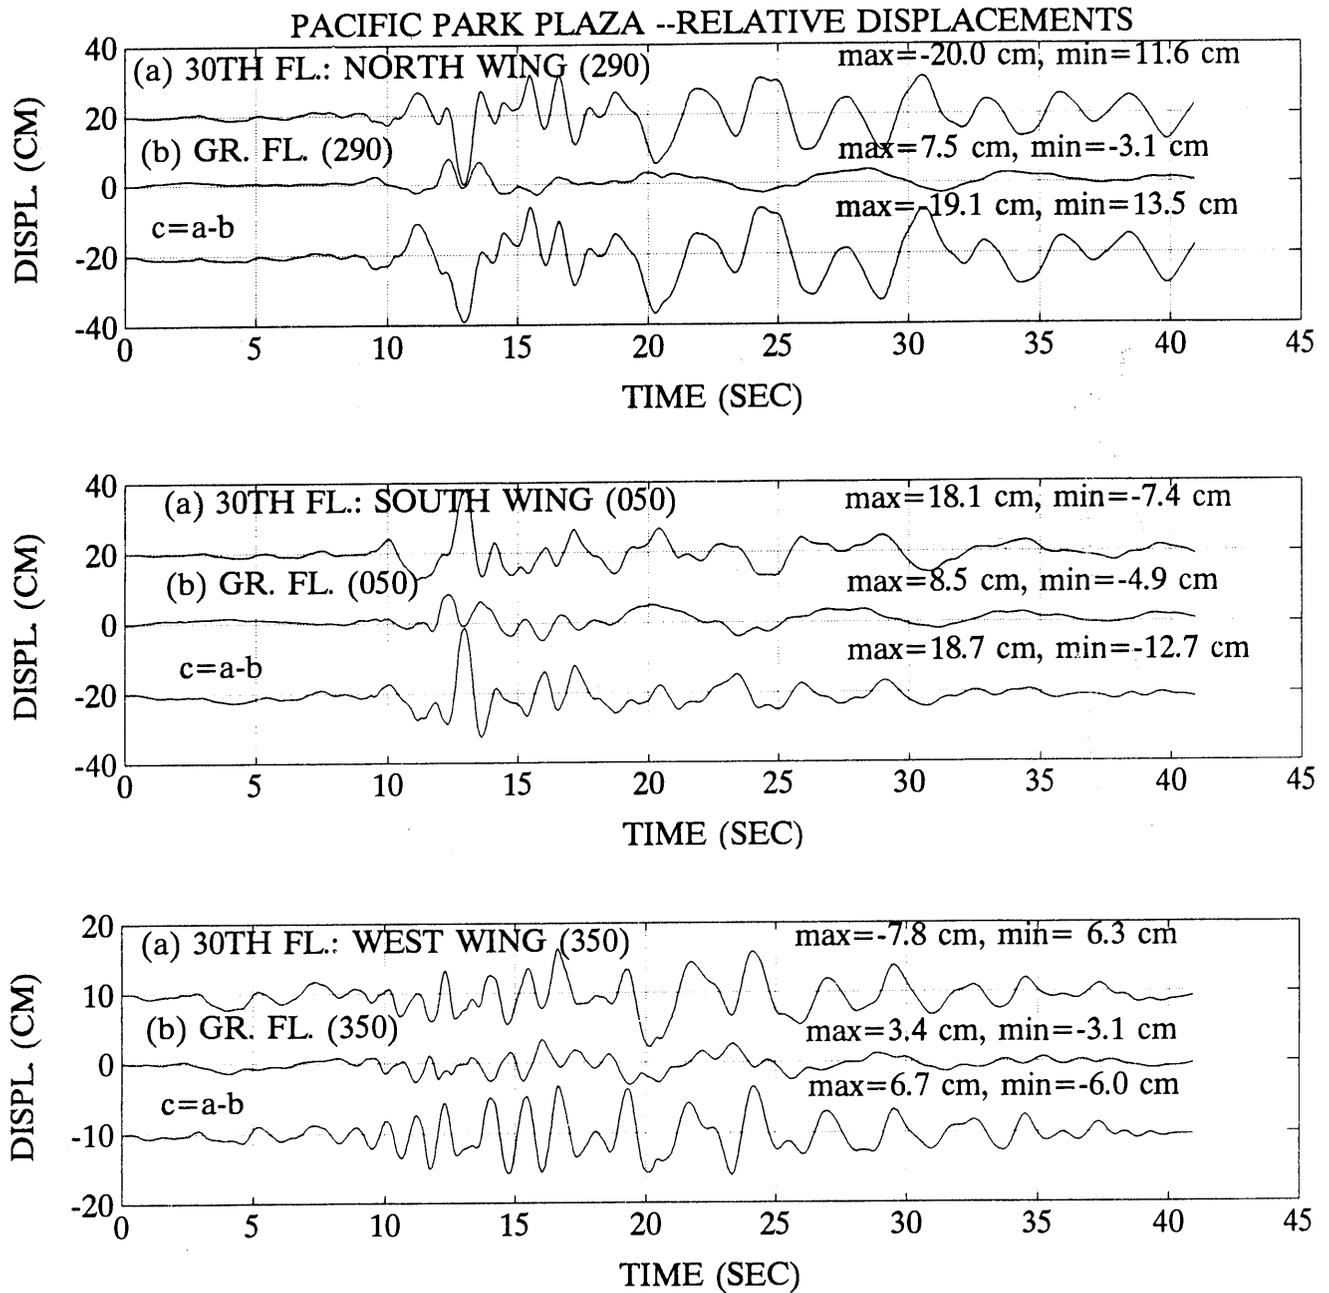
Figure 8.—Relative displacements at the wings of 30th floor of Pacific Park Plaza.

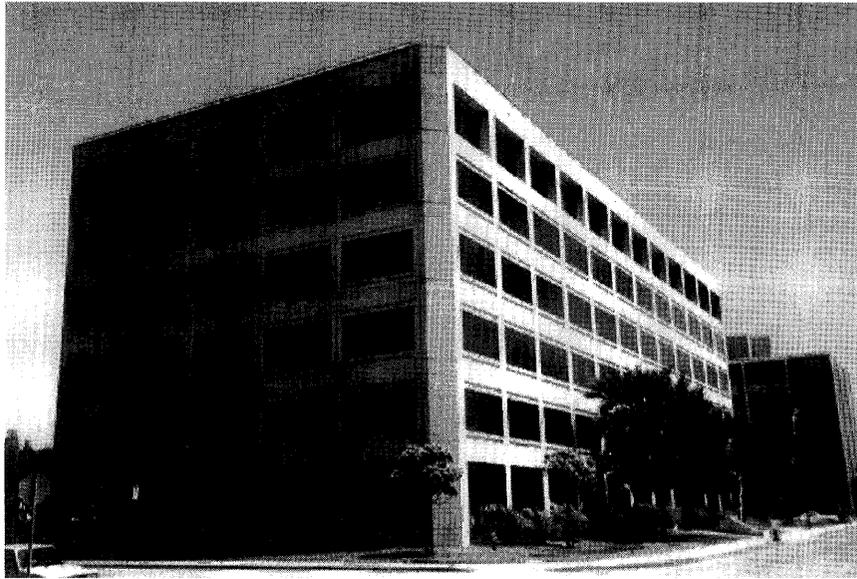
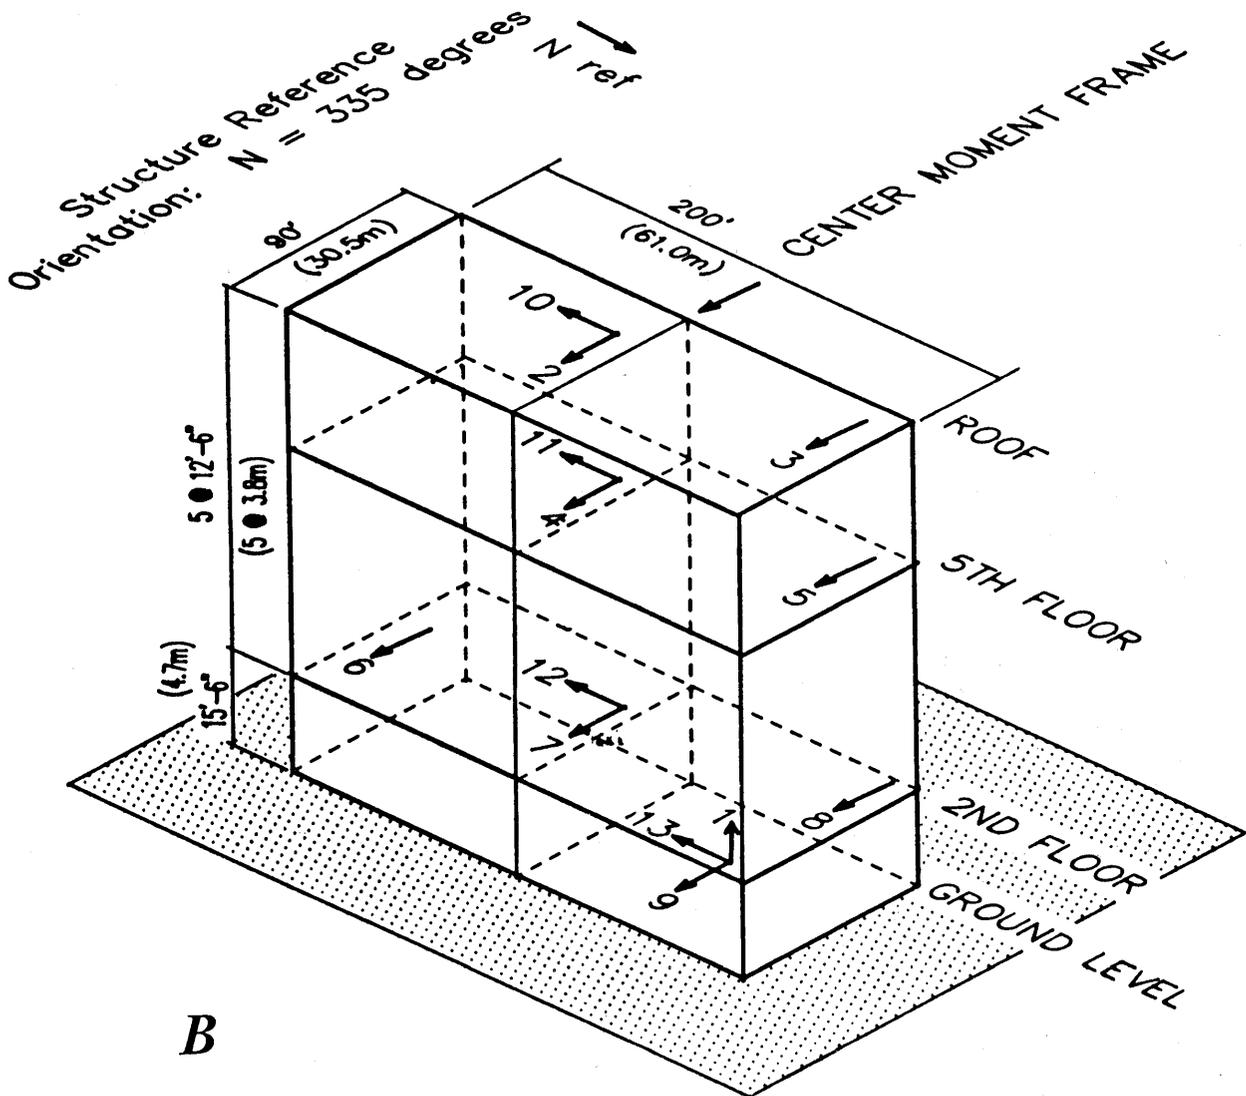
Figure 9.—A, Six-story commercial building in San Bruno. B, Three-dimensional schematic of San Bruno building.

A general view and the instrumentation scheme a six-story, reinforced concrete framed building in San Bruno (SBR) is shown in figure 9 (Çelebi, 1996). The building is rectangular in plan and has four moment-resistant frames in the exterior and one in the interior in the transverse direction (355°). Anderson and Bertero (this chapter) developed three-dimensional, linear elastic models of the building and studied its response under recorded base motions and code-prescribed lateral forces. They reported that under Loma Prieta motions the models confirmed limited inelastic behavior, as was observed in the building following the earthquake.

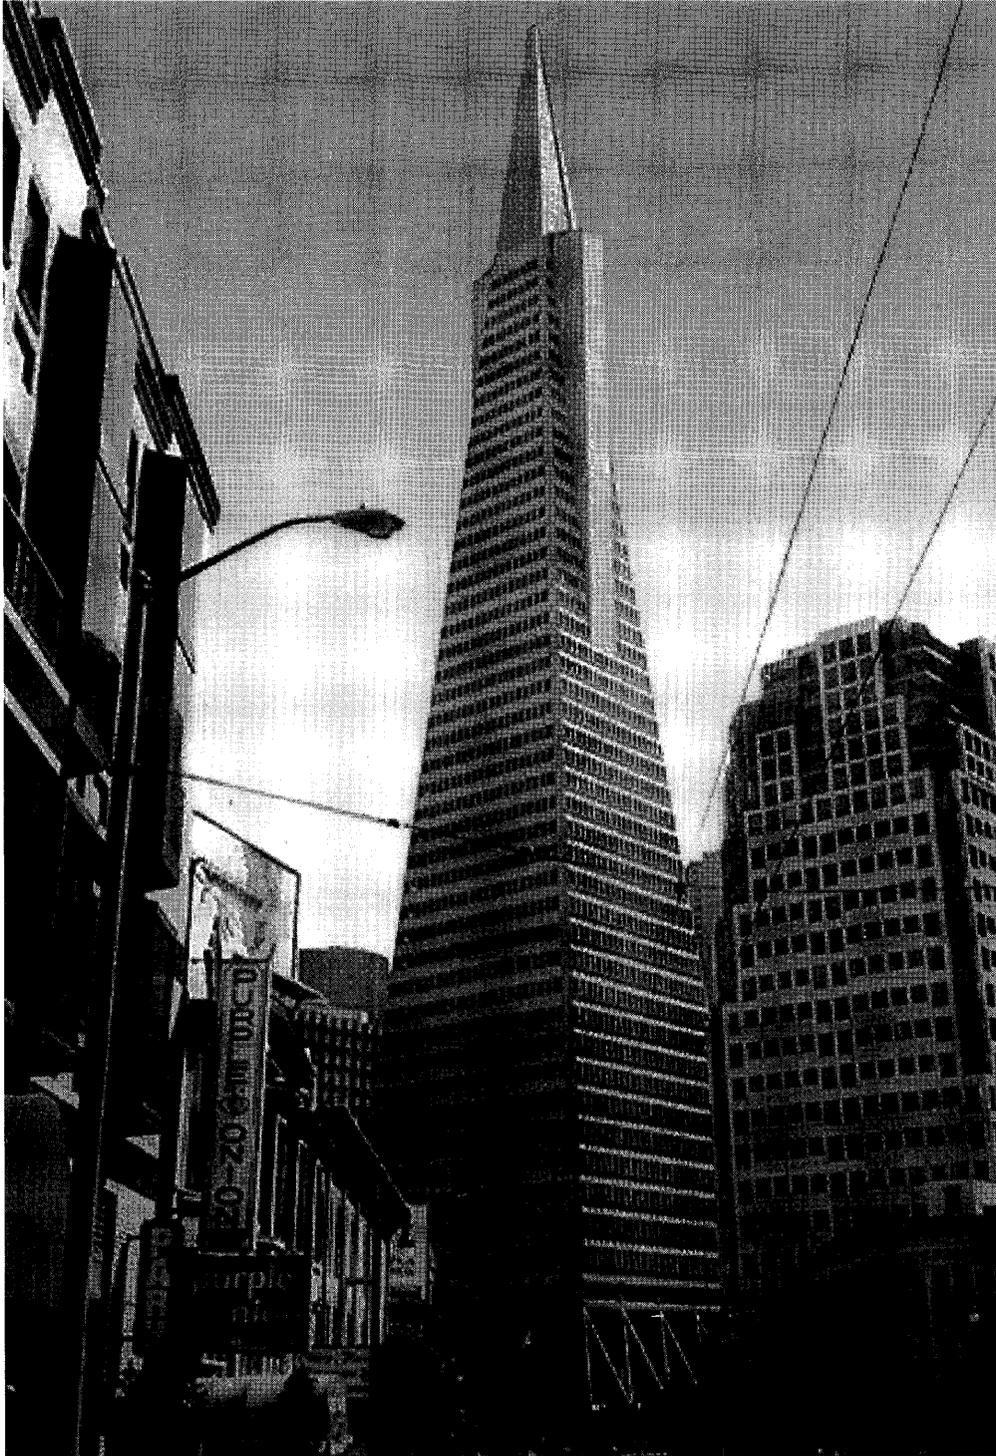
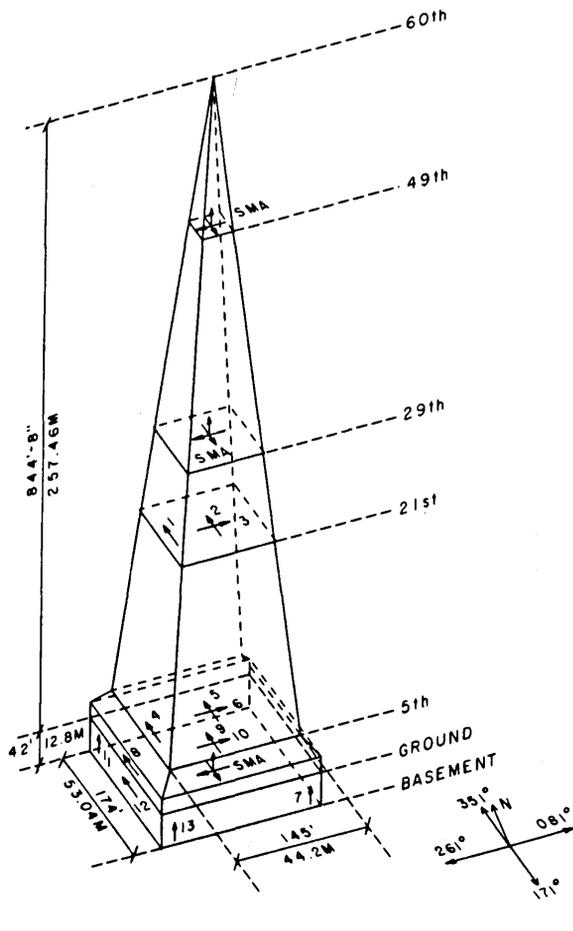
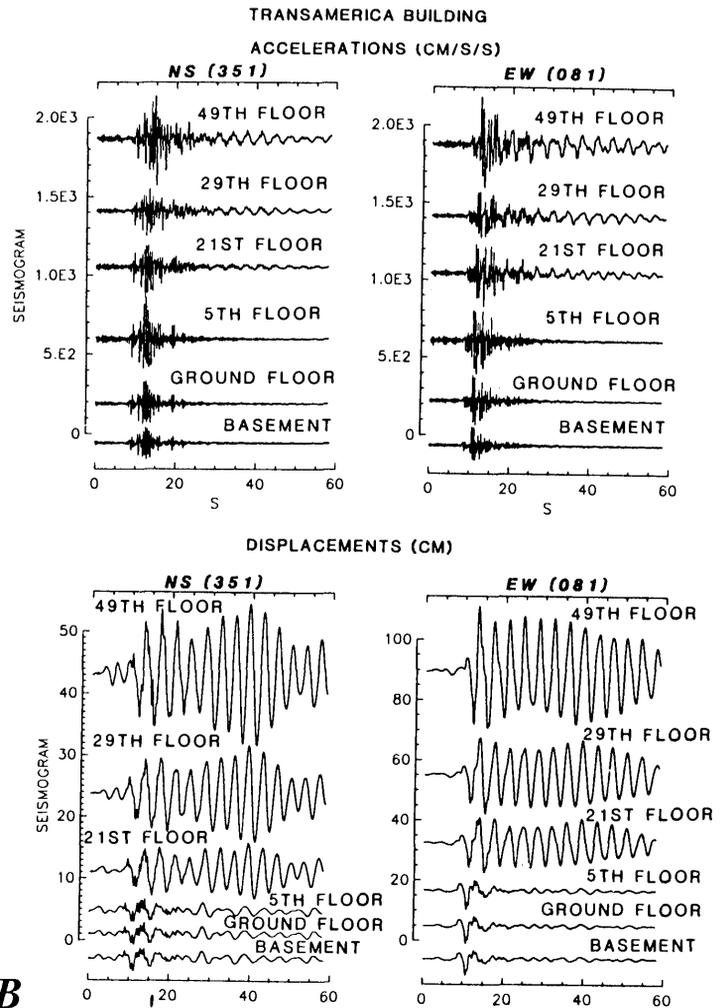
Figure 10.—A, Transamerica Building. B, Three-dimensional schematic of Transamerica Building and recorded accelerations and displacements (Çelebi, 1992, 1996).

A general view, a three-dimensional schematic, overall dimensions, the instrumentation scheme, and recorded accelerations and displacements at some locations of the building are shown in figure 10. The instrumentation scheme was designed and implemented to study the response and associated dynamic characteristics of the building, including its translational, rocking, and torsional motions. There are a total of 22 channels.² Three triaxial strong-motion accelerographs with a total of nine channels are deployed synchronously with 13 uniaxial force-balance accelerometers, all connected to a central recorder with common-time recording capability. The three triaxial accelerographs are located on the 49th, 29th, and basement levels. At the 21st, 5th, and ground levels, three uniaxial accelerometers are deployed, two parallel

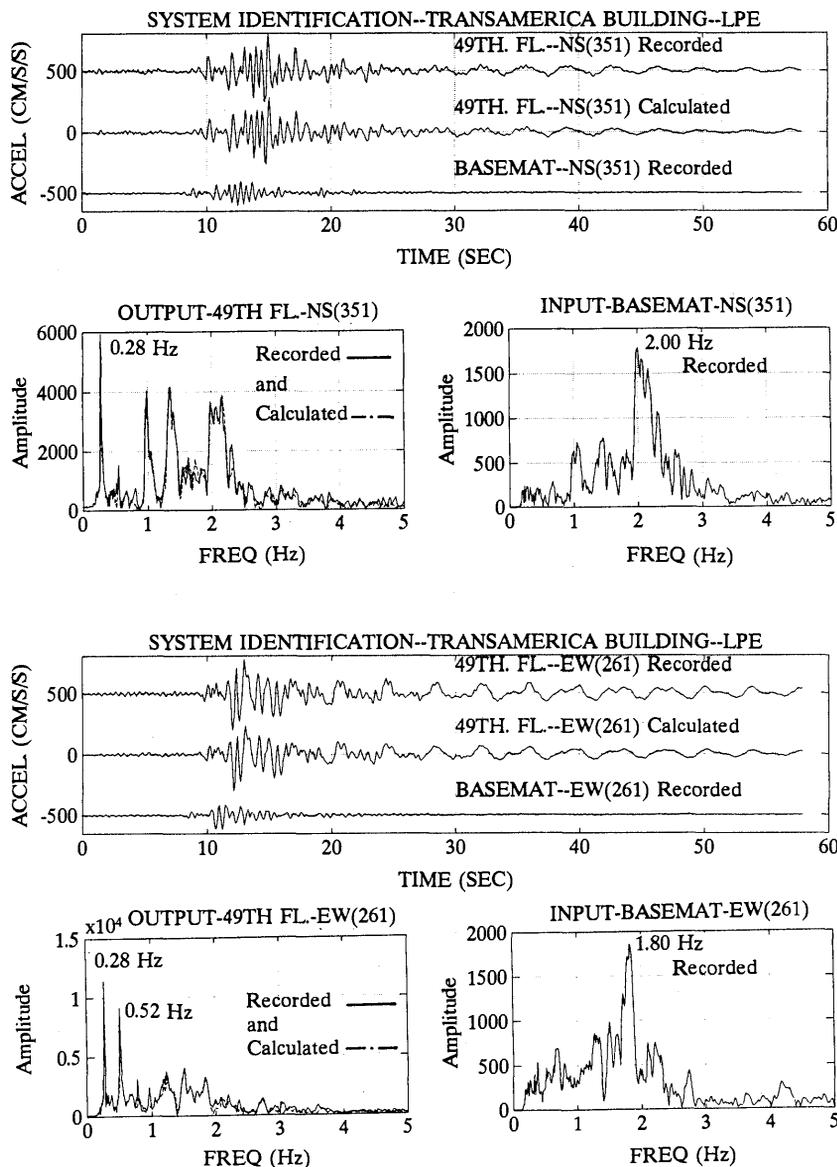
Figure 11.—System identification applied with accelerations recorded at 21st floor and basement of Transamerica Building.

at the 21st floor and the vertical motion in the basement are coherent and in phase. These frequencies are also observed in the Fourier amplitude spectra for the horizontal acceleration components (both directions) at the roof level,

as shown in figure 11. Figure 13 shows (A) the east-west component of acceleration at the 49th floor, (B) its amplitude spectrum, (C) the east-west displacement at the 49th floor, (D) the rocking contribution of acceleration at the 49th floor, (E) its amplitude spectrum clearly displaying the 2 Hz (0.5 s) rocking frequency (period), and (F) the rocking contribution of displacement at the 49th floor. It is noted that amplitudes of the rocking contribution (calculated by multiplying the rotation by the total distance between the basemat and the 49th floor) to the 49th floor displacement are very small.

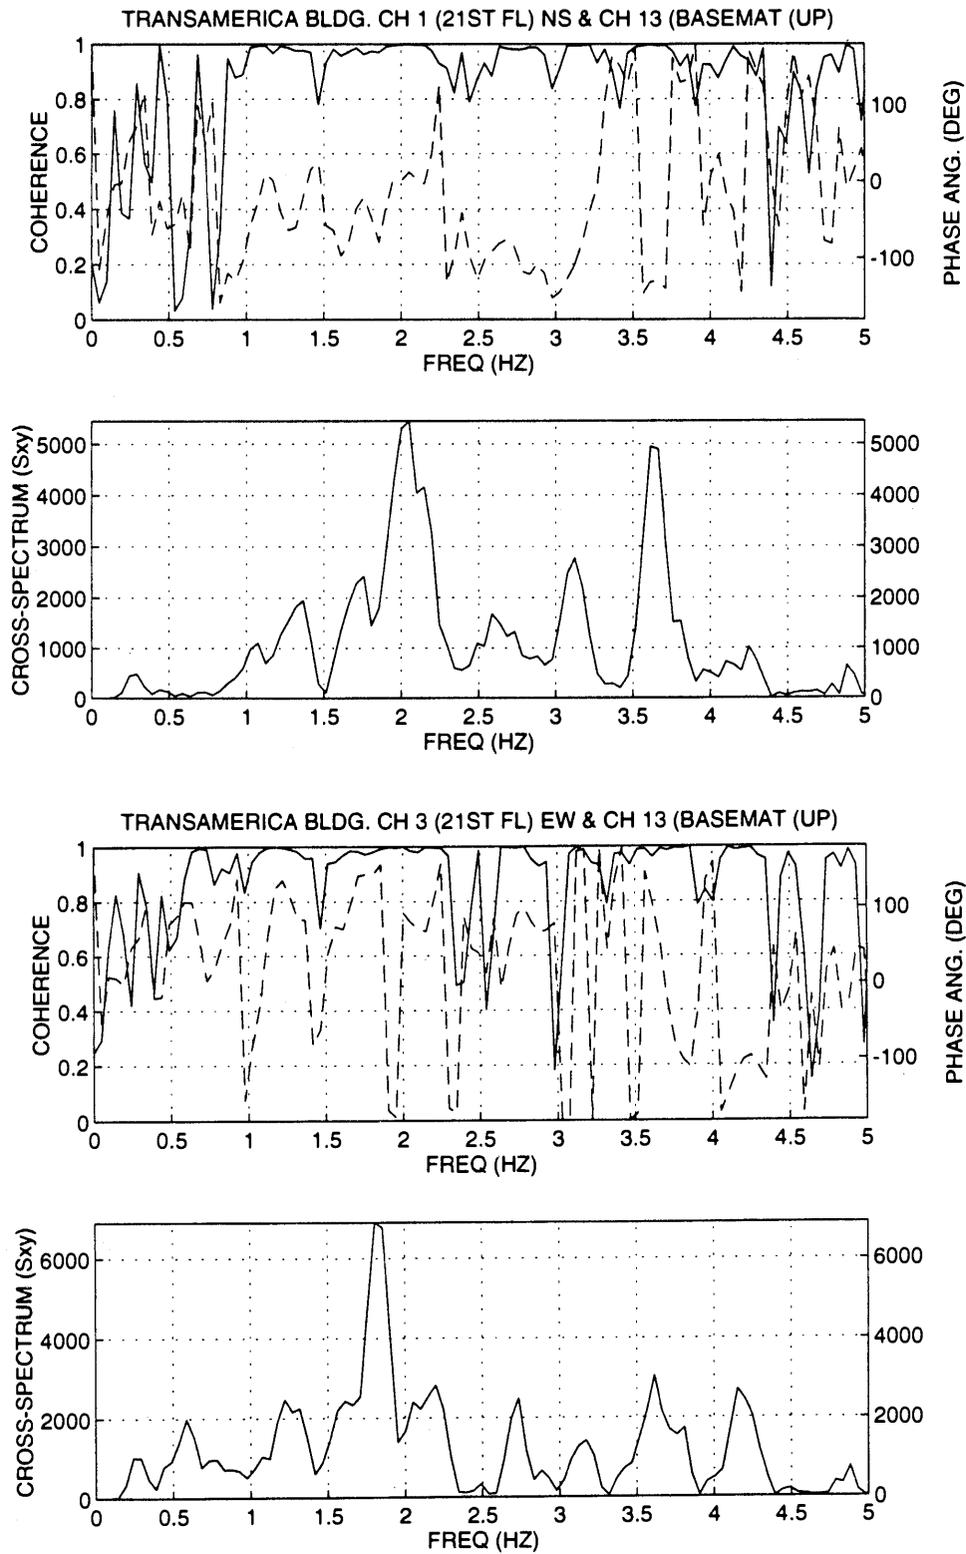
Figure 12.—Rocking investigated with cross-spectrum, coherency (solid line), and phase angle (dashed line) plots of horizontal motions at 21st floor and vertical motion at basemat of Transamerica Building.

The possibility of rocking was investigated using both the vertical motions recorded at the basemat and the horizontal motions recorded at the ground level and the basemat. Shown in figure 12 are the coherency, phase angle, and cross-spectrum plots for both north-south (351°) and east-west (081°) directions of pairs of horizontal acceleration on the 21st floor and vertical acceleration of

the basemat. It is observed from these that the rocking motion occurs at 2.0 Hz (or 0.5 s) in the north-south (351°) direction and at 1.8 Hz (or 0.56 s) in the east-west (081°) direction, since at these frequencies the horizontal motion

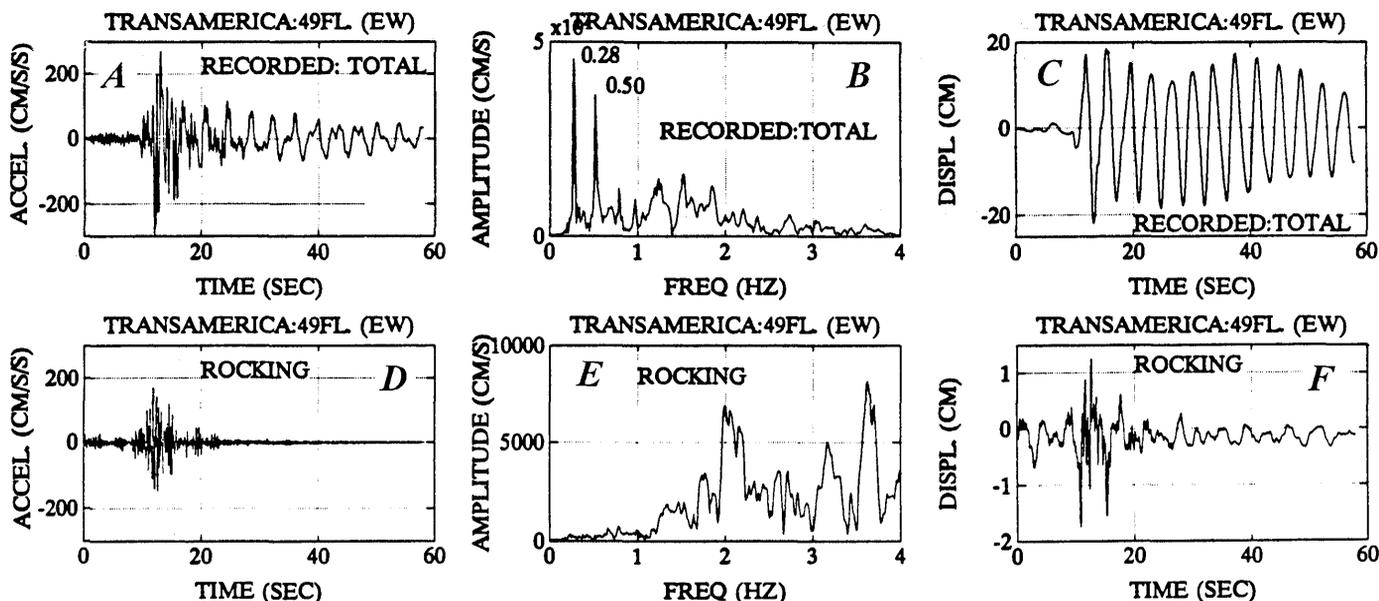
Figure 13.—A, East-west component of acceleration at 49th floor. B, Amplitude spectrum of east-west component at 49th floor. C, East-west displacement at 49th floor. D, Rocking contribution of acceleration at 49th floor. E, Amplitude spectrum of rocking contribution of acceleration at the 49th floor clearly displaying the 2 Hz (0.5 s) rocking frequency (period). F, Rocking contribution of displacement at 49th floor.

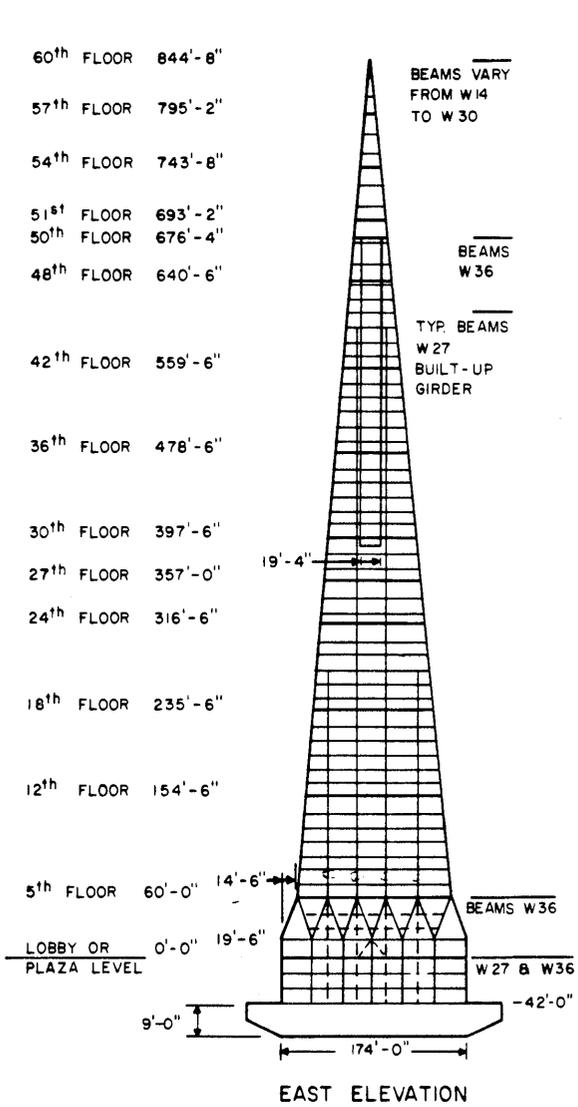
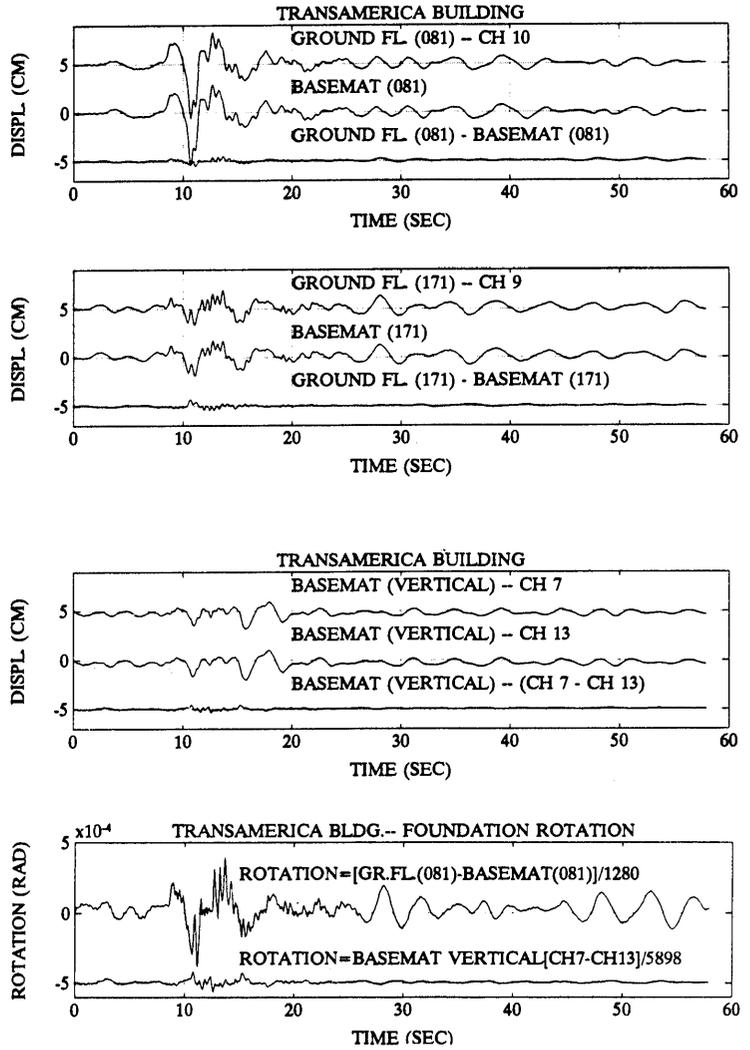
Figure 14.—Rotation of basemat and basement walls at Transamerica Building.
