The Loma Prieta, California, Earthquake of October 17, 1989—Building Structures

U.S. GEOLOGICAL SURVEY PROFESSIONAL PAPER 1552-C

BUILDING STRUCTURES

INTRODUCTION

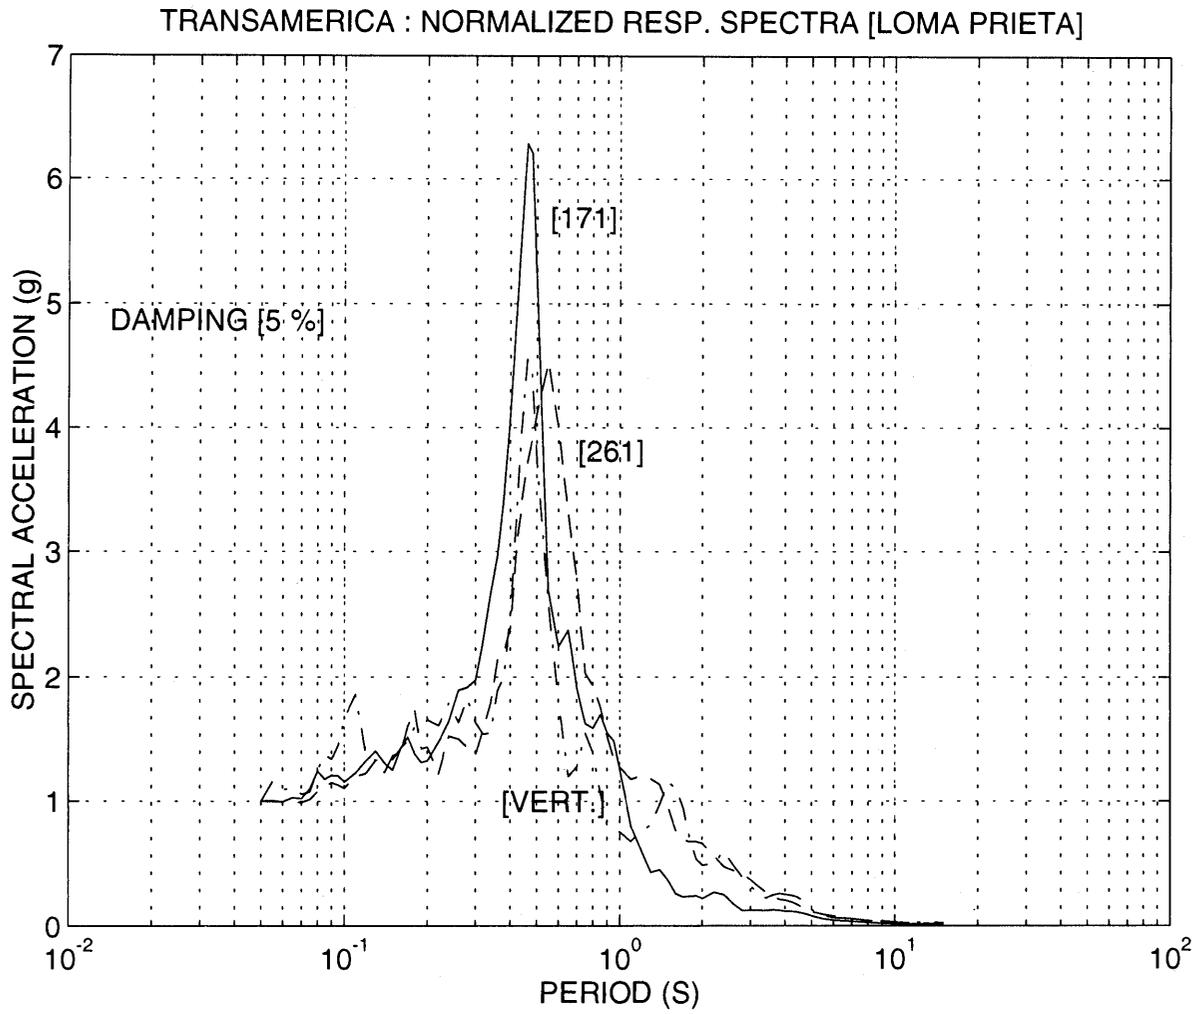
Figure 15.—Normalized response spectra for records from three components of the triaxial accelerograph at basement of Transamerica Building.

Although very small in amplitude, the rocking motions significantly influenced the motions at the basement and the ground level. This is evidenced by the normalized response spectra (fig. 15) for the records from the three components of the triaxial accelerograph at the basemat. Thus, this type of response may be pertinent to the incorporation of response spectra used in the design process of buildings. The design response spectra represents, in general, free-field motions assumed to be applicable at the foundation level of a structure; while it may include site effects, it should not include the effect of the vibration of the structure or soil-structure interaction. In this case, it was shown that the motions at the foundation (basemat) level are influenced by the soil-structure interaction effects.

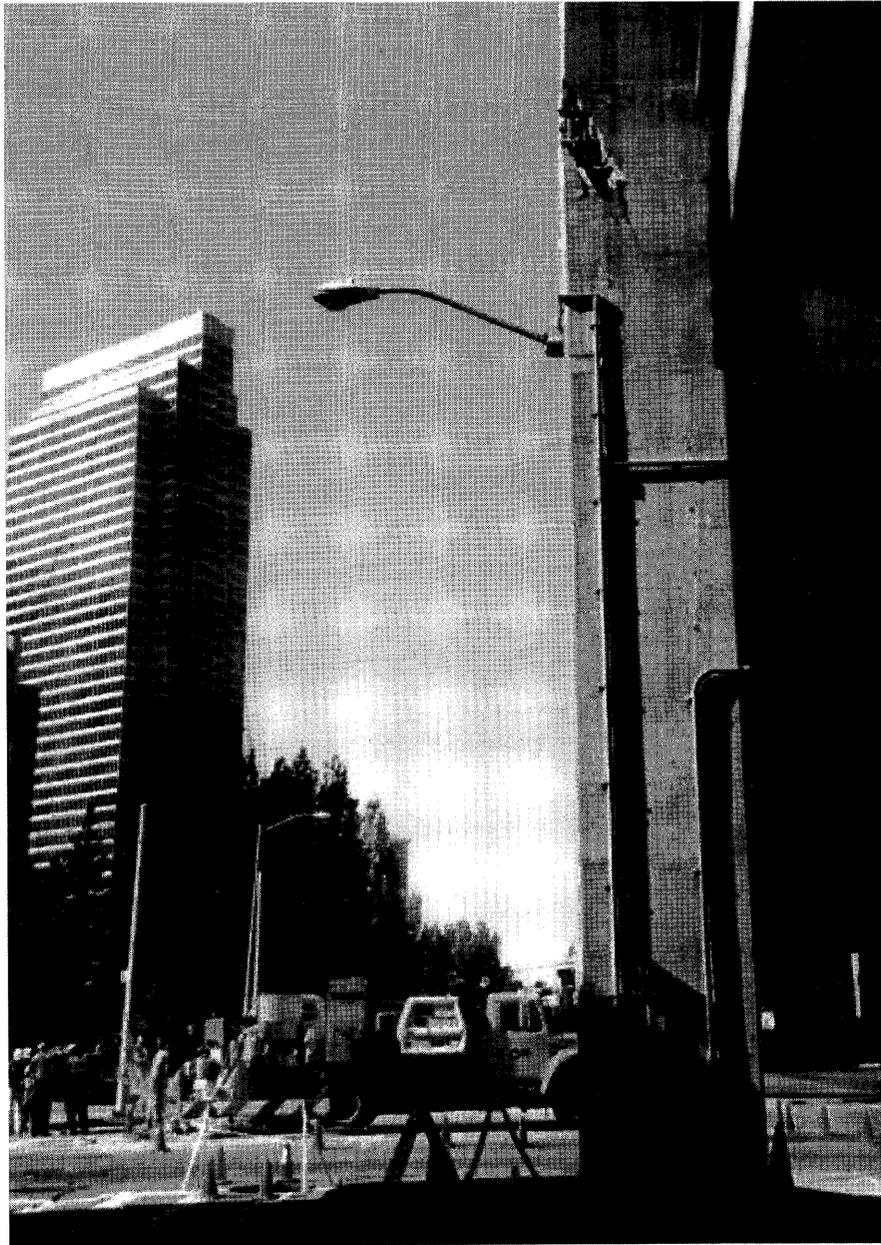
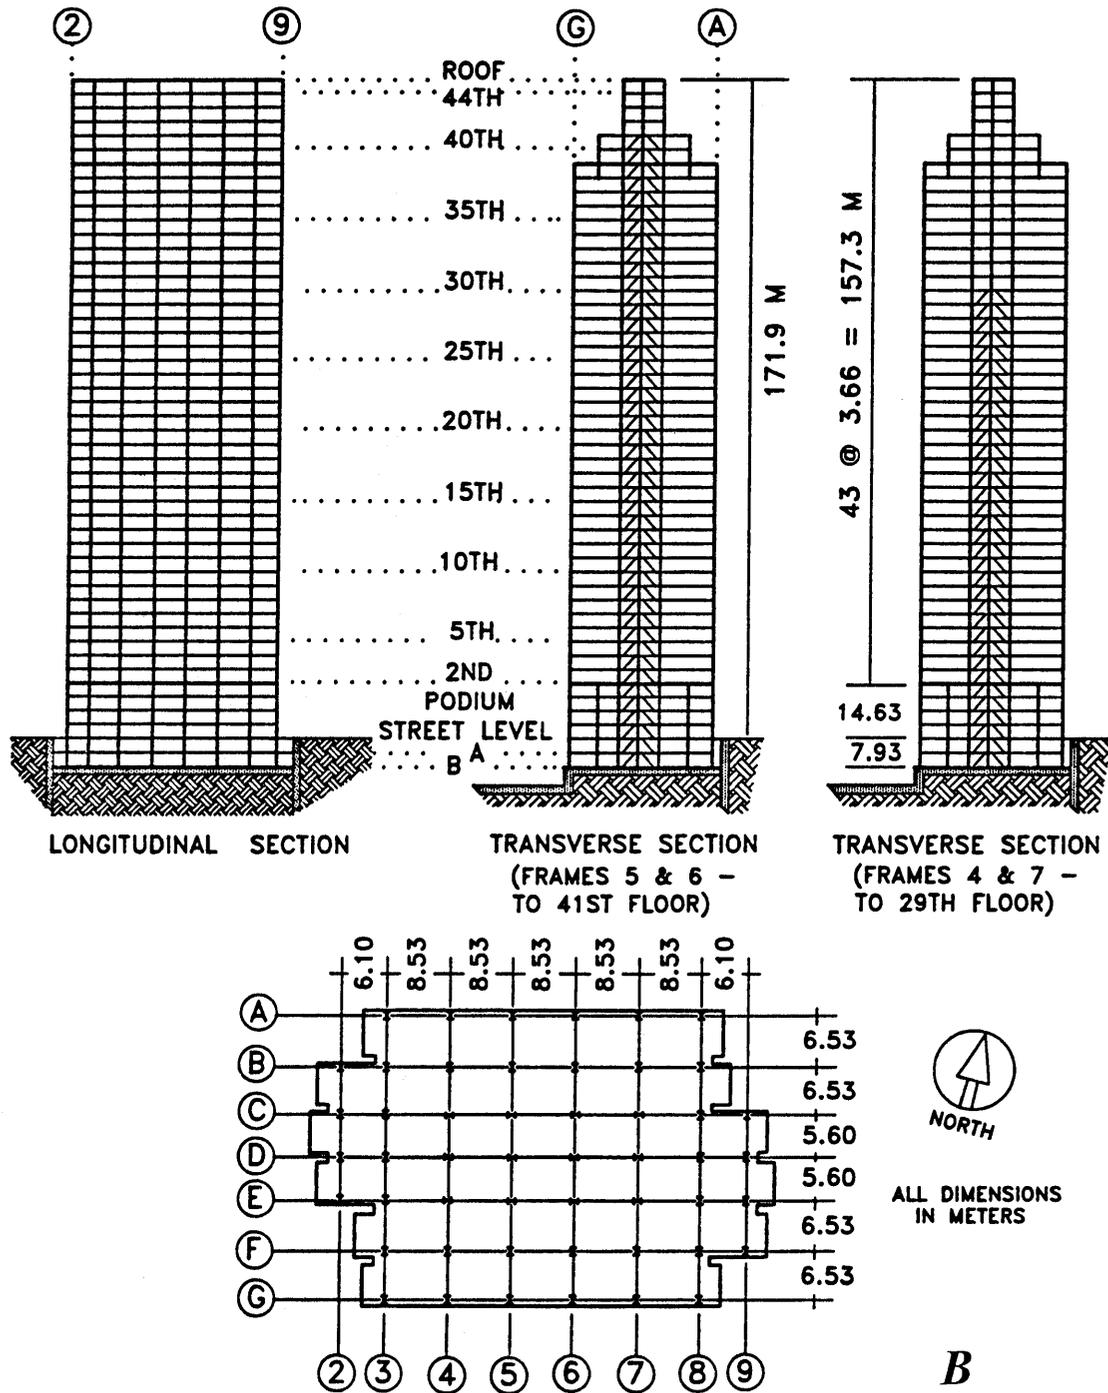
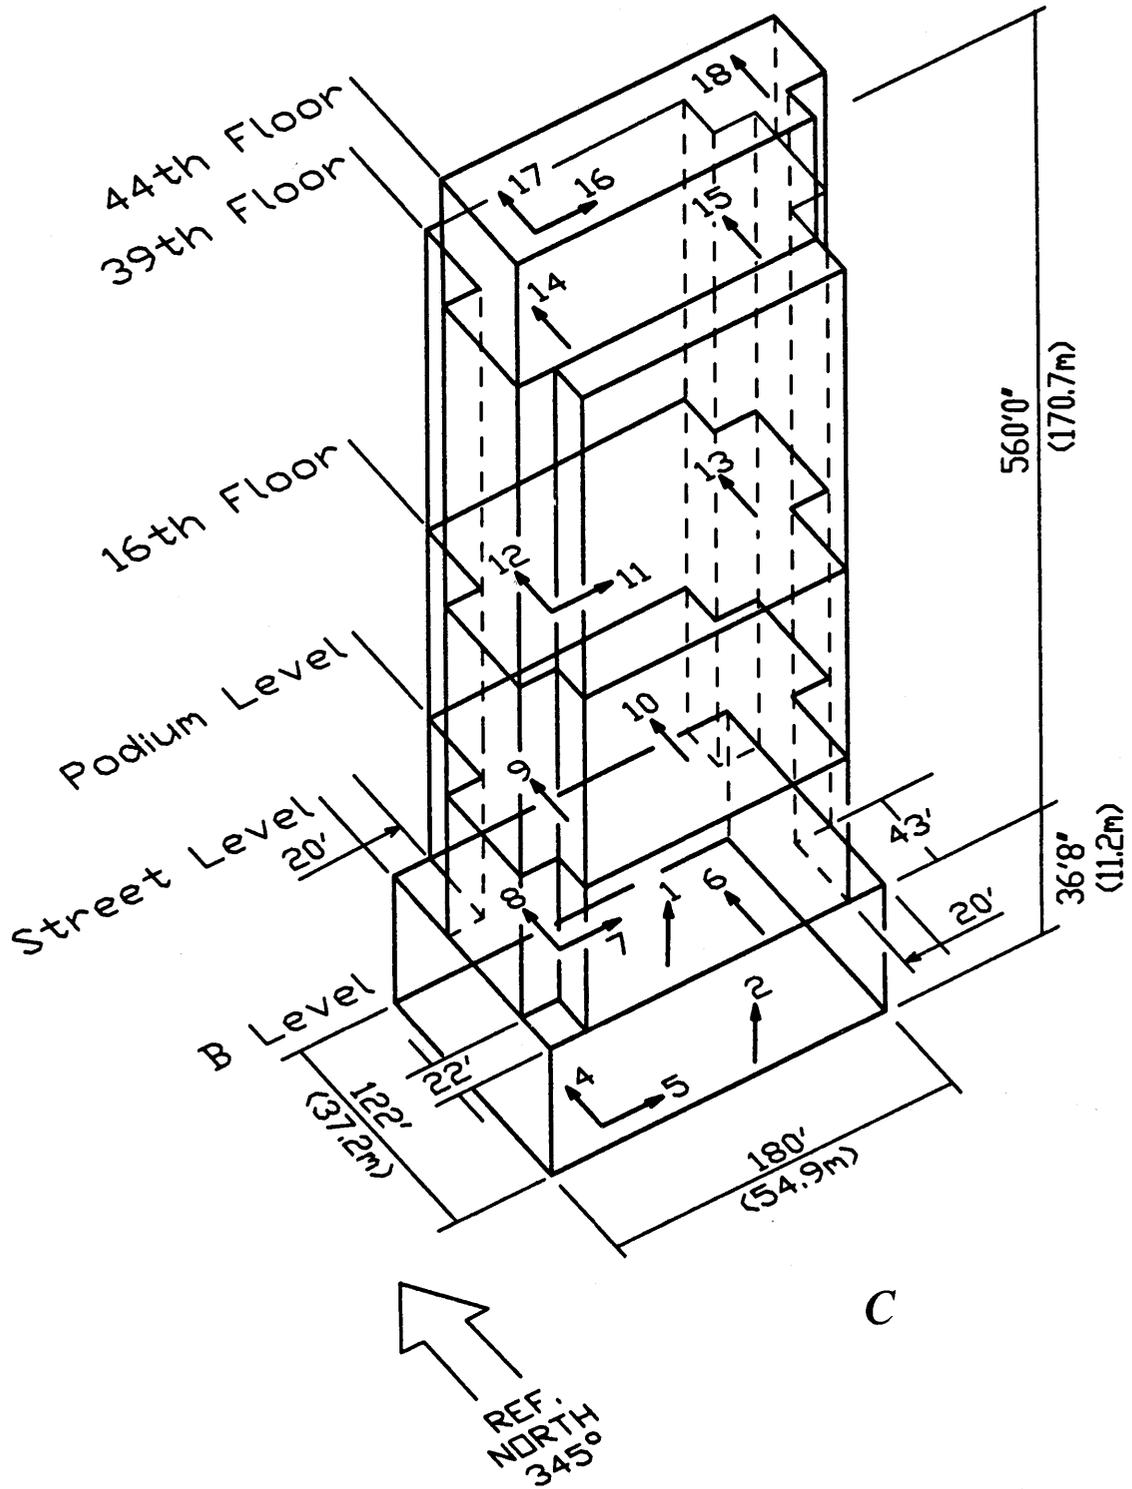
Figure 16.—A, Embarcadero Building. Also shown is one of the damaged columns of Embarcadero Freeway, razed in 1991. B, Typical plan view and vertical sections of Embarcadero Building. C, Three-dimensional view and instrumentation scheme of Embarcadero Building.

The Embarcadero Building is 172 m (564 ft) high. The building actually consists of two structures; an above-grade 47-story building and an above-grade 3-story building. The below-grade 2-story shear walls and diaphragms are common to the two structures. The 47-story tower, referred to as the Embarcadero Building herein, is a moment-resisting steel-framed structure. Four center north-south frames are eccentrically braced (two up to the 41st floor and two up to the 29th floor). Plan dimensions decrease above the 39th and again above the 41st floors. Eccentric diagonal braces consist of double angles which are offset by approximately 1.5 m (4.5 ft) from the column-beam intersections. Recent codes (Uniform Building Code, 1991) term this type of structural framing as special moment-resisting frames. A general view of this building, the vertical sections showing the eccentric bracing and a typical plan view with significant dimensions, and a three-dimensional view of the building and instrumentation scheme are provided in figure 16 (Çelebi, 1993).

The strong-motion instrumentation scheme implemented in 1985 by the California Strong Motion Instrumentation Program of the California Division of Mines and Geology at six different levels of the building is shown in figure 16C (Shakal and others, 1989). There are 6 digital seismic accelerographs (DSA-1) with a total of 18 channels of synchronous, uniaxial (FBA-11) and biaxial (FBA-21) force-balance accelerometers within the structure. One of the unidirectional accelerometers is in the adjacent building basement. The reference north-south orientation is 345° clockwise from true north (fig. 16C).

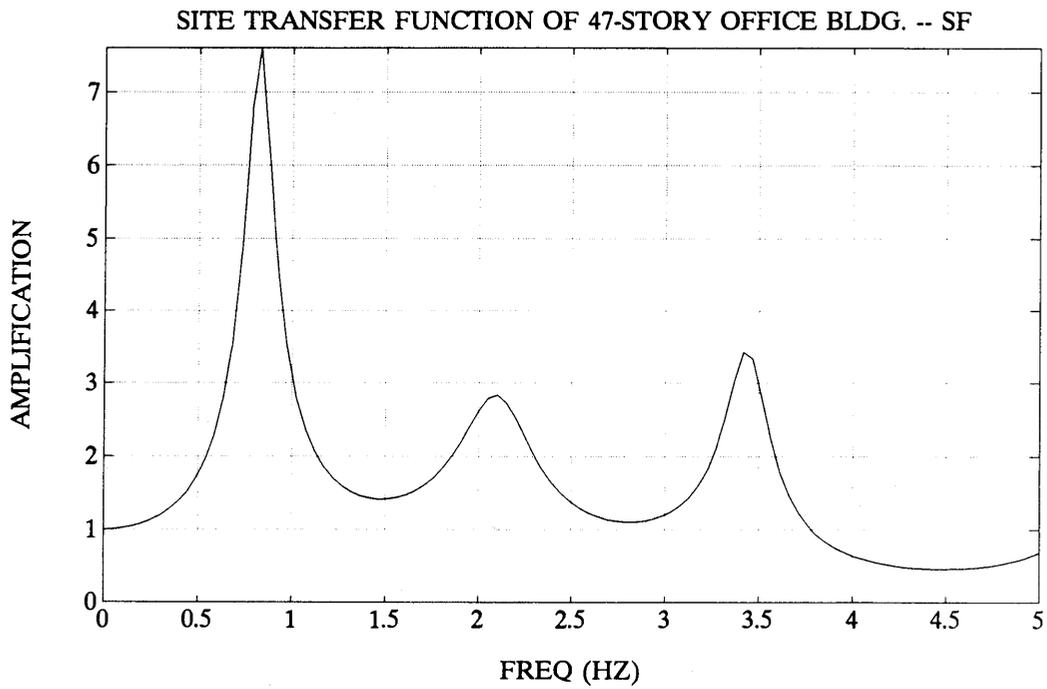
Figure 17.—Site transfer function of Embarcadero Building site.

in figure 17. From this, a site frequency (period) of 0.8 Hz (1.25 s) is inferred. Alternatively, using the well-known formula $T_s = 4H/V_s$, a depth (H) of 64 m, and an average shear-wave velocity (V_s) of 200 m/s, an approximate site frequency (period) of 0.77 Hz (1.3 s) is obtained (Çelebi, 1993). The match between the calculated site periods is very good. The significance of the site period is discussed later in this section.

The amplitude at approximately 0.75-0.8 Hz (1.25-1.33 s), noted in the Fourier amplitude spectra (figs. 21, 22), is attributed to belonging to the site because the amplitude at the roof does not increase significantly when compared to that at the ground floor. Furthermore, the site period, estimated to be around 1.25-1.40 s, falls within the range of modal periods of the building, and therefore the building may have been subjected to a double-resonance effect. It is noted that the site-specific response spectra (fig. 18) do not adequately reflect the resonating site period (fig. 17) (Çelebi, 1993).

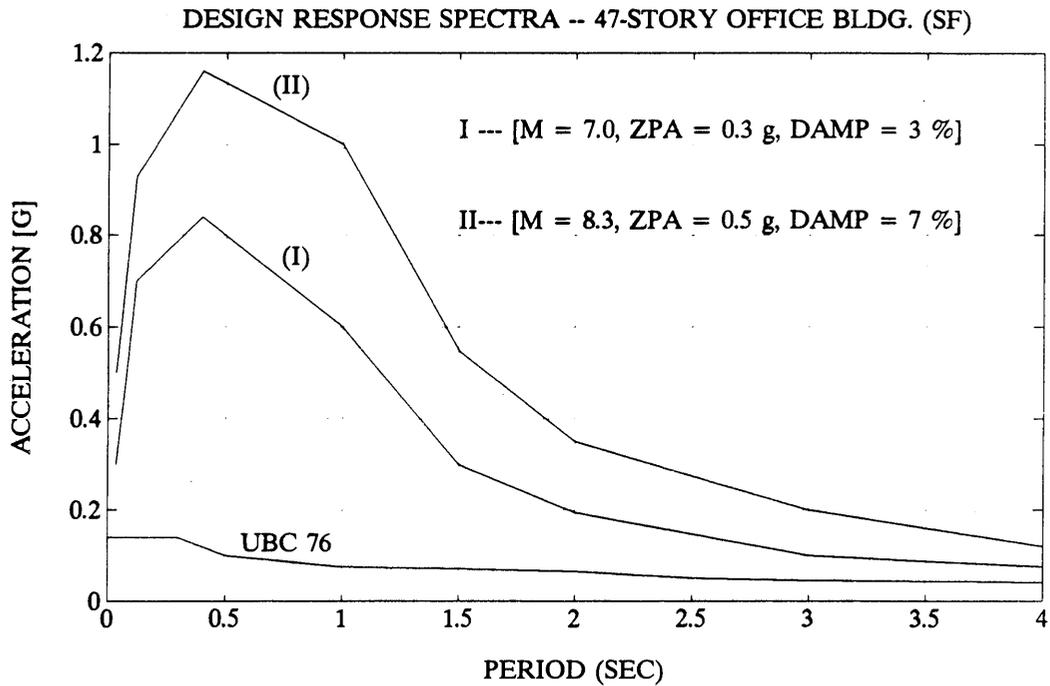
Figure 18.—Design response spectra of Embarcadero Building.

For the design of the building, site-specific design response spectra based on two levels of performance of the building were used. The first level of performance requires elastic response without structural or nonstructural damage under a moderate earthquake ($M=7$) that is likely to occur during the economic life of the building. The second level of performance demands that the structure will not collapse under the most severe (major) earthquake ($M=8.3$) that could occur during the economic life of the building. Substantial structural and nonstructural damage (without collapse) is considered acceptable under such an event. Design response spectra based on United States Nuclear Commission Regulatory Guide 1.60 (United States Nuclear Regulatory Commission, 1973) of earthquake level I (anchored at zero period acceleration, 0.3 g and 3 percent damping) and earthquake level II (zero period acceleration, 0.5 g and 7 percent damping) are provided in figure 18, which also shows the 1976 Uniform Building Code spectrum for comparison (Çelebi, 1993).

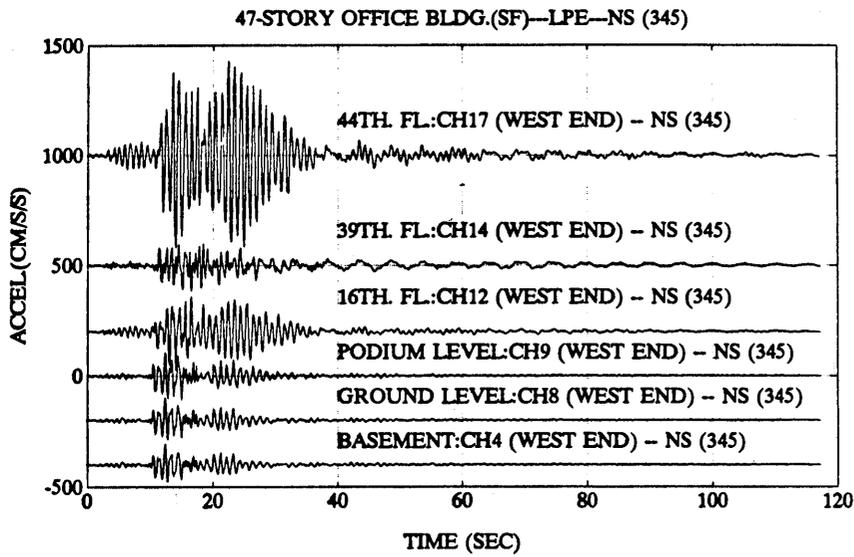
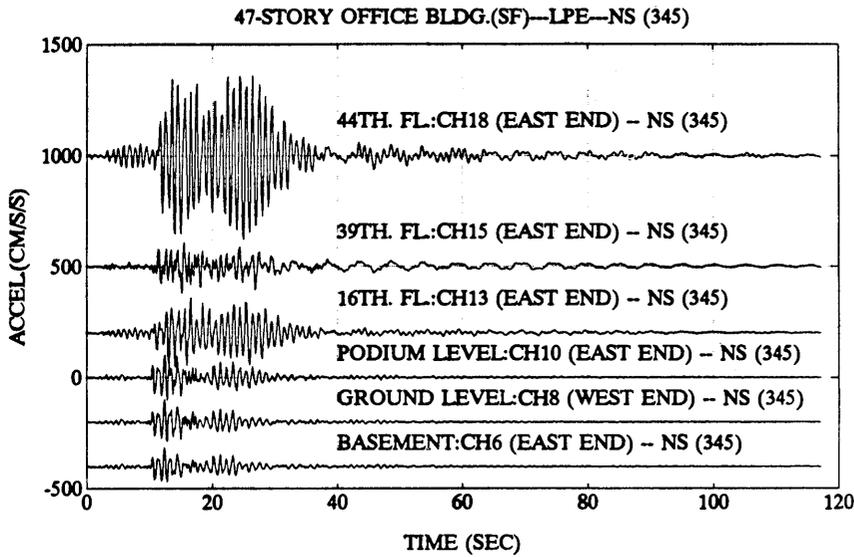
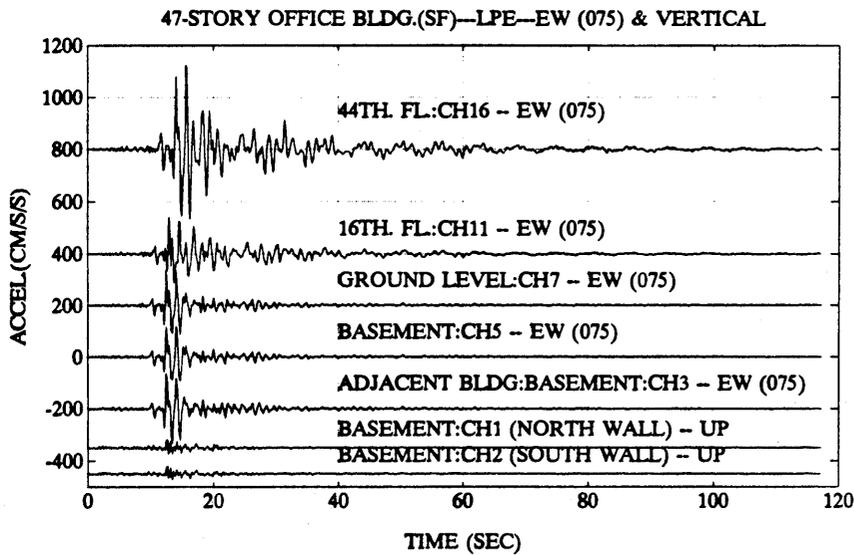
Figure 19.—Recorded accelerations. This data has been band-pass filtered with ramps at 0.07-0.14 Hz and 23-25 Hz (Shakal and others, 1989).

The processed 120 seconds of the recorded acceleration and the calculated displacements at different levels are shown in figures 19 and 20. This data has been band-pass filtered with ramps at 0.07-0.14 Hz and 23-25 Hz (Shakal and others, 1989). Peak accelerations and displacements are summarized in table 4. In figures 19 and 20 and in table 4, it is noted that the north-south peak responses (accelerations and displacements) at the 39th floor are

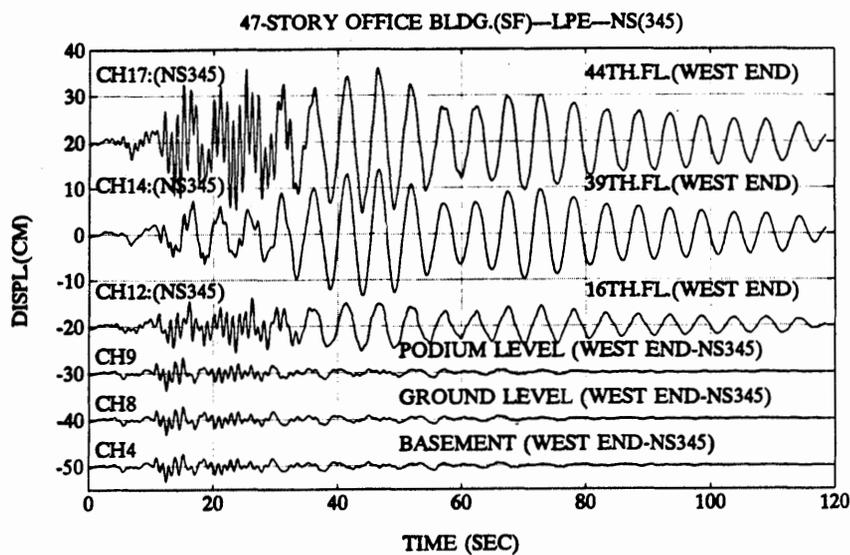
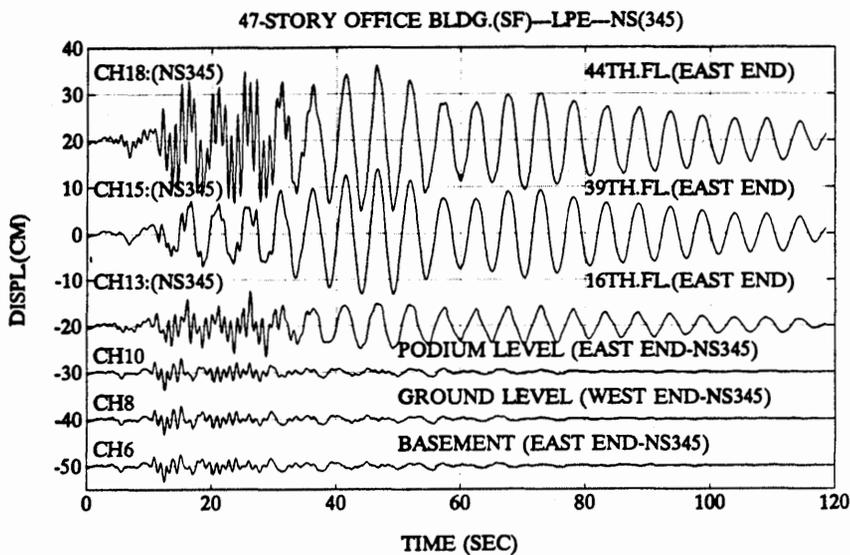
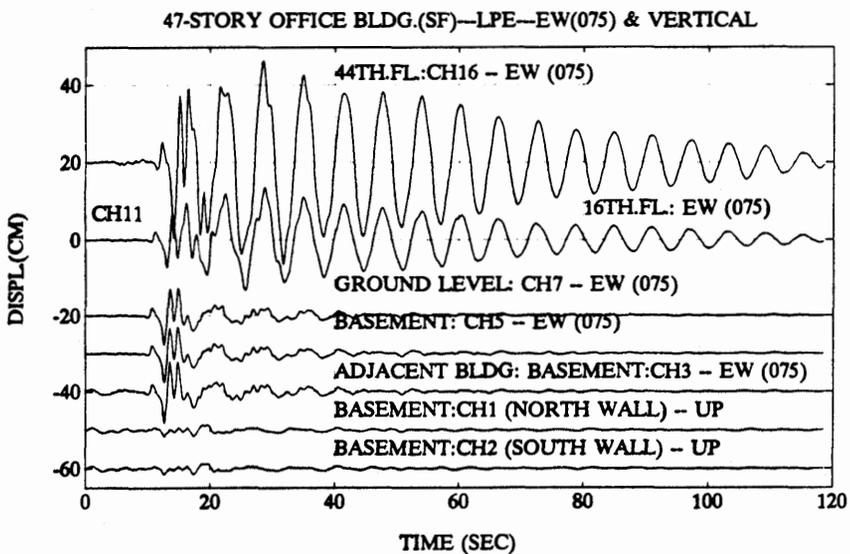
Figure 20.—Recorded displacements. This data has been band-pass filtered with ramps at 0.07-0.14 Hz and 23-25 Hz (Shakal and others, 1989).

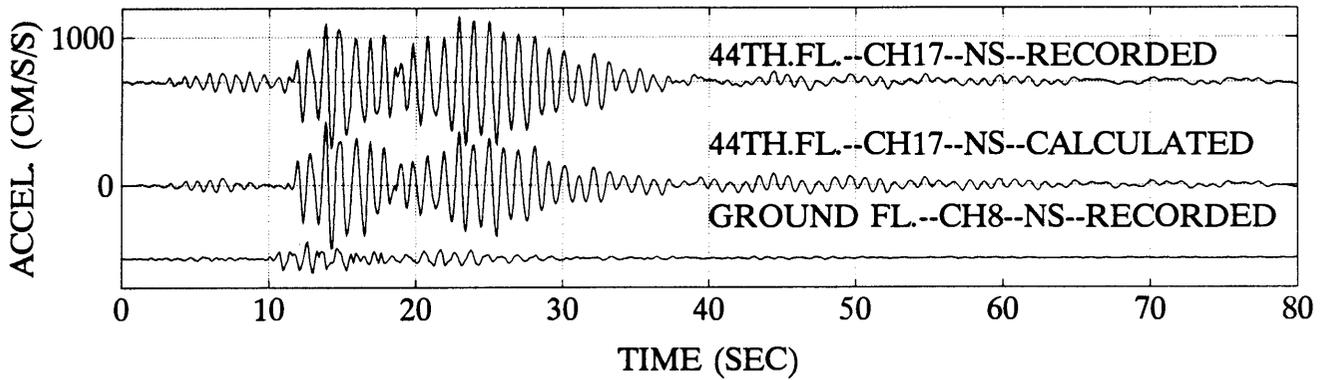
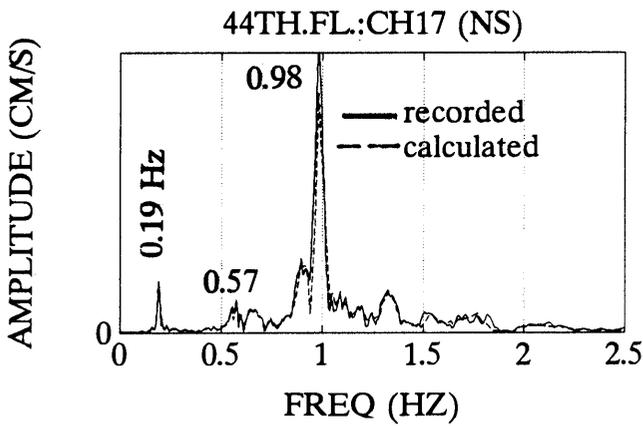
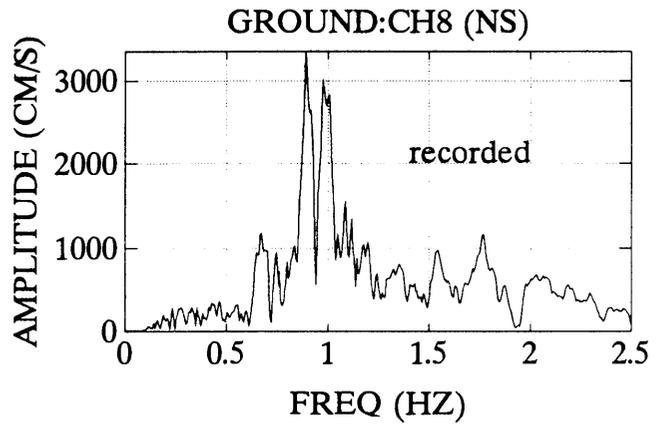
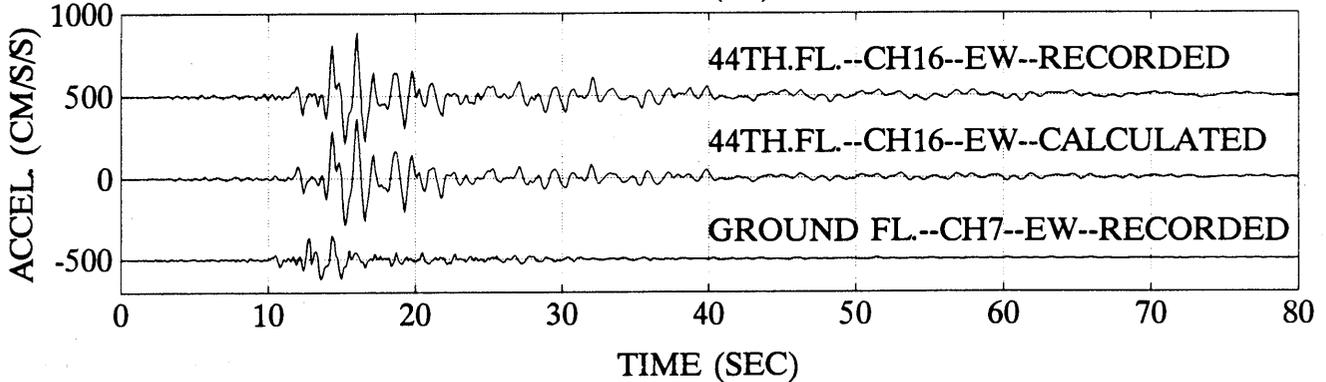
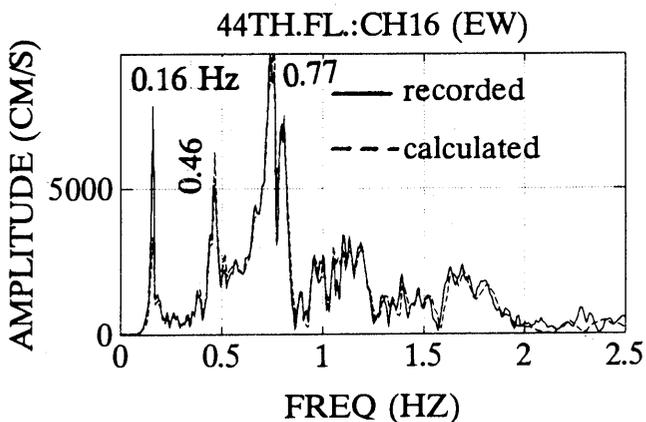
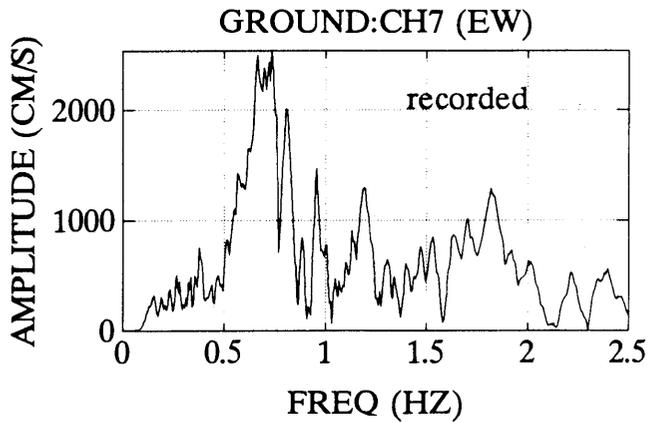
Figure 21.—System identification using ground-floor accelerations as input and 44th-floor accelerations as output for Embarcadero Building.

Figure 21 shows results of system-identification analysis, using 80 seconds of the recorded basement accelerations as input and the recorded 44th floor accelerations as output. Figure 22 shows the same, using displacements to obtain better identification at the lower frequencies. Both approaches exhibit excellent match between the calculated and observed outputs (Çelebi, 1993).

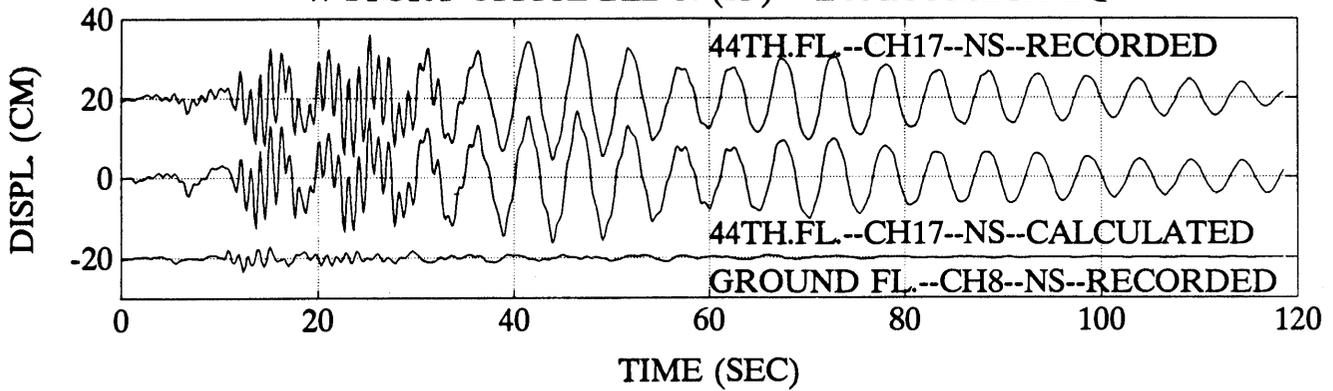
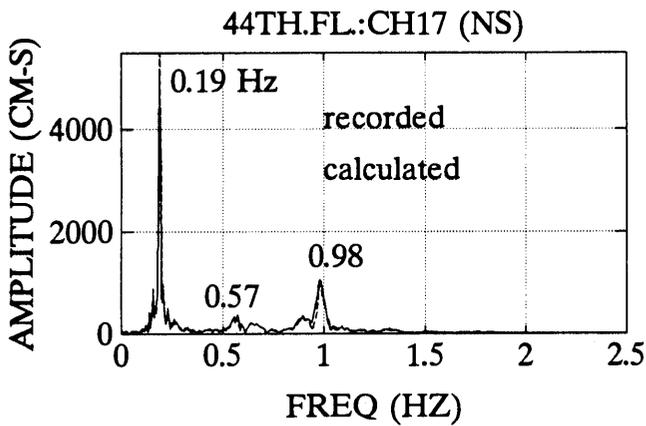
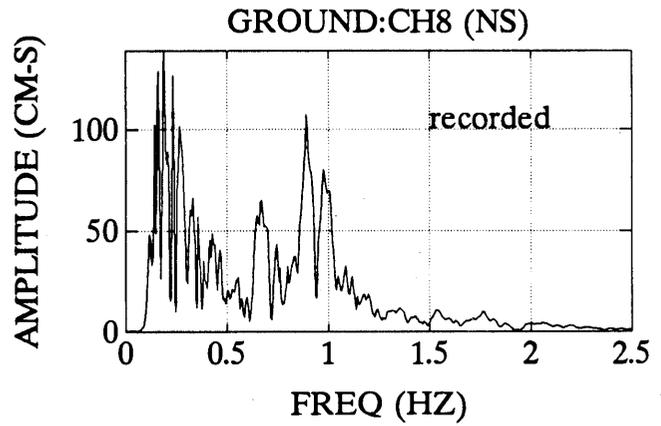
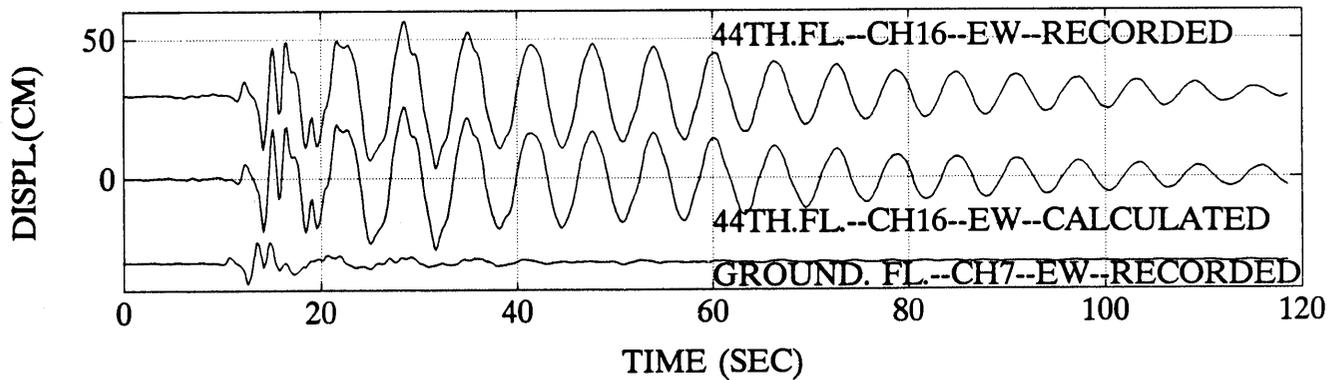
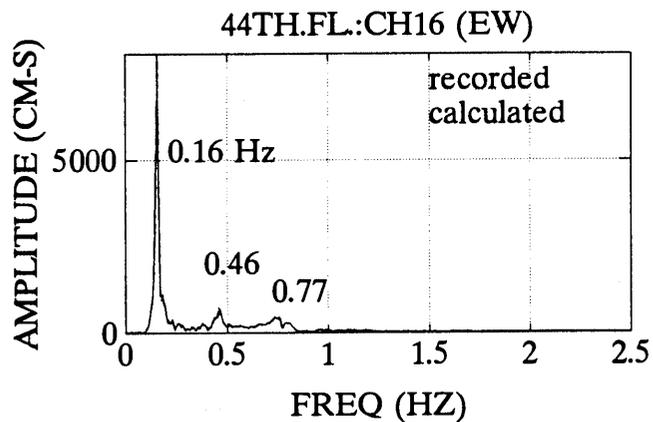
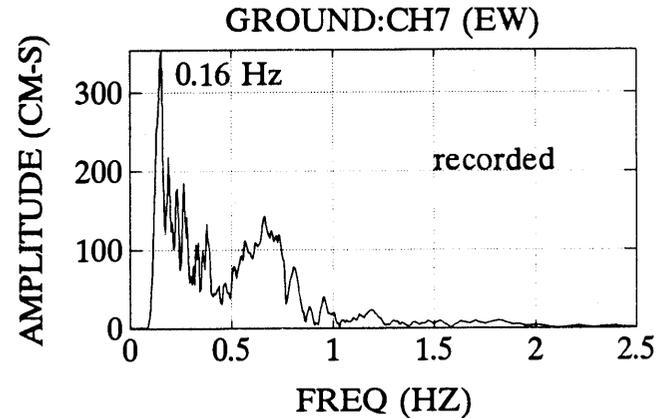
Figure 22.—System identification using ground-floor displacements as input and 44th-floor displacements as output for Embarcadero Building.

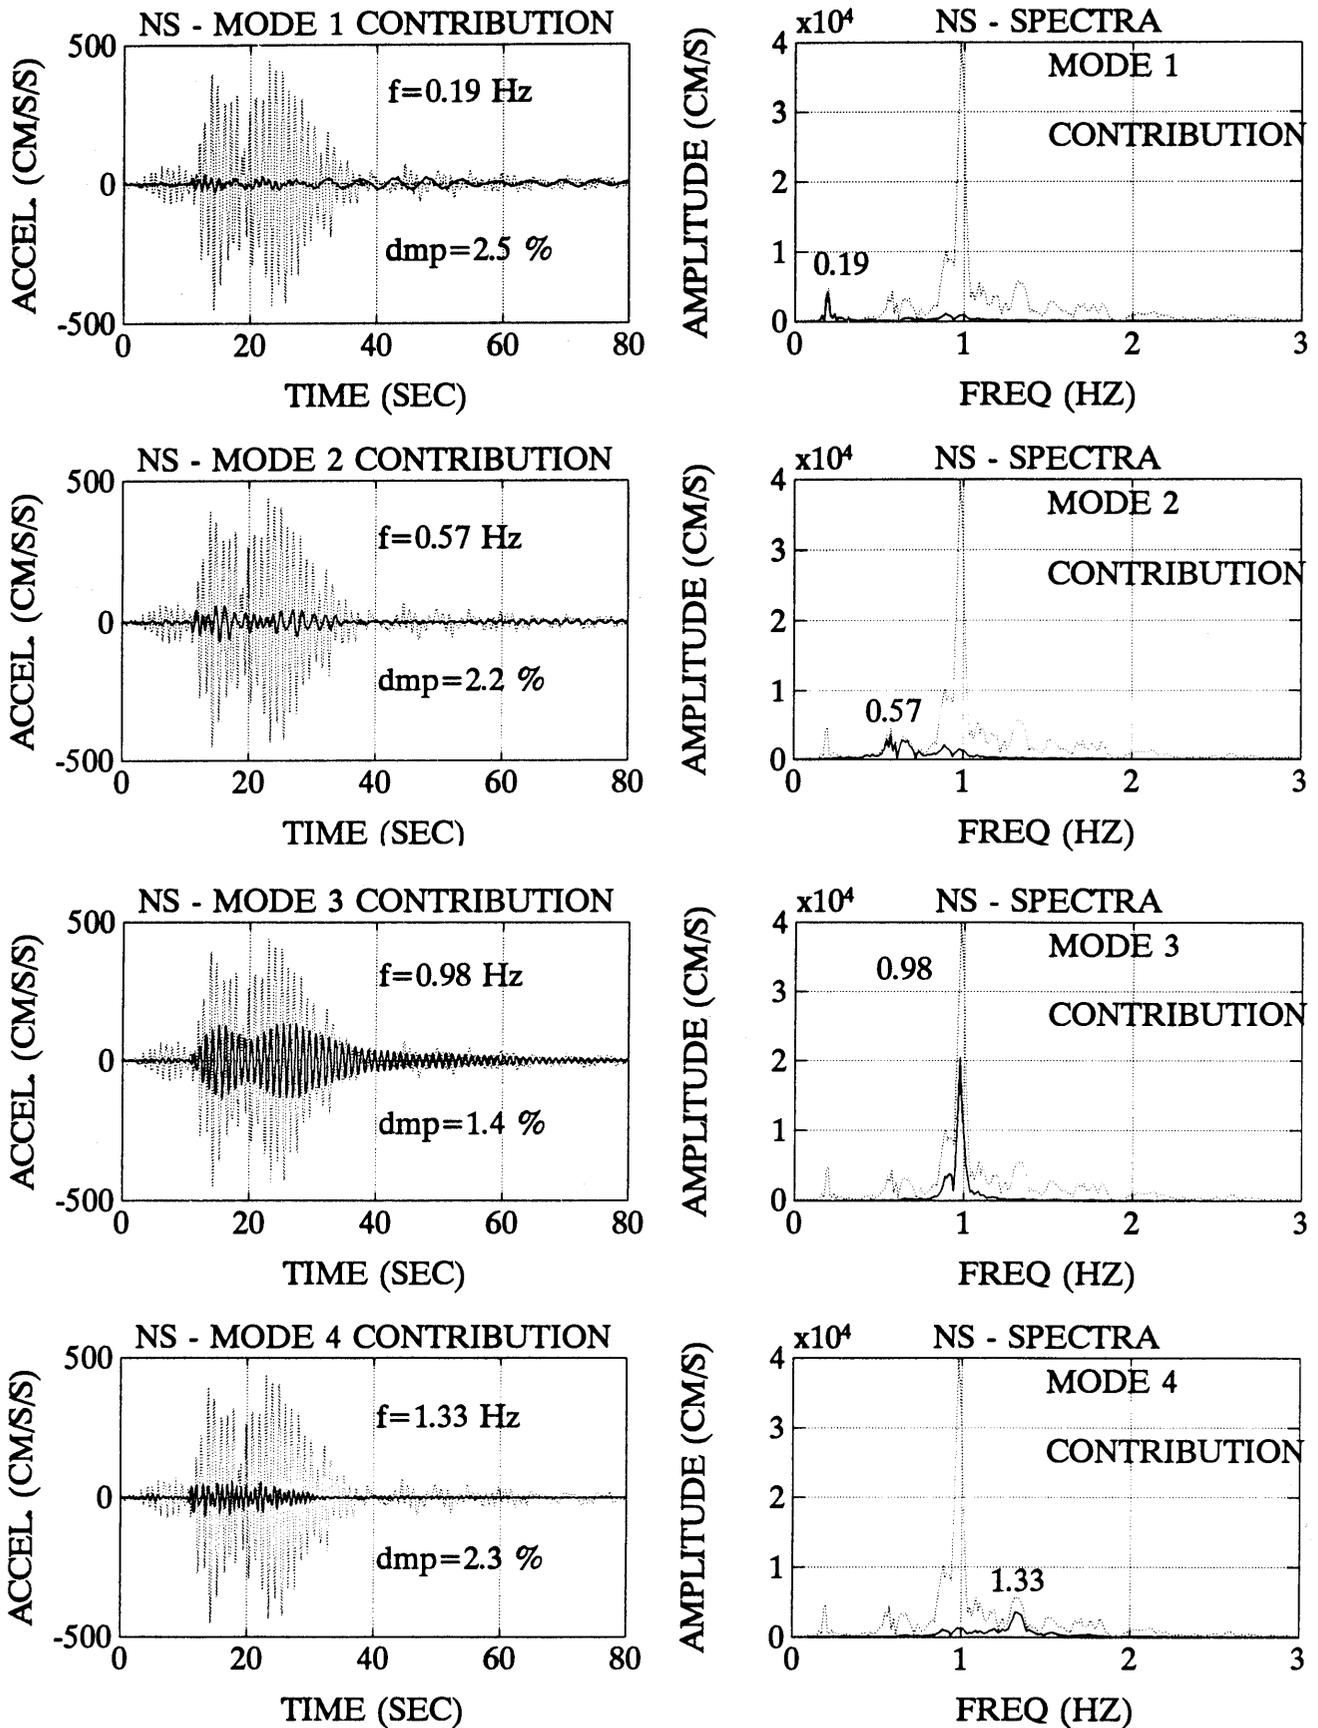
Figure 23.—Significant north-south modal accelerations (and their amplitude spectra) of the 44th-floor for Embarcadero Building extracted from system identification analysis and comparison with the total 44th-floor acceleration.

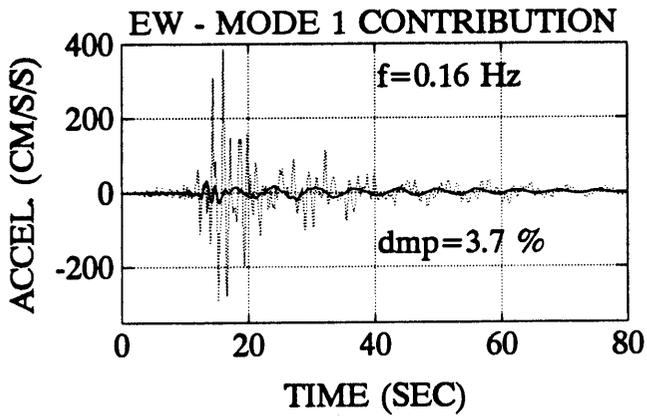
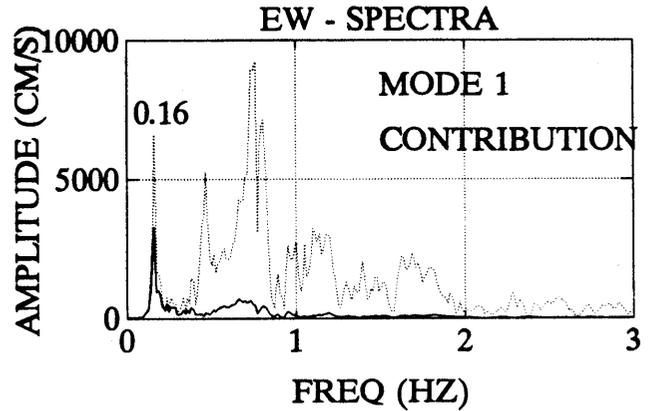
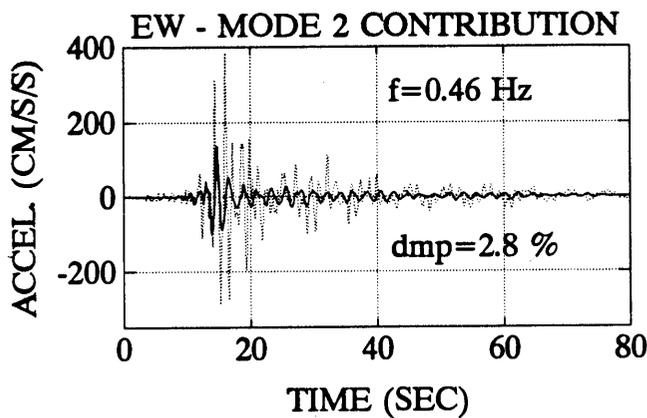
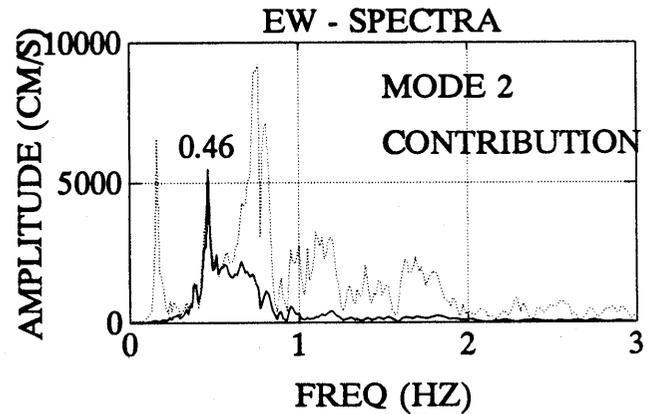
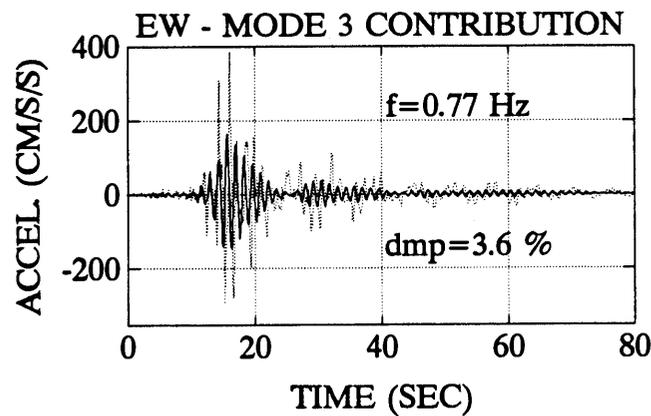
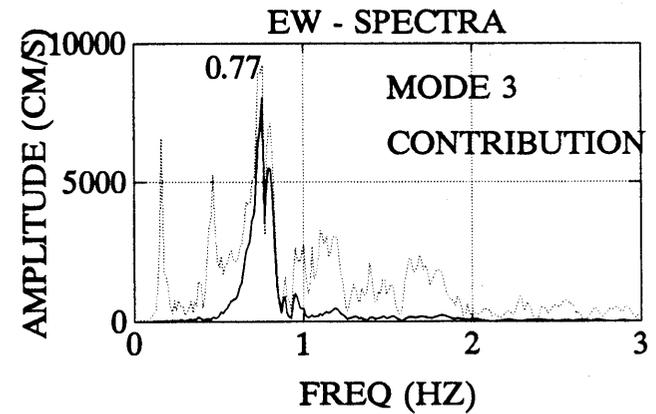
Figure 24.—Significant east-west modal accelerations (and their amplitude spectra) of the 44th-floor for Embarcadero Building extracted from system identification analysis and comparison with the total 44th-floor acceleration.

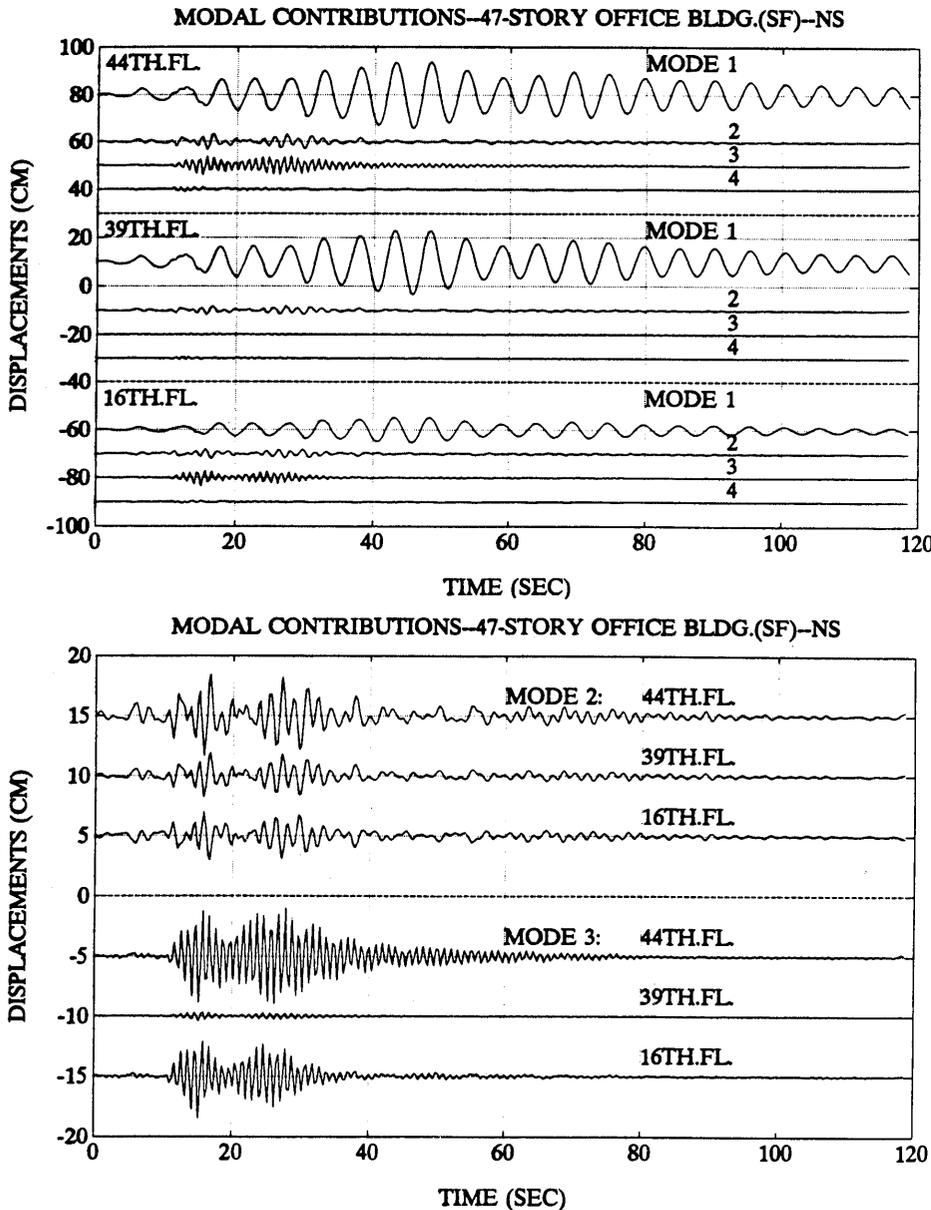
Figure 25.—Comparison of modal displacement contributions at the top three north-south instrumented floors for Embarcadero Building.

The extracted modal displacements at the top three north-south instrumented floors are grouped and plotted in figure 25. A separate system identification analysis is performed for each of the additional input-output pairs (39th and ground floor, and 16th and ground floor). This is done primarily to investigate why the 39th level north-south motions are smaller than those of the 16th floor. It is noted in figure 25 that the third-mode contribution to the 39th floor motions is much smaller than at the 44th or the 16th floor. On the other hand, while the second-mode contribution is comparable in amplitude for the 44th, 39th, and 16th floors, it is in phase between the 44th and the 39th floor, 180° out of phase between the 39th and 16th floors. This anomaly of reduced motions at the 39th floor may be directly attributable to the discontinuity of the stiffness at the 40th floor, causing (1) the 39th floor to behave as the upper nodal point of the third mode, (2) a whipping effect of the top floors, and/or (3) a resonating appendage effect of the floors above the 39th floor, where the bracing is discontinued and the plan of the floors gets smaller (in stiffness and mass). Whatever combination occurs, the main reason is the change in stiffness (Çelebi, 1993; Astaneh and others, 1991; Chen and others, 1992).
