The Loma Prieta, California, Earthquake of October 17, 1989—Building Structures

U.S. GEOLOGICAL SURVEY PROFESSIONAL PAPER 1552-C

BUILDING STRUCTURES

INTRODUCTION

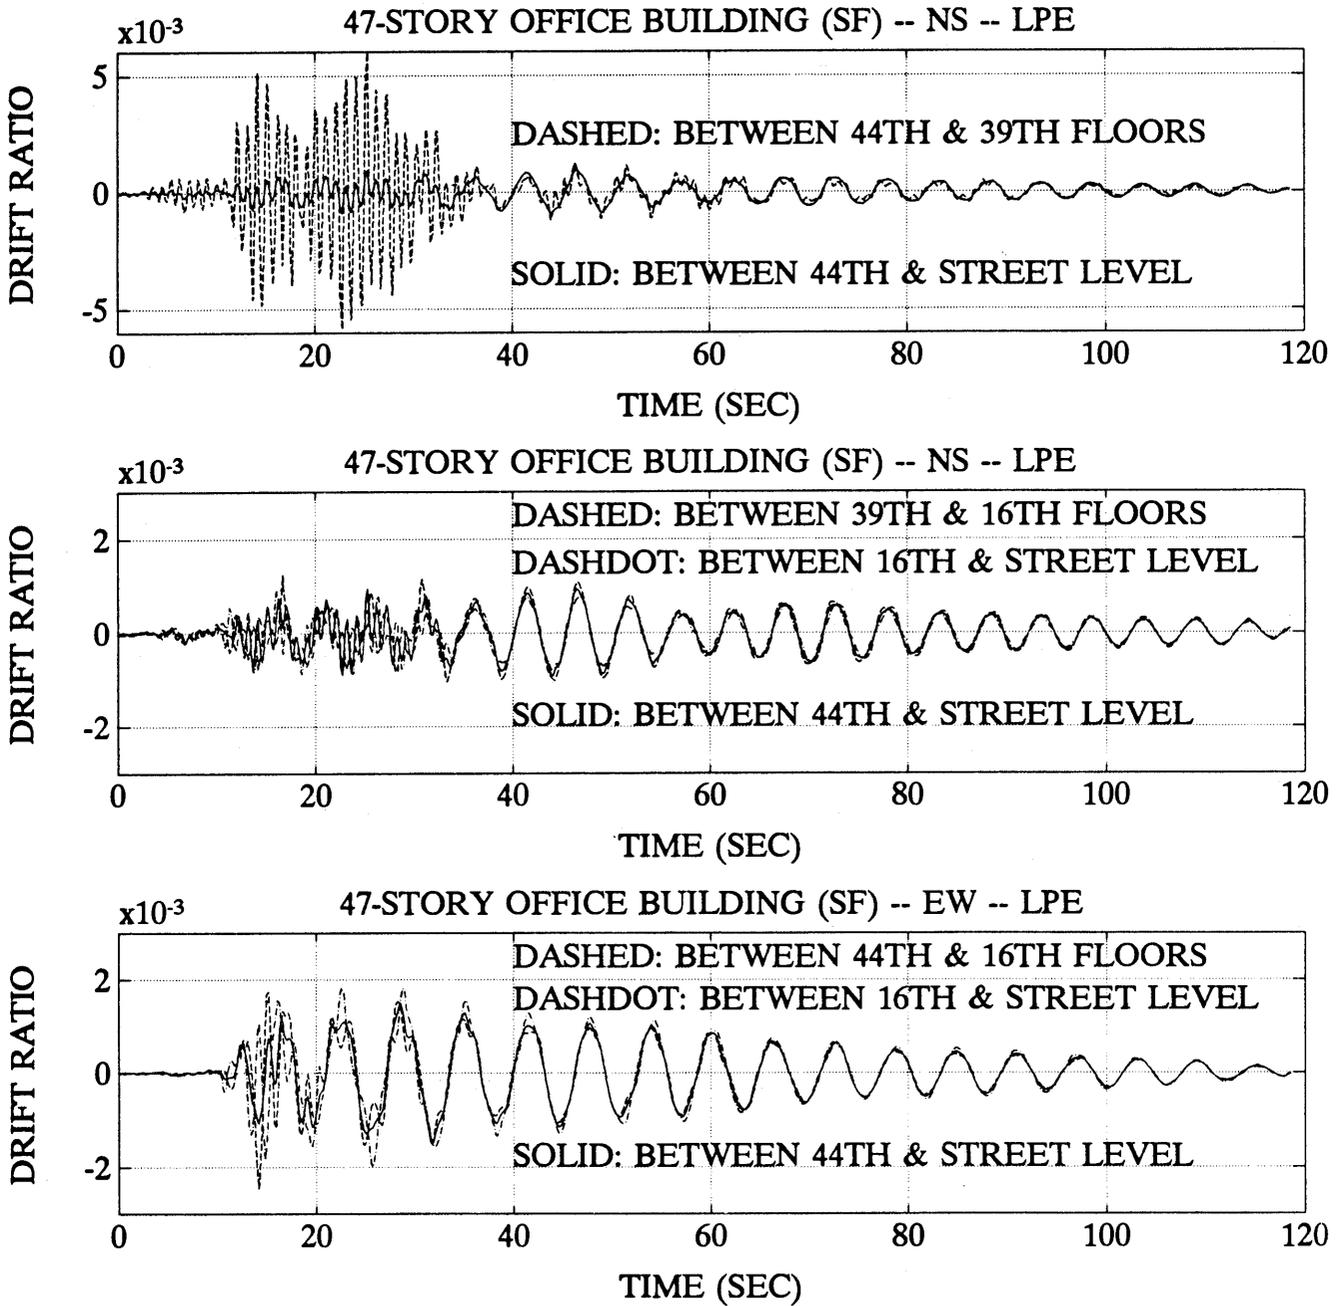
Figure 26.—Drift ratios for Embarcadero Building.

The explanations provided above are also related to discussions on drift. For the north-south direction, figure 26 shows superimposed drift ratio time-history between the 44th and 39th floors and between the 44th floor and street level. Figure 26 shows superimposed drift ratios between the 16th floor and street level, between the 39th and 16th floors, and between the 44th floor and street level. When average drift ratios between the 44th floor and street level are considered, the peak is approximately 0.0014 or less (28 percent of 1976 Uniform Building Code allowable). Average drift ratio exceeds the 0.005 allowable only between the 44th and 39th floors (with a peak of 0.006). This may be attributed to either the discontinuity of the eccentric bracing above the 40th floor or the whipping effect at the top floor, which cannot be confirmed since there are no sensors at the two consecutive top floors. Similarly, for the east-west direction, the superimposed drift ratio time-histories between the 16th floor and street level, between the 44th floor and the 16th floor, and between the 44th floor and street level are provided in figure 26. Since, in the east-west direction, there are no sensors on the 39th floor or the two top consecutive floors, it is not possible to determine whether the code-allowable drift ratio of 0.005 was exceeded. However, there appears to be a mostly consistent average drift ratio with a peak of less than 0.002 in this direction. Maximum drift ratio is 0.0023 between the 44th and 16th floors. Therefore, drift ratios on the average were about 40 percent (or less) of

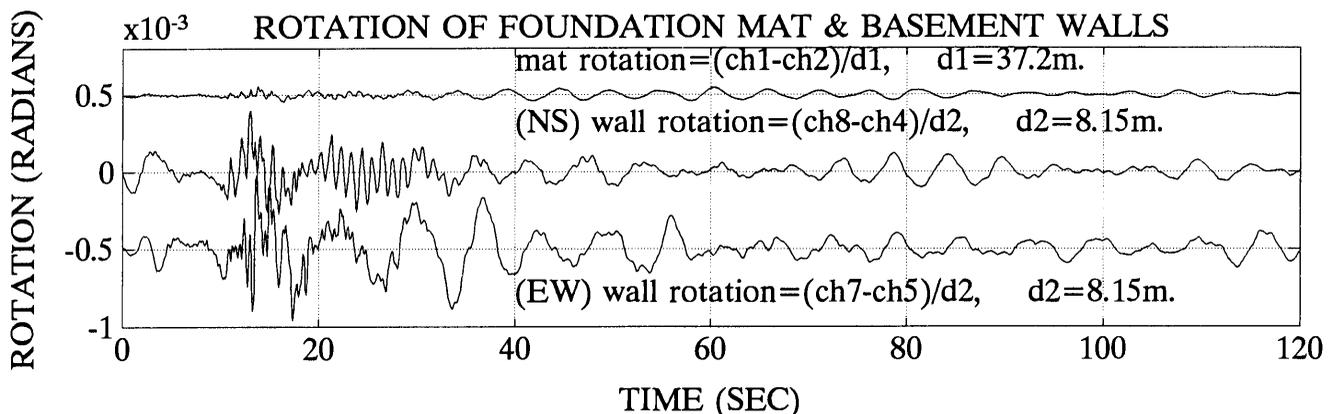
Figure 27.—Rotation of basemat compared to rotation of basement walls for Embarcadero Building.

In figure 27, rotation time-histories (calculated from displacement time-histories) of the mat as well as the basement walls are shown. The significance of this plot is that (1) the mat rotation has a peak value of 0.000057 radians (0.0033°) while the peaks of the wall rotations are (north-south) 0.0004 radians (0.023°) and (east-west) 0.00048 radians (0.028°), and (2) the frequencies of these rotations are the same as those of significant translational frequencies in respective directions, thus confirming the presence of structural frequencies in the basement motions. The anomaly here is that the rotations of the walls are 7-8 times larger than the rotations of the mat. Although there may be some numerical errors related to data processing, these ratios are too high to ignore. Similar magnitude peak rotations were observed from the response data of the nearby Transamerica Building (Çelebi and Şafak, 1991; Soydemir and Çelebi, 1992).

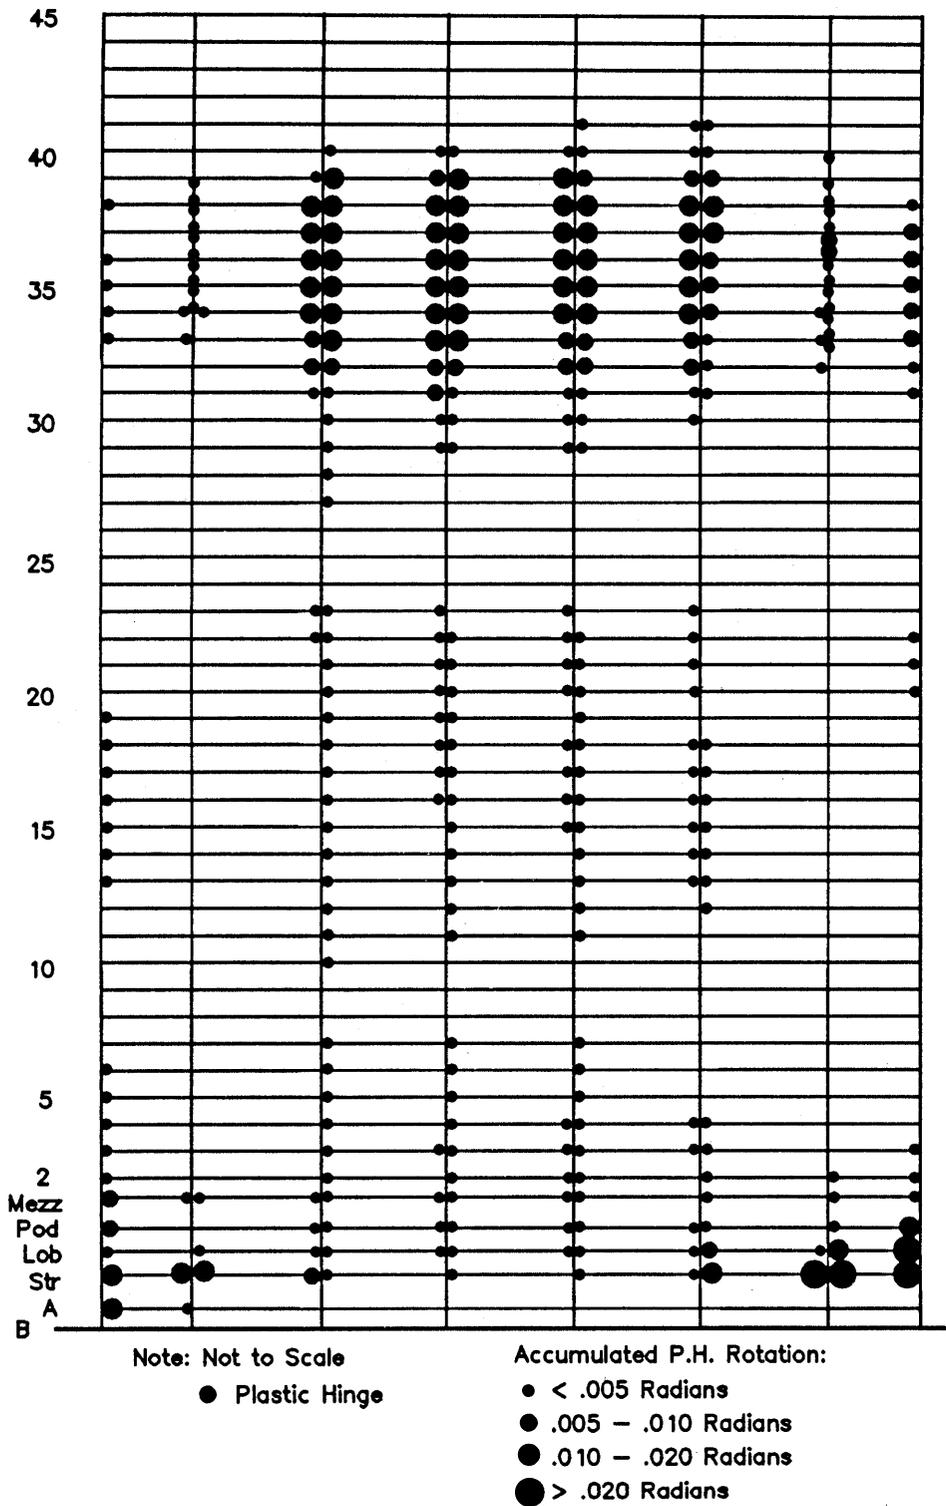
ENVELOPE OF PLASTIC HINGES — E-W FRAME
(2.75x LOMA PRIETA RECORD)

Figure 28.—Development of plastic hinges formed in the east-west frame modeled by Astaneh and others (1991) for 2.75 times the Loma Prieta earthquake motions (with permission of A. Astaneh).

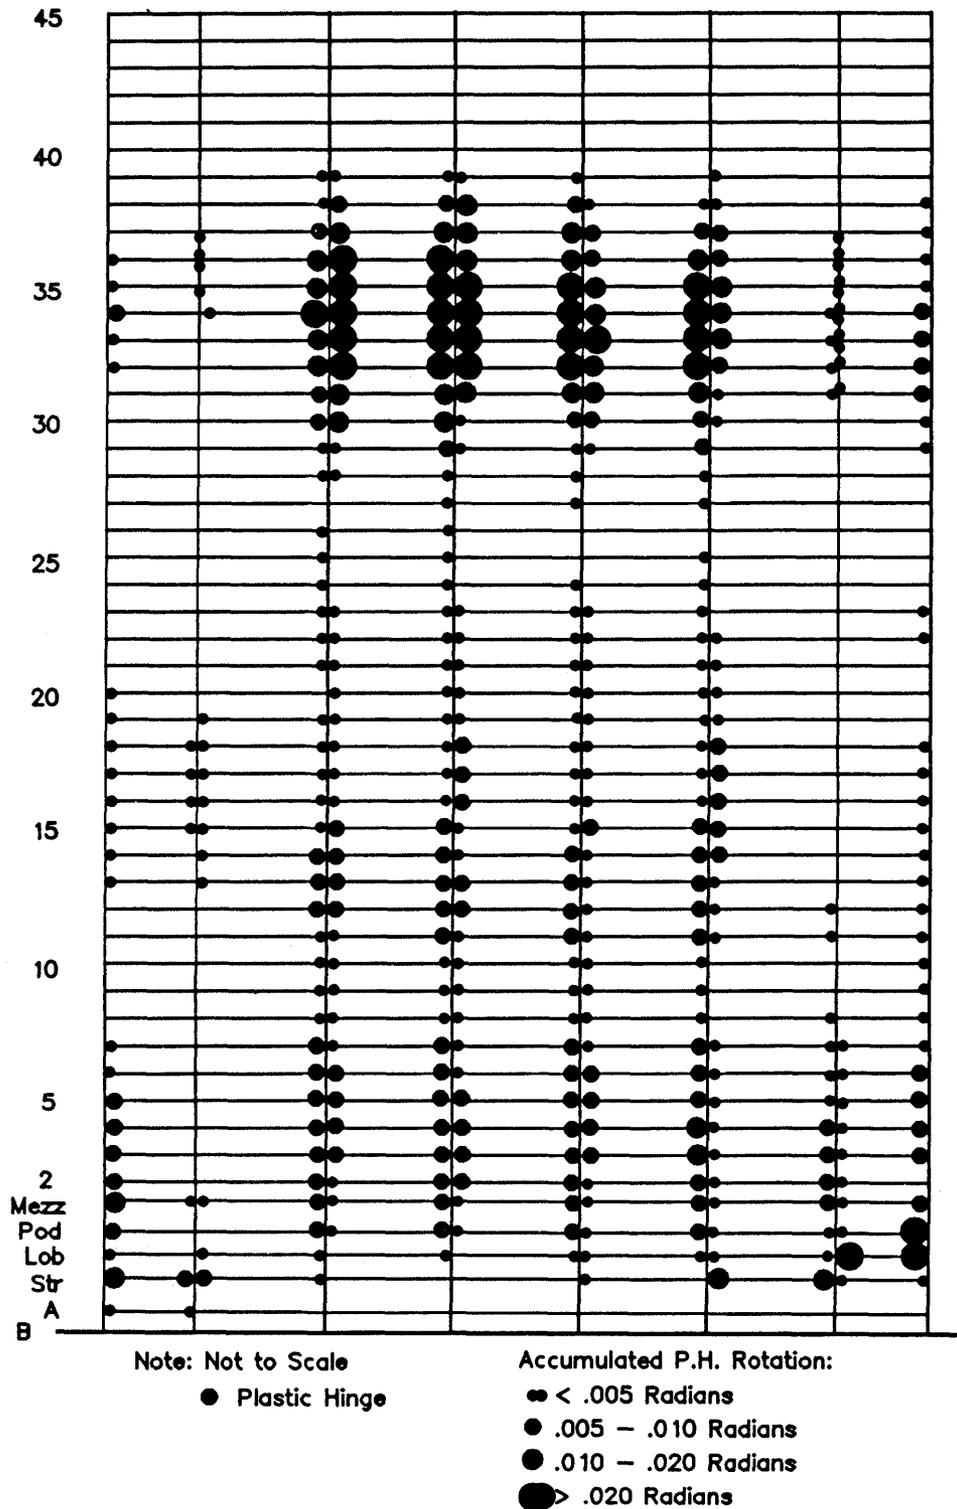
ENVELOPE OF PLASTIC HINGES - E-W FRAME
(SAN ANDREAS EVENT)

Figure 29.—Development of plastic hinges formed in the east-west frame modeled by Astaneh and others (1991) for a hypothetical M=8+ San Andreas event (with permission of A. Astaneh).

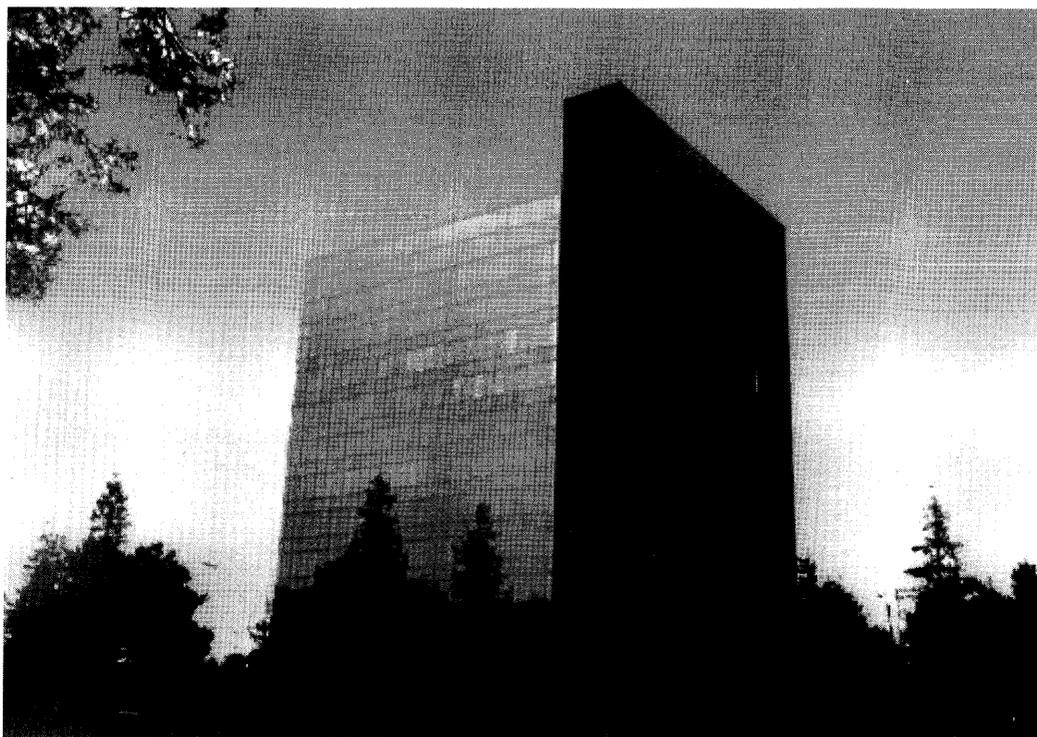
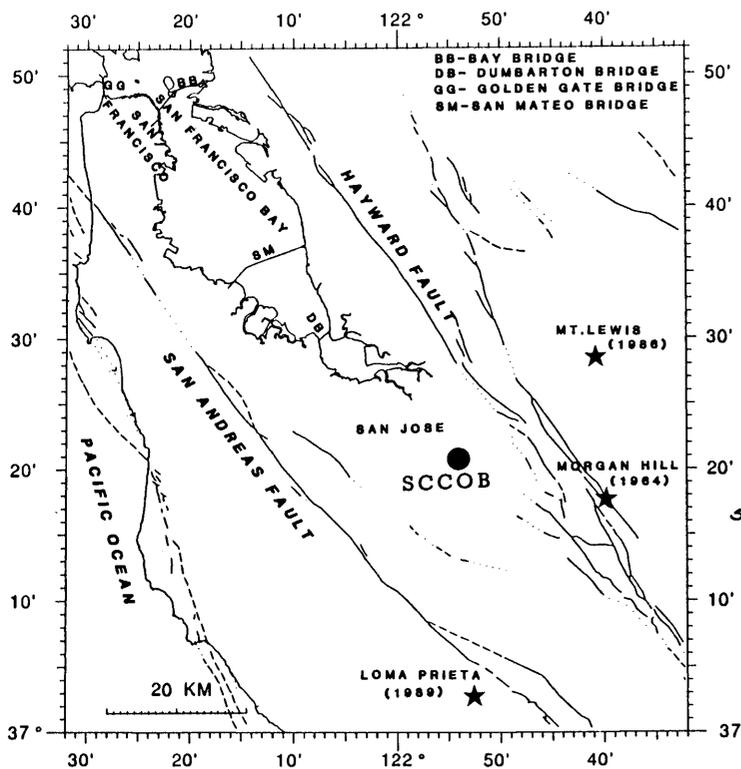
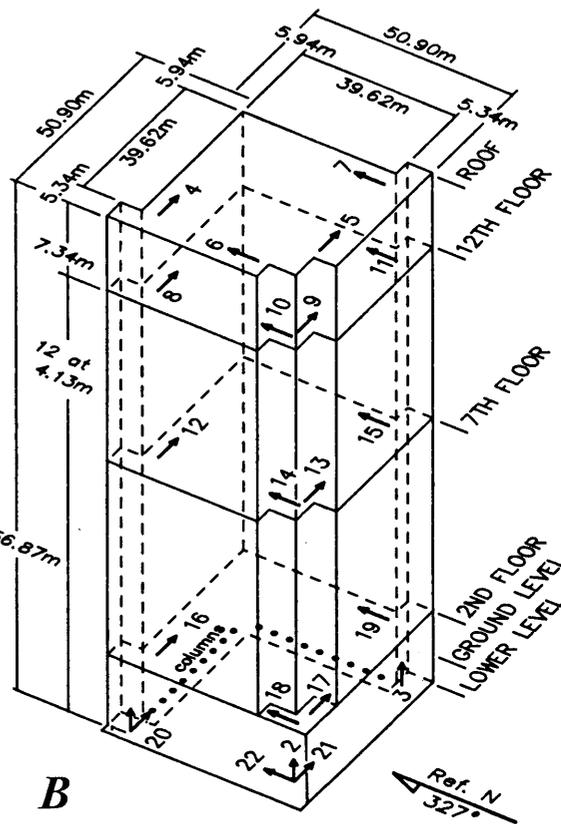
Figure 30.—A, Santa Clara County Office Building (SCCOB). B, Location of Santa Clara County Office Building, its overall dimensions and instrumentation, and epicenters of three nearby earthquakes.

A general view of the Santa Clara County Office Building is seen in figure 30A. The location of the building, the epicentral locations of the three earthquakes referred to above, and the instrumentation scheme are shown in figure 30B (Çelebi, 1994a). This 13-story, 56-m-tall, moment-resisting steel-framed building was built in 1975 according to the Uniform Building Code (1970). There are six column lines in each direction of the approximately 51×51m plan of the building.

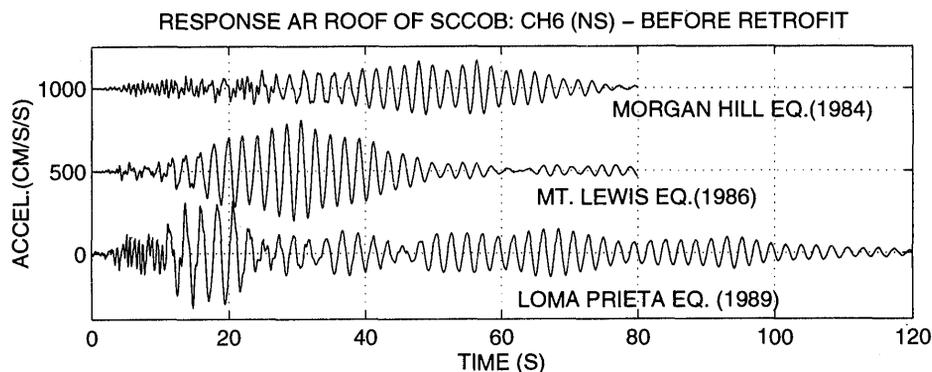
Figure 31.—Acceleration responses at the roof of Santa Clara County Office Building recorded during the Loma Prieta, Morgan Hill, and Mt. Lewis earthquakes.

Figure 31 shows acceleration responses at the roof recorded during the three earthquakes. The figure clearly indicates the long-duration and resonating responses of the structure and the beating effect observed in the responses. Figure 32 shows typical system identification analysis results (Çelebi, 1994a) for only Loma Prieta data. Peak accelerations at the roof and basement levels, the fundamental translational and torsional frequencies (and periods), and damping percentages extracted by system identification techniques (for all three earthquakes) are presented in table 6. The second and the third modes (at approximately 1.45 and 2.50 Hz) contribute very little to the overall response; therefore, the remainder of the discussion will be devoted to the fundamental modes only. The small differences between the periods determined from the three earthquake response data are noted. Since the structural characteristics of the building during the three earthquakes are very similar, only Loma Prieta is chosen to further characterize the structural response.

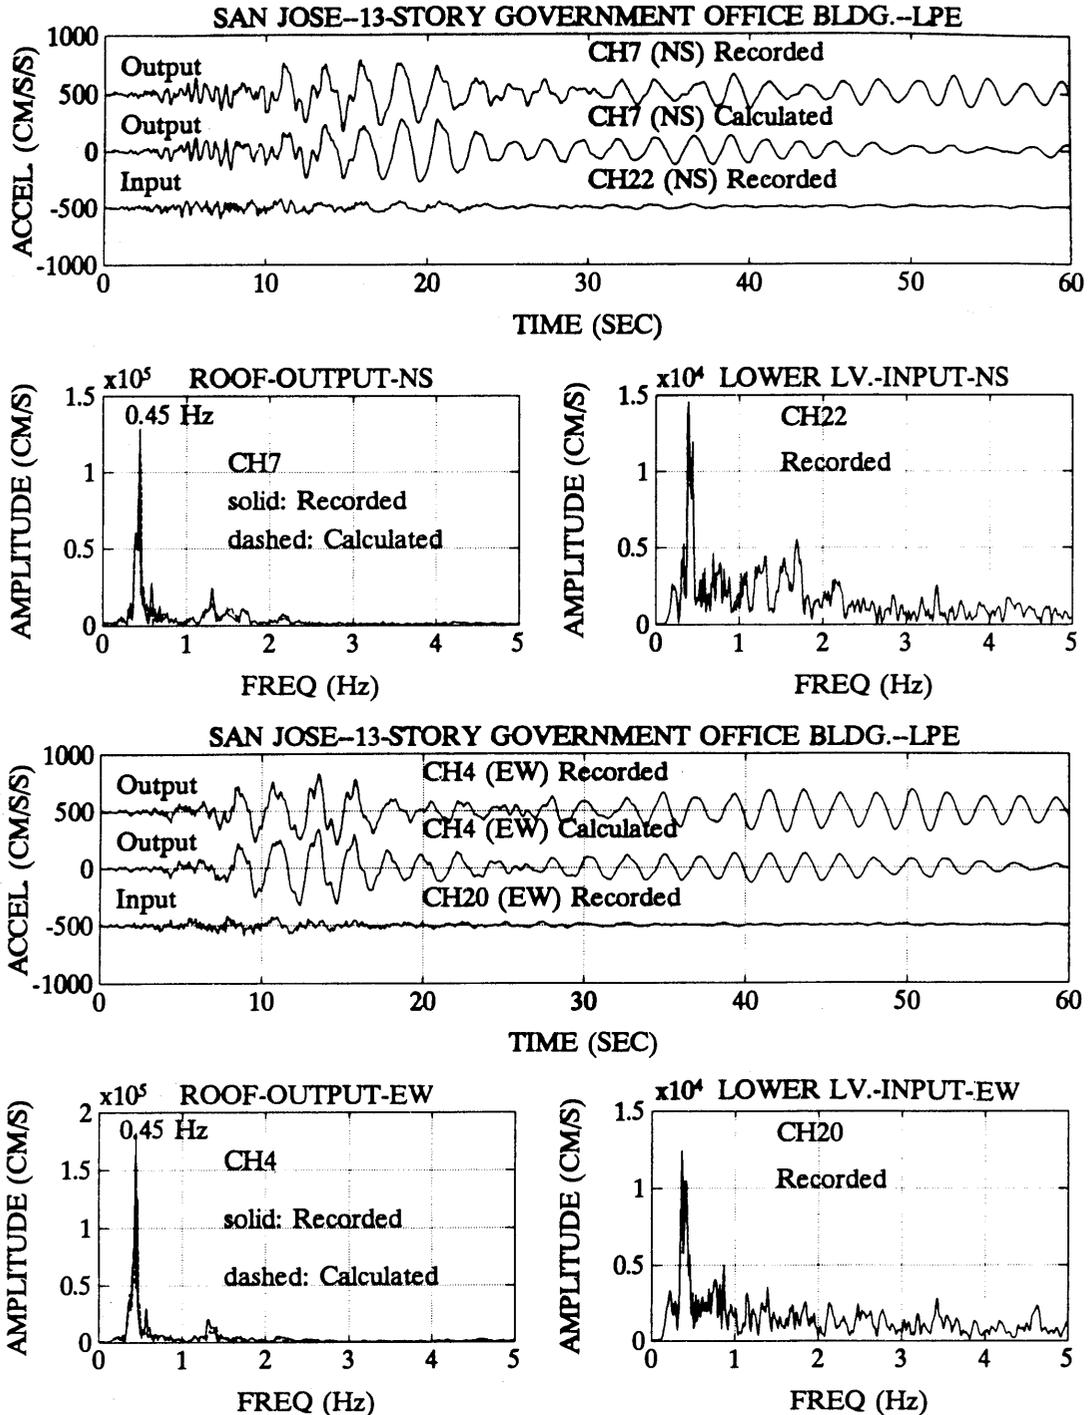
Figure 32.—Typical system identification analysis results of Santa Clara County Office Building for Loma Prieta data (Çelebi, 1994).

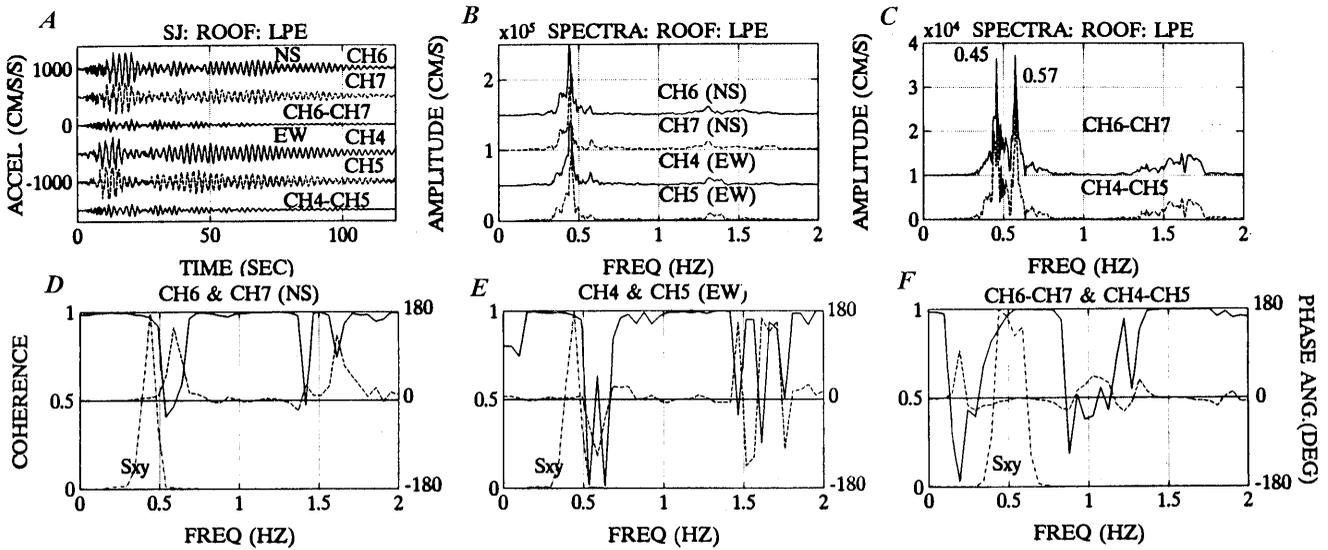
Figure 33.—A, Acceleration time histories of roof of Santa Clara County Office Building. B, C, Amplitude spectra. D, E, F, Coherence (solid line), phase angle (dashed line) plots with cross-spectra, S_{xy} , (dashed-dot line) superimposed to distinguish translational and torsional frequencies.

Figure 33A shows acceleration responses at the roof level, as well as the difference of parallel accelerations at the roof level (nominal torsional accelerations—actual tor-

sional accelerations can be calculated by dividing the nominal torsional accelerations by the distance between the two parallel sensors). Figure 33B shows the amplitude spectra of the unidirectional responses clearly peaking at the translational frequency (period) 0.45 Hz (2.22 s). Figure 33C shows amplitude spectra of the nominal torsional accelerations (calculated from parallel records in the north-south and east-west directions respectively) that peak at 0.57 Hz (1.69 s) and 0.45 Hz (2.22 s). Figures 33D and E show the coherence, phase angle, and normalized cross-spectra of the unidirectional response and confirm the translational frequency at 0.45 Hz. At this frequency, the motions are coherent and are in phase, clearly indicating that they are related. Figure 33F, on the other hand, confirms the torsional frequency at 0.57 Hz that were identified from the nominal torsional accelerations represented by the differential accelerations of two parallel sensors at a floor. There is unity coherence and the phase angle is zero at 0.57 Hz (Çelebi, 1994a). The proximity of the torsional frequency (period) at 0.57 Hz (1.69 s) to the translational frequency (period) at 0.45 Hz (2.2 s) causes the observed coupling and beating effect.

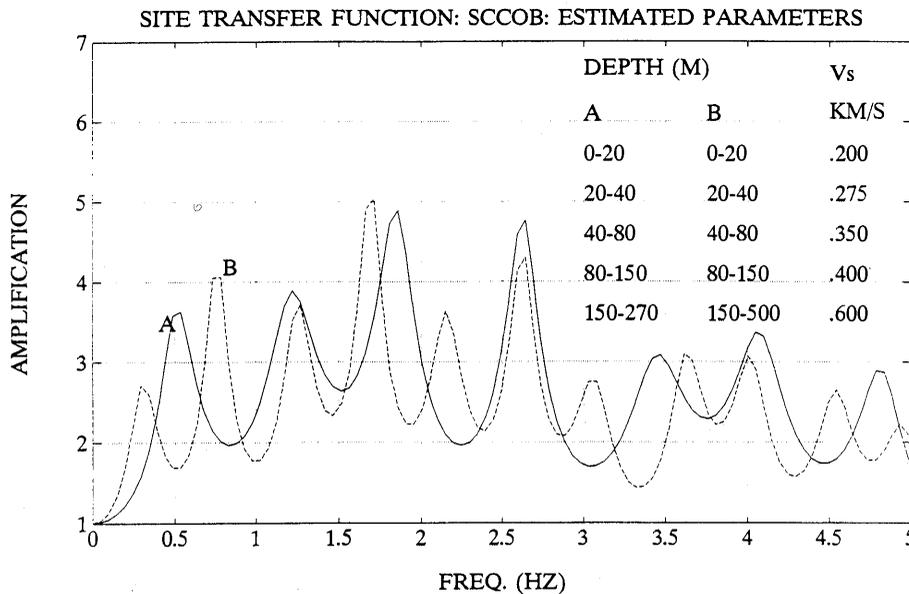
Figure 34.—Site transfer function for Santa Clara County Office Building.

The mat foundation of the building rests on alluvial site conditions. The depth to bedrock at the site is estimated to be between 270 m and 500 m. Figure 34 shows the site transfer function plots for two estimated depths to

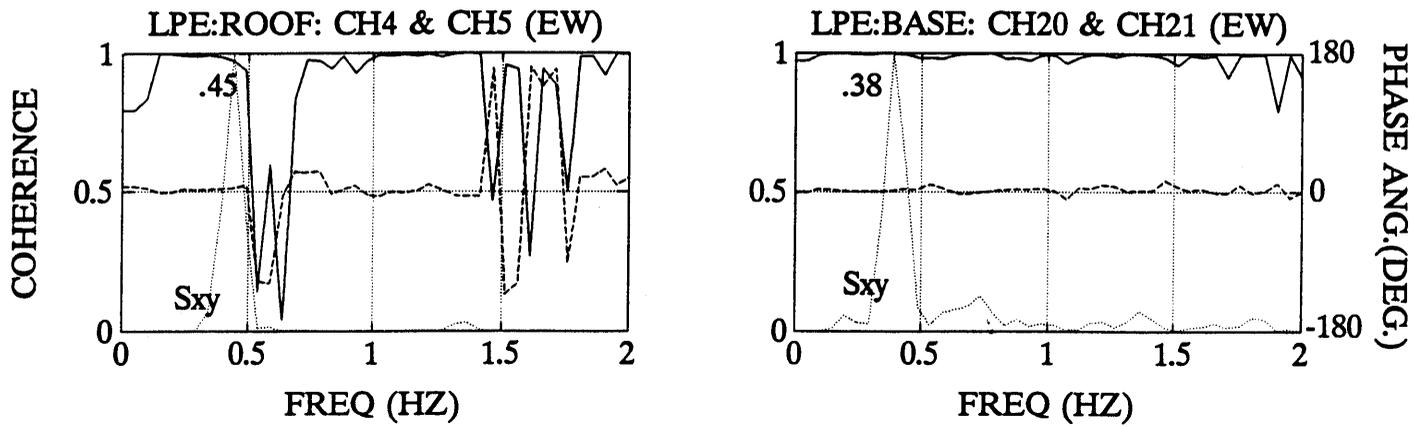
Figure 35.—Cross-spectra (dotted line), coherence (solid line), and phase angle (dashed line) plots for east-west motions at the roof and basement of Santa Clara County Office Building to distinguish structural and site frequencies.

Figure 35 shows the coherence, phase angle, and normalized cross-spectra for the roof and basement motions calculated only for the east-west direction, since at the basement the two parallel sensors are in this direction. The proximity of the site frequency at 0.33-0.38 Hz and the fundamental frequency at 0.45 Hz is the cause of the resonating (more or less steady-state surface wave) motions of the building. This is simply explained using the relationship for the amplification (A) of a damped system (in percent), with a frequency ratio (r) of ground to structure):

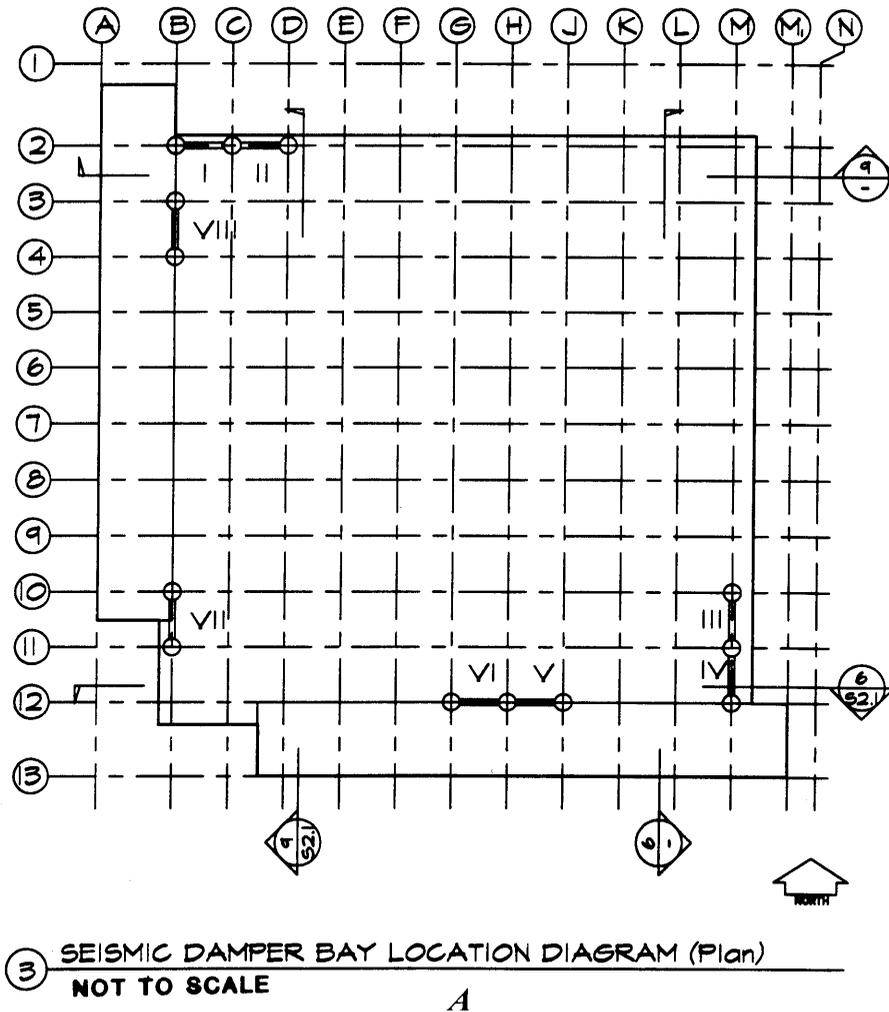
Figure 36.—A, Plan view of Santa Clara County Office Building. B, Vertical sections of building show bays where viscous elastic dampers have been installed for retrofitting the structural system to alter its dynamic behavior. C, Typical damper installed. (All figures courtesy of P. Crosby, The Crosby Group, Redwood City, Calif.)

In retrofitting the building, Crosby and others (1994) installed viscous elastic dampers in selective bays of the building. Figure 36A and B show the plan view and vertical sections. The bays of the framed structure where the dampers were installed are indicated in the figures. Figure 36C shows a typical viscous elastic damper (Crosby and others, 1994). Çelebi and Liu (1997) performed ambient tests of the building following the retrofit; preliminary results show that for low-amplitude excitation, the dampers produce small changes in the dynamic characteristics but are expected to alter the dynamic behavior significantly during strong shaking. Before the retrofit, Marshall and others (1991) and Çelebi (1996) observed significant differences in the dynamic characteristics of the building for strong- and low-amplitude shaking. This is discussed later in this paper.

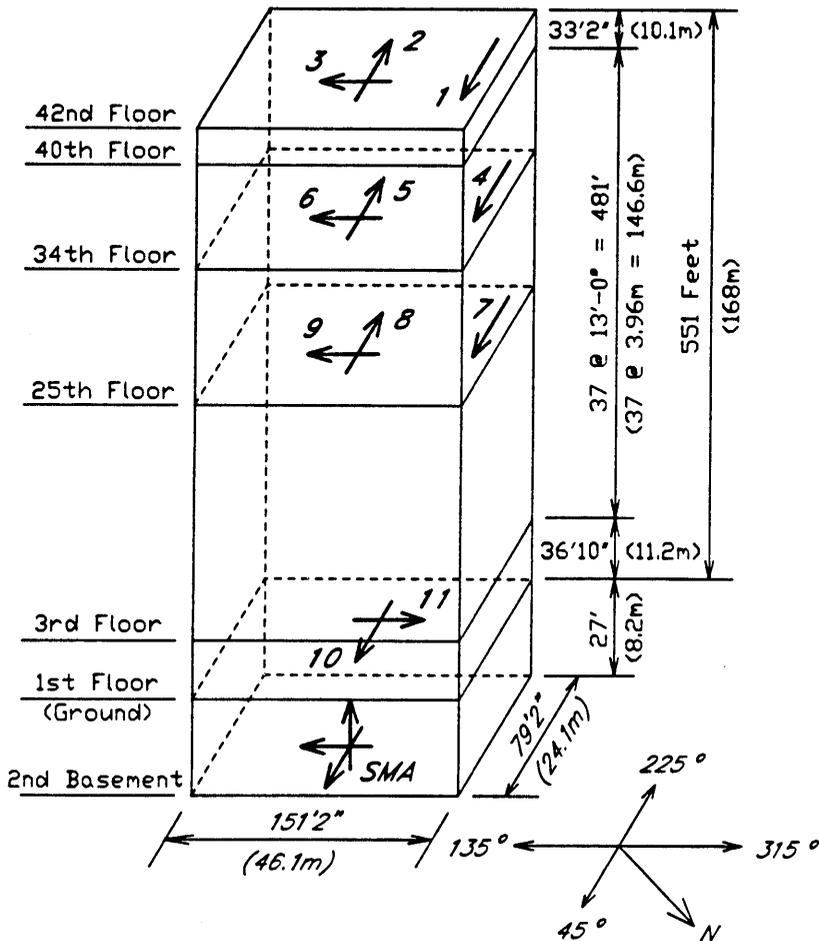
Figure 37.—General three-dimensional view and instrumentation scheme of Chevron Building, San Francisco.

The 42-story Chevron Building at 575 Market St. is a steel, moment-resisting framed, slender, rectangular in-plan building. It has two levels of basements and is built on 10-m-long precast pile clusters. A three-dimensional schematic of the building and its instrumentation scheme is shown in figure 37 (Çelebi, 1992). Recorded accelerations at different levels of the building and corresponding displacements are shown in figure 38. System identification analyses results are shown in figure 39.

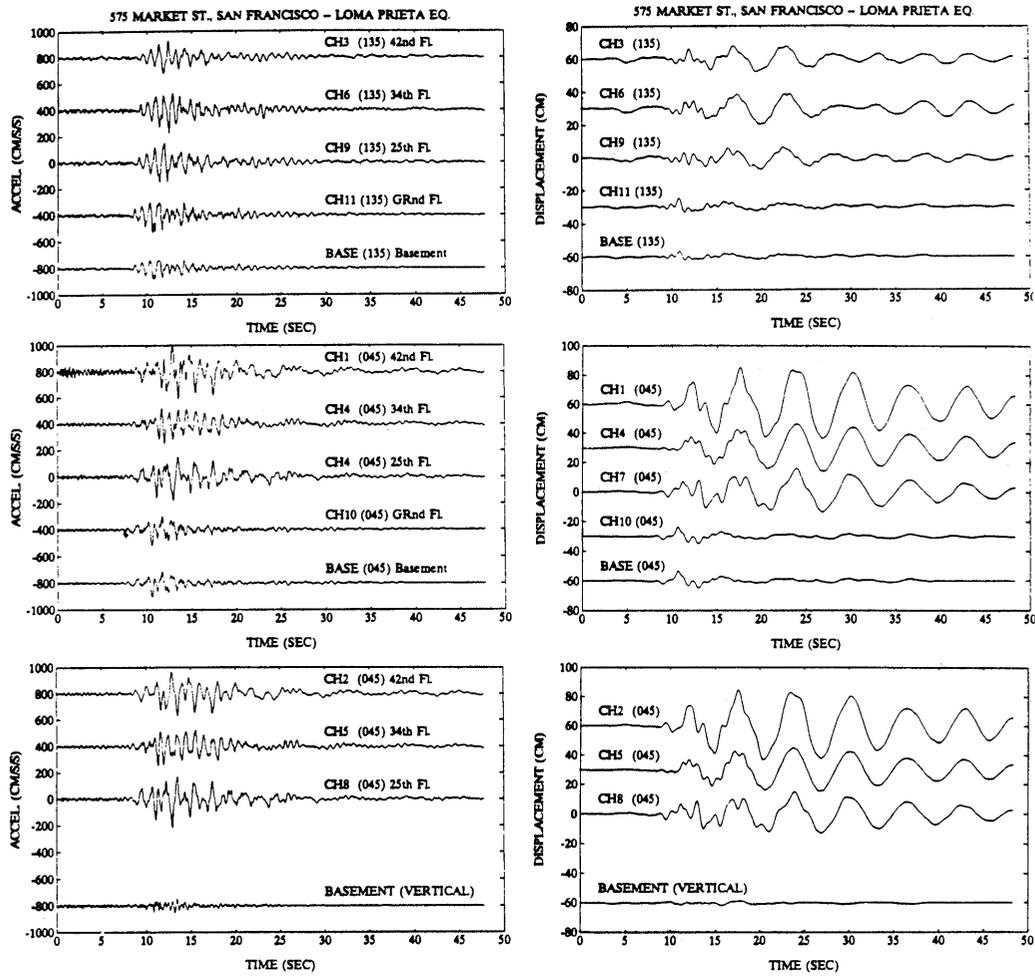
Figure 38.—Acceleration and displacement time-histories of Chevron Building.

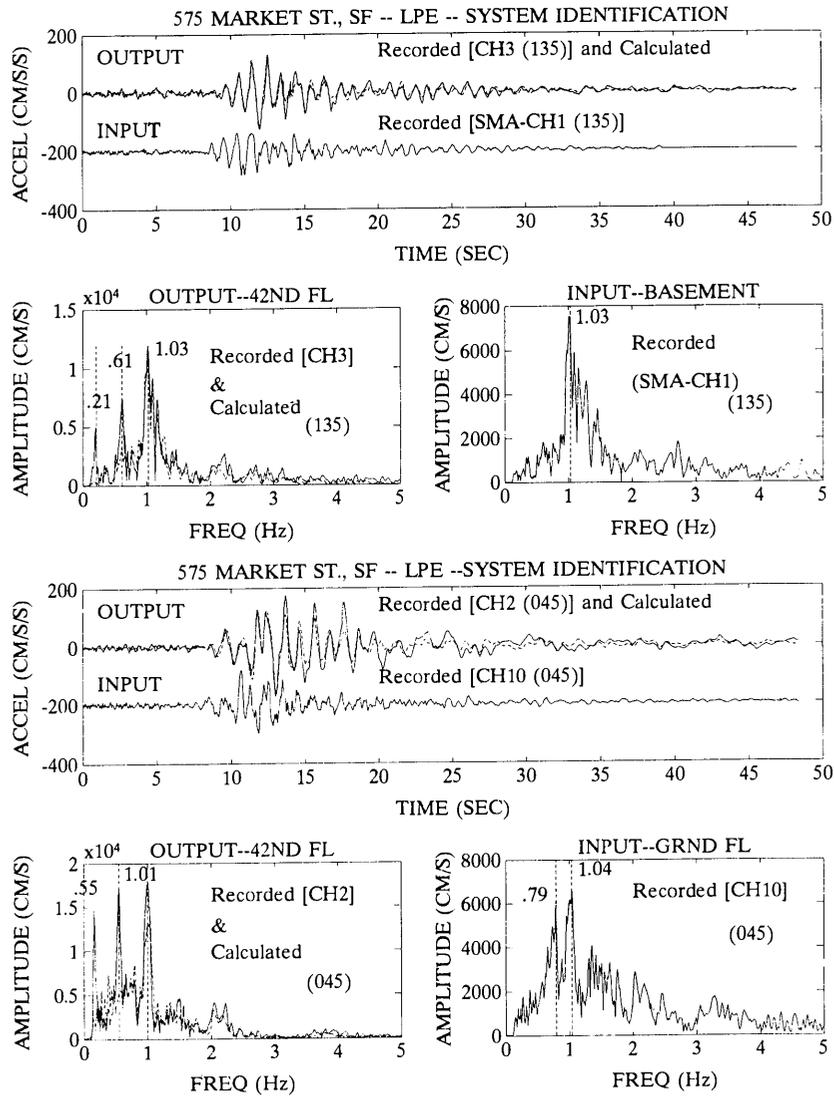
Figure 39.—System identification for Chevron Building.

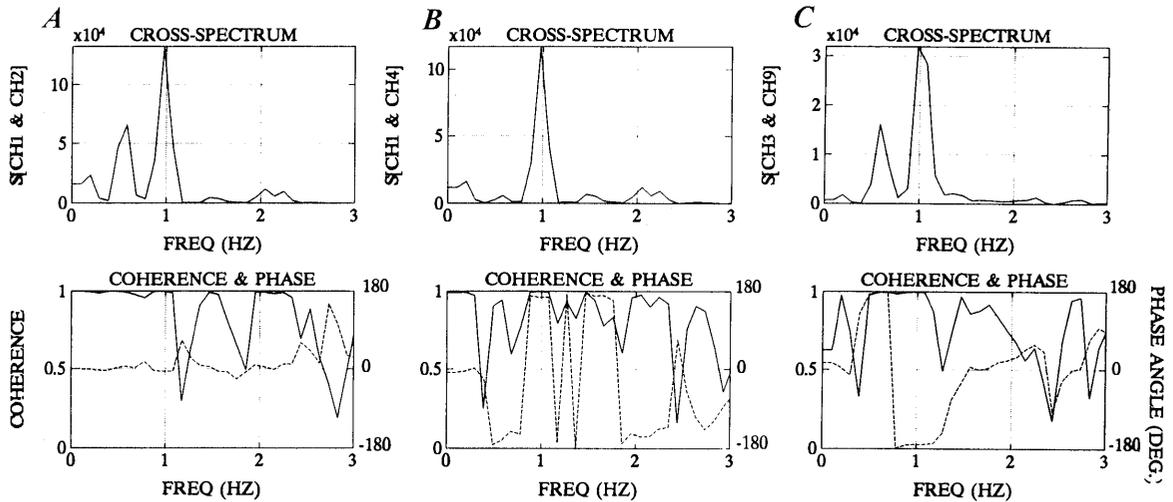
Figure 40.—Cross-spectrum, coherence, and phase angle plots for (A) parallel (225°) motions at 42d floor, (B) parallel (225°) motions at 42d and 34th floors, and (C) parallel (135°) motions at 42d and 34th floors.

Identified first-mode frequencies (periods) are 0.16 Hz (6.25 s) in the 225° direction and 0.21 Hz (4.76 s) in the 135° direction. Figure 40 shows coherency and phase-angle plots for (1) two parallel 225°-oriented motions (horizontal plane) at the roof, (2) two parallel 225° motions (in the vertical plane), and (3) two parallel 135° motions (also in the vertical plane) of the building. From these plots, we conclude that (1) torsion is insignificant since the motions in the horizontal plane at the roof are in

phase and coherent, (2) 0.55 Hz and 1.0 Hz in the 225° direction are the second and third modal frequencies since the phase angles are 180° and -180° out of phase, and (3) similarly for the 135° direction, 0.61 Hz and 1 Hz are the second and third modal frequencies. The recorded peak accelerations and extracted frequencies (periods) and damping percentages are summarized in table 7 (Çelebi, 1992).

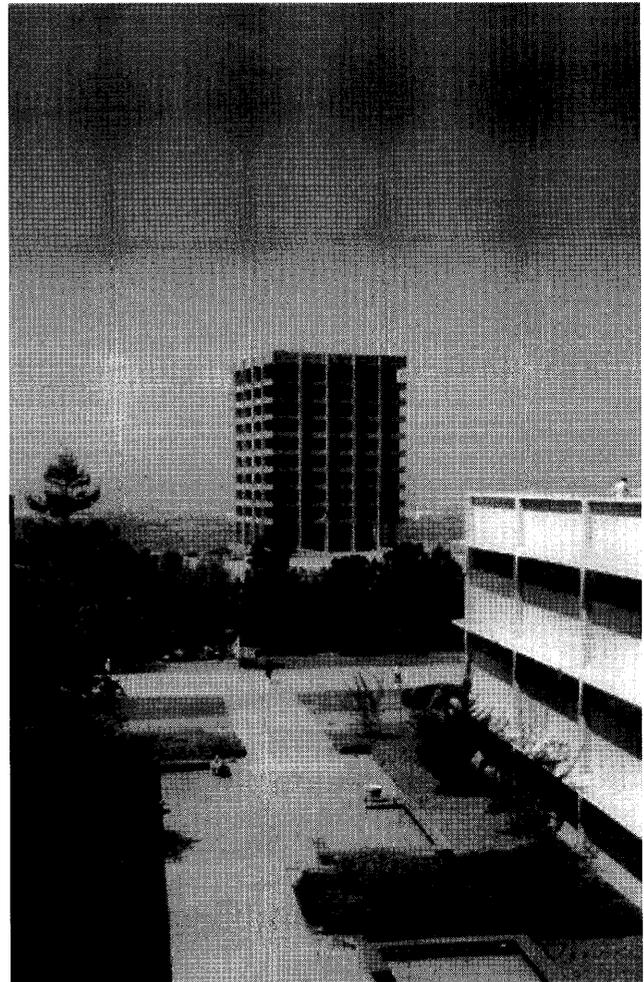
A

Figure 41.—A, California State University (Hayward) Administration Building. B, Three-dimensional schematic of building

Channels 2, 7, and 10 (parallel sensors in the north-south direction at the roof, 2d, and 1st floors, respectively) (fig. 41B) malfunctioned during the earthquake (Shakal and others, 1989); therefore, identification of torsional motions of the structure cannot readily be made.

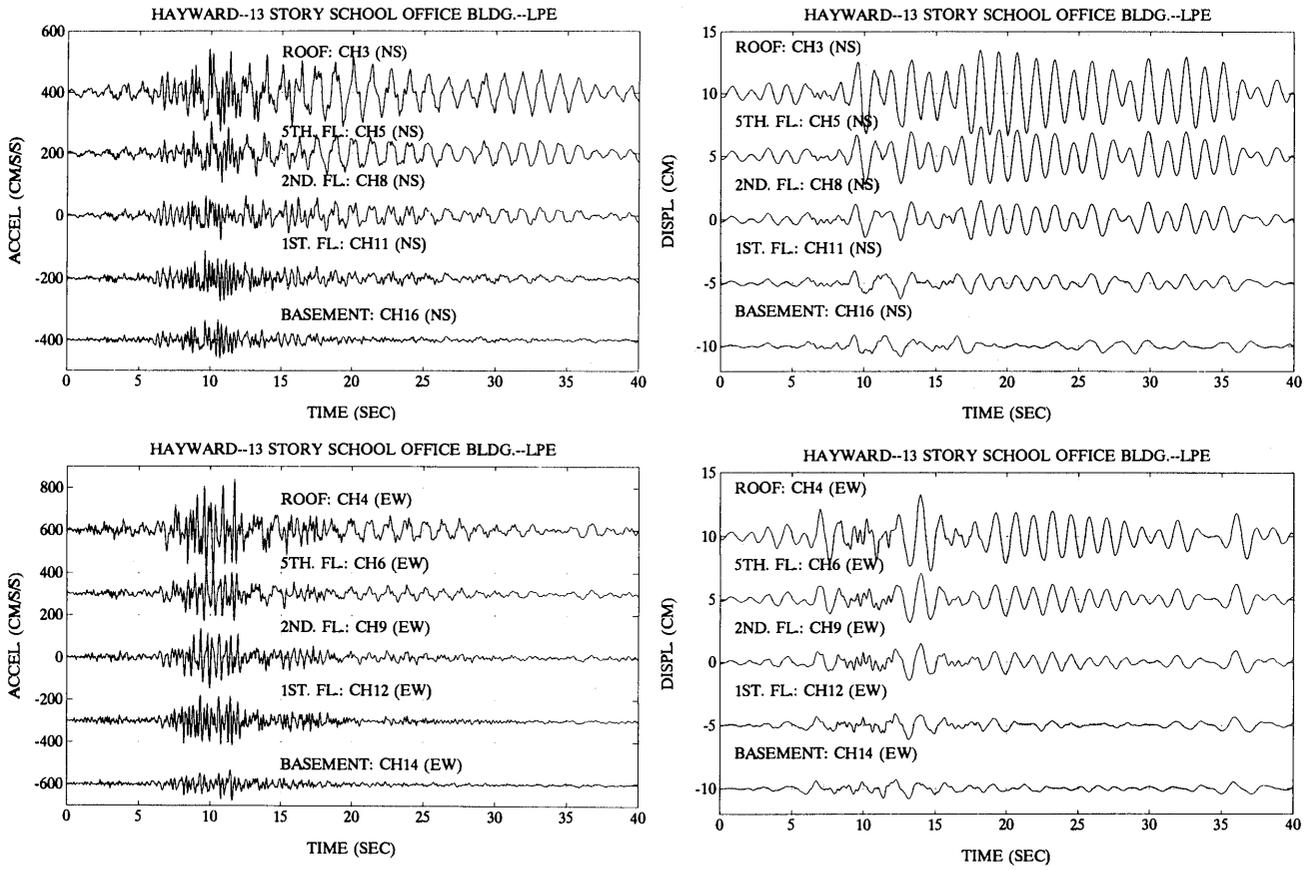
Figure 42.—Acceleration and displacement time-histories of California State University (Hayward) Administration Building.

Table 8.—Accelerations and displacements at California State University (Hayward) Administration Building

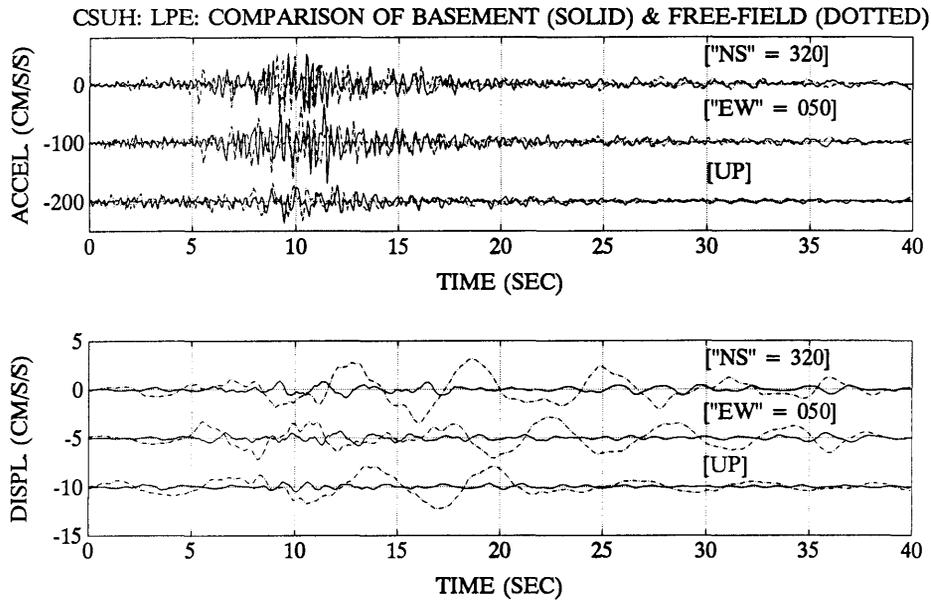
Figure 43.—Comparison of basement (solid line) and free-field (dash-dot lines) motions for California State University (Hayward) Administration Building.

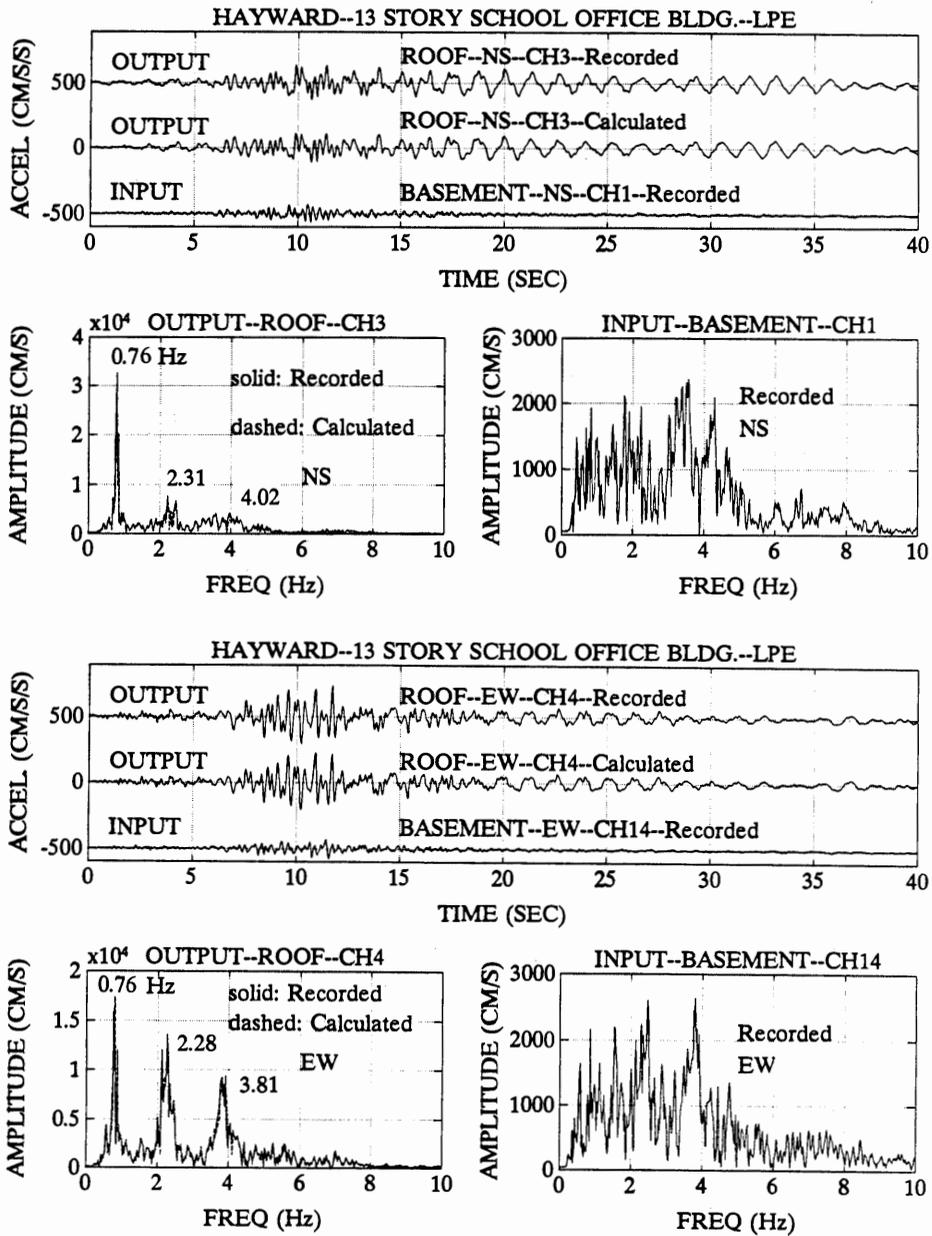
Figure 44.—System identification for California State University (Hayward) Administration Building.

In figure 44, calculated output of system identification analysis using 40 seconds of the basement accelerations

(recorded input) and roof accelerations (recorded output) of the building are shown. System identification calculations were also performed using the 5th floor accelerations as recorded output. The three significant frequencies (periods) and damping values also determined from system identification procedures are summarized in table 9. Figure 45 shows the structural frequencies in the spectral ratios calculated from amplitude spectra of roof and basement motions. It is noted that the three significant modal periods in each of the principal axes of the building follow the approximation of T , $T/3$, and $T/5$.

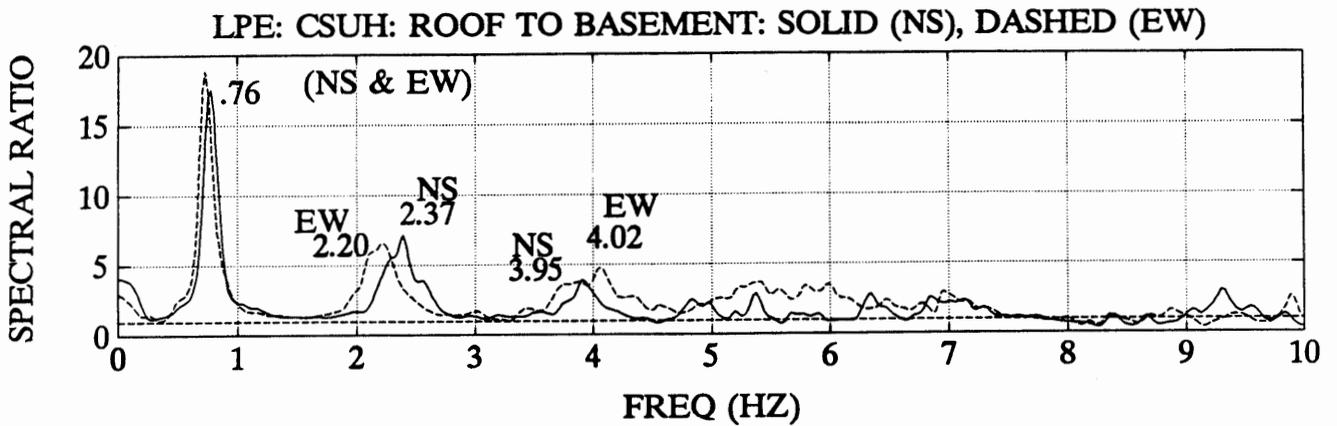
Figure 45.—Spectral ratios for California State University (Hayward) Administration Building.
