The Loma Prieta, California, Earthquake of October 17, 1989—Building Structures

U.S. GEOLOGICAL SURVEY PROFESSIONAL PAPER 1552-C

BUILDING STRUCTURES

INTRODUCTION

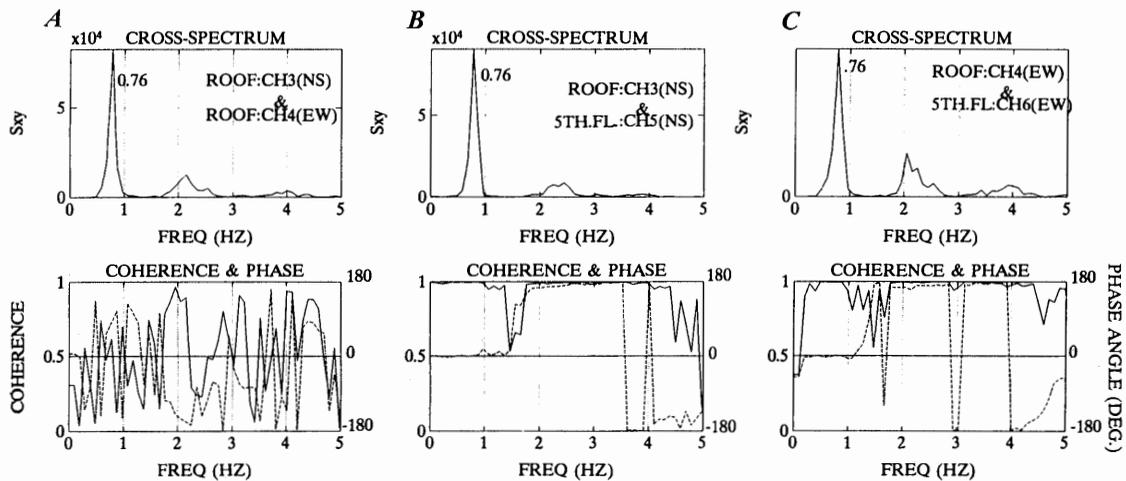
Figure 46.—Cross-spectrum, coherence, and phase-angle plots for California State University (Hayward) Administration Building.

The possibility of torsion was investigated by coherence function and phase angle plots as shown in figure 46. At 0.76 Hz, the two horizontal orthogonal motions at the roof are not coherent and are not in phase, which may imply that torsion is insignificant. However, this may be misleading if the two horizontal sensors are located at or close to the center of rigidity of the floor, in which case the torsional contributions would not show in the unidirectional motions. Thus, the importance of acquiring two parallel motions at a floor is emphasized.

Figures 46B and C show the peaks of the first three modes in the cross-spectrum of north-south and east-west motions at the roof and 5th floor, respectively, indicating that the coherence is unity for all modes and the phase angles are 0° at the fundamental frequency and 180° at the second and third modal frequencies.

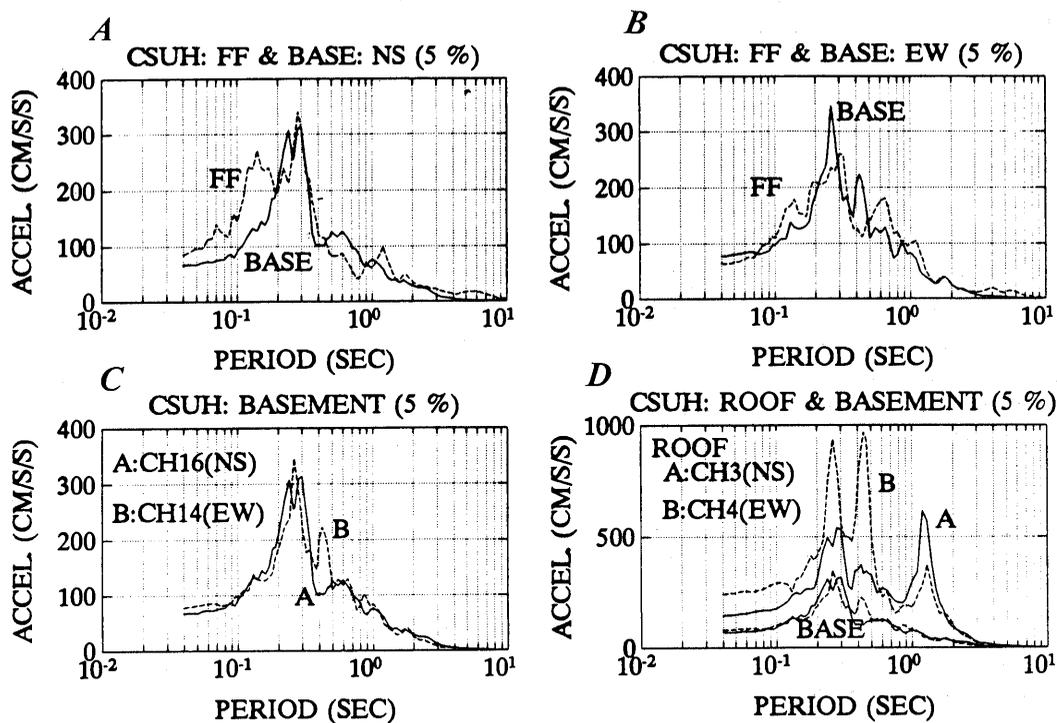
Figure 47.—Comparison of response spectra for California State University (Hayward) Administration Building. A, B, Free-field vs. basement. C, Orthogonal motions of basement. D, Roof and basement.

Figures 47A and B show 5 percent damped response spectra of the north-south and east-west free-field and basement motions of the building. Figure 47C shows the basement north-south and east-west response spectra superimposed. It is clear from these spectra that both free-

field and basement have peaks in the range 0.25-0.3 s (3.3-4.0 Hz). Figure 47C shows roof and basement response spectra. Clearly, the first three modal frequencies (periods) can be identified directly from these spectra.

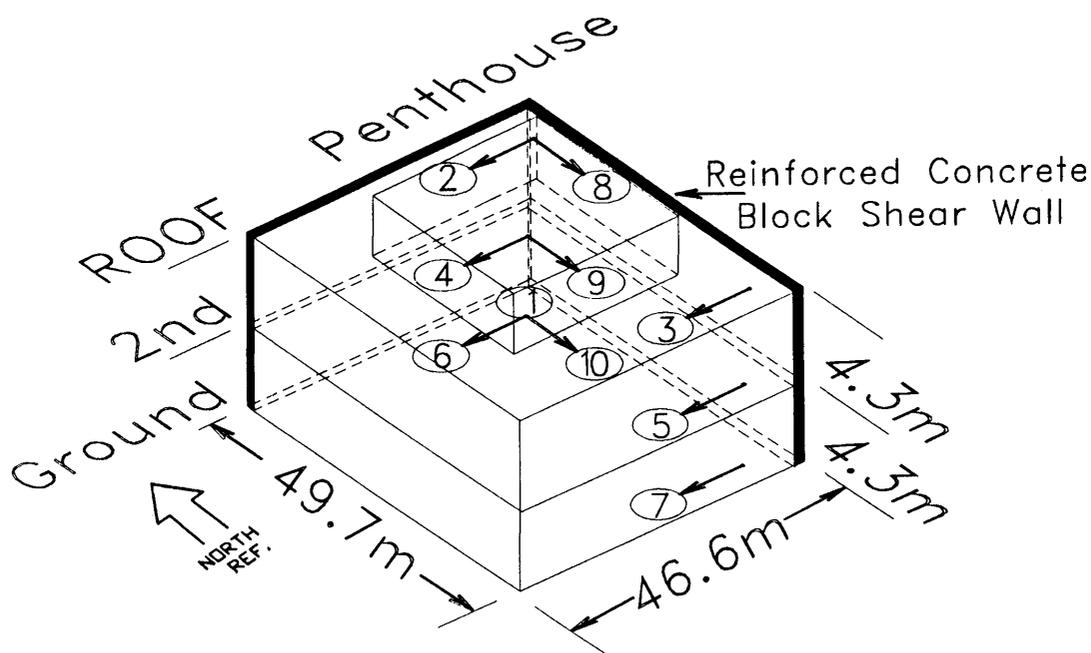
Figure 48.—Three-dimensional schematic of two-story building in Oakland.

McClure (1991) analyzed the data from the two-story Oakland office building designed by him in 1964. The building was designed according to the 1961 Oakland City Building Code (same as 1961 Uniform Building Code). The building is essentially structural steel framed with reinforced concrete block masonry infill walls. A three-dimensional schematic of the building, its dimensions, and the instrumentation scheme is shown in figure 48 (Çelebi, unpub. data, 1997). As shown in figure 48, the building had a severe plan torsional irregularity. The building was subjected to large peak accelerations (ground 0.26 g, second-floor 0.54 g, and roof 0.69 g). Recorded accelerations and their peaks are shown in figure 49. The building suffered no damage. Its inherent stiffness provided by infill walls reduced the drift ratio. The three-dimensional computer model analyses by McClure (1991) showed that the building behaved elastically when subjected to Loma Prieta motions. The time-histories of the translational and torsional roof accelerations and corresponding amplitude spectra are shown in figure 50 (Çelebi, unpub. data, 1997). The amplitude spectra by themselves reveal frequencies at approximately 0.8, 1.7, and 1.95 Hz. To distinguish these frequencies, spectral

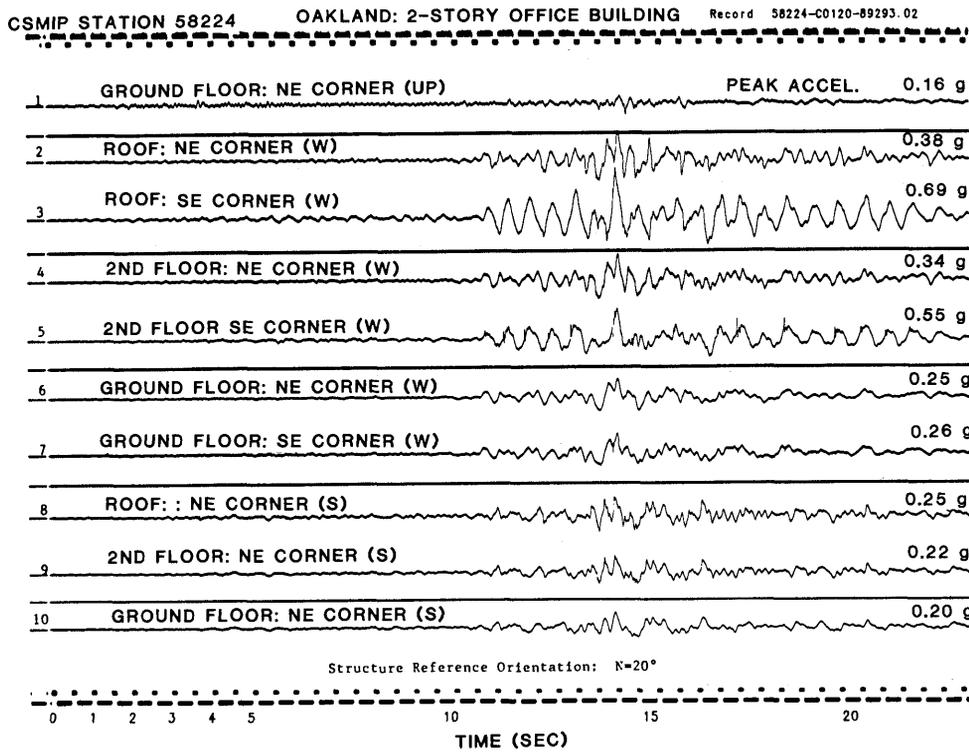
Figure 49.—Recorded responses of two-story building in Oakland.

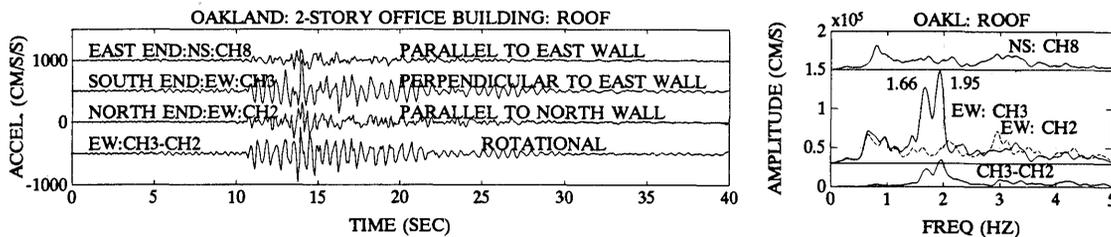
Figure 50.—Roof responses and amplitude spectra of two-story building in Oakland.

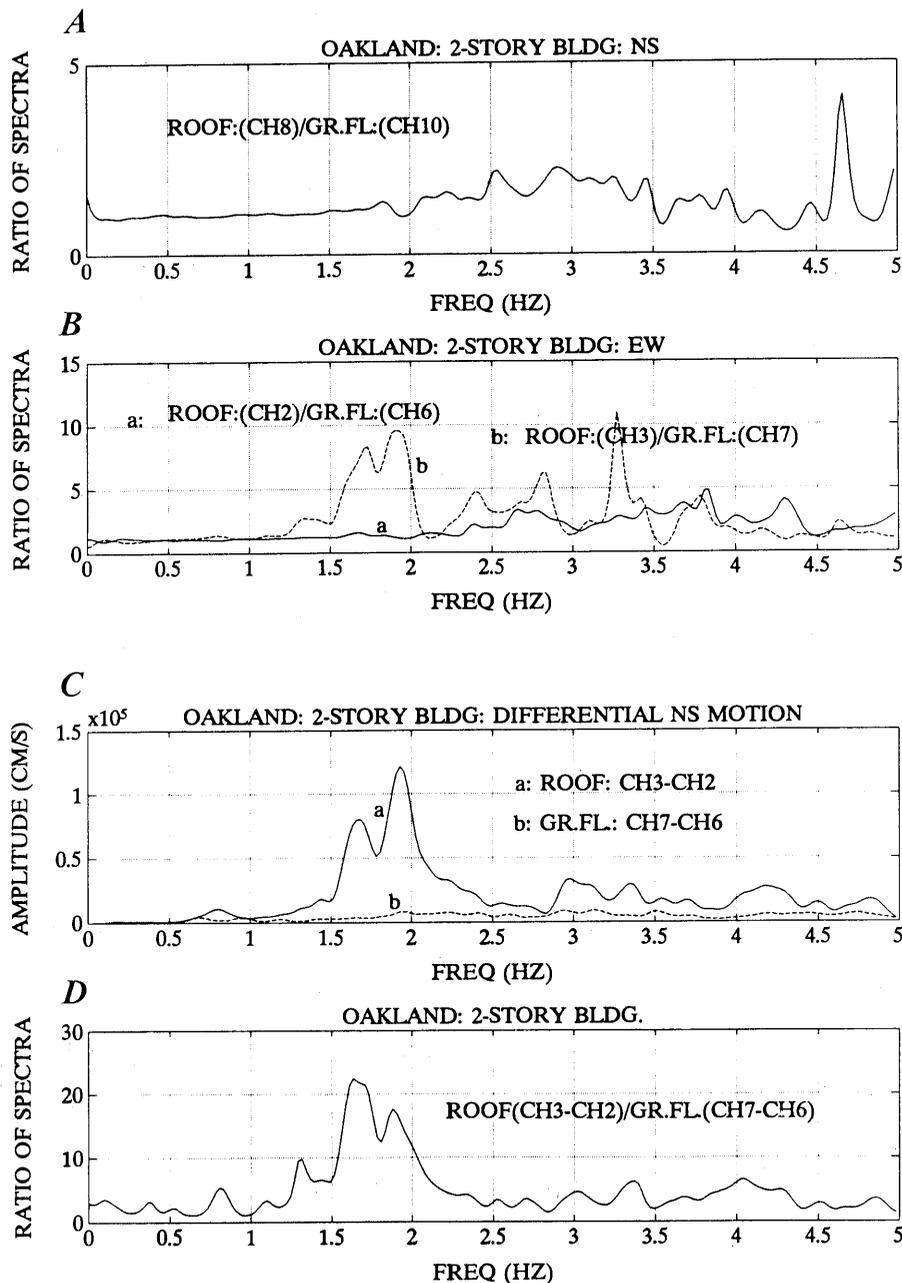
Figure 51.—Spectral ratios of amplitude spectra of two-story building in Oakland.

ratios are shown in figures 51A and B. It is noted that the spectral ratio in the north-south direction is approximately unity up to 2 Hz because the east wall of the building does not amplify the structural response (figure 51B). The building was subjected to severe torsional behavior that is close-coupled with the translational mode at approximately 1.67 and 2 Hz (0.67 and 0.5 s). These frequencies are identified in the spectral ratios of torsional accelerations of the roof (figs. 51C and D). The weak peak at approximately 0.7 Hz observed in the amplitude spectra is attributed to the site frequency (Çelebi, unpub. data, 1997). McClure (1991) stated that the ambient vibration tests of the building performed in 1965 by the USGS (then U.S. Coast and Geodetic Survey) indicated a period of 0.47 s for the building. Later, in 1966, forced vibration tests of the building by Bouwkamp and Blohm (1966) yielded a first-mode period of 0.416 s. The mathematical model McClure used to perform dynamic analyses of the building was based on matching the period of the building to one of those from the low-amplitude tests. However, McClure noted that the building periods were 0.5-0.6 s during Loma Prieta and attributed this to possible disengagement of the nonstructural elements that were not well connected to the structural frame (1991).

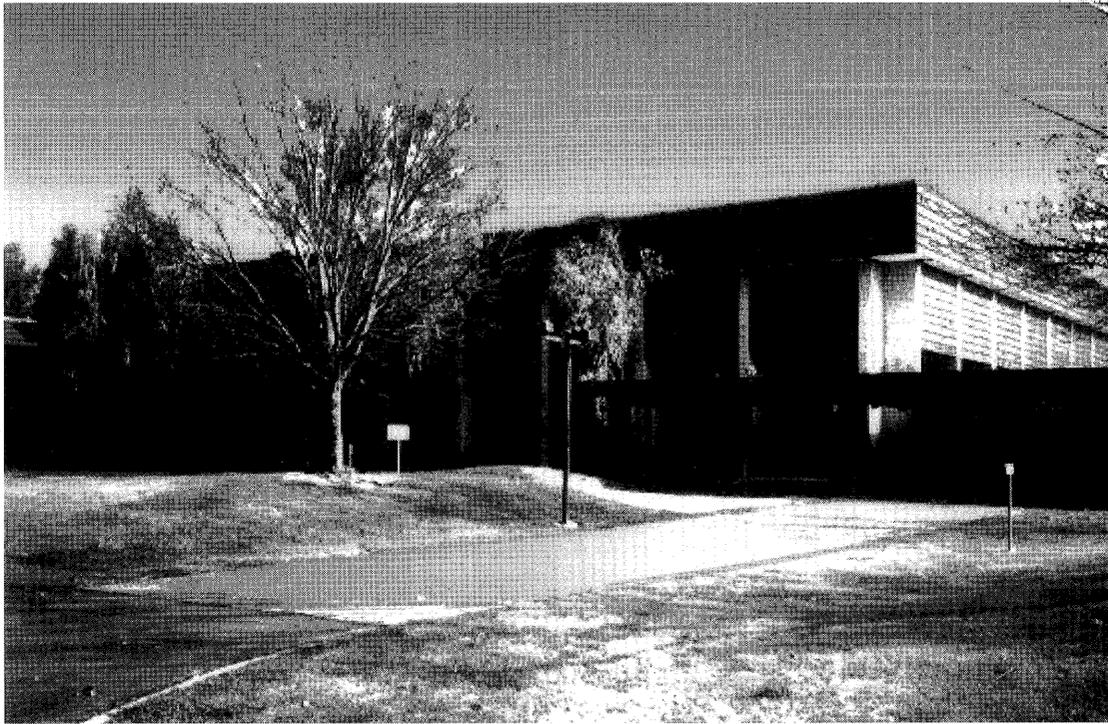
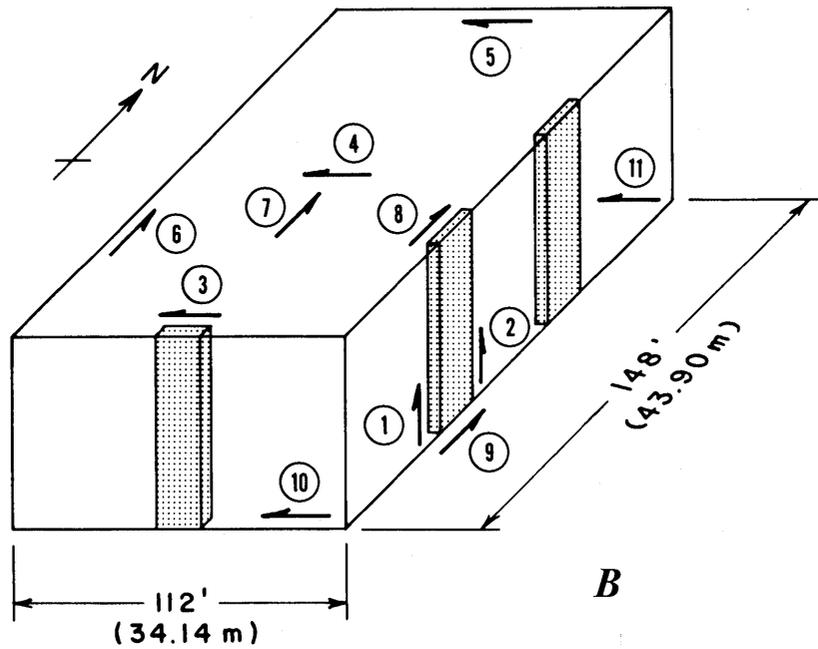
Figure 52.—A, West Valley College Gymnasium. B, Three-dimensional schematic of West Valley College Gymnasium.

The West Valley College gymnasium was studied in detail by Çelebi and others (1989) using the 1984 Morgan Hill earthquake records. A general view and schematic of the gymnasium and its instrumentation scheme is shown in figure 52 (Çelebi and others, 1989). The Morgan Hill

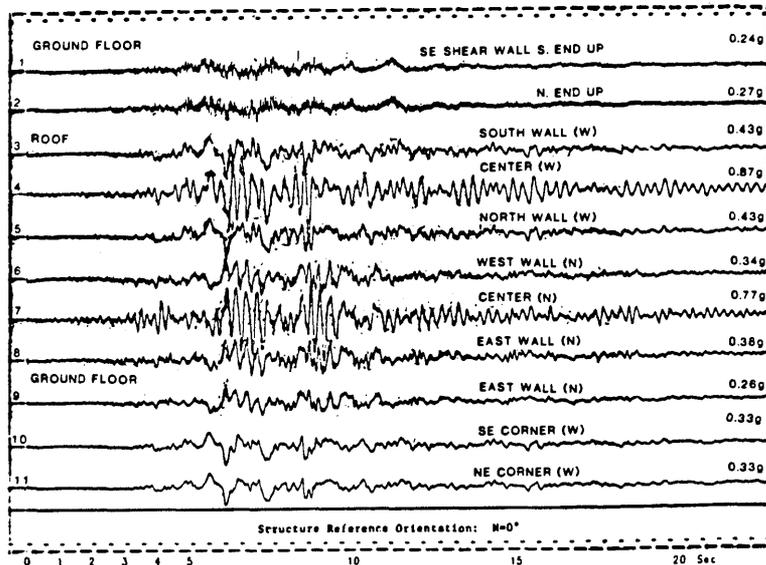
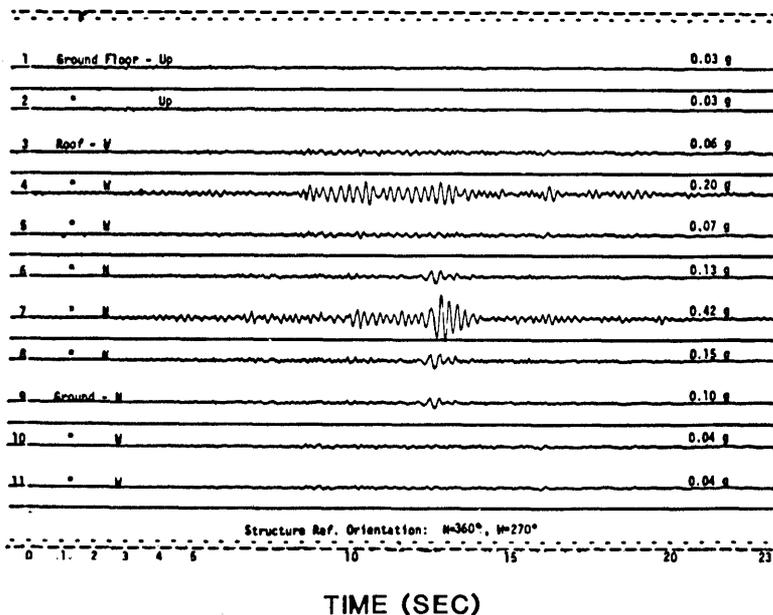
WEST VALLEY COLLEGE (SARATOGA, CA.) GYMNASIUM
 CDMG LOMA PRIETA RECORD (27 km from the epicenter)

CDMG MORGAN HILL RECORD (30 km from the epicenter)

Figure 53.—Recorded responses of West Valley College Gymnasium for two earthquakes.

earthquake records are compared to the Loma Prieta records in figure 53. In short, the records of the building are greatly influenced by the diaphragm frequency at approximately 4 Hz. Significant peak accelerations of the gymnasium are summarized in table 10 for the two earthquakes (Çelebi, 1990). As a result of these studies, the design requirements for the restraints at the edges of the roof diaphragm were increased in the 1991 Uniform Building Code by 50 percent.

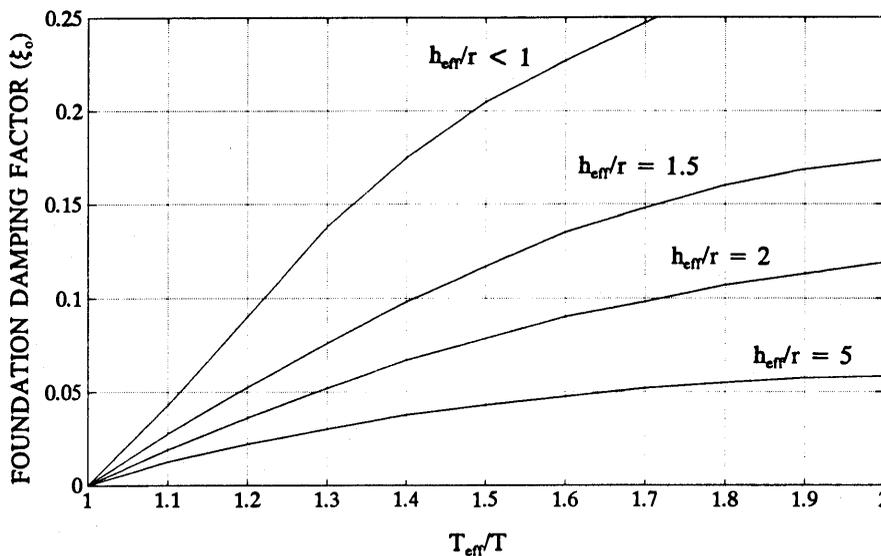
Figure 54.—Foundation damping in terms of ratio of periods and ratio of building height-to-equivalent radius of foundation (from Veletsos (1977) and Applied Technology Council (1978)).

Accepting 0.38 Hz (2.63 s) as the frequency (period) with soil-structure interaction and 0.48 Hz (2.08 s) or 0.57 Hz (1.75 s) as that without soil-structure interaction, then it is possible to make some quantification of the amount of foundation damping using equations developed by Veletsos (1977) and included in the Applied Technology Council's publication ATC 3-06 (Applied Technology Council, 1978). The area (A) of the foundation mat is approximately 1,600 m². The equivalent circular radius of the foundation is calculated as $r = (A/\pi)^{0.5} = 22.6$ m (this number is possibly too low considering that the Pacific Park Plaza is a three-winged building, and therefore the effective radius is possibly larger than the conversion provided above). The height of the building (h) is 89.2 m; the effective height (h_{eff}) as defined by the Applied Technology Council (1978) is $h_{\text{eff}} = 0.7h = 62.4$ m. For $h_{\text{eff}}/r = 62.4/22.6 = 2.8$, and for $T_{\text{ssi}}/T = 2.63/2.08 = 1.26$ or $2.63/1.75 = 1.50$, the foundation (including radiation and material) damping can be approximated at 5-6 percent from figure 54 (adopted from Applied Technology Council,

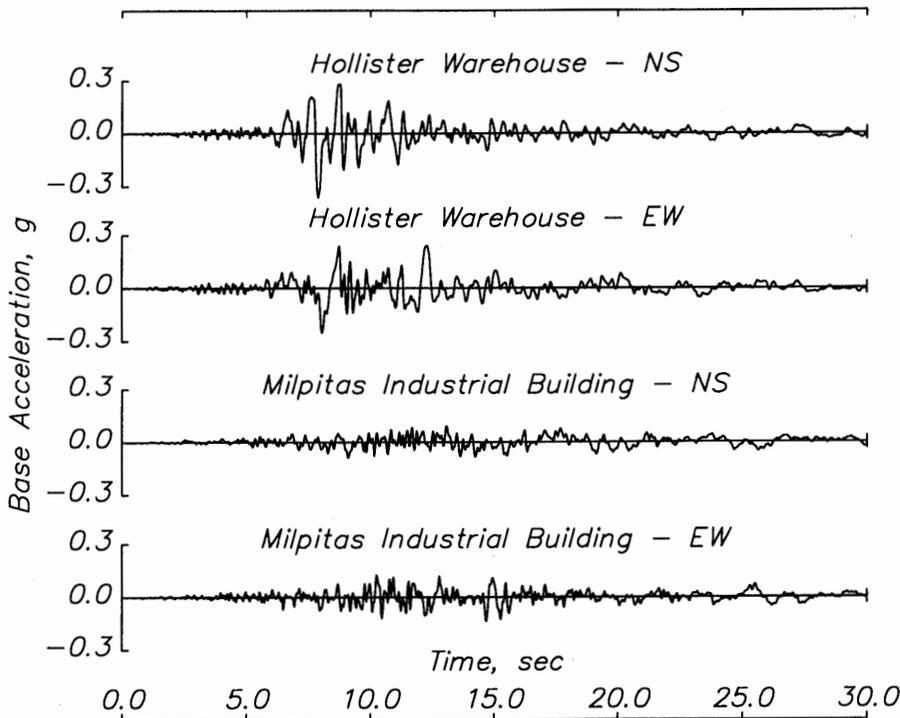
Figure 1.—Horizontal ground accelerations recorded in Hollister and Milpitas.

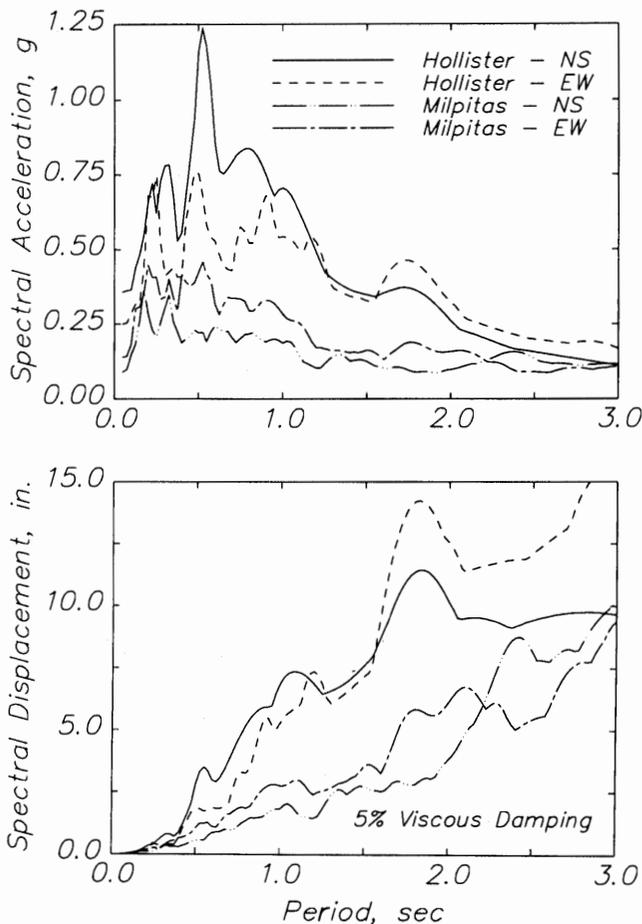
Figure 2.—Linear response spectra recorded in Hollister and Milpitas.

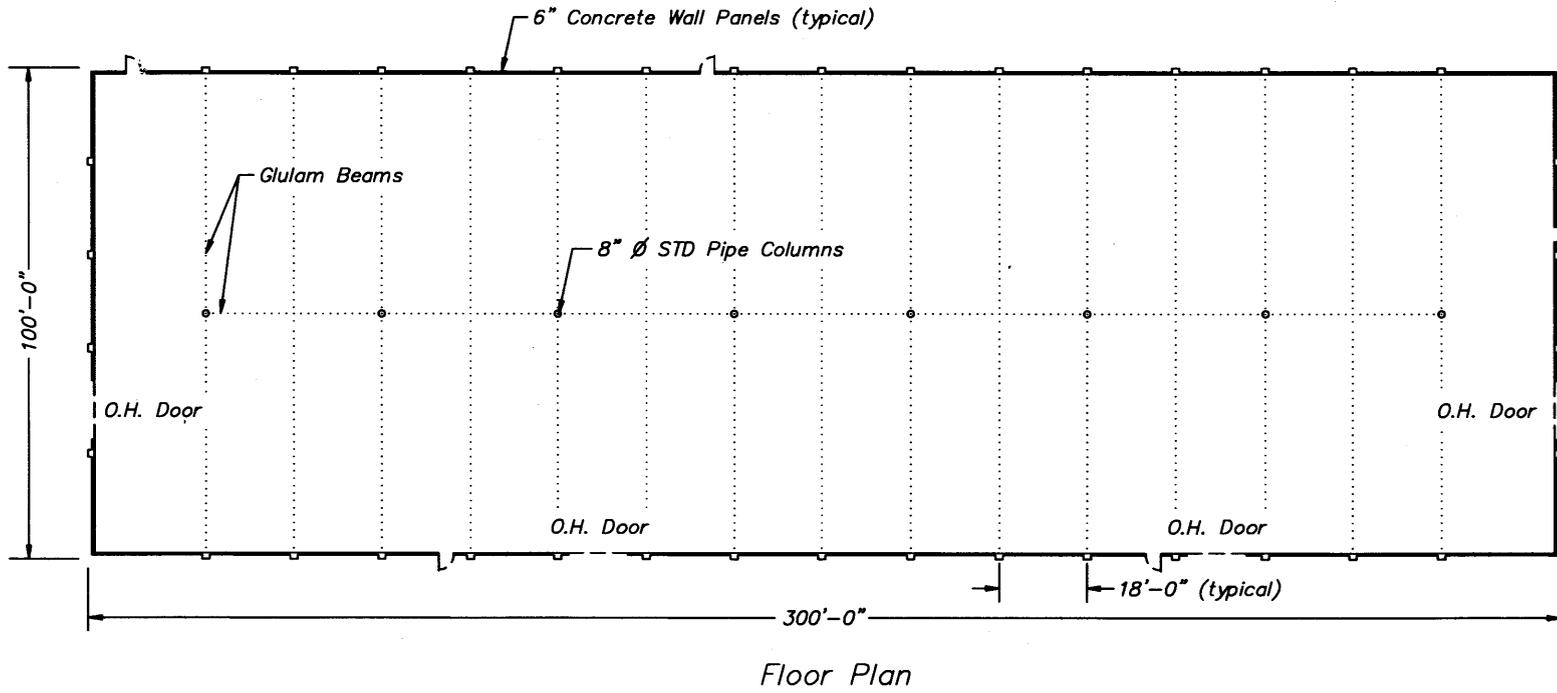
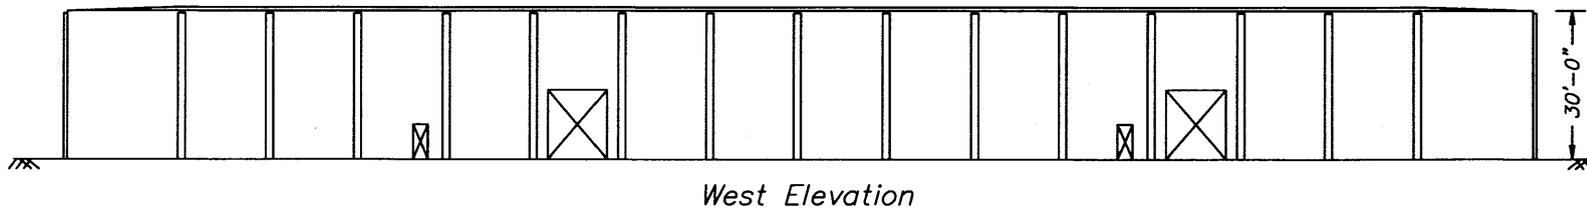
Figure 3.—Structural configuration of Hollister warehouse.

The warehouse in Hollister was built in 1979; however, the structural details are more representative of construction in the early 1970's. The building is 300 by 100 ft in plan (fig. 3). Concrete wall panels 6 in. thick are connected by cast-in-place pilasters which form continuous connections between adjacent wall panels. Cambered glulam beams run in both directions of the building and are supported on a single line of pipe columns. Purlins 14 in. deep are spaced at 8 ft on center in the roof and overlain with one-half in. structural plywood. The building was designed with nine openings: four overhead doors for fork-lift access and five personnel doors.

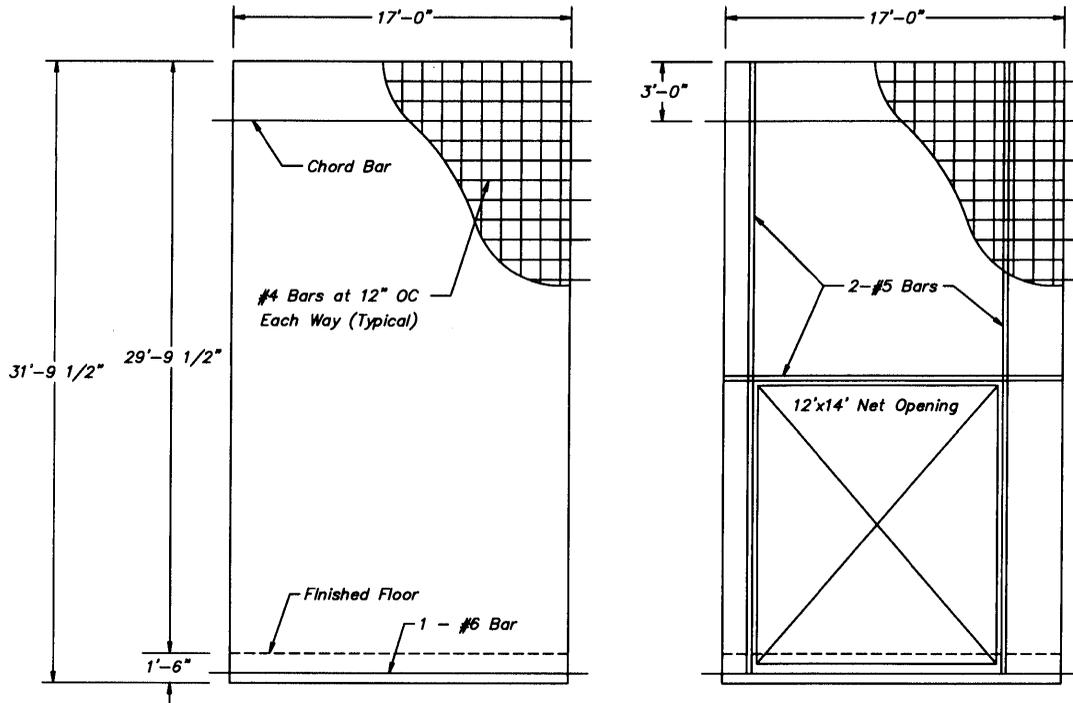
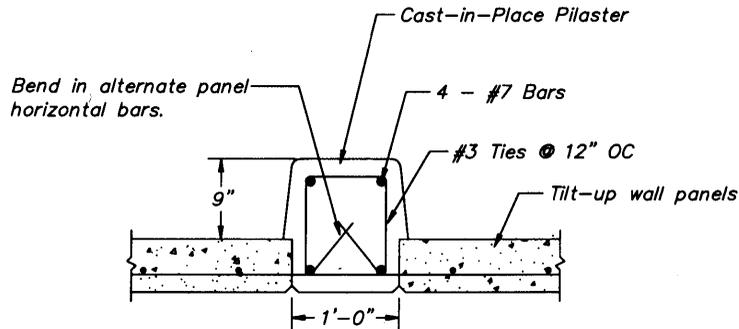
TYPICAL PANEL DETAILS

TYPICAL PANEL-TO-PANEL CONNECTION

Figure 4.—Typical structural details in Hollister warehouse.

Typical reinforcement details are shown in figure 4. The panel reinforcement comprised a single layer of #4 bars spaced at 12 in. on center in each direction. Two #5 bars were added around panel openings. Chord reinforcement for the diaphragm was located in the wall panels. The reinforcing bars extended beyond the panel boundaries and were welded to chord reinforcement from adjacent panels. The chord reinforcement and horizontal panel reinforcement were then encased in the pilasters.

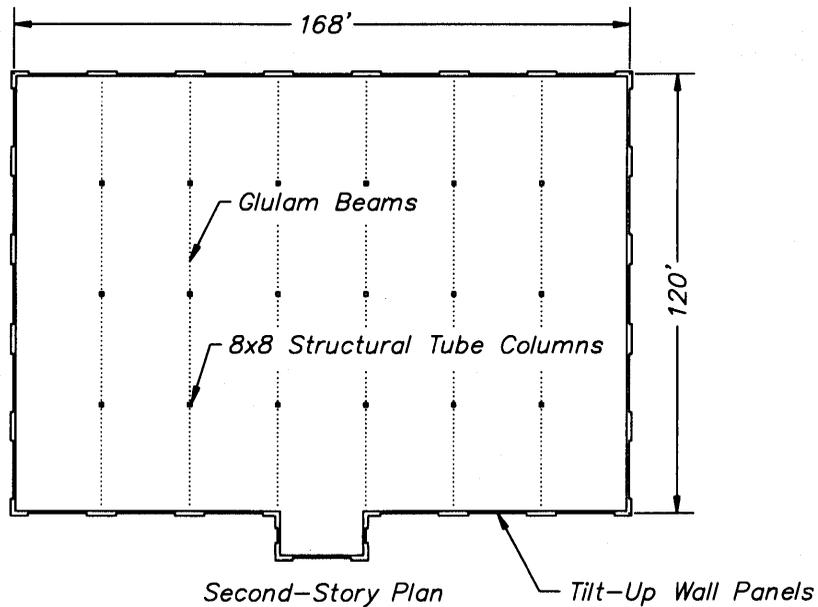
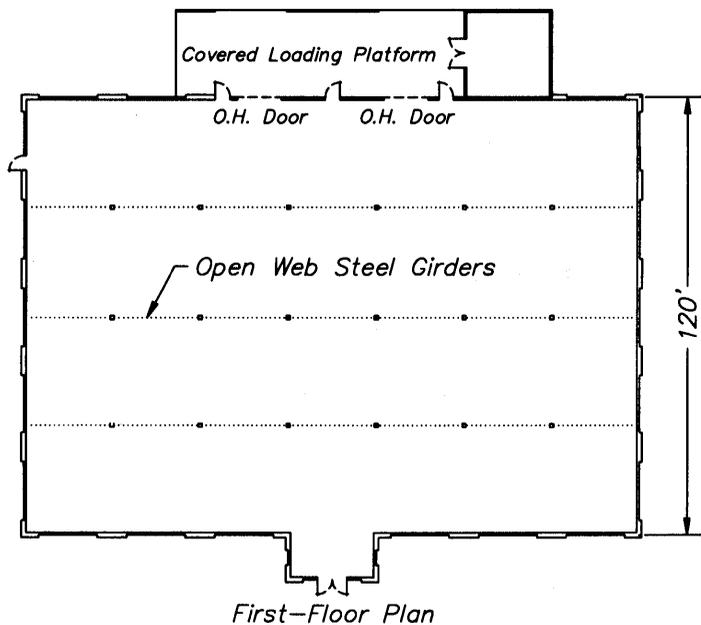
Figure 5.—Structural configuration of Milpitas industrial building.

The two-story industrial building in Milpitas was constructed in 1984. The building is 168 by 120 ft in plan (fig. 5), with the first story used as a warehouse and the second for offices. Nearly every wall panel has window

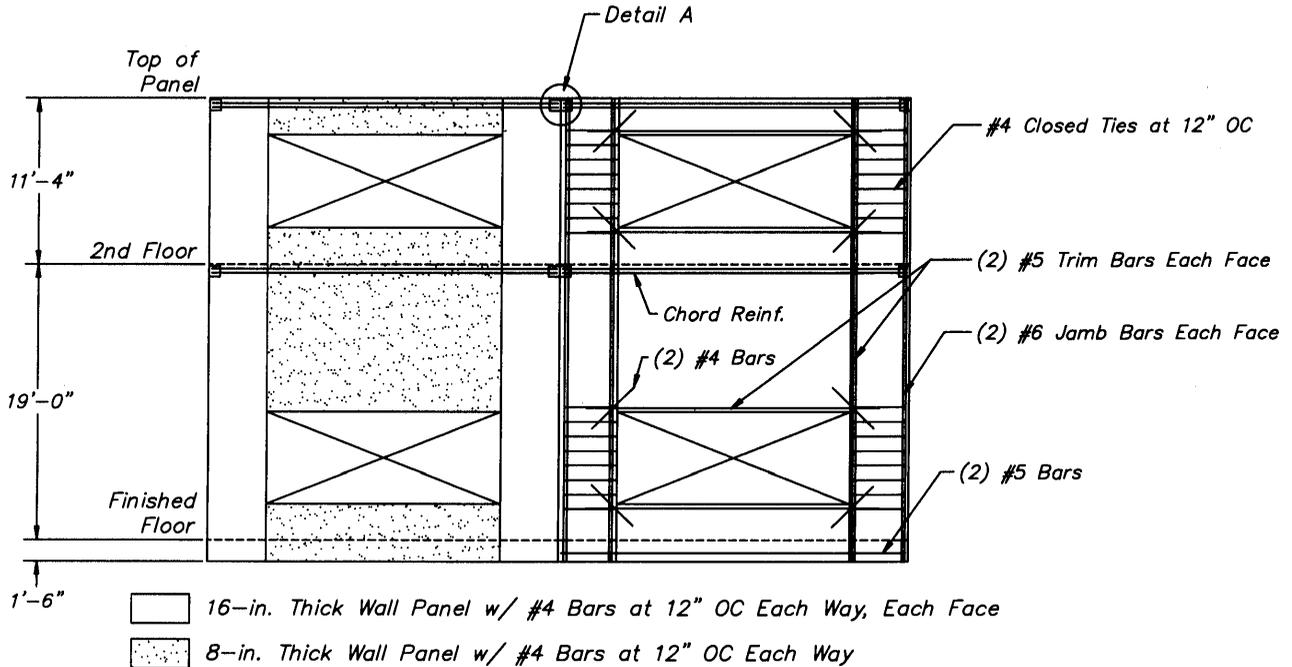
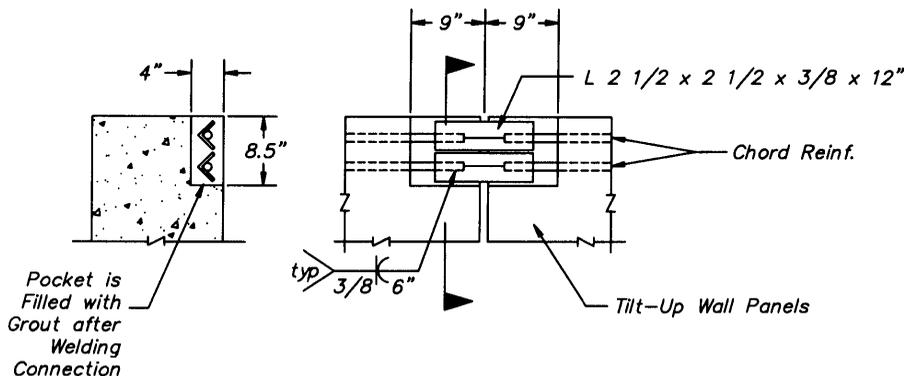
TYPICAL PANEL DETAILS

DETAIL A

Figure 6.—Typical structural details in Milpitas industrial building.

Typical reinforcement details are shown in figure 6. The panel reinforcement may be divided into six categories: distributed vertical and horizontal panel reinforcement, vertical jamb bars along the panel edges, vertical and horizontal trim bars around the openings, diagonal reinforcement around the openings, closed ties in the wall

boundary elements near the openings, and chord reinforcement. A pocket was left around the chord reinforcement near the panel boundary at the second-story and roof levels to provide access to the chord reinforcement. Chord reinforcement from adjacent panels was welded to steel angles to create a lapped connection. Adjacent wall panels were connected only at the second-floor and roof levels.

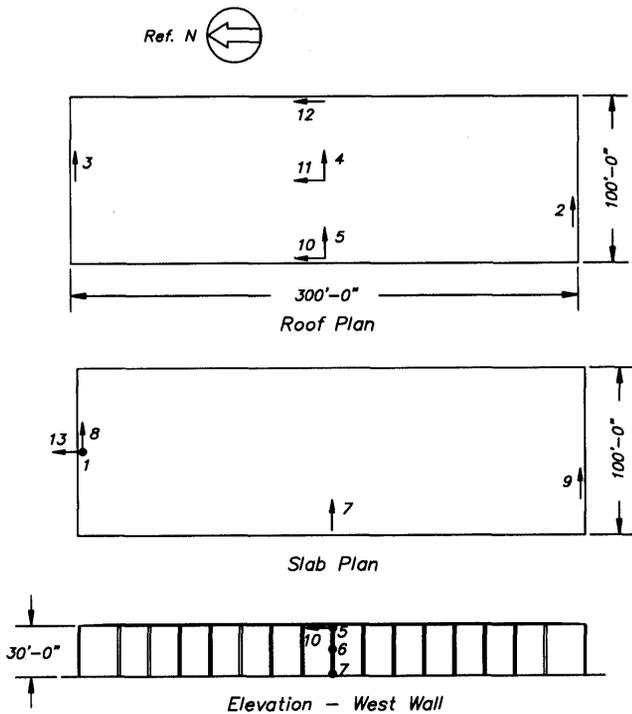
Sensors 4 and 11 are mounted on glulam beams.
Sensor 13 is mounted on the floor slab.
All other sensors are mounted on the wall panels.

Figure 7.—Location of strong motion instruments in Hollister warehouse.

Records from 13 strong-motion instruments were obtained from each building during the earthquake (California Strong Motion Instrumentation Program, 1991). In the Hollister warehouse, five instruments recorded the ground motion, seven monitored motion at the roof, and one measured the out-of-plane response of a longitudinal wall panel at mid-height (fig. 7). In the Milpitas building, five instruments recorded the ground motion, four measured the response at the roof, and four measured the response of the second floor (fig. 8). Instrument locations are summarized in tables 1 and 2 for the Hollister and Milpitas buildings, respectively.

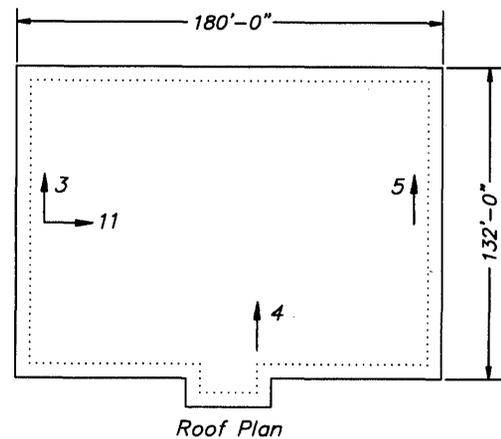
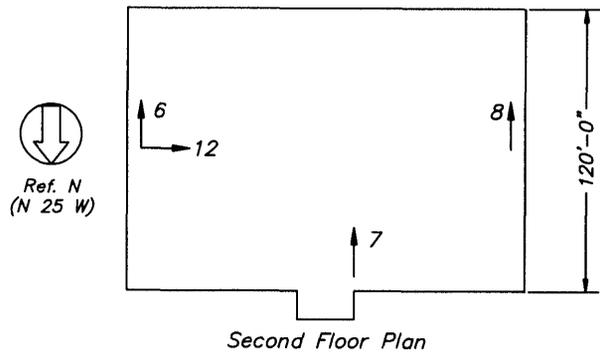
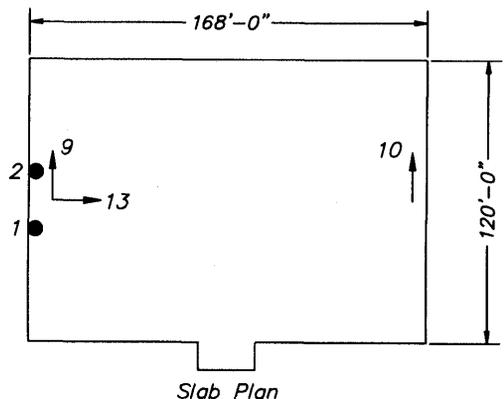
Figure 8.—Location of strong motion instruments in Milpitas industrial building.

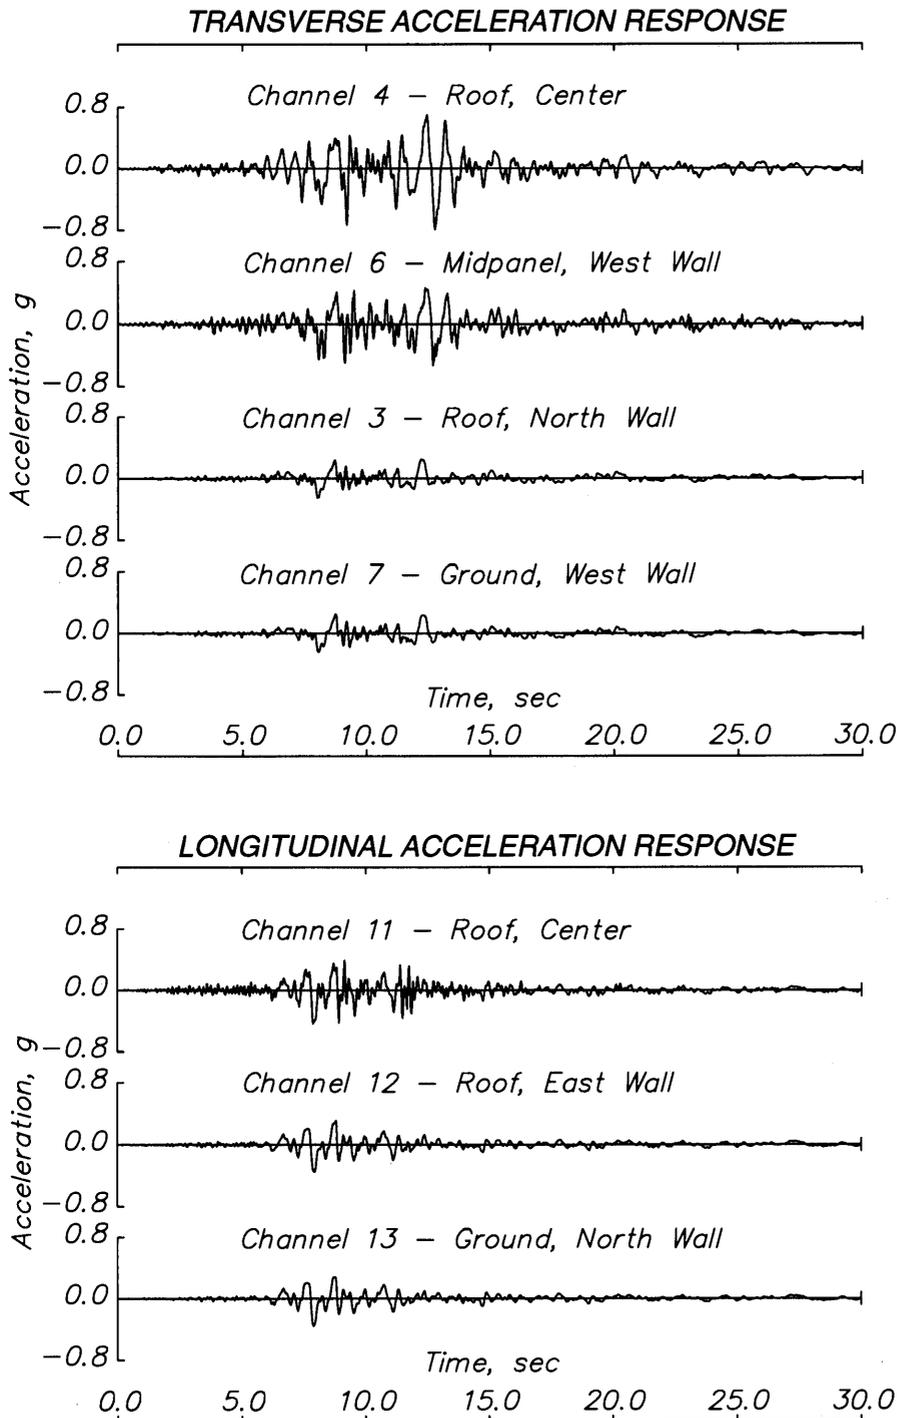
Figure 9.—Measured acceleration records in Hollister warehouse.

Measured acceleration histories from the Hollister warehouse are shown in figure 9. Response in the transverse (east-west) direction is shown at the base of the structure (channel 7), at the top of the transverse walls (channel 3), at mid-height of the center longitudinal wall panel (channel 6), and at the center of the roof (channel 4). In the longitudinal (north-south) direction, response histories are shown at the base of the structure (channel 13), the top of the longitudinal walls (channel 12), and the center of the

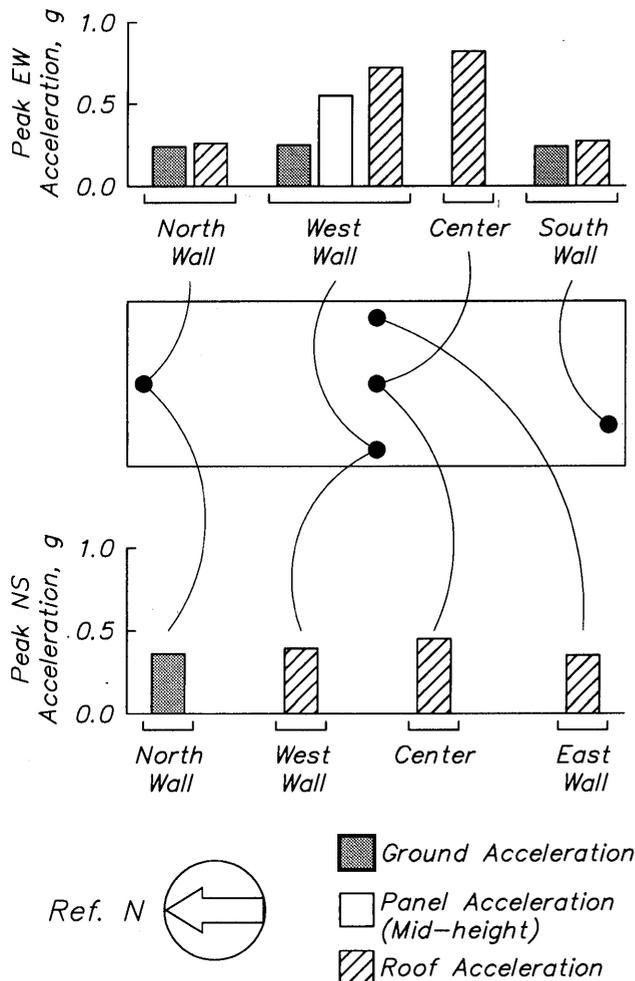
Figure 10.—Measured peak accelerations in Hollister warehouse.

The data indicate a significant amplification of the transverse accelerations at the center of the roof for the Hollister warehouse (fig. 10). The peak roof accelerations were approximately three times the ground peak accelerations at the center of the diaphragm. In contrast, the in-plane accelerations measured at the top of the transverse wall panels were essentially the same as the ground motions.

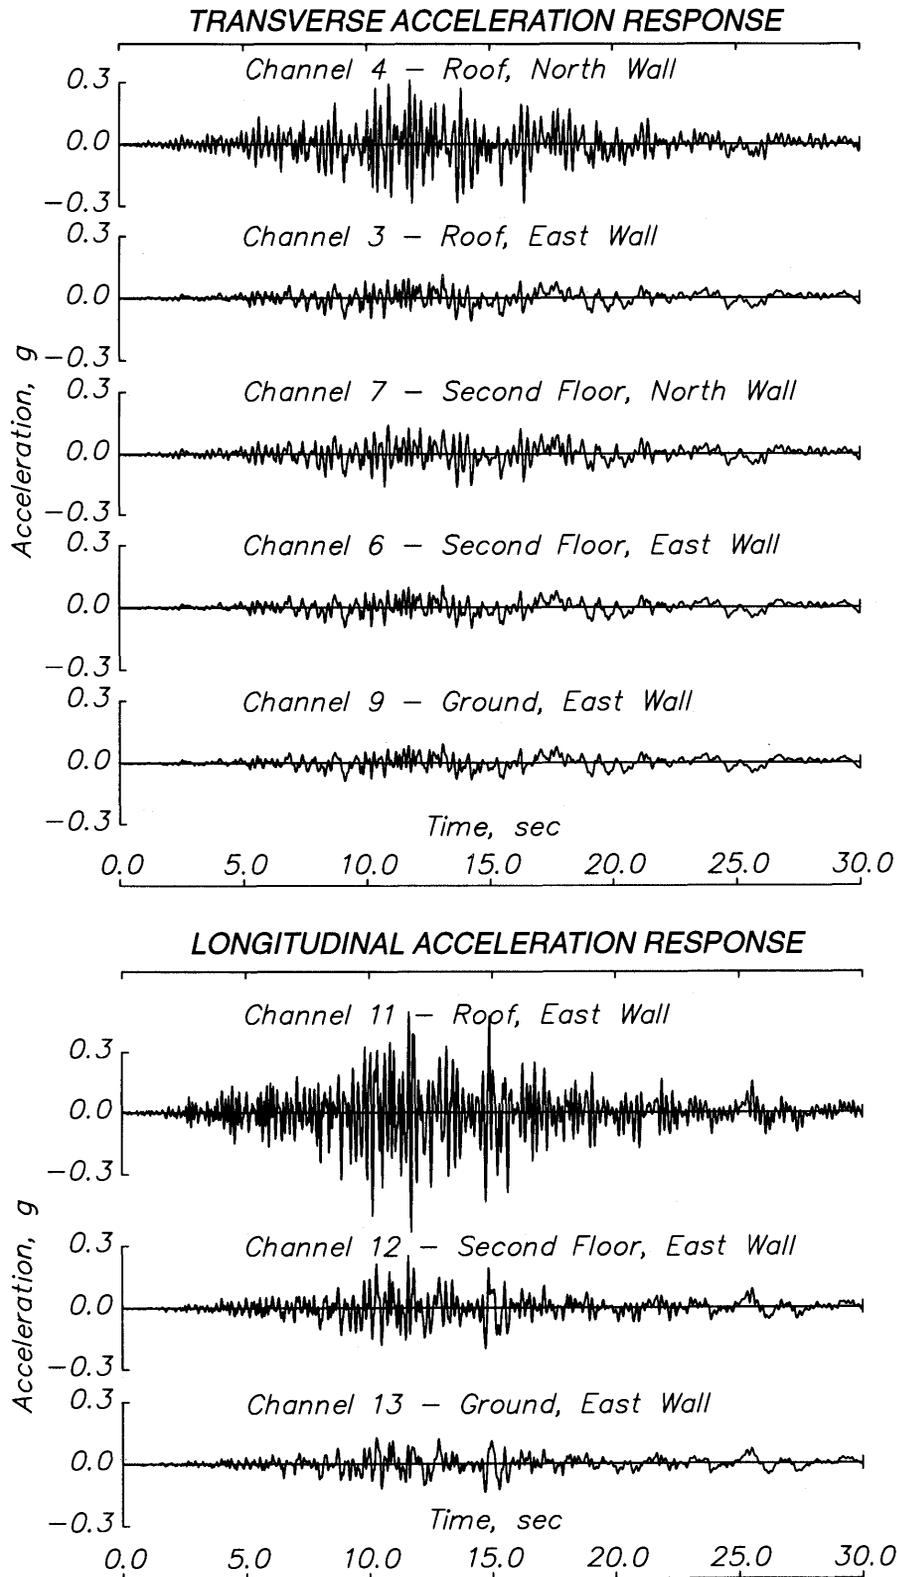
Figure 11.—Measured acceleration records in Milpitas industrial building.

Measured acceleration histories in the Milpitas industrial building are shown in figure 11. Response in the trans-

verse (north-south) direction is characterized by the ground motion (channel 9), the in-plane response of the transverse walls at the second-floor and roof levels (channels 6 and 3), and the out-of-plane response of the longitudinal walls at the second-floor and roof levels (channels 7 and 4). In the longitudinal (east-west) direction, measured response at the ground (channel 13) is shown along with the out-of-plane response at the second-floor and roof eleva-

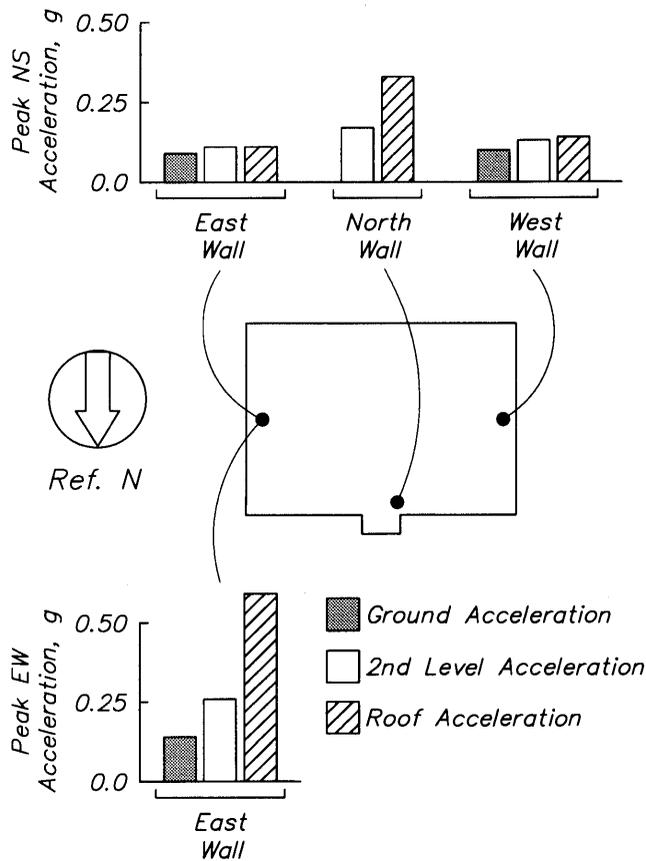
Figure 12.—Measured peak accelerations in Milpitas industrial building.

Transverse accelerations were amplified by a factor of approximately three between the base and the center of the roof in both buildings. Peak transverse accelerations measured at mid-height of the longitudinal wall panels in the Hollister warehouse and at the second-floor level of the longitudinal wall panels in the Milpitas building were

greater than one-half the peak transverse accelerations measured at the center of the roof.

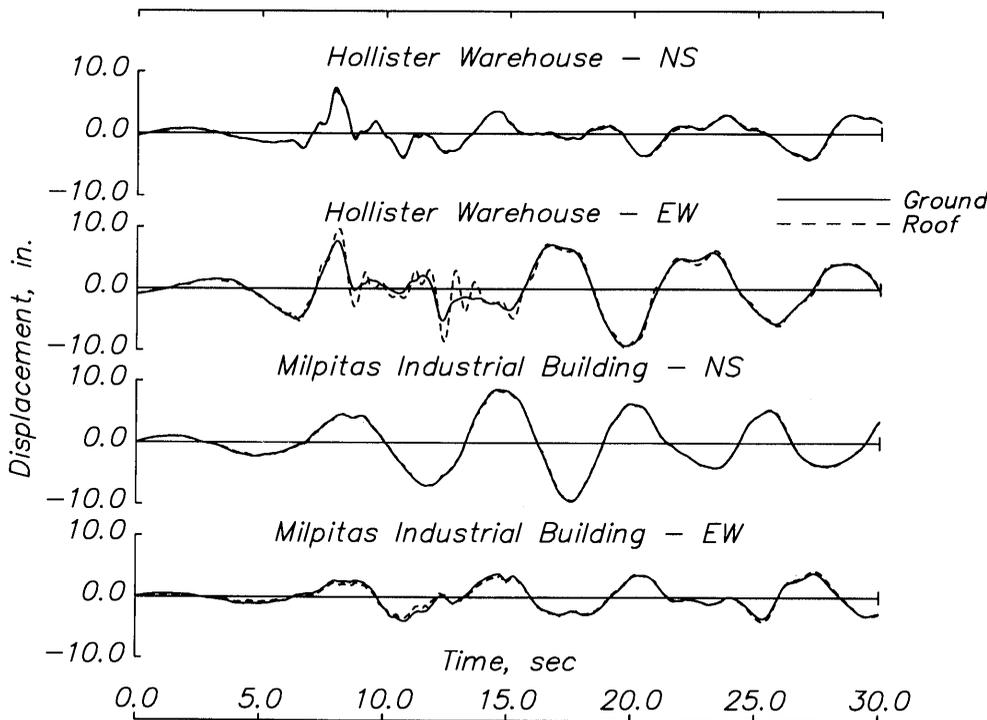
Figure 13.—Absolute displacement response of ground and roof.

The digitized data provided by the California Department of Conservation included displacement histories that were obtained by integrating and filtering the corrected acceleration response (California Strong Motion Instrumentation Program, 1991). Recorded displacement data at the base of the two buildings and at the centers of the roofs are shown in figure 13. The peak ground displacement at both sites was approximately 10 in. With the exception of the transverse response of the Hollister warehouse, the absolute displacement response at the centers of the roofs of both buildings was approximately the same as the ground displacements. Amplification of the transverse displacements at the center of the roof in the Hollister warehouse may be observed.
