The Loma Prieta, California, Earthquake of October 17, 1989—Building Structures

U.S. GEOLOGICAL SURVEY PROFESSIONAL PAPER 1552-C

BUILDING STRUCTURES

INTRODUCTION

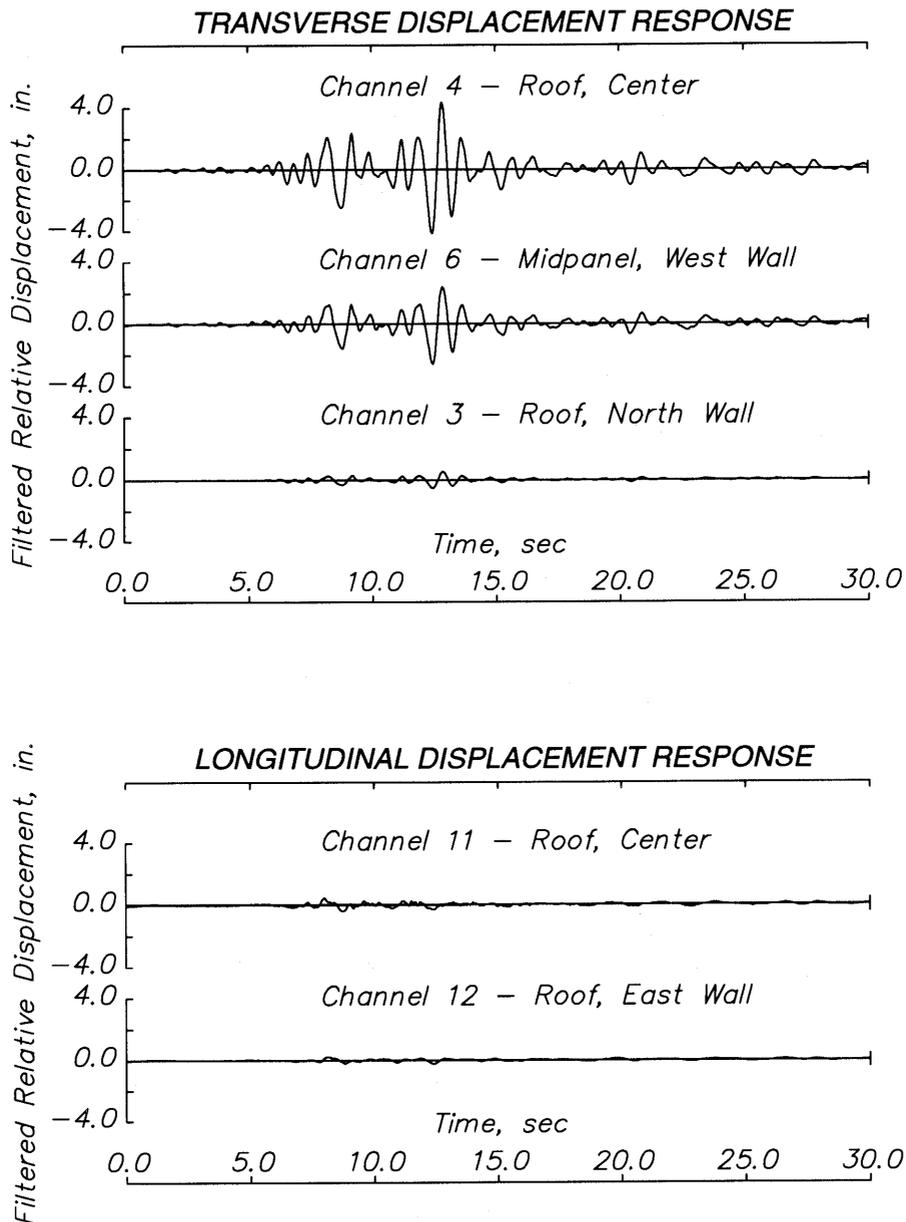
Figure 14.—Relative displacement response of Hollister warehouse.

Relative displacement histories for the Hollister warehouse are shown in figure 14. Peak relative transverse displacements at the center of the roof exceeded 4 in., or

1 percent of the height of the building. The displacement response in the longitudinal direction and in the transverse direction at the top of the transverse walls was negligible. Elastic deformations within the plane of the diaphragm must occur to accommodate these displacements without structural damage.

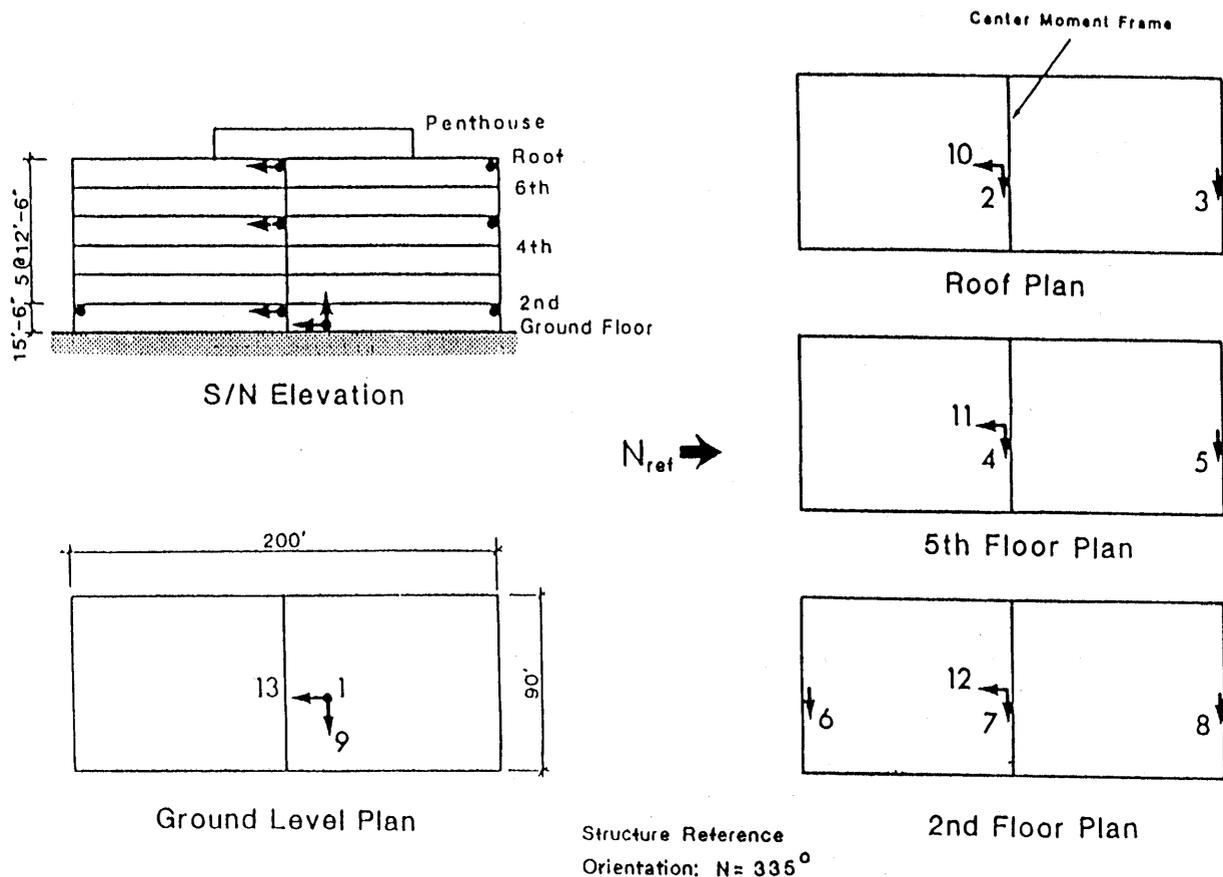
Figure 1.—Location of strong motion instrumentation.

The building was instrumented by the California Strong Motion Instrumentation Program (CSMIP) with 13 strong motion accelerometers at the time of the earthquake. These instruments were distributed throughout the building as shown in figure 1 which is taken from the California Department Mines Geology (California Division of Mines and Geology, 1989). The time histories of the recorded accelerations are shown in figures 2 to 14. The vertical accelerations recorded at ground level near the center of the building are shown in figure 2. Here it can be seen that the vertical acceleration has a peak value of 0.12 g, which is almost equal to the peak horizontal acceleration of 0.14 g recorded in the north-south direction (fig. 14).

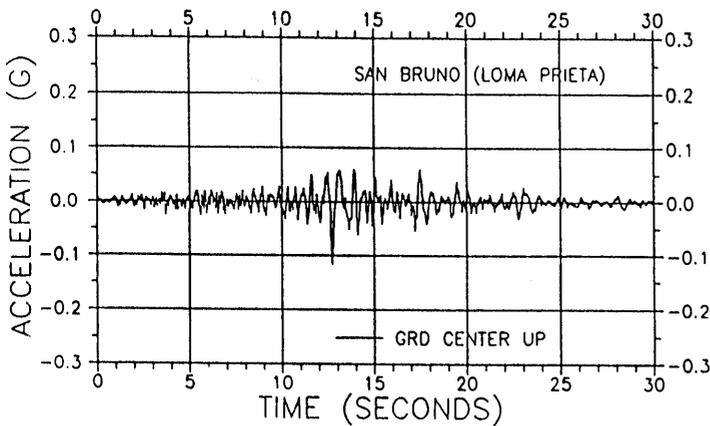
Figure 2.—Recorded acceleration, vertical, base level, center.

1. The vertical accelerations recorded at the base have a peak amplitude which is similar to that of the horizontal accelerations at the same location.
2. Peak ground acceleration occurred in the longitudinal (north-south) direction, whereas peak building response occurred in the transverse (east-west) direction.
3. Examination of the acceleration data recorded at the roof level indicates that the fundamental period of vibration in both directions is in the range of 0.9 to 1.0 s.

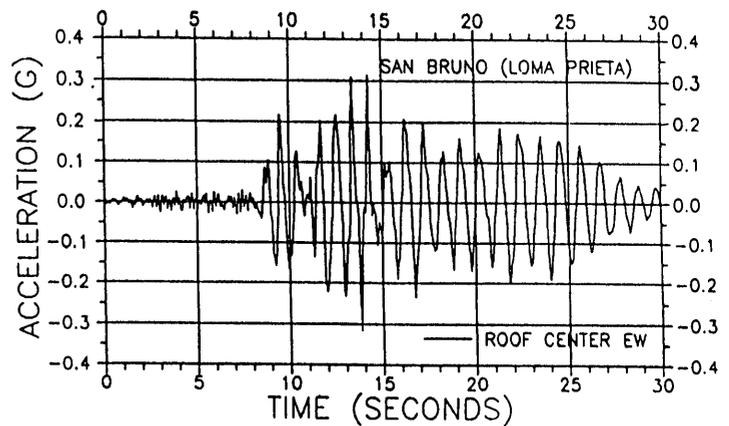
Figure 3.—Recorded acceleration, east-west, roof level, center.

The transverse acceleration recorded at the roof, near the center of the building, is shown in figure 3. Here it can be seen that the peak acceleration reaches 0.31 g and

that the duration of strong motion response is approximately 17 s. The transverse accelerations recorded at the roof level near the north end of the building are shown in figure 4. At this location the peak acceleration reaches 45 percent of gravity. A comparison of this record with the one just discussed indicates that there is a torsional response of the structure at this level. Similar acceleration data for the fifth story level is shown in figure 5 for the center and in figure 6 for the north end. At the center, the peak acceleration is 0.20 g and at the north end it increases to 0.23 g, which also indicates a torsion response but not as much as the roof level. Transverse acceleration data at the south, center, and north locations at the second-floor level is shown in figures 7 to 9. At these locations the peak recorded accelerations are 0.11, 0.11, and 0.14 g, respectively. The recorded base acceleration at the center of the building in the transverse (east-west) direction is shown in figure 10. Here it can be seen that the peak acceleration is 0.11 g and that the duration of strong ground motion is about 7 s.

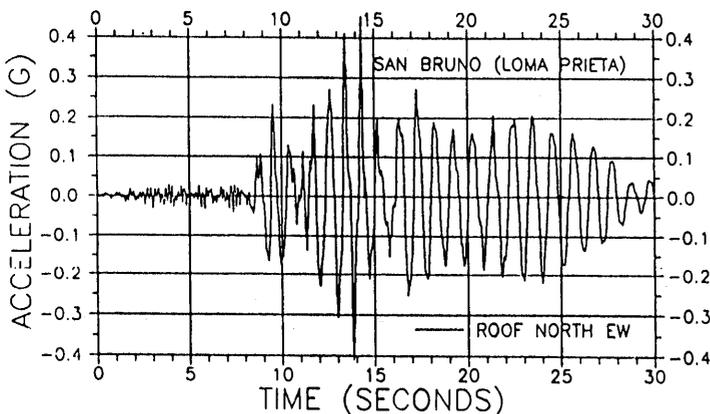
Figure 4.—Recorded acceleration, east-west, roof level, north.

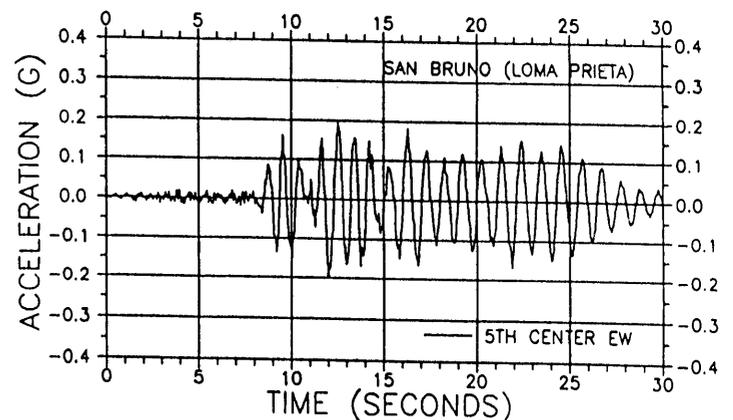
Figure 5.—Recorded acceleration, east-west, fifth level, center.

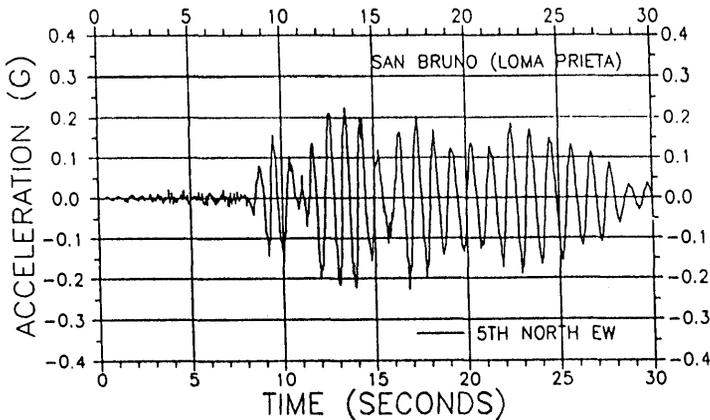
Figure 6.—Recorded acceleration, east-west, fifth level, north.

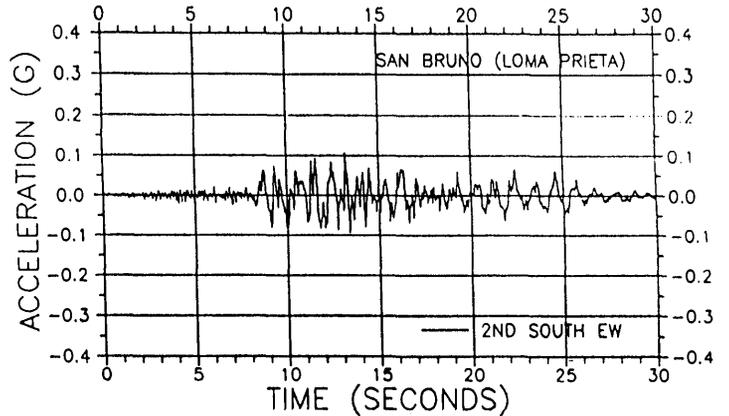
Figure 7.—Recorded acceleration, east-west, second level, south.

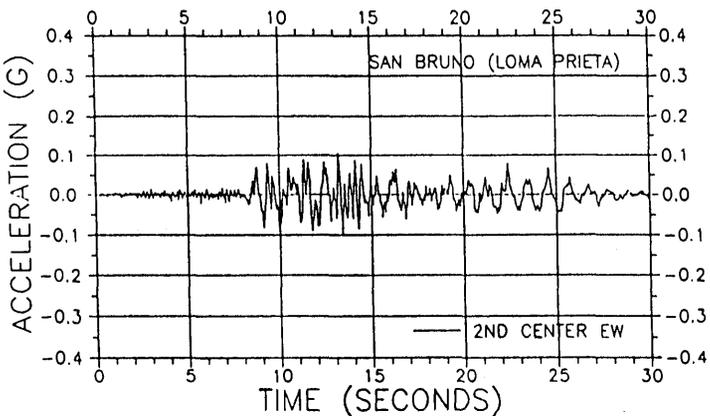
Figure 8.—Recorded acceleration, east-west, second level, center.

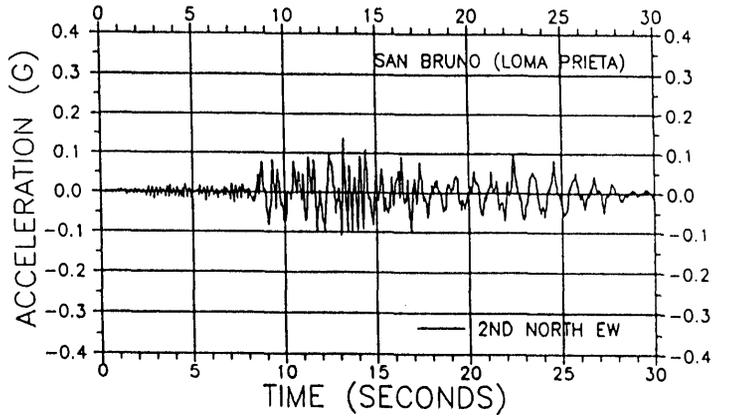
Figure 9.—Recorded acceleration, east-west, second level, north.

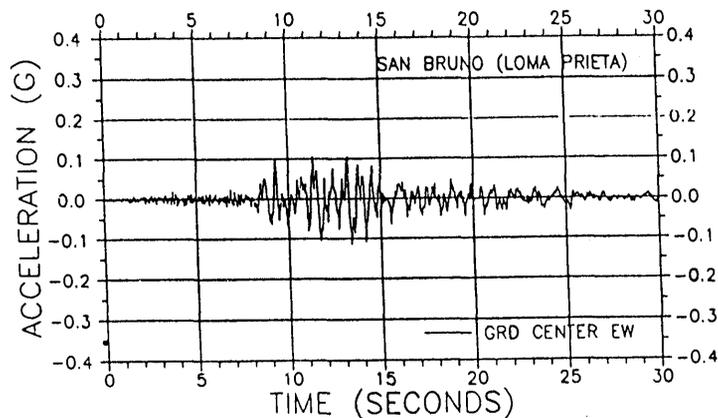
Figure 10.—Recorded acceleration, east-west, base level, center.

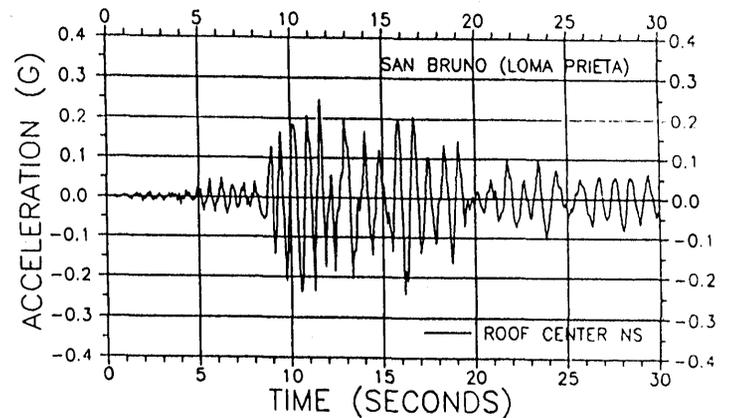
Figure 11.—Recorded acceleration, north-south, roof level, center.

In the longitudinal (north-south) direction, all recordings were from instruments located near the center of the building. The acceleration recorded at the roof level is shown in figure 11, which indicates a peak acceleration in

the longitudinal (north-south) direction of 0.25 g which compares with 0.32 g in the east-west direction. Recall that the direction of fault propagation was approximately north-south. Also, at this location, the duration of strong

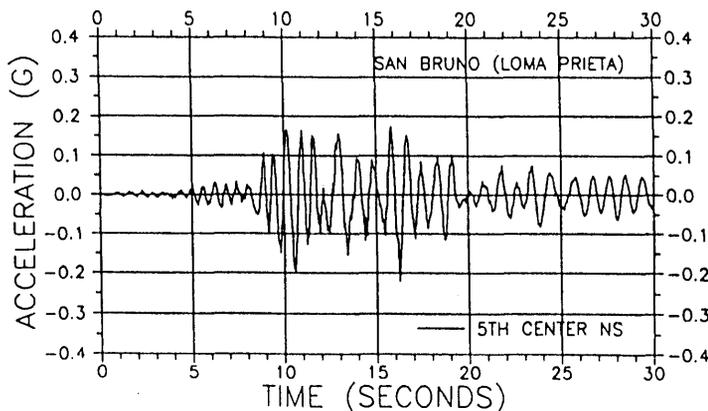
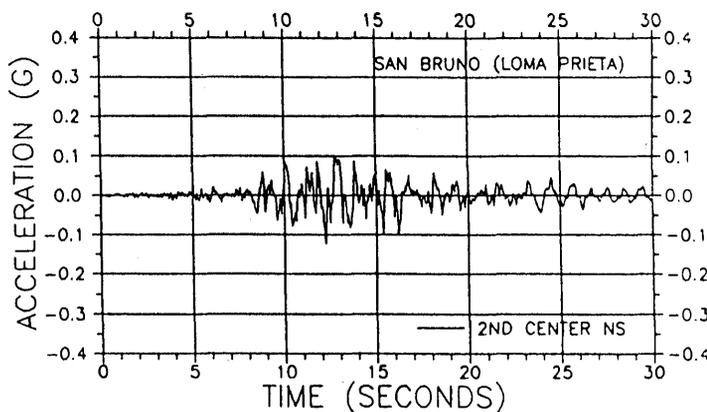
Figure 12.—Recorded acceleration, north-south, fifth level, center.

Figure 13.—Recorded acceleration, north-south, second level, center.

motion response is approximately 10 s compared with 17 s in the transverse direction. Acceleration data at the fifth and second floors is given in figures 12 and 13. The recorded base acceleration is shown in figure 14, where it can be seen that the peak acceleration is 0.14 g compared to 0.11 g transverse.

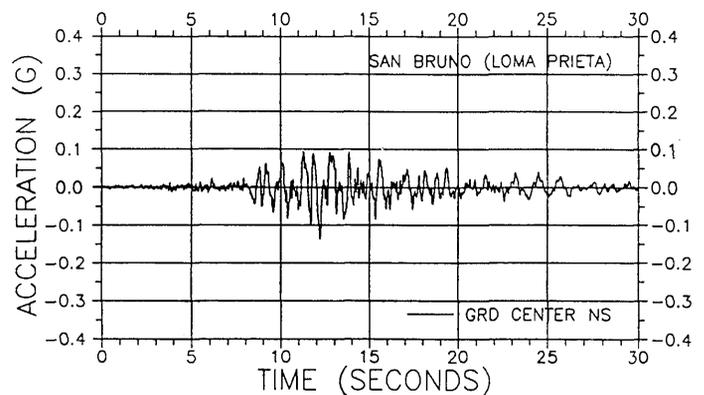
Figure 14.—Recorded acceleration, north-south, base level, center.

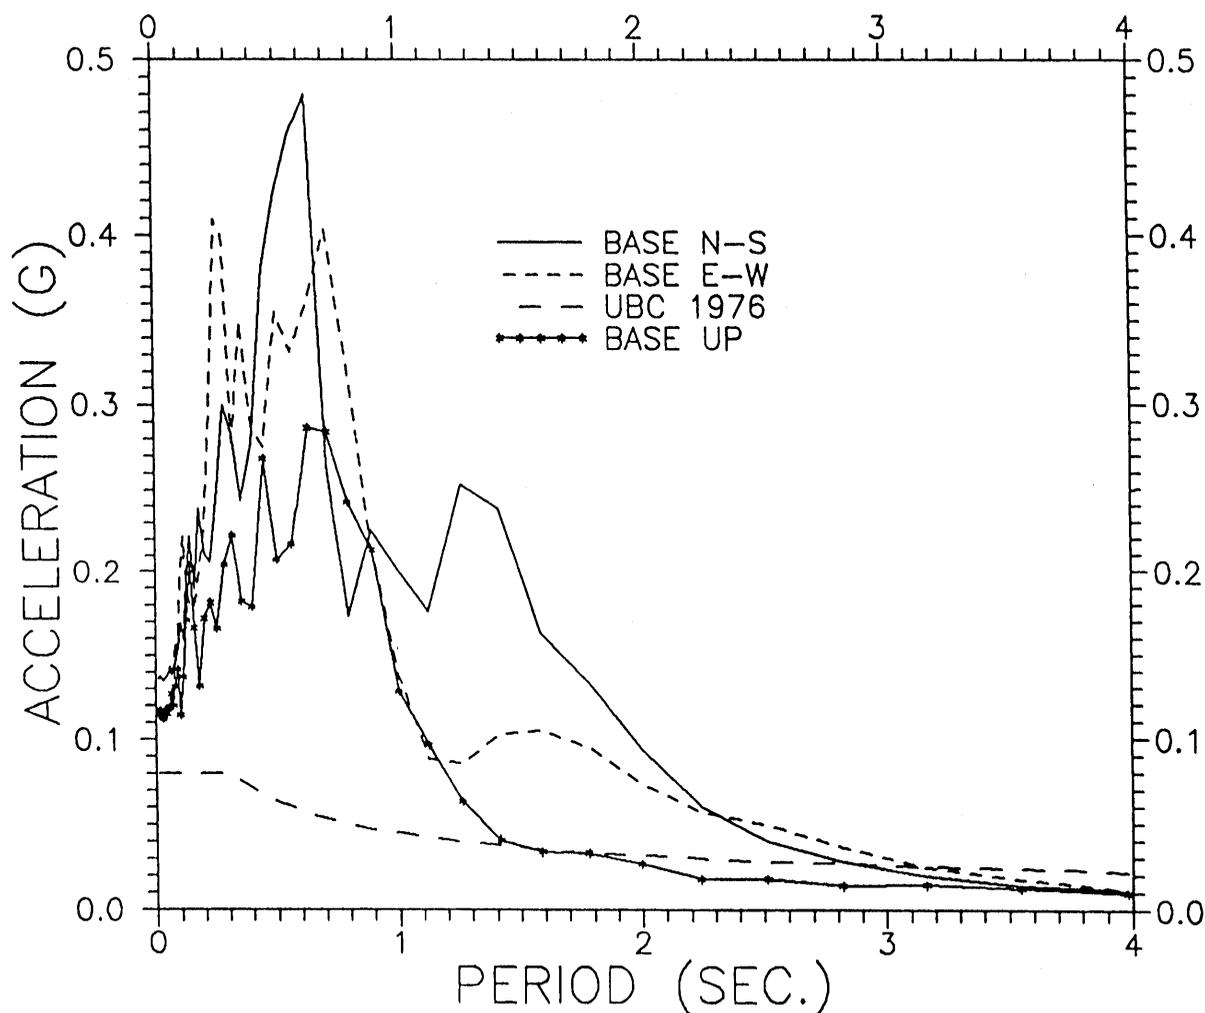
Figure 15.—Spectra of recorded motions vs. code requirement.

Linear elastic response spectra (LERS) showing the spectral accelerations for the three components of motion recorded at the base of the building are shown in figure 15 along with the acceleration spectrum of the 1976 UBC.

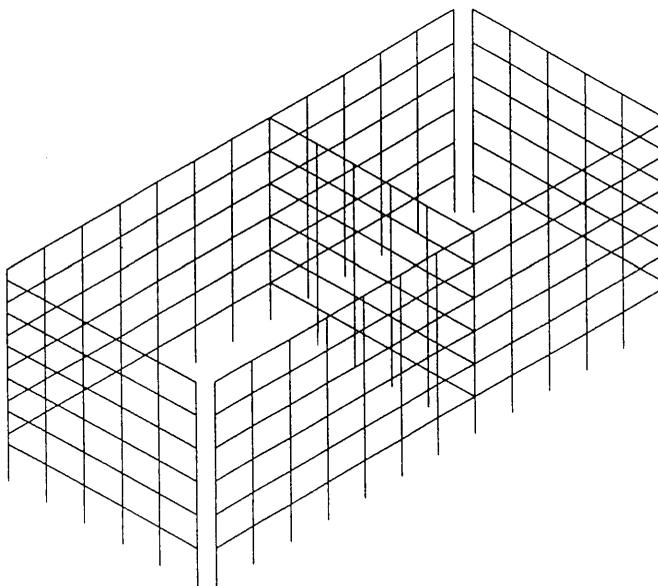
Figure 16.—Lateral force framing system.

An isometric view of the analytical model used in the SAP90 program to represent the lateral force-resisting system of the building is shown in figure 16. Here it can be seen that there are two moment resistant frames in the longitudinal direction (north-south) and three moment resistant frames in the transverse direction (east-west). The floor is modeled as a rigid diaphragm. Views of the building model used in the ETABS program are shown in figure 17. An isometric view of the ETABS model, shown in figure 17A, includes the gravity framing in addition to the lateral force framing. A plan view indicating the two basic types of frames and the location of the column lines is shown in figure 17B.

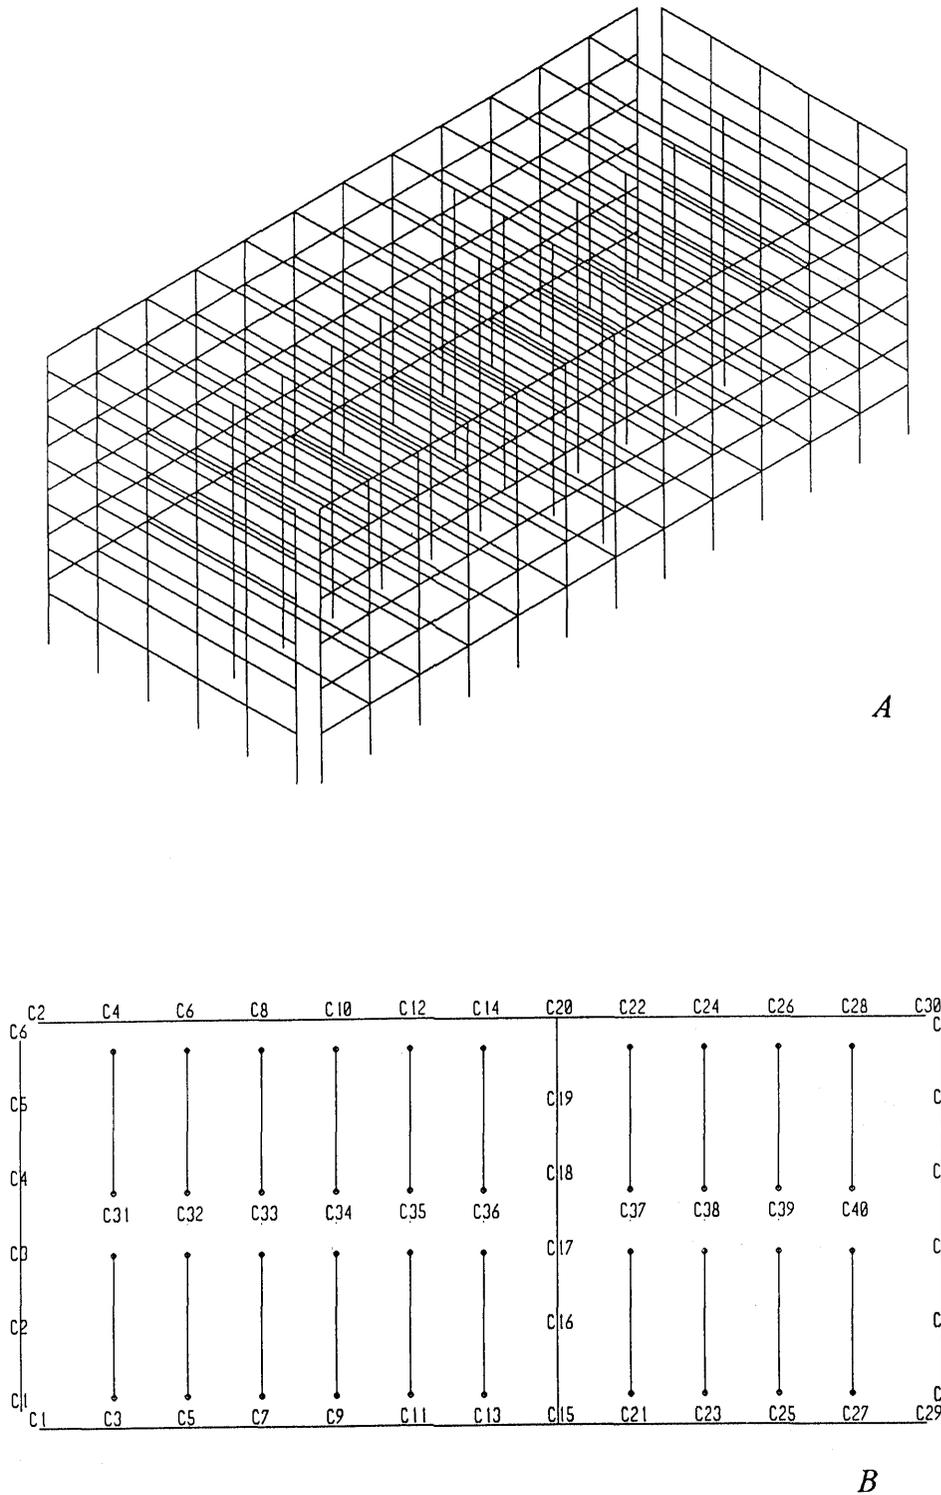
Figure 17.—Gravity and lateral force framing. A, Isometric view; B, plan view.

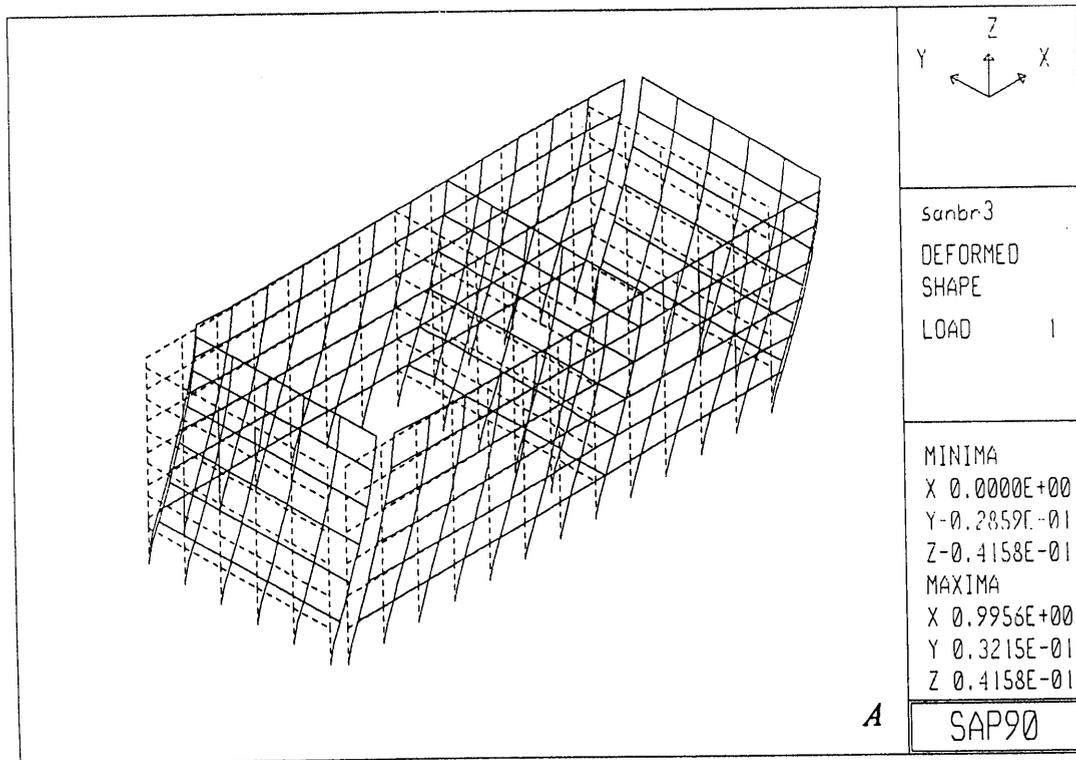
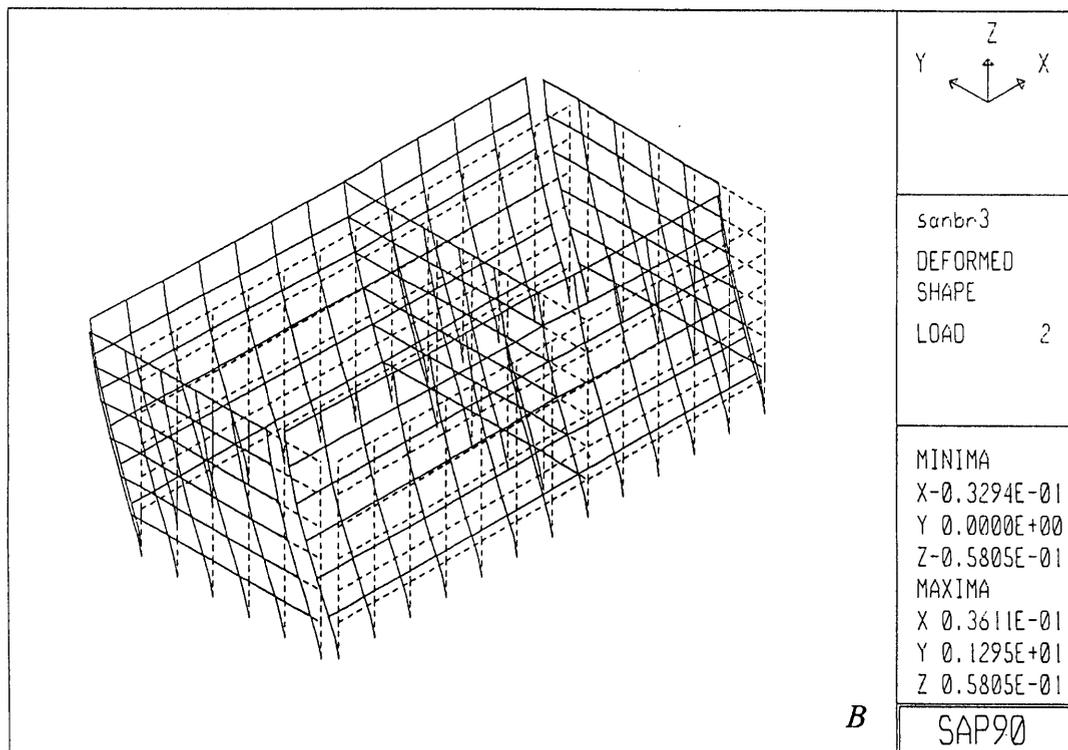
Figure 18.—Static lateral force deflections, SAP90. A, Longitudinal (north-south); B, transverse (east-west).

The static deflected shape of the building in the longitudinal (north-south) direction obtained using the SAP model with the lateral seismic loads specified in UBC76 is shown in figure 18A. Here it can be seen that the maximum deflection at the roof level is almost 1 inch. A similar plot showing the deflected shape in the transverse (east-west) direction is presented in figure 18B. In this direction the maximum deflection is seen to be 1.3 inches.

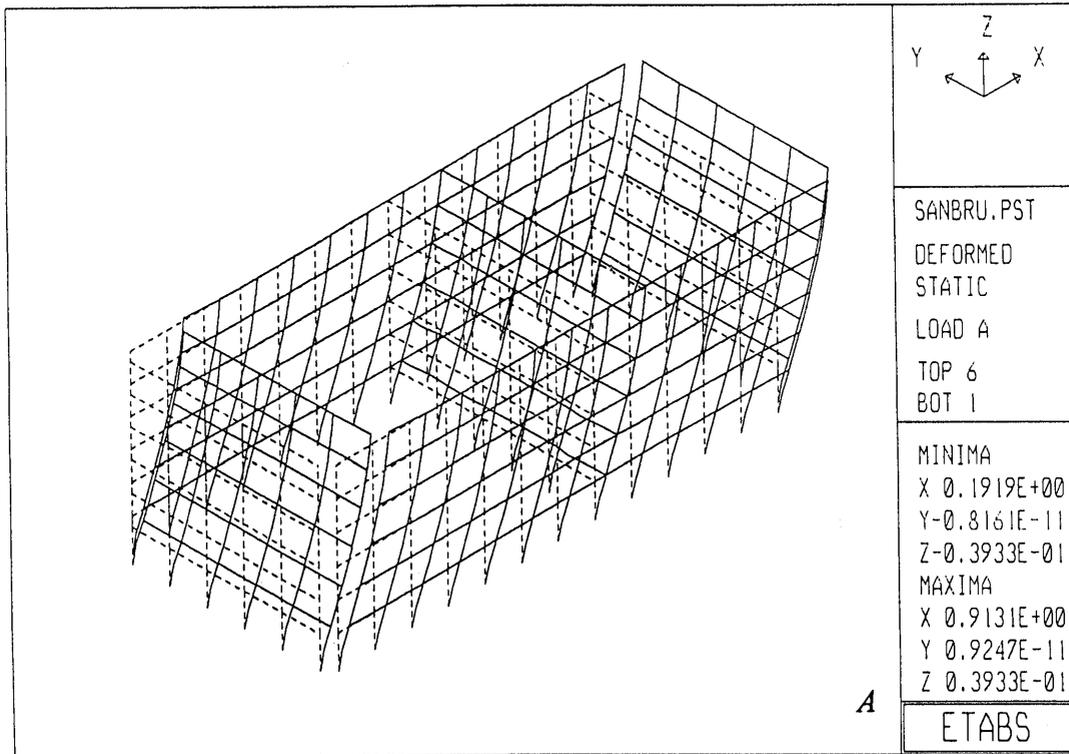
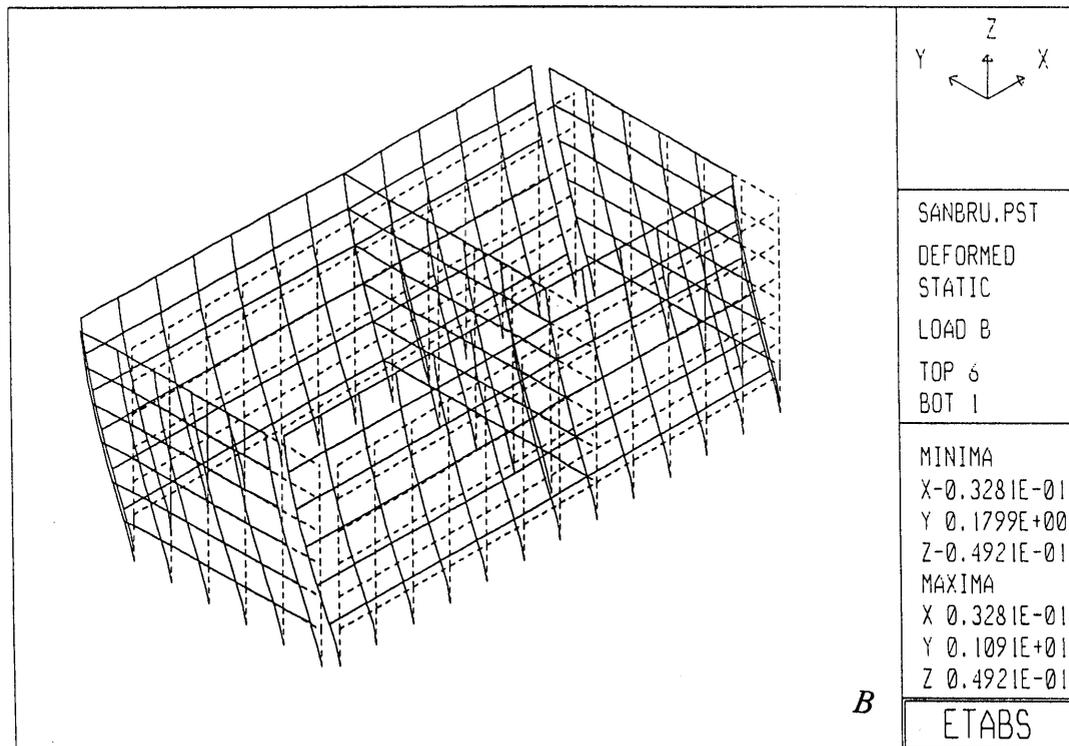
Figure 19.—Static lateral force deflections, ETABS. A, Longitudinal (north-south); B, transverse (east-west).

The static deflected shapes obtained using the ETABS program and the code lateral loads are shown in figure 19. The deflected shape in the north-south direction is shown in figure 19A and the static deflected shape in the east-west direction is shown in figure 19B. Comparing the results shown in figure 19 with those shown in figure 18 indicates the following: (1) The roof deflection in the longitudinal direction calculated using the SAP90 model

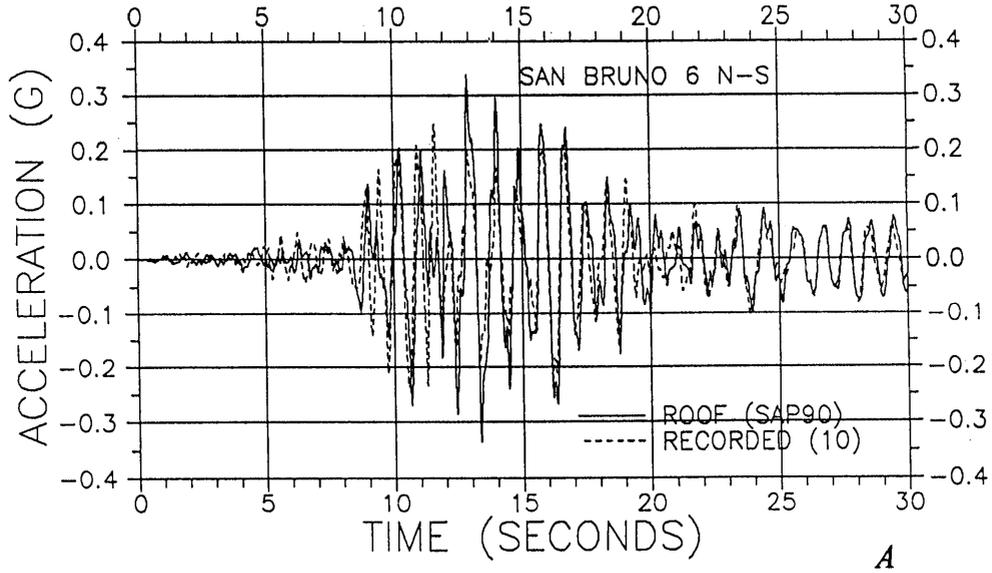
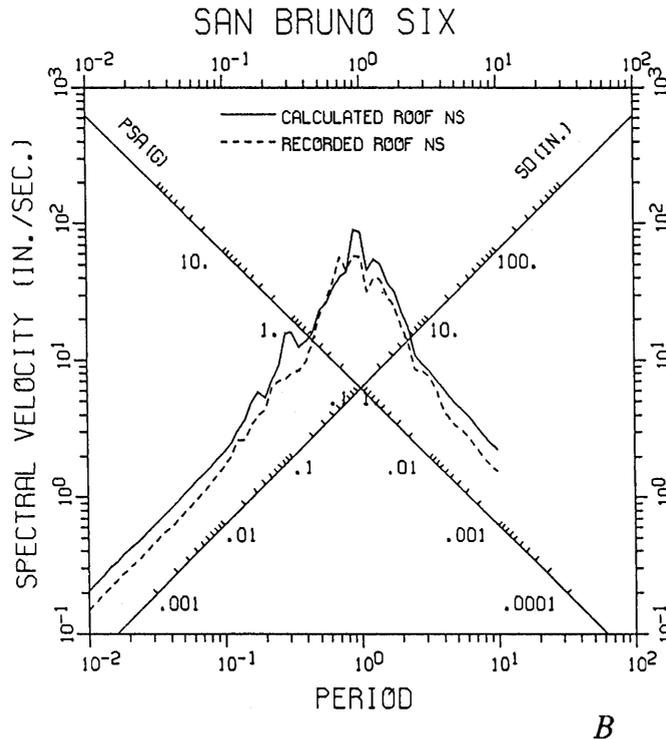
Figure 20.—Roof response, north-south. A, Calculated vs. recorded accelerations; B, calculated vs. recorded LERS.

The time-history of the accelerations recorded at the roof level in the north-south direction near the center of the building are compared with the calculated values in figure 20A. Here the match with the frequency is quite good; however, the amplitudes of the calculated values tend to exceed the recorded values for a couple of cycles in the 10- to 15-s region of the time-history. The corresponding response spectra are shown in figure 20B. Here it can be seen that the spectra obtained from the calculated accelerations tends to fall above that of the recorded accelerations over much of the period range but the difference is not large.

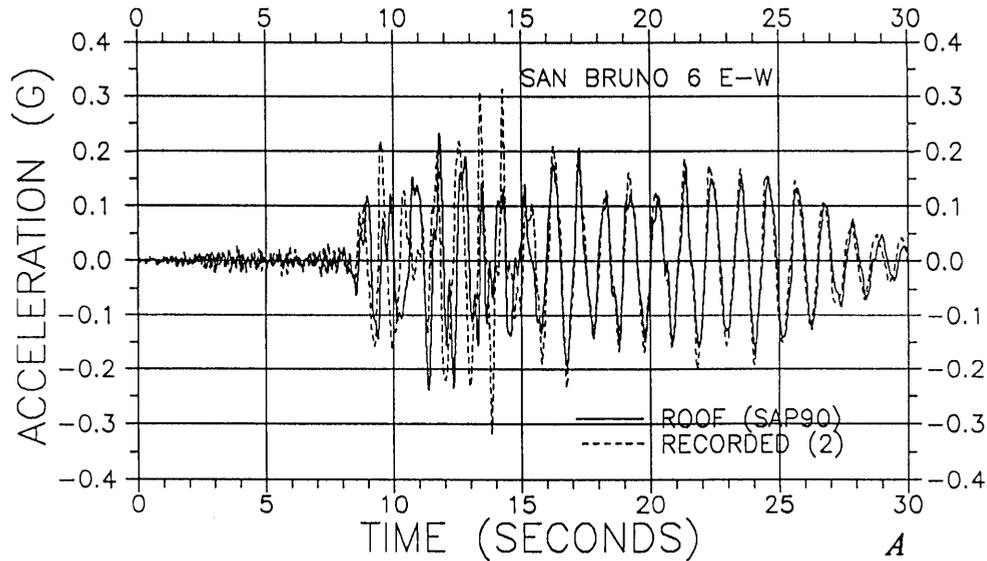
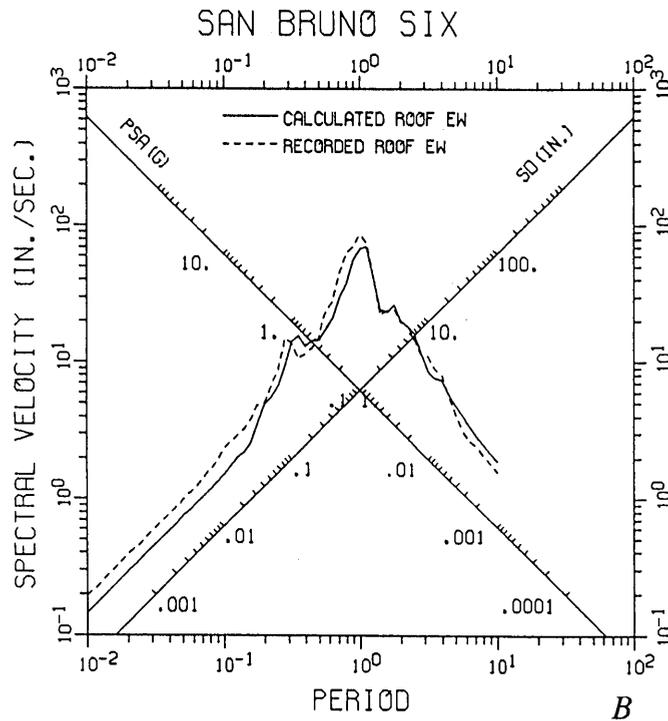
Figure 21.—Roof response, east-west. A, Calculated vs. recorded accelerations; B, Calculated vs. recorded LERS.

Similar comparisons in the east-west direction are shown in figure 21. The time histories are shown in figure 21A, where it can be seen that in this direction, the recorded values tend to exceed the calculated values during a couple of cycles in the 10- to 15-s time period. The corresponding spectra are shown in figure 21B where the spectral values for the recorded response tend to fall above the calculated values. A similar pattern to that just described for the roof level is seen in the data for the fifth floor, which is presented in figure 22 (north-south) and figure 23 (east-west), and for the second floor, which is presented in figure 24 (north-south) and figure 25 (east-west).

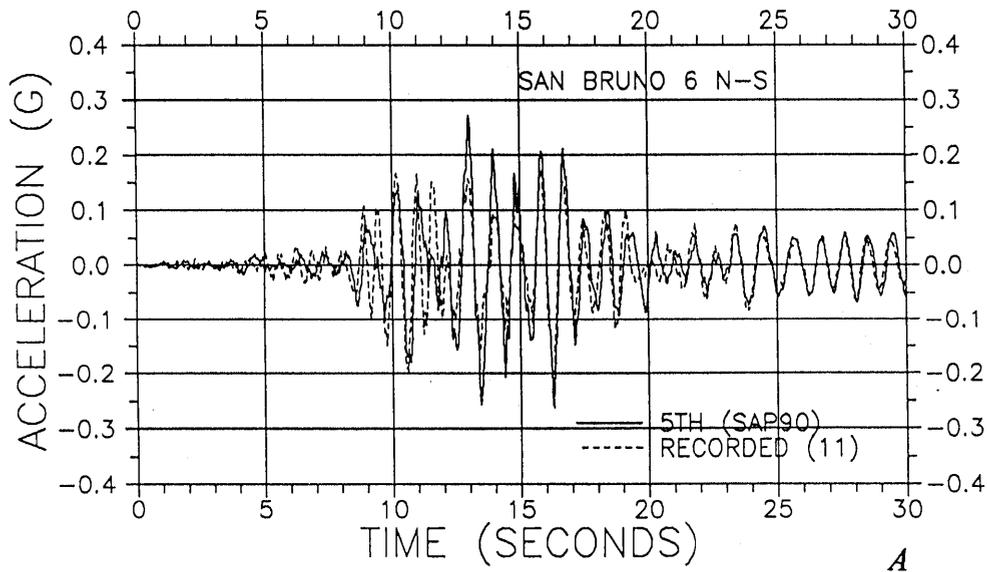
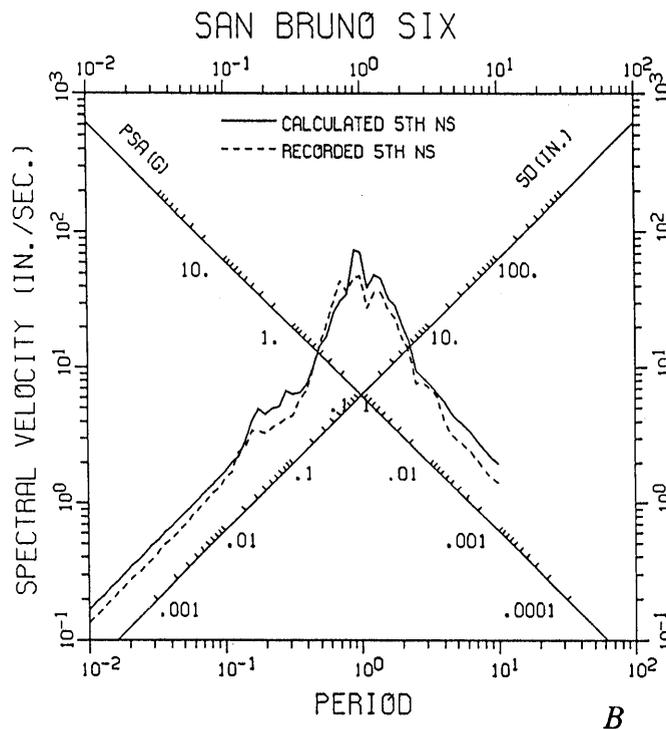
Figure 22.—Fifth floor response, north-south. A, Calculated vs. recorded accelerations; B, calculated vs. recorded LERS.

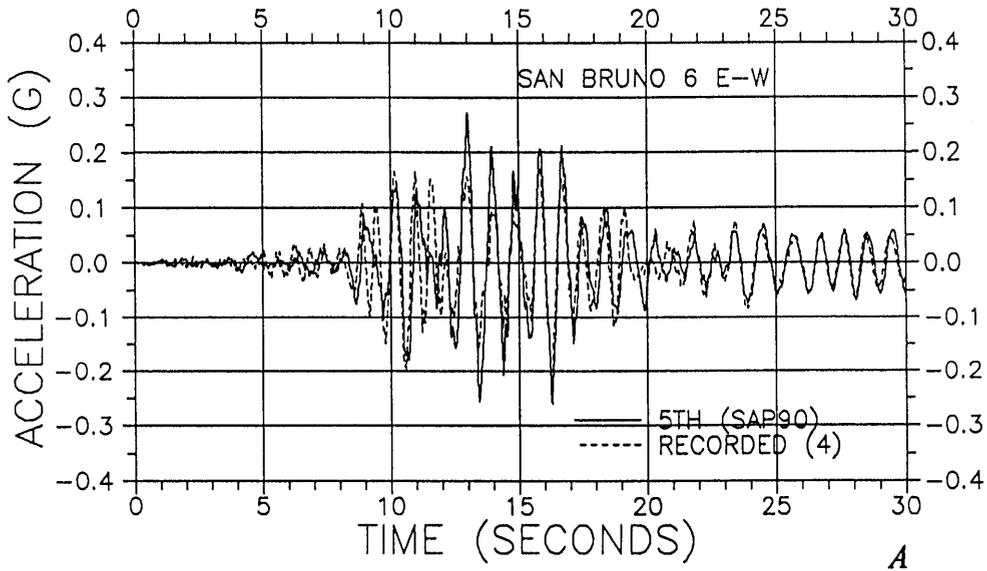
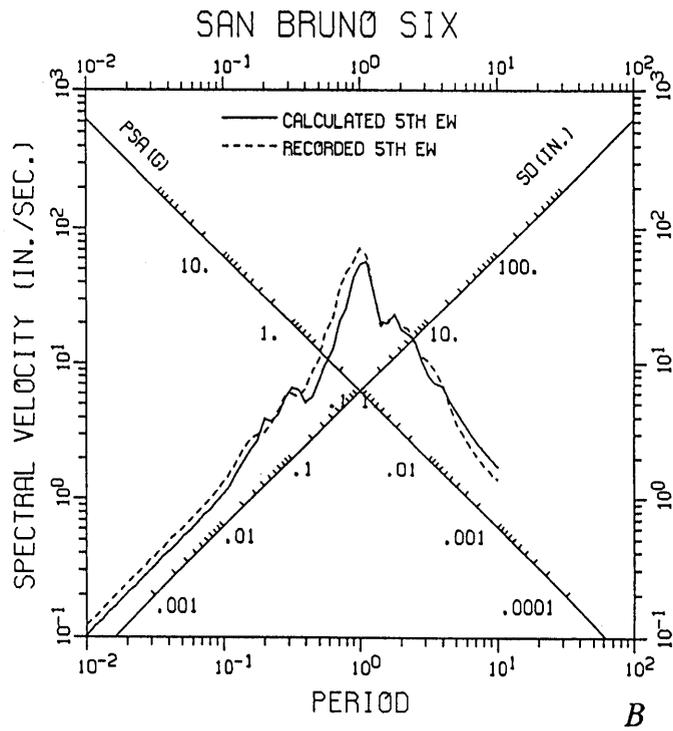
Figure 23.—Fifth floor response, east-west. A, Calculated vs. recorded accelerations; B, calculated vs. recorded LERS.

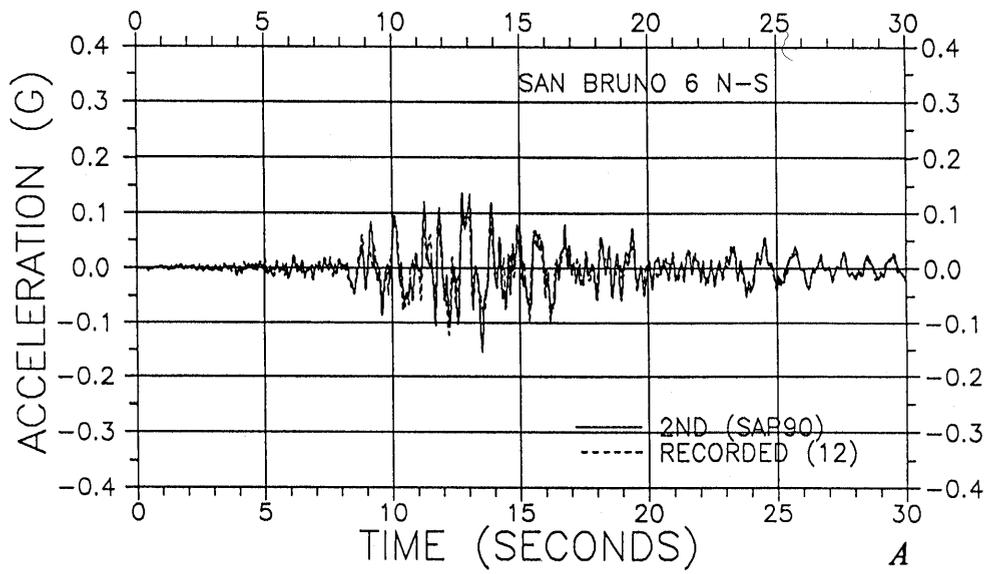
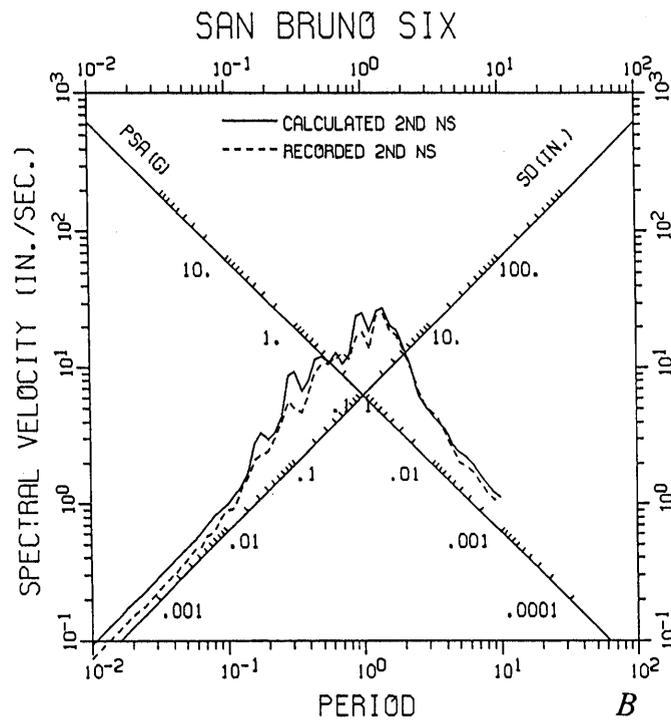
Figure 24.—Second floor response, north-south. A, Calculated vs. recorded accelerations; B, calculated vs. recorded LERS.

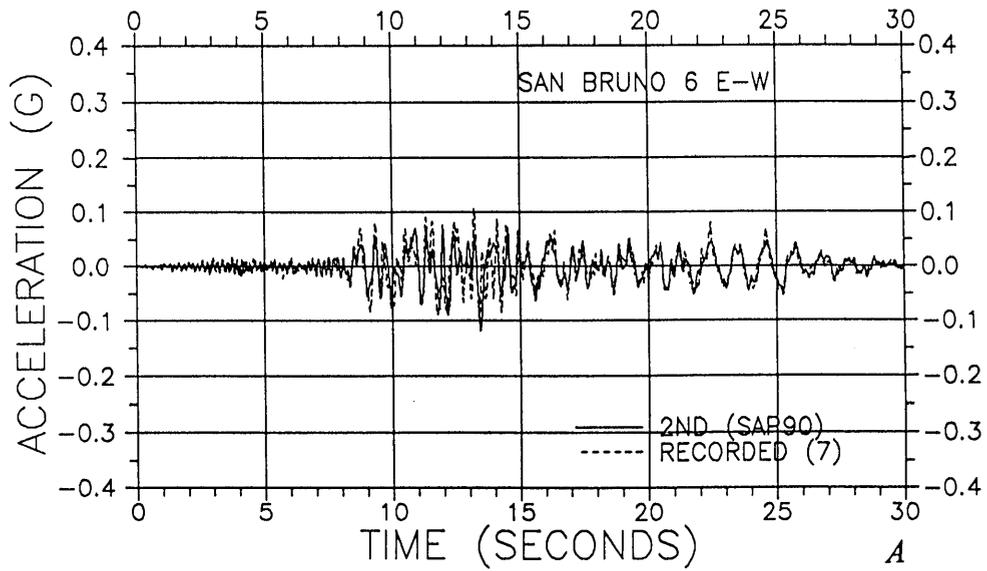
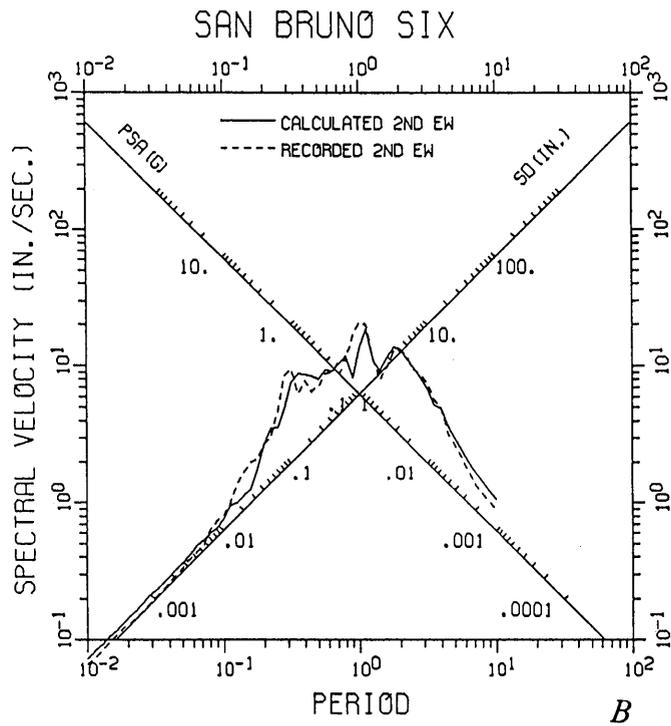
Figure 25.—Second floor response, east-west. A, Calculated vs. recorded accelerations; B, calculated vs. recorded LERS.

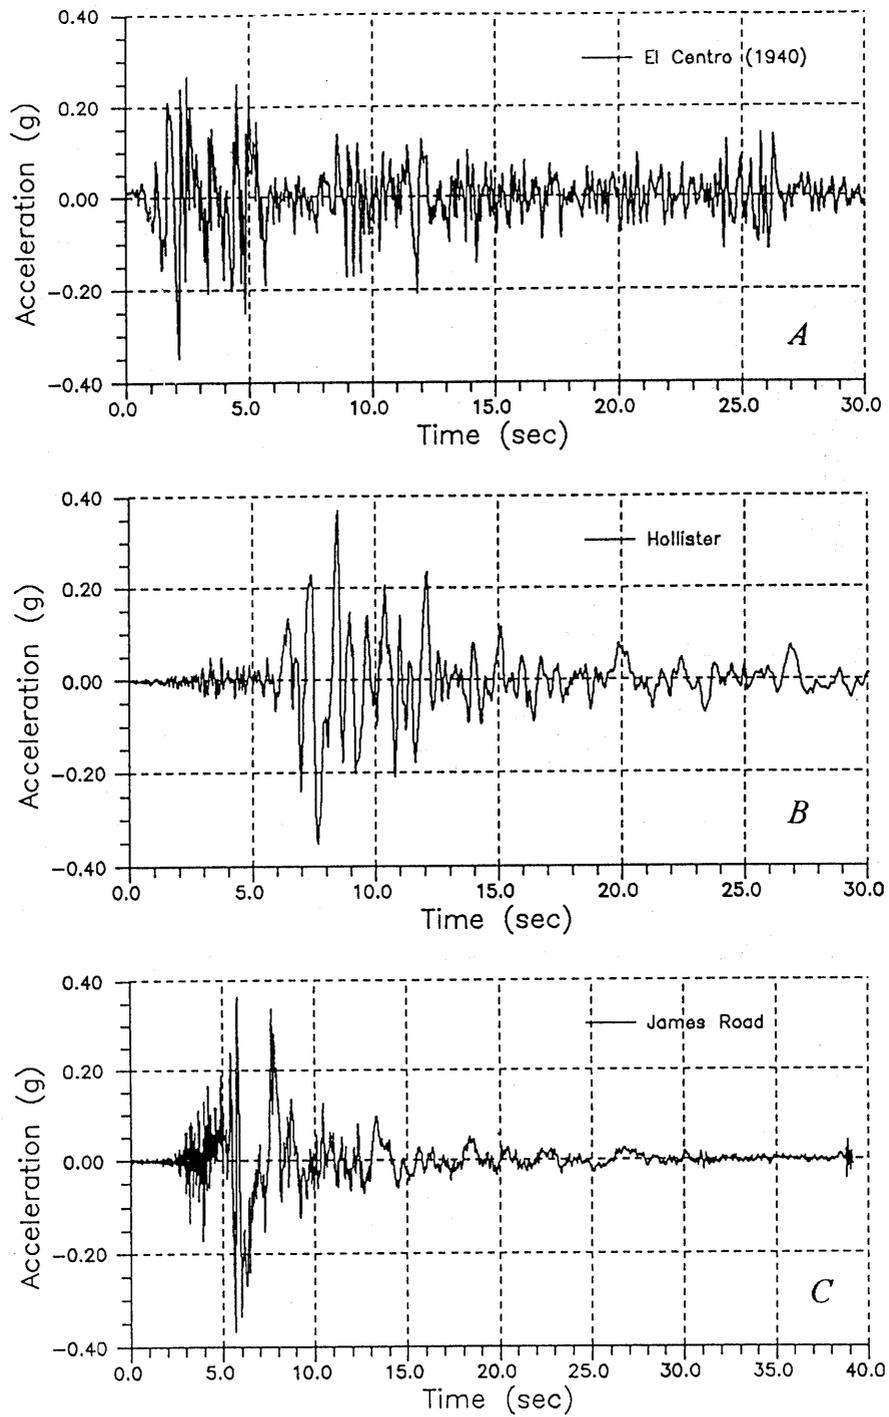
Figure 26.—Recorded free field ground motions. A, *El Centro*, 1940; B, *Hollister*, 1989; C, *James Road*, 1979.

histories for these three ground motions are shown in figure 26. Elastic response spectra for these three motions for 5 percent of critical damping are given in figure 27.
