The Loma Prieta, California, Earthquake of October 17, 1989—Building Structures

U.S. GEOLOGICAL SURVEY PROFESSIONAL PAPER 1552-C

BUILDING STRUCTURES

INTRODUCTION

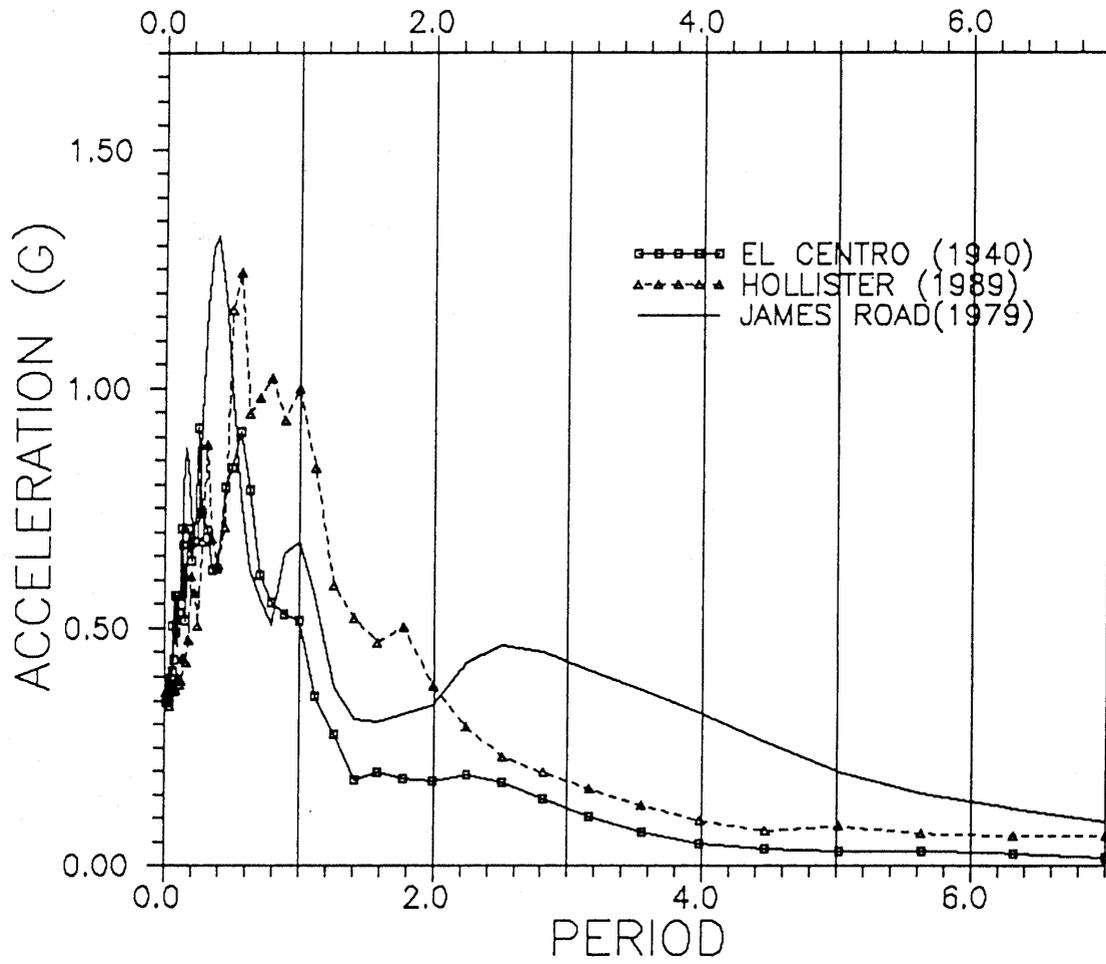
Figure 27.—Spectra of free field motions. A, *El Centro*, 1940; B, *Hollister*, 1989; C, *James Road*, 1979.

histories for these three ground motions are shown in figure 26. Elastic response spectra for these three motions for 5 percent of critical damping are given in figure 27.

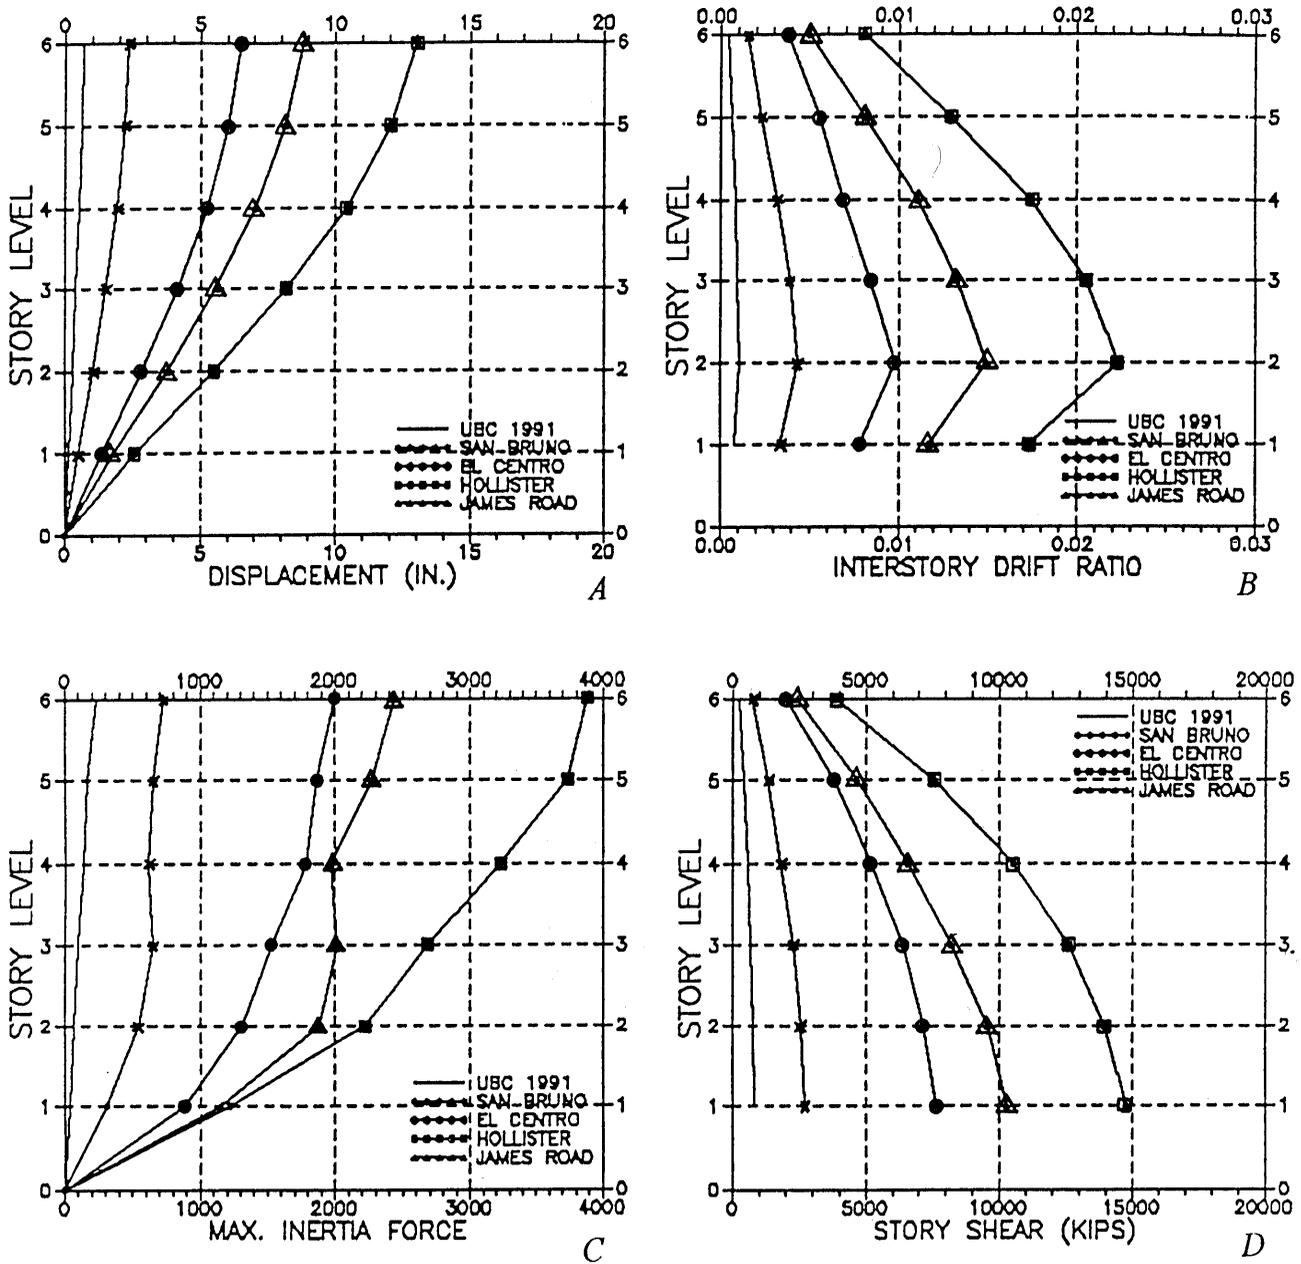
Figure 28.—Maximum response envelopes, transverse. A, Lateral displacement; B, interstory drift index; C, inertia force; D, story shear.

shear. Comparisons are made between the static analysis for UBC 1991 lateral forces and the dynamic response analyses for the four earthquake ground motions. The response envelopes in the transverse (east-west) direction are shown in figure 28, and those for the longitudinal (north-south) direction are shown in figure 29.

The envelopes of maximum lateral displacement, shown in figure 28A, indicate that the displacement due to the recorded base motions is 2.35 inches compared to the 0.68 inches due to code loads, a factor of 3.4 larger. The largest displacement is due to the Hollister motion and has a value of 13 inches at the roof. The envelopes of interstory drift index are shown in figure 28B. Under the recorded motion, the maximum drift occurs at the second story level and reaches a value of 0.4 percent; however, a drift of more than 2 percent occurs at the second story level under the Hollister ground motion. This amount of drift would certainly cause damage to both structural and nonstructural components.

The lateral inertia forces specified by the code are compared with those developed during the four time-history analyses in figure 28C. Here it can be seen that the forces developed at the building, based on the recorded base motion, are more than three times larger than those used for the design. In the case of the Hollister ground motion, the forces at the top of the structure are almost 20 times larger than the code values. The envelopes of maximum story shear are shown in figure 28D. Here it can be seen that the story shears developed during the Loma Prieta earthquake are 2.7 times larger than the code values. As in the previous response parameters, the Hollister motion develops a significant increase in the base shear which is 20 times the code values.

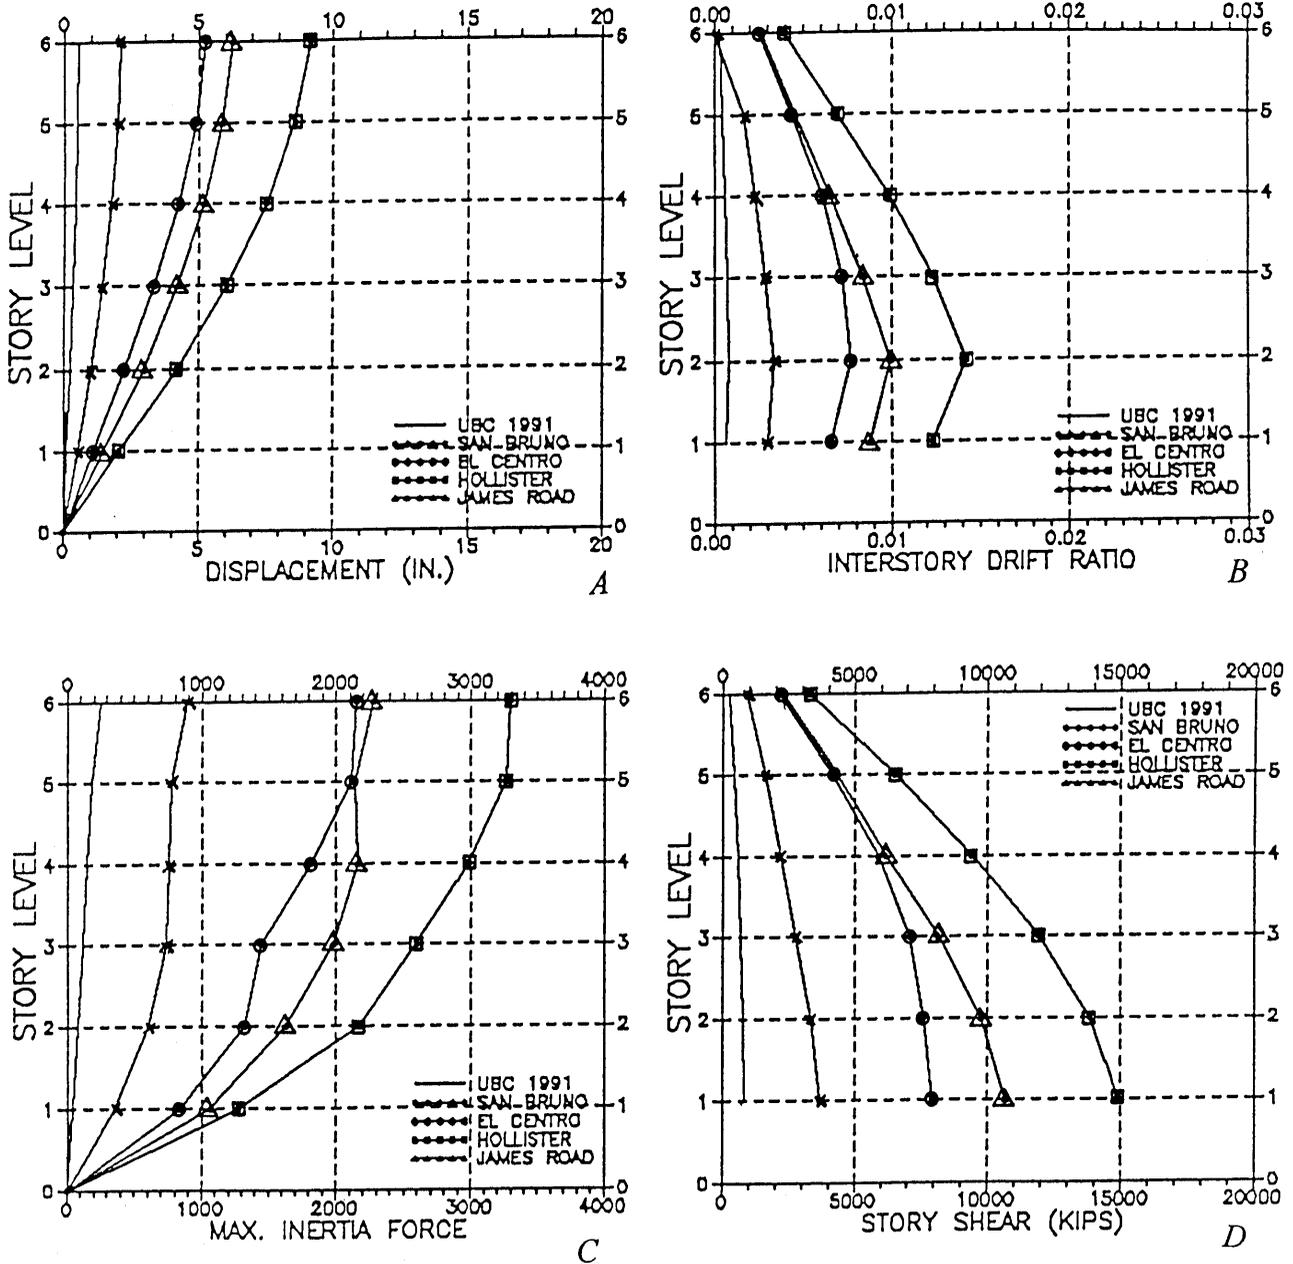
Figure 29.—Maximum response envelopes, longitudinal. A, Lateral displacement; B, interstory drift index; C, inertia force; D, story shear.

The response envelopes for the north-south (longitudinal) direction are shown in figure 23. The envelopes of maximum lateral displacement (fig. 23A) are similar to those just discussed for the transverse direction. In this case, the displacements due to the design spectrum ex-

ceed those due to the CCSF code over the height of the structure, and both of these exceed the displacements due to the recorded base motions. The displacement at the roof level due to the Hollister ground motion exceeds that due to the design spectrum by a factor of 1.9, which is slightly less than in the transverse direction. The envelopes of IDI are shown in figure 23B. The values due to the recorded base motions are less than those due to the design spectrum over the height of the structure; how-

ever, they do exceed those due to the CCSF code in the upper 10 floors. The IDI due to the Hollister motions is considerably larger than those due to either the design spectrum or the recorded base motions.

The envelopes of maximum inertia force are shown in figure 23C. As before, the forces specified in the CCSF code represent minimum values. It is interesting to note

that the inertia forces due to the recorded base motion exceed those due to the design spectrum between floors 26-33. The forces due to the Hollister motions exceed all others by a substantial margin. The envelopes of story shear (fig. 23D) indicate that the shears due to the recorded motions are less than those due to the design spectrum over the total building height. This indicates

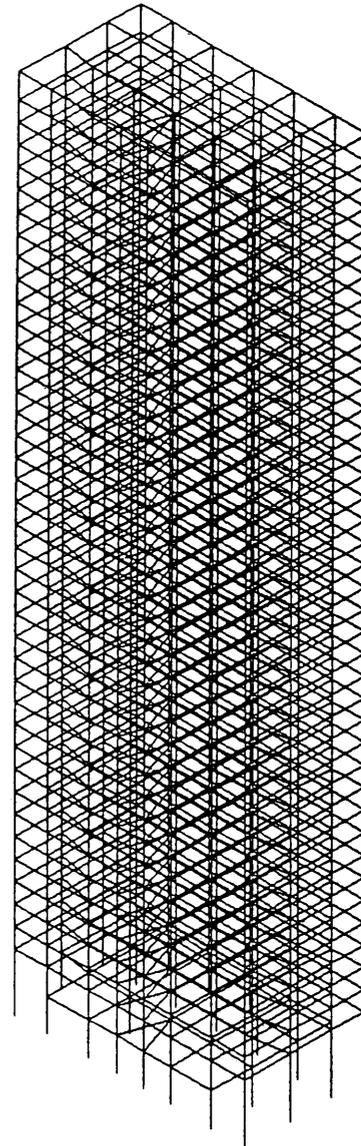
Figure 1.—Schematic plan of 42 story building.

The building is supported on 491 precast concrete piles which are 16 inches square. Pile groups consisting of 13 to 25 piles are located under the 29 column lines. Pile groups are capped by concrete pile caps which are 78 to 84 inches thick. The 29 pile groups are interconnected by concrete tie beams which are typically 24 by 27 inches. An isometric view of the three-dimensional computer model of the building used for the elastic analyses is shown in figure 1.

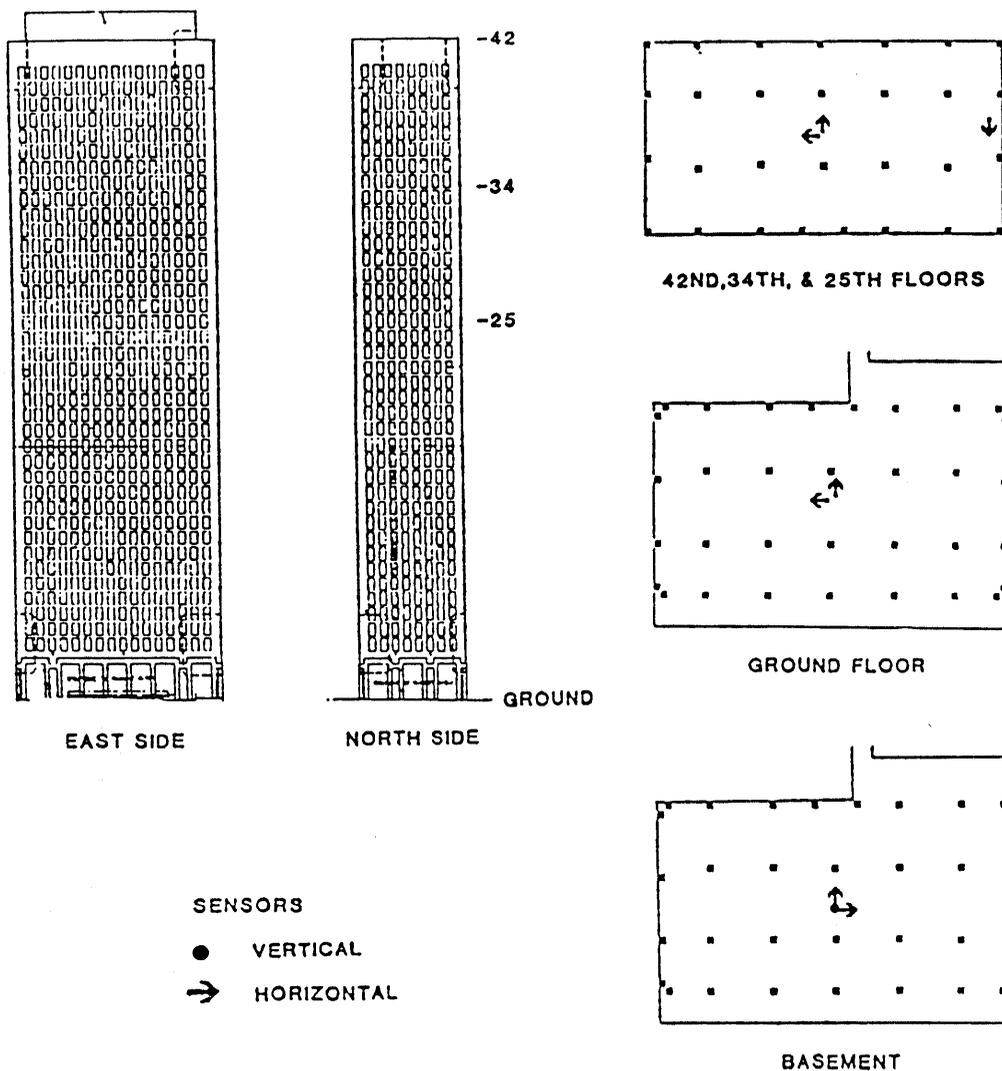
Figure 2.—Instrument locations in building.

At the time of the earthquake, the building was instrumented with 14 strong-motion accelerometers located at the base, ground, 25th, 34th, and 42d levels. Each of these levels included a longitudinal and transverse component

located at the geometric center of the tower. In addition the base included a vertical component, and the 25th, 34th, and 42d floors included a transverse component at the end of the tower. Unfortunately, no vertical-motion accelerometers are located in the building, which would have permitted the effect of vertical ground motion to be evaluated. The location of the instrumentation is summarized in figure 2.

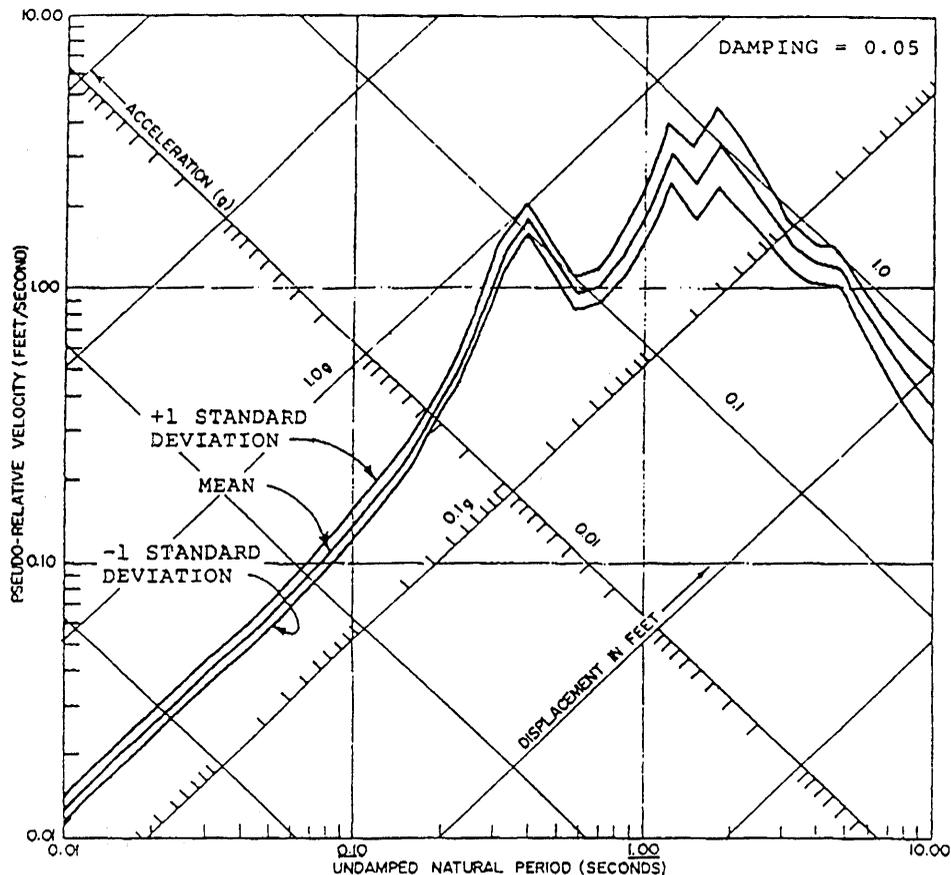
Figure 3.—Site specific design spectra for building.

In addition, the owner and the structural engineer decided to use a site-specific design spectrum and a dynamic analysis to determine the lateral design forces. The design criteria required that the structural frame should withstand the lateral forces due to the base design spectrum with stresses less than the yield stress. The design earthquake was specified as having an effective peak acceleration on rock of 0.2 g, which was considered representative of an M=7 earthquake on either the San Andreas or Hayward fault systems. This design earthquake led to the development of a site-specific spectrum representative of rock motions. The rock spectrum was further modified to reflect the effect of local soil conditions using the methods suggested by Ruiz and Penzien (1969). This led to the development of the base design spectrum (fig. 3) which was used for the design of the structure. The use of this spectrum resulted in design base shears of 3,469 kips longitudinal (north-south) and 3,996 kips transverse (east-west). It must be recognized that the CCSF code

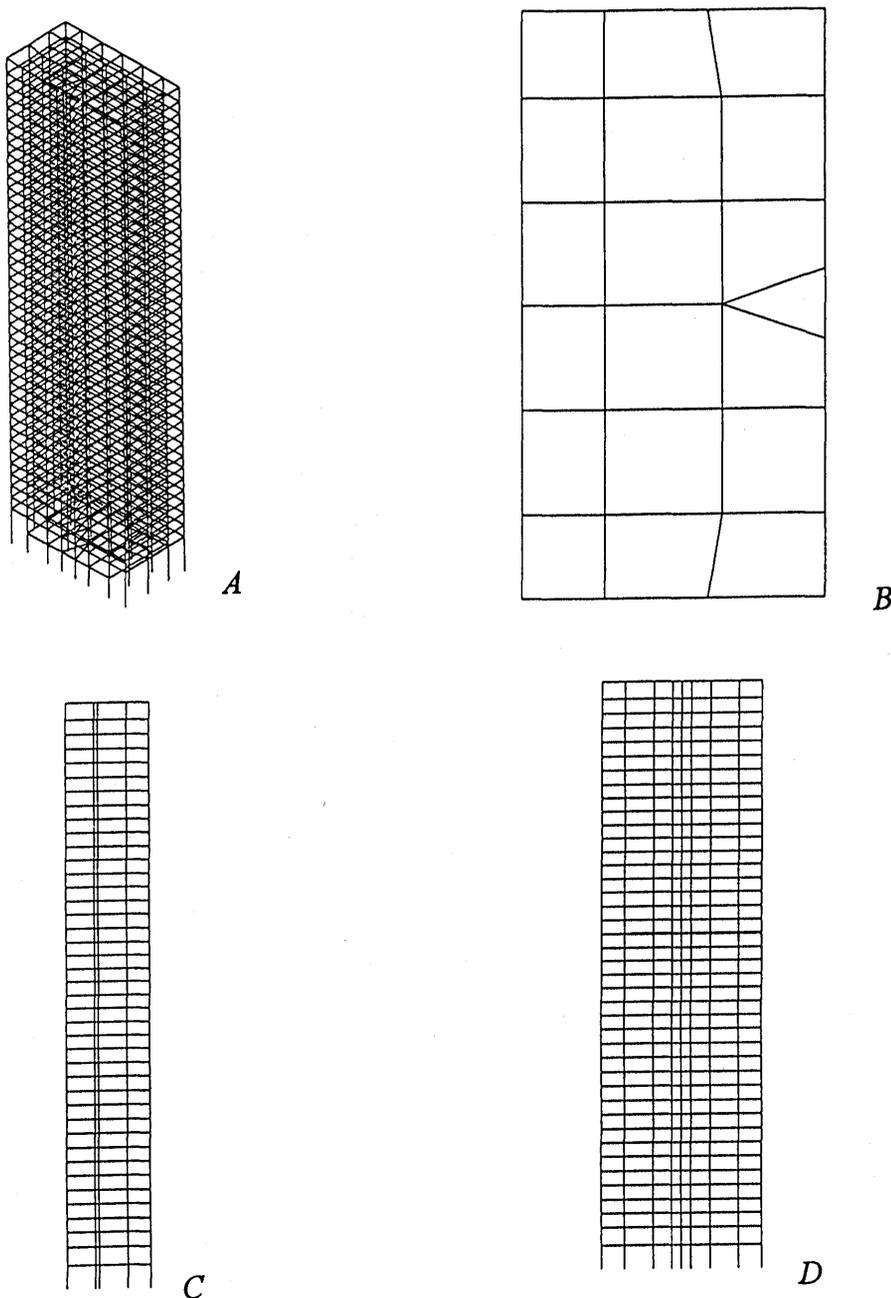
Figure 4.—Building configuration: isometric view (A); plan view (B); transverse elevation (C); longitudinal elevation (D).

freedom is shown in figure 4. An overall isometric view is shown in figure 4A and a plan view is shown in figure 4B. This view shows that the structure is symmetrical about the transverse axis but has some nonsymmetry in the stiffness about the longitudinal axis. An elevation view in the transverse (east-west) direction is shown in figure 4C and an elevation view in the longitudinal (north-south) direction is shown in figure 4D

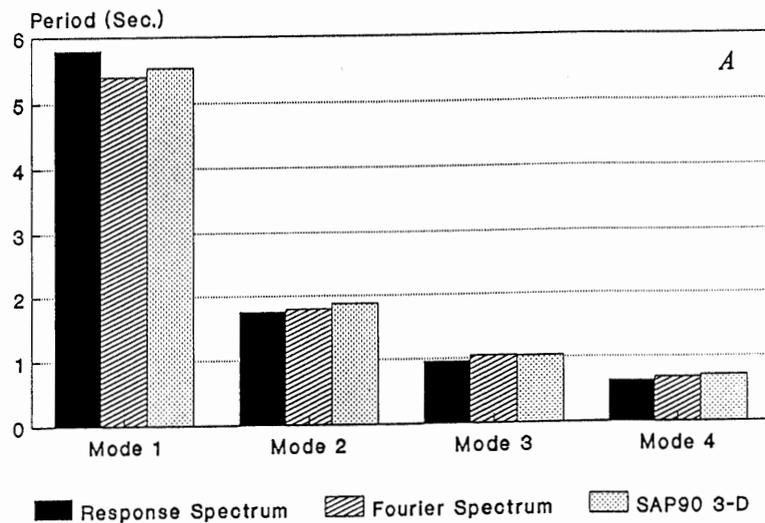
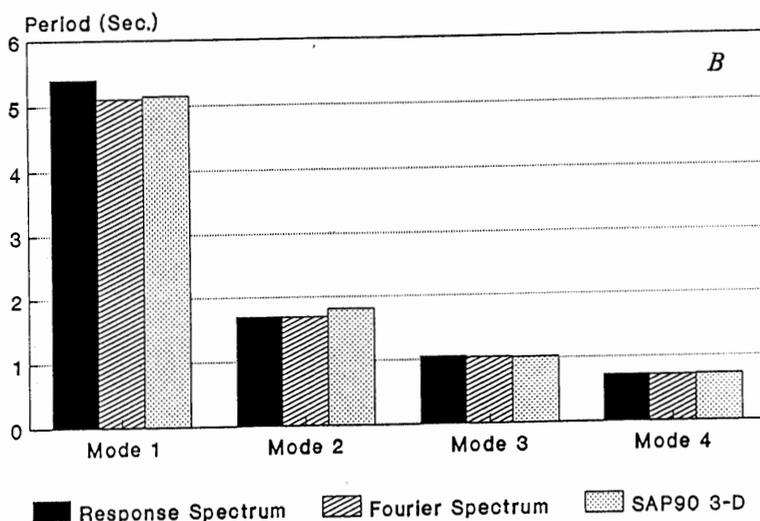
Figure 5.—Identified and calculated periods of vibration: transverse (east-west) direction (A); longitudinal (north-south) direction (B).

In order to determine the periods of vibration from the recorded data, analyses are conducted in both the time and frequency domains. The recorded responses are evaluated in the time domain using a linear elastic-response spectra with 5 percent of critical damping. Analyses in the frequency domain are done using nonparametric time invariant and nonparametric time variant system-identification techniques. The modal periods identified from the recorded data are compared with the calculated values in figure 5. Periods for the transverse direction are compared in figure 5A and periods for the longitudinal direction in figure 5B.

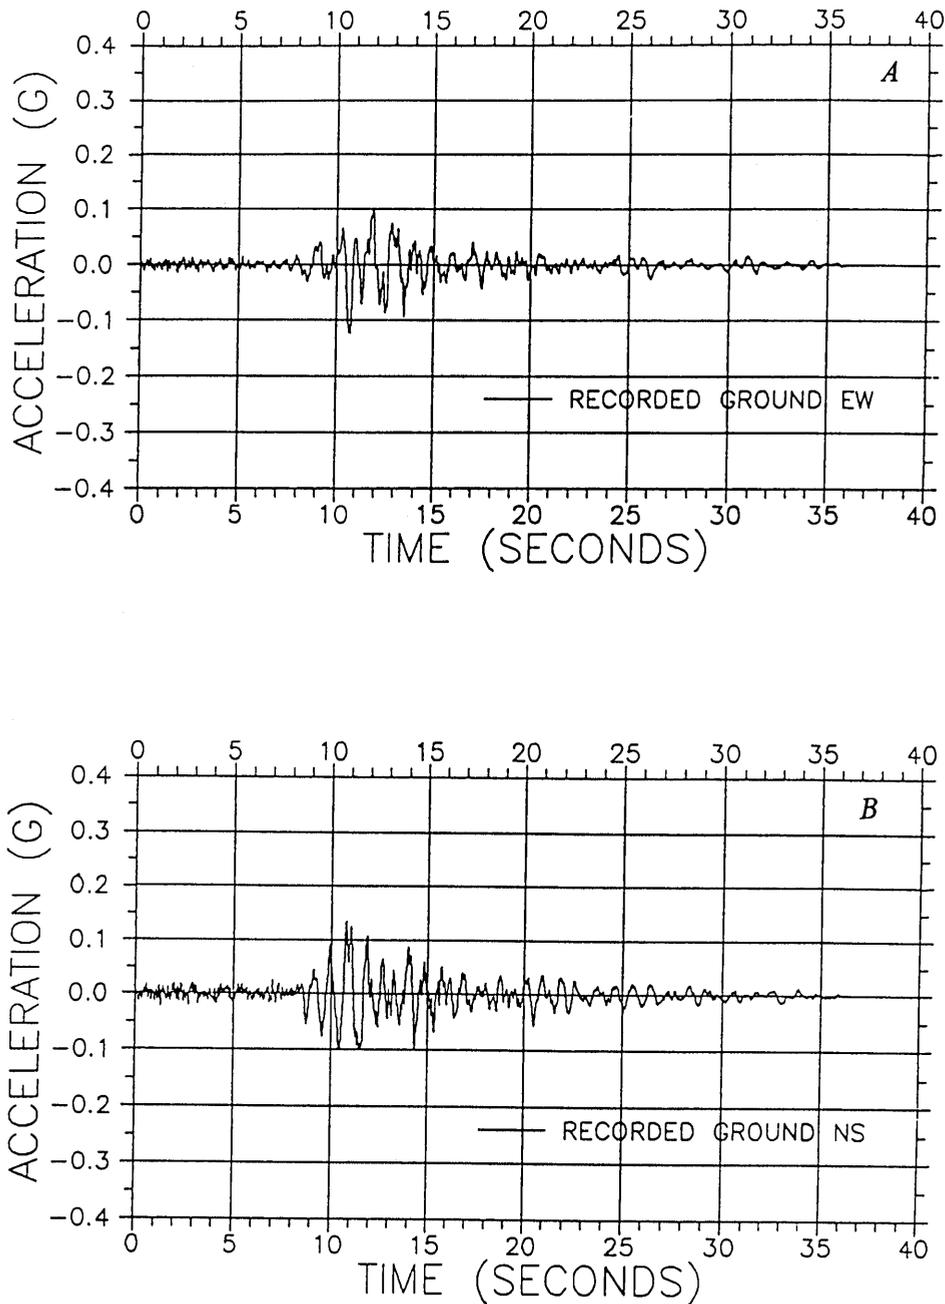
Figure 6.—Recorded base motion (ground level).

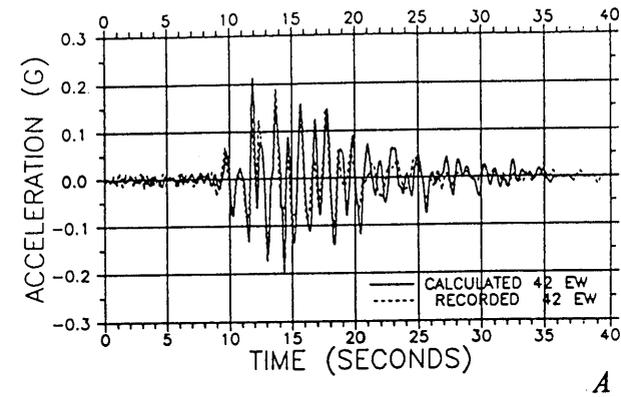
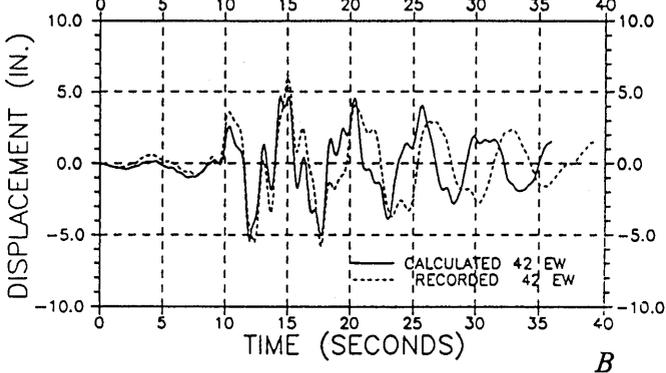
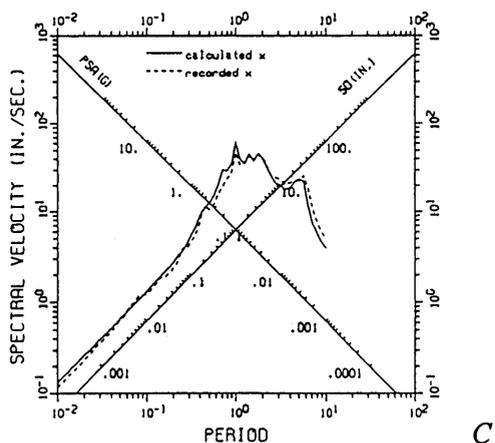
Figure 7.—Recorded response vs. calculated, 42d level, east-west.

The data recorded at the 42d level in the east-west (transverse) direction are compared with the calculated results in figure 7. It can be seen in figure 7A that the maximum calculated acceleration (0.21 g) is slightly larger than the recorded value (0.19 g); however, the frequency match is very good. The comparison of displacements (fig. 7B)

shows that the maximum calculated displacement is 5.5 inches versus 5.8 inches recorded. Here the frequency match is good for the first 20 seconds, and beyond that point the period of the recorded values appears to lengthen. Considering the floor spectra (fig. 7C) the comparison is good over the entire period range.

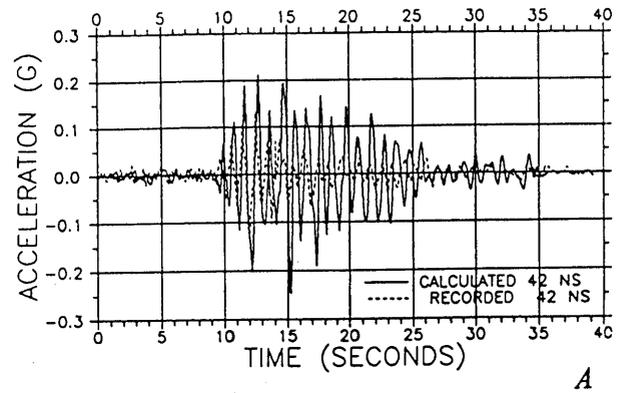
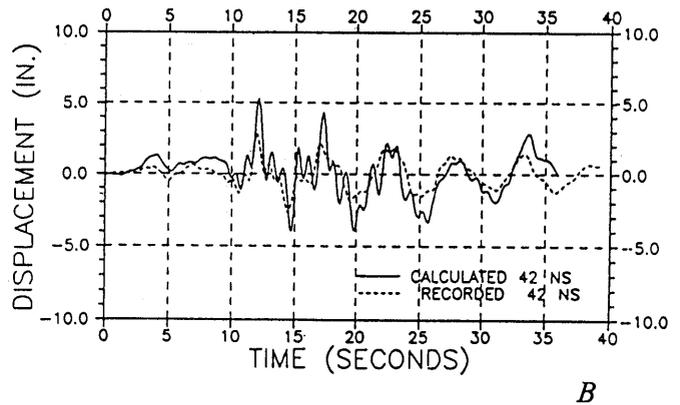
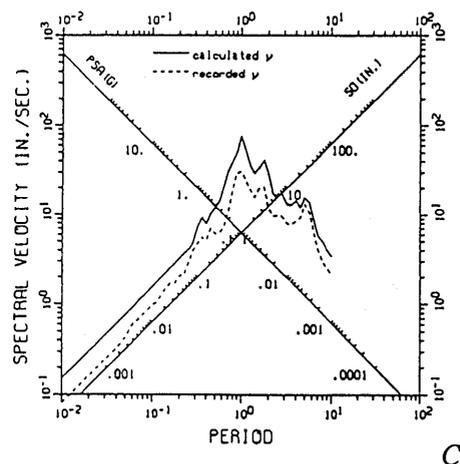
Figure 8.—Recorded response vs. calculated, 42d level, north-south.

Similar data at the 42d level in the north-south (longitudinal) direction are compared with the calculated results in figure 8. The time-history plots of the acceleration (fig. 8A) indicate that in this direction, the calculated response tends to overestimate the recorded response, although the frequency comparison is reasonably good. A similar result is shown in figure 8B for the displacement response, where the maximum calculated displacement is 5.3 inches compared with 2.8 inches recorded. The floor spectra (fig. 8C) indicate that the calculated response exceeds the recorded response over the entire period range. It should be

noted that this calculated response could be reduced by increasing the damping for the modes in this direction. However, this caused an excessive reduction in the response in this direction in the floors below this level.

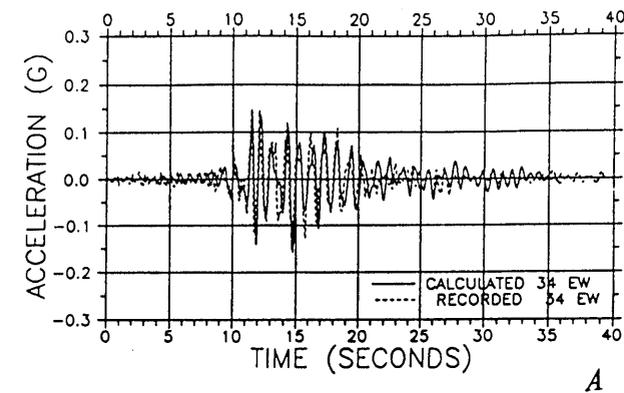
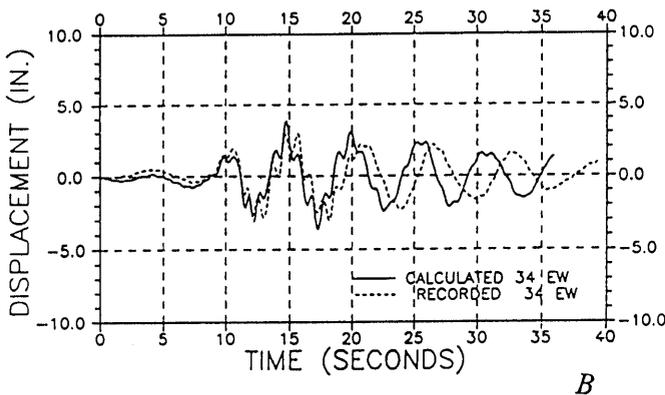
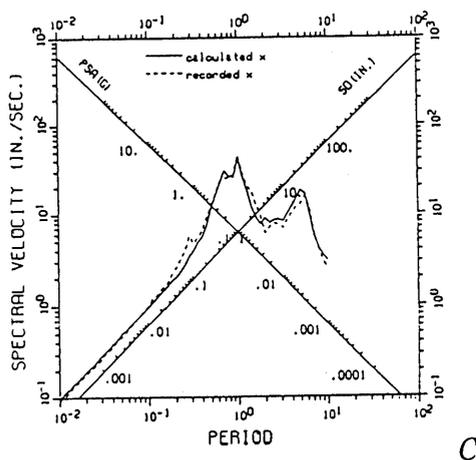
Figure 9.—Recorded response vs. calculated, 34th level, east-west.

The recorded response data at the 34th level in the east-west direction are compared with the calculated results in figure 9. The time-history results are compared in figure 9A. Here it can be seen that the comparison with both amplitude and frequency is very good, with a maximum calculated value of 0.16 g compared to recorded value of

0.148 g. The displacement time history is shown in figure 9B. The maximum calculated displacement is 3.9 inches compared to a maximum recorded value of 3.1 inches. As discussed previously, the period match is good for the first 20 seconds, but beyond this point the period of the recorded data tends to lengthen. The floor spectra (fig. 9C) indicate that the comparison is very good over the complete period range.

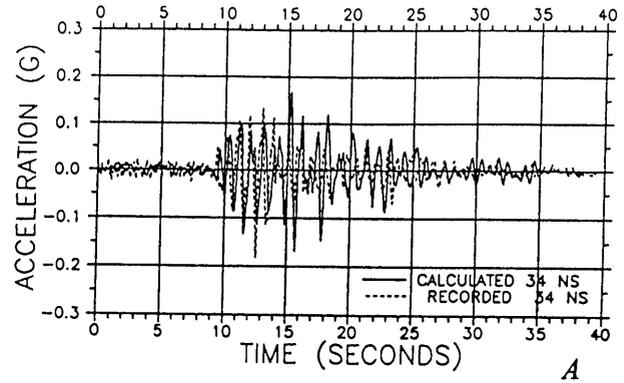
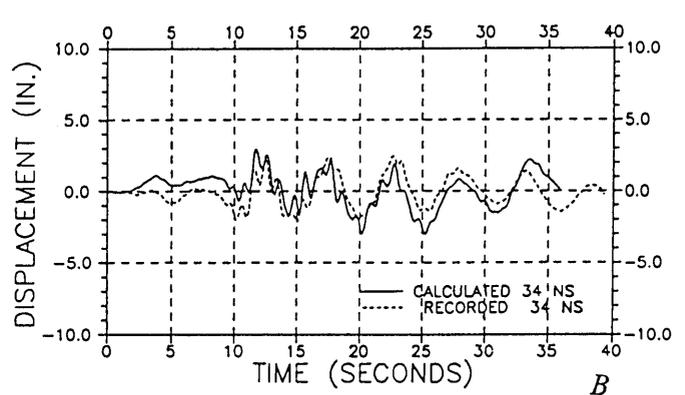
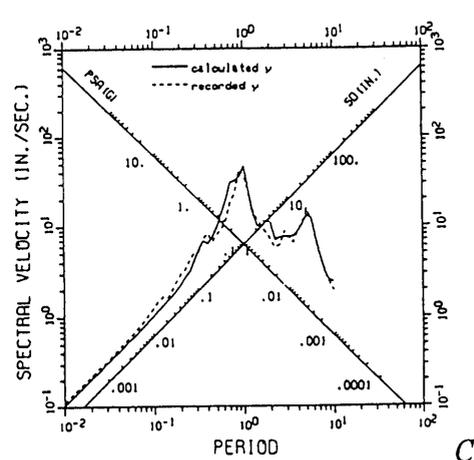
Figure 10.—Recorded response vs. calculated, 34th level, north-south.

Similar comparisons at the 34th level for motions in the north-south direction are shown in figure 10. Considering

the time-history response (fig. 10A) the maximum calculated acceleration is 0.168 g compared with a recorded value of 0.183 g. The displacement response (fig. 10B) indicates a maximum calculated displacement of 3.0 inches compared with a maximum recorded value of 2.5 inches. The floor spectra (fig. 10C) compare favorably over the entire period range.

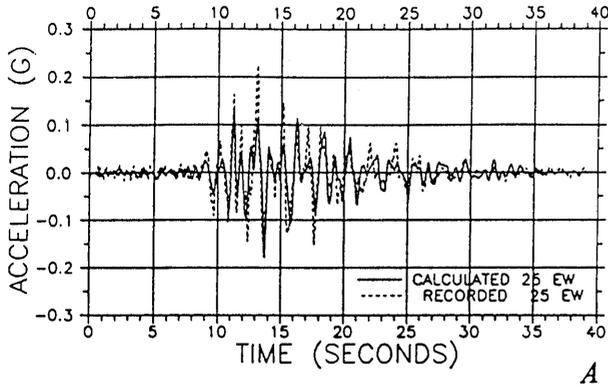
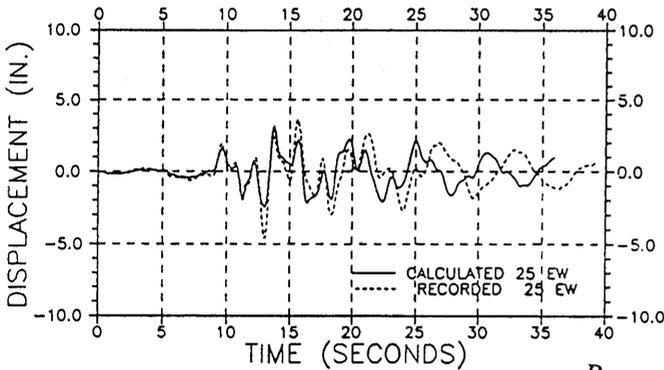
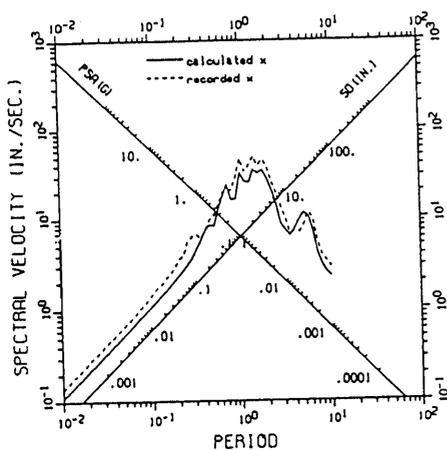
Figure 11.—Recorded response vs. calculated, 25th level, east-west.

The recorded response data at the 25th level in the east-west direction is compared with the calculated values in figure 11. The acceleration time-history (fig. 11A) indicates a peak calculated acceleration of 0.18 g compared to a recorded value of 0.22 g. Frequency compari-

in the floor spectra (fig. 11C). Here it can be seen that the calculated spectrum is below the recorded spectrum over much of the period range.

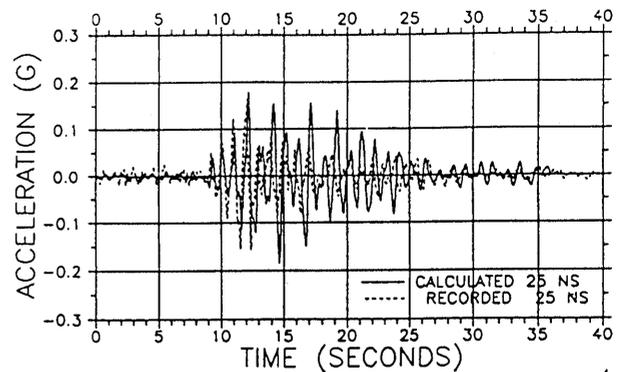
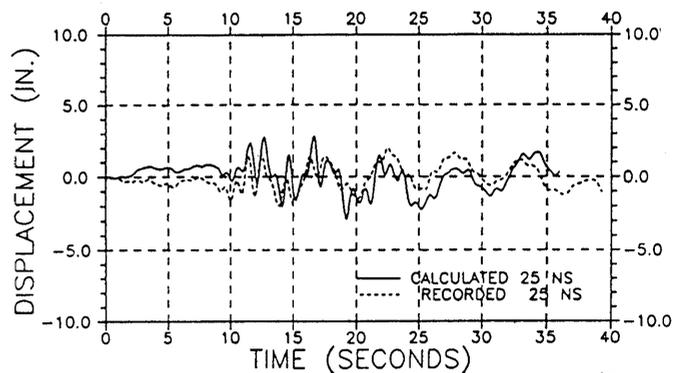
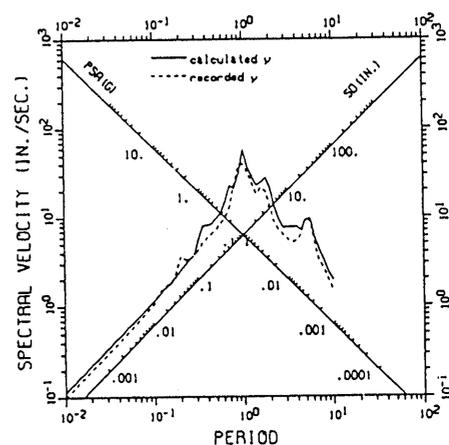
Figure 12.—Recorded response vs. calculated, 25th level, north-south.

Similar data at the 25th level in the north-south direction are presented in figure 12. The time-history

data (fig. 12A) indicate a peak calculated acceleration of 0.188 g compared with a recorded value of 0.163 g. The time-history of the displacements is shown in figure 12B. Here it can be seen that the maximum calculated displacement is 2.9 inches compared with a recorded value

of 2.0 inches. The overestimation of the response by the calculated results is also indicated in the floor spectra (fig. 12C). Here it can be seen that the calculated spectrum falls above the recorded spectrum in most period ranges.

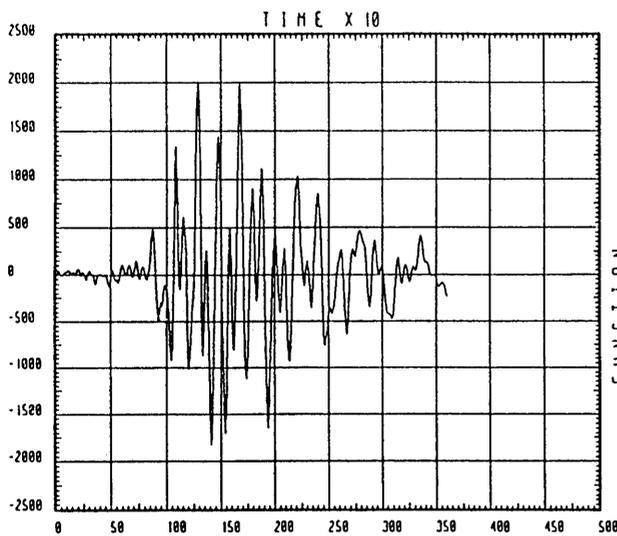
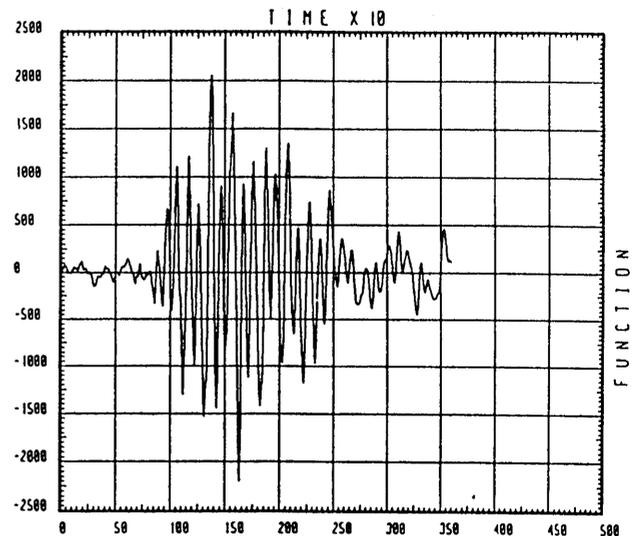
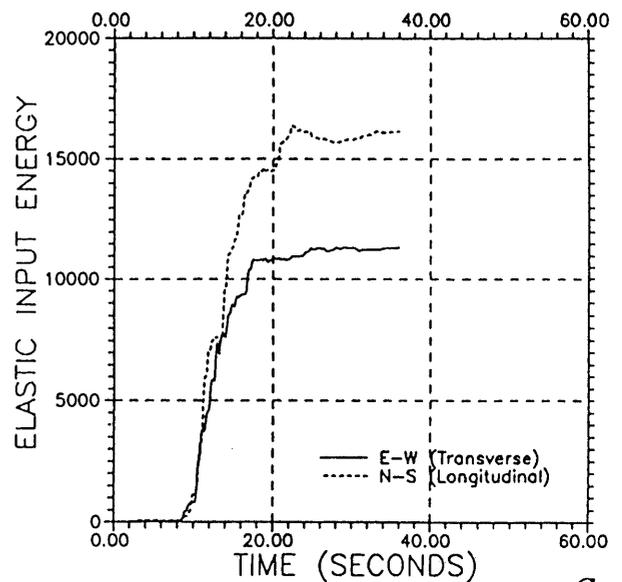
Figure 13 Elastic energy input: base shear time history, transverse (A); base shear time history, longitudinal (B); elastic input energy time history (C).

The time-history of the base shear in the east-west direction is shown in figure 13A, and the corresponding values for the north-south direction are shown in figure 13B. The figures indicate that the maximum base shears in both directions are almost equal, being 2,000 kips in the east-west direction and 2,200 kips in the north-south direction. A comparison of the elastic input energies (fig. 13C) indicates that there is about 50 percent more input energy in the north-south direction as compared to the east-west direction.

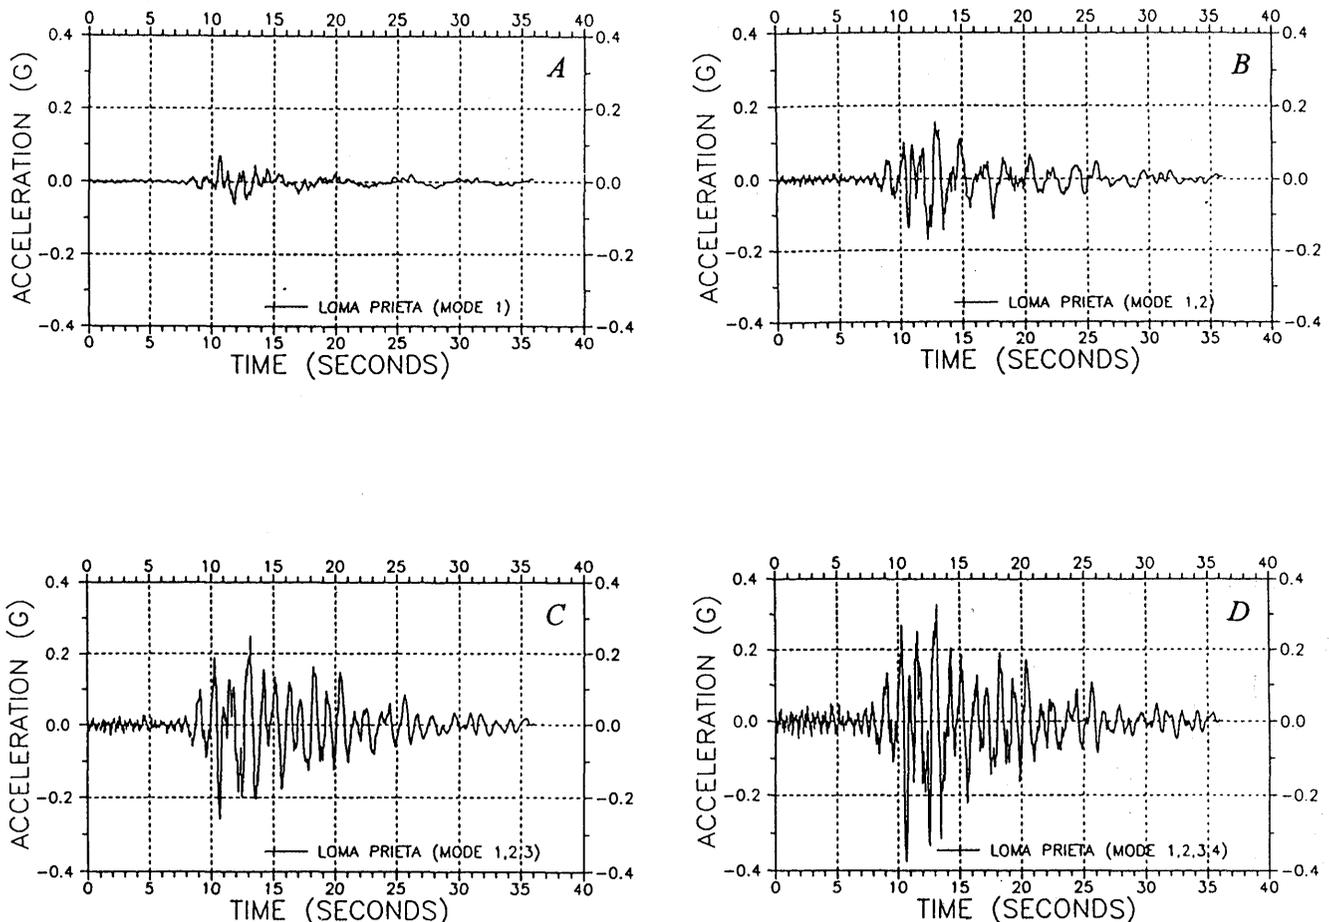
Figure 14.—Modal accelerations, roof level, transverse: first mode (A); first and second modes (B); first, second, and third modes (C) first, second, third, and fourth modes (D).

The relative contributions of the first four modes of vibration in the east-west (transverse) direction to the absolute acceleration at level 42 are shown in figure 14. The absolute acceleration due to the first mode response (fig. 14a) indicates that the peak acceleration due to this mode is only 0.072 g. Inclusion of the second mode response increases the peak acceleration to 0.17 g (fig. 14b), indicating an increase of more than 100 percent from the second mode. Inclusion of the third mode response (fig. 14c) indicates a peak acceleration of 0.255 g which represents another increase of 50 percent. With the inclusion of the first four modes of vibration (fig. 14d) the peak acceleration increases another 49 percent to a value of 0.38 g. These results indicate that for this tall building, the acceleration response at the top of the building is primarily due to the 2d, 3d, and 4th modes with a minimal contribution from the 1st mode. Note that had the code guideline of considering participation of 90 percent of the reactive mass been followed, the fourth mode would have been neglected,

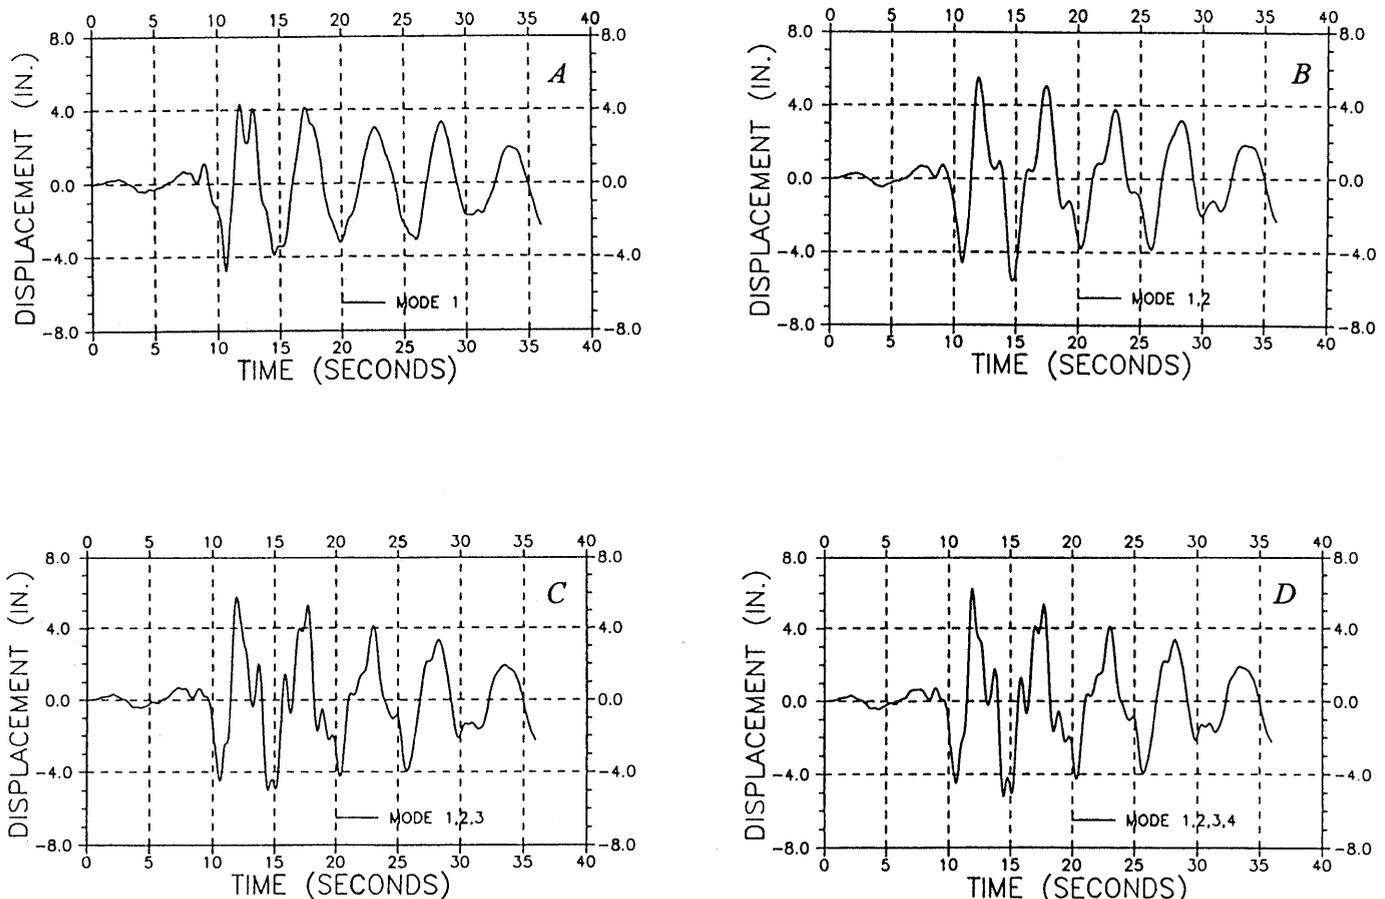
Figure 15.—Modal displacements, roof level, transverse: first mode (A); first and second modes (B); first, second, and third modes (C); first, second, third, and fourth modes (D).

Displacement data for this level is presented in figure 15. The relative displacement response due to the first mode (fig. 15A) has a maximum value of 4.75 inches. Inclusion of the second mode response (fig. 15B) increases the maximum displacement to 5.5 inches. With three modes, the displacement increases to 5.7 inches (fig. 15C). Considering four modes of vibration, the maximum displacement becomes 6.2 inches (fig. 15D). These results indicate that the displacement response is primarily due to the first mode; however, inclusion of the fourth mode increased the displacement by 9 percent.
