The Loma Prieta, California, Earthquake of October 17, 1989—Building Structures

U.S. GEOLOGICAL SURVEY PROFESSIONAL PAPER 1552-C

BUILDING STRUCTURES

INTRODUCTION

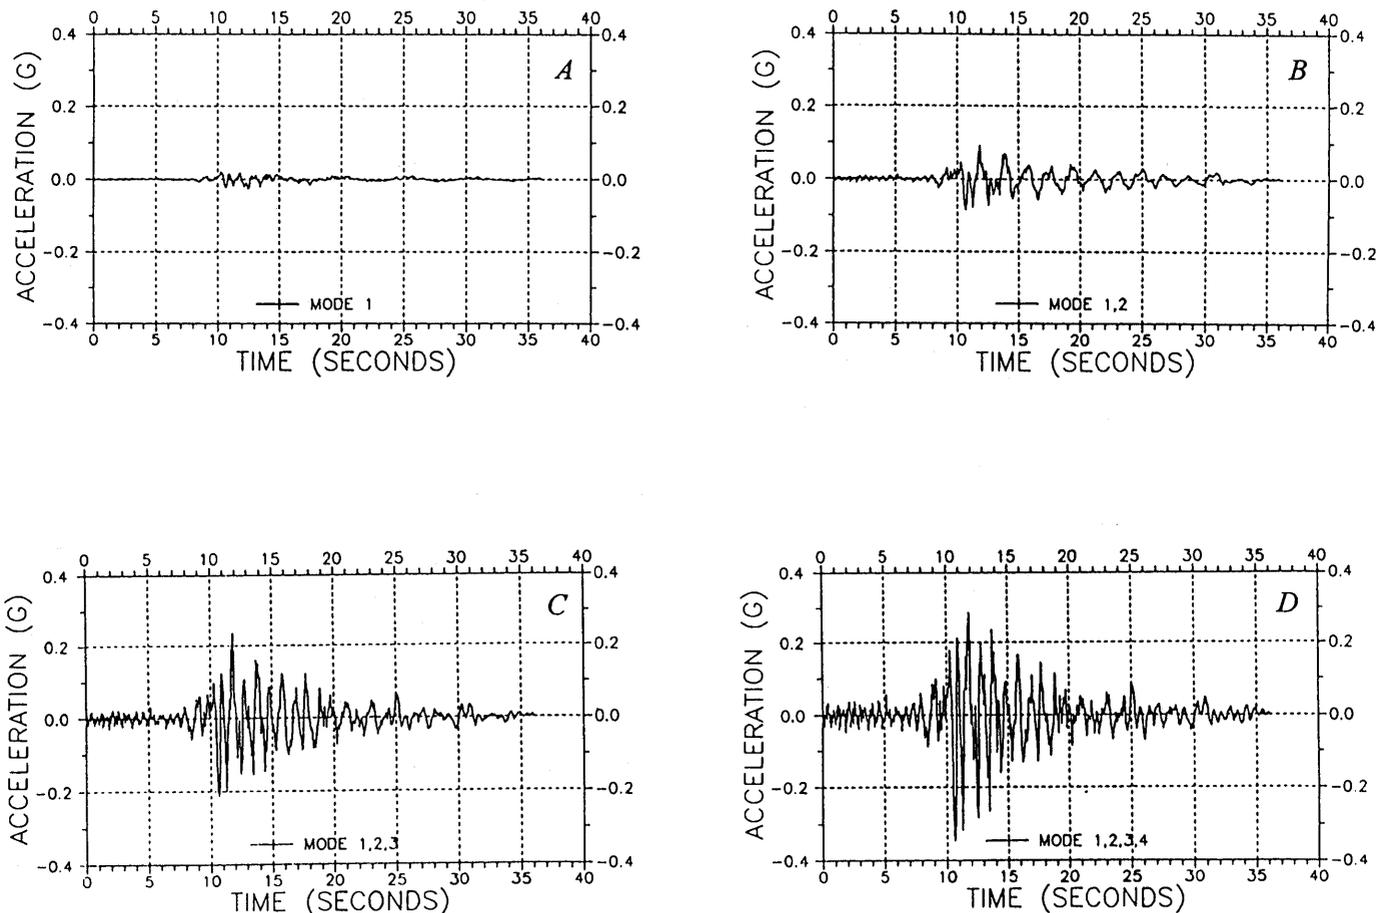
Figure 16.—Modal accelerations, 25th level, transverse: first mode (A); first and second modes (B); first, second, and third modes (C); first, second, third, and fourth modes (D).

The absolute acceleration response at the 25th level is shown in figure 16. The absolute acceleration due to the first mode (fig. 16A) is very small (0.026 g). Inclusion of the second mode response increases the maximum acceleration to 0.10 g (fig. 16B). With the inclusion of the third mode (fig. 16C) the maximum acceleration reaches 0.23 g. Consideration of the first four modes increases the peak acceleration to 0.35 g (fig. 16D). These results indi-

cate the absolute acceleration at this level is primarily due to the second, third, and fourth mode response with almost no contribution from the first mode.

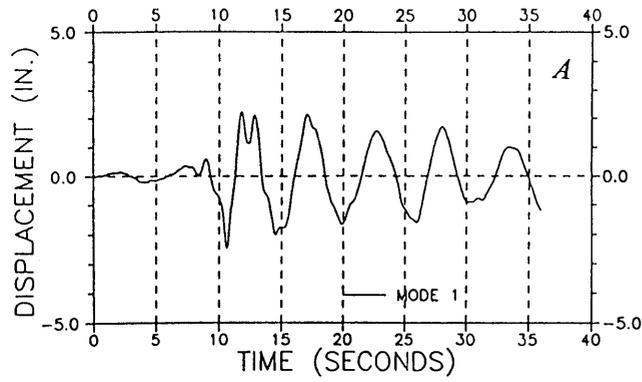
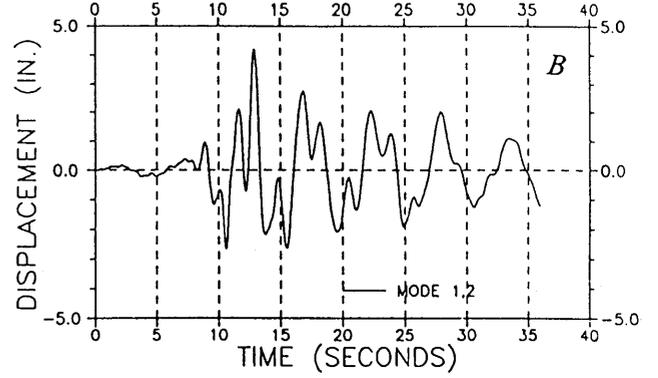
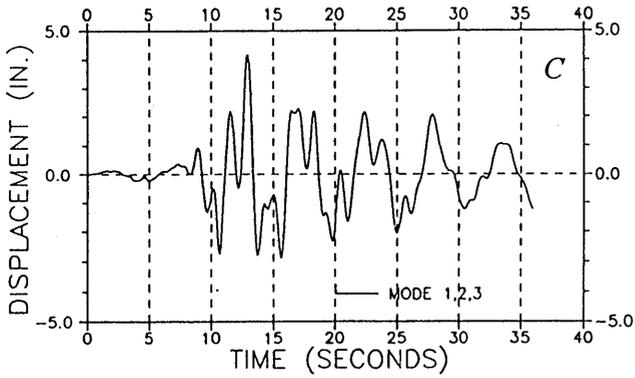
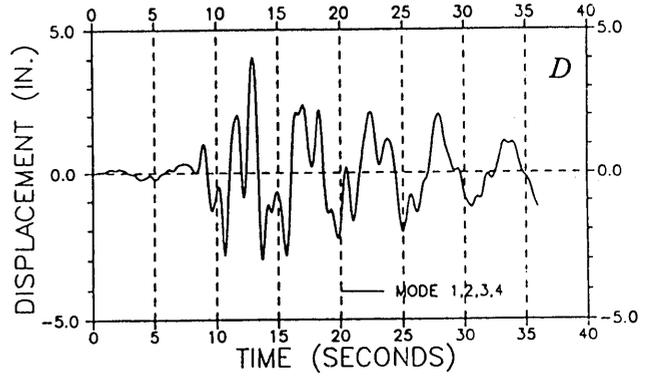
Figure 17.—Modal displacements, 25th level, transverse: first mode (A); first and second modes (B); first, second, and third modes (C); first, second, third, and fourth modes (D).

The relative displacement response at this level is shown in figure 17. The displacement response due to the first mode has a maximum value of 2.5 inches (fig. 17A). Inclusion of the second mode response increases the maximum displacement to 4.2 inches (fig. 17B). Adding the displacement response of the third mode, (fig. 17C) results in no change in the maximum displacement, and inclusion of the fourth mode actually decreases the maximum displacement at this level to 4.05 inches (fig. 17D). These results indicate that the displacement response at this level is primarily due to the first and second modes of vibration in this direction.

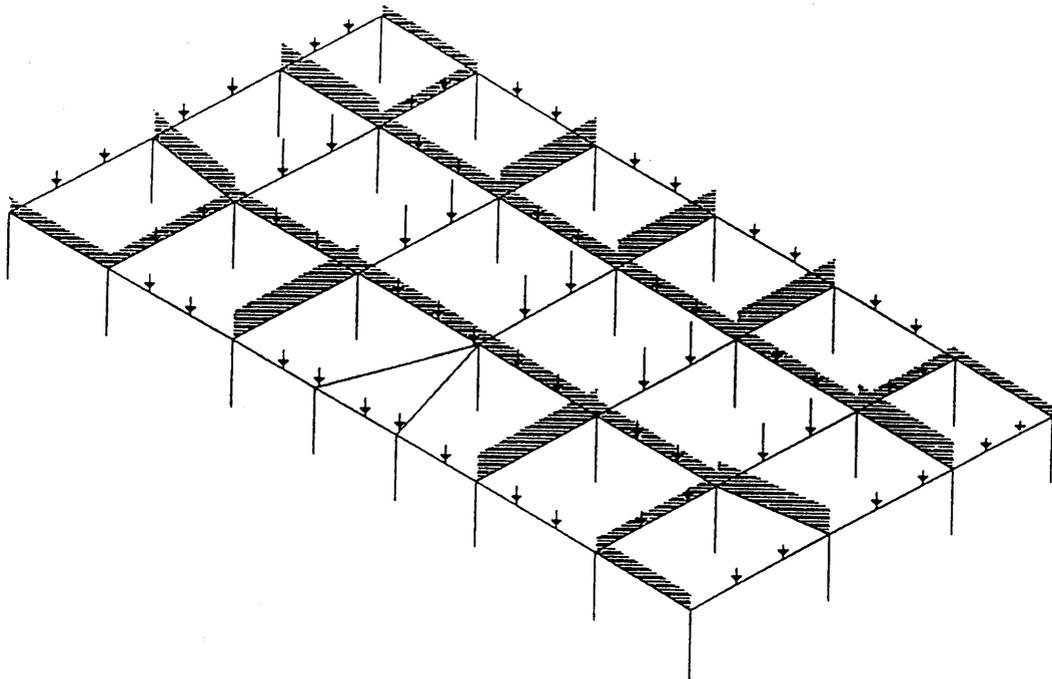
Figure 18.—Gravity load distribution.

In order to verify the design condition which required that stresses in the members remain below yield under the lateral forces developed by the design spectrum, a stress check was performed using the postprocessing program STEELER, developed by Habibullah (1989). This required that the gravity loading be represented as accurately as possible. Based on the geometry of the framing system, the gravity load was distributed to the members of each floor level as shown in figure 18. Since the design spectra is representative of yield load and not allowable load, use of the stress check program, which is based on allowable stress, requires that the applied load be reduced by a factor of 0.66.

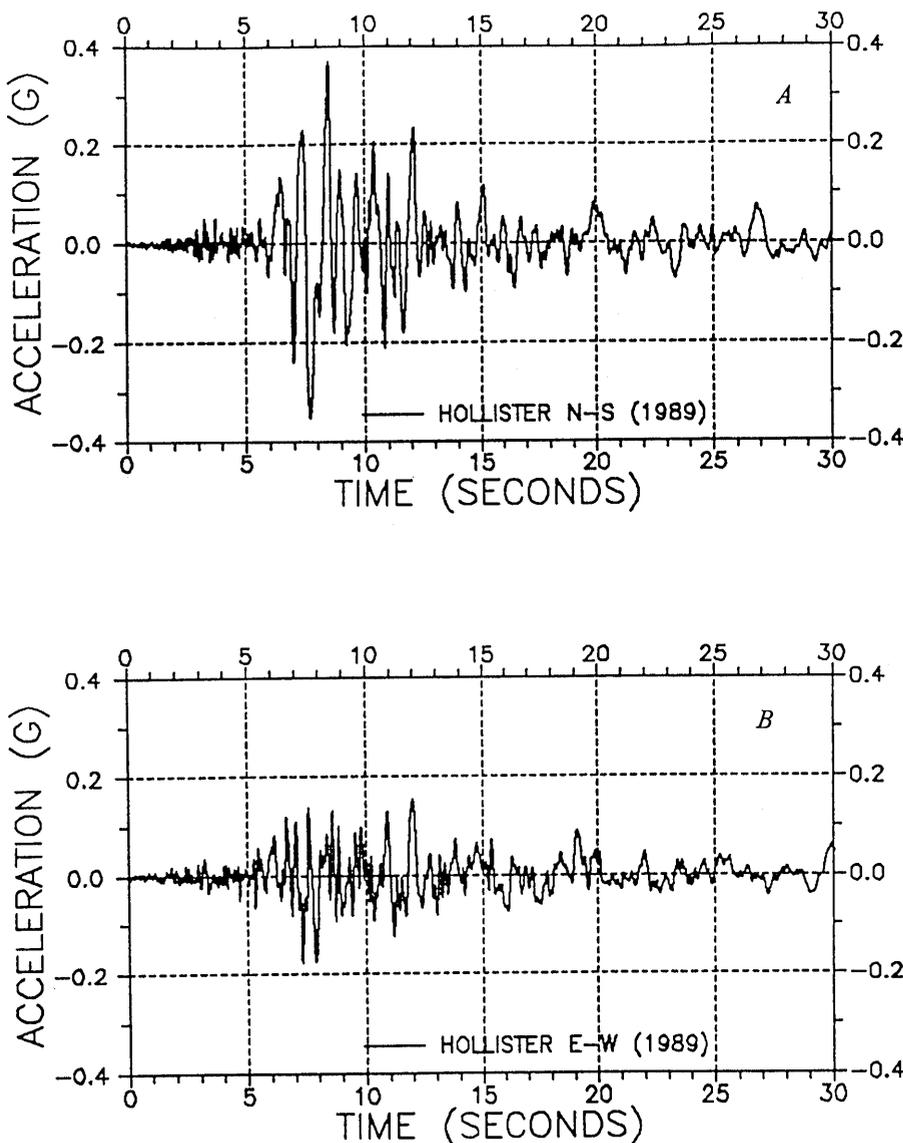
Figure 21.—Ground acceleration recorded at Hollister, Loma Prieta earthquake: north-south component (A); east-west component (B).

The two horizontal components of the ground accelerations recorded at Hollister are shown in figure 21. Here it can be seen that the north-south component (fig. 21A) of this ground motion is considerably stronger than the east-west component (fig. 21B). These two components are applied simultaneously to the base of the structure and the resulting response is calculated for comparison with the other responses.

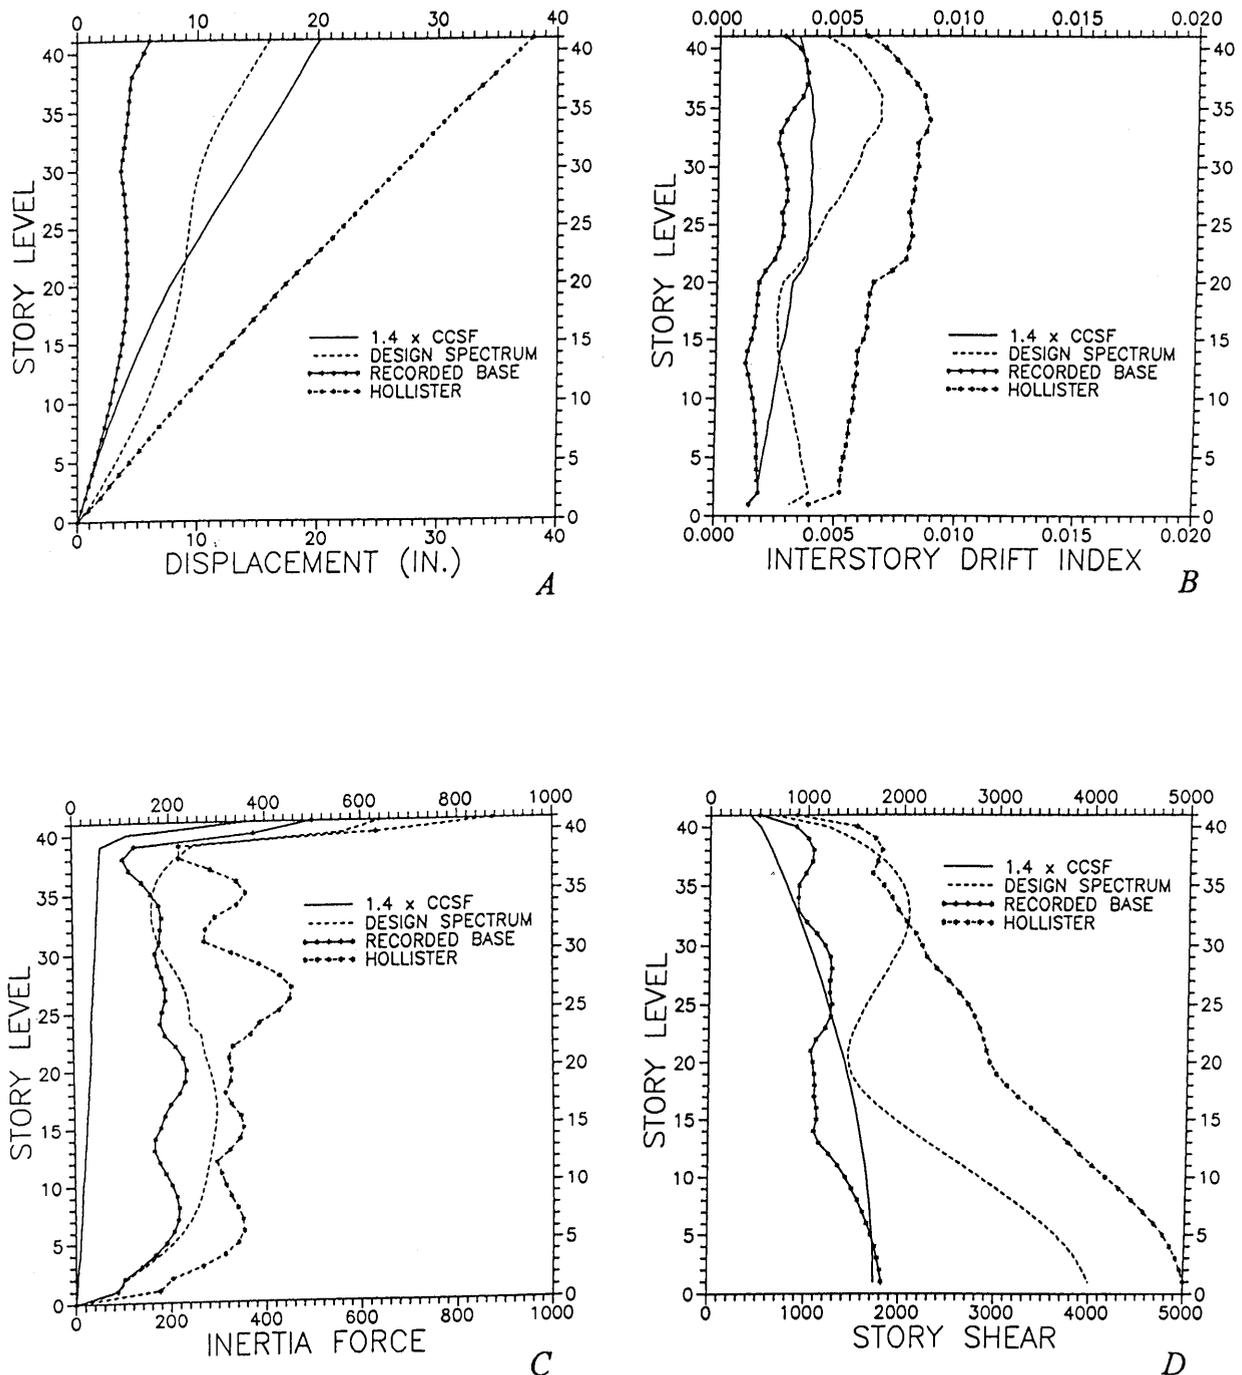
Figure 22.—Transverse response envelopes: lateral displacement (A); interstory drift index (B); inertia force (C); story shear (D).

The response envelopes for the east-west (transverse) direction are given in figure 22. The envelopes of lateral displacement (fig. 22A) indicate that the displacement due

to the recorded base motion is less than that due to the lateral design forces. It is of interest to note that the displacements due to the CCSF code loads, when factored to represent yield, exceed the lateral displacements due to

two. Envelopes for the maximum interstory drift index are shown in figure 22B. As before, the IDI due to the recorded base motion is less than that due to the design spectrum. For this parameter, the indices due to the design spectrum exceed those due to the factored CCSF lateral forces over most of the building height with the exception of floor levels 15 to 22. The envelope due to the Hollister ground motion is considerably larger than the others.

The envelopes of maximum inertia force over the building height are shown in figure 22C. It can be seen that the inertia forces due to the design spectrum exceed those due to the recorded ground motion with the exception of three floors near the top of the structure (floors 32-34). It can also be seen that the inertia forces due to the Hollister ground motion exceed those due to the design spectrum at all floor levels except the 39th. The inertia forces speci-

The envelopes of maximum story shear are shown in figure 22D. This figure indicates that the story shears due to the design spectrum exceed those developed by the recorded base motions at all story levels. This tends to indicate that the behavior of the structure in this direction is linear elastic. However, it is of interest to note that had the minimum lateral-force requirements of the CCSF code been used for design, the story shears due to the recorded base motions would have exceeded the design values in the upper 15 floor levels. The story shears due to the Hollister motions exceed the design values over most of the building and indicate yielding of the structural frames, which will have to be investigated using a nonlinear analysis. It is also of interest to note that the decrease in story shear, indicated by the design spectrum at the 20th story

level, does not occur in the response envelope of the Hollister motion. Such a decrease, if used to reduce member sizes, could result in a weak section of the structure, although this was not the case for this building.

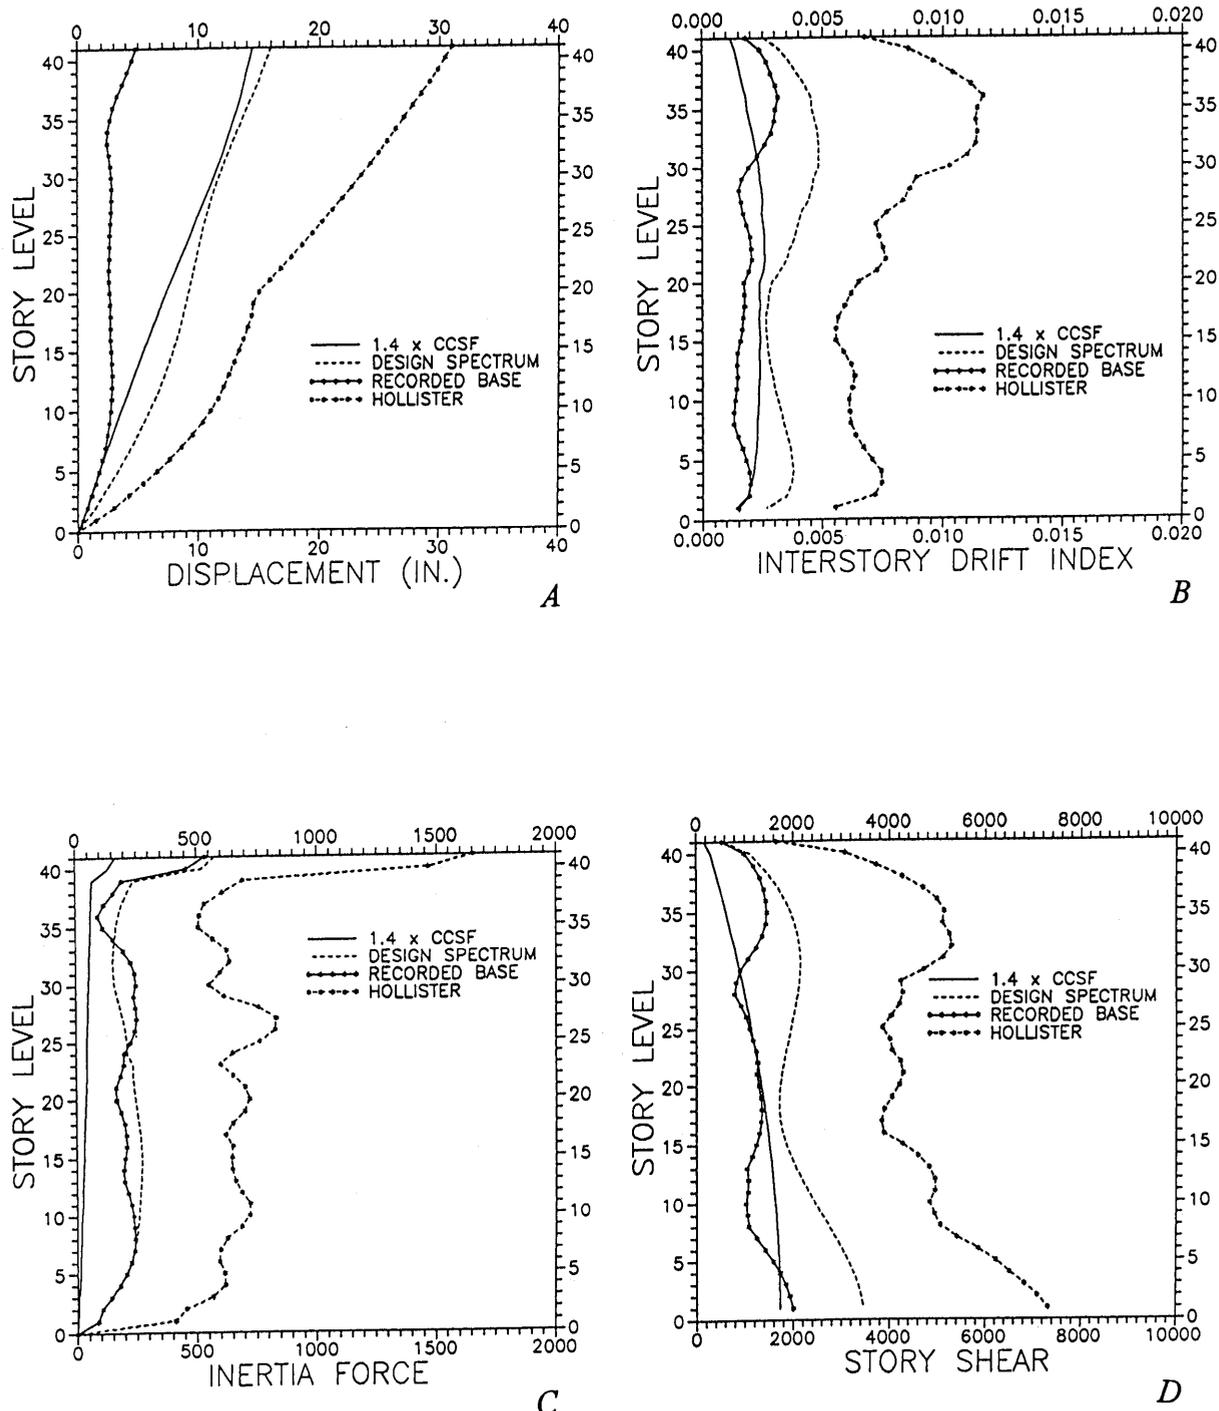
Figure 23.—Longitudinal response envelopes: lateral displacement (A); interstory drift index (B); inertia force (C); story shear (D).

The response envelopes for the north-south (longitudinal) direction are shown in figure 23. The envelopes of maximum lateral displacement (fig. 23A) are similar to those just discussed for the transverse direction. In this case, the displacements due to the design spectrum ex-

The envelopes of maximum inertia force are shown in figure 23C. As before, the forces specified in the CCSF code represent minimum values. It is interesting to note

that the inertia forces due to the recorded base motion exceed those due to the design spectrum between floors 26-33. The forces due to the Hollister motions exceed all others by a substantial margin. The envelopes of story shear (fig. 23D) indicate that the shears due to the recorded motions are less than those due to the design spectrum over the total building height. This indicates

that the behavior of the building in this direction was most likely linear elastic. As in the transverse direction, the shears due to the Hollister motions exceed those due to the design spectrum over the height of the building, indicating inelastic behavior.

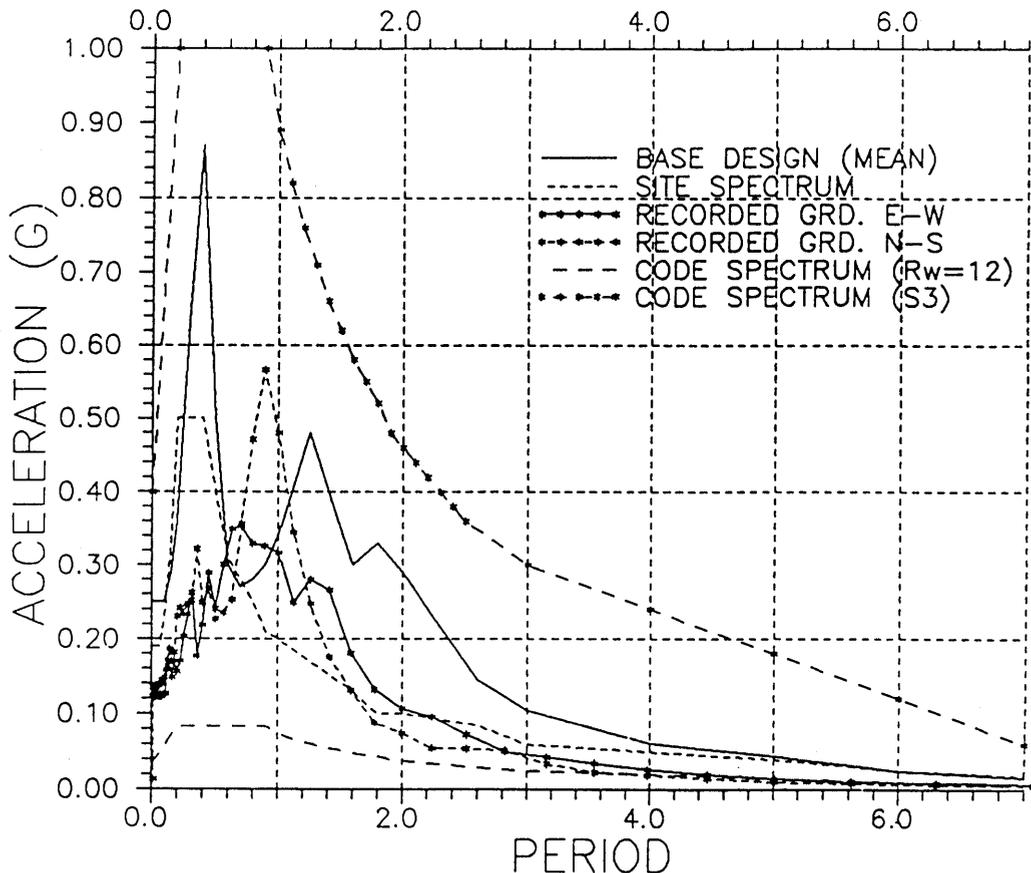
Figure 24.—Design spectra vs. recorded motion.

The code design spectrum and the site-specific design spectrum are compared with the spectra of the recorded ground motions in figure 24. The code spectra with a structural system coefficient ($R_w=1$) results in the highest spectral values, whereas using a system coefficient of $R_w=12$, which is typical for this type of structure, results in the lowest spectral values. Hence the code design spectra envelope the other spectra depending on the value of the structural system coefficient that is used. Based on the results presented, it would appear that the use of a value of 12 is excessive.

The site spectrum has a peak spectral acceleration of 0.5 g in the period range of 0.2 to 0.4 s, which is representative of rock motion at the site. The base design spectrum reflects the influence of local soil conditions on the response. It has a peak spectral acceleration of 0.87 g at a period of 0.4 s and a second peak of 0.48 g at 1.25 s. The spectrum for the recorded ground motion in the east-west direction has a peak spectral acceleration of 0.57 g at a period of 0.9 s. The spectral values of the two components of recorded base motion in the east-west and north-south directions are very similar, with the exception of the period range around 0.9 sec where the spectral acceleration in the north-south direction is truncated and only reaches 0.36 g.

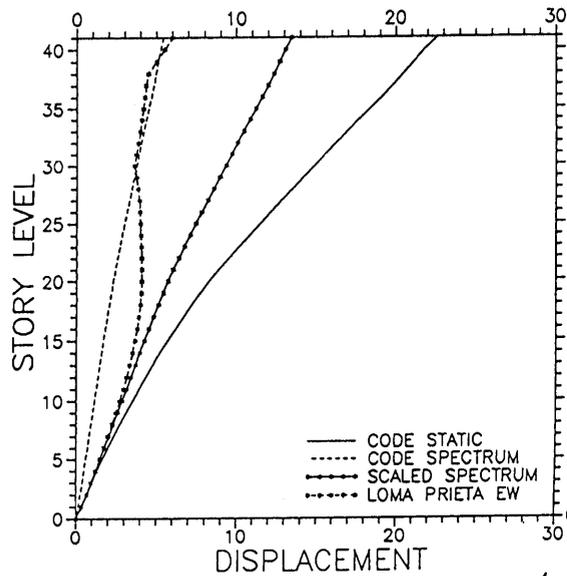
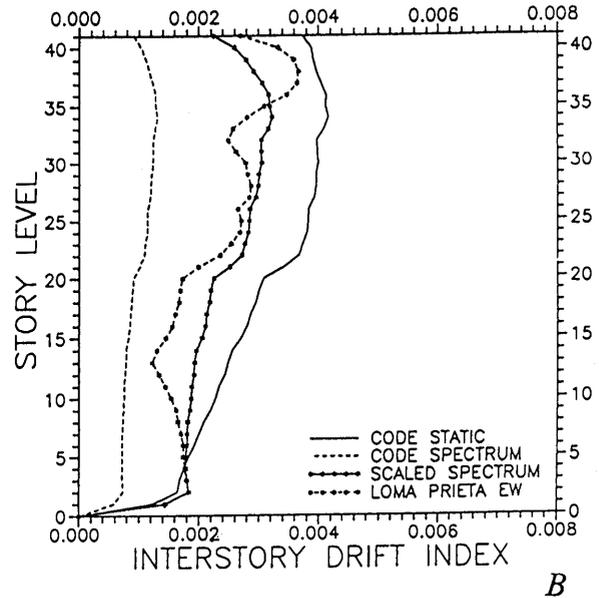
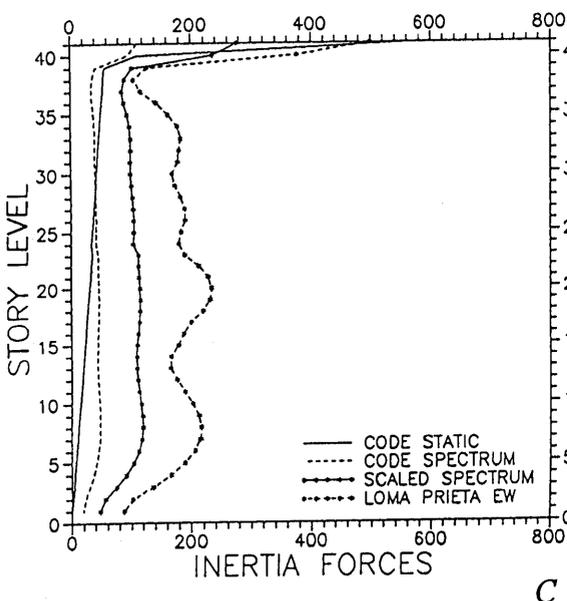
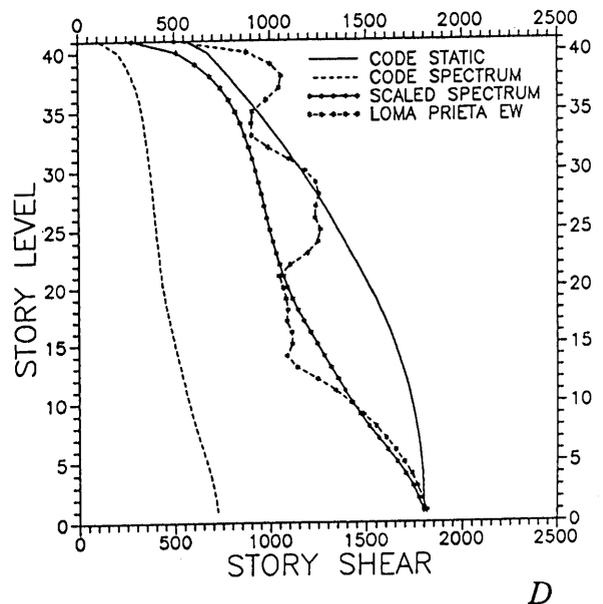
Figure 25.—Code design vs. recorded response, transverse: lateral displacement (A); interstory drift index (B); inertia force (C); story shear (D).

The lateral displacements and forces obtained using the code spectrum for a type 3 soil are compared with the static lateral force requirements and the recorded values in figure 25 for the east-west (transverse) direction. The envelopes of maximum lateral displacement (fig. 25A) indicate that the displacements obtained from the static lateral forces far exceed those obtained from the scaled spectrum. This reflects the influence of the code requirement that places up to 25 percent of the base shear at the top of the structure. The displacement response due to Loma Prieta is less than that obtained using the scaled

spectrum. The envelopes of maximum interstory drift index (IDI) are shown in figure 25B. As before, the IDI for the static lateral loads exceeds the spectral values, with the exception of the bottom four floor levels. The response due to the scaled spectrum is equal to or greater than the recorded response, with the exception of the upper six floors.

The envelopes of the maximum lateral inertia forces are shown in figure 25C, and the corresponding envelopes of maximum story shear are shown in figure 25D. It can be seen in figure 25D that the base shears due to the static forces and the scaled spectrum are equal as a result of the scaling procedure. By coincidence, the base shear due to the recorded ground motion is also approximately equal to the code value. However, it is of particular interest to note that story shears due to the recorded ground motion exceed the scaled code spectrum in the upper half of the structure, with peak differences at the 38th level and the 28th level. This clearly indicates the importance of the response of the higher modes of vibration and their influence on the scaling procedure, which is based on base shear. The higher modes tend to increase the response at the base and in the upper portions of the structure. Scaling upward, based on the base shear, can result in reduced design shear forces over much of the building height.

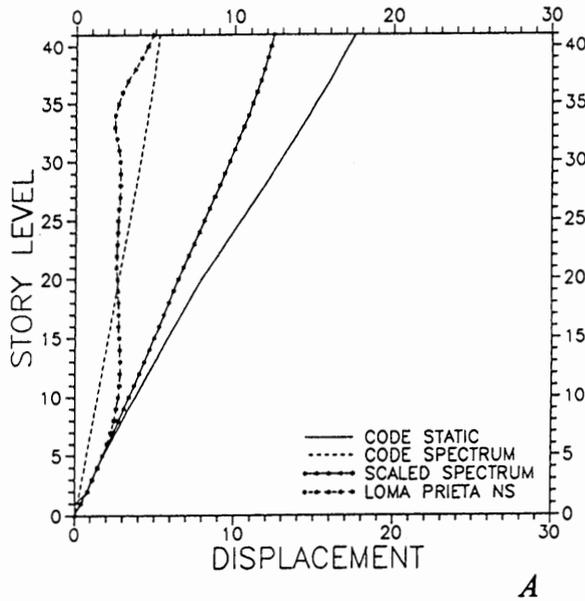
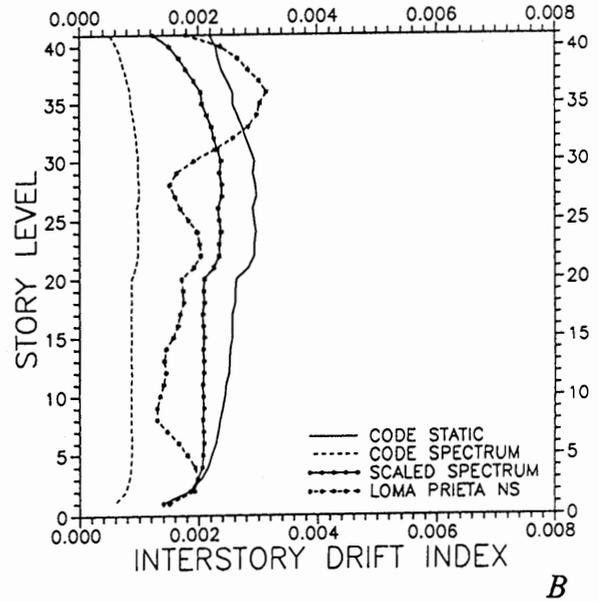
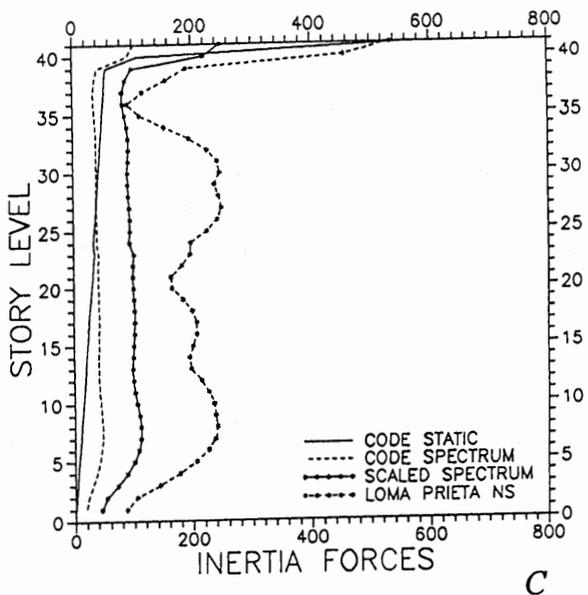
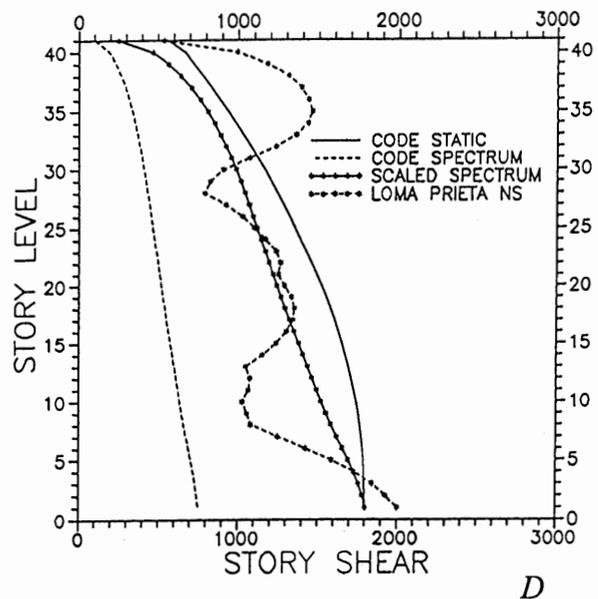
Figure 26.—Code design vs. recorded response, longitudinal: lateral displacement (A); interstory drift index (B); inertia force (C); story shear (D).

The lateral displacements and forces obtained using the code spectrum are compared with the static lateral force requirements and the recorded Loma Prieta values in figure 26 for the north-south (longitudinal) direction. The lateral-displacement response shown in (fig. 26A) is very similar to that of the previous case, wherein the displacements of both the static and scaled spectra exceeded the displacements due to the recorded motions over the height of the structure. The envelopes of maximum IDI are shown in figure 26B. It can be seen that the IDI due to the recorded base motion exceeds that of the scaled spectrum for all stories above the 32d floor. It even exceeds that of the equivalent static loading for floor levels 33 to 40.

The envelopes of maximum lateral inertia forces are shown in figure 26c where it can be seen that the forces due to the recorded base motion exceed those of the scaled spectrum over the entire building height. The envelopes of maximum story shear are given in figure 26d. As required by the scaling procedure, the shear due to the static load and that due to the scaled spectrum are equal at the base. This figure indicates that in the upper nine floors the story shears due to the recorded base motion exceed those due to both the static forces and the scaled spectrum. The shears of the scaled spectrum are also exceeded at mid-height, between stories 17 and 25. Toward the base of the structure, both the static and scaled spectrum values are exceeded in the bottom three stories. This indicates that had this structure been designed according to

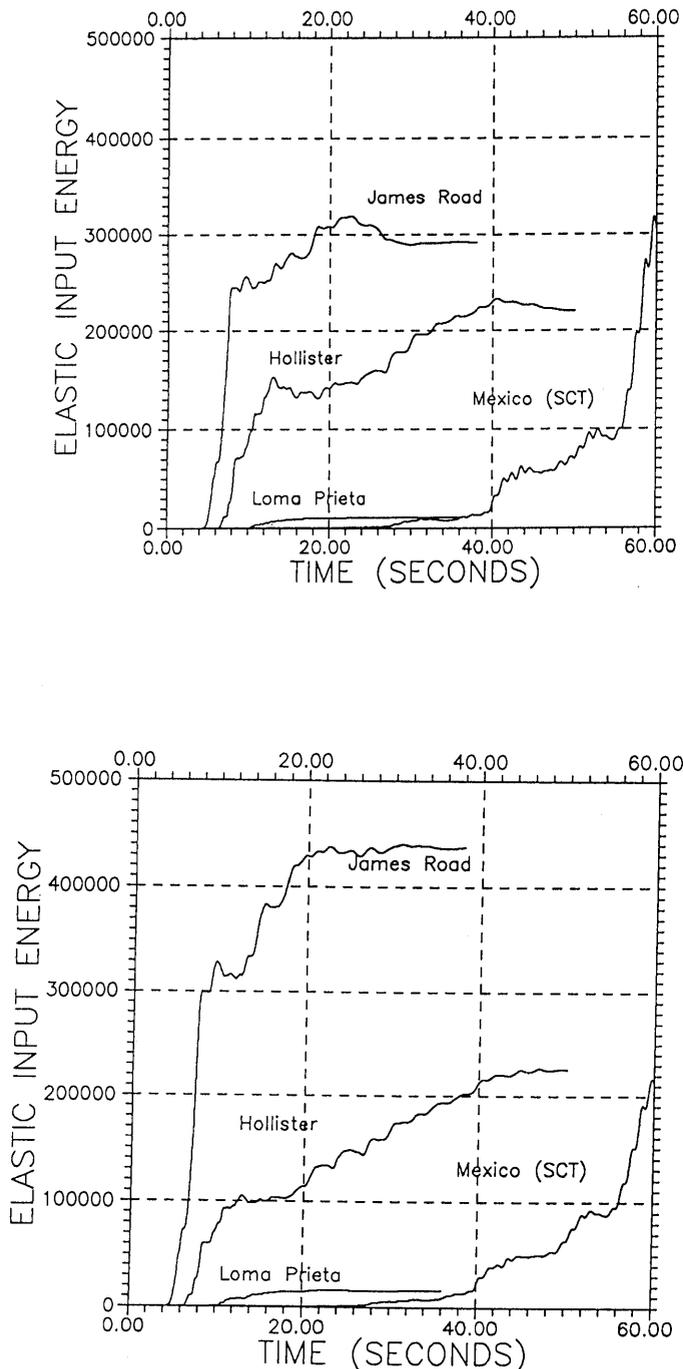
Figure 27.—Elastic input energies, strong earthquakes: transverse (east-west) (A); longitudinal (north-south) (B).

product of the base shear and the base displacement as mentioned previously. The elastic input energy for this structure due to the Loma Prieta base motion is compared with that of three other strong motion earthquakes in figure 27. These include James Road (Imperial Valley, 1979), SCT (Mexico City, 1985) and Hollister (Loma Prieta,

1989). The input energy in the east-west direction is shown in figure 27A, which clearly indicates that the motion from the Loma Prieta earthquake which was recorded at the base of this structure did not input a significant amount of energy to the structural system. It does indicate that the James Road ground motion, discussed previously by

Anderson and Bertero (1994), and the Hollister ground motion discussed in this paper are much more severe. It can be seen that the energy input due to James Road occurs with a sudden jump, whereas that due to the SCT ground motion builds up over a long period of time. Recall that the James Road record contains large accelera-

tion pulses and is representative of near-fault motion, whereas the SCT record is almost sinusoidal in character, starts very slowly, and is representative of a large, distant earthquake. Elastic input energy in the north-south direction has similar characteristics and is shown in figure 27B.

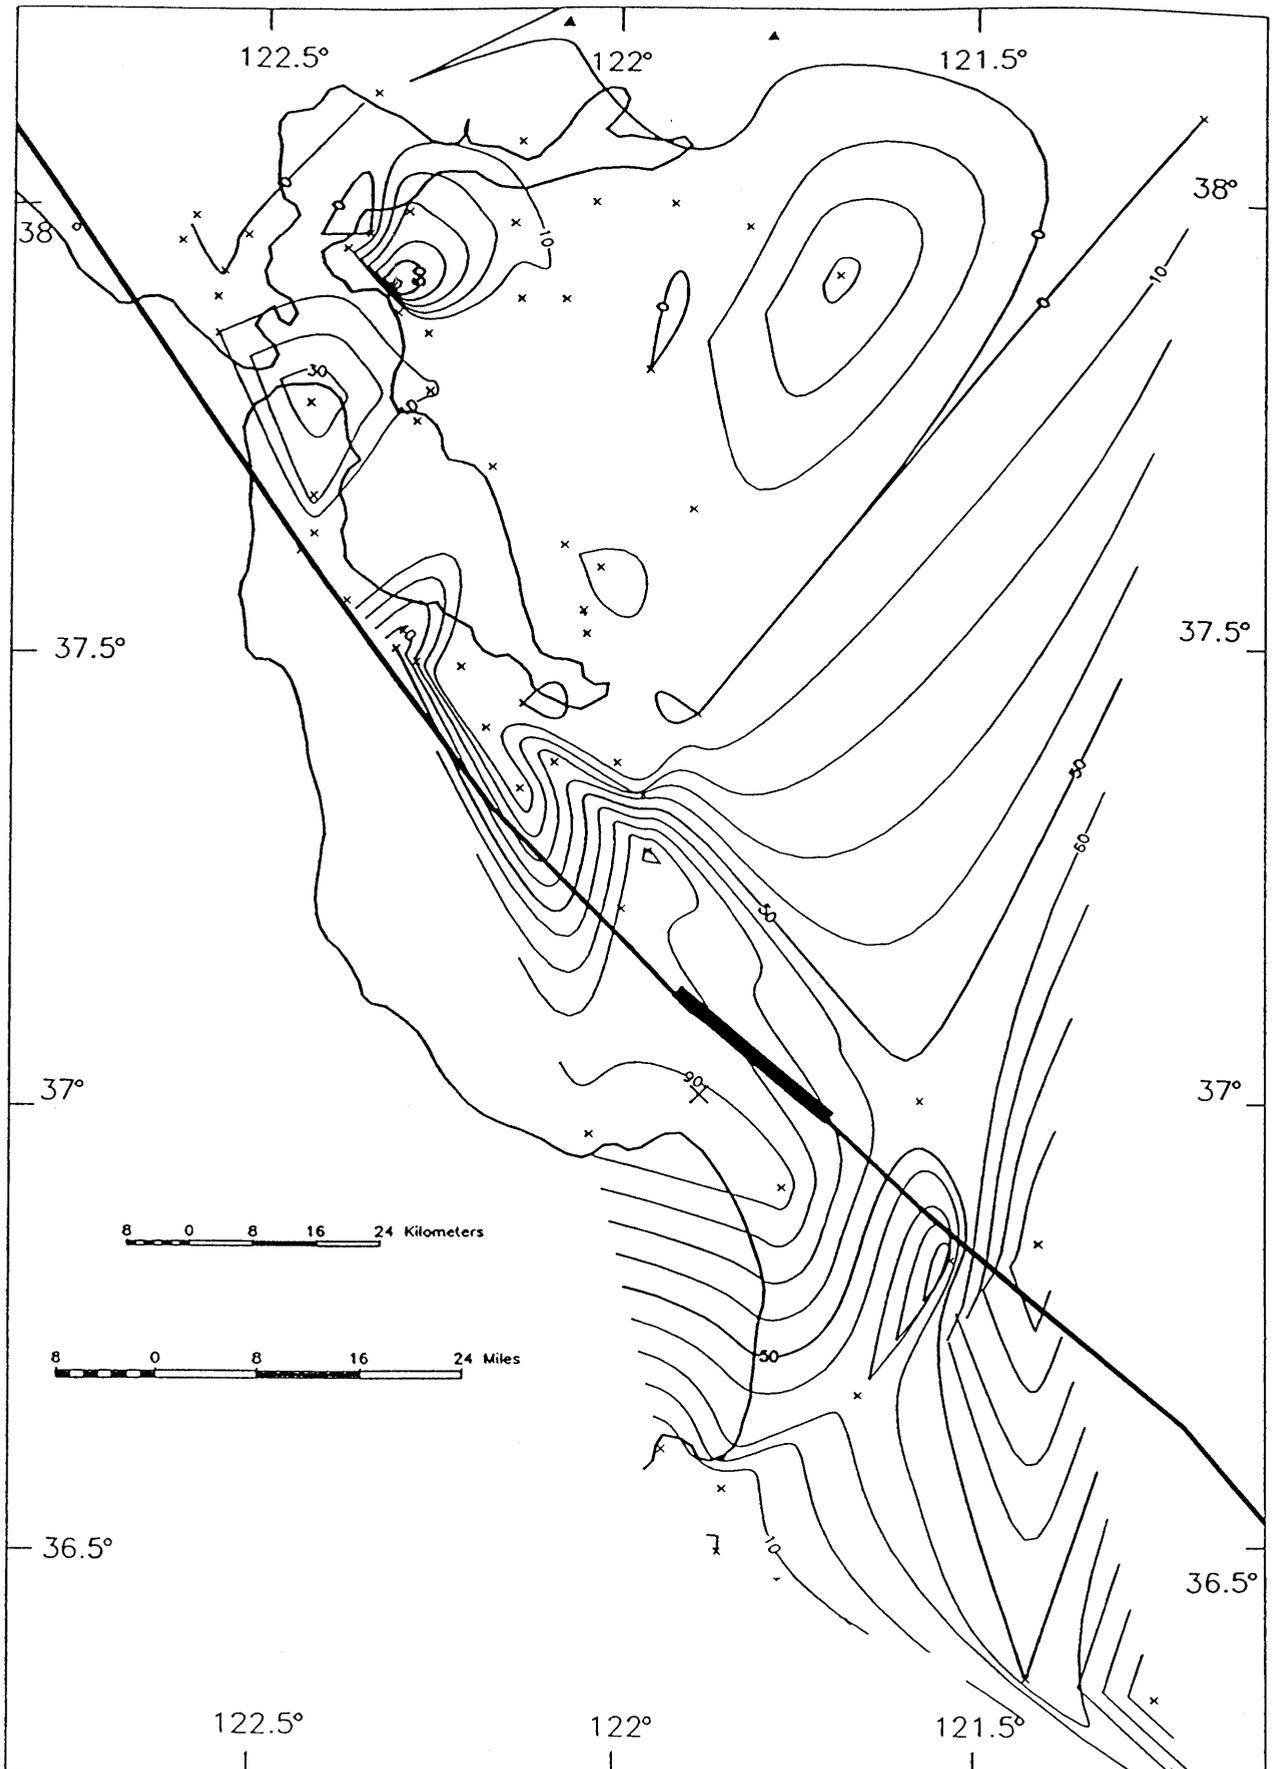
Figure 2.— Contour percentages of total URM buildings which were damaged (cities with four or more total buildings)

The collected data have been categorized into three levels of quality. The lowest level, Level 1, has data from 113 communities in the nine-county Bay Area—a region which easily encompasses the modified Mercalli intensity (MMI)=VI-VII contour line on the USGS intensity map (U.S. Geological Survey, 1989). These communities are shown in figure 1. Level 1 data have the greatest number of building records, but the information is restricted to “general damage status”—the number of damaged, vacated, and demolished buildings in each community. In these nine counties, there were at least 4,824 unstrengthened URM bearing wall buildings, of which at least 758 were damaged. Of those damaged, at least 384 were vacated, and of those vacated, at least 54 were demolished. Using data from the 78 communities with four or more URM buildings, we have generated geographic contour maps showing the percentage of damaged and vacated buildings (figs. 2, 3).

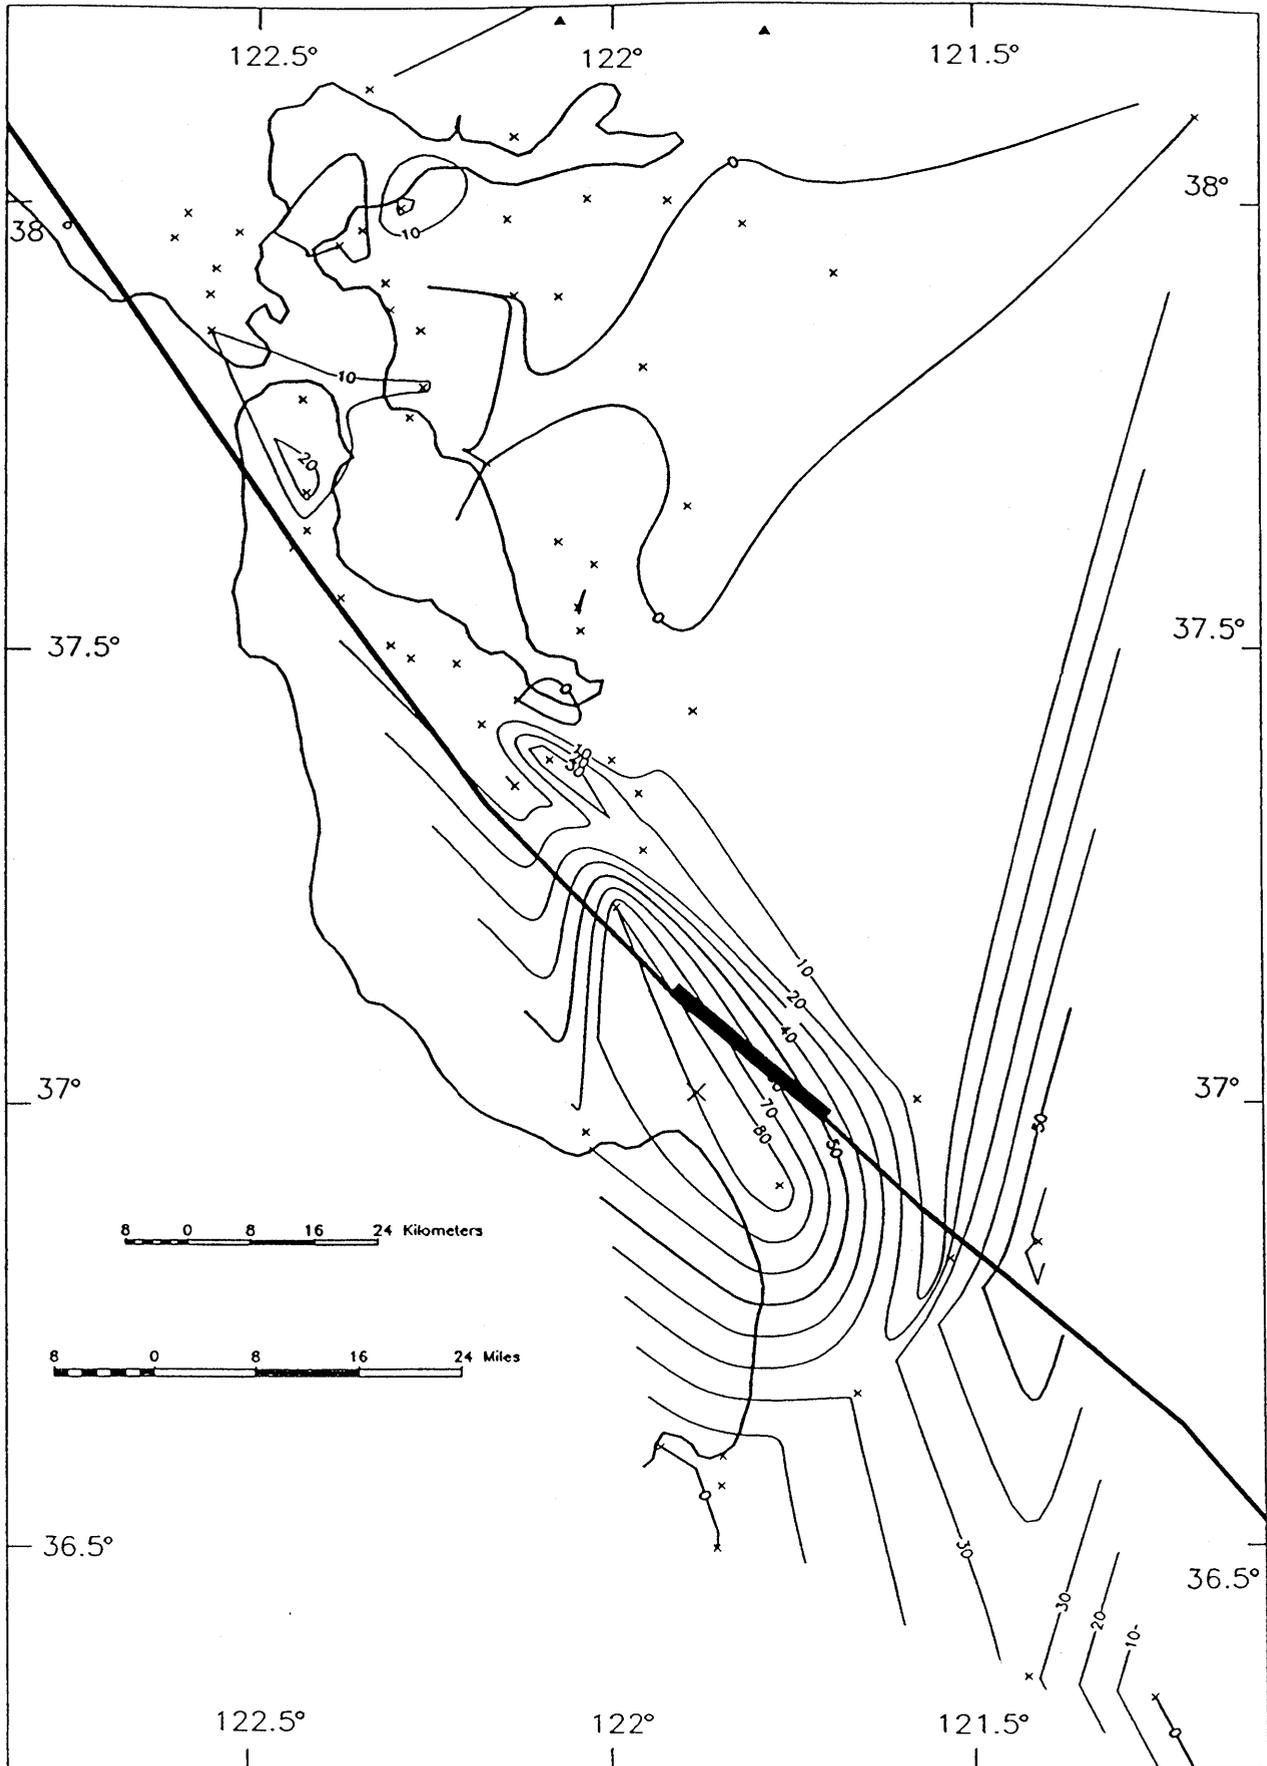
Figure 3.— Contour percentages of total URM buildings which were vacated (cities with four or more total buildings)

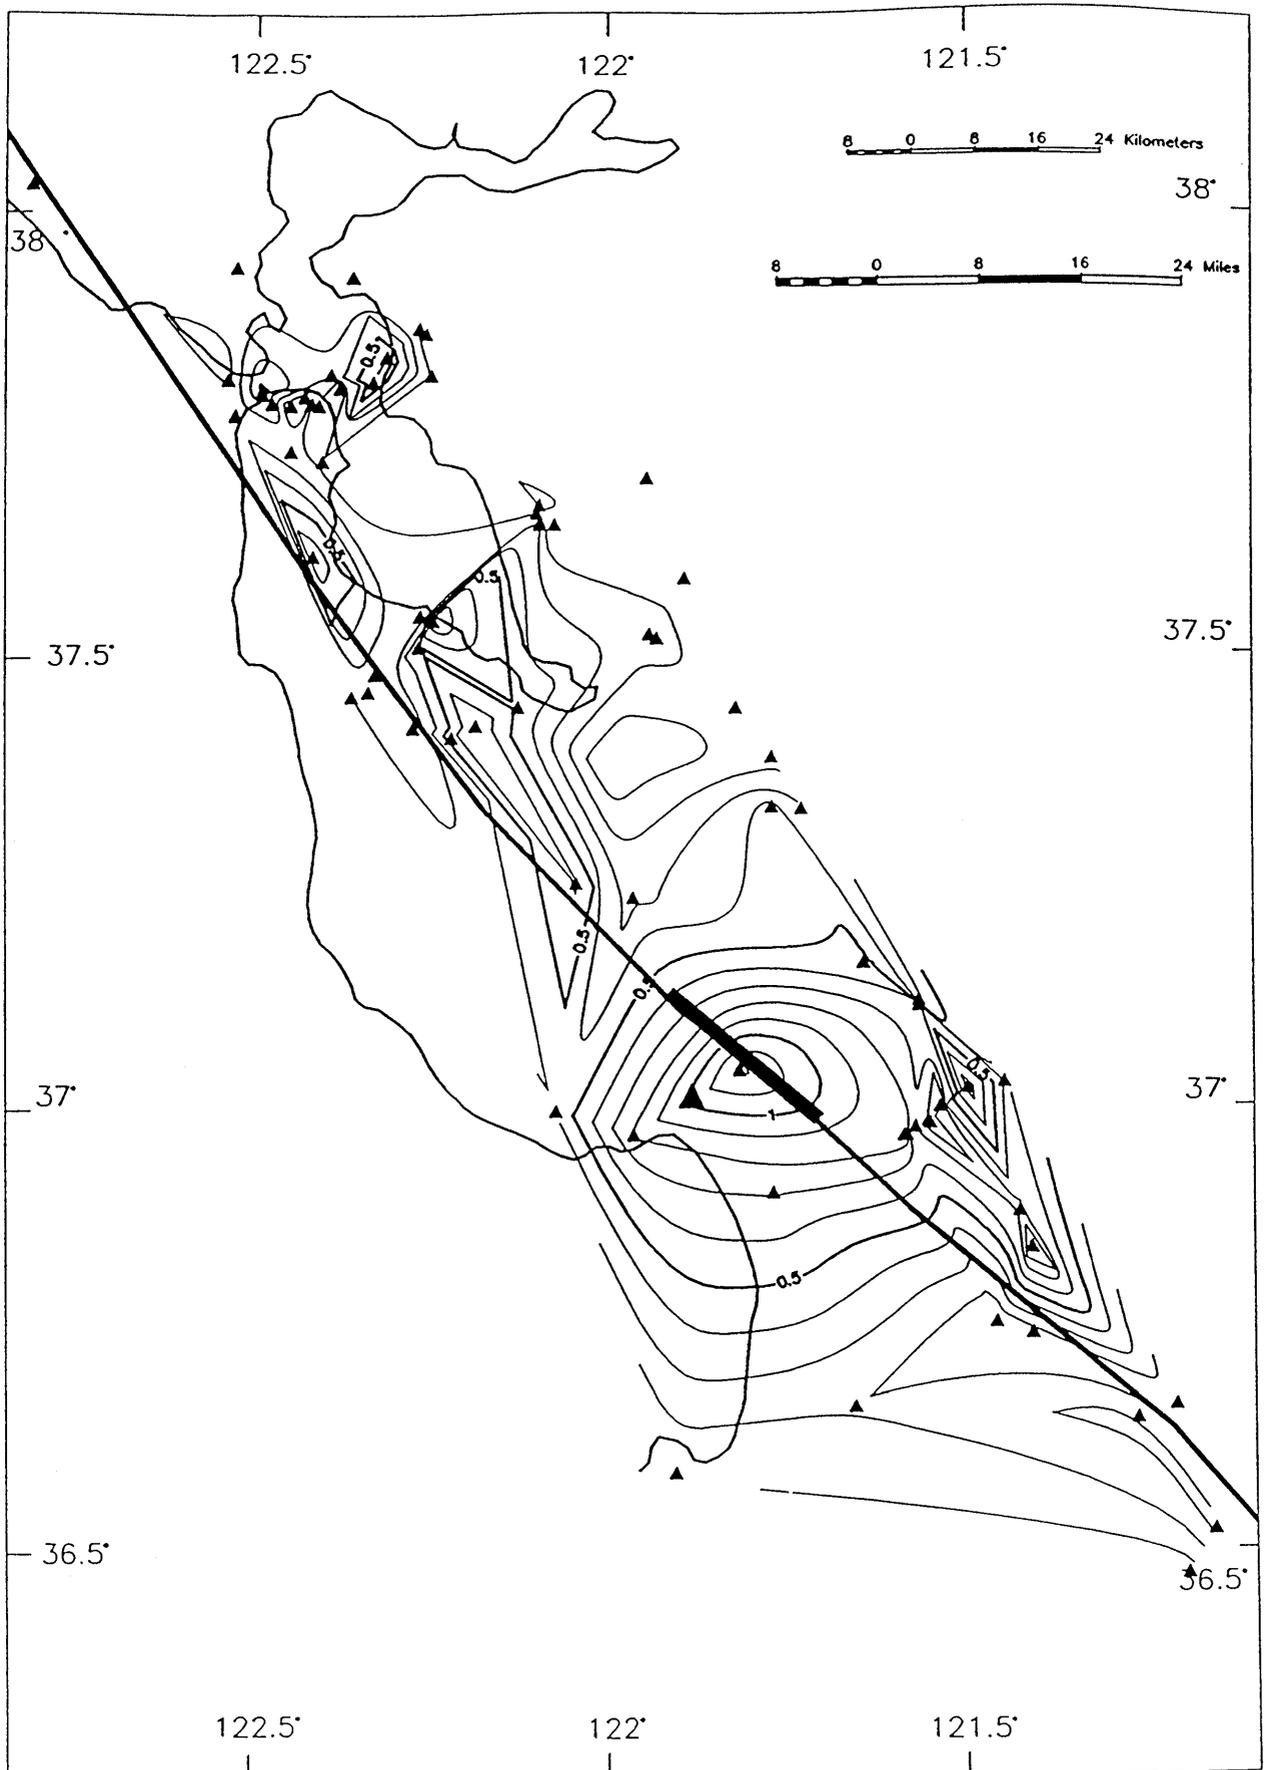
Figure 5.—Pseudospectral acceleration (T=0.5 s)—all soil types
