The Loma Prieta, California, Earthquake of October 17, 1989—Building Structures

U.S. GEOLOGICAL SURVEY PROFESSIONAL PAPER 1552-C

BUILDING STRUCTURES

INTRODUCTION

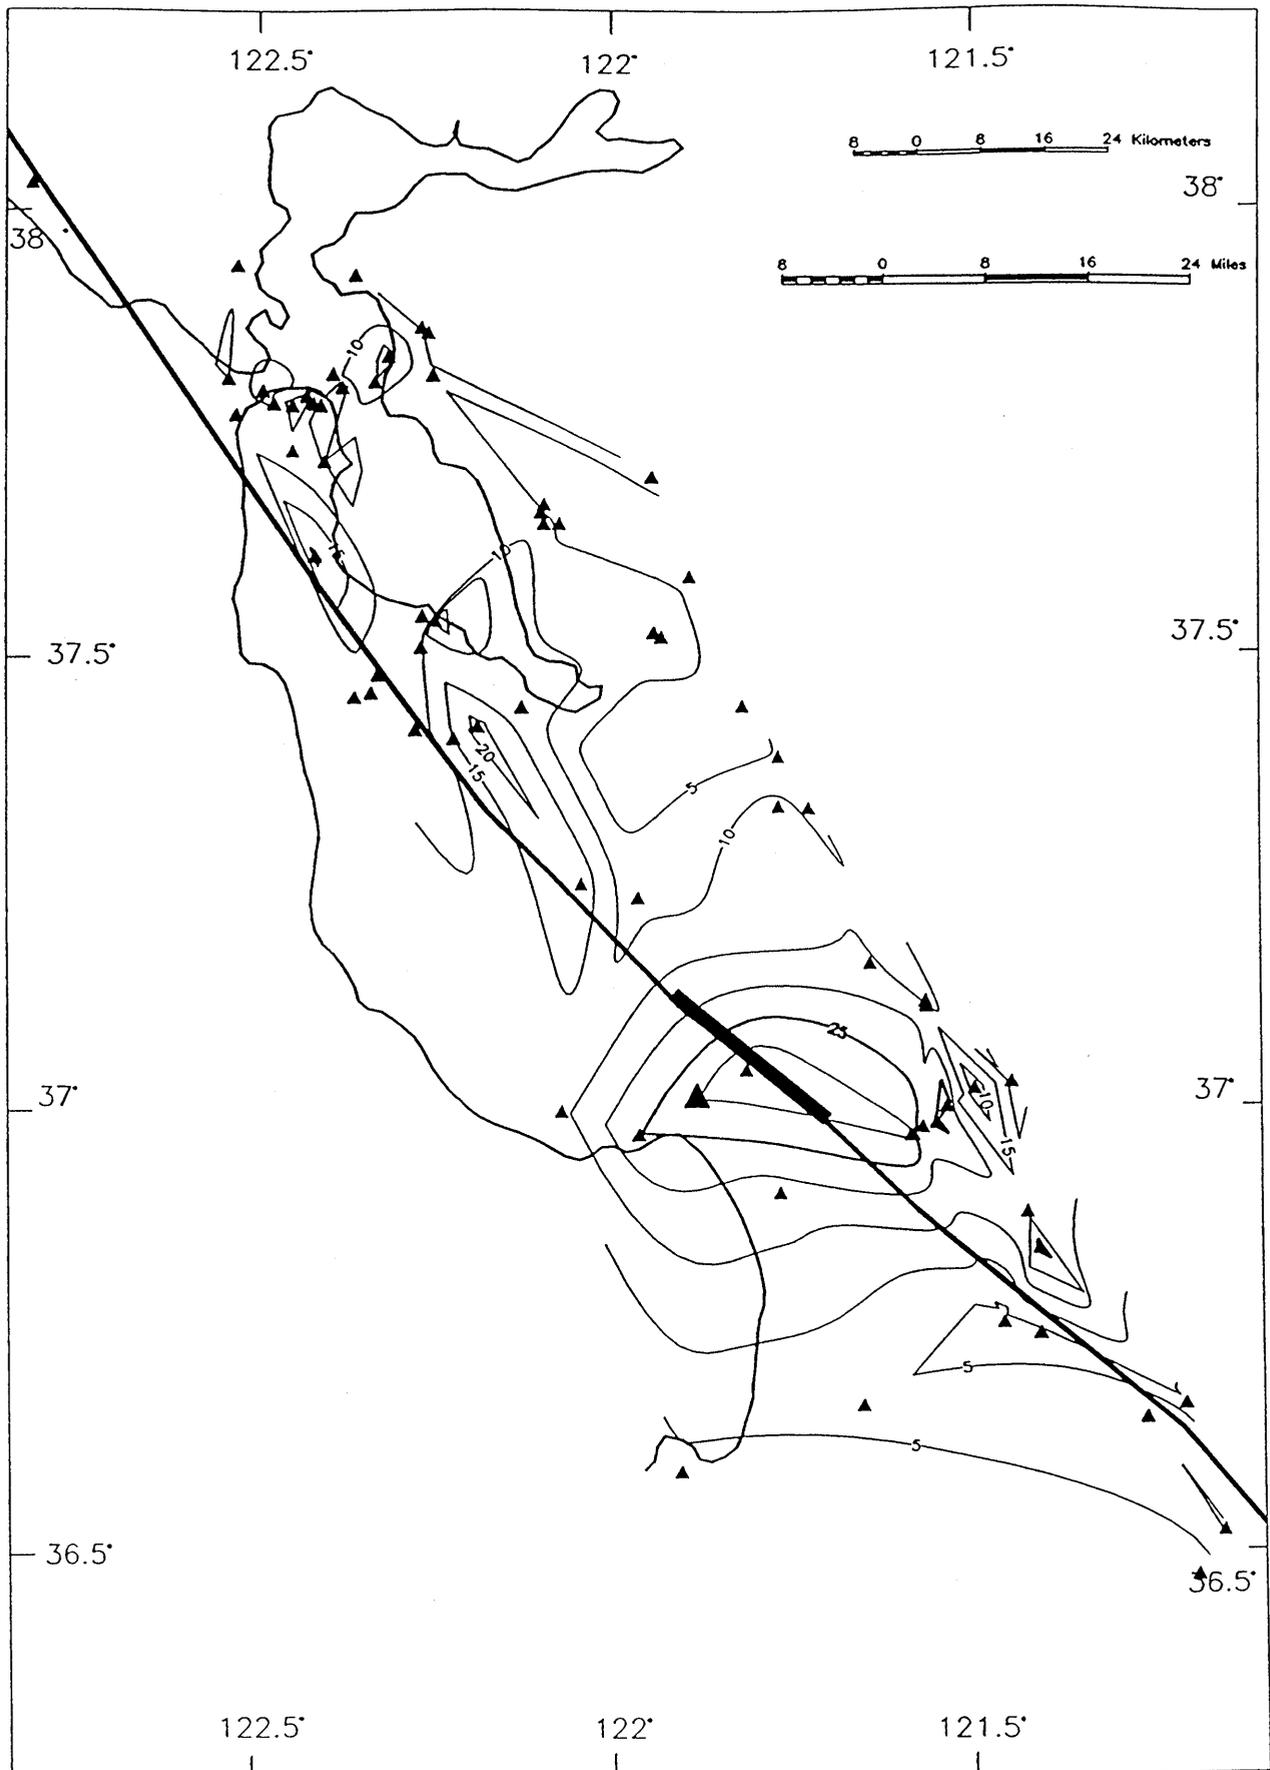
Figure 6.—Pseudospectral velocity (T=0.5 s)—all soil types

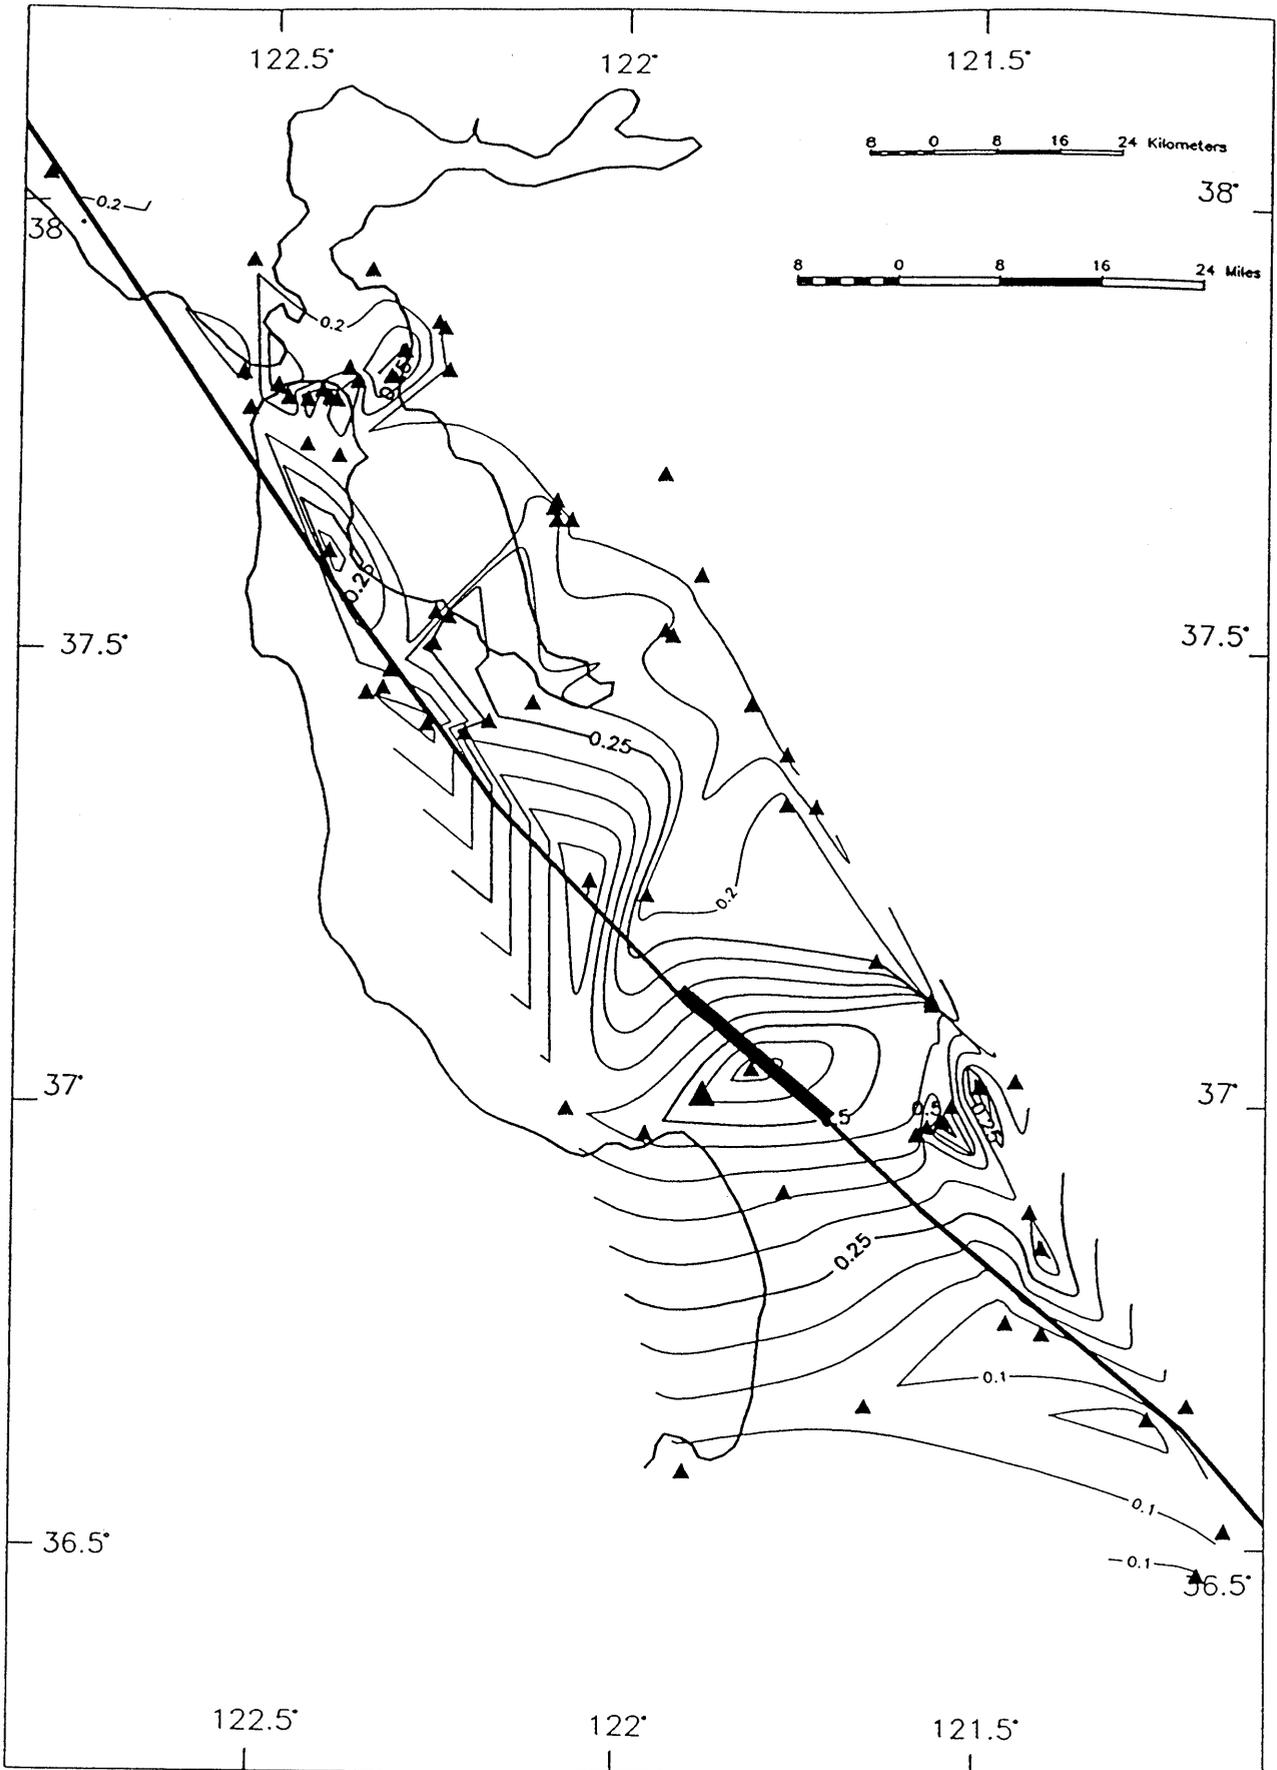
Figure 7.—Maximum horizontal acceleration—all soil types

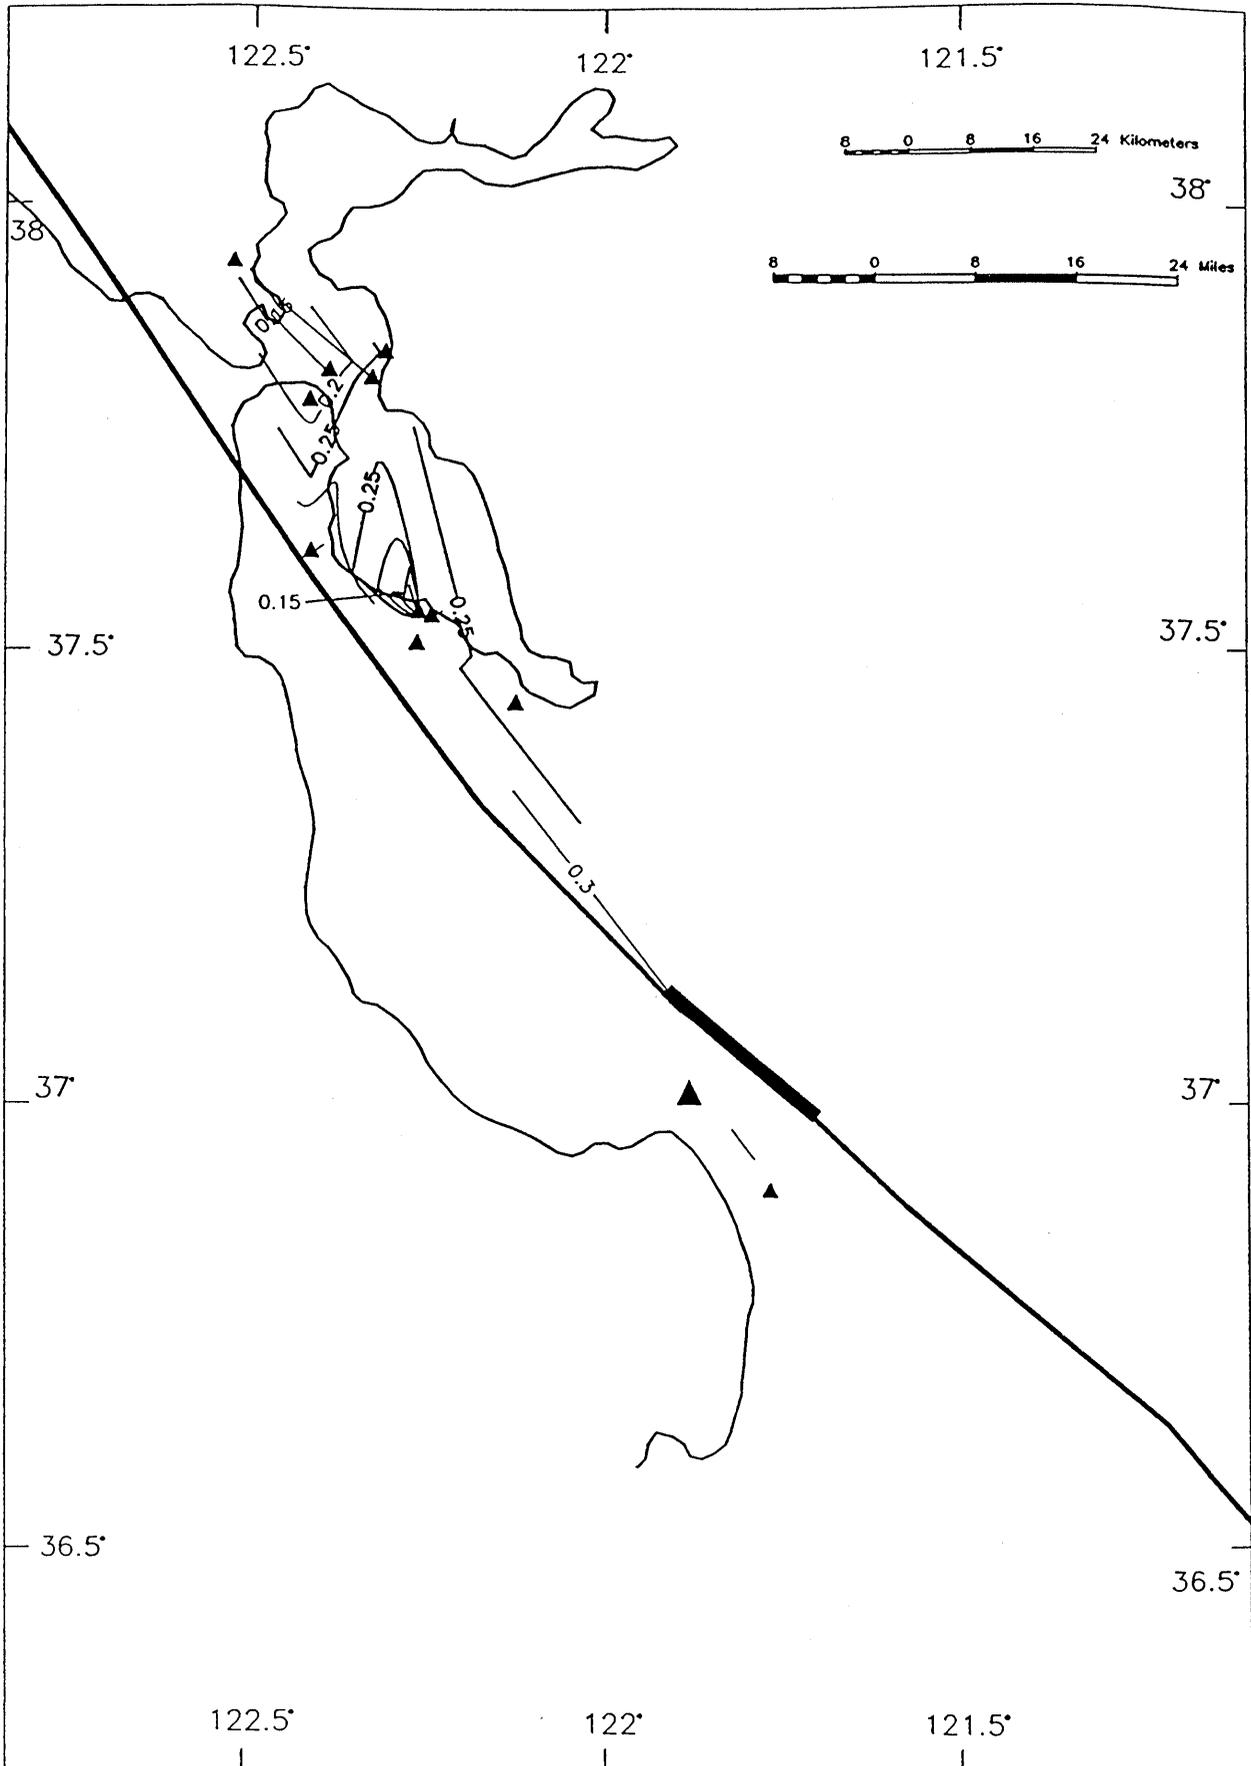
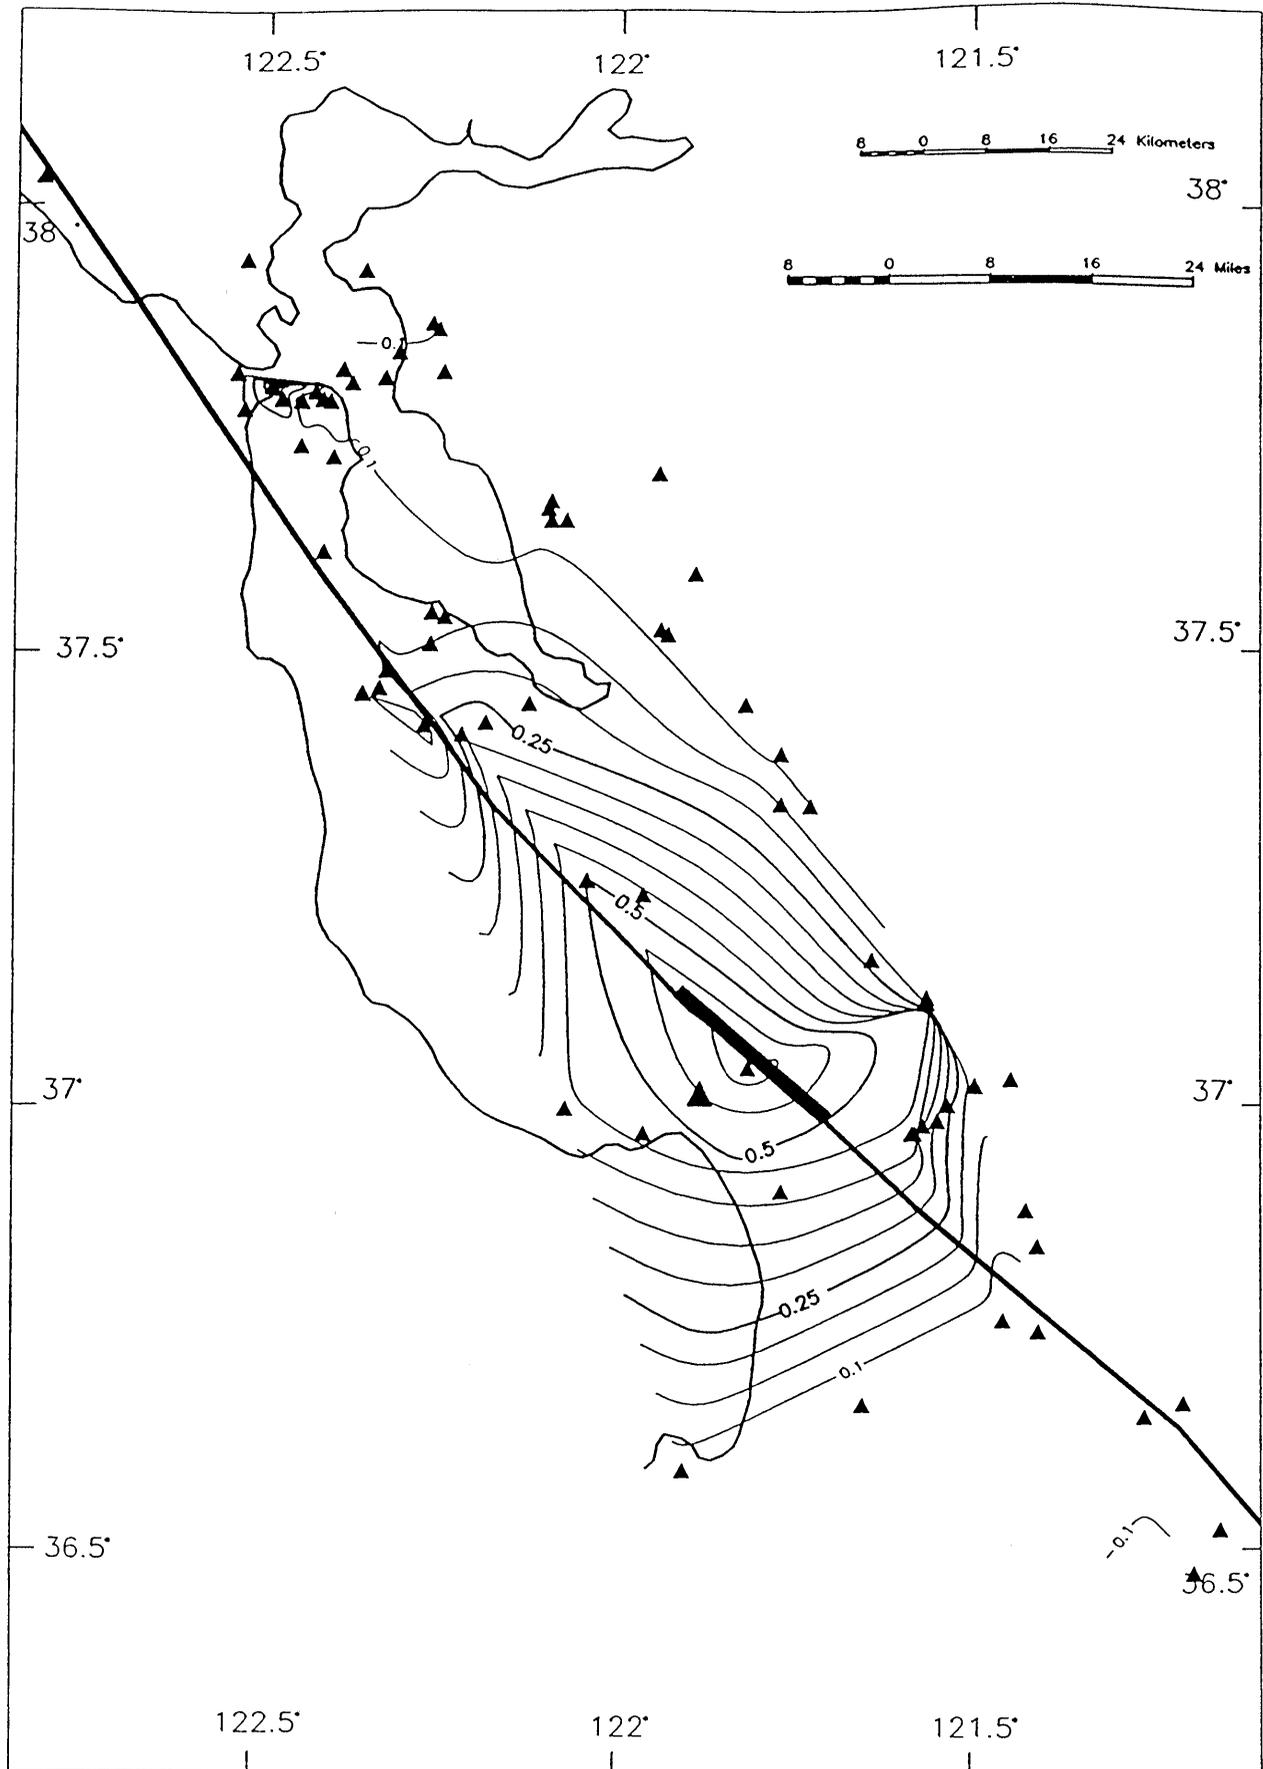
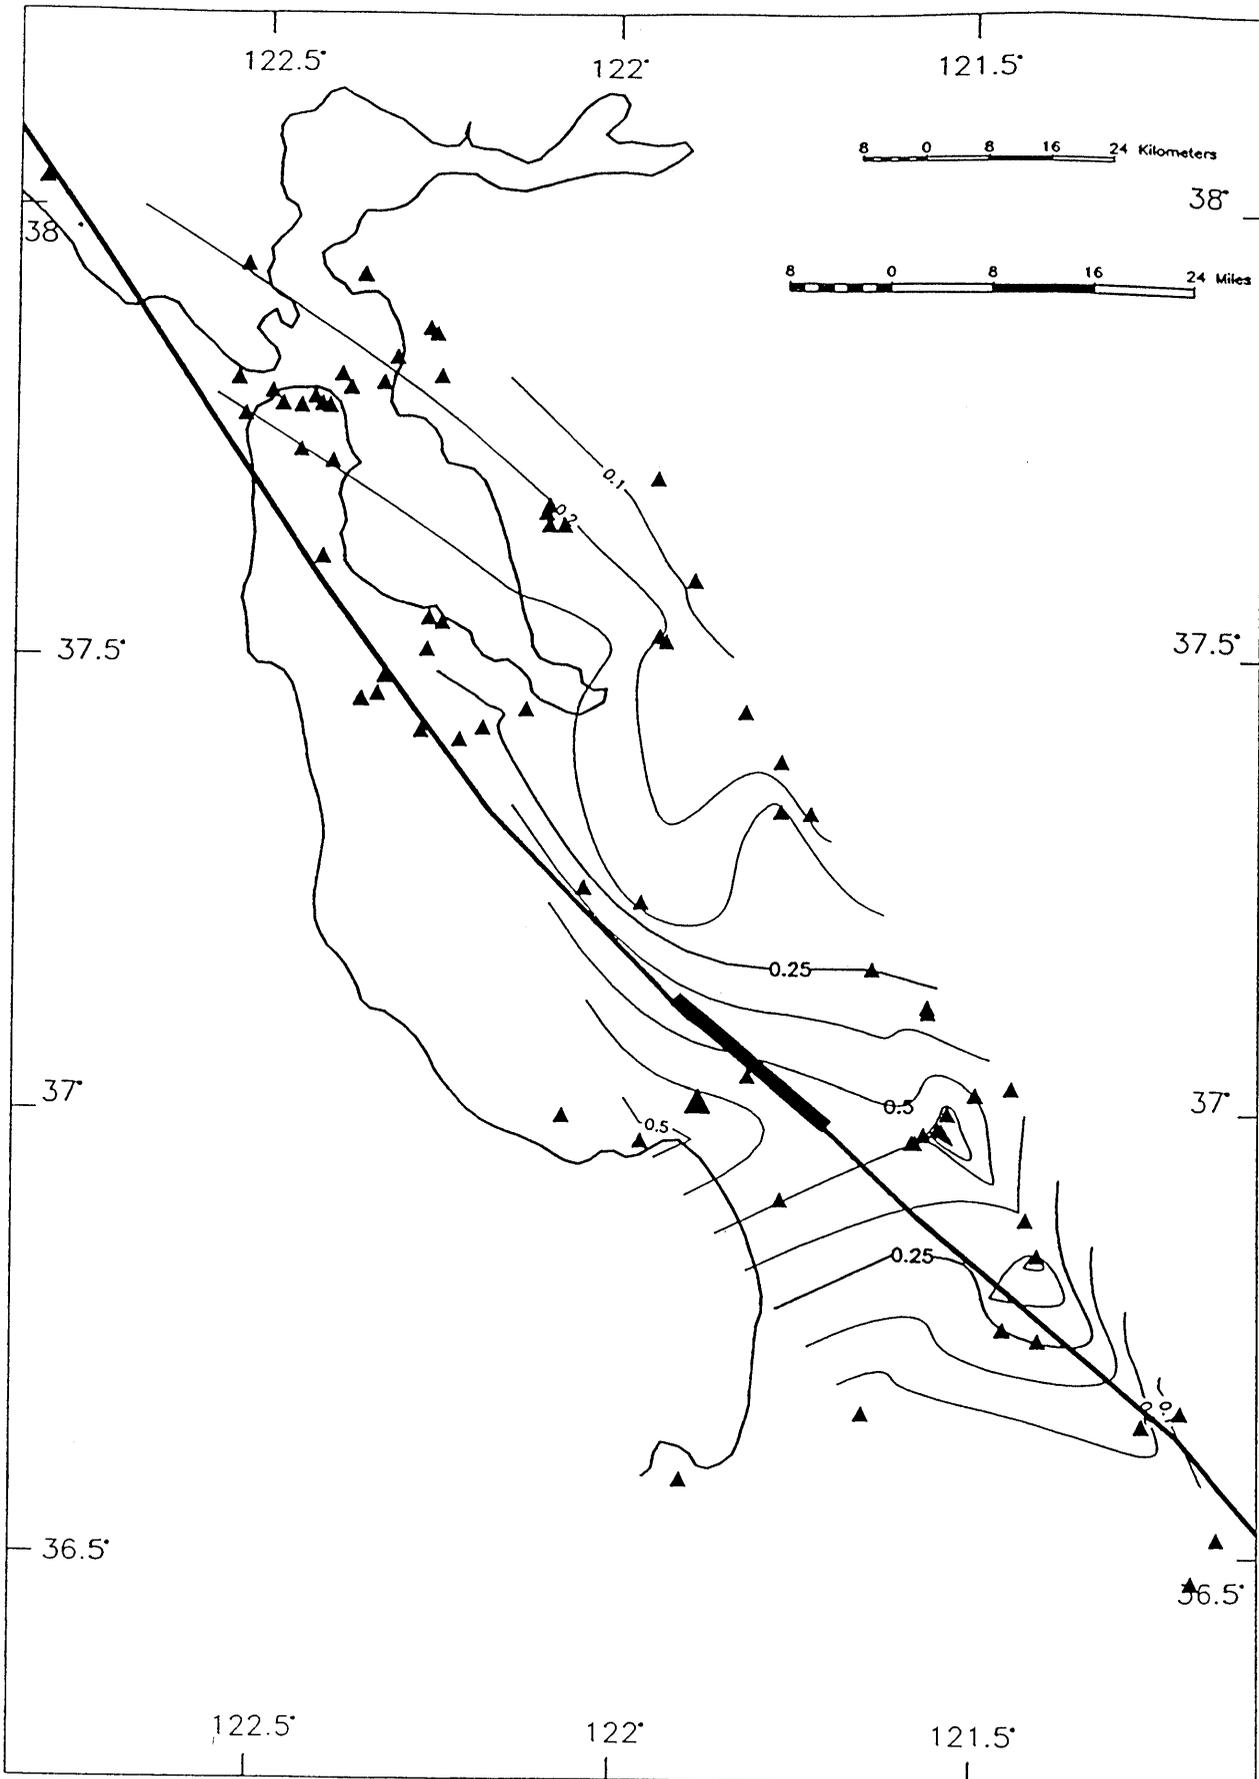
Figure 8.—Maximum horizontal acceleration—Soil Type 1

Figure 9.—Maximum horizontal acceleration—Soil Type 2

Figure 10.—Maximum horizontal acceleration—Soil Type 3

Geological Survey free-field strong motion recordings have been correlated with observed damage patterns. These measures include the maxima and mean of horizontal and vertical components of acceleration, velocity, pseudospectral acceleration and pseudospectral velocity, "frequency" (defined as the number of zero crossings in the acceleration record), bracketed duration, Arias Intensity, the "destructiveness potential factor" of Araya and Saragoni (1985), and the number of horizontal acceleration peaks over 0.10 g and the sum of those excursions. Selected strong motion stations are shown in figure 4. Several different correlation techniques were used. The first technique was a visual comparison of the building damage contour maps (figs. 2, 3) with similar maps of the various ground motion parameters. Pseudospectral acceleration (SPA) and pseudospectral velocity (SPV) maps at a 0.5-s period were found to provide potentially the best match with the damage maps. They are shown in figures 5 and 6. Figure 7 shows the maxima of the two horizontal acceleration records (AHMAX) plot when all soil types are included. Strong motion stations were, in fact, assigned to three different site soil types. Soil Types 1 and 2 correspond to 1991 UBC categories. Soil Type 3 is a combination of UBC categories 3 and 4 since there are so few records for these soft soil sites. Comparison of plots of ground motion instruments from one soil type with another clearly shows the impact of surficial soils in influencing the recorded ground motion. See figures 8, 9, and 10 for the influence on AHMAX.

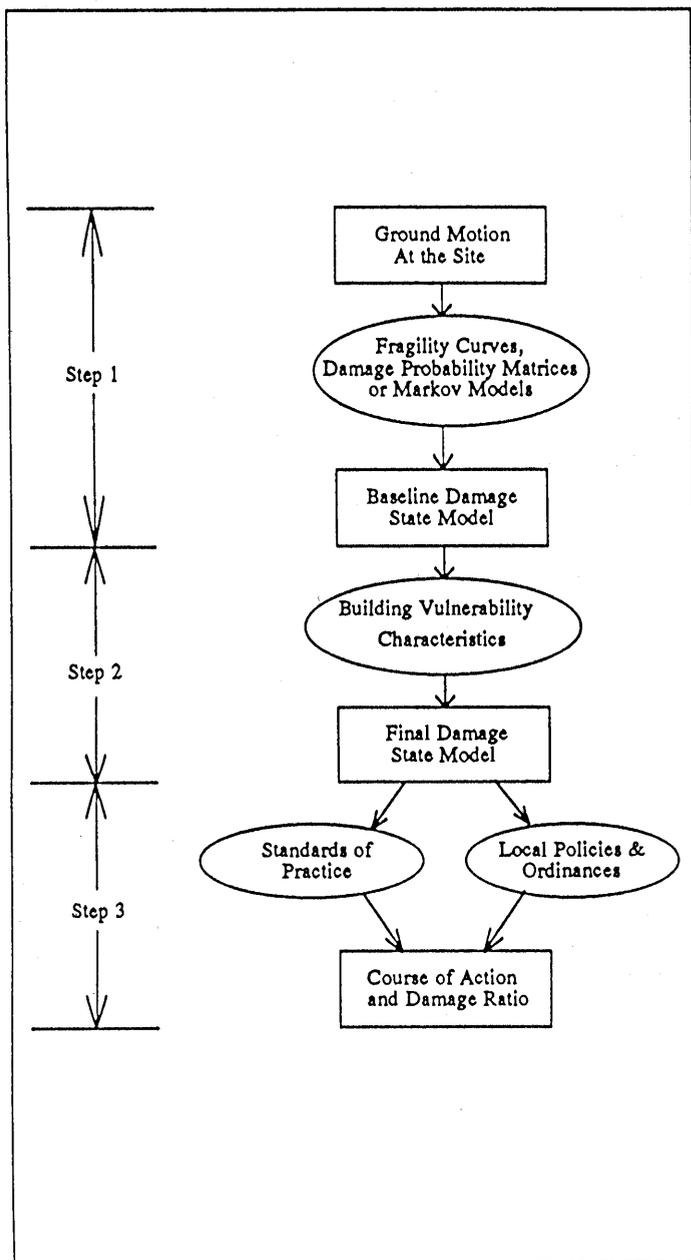
Figure 11.—Proposed loss estimation model

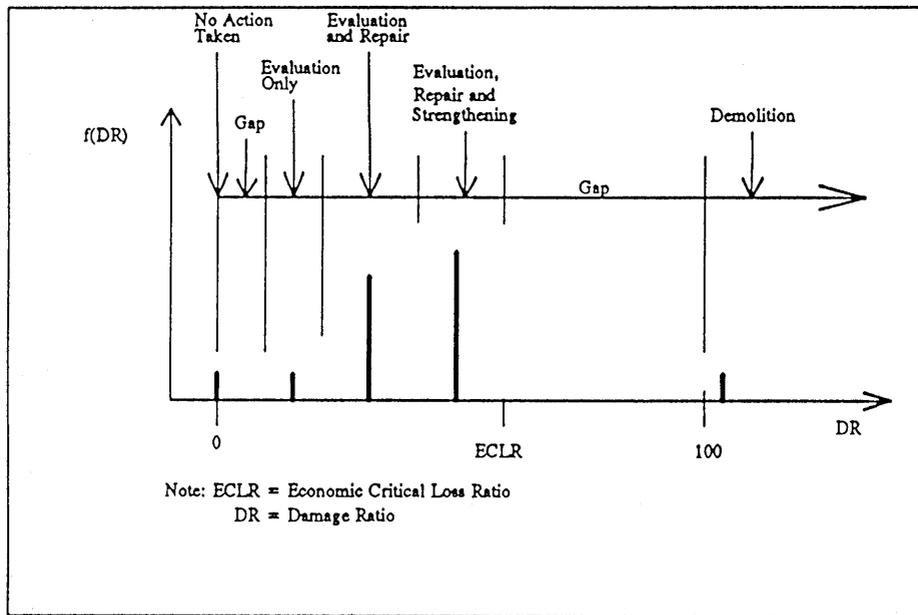
Figure 12.—Probability mass function for a given damage state

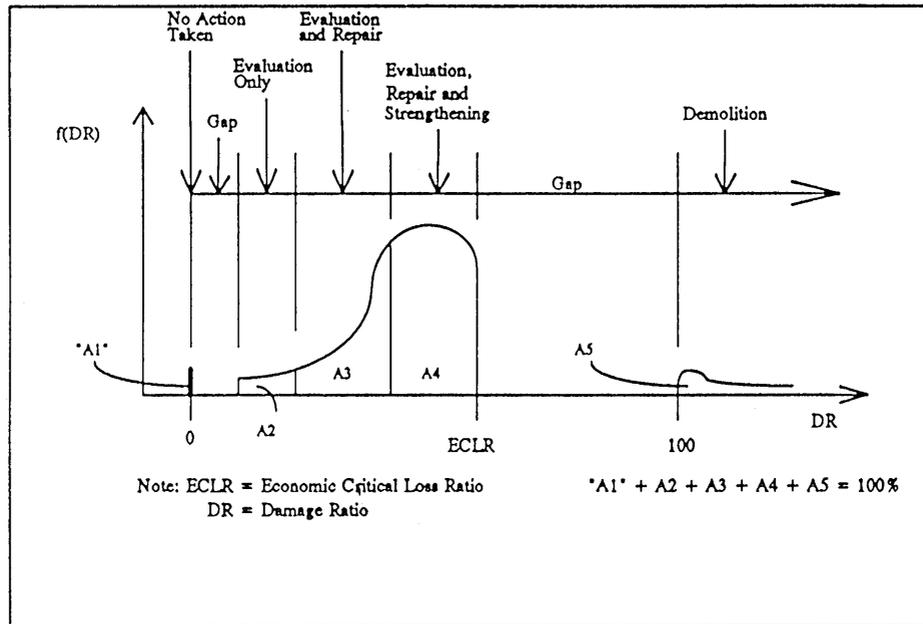
Figure 13.—Probability density function (with discrete component at DR=0%) for a given damage state

One of the key concepts shown in tables 7 and 8 and observed following the Loma Prieta earthquake is that when the cost of strengthening a damaged building rises to a certain level—what we call here the economic critical loss ratio (ECLR)—then an owner will choose not to repair and strengthen the building. The building may lie vacant for a long period of time, or it may be demolished and replaced. Little effort has been applied to determining the ECLR, but Rutherford & Chekene (1990) used 40 percent. Regardless of the exact value, it will certainly be much less than 100 percent. Using the ECLR concept, we can represent the resulting probability mass and density functions (PMF and PDF) for a selected damage state. Figure 12 is a PMF representation where each course of action in tables 7 and 8 is given a discrete damage ratio. Figure 13 smooths out the nonzero portion of the damage ratios into a PDF to provide a range of damage ratios for each course of action. Note the gap between the ECLR and 100 percent. A similar gap between 0 percent and the "Evaluation Only" line occurs because even the most minimal evaluation by a consulting engineer has a nonzero cost. Figures 12 and 13 apply only to a single building and are expected in an actual loss estimate to be aggregated across the total population of buildings, resulting in a smoothed, nonzero PDF measuring "average" damage for the population.

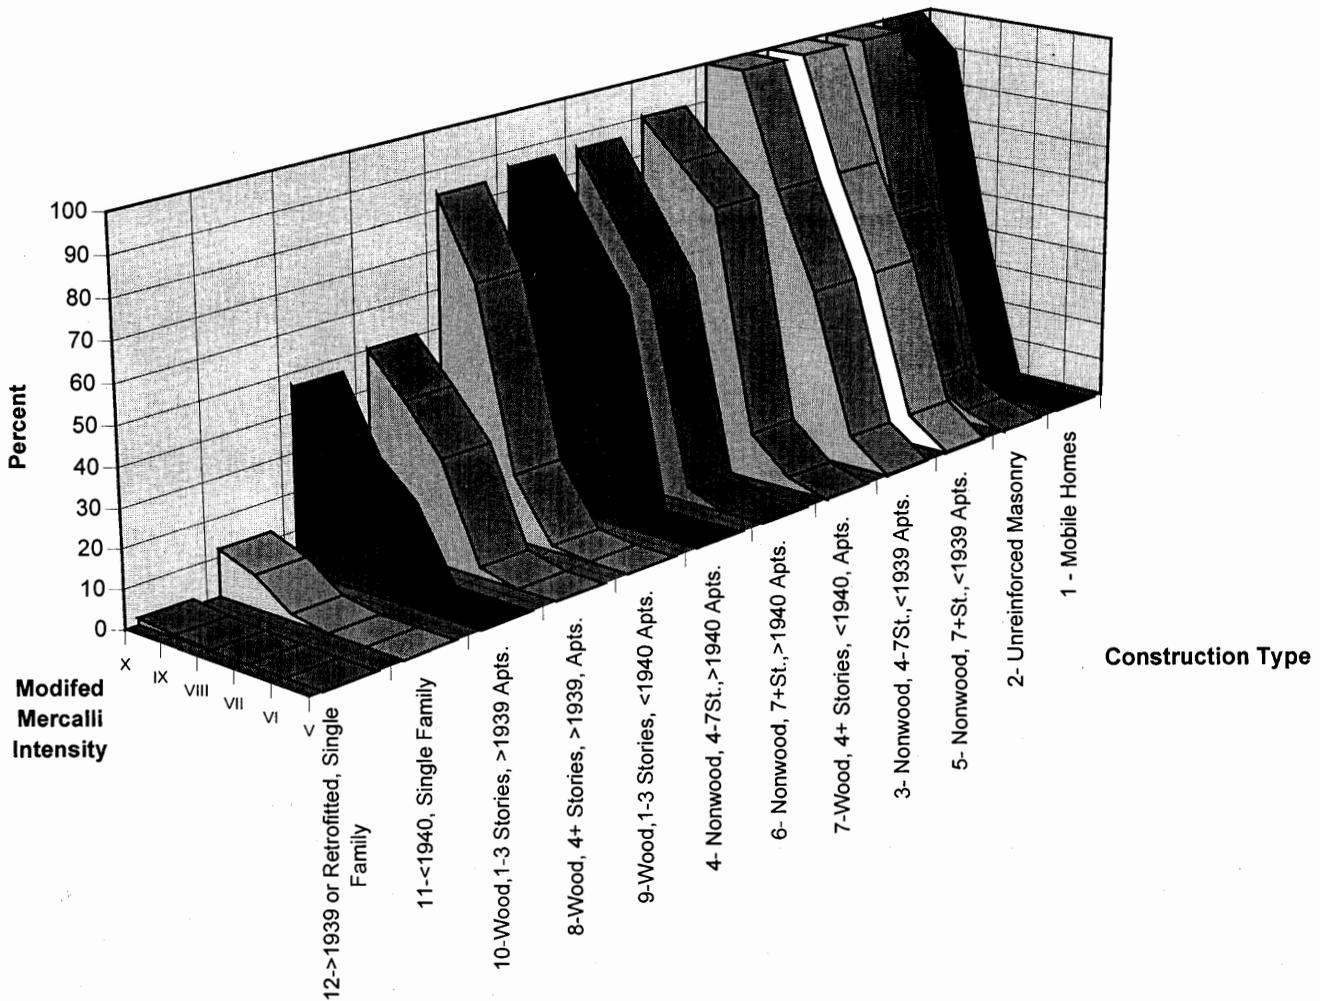
Figure 2.—Result of analysis and comparison of percentages of units rendered uninhabitable, by construction type, obtained by summing the percents in tables 7 and 8.
