GEOLOGICAL SURVEY CIRCULAR 691-A, B

The Van Norman Reservoirs Area, Northern San Fernando Valley, California

Geologic Environment of the
Van Norman Reservoirs Area

Expectable Earthquakes and
Their Ground Motions in the
Van Norman Reservoirs Area

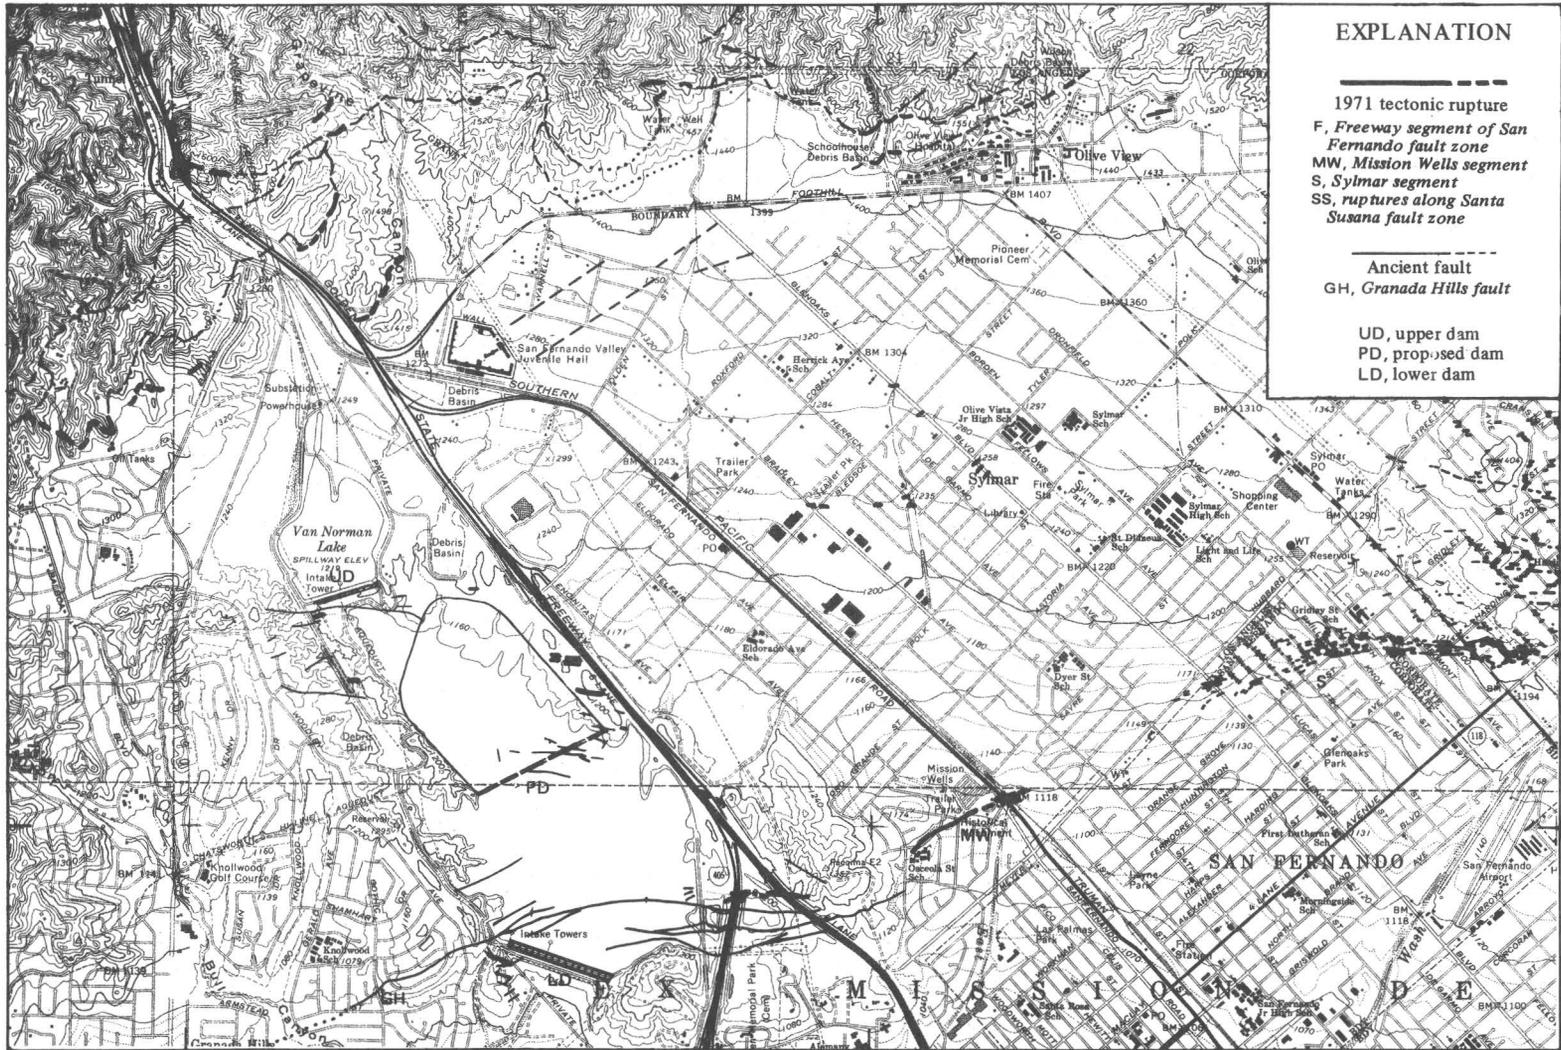
FIGURE 3.—Northern San Fernando Valley showing 1971 ruptures and ancient faults.

1971 tectonic rupture
 F, Freeway segment of San Fernando fault zone
 MW, Mission Wells segment
 S, Sylmar segment
 SS, ruptures along Santa Susana fault zone

Immediately north of the lower dam, the south limb of the syncline intersects the east-trending zone of generally north-dipping faults that extends westward along the trend of the San Fernando zone. This zone includes an element of the Granada Hills fault (fig. 3) which extends westward from immediately west of the lower dam within the Sunshine Ranch Member. East of the lower dam, faults of the zone form boundaries of the stratigraphic units. The faults generally dip northward subparallel to stratification in the bedrock, and the compressive nature of the faulting has locally caused overturning of the bedrock and greatly decreased the exposed thickness of the bedrock units. The westernmost (Freeway) segment of the main zone of 1971 tectonic ruptures is about 1,200 feet (360 m) long and parallels the zone of older faults immediately east of the lower reservoir. The 1971 displacement on this segment and on the San Fernando zone in general was left-oblique-reverse, which is compatible with north-south compressive deformation. The similarity in attitude and compressive nature of deformation along the older faults suggests that movement on them was similar to that of 1971.
